## 4. Watershed Restoration Strategies

#### **4.1 Watershed Project Descriptions**

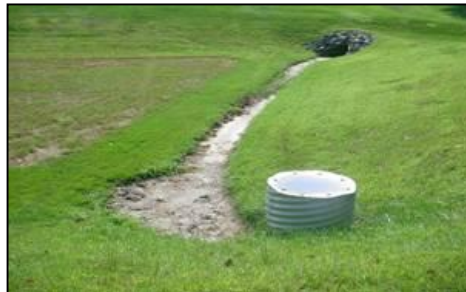
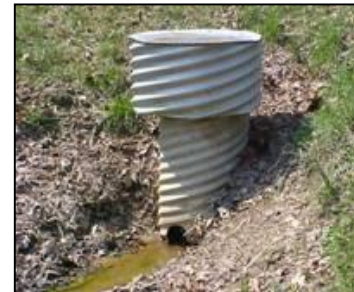
#### PRE-CONSTRUCTION

**Problematic Conditions:** Stormwater Pond was non-functional due to deterioration of control structures and depleted storage volume.

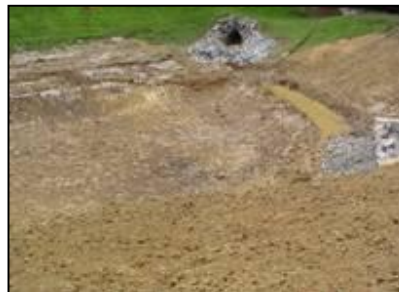
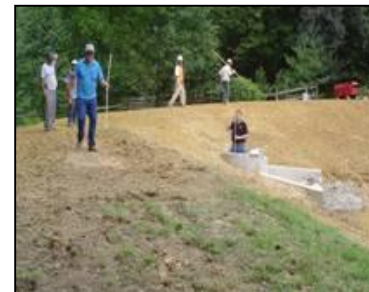
#### CONSTRUCTION

**Key Project Elements:** The height of the dam was increased, new control structures were installed, and a marsh was excavated in the pond floor.

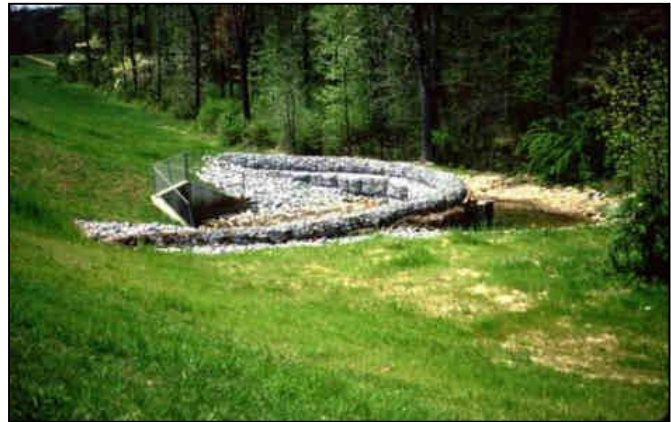
### Culvert Retrofit Example:

There are two types of culvert retrofits: one to modify the culvert to address the culvert capacity and road flooding, and another to retrofit the upstream side of the culvert to provide stormwater management. This stormwater retrofit option is installed upstream from existing road culverts by constructing a control structure and excavating a micropool. These projects are designed for intermittent or ephemeral streams. The control structure will consist of a gabion weir that will detain and reduce stormwater flow; the micropool is a small pool that allows infiltration of stormwater runoff, improving water quality.

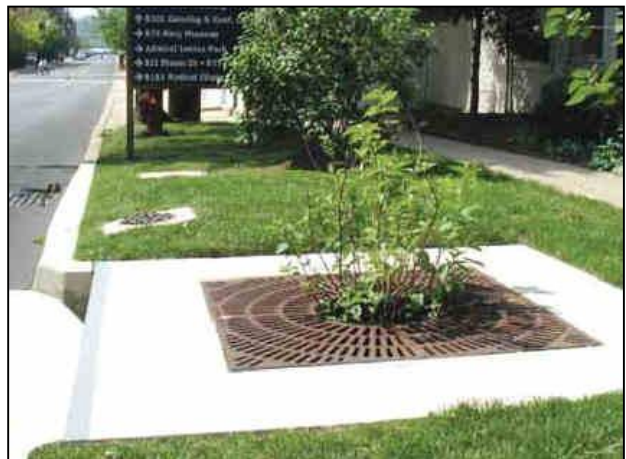
### Tree Box Filter Example:

Tree box filters allow stormwater to flow through a specially designed filter mixture contained in a landscaped concrete container. The mixture immobilizes pollutants; those pollutants are then decomposed, volatilized and incorporated into the biomass of the tree box filter. Stormwater runoff flows through the media and into an underdrain system at the bottom of the container, where the treated water is discharged. They are useful on highly developed sites such as parking lots and streetscapes.

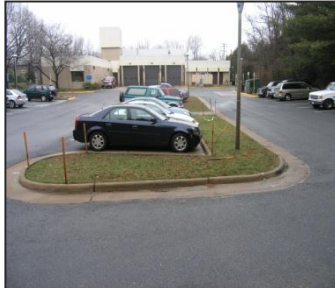
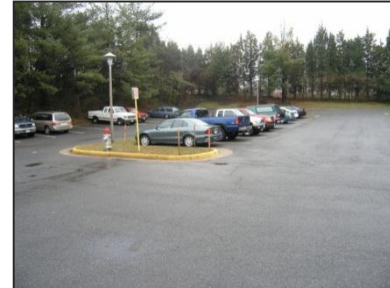
#### PRE-CONSTRUCTION Problematic Conditions:

Stormwater from impervious surfaces lacked quality and quantity treatment. Installation of a rain garden (bioretention basin) provides for water quality treatment and groundwater recharge through infiltration. The porous pavement provides for greater infiltration of runoff.

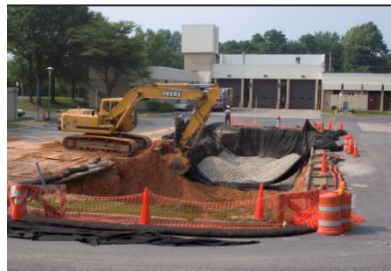
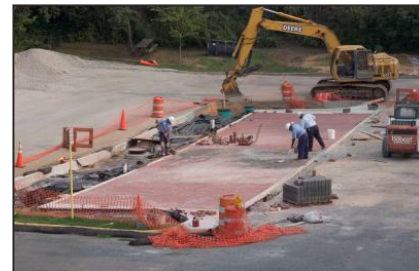
#### CONSTRUCTION

Stormwater runoff is treated by rapid filtering through bioretention soil media, biological and biochemical reactions within the soil matrix and around the root zones of the plants, and infiltration into the underlying soil strata.

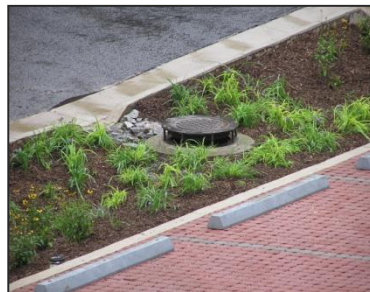
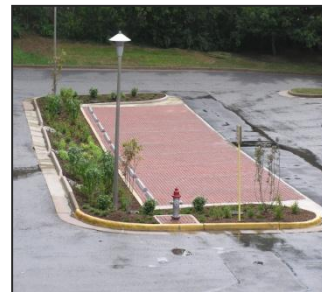
#### POST-CONSTRUCTION

The rain garden was planted with a combination of native trees, shrubs and herbaceous plants that provide nutrient uptake and an aesthetic benefit. The plantings also provide habitat for organisms like birds and butterflies.

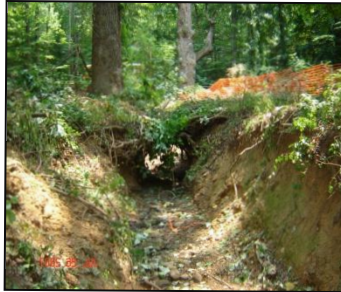
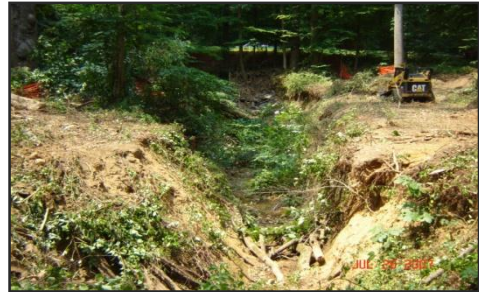
#### PRE-CONSTRUCTION

Large quantities of uncontrolled stormwater caused bank erosion, tree loss and negative impacts to aquatic life.

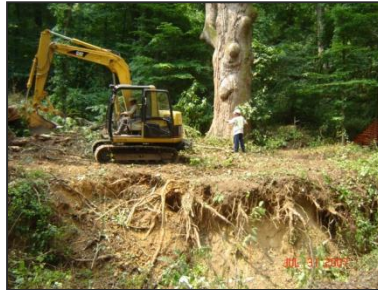
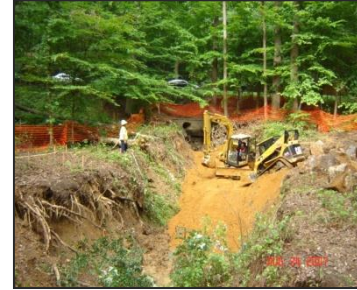
#### CONSTRUCTION

**Key Project Elements:** The eroded stream was filled with suitable material to reconnect the channel to the natural floodplain. The project was designed using “natural stream restoration techniques” which aim at creating habitat for native wildlife.

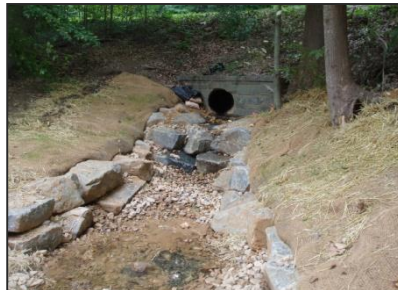
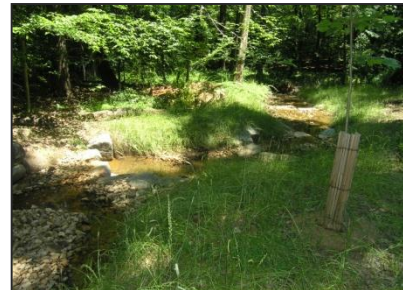
#### POST-CONSTRUCTION

The stream was restored to a more natural design. A riparian seed mix and native trees were planted on impacted areas of the site. Continued monitoring of the vegetation and structures (cross veins, log jams, etc.) will occur. Ideally, aquatic organisms will re-inhabit the restored reach.

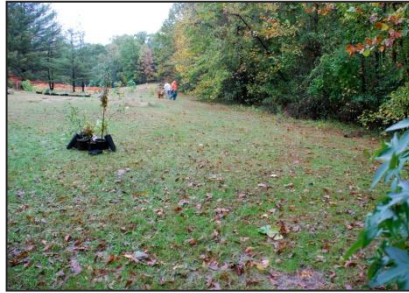
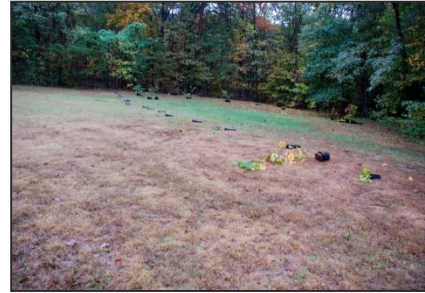
### PRE-CONSTRUCTION

Lack of a native riparian buffer decreases the amount of rain that infiltrates into the groundwater and increases the amount of pollutants that enter our waterways.

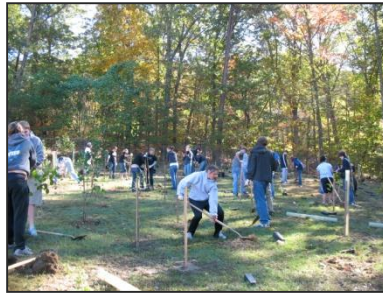
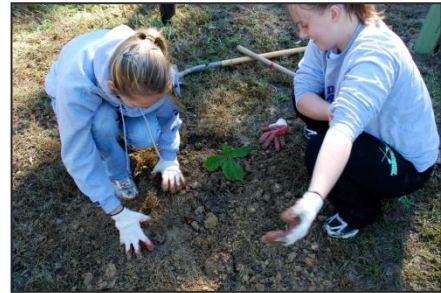
### CONSTRUCTION

Establishing a native riparian buffer will reduce the amount of stormwater entering streams and filter nonpoint source pollutants. Educating residents on the importance of riparian buffers is key to the success of the planting. This site had 1005 trees and shrubs planted by 180 volunteers over two days.

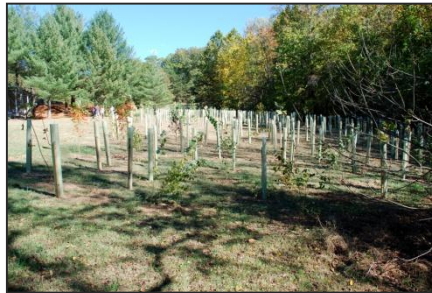
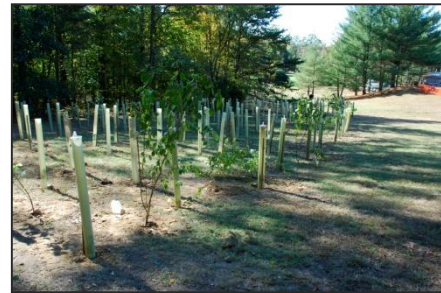
### POST-CONSTRUCTION

Future monitoring and maintenance is required to ensure survival of the plants. When mature, this area will provide a balanced ecosystem that will help reduce stormwater impacts and create habitat for wildlife.
