*Final Report*

# **Fairfax County Stream Physical Assessment**

Prepared for  
**Department of Public Works and  
Environmental Services  
Fairfax County, Virginia**

August 2005

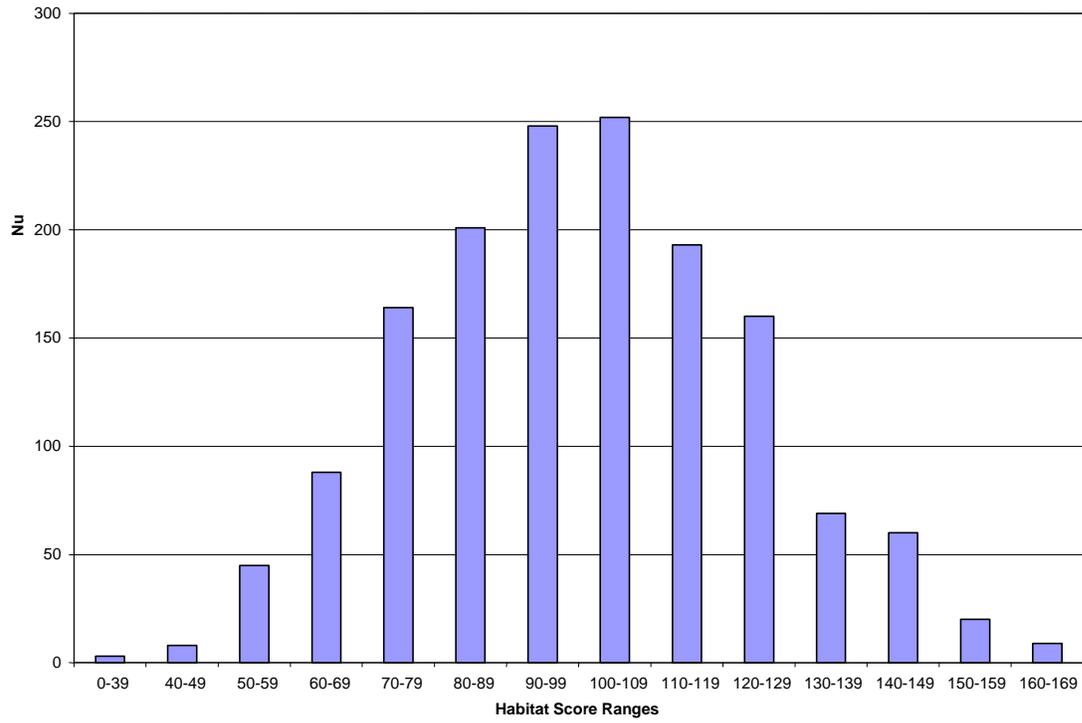
**FIGURE 3-1**  
Distribution of Stream Habitat Scores by Number of Reaches

The habitat assessments yielded scores from 32 to 168, out of a maximum possible score of 200. The mean value of all the scores was 100, while the reach-length-weighted mean was 104. Figure 3-1 shows the distribution of the habitat scores based on score ranges for the reaches. Figure 3-2 shows the distribution of habitat scores based on stream lengths. The data indicate that the habitat and biotic integrity of many of the streams in Fairfax County have been somewhat degraded. There are a few stream reaches in very good condition and several in very poor condition.

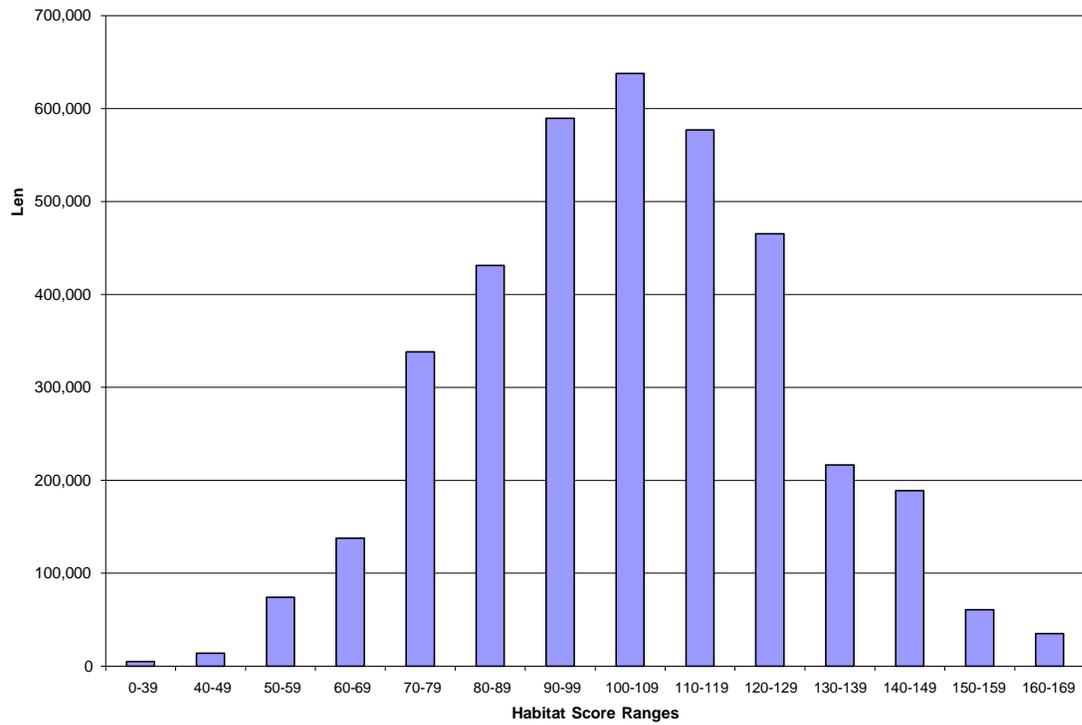
**FIGURE 3-2**  
Distribution of Stream Habitat Scores by Stream Length

In order to allow qualitative interpretations of the habitat assessment results, stream reaches were classified into one of five categories on the basis of total habitat score: excellent, good, fair, poor, and very poor. Three options were considered for categorizing the total habitat score into these categories. Equal partitioning of the data was considered (1) over the theoretical range of 0 to 200, (2) on the basis of USEPA-recommended ranges, and (3) over the range of observed scores. Following discussions with County staff, it was agreed that for consistency with the approach used in the SPS baseline, the third option would be used. The resulting rating category names and score ranges are

- Excellent (142–168)
- Good (114–141)
- Fair (87–113)
- Poor (59–86)
- Very Poor (32–58)

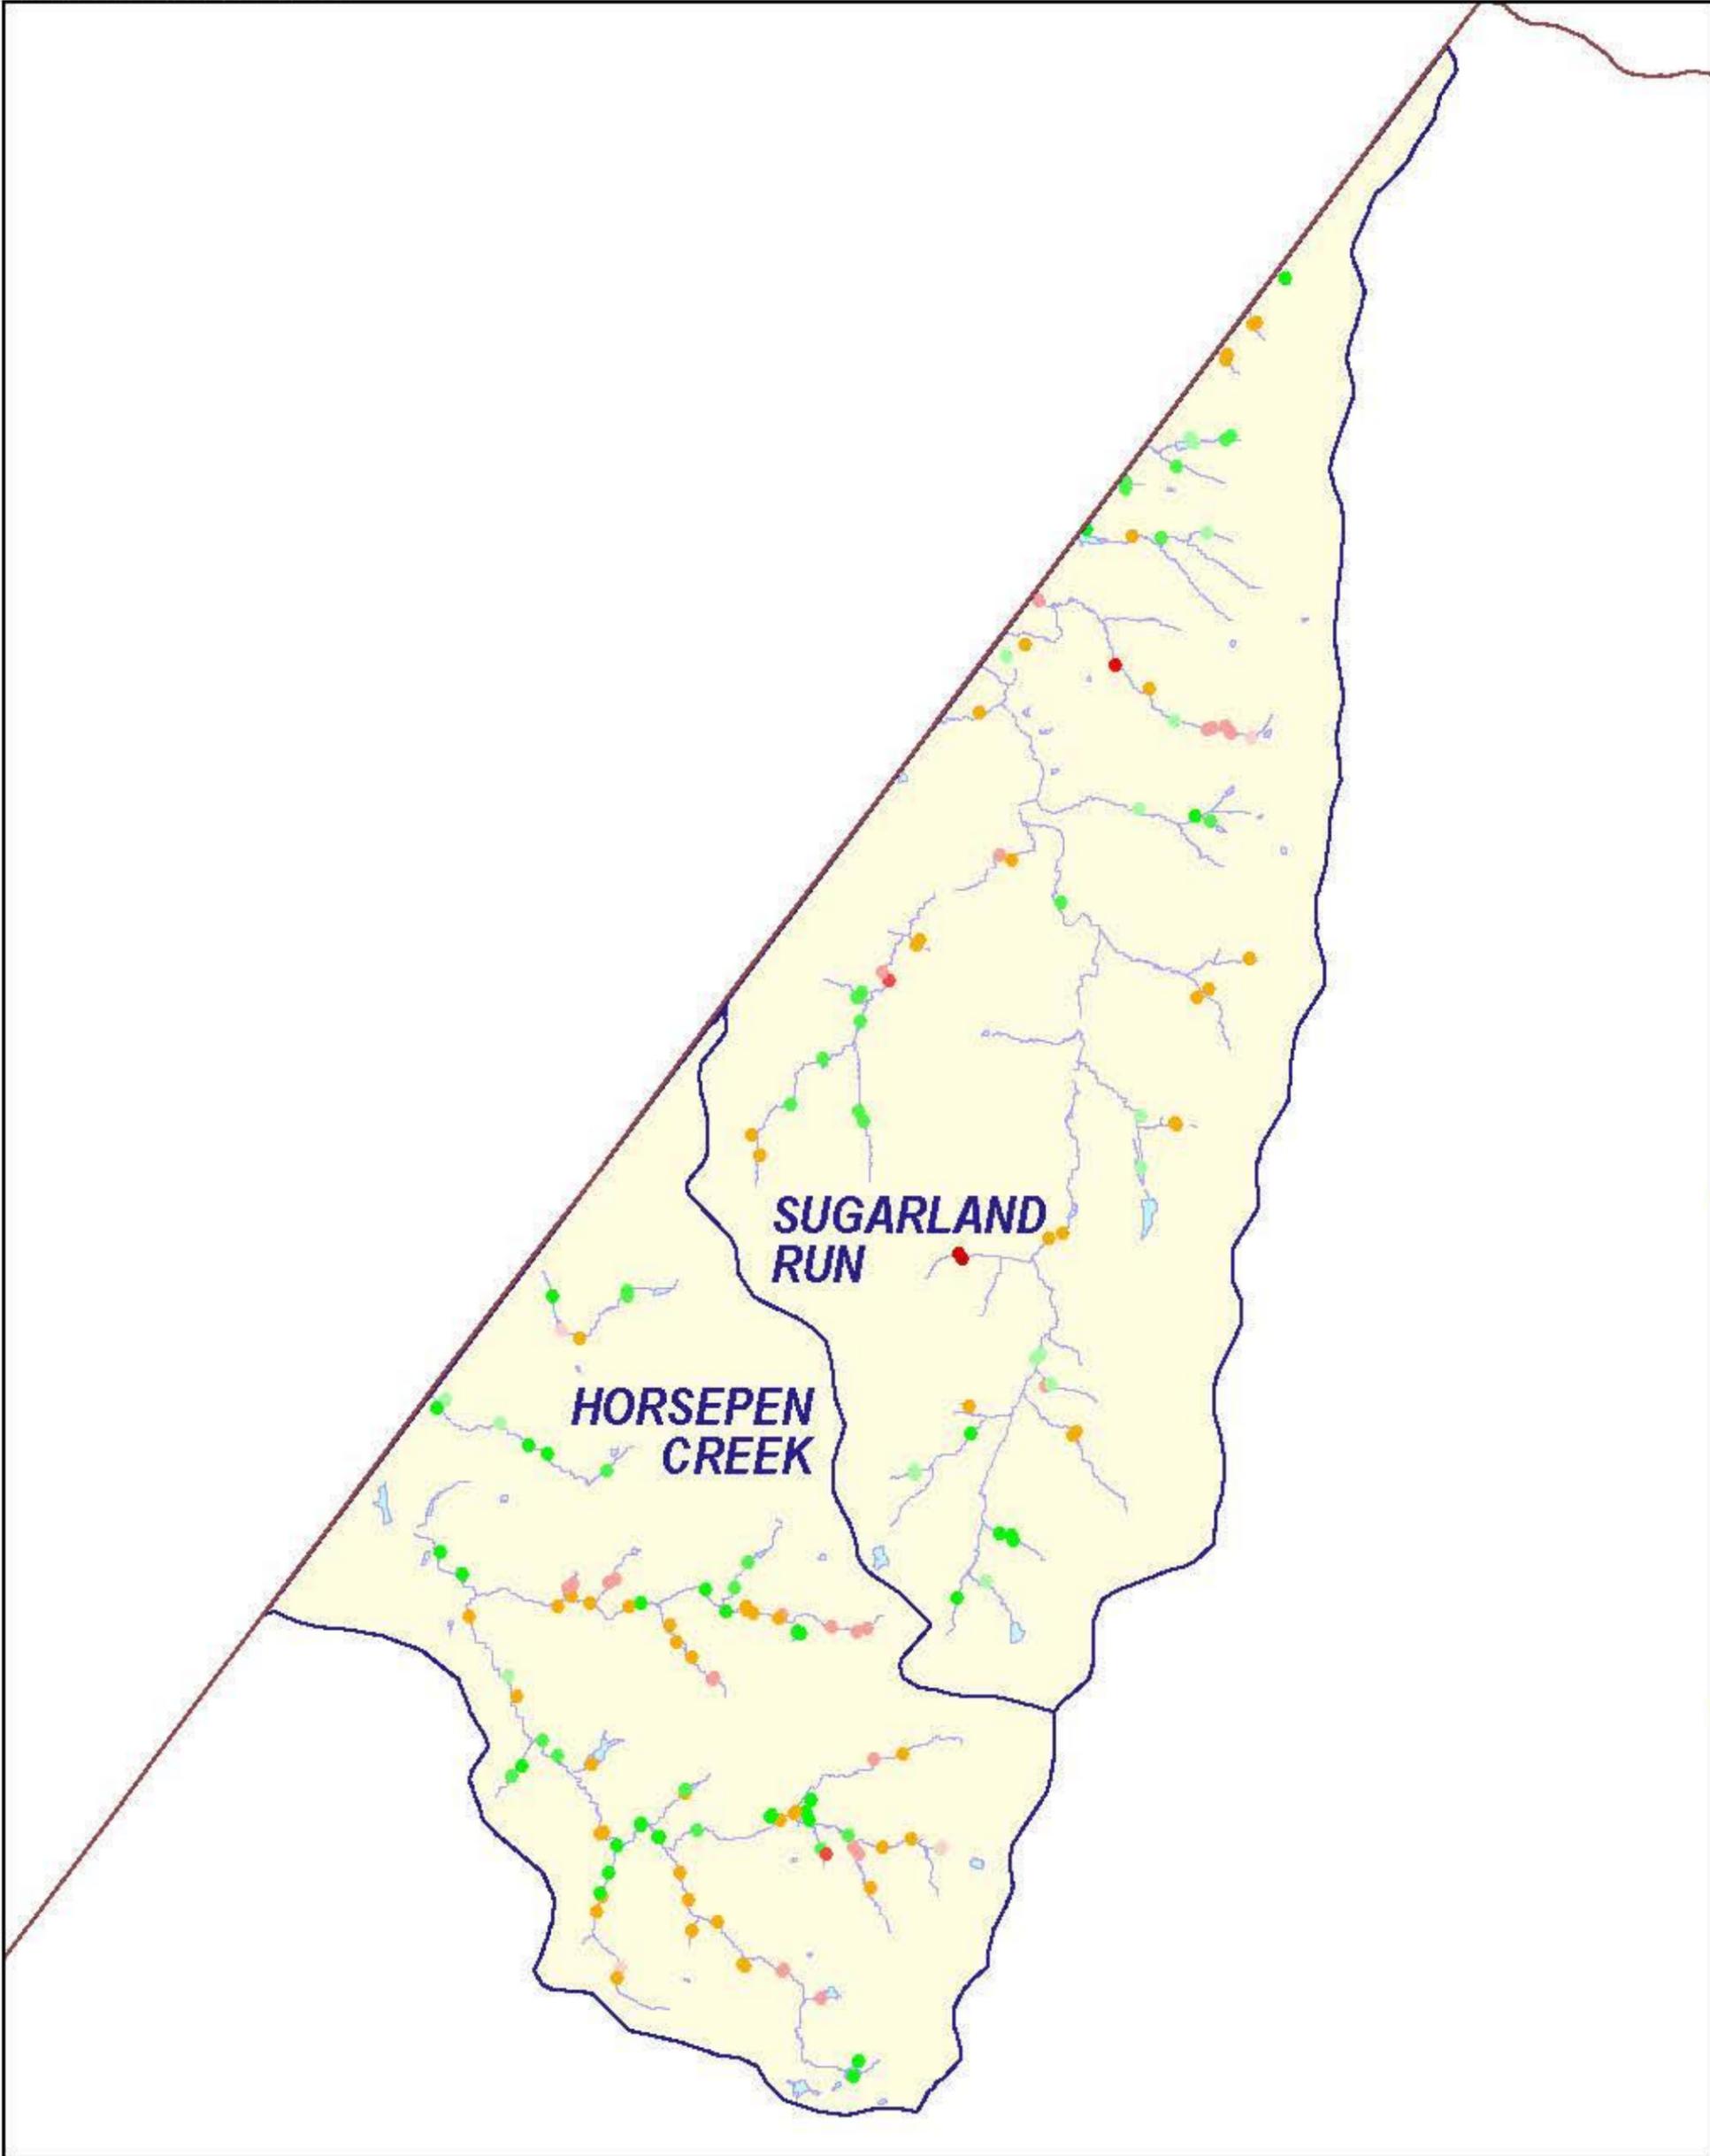
**Figure 3-6**  
**Deficient Buffer Impacts**  
**Sugarland Run Group**  
**Fairfax County Stream Physical Assessment**

Deficient Buffer by Impact Score

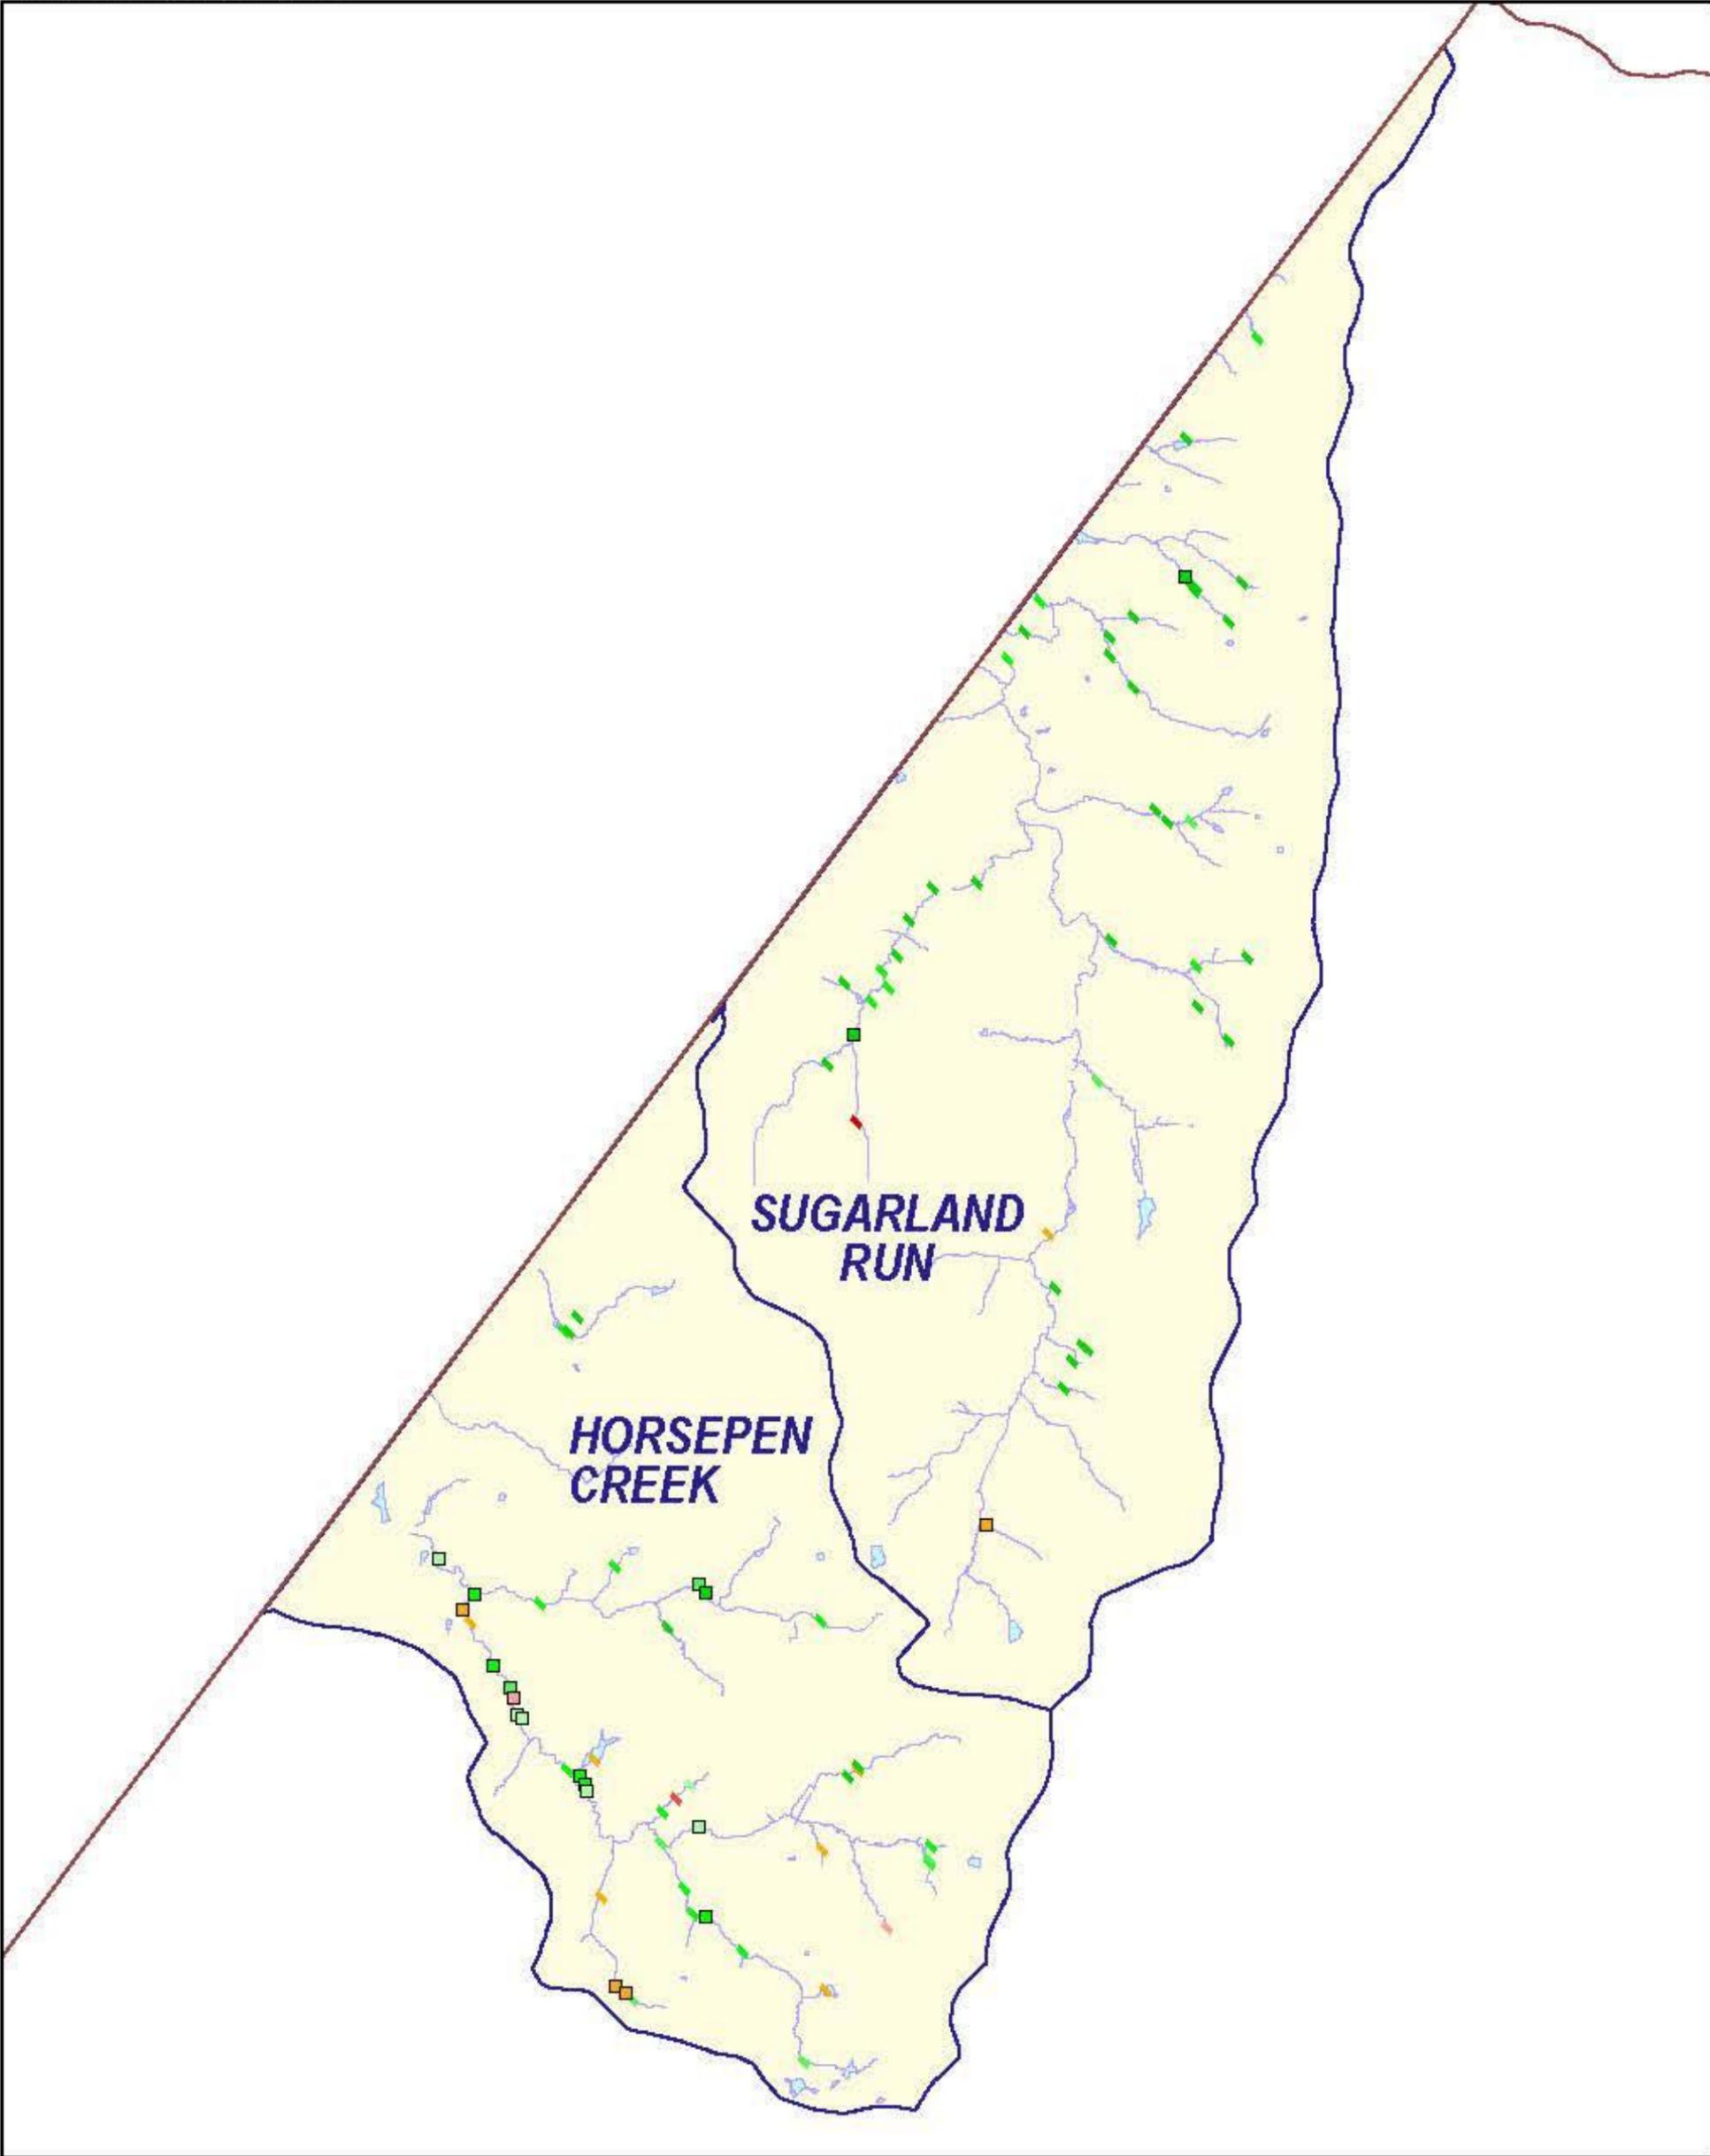
**Figure 3-7**  
**Pipe and Ditch Impacts**  
**Sugarland Run Group**  
**Fairfax County Stream Physical Assessment**

Pipe / Ditch by Impact Score

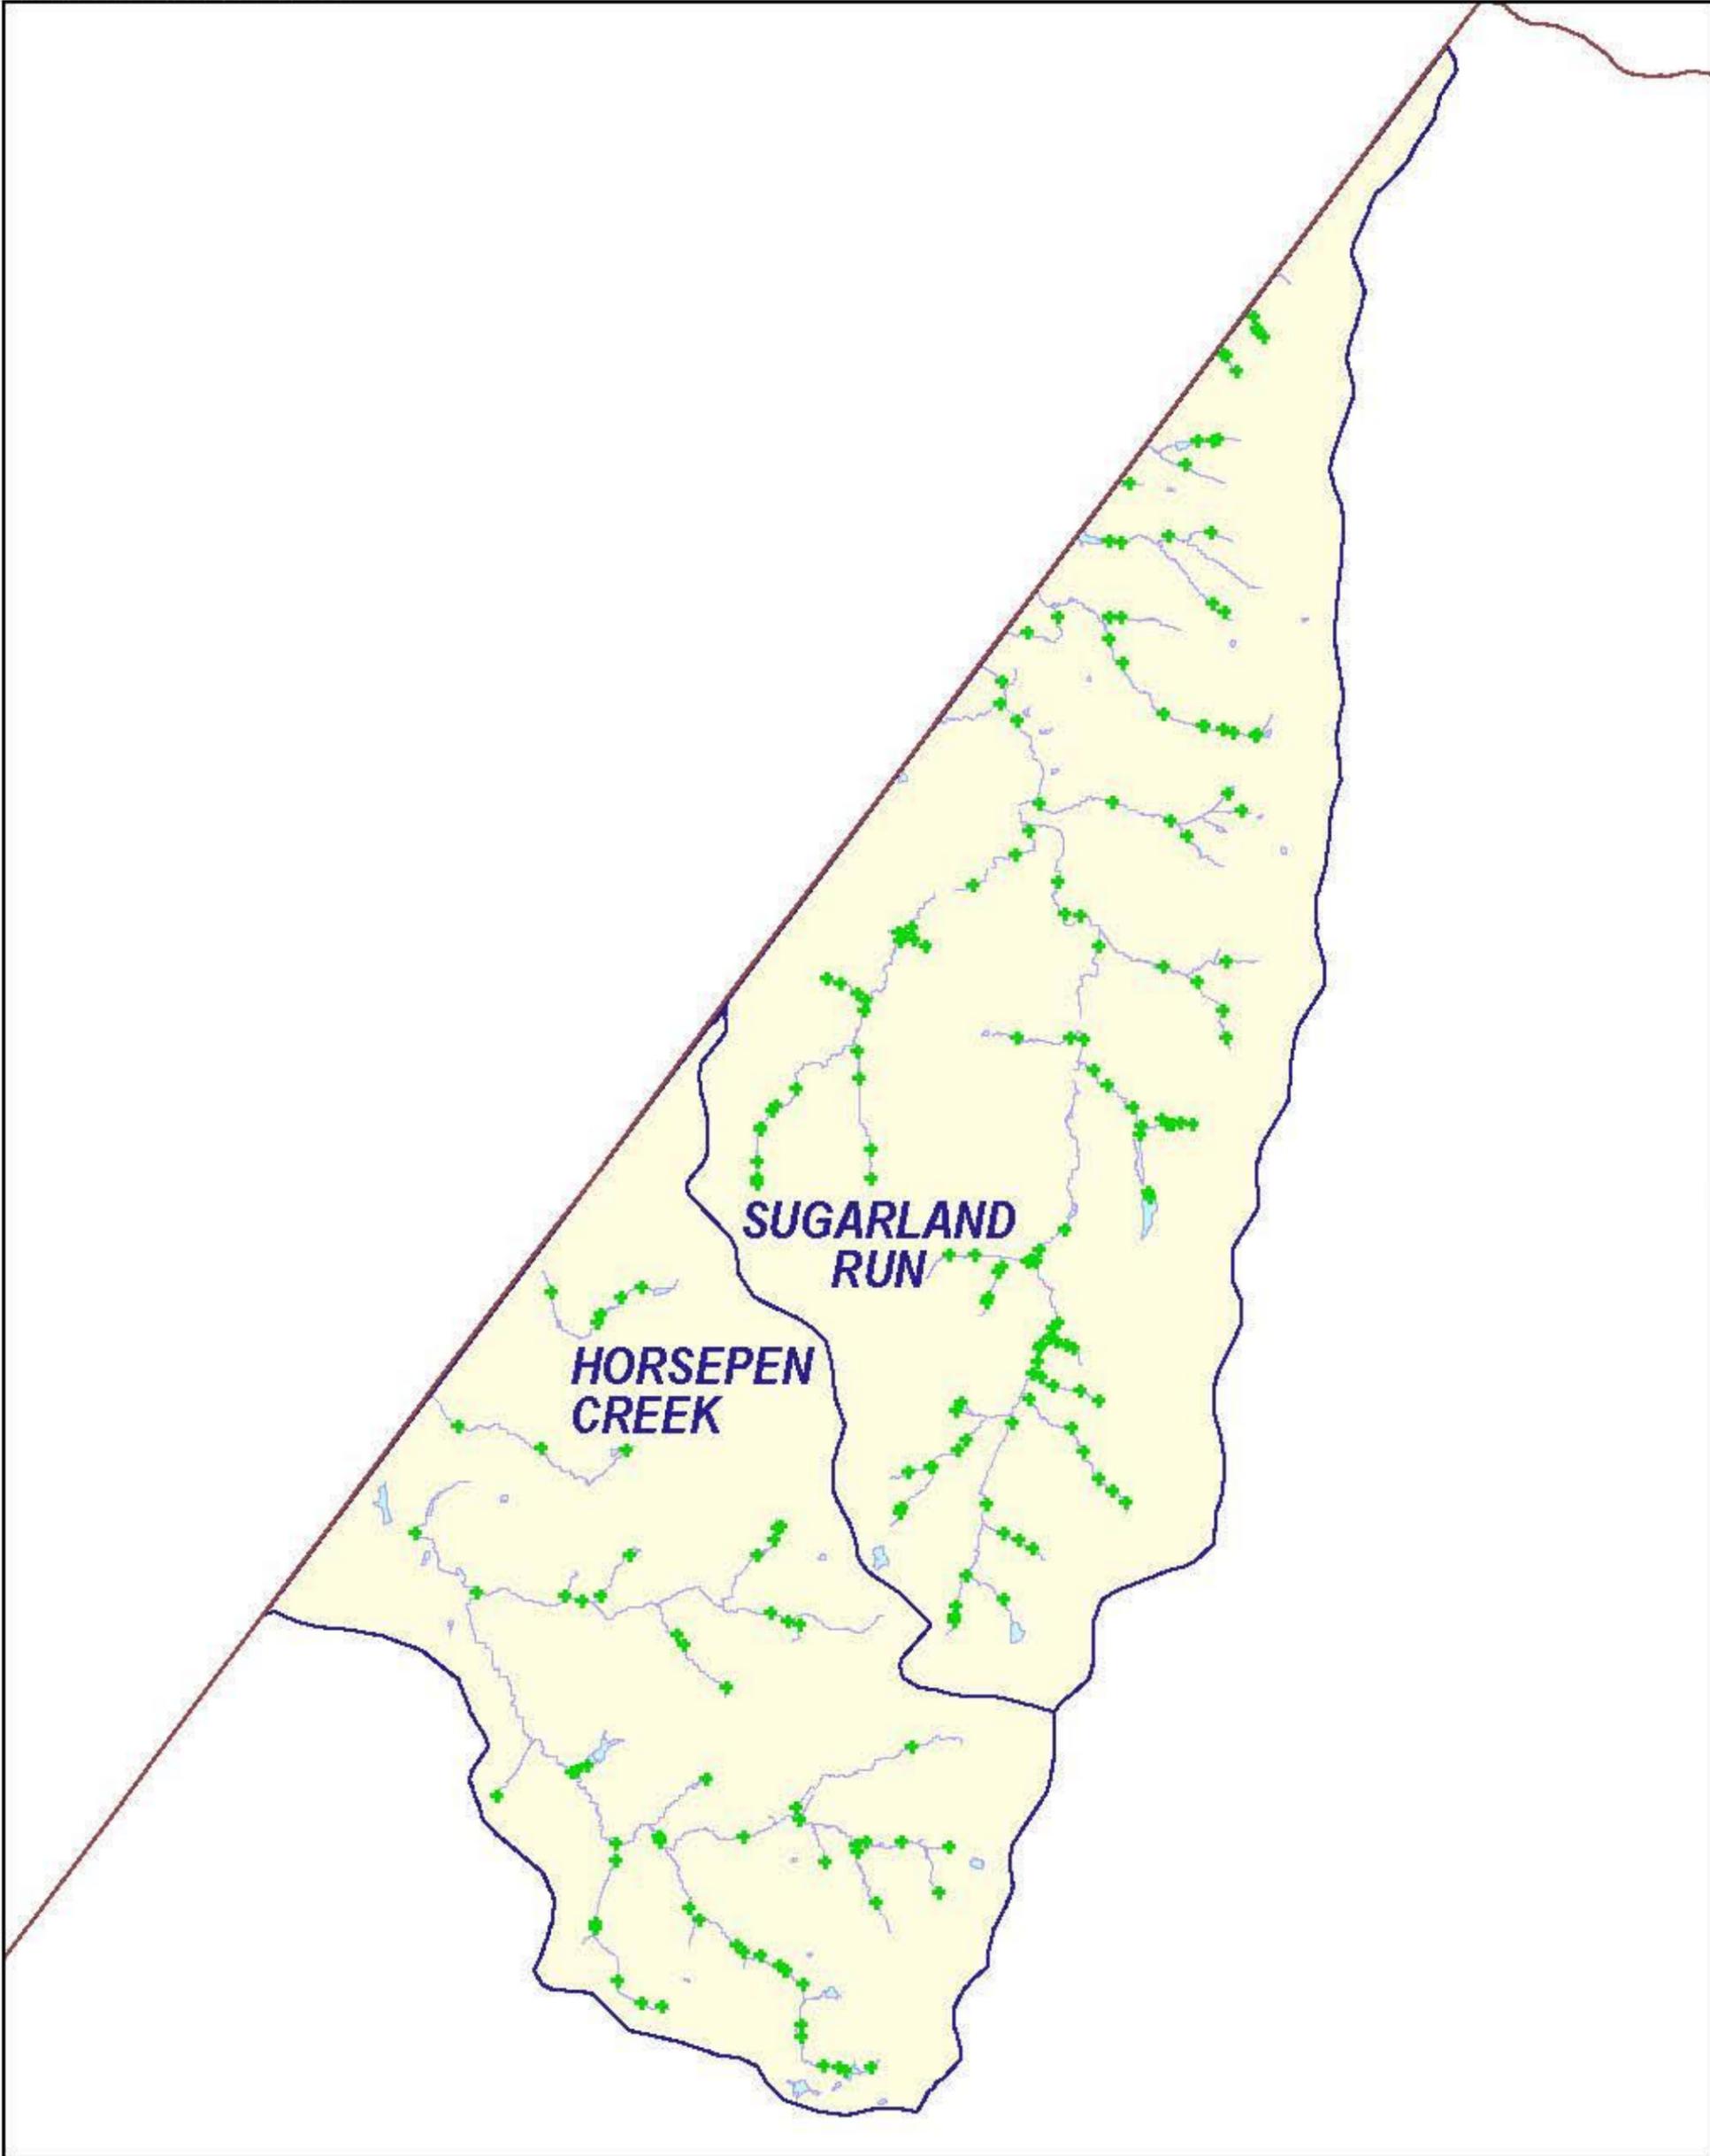
**Figure 3-8  
Crossings  
Sugarland Run Group  
Fairfax County Stream Physical Assessment**

**Inventory Type**

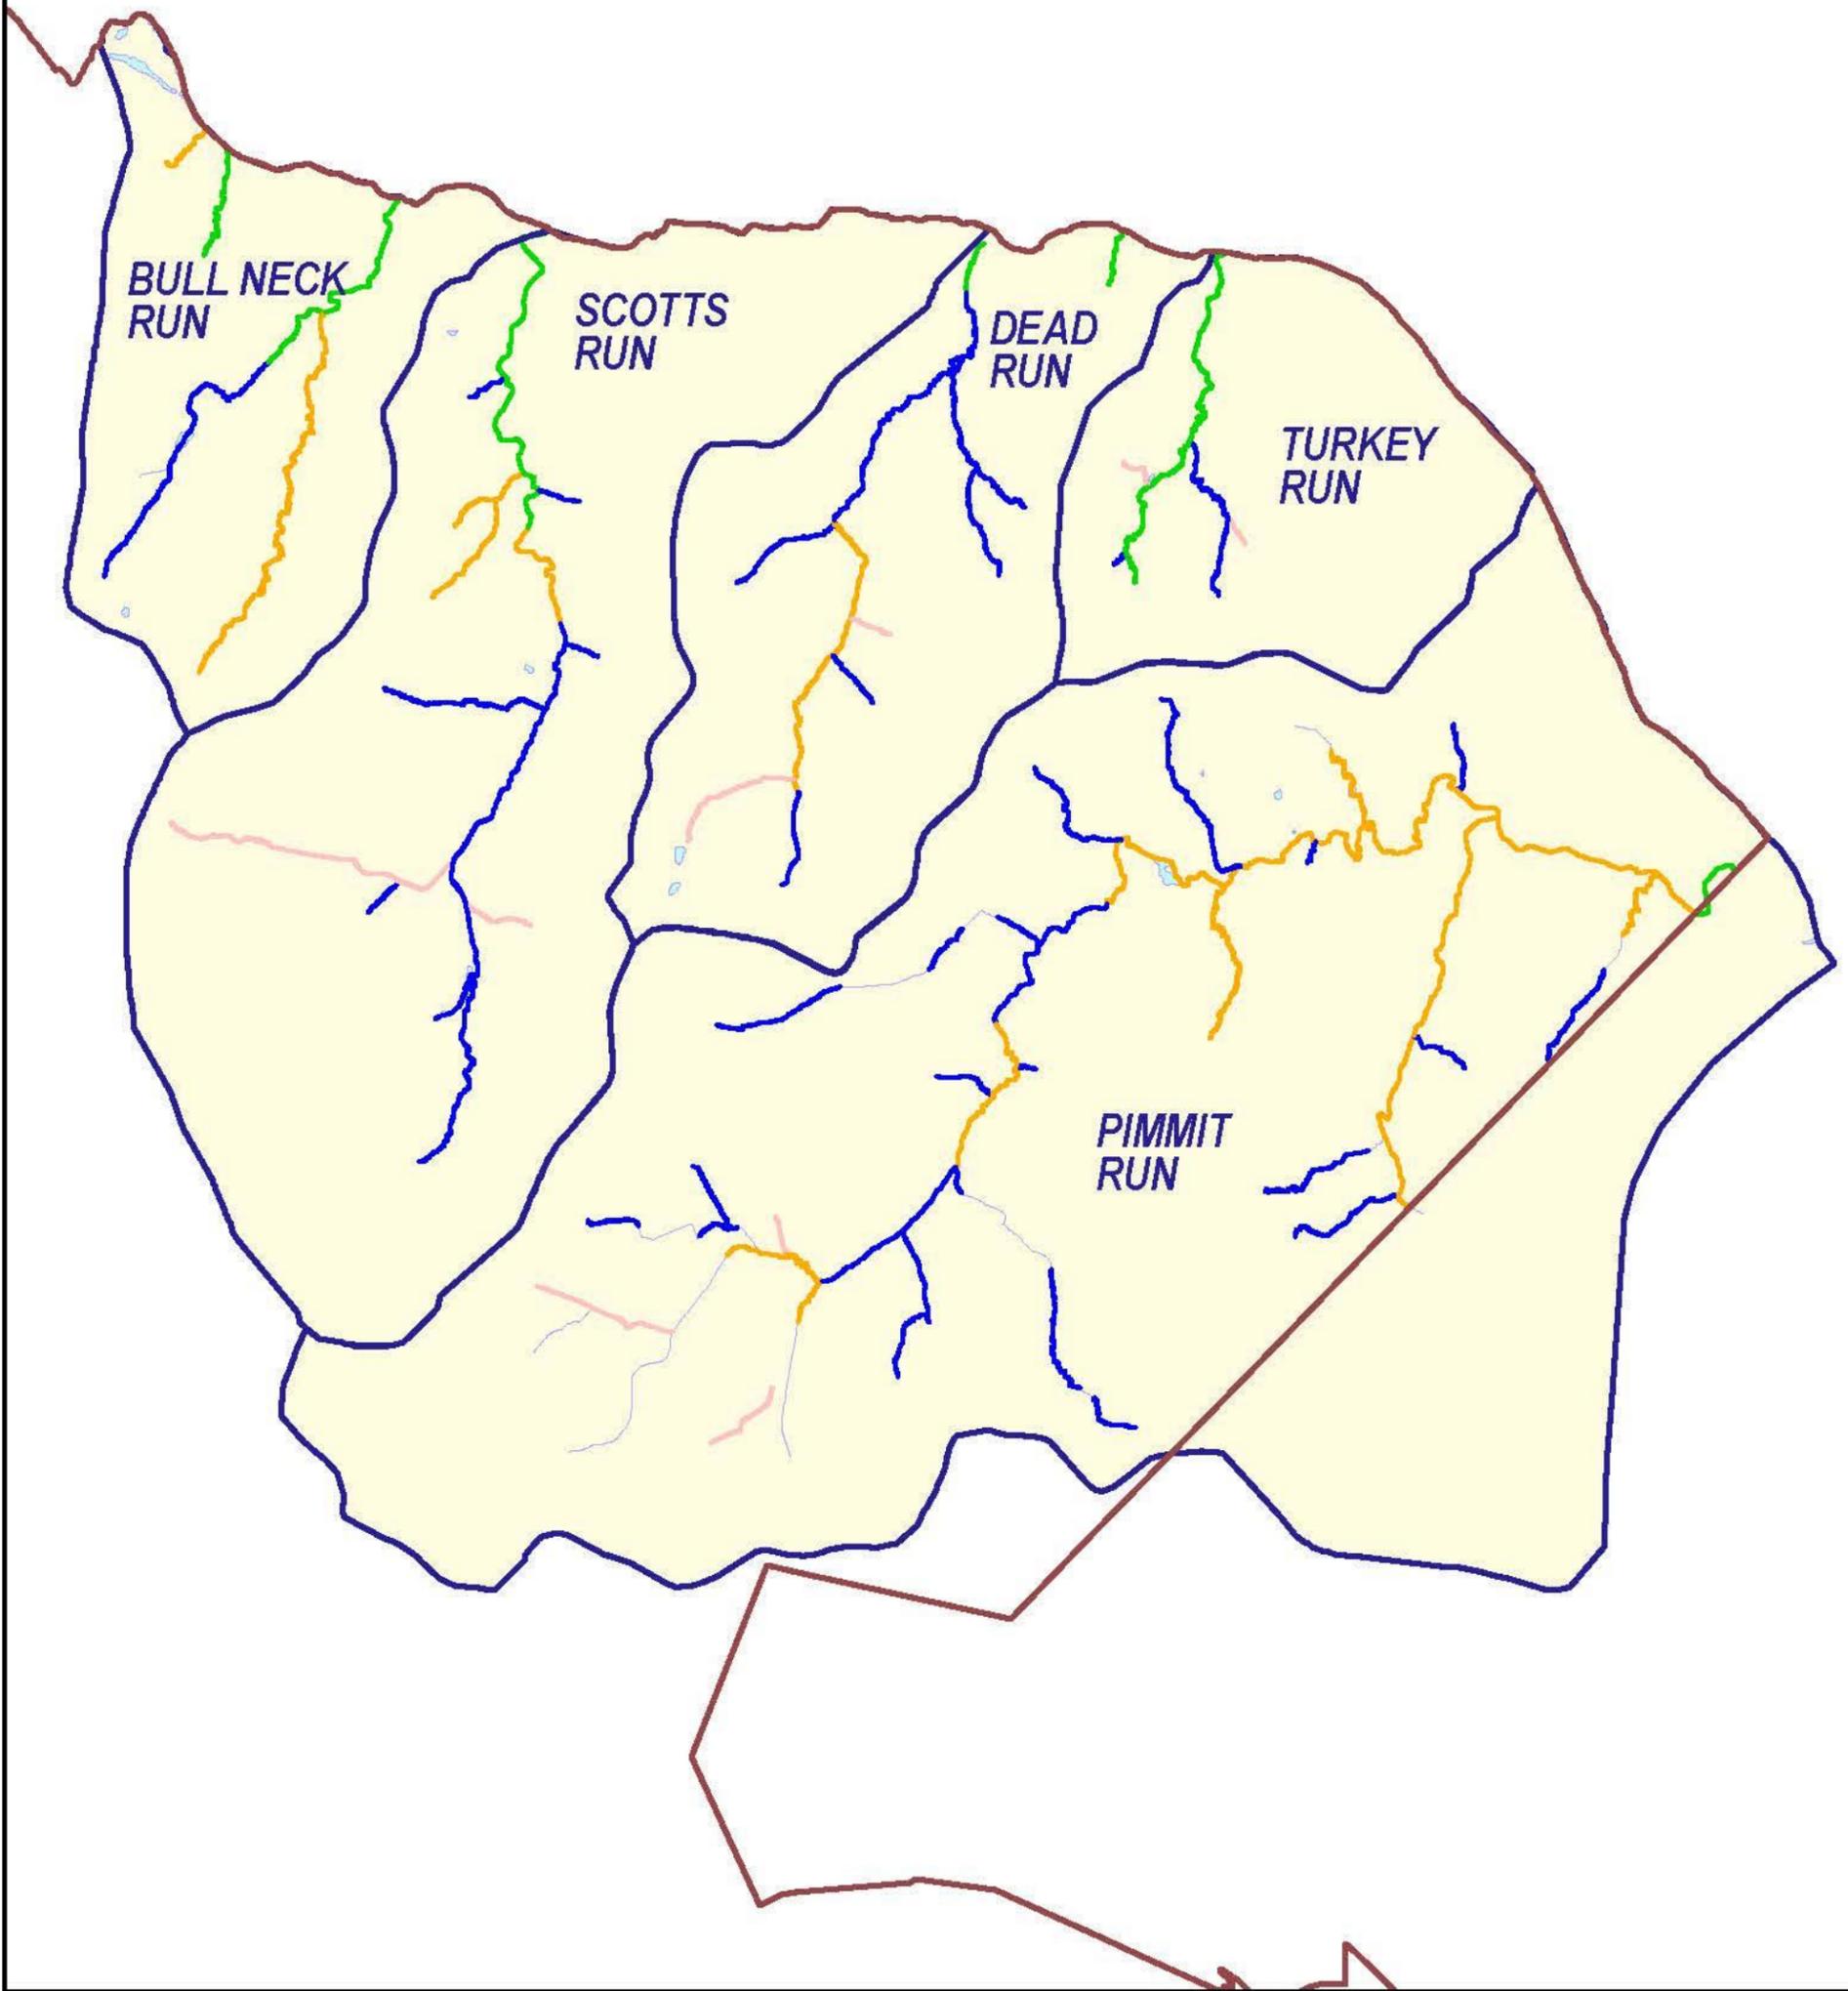
**Figure 3-24**  
**Habitat Assessment**  
**Middle Potomac Group**  
**Fairfax County Stream Physical Assessment**

- Fairfax County Boundary
- Habitat Rating
  - Excellent
  - Good
  - Fair
  - Poor
  - Very Poor
  - No Habitat Assessment
- Lakes and Ponds
- Watersheds

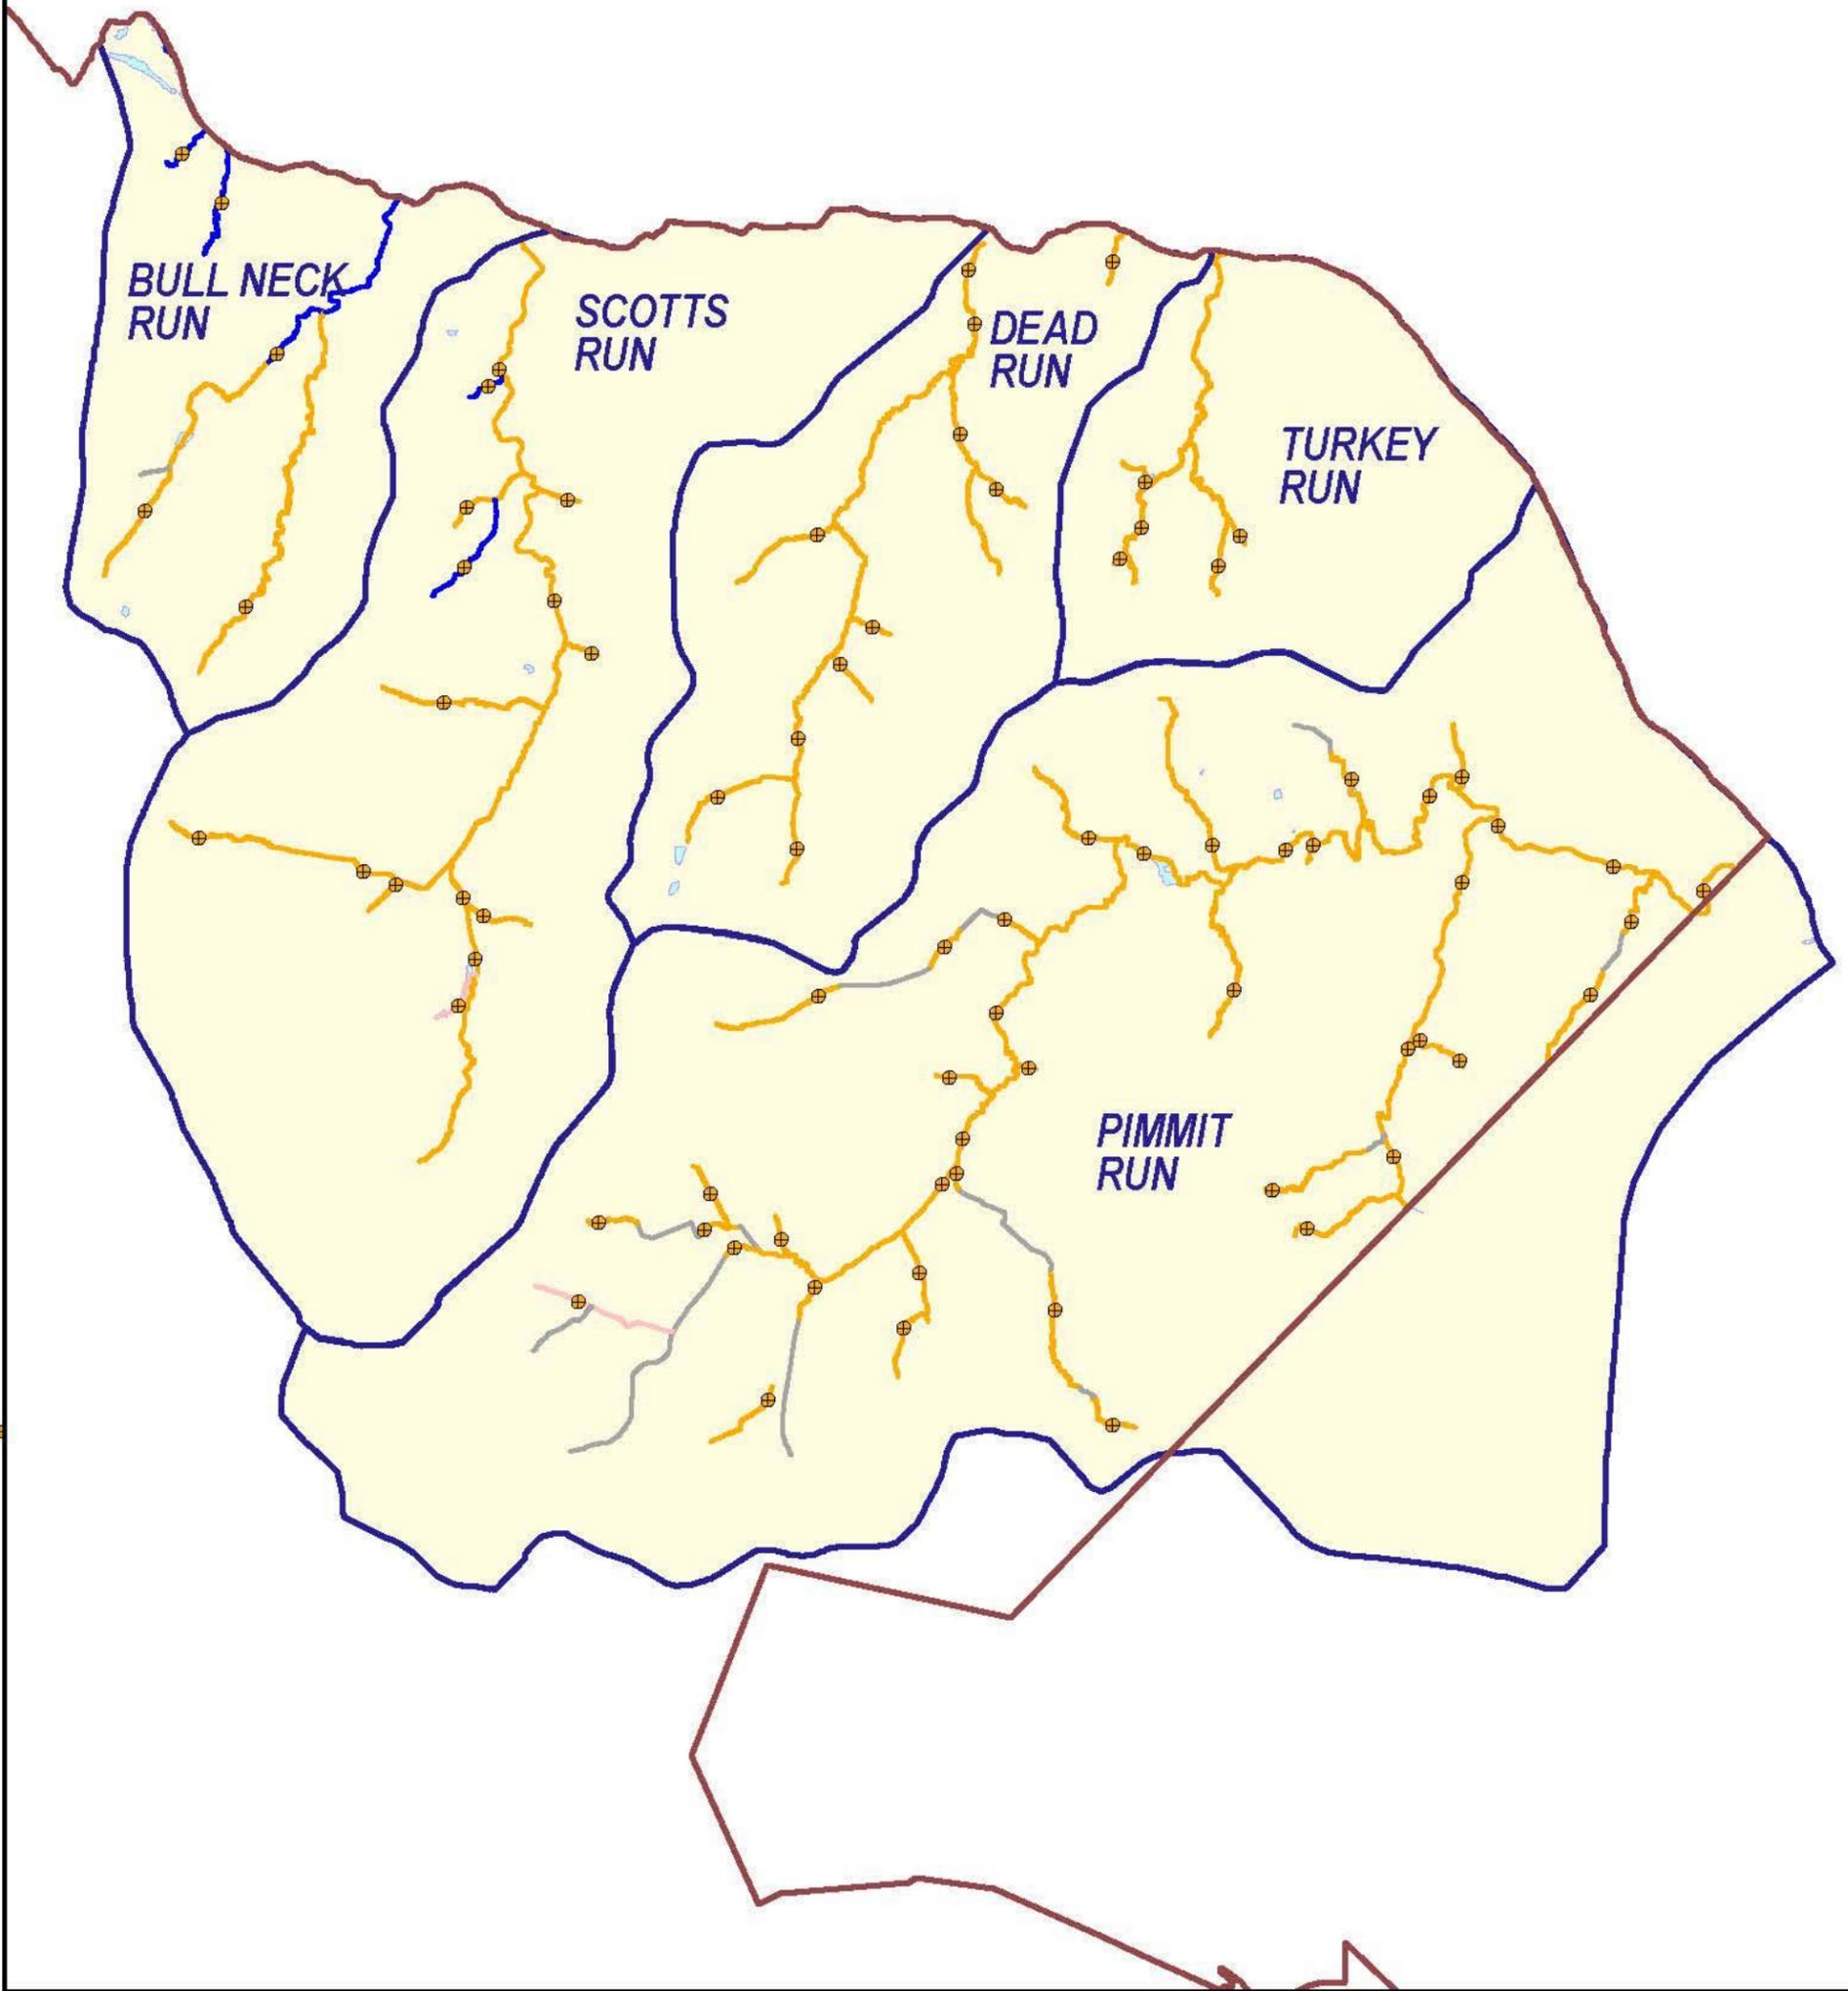
Figure 3-25  
CEM Categories  
Middle Potomac Group  
Fairfax County Stream Physical Assessment

Inventory Types

- Cross Section
- ⚡ Head Cut
