*Final Report*

# **Fairfax County Stream Physical Assessment**

Prepared for  
**Department of Public Works and  
Environmental Services  
Fairfax County, Virginia**

August 2005

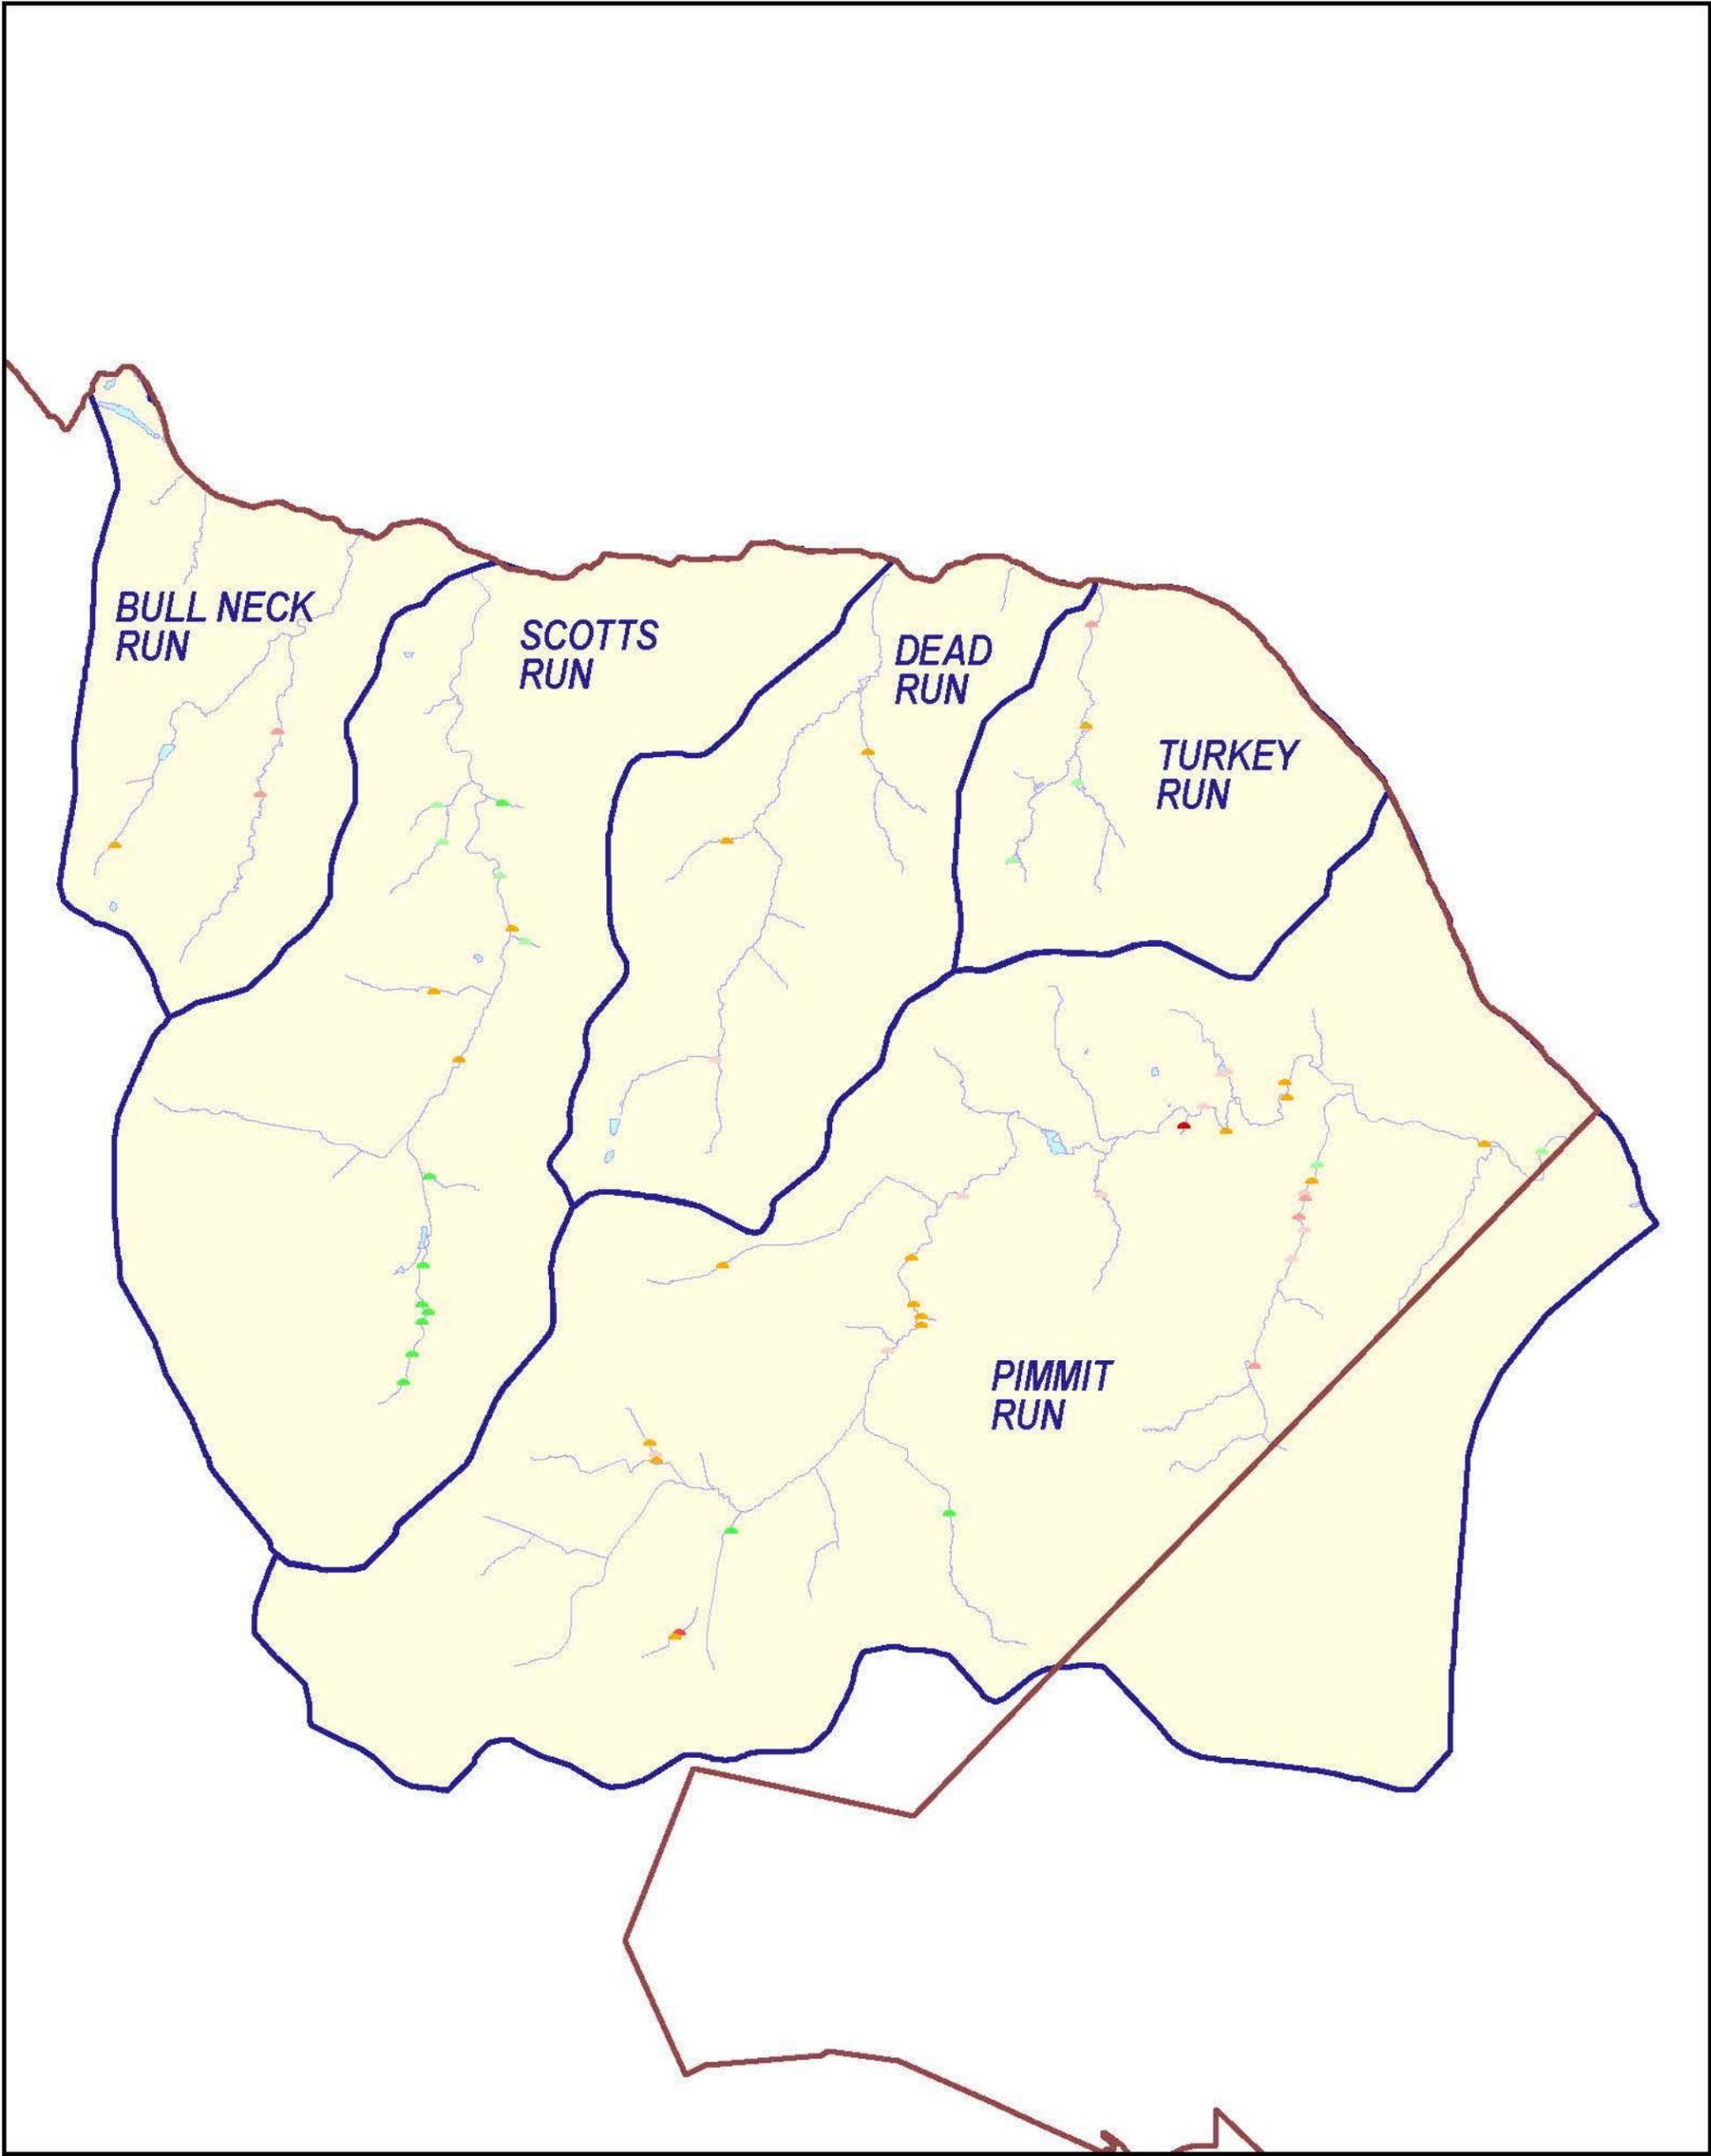
**Figure 3-26**  
**Erosion Impacts**  
**Middle Potomac Group**  
**Fairfax County Stream Physical Assessment**

Erosion by Impact Score

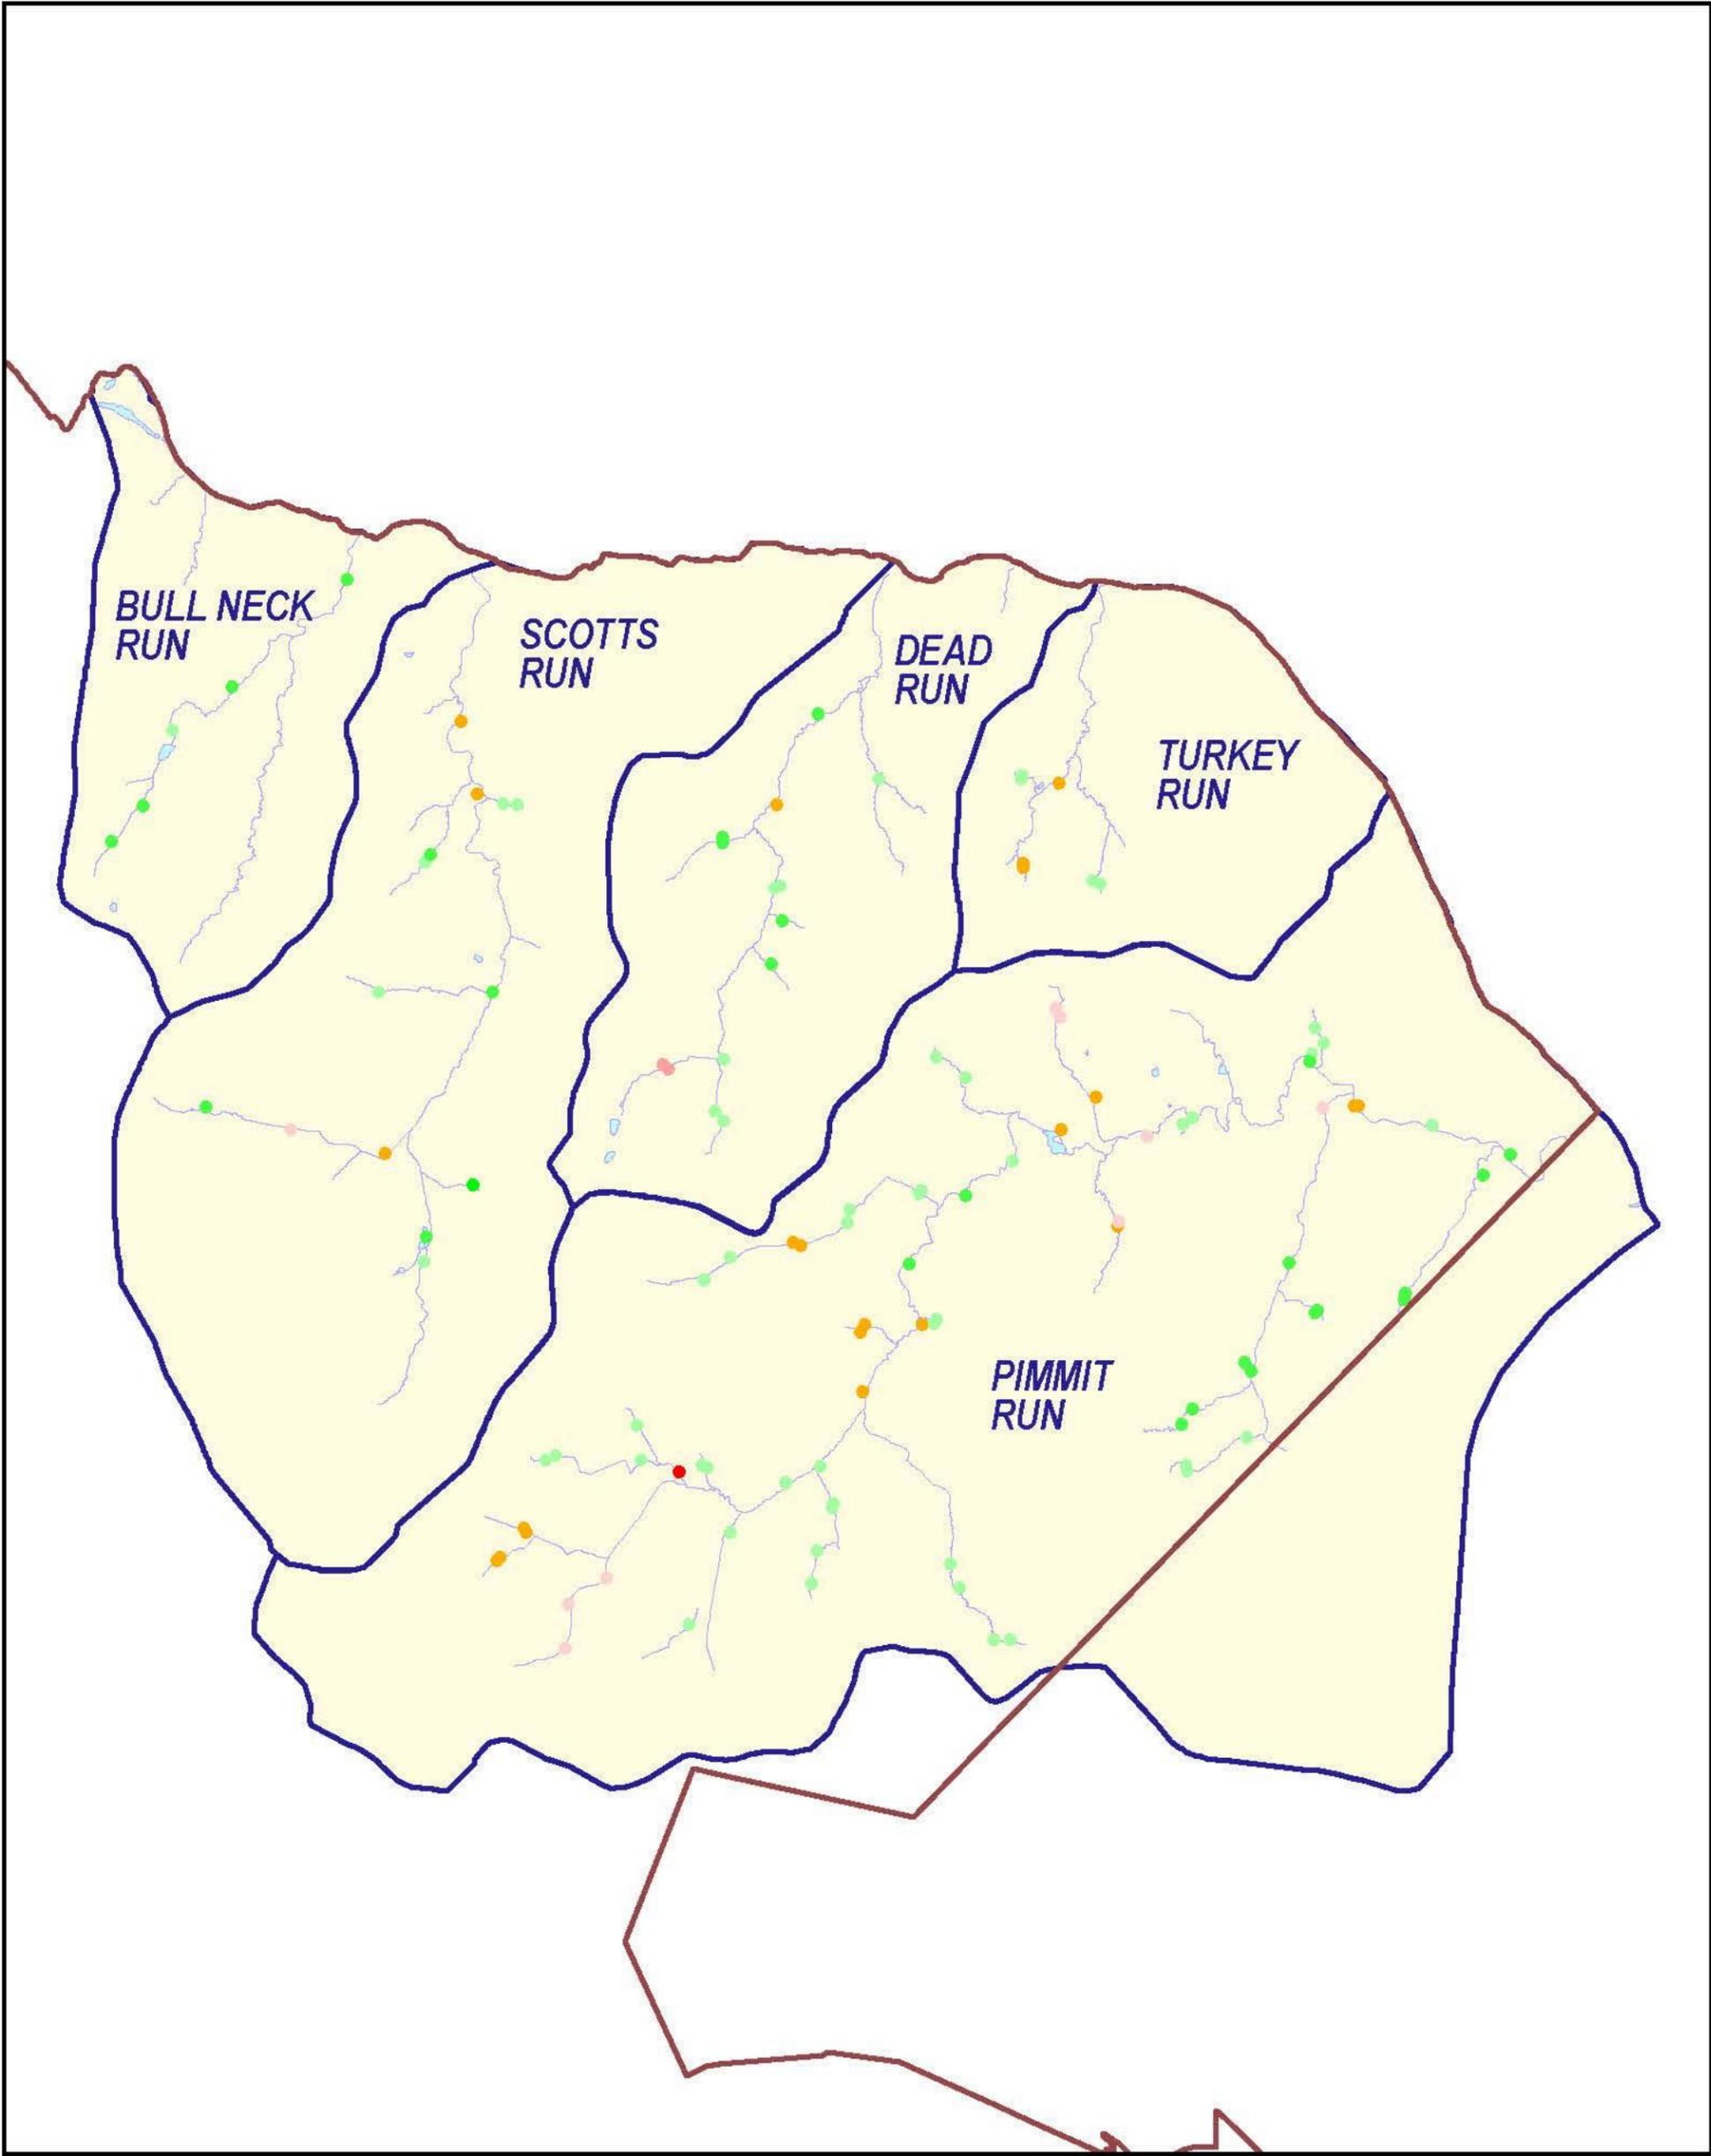
**Figure 3-27**  
**Deficient Buffer Impacts**  
**Middle Potomac Group**  
**Fairfax County Stream Physical Assessment**

Deficient Buffer by Impact Score

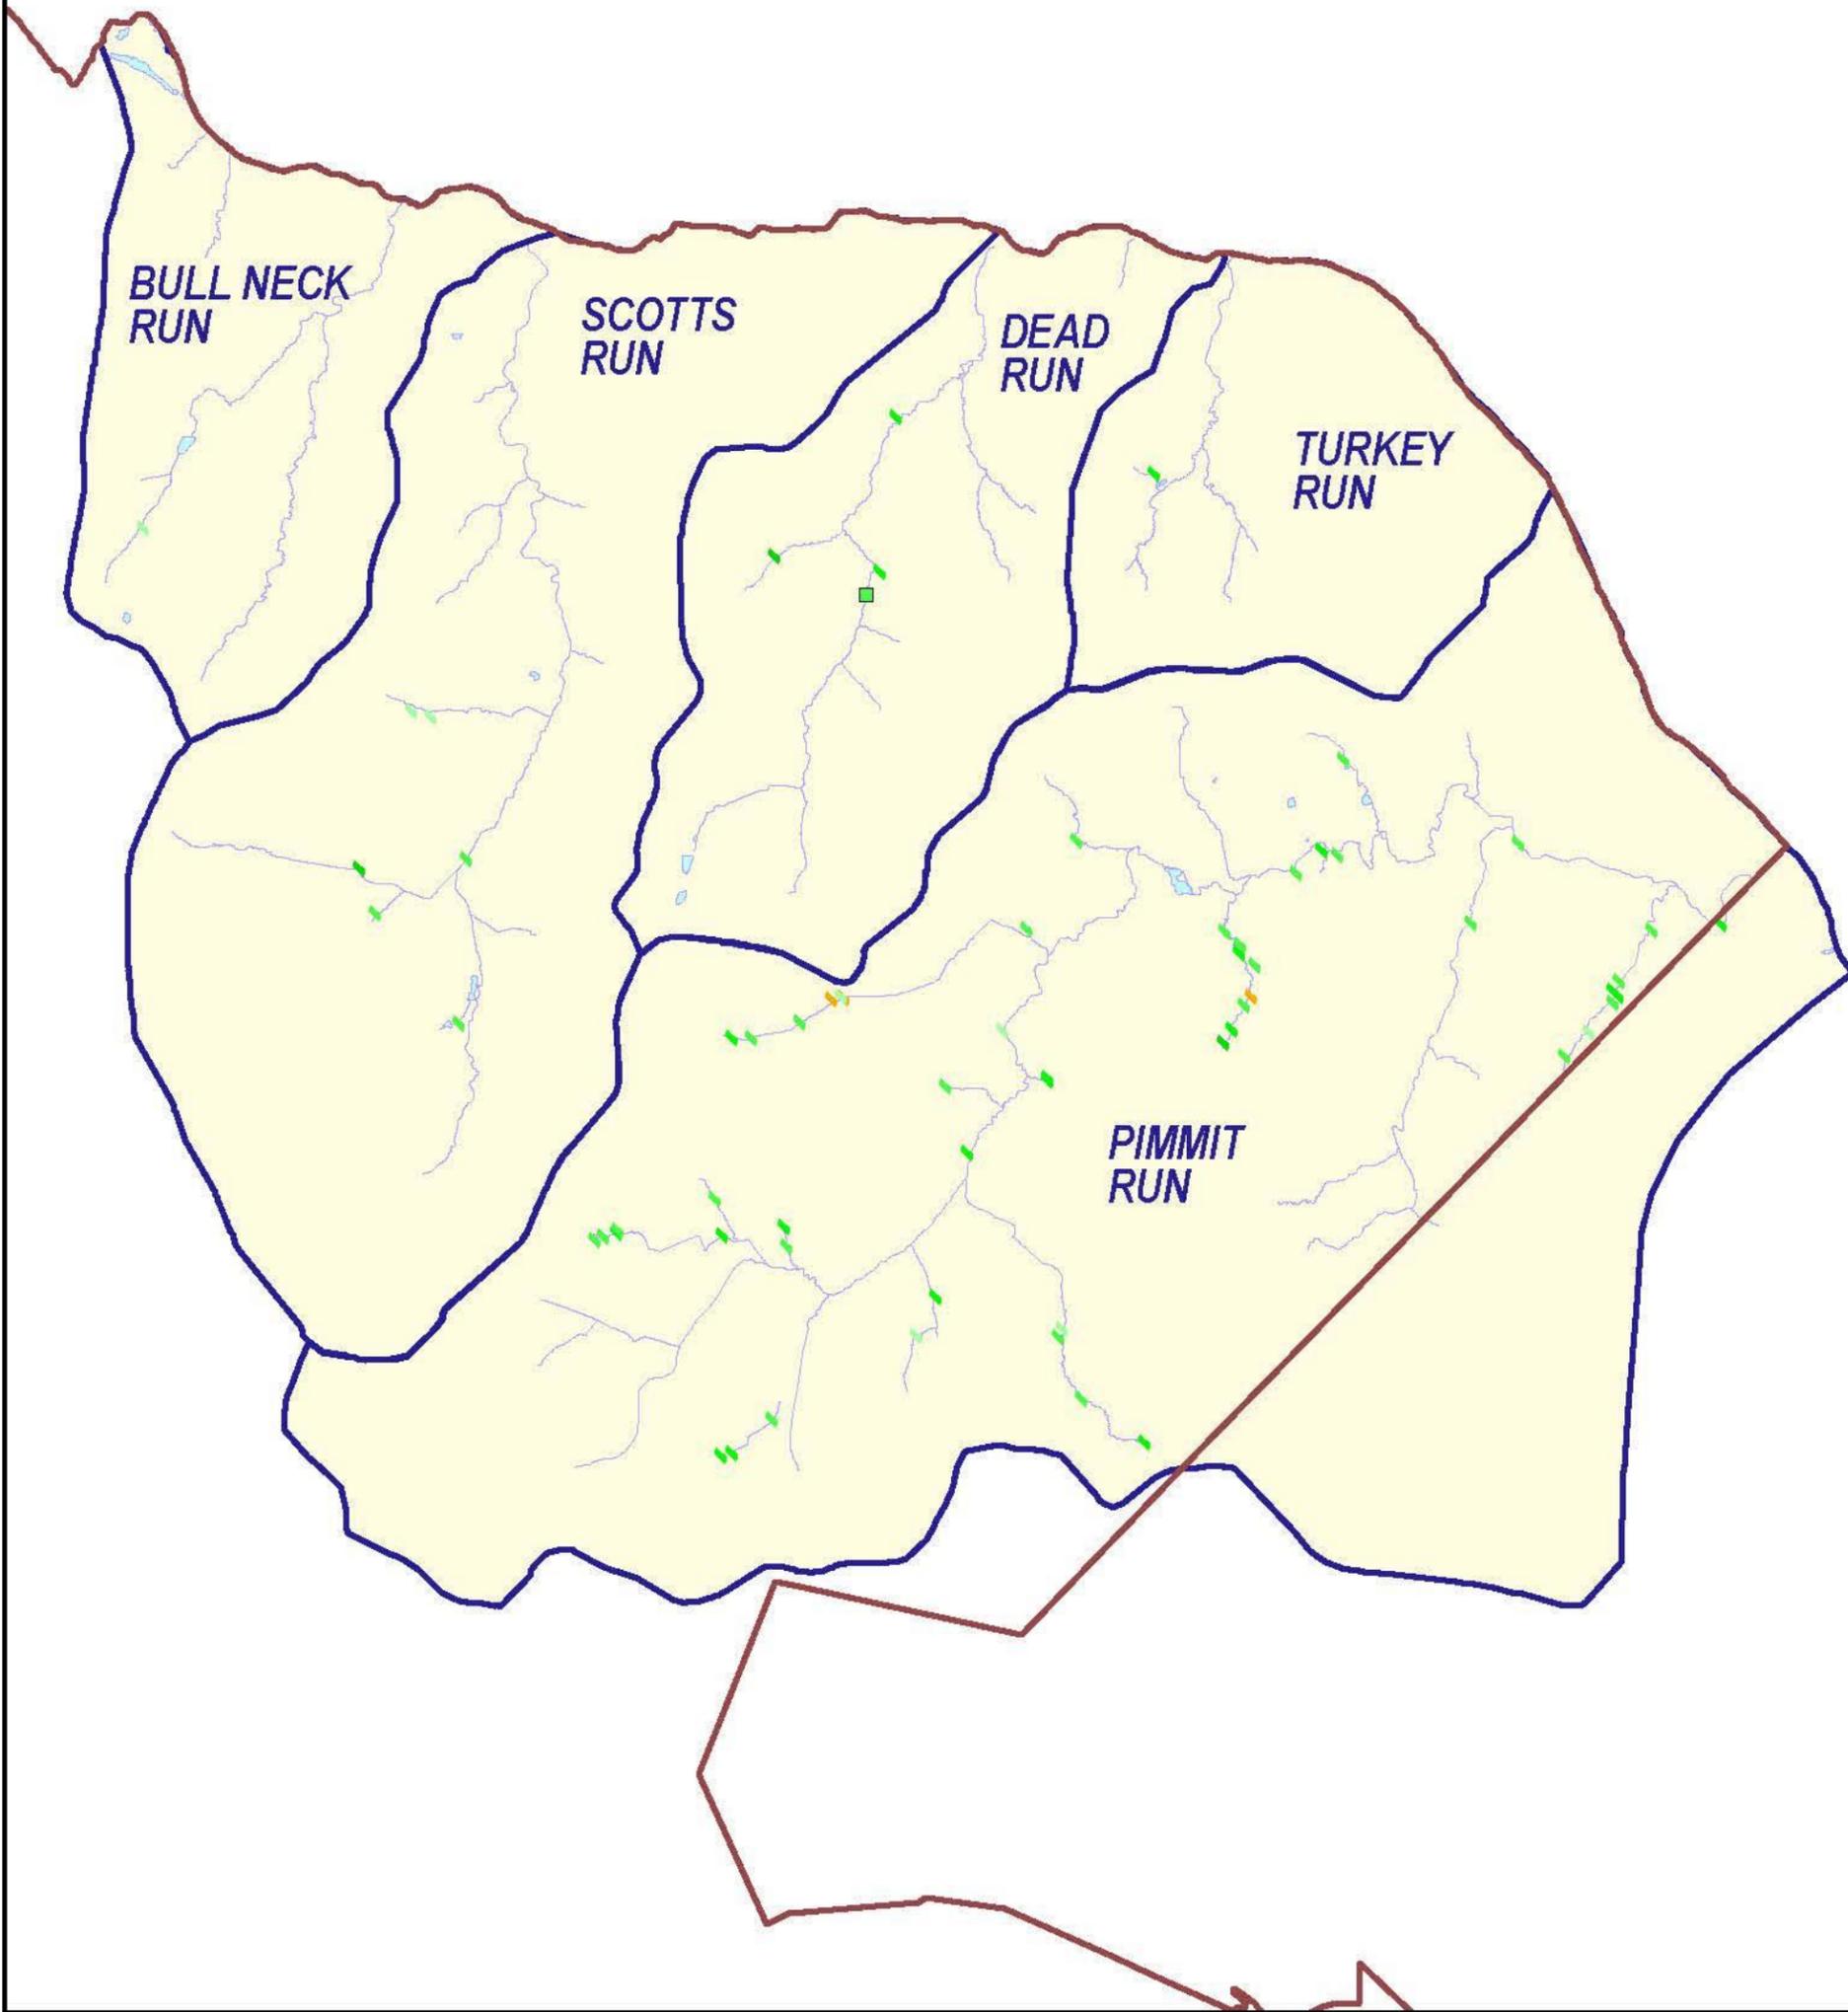
Figure 3-29  
Pipe and Ditch Impacts  
Middle Potomac Group  
Fairfax County Stream Physical Assessment

Pipe / Ditch by Impact Score

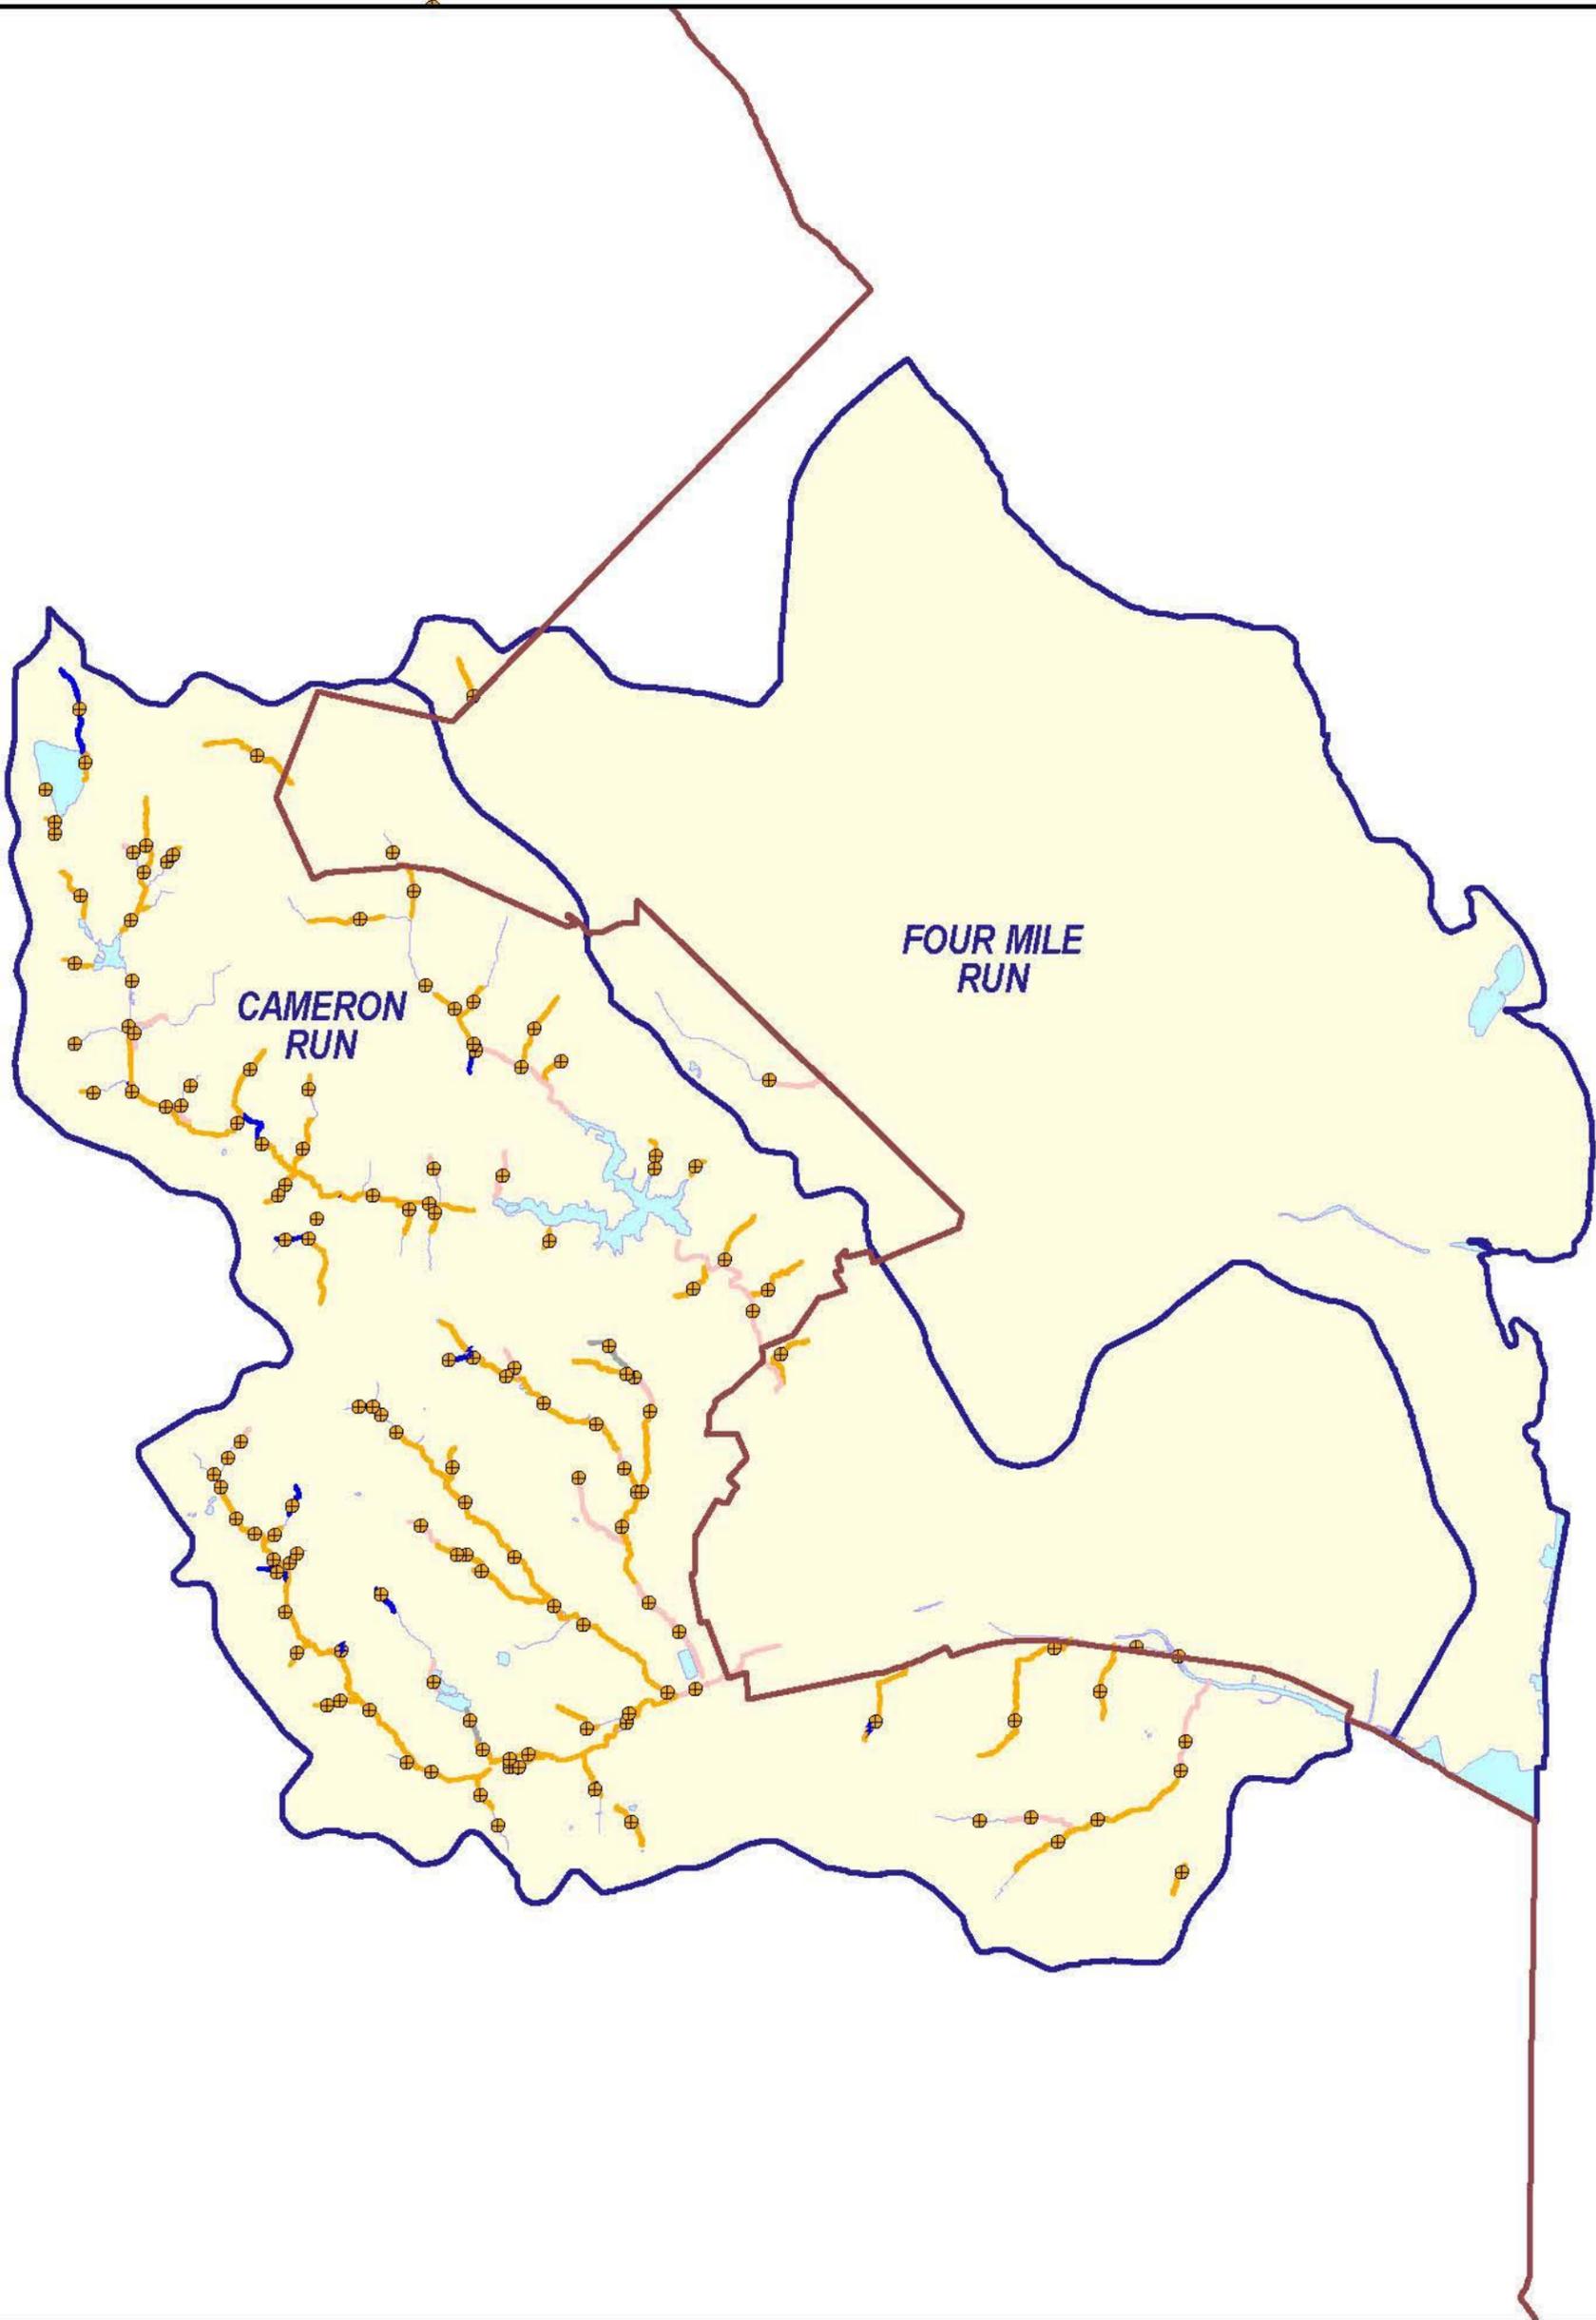
**Figure 3-31**  
**Habitat Assessment**  
**Cameron Run Group**  
**Fairfax County Stream Physical Assessment**

**Habitat.** The habitat assessment results for Cameron Run Watershed are summarized by stream in Table 3-25. Habitat scores for each reach are depicted in Figure 3-31. Based on a length weighted habitat score of 92 (Table 3-2), Cameron Run Watershed is one of the poorest watersheds, compared to the rest of the County. Approximately 2 miles of stream were categorized as having “very poor” habitat conditions, 19 miles as “poor,” 23 miles as “fair,” and 4 miles as “good.”

**Habitat.** The habitat assessment results for Four Mile Run Watershed are summarized by stream in Table 3-27. Habitat scores for each reach are depicted in Figure 3-31. Based on a length weighted habitat score of 96 (Table 3-2), Four Mile Run Watershed is in the lower range of quality, compared to the rest of the County. Nearly the entire mile assessed was categorized as “fair.”

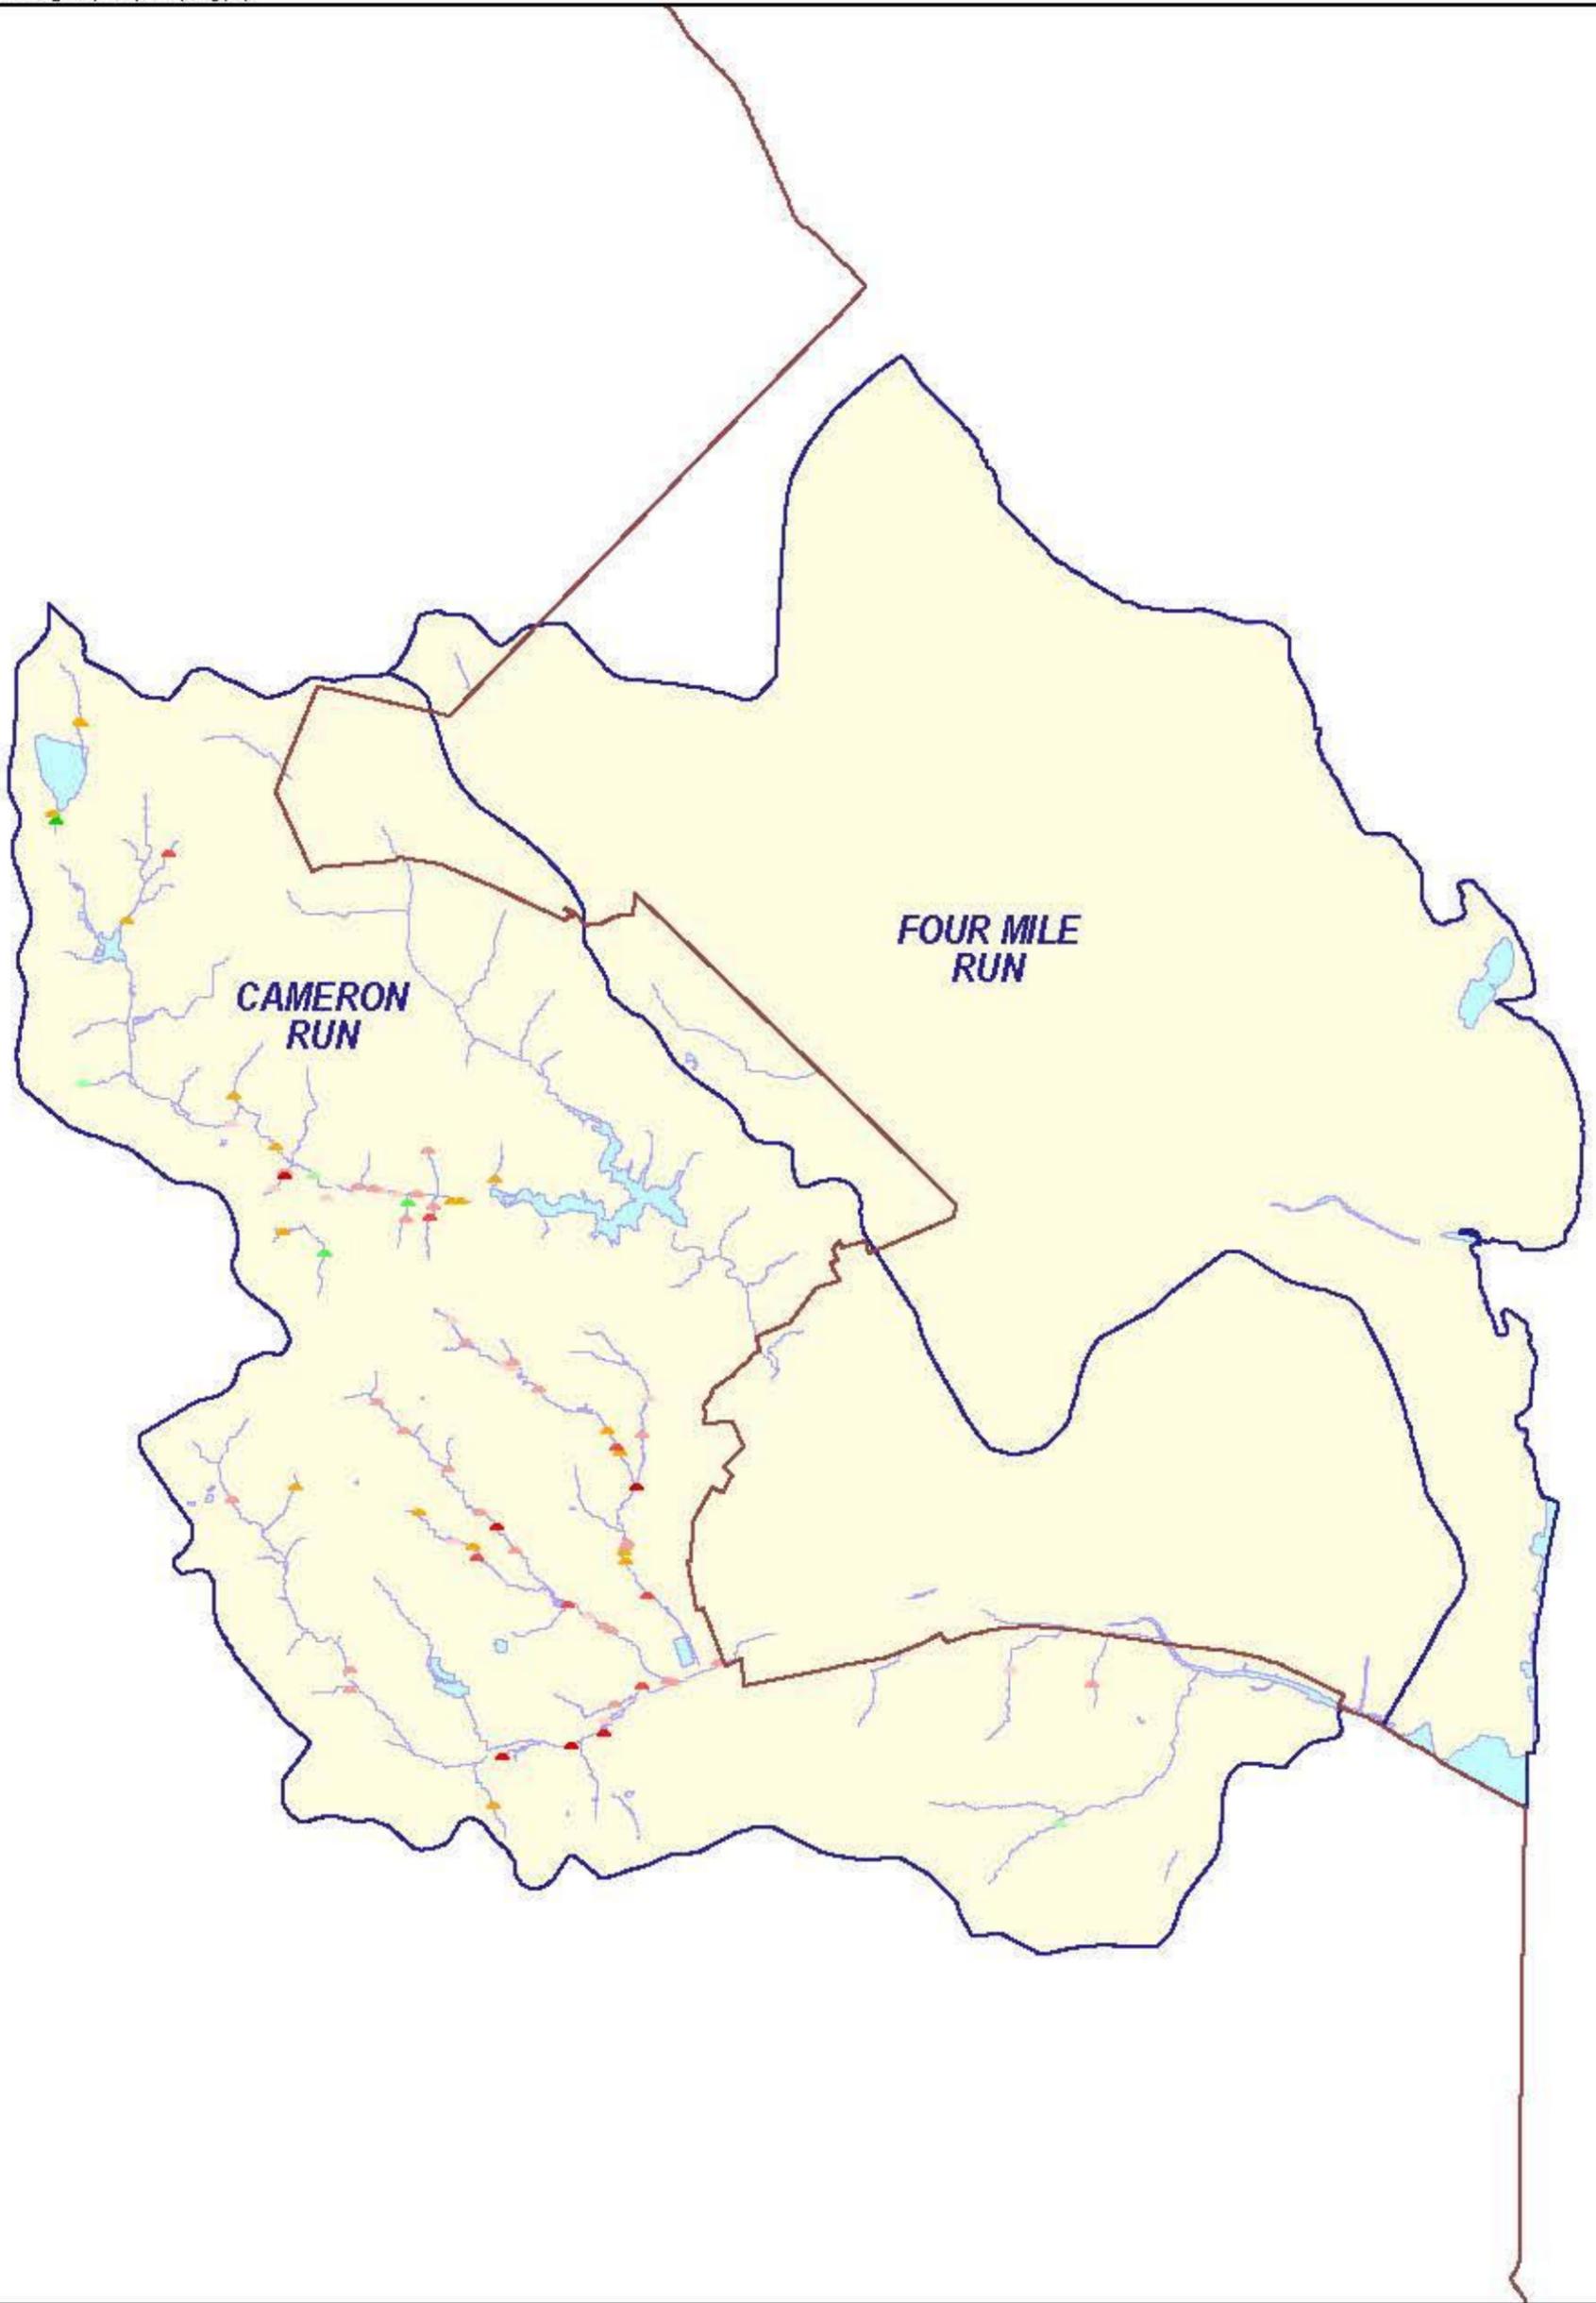
**Figure 3-32**  
**CEM Stages**  
**Cameron Run Group**  
**Fairfax County Stream Physical Assessment**

**CEM.** Based on the CEM evaluations approximately three quarters of the channels assessed in Cameron Run Watershed are in Evolutionary Stage 3 (Table 3-3), with most of the remainder of the watershed in Stage 4. Figure 3-32 summarizes the CEM results for Cameron Run Watershed.

**CEM.** Based on the CEM evaluations approximately 60 percent of the channels assessed in Four Mile Run Watershed are in Evolutionary Stage 4 (Table 3-3), with most of the remainder of the watershed in Stage 3. Figure 3-32 summarizes the CEM results for Four Mile Run Watershed.

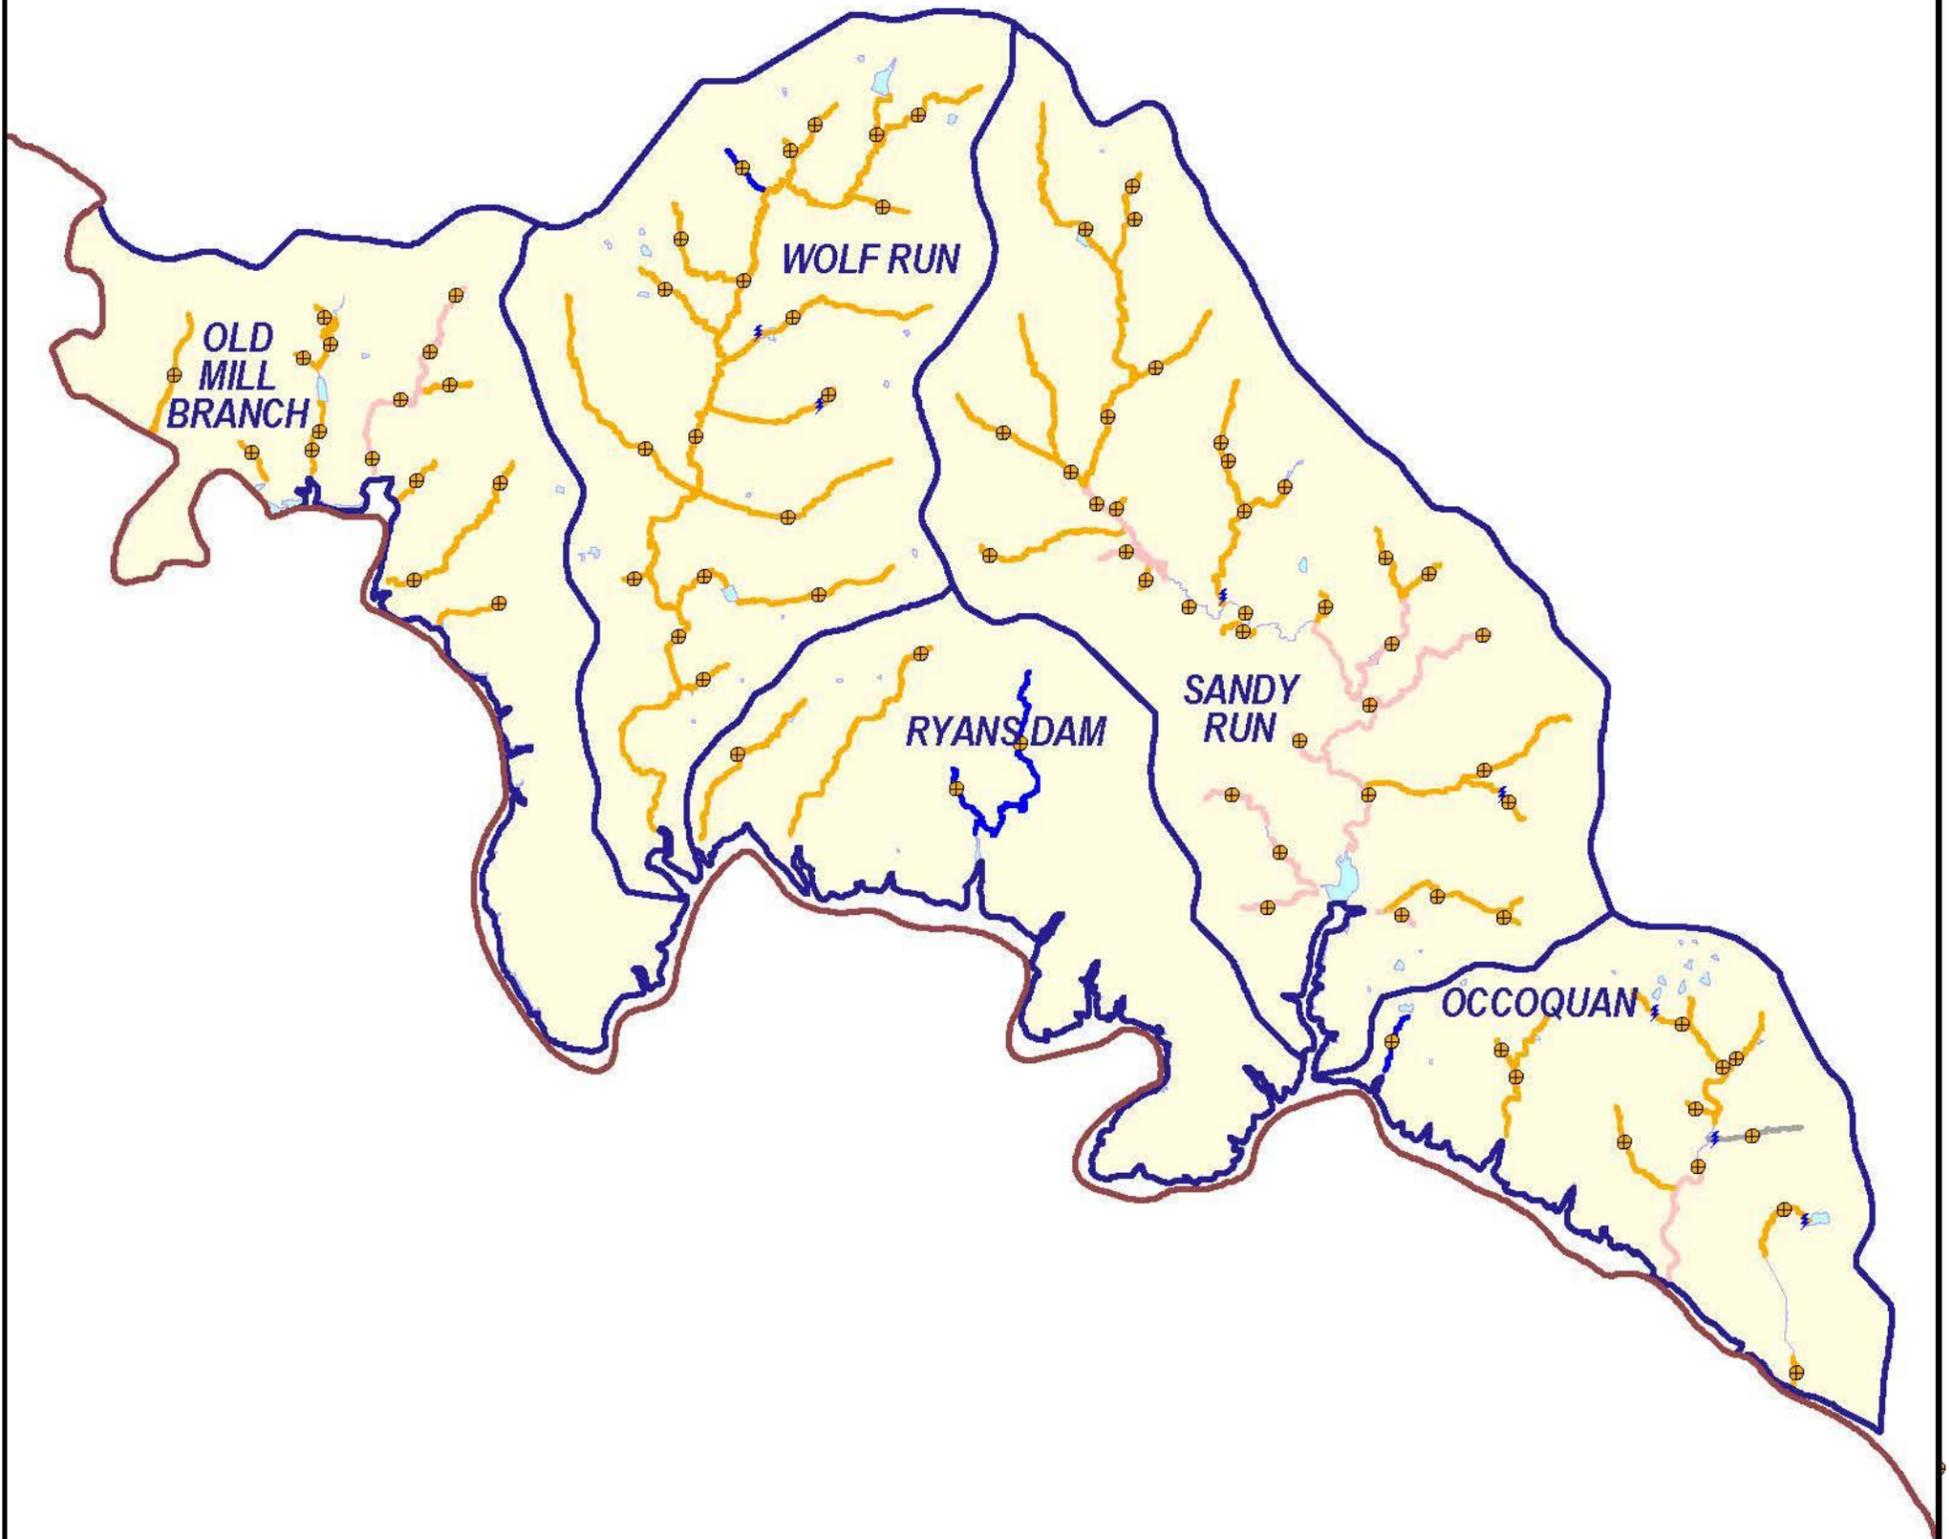
**Figure 3-73**  
**Habitat Assessment**  
**Upper Occoquan Group**  
**Fairfax County Stream Physical Assessment**

**Habitat.** The habitat assessment results for Old Mill Branch Watershed are summarized by stream in Table 3-49. Habitat scores for each reach are depicted in Figure 3-73. Based on a length weighted habitat score of 99 (Table 3-2), Old Mill Branch Watershed is lower range of quality compared to the rest of the County. Nearly all 6 miles of stream assessed were categorized as “fair.”

**Habitat.** The habitat assessment results for Wolf Run Watershed are summarized by stream in Table 3-51. Habitat scores for each reach are depicted in Figure 3-73. Based on a length weighted habitat score of 99 (Table 3-2), Wolf Run Watershed is in the lower range of quality, compared to the rest of the County. Approximately 1.5 miles of stream were categorized as having “poor” habitat conditions, 11 miles as “fair,” and 3 miles as “good.”

**Habitat.** The habitat assessment results for Sandy Run Watershed are summarized by stream in Table 3-53. Habitat scores for each reach are depicted in Figure 3-73. Based on a length weighted habitat score of 104 (Table 3-2), Sandy Run Watershed is in the middle range of quality, compared to the rest of the County. Approximately 17 miles of stream were categorized as having “fair” habitat conditions and 3 miles as “fair.”

**Habitat.** The habitat assessment results for Ryans Dam Watershed are summarized by stream in Table 3-55. Habitat scores for each reach are depicted in Figure 3-73. Based on a length weighted habitat score of 145 (Table 3-2), Ryans Dam Watershed is the highest rated watershed in the County. Nearly 2 miles of stream were categorized as having “good” habitat conditions and 2.5 miles as “excellent.”

**Habitat.** The habitat assessment results for Occoquan Watershed are summarized by stream in Table 3-57. Habitat scores for each reach are depicted in Figure 3-73. Based on a length weighted habitat score of 117 (Table 3-2), Occoquan Watershed is in the upper middle range of quality, compared to the rest of the County. Approximately 3 miles of stream were categorized as having “fair” habitat conditions and 3 miles as “good.”
