*Final Report*

# **Fairfax County Stream Physical Assessment**

Prepared for  
**Department of Public Works and  
Environmental Services  
Fairfax County, Virginia**

August 2005

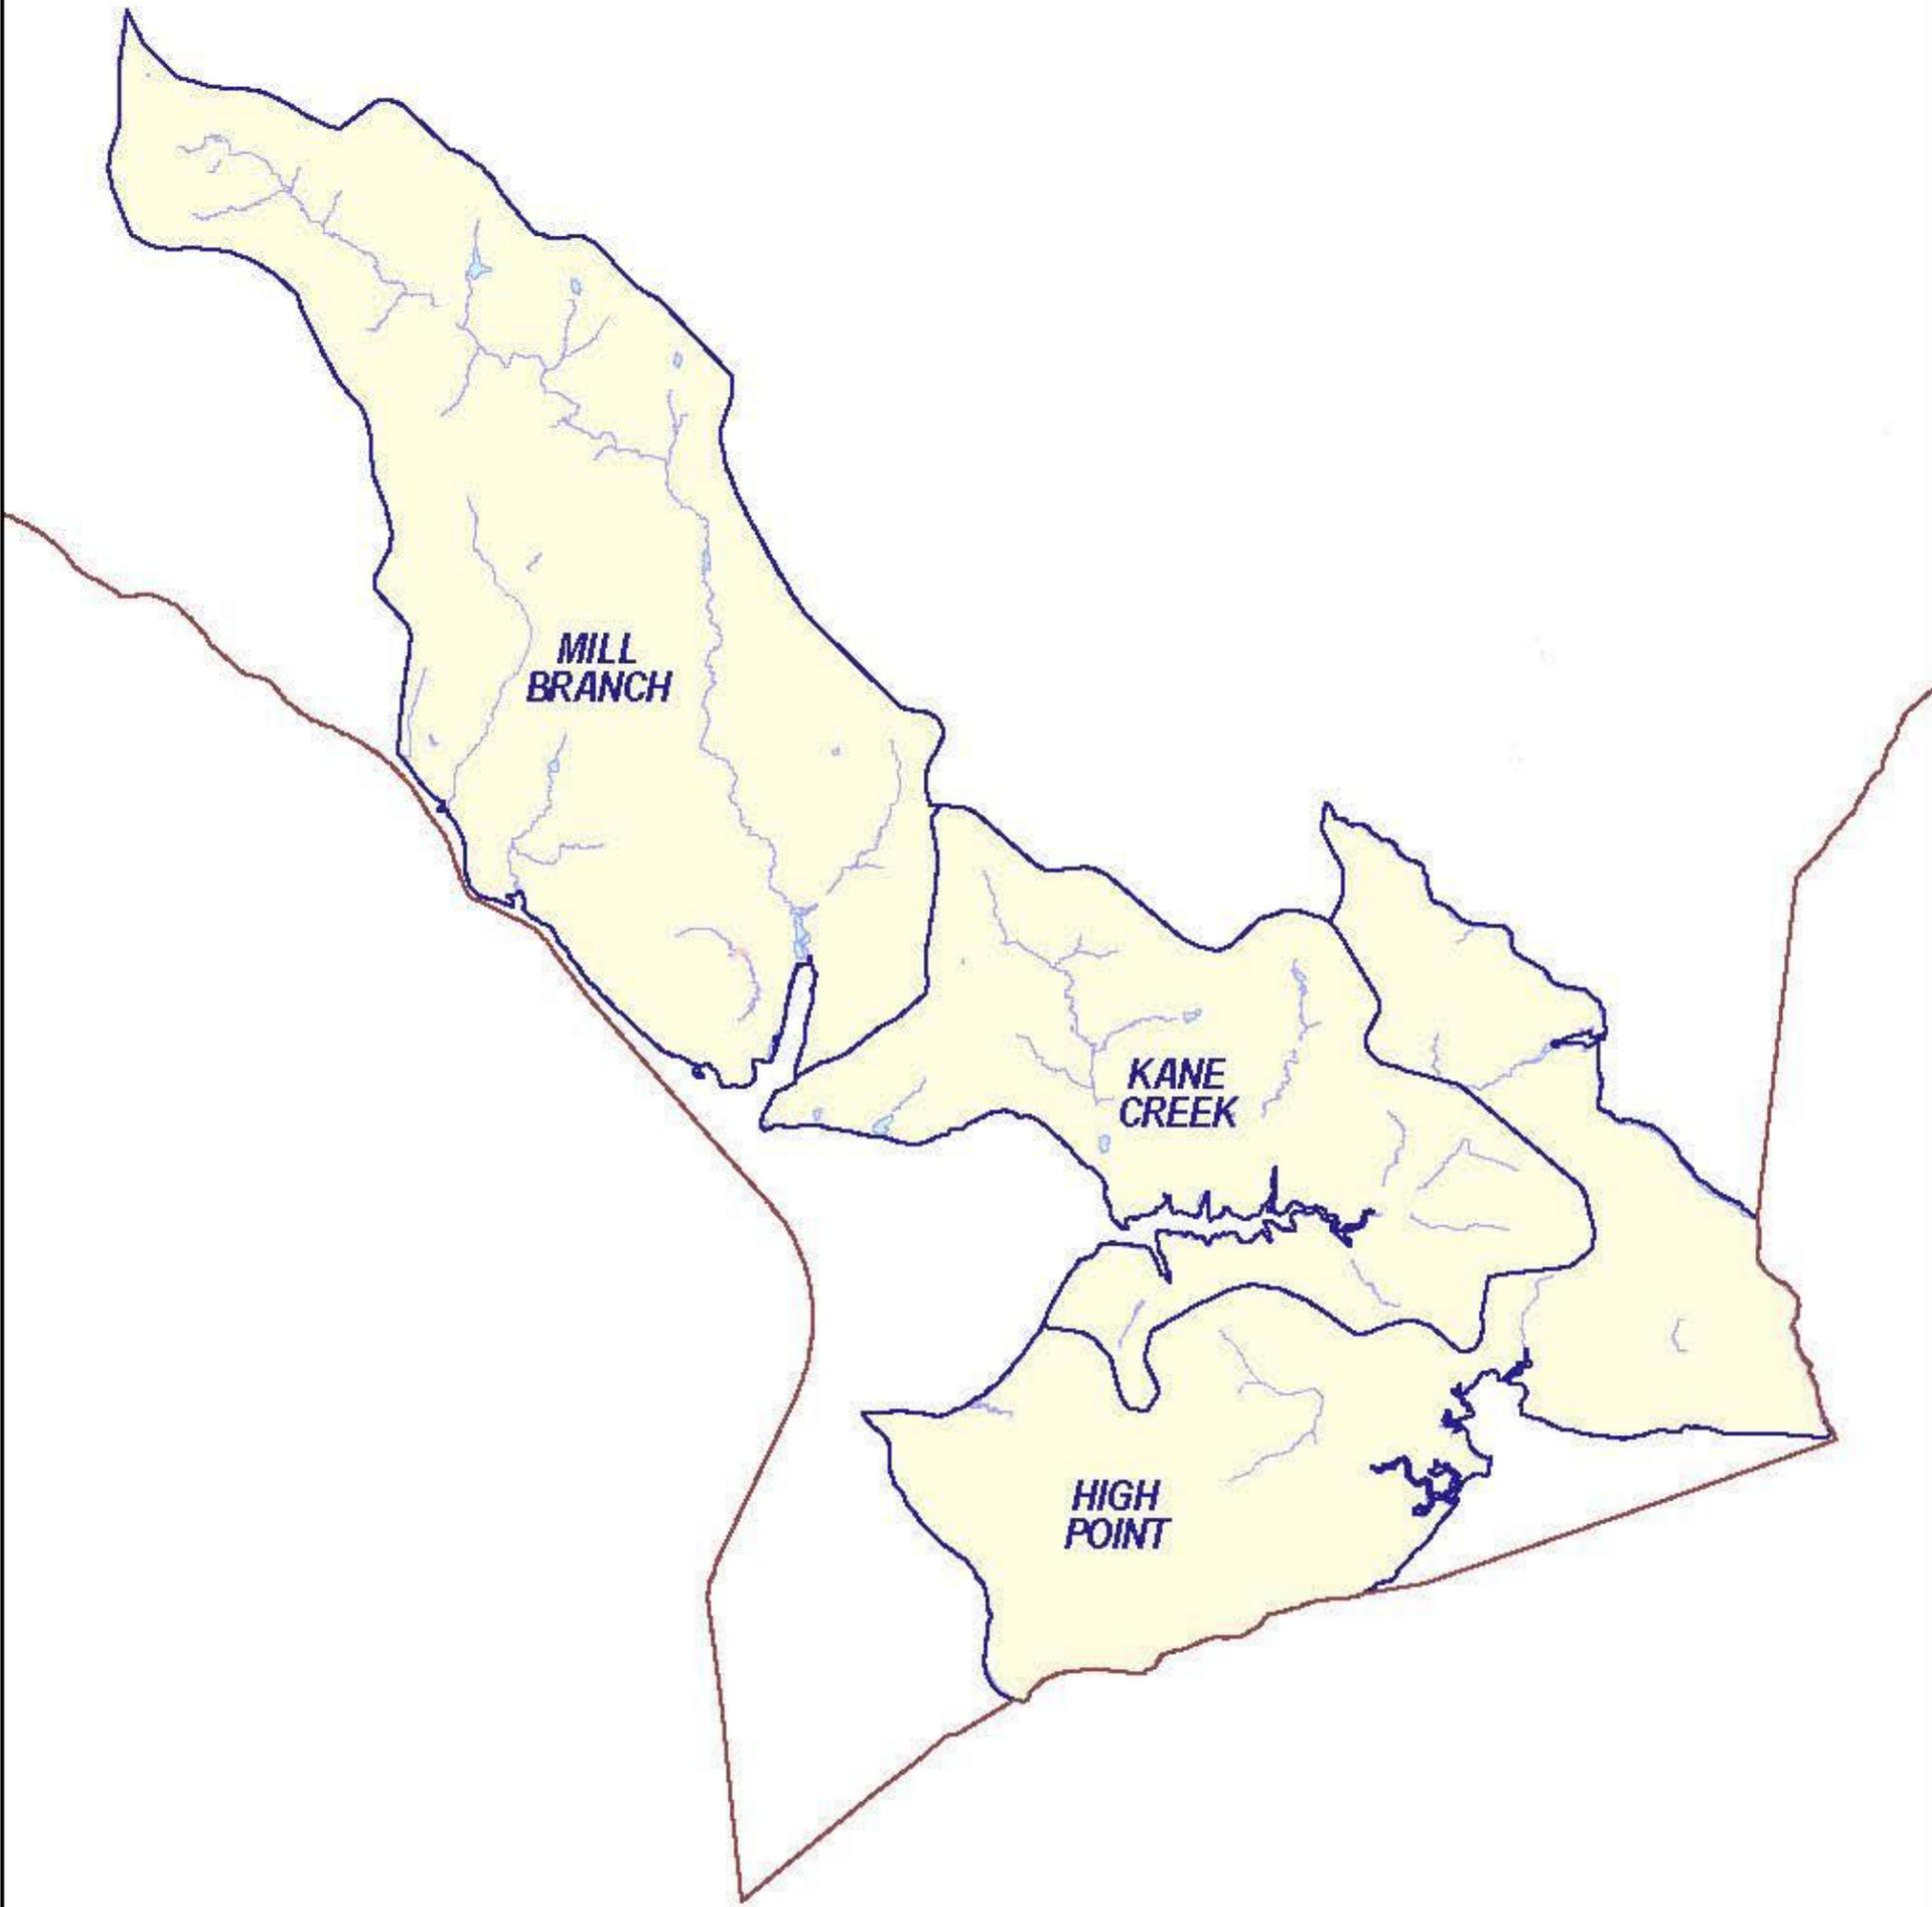
**Figure 3-81**  
**CEM Stages**  
**Lower Occoquan Group**  
**Fairfax County Stream Physical Assessment**

**CEM.** Based on the CEM evaluations approximately three quarters of the channels assessed in Mill Branch Watershed are in Evolutionary Stage 3 (Table 3-3), with the remainder of the watershed in Stage 2. Figure 3-81 summarizes the CEM results for Mill Branch Watershed.
