3.2.5 Cameron Run Group Summary

3.2.5.1 Cameron Run Watershed

3.2.6 Lower Potomac Group Summary

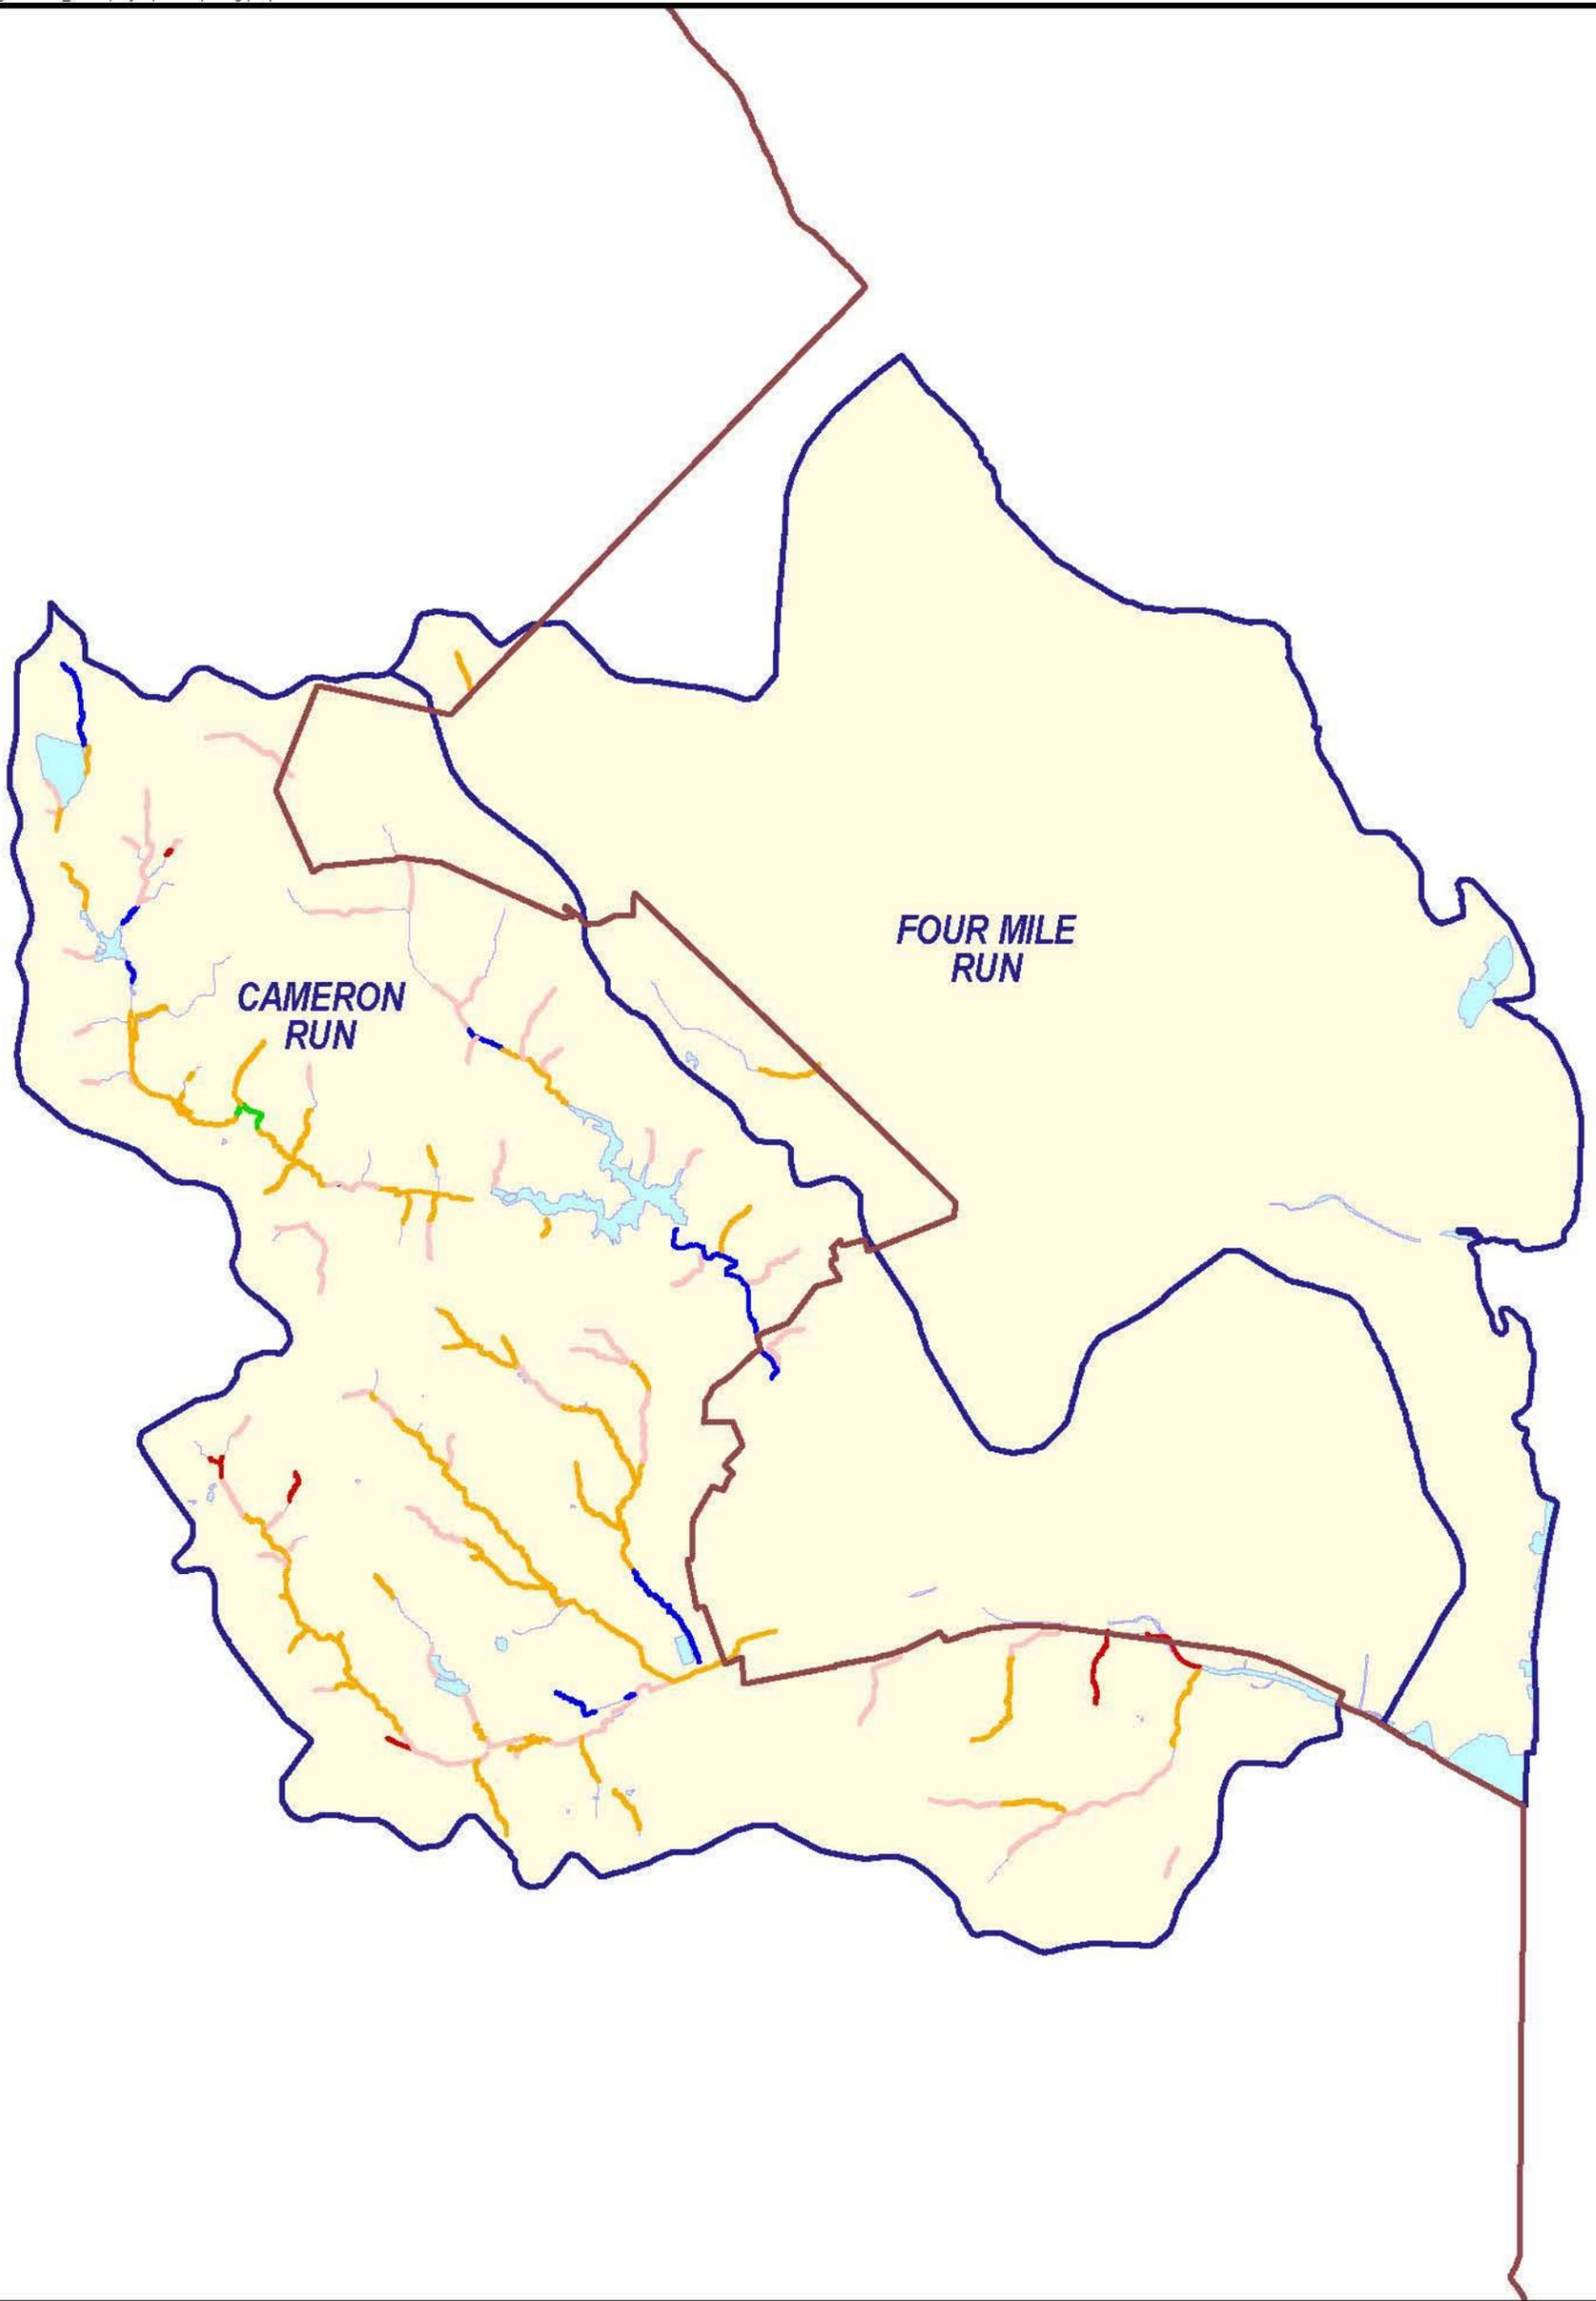
Habitat. The habitat assessment results for Cameron Run Watershed are summarized by stream in Table 3-25. Habitat scores for each reach are depicted in Figure 3-31. Based on a length weighted habitat score of 92 (Table 3-2), Cameron Run Watershed is one of the poorest watersheds, compared to the rest of the County. Approximately 2 miles of stream were categorized as having “very poor” habitat conditions, 19 miles as “poor,” 23 miles as “fair,” and 4 miles as “good.”

Figure 3-31
Habitat Assessment
Cameron Run Group
Fairfax County Stream Physical Assessment

Habitat. The habitat assessment results for Four Mile Run Watershed are summarized by stream in Table 3-27. Habitat scores for each reach are depicted in Figure 3-31. Based on a length weighted habitat score of 96 (Table 3-2), Four Mile Run Watershed is in the lower range of quality, compared to the rest of the County. Nearly the entire mile assessed was categorized as “fair.”

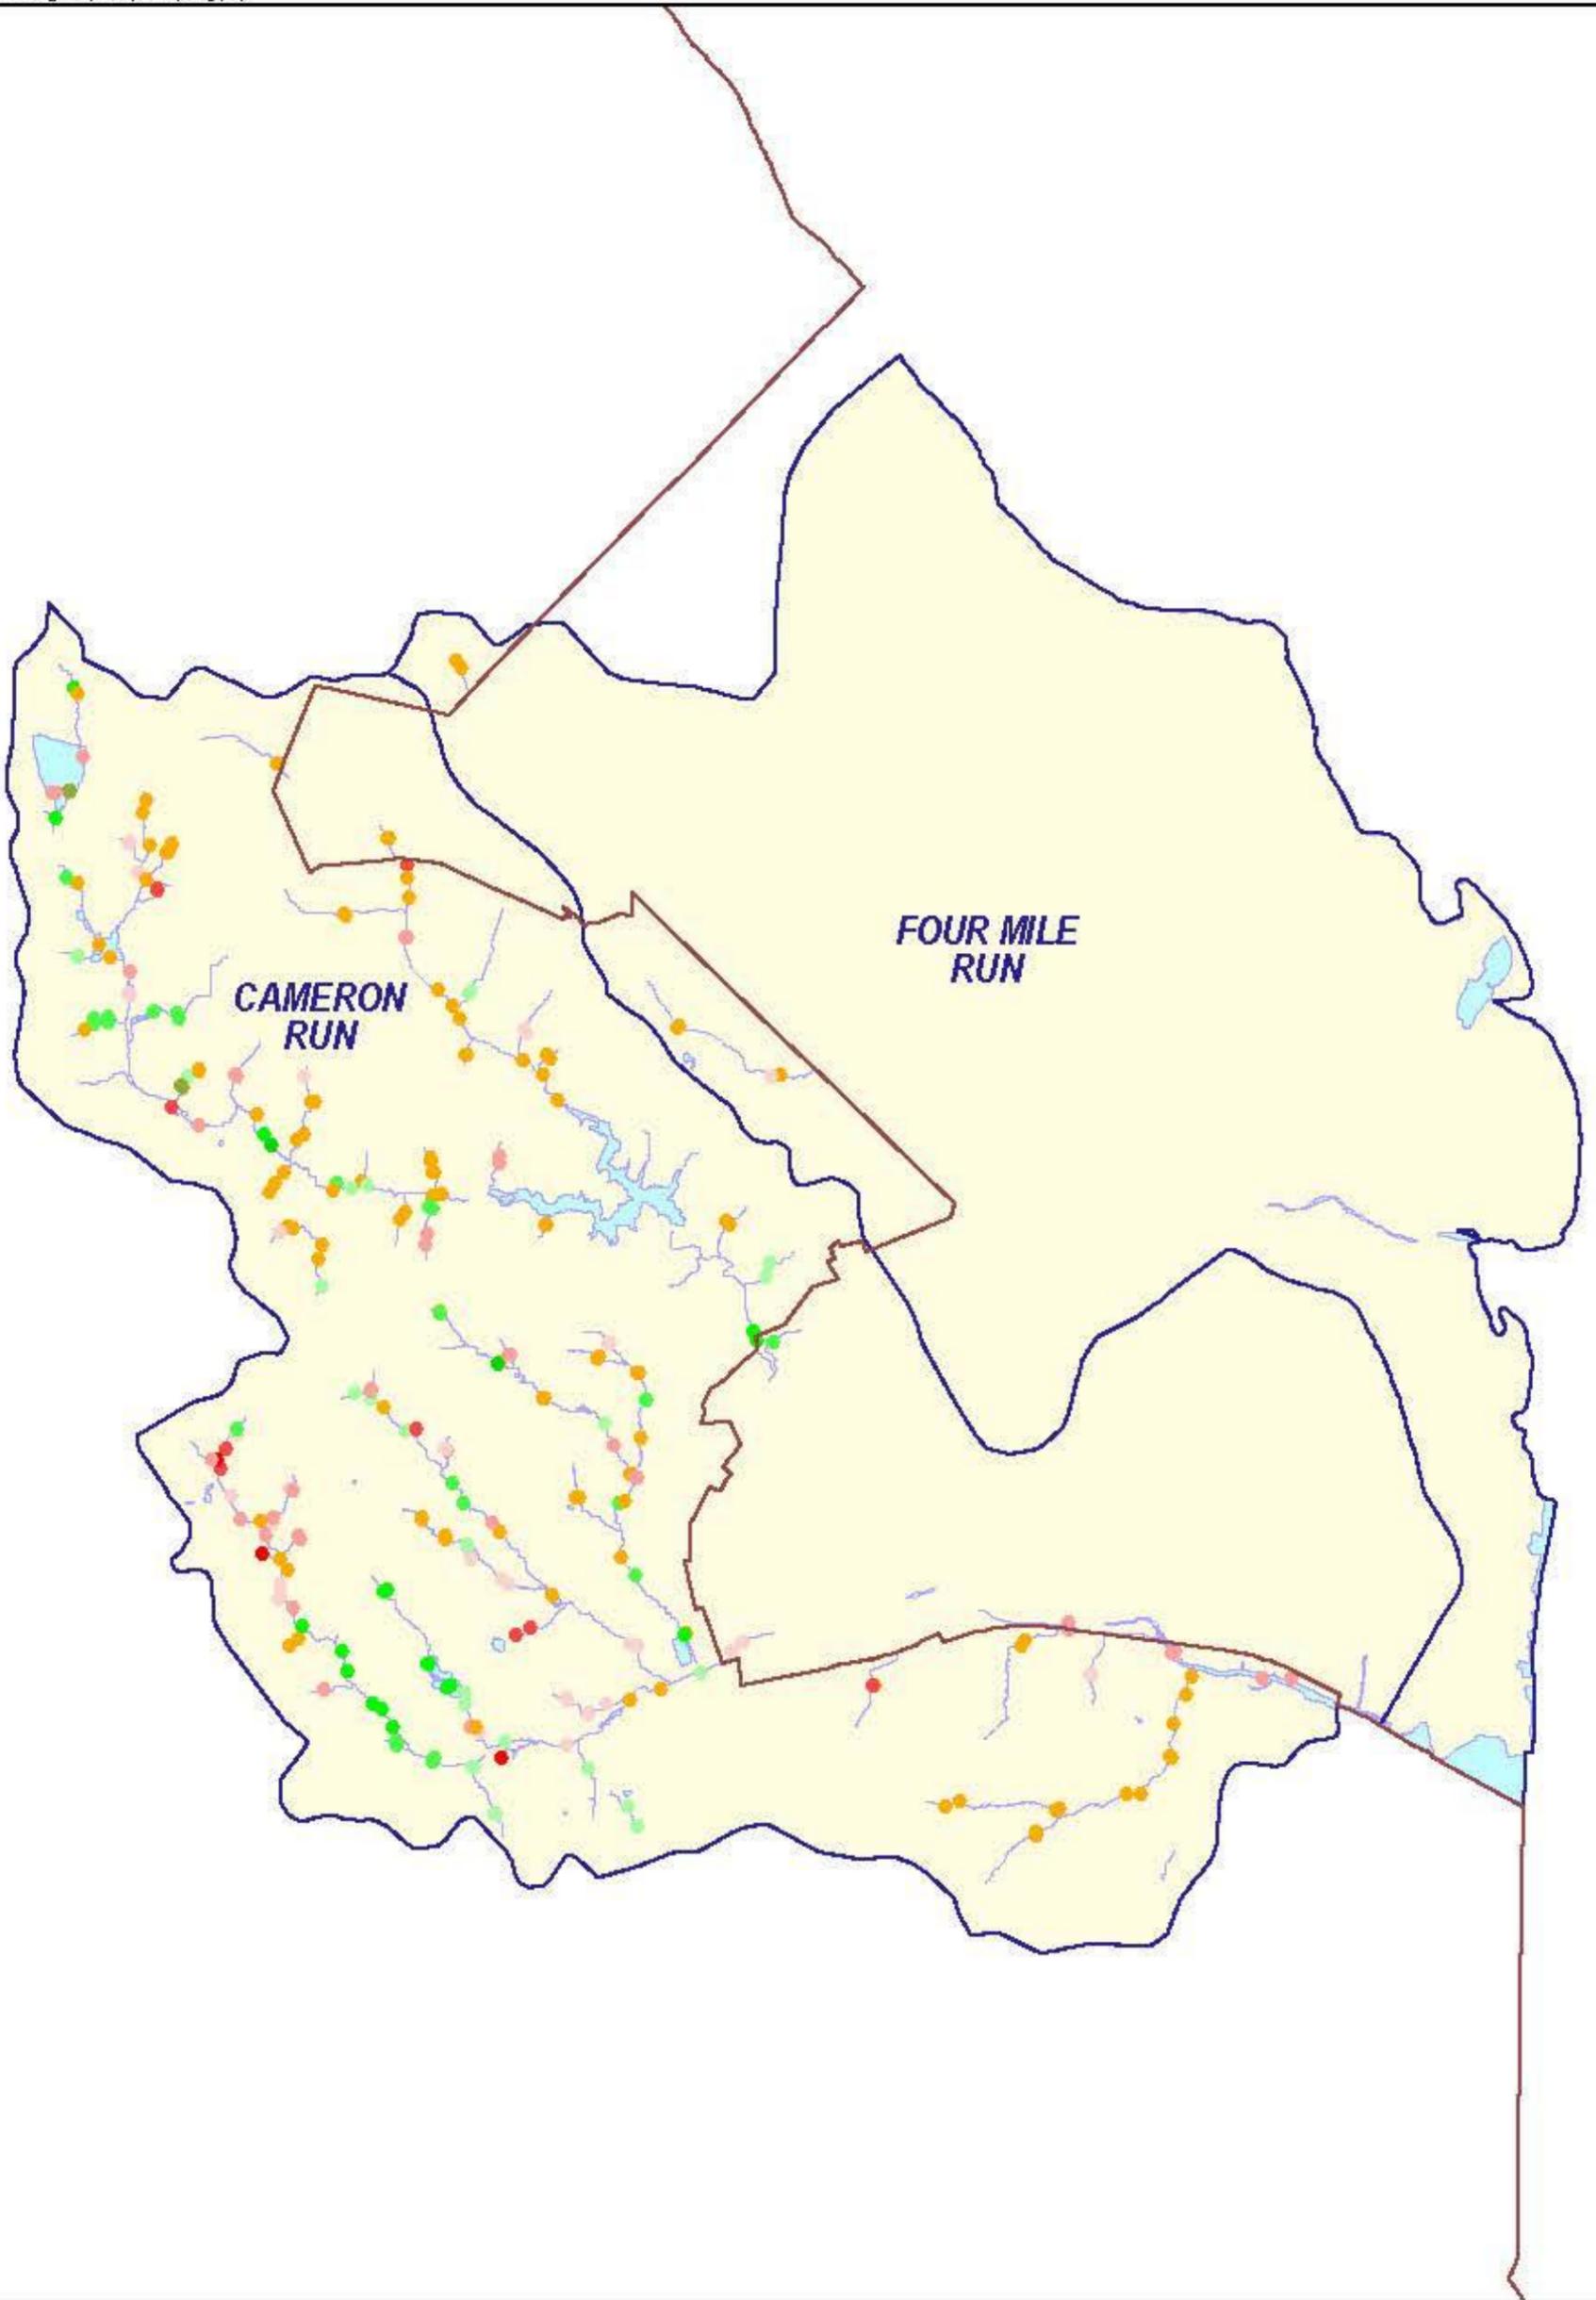
Infrastructure. The infrastructure inventory resulted in 1015 inventory points. The most significant problems were related to a utility line, which was given an impact score of 15, and several pipes, ditches, erosional areas that were given impact scores of 10. The infrastructure inventory results are summarized in Table 3-26. Figures 3-33, 3-34, 3-35, 3-36, and 3-37 summarize impact scores for the erosion problems; deficient buffers; crossings; pipes/ ditches; and dumps, obstructions, and utilities, respectively.

Figure 3-34
Deficient Buffer Impacts
Cameron Run Group
Fairfax County Stream Physical Assessment

Infrastructure. The infrastructure inventory resulted in 32 inventory points. The most significant problems were related to two utilities and a buffer, which was given impact scores of 6. The infrastructure inventory results are summarized in Table 3-28. Figures 3-33, 3-34, 3-35, 3-36, and 3-37 summarize impact scores for the erosion problems; deficient buffers; crossings; pipes/ ditches; and dumps, obstructions, and utilities, respectively.

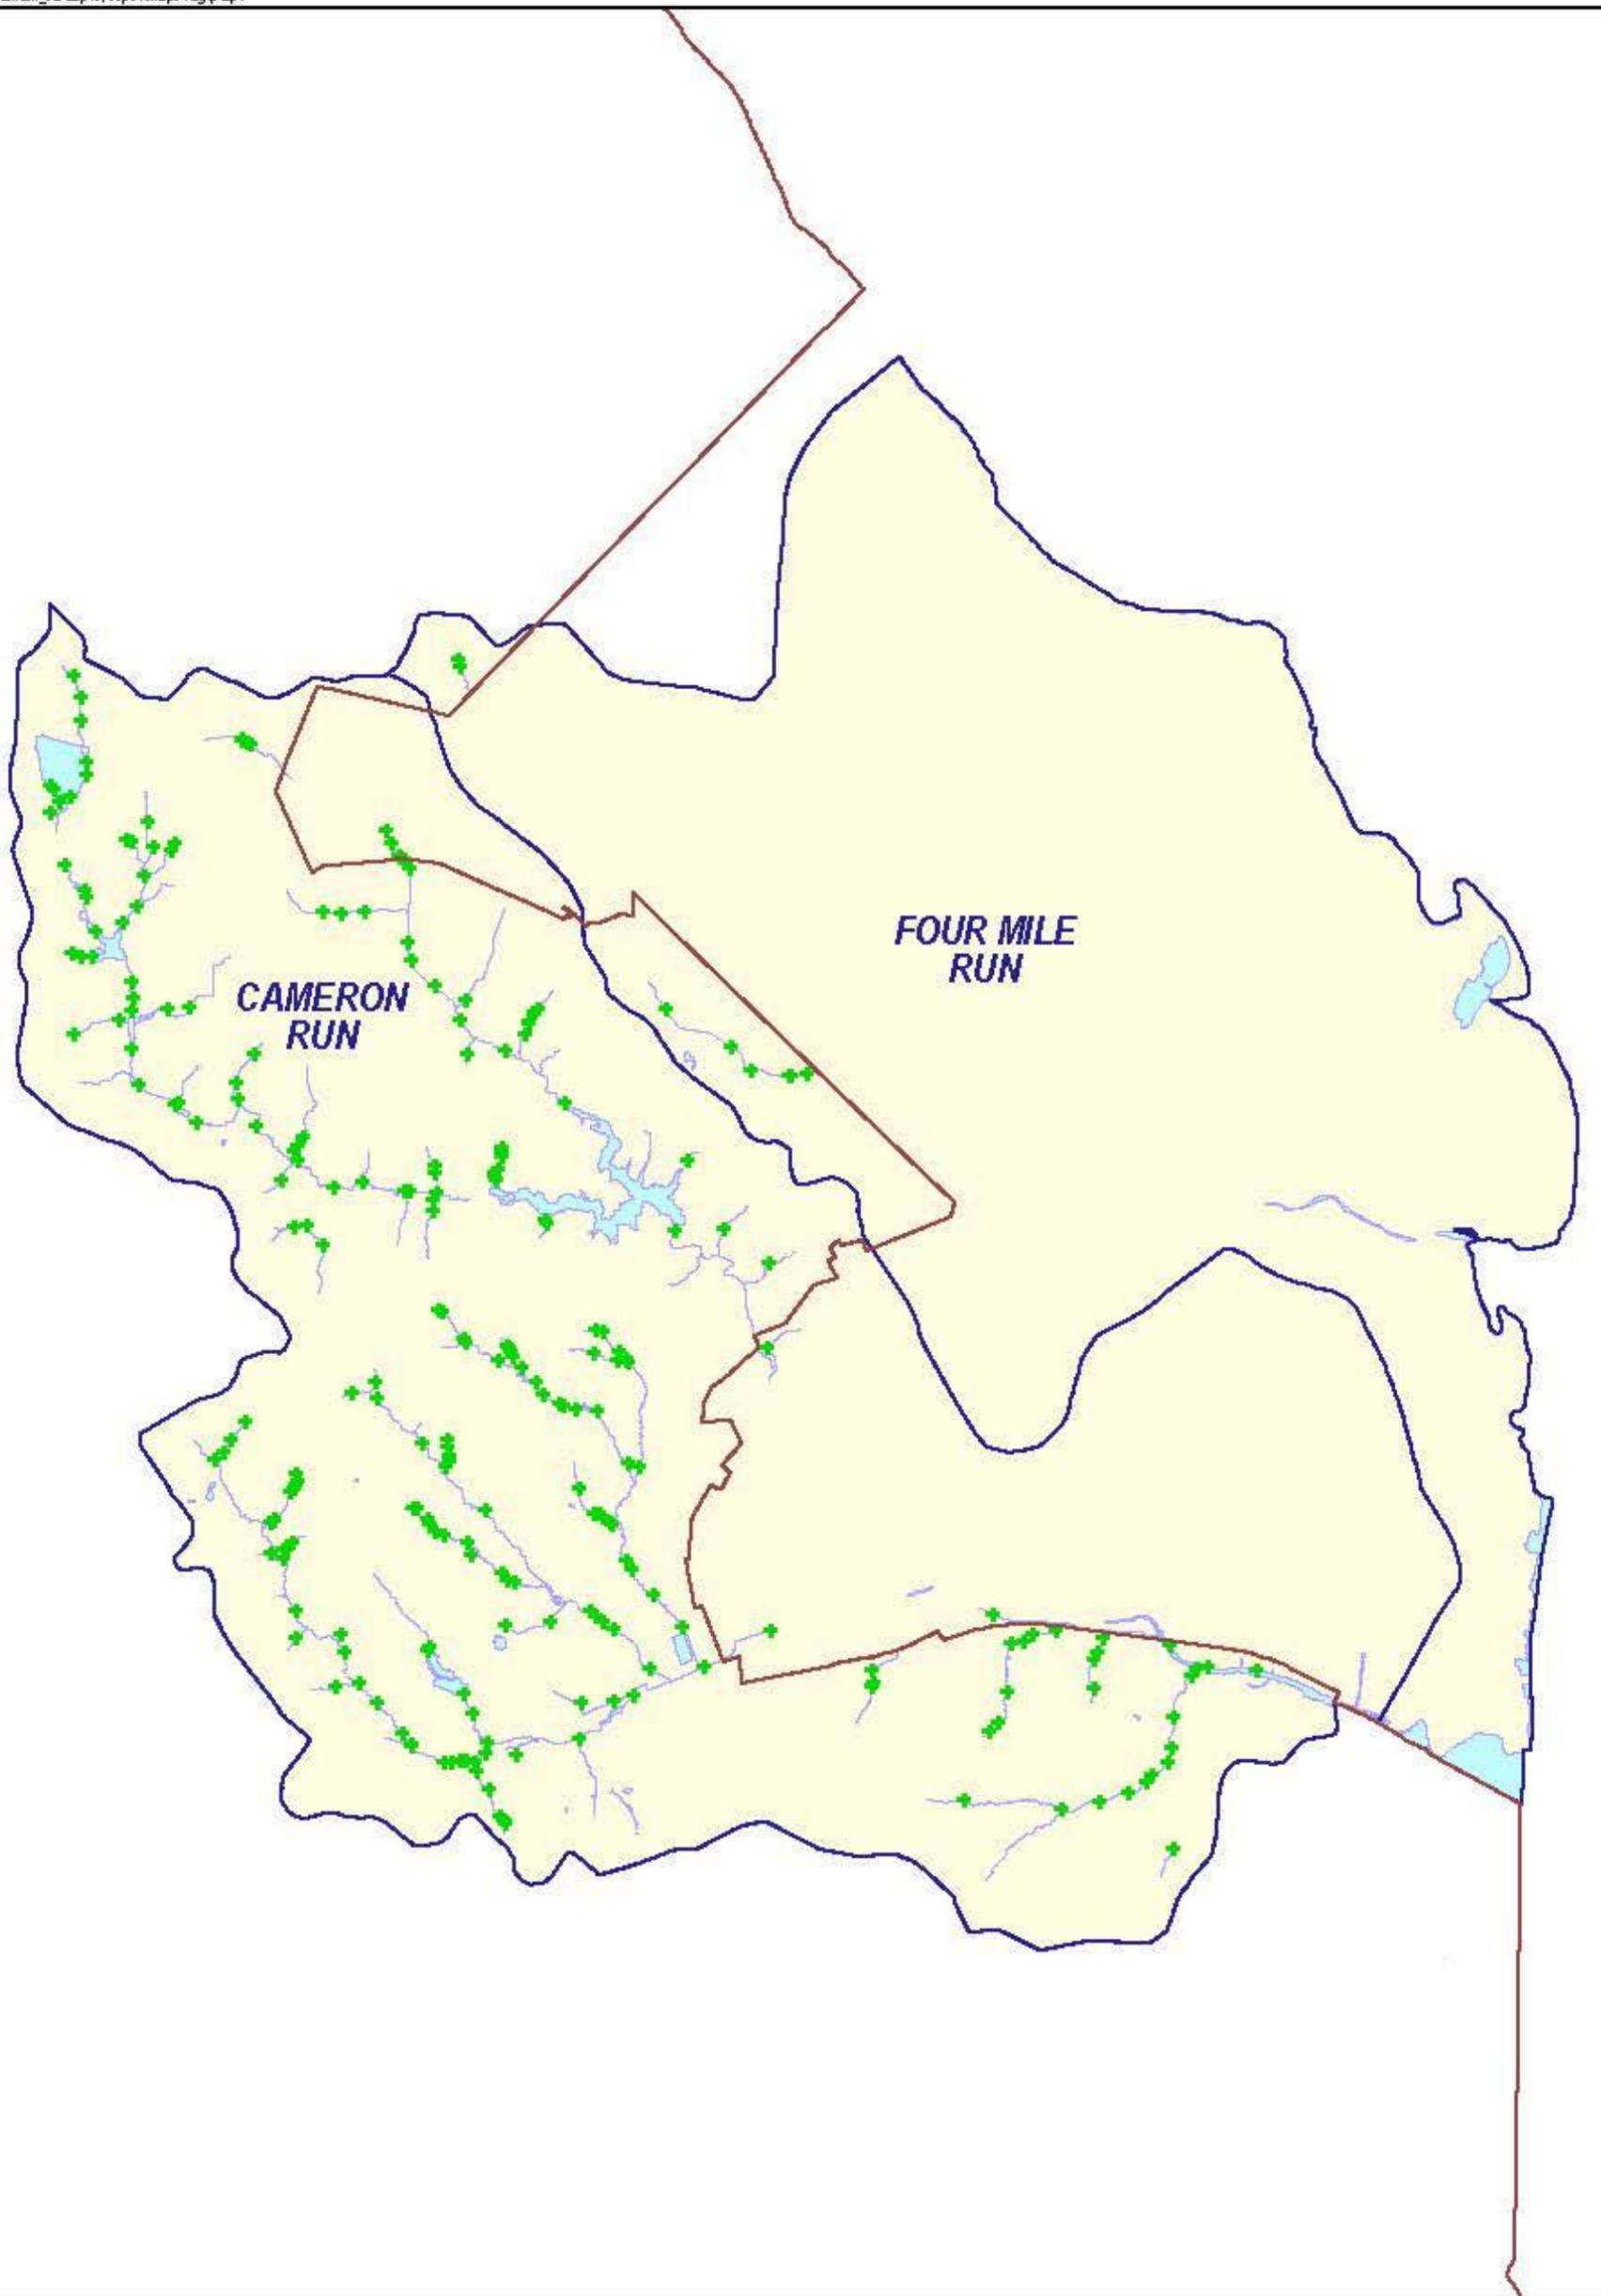
**Figure 3-35
Crossings
Cameron Run Group
Fairfax County Stream Physical Assessment**

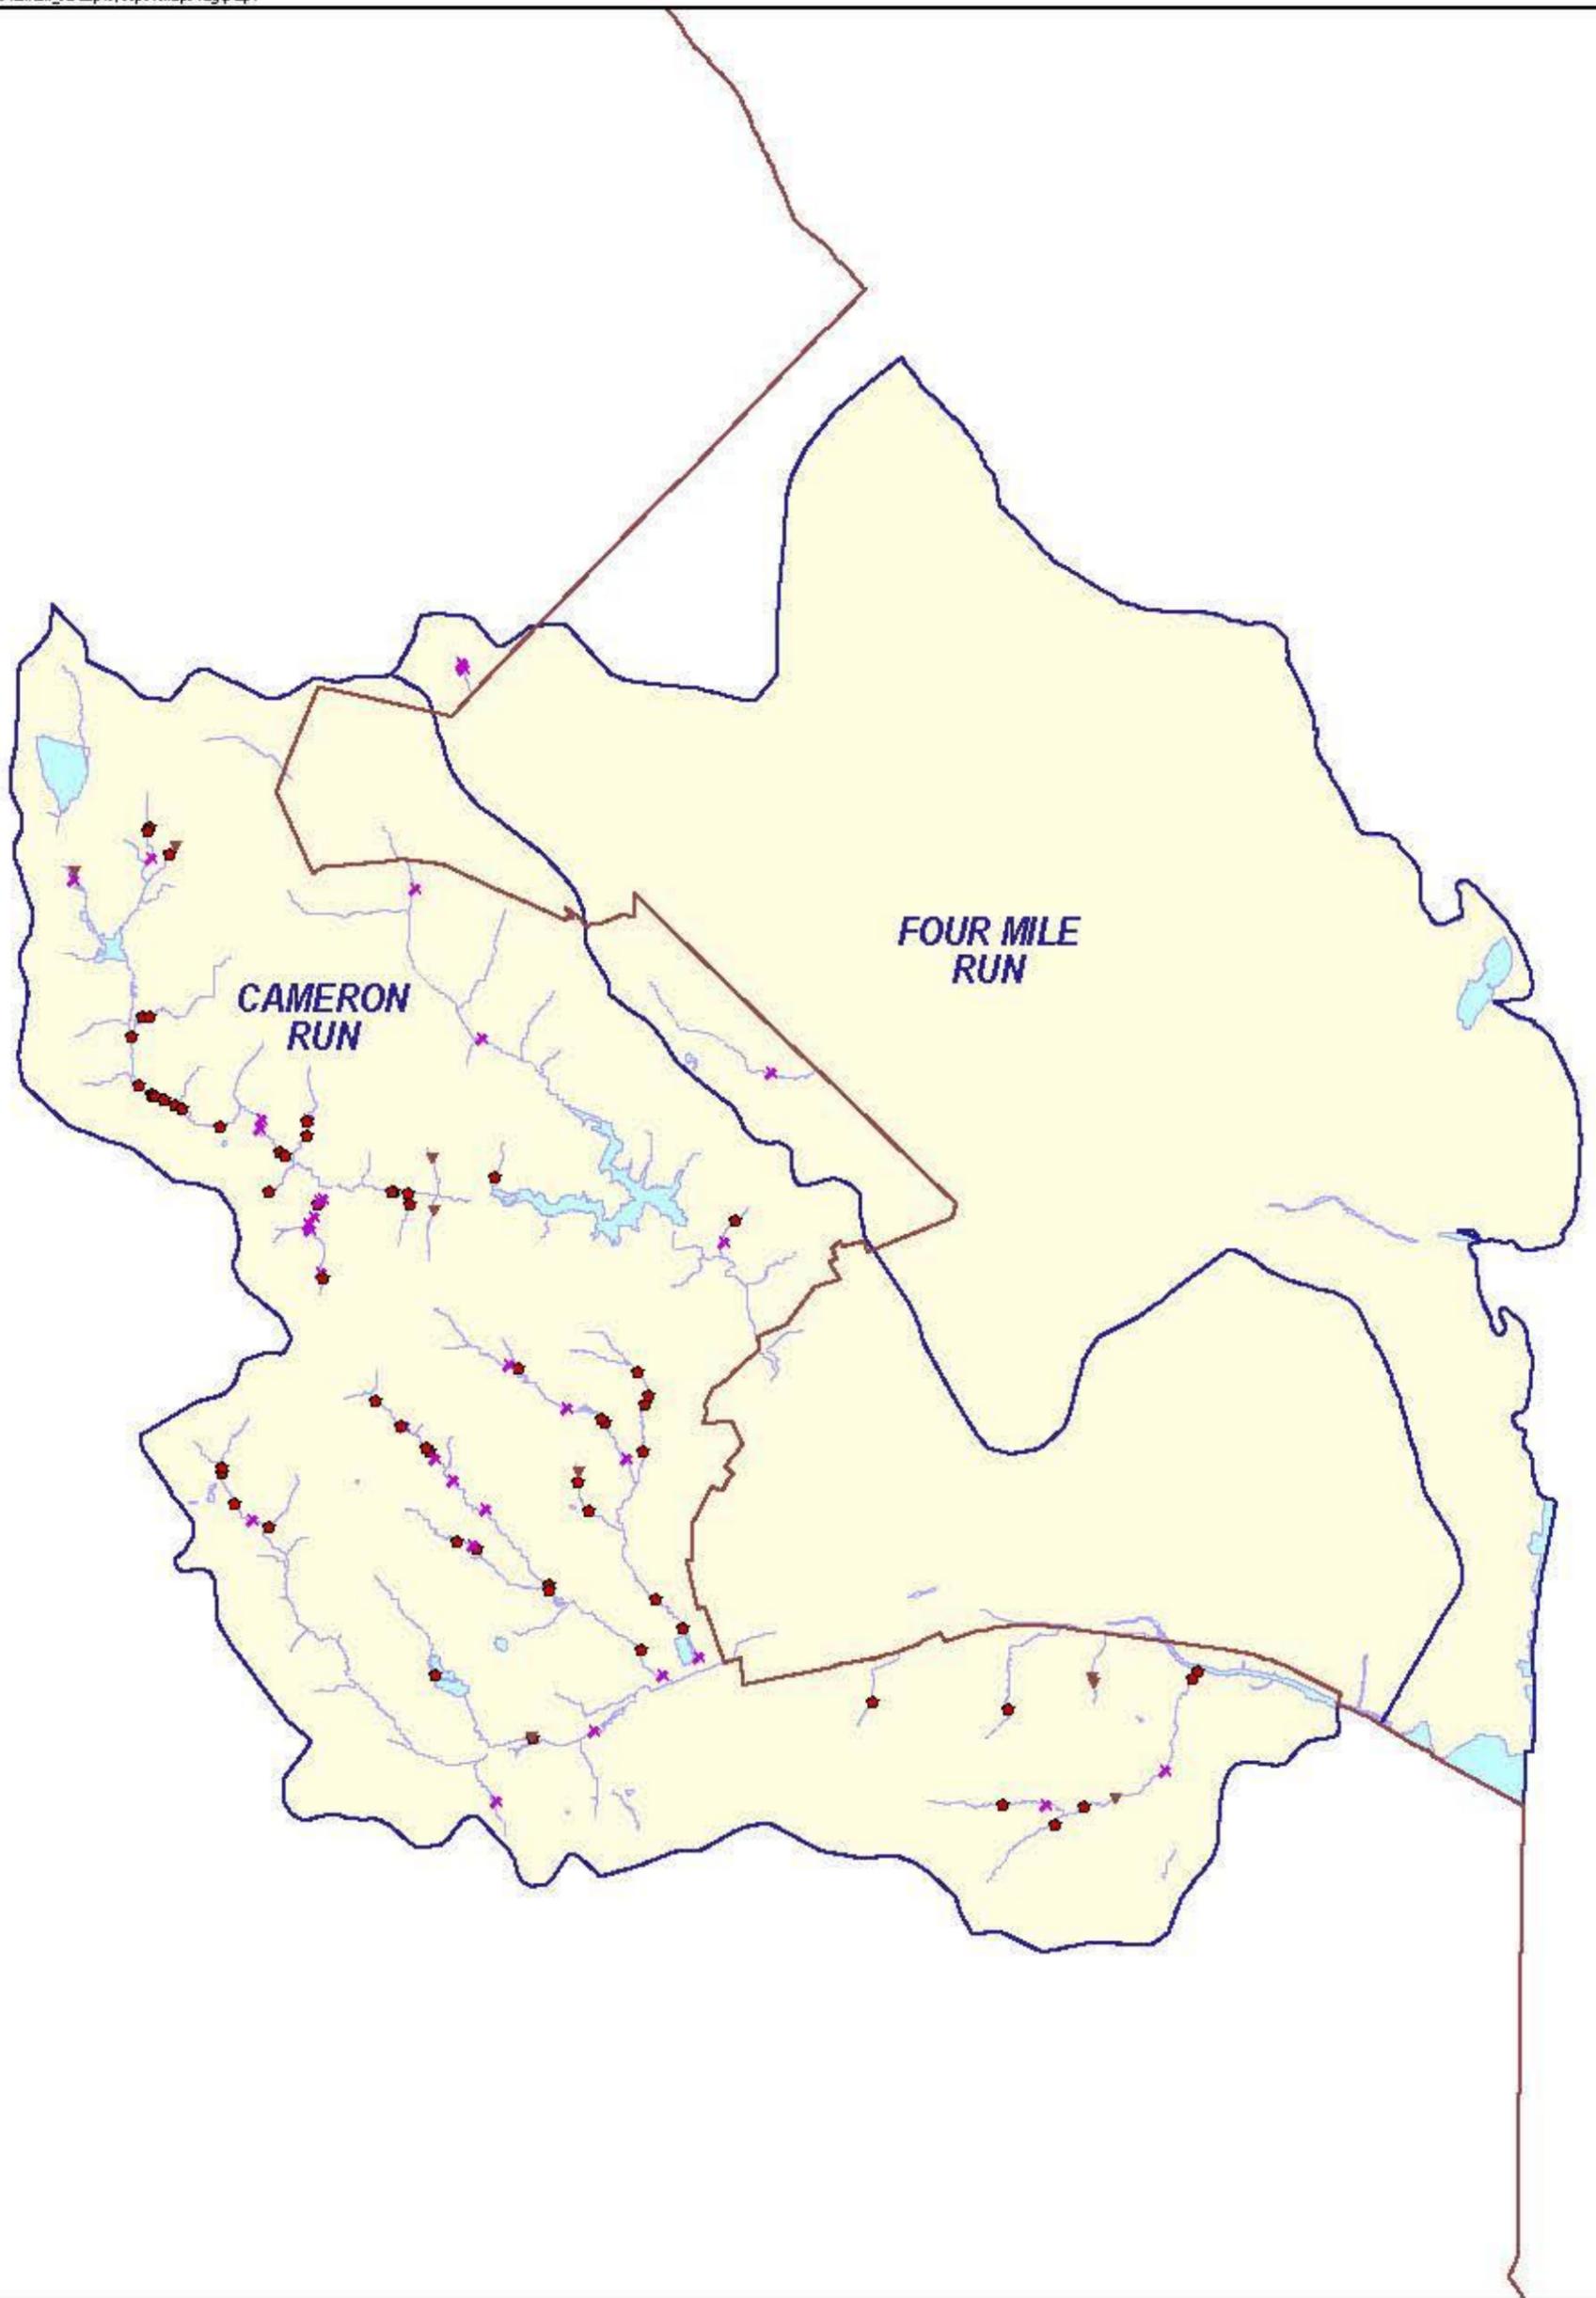
Figure 3-37
Dumps, Obstructions, and Utilities
Cameron Run Group
Fairfax County Stream Physical Assessment

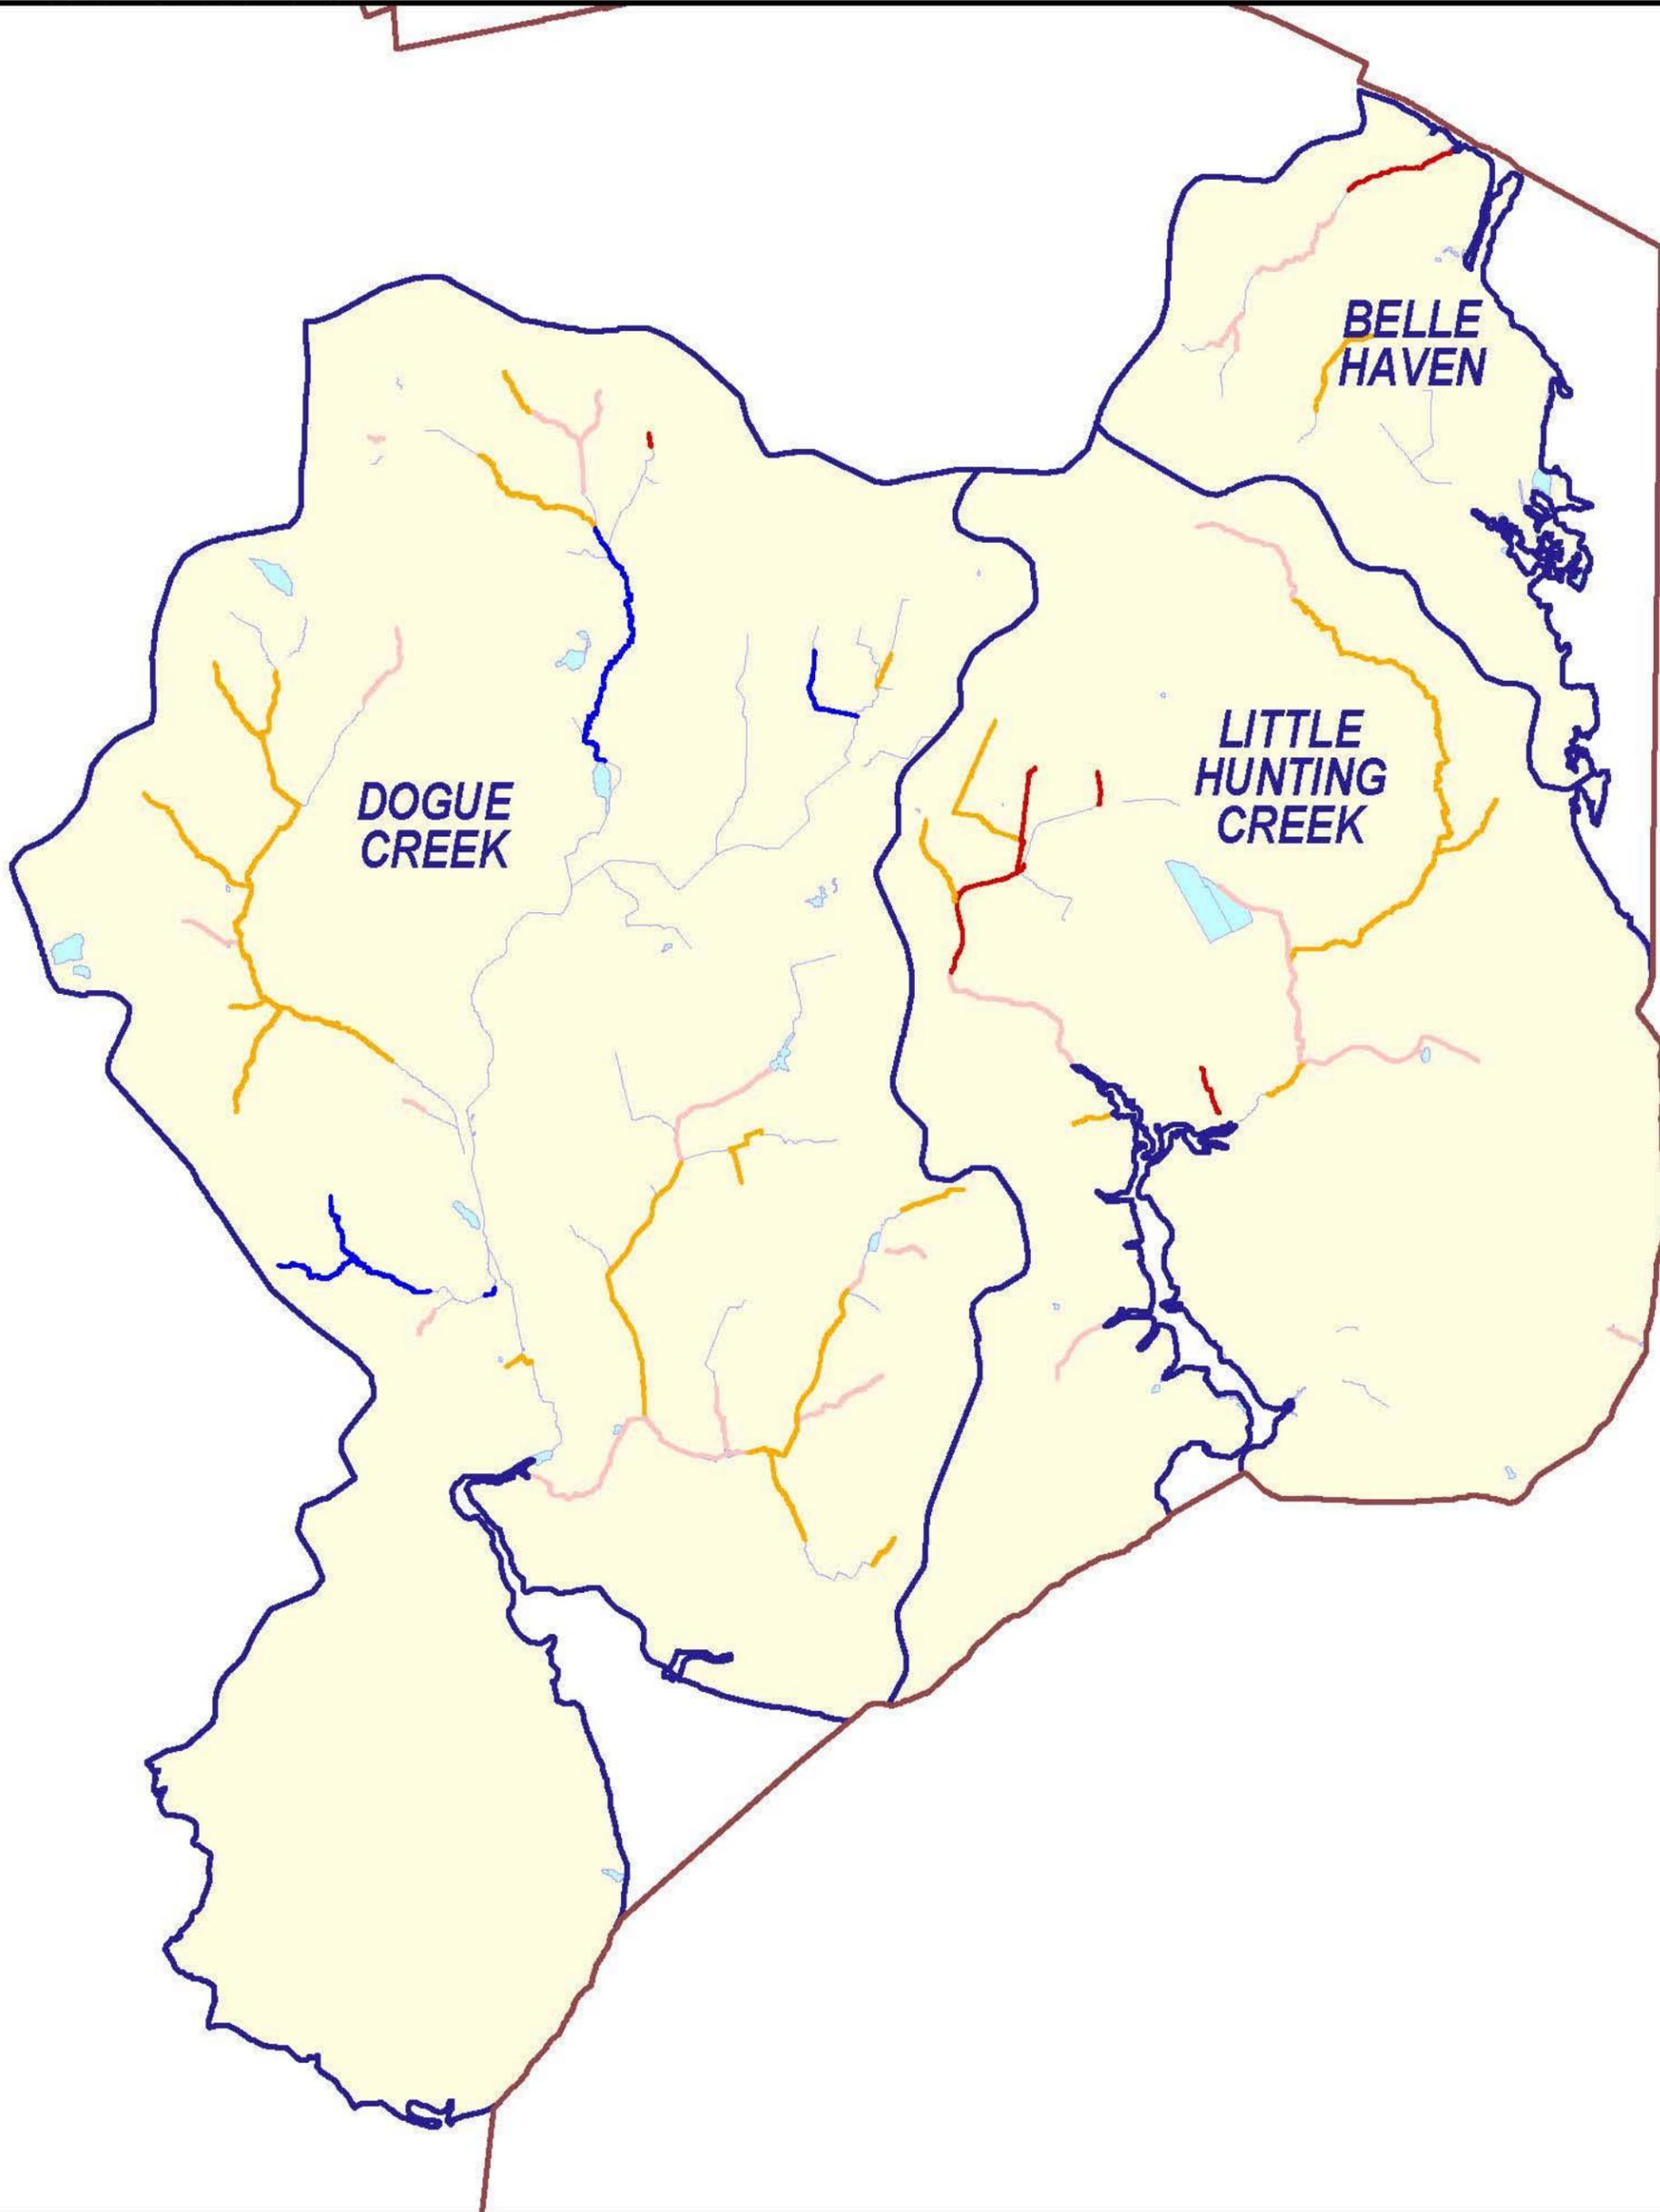
Habitat. The habitat assessment results for Dogue Creek Watershed are summarized by stream in Table 3-29. Habitat scores for each reach are depicted in Figure 3-38. Based on a length weighted habitat score of 96 (Table 3-2), Dogue Creek Watershed is in the lower range of quality, compared to the rest of the County. Approximately 5 miles of stream were categorized as having “poor” habitat conditions, 9 miles as “fair,” and 3 miles as “good.”

Figure 3-38
Habitat Assessment
Lower Potomac Group
Fairfax County Stream Physical Assessment

Habitat. The habitat assessment results for Little Hunting Creek Watershed are summarized by stream in Table 3-31. Habitat scores for each reach are depicted in Figure 3-38. Based on a length weighted habitat score of 82 (Table 3-2), Little Hunting Creek Watershed is one of the poorest quality watersheds in the County. Approximately 2 miles of stream were categorized as having “very poor” habitat conditions, 4 miles as “poor,” 5 miles as “fair.”

Habitat. The habitat assessment results for Belle Haven Watershed are summarized by stream in Table 3-33. Habitat scores for each reach are depicted in Figure 3-38. Based on a length weighted habitat score of 71 (Table 3-2), Belle Haven Watershed is the poorest quality watershed in the County. Approximately 1 mile of stream was categorized as having “poor” habitat conditions and 0.5 mile as “fair.”
