3.2.5 Cameron Run Group Summary

3.2.5.1 Cameron Run Watershed

3.2.6 Lower Potomac Group Summary

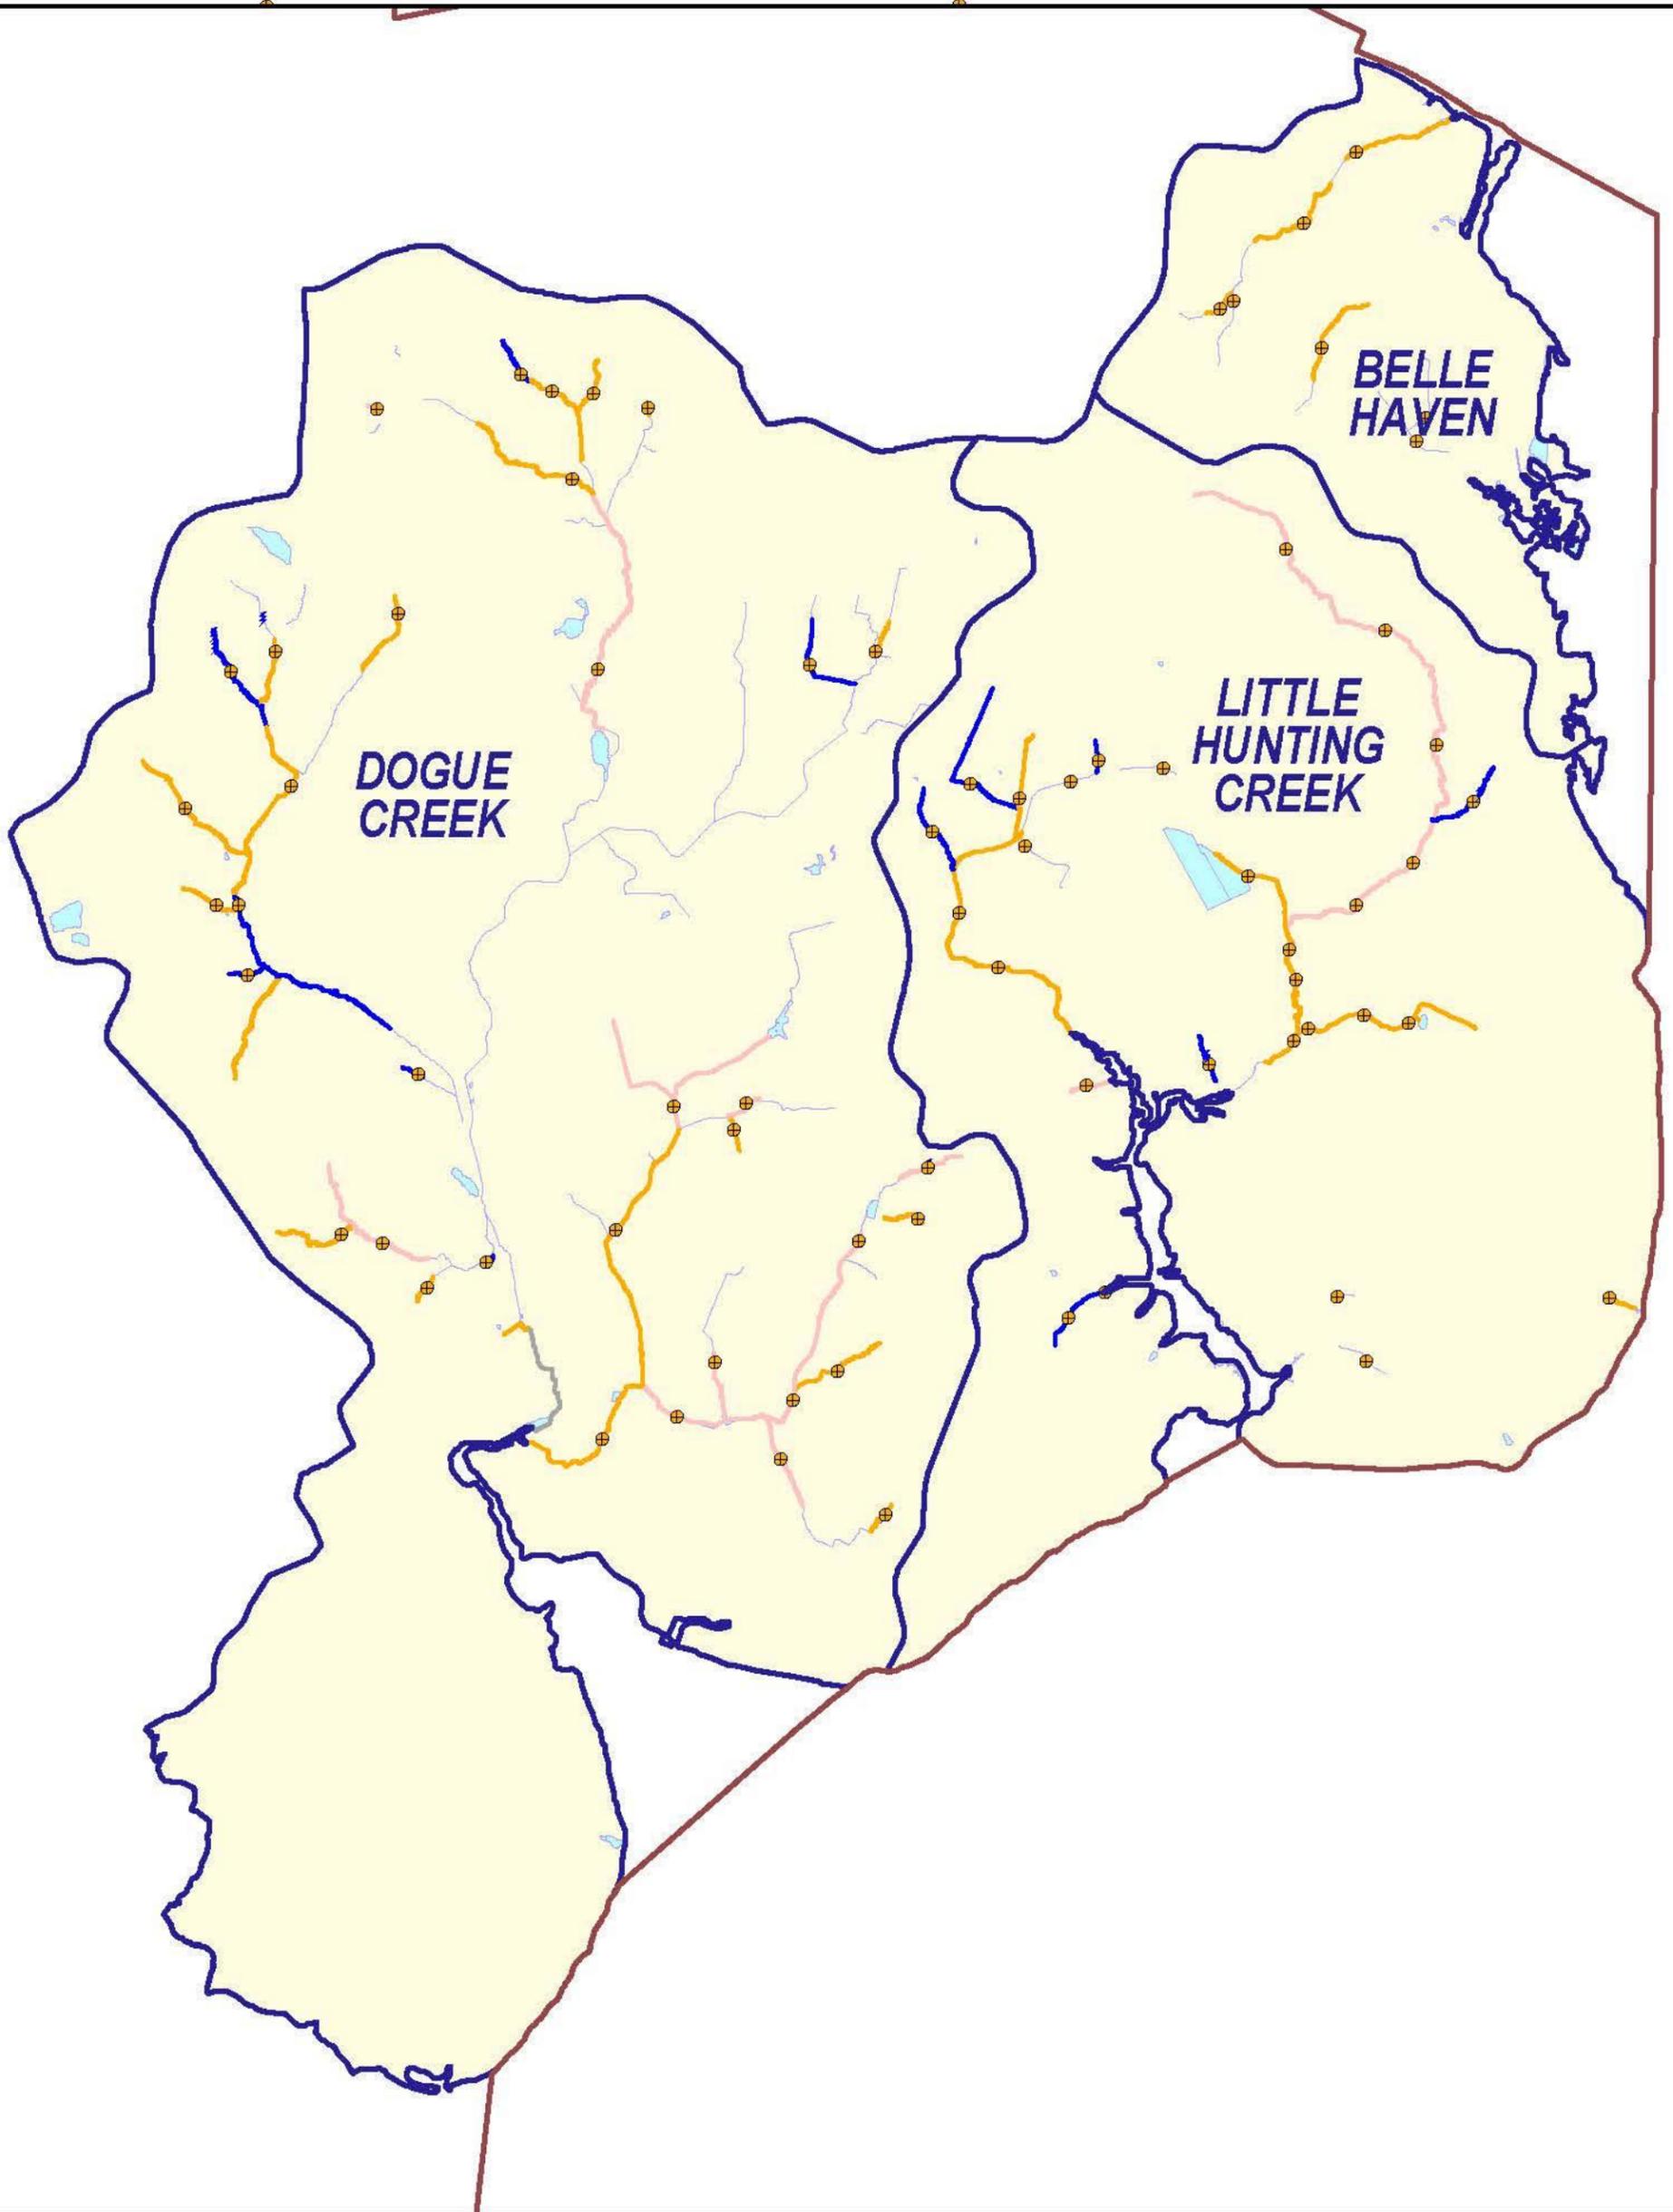
CEM. Based on the CEM evaluations approximately 50 percent of the channels assessed in Dogue Creek Watershed are in Evolutionary Stage 3 (Table 3-3), with most of the remainder of the watershed in Stage 4. Figure 3-39 summarizes the CEM results for Dogue Creek Watershed.

Figure 3-39
CEM Stages
Lower Potomac Group
Fairfax County Stream Physical Assessment

CEM. Based on the CEM evaluations approximately 40 percent of the channels assessed in Little Hunting Creek Watershed are in Evolutionary Stage 3 (Table 3-3), with most of the remainder of the watershed in Stage 4. Figure 3-39 summarizes the CEM results for Little Hunting Creek Watershed.

CEM. Based on the CEM evaluations all of the channels assessed in Belle Haven Watershed are in Evolutionary Stage 3 (Table 3-3). Figure 3-39 summarizes the CEM results for Belle Haven Watershed.

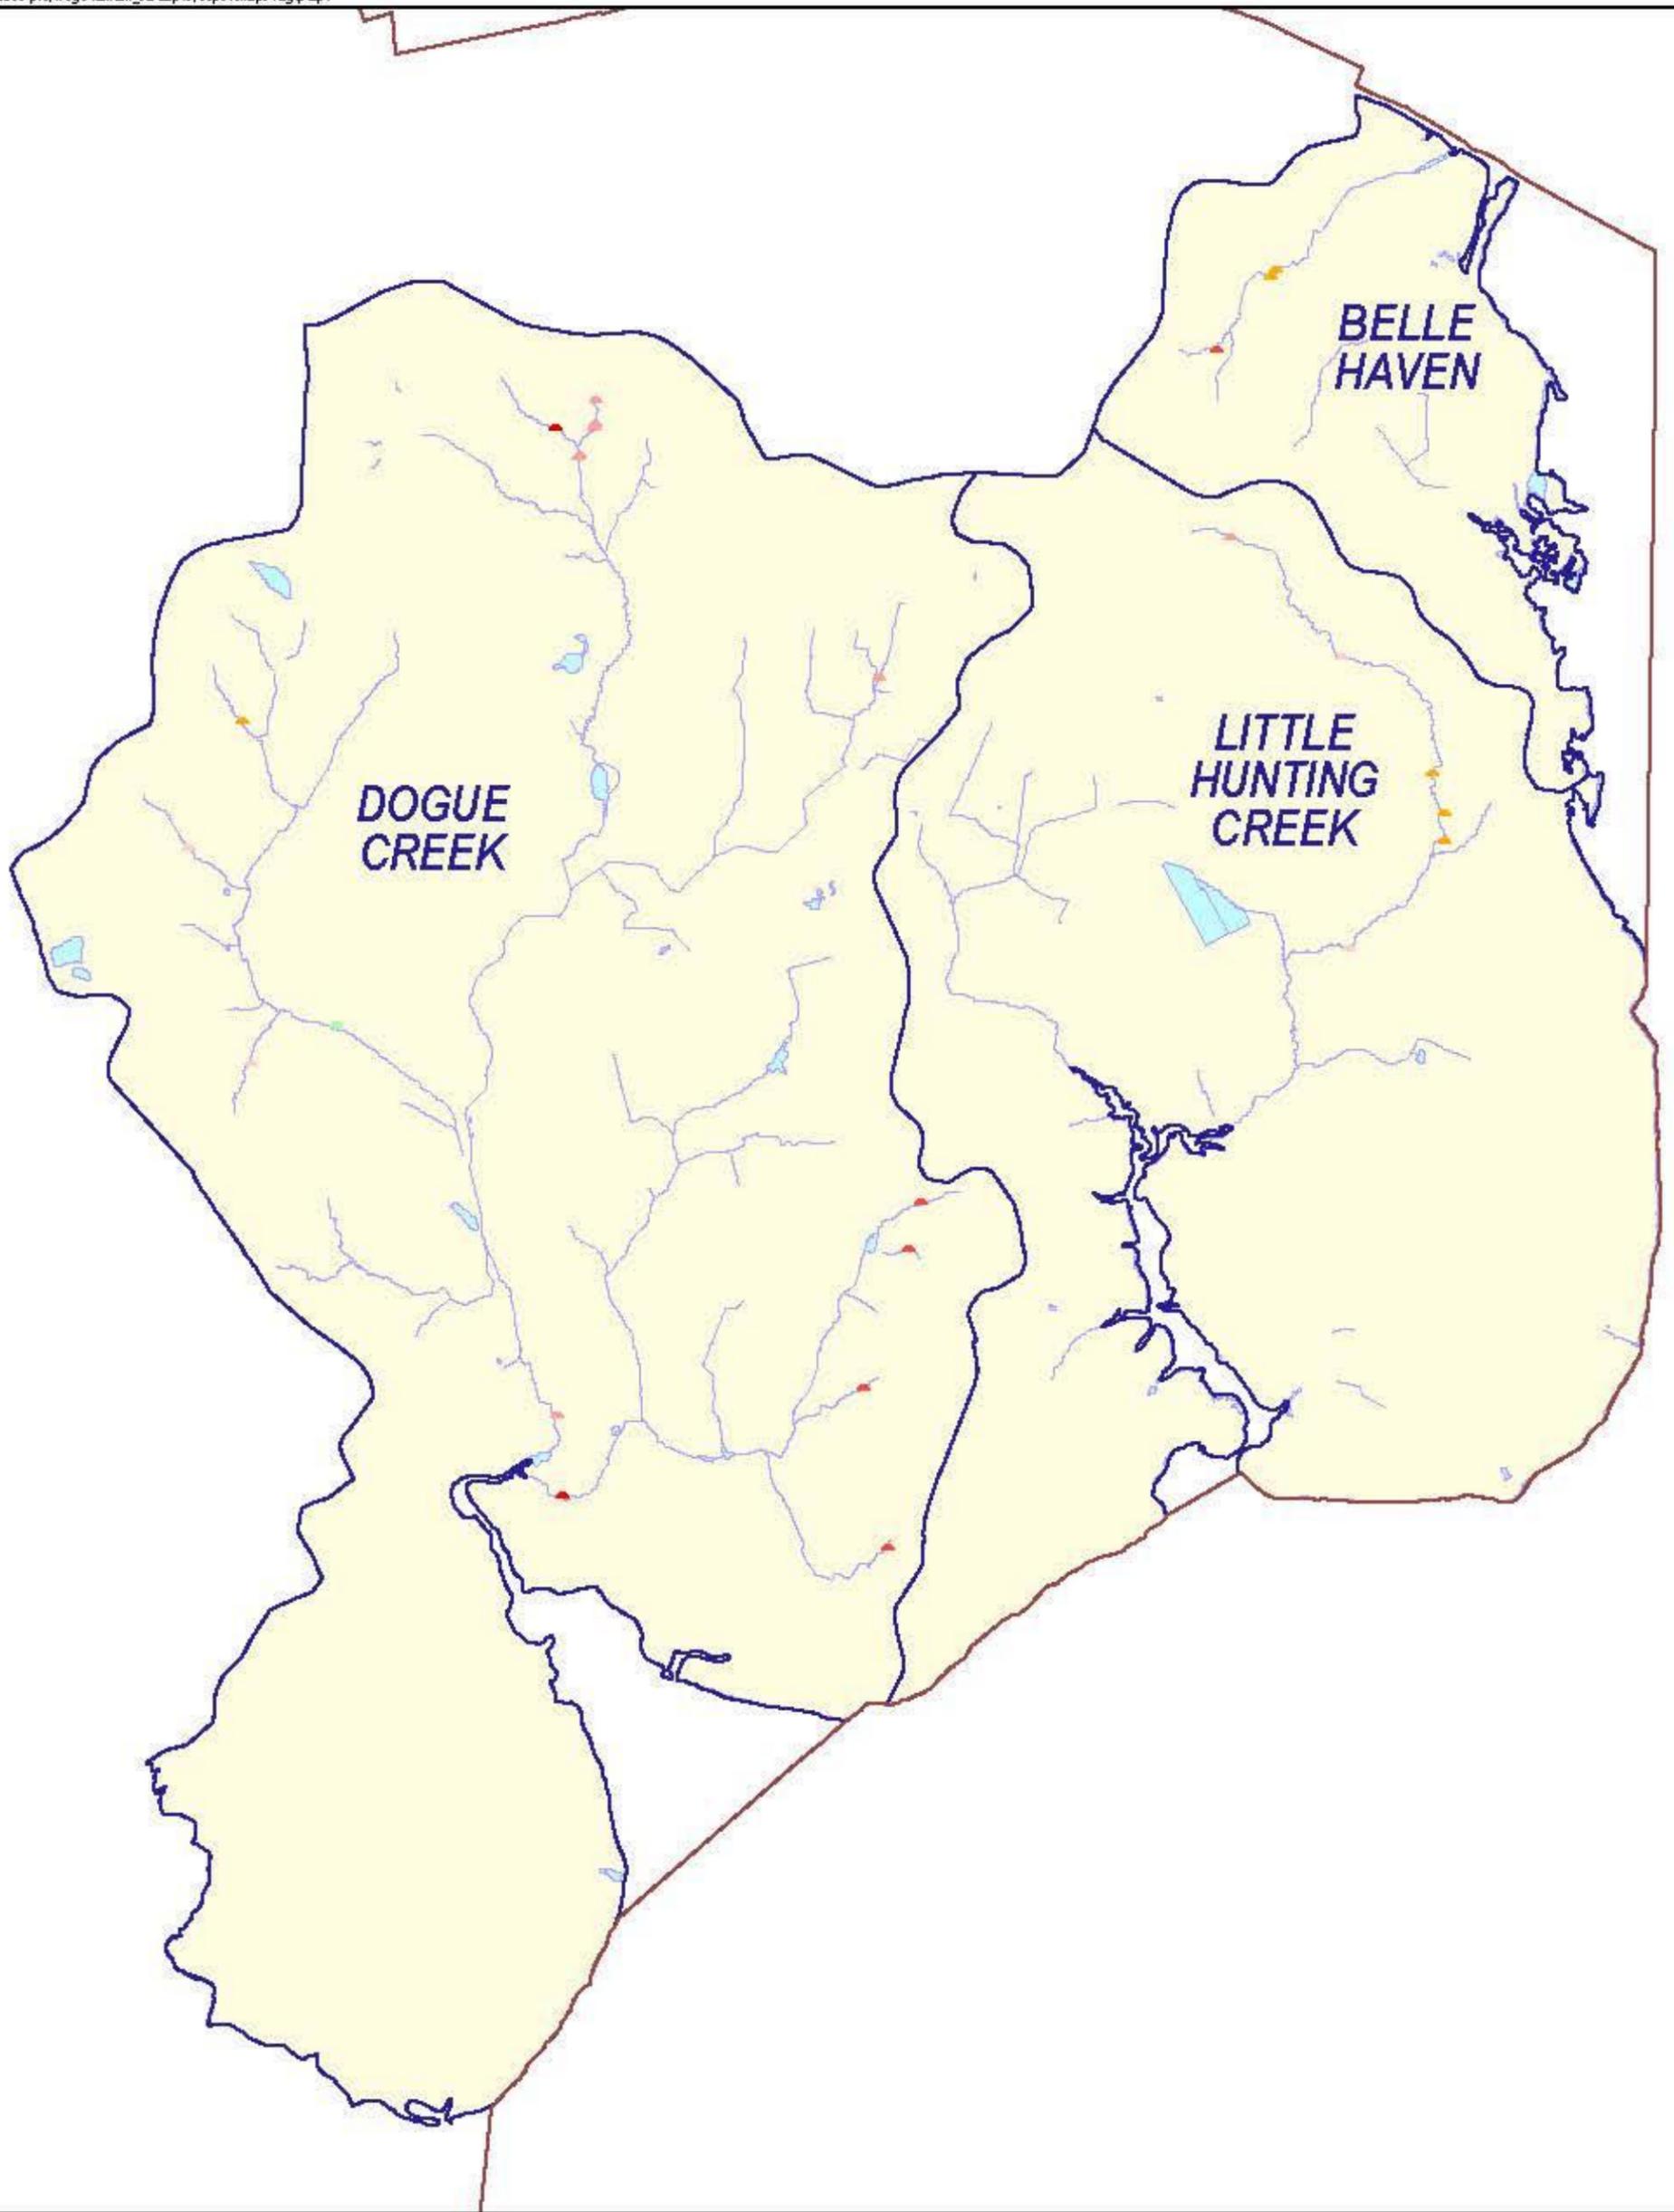
Infrastructure. The infrastructure inventory resulted in 313 inventory points. The most significant problems were 10 inventory points, which was given impact scores of 10, including deficient buffers, head cuts, obstructions, and an erosional area. The infrastructure inventory results are summarized in Table 3-30. Figures 3-40, 3-41, 3-42, 3-43, and 3-44 summarize impact scores for the erosion problems; deficient buffers; crossings; pipes/ ditches; and dumps, obstructions, and utilities, respectively.

Figure 3-40
Erosion Impacts
Lower Potomac Group
Fairfax County Stream Physical Assessment

Infrastructure. The infrastructure inventory resulted in 207 inventory points. The most significant problems were related to a pipe and a deficient buffer, which was given impact scores of 9. The infrastructure inventory results are summarized in Table 3-32. Figures 3-40, 3-41, 3-42, 3-43, and 3-44 summarize impact scores for the erosion problems; deficient buffers; crossings; pipes/ ditches; and dumps, obstructions, and utilities, respectively.

Infrastructure. The infrastructure inventory resulted in 35 inventory points. The most significant problem was related to an erosional area, which was given an impact score of 8. The infrastructure inventory results are summarized in Table 3-34. Figures 3-40, 3-41, 3-42, 3-43, and 3-44 summarize impact scores for the erosion problems; deficient buffers; crossings; pipes/ditches; and dumps, obstructions, and utilities, respectively.

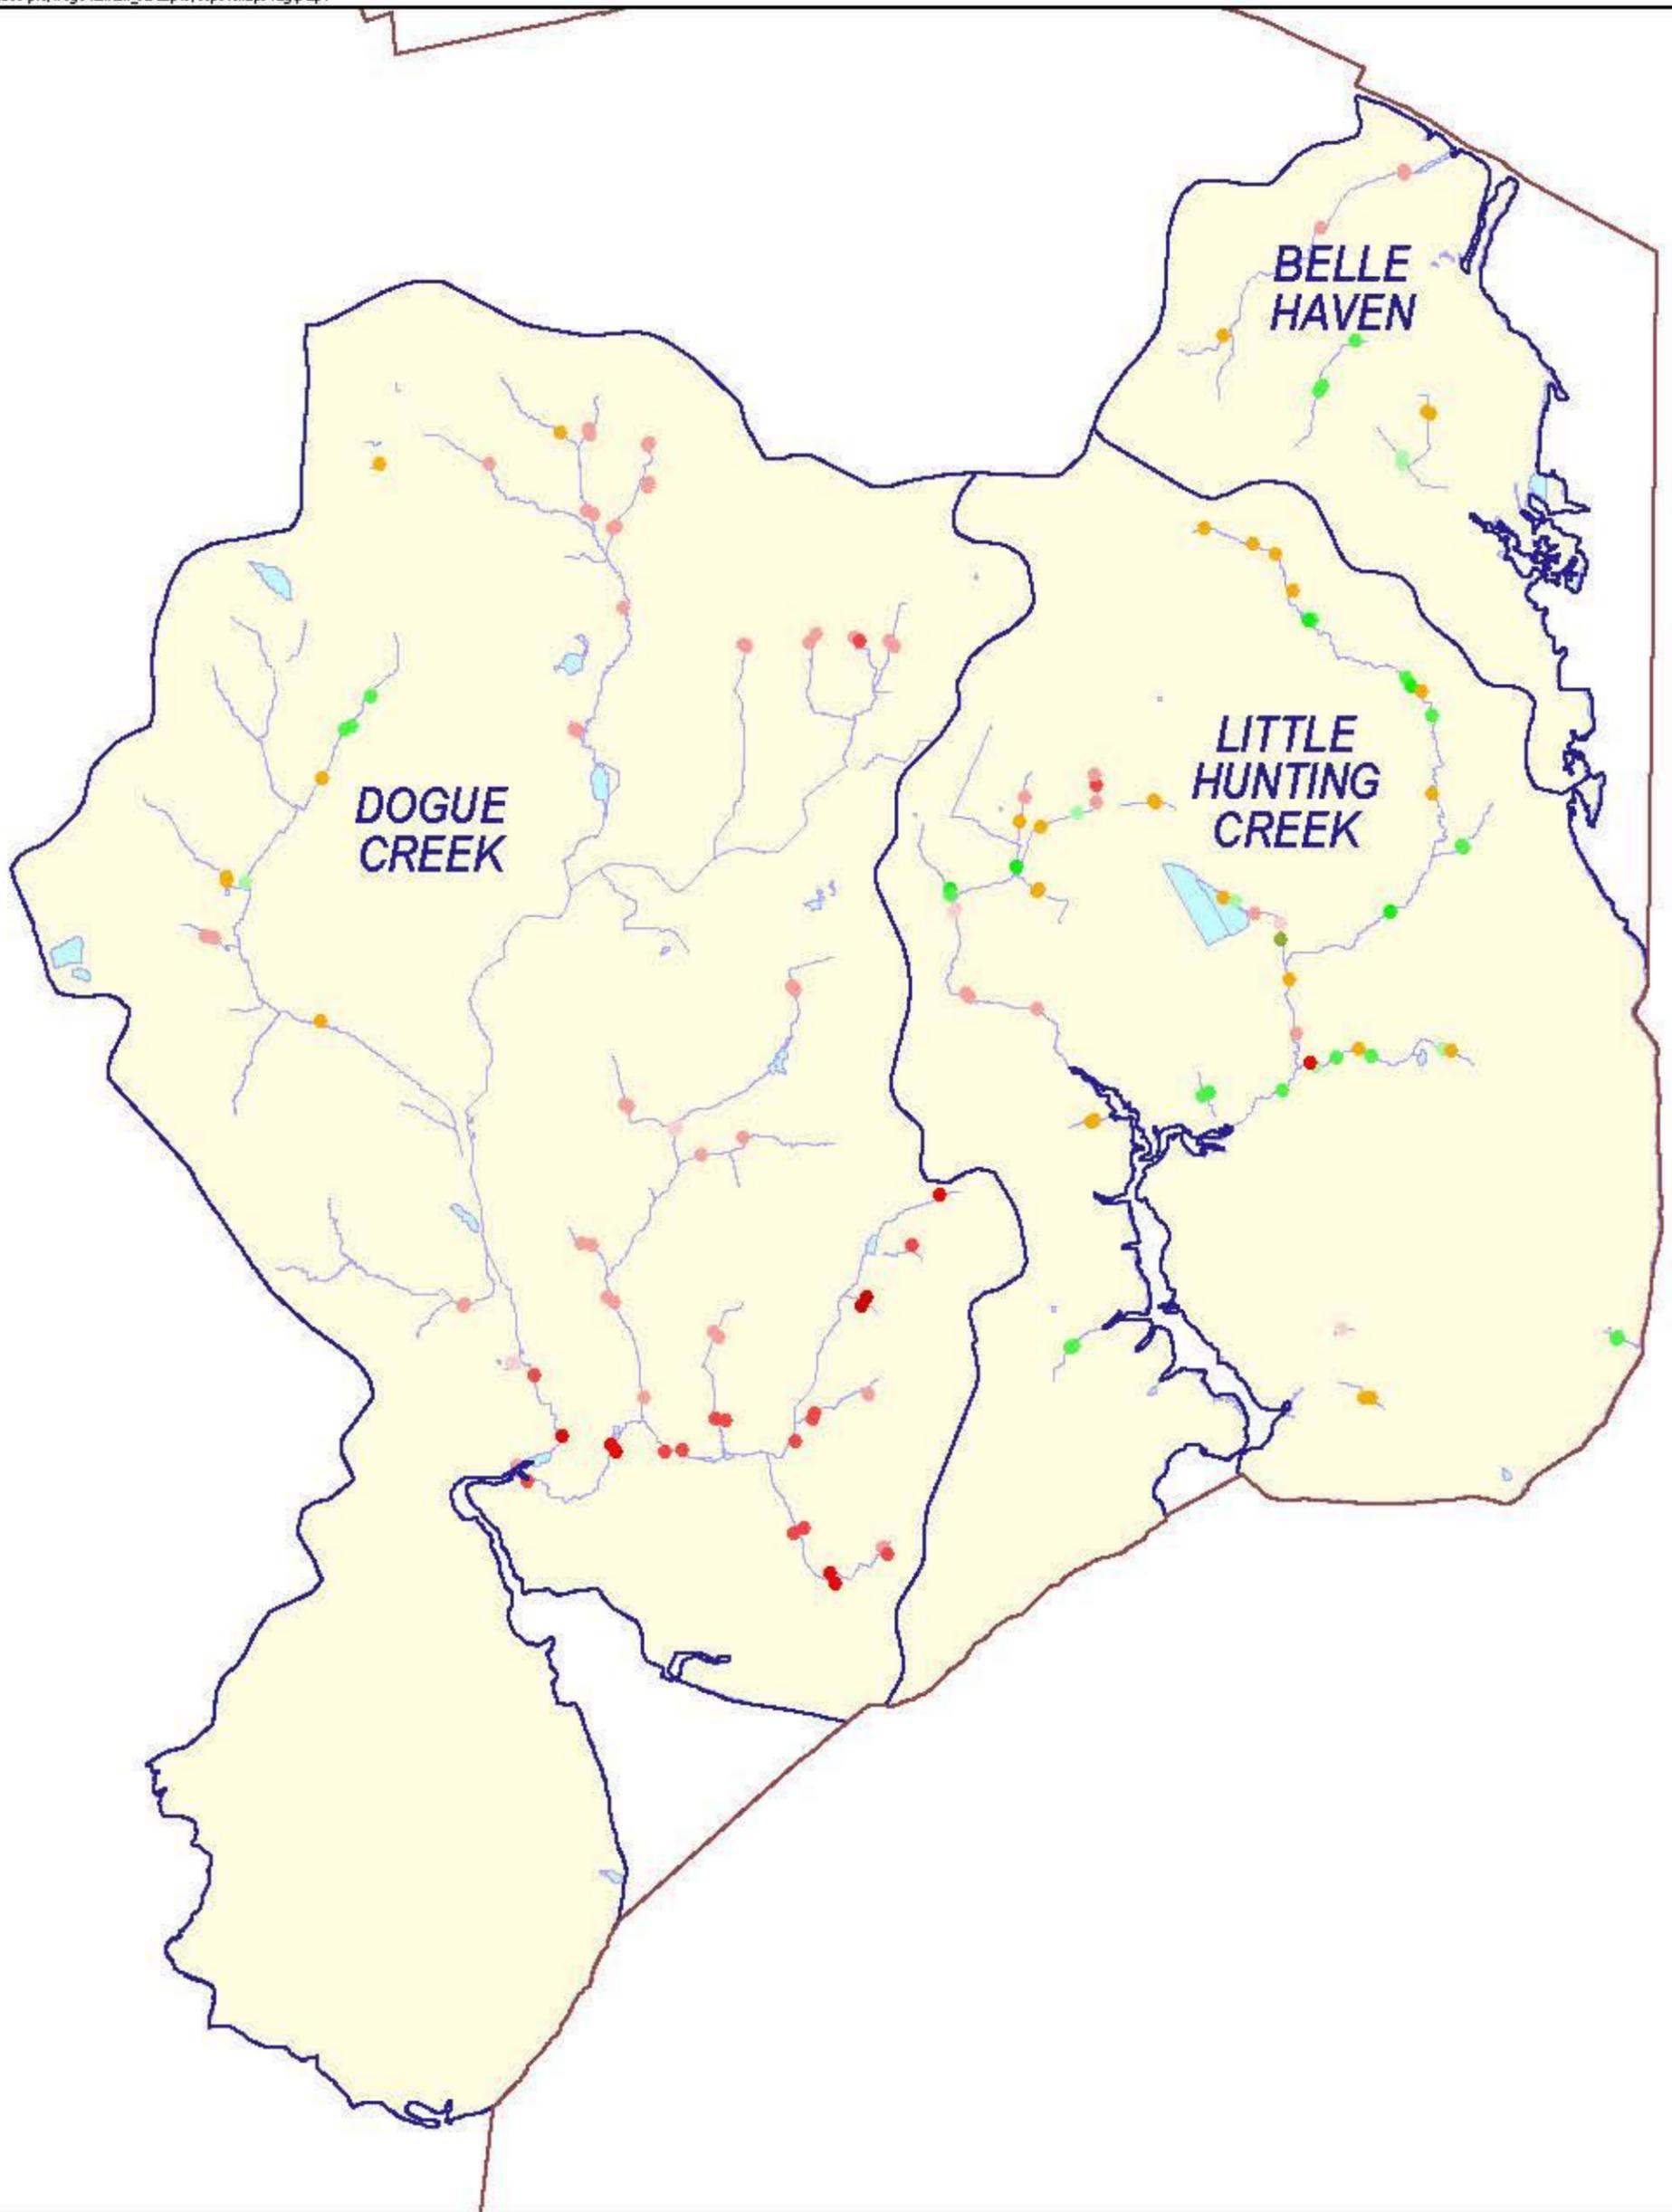
Figure 3-41
Deficient Buffer Impacts
Lower Potomac Group
Fairfax County Stream Physical Assessment

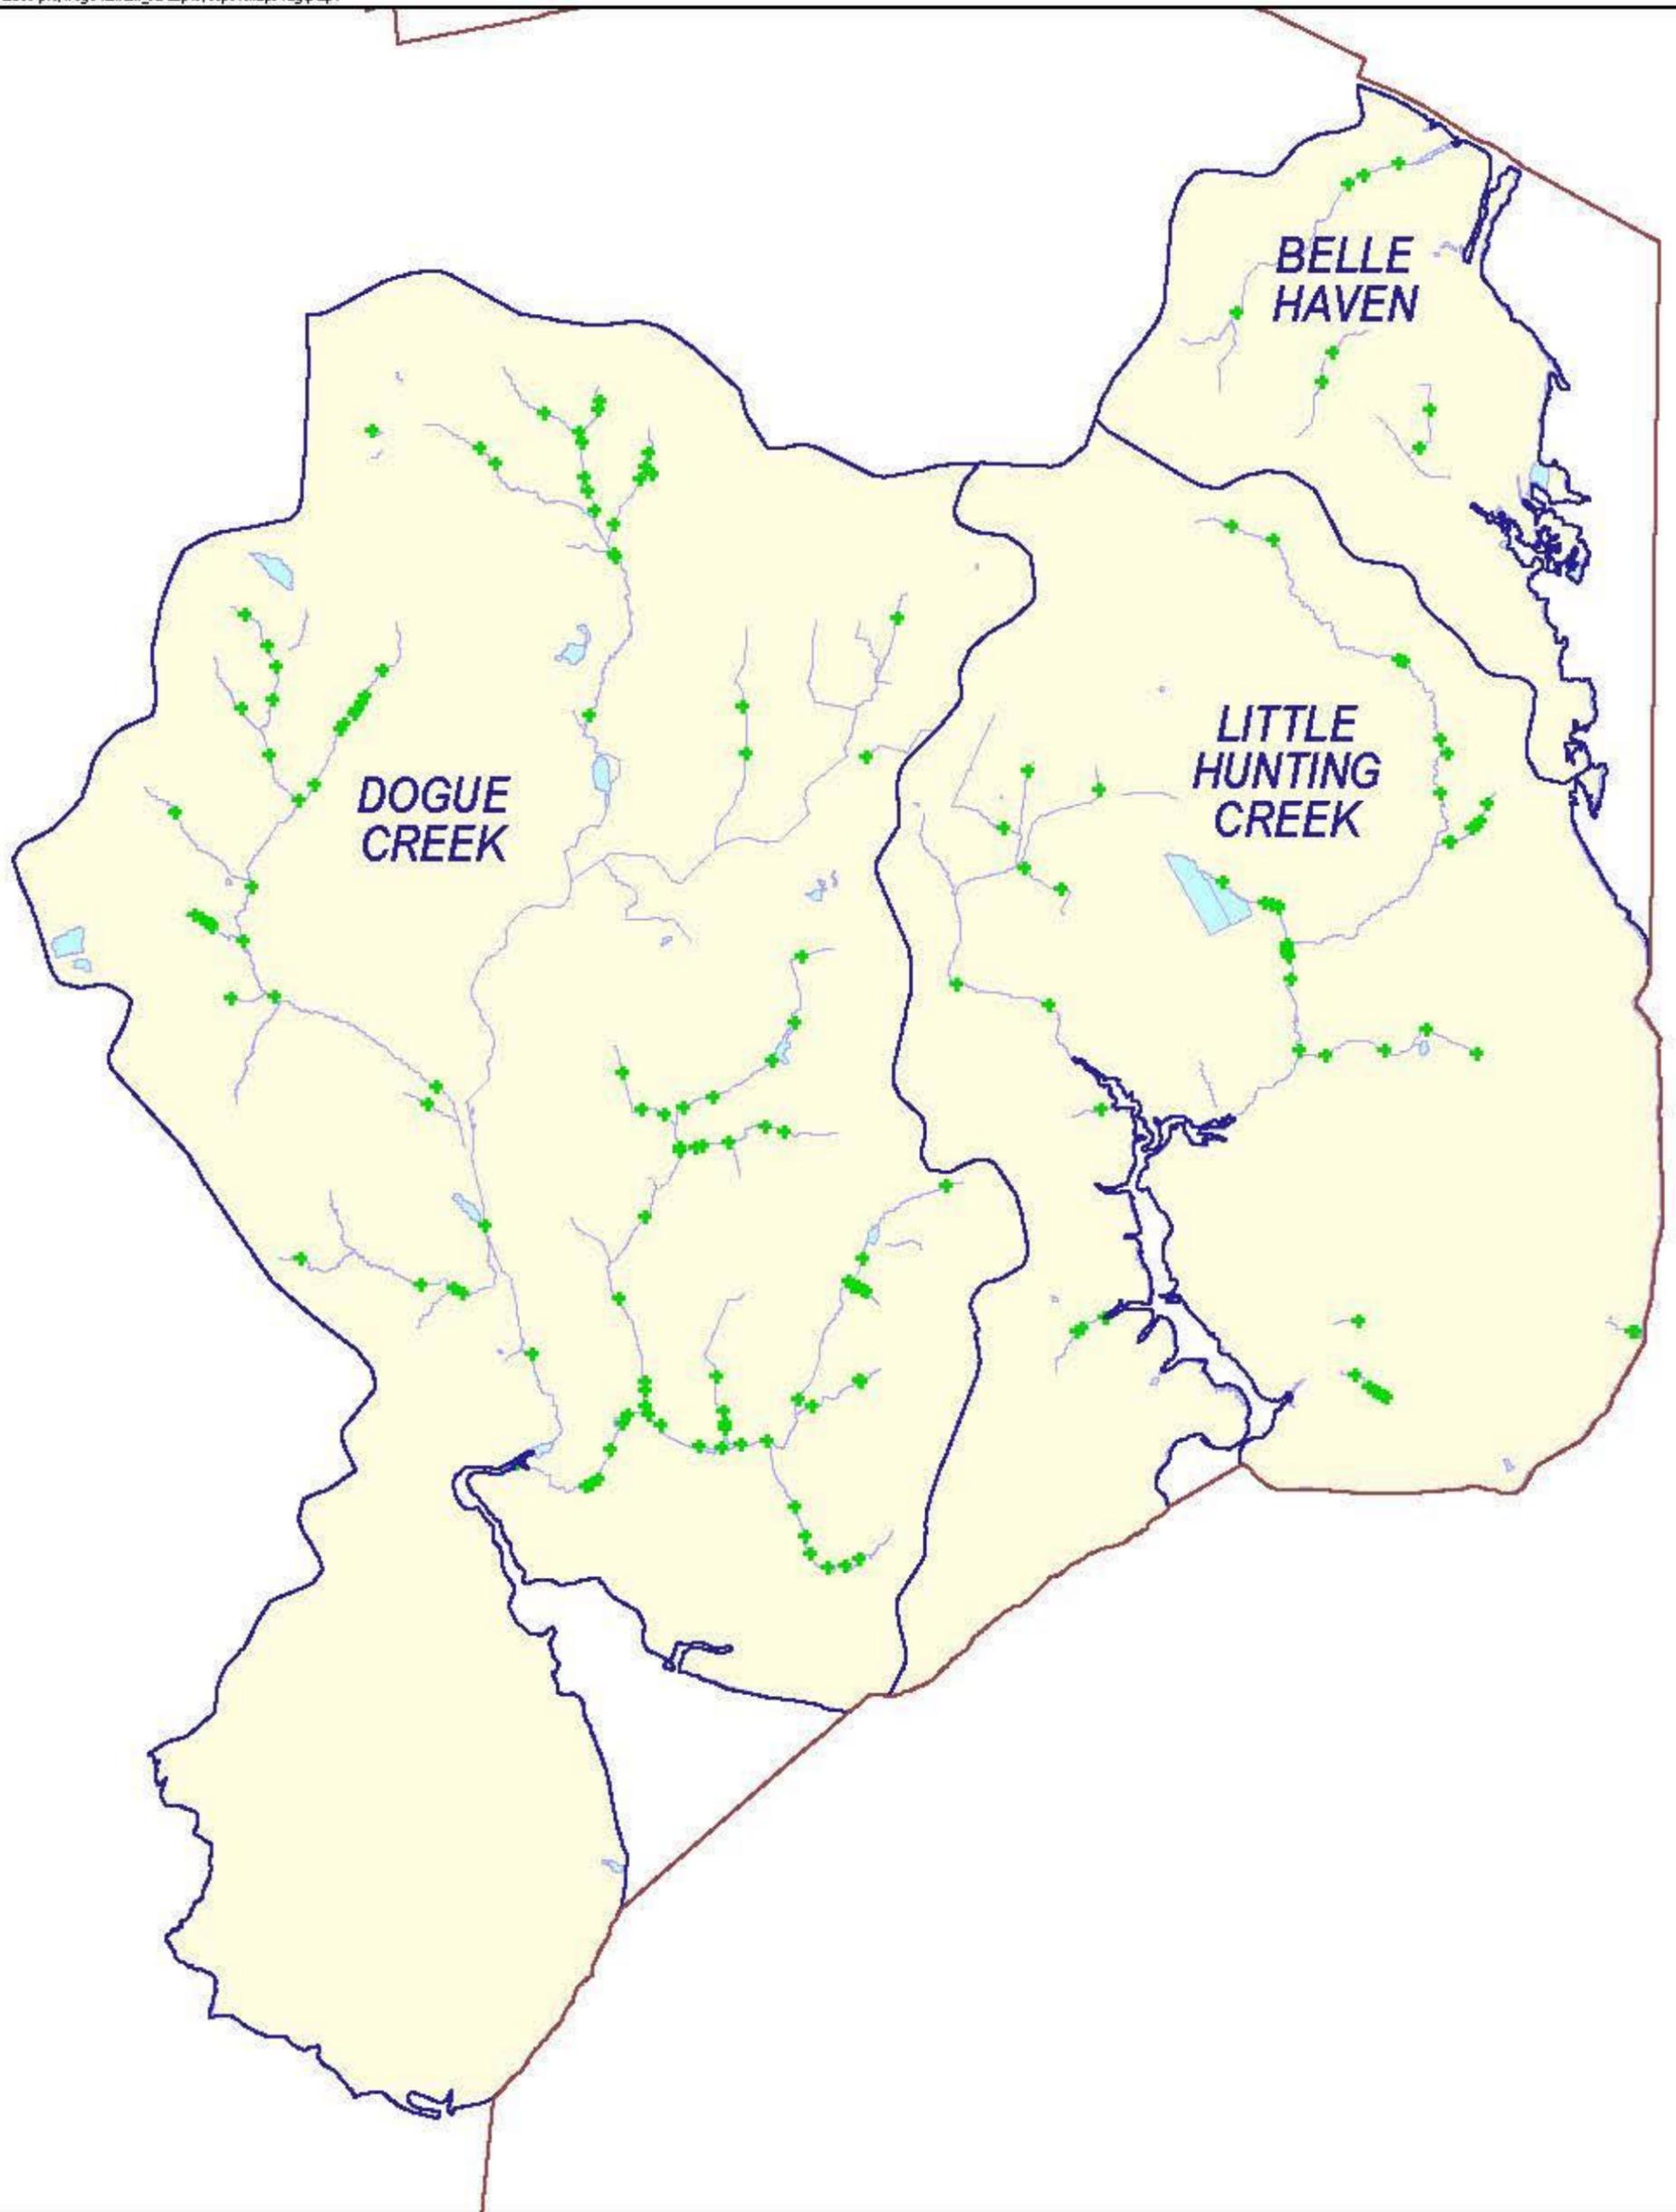
**Figure 3-42
Crossings
Lower Potomac Group
Fairfax County Stream Physical Assessment**

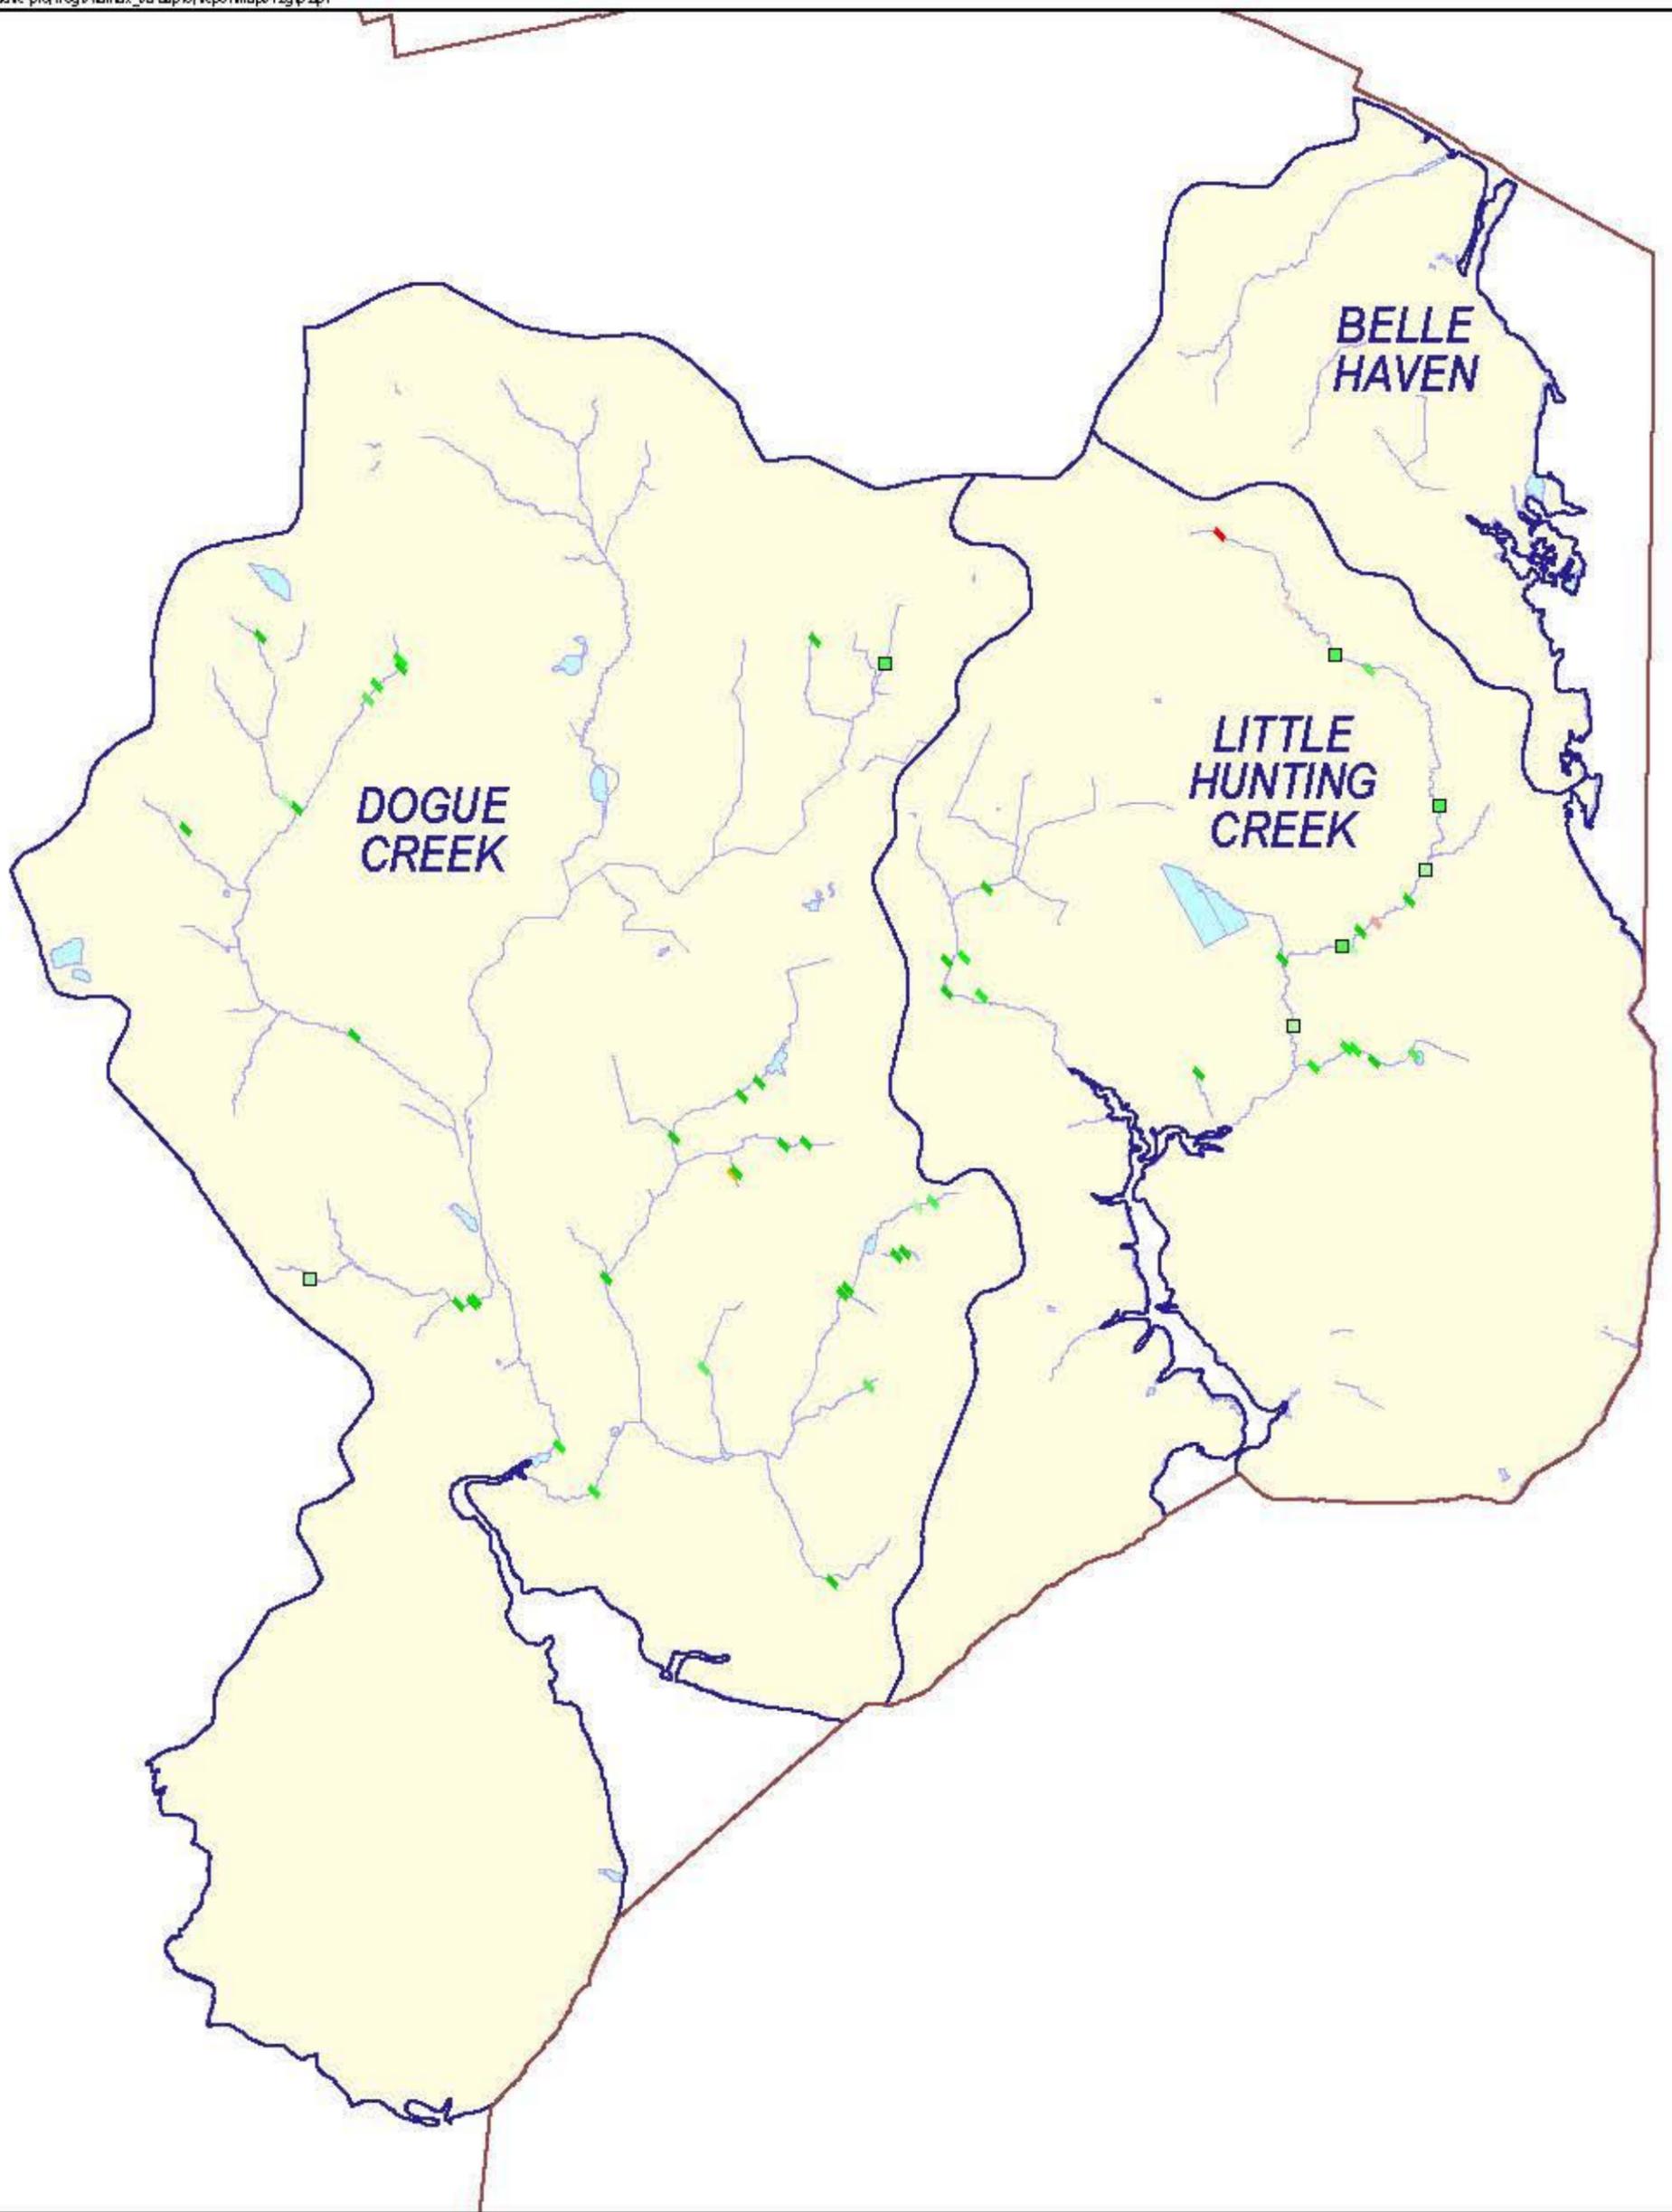
Figure 3-43
Pipe and Ditch Impacts
Lower Potomac Group
Fairfax County Stream Physical Assessment
