3.2.5 Cameron Run Group Summary

3.2.5.1 Cameron Run Watershed

3.2.6 Lower Potomac Group Summary

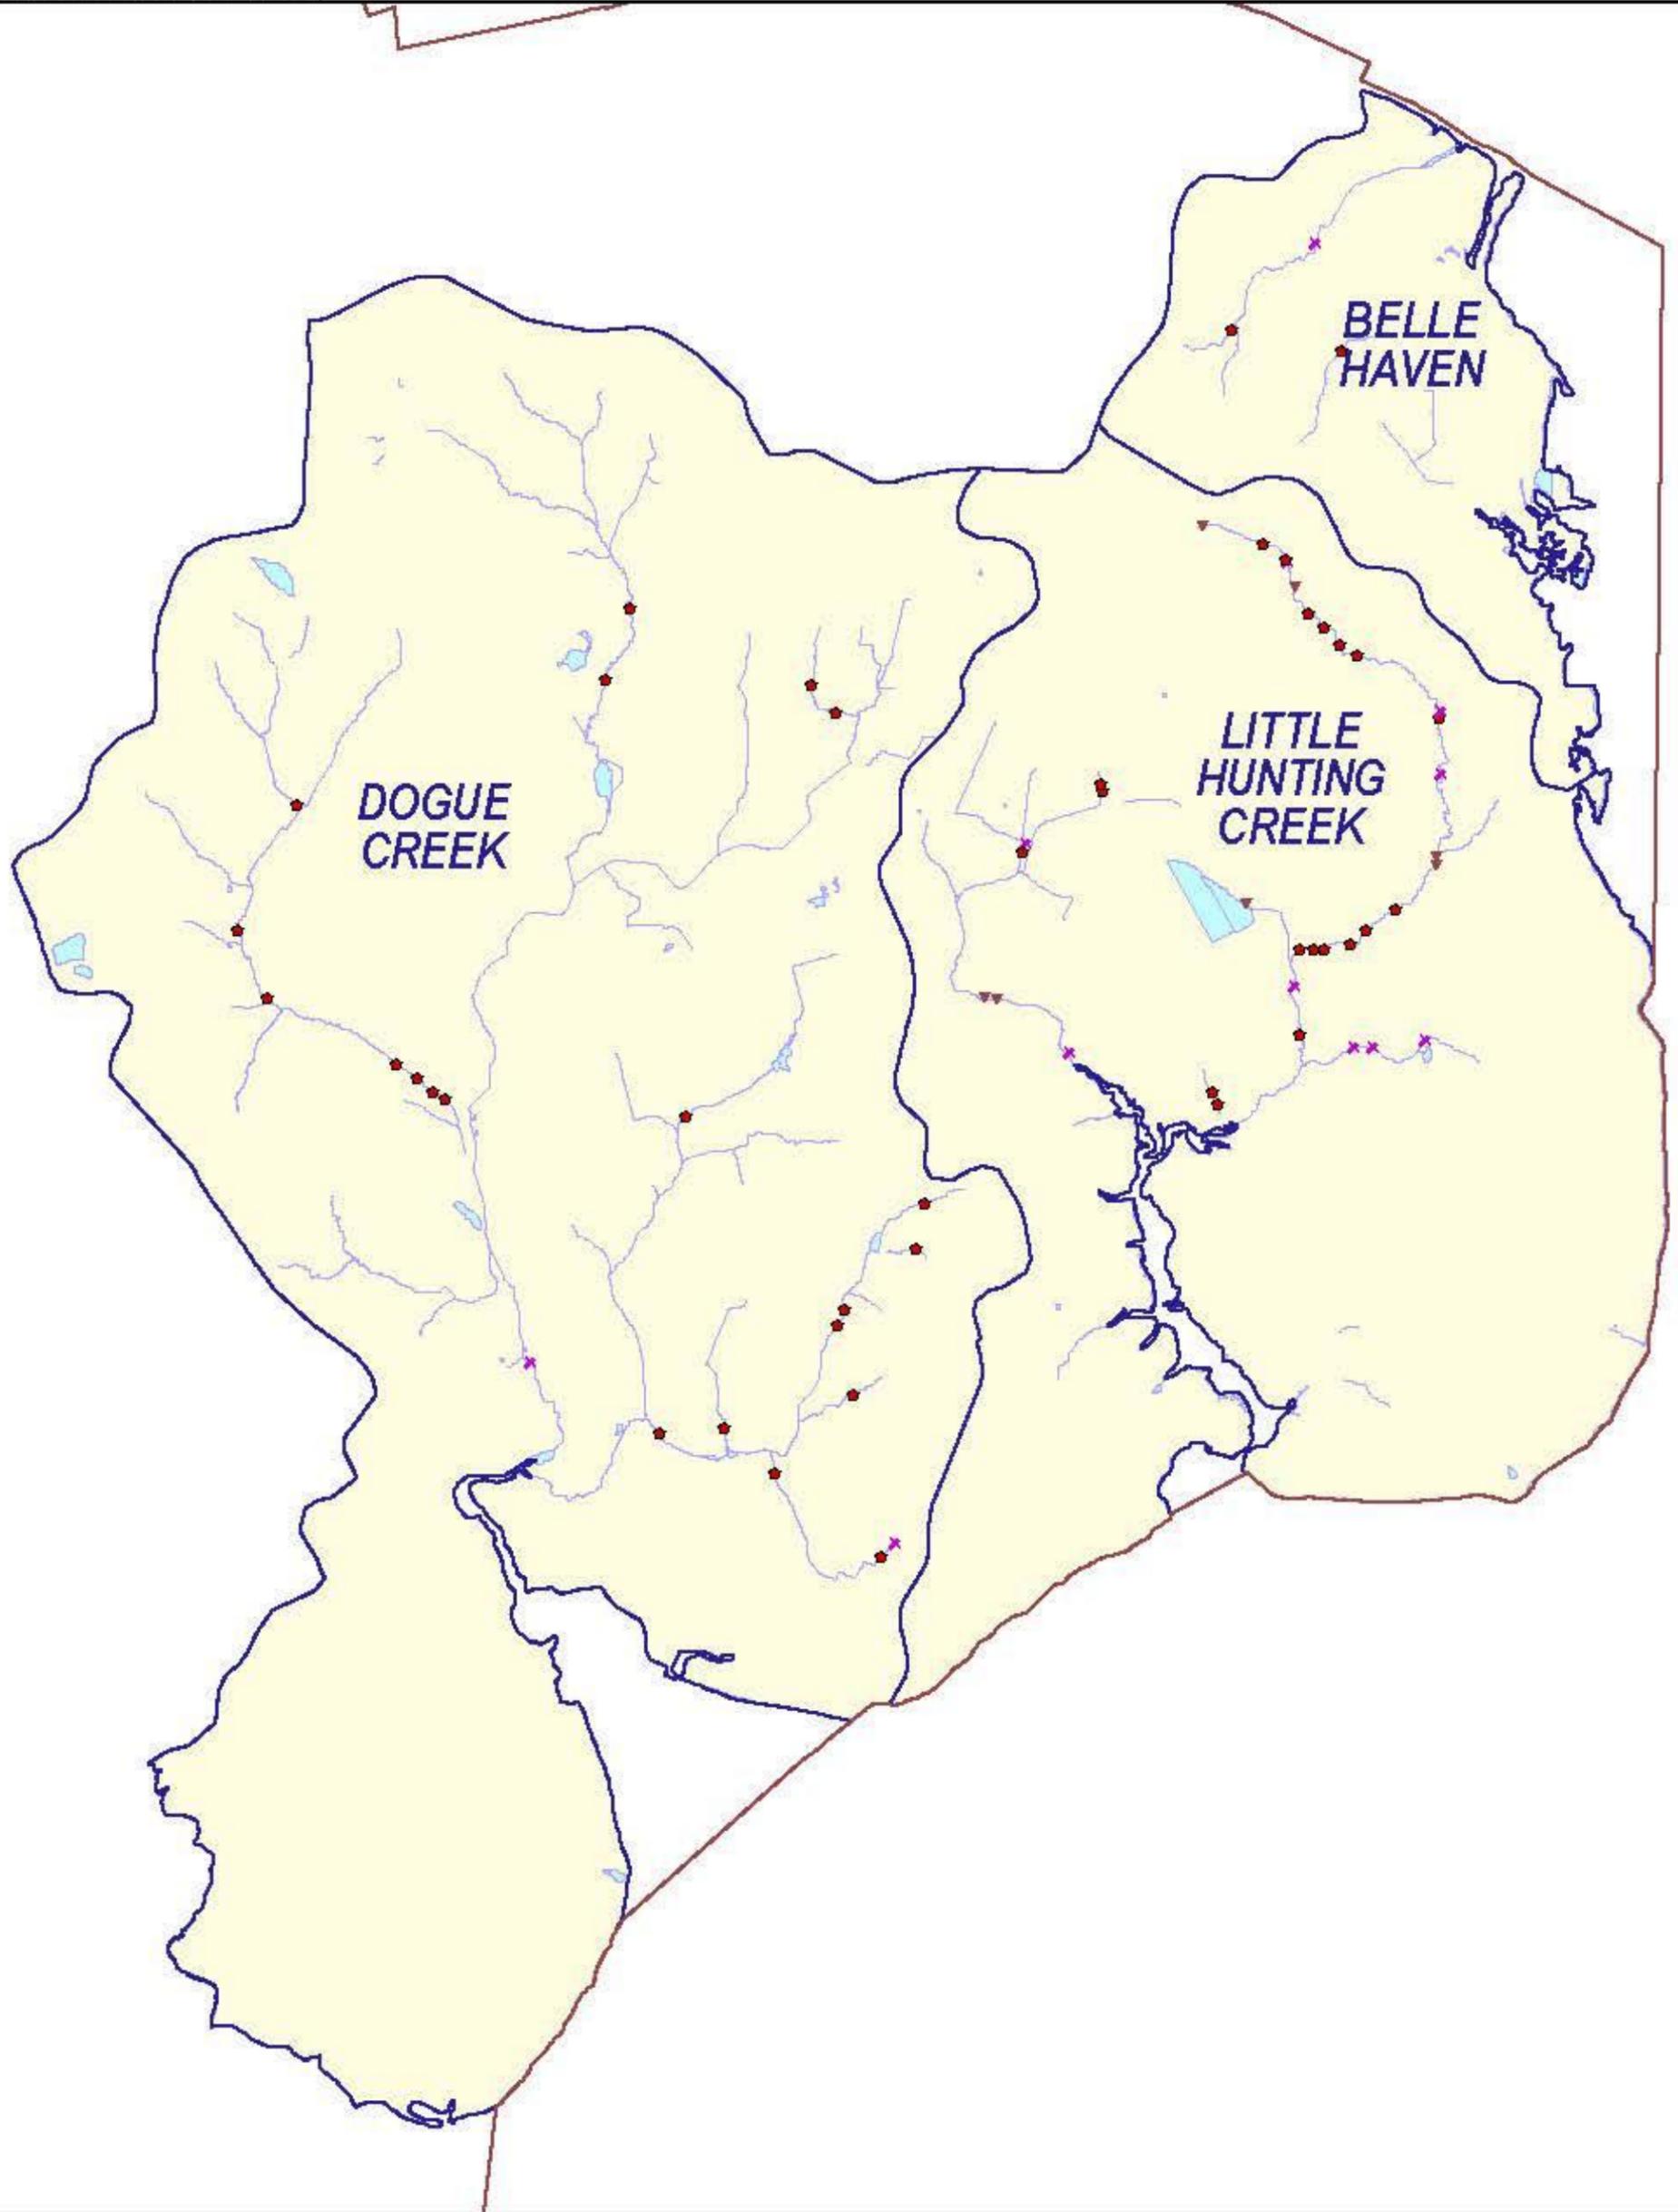
Infrastructure. The infrastructure inventory resulted in 313 inventory points. The most significant problems were 10 inventory points, which was given impact scores of 10, including deficient buffers, head cuts, obstructions, and an erosional area. The infrastructure inventory results are summarized in Table 3-30. Figures 3-40, 3-41, 3-42, 3-43, and 3-44 summarize impact scores for the erosion problems; deficient buffers; crossings; pipes/ ditches; and dumps, obstructions, and utilities, respectively.

Figure 3-44
Dumps, Obstructions, and Utilities
Lower Potomac Group
Fairfax County Stream Physical Assessment

Infrastructure. The infrastructure inventory resulted in 207 inventory points. The most significant problems were related to a pipe and a deficient buffer, which was given impact scores of 9. The infrastructure inventory results are summarized in Table 3-32. Figures 3-40, 3-41, 3-42, 3-43, and 3-44 summarize impact scores for the erosion problems; deficient buffers; crossings; pipes/ ditches; and dumps, obstructions, and utilities, respectively.

Infrastructure. The infrastructure inventory resulted in 35 inventory points. The most significant problem was related to an erosional area, which was given an impact score of 8. The infrastructure inventory results are summarized in Table 3-34. Figures 3-40, 3-41, 3-42, 3-43, and 3-44 summarize impact scores for the erosion problems; deficient buffers; crossings; pipes/ditches; and dumps, obstructions, and utilities, respectively.
