3.2.7 Accotink Creek Group Summary

3.2.7.1 Accotink Creek Watershed

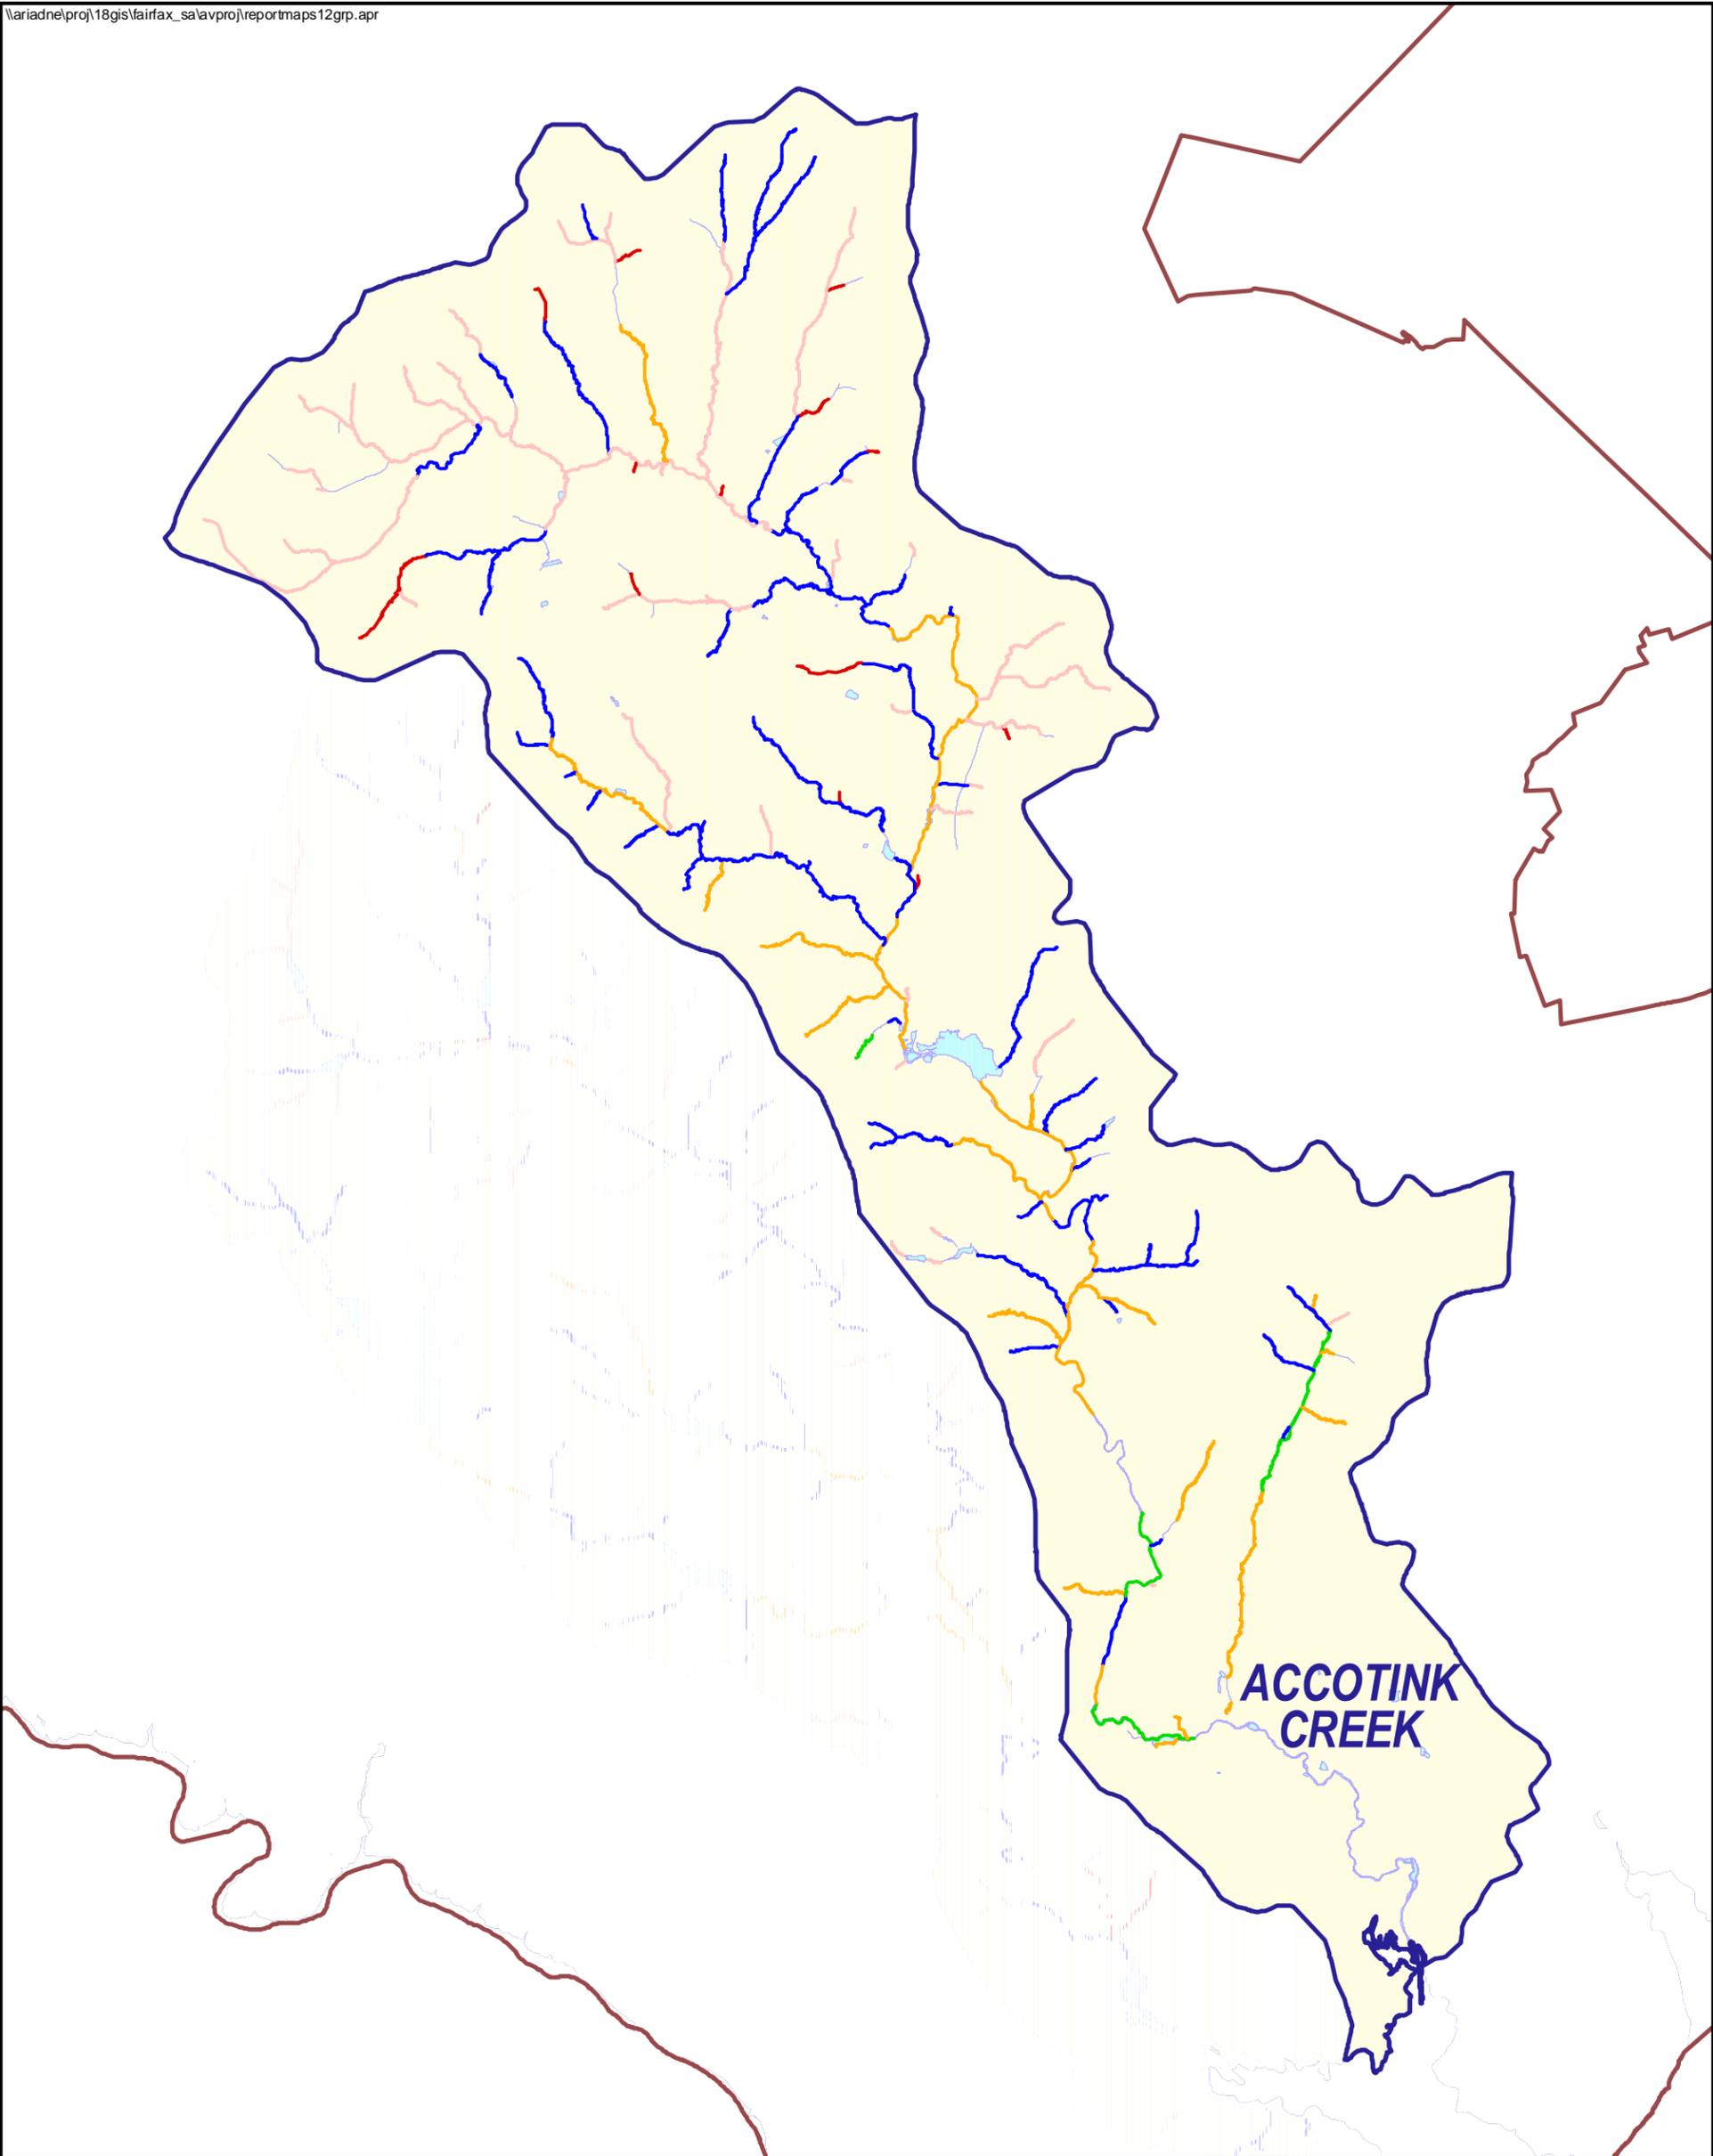
Figure 3-45
Habitat Assessment
Accotink Creek Group
Fairfax County Stream Physical Assessment

Habitat. The habitat assessment results for Accotink Creek Watershed are summarized by stream in Table 3-35. Habitat scores for each reach are depicted in Figure 3-45. Based on a length weighted habitat score of 100 (Table 3-2), Accotink Creek Watershed is in the lower middle range of quality, compared to the rest of the County. Just over 3 miles of stream were categorized as having “very poor” habitat conditions, 26 miles as “poor,” 33 miles as “fair,” 25 miles as “good,” and 4 miles as “excellent.”

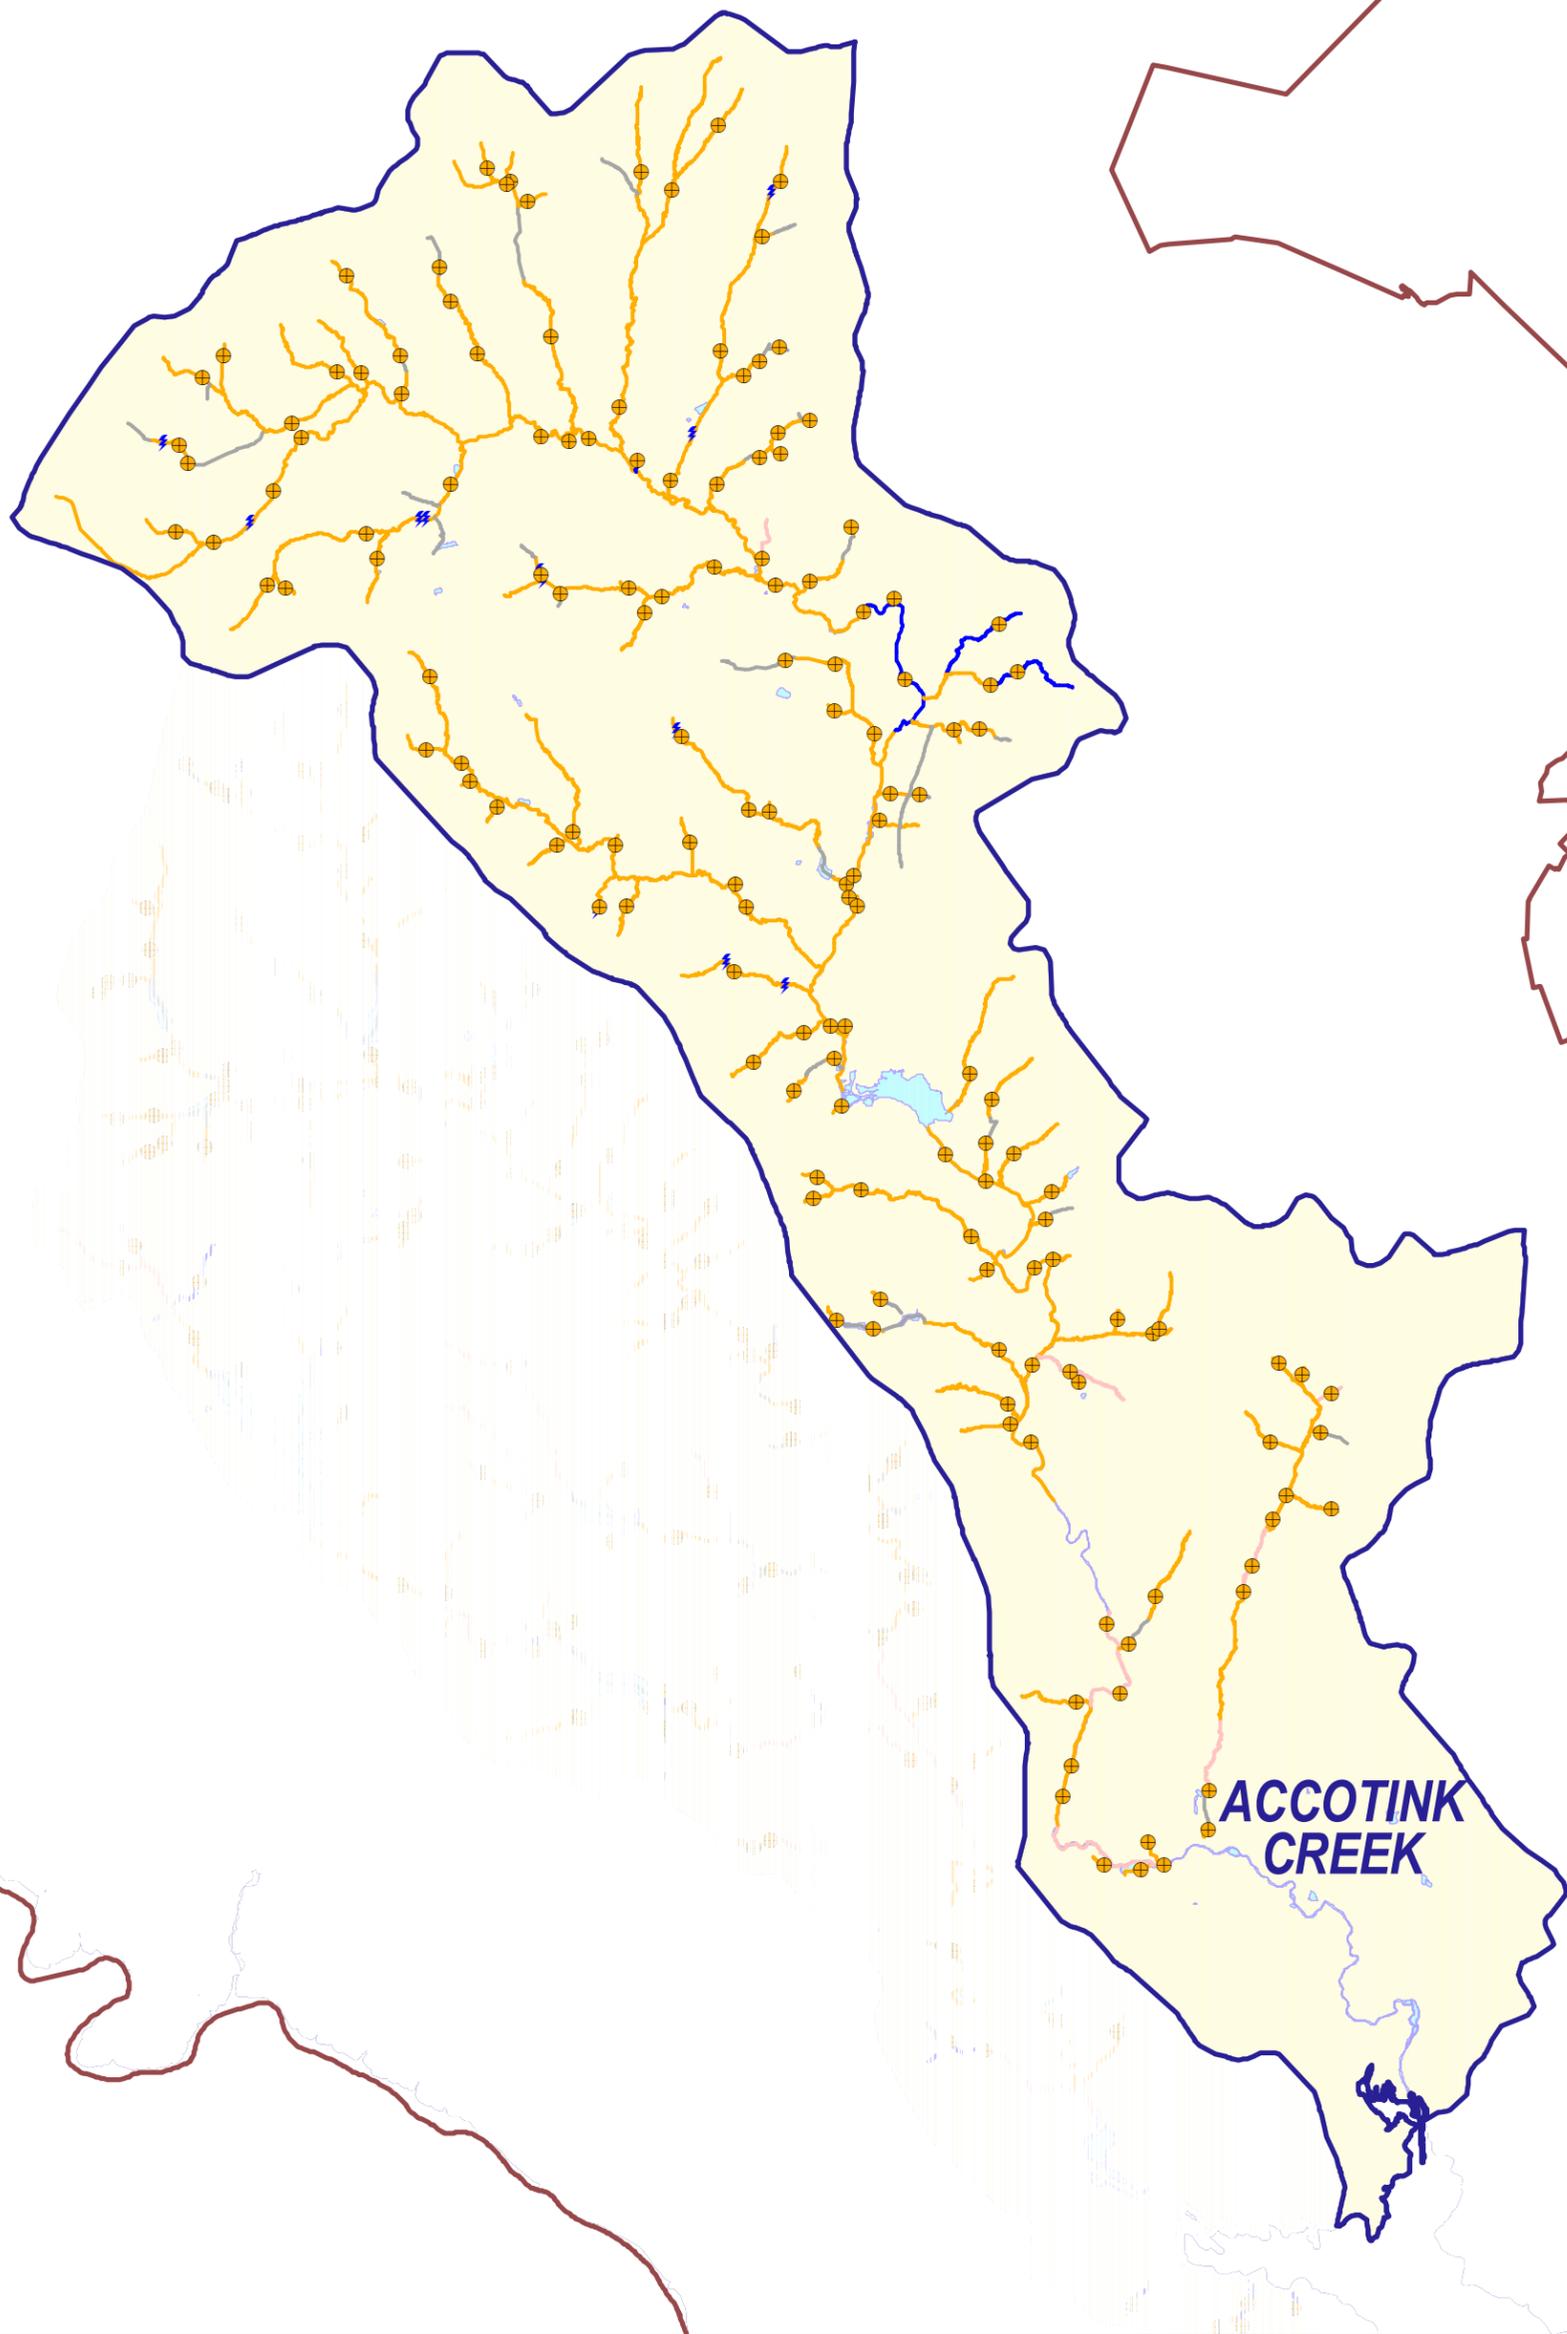
Figure 3-46
CEM Categories
Accotink Creek Group
Fairfax County Stream Physical Assessment

CEM. Based on the CEM evaluations 91 percent of the channels assessed in Accotink Creek Watershed are in Evolutionary Stage 3 (Table 3-3). Figure 3-46 summarizes the CEM results for Accotink Creek Watershed.

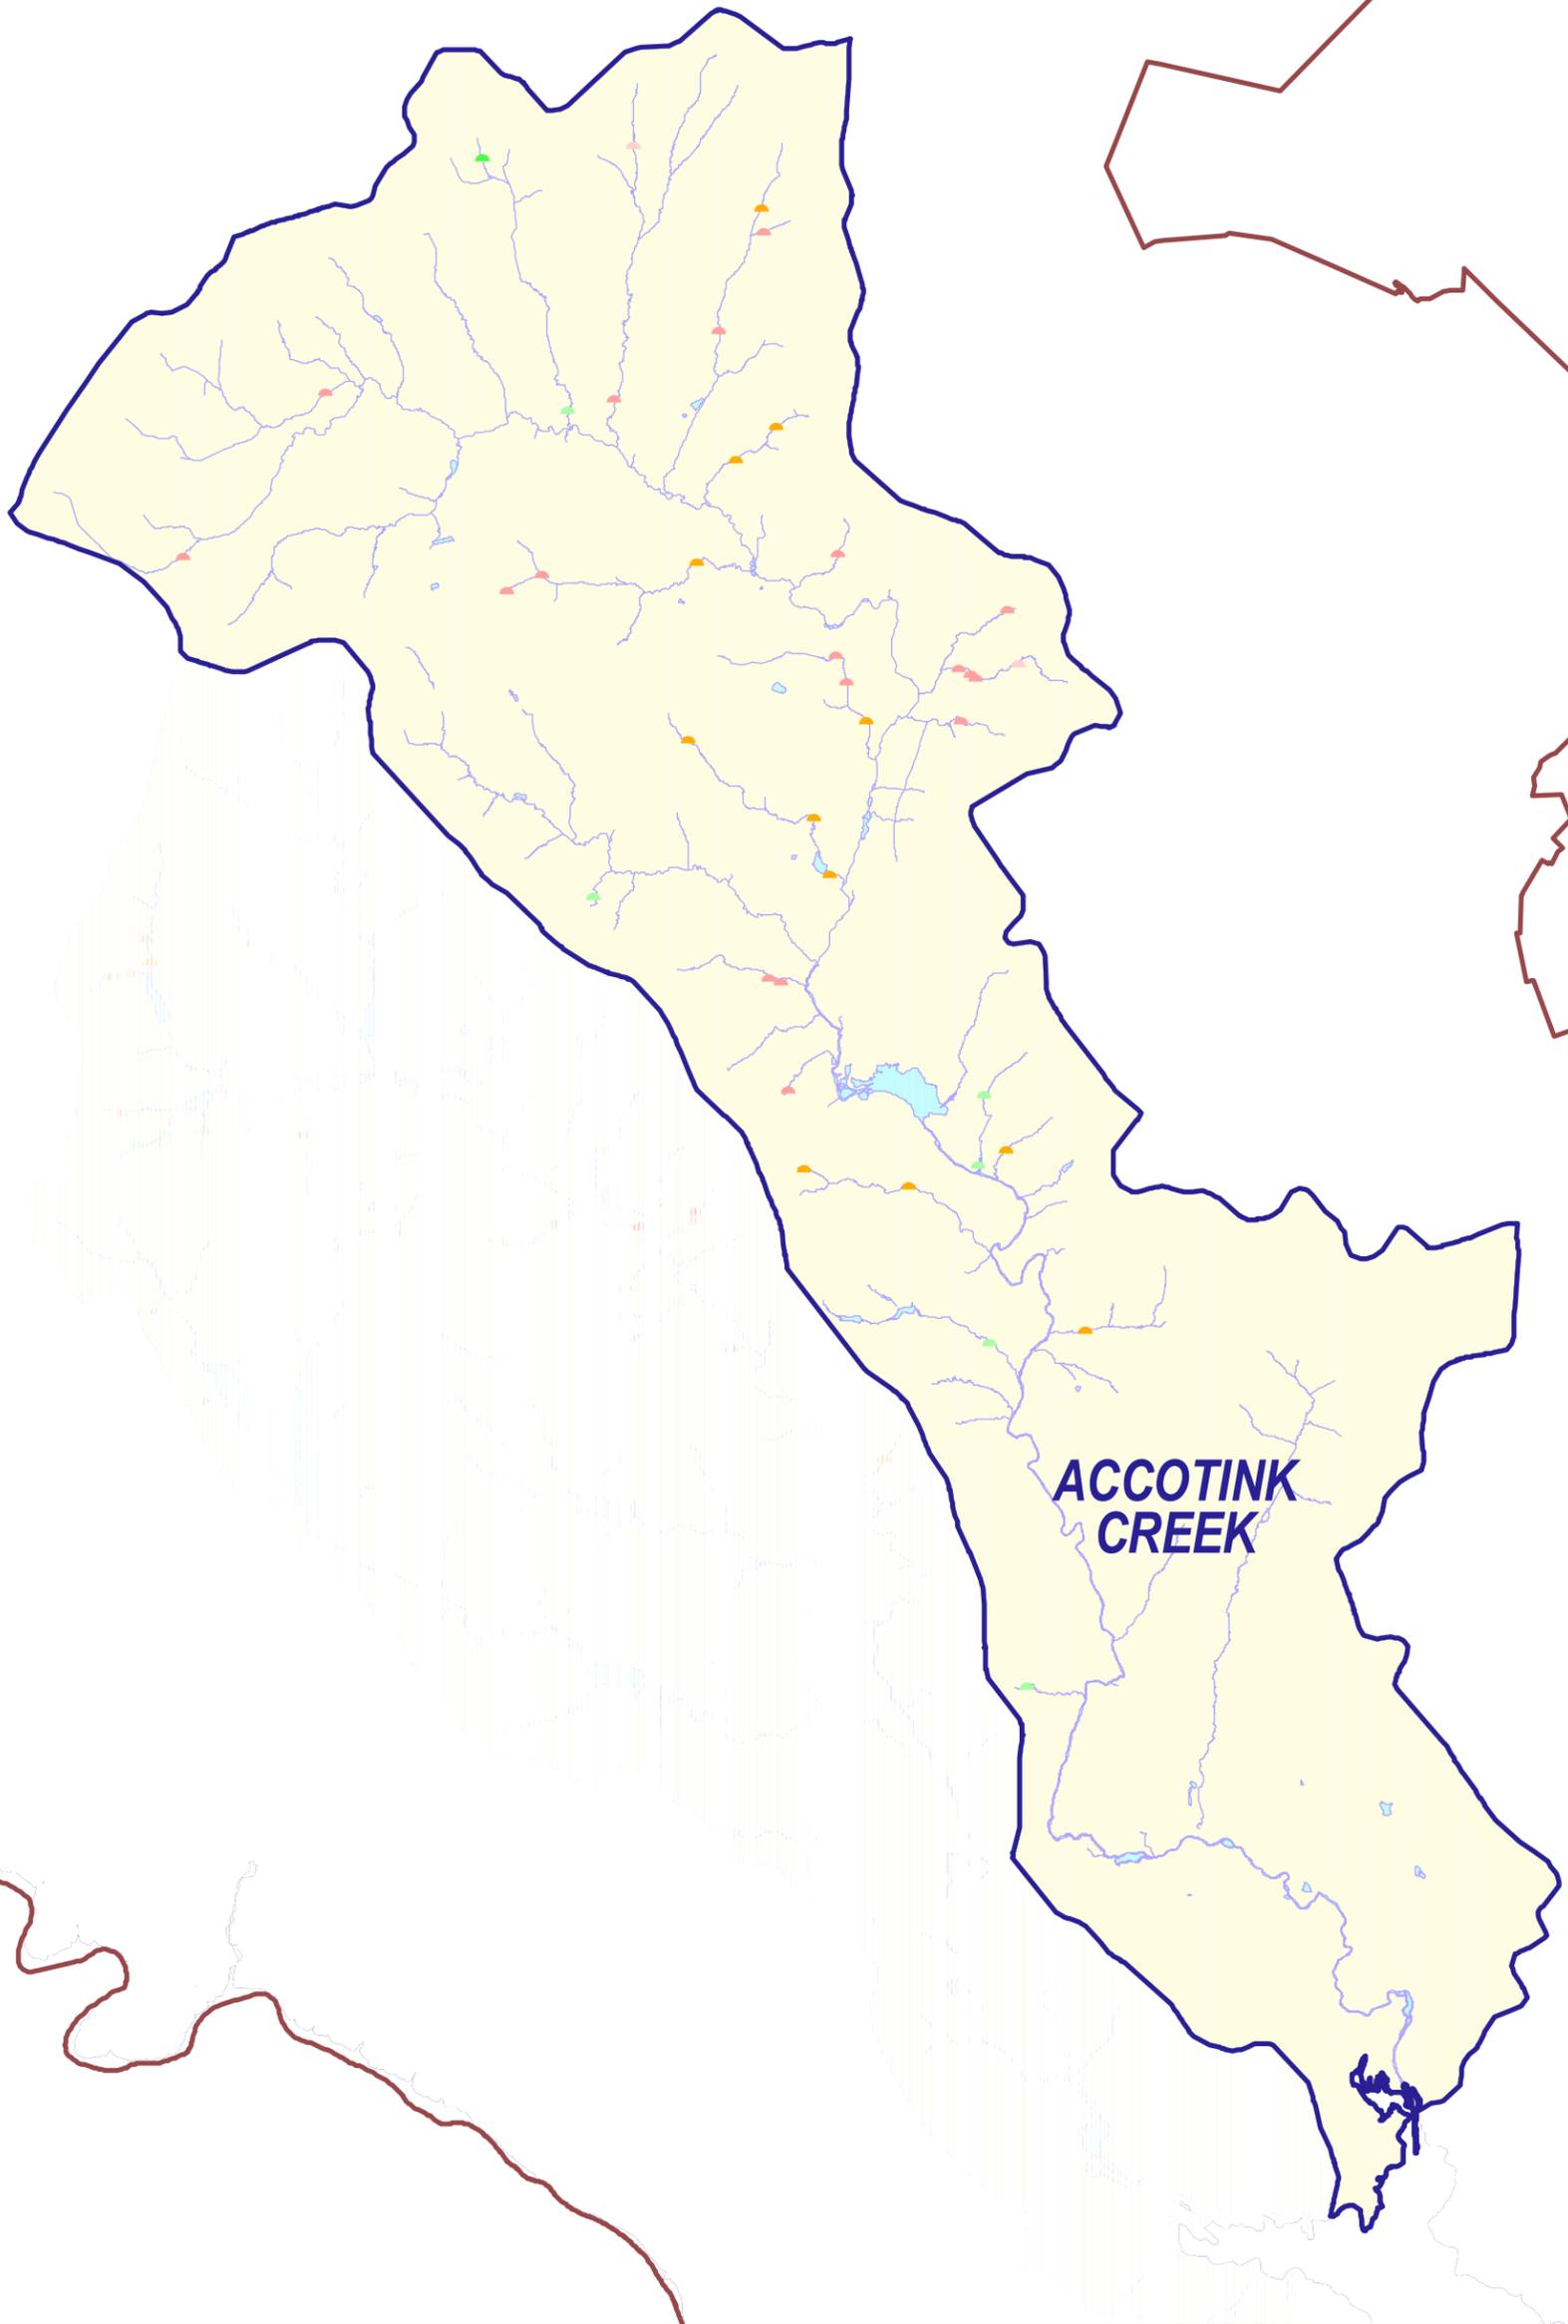
Figure 3-47
Erosion Impacts
Accotink Creek Group
Fairfax County Stream Physical Assessment

Infrastructure. The infrastructure inventory resulted in 1211 inventory points. The most significant problems were related to 15 deficient buffers, 4 head cuts, 2 exposed utility lines, and 1 pipe that were each given an impact score of 10. The infrastructure inventory results are summarized in Table 3-36. Figures 3-47, 3-48, 3-49, 3-50, and 3-51 summarize impact scores for the erosion problems; deficient buffers; crossings; pipes/ditches; and dumps, obstructions, and utilities, respectively.

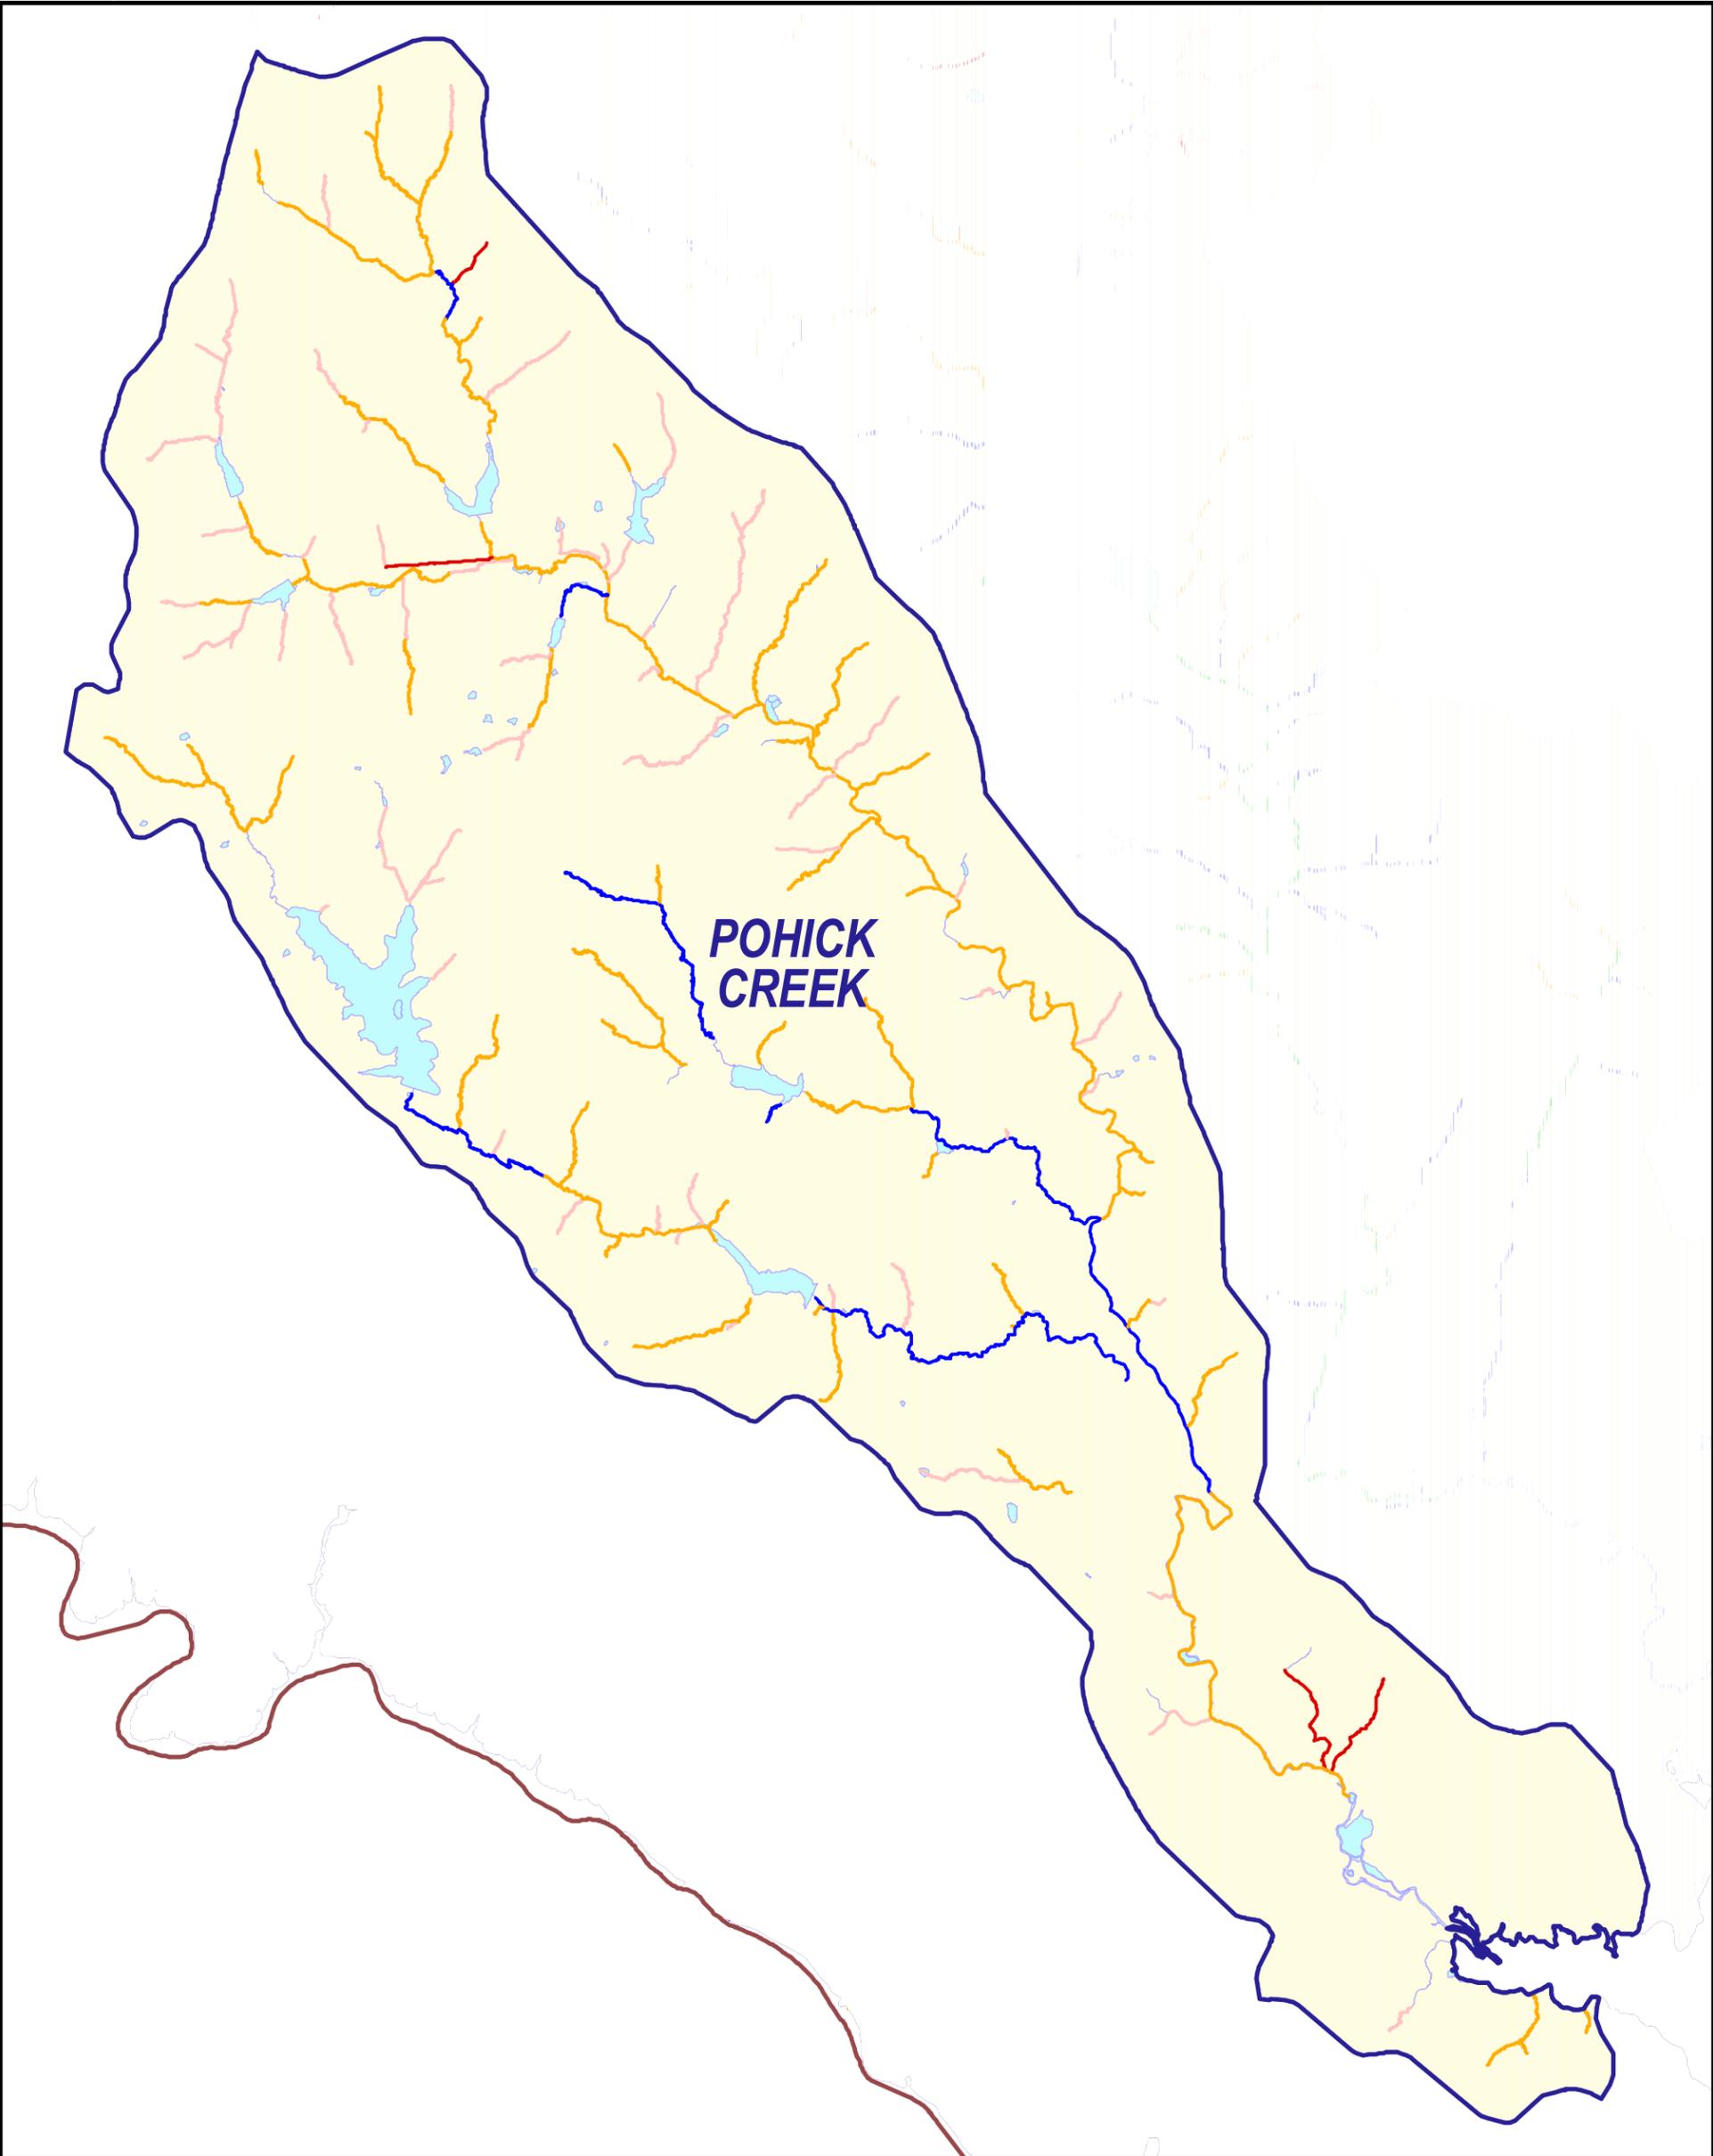
Figure 3-52
Habitat Assessment
Pohick Creek
Fairfax County Stream Physical Assessment

Habitat. The habitat assessment results for Pohick Creek Watershed are summarized by stream in Table 3-37. Habitat scores for each reach are depicted in Figure 3-52. Based on a length weighted habitat score of 95, Pohick Creek Watershed is one of the poorest quality watersheds, compared to the rest of the County. Approximately 2 miles of stream were categorized as having “very poor” habitat conditions, 20 miles as “poor,” 37 miles as “fair,” and 10 miles as “good.”

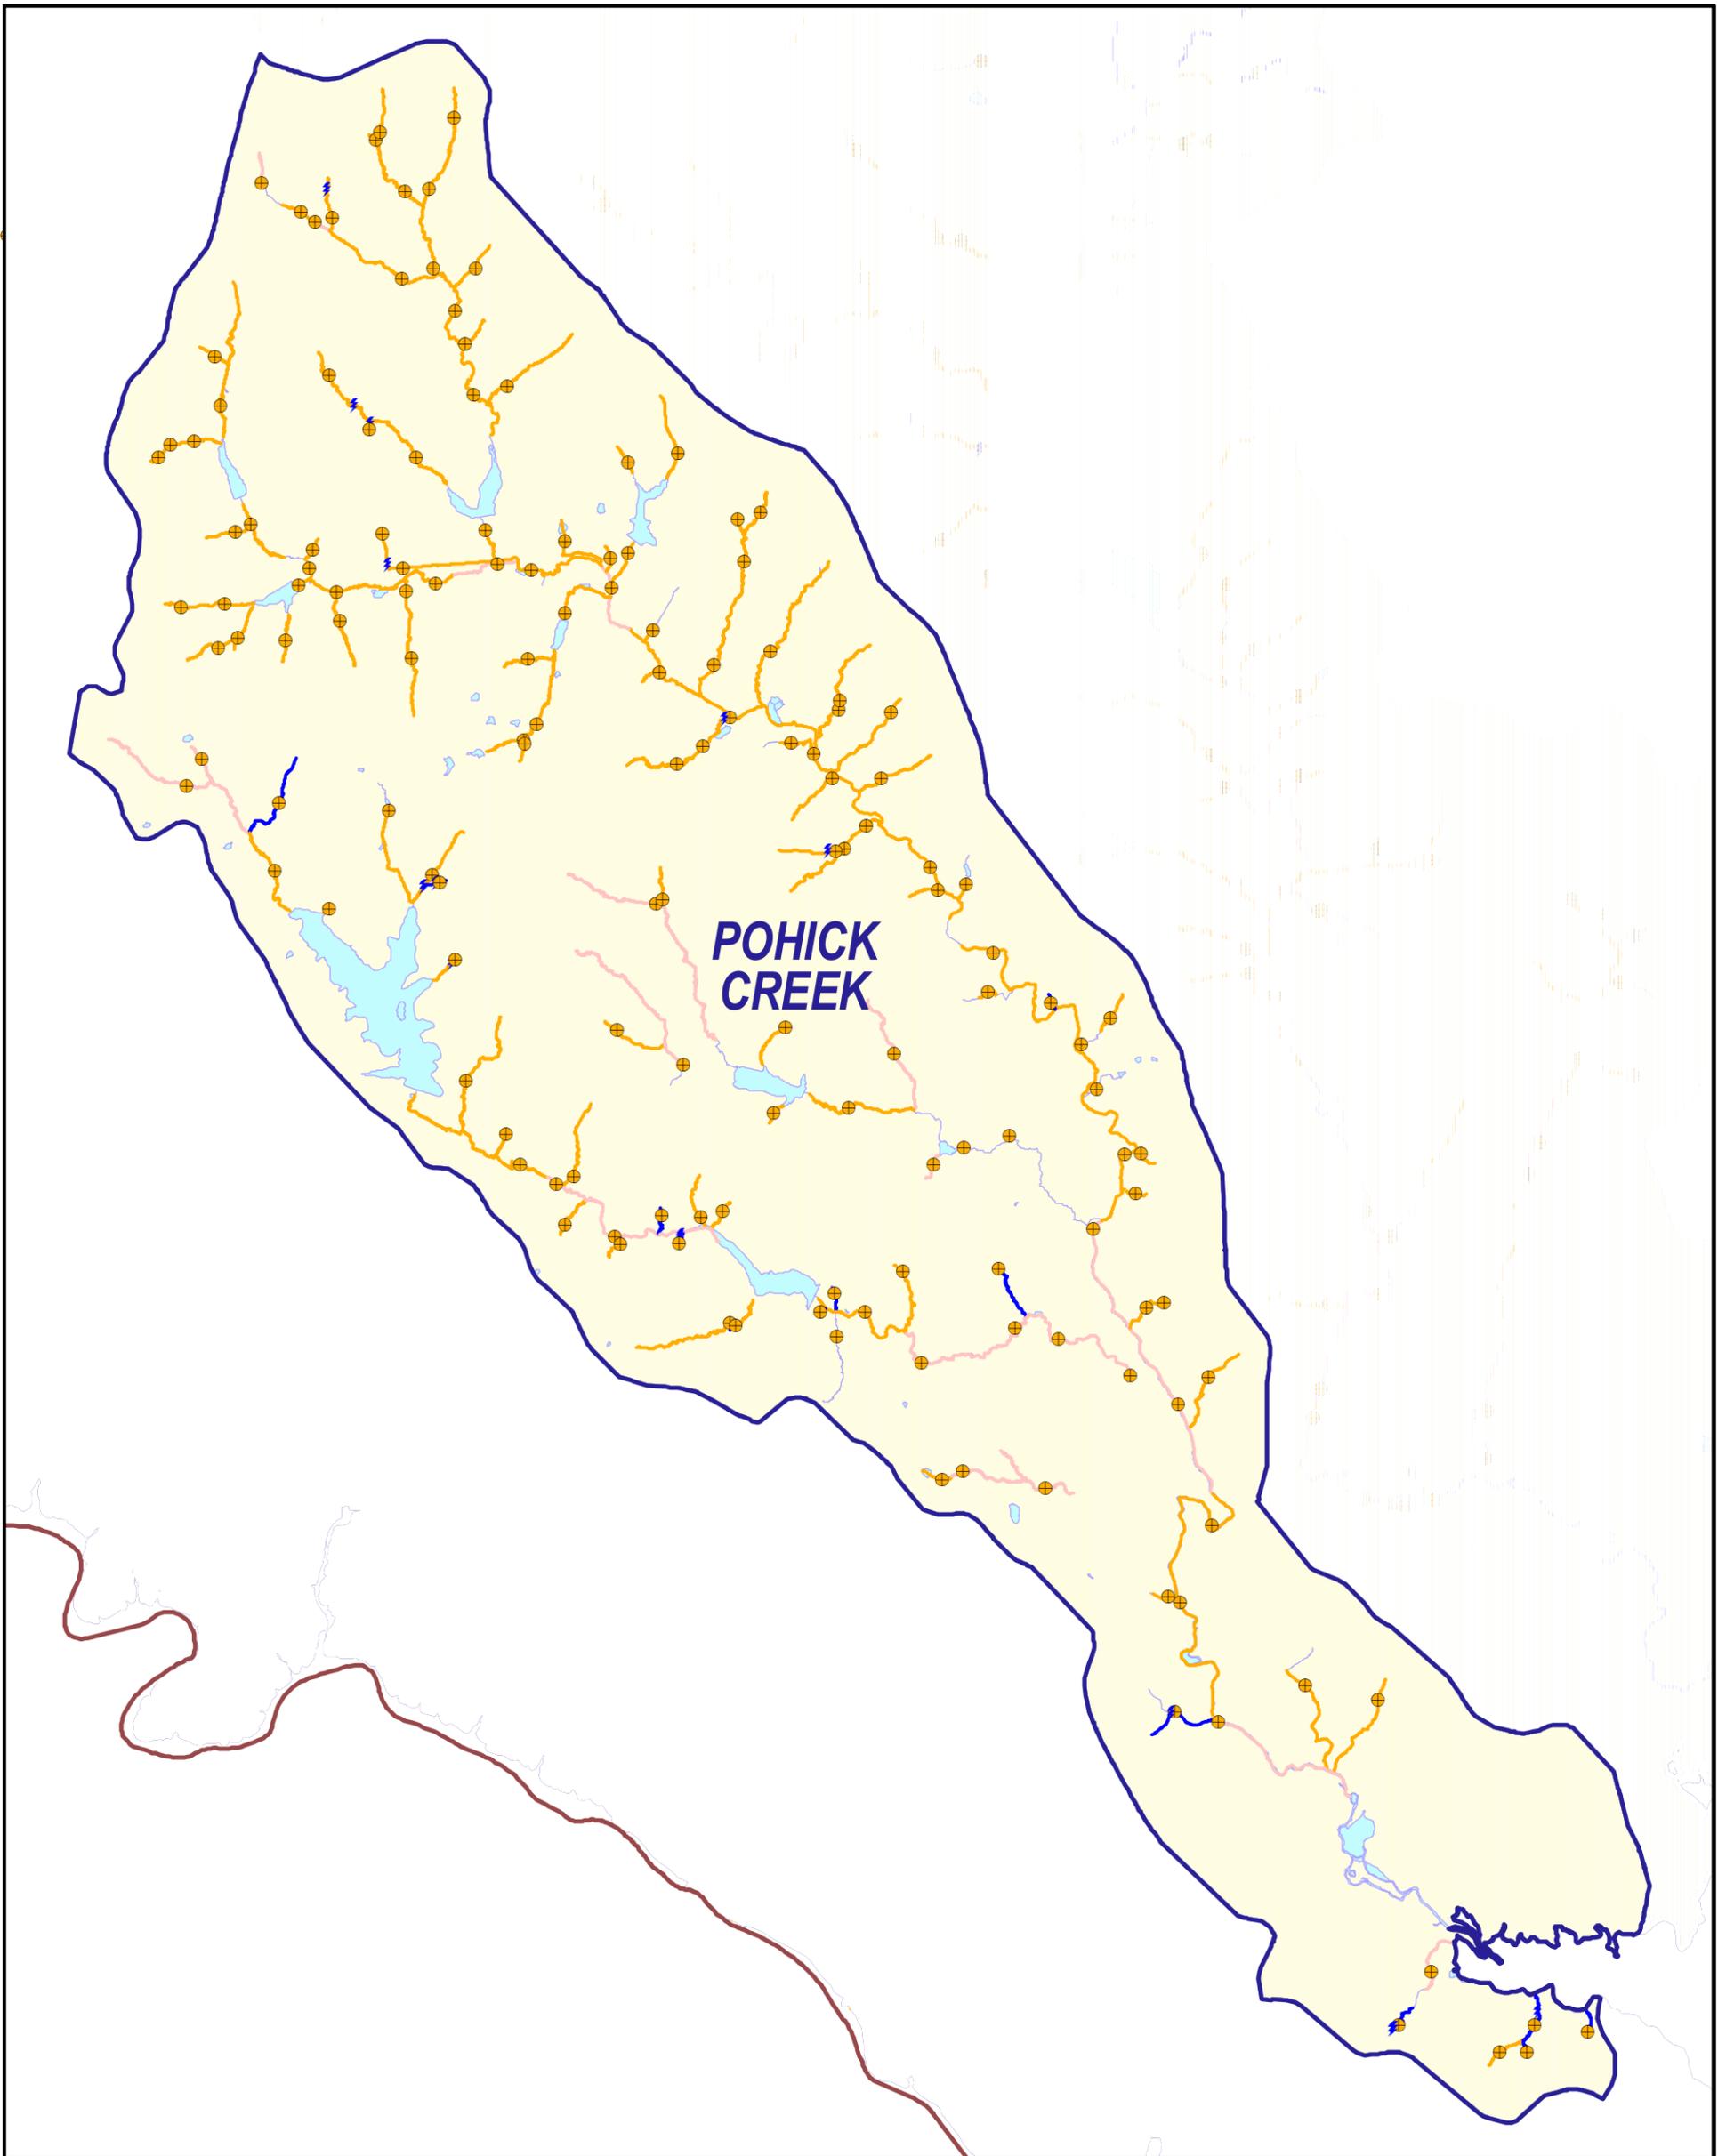
Figure 3-53
CEM Stages
Pohick Creek
Fairfax County Stream Physical Assessment

CEM. Based on the CEM evaluations approximately three quarters of the channels assessed in Pohick Creek Watershed are in Evolutionary Stage 3 (Table 3-3), with most of the remainder of the watershed in Stage 4. Figure 3-53 summarizes the CEM results for Pohick Creek Watershed.

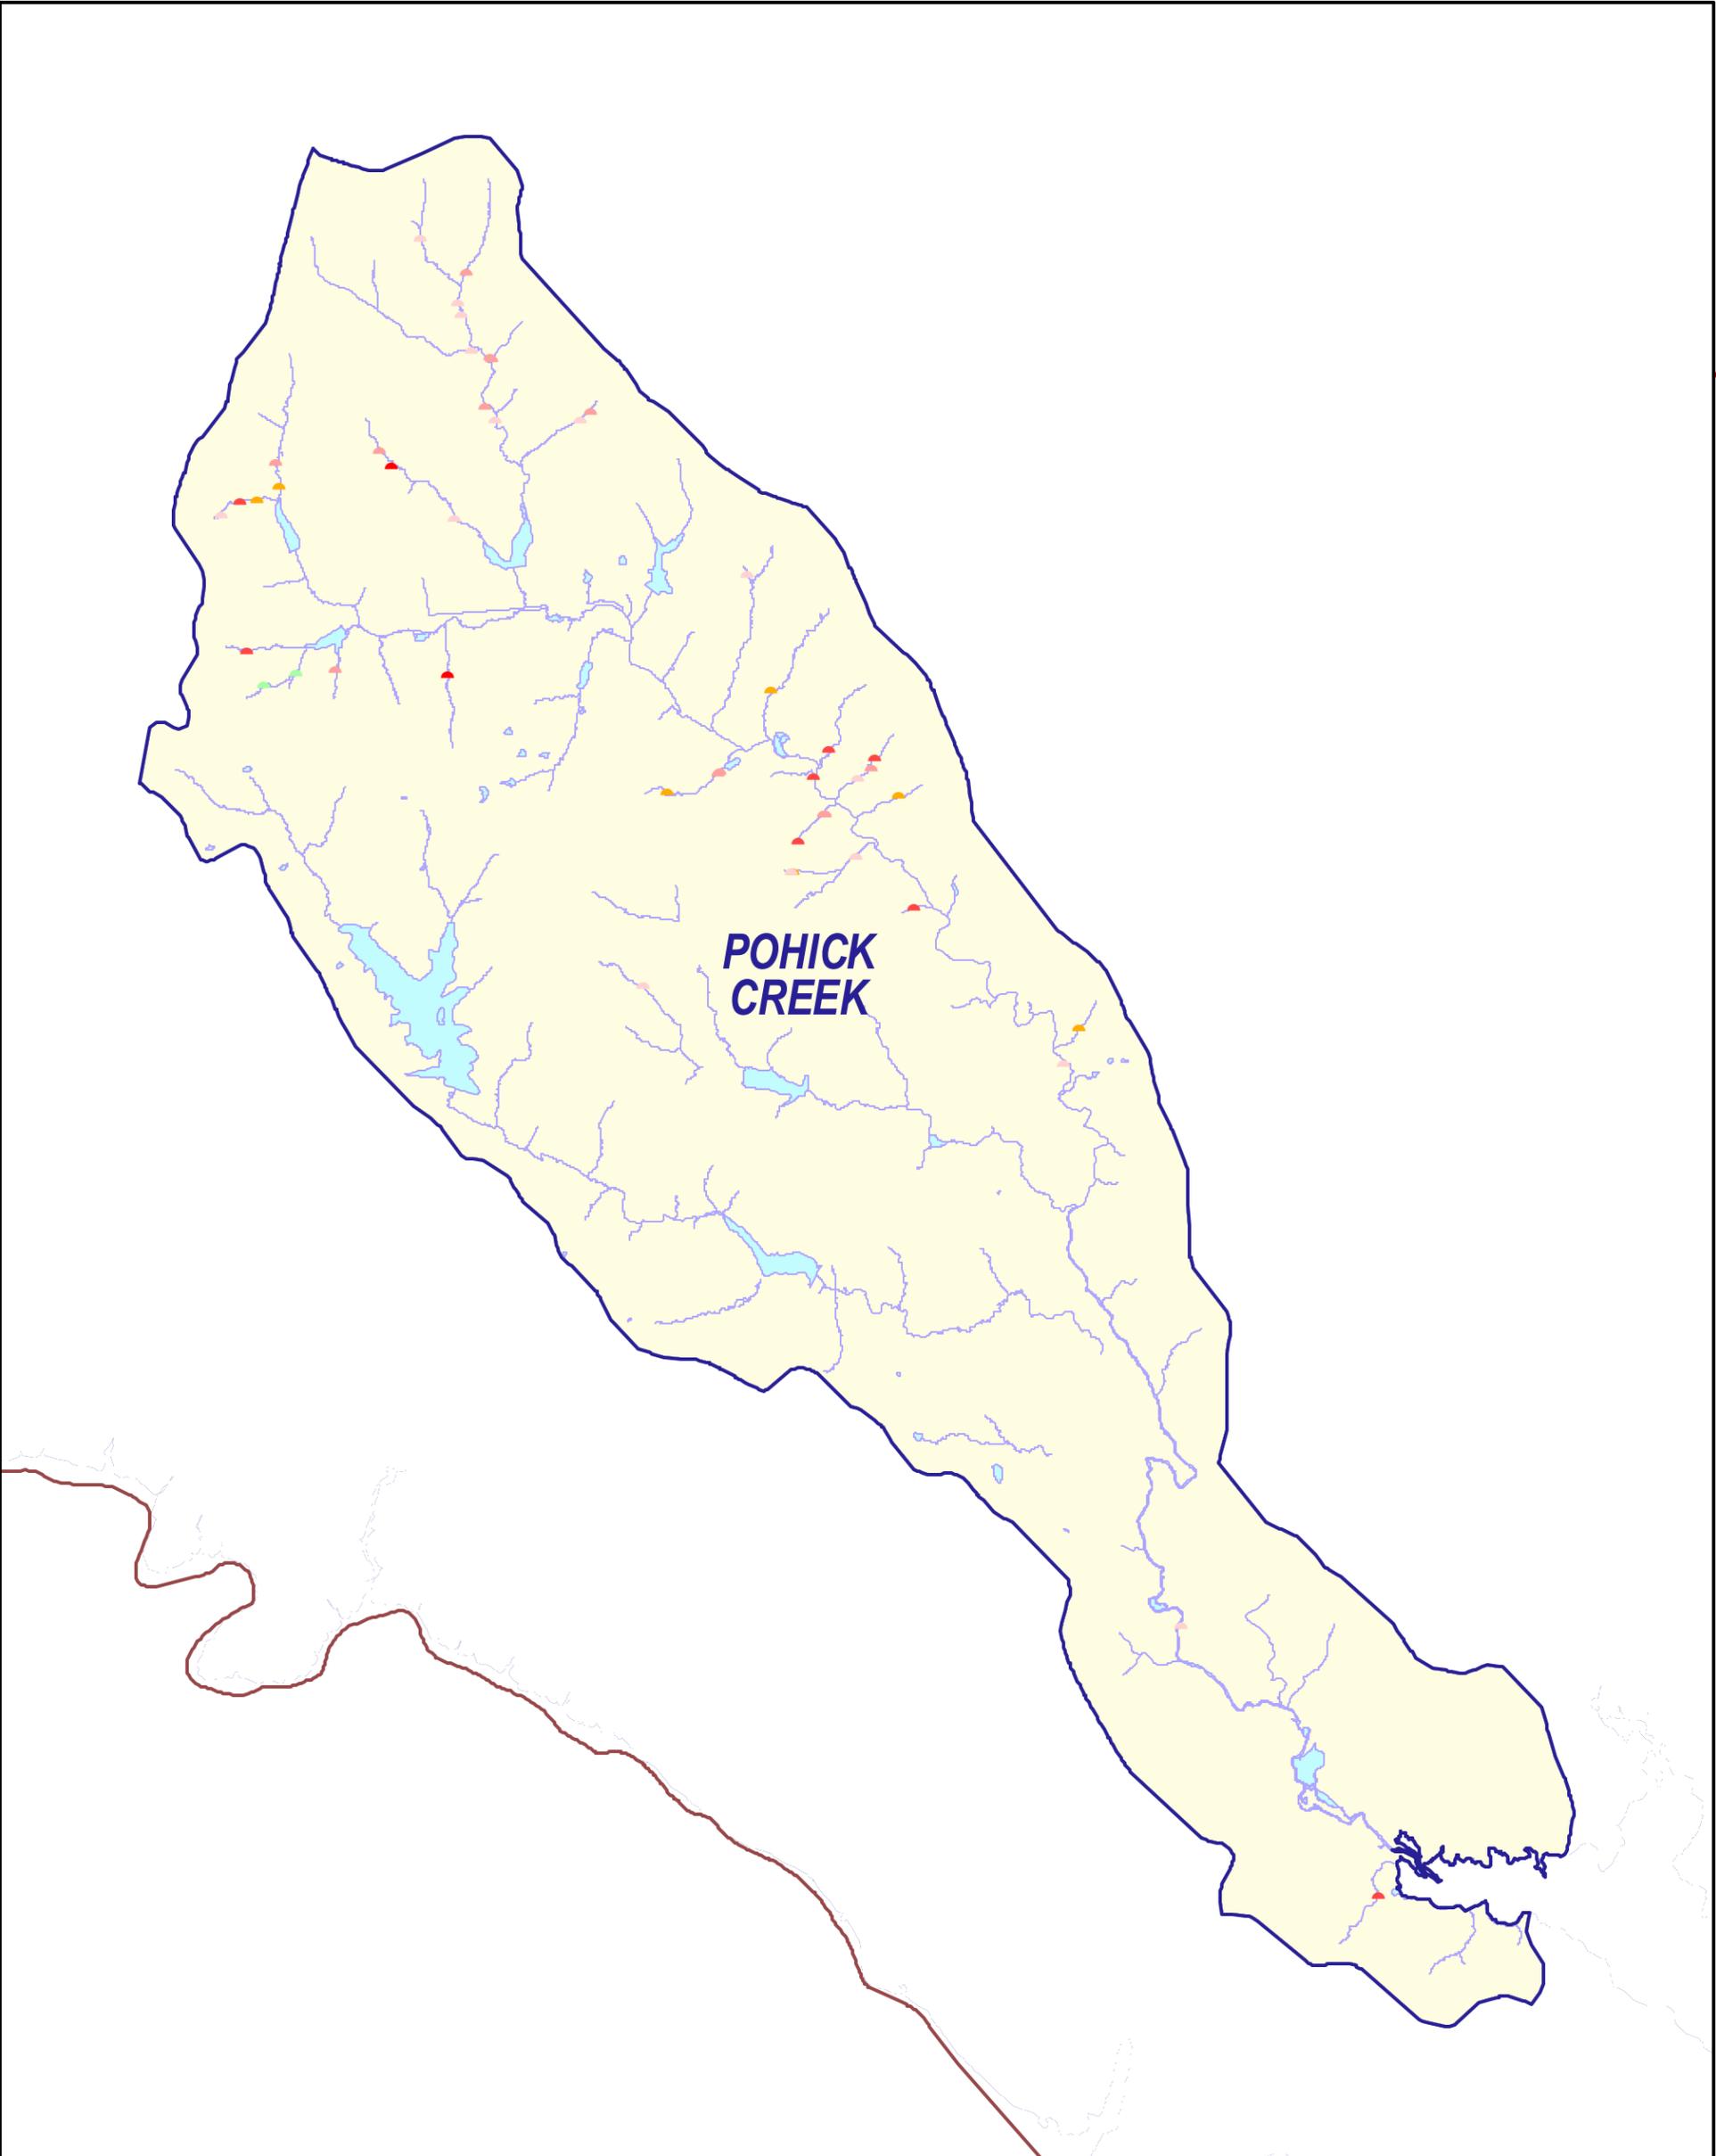
Figure 3-54
Erosion Impacts
Pohick Creek
Fairfax County Stream Physical Assessment

Infrastructure. The infrastructure inventory resulted in 871 inventory points. The most significant problems were related to four head cuts, two exposed utility lines and one pipe, which were each given an impact score of 10. The infrastructure inventory results are summarized in Table 3-38. Figures 3-54, 3-55, 3-56, 3-57, and 3-58 summarize impact scores for the erosion problems; deficient buffers; crossings; pipes/ditches; and dumps, obstructions, and utilities, respectively.
