3.2.7 Accotink Creek Group Summary

3.2.7.1 Accotink Creek Watershed

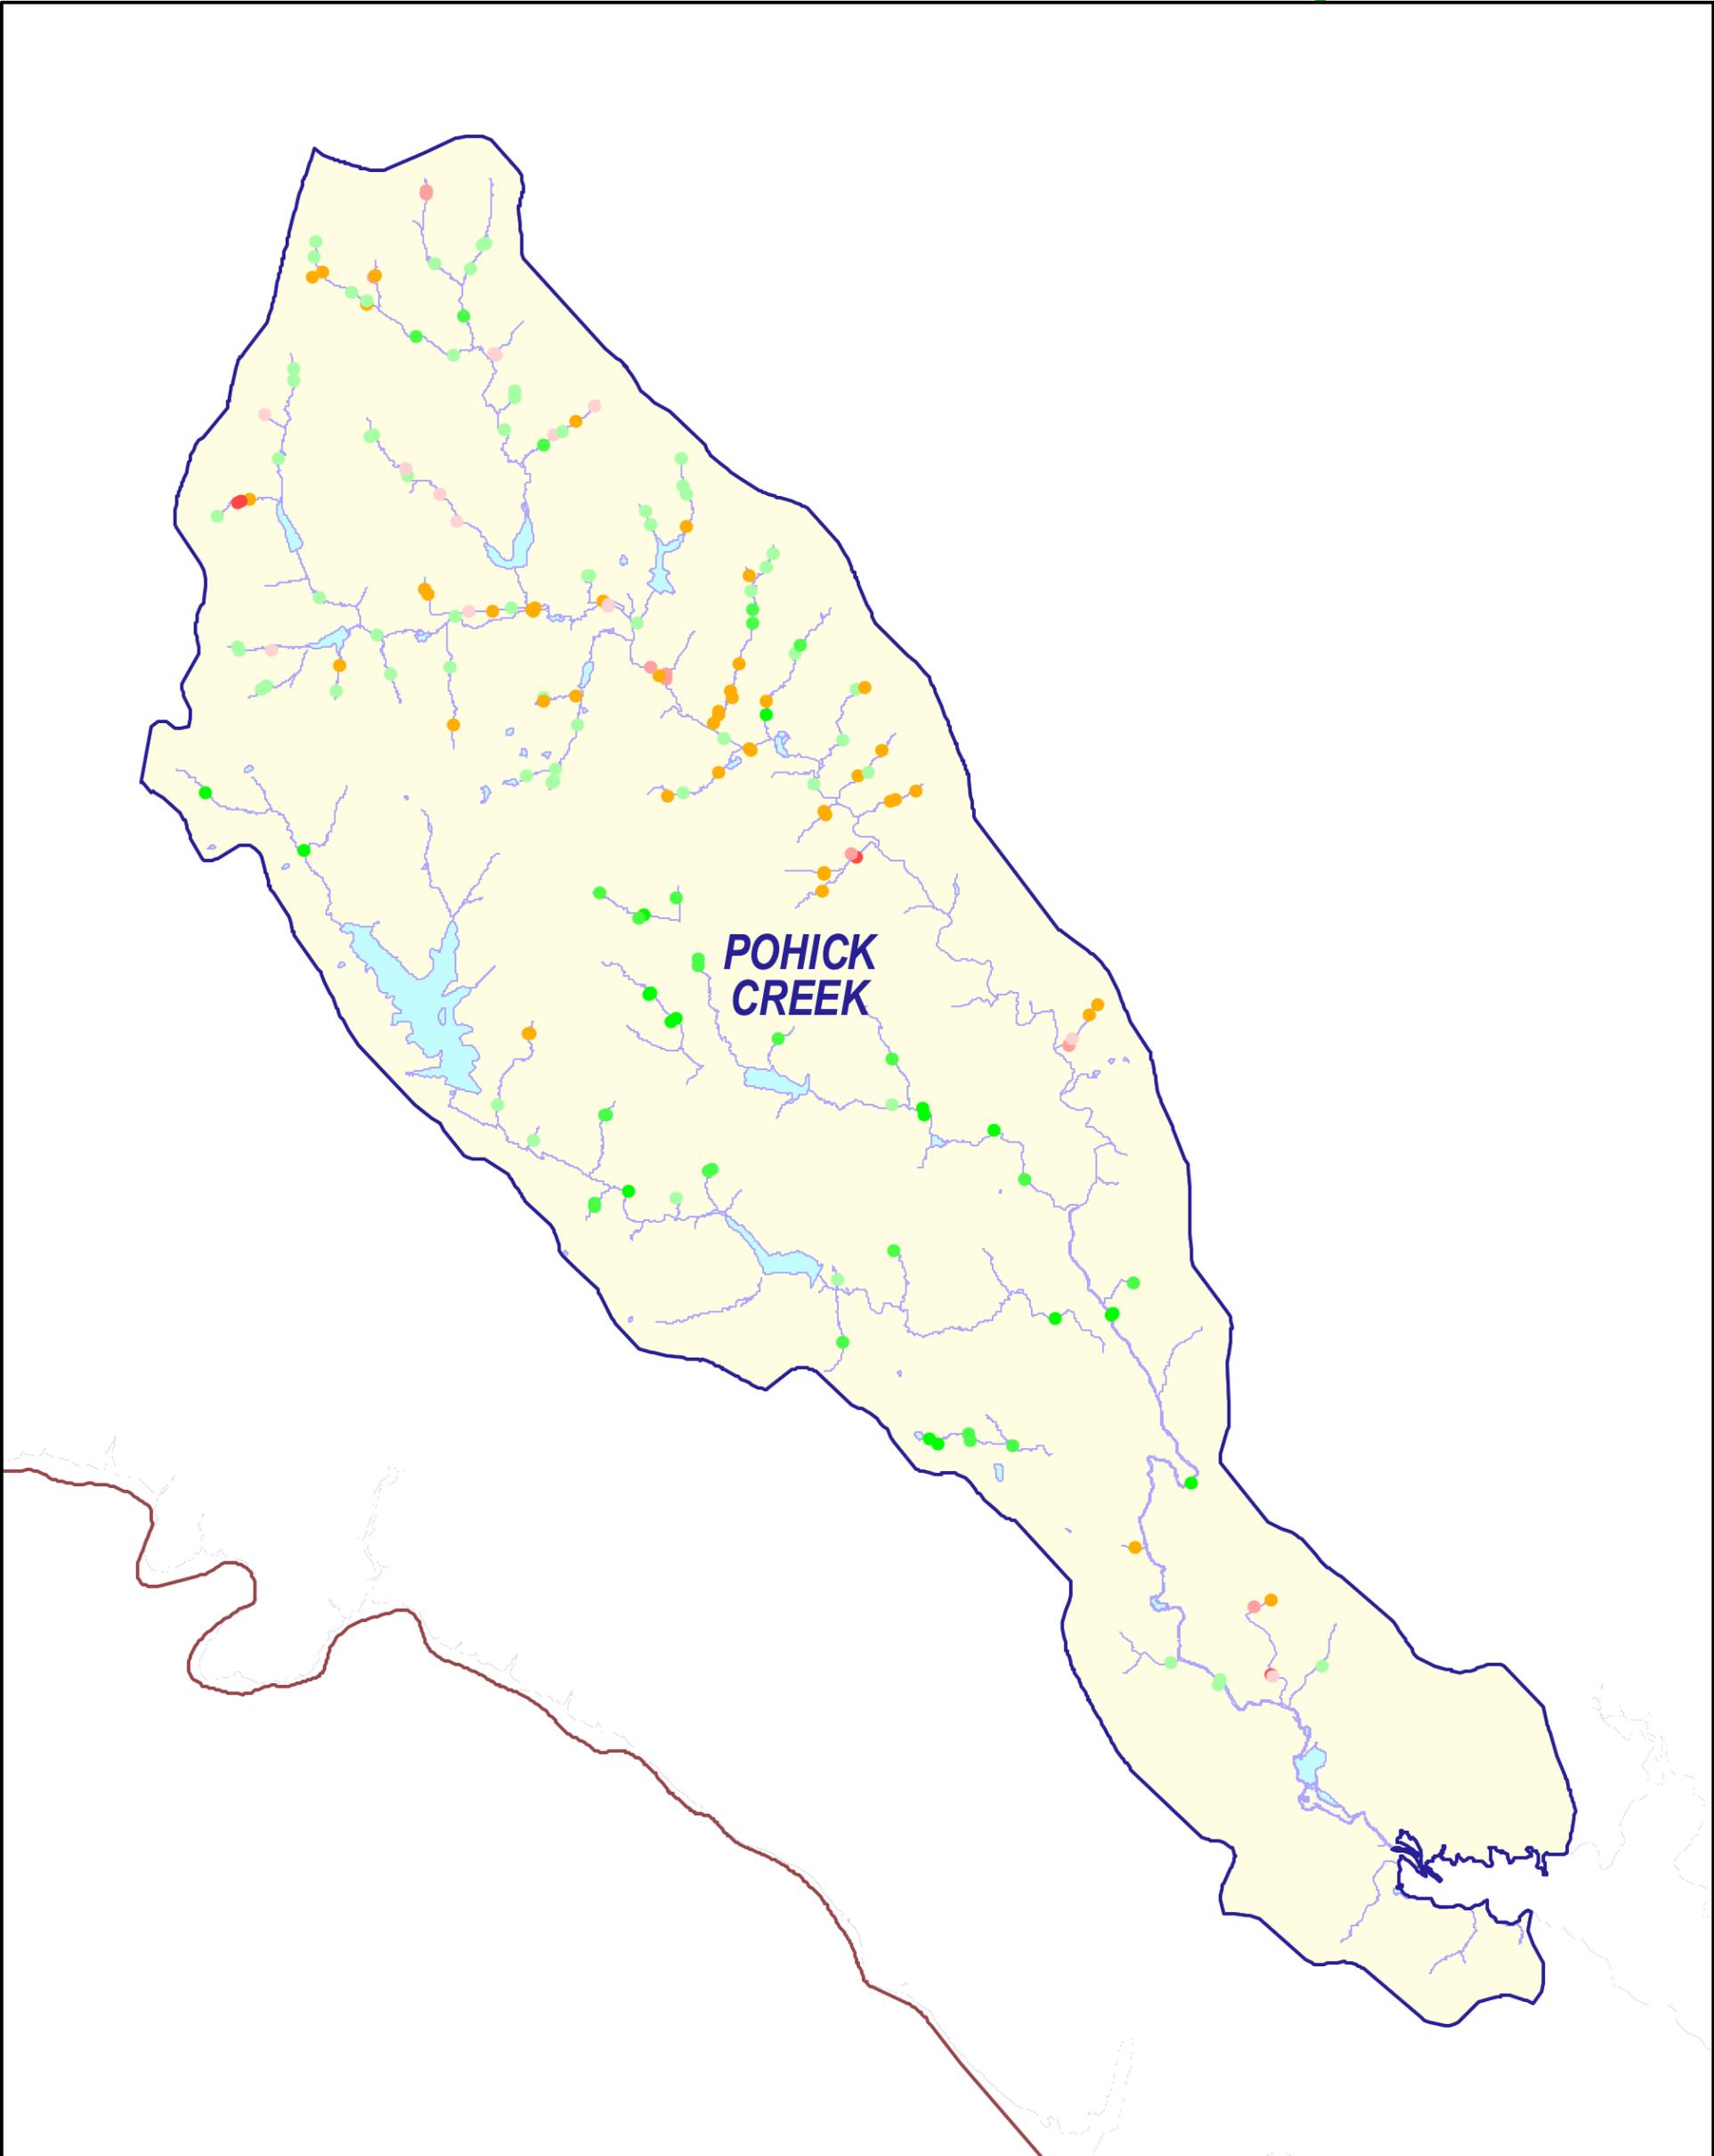
Figure 3-55
Deficient Buffer Impacts
Pohick Creek
Fairfax County Stream Physical Assessment

Infrastructure. The infrastructure inventory resulted in 871 inventory points. The most significant problems were related to four head cuts, two exposed utility lines and one pipe, which were each given an impact score of 10. The infrastructure inventory results are summarized in Table 3-38. Figures 3-54, 3-55, 3-56, 3-57, and 3-58 summarize impact scores for the erosion problems; deficient buffers; crossings; pipes/ditches; and dumps, obstructions, and utilities, respectively.

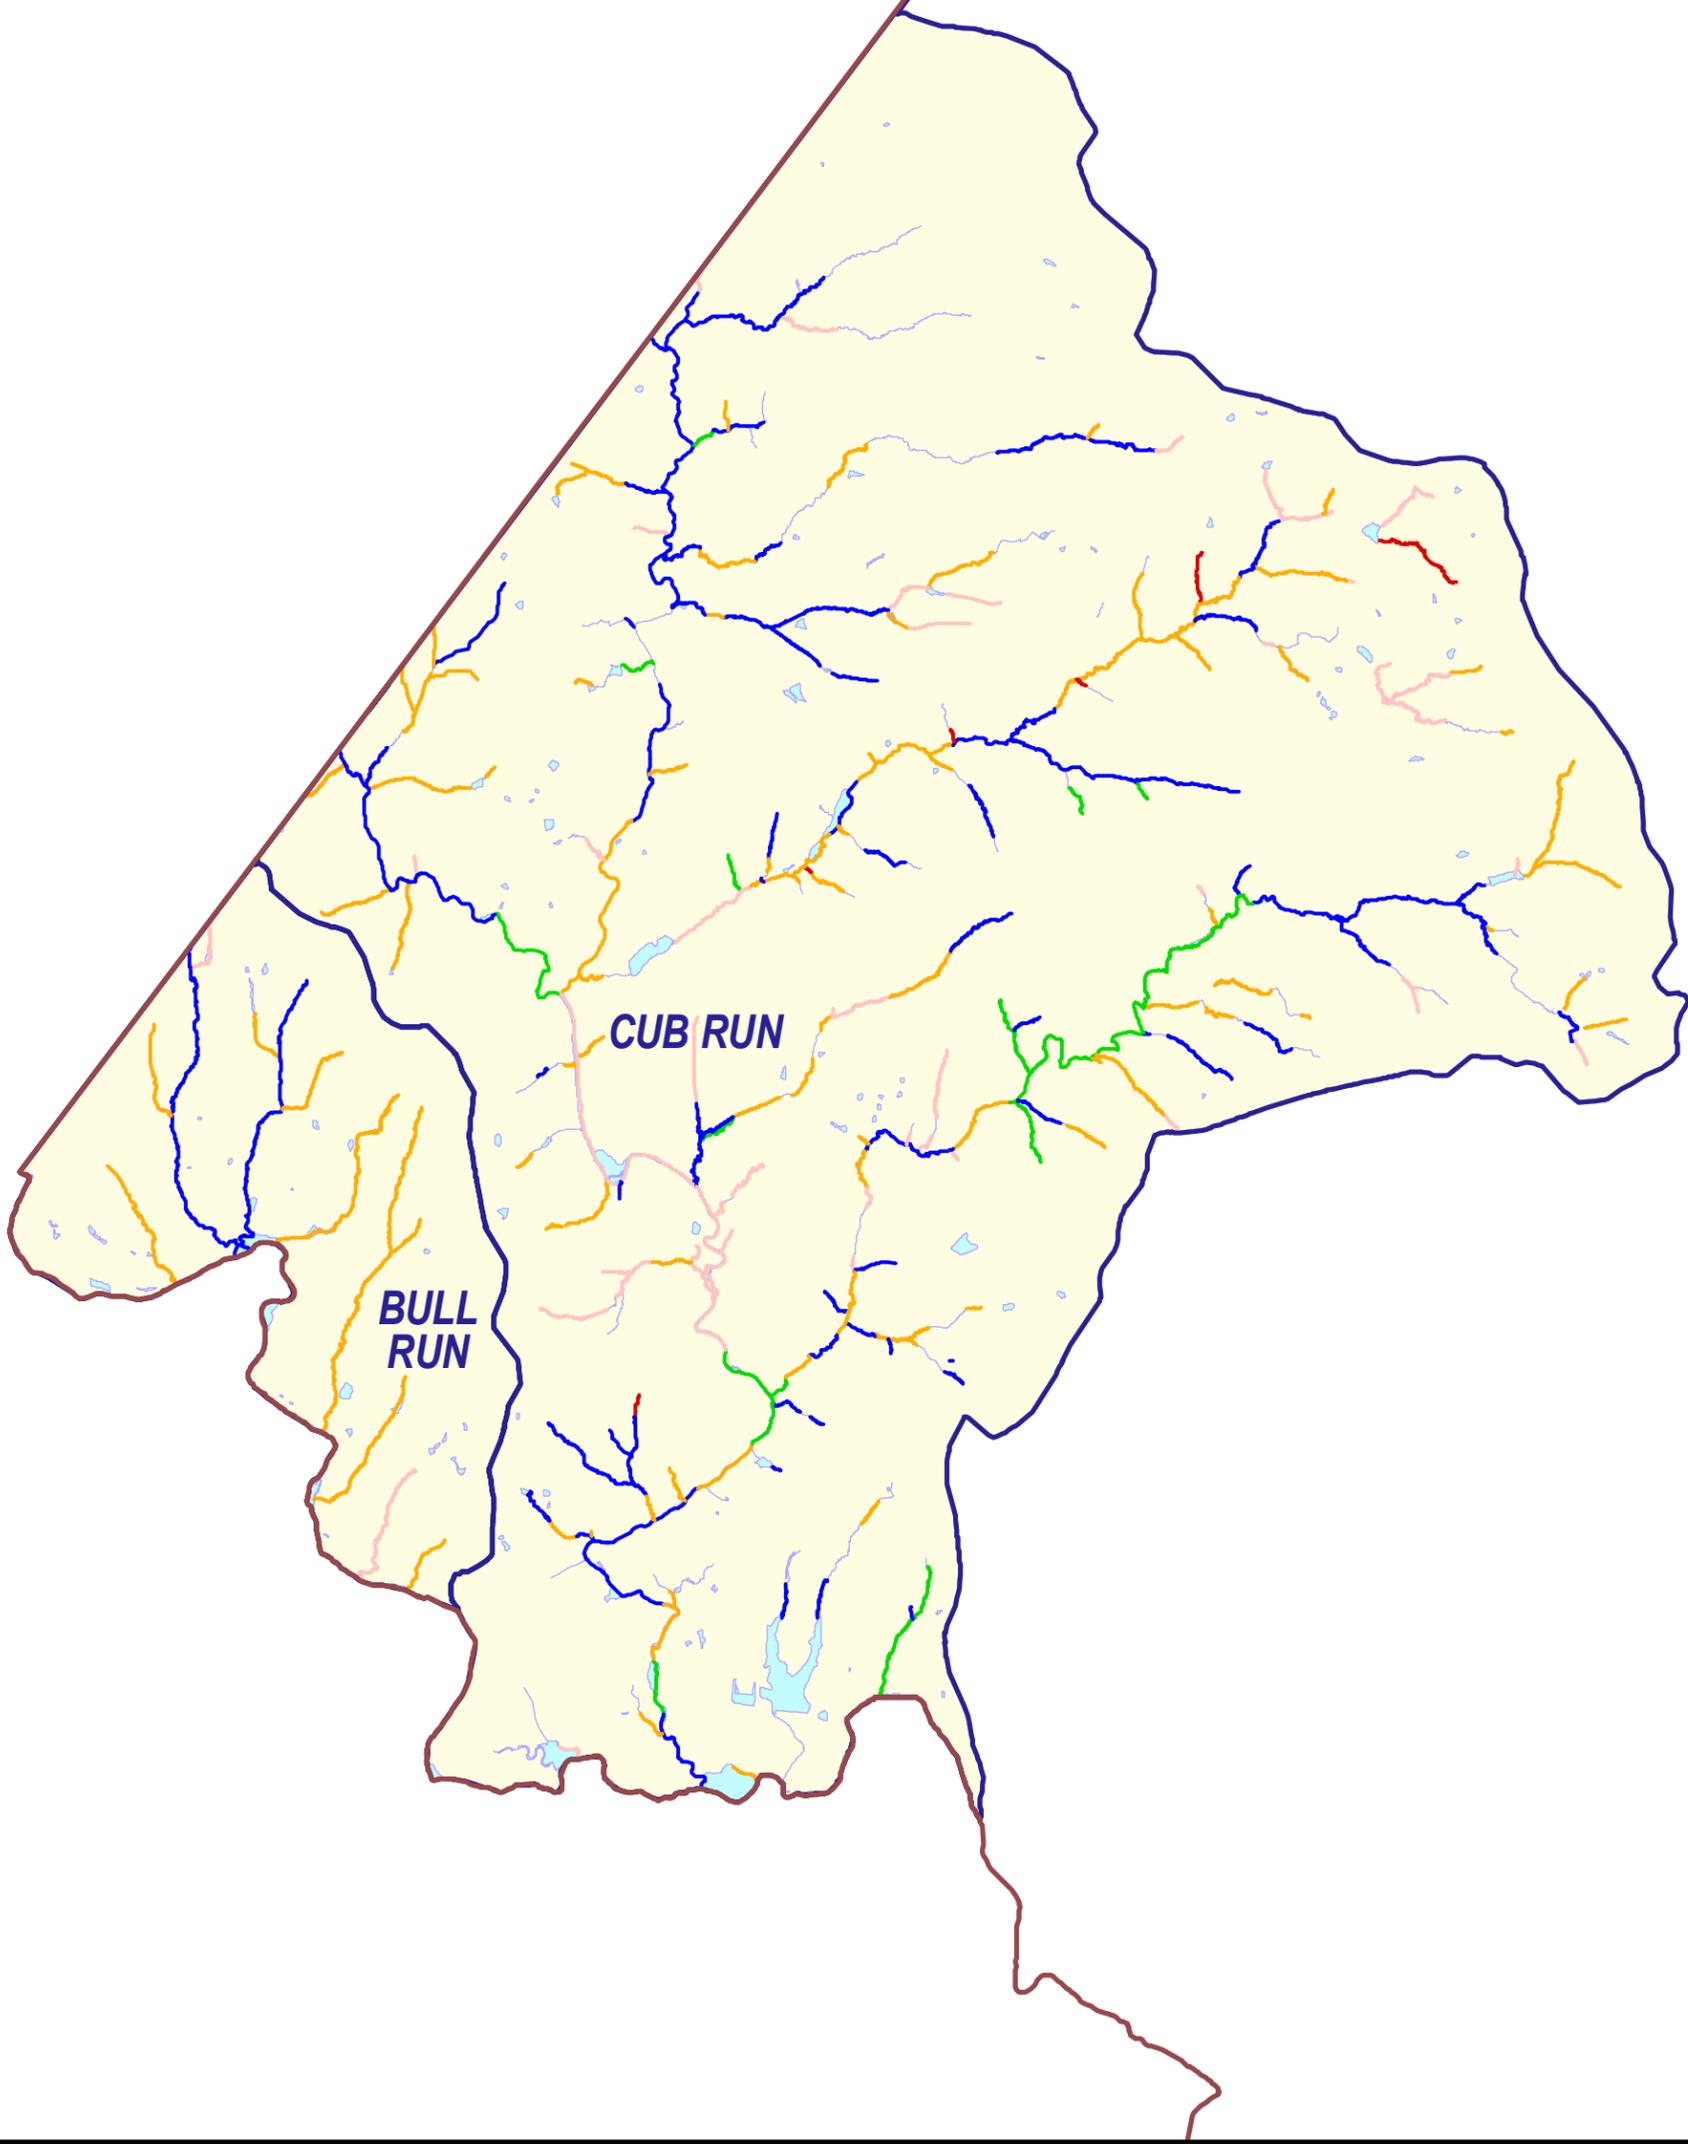
Figure 3-59
Habitat Assessment
Upper Bull Run Group
Fairfax County Stream Physical Assessment

Habitat. The habitat assessment results for Cub Run Watershed are summarized by stream in Table 3-39. Habitat scores for each reach are depicted in Figure 3-59. Based on a length weighted habitat score of 110 (Table 3-2), Cub Run Watershed is in the upper middle range of quality, compared to the rest of the County. Approximately 1 mile of stream was categorized as having “very poor” habitat conditions, 13 miles as “poor,” 24 miles as “fair,” and 28 miles as “good,” and 8 miles as “excellent.”

Habitat. The habitat assessment results for Bull Run Watershed are summarized by stream in Table 3-41. Habitat scores for each reach are depicted in Figure 3-59. Based on a length weighted habitat score of 108 (Table 3-2), Bull Run Watershed is in the upper middle range of quality, compared to the rest of the County. Just over 1 mile of stream was categorized as having “poor” habitat conditions; 8 miles were “fair,” and 4 miles were “good.”

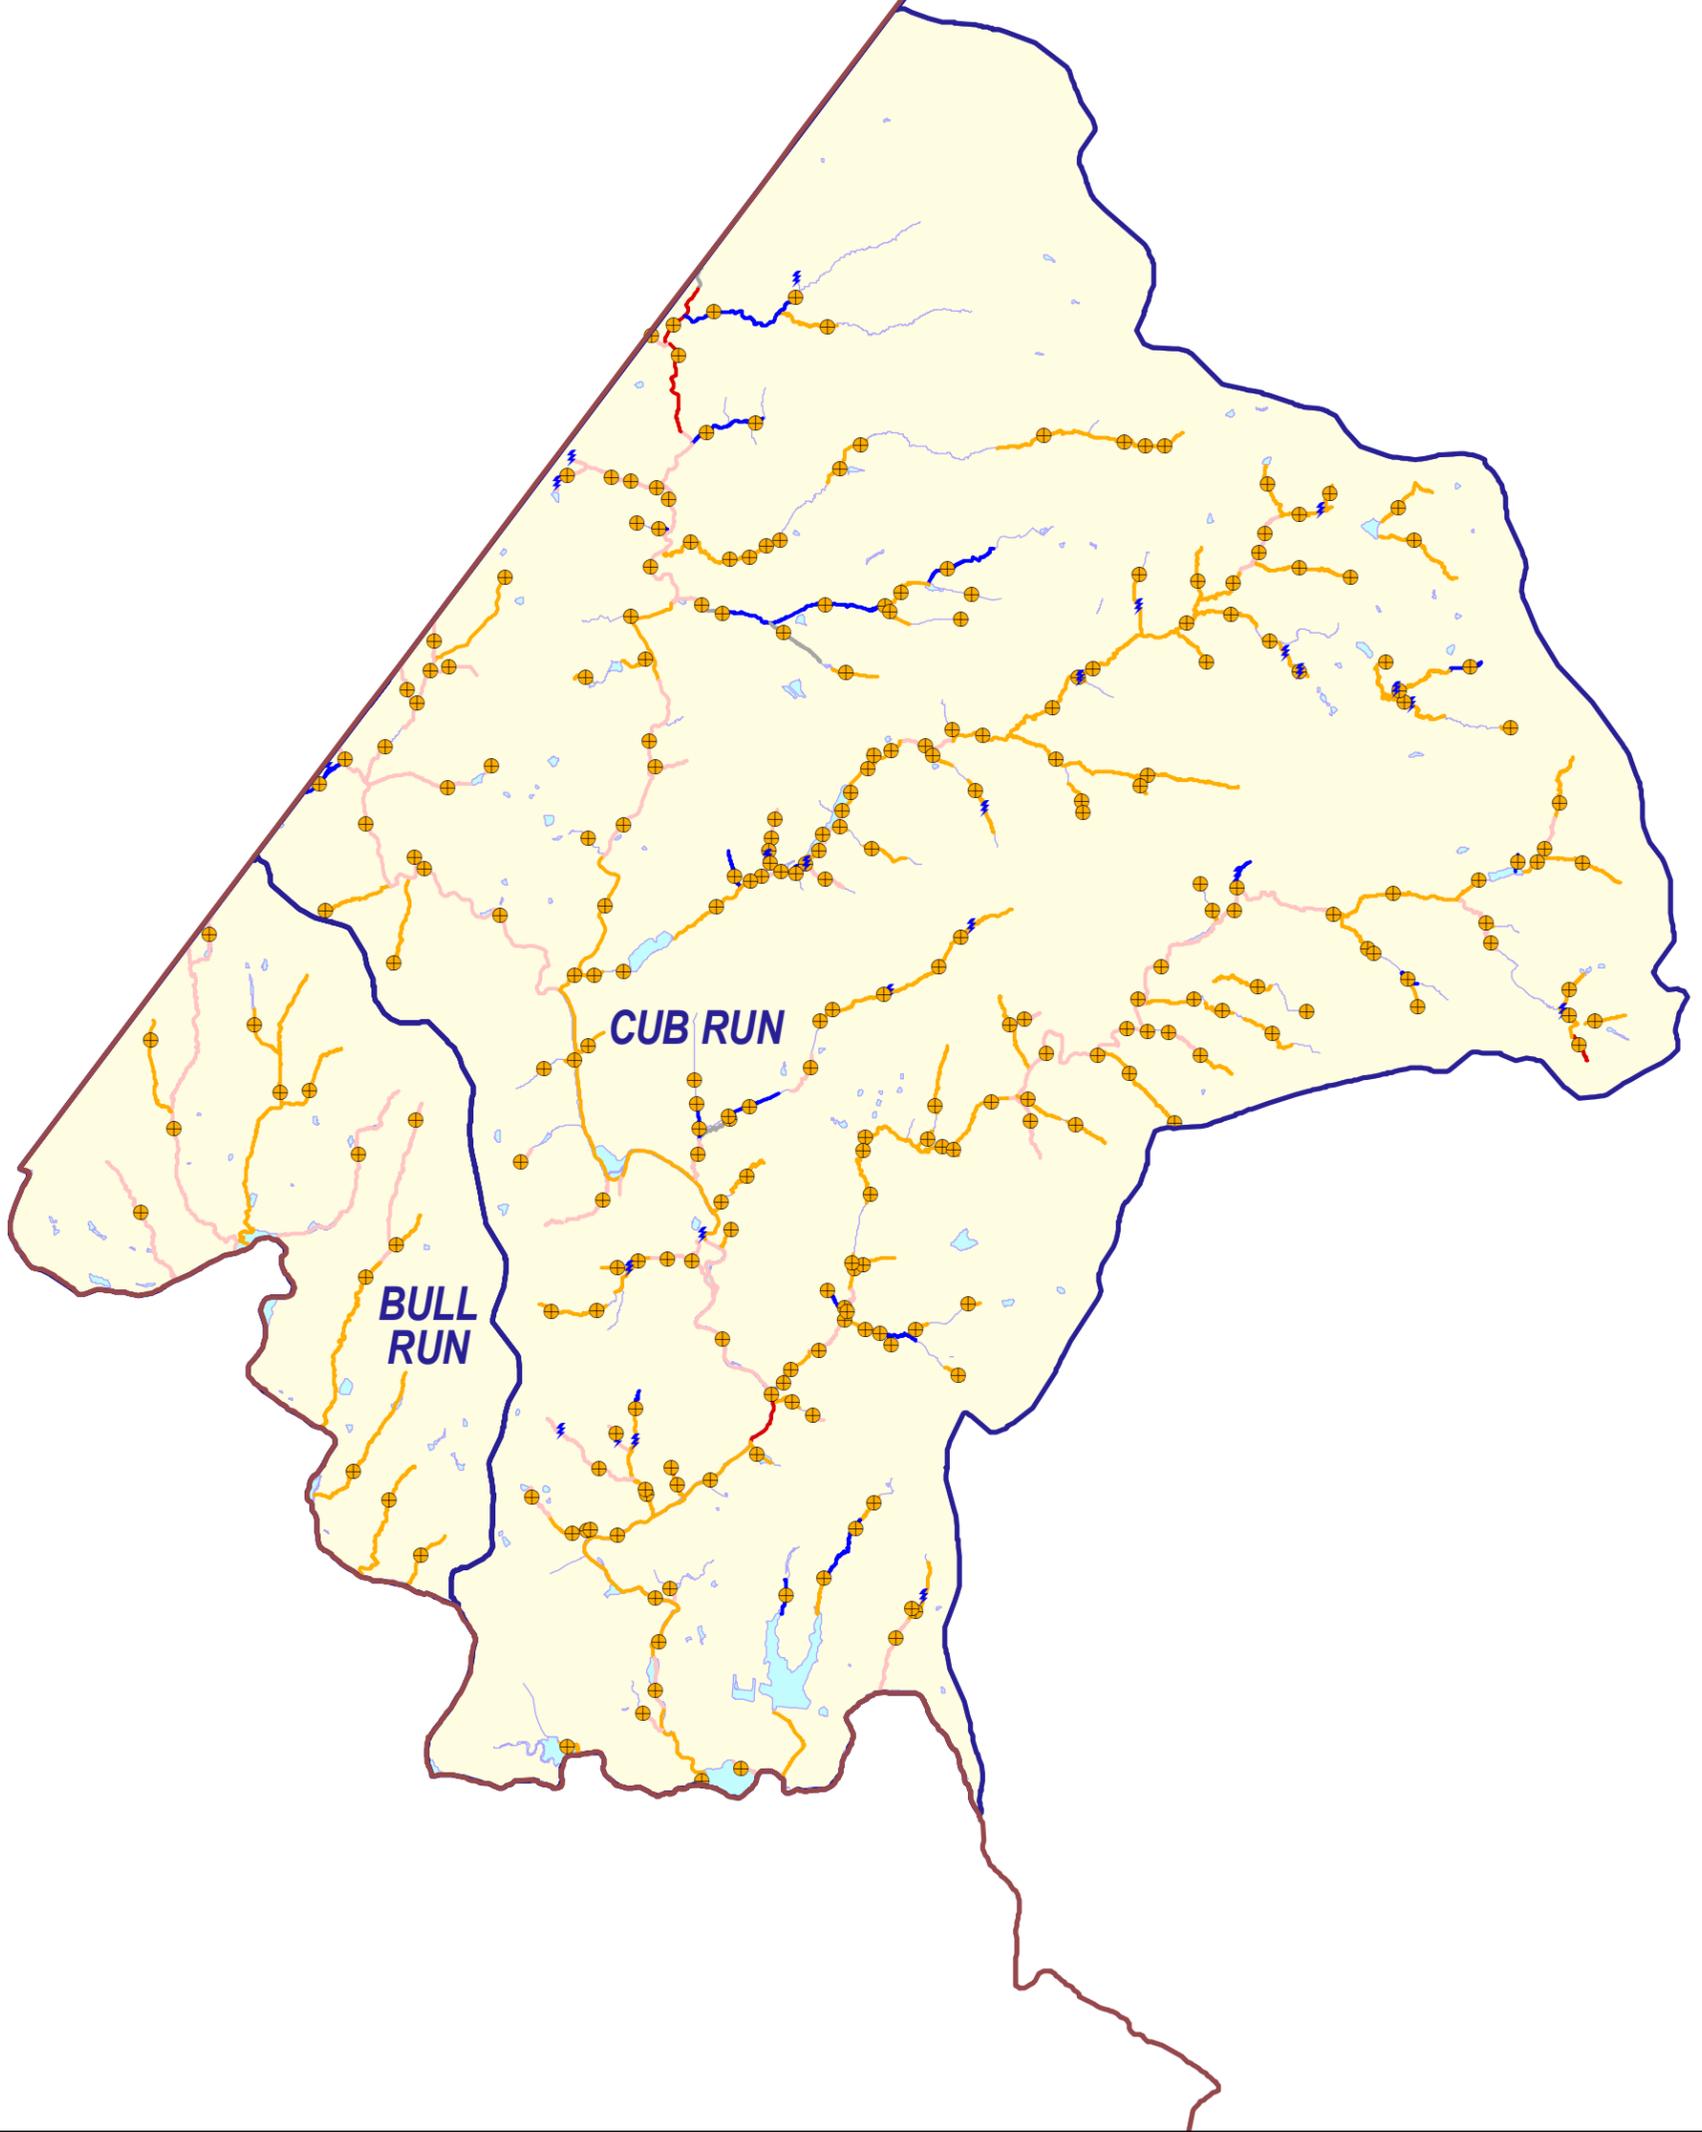
Figure 3-60
CEM Stages
Upper Bull Run Group
Fairfax County Stream Physical Assessment

CEM. Based on the CEM evaluations approximately 60 percent of the channels assessed in Cub Run Watershed are in Evolutionary Stage 3 (Table 3-3) and most of the rest are in Stage 4. Figure 3-60 summarizes the CEM results for Cub Run Watershed.

CEM. Based on the CEM evaluations approximately two thirds of the channels assessed in Bull Run Watershed are in Evolutionary Stage 3 (Table 3-3) with the remainder in Stage 2. Figure 3-60 summarizes the CEM results for Bull Run Watershed.

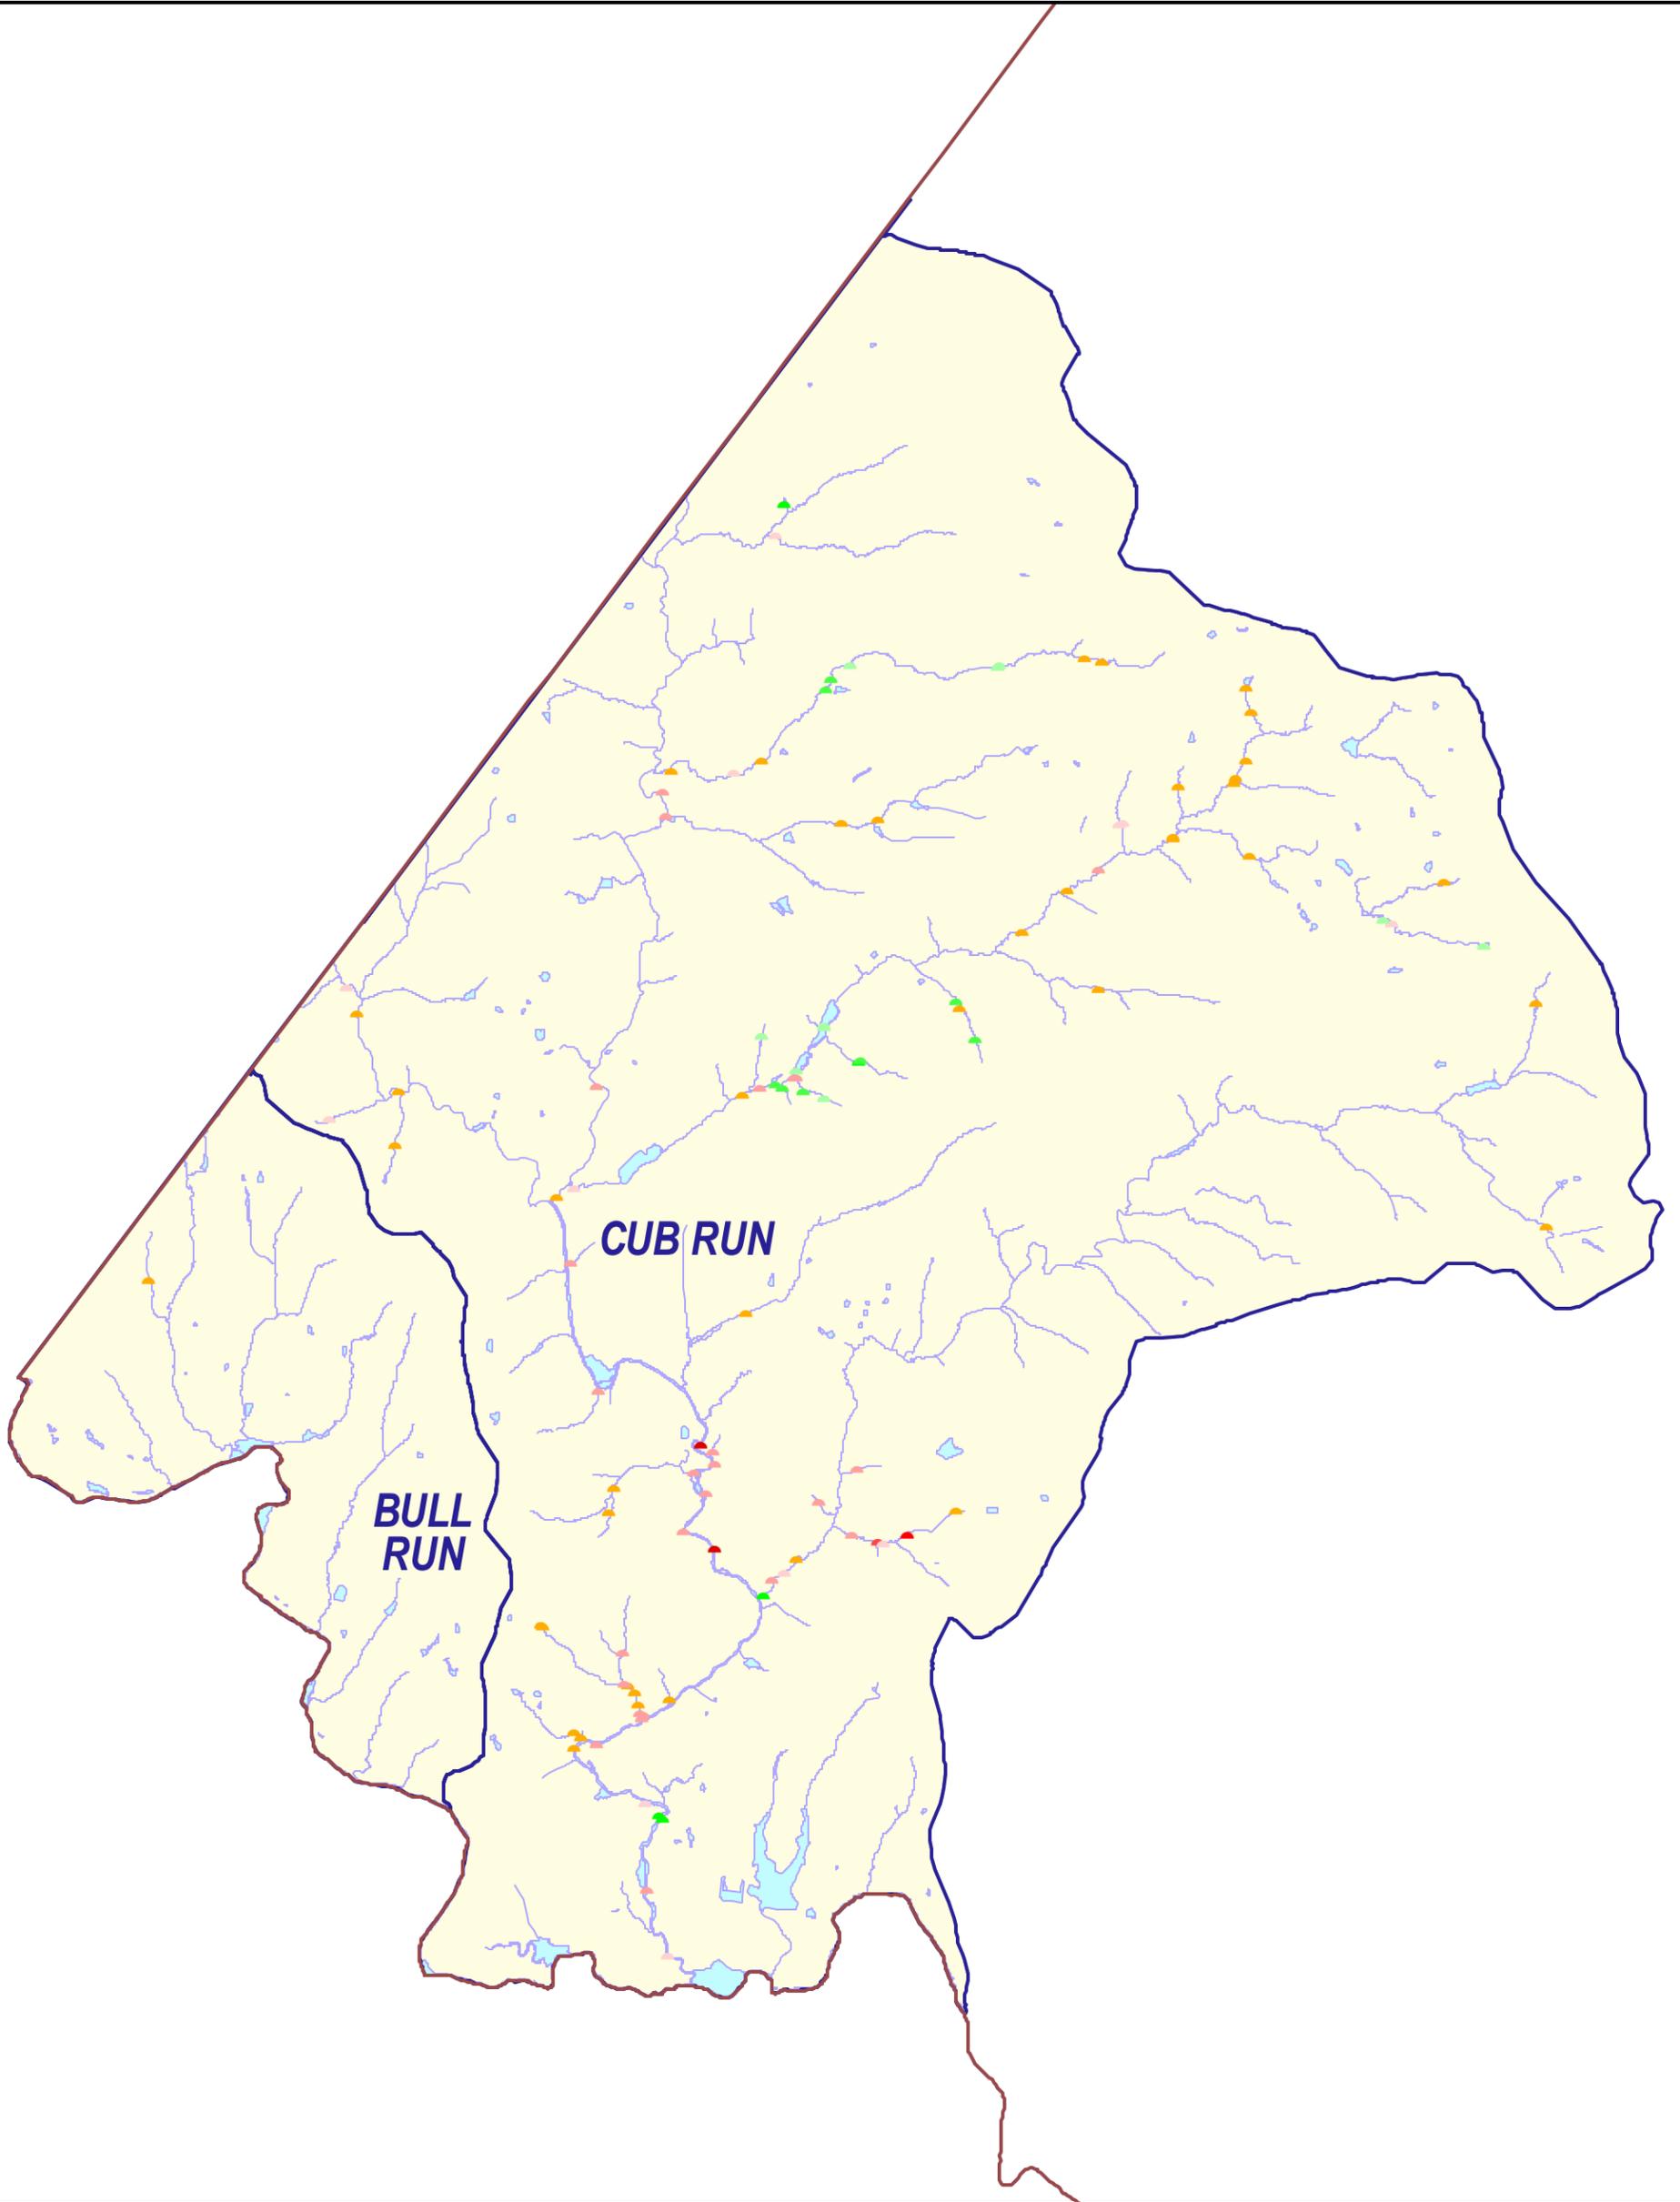
Figure 3-61
Erosion Impacts
Upper Bull Run Group
Fairfax County Stream Physical Assessment

Infrastructure. The infrastructure inventory resulted in 1473 inventory points. The most significant problem was related to 20 deficient buffers as well as a variety of other infrastructures with an impact score of 10. Figures 3-61, 3-62, 3-63, 3-64, and 3-65 summarize impact scores for the erosion problems; deficient buffers; crossings; pipes/ditches; and dumps, obstructions, and utilities, respectively.

Infrastructure. The infrastructure inventory resulted in 59 inventory points. The most significant problems were related to a crossing that was given an impact score of 8 and five deficient buffers that were given an impact score of 7. The infrastructure inventory results are summarized in Table 3-42. Figures 3-61, 3-62, 3-63, 3-64, and 3-65 summarize impact scores for the erosion problems; deficient buffers; crossings; pipes/ditches; and dumps, obstructions, and utilities, respectively.
