## 3.2.10 Lower Bull Run Group Summary

### 3.2.10.1 Little Rocky Run Watershed

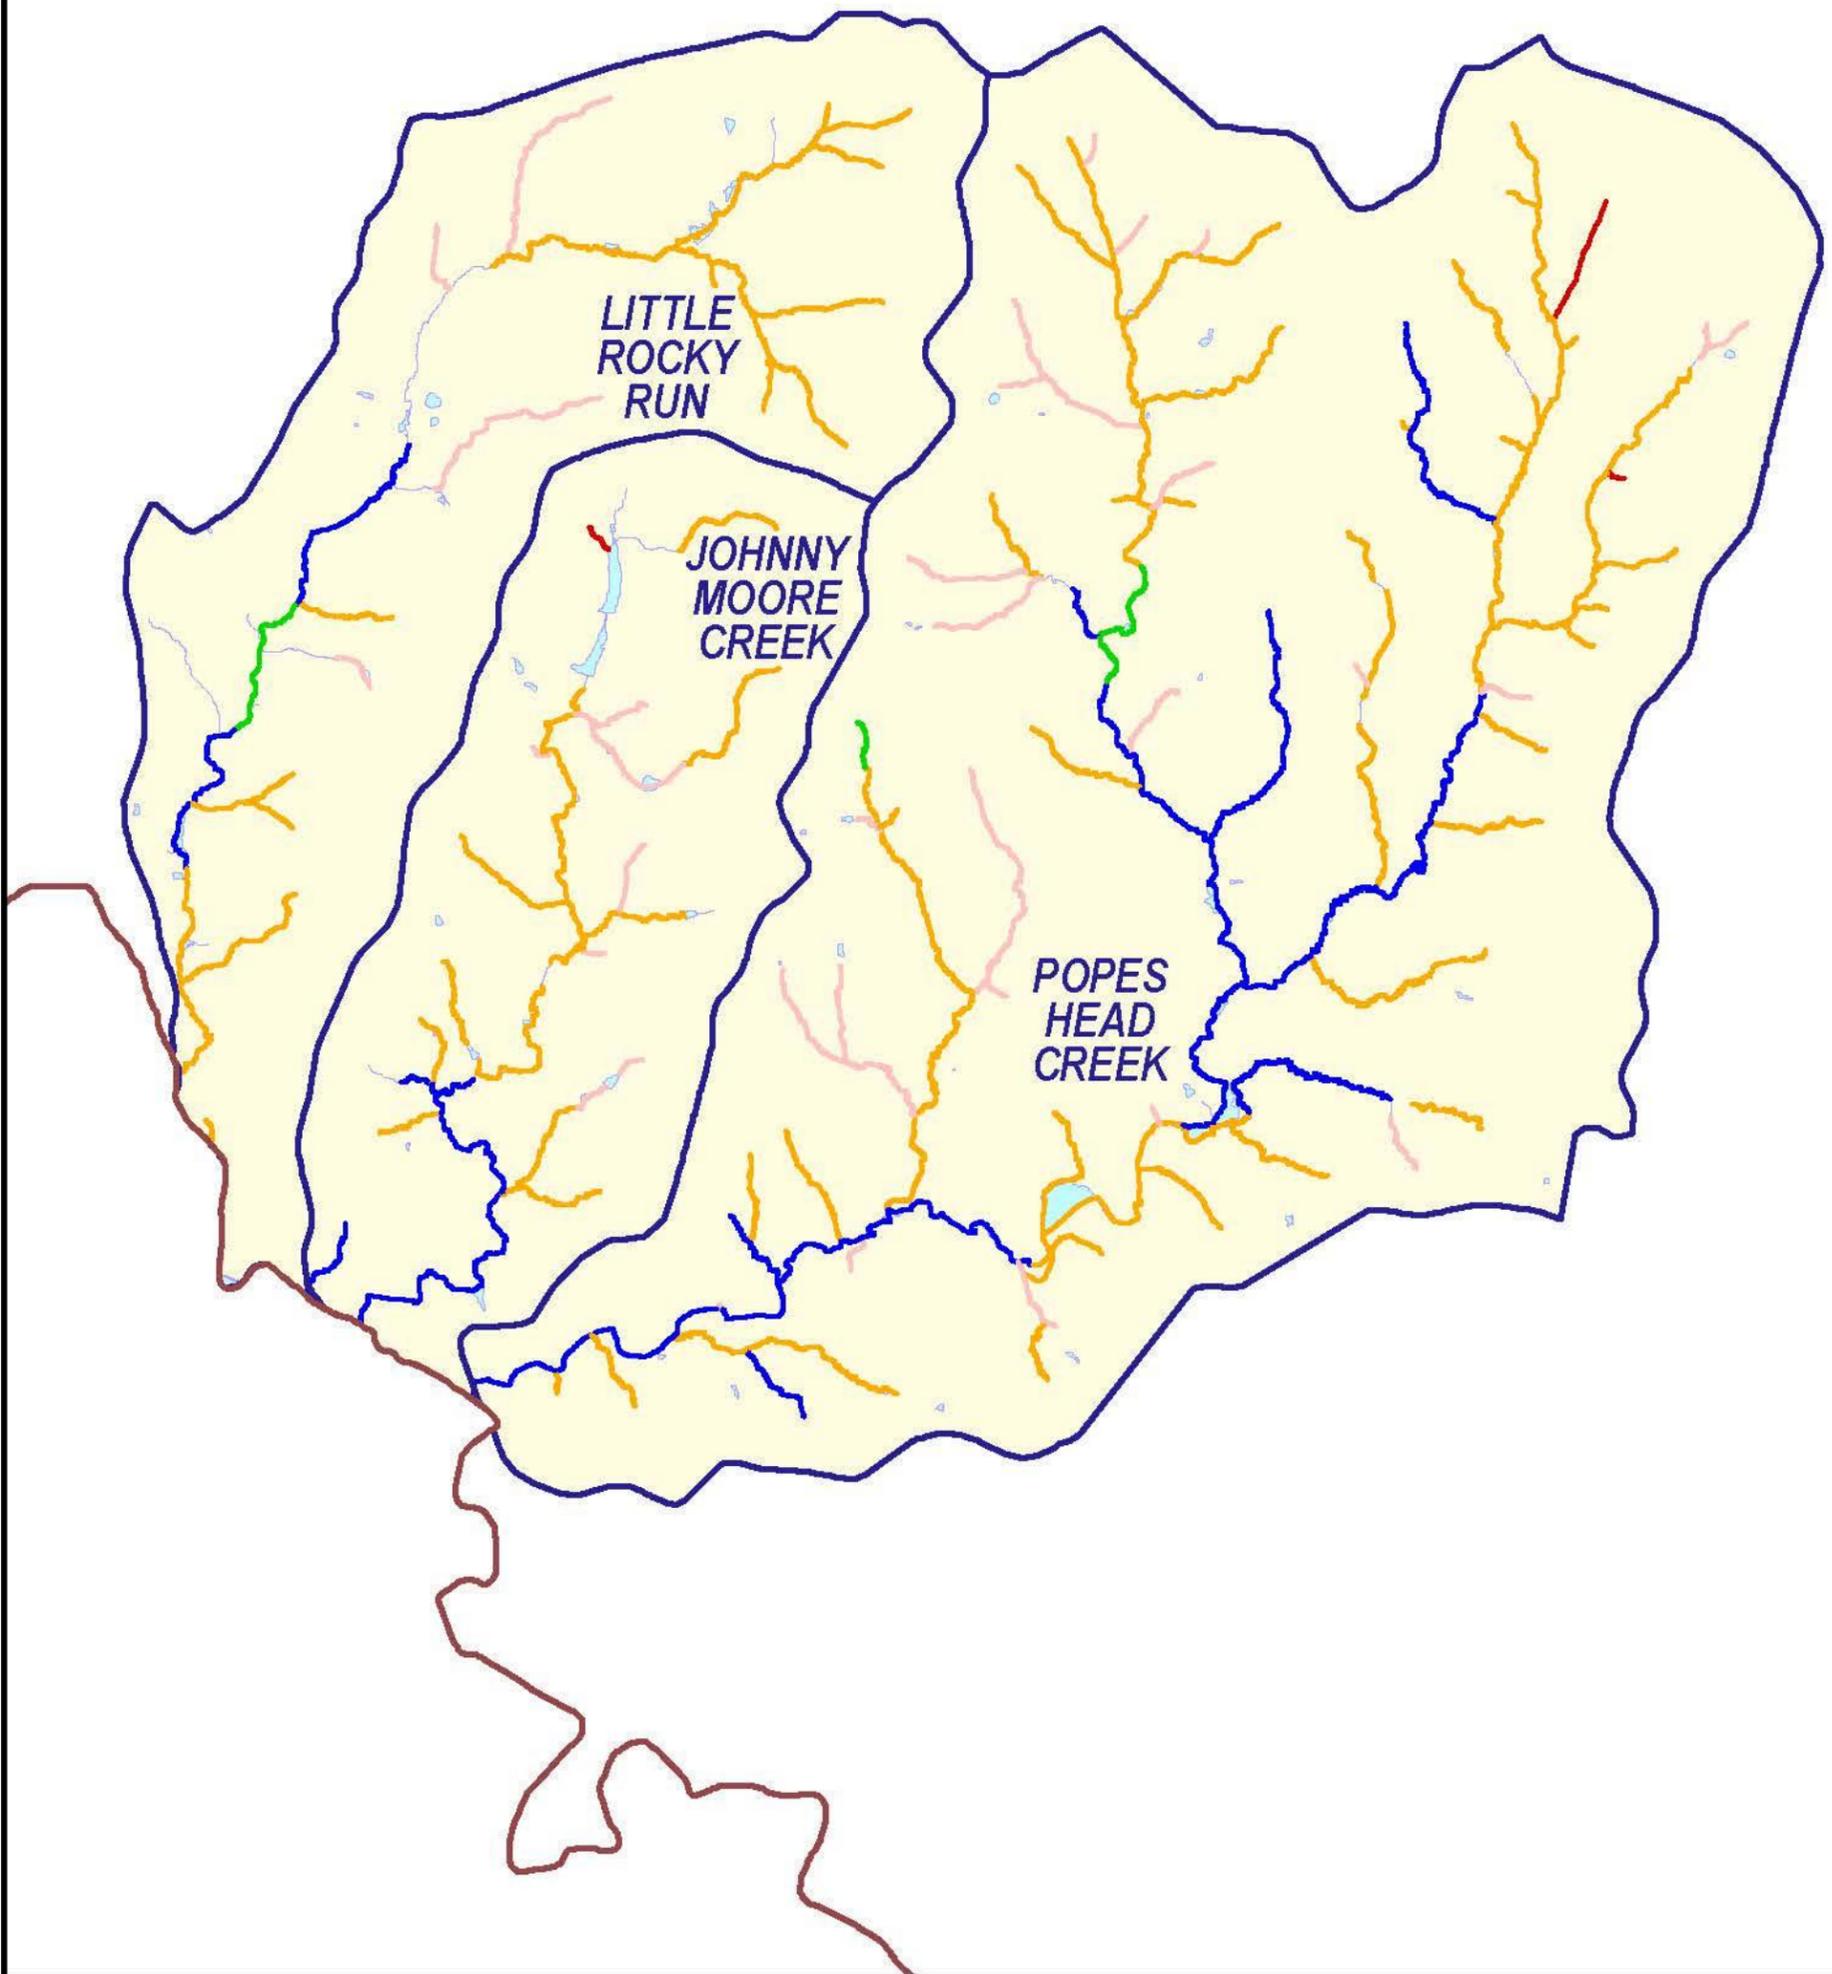
**Figure 3-66**  
**Habitat Assessment**  
**Lower Bull Run Group**  
**Fairfax County Stream Physical Assessment**

**Habitat.** The habitat assessment results for Little Rocky Run Watershed are summarized by stream in Table 3-43. Habitat scores for each reach are depicted in Figure 3-66. Based on a length weighted habitat score of 102 (Table 3-2), Little Rocky Run Watershed is in the lower middle range of quality, compared to the rest of the County. Approximately 2 miles of stream were categorized as having “poor” habitat conditions, 8 miles as “fair,” 2 miles as “good,” and less than 1 mile as “excellent.”

**Habitat.** The habitat assessment results for Johnny Moore Creek Watershed are summarized by stream in Table 3-45. Habitat scores for each reach are depicted in Figure 3-66. Based on a length weighted habitat score of 104 (Table 3-2), Johnny Moore Creek Watershed is in the middle range of quality, compared to the rest of the County. Approximately 2 miles of stream were categorized as having “poor” habitat conditions, 7 miles as “fair,” and nearly 3 miles as “good.”

**Habitat.** The habitat assessment results for Popes Head Creek Watershed are summarized by stream in Table 3-47. Habitat scores for each reach are depicted in Figure 3-66. Based on a length weighted habitat score of 103 (Table 3-2), Popes Head Creek Watershed is in the middle range of quality, compared to the rest of the County. Approximately 1 mile of stream was categorized as having “very poor” habitat conditions, 8 miles as “poor,” 27 miles as “fair,” and 13 miles as “good.”

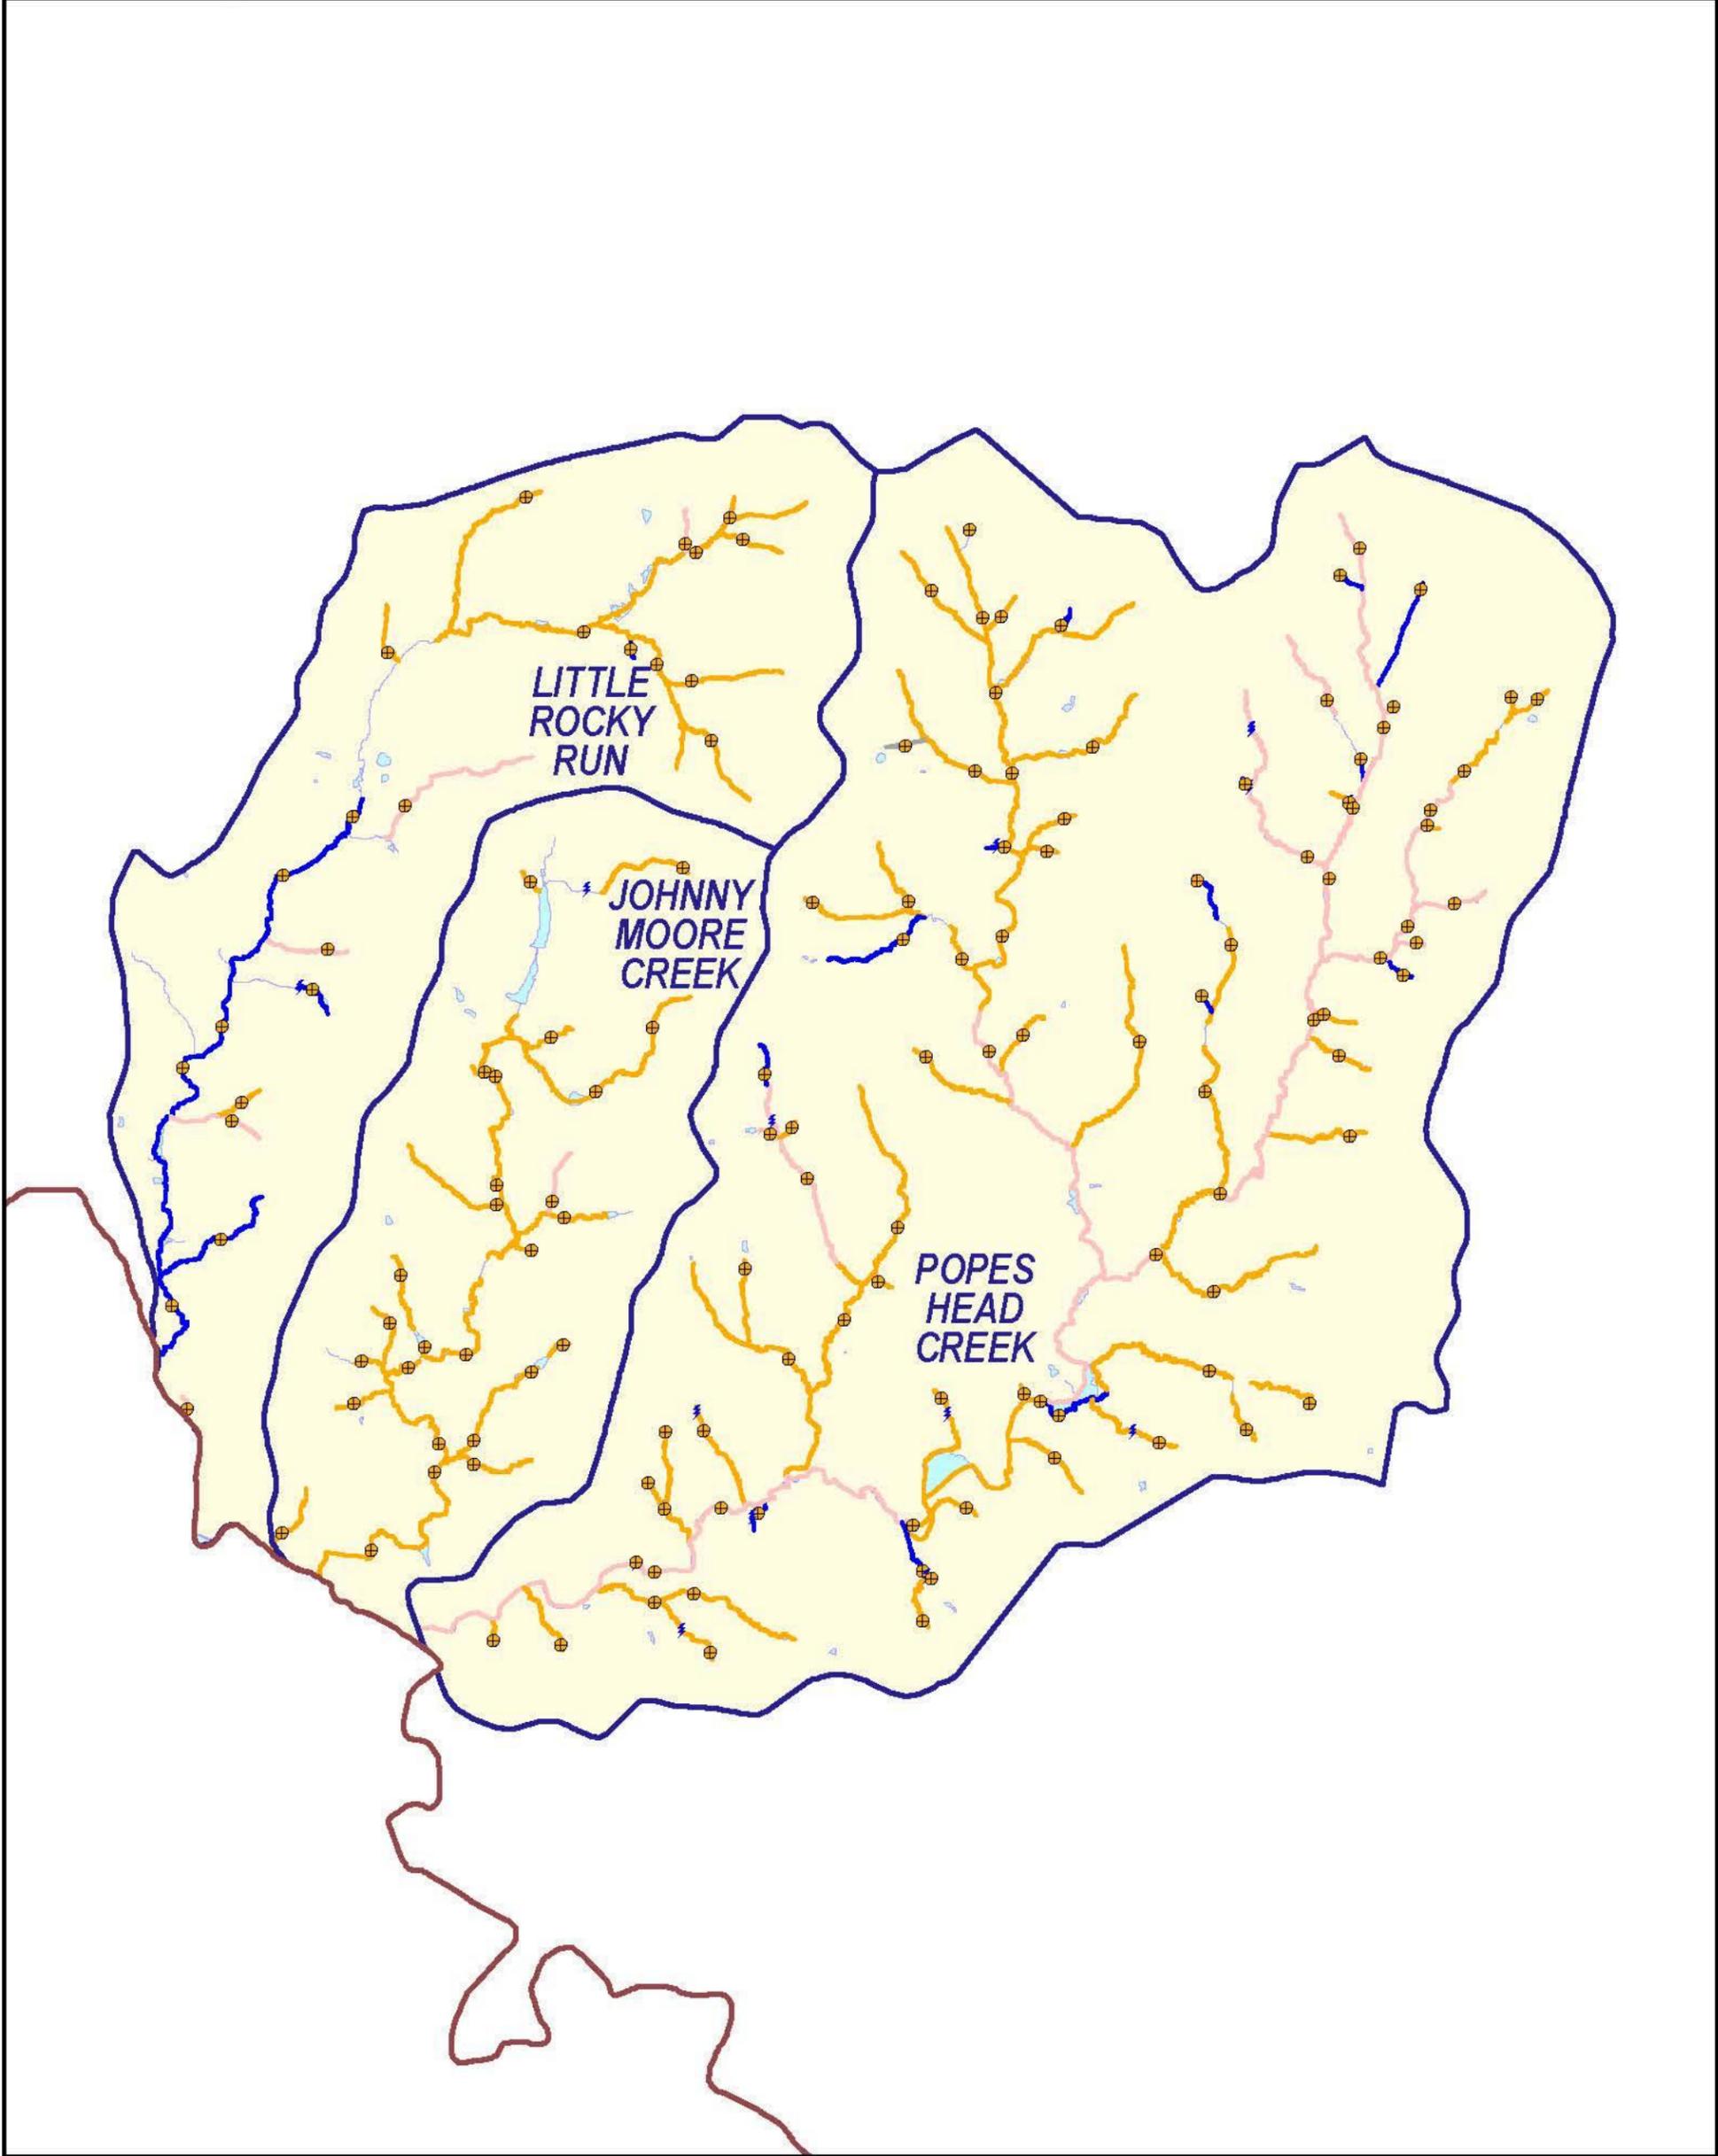
**Figure 3-67**  
**CEM Stages**  
**Lower Bull Run Group**  
**Fairfax County Stream Physical Assessment**

**CEM.** Based on the CEM evaluations approximately half of the channels assessed in Little Rocky Run Watershed are in Evolutionary Stage 3 (Table 3-3) and the remainder are split between Stages 2 and 4. Figure 3-67 summarizes the CEM results for Little Rocky Run Watershed.

**CEM.** Based on the CEM evaluations approximately 97 percent of the channels assessed in Johnny Moore Creek Watershed are in Evolutionary Stage 3 (Table 3-3). Figure 3-67 summarizes the CEM results for Johnny Moore Creek Watershed.

**CEM.** Based on the CEM evaluations approximately 60 percent of the channels assessed in Popes Head Creek Watershed are in Evolutionary Stage 3 (Table 3-3), with most of the remainder of the watershed in Stage 4. Figure 3-67 summarizes the CEM results for Popes Head Creek Watershed.

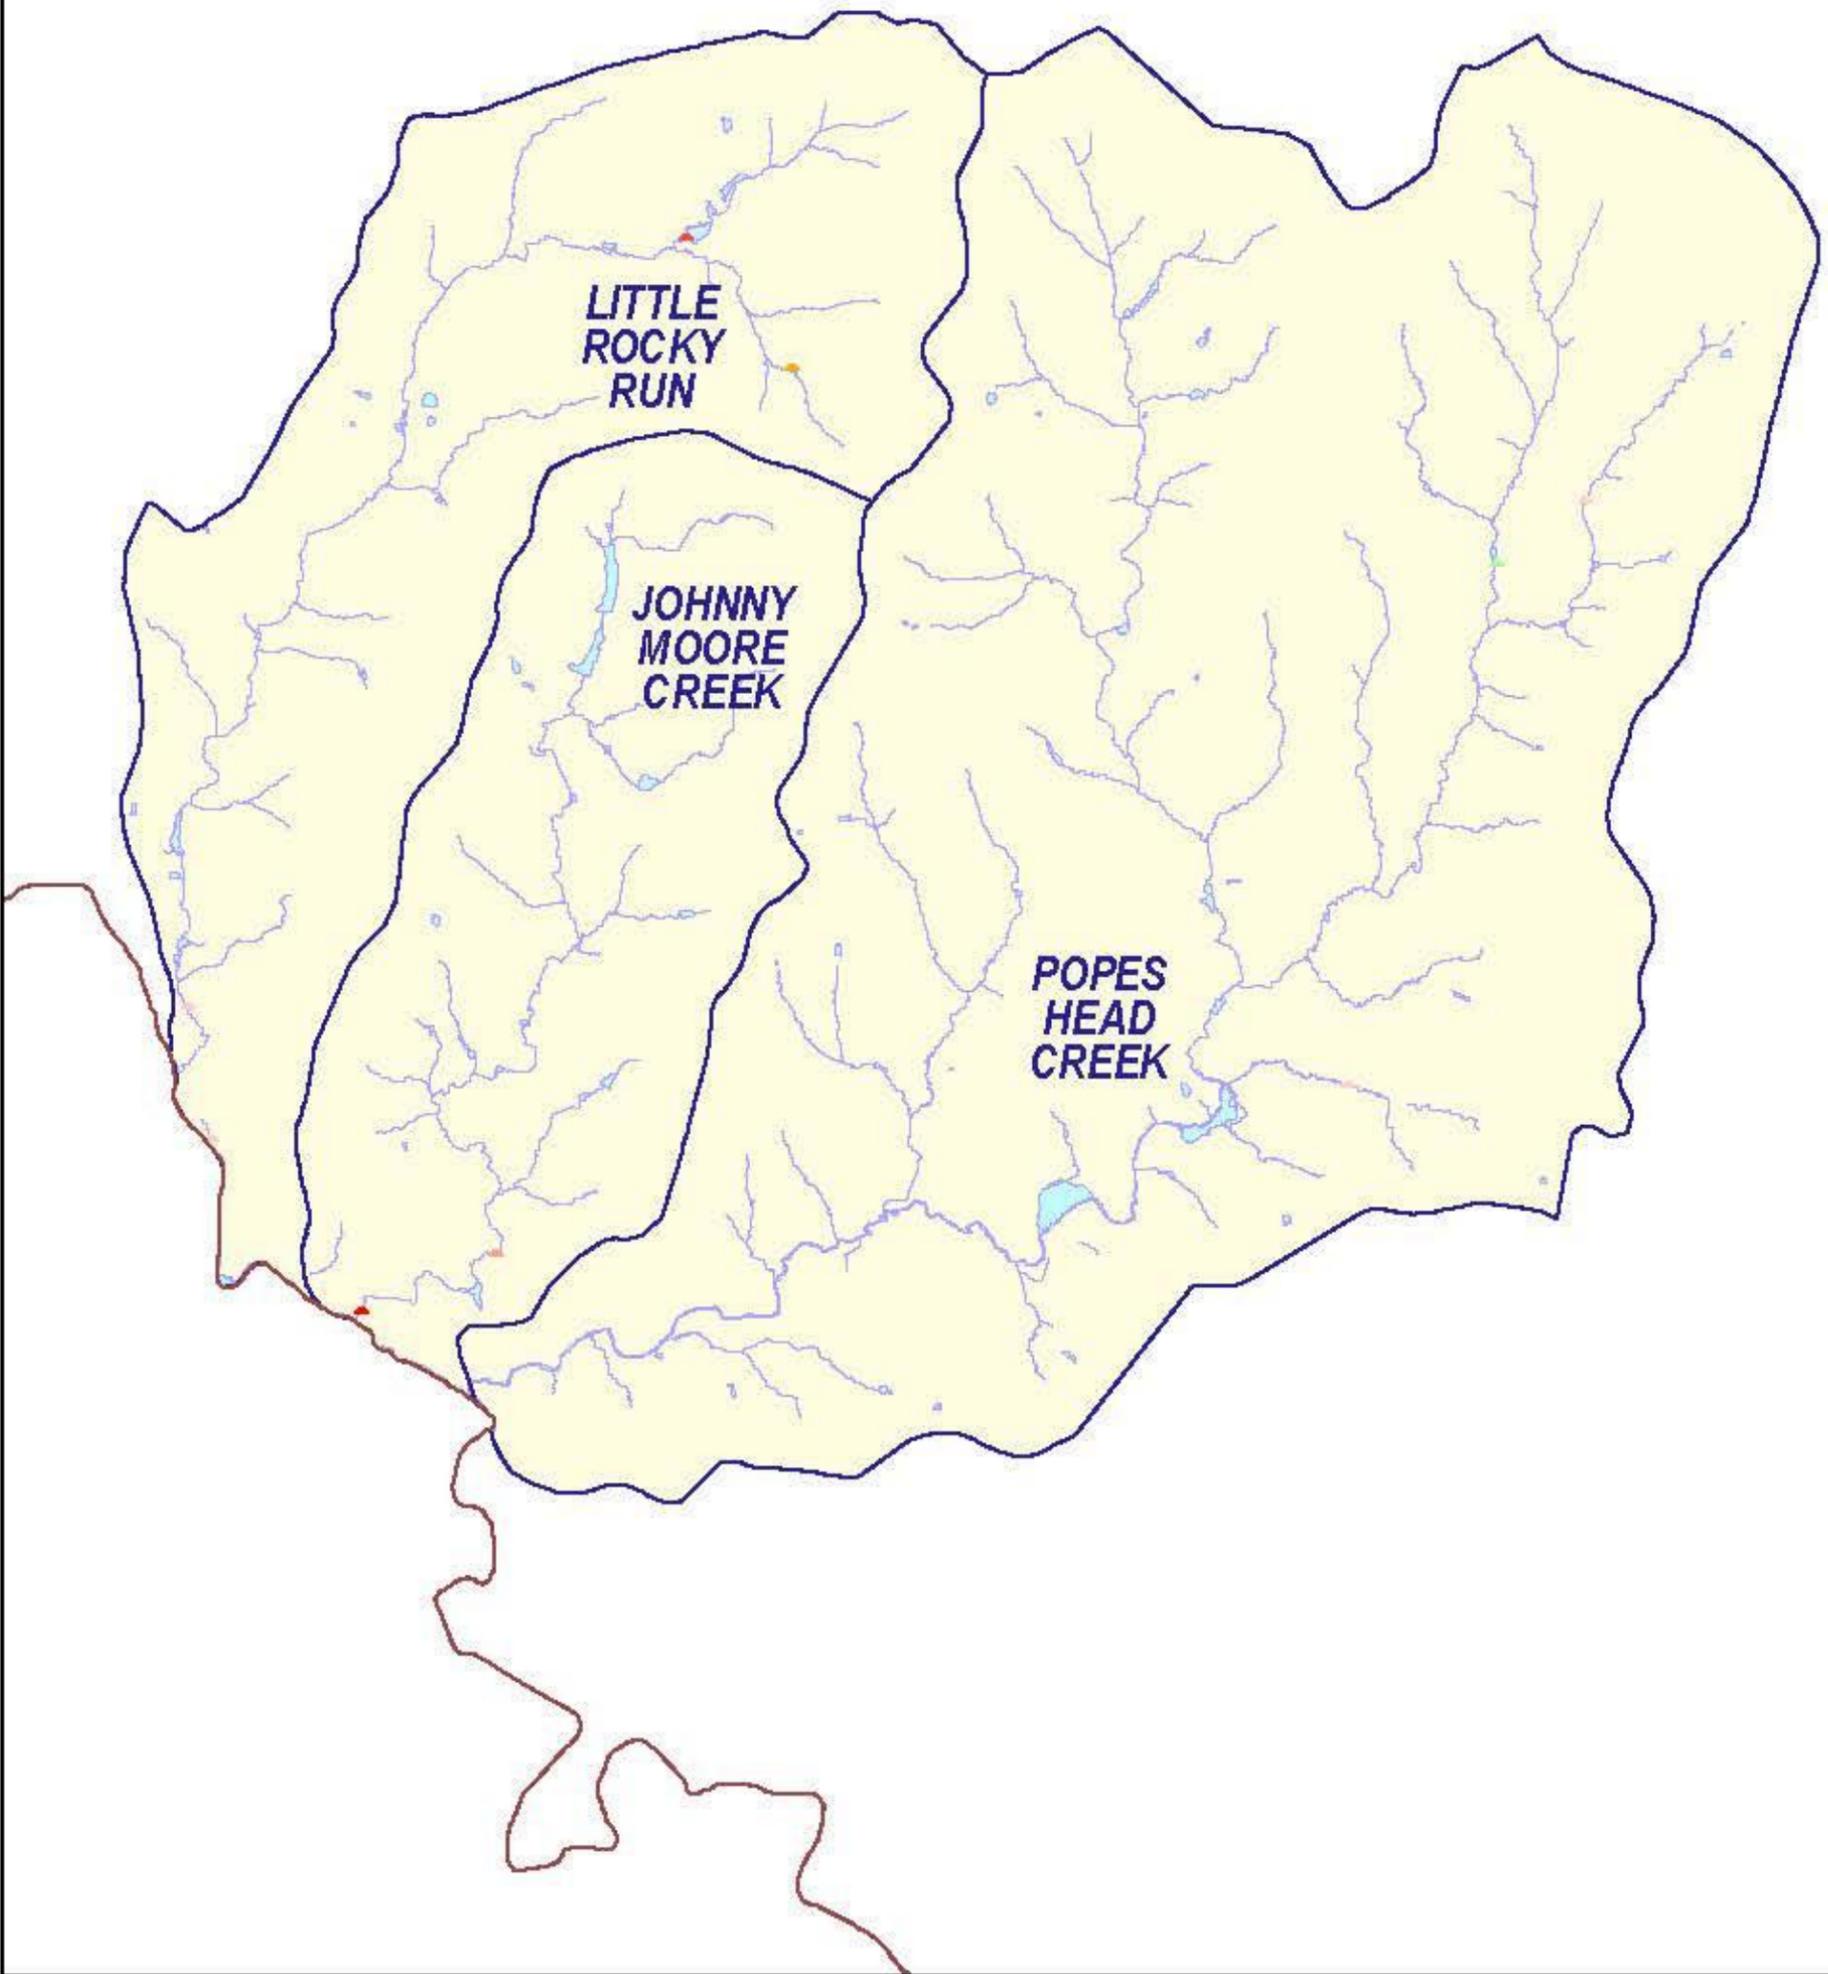
**Figure 3-68**  
**Erosion Impacts**  
**Lower Bull Run Group**  
**Fairfax County Stream Physical Assessment**

**Infrastructure.** The infrastructure inventory resulted in 153 inventory points. The most significant problem was related to an erosional area, which was given an impact score of 8. The infrastructure inventory results are summarized in Table 3-44. Figures 3-68, 3-69, 3-70, 3-71, and 3-72 summarize impact scores for the erosion problems; deficient buffers; crossings; pipes/ditches; and dumps, obstructions, and utilities, respectively.

**Infrastructure.** The infrastructure inventory resulted in 127 inventory points. The most significant problem was related to an erosional area, which was given an impact score of 9. The infrastructure inventory results are summarized in Table 3-46. Figures 3-68, 3-69, 3-70,

3-71, and 3-72 summarize impact scores for the erosion problems; deficient buffers; crossings; pipes/ ditches; and dumps, obstructions, and utilities, respectively.

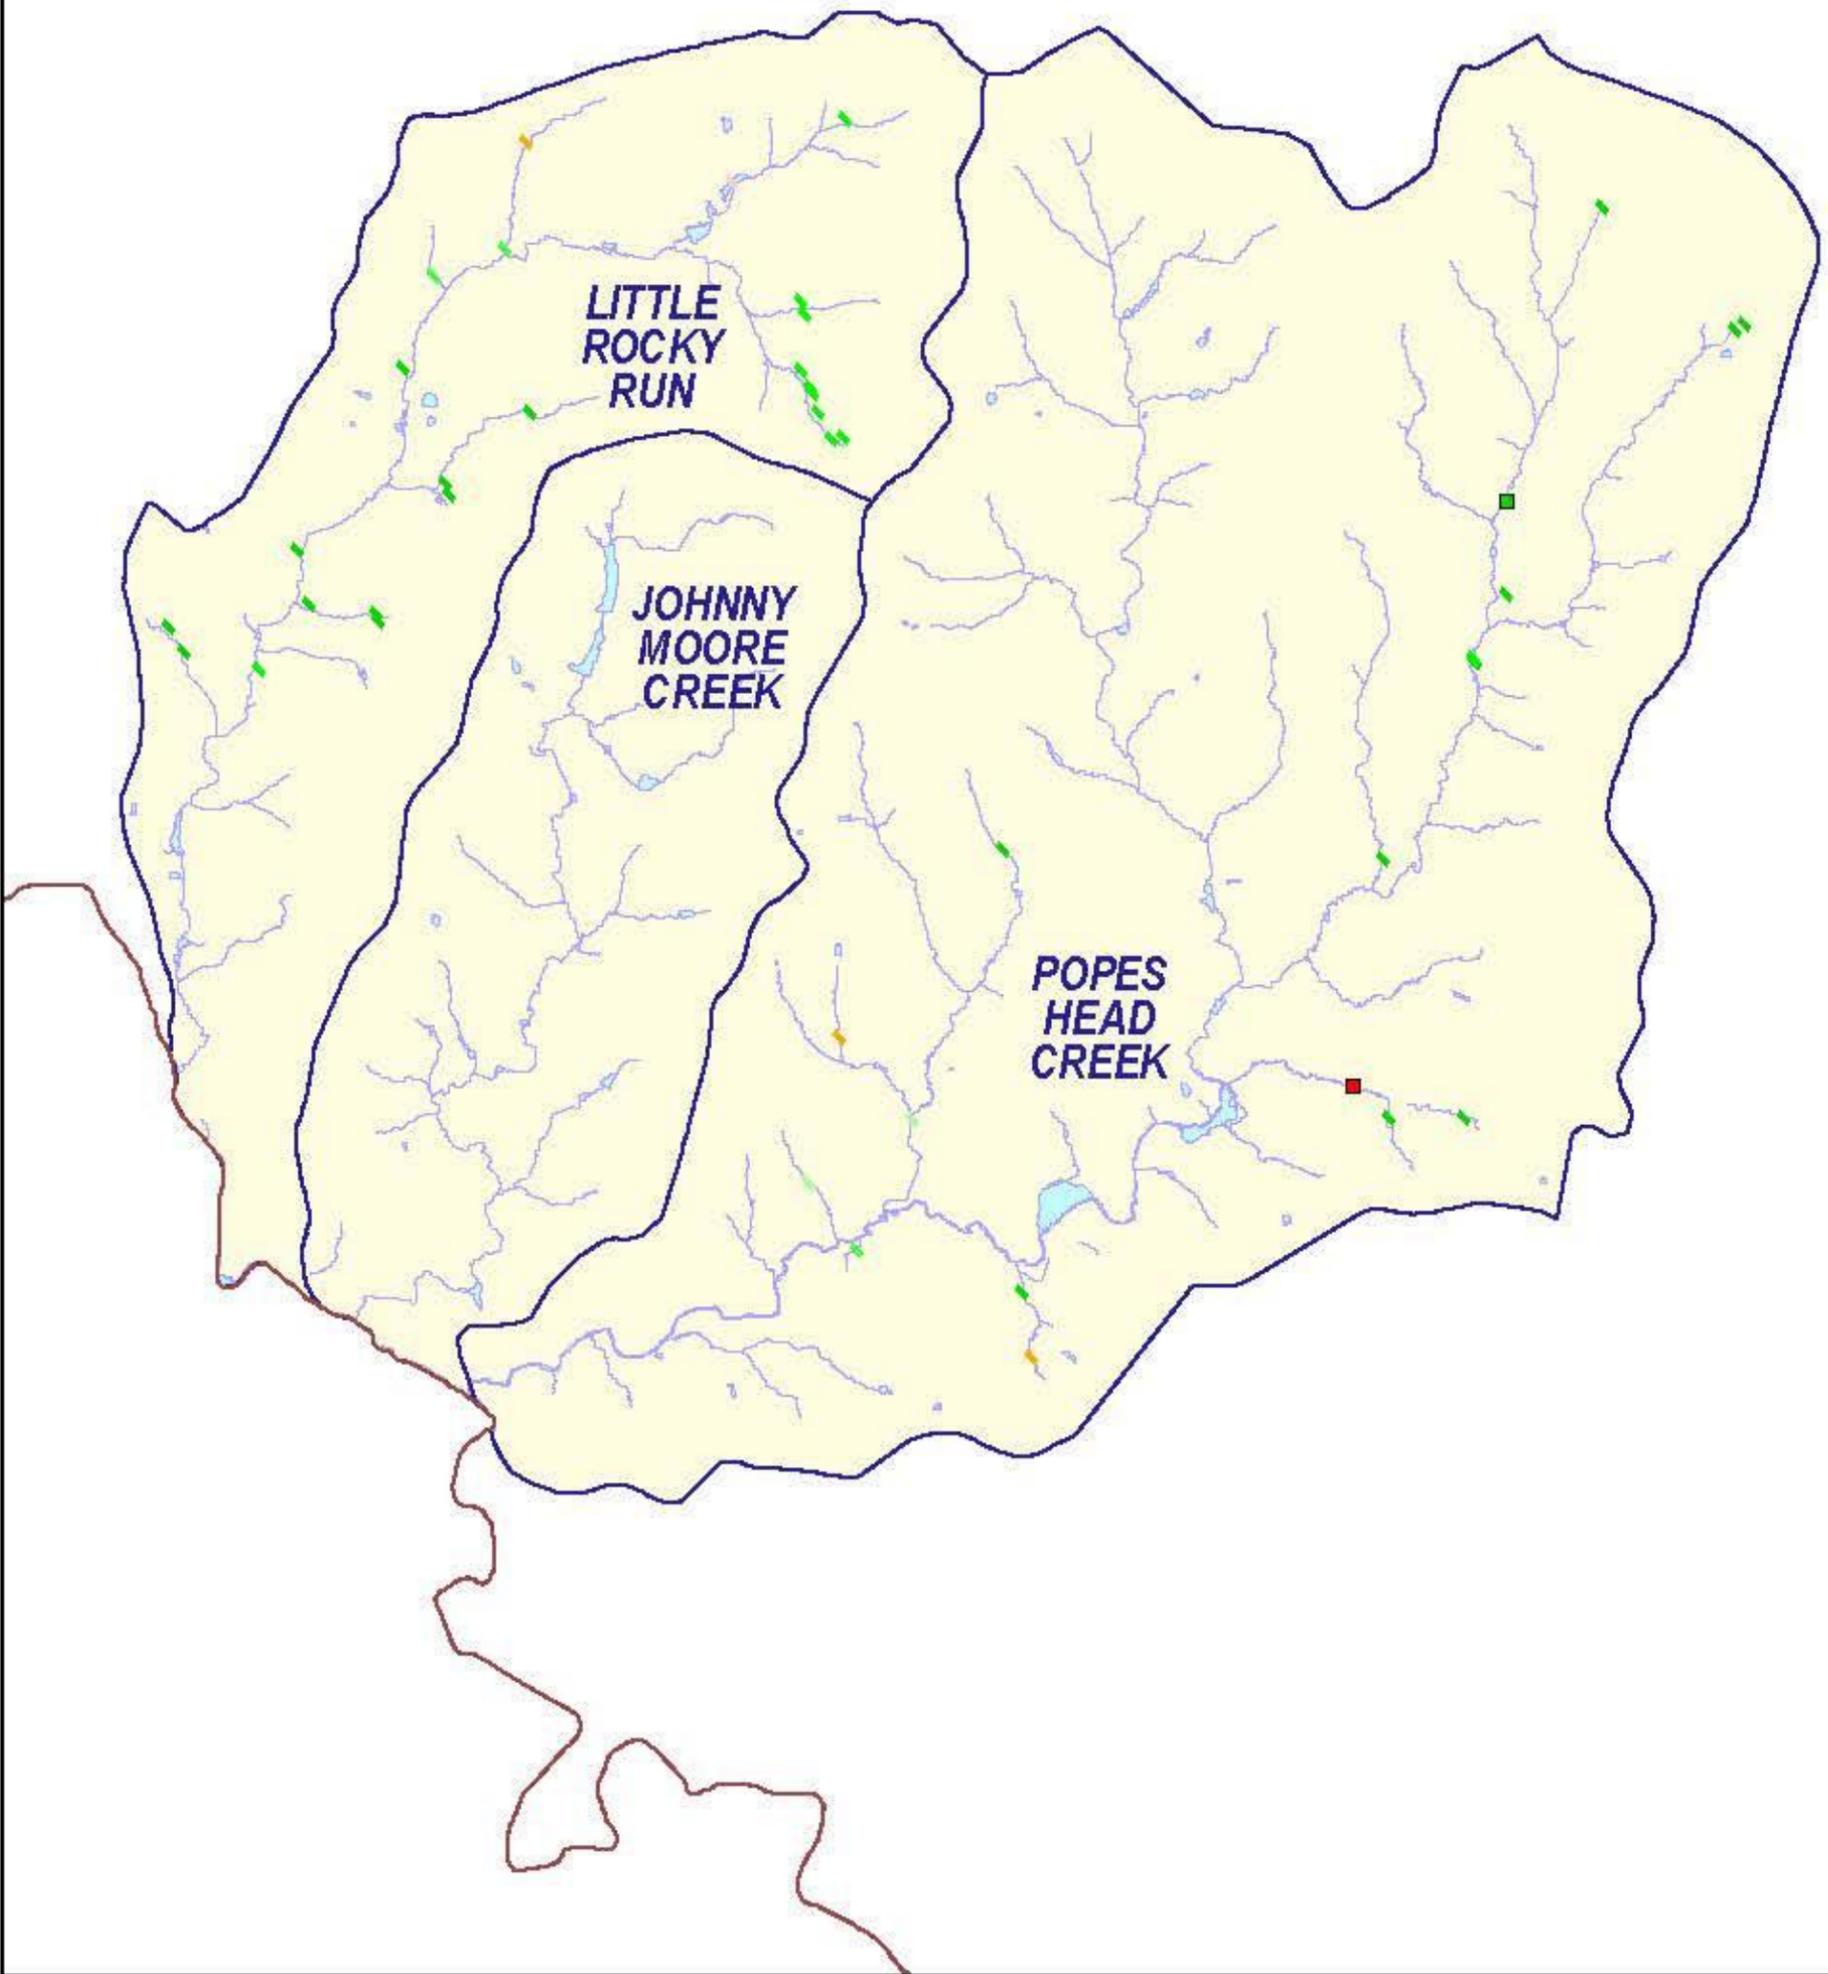
**Figure 3-71**  
**Pipe and Ditch Impacts**  
**Lower Bull Run Group**  
**Fairfax County Stream Physical Assessment**

**Infrastructure.** The infrastructure inventory resulted in 382 inventory points. The most significant problem was related to a pipe, which was given an impact score of 9. The infrastructure inventory results are summarized in Table 3-48. Figures 3-68, 3-69, 3-70, 3-71, and 3-72 summarize impact scores for the erosion problems; deficient buffers; crossings; pipes/ ditches; and dumps, obstructions, and utilities, respectively.

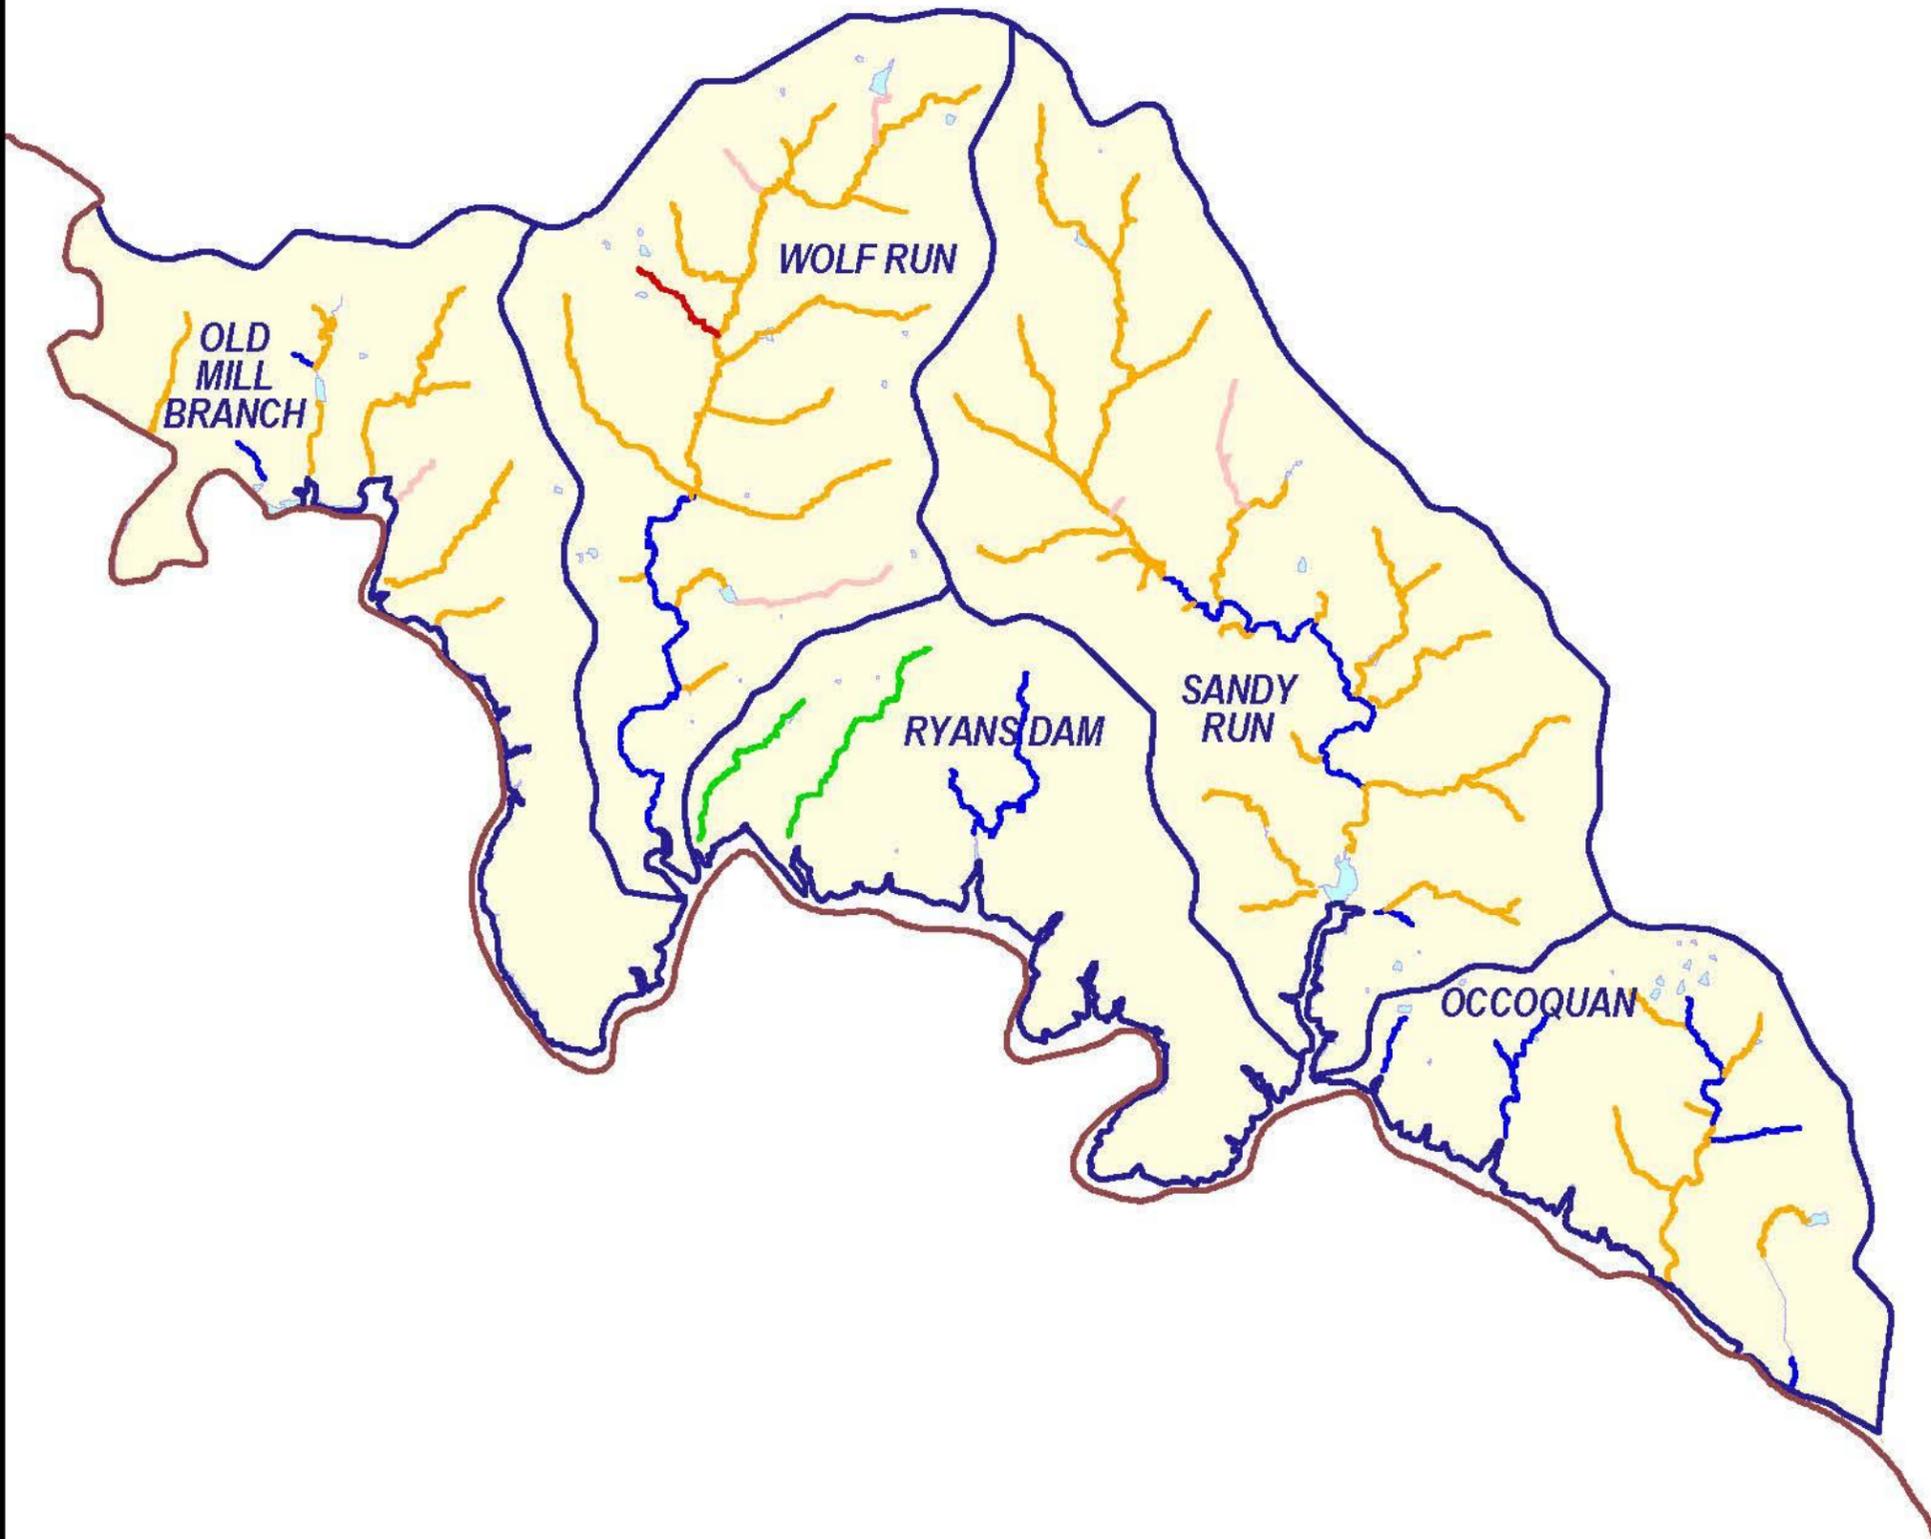
**Figure 3-73  
Habitat Assessment  
Upper Occoquan Group  
Fairfax County Stream Physical Assessment**

**Habitat.** The habitat assessment results for Old Mill Branch Watershed are summarized by stream in Table 3-49. Habitat scores for each reach are depicted in Figure 3-73. Based on a length weighted habitat score of 99 (Table 3-2), Old Mill Branch Watershed is lower range of quality compared to the rest of the County. Nearly all 6 miles of stream assessed were categorized as “fair.”

**Habitat.** The habitat assessment results for Wolf Run Watershed are summarized by stream in Table 3-51. Habitat scores for each reach are depicted in Figure 3-73. Based on a length weighted habitat score of 99 (Table 3-2), Wolf Run Watershed is in the lower range of quality, compared to the rest of the County. Approximately 1.5 miles of stream were categorized as having “poor” habitat conditions, 11 miles as “fair,” and 3 miles as “good.”

**Habitat.** The habitat assessment results for Sandy Run Watershed are summarized by stream in Table 3-53. Habitat scores for each reach are depicted in Figure 3-73. Based on a length weighted habitat score of 104 (Table 3-2), Sandy Run Watershed is in the middle range of quality, compared to the rest of the County. Approximately 17 miles of stream were categorized as having “fair” habitat conditions and 3 miles as “fair.”

**Habitat.** The habitat assessment results for Ryans Dam Watershed are summarized by stream in Table 3-55. Habitat scores for each reach are depicted in Figure 3-73. Based on a length weighted habitat score of 145 (Table 3-2), Ryans Dam Watershed is the highest rated watershed in the County. Nearly 2 miles of stream were categorized as having “good” habitat conditions and 2.5 miles as “excellent.”

**Habitat.** The habitat assessment results for Occoquan Watershed are summarized by stream in Table 3-57. Habitat scores for each reach are depicted in Figure 3-73. Based on a length weighted habitat score of 117 (Table 3-2), Occoquan Watershed is in the upper middle range of quality, compared to the rest of the County. Approximately 3 miles of stream were categorized as having “fair” habitat conditions and 3 miles as “good.”

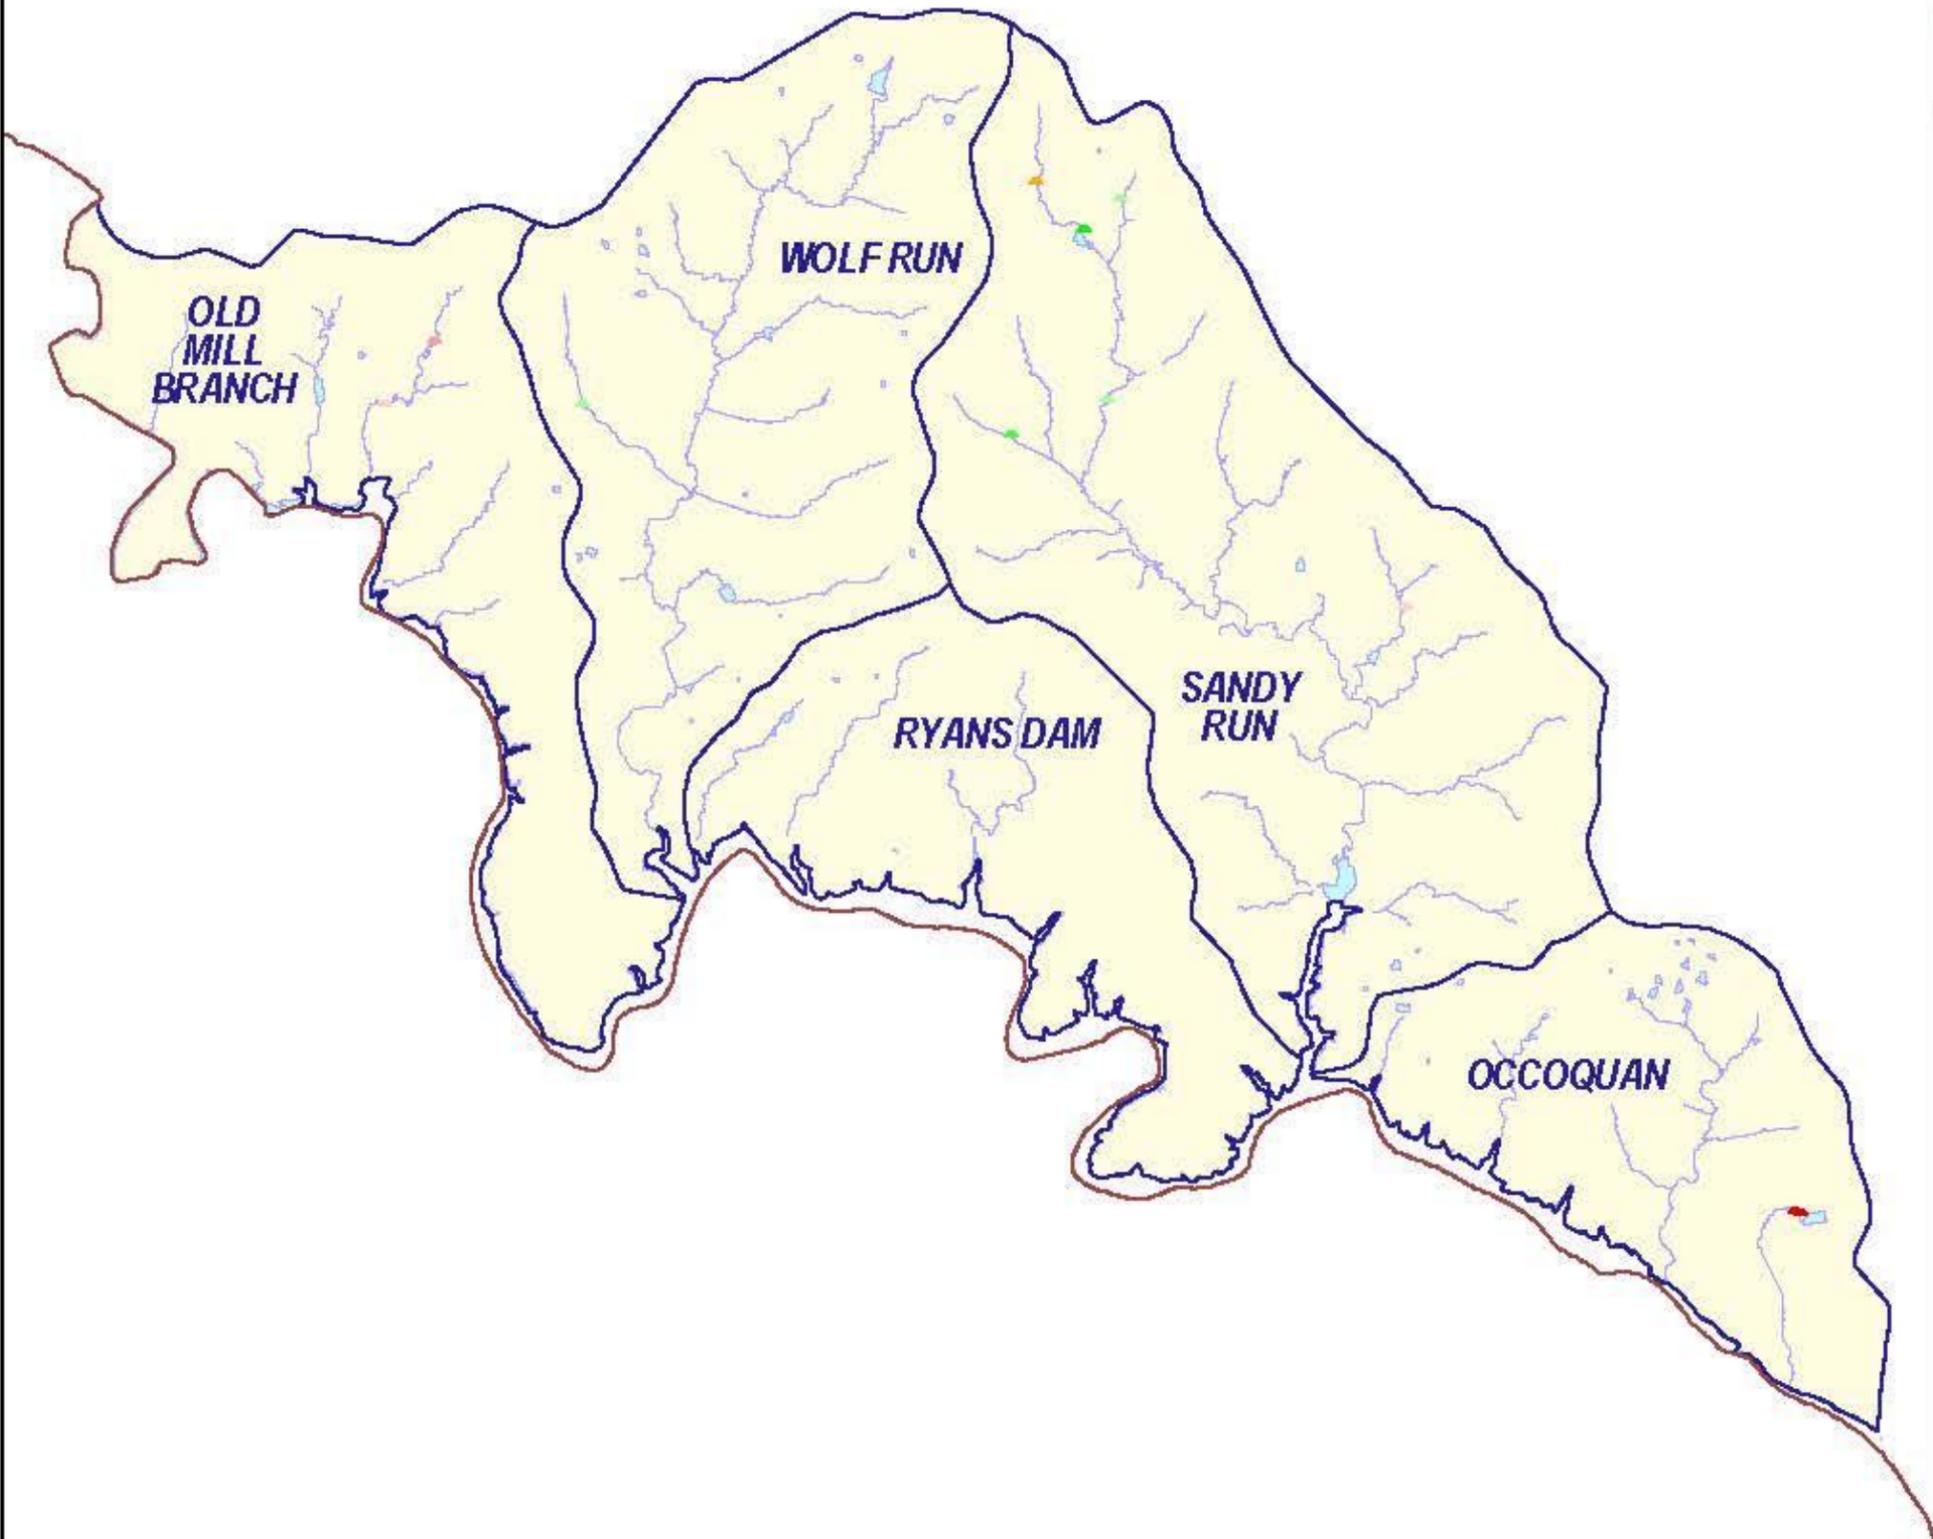
**Figure 3-75**  
**Erosion Impacts**  
**Upper Occoquan Group**  
**Fairfax County Stream Physical Assessment**

**Infrastructure.** The infrastructure inventory resulted in 40 inventory points. The most significant problems were related to two erosional areas and a head cut, which were given impact scores of 10. The infrastructure inventory results are summarized in Table 3-58. Figures 3-75, 3-76, 3-77, 3-78, and 3-79 summarize impact scores for the erosion problems; deficient buffers; crossings; pipes/ditches; and dumps, obstructions, and utilities, respectively.
