## 3.2.10 Lower Bull Run Group Summary

### 3.2.10.1 Little Rocky Run Watershed

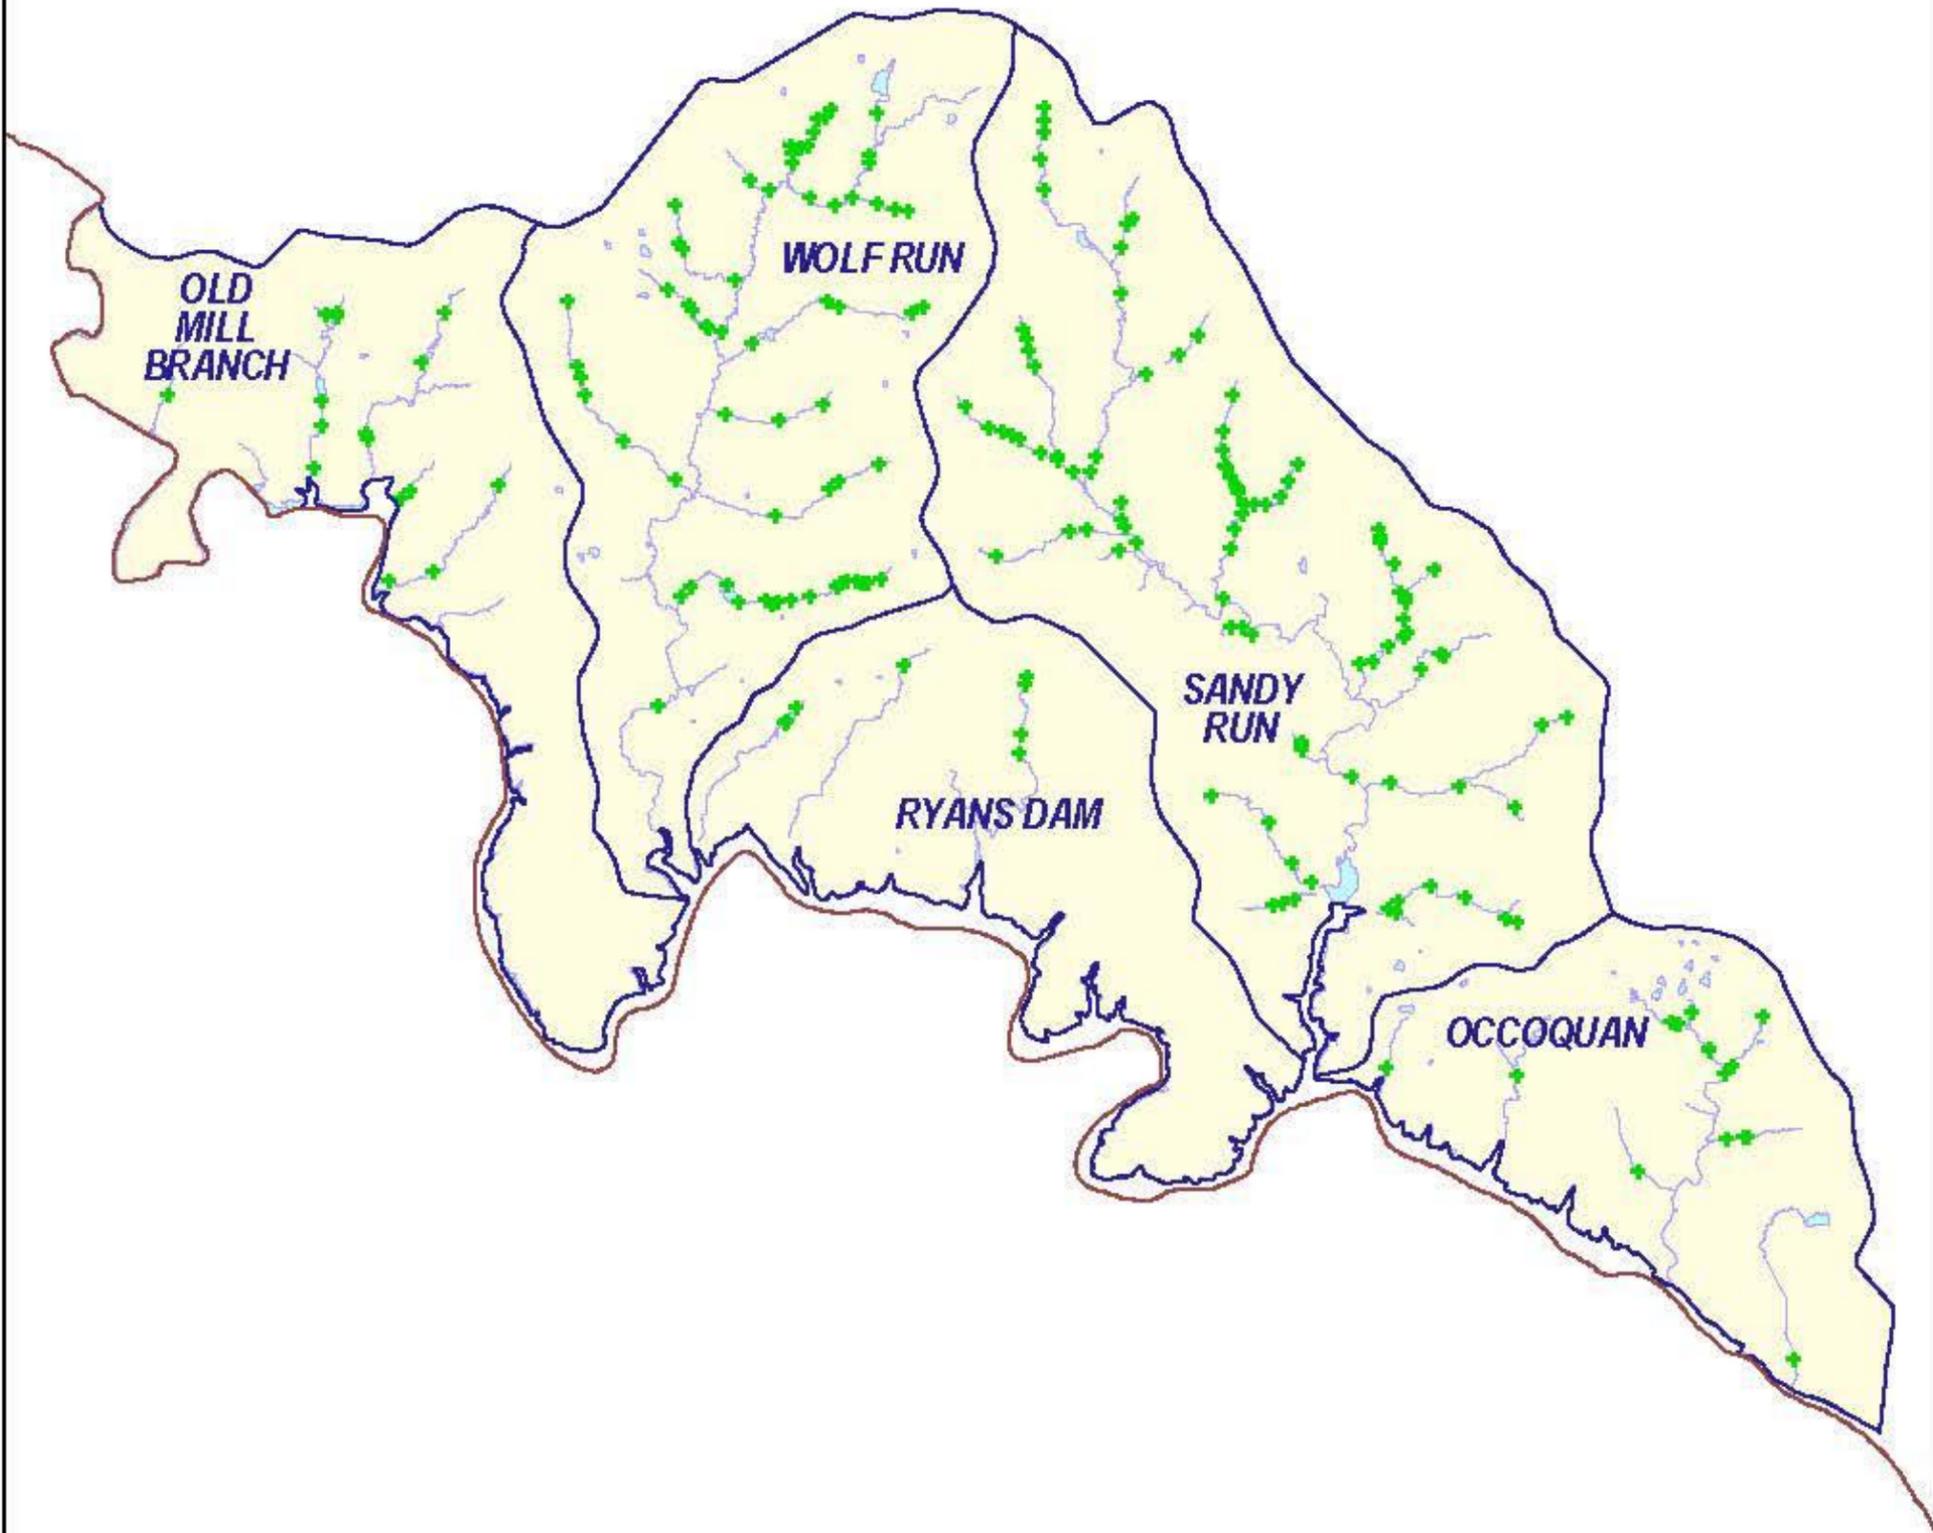
**Figure 3-77**  
**Crossings**  
**Upper Occoquan Group**  
**Fairfax County Stream Physical Assessment**

**Infrastructure.** The infrastructure inventory resulted in 29 inventory points. The most significant problem was related to a crossing, which was given an impact score of 9. The infrastructure inventory results are summarized in Table 3-50. Figures 3-75, 3-76, 3-77, 3-78, and 3-79 summarize impact scores for the erosion problems; deficient buffers; crossings; pipes/ditches; and dumps, obstructions, and utilities, respectively.

**Infrastructure.** The infrastructure inventory resulted in 10 inventory points. The most significant problem was related to crossing which was given an impact score of 8. The infrastructure inventory results are summarized in Table 3-56. Figures 3-75, 3-76, 3-77, 3-78, and 3-79 summarize impact scores for the erosion problems; deficient buffers; crossings; pipes/ditches; and dumps, obstructions, and utilities, respectively.

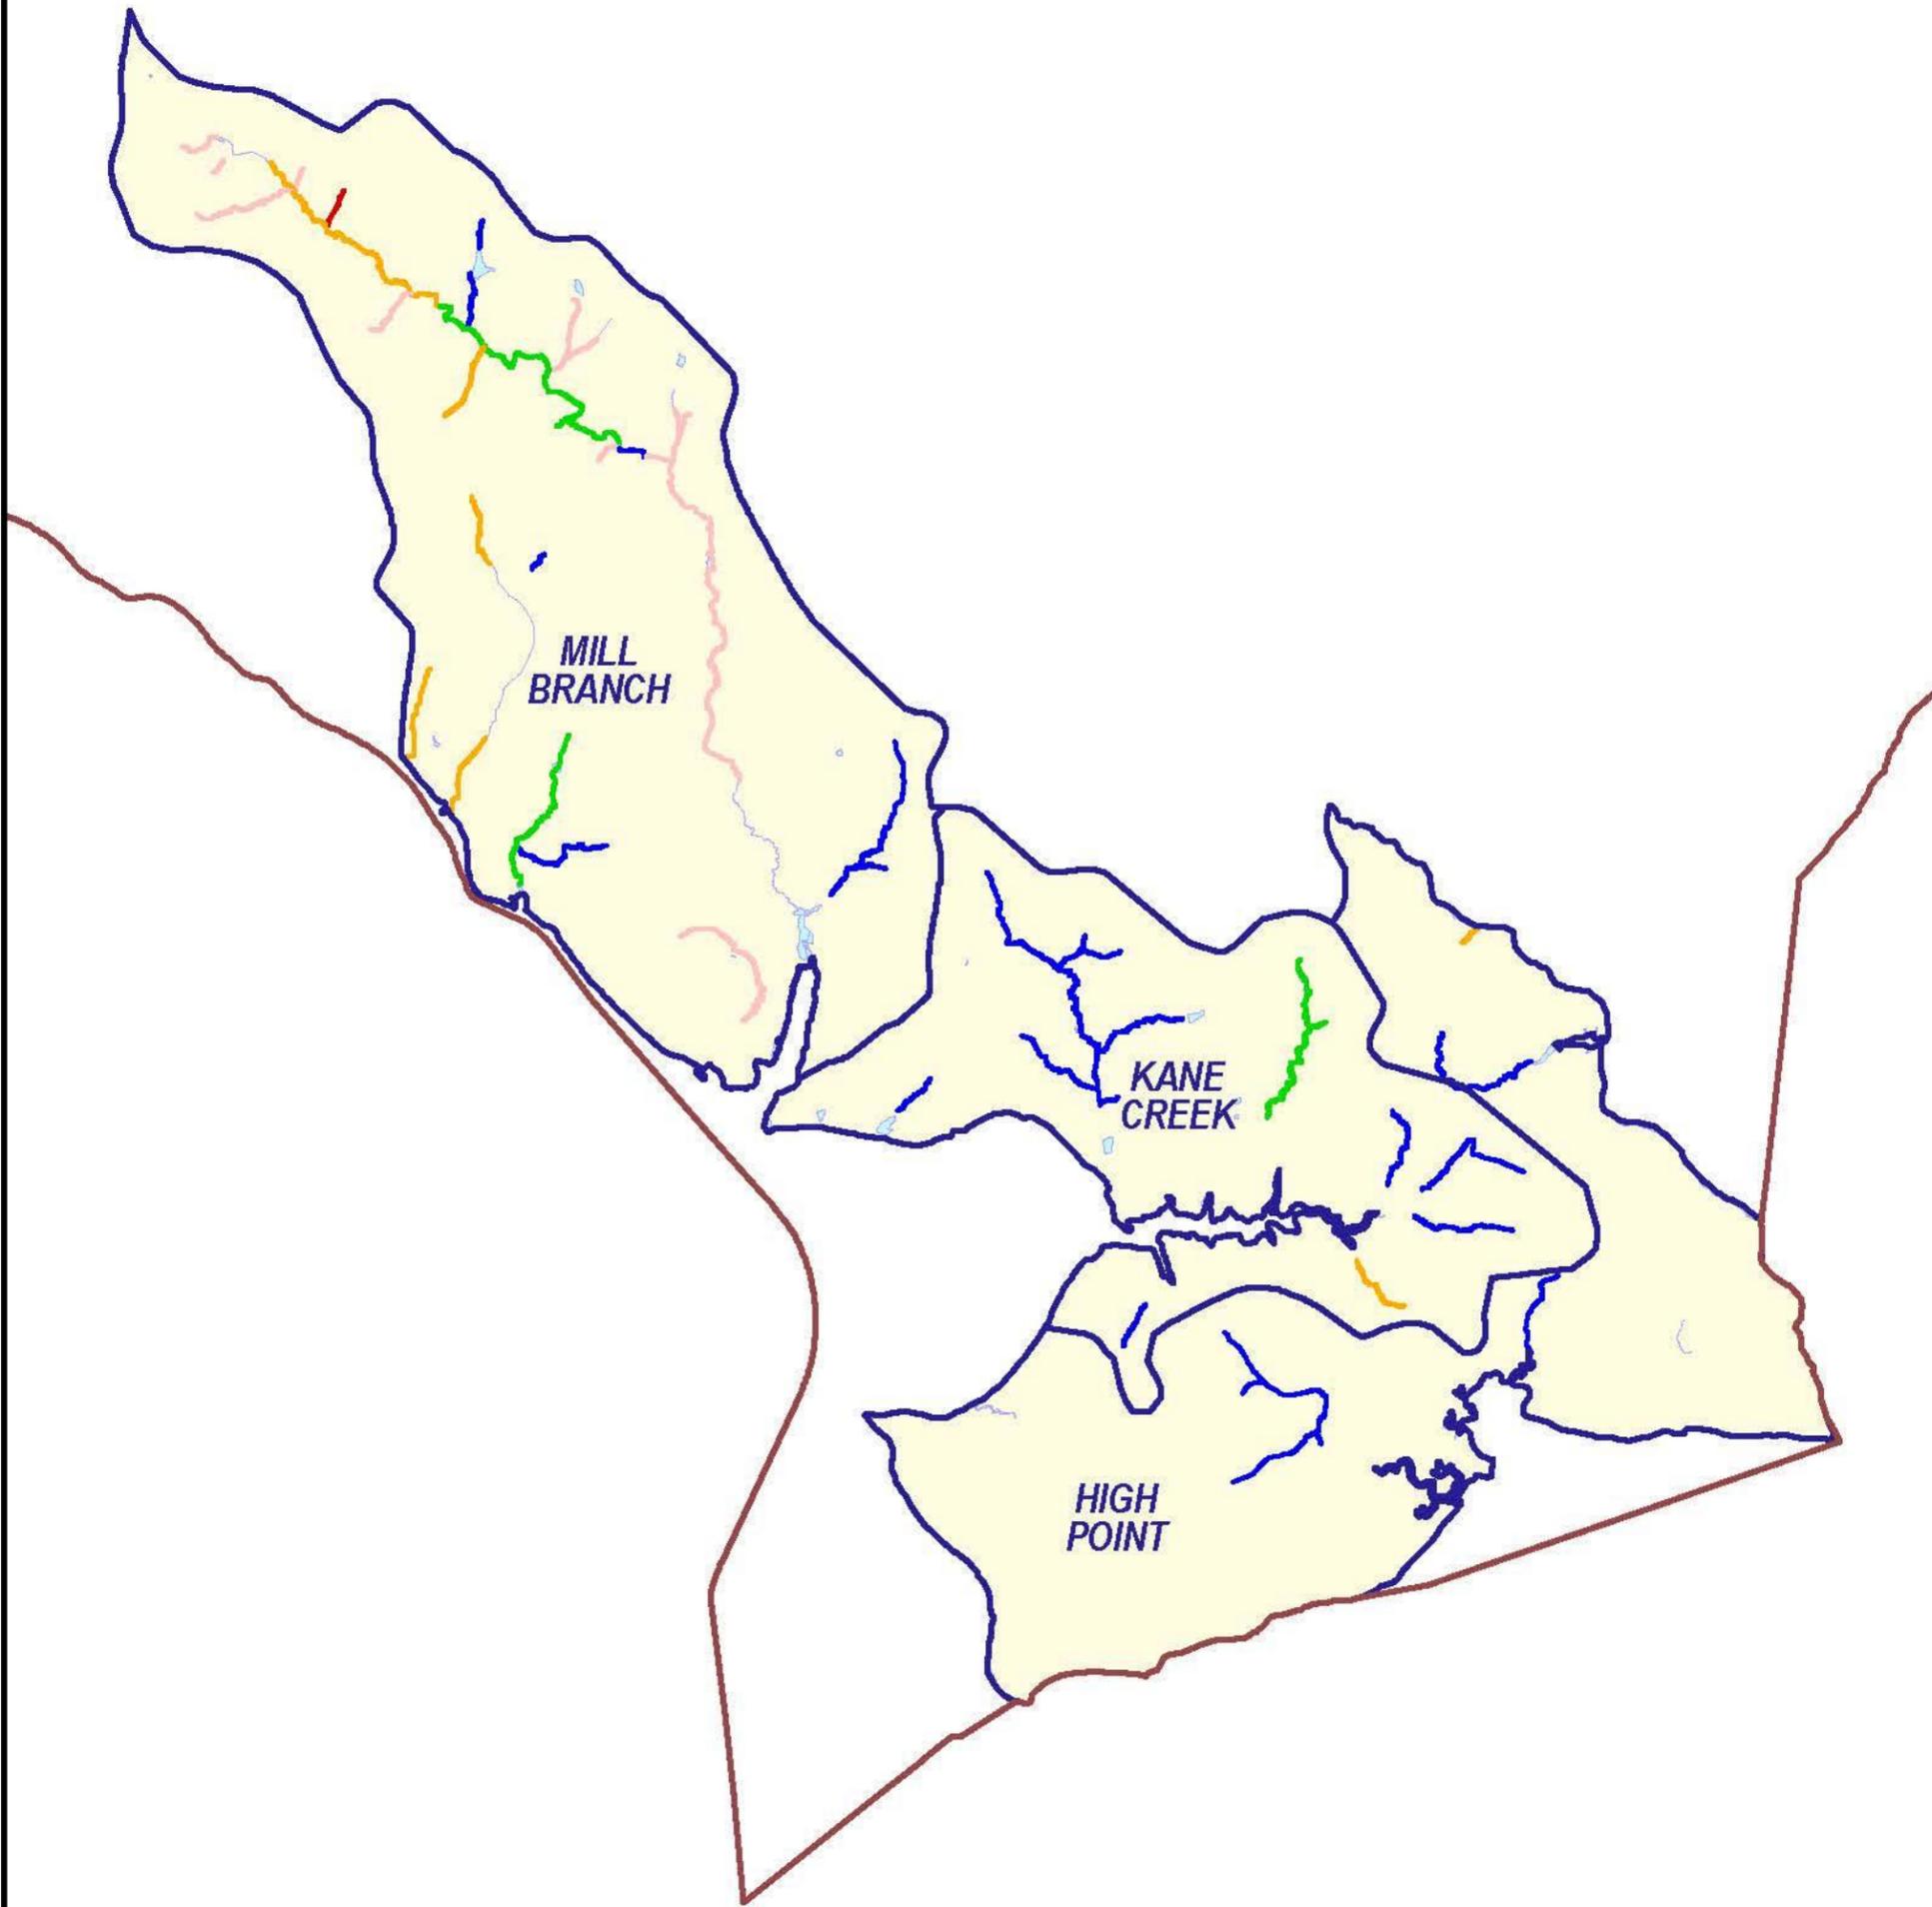
**Figure 3-80**  
**Habitat Assessment**  
**Lower Occoquan Group**  
**Fairfax County Stream Physical Assessment**

**Habitat.** The habitat assessment results for Mill Branch Watershed are summarized by stream in Table 3-59. Habitat scores for each reach are depicted in Figure 3-80. Based on a length weighted habitat score of 106 (Table 3-2), Mill Branch Watershed is in the middle range of quality, compared to the rest of the County. Approximately 6 miles of stream were categorized as having “poor” habitat conditions, 3 miles as “fair,” 3 miles as “good,” and 3 miles as “excellent.”

**Habitat.** The habitat assessment results for High Point Watershed are summarized by stream in Table 3-63. Habitat scores for each reach are depicted in Figure 3-80. Based on a length weighted habitat score of 124 (Table 3-2), High Point Watershed is in the upper range of quality, compared to the rest of the County. Nearly all 3 miles of stream were categorized as having “good” habitat conditions.

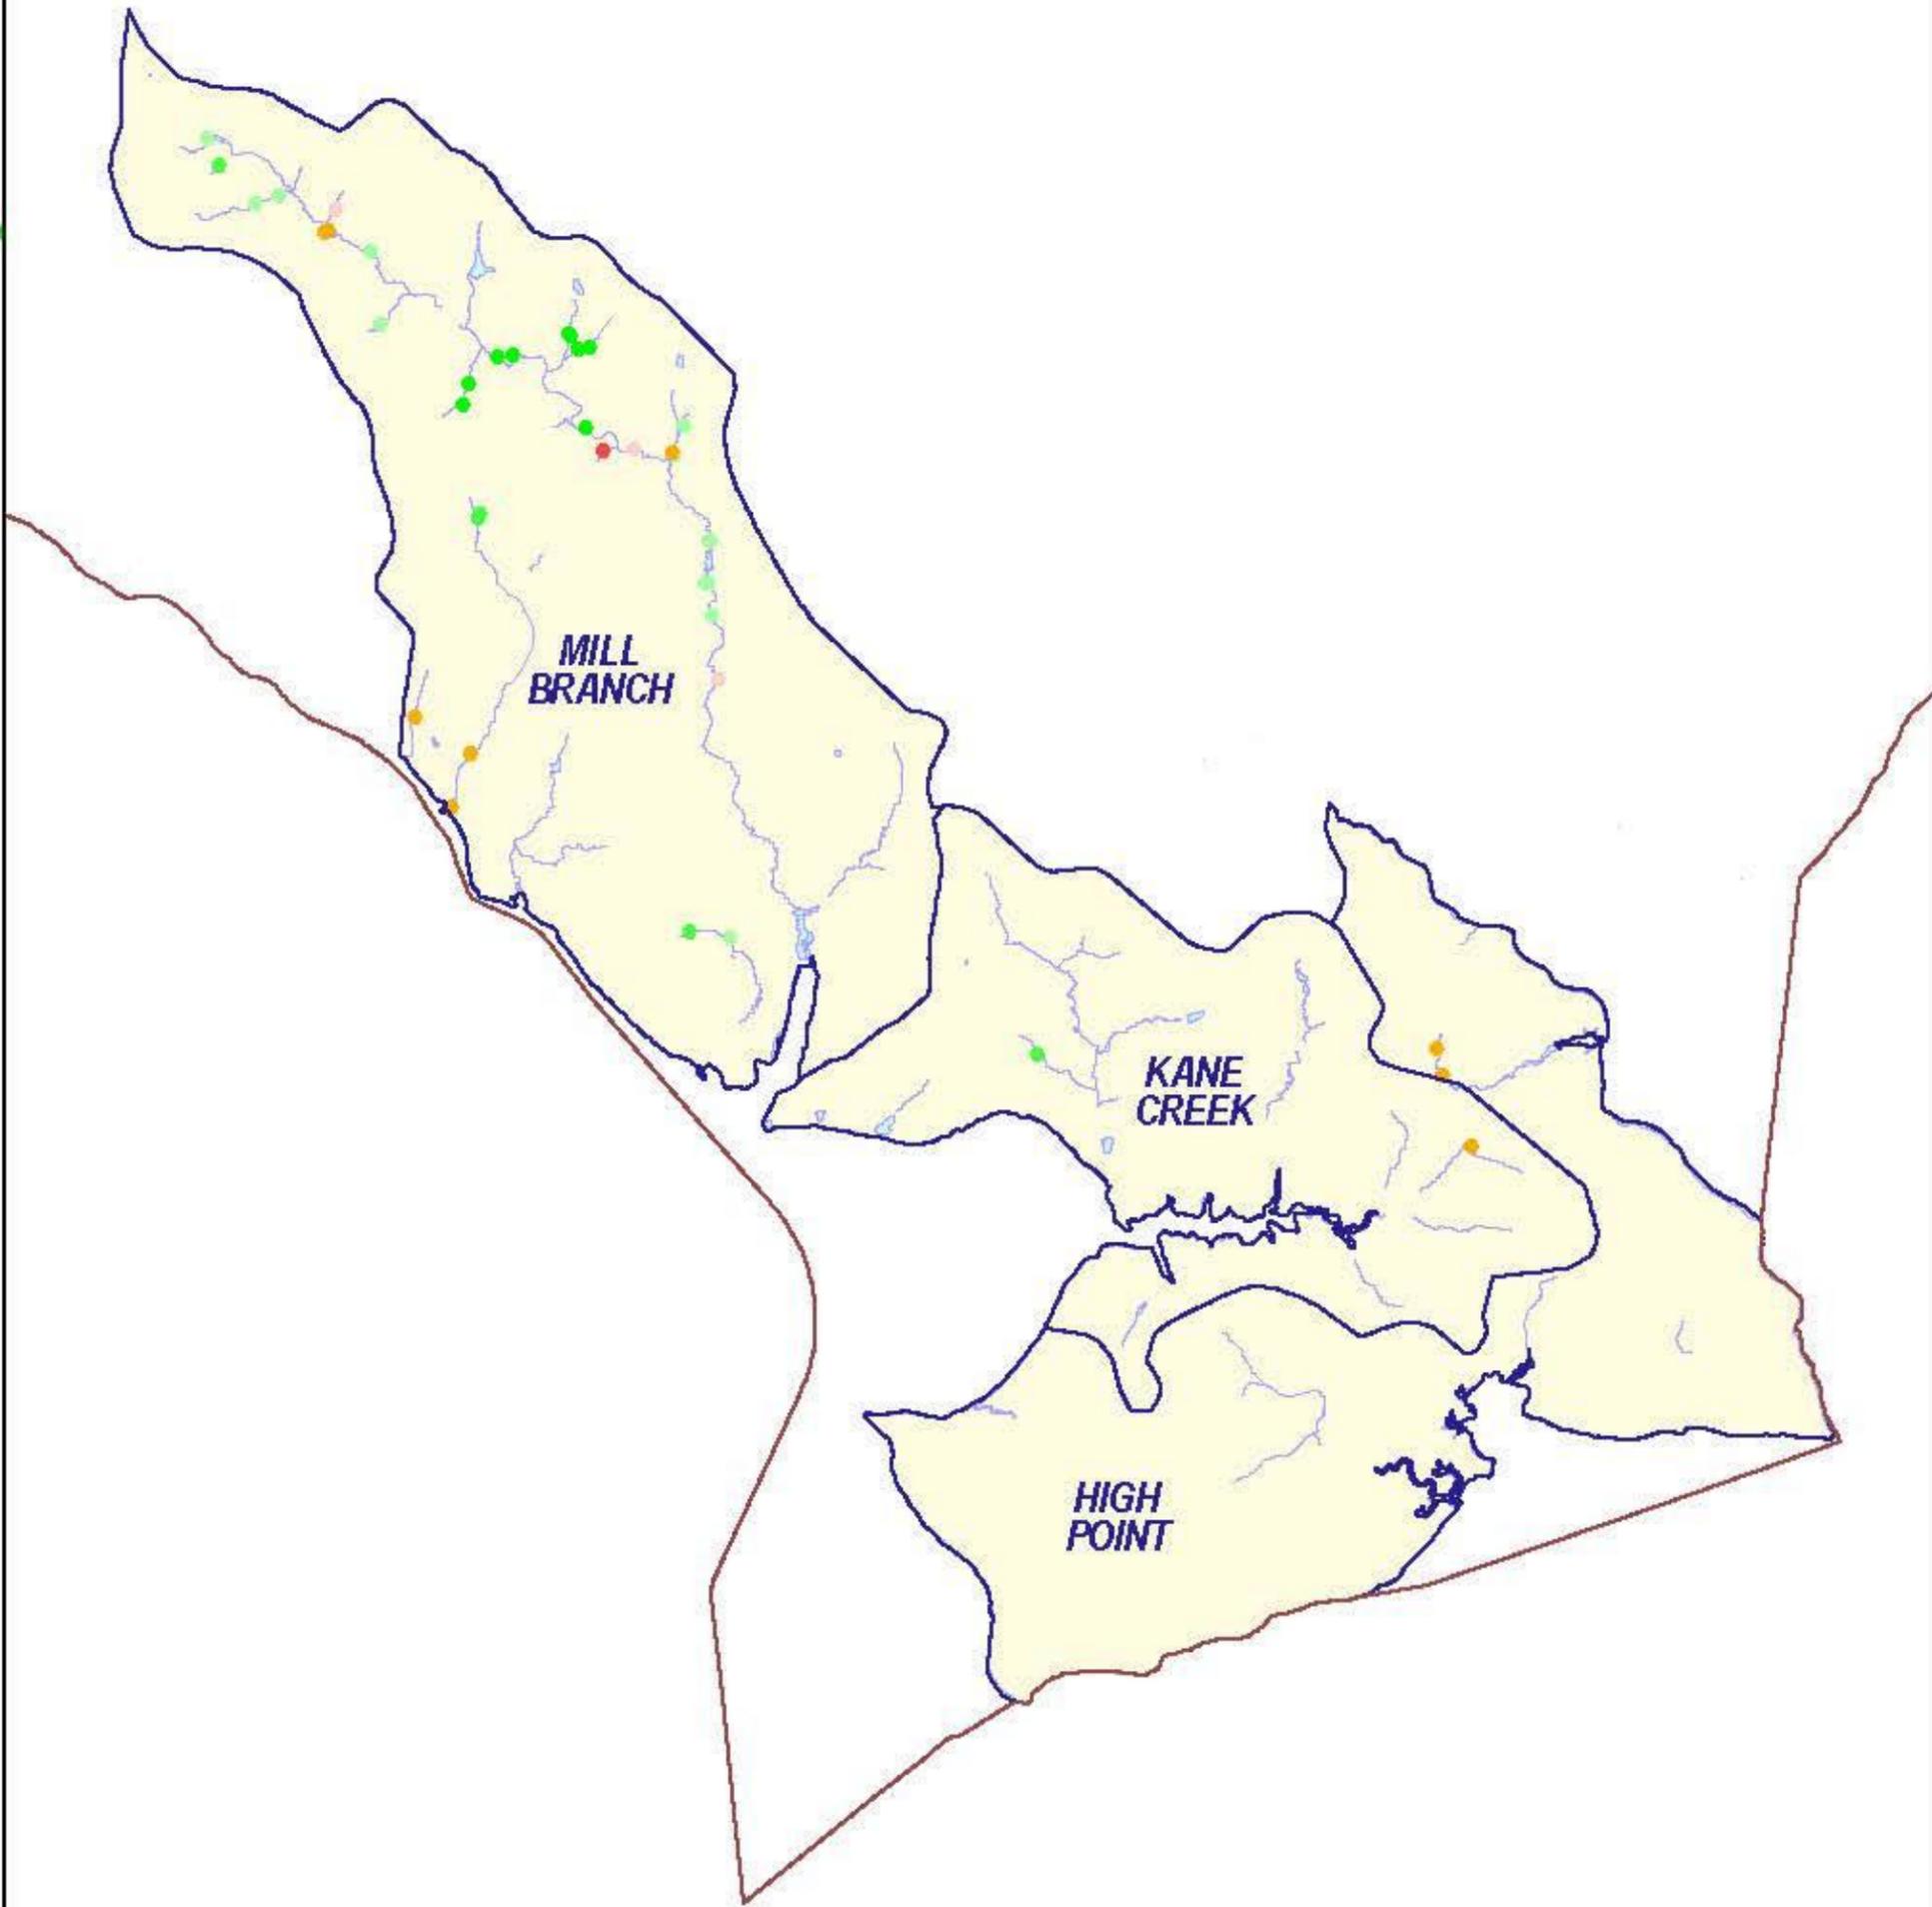
**Figure 3-83**  
**Deficient Buffer Impacts**  
**Lower Occoquan Group**  
**Fairfax County Stream Physical Assessment**

**Infrastructure.** The infrastructure inventory resulted in 6 inventory points. The most significant problems were related to two deficient buffers, which were given impact scores of 5. The infrastructure inventory results are summarized in Table 3-64. Figures 3-82, 3-83, 3-84, 3-85, and 3-86 summarize impact scores for the erosion problems; deficient buffers; crossings; pipes/ditches; and dumps, obstructions, and utilities, respectively.

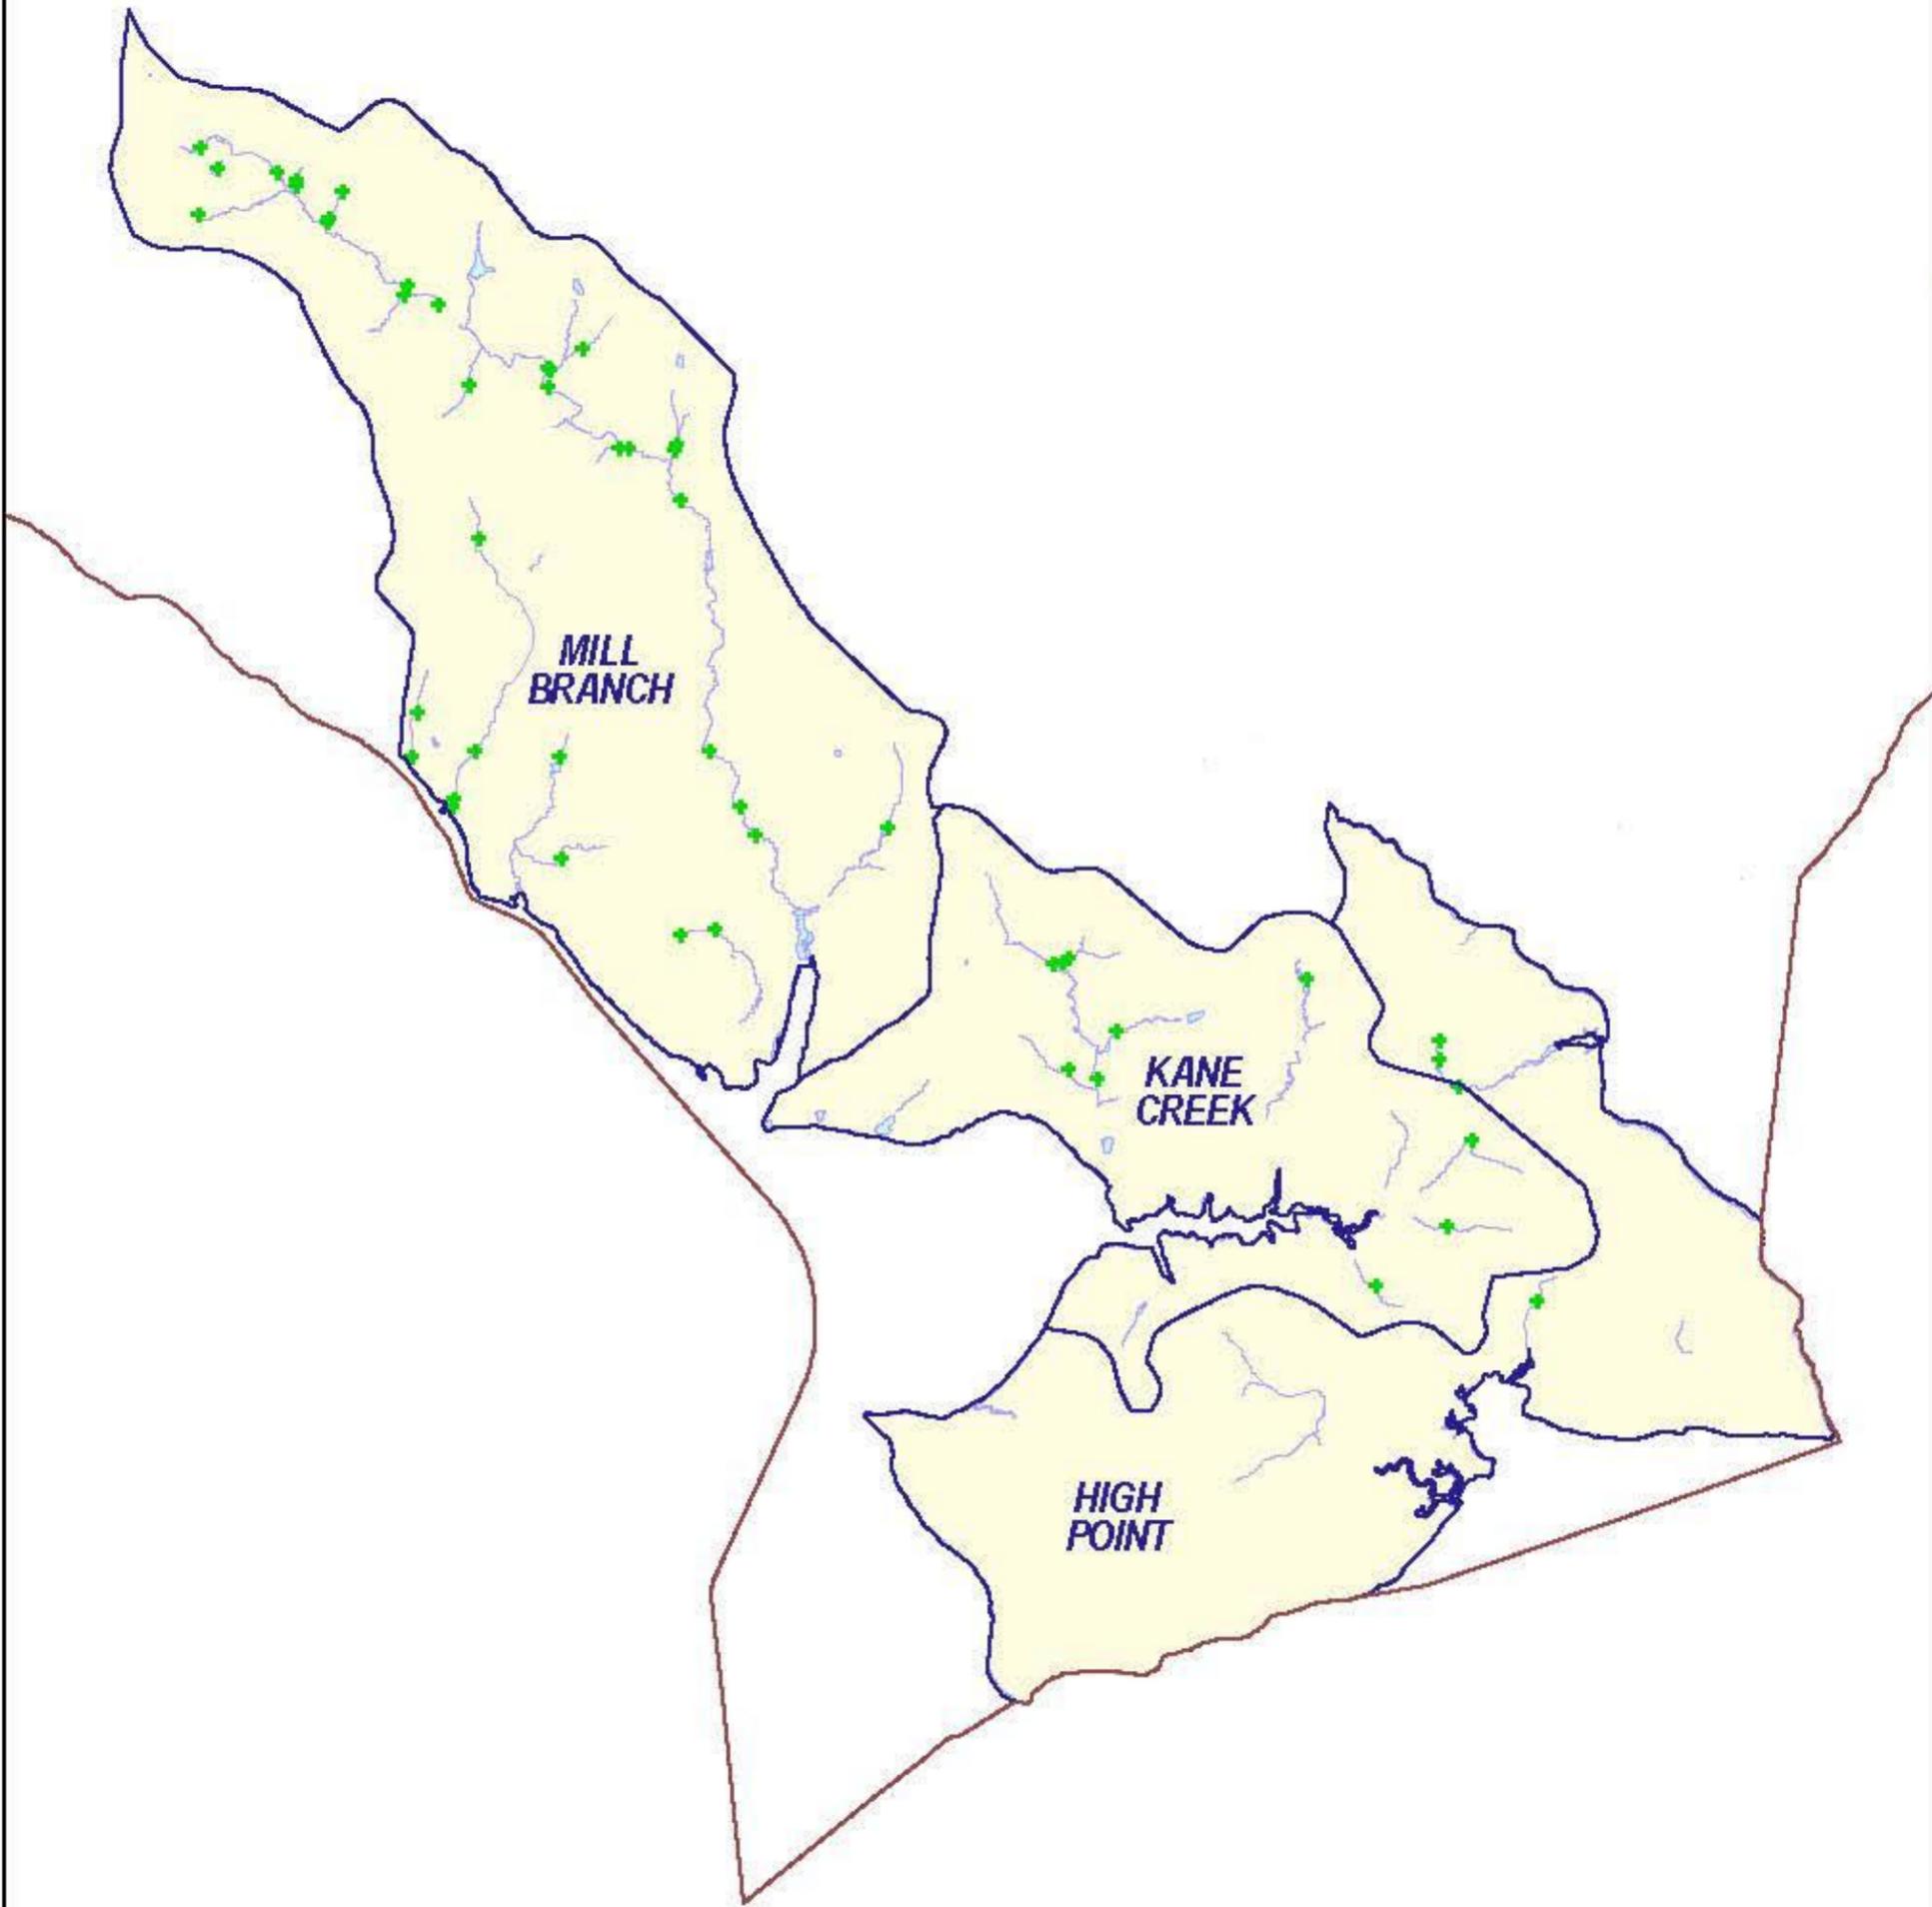
**Figure 3-84**  
**Crossings**  
**Lower Occoquan Group**  
**Fairfax County Stream Physical Assessment**

**Infrastructure.** The infrastructure inventory resulted in 13 inventory points. The most significant problem was related to a crossing, which was given an impact score of 5. The infrastructure inventory results are summarized in Table 3-62. Figures 3-82, 3-83, 3-84, 3-85, and 3-86 summarize impact scores for the erosion problems; deficient buffers; crossings; pipes/ditches; and dumps, obstructions, and utilities, respectively.
