JUNE 2006 FLOOD INVESTIGATION FOR CAMERON RUN

FAIRFAX COUNTY, VIRGINIA

FINAL REPORT JANUARY 2007

**U.S. Army Corps of Engineers, Baltimore District
P.O. Box 1715
Baltimore, Maryland 21203-1715**

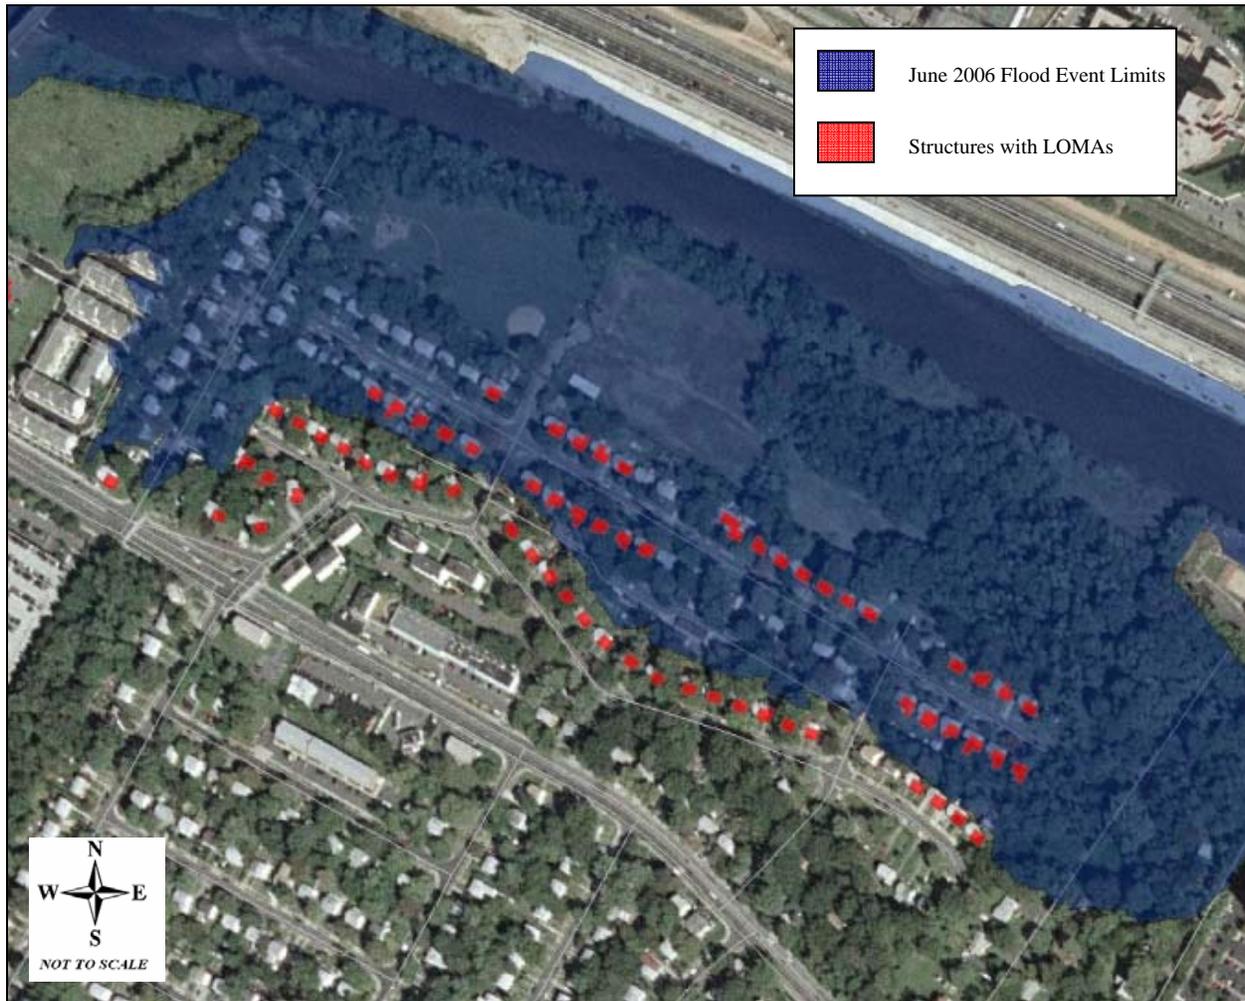
Figure 4.1. Structures in Huntington with FEMA Letters of Map Amendment (LOMAs)

The application for LOMAs shows that although residents of Huntington knew that the risk of flooding in the community was present, some did not feel the flooding would cause damages to their structures. Note that although officially many applied for LOMAs, it is clear from the interviews with some of the residents that they were not familiar with what a LOMA is. This may be due to (1) the current tenant was not in residence at the time of the LOMA, as the LOMA may have been granted to the previous owner or (2) the LOMA was submitted for them by another entity, such as the County, lending institution, or homeowners association.

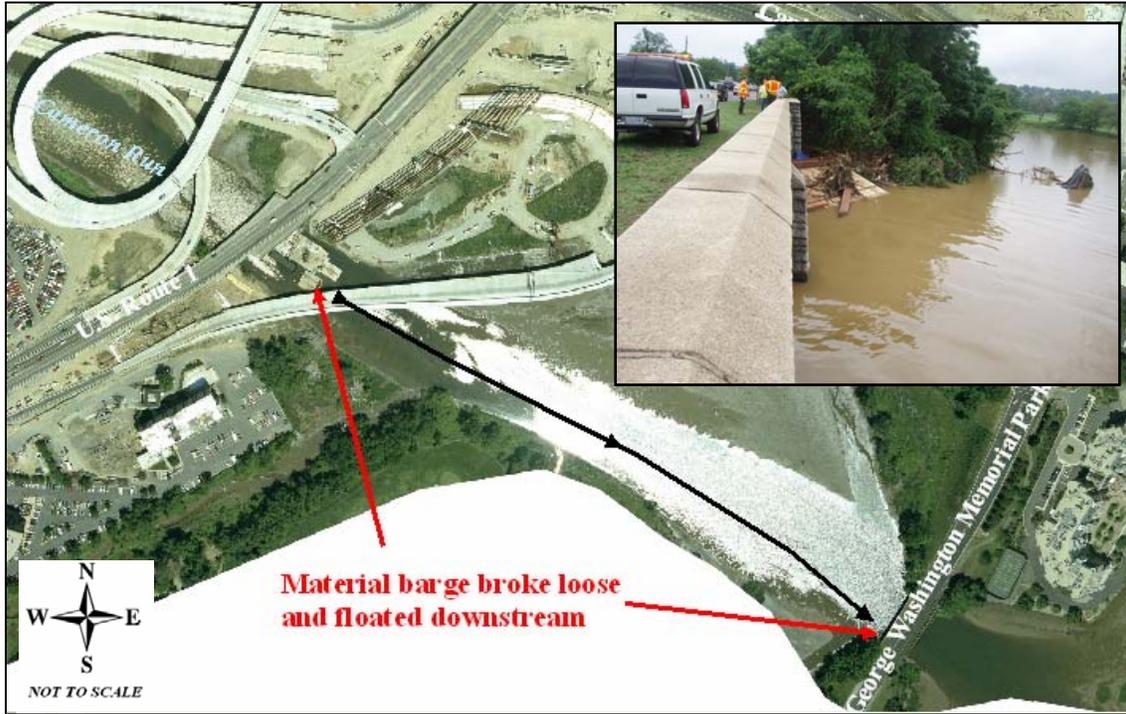
Figure 7.2. Barge Blockage at the George Washington Memorial Parkway

The results of the JUNE 2006 FLOOD EVENT plan were compared to the results of the JUNE 2006 FLOOD EVENT (NO BARGE) plan to determine the impact the barge blockage had on the water surface elevations during the flood event. The objective was to determine how severe the flooding would have been during the June 2006 flood event if the barge blockage did not occur. The results are shown in Table 7.3. As shown in the table, the impact was negligible.

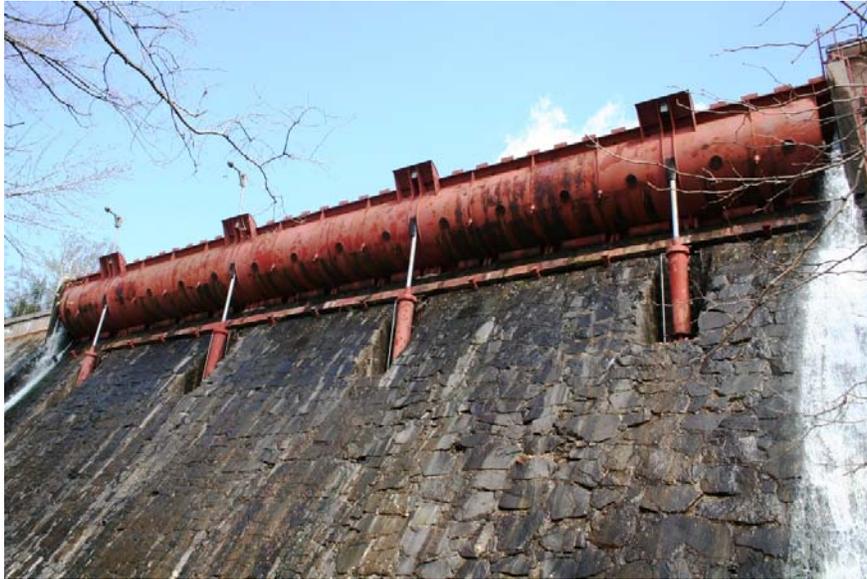
LAKE BARCROFT DAM AND GATE

and essentially remove the risk of the dam failing in the manner it did during Hurricane Agnes. The picture, below, is the dam and its hydraulic rams seen from downstream.
