II. Capital Improvements and Infrastructure Retrofit

Projects Constructed in 2004

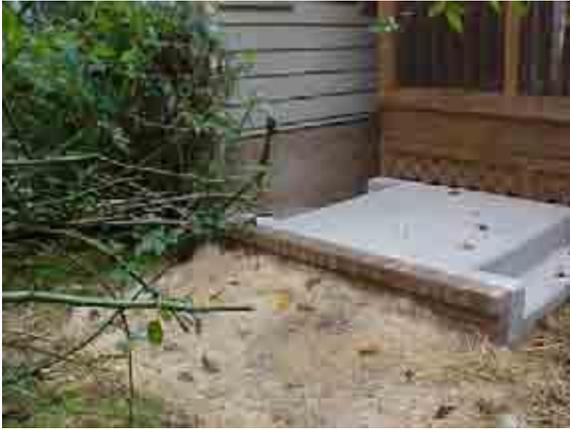
Bridle Path flood proofing

There was no overland relief for the public storm sewer system for this residential property and, as a result, significant house flooding occurred. A floodwall with a two step concrete landing at the basement was installed, alleviating the problem for a cost of \$4,223.

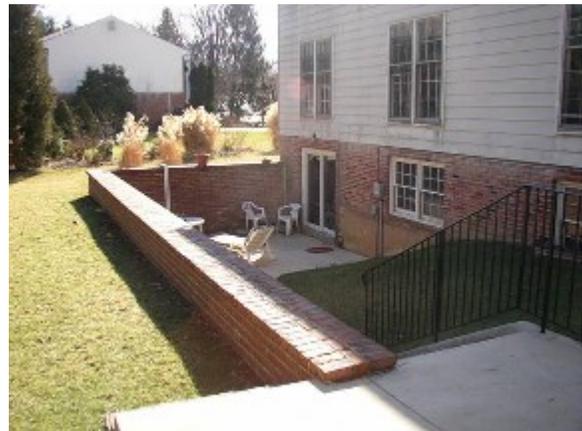
The existing storm sewer system in the vicinity of the property was unable to handle the volume of stormwater generated during a 100-year storm event, causing the inlet behind the property to surcharge. Sufficient overland relief for the water was not available and the basement of 1865 Foxstone Drive in Vienna, VA was flooded regularly. The house was flood proofed by constructing a reinforced concrete wall with brick liner, eight feet tall and 65 feet long, and an overflow swale 75 feet long. The flood proofing wall with associated pump system and overland relief swale alleviated the house flooding. The project was completed in November 2003 for a cost of \$82,000.

Foxstone Drive flood proofing

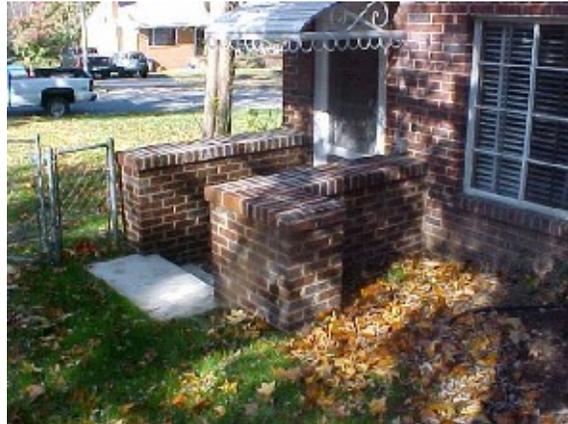
Marl Pat Drive

There was no overland relief for the public storm sewer system for this residential property and, as a result, significant house flooding has occurred at the property. The project consisted of the installation of a two-step walkout from the basement entrance door and a concrete paved ditch, and grading of the side yard for a cost of \$ 36,470.

Marl Pat Drive, two steps

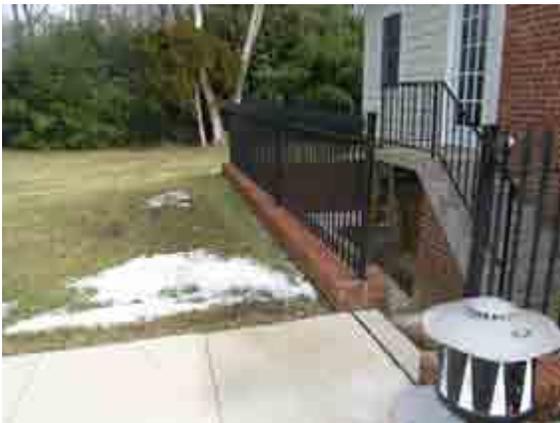
Tucker Avenue

Flooding of two houses was occurring along a reach of Pimmit Run on Tucker Avenue in McLean, Virginia. On one house, a floodwall was retrofitted to the dwelling's architecture to block off a lower walk-out carport/house entry point that was subject to flooding. Window wells with grading were also included to block floodwater from entering. For the second house, the patio was raised in elevation and additional basement stairs were included to block the flood flows from entering the dwelling. The cost of this project was \$150,000.

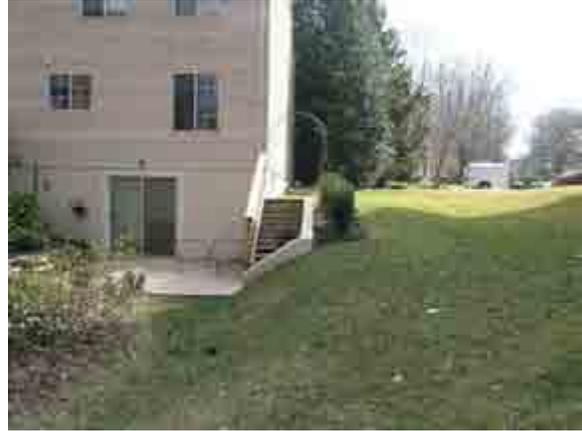
The rear door of the house at 10722 Burr Oak Way in Burke, Virginia, is at an elevation that is subject to flooding during major storm events. A reinforced concrete flood proofing wall, six feet tall and 20 feet long, was constructed by the door and the yard was regraded to provide an overflow swale 120 feet long. The swale between houses 10722 and 10724 conveys the storm drain surcharge to the existing channel behind house 10722. The cost of this project was \$110,000.

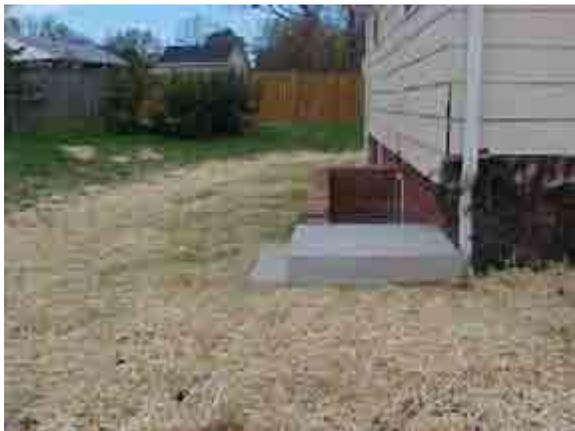
There was no overland relief for the public storm sewer system for this residential property and, as a result, significant house flooding occurred. A two step walkout from the basement entrance door was constructed, raising the areaway wall. The side yard was regraded and an additional yard inlet was installed to pick up the increased stormwater. The cost of the project was \$19,419.

Fern Oak, two steps

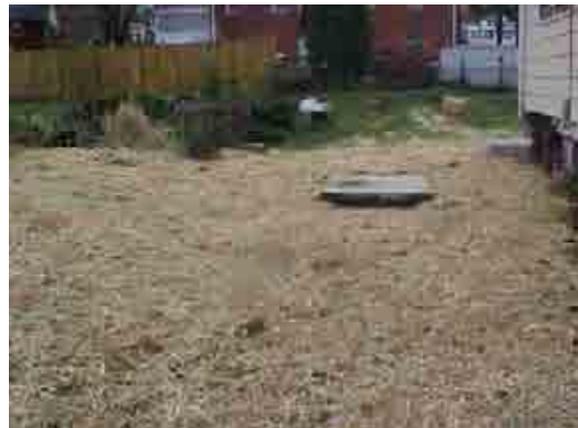
Fern Oak, yard inlet

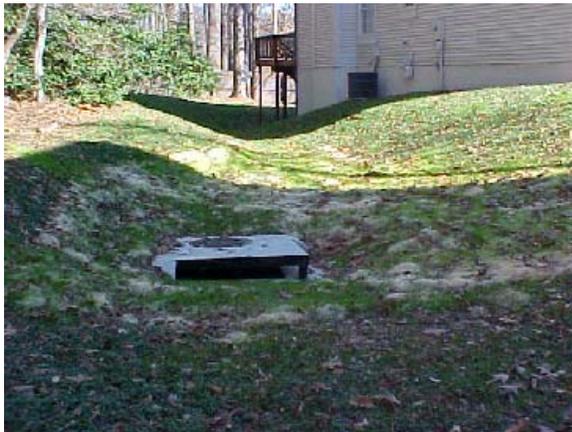
Linda Marie Court

There was no overland relief for the public storm sewer system for this residential property and, as a result, significant house flooding has occurred at the property. The project consisted of the modification of an existing yard inlet and the grading of an overland relief swale through the side yard of an adjacent property for a cost of \$6,911.

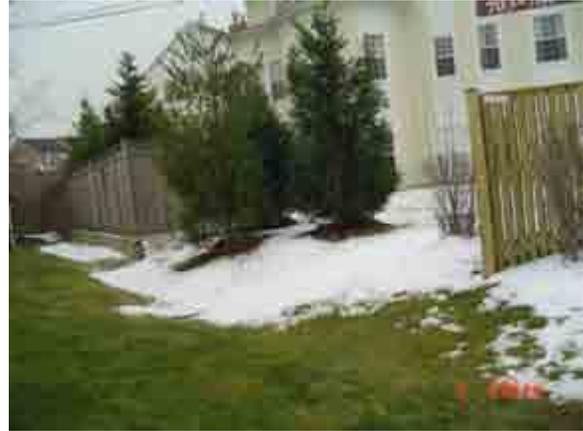
Mt. Vee Manor is a developer default project and is located on Richmond Hwy in Mt. Vernon district. The developer had not developed the property per approved design plans and the adjacent property was being frequently flooded due to runoff from the site. To address this flooding situation, a minor storm drainage collection and conveyance system was built for a cost of \$5,000. This, combined with re-grading the site, insured that the run-off from the site did not flood the neighboring property.

Mt. Vee Manor flood protection

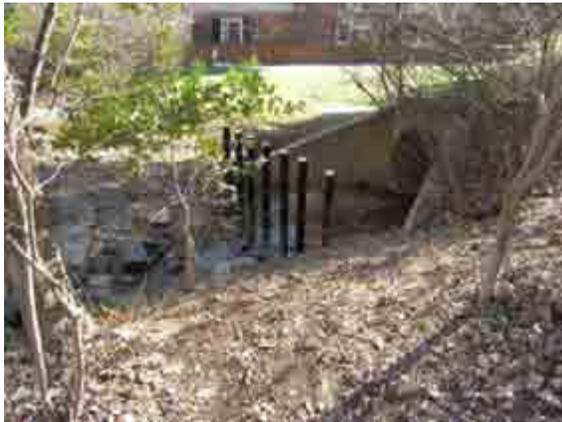
Prelude Court

The existing in-take pipe system had a history of clogging with debris. There was no overland relief and, as a result, significant house flooding has occurred. A low maintenance improvement was made to the system that allows smaller debris into the pipe system but prevents larger debris from blocking the opening or getting jammed in the pipe system. The cost of installing the row of concrete-filled bollards with cables as a debris barricade was \$6000.

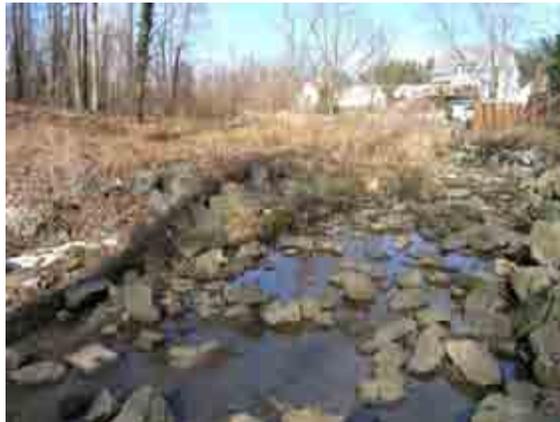
Streambank erosion was occurring along a reach of Indian Run near Little River Turnpike in Annandale, Virginia, and there was house flooding. The streambanks were armored with riprap for a distance of 250 feet and an unnamed tributary to Indian Run was placed inside 250 feet of 60 by 38-inch elliptical pipe with a three-foot overflow swale to redirect the flood flows to Indian Run, eliminating flooding of the house. Cost of this project was \$560,000.

Indian Run, streambank erosion

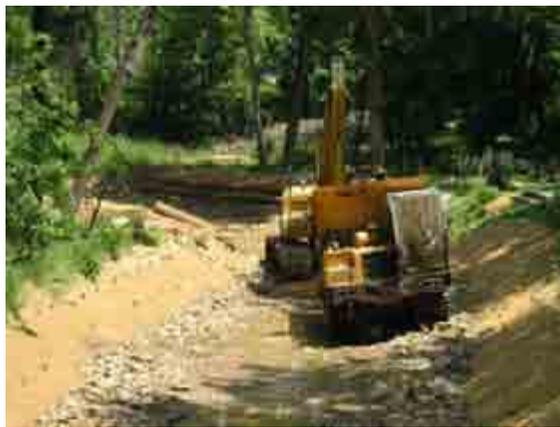
Increased inflows into the stream from a highly urbanized drainage area resulted in considerable deterioration of the Long Branch Stream located at the border of Fairfax and Arlington Counties. Stream restoration was performed to rectify a majority of the problems. However, soon after the stream restoration, Hurricane Isabel caused considerable damage to the in-stream restoration efforts. This damage was corrected for a cost of \$343,000.

Long Branch stream rehabilitation

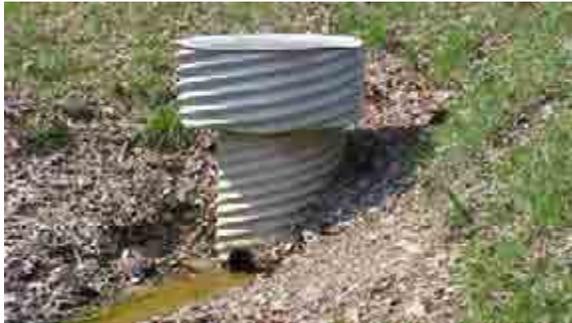
The pond's function was impaired due to failures of the corrugated metal riser pipe, deterioration of the principal spillway pipe, sediment build up, and deterioration of the control structure. Repairs and improvements were made to the dam embankment, a new riser structure and pipes were installed, a new water quality control device was installed, and the pond was enhanced with wetland marsh (to be planted in spring 2005) for a cost of \$85,000.

Braddock Forest before retrofit

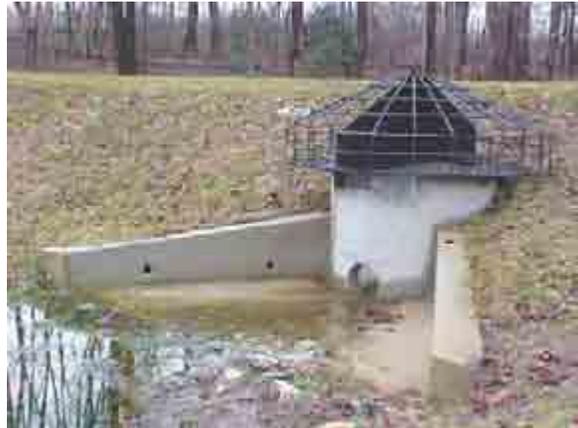
Braddock Forest after retrofit

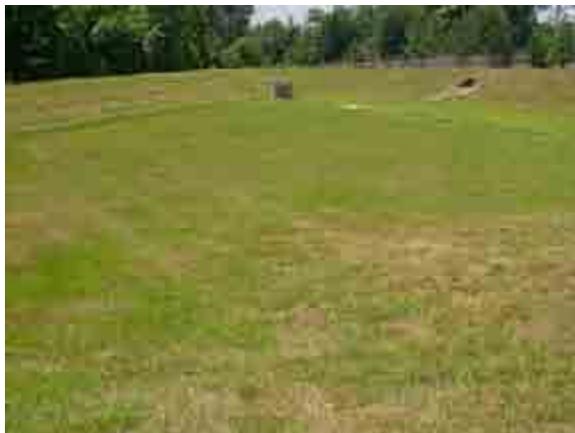
The pond's function was impaired due to pipe separation, sediment build up, constant blockage, and water quality control deterioration. Repairs and improvements were made to the dam embankment and riser structure, a new water quality control device was installed, and the pond was enhanced with a wetland marsh (scheduled planting spring 2005) for a cost of \$63,000.

Centreville Green before retrofit

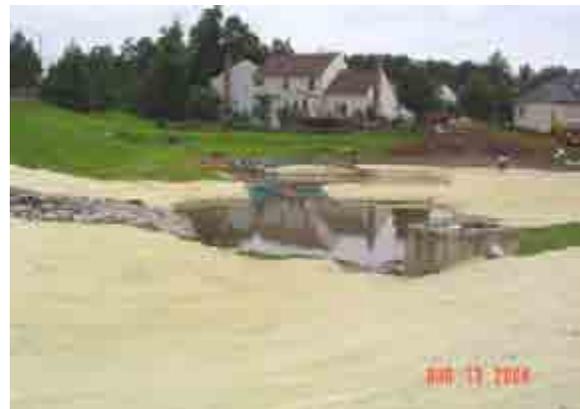
Centreville Green after retrofit, prior to wetland planting

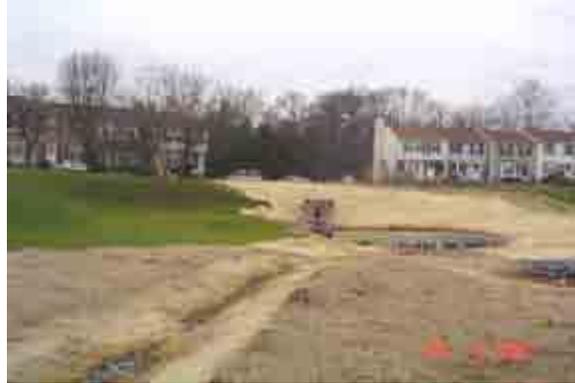
The pond's function was impaired due to failures including pipe separations, sediment build up, constant blockage, and water quality control device deterioration. Structural repairs and improvements to a dam embankment and riser structure were made, a new water quality control device was installed, and the pond was enhanced with wetland marsh (scheduled planting spring 2005) for a cost of \$61,000.

Stone Crossing after retrofit

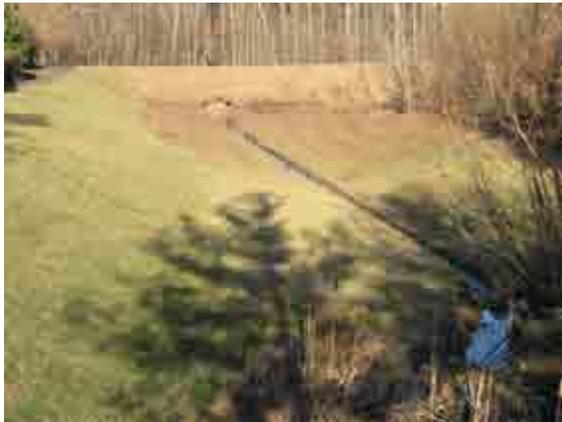
Sully Station (Ph I) Pond II

Piping problems along the principal spillway were noticed during routine maintenance operations of the Sully Station (Ph I) Pond II, a dry pond with BMP located off route 28 on Westfields Boulevard. Non-rehabilitation could have led to failure of the dam and subsequent flooding. The following improvements were made: the principal spillway was replaced, a concrete apron was installed in front of the riser, a new BMP plate was installed, a concrete cradle was installed along the entire length of the principal spillway, a drainage blanket was installed along the downstream third of principal spillway, and new trash rack was installed. The cost was \$25,000.

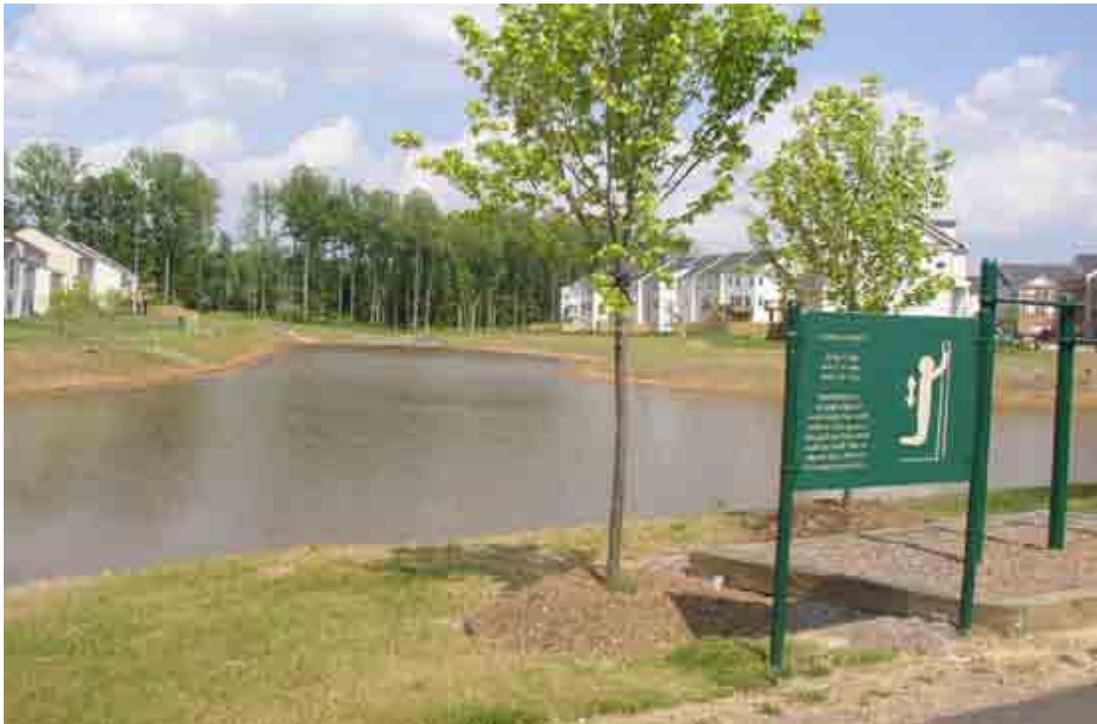
R-8 Regional Pond

This facility provides water quality and quantity control for a 100-acre drainage area. It is designed as a “wet” pond that incorporates wetlands plantings along a ten-foot wide bench around the perimeter. The pond and accompanying trail serve as an amenity within the center of the Buckley’s Reserve Subdivision. The facility was constructed by the site developer via a cost sharing arrangement with the county. The total project cost is \$900,000.

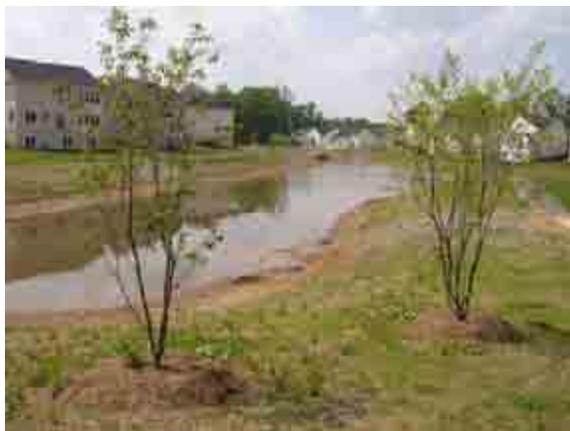
Regional Pond R-8, Rocky Run watershed retrofit

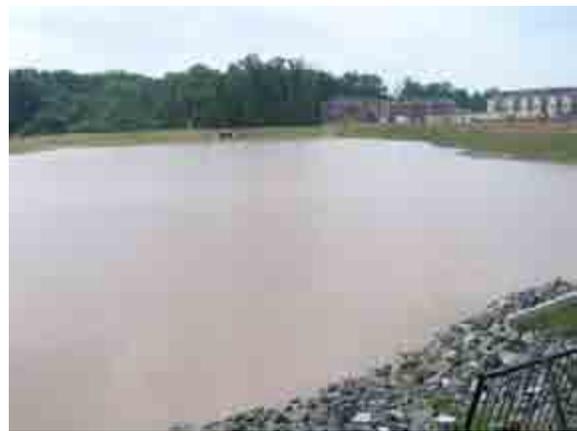
Regional Pond R-161, Rocky Run watershed retrofit

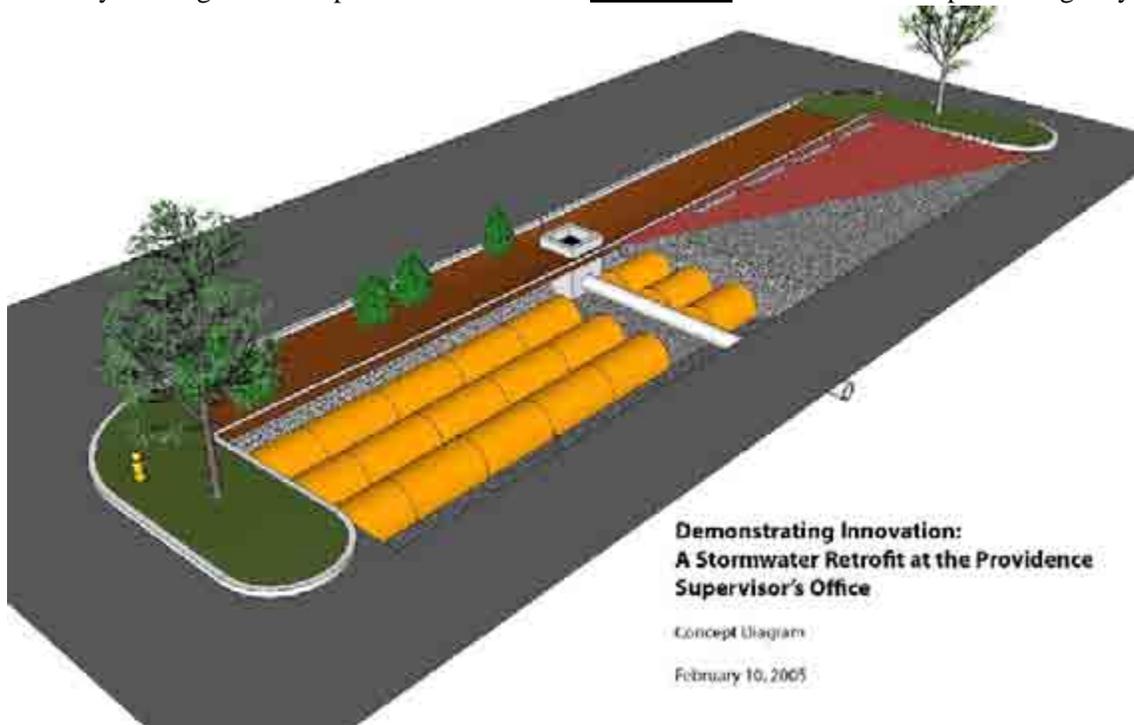
Demonstrating Innovation: A Stormwater Retrofit at the Providence Supervisor’s Office

This LID demonstration project is located within the Accotink Creek watershed and has a drainage area of 0.83 acre. In addition to the Providence Supervisor’s Office, the site is also the location of the county’s Merrifield Fire Station. DPWES and NVSWCD are partnering in the analysis, design, and construction. The overall complex encompasses a land area of 1.8 acres with approximately 1.44 acres being impervious. The proposed work will serve as a highly visible demonstration project featuring three LID practices: a bioretention basin (rain garden), a green roof, and permeable pavers. The bioretention basin and permeable pavers with underlying gravel infiltration bed will allow runoff to drain into a retention area where it can then slowly infiltrate into the surrounding soil. The green roof installation on an existing concrete storage structure will serve to reduce rooftop stormwater runoff and provide a comparison to an adjacent storage structure with an impervious roof. The bioretention basin will occupy an area of 680 square feet and the permeable paver area is 1,550 square feet in size, with a combined volume of approximately 9,841 cubic feet in the underlying gravel infiltration bed. The disturbed area will be 2300 square feet in size. The green roof will occupy an area of approximately 240 square feet. These three integrated LID practices will work in harmony to address both water quality and water quantity retrofit goals on the site. They are expected to retain and infiltrate a significant amount of the stormwater currently running off the impervious surface. See Appendix C for the LID conceptual design layout.

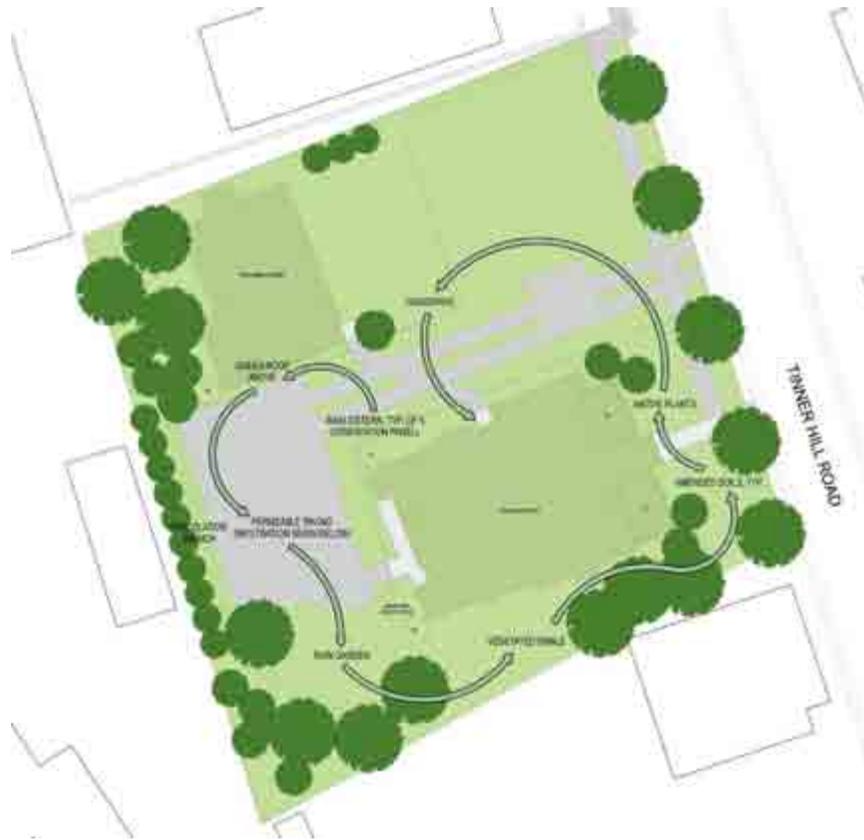
Tinner Hill Cultural Center—"The Drinking Gourd Trail"
The trail leads visitors past each of the LID designs,
each with narrative signage.

The top of Tinner Hill, along the Fairfax County/City of Falls Church border is being developed to commemorate the historic founding of the first rural branch of the N.A.A.C.P. in the nation. To honor the original importance of water to this historic community and to protect the current residents of the hill who live below this small county-owned site, the project will include eight separate LID design techniques to contain, reuse, and infiltrate up to the 100-year storm event. Assisted by county stormwater planners and the Northern Virginia Soil and Water Conservation District (NVSWCD) and with the help of a DCR state grant through the Northern Virginia Regional Commission, The Tinner Hill Heritage Foundation will develop “The Drinking Gourd Trail” to lead visitors past each of the LID designs, each with narrative signage.

This site will become a primary county demonstration site to display LID practices that all developers and landowners can use on any size property. The design techniques include a vegetated green roof, rain garden, permeable pavers, grass pavers, vegetated swale, infiltration trench, above- and below-ground cisterns, and a “carriage-road-style” driveway. See [Appendix C](#) for the LID conceptual design layout. For further information call (703) 241-4109 or visit:

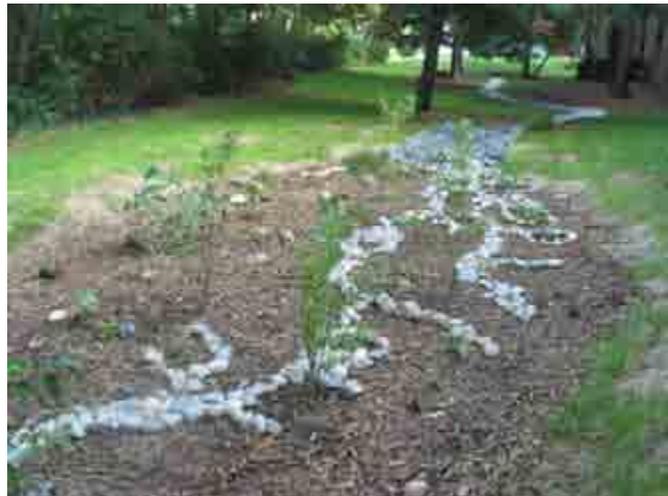
NVSWCD designed a rain garden at the Yorktowne Square Condominiums to overcome an existing drainage problem within the community. The rain garden controls and treats runoff from 0.56 acres of rooftops, parking lots, and lawns. DPWES-MSMD helped to install the project by providing heavy equipment and operators to excavate and install underdrains, and the rain garden materials. The layers consist of mulch, a nutrient-rich and well-drained planting soil layer, and two filter layers. It is equipped with an underdrain system and an observation pipe, which helps with maintenance and monitoring. The surface area of the rain garden is 600 square feet. The residents of Yorktowne Square planted the vegetation and also constructed a dry stream bed to direct stormwater runoff from a parking lot to the rain garden.

Yorktowne Square raingarden

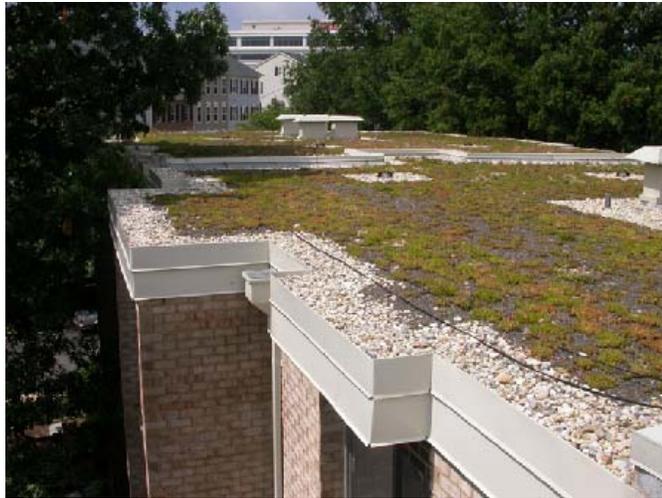
The 5,000-square-foot green roof at Yorktowne Square Condominium is one of the first, if not the first, retrofitted green roof in the state. Building Logics' German design green roof system was chosen because it was lightweight and the 35-year-old building had structural limitations. The soil substrate contains less than fifteen percent organic matter and is made up of a lightweight, highly absorbent clay baked material. There were 8,400 sedums planted on the roof (*Sedum album*, *Sedum sexangular*, and *Sedum reflexum*). Within one year, the vegetated cover more than doubled. A graduate student in civil engineering at George Mason University has set up an experiment to measure the effectiveness of the green roof in reducing water runoff by measuring the volume of water draining from the green roof and an identical roof without vegetation. In addition, the water runoff from both roofs will be tested to measure any filtering qualities the green roof may provide (see [Appendix D](#)).

Yorktowne Square green roof
