Summary of Stream Assessment Data

3.1 County-Wide Summary

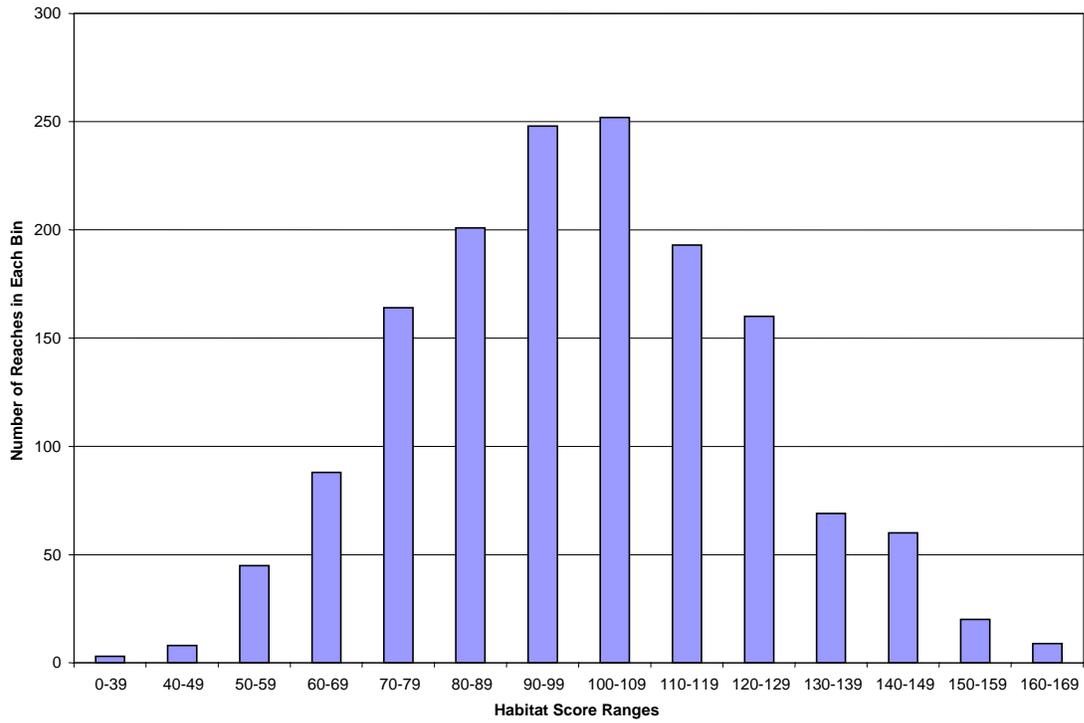
FIGURE 3-1
Distribution of Stream Habitat Scores by Number of Reaches

The habitat assessments yielded scores from 32 to 168, out of a maximum possible score of 200. The mean value of all the scores was 100, while the reach-length-weighted mean was 104. Figure 3-1 shows the distribution of the habitat scores based on score ranges for the reaches. Figure 3-2 shows the distribution of habitat scores based on stream lengths. The data indicate that the habitat and biotic integrity of many of the streams in Fairfax County have been somewhat degraded. There are a few stream reaches in very good condition and several in very poor condition.

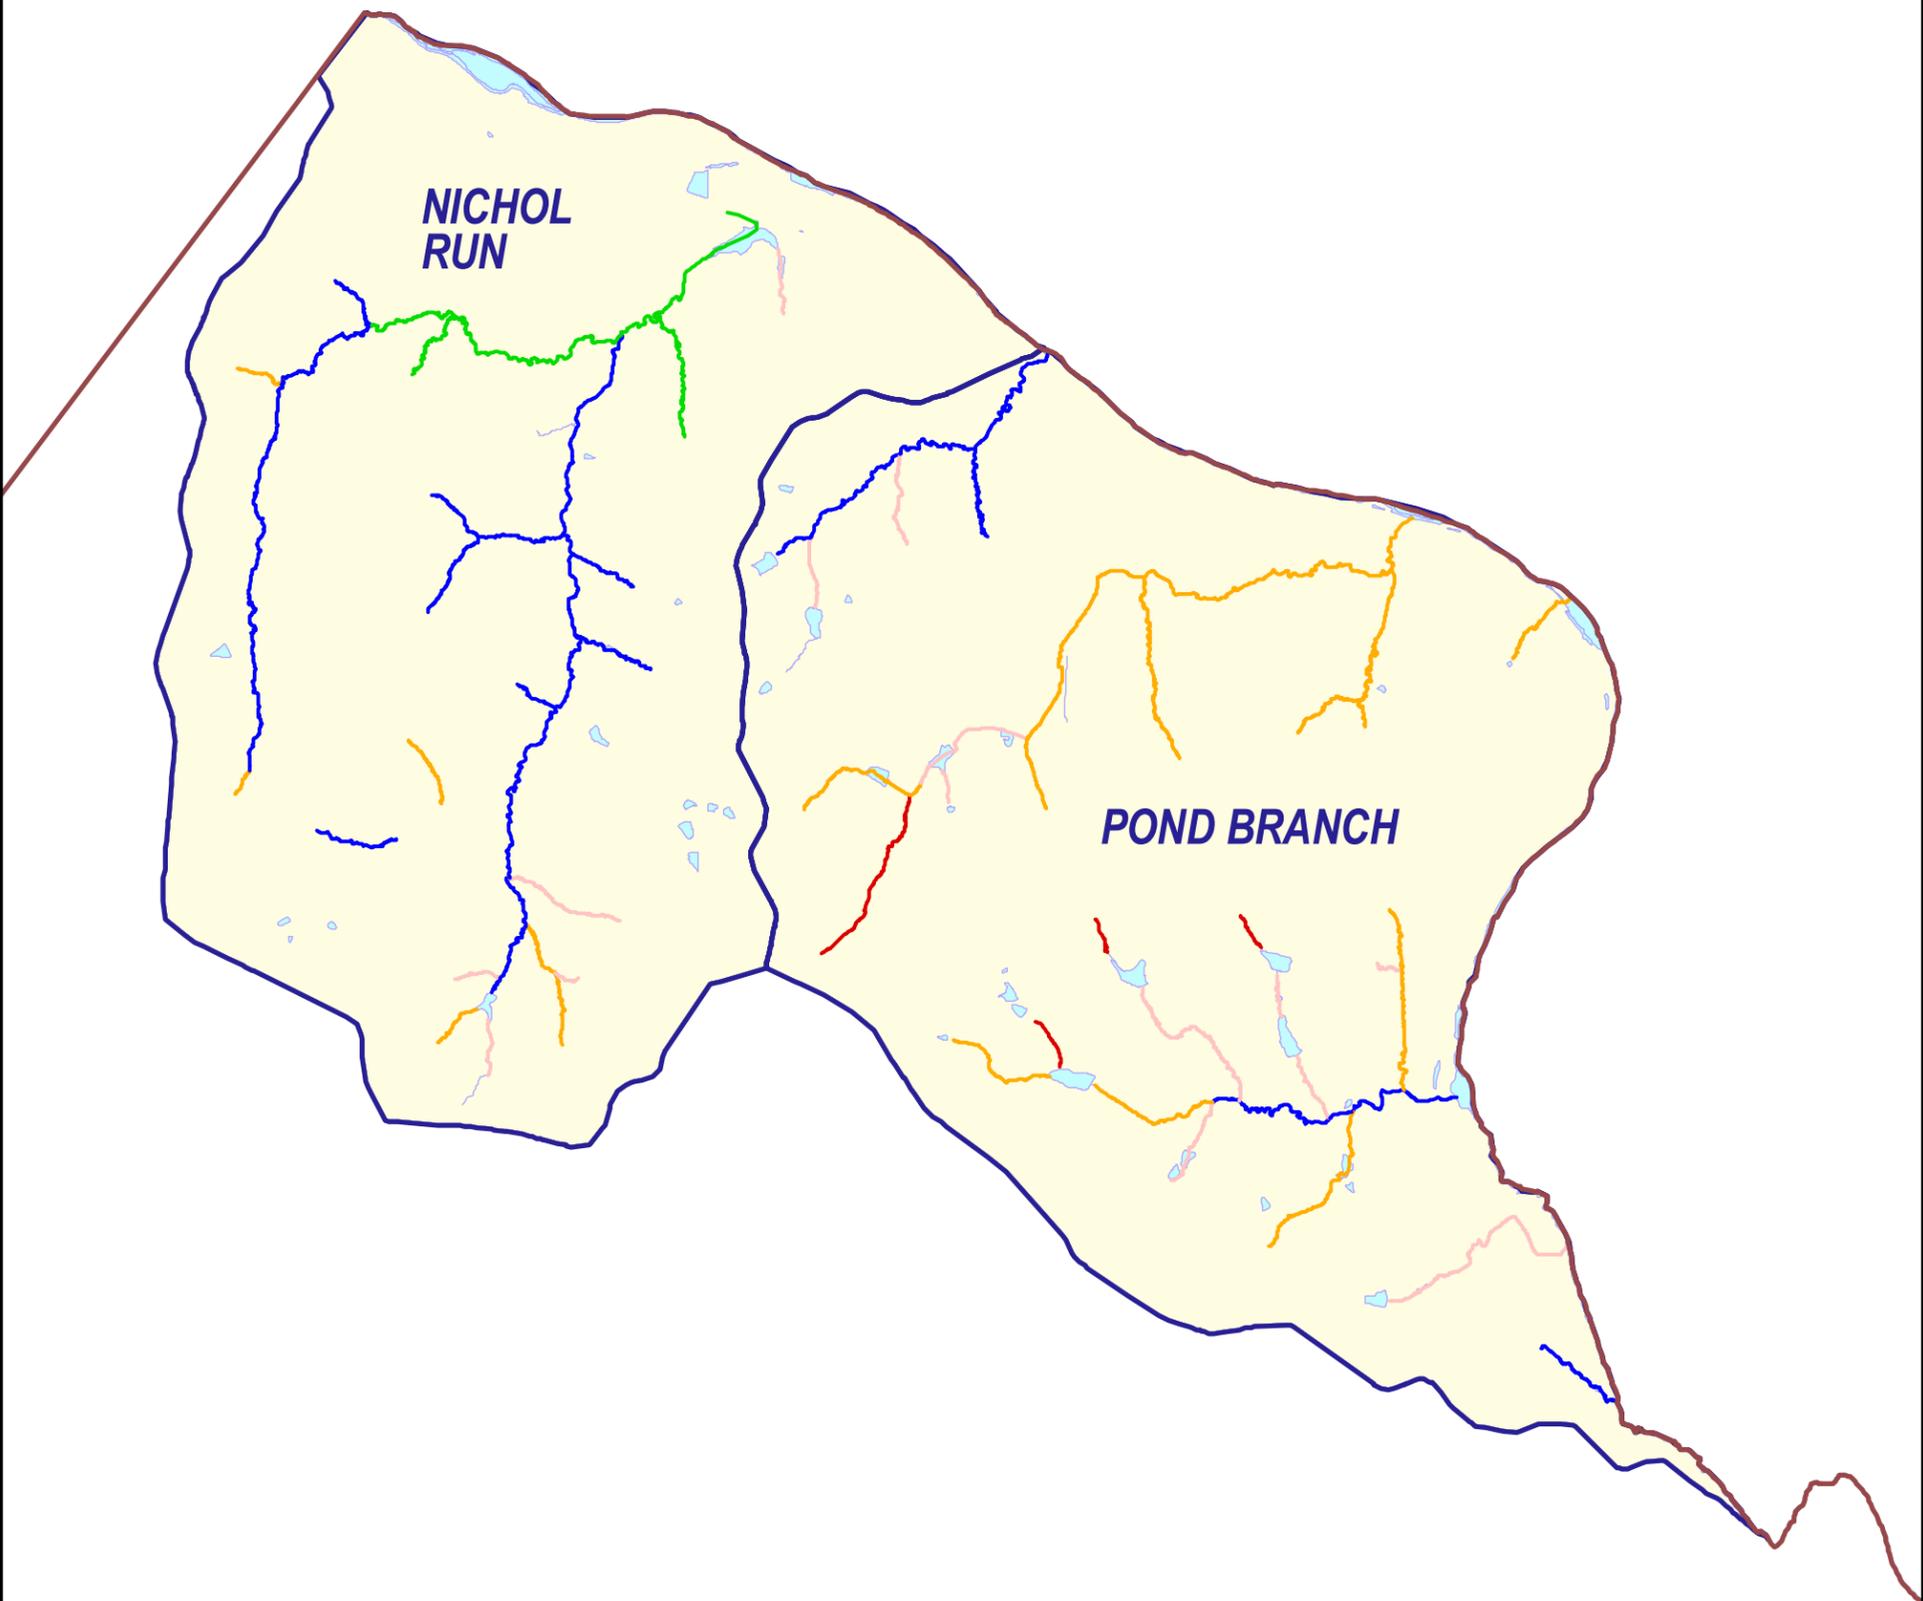
Figure 3-10
Habitat Assessment
Upper Potomac Group
Fairfax County Stream Physical Assessment

Habitat. The habitat assessment results for Nichol Run Watershed are summarized by stream in Table 3-9. Habitat scores for each reach are depicted in Figure 3-10. Based on a length-weighted habitat score of 127 (Table 3-2), Nichol Run Watershed is one of the highest-quality watersheds in the County. Approximately 1 mile of stream was categorized as having “poor” habitat conditions, 1 mile as “fair,” and 8 miles as “good,” and 3 miles as “excellent.”

Habitat. The habitat assessment results for Pond Branch Watershed are summarized by stream in Table 3-11. Habitat scores for each reach are depicted in Figure 3-10. Based on a length weighted habitat score of 99 (Table 3-2), Pond Branch Watershed is in the lower middle range of quality, compared to the rest of the County. Approximately 1 mile of stream was categorized as having “very poor” habitat conditions, 4 miles were categorized as “poor,” 8 miles as “fair,” and 4 miles as “good.” No miles were “excellent.”

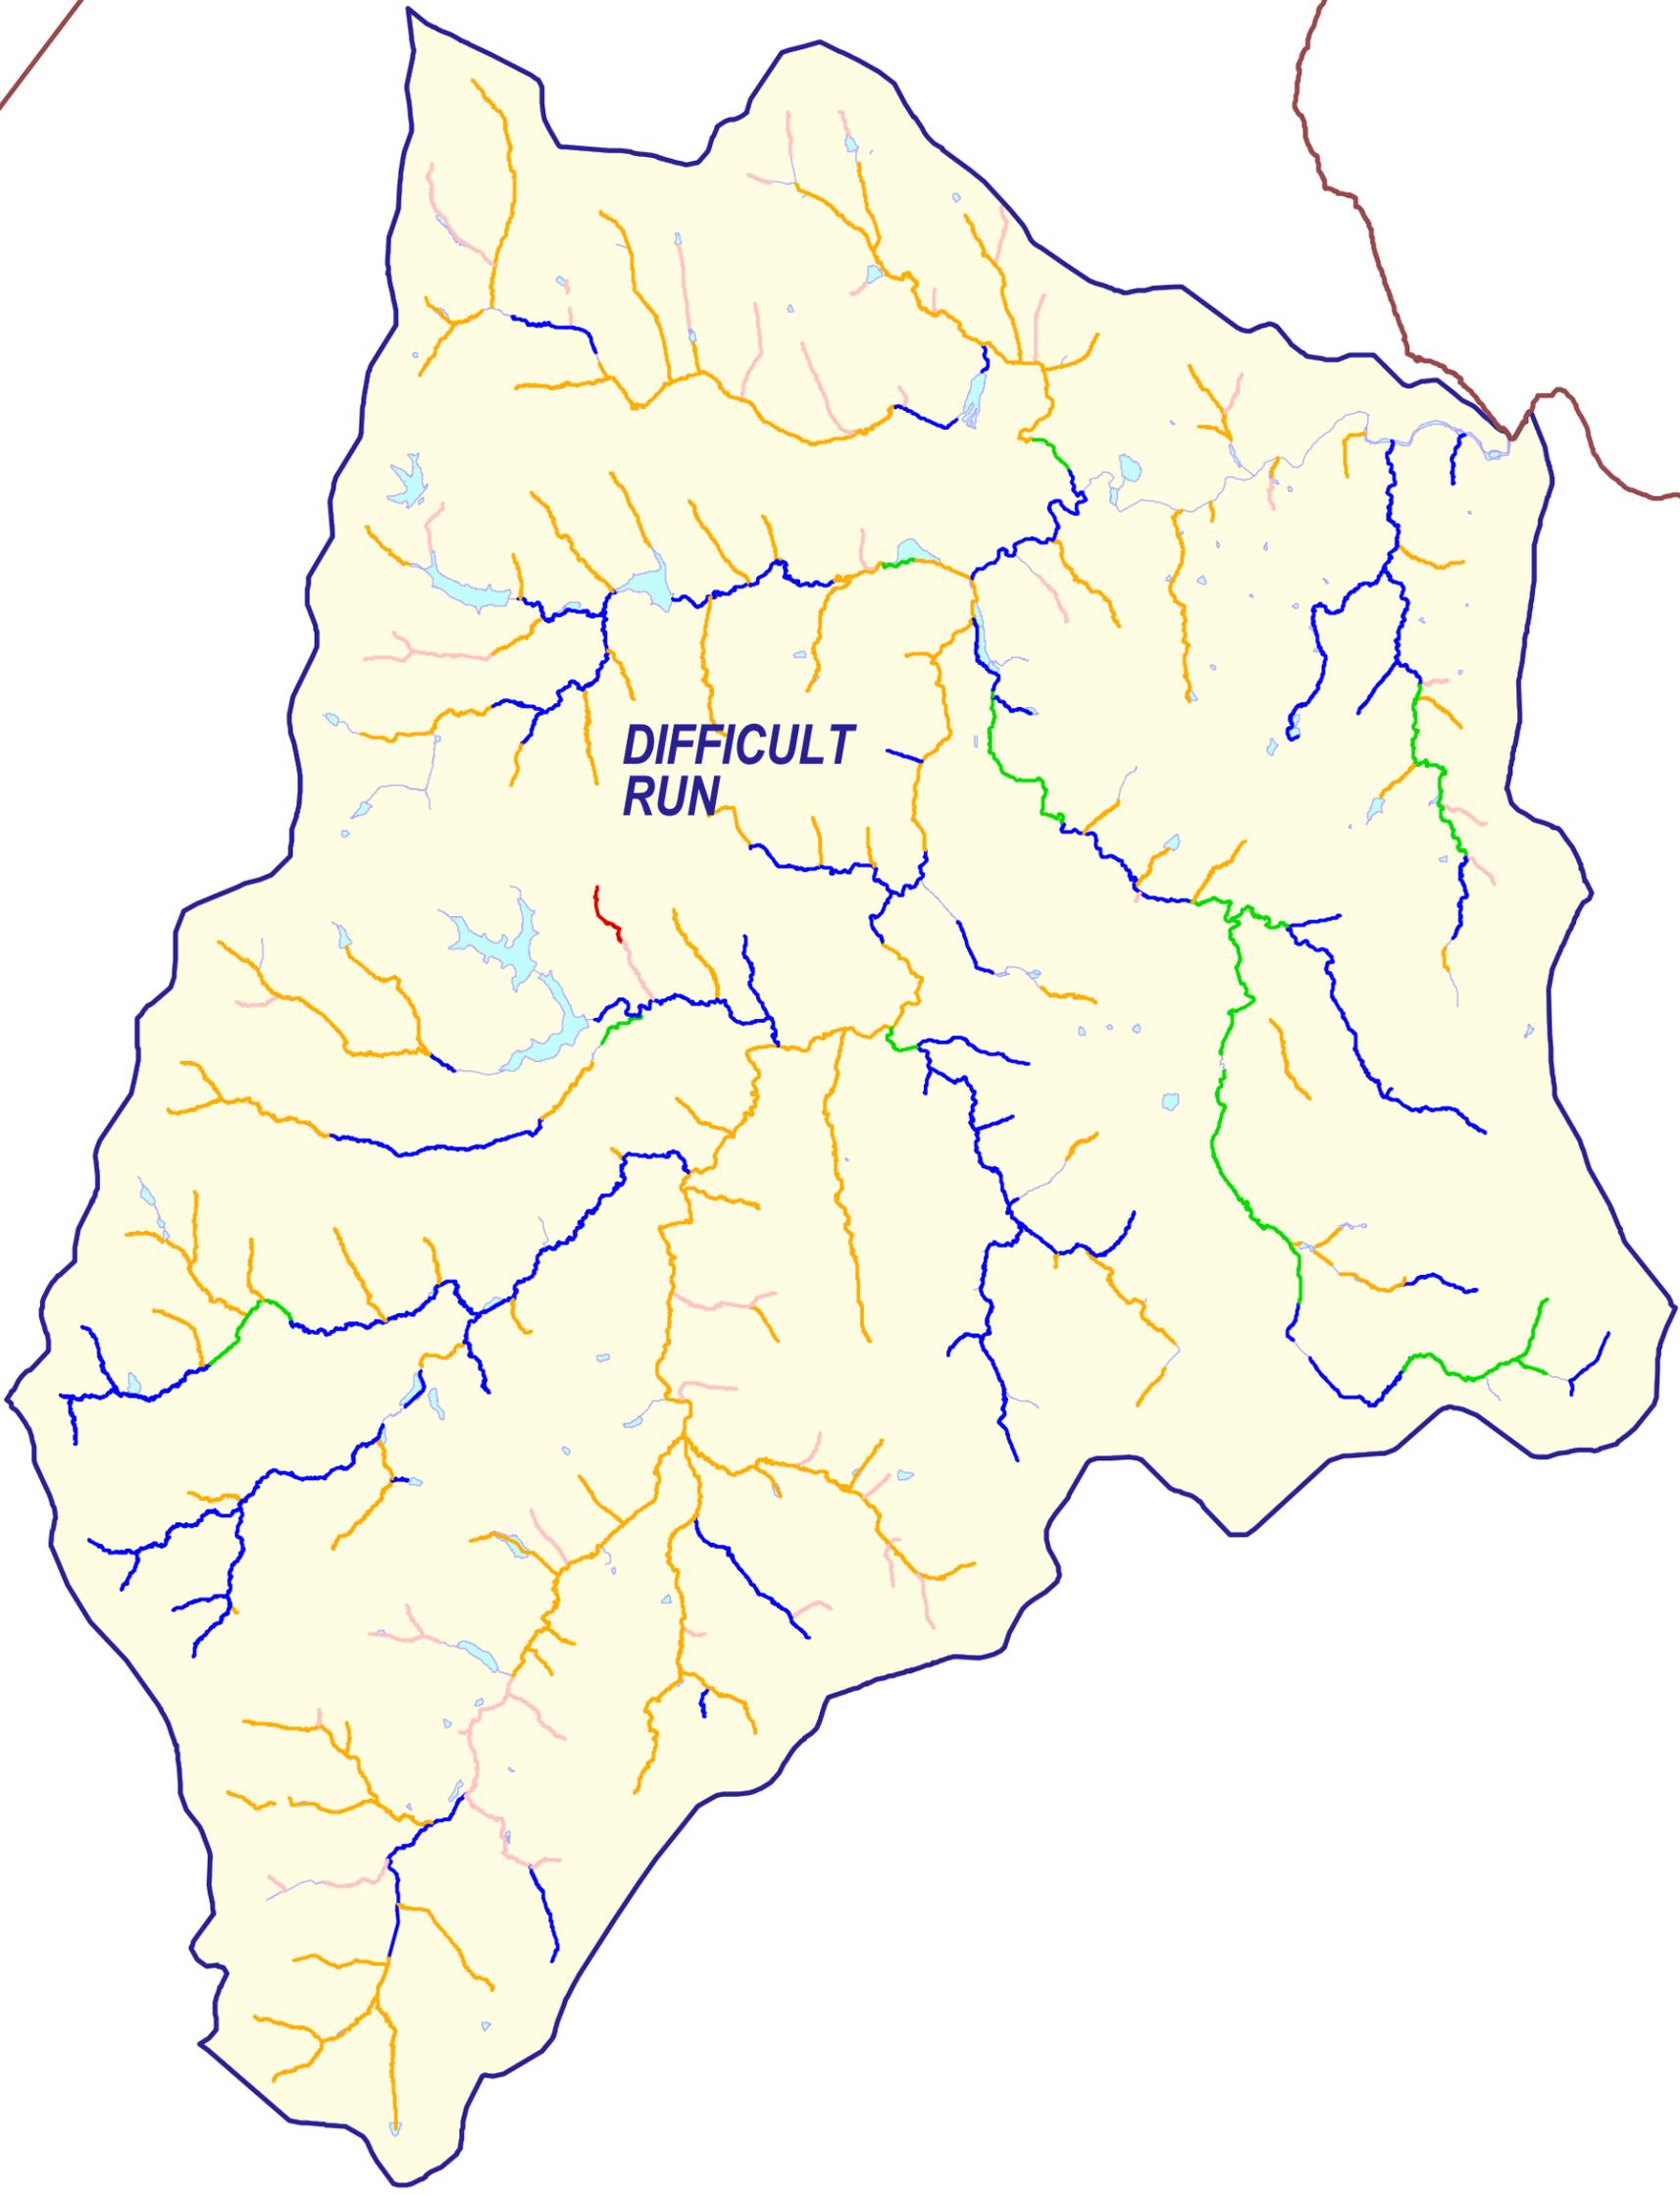
Figure 3-17
Habitat Assessment
Difficult Run
Fairfax County Stream Physical Assessment

Habitat. The habitat assessment results for Difficult Run Watershed are summarized by stream in Table 3-13. Habitat scores for each reach are depicted in Figure 3-17. Based on a length-weighted habitat score of 108 (Table 3-2), Difficult Run Watershed is in the middle to upper range of quality, compared to the rest of the County. Less than 1 mile of stream was categorized as having “very poor” habitat conditions; approximately 14 miles were categorized as “poor,” 64 miles as “fair,” 42 miles as “good,” and 9 miles as “excellent.”

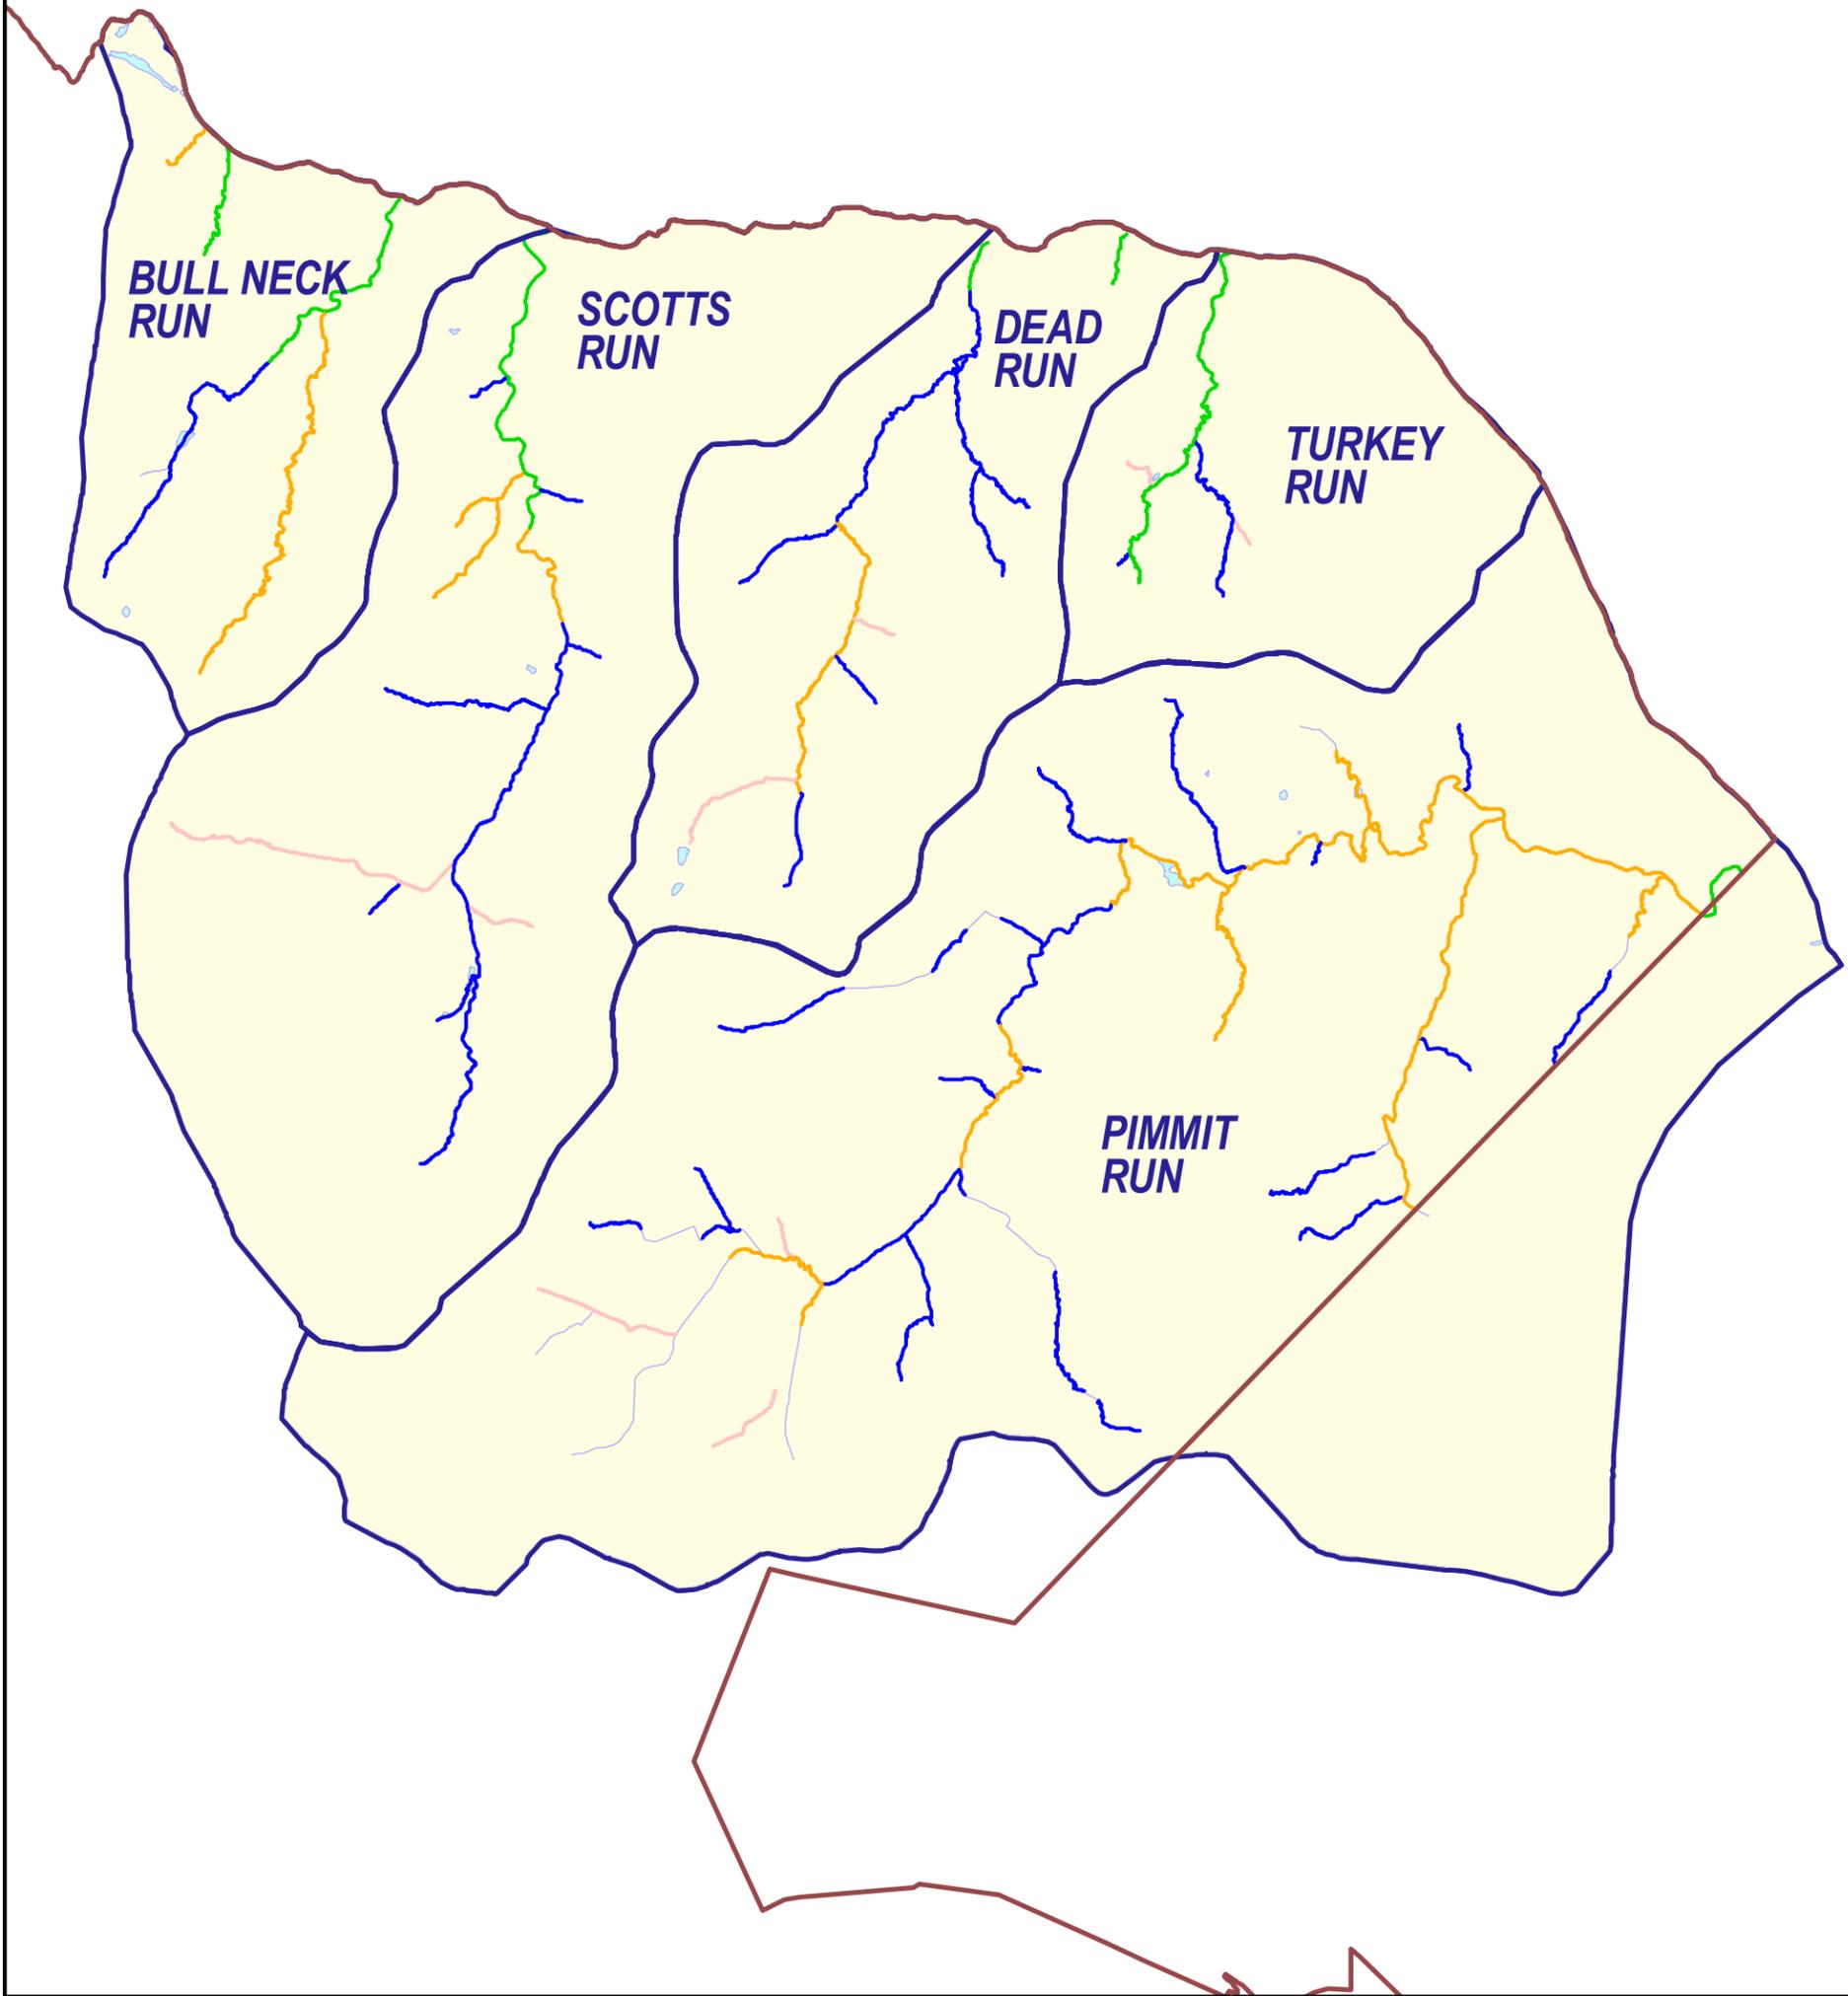
Figure 3-24
Habitat Assessment
Middle Potomac Group
Fairfax County Stream Physical Assessment

Habitat. The habitat assessment results for Bull Neck Run Watershed are summarized by stream in Table 3-15. Habitat scores for each reach are depicted in Figure 3-24. Based on a length weighted habitat score of 128 (Table 3-2), Bull Neck Run Watershed is one of the highest quality streams, compared to the rest of the County. Just over 1 mile of stream was categorized as having “fair” habitat conditions; 2 miles were categorized as “good,” and 1 mile as “excellent.”

Habitat. The habitat assessment results for Scotts Run Watershed are summarized by stream in Table 3-17. Habitat scores for each reach are depicted in Figure 3-24. Based on a length weighted habitat score of 108 (Table 3-2), Scotts Run Watershed is in the middle range of quality, compared to the rest of the County. Approximately 1.5 miles of stream were categorized as having “poor” habitat conditions, 4 miles as “fair,” and 1 mile as “good,” and 1.5 miles as “excellent.”

Habitat. The habitat assessment results for Dead Run Watershed are summarized by stream in Table 3-19. Habitat scores for each reach are depicted in Figure 3-24. Based on a length weighted habitat score of 103 (Table 3-2), Dead Run Watershed is in the middle range of quality, compared to the rest of the County. Less than 1 mile of stream was categorized as having “poor” habitat conditions, approximately 4 miles of stream were categorized as having “fair,” and 1 mile as having “good.”

Habitat. The habitat assessment results for Turkey Run Watershed are summarized by stream in Table 3-21. Habitat scores for each reach are depicted in Figure 3-24. Based on a length weighted habitat score of 124 (Table 3-2), Turkey Run Watershed is one of the highest quality watersheds in the County. Approximately 1 mile of stream was categorized as having “fair” habitat conditions and 2 miles as “excellent.”

Habitat. The habitat assessment results for Pimmit Run Watershed are summarized by stream in Table 3-23. Habitat scores for each reach are depicted in Figure 3-24. Based on a length weighted habitat score of 112 (Table 3-2), Pimmit Run Watershed is in the upper middle range, compared to the rest of the County. Just over 1 mile of stream was categorized as having “poor” habitat conditions, approximately 8 miles as “fair,” 8 miles as “good,” and nearly 0.5 mile as “excellent.”

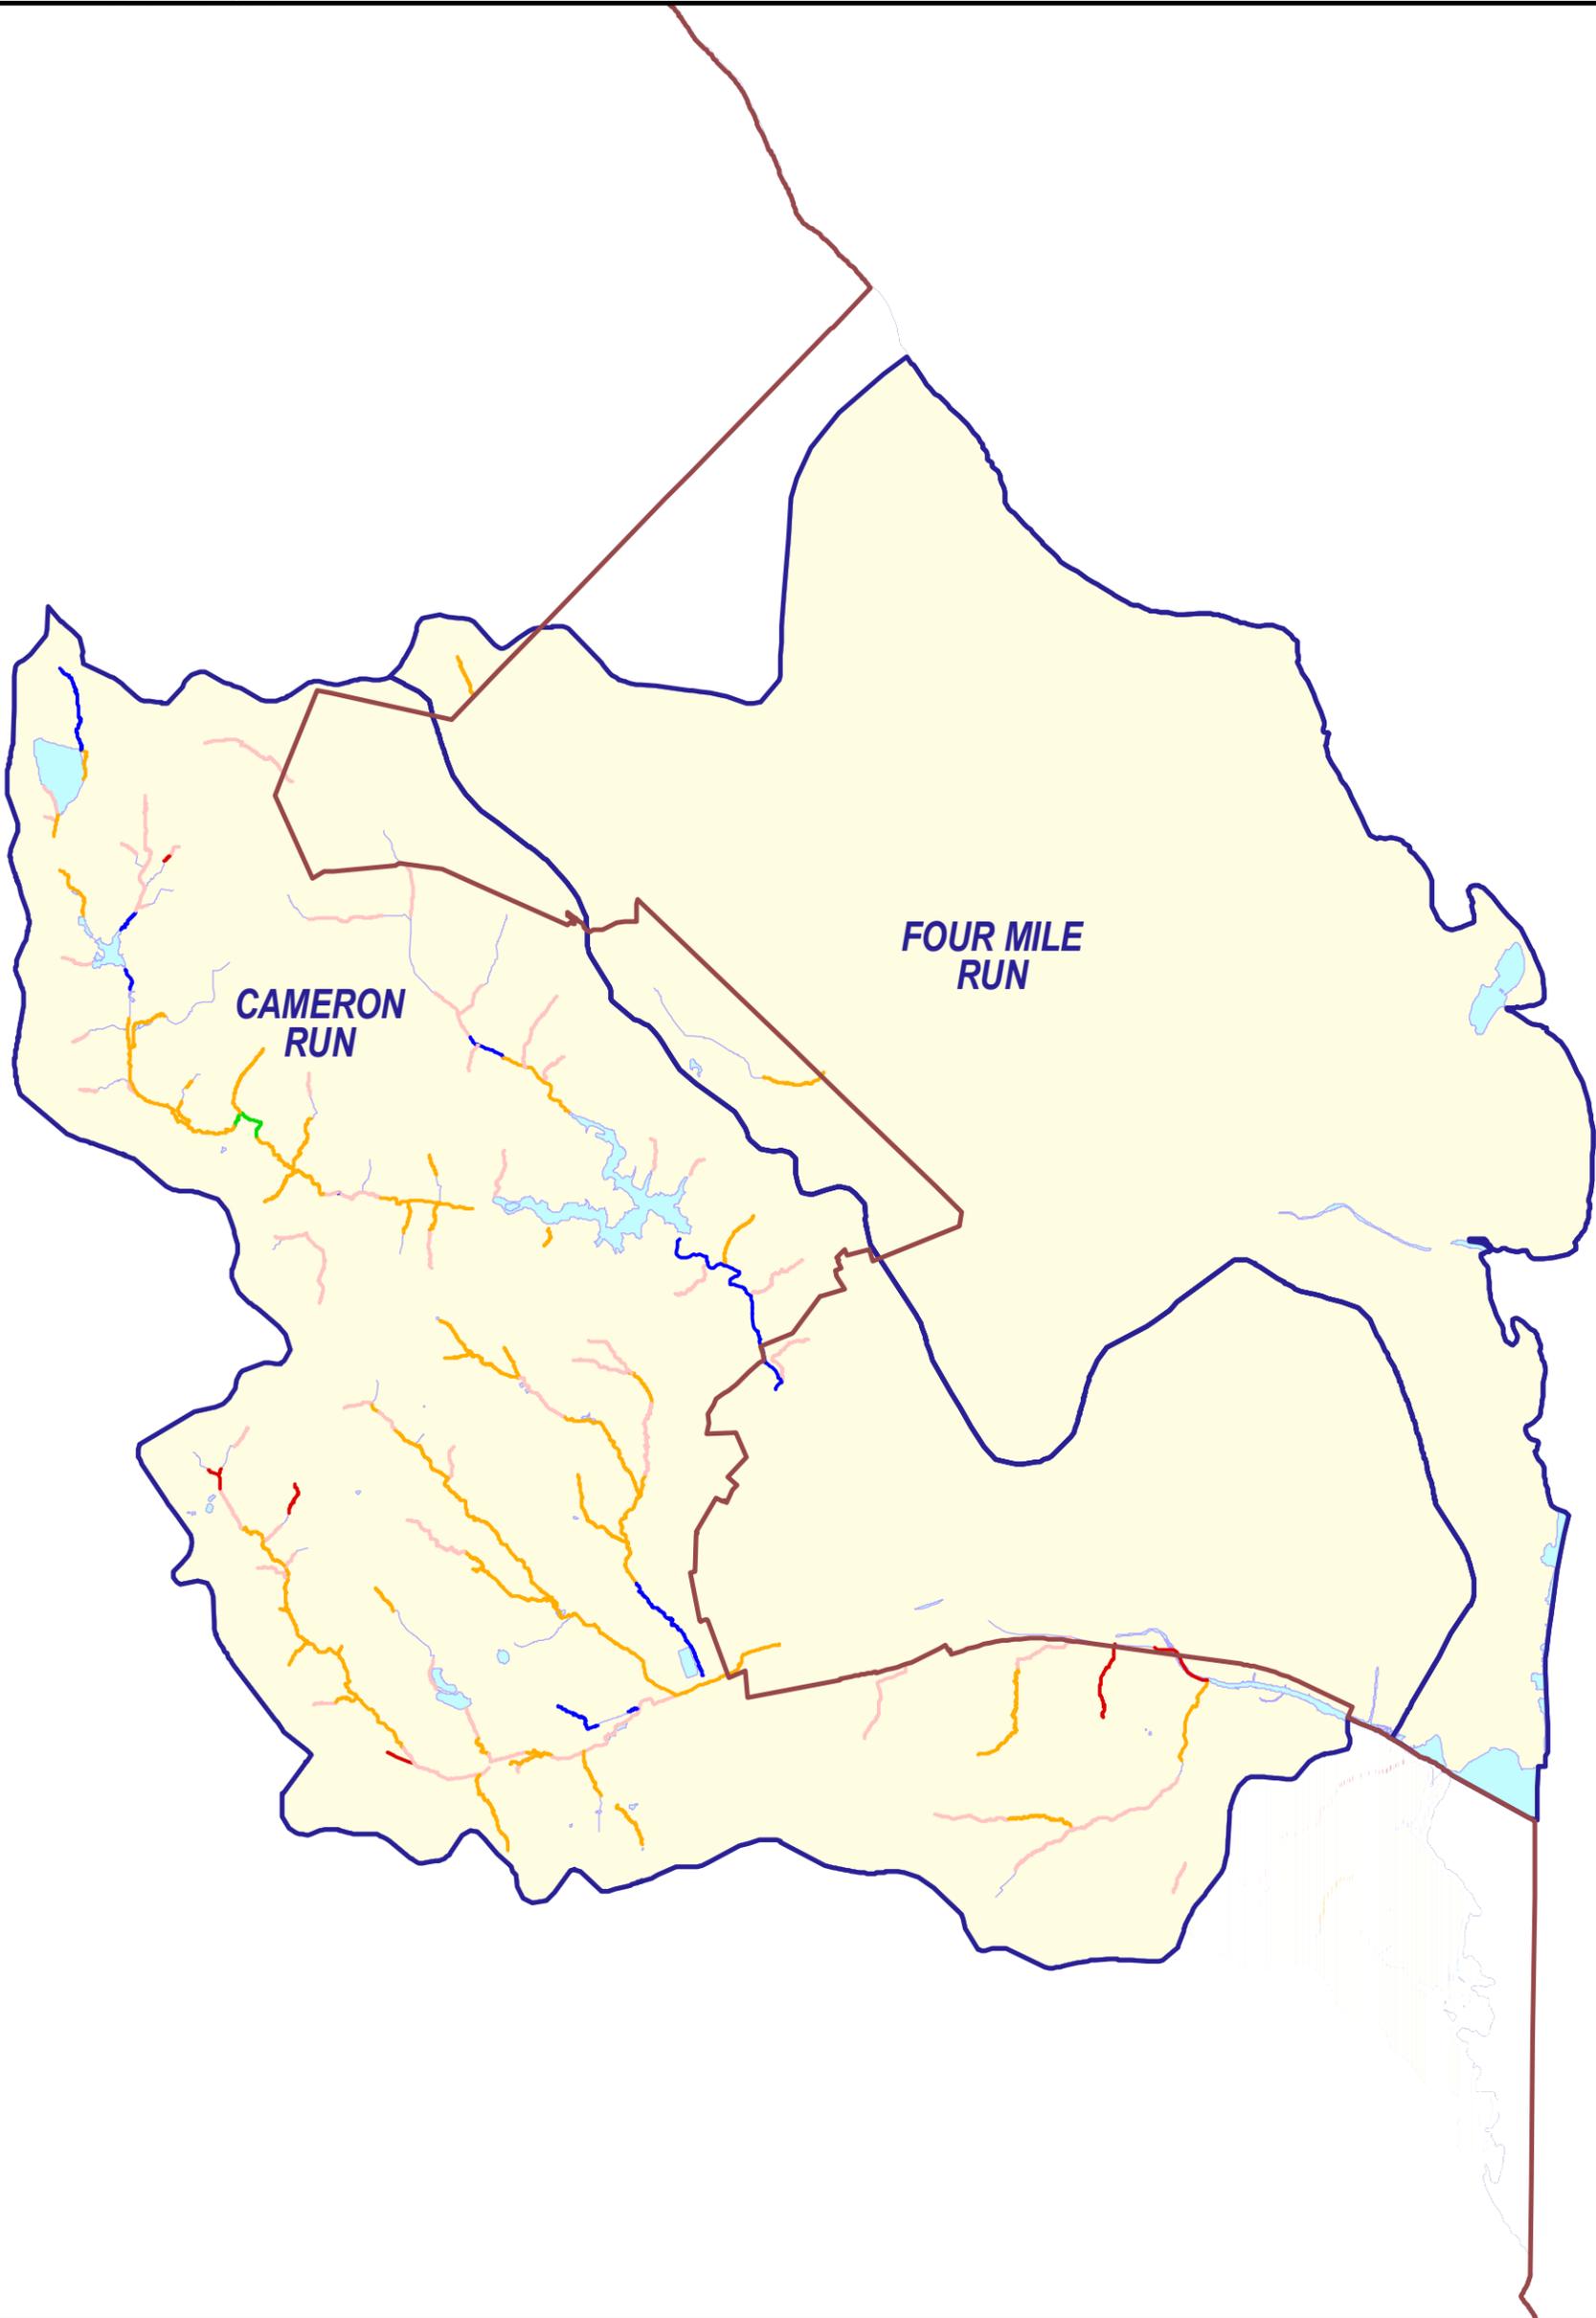
**Figure 3-31
Habitat Assessment
Cameron Run Group
Fairfax County Stream Physical Assessment**

Habitat. The habitat assessment results for Cameron Run Watershed are summarized by stream in Table 3-25. Habitat scores for each reach are depicted in Figure 3-31. Based on a length weighted habitat score of 92 (Table 3-2), Cameron Run Watershed is one of the poorest watersheds, compared to the rest of the County. Approximately 2 miles of stream were categorized as having “very poor” habitat conditions, 19 miles as “poor,” 23 miles as “fair,” and 4 miles as “good.”

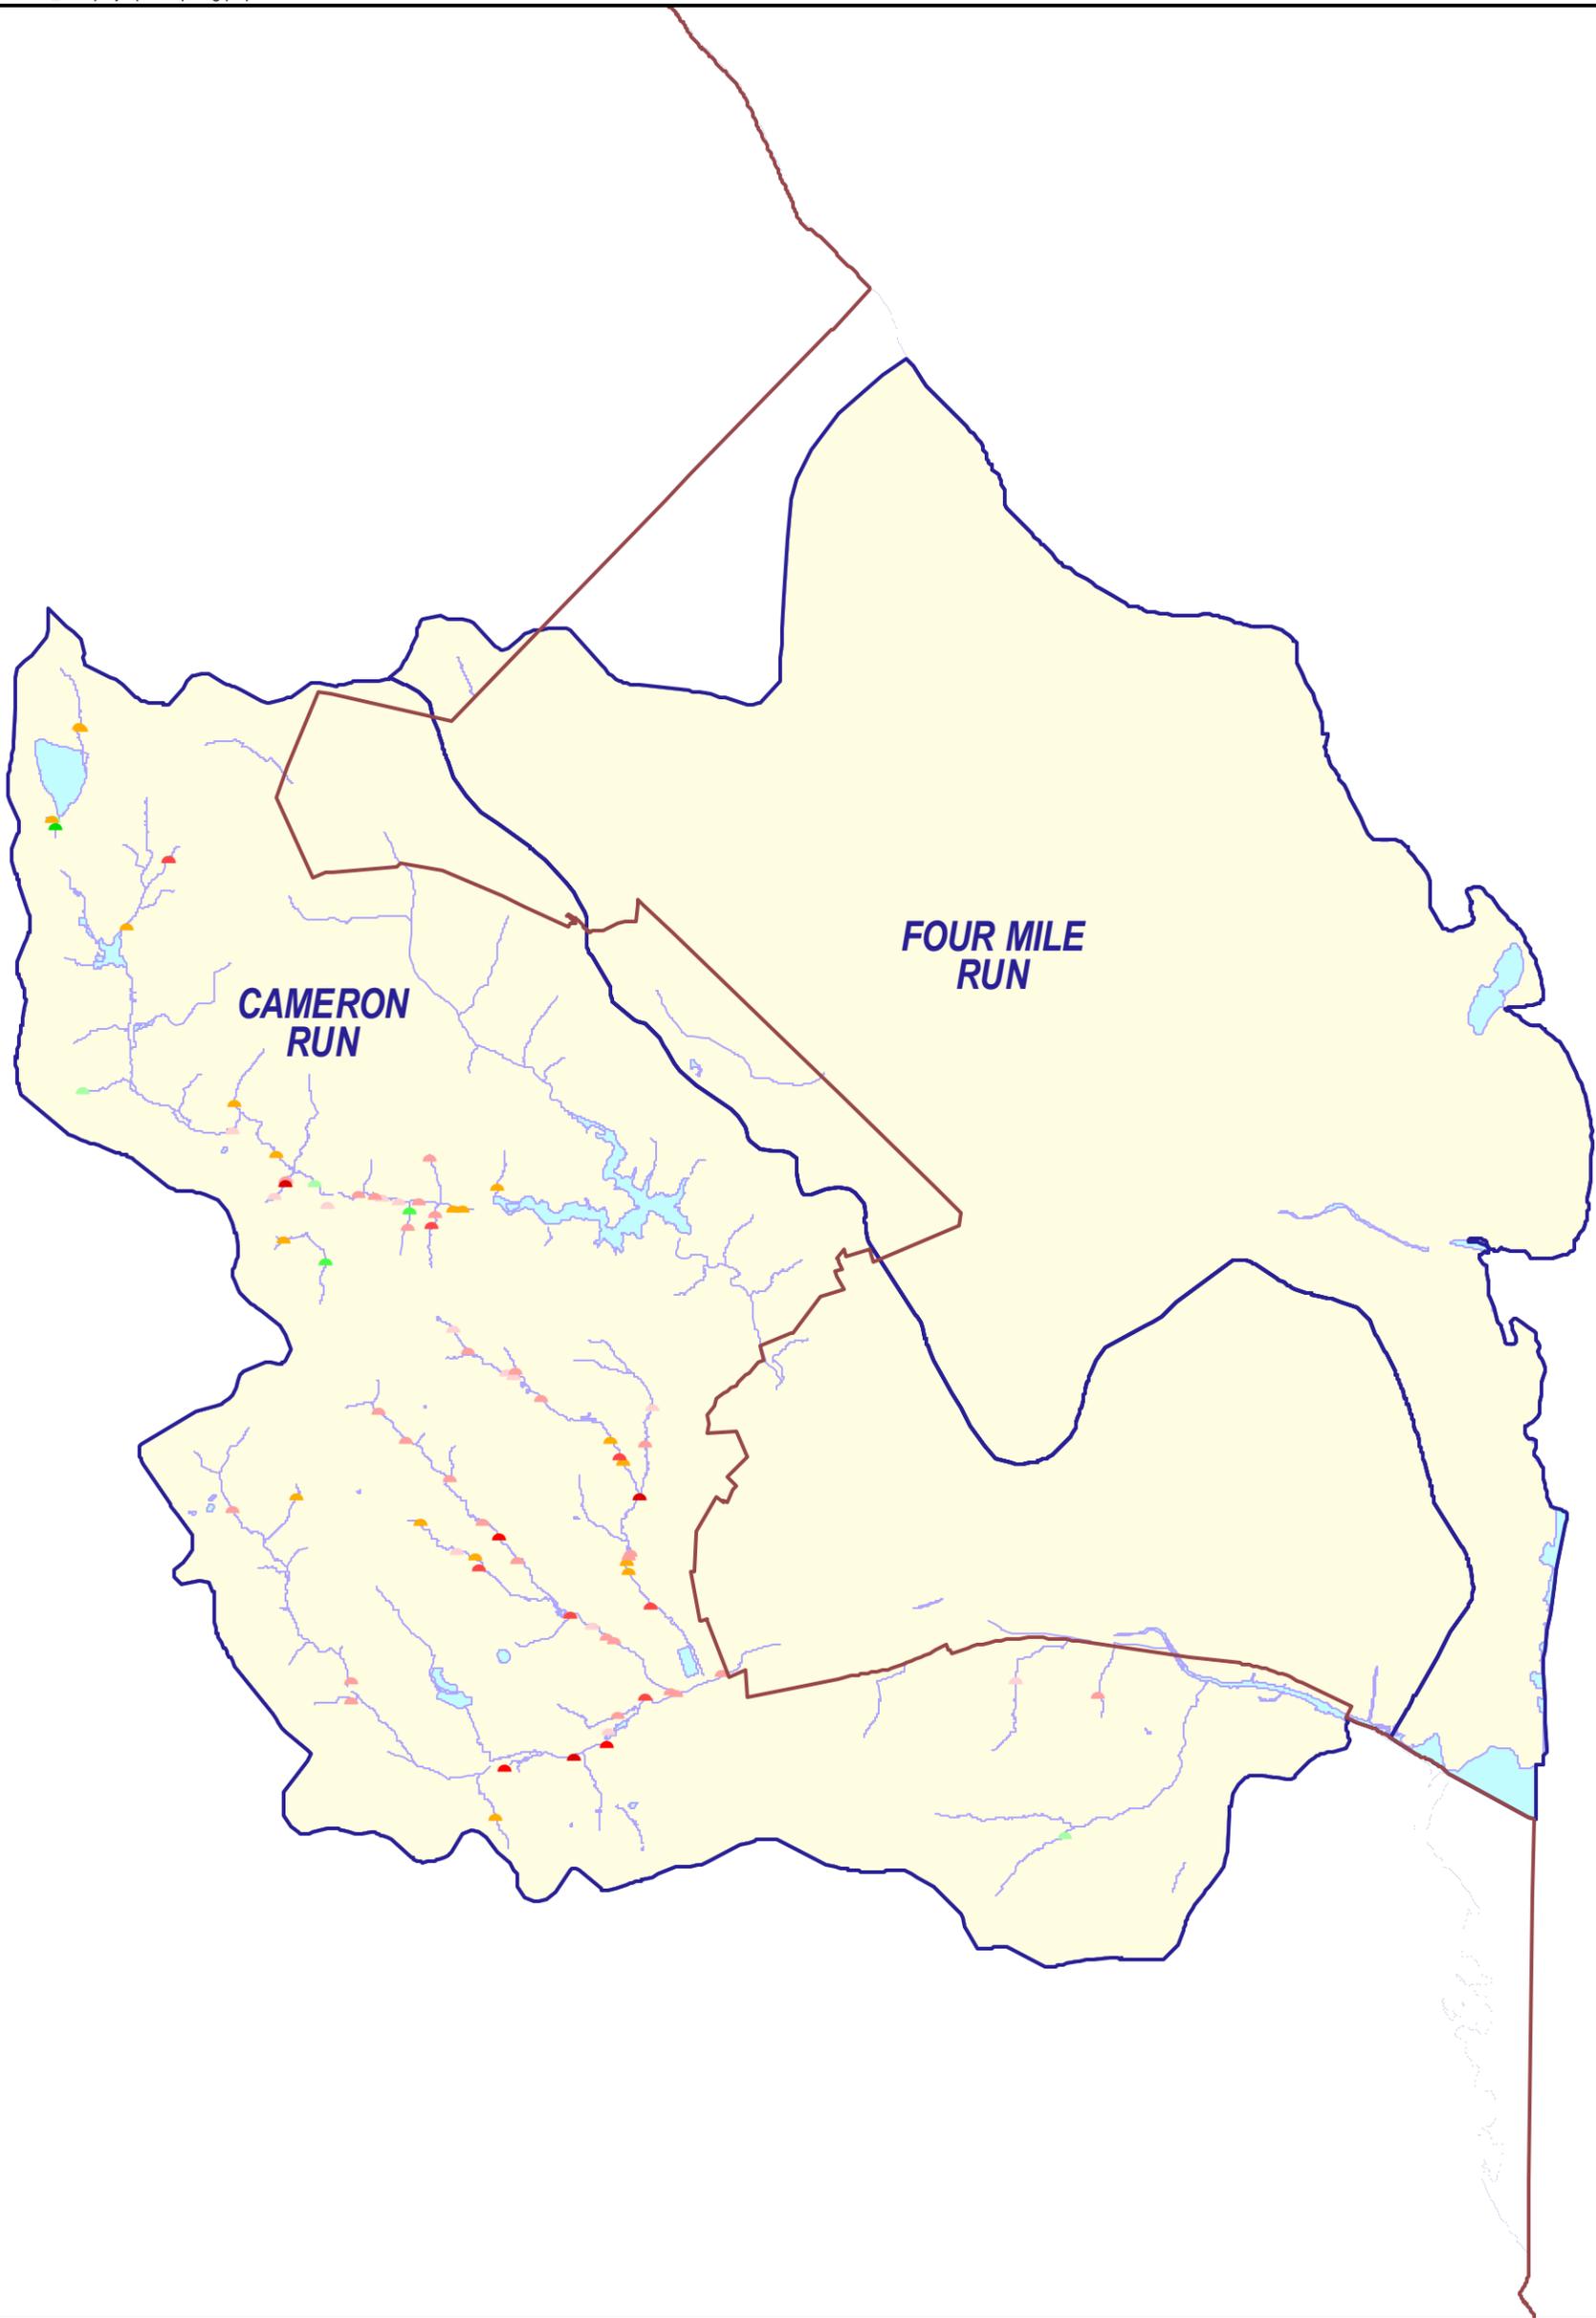
Figure 3-32
CEM Stages
Cameron Run Group
Fairfax County Stream Physical Assessment

CEM. Based on the CEM evaluations approximately three quarters of the channels assessed in Cameron Run Watershed are in Evolutionary Stage 3 (Table 3-3), with most of the remainder of the watershed in Stage 4. Figure 3-32 summarizes the CEM results for Cameron Run Watershed.

CEM. Based on the CEM evaluations approximately 60 percent of the channels assessed in Four Mile Run Watershed are in Evolutionary Stage 4 (Table 3-3), with most of the remainder of the watershed in Stage 3. Figure 3-32 summarizes the CEM results for Four Mile Run Watershed.
