## 3.2.10 Lower Bull Run Group Summary

### 3.2.10.1 Little Rocky Run Watershed

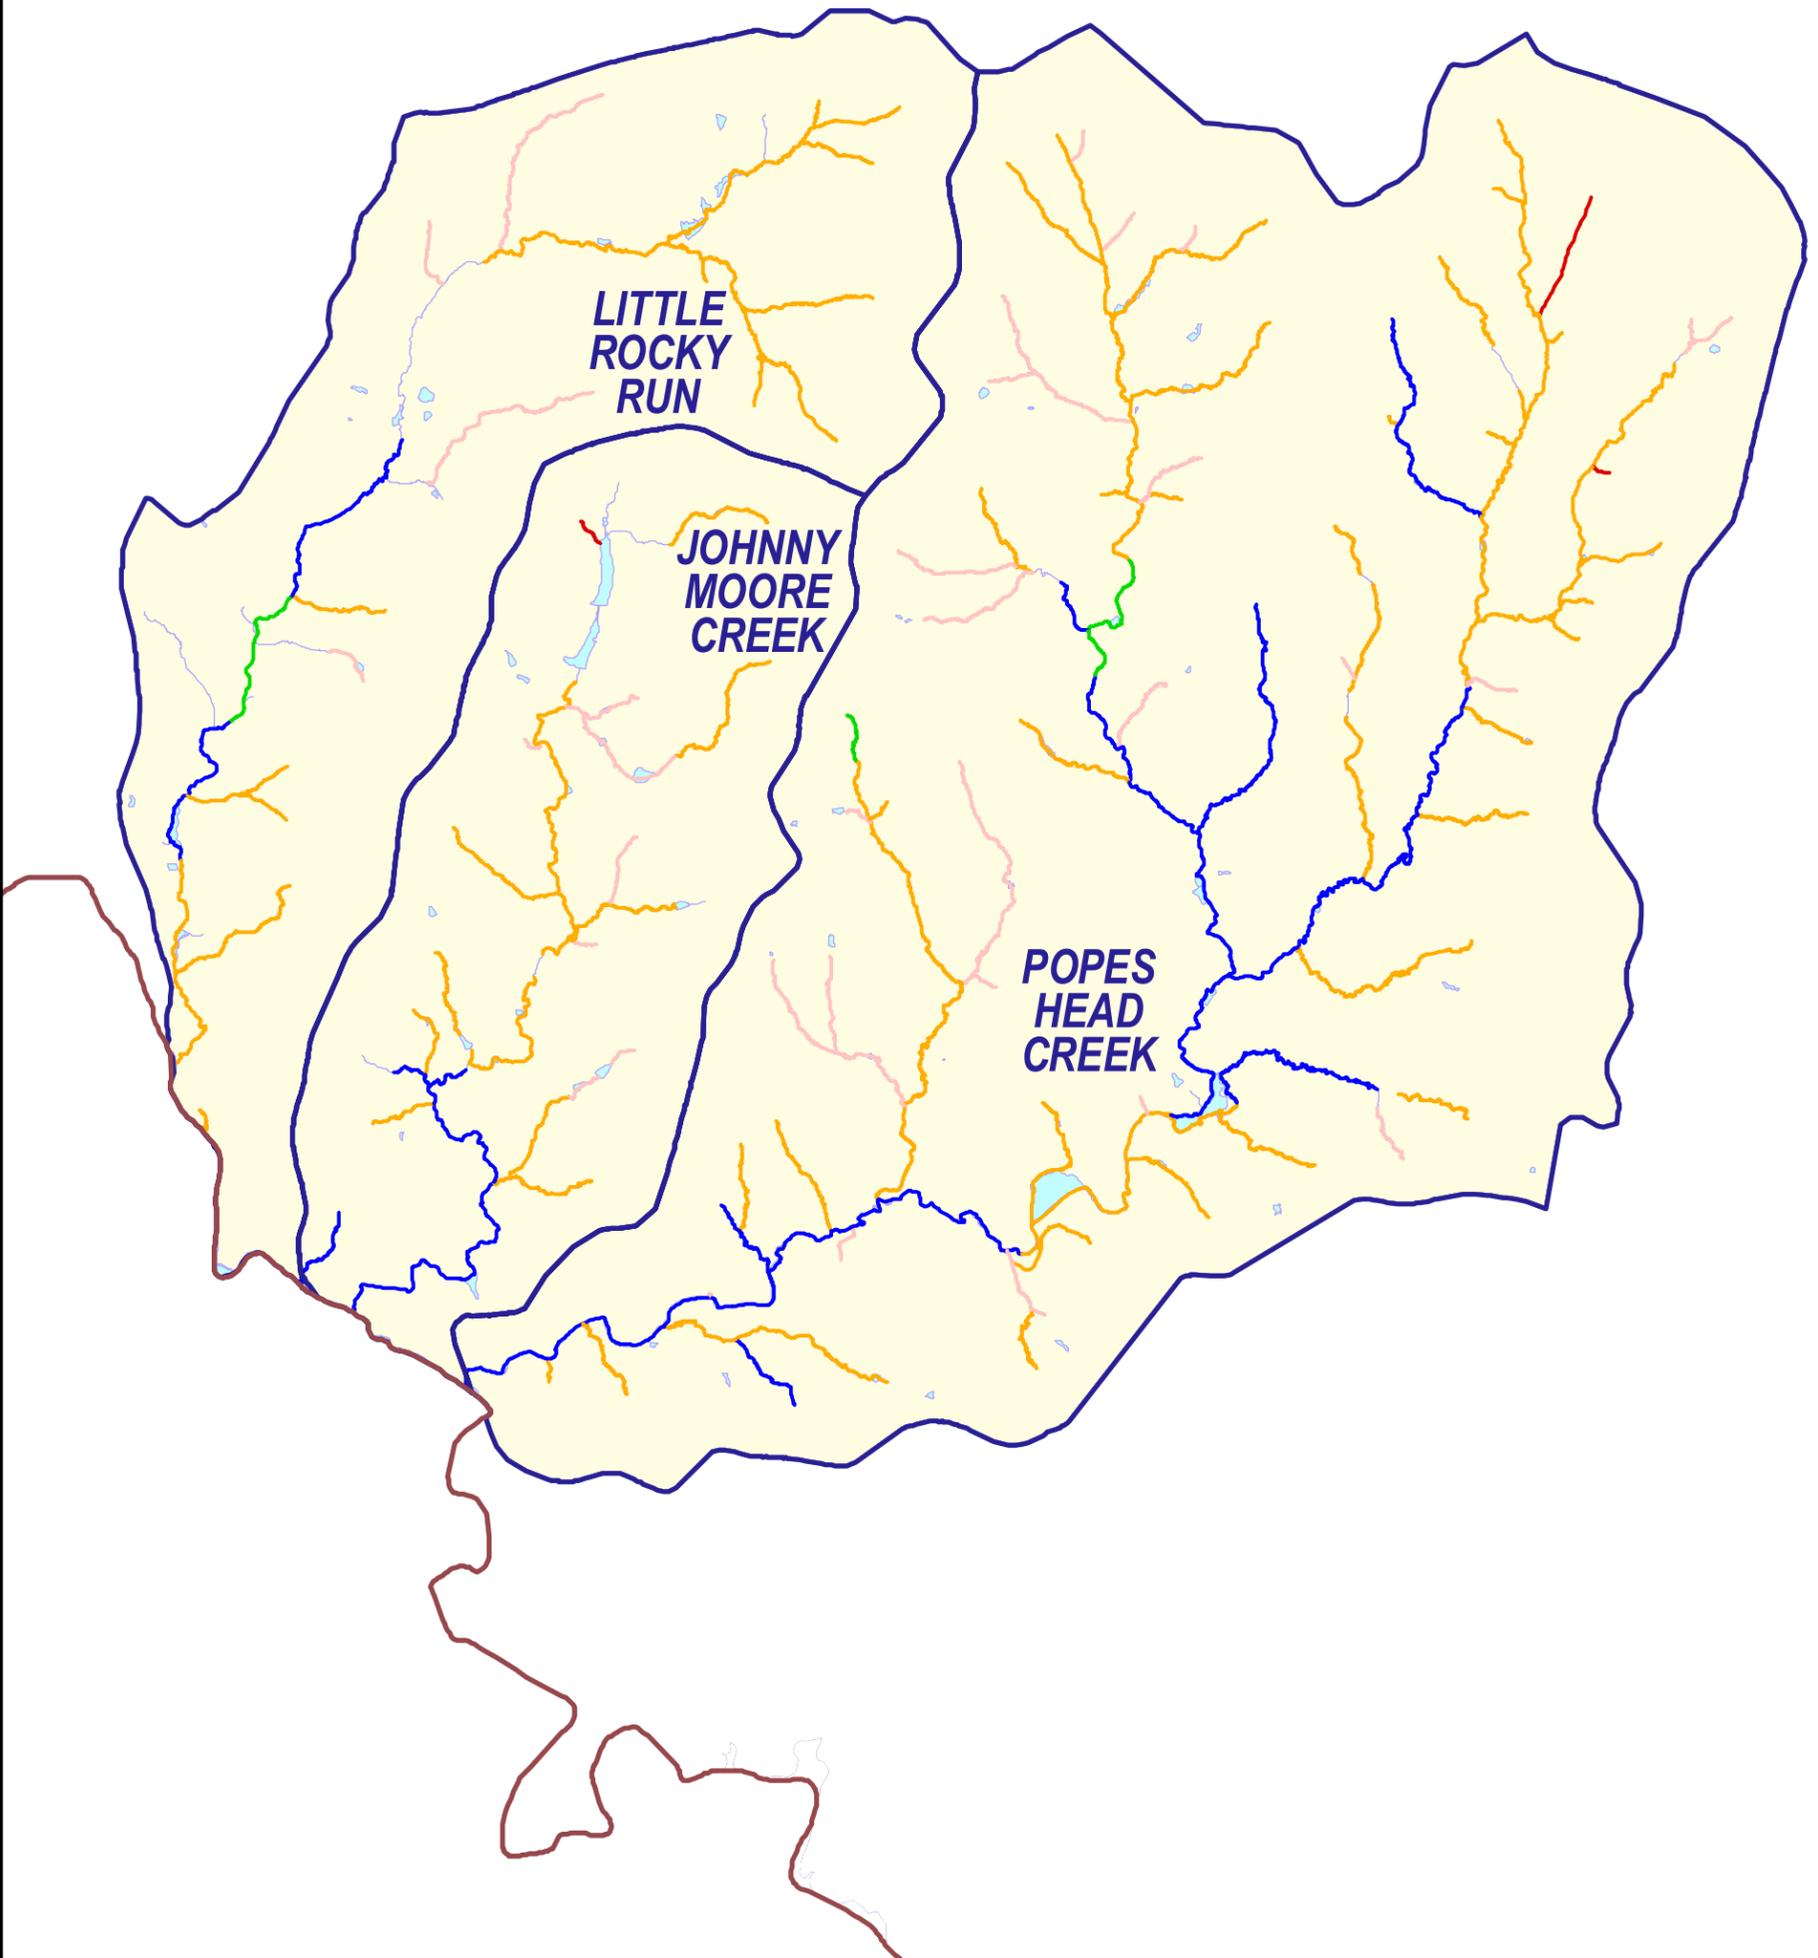
**Figure 3-66**  
**Habitat Assessment**  
**Lower Bull Run Group**  
**Fairfax County Stream Physical Assessment**

**Habitat.** The habitat assessment results for Little Rocky Run Watershed are summarized by stream in Table 3-43. Habitat scores for each reach are depicted in Figure 3-66. Based on a length weighted habitat score of 102 (Table 3-2), Little Rocky Run Watershed is in the lower middle range of quality, compared to the rest of the County. Approximately 2 miles of stream were categorized as having “poor” habitat conditions, 8 miles as “fair,” 2 miles as “good,” and less than 1 mile as “excellent.”

**Habitat.** The habitat assessment results for Johnny Moore Creek Watershed are summarized by stream in Table 3-45. Habitat scores for each reach are depicted in Figure 3-66. Based on a length weighted habitat score of 104 (Table 3-2), Johnny Moore Creek Watershed is in the middle range of quality, compared to the rest of the County. Approximately 2 miles of stream were categorized as having “poor” habitat conditions, 7 miles as “fair,” and nearly 3 miles as “good.”

**Habitat.** The habitat assessment results for Popes Head Creek Watershed are summarized by stream in Table 3-47. Habitat scores for each reach are depicted in Figure 3-66. Based on a length weighted habitat score of 103 (Table 3-2), Popes Head Creek Watershed is in the middle range of quality, compared to the rest of the County. Approximately 1 mile of stream was categorized as having “very poor” habitat conditions, 8 miles as “poor,” 27 miles as “fair,” and 13 miles as “good.”

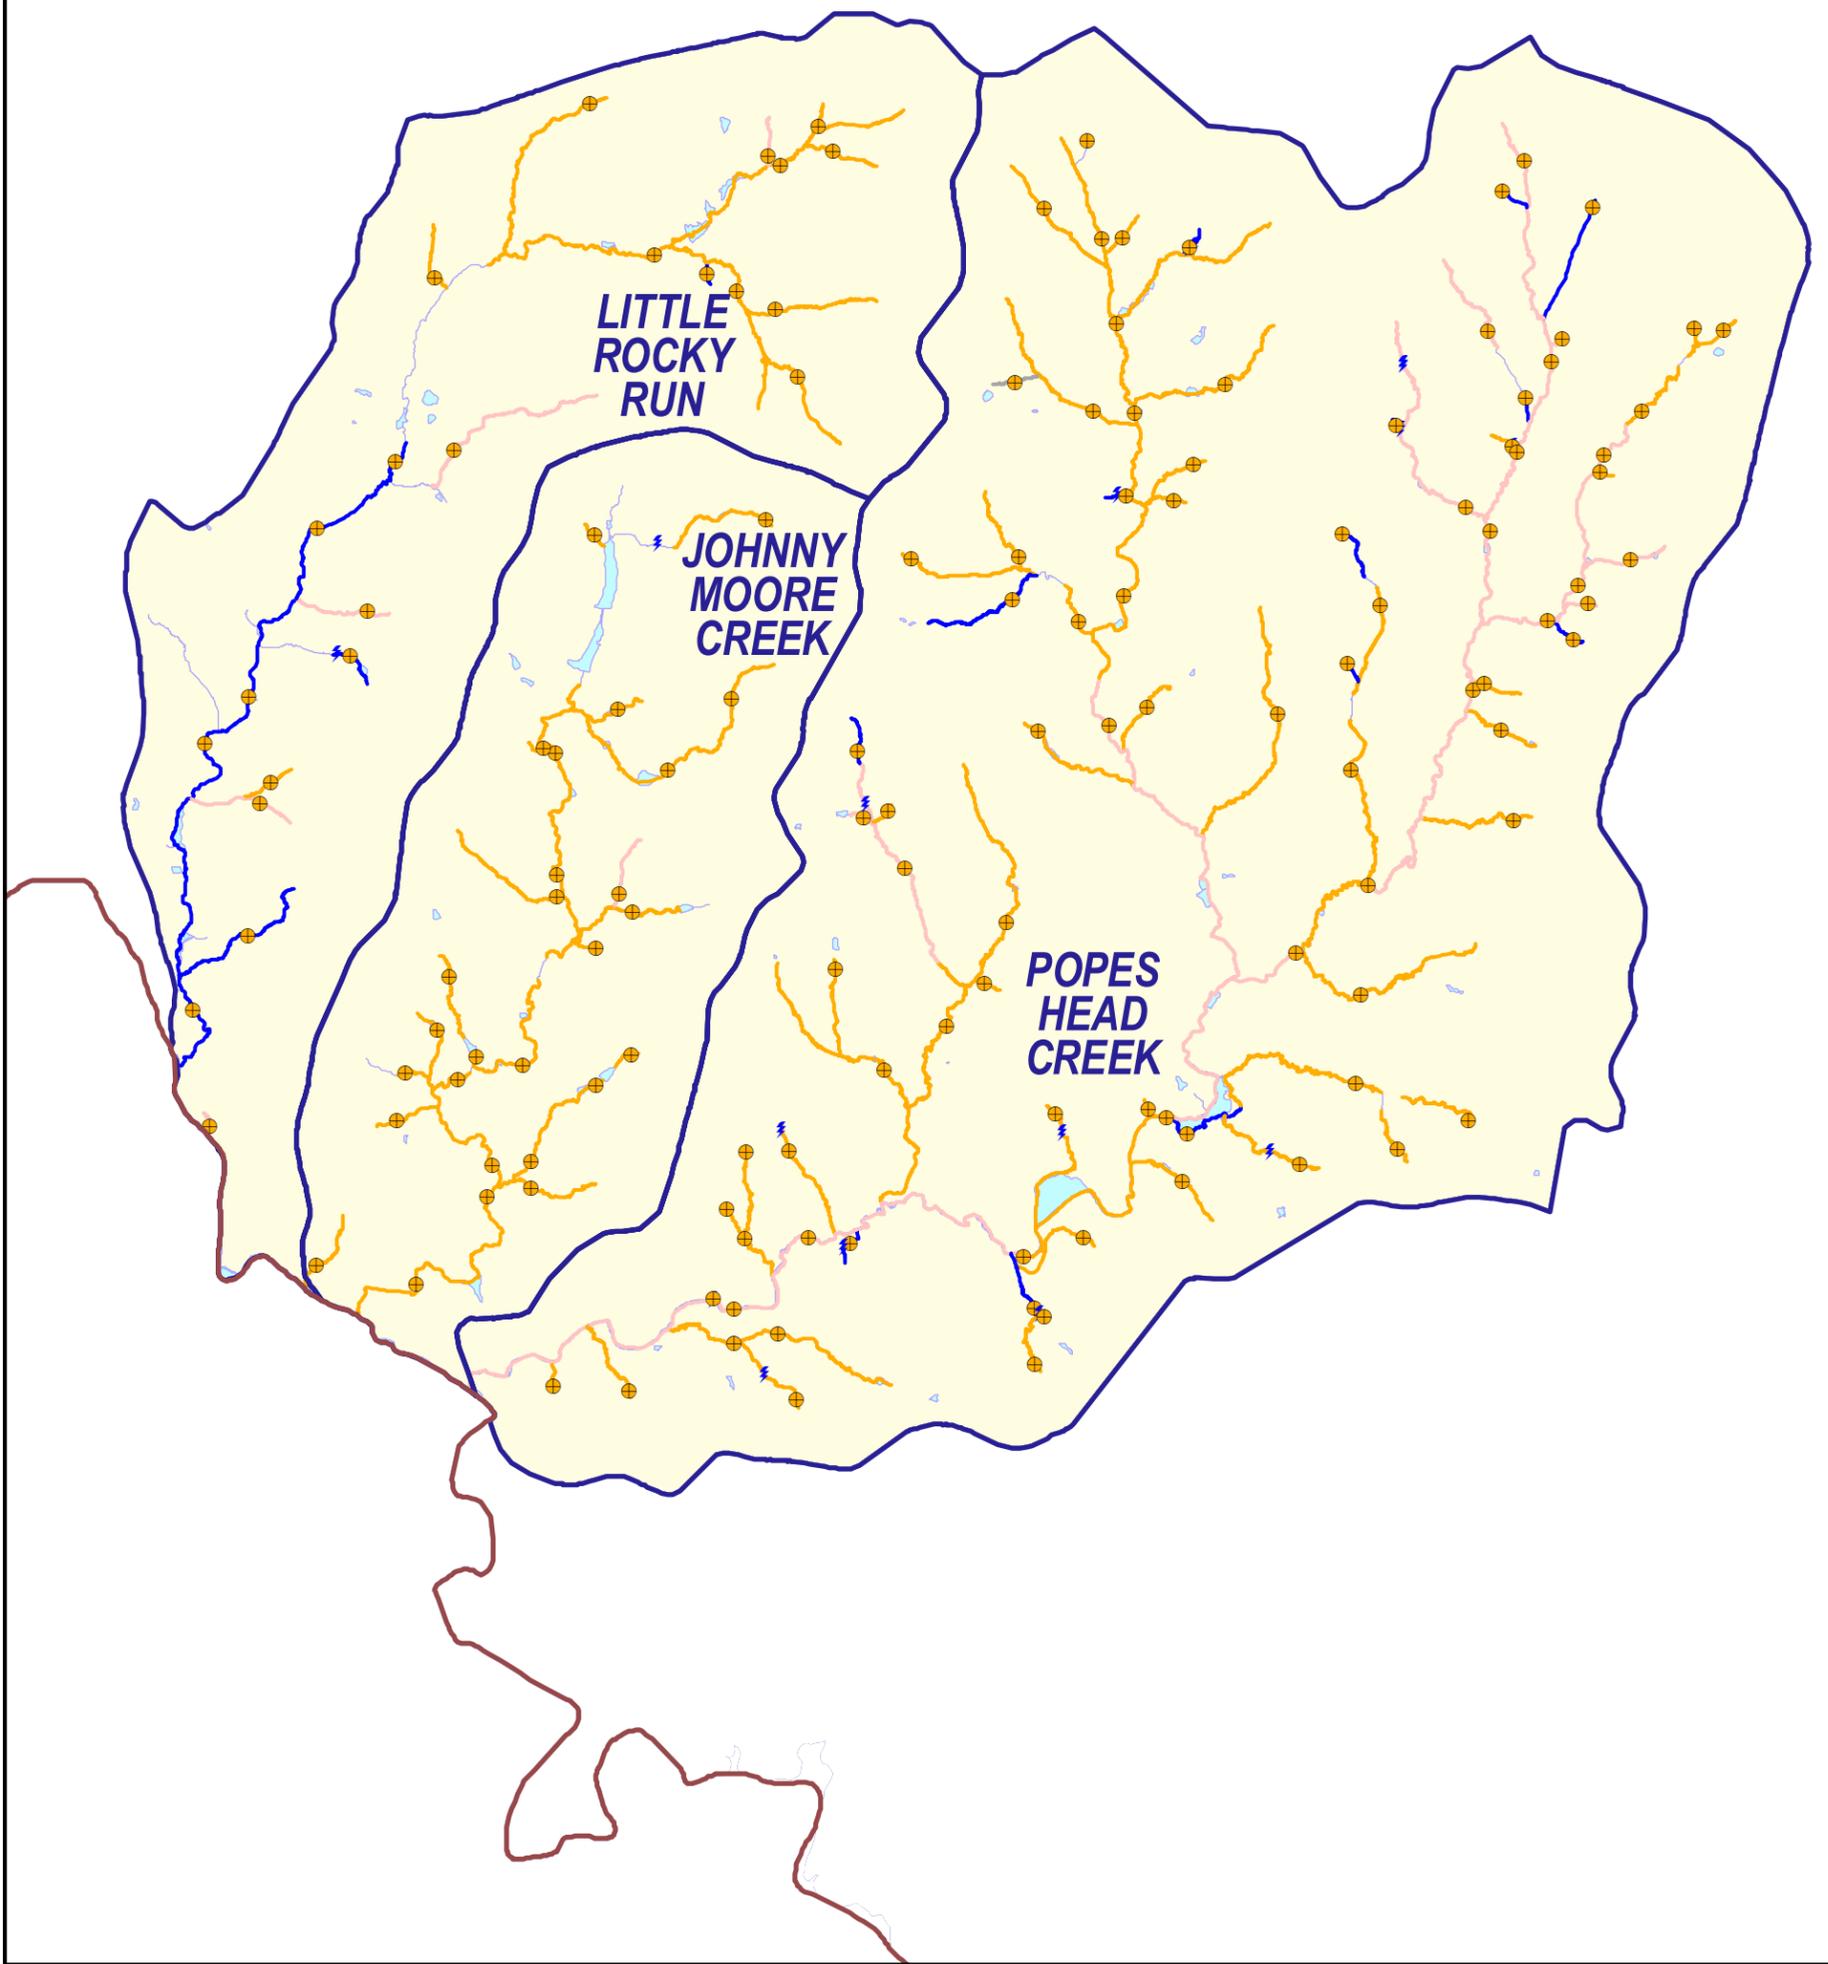
**Figure 3-67**  
**CEM Stages**  
**Lower Bull Run Group**  
**Fairfax County Stream Physical Assessment**

**CEM.** Based on the CEM evaluations approximately half of the channels assessed in Little Rocky Run Watershed are in Evolutionary Stage 3 (Table 3-3) and the remainder are split between Stages 2 and 4. Figure 3-67 summarizes the CEM results for Little Rocky Run Watershed.

**CEM.** Based on the CEM evaluations approximately 97 percent of the channels assessed in Johnny Moore Creek Watershed are in Evolutionary Stage 3 (Table 3-3). Figure 3-67 summarizes the CEM results for Johnny Moore Creek Watershed.

**CEM.** Based on the CEM evaluations approximately 60 percent of the channels assessed in Popes Head Creek Watershed are in Evolutionary Stage 3 (Table 3-3), with most of the remainder of the watershed in Stage 4. Figure 3-67 summarizes the CEM results for Popes Head Creek Watershed.

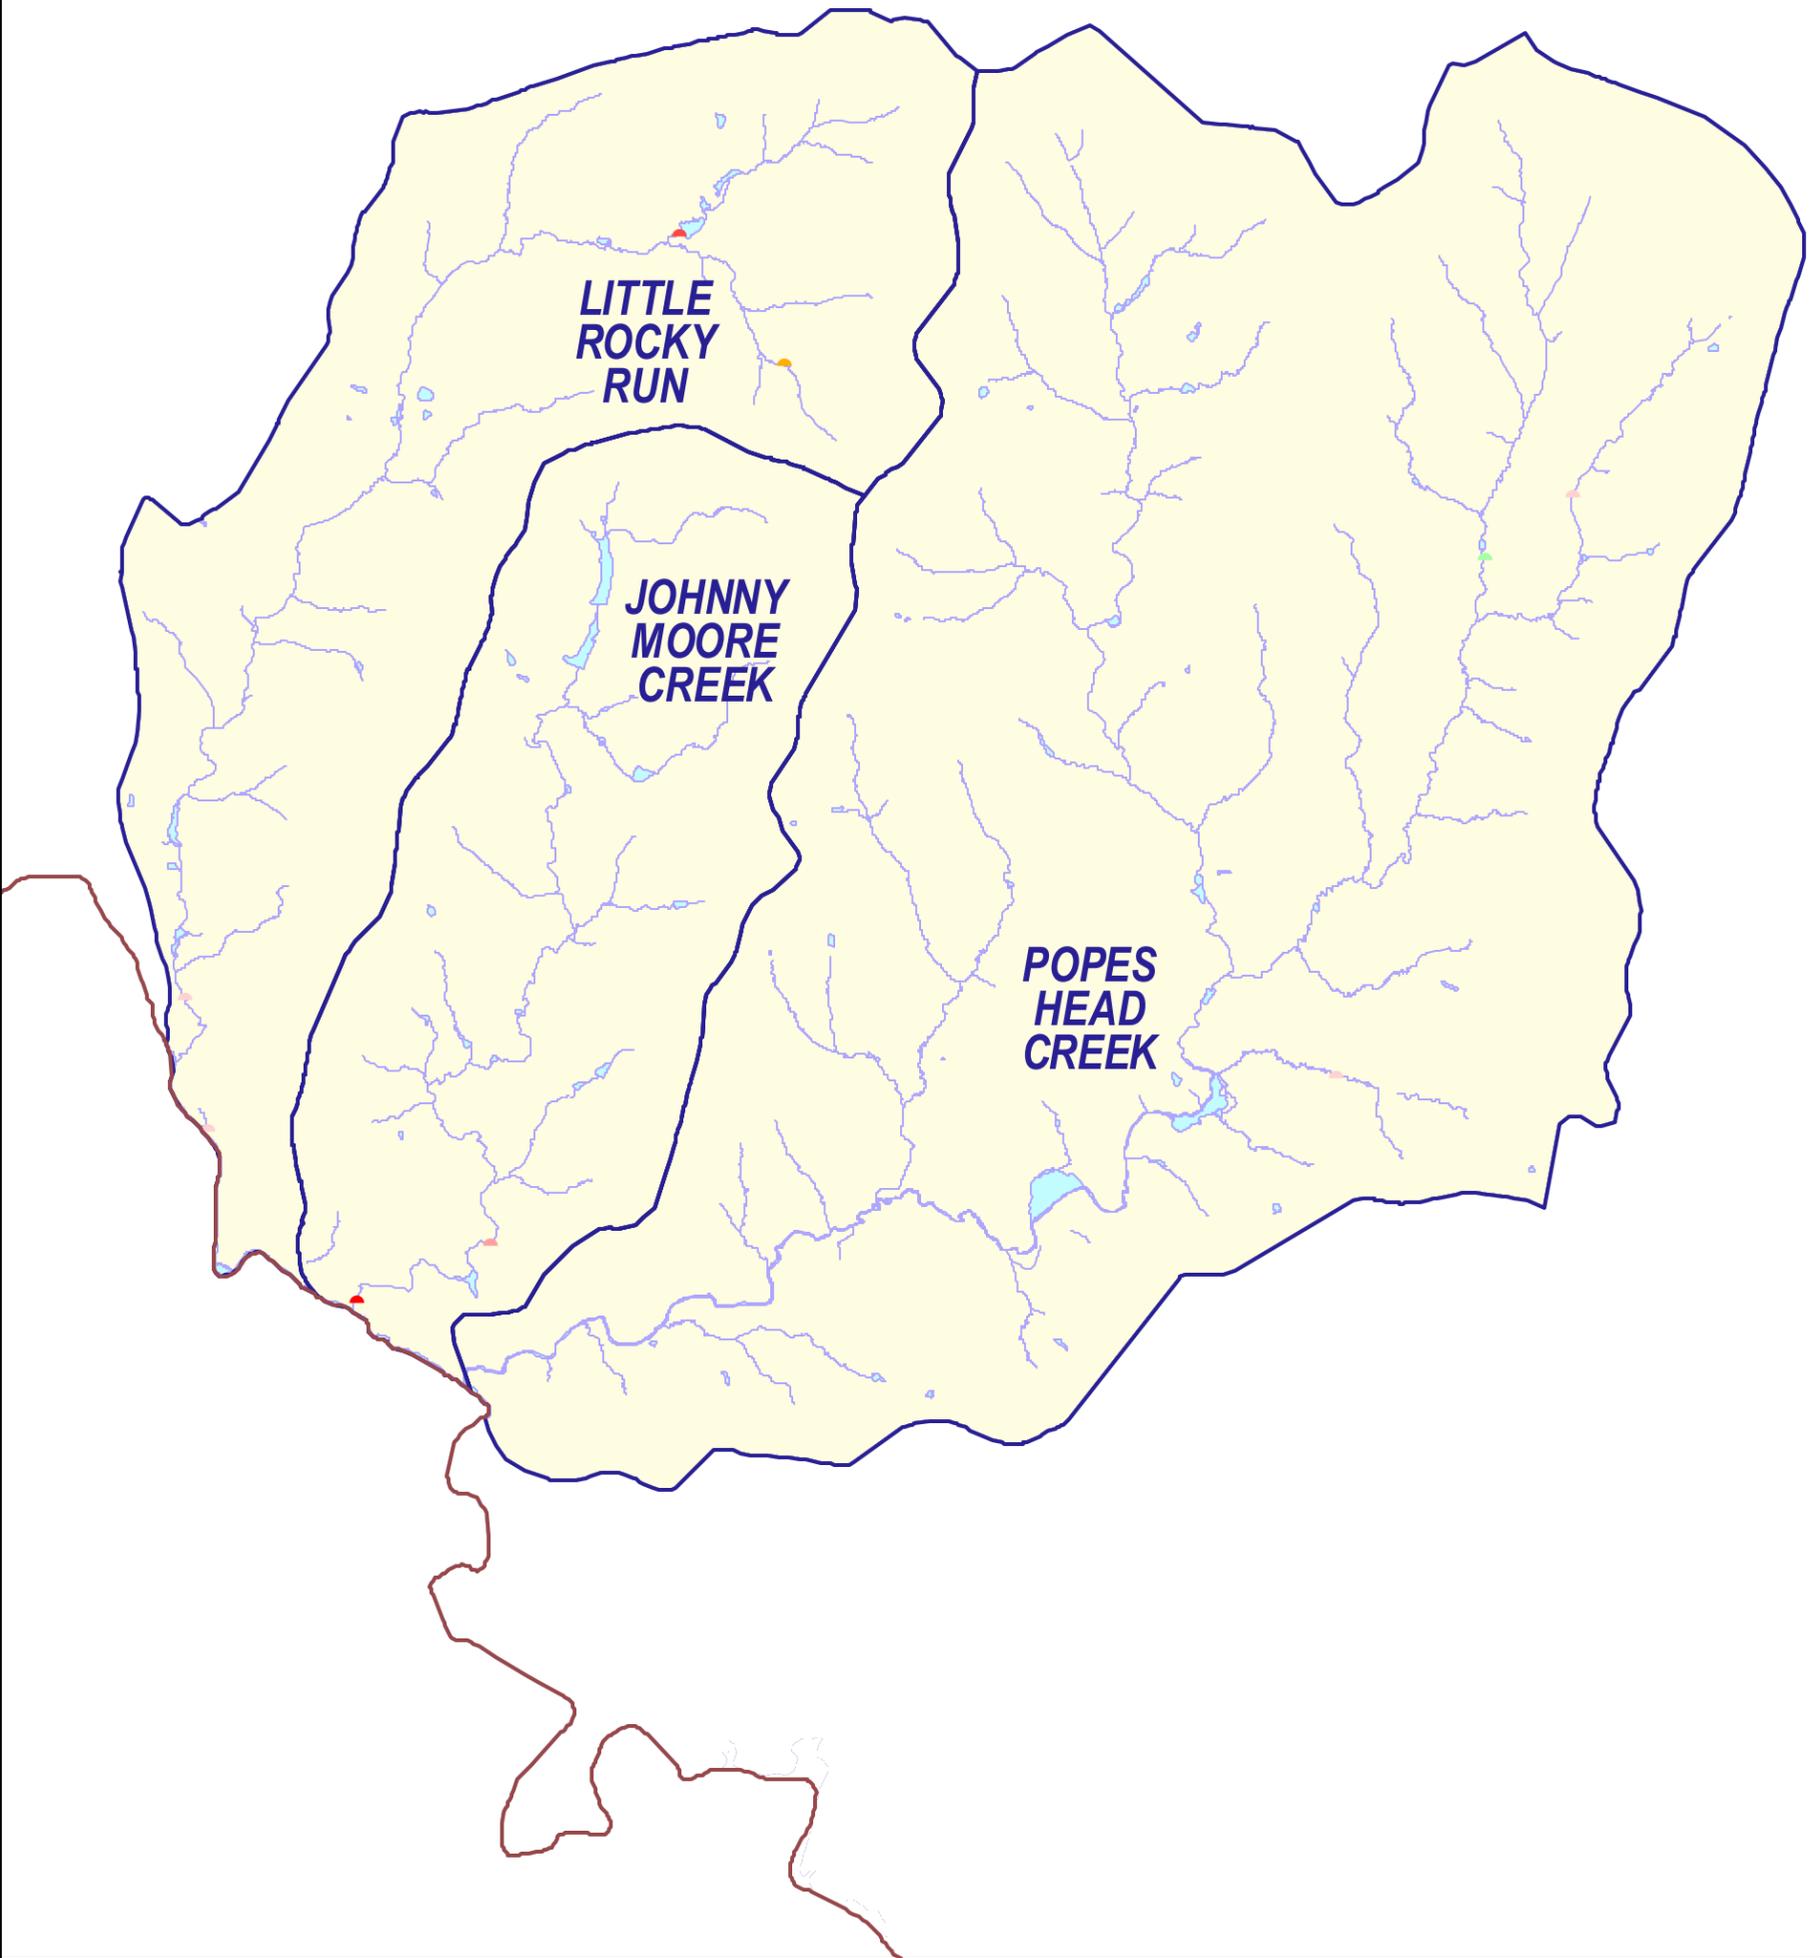
Figure 3-68  
Erosion Impacts  
Lower Bull Run Group  
Fairfax County Stream Physical Assessment

**Infrastructure.** The infrastructure inventory resulted in 153 inventory points. The most significant problem was related to an erosional area, which was given an impact score of 8. The infrastructure inventory results are summarized in Table 3-44. Figures 3-68, 3-69, 3-70, 3-71, and 3-72 summarize impact scores for the erosion problems; deficient buffers; crossings; pipes/ditches; and dumps, obstructions, and utilities, respectively.

**Infrastructure.** The infrastructure inventory resulted in 127 inventory points. The most significant problem was related to an erosional area, which was given an impact score of 9. The infrastructure inventory results are summarized in Table 3-46. Figures 3-68, 3-69, 3-70,

3-71, and 3-72 summarize impact scores for the erosion problems; deficient buffers; crossings; pipes/ditches; and dumps, obstructions, and utilities, respectively.

**Infrastructure.** The infrastructure inventory resulted in 382 inventory points. The most significant problem was related to a pipe, which was given an impact score of 9. The infrastructure inventory results are summarized in Table 3-48. Figures 3-68, 3-69, 3-70, 3-71, and 3-72 summarize impact scores for the erosion problems; deficient buffers; crossings; pipes/ditches; and dumps, obstructions, and utilities, respectively.

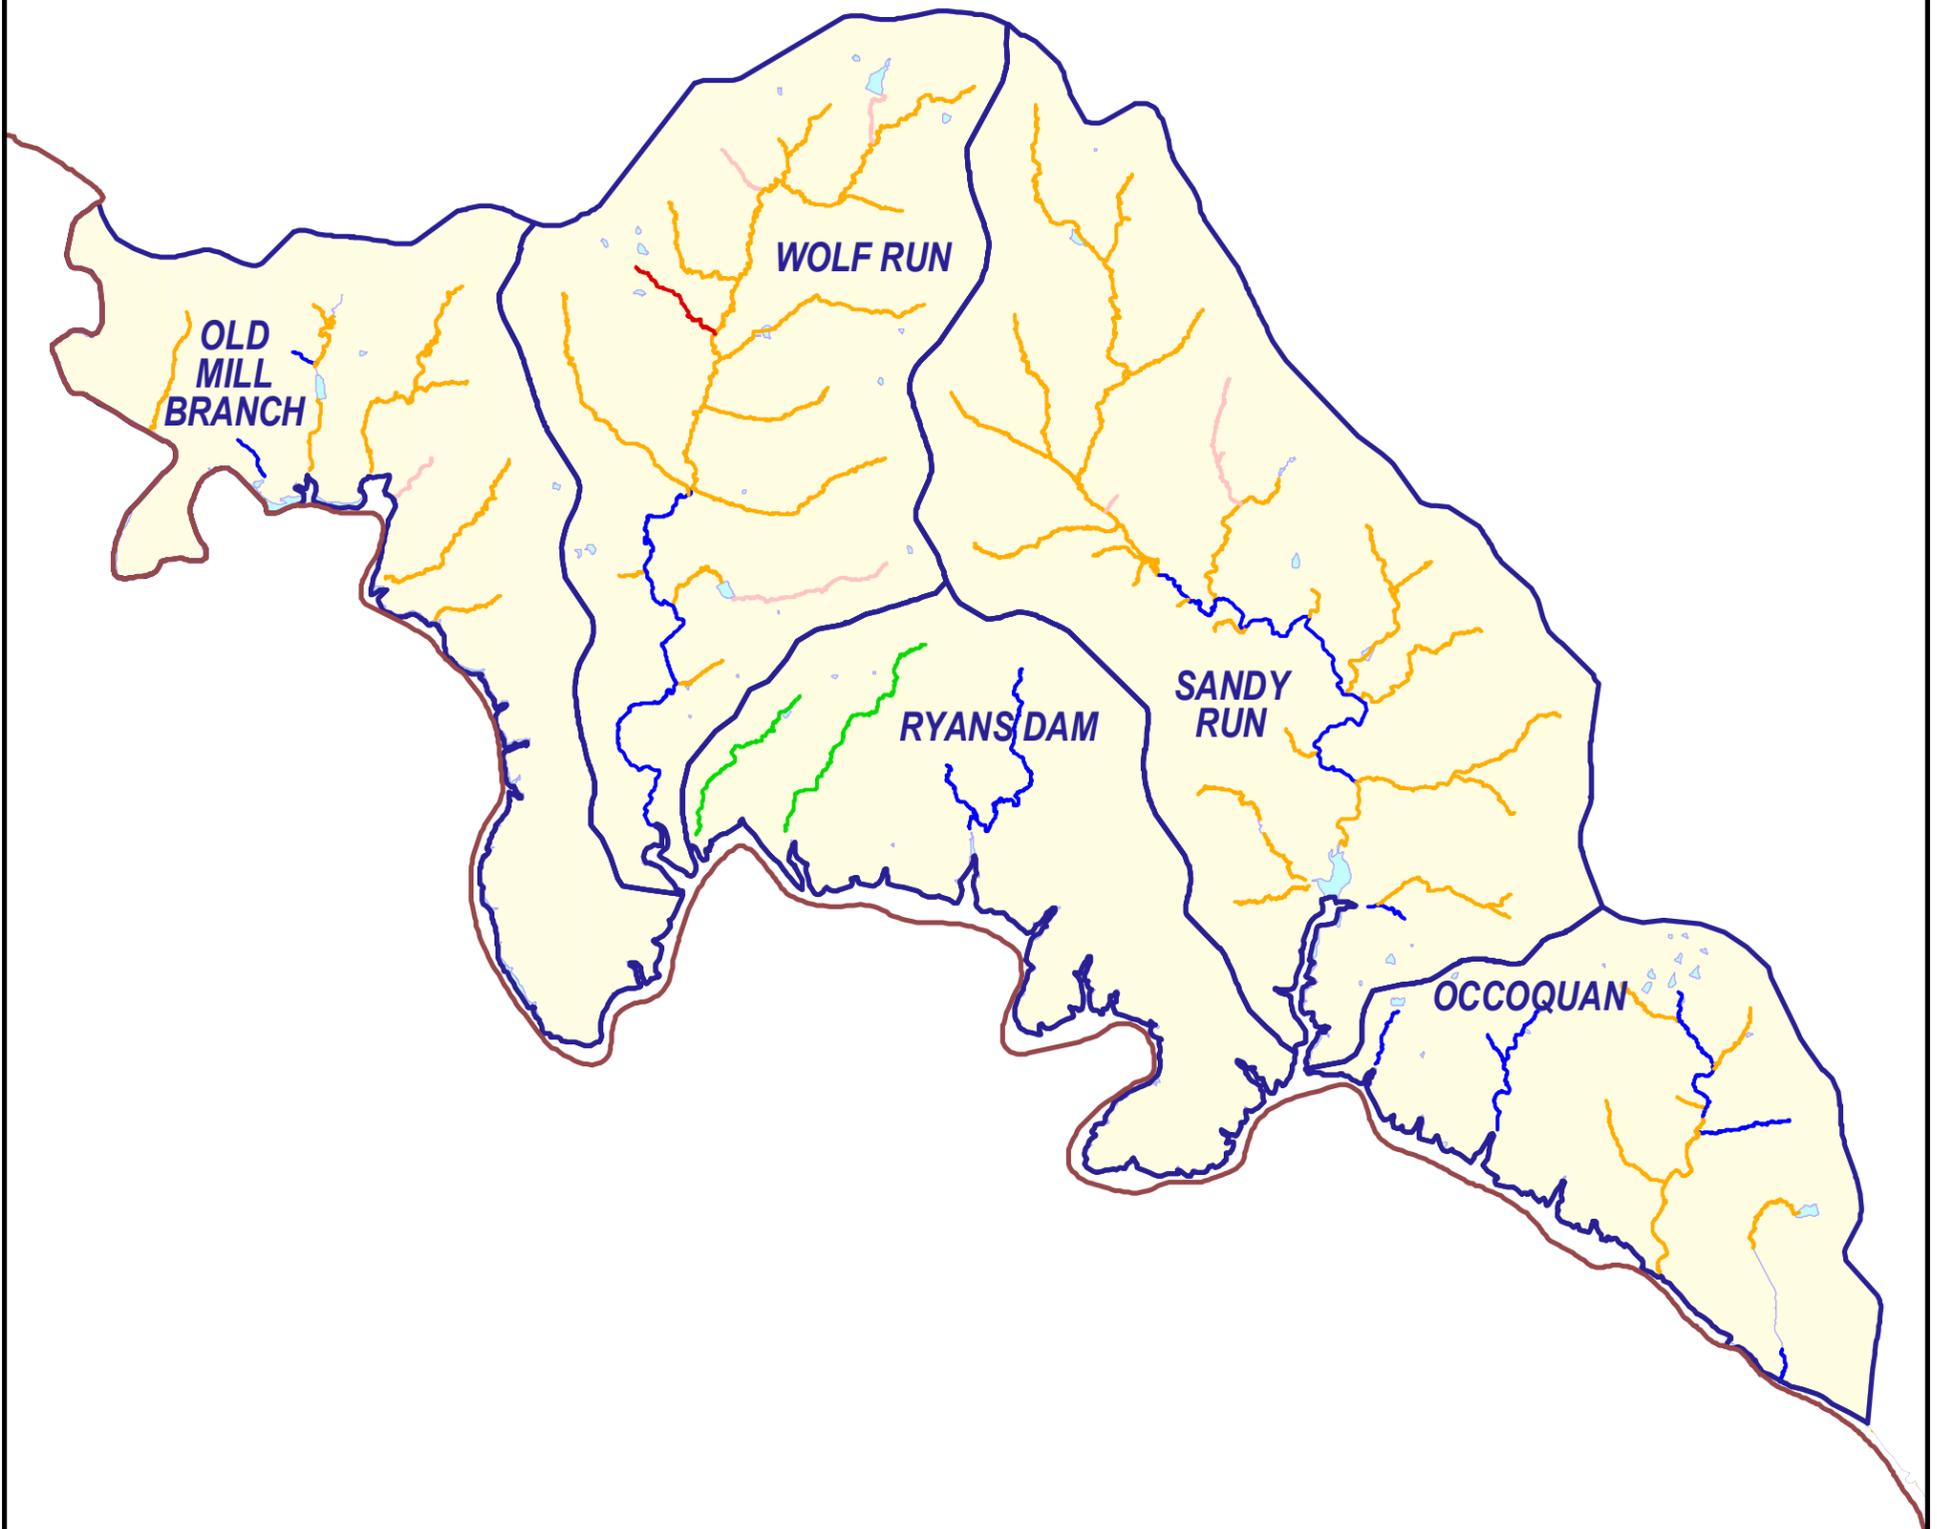
**Figure 3-73**  
**Habitat Assessment**  
**Upper Occoquan Group**  
**Fairfax County Stream Physical Assessment**

**Habitat.** The habitat assessment results for Wolf Run Watershed are summarized by stream in Table 3-51. Habitat scores for each reach are depicted in Figure 3-73. Based on a length weighted habitat score of 99 (Table 3-2), Wolf Run Watershed is in the lower range of quality, compared to the rest of the County. Approximately 1.5 miles of stream were categorized as having “poor” habitat conditions, 11 miles as “fair,” and 3 miles as “good.”

**Habitat.** The habitat assessment results for Sandy Run Watershed are summarized by stream in Table 3-53. Habitat scores for each reach are depicted in Figure 3-73. Based on a length weighted habitat score of 104 (Table 3-2), Sandy Run Watershed is in the middle range of quality, compared to the rest of the County. Approximately 17 miles of stream were categorized as having “fair” habitat conditions and 3 miles as “fair.”

**Habitat.** The habitat assessment results for Ryans Dam Watershed are summarized by stream in Table 3-55. Habitat scores for each reach are depicted in Figure 3-73. Based on a length weighted habitat score of 145 (Table 3-2), Ryans Dam Watershed is the highest rated watershed in the County. Nearly 2 miles of stream were categorized as having “good” habitat conditions and 2.5 miles as “excellent.”

**Habitat.** The habitat assessment results for Occoquan Watershed are summarized by stream in Table 3-57. Habitat scores for each reach are depicted in Figure 3-73. Based on a length weighted habitat score of 117 (Table 3-2), Occoquan Watershed is in the upper middle range of quality, compared to the rest of the County. Approximately 3 miles of stream were categorized as having “fair” habitat conditions and 3 miles as “good.”

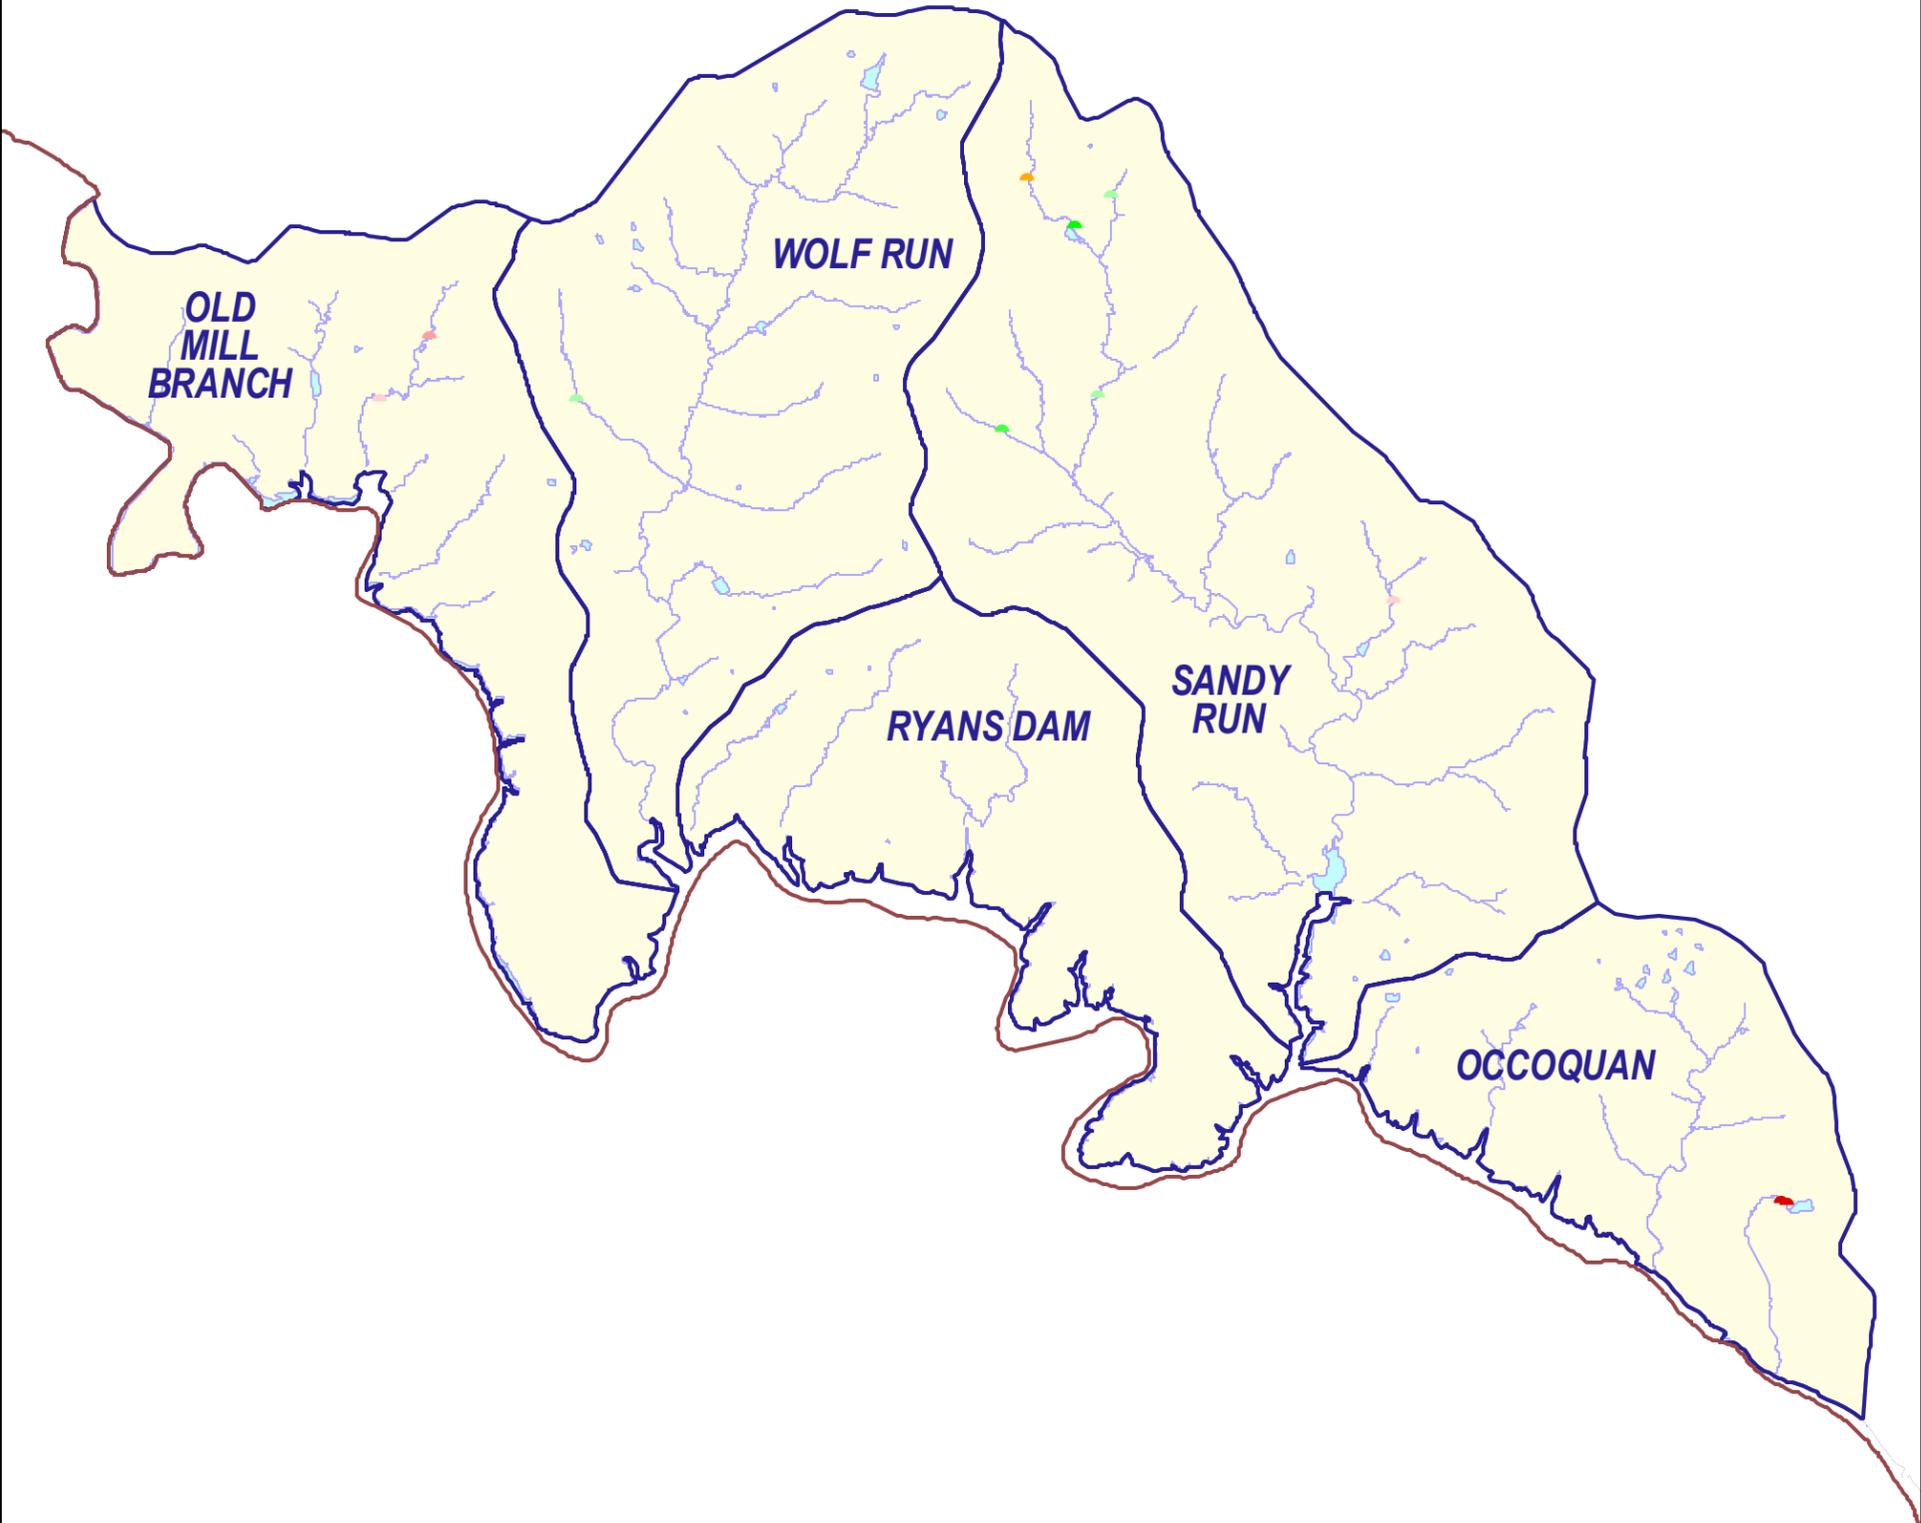
**Figure 3-74**  
**CEM Stages**  
**Upper Occoquan Group**  
**Fairfax County Stream Physical Assessment**

**CEM.** Based on the CEM evaluations approximately three quarters of the channels assessed in Old Mill Branch Watershed are in Evolutionary Stage 3 (Table 3-3) with the remainder in Stage 4. Figure 3-74 summarizes the CEM results for Old Mill Branch Watershed.

**CEM.** Based on the CEM evaluations approximately 98 percent of the channels assessed in Wolf Run Watershed are in Evolutionary Stage 3 (Table 3-3). Figure 3-74 summarizes the CEM results for Wolf Run Watershed.

**CEM.** Based on the CEM evaluations approximately 65 percent of the channels assessed in Sandy Run Watershed are in Evolutionary Stage 3 (Table 3-3), with the remainder in Stage 4. Figure 3-74 summarizes the CEM results for Sandy Run Watershed.

**CEM.** Based on the CEM evaluations the channels assessed in Ryans Dam Watershed are nearly evenly divided between Evolutionary Stages 2 and 3 (Table 3-3). Figure 3-74 summarizes the CEM results for Ryans Dam Watershed.

**CEM.** Based on the CEM evaluations approximately 80 percent of the channels assessed in Occoquan Watershed are in Evolutionary Stage 3 (Table 3-3), with the remainder of the watershed in Stages 2 and 4. Figure 3-74 summarizes the CEM results for Occoquan Watershed.

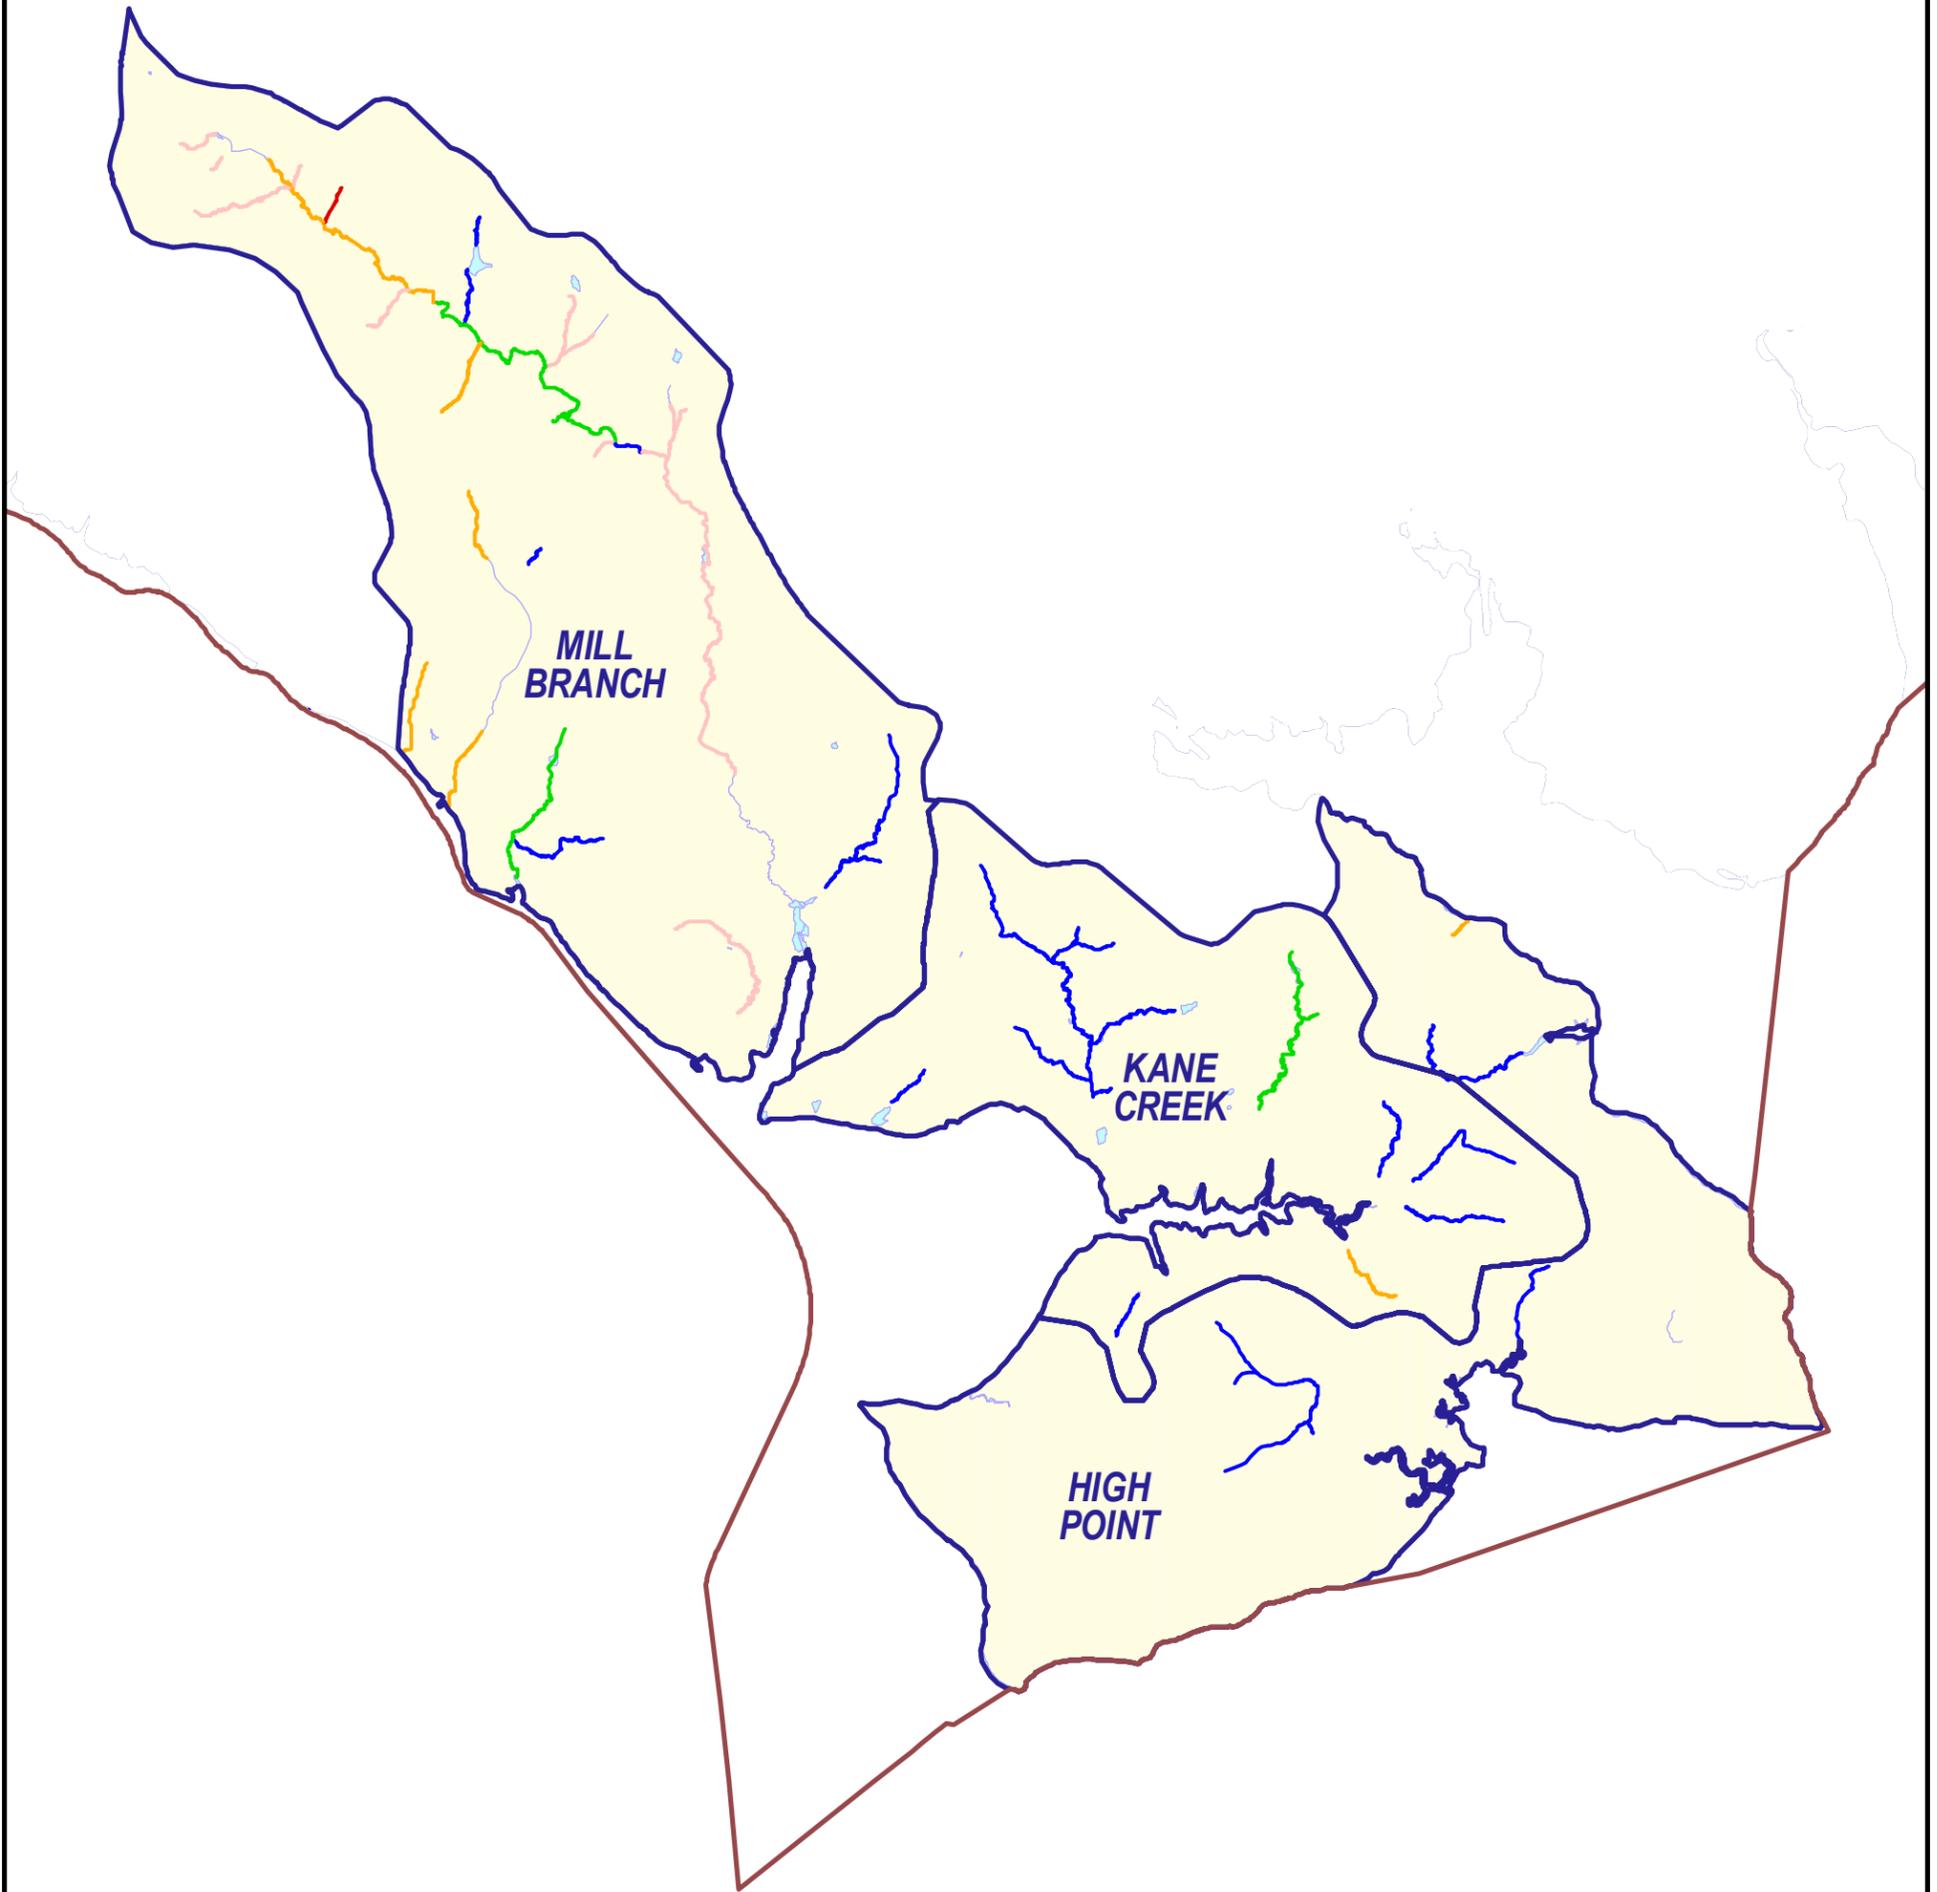
**Figure 3-80**  
**Habitat Assessment**  
**Lower Occoquan Group**  
**Fairfax County Stream Physical Assessment**

**Habitat.** The habitat assessment results for Mill Branch Watershed are summarized by stream in Table 3-59. Habitat scores for each reach are depicted in Figure 3-80. Based on a length weighted habitat score of 106 (Table 3-2), Mill Branch Watershed is in the middle range of quality, compared to the rest of the County. Approximately 6 miles of stream were categorized as having “poor” habitat conditions, 3 miles as “fair,” 3 miles as “good,” and 3 miles as “excellent.”

**Habitat.** The habitat assessment results for High Point Watershed are summarized by stream in Table 3-63. Habitat scores for each reach are depicted in Figure 3-80. Based on a length weighted habitat score of 124 (Table 3-2), High Point Watershed is in the upper range of quality, compared to the rest of the County. Nearly all 3 miles of stream were categorized as having “good” habitat conditions.
