## 3.2.10 Lower Bull Run Group Summary

### 3.2.10.1 Little Rocky Run Watershed

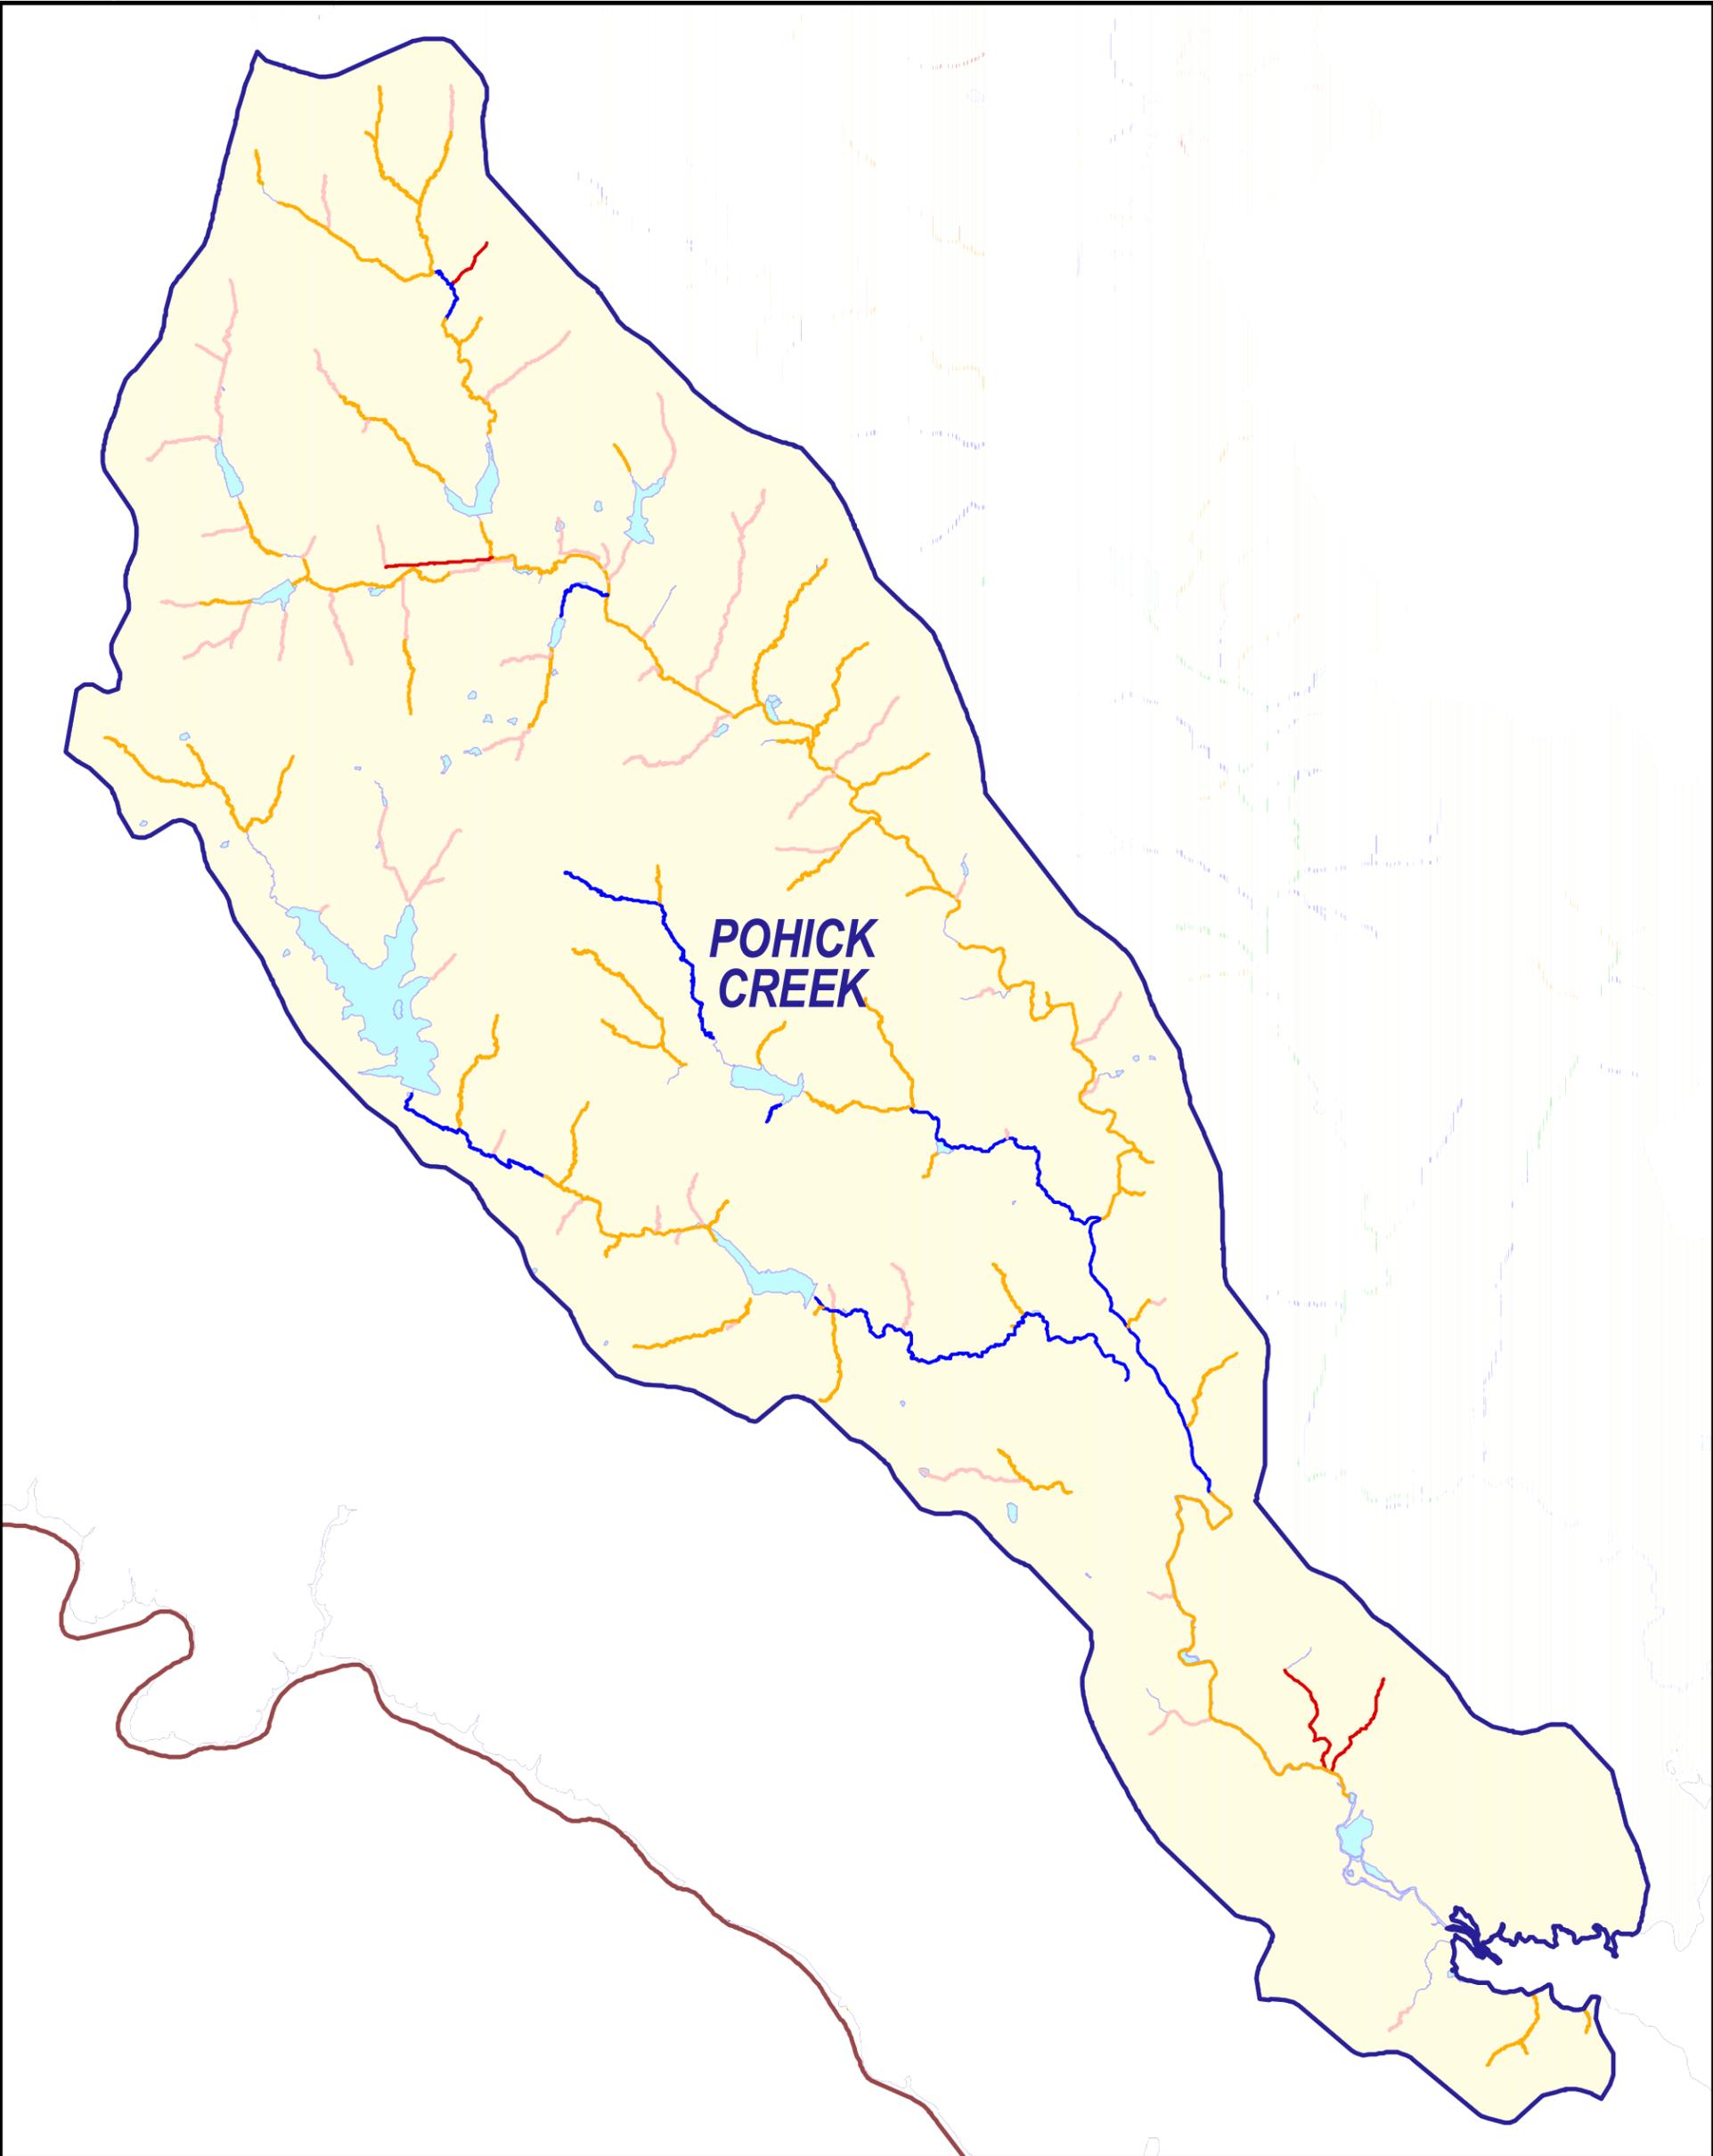
**Figure 3-52**  
**Habitat Assessment**  
**Pohick Creek**  
**Fairfax County Stream Physical Assessment**

**Habitat.** The habitat assessment results for Pohick Creek Watershed are summarized by stream in Table 3-37. Habitat scores for each reach are depicted in Figure 3-52. Based on a length weighted habitat score of 95, Pohick Creek Watershed is one of the poorest quality watersheds, compared to the rest of the County. Approximately 2 miles of stream were categorized as having “very poor” habitat conditions, 20 miles as “poor,” 37 miles as “fair,” and 10 miles as “good.”

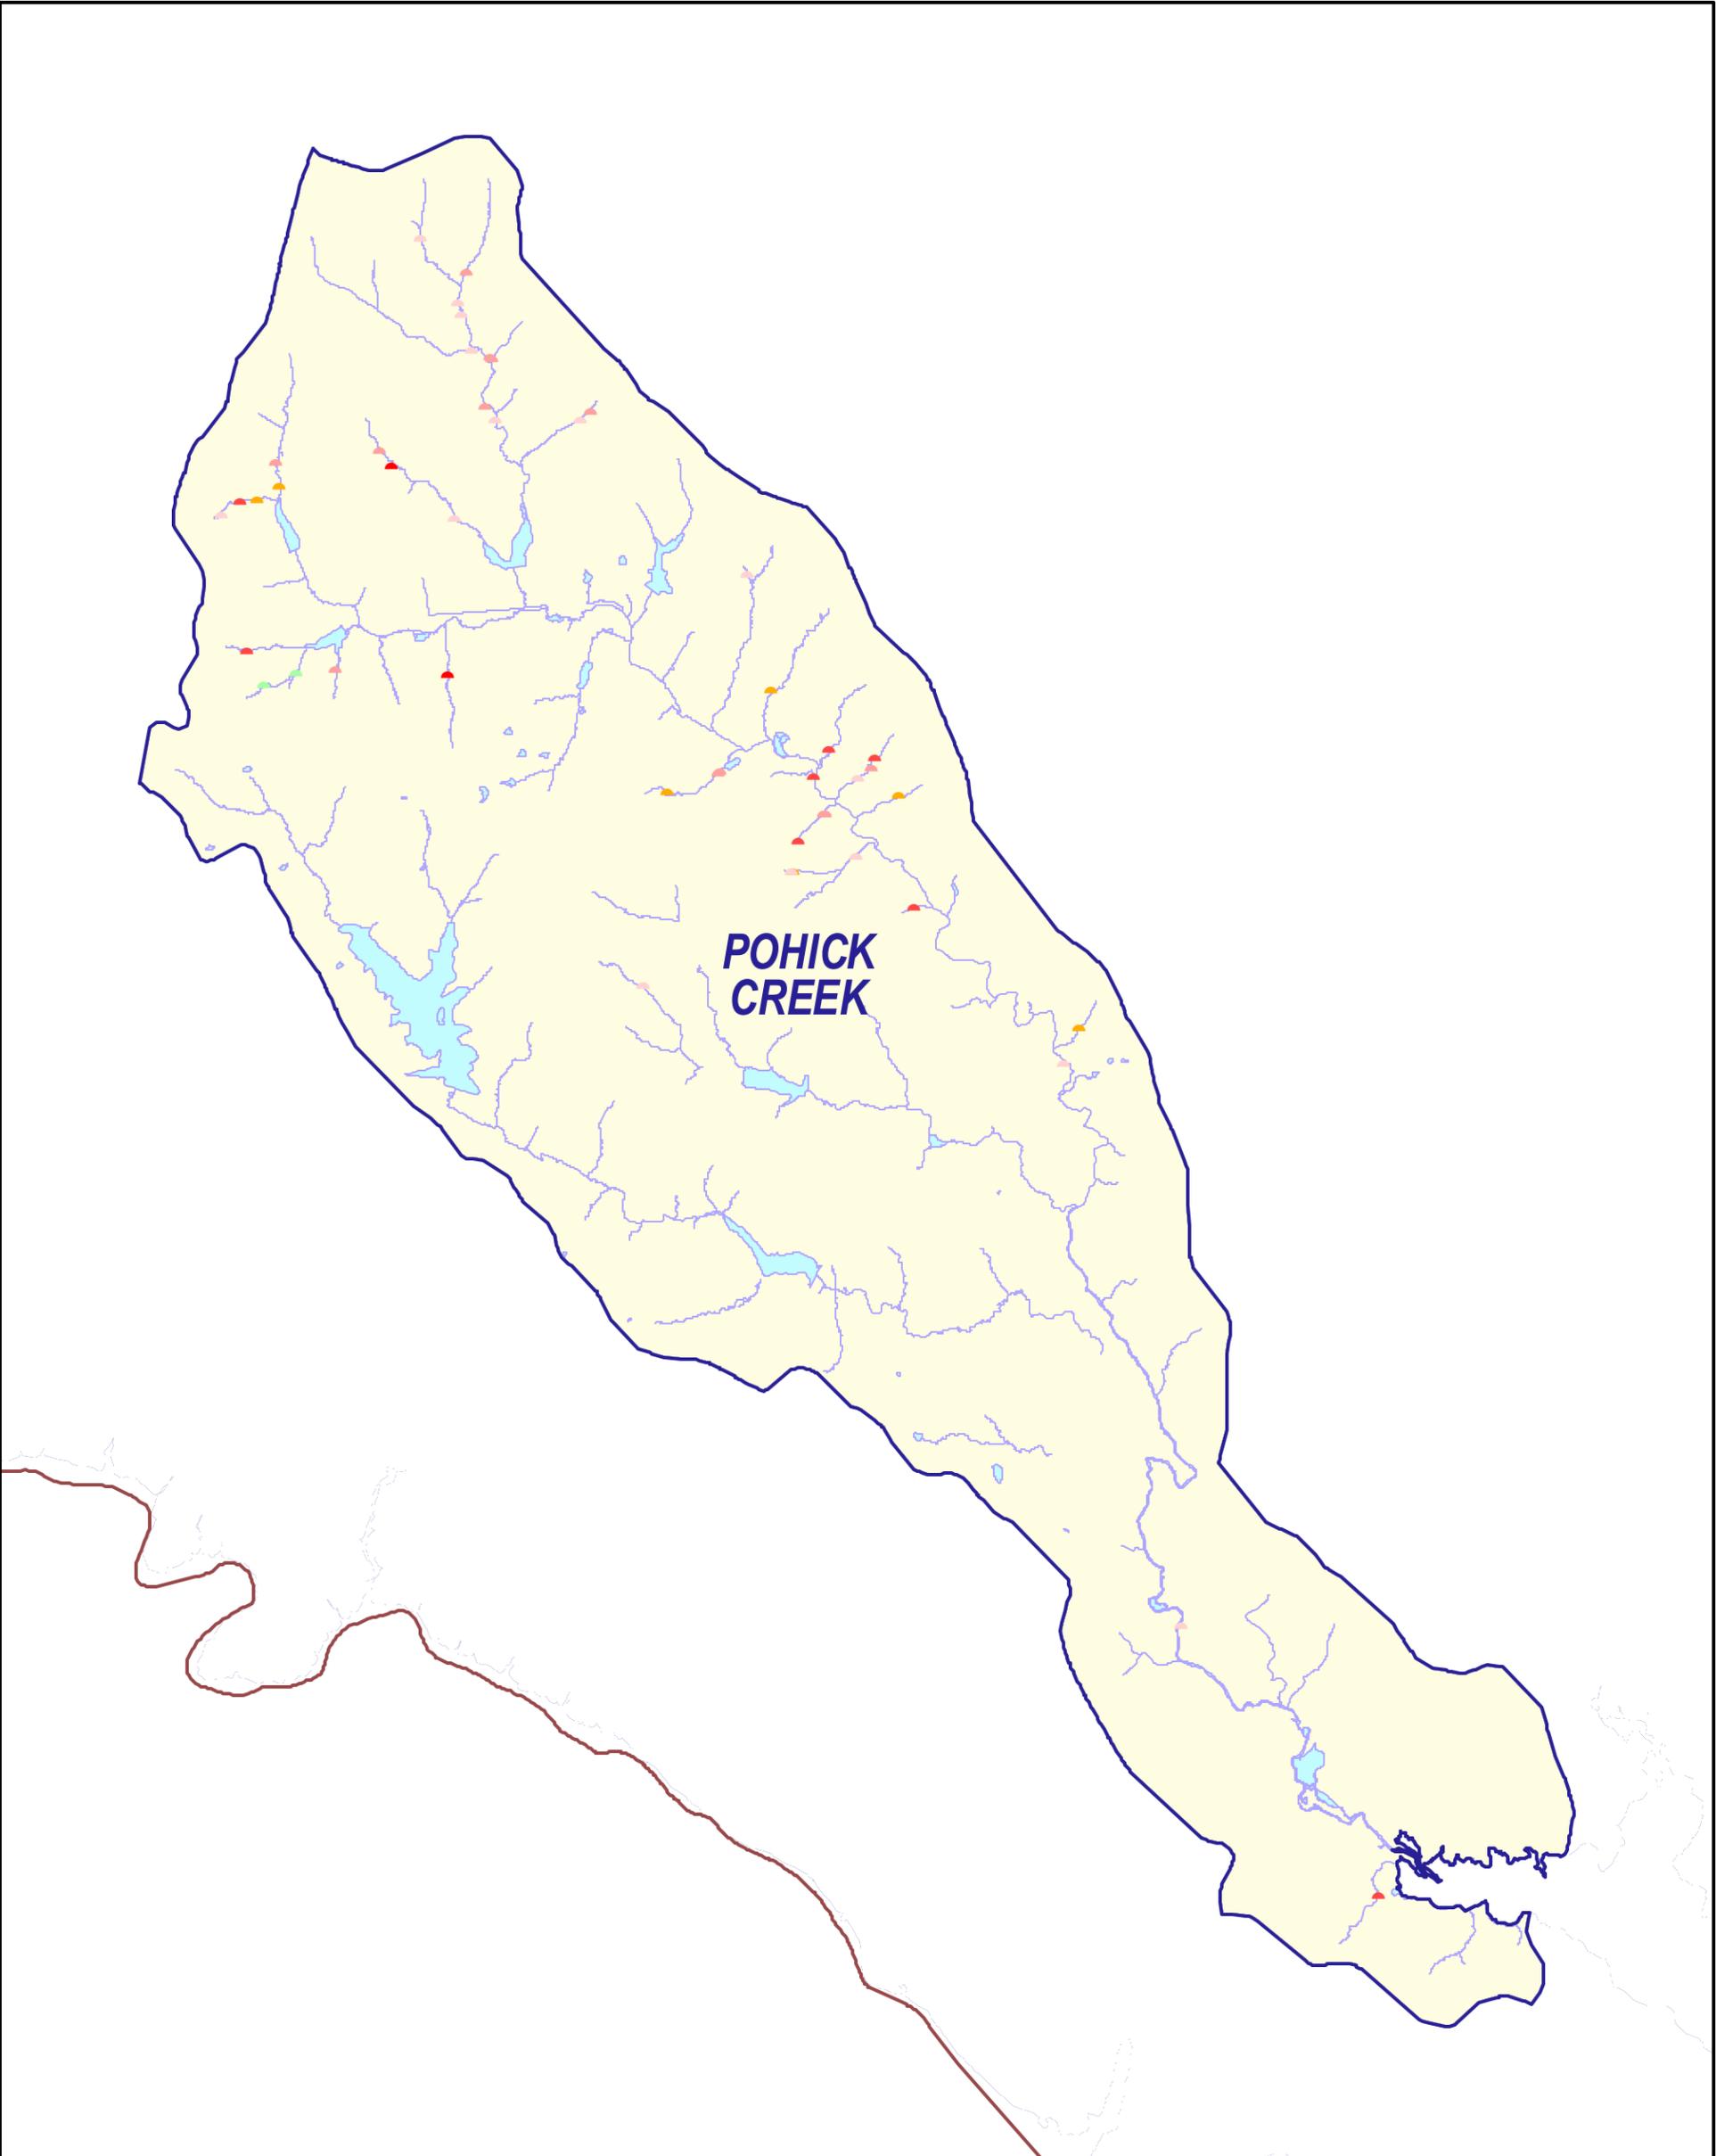
**Figure 3-53**  
**CEM Stages**  
**Pohick Creek**  
**Fairfax County Stream Physical Assessment**

**CEM.** Based on the CEM evaluations approximately three quarters of the channels assessed in Pohick Creek Watershed are in Evolutionary Stage 3 (Table 3-3), with most of the remainder of the watershed in Stage 4. Figure 3-53 summarizes the CEM results for Pohick Creek Watershed.

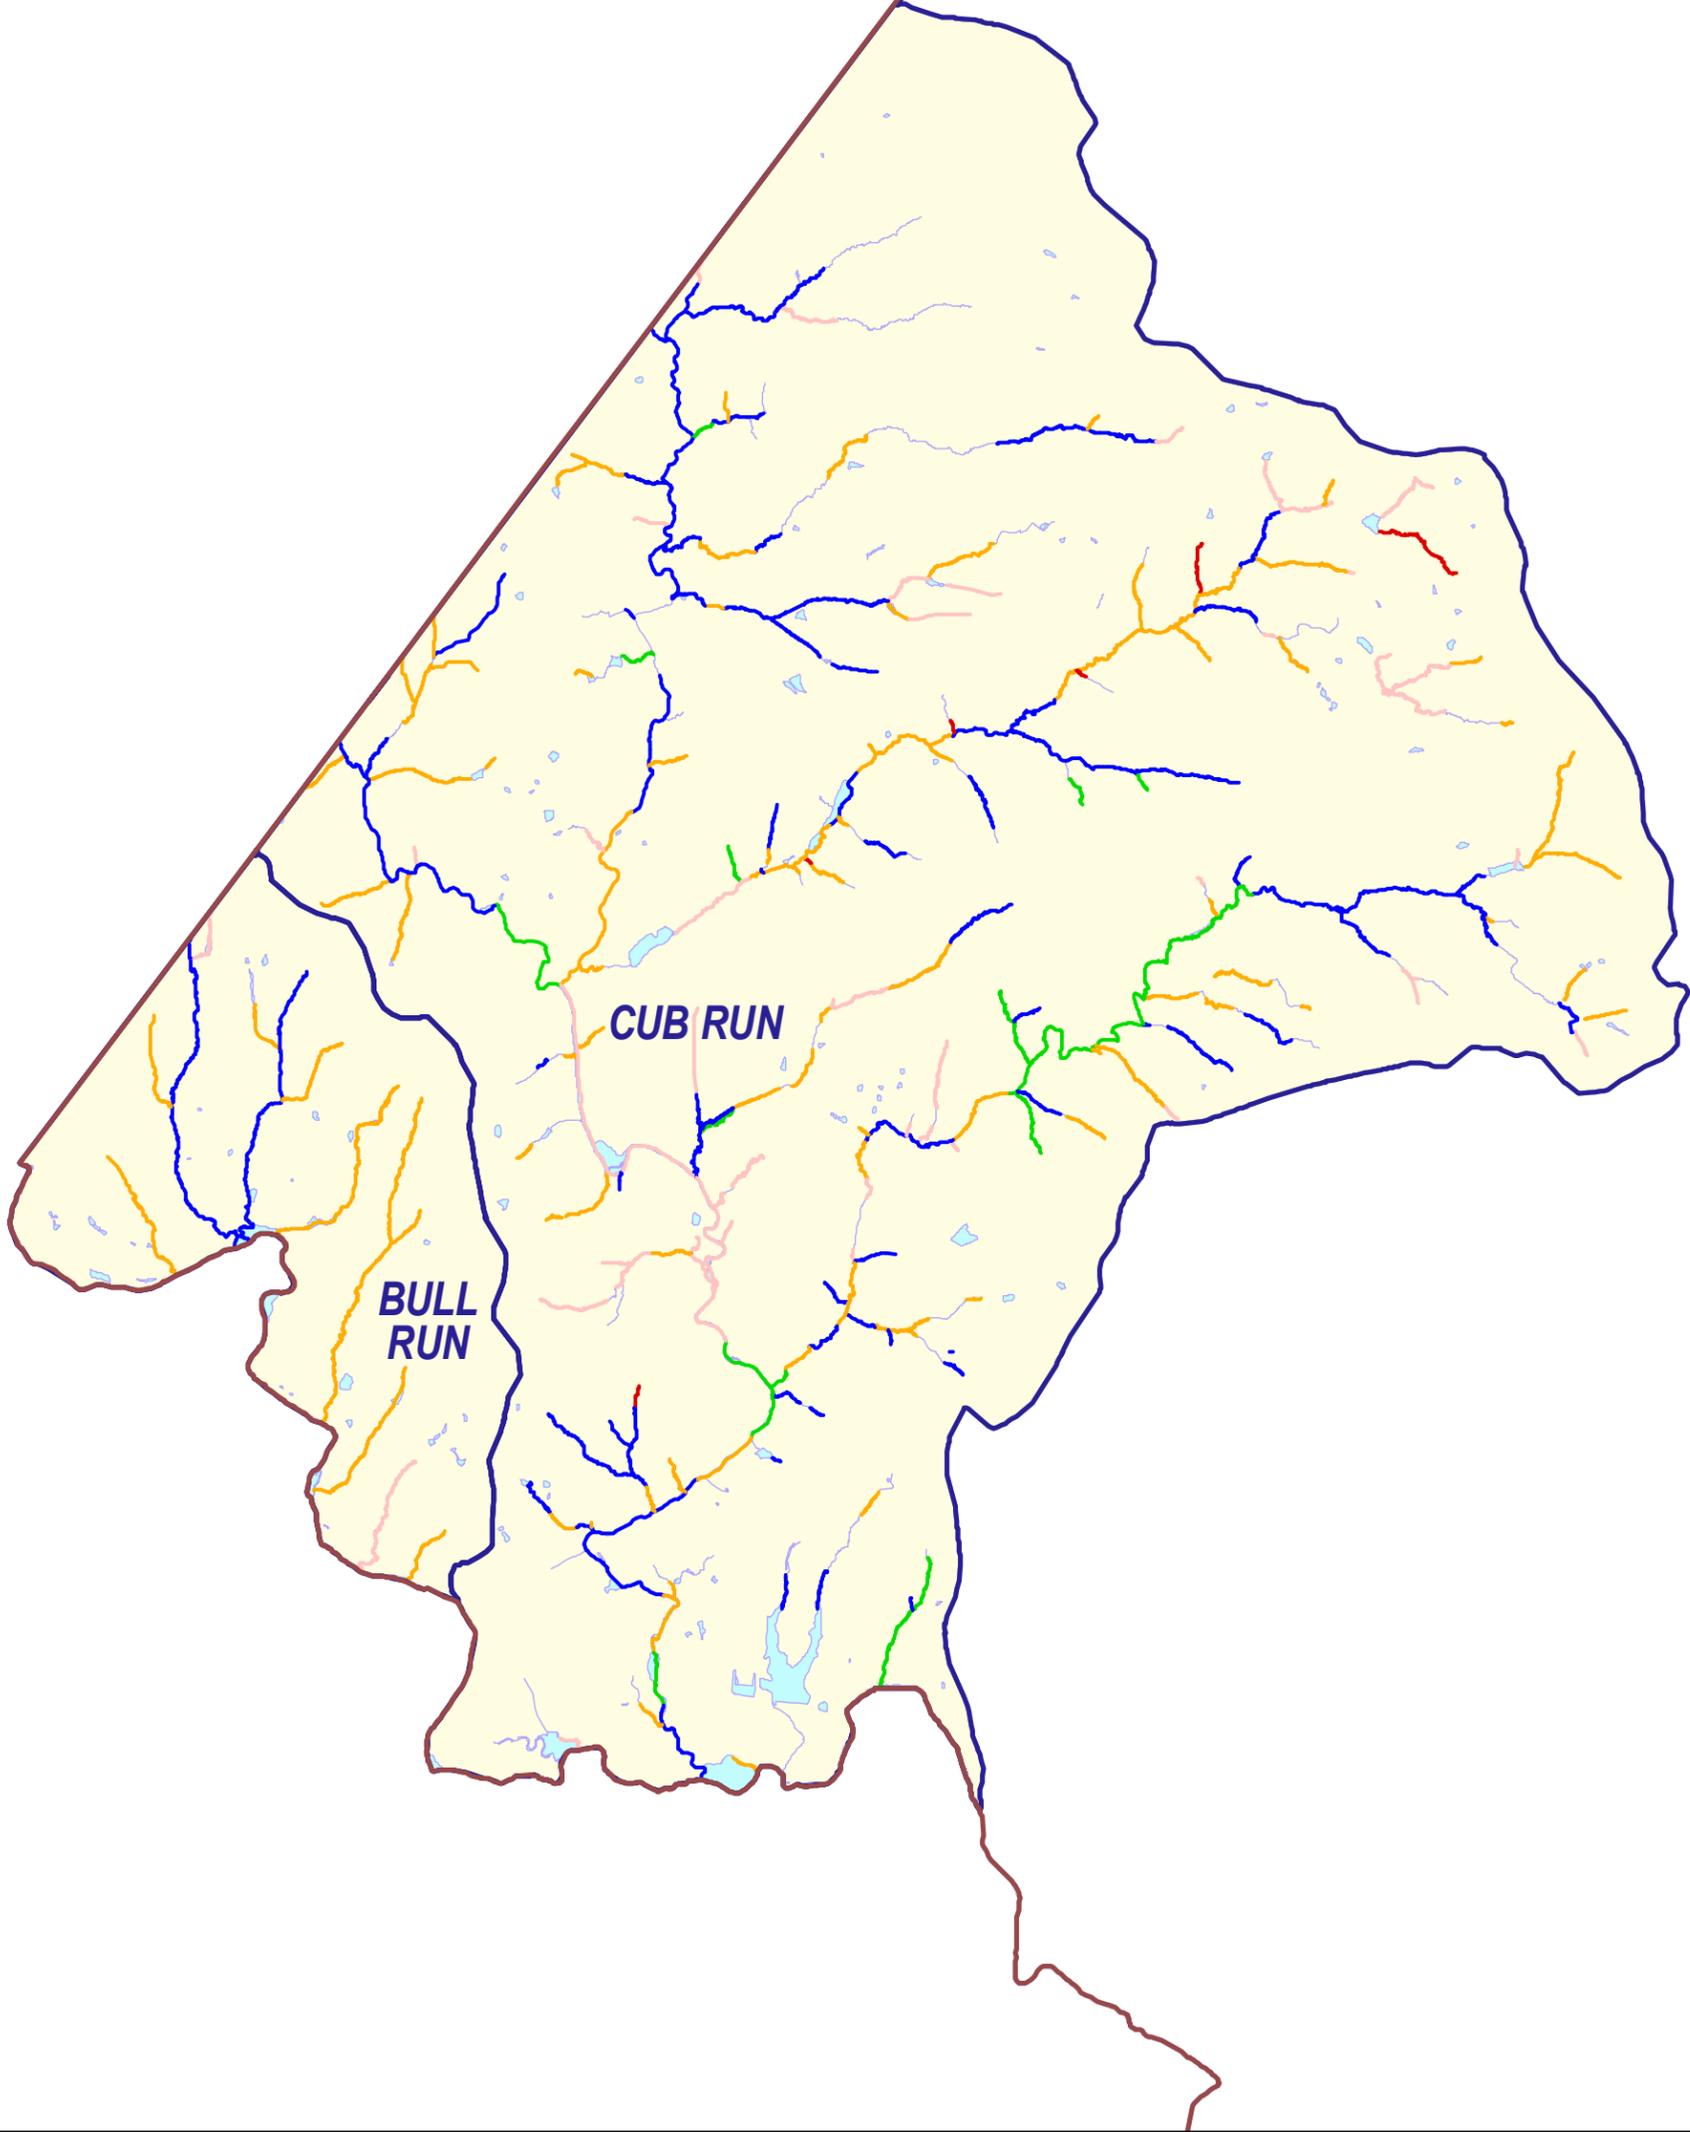
**Figure 3-59**  
**Habitat Assessment**  
**Upper Bull Run Group**  
**Fairfax County Stream Physical Assessment**

**Habitat.** The habitat assessment results for Cub Run Watershed are summarized by stream in Table 3-39. Habitat scores for each reach are depicted in Figure 3-59. Based on a length weighted habitat score of 110 (Table 3-2), Cub Run Watershed is in the upper middle range of quality, compared to the rest of the County. Approximately 1 mile of stream was categorized as having “very poor” habitat conditions, 13 miles as “poor,” 24 miles as “fair,” and 28 miles as “good,” and 8 miles as “excellent.”

**Habitat.** The habitat assessment results for Bull Run Watershed are summarized by stream in Table 3-41. Habitat scores for each reach are depicted in Figure 3-59. Based on a length weighted habitat score of 108 (Table 3-2), Bull Run Watershed is in the upper middle range of quality, compared to the rest of the County. Just over 1 mile of stream was categorized as having “poor” habitat conditions; 8 miles were “fair,” and 4 miles were “good.”
