***Snakeden Branch*** in Reston was the latest stream to benefit from a restoration plan designed and implemented by the Northern Virginia Soil and Water Conservation District and the Virginia Department of Forestry in August of 2003. This project marked the start of the implementation phase of the Reston Association's new watershed management plan. The upper 200-ft section was completed as a partnership project by the Northern Virginia Soil & Water Conservation District, Virginia Department of Forestry, Reston Association (RA), and the Fairfax County Department of Public Works and Environmental Services, Maintenance and Stormwater Management Division. The lower 800-ft was completed by RA working with private consulting firms. RA received grant and mitigation funding to support the project. The banks were severely eroded, and the roots of many large trees were exposed. The streambanks were re-graded to gentler slopes. In the upper section, large stones were strategically placed to help stabilize a large tulip poplar tree, and both single and two-tier rows of biologs were placed along a stretch. The series of pictures below, Figures 8-13, show the restoration process in various stag

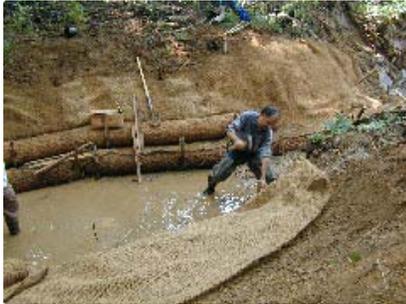
**Figure 8.** Root mat staking at the Snake Den stream restoration site. (Photo courtesy of NVSWCD)

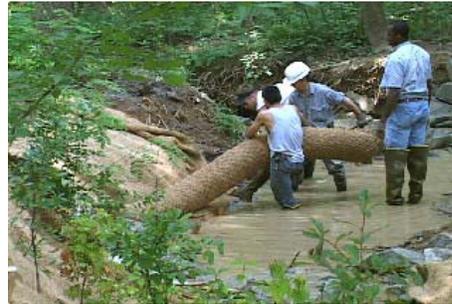
**Figure 9.** Snake Den Restoration Project—Biolog installation. (Photo courtesy of RA)

By the time the logs degrade in seven or eight years, a root network of plants will have been established through and behind it. In addition to stabilize the bank. Biodegradable coconut fiber on the banks until the roots of native grass and Several rock cross vanes were built to concentrate reducing bank erosion as well as increasing water structures were built throughout the project. More at:

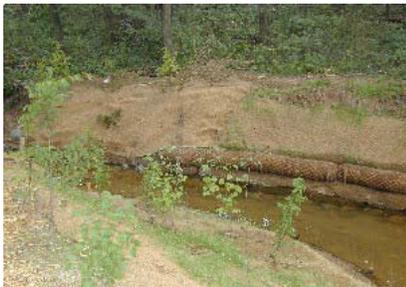
**Figure 10.** Snake Den stream restoration site, after root mat's and biologs are put in place. (Photo courtesy of NVSWCD)

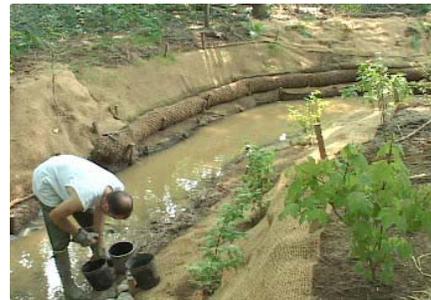
**Figure 11.** Snake Den Restoration project—replanting of vegetative stream buffer. (Photo courtesy of RA)
