## 4 Watershed Restoration Strategies

### 4.1 Subwatershed Strategies

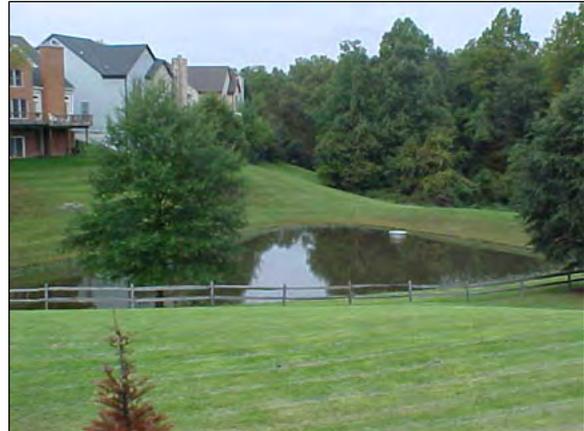
**Figure 4-1: Stormwater Management Wet Pond**  
(Source: Fairfax County)

Wet ponds and stormwater wetlands can also provide water quality and habitat benefits through landscaping with aquatic vegetation. Vegetation is added to the pond design to treat dissolved nutrients (nitrogen and phosphorus), which can be difficult to remove through settling and filtering. In the process of growing, aquatic vegetation takes the nutrients up out of the water through its roots and sequesters them.

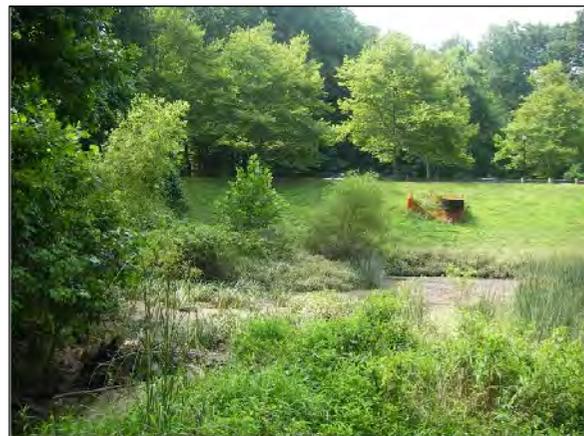
**Figure 4-1: Engineered Stormwater Wetland**  
(Source: Fairfax County)

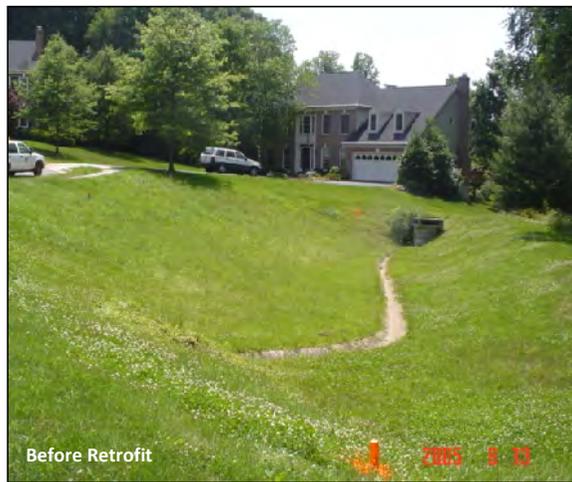
Figure 4-2: Stormwater Dry Pond Retrofit (Source: Fairfax County)

- Creating an shallow subsurface wetland bench around the perimeter which provides an opportunity for aquatic vegetation to take up nutrients
- Creating wetland areas within the pond
- Creating a forebay to capture sediment before it enters the pond, which improves maintainability
- Creating a micropool at the outlet to add an additional location for sedimentation.

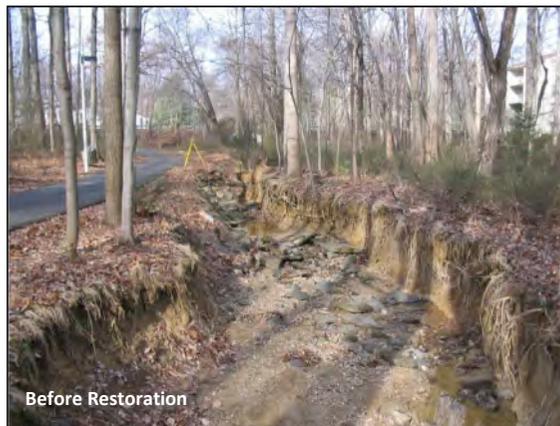
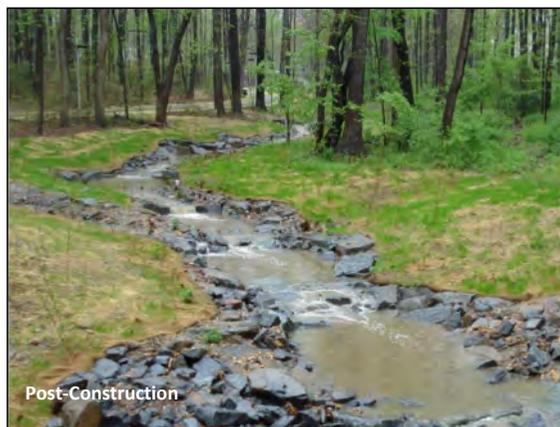
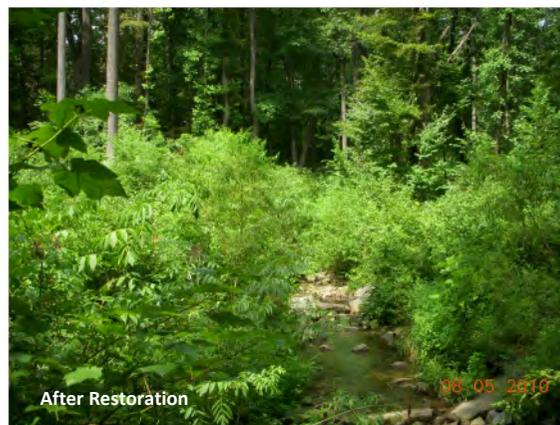
**Figure 4-3: Stream Restoration (Source: Fairfax County)**

For incised urban channels, there are several options available, depending on the severity of the degradation and availability of adjacent land. The most extensive restoration designs may move the stream itself, creating a new channel on a new alignment at the original floodplain elevation. Other alternatives could involve adjusting the cross-section, reducing bank slopes, or creating a new floodplain bench within an over-widened channel. For incised channels with no room to increase meander width, a restoration design could include using grade controls to flatten the slope of the stream and dissipate stream energy.

Less extensive restoration approaches could be undertaken where there is insufficient space or the existing flows make it infeasible to recreate a natural channel. These could involve armoring stream banks with rock or bioengineering materials to prevent further erosion, grading to lay back over-steepened banks and create a more stable cross-section.

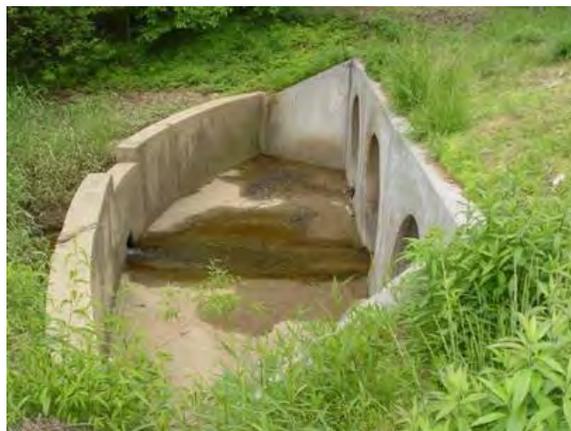
Figure 4-4: Culvert Retrofit Control Structure, Flow Left to Right (Source: KCI)

This retrofit option is installed upstream from existing road culverts by constructing a control structure and potentially excavating a micro-pool.

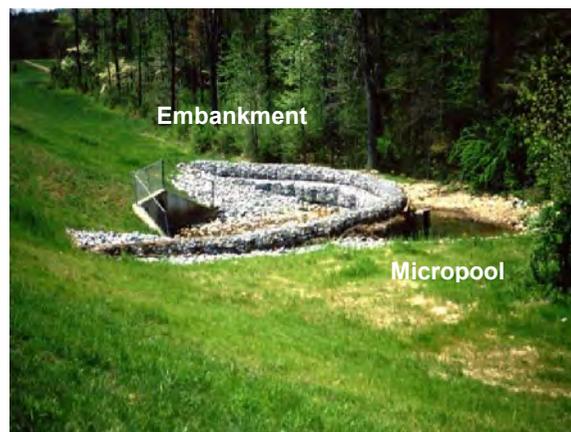
Figure 4-5: Culvert Retrofit, Flow Right to Left (Source: Center for Watershed Protection)

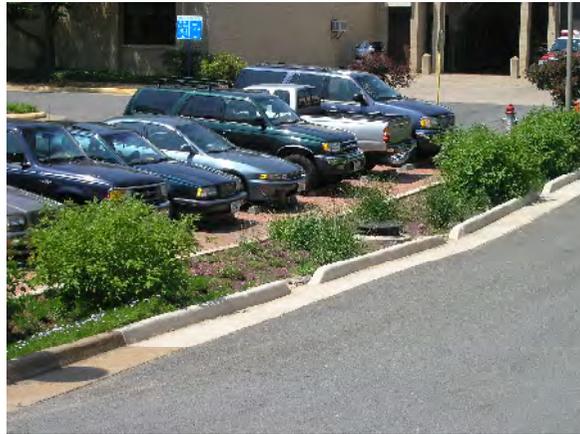
Figure 4-6: Parking lot bioretention (Source: Fairfax County)

Area-Wide Drainage Improvements are projects (or suites of projects) which improve multiple outfalls and/or other stormwater infrastructure throughout a neighborhood. Controls could be proprietary devices such as inlet filters or tree boxes (Figure 4-8), or custom-designed filters or bioretention systems (Figure 4-6).

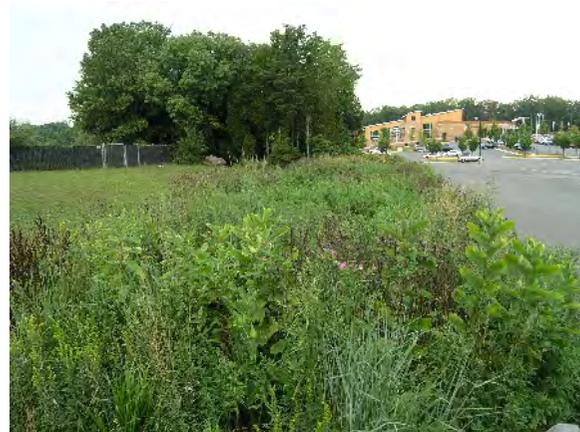
Figure 4-7: Vegetated Swale (Source: Fairfax County)

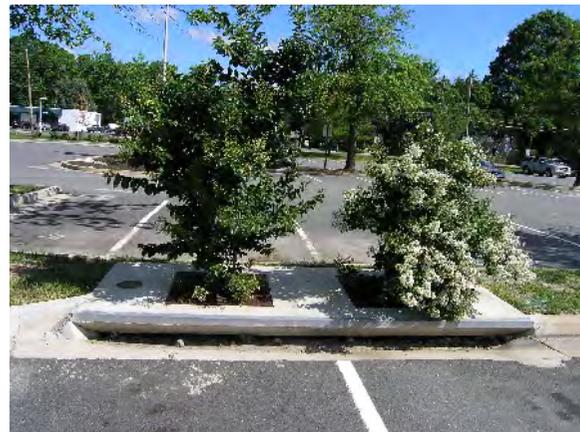
Figure 4-8: Tree Box Filter (Source: Fairfax Count)

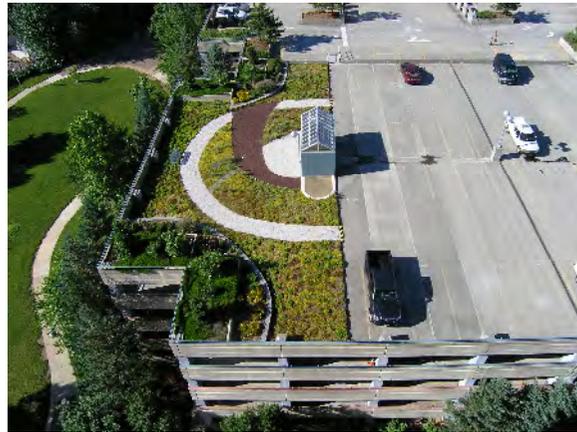
**Figure 4-9: A green roof on a park building (Source: Fairfax County)**

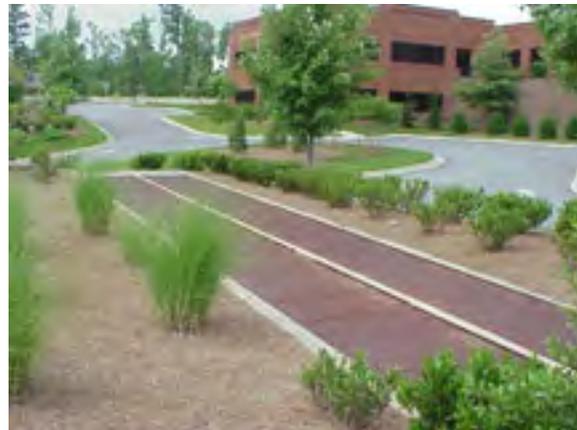
**Figure 4-10: A parking lot sand filter (Source: City of Greensboro, NC)**

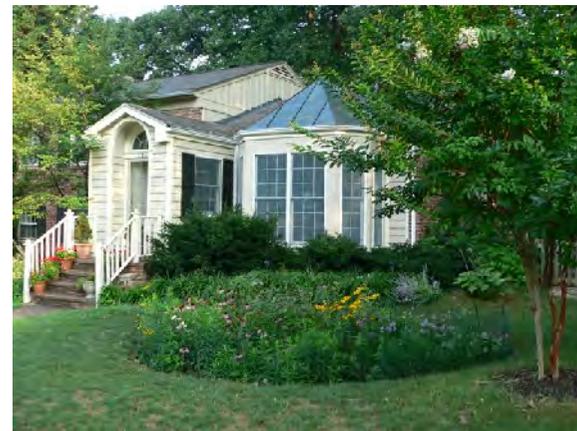
**Figure 4-11: Residential Rain Garden (Source: Fairfax County)**

Rain gardens are essentially a non-engineered form of bioretention that treats rooftop runoff from individual roof leaders. They consist of small, landscaped depressions with a sand/soil mixture planted with native shrubs, grasses or flowering plants. Rooftop runoff is detained in the depression for no more than a day. Rain gardens can replenish groundwater, reduce stormwater volumes, and remove pollutants

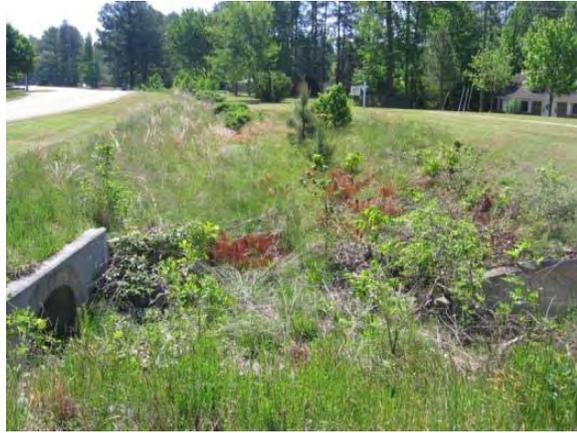
**Figure 4-12: A vegetated swale for roadside drainage (Source: KCI)**

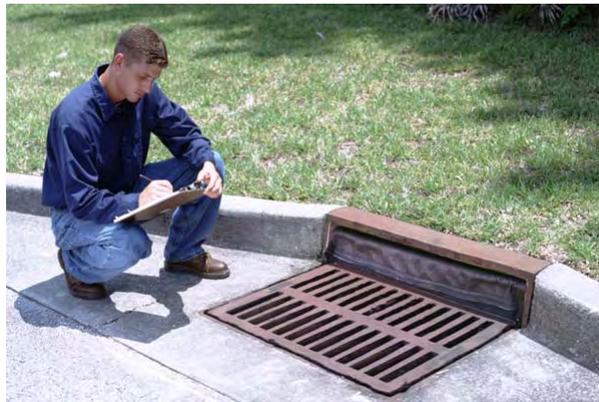
**Figure 4-13: Inlet Filter (Source: Ultra-Tech Int'l)**

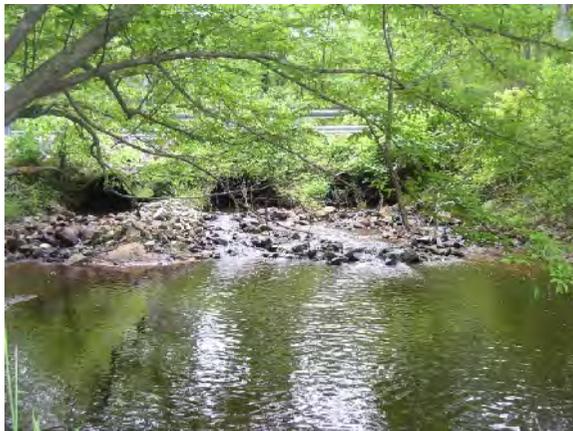
Figure 4-14: Obsolete Culvert (Source: KCI)

These improvements can include raising the roadbed above the flood level, rebuilding culverts so they can pass more water, replacing worn or damaged culverts with newer ones that allow water to flow more quickly. The example shown in Figures 4-15 and 4-16 included all of these techniques, with the roadway height increased and the larger double box culvert replacing the three smaller round metal ones,

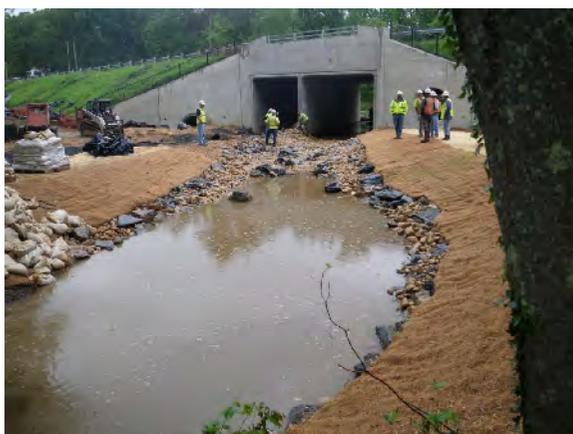
Figure 4-15: New Replacement Culvert (Source: KCI)

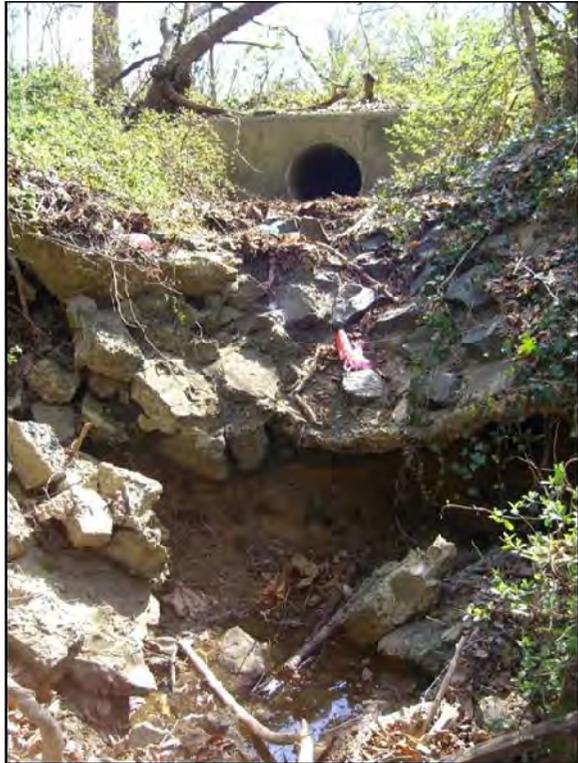
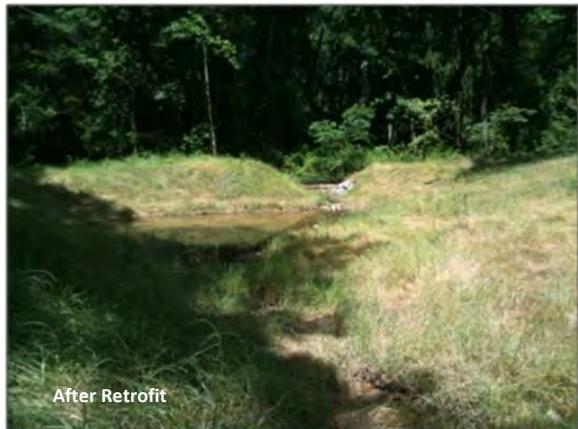
**Figure 4-16: Outfall Improvement (Source: Fairfax County)**

Outfall improvements can be designed to provide water quality treatment along with energy dissipation. In an area with more constraints, a more common approach is to improve the conveyance immediately below the outfall structure to provide more energy dissipation and reduce scour and erosion. Methods include the use of rip rap, plunge pools to break the flow of water and energy dissipation structures which adds turbulence to reduce the velocity of the outfall discharge.

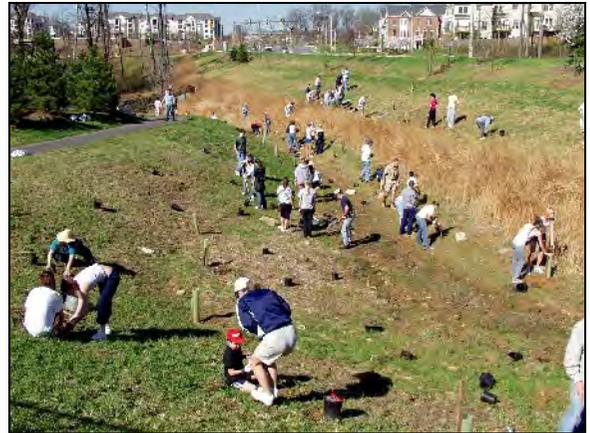
Figure 4-17: A buffer restoration project in Fairfax County (Source: Fairfax County)

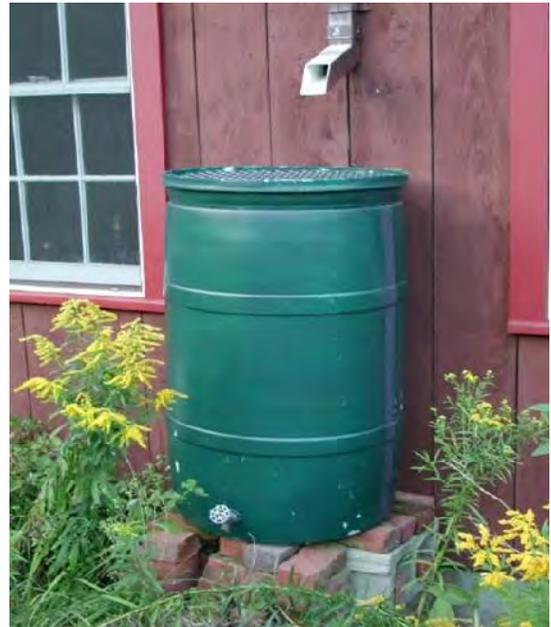
Figure 4-18: A rain barrel (Source: Project Clean Water)

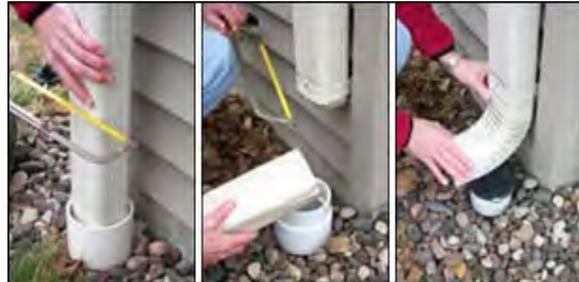
Figure 4-19: Disconnecting a downspout (Source: City of Toronto)

Downspout disconnection consists of adding piping or gutter systems on the ground to turn the flow from a downspout away from driveways or sidewalks to lawns or landscaped areas. Rooftop runoff redirected in this fashion is treated by surface filtration through the vegetated area and infiltration into the soil. Directing runoff onto vegetation allows the biological processes to reduce pollutants. This is also an effective method of preventing temperature increases in runoff.

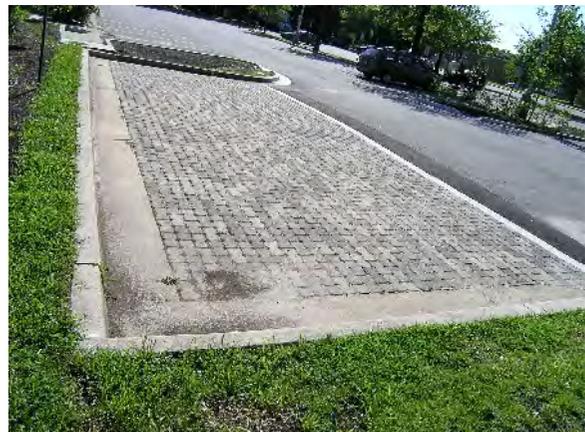
Figure 4-20: Permeable pavement blocks in a parking lot (Source: Fairfax County)

For parking lots, driveways, walkways and other hard surfaces the use of pervious pavement systems can provide a form of disconnection. These systems may consist of a special asphaltic paving material (porous pavement), a special concrete material (porous concrete) or open jointed concrete blocks (permeable pavement blocks). They allow stormwater to infiltrate directly through the surface instead of flowing to a collection system. The most significant constraint is the requirement for an underdrain if the soils below the surface are not permeable and will not allow the runoff to infiltrate. Maintenance is also required to prevent sediment from clogging the surface and preventing the water from infiltrating through the surface.

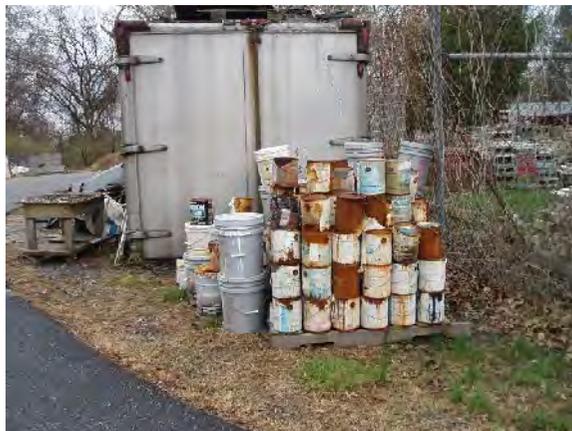
**Figure 4-24: Improperly Stored Outdoor Materials**  
(Source: Center for Watershed Protection)

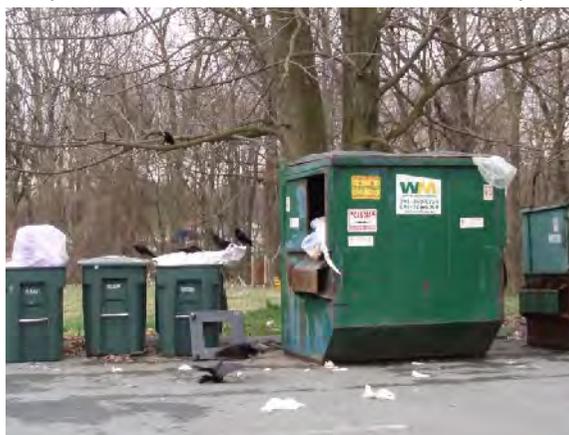
**Figure 4-25: Improper Dumpster Maintenance**  
(Source: Center for Watershed Protection)

Dumpsters provide temporary storage of solid waste at many businesses and can be a significant pollution source if improperly maintained. Many dumpsters are open, which allows rainfall to mix with the wastes, generating a source of trash, oil and grease, metals, bacteria, organic material, excess nutrients and sediments. Good dumpster management is particularly important to reduce trash loadings to a stream.

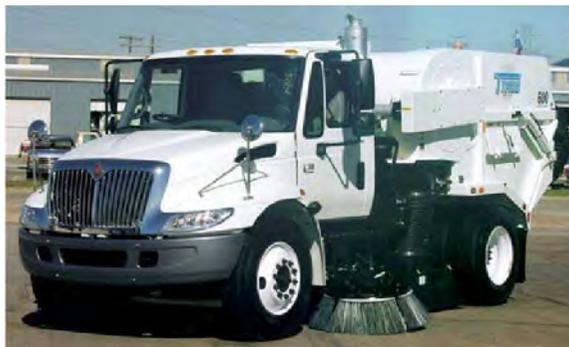
**Figure 4-26: Street Sweeper (Source: Tymco, Inc.)**

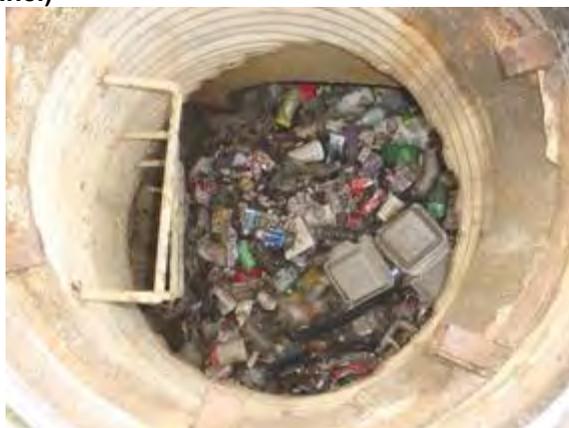
**Figure 4-27: Catch Basin Fairfax County (Source: Fairfax County)**
