### 3.13 Sharpers Run – Subwatershed Condition

#### 3.13.1 Subwatershed Characteristics

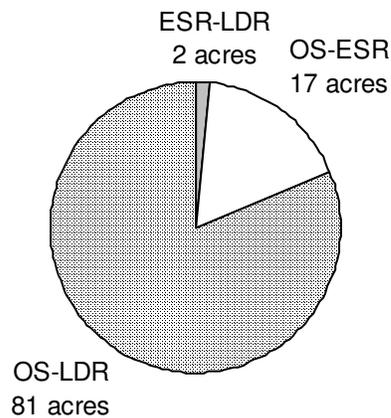
**Figure 3.16: Changed Land Use**

According to Figure 3.16, 81 acres are projected to shift from open space to low-density residential and 17 acres are projected to shift from open space to estate residential. This does not guarantee that the open space will become developed – it suggests that these areas of open space can be used for development/ redevelopment in the future. There is the possibility that Sharpers Run could lose much of its open space to development, which may result in increased levels of **impervious** surface and contribute **runoff** to the stream system. These shifts illustrate a demand for additional housing in the future.

The notable changes between existing land use and future land use in Sharpers Run are projected in the open space, estate and low-density residential categories. There is projected to be a 24 percent loss in the open space category, with compensatory increases in the estate residential category and low-density residential categories (4 percent and 20 percent respectively).

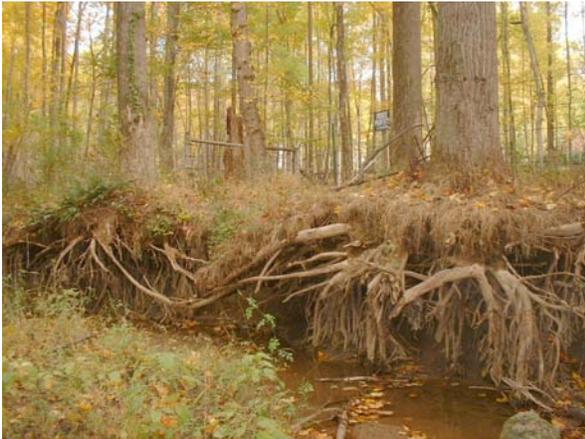
There were three specific erosion points totaling 65 feet that were noted in the subwatershed. All were creating a severe impact on the stream condition and had moderate restoration potential.

*Photo 3.34 Eroding bank located east of the Lawns of Towlston Community (DFSP002.E001)*

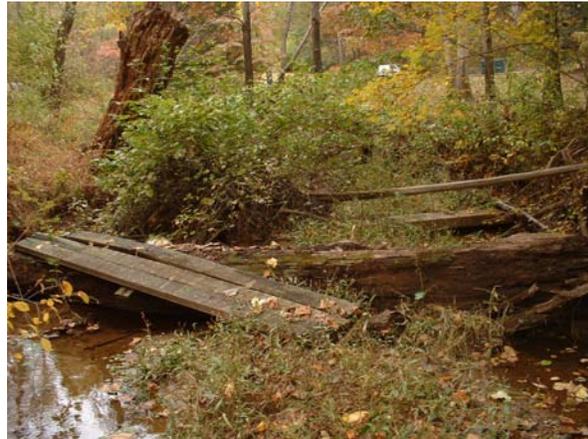
There was one stream blockage made up of trees and debris that appeared to be restricting fish movement. The obstruction also has the potential to create **flooding** problems under high flow conditions. The obstruction is shown in Photo 3.35 and is a candidate site for restoration S90.

*Photo 3.35 Obstruction at the northern end of Sharpers Run near the confluence with Rocky Run between the Bryan Pond and Peacock Station communities (DFSP001.T001).*

S90 The Stream Physical Assessment identified this site as having buffer and erosion problems along with active widening. There is also a stream blockage at this site (Photo 3.35, 3.36).

Site Investigation and Projects: The site investigation showed moderately eroding streambanks and a non-forested area within the left riparian zone. The stream is located between two gravel residential driveways.

*DF9290 (Streambank Stabilization/Buffer Restoration)* The banks would be regraded and stabilized. The left riparian area would be planted with native trees and shrubs.

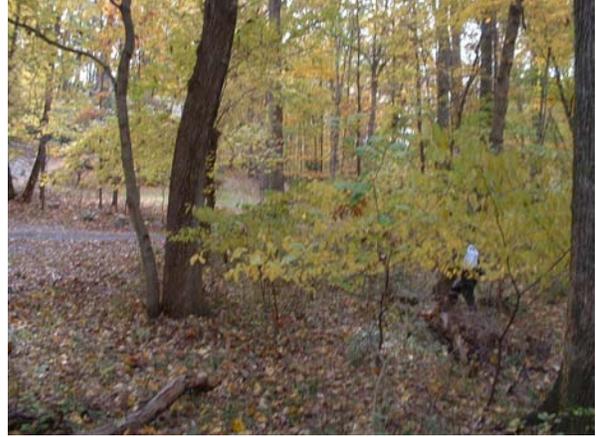
- All of the reaches have Fair habitat for aquatic insects and fish.
- There is 6,450 feet of **riparian buffer** encroachment (this length includes left and right banks combined). Of this total, 5,650 feet (88 percent) is impacted by lawns, and 800 feet (12 percent) is bordered by meadow.
- Fifty-six percent of the buffer encroachment length is affecting the stream channel by reducing shading effects. One of the buffer encroachment sites is shown below in Photo 3.36. This site is a stream restoration candidate site S90.
- Seventy-one percent of the **buffer** encroachment length has a moderate restoration potential while 29 percent was identified only having low restoration potential.

*Photo 3.36 Buffer encroachment between Rocky Run Road and Cedrus Lane (DFSP001.B004).*

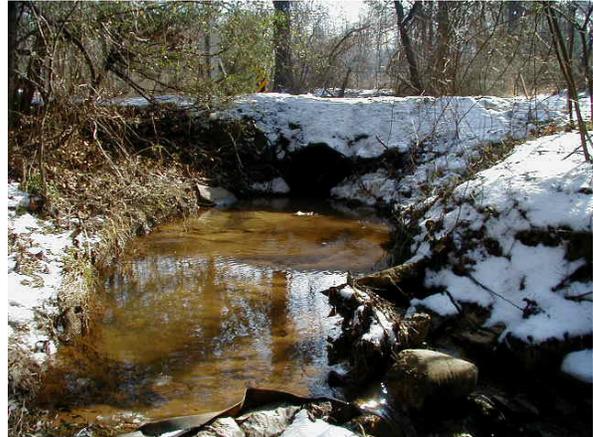
Culvert #80 (Photo 3.37) overtopped for all events except the one and two-year. Bellview Road carries through traffic, so it is considered a primary road. This means that it must pass the 25-year event.

*Photo 3.37 Sharpers Run mainstem at Bellview Road.*

One culvert in the subwatershed was overtopped with existing flows, as shown in Table 3.23. Road crossings that experience overtopping are listed in Appendix F and it is anticipated that improvements will be pursued with VDOT independent of the watershed planning process.

F80 The culvert under Bellview Road, which is considered a primary road, overtops for 5-year and greater events. Primary roads must pass the 25-year event (Photo 3.37).
