Chapter 2: Watershed Condition

2.1 General Watershed Information

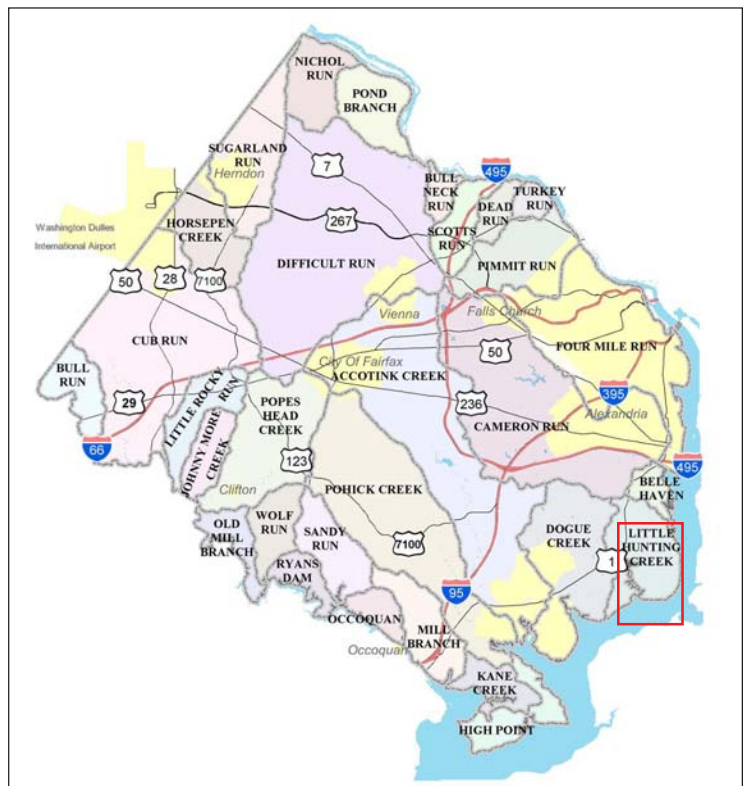
Figure 2.1 Location of the Little Hunting Creek Watershed

The Little Hunting Creek Watershed is located in the Chesapeake Bay watershed in the southeastern part of Fairfax County, Virginia, as shown on Figure 2.1 and in greater detail on Map 2.1. It is bounded to the west by the Dogue Creek Watershed, to the south and east by the Potomac River, and to the north by the Belle Haven Watershed. The Little Hunting Creek Watershed encompasses 7,067 acres (11.042 square miles) and is located in the coastal plain physiographic province, a region characterized by sandy soil and low-gradient topography.
