Little Rocky Run Johnny Moore Creek

Watershed Workbook Draft

Fairfax County
Stormwater Planning Division
Department of Public Works and
Environmental Services

October 2008

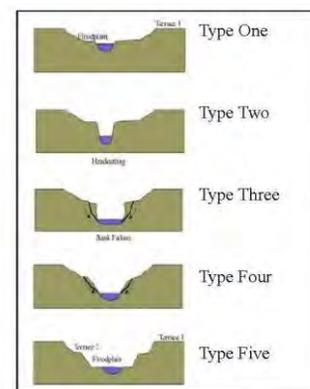
CEM Type	Description
1	Stable stream banks and developed channel
2	Deep incised channel
3	Unstable stream banks and actively widening channel
4	Stream bank stabilizing and channel developing
5	Stable stream banks and widened channel

Incised Channel Evolution Model (Schumm, Harvey, and Watson, 1984)

The CEM Types 2 and 3 are shown on the stream condition map because these types are considered the most unstable. In the WMAs, all of the assessed reaches are CEM Type 3, except for the tributary that crosses Fox Shadow Lane, which is a CEM Type 4.

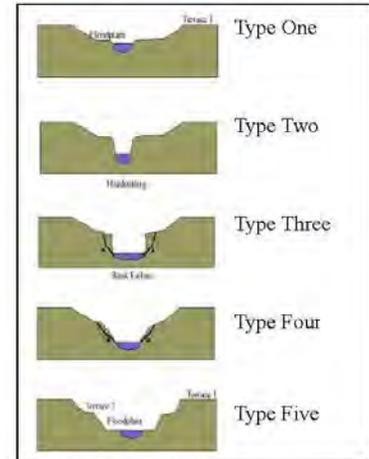
CEM Type	Description
1	Stable stream banks and developed channel
2	Deep incised channel
3	Unstable stream banks and actively widening channel
4	Stream bank stabilizing and channel developing
5	Stable stream banks and widened channel

Incised Channel Evolution Model (Schumm, Harvey, and Watson, 1984)
