2.4 Little Rocky Run - Lower and Little Rocky Run – Bull Run WMAs

2.4.1 WMA Characteristics

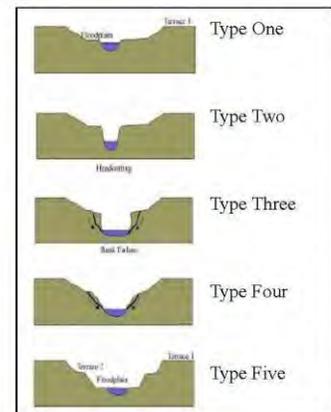
Incised Channel Evolution Model (Schumm, Harvey, and Watson, 1984)

The geomorphological assessment of the stream channels in the WMA was performed in 2003 and was based on the conceptual incised channel evolution model (CEM) developed by Schumm et al (1984). The CEM provides information about the evolution of a stream channel in response to disturbance. Based on visual observation of the channel cross section and other morphological observations of the channel segment, the CEM type was assigned for the channel segment. The CEM types are summarized below.

CEM Type	Description
1	Stable stream banks and developed channel
2	Deep incised channel
3	Unstable stream banks and actively widening channel
4	Stream bank stabilizing and channel developing
5	Stable stream banks and widened channel

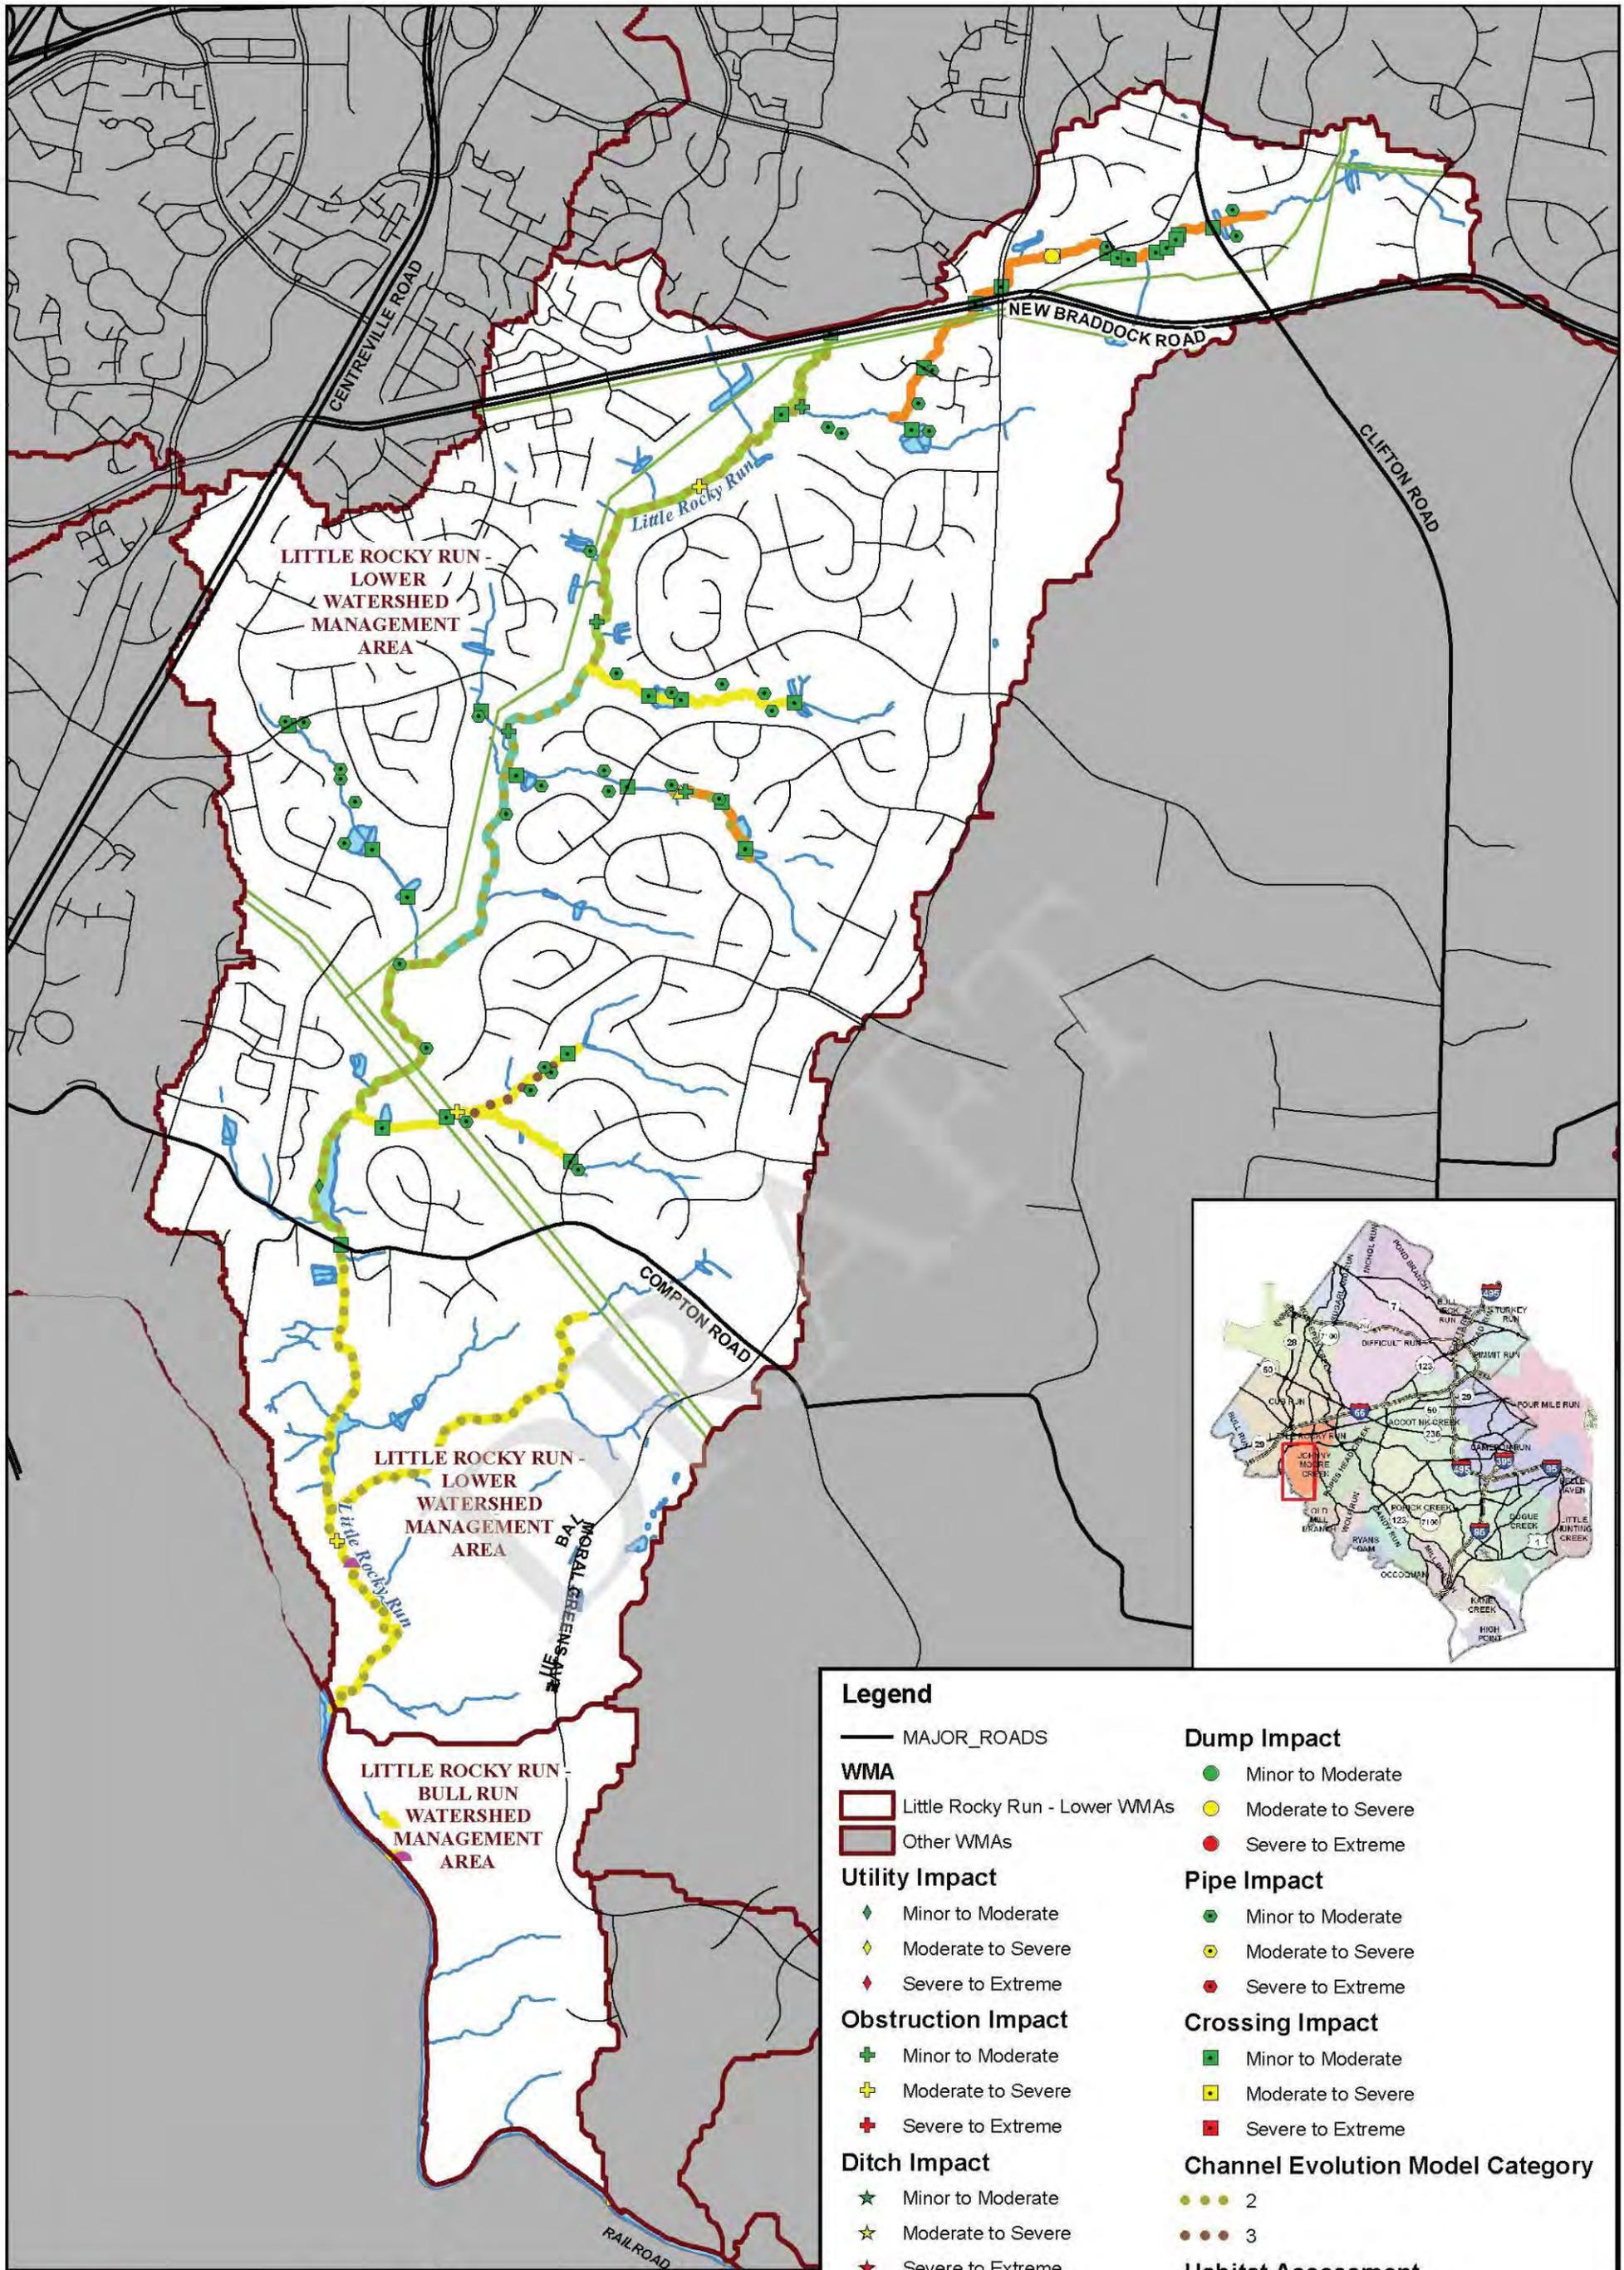
Map 2-12
Little Rocky Run - Lower and Little Rocky Run - Bull Run WMAs
Stream Condition

The County conducted a *Stream Physical Assessment (SPA)* in August 2005 that assessed the habitat, stream geomorphology and impacts to the streams from crossings, ditches, pipes, headcuts, dump sites, utilities and obstructions. Map 2-12 summarizes the SPA data.

The CEM Types 2 and 3 are shown on the stream condition map because these types are considered the most unstable. In the WMAs, 4.6 miles (69%) is Type 2, 1.9 miles (28%) is Type 4 and 0.2 (3%) miles is Type 3.

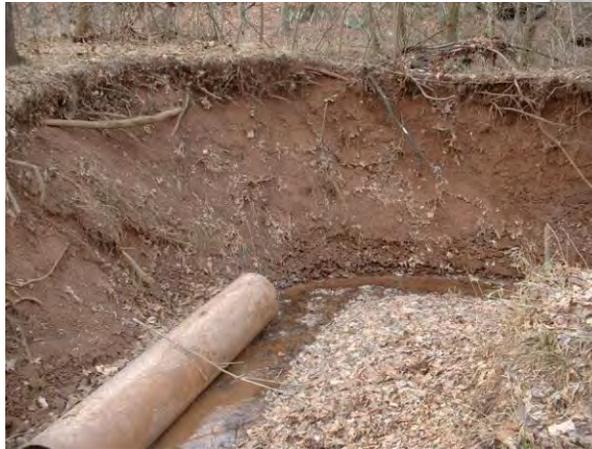
Figure 2-16: Erosion area on tributary in Little Rocky Run - Bull Run

There were two noted areas of moderate erosion, one on Little Rocky Run approximately 1,800 feet upstream of the confluence with Bull Run and one on a tributary in the Little Rocky Run – Bull Run WMA. A photo of the Little Rocky Run – Bull Run erosion area is shown below.

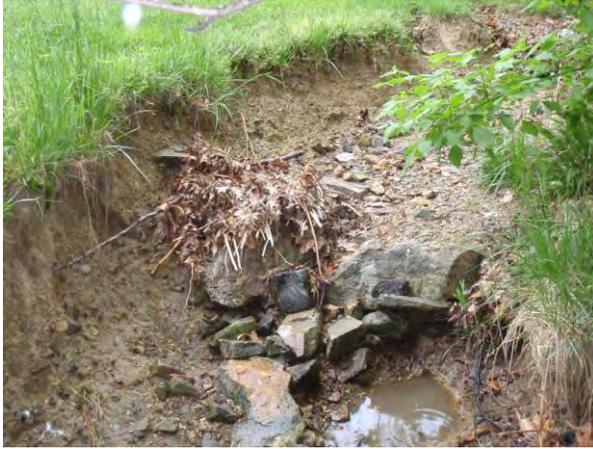
Figure 2-20: Severe erosion occurring at the end of a concrete trickle ditch in the Little Rocky Run subdivision (Battle Rock Drive)

The tributary segment observed as poor in 2005 near South Springs Dr. is currently experiencing severe erosion problems. The following photos show the severe erosion and headcuts occurring at several different locations in this area. This erosion is affecting several smaller tributaries, however the main channel of the tributary appears fairly stable.

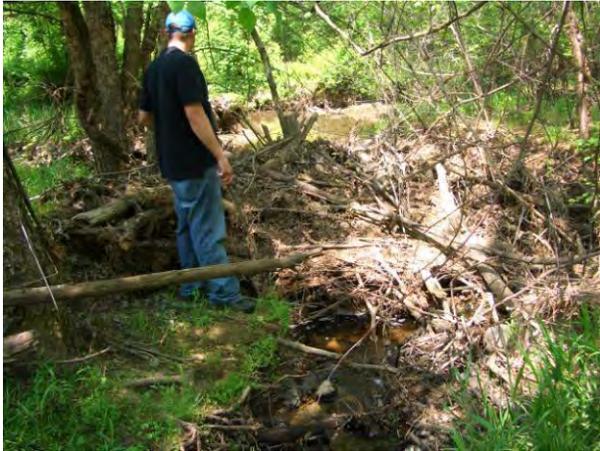
Figure 2-23: Major debris obstruction at the confluence of a tributary and Little Rocky Run behind the Little Rocky Run subdivision

The poor tributary segment observed in 2005 near the intersection of Union Mill Road and Braddock Road has poorly vegetated and swampy buffers as well as several obstructions. These problems exist in areas downstream of the intersection and past the tributary's confluence with Little Rocky Run. The following photos show two debris blockages located in this area.

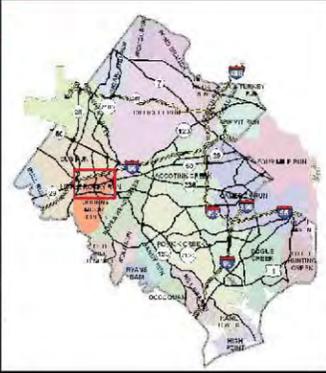
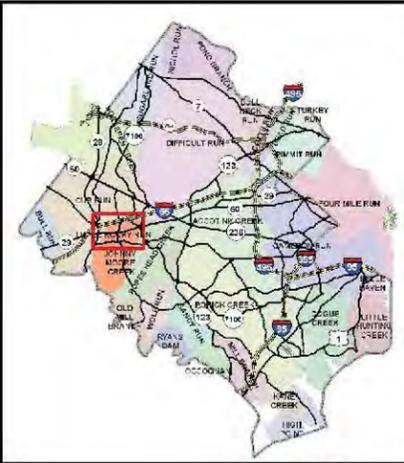
Map 2-20
 Little Rocky Run - Upper
 WMAs
 Stream Condition

LITTLE ROCKY - UPPER
WATERSHED MANAGEMENT
AREA

The CEM Types 2 and 3 are shown on the stream condition map because these types are considered the most unstable. In the WMA, 6.2 (95%) miles is Type 3, 0.2 miles (3%) is Type 4 and 0.1 miles (2%) is Type 2.

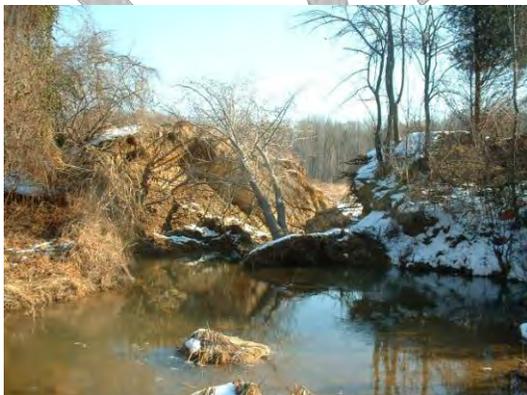
Figure 2-27: Erosion area on Little Rocky Run upstream of Willow Springs Branch

A severe erosion site was located on Little Rocky Run just upstream of its confluence with Willow Springs Branch. The picture below shows that this is a dam that appears to have failed. There was also an area of moderate erosion noted on Willow Springs Branch approximately 1,400 feet upstream of Ashleigh Road.

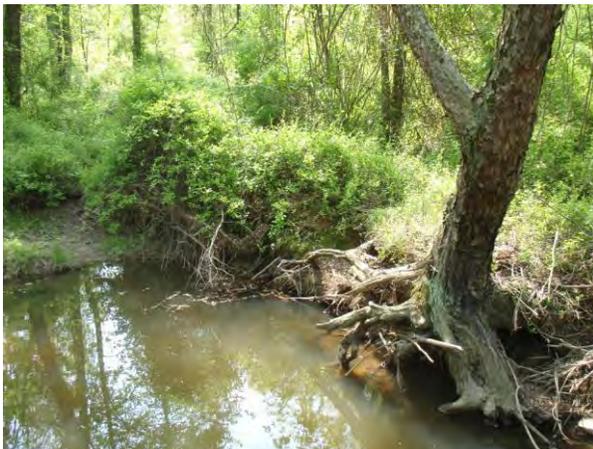
Figure 2-33: Severe erosion on Little Rocky upstream of Stringfellow Road

Little Rocky Run upstream of Stringfellow Road is experiencing erosion and beaver activity, negatively impacting the health of the watershed. The following photographs show these impacts.

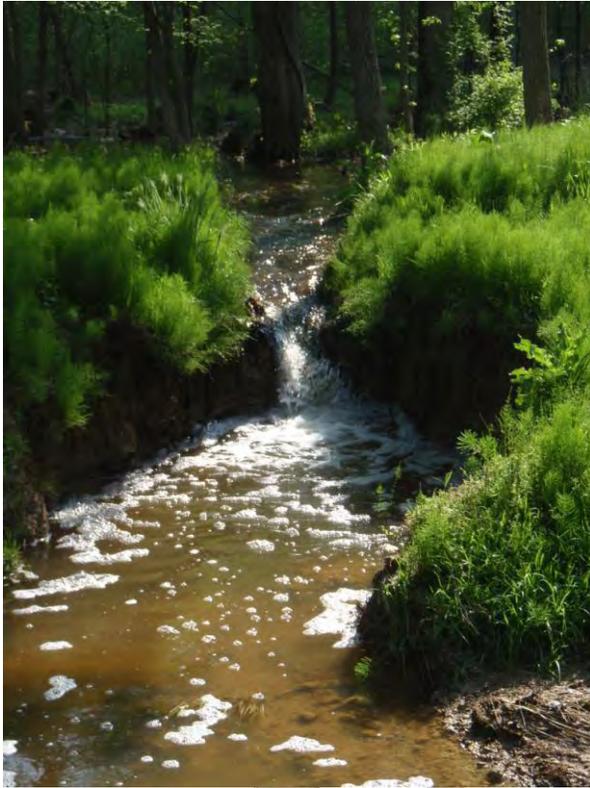
Figure 2-36: Approximately 2ft headcut in tributary upstream of regional pond R17

The area of the watershed upstream of regional pond R17 is experiencing impacts from man-made obstructions, beaver activity, bank erosion and headcuts. The following photos show several examples from this area.
