Little Rocky Run Johnny Moore Creek Watershed Management Plan

Watershed Advisory Group #3
May 18, 2009

**Fairfax County Department of Public Works
and Environmental Services**

Presented by Watershed Planning & Assessment Branch,
Stormwater Management

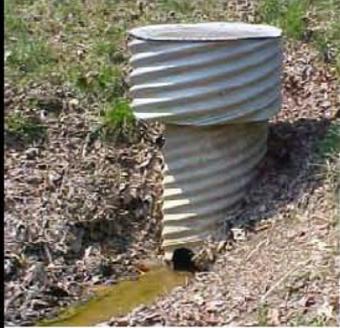
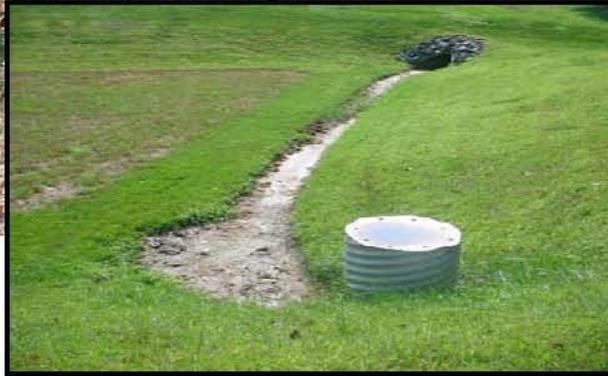
Problematic Conditions: Stormwater Pond was non-functional due to deterioration of control structures and depleted storage volume.

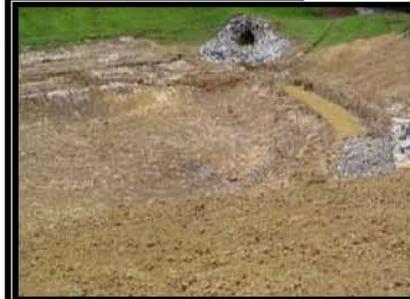
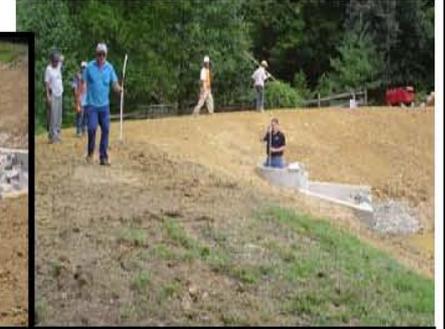
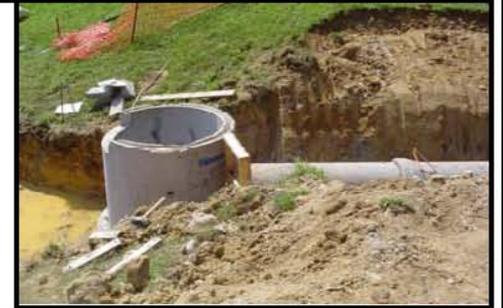
Key Project Elements: The height of the dam was increased, new control structures were installed, and a marsh was excavated in the pond floor.

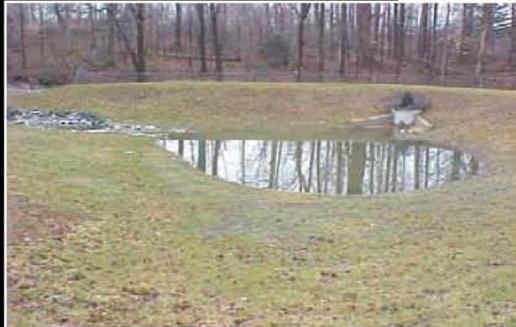
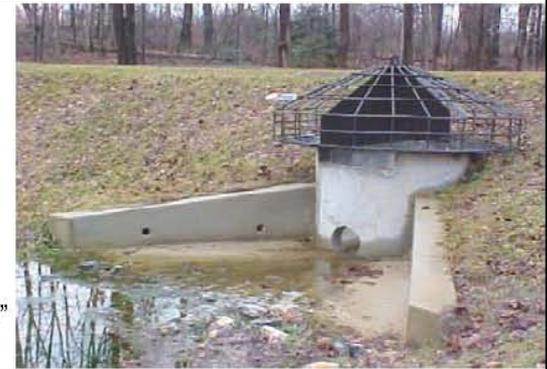
Existing Conditions: The pond has been seeded with an approved wetland seed mix and is currently stabilizing. Once it is stable the control devices (BMP plate and Trash Rack) will be installed.

Future activities: The pond was planted with a combination of wetland tolerant trees, shrubs and herbaceous plants in May 2005. The plantings help jump start the wetland habitat within the pond.

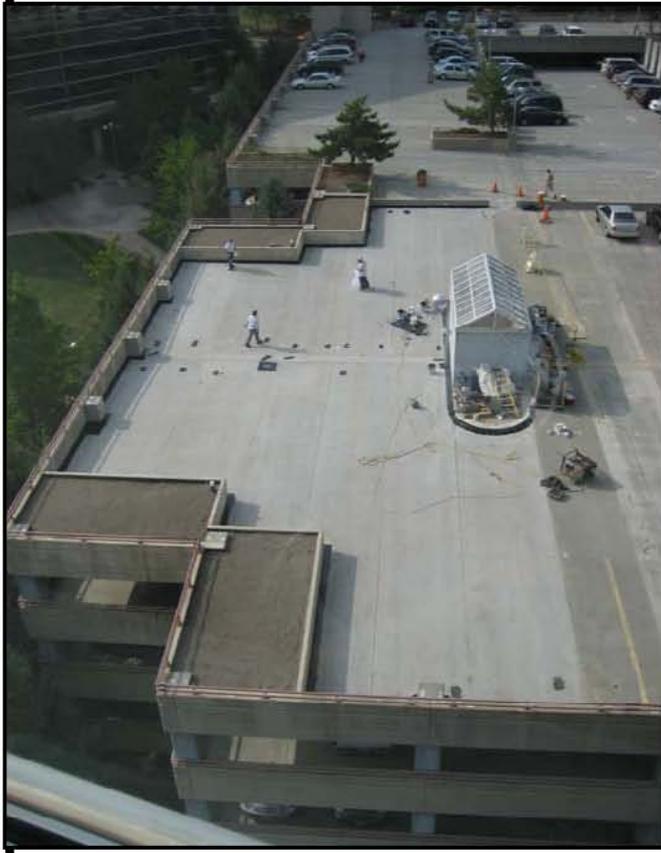
Problematic Conditions: Impervious surface rapidly conveyed stormwater from the rooftop, washing away pollutants from the parking area. Uncontrolled stormwater runoff leads to degraded water quality and in stream habitat.

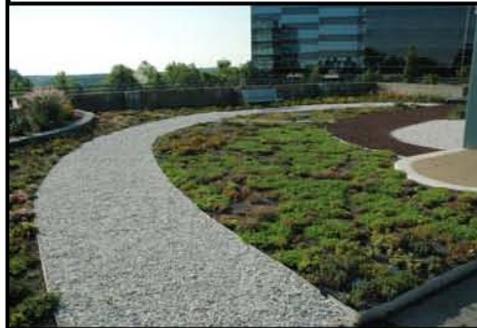
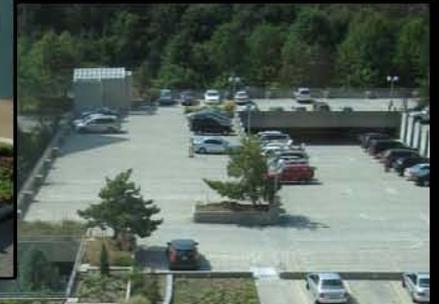
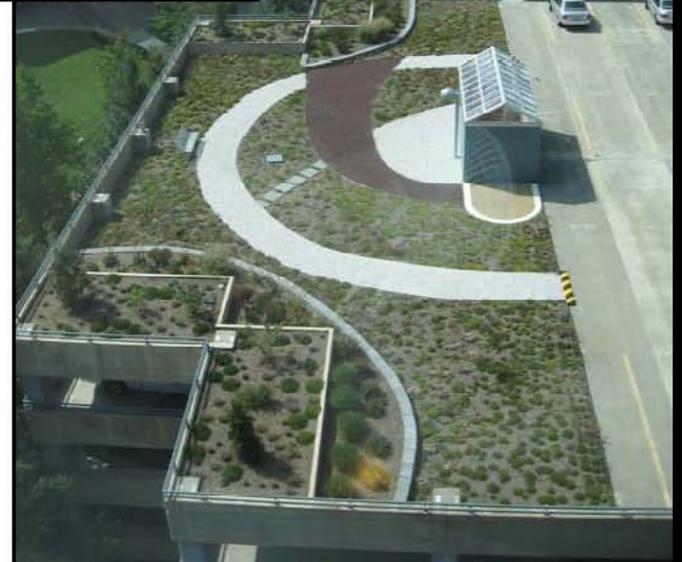
Key Project Elements: Decreased impervious surface; provides better water quality; created an amenity for workers; reduced amount of pollutants from the area where installed.

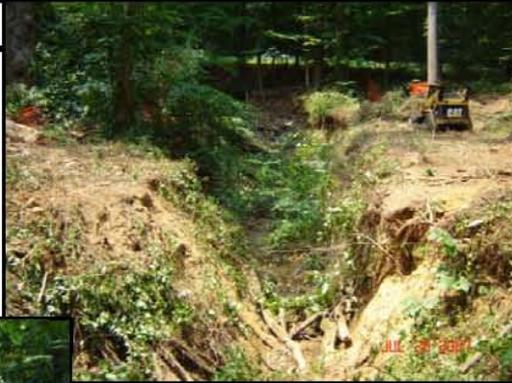
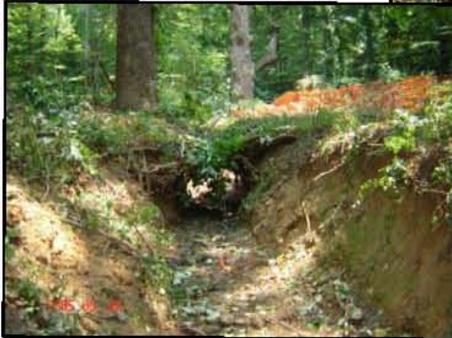
Problematic Conditions:
Large quantities of uncontrolled stormwater caused bank erosion, tree loss and negative impacts to aquatic life.

Possible Solution: Reduce runoff from upstream (LID & SWM); stabilize eroding banks & re-vegetate.

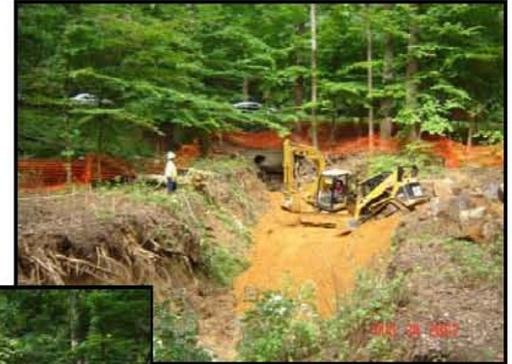
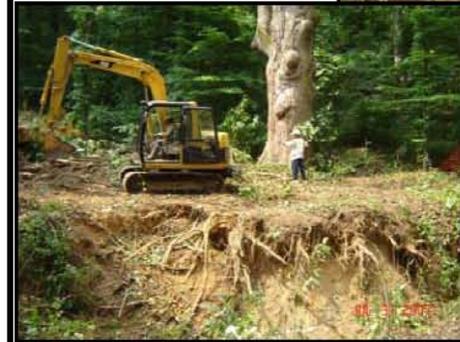
Key Project Elements:
The eroded stream was filled with suitable material to reconnect the channel to the natural floodplain.

Key Project Elements:
The project was designed using “natural stream restoration techniques” which aim at creating habitat for native wildlife.

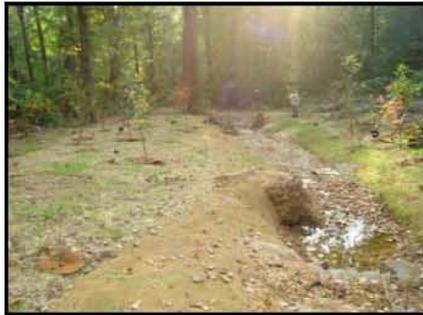
Existing Conditions: The stream was restored to a more natural design. A riparian seed mix and native trees were planted on impacted areas of the site.

Future activities: Continued monitoring of the vegetation and structures (cross veins, log jams, etc.) will occur. Ideally, aquatic organisms will re-inhabit the restored reach.

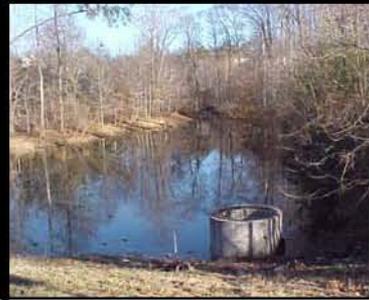
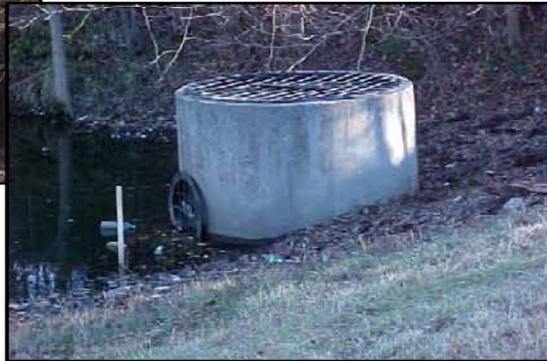
Problematic Conditions: Stormwater pond was non-functional due to deterioration of control structures and depleted storage volume.

Solution: Dredge silt from basin to increase volume. Retrofit existing Regional Pond with micro-pools, a gabion baffle, and wetland vegetation. Retrofit outlet control structure.

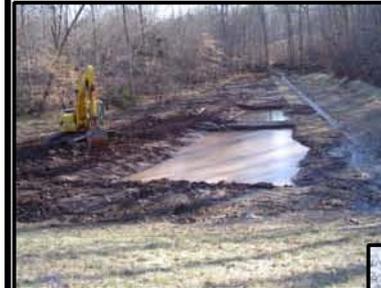
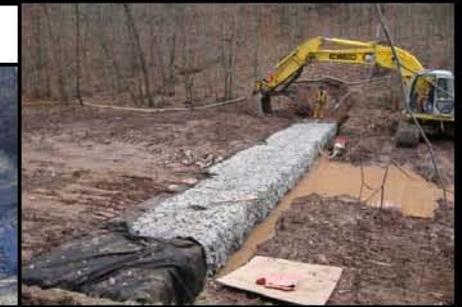
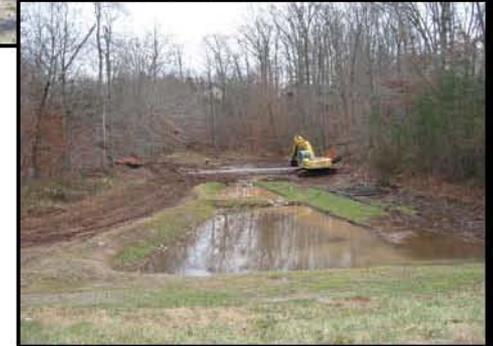
Key Project Elements: A sediment filter (gabion baffle) and micro-pools were installed to allow sediment to settle out of the stormwater before flowing out of the facility.

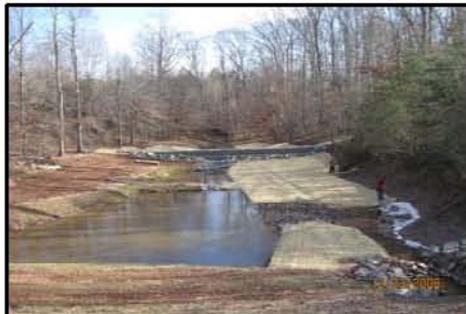
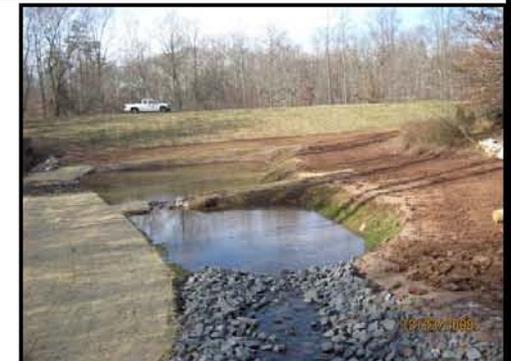
Existing Conditions: The pond has been seeded with an approved wetland seed mix and is currently stabilizing. Once it is stable the control devices (BMP plate and Trash Rack) will be installed.

Future activities: The pond was planted with a combination of wetland tolerant trees, shrubs and herbaceous plants. The plantings will help to jump start the wetland habitat within the pond.

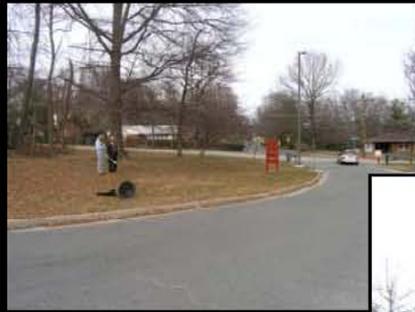
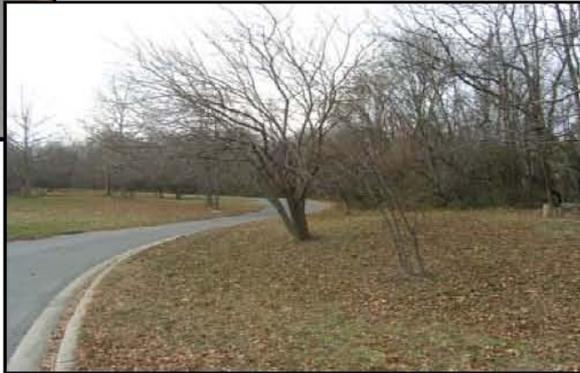
Problematic Conditions: Stormwater from impervious surfaces lacked quality treatment (i.e.: nutrients, oil & other pollutants). Installation of a rain garden (bioretention basin) provides for water quality treatment and groundwater recharge through infiltration.

Key Project Elements: Bioretention basins are hybrid retention/detention facilities that provide both water quality control and peak discharge rate control for runoff from impervious areas.

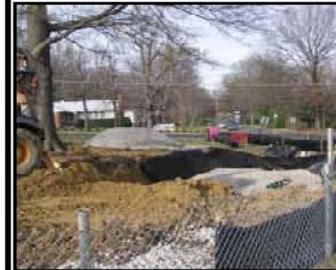
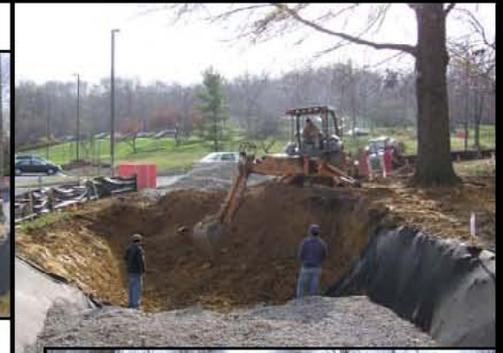
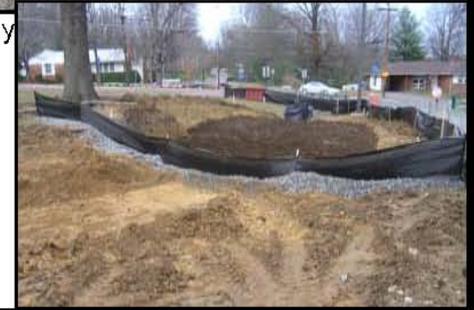
Key Project Elements: Stormwater runoff is treated by rapid filtering through bioretention soil media, biological and biochemical reactions within the soil matrix and around the root zones of the plants, and infiltration into the underlying soil strata.

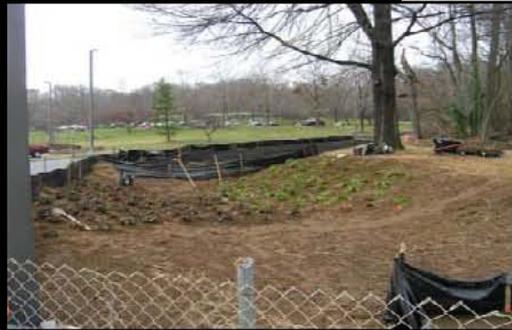
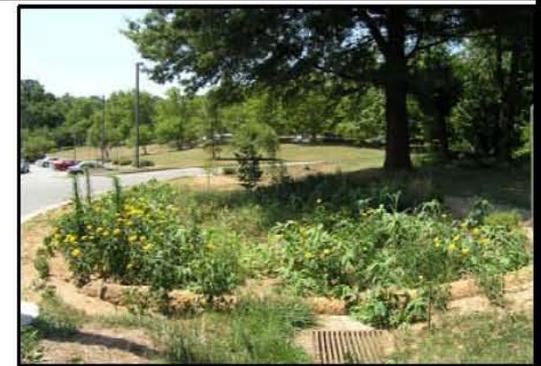
POST-CONSTRUCTION

Future activities: The rain garden was planted with a combination of native trees, shrubs and herbaceous plants that will provide nutrient uptake and provide an aesthetic benefit. The plantings will also provide habitat for organisms like birds and butterflies.

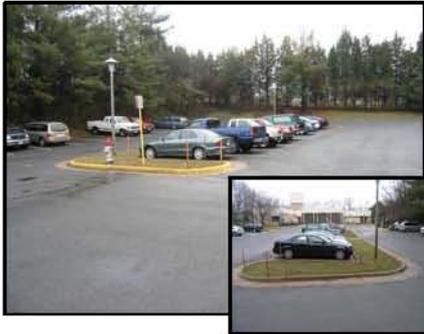
Key Project Elements: Bioretention basins are hybrid retention/detention facilities that provide both water quality control and peak discharge rate control for runoff from impervious areas.

Problematic Conditions: Stormwater from impervious surfaces lacked quality & quantity treatment (ie.: nutrients, oil, SW volume & other pollutants). Installation of a rain garden (bioretention basin) provides for water quality treatment and groundwater recharge through infiltration. The porous pavement provides for greater infiltration of runoff.

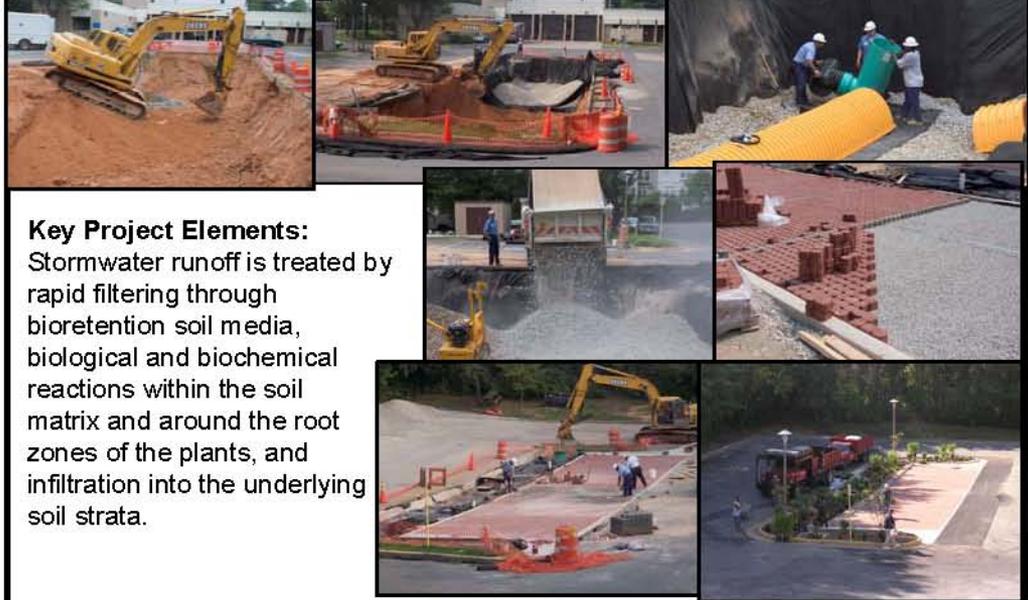
Key Project Elements: Stormwater runoff is treated by rapid filtering through bioretention soil media, biological and biochemical reactions within the soil matrix and around the root zones of the plants, and infiltration into the underlying soil strata.

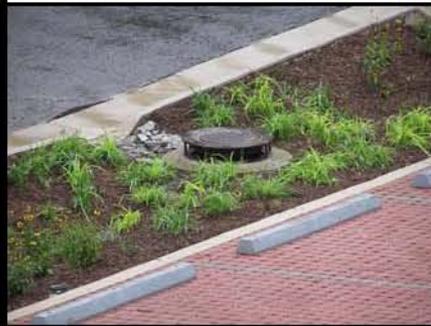
POST-CONSTRUCTION

Future activities: The rain garden was planted with a combination of native trees, shrubs and herbaceous plants that provide nutrient uptake and an aesthetic benefit. The plantings also provide habitat for organisms like birds and butterflies.

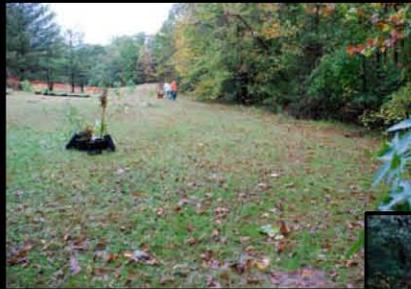
PRE-CONSTRUCTION

Problematic Conditions: Lack of a native riparian buffer decreases the amount of rain that infiltrates into the groundwater and increases the amount of pollutants that enter our waterways.

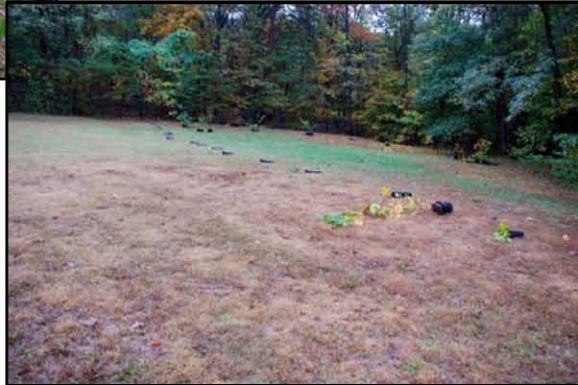
Establishing a native riparian buffer will reduce the amount of stormwater entering streams and filter nonpoint source pollutants.

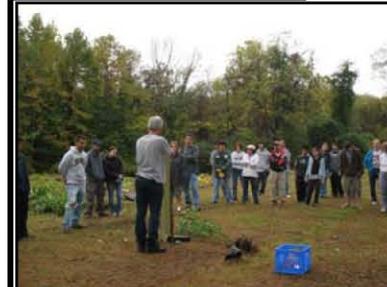
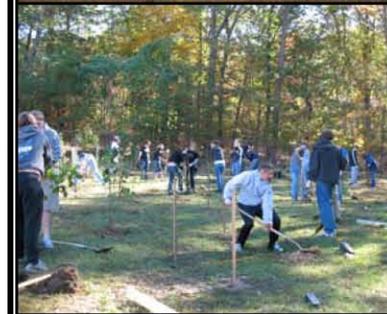
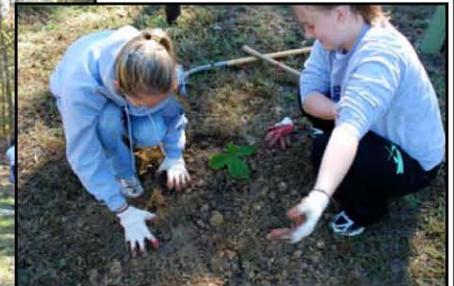
CONSTRUCTION

Key Project Elements: Educating residents on the importance of riparian buffers is key to the success of the planting. This site had 1005 trees and shrubs planted by 180 volunteers over two days.

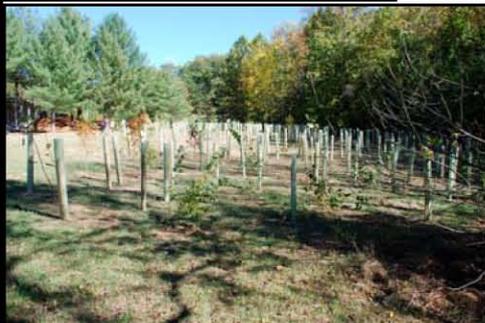
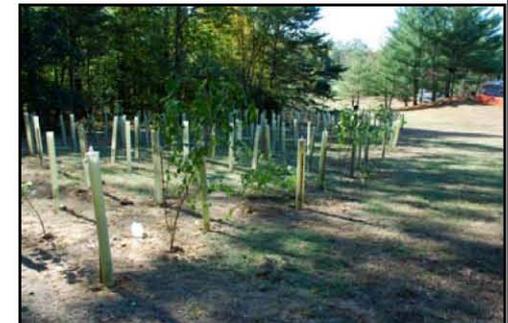
POST-CONSTRUCTION

Future activities: Future monitoring and maintenance is required to ensure survivorship of the plants. When mature, this area will provide a balanced ecosystem that will help reduce stormwater impacts and create habitat for wildlife.

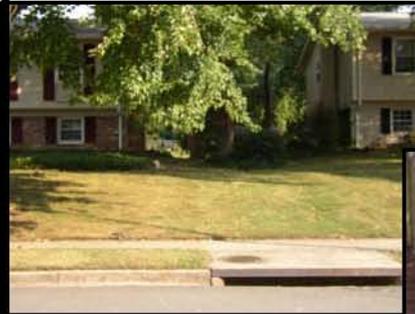
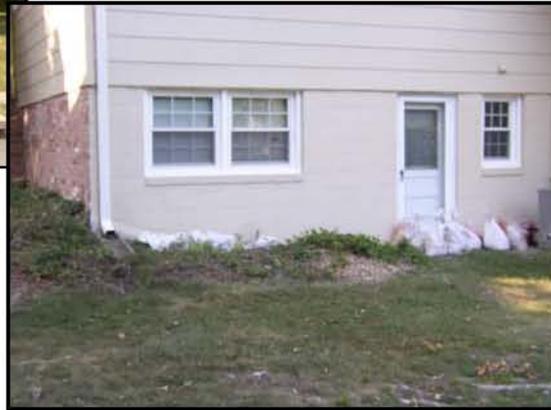
Problematic Conditions: The residential property flooded through the basement door in the rear yard.

Key Project Elements: Establishing a drainage swale to provide overland relief and prevent flooding.

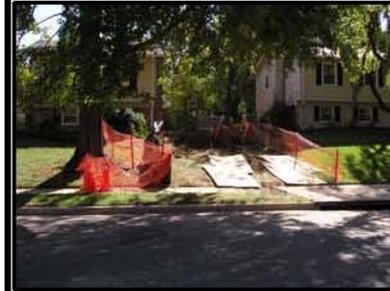
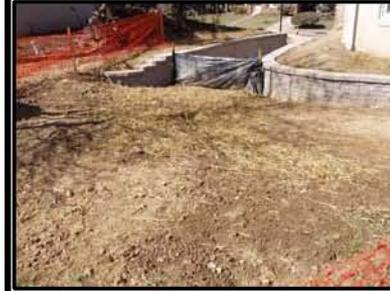
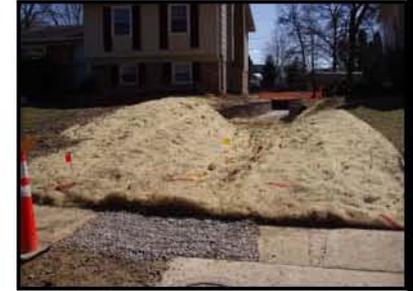
Key Project Elements: The project consisted of excavating an overland relief swale from the rear yard to the front yard and street. The narrow space and depth of the overland swale required the construction of two small retaining walls and the re-grading of the rear yard.

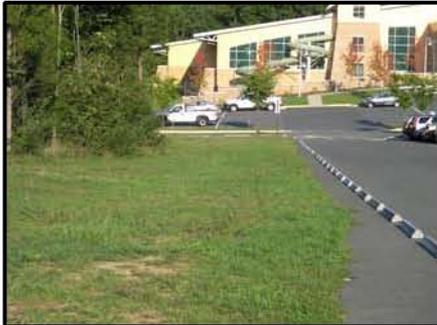
Problematic Conditions: Stormwater from impervious surfaces lacked quality & quantity treatment (ie.: nutrients, oil, SW volume & other pollutants). Installation of a rain garden (bioretention basin) and an infiltration trench (vegetated swale) provides for water quality treatment and groundwater recharge through infiltration.

Key Project Elements: Infiltration trenches serve as a stormwater management trench will allows for ponding/conveyance and eventual infiltration.

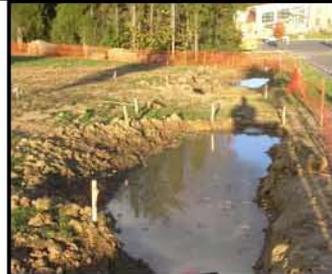
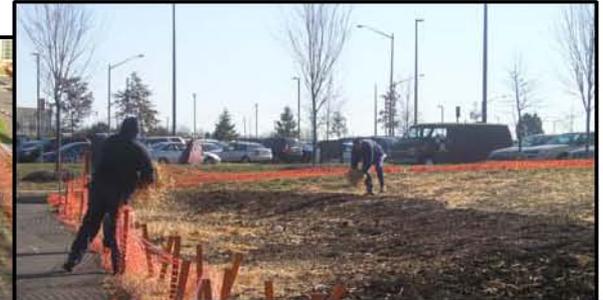
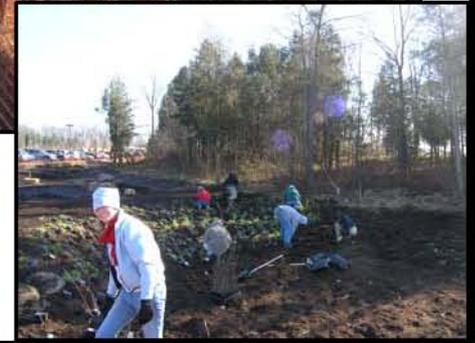
Key Project Elements: Stormwater runoff is treated by rapid filtering through bioretention soil media, biological and biochemical reactions within the soil matrix and around the root zones of the plants, and infiltration into the underlying soil strata.

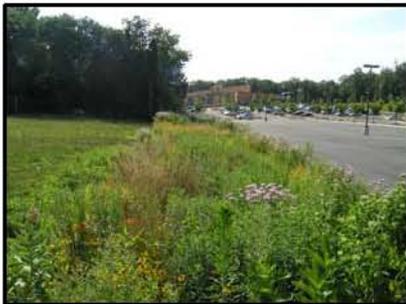
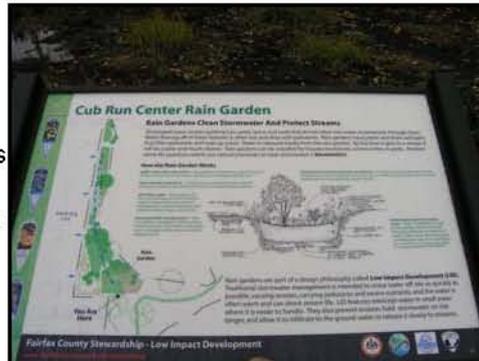
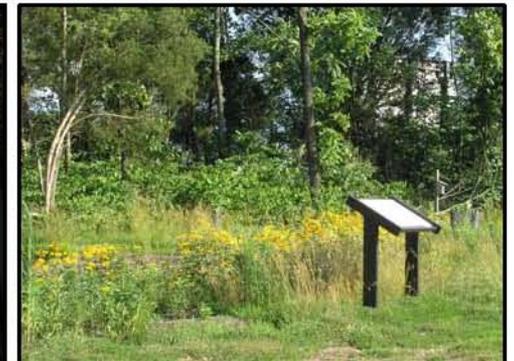
POST-CONSTRUCTION

Future activities: The rain garden was planted with a combination of native trees, shrubs and herbaceous plants that provide nutrient uptake and an aesthetic benefit. The plantings also provide habitat for organisms like birds and butterflies.
