4. Watershed Restoration Strategies

4.1 Watershed Project Descriptions

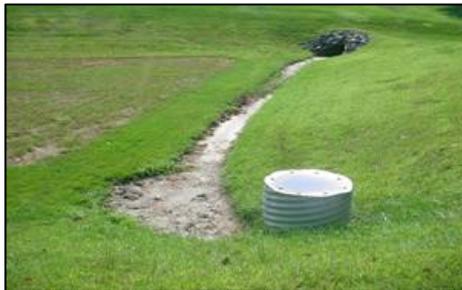
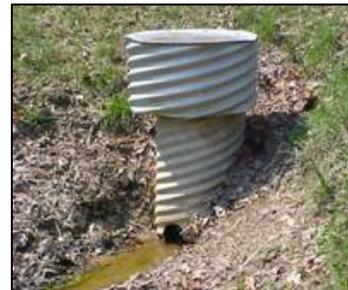
PRE-CONSTRUCTION

Stormwater Pond was non-functional due to deterioration of control structures and depleted storage volume.

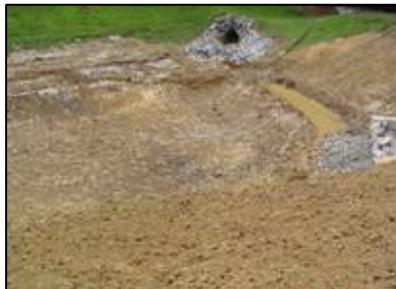
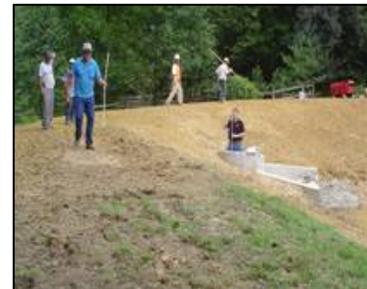
CONSTRUCTION

The height of the dam was increased, new control structures were installed, and a marsh was excavated in the pond floor.

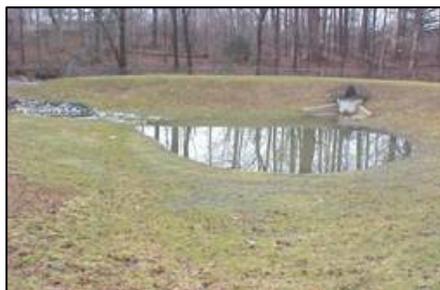
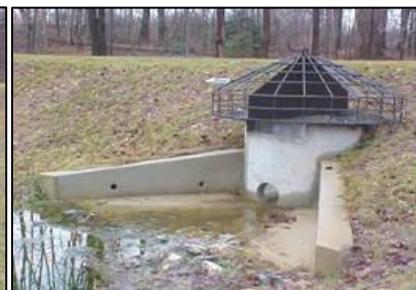
POST-CONSTRUCTION

The pond has been seeded with an approved wetland seed mix and is currently stabilizing. Once it is stable the control devices (BMP plate and Trash Rack) will be installed.

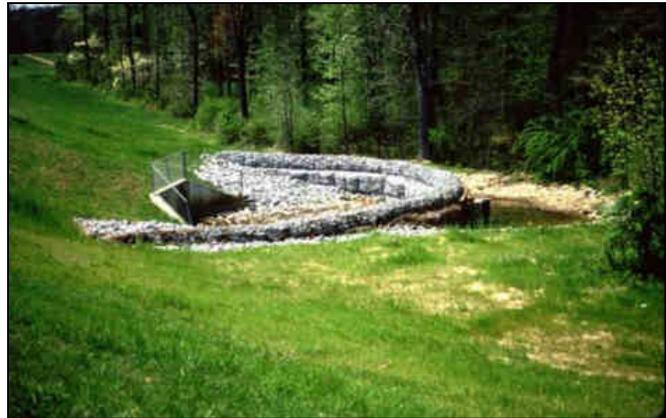
Culvert Retrofit Example:

There are two types of culvert retrofits: one to modify the culvert to address the culvert capacity and road flooding, and another to retrofit the upstream side of the culvert to provide stormwater management. This stormwater retrofit option is installed upstream from existing road culverts by constructing a control structure and excavating a micropool. These projects are designed for intermittent or ephemeral streams. The control structure will consist of a gabion weir that will detain and reduce stormwater flow; the micropool is a small pool that allows infiltration of stormwater runoff, improving water quality.

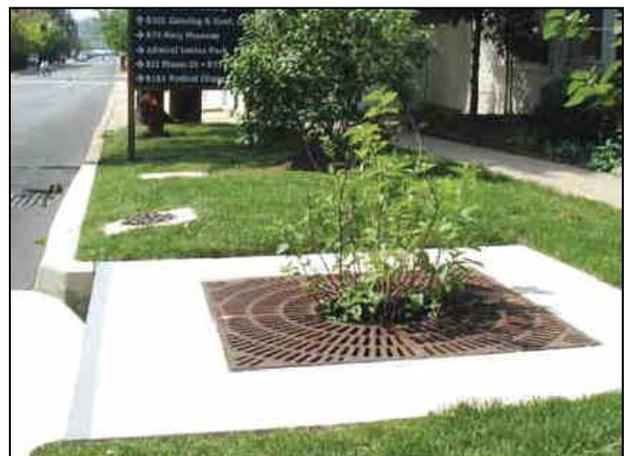
Tree Box Filter Example:

Tree box filters allow stormwater to flow through a specially designed filter mixture contained in a landscaped concrete container. The mixture immobilizes pollutants; those pollutants are then decomposed, volatilized and incorporated into the biomass of the tree box filter. Stormwater runoff flows through the media and into an underdrain system at the bottom of the container, where the treated water is discharged. They are useful on highly developed sites such as parking lots and streetscapes.

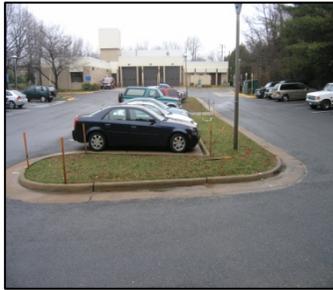
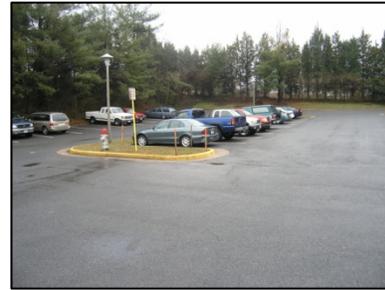
PRE-CONSTRUCTION

Stormwater from impervious surfaces lacked quality and quantity treatment. Installation of a rain garden (bioretention basin) provides for water quality treatment and groundwater recharge through infiltration. The porous pavement provides for greater infiltration of runoff.

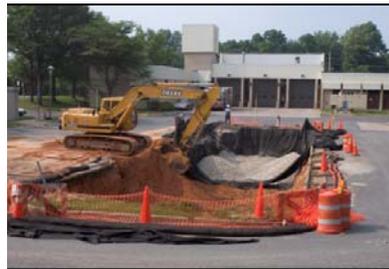
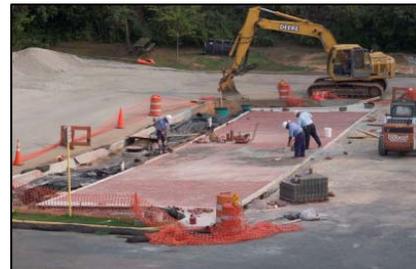
CONSTRUCTION

Stormwater runoff is treated by rapid filtering through bioretention soil media, biological and biochemical reactions within the soil matrix and around the root zones of the plants, and infiltration into the underlying soil strata.

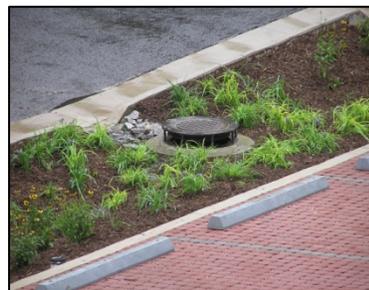
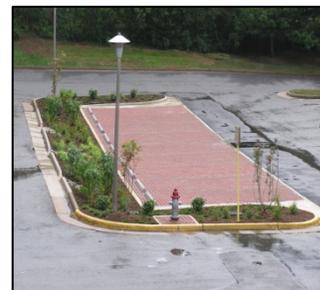
POST-CONSTRUCTION

The rain garden was planted with a combination of native trees, shrubs and herbaceous plants that provide nutrient uptake and an aesthetic benefit. The plantings also provide habitat for organisms like birds and butterflies.

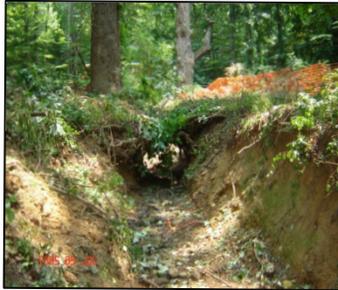
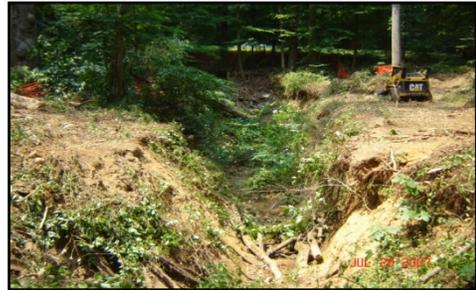
PRE-CONSTRUCTION

Large quantities of uncontrolled stormwater caused bank erosion, tree loss and negative impacts to aquatic life.

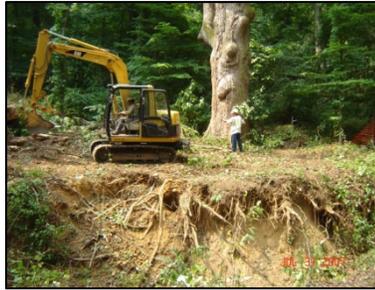
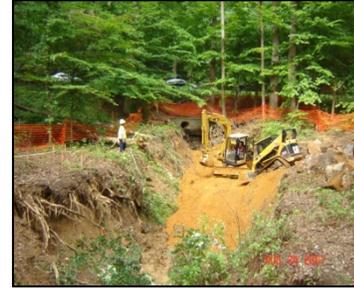
CONSTRUCTION

Key Project Elements: The eroded stream was filled with suitable material to reconnect the channel to the natural floodplain. The project was designed using “natural stream restoration techniques” which aim at creating habitat for native wildlife.

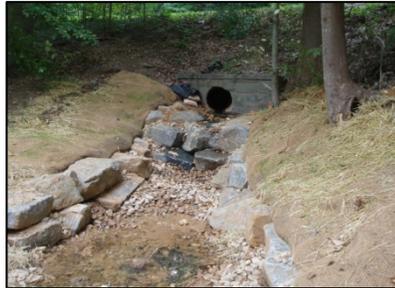
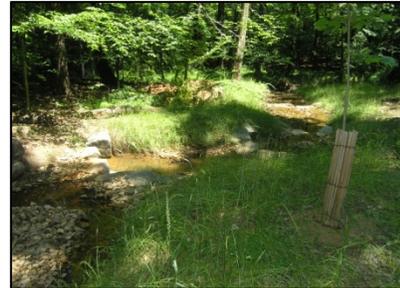
POST-CONSTRUCTION

The stream was restored to a more natural design. A riparian seed mix and native trees were planted on impacted areas of the site. Continued monitoring of the vegetation and structures (cross veins, log jams, etc.) will occur. Ideally, aquatic organisms will re-inhabit the restored reach.

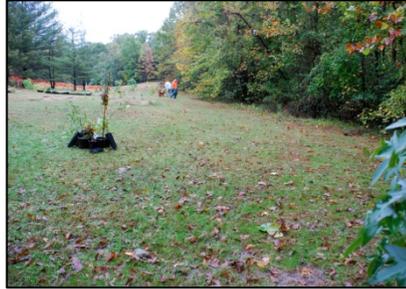
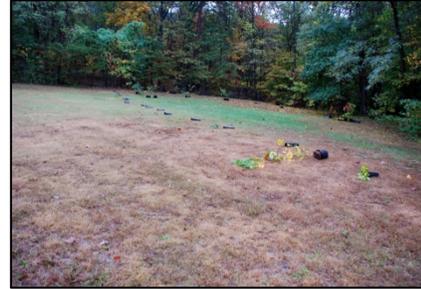
PRE-CONSTRUCTION

Lack of a native riparian buffer decreases the amount of rain that infiltrates into the groundwater and increases the amount of pollutants that enter our waterways.

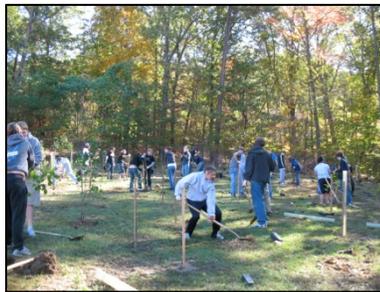
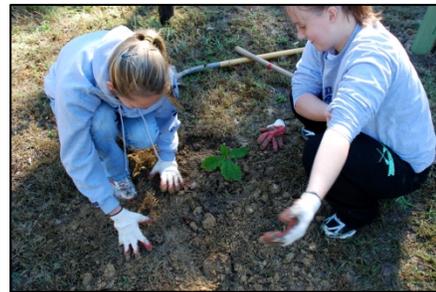
CONSTRUCTION

Establishing a native riparian buffer will reduce the amount of stormwater entering streams and filter nonpoint source pollutants. Educating residents on the importance of riparian buffers is key to the success of the planting. This site had 1005 trees and shrubs planted by 180 volunteers over two days.

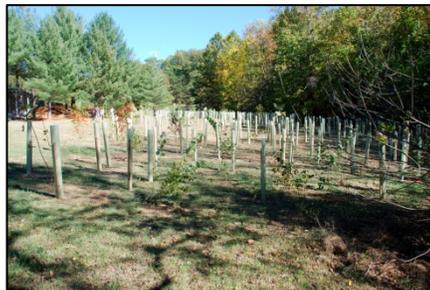
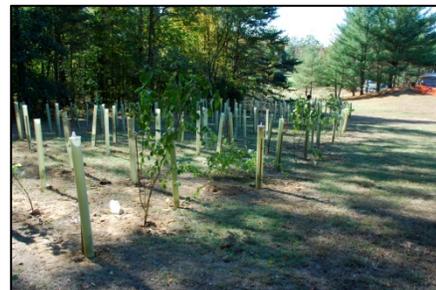
POST-CONSTRUCTION

Future monitoring and maintenance is required to ensure survival of the plants. When mature, this area will provide a balanced ecosystem that will help reduce stormwater impacts and create habitat for wildlife.
