Chapter 2:

Watershed Group Condition

2.1 General Watershed Group Information

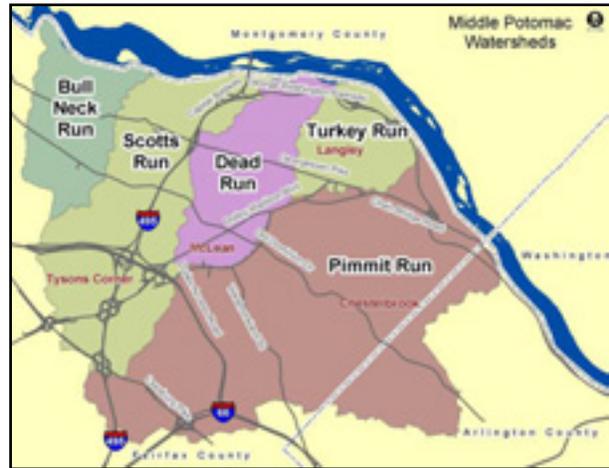
Figure 2.1 Middle Potomac Watersheds

The Middle Potomac Watershed Group is located in the Chesapeake Bay Watershed in the northeast part of Fairfax County, Virginia, and comprises five separate watersheds: Bull Neck Run, Scotts Run, Dead Run, Turkey Run and Pimmit Run (Figure 2.1). A portion of the Pimmit Run Watershed is located in Arlington County, Virginia, while the other four watersheds are entirely within Fairfax County.

The group is bounded to the west by the Difficult Run Watershed, to the south by the Cameron Run Watershed, and to the southeast by the Four Mile Run Watershed. The Potomac River is located to the north and northeast of the watershed group. The small areas of land located between the watersheds that drain directly into the Potomac River are also included as part of this group. The Middle Potomac Watershed Group covers an area of approximately 26 square miles (16,672 acres). The watersheds are primarily located within the Dranesville magisterial district with a small portion to the south in the Providence district.

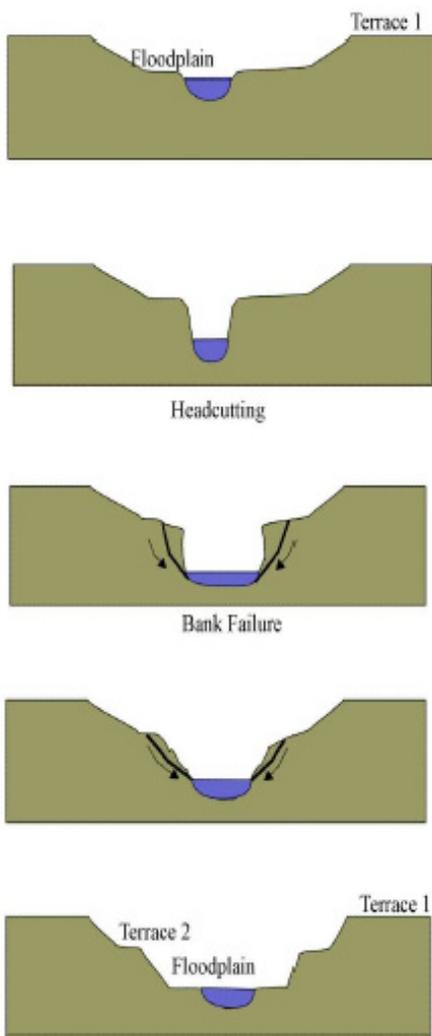
Type 1: Well-developed base flow and bankfull channel; consistent floodplain features easily identified; one terrace apparent above active floodplain; predictable channel morphology; floodplain covered by diverse vegetation; stream banks less than or equal to 45°

Type 2: Head cuts; exposed cultural features (along channel bottom); sediment deposits absent or sparse; exposed bedrock (parts of reach); stream bank slopes greater than 45°

The geomorphologic assessment of the stream channels in the Middle Potomac Watershed Group was based on the conceptual incised Channel Evolution Model (CEM) developed by

Schumm et al. (1984). Based on visual observation of the channel cross section and other morphological observations of the channel segment, a CEM type was assigned for the channel segment. A list of the CEM types is provided in Table 2.7 and the five stages of the channel evolution process are shown in Figure 2.2. The CEM type for the stream segments is shown on the stream geomorphology maps provided for each of the watersheds in Chapters 4 through 8.

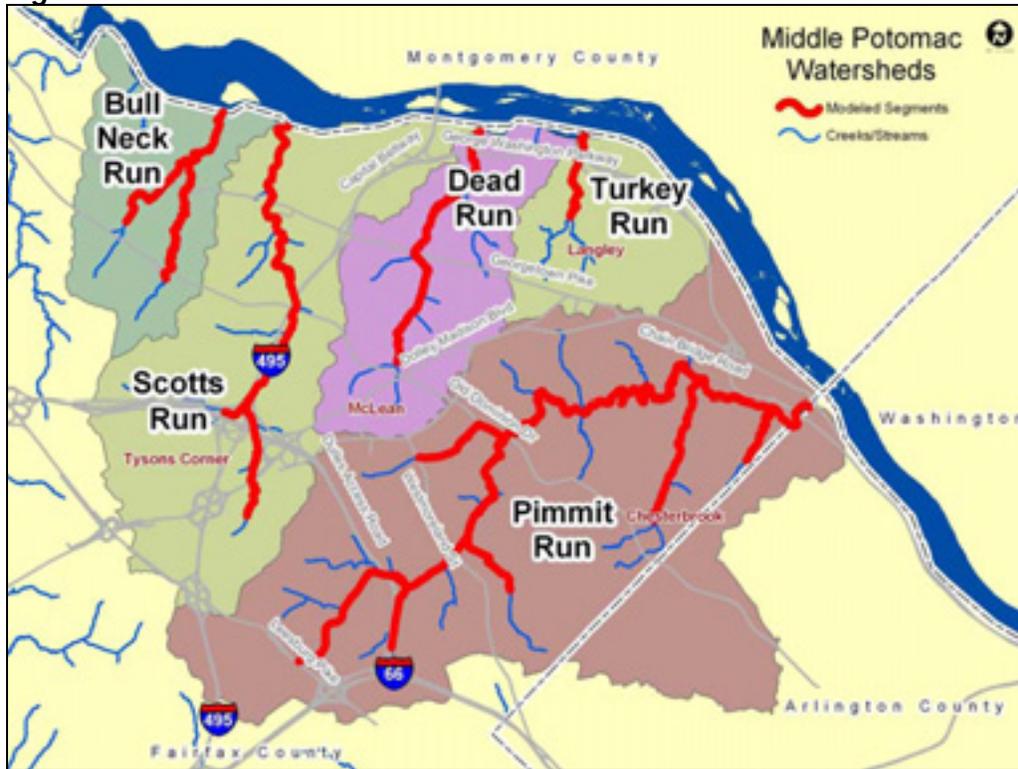
Figure 2.3 Modeled Portions of Streams in Middle Potomac Watersheds

The hydraulic models start downstream of the headwater subbasins and continue to the Potomac River. Figure 2.3 below shows the stream segments in the hydraulic models as well as the extent of streams walked during the SPA.

The hydrologic and water quality models cover all 26 square miles contained in the Middle Potomac Watersheds. This area was divided into 86 subbasins that are the smallest watershed area units in the hydrologic model with an average size of approximately 194 acres. The subbasins are shown on Map 2.4 at the end of this chapter. Runoff and water quality data for existing and future conditions was generated for each of the subbasins. For the hydraulic models, all streams that traversed more than one subbasin were modeled.
