Chapter 8

Pimmit Run Watershed

8.1 Watershed Condition

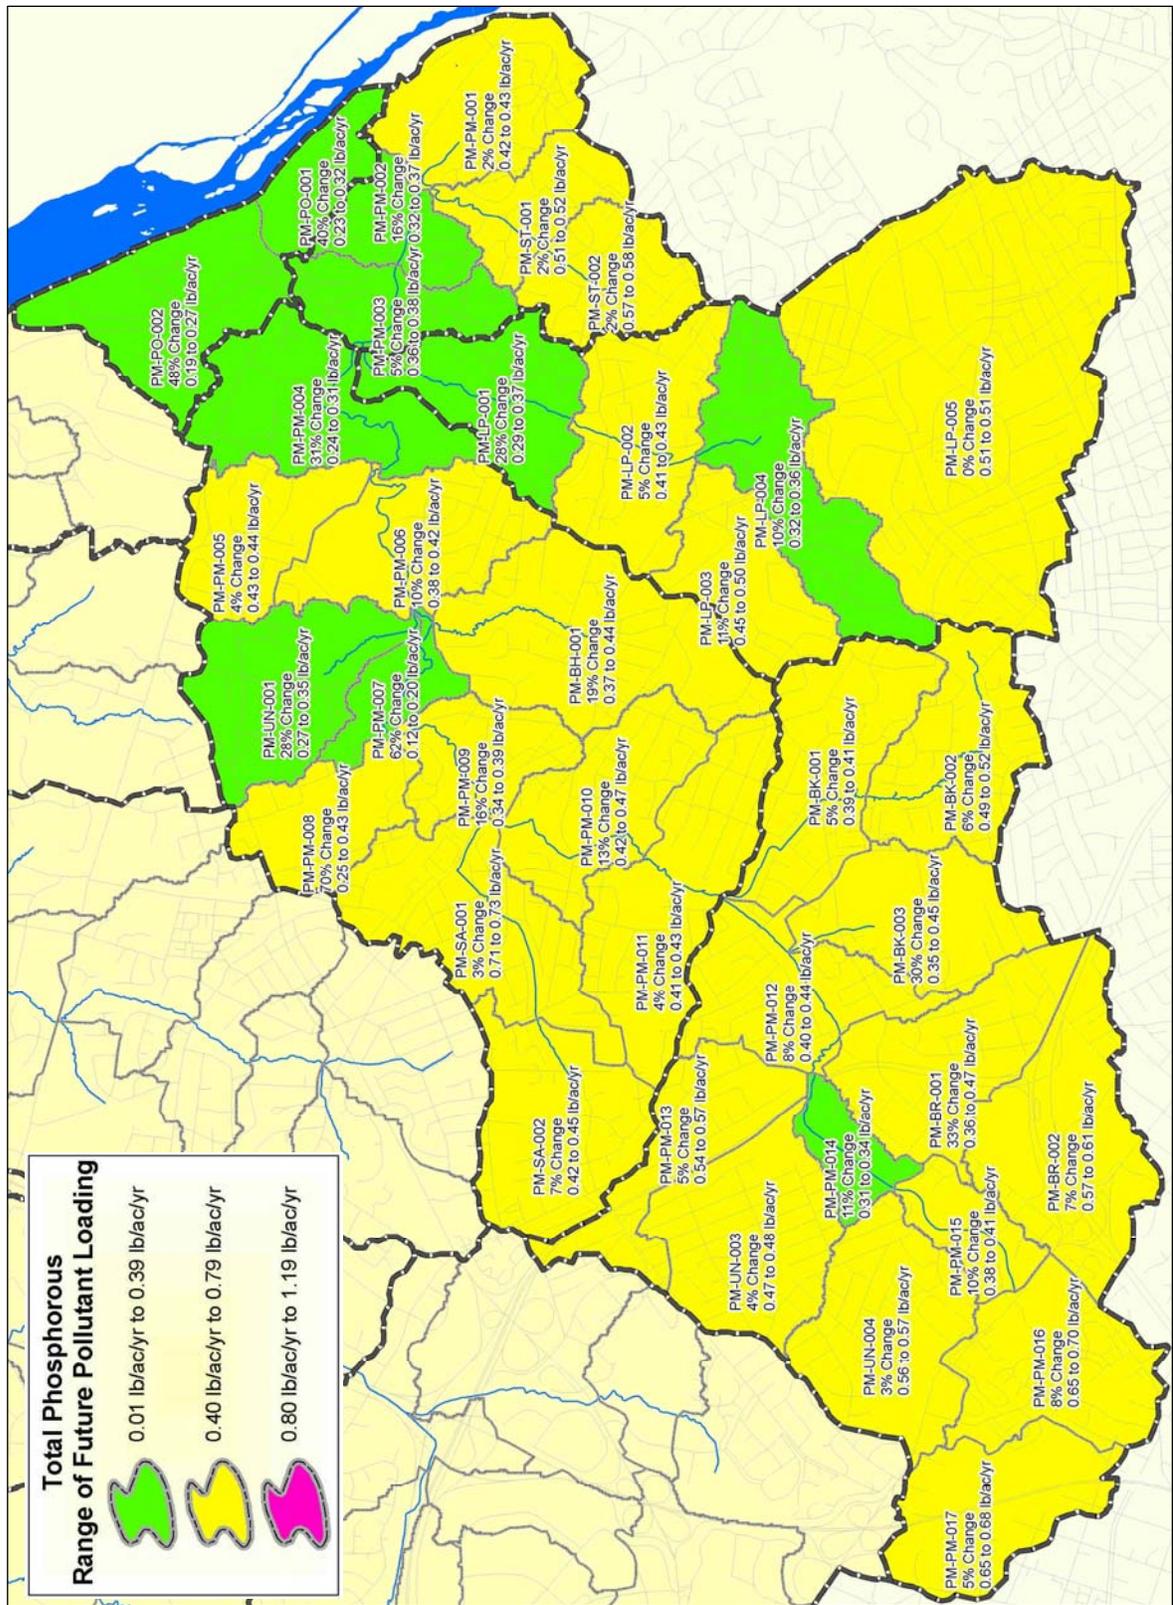
Figure 8.1 Pimmit Run Future Total Phosphorous Loading

Hydrologic, hydraulic, and water quality models were developed for the Pimmit Run Watershed to simulate the generation of runoff, how the runoff is transported downstream, and the amount of pollutants in the runoff and stream flow. The hydrologic and water quality models include the entire Pimmit Run Watershed which also includes the area draining from portions of Arlington County. The Pimmit Run Watershed was divided into five subwatersheds and further divided into thirty-seven subbasins in order to provide more detail for the modeling results. These subbasins are shown in Figure 8.1 below with the future total phosphorus loading.

In the water quality model, the moderate levels of pollutants for both existing and future land use conditions can be attributed to the large amount of open space in the watershed. The subbasins that drain to Pimmit Run and its tributaries have a predominant land use of medium density residential for both existing and future land use conditions. The predicted increase in pollutant loads for future land use conditions can be attributed to the projected development of vacant parcels and the projected development of estate residential areas. Table 8.6 shows the annual pollutant loading rates for each subbasin and shows the comparison of the existing and future pollutant loading rates for the Pimmit Run Watershed.
