The Pohick Creek Watershed Management Plan was a large effort and was made possible because of help and input from many people. We would like to thank those individuals and organizations for their time and effort.

Pohick Creek watershed is divided into 10 smaller watershed management areas (WMAs). A WMA is a small area, approximately 4 square miles, which drains to a specific stream or tributary. Each WMA is then divided into smaller subwatersheds, typically 100 to 300 acres. The purpose of these areas is to identify specific projects or opportunities to enhance the overall stream conditions, as well as to serve the basic units for watershed modeling and other

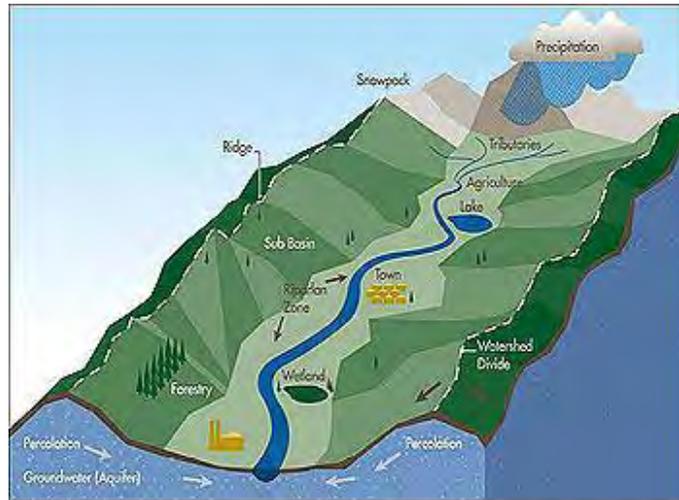
**Figure 1-1: Diagram of a watershed**

Streams and rivers may flow through many different types of land use in their paths to the ocean. In the above illustration from the U.S. Environmental Protection Agency, water flows from agricultural lands to residential areas to industrial zones as it moves downstream. Each land use presents unique impacts and challenges on water quality.

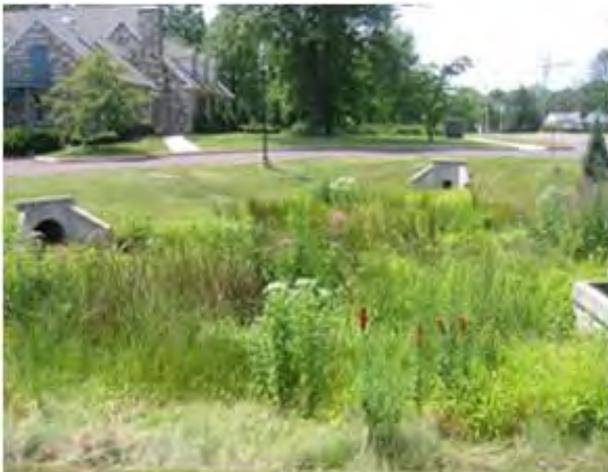
Figure 4-1: Dry stormwater pond

A new stormwater pond project involves the creation of an extended detention dry pond that will improve water quality and quantity treatment for the surrounding area. Wet pond retrofits will modify the existing pond to increase pollutant removal and to provide adequate channel protection above the permanent pool. The retrofit will create a better-functioning environment for gravitational settling, biological uptake, and microbial activity with a permanent pool of standing water, providing for high and reliable pollutant removal performance. The pool prevents re-suspension of sediments and other pollutants and allows for numerous pollutant removal mechanisms to operate. Dry pond retrofits will modify the existing pond to provide adequate downstream channel protection and allow for better function of temporary ponding using a control structure, which enables particulate pollutants to settle out, providing fair to good removal for particulate pollutants.

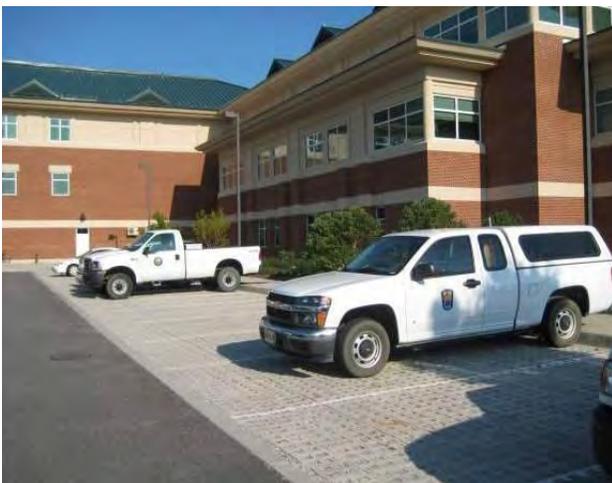
Figure 4-3: Parking lot pervious pavement

A BMP/Low Impact Development (LID) project is designed to minimize the impact of changes in land use on surface and groundwater systems, with the primary goal of mimicking predevelopment site hydrology. Structural BMP/LID projects include: bioswales, pervious pavement, and bioretention filters. Bioswales will capture sheet flow from impervious areas and reduce runoff volume and increase groundwater recharge. Pervious pavement will treat and/or reduce parking lot runoff using a (semi-)porous material that allows runoff to infiltrate and then trap pollutants in the soil. The pavement will also allow for surface storage, reducing runoff volumes. Bioretention will capture sheet flow from impervious areas and create an ideal environment for filtration, biological uptake and microbial activity, providing moderate to high pollutant removal. It will also reduce the outflow to the storm sewer system.

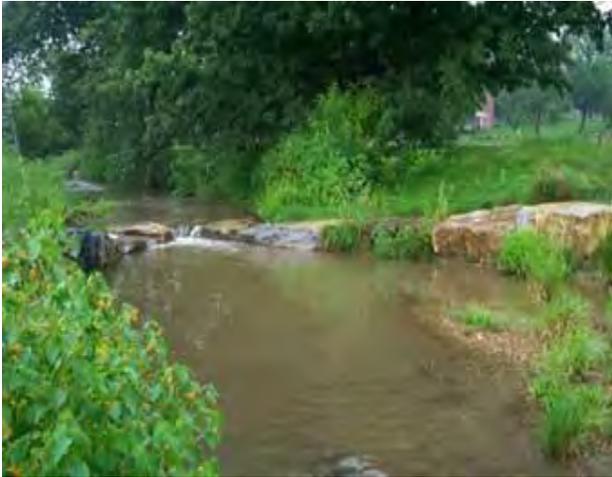
**Figure 4-7: Cross vane added to stream**

Stream restoration is the re-establishment of the general structure, function and self-sustaining behavior of a stream. Restoration can include numerous methods such as installation of structures and planting of vegetation to stabilize and protect stream banks, reshaping or re-aligning stream banks, and repairing stream bed erosion in order to restore the natural morphology of the stream. A stream restoration project can consist of reopening to daylight, sections of a stream that had previously been piped. This is also known as daylighting. Other stream restorations include improving conditions around a stream's inflow pipes by providing outfall protection with energy dissipation devices. This will also help to minimize erosion.

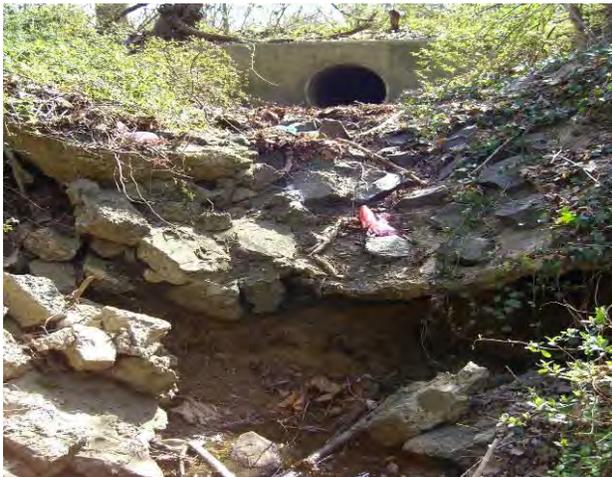
**Figure 4-9: An eroded outfall**

Outfall improvement projects consist of several different measures designed to reduce erosive velocities and sediment loads at the stormwater outfalls. Outfall improvement projects can include reconstruction of the outfall to provide an energy dissipation device and erosion protection, reconstruction of roadside swales or concrete channels with vegetated plantings, and construction of a new storage and treatment area below an outfall.

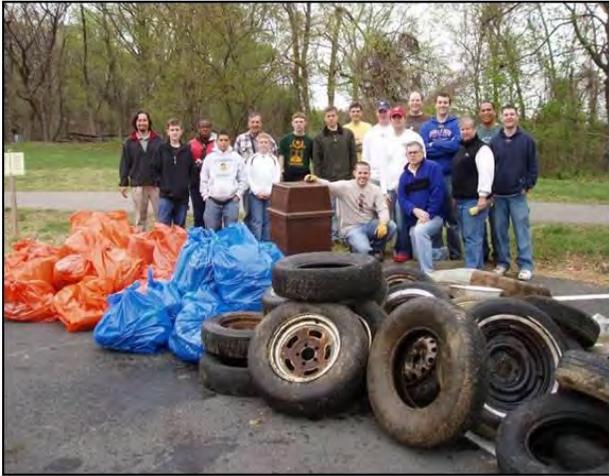
**Figure 4-12: Tires and debris removed near or from stream**  
Dumpsite/Obstruction Removals

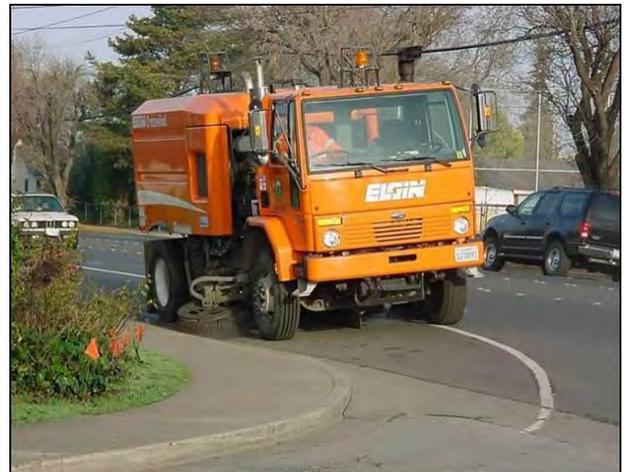
**Figure 4-13: Street-sweeping truck**

Street sweeping helps reduce the amount of potential pollutants entering nearby streams and storm systems. In addition, these programs add the aesthetic benefits of having clean streets and the safety benefits of removing debris that can block storm systems and stormwater facilities. Areas where these projects were proposed are primarily comprised of dense residential development, many of which have their streets piped directly into the nearby streams with little or no stormwater controls.

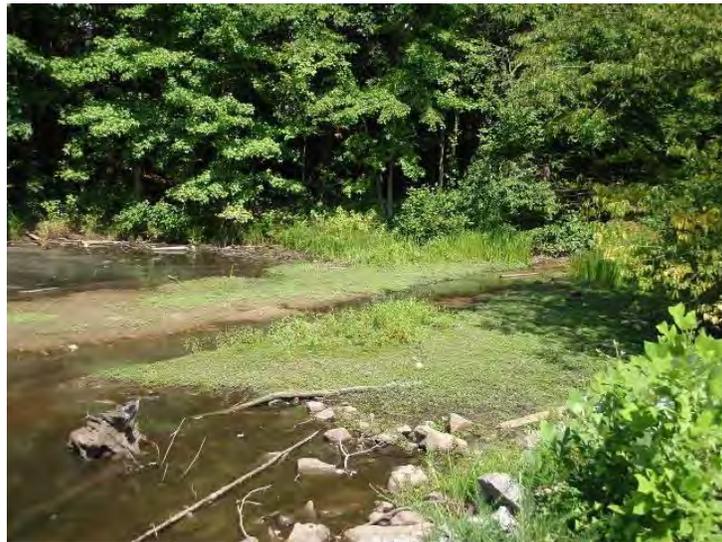
**Figure 4-14: Sediment build-up at Huntsman Lake**

This project is a study to determine the water quality benefits of dredging the six lakes that were created by the PL-566 Dams. These lakes include; Lake Mercer, Huntsman Lake, Royal Lake, Lake Braddock, Lake Barton, and Woodglen Lake. These lakes are currently trapping sediment. One possible benefit of dredging includes an increased permanent pool volume (which will in turn trap more sediment). Other benefits include extending the lifespan of the lakes, and enhancing recreation. Other water quality benefits include removing shallow foraging areas which may decrease the number of waterfowl and associated fecal contamination. Increased depth benefits thermal stratification which in turn benefits fisheries. If the lake is eutrophic, dredging may increase dissolved oxygen by decreasing biological oxygen demand (BOD) by removing organic sediment. Dredging may also remove phosphorus bound to these sediments, although this phosphorus is currently locked in place within the lake.

PC9824	Lake Management for W.Q. Study	PC-MR-0005	Huntsman Lake, Near 7600 Modisto Ln.	Water quality and quantity control	Public/Local - FCPA

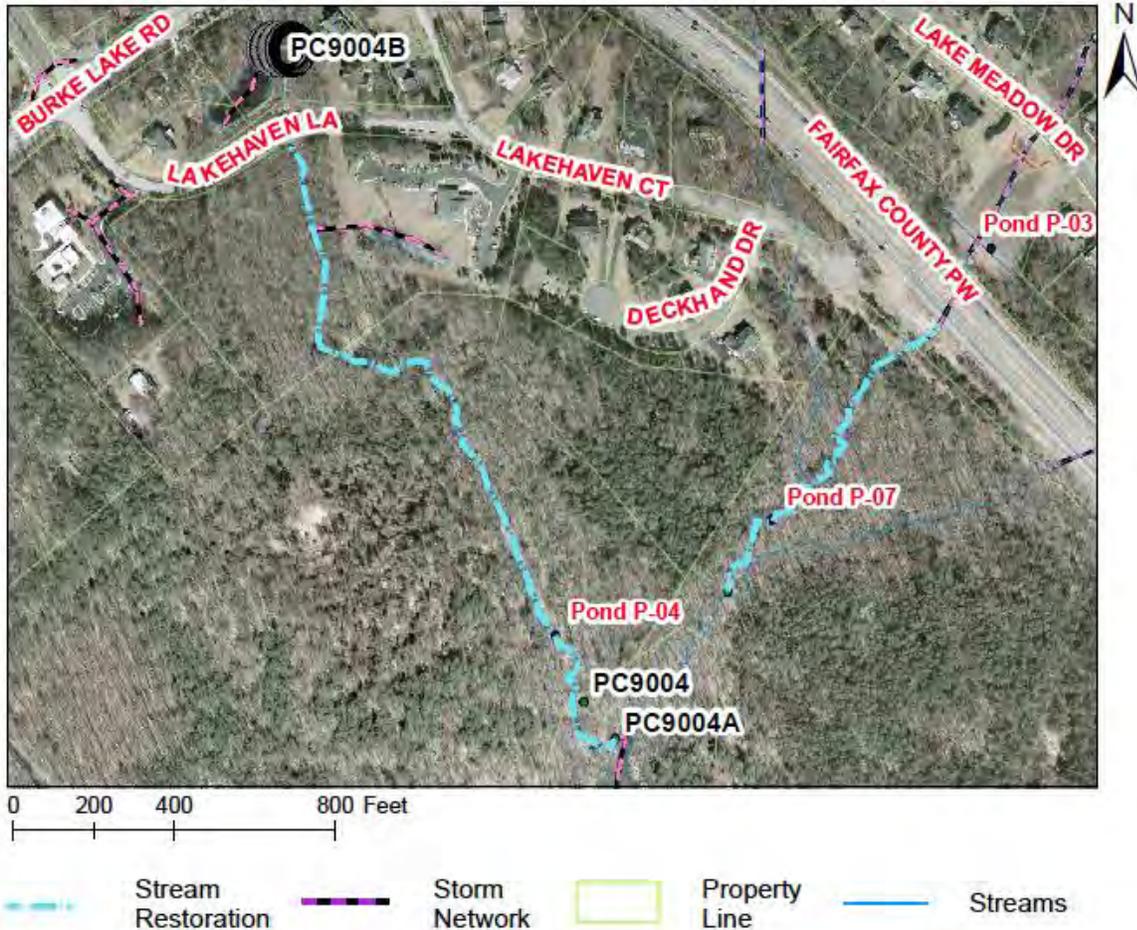
# PC9004 Stream Restoration Suite

**Description:** This project suite is a proposed alternative to Regional Pond P-04, which was proposed upstream (northwest) of Burke Lake but was not constructed. Subproject A is the stabilization of the stream northwest of Burke Lake. This project proposes repairing bank and bed erosion to restore channel morphology. The stream stabilization will reduce sediment loads to Burke Lake maintaining the capacity of the stream and controlling unwanted meander. This project is critical due to its impact on Burke Lake. Subproject B proposes removing an obstruction farther upstream of Burke Lake. This obstruction was verified during field verification. Removing the obstruction will help restore the stream channel to its natural conditions and improve the function of the stream.

**Project Benefits:** The stream stabilization will reduce sediment loads to the stream, maintaining the capacity of the stream and controlling unwanted meander. Removing the obstruction will help restore the stream channel to its natural conditions and improve the function of the stream. This suite of projects will help to return the stream to its natural condition and reduce pollutant loads and erosion. Below are the project's estimated pollutant removal amounts.

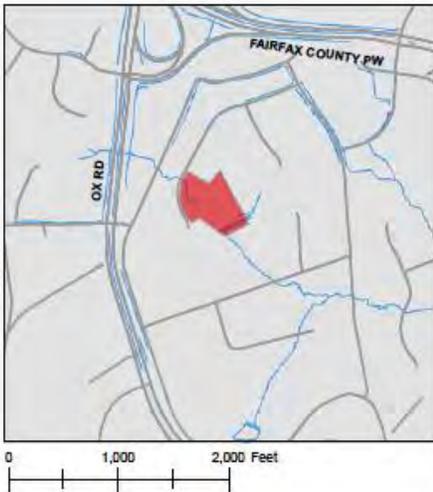
# PC9008 Stormwater Pond Retrofit

**Address:** Next to 10995 Rice Field Pl, Fairfax Station, Virginia  
**Location:** Wet Pond near Rice Field Pl  
**Land Owner:** Private – Private Owner  
**PIN:** 0773 12 A1, 0773 12 C  
**Control Type:** Water quality and quantity control  
**Drainage Area:** 121.67 acres  
**Receiving Waters:** Tributary of South Run

**Description:** This project is a proposed supplement to the existing Regional Pond P-05 (0525DP) and will retrofit the pond into an extended detention dry pond with sediment forebays and additional planting. The pond is located southeast of Rice Field Place. The primary indicators are wetland habitat and pollutants, including nitrogen, phosphorus and total suspended solids. The pond collects runoff from a large drainage area that is mostly single-family residential development and roadways.

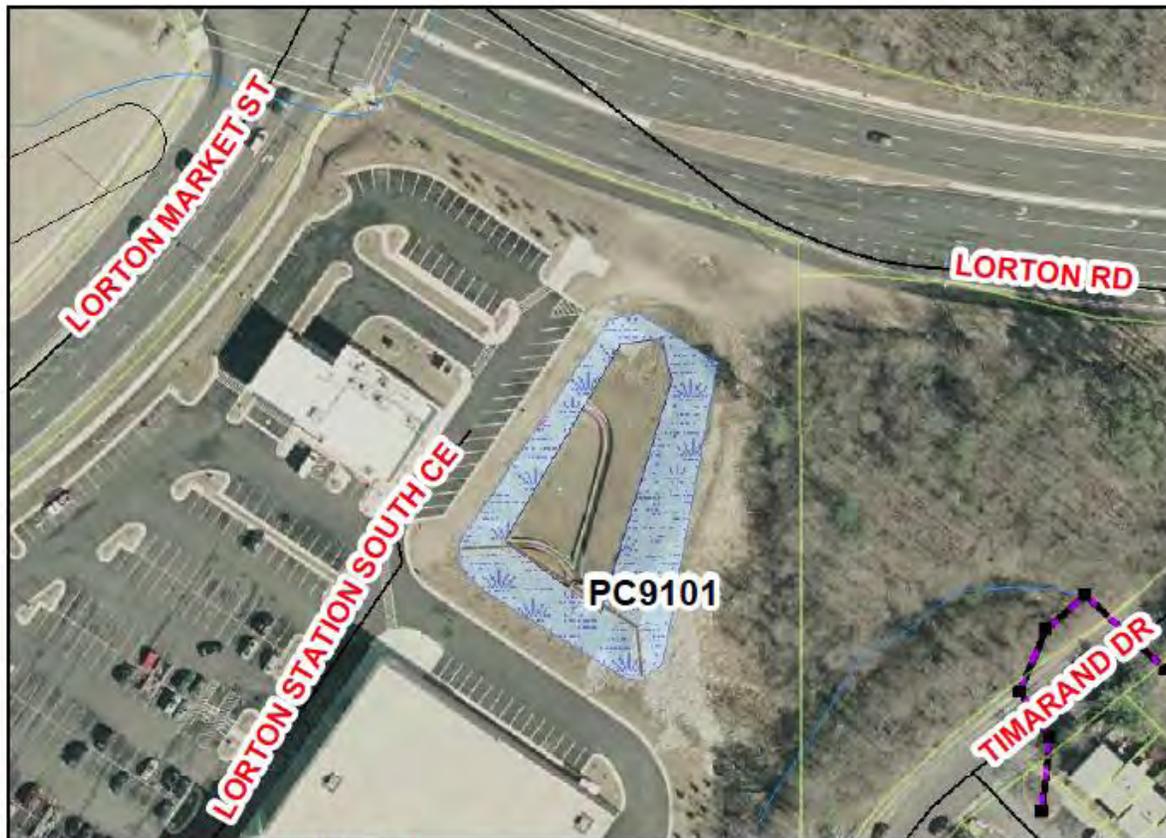
**Description:** This project proposes the retrofitting of an existing pond to create an extended detention dry pond with a sediment forebay at 9409 Lorton Market St. (Lorton Marketplace Shopping Center). The primary indicators are pollutants including nitrogen, phosphorus and total suspended solids. The existing discharge structure will be modified to increase the amount of time water is detained in the pond. The existing concrete pilot channels will be removed to promote infiltration of low flows which can have high concentrations of pollutants.

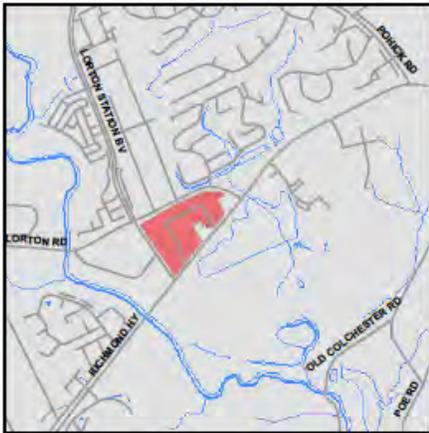
# PC9103 Stormwater Pond Retrofit

**Address:** 7665 Lorton Rd., Lorton, Virginia  
**Location:** Gunston Shopping Plaza  
**Land Owner:** Private – Gunston Station, LLC  
**PIN:** 1074 03 0001B  
**Control Type:** Water quality and quantity control  
**Drainage Area:** 11.12 acres  
**Receiving Waters:** Tributary of Pohick Creek

**Description:** This project proposes the retrofit of an existing pond to create an extended detention dry pond with sediment forebays at Gunston Plaza Shopping Center, northwest of Richmond Highway. The pond receives runoff from the shopping center and outfalls across Richmond Highway into wooded area. The indicators are pollutants including nitrogen, phosphorus and total suspended solids. The sediment forebays will provide pretreatment of stormwater runoff.

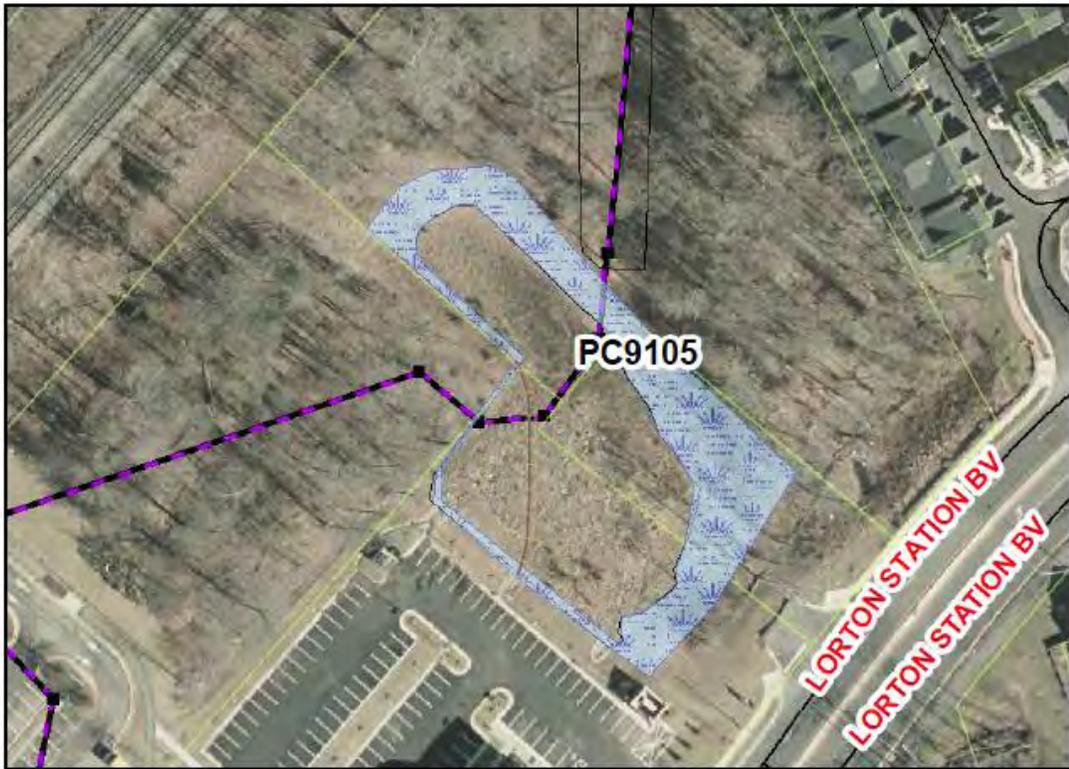
**Description:** This project proposes the retrofit of an existing dry pond northwest of Lorton Station Boulevard to create an extended detention dry pond with a sediment forebay. The pond's existing discharge structure will be modified to increase the pond's detention time, and the pond's size will be enlarged to handle the longer detention time. Primary indicators are pollutants, including nitrogen, phosphorus and total suspended solids. Pond collects runoff from dense residential development and highly impervious commercial areas. The pond outfalls to the north and is conveyed in a concrete swale under a railroad track before discharging into a wooded area. The large majority of the drainage area is impervious.

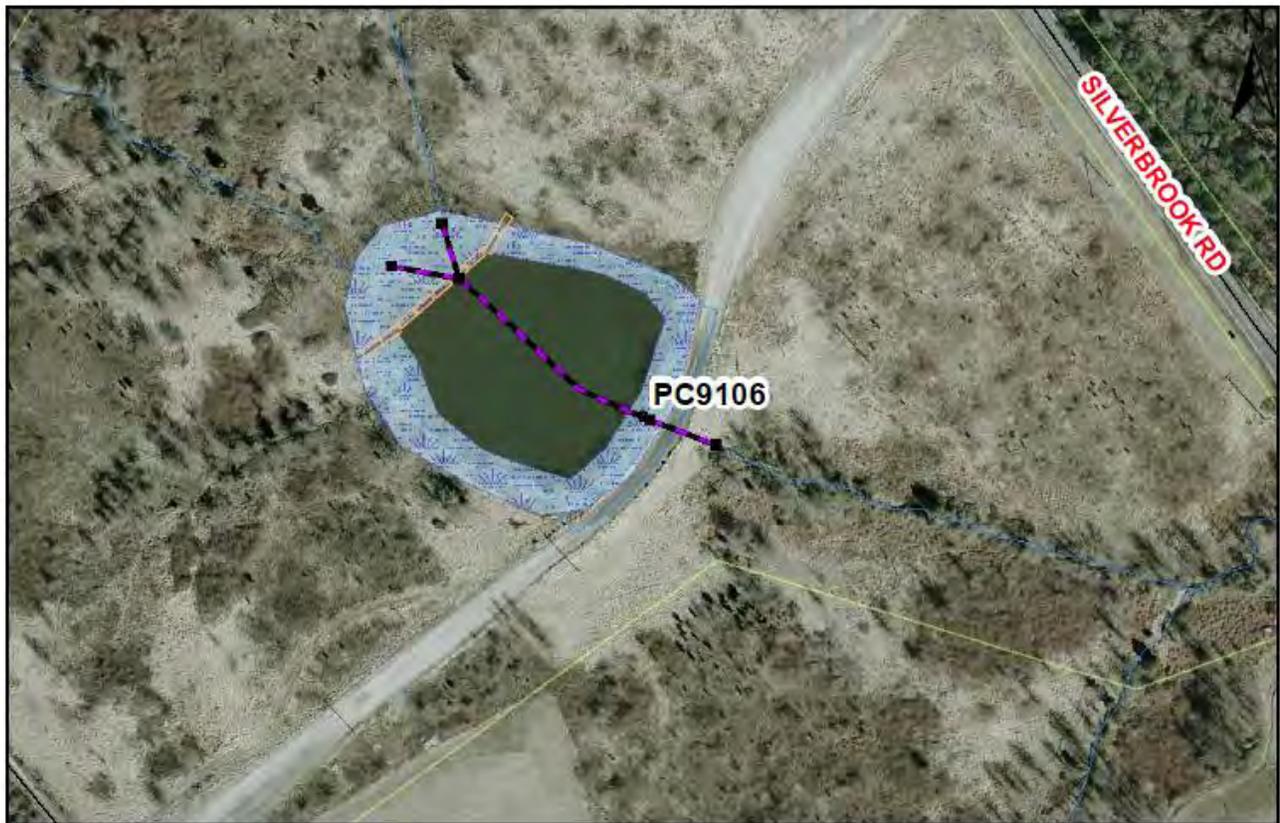
**Description:** Wet pond retrofit planned near South County Secondary School. Pond is set back from main road. This project proposes creating wetland system with the construction of a sediment forebay and the addition of bench planting. The primary indicators are wetland habitat and pollutants, including nitrogen, phosphorus and total suspended solids.

- SW Pond Retrofit
- Storm Network
- Sediment Forebay
- Property Line
- Streams

**Project Benefits:** This retrofit will increase pollutant removal and provide adequate channel protection above the permanent pool. The retrofit will create a better functioning environment for gravitational settling, biological uptake and microbial reliable pollutant removal performance. Below are the project's estimated pollutant removal amounts.

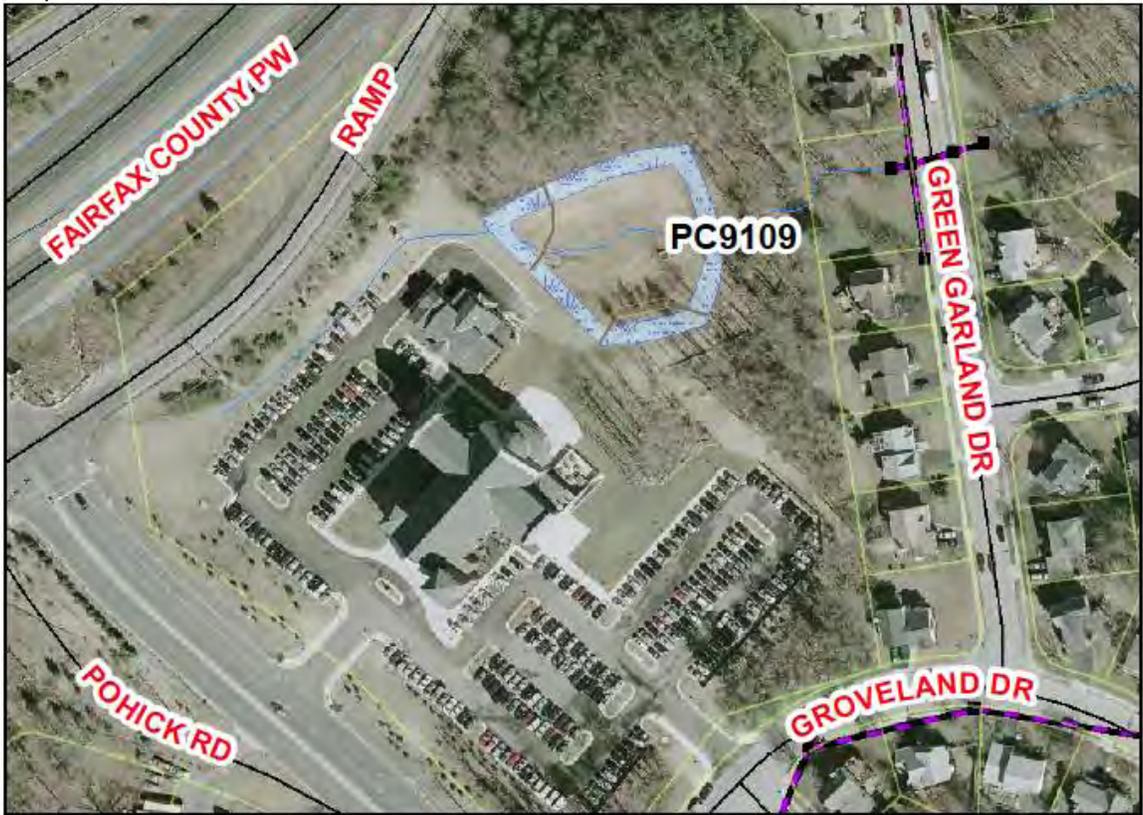
**Description:** This stormwater pond retrofit is located at St. Raymond’s Penafort Catholic Church east of Fairfax County Parkway and north of Pohick Road. The pond receives runoff from church and parking lot. This project proposes modifying the existing discharge structure and expanding the pond to create an extended detention dry pond with a sediment forebay. The primary indicators are pollutants including nitrogen, phosphorus and total suspended solids.

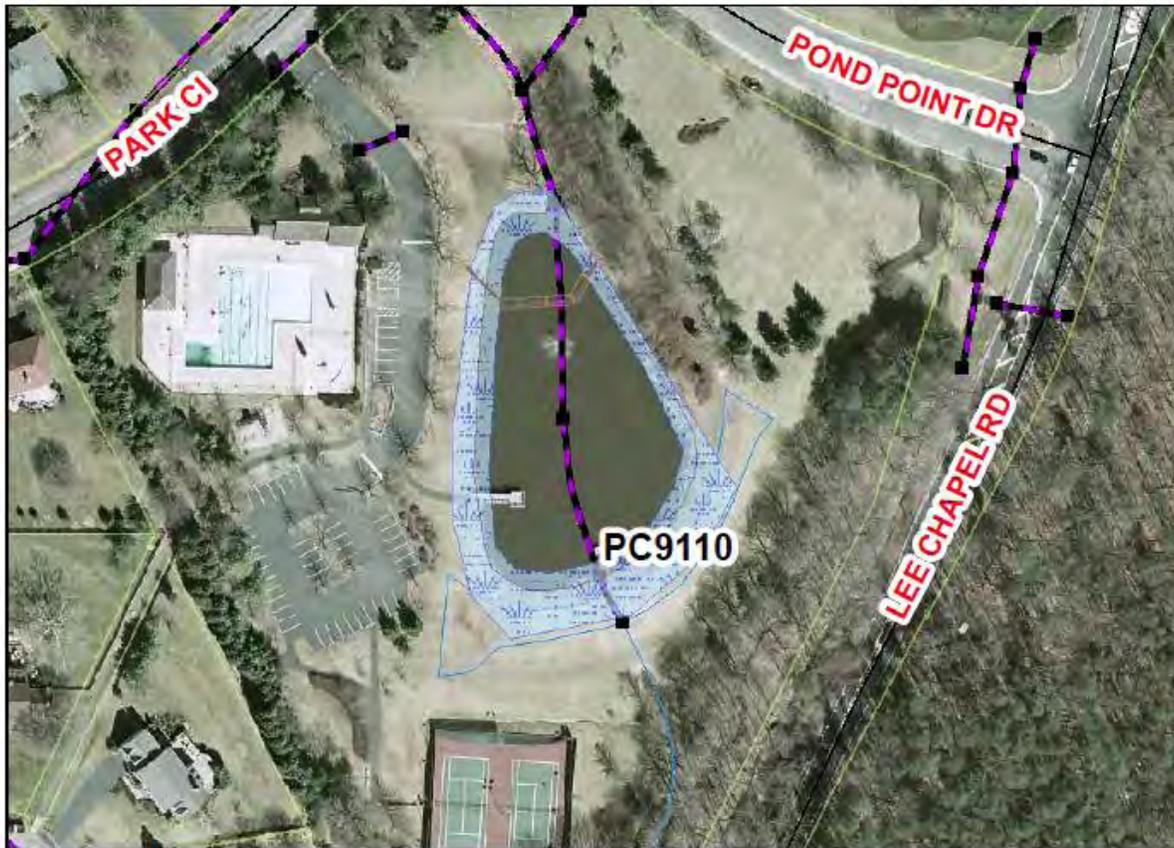
**Description:** This project proposes the retrofit of an existing wet pond at a community center off of Park Circle to create a wetland system with construction of a sediment forebay and the addition of a bench planting. The pond collects runoff from adjacent neighborhoods and roadways to the north and outfalls into a stream to the south. The primary indicators are wetland habitat and pollutants, including nitrogen, phosphorous and total suspended solids.

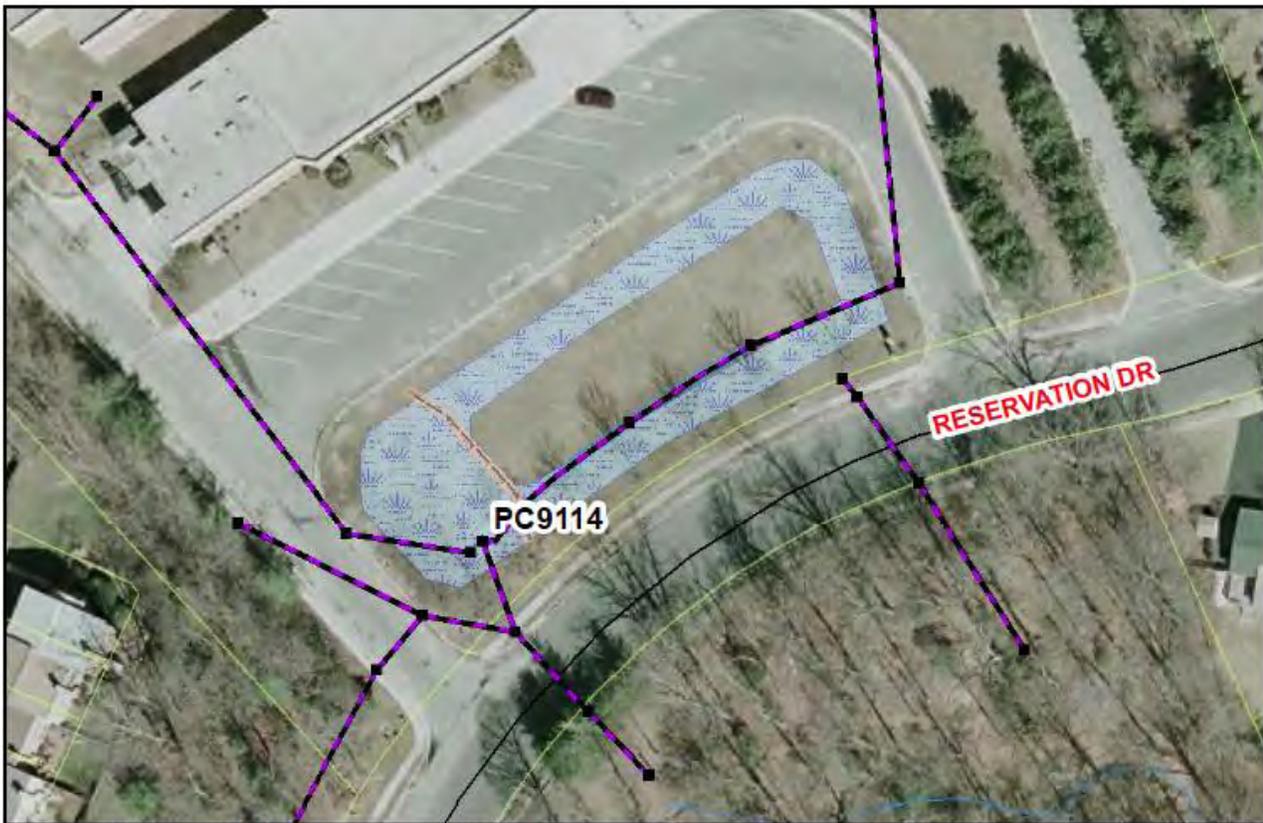
**Description:** This project proposes a pond retrofit at Sangster Elementary School northwest of Reservation Drive. Stormwater runoff is collected in a closed system and outfalls into a dry pond near the school's entrance. The pond outfalls across Reservation Drive into a wooded area and ultimately into a stream. This project proposes removing the pond's existing pilot channel and retrofitting the pond to create a wetland system with sediment forebays for the two inflows and bench planting to help increase pollutant uptake. The primary indicators are wetland habitat, nitrogen, phosphorus and total suspended solids.

**Project Benefits:** This retrofit will increase the time stormwater remains in the basin to be treated and will allow more time for the stormwater to infiltrate. This will help decrease erosion downstream where the pond outfalls through a culvert directly into a wooded area. The retrofit will increase pollutant removal and provide adequate downstream channel protection to minimize erosion.

**Project Design Considerations:** The existing dry pond’s pilot channels direct flows from small storm events with high pollutant concentrations directly to the outfall with no chance for infiltration. Due to the existing pond’s limited difference in outfall elevation, and the need to remove the concrete pilot channels, it is necessary to convert the existing dry pond into a wetland system. The pond’s footprint will be expanded to utilize most of the area in the landscape island as shown by the hatched area. Additional planting would be added in this area. The existing trees would be incorporated into the design. To allow more infiltration and pretreatment of the stormwater, curb cuts and gravel filter strips should be used along the road edge. The stormwater facility would be an educational asset to the school, because of its ability to showcase how stormwater can be treated by natural processes.

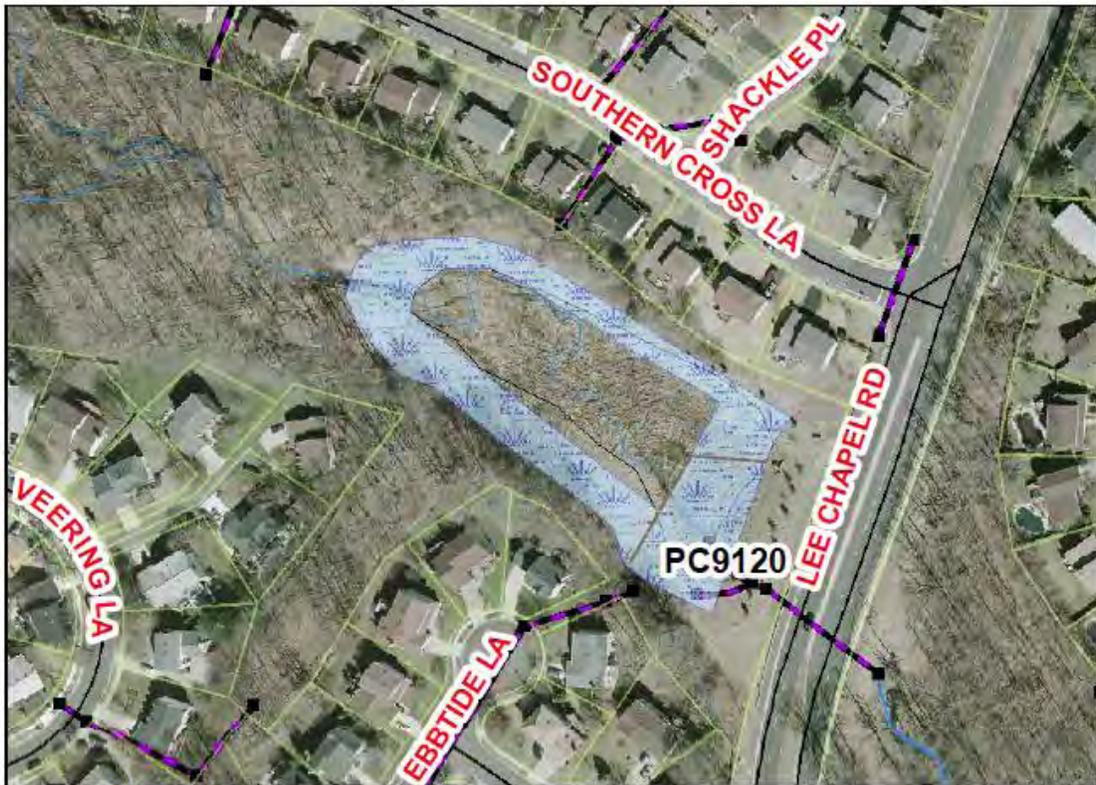
**Description:** This project proposes the creation of an extended detention dry pond with sediment forebay. The existing dry pond northwest of Lee Chapel Road and southwest of Southern Cross Lane receives runoff from these roads as well as Ebb tide Lane. Due to pollutants such as phosphorous, nitrogen and total suspended solids, a retrofit is proposed. This will allow for better downstream channel protection and allow for better function of temporary ponding, as well as promote the settlement of particulate pollution. Pond has easy access and room for expansion.

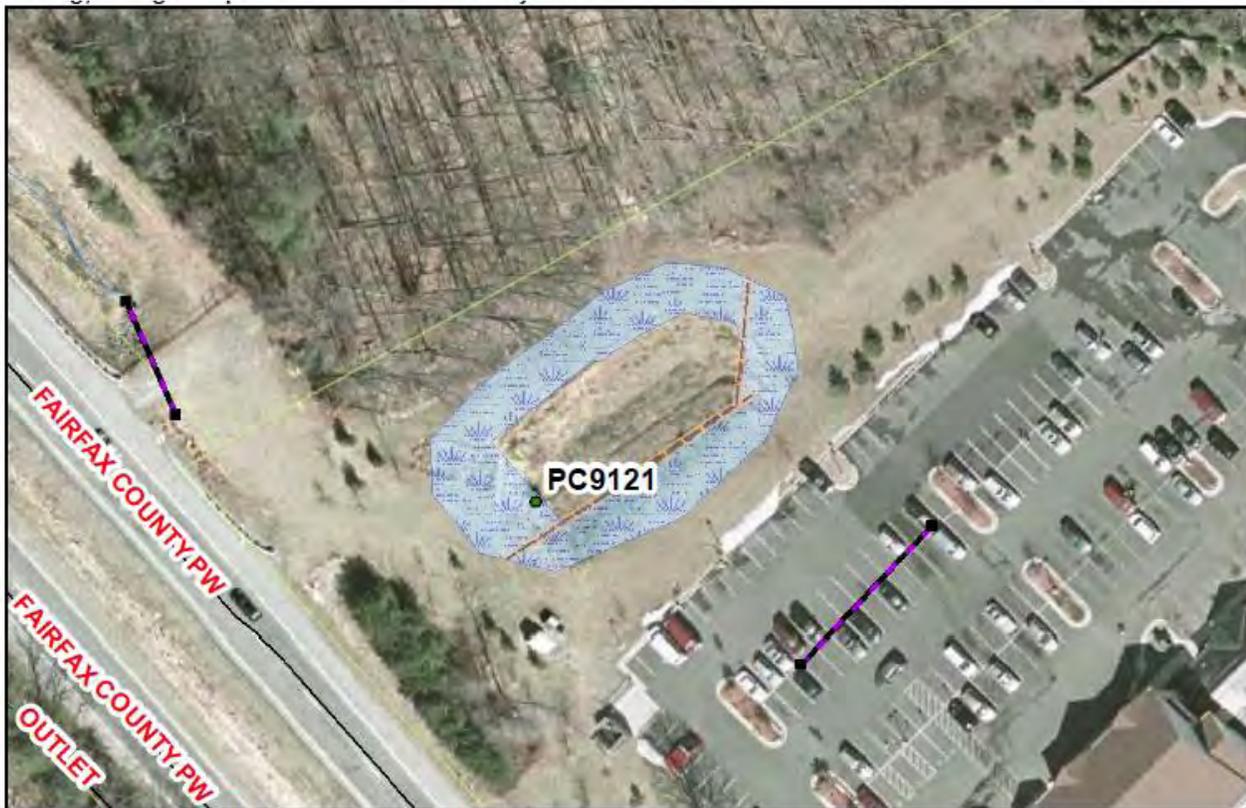
**Description:** This project proposes to retrofit an existing pond northeast of Fairfax County Parkway at Burke Community Church to create a wetland system with construction of a sediment forebay and the addition of low marsh and high marsh plantings. The primary indicators are wetland habitat and pollutants. The pond receives runoff from the church and parking lot. The retrofit will modify the existing pond to increase pollutant removal and to provide adequate channel protection. The retrofit will create a better functioning environment for gravitational settling, biological uptake and microbial activity.

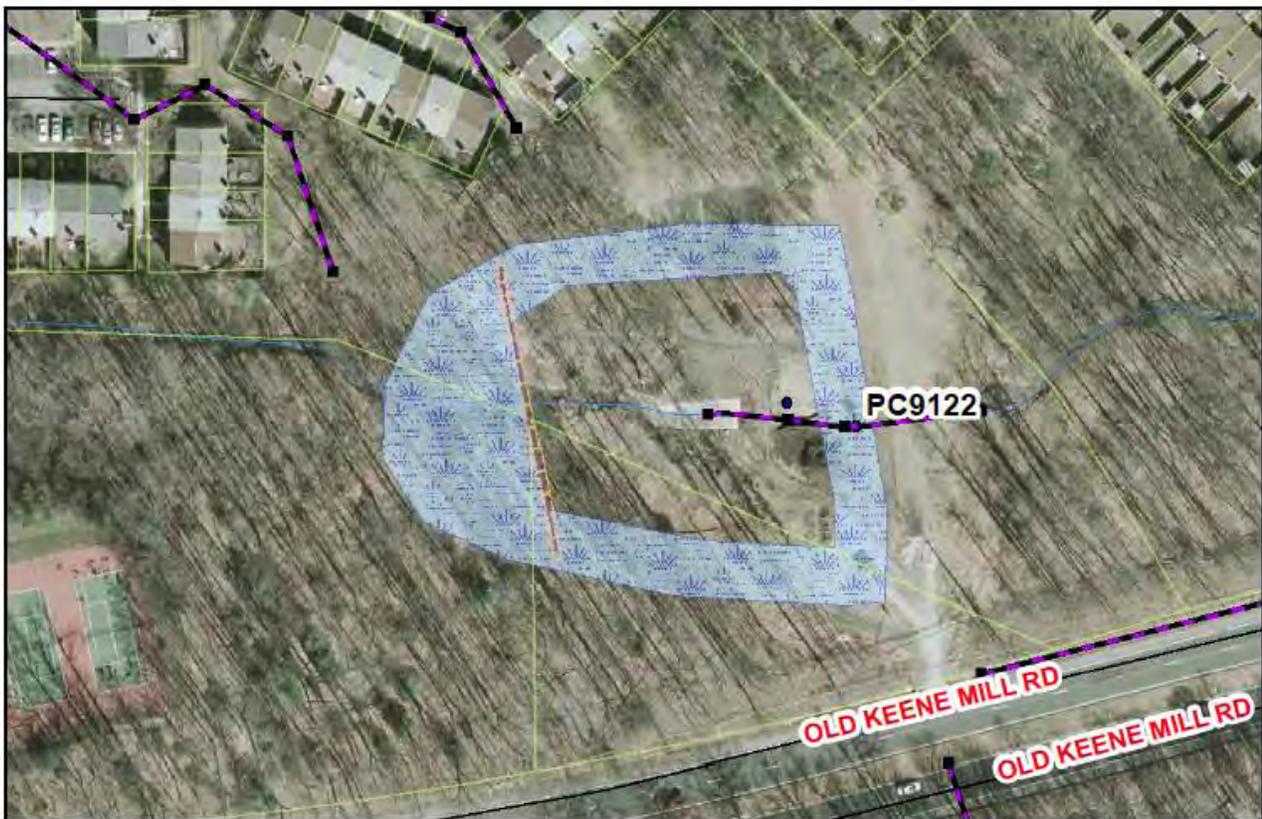
**Description:** This project proposes the retrofit of an existing pond north of Old Keene Mill Road and east of Field Master Drive, which receives runoff from adjacent roads and neighborhoods. The existing dry pond will be retrofitted to create an extended detention dry pond with a sediment forebay. Pond receives runoff from a large drainage area consisting of dense residential development, roadways and wooded areas. Pond outfalls to the adjacent stream in the wooded area to the east.

- SW Pond Retrofit
- Storm Network
- Sediment Forebay
- Property Line
- Streams

**Project Benefits:** Extending the pond’s detention time will help prevent downstream channel erosion and will increase pollutant settlement in the pond. The forebay will collect the majority of the roadway fines and help maintain the infiltration capacity of the pond and reduce major maintenance repairs. Below are the project’s estimated pollutant removal amounts.

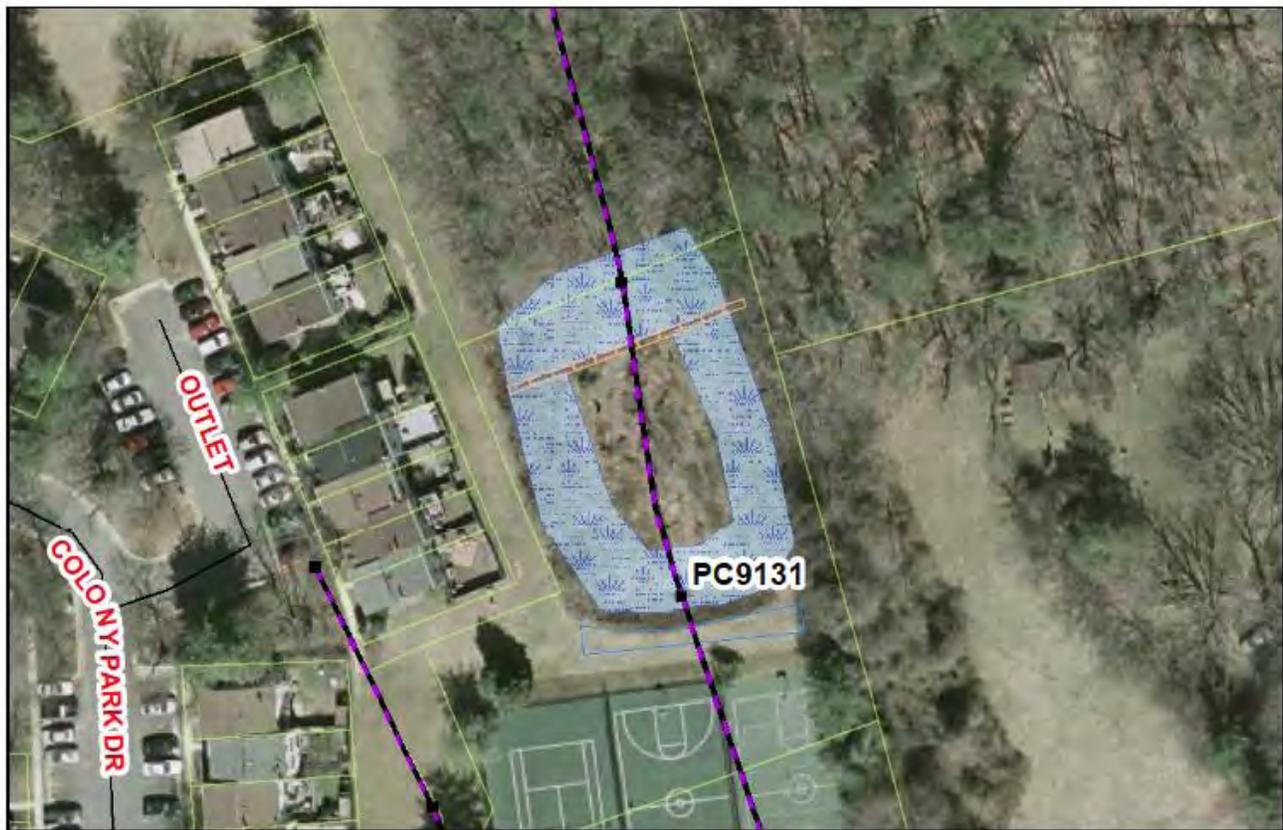
**Description:** This large dry pond behind a residential community is currently very well vegetated. This pond retrofit will modify the existing discharge structure to create an extended detention dry pond with sediment forebay. The primary indicators are pollutants, including nitrogen, phosphorus and total suspended solids. The large drainage area captures runoff from dense residential, single family residential, roadways and wooded areas.

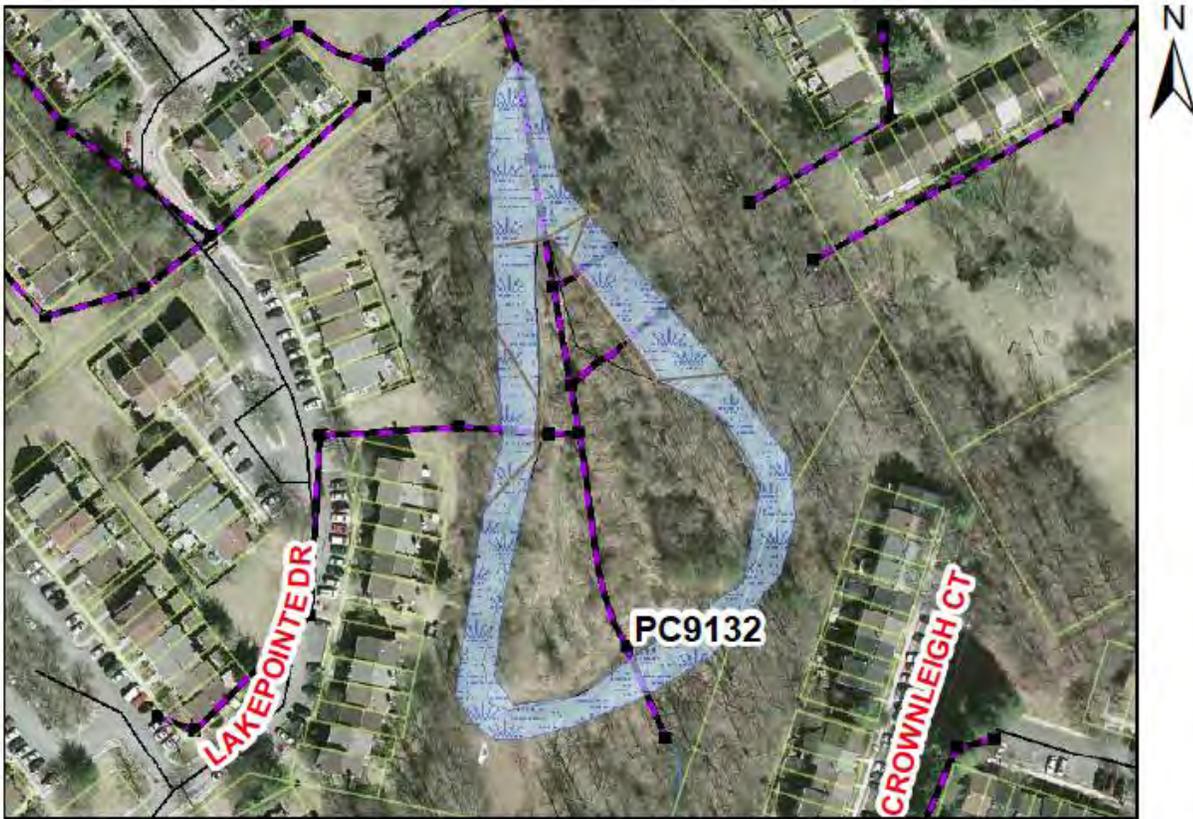
**Description:** This project is the large pond behind Lakepointe Drive. The project proposes the retrofit of the pond to create an extended detention dry pond with a sediment forebay. The primary indicators are pollutants including nitrogen, phosphorus and total suspended solids. The retrofit will modify the existing pond to provide adequate downstream channel protection and allow for better function of temporary ponding using a control structure, which enables particulate settlement.

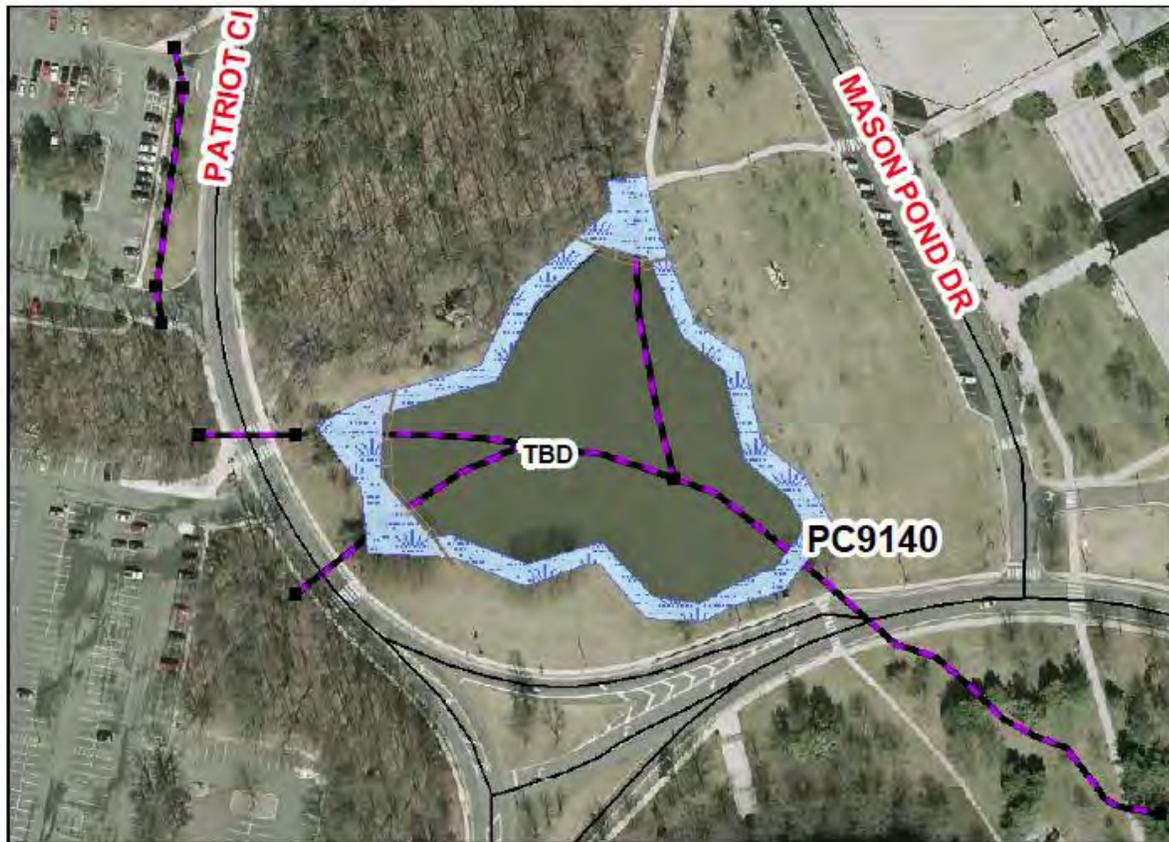
**Description:** This project proposes the retrofit of an existing wet pond at George Mason University, near Mason Pond Drive and Roanoke River Lane, to create a wetland system with sediment forebays and bench planting. The sediment forebays will provide pretreatment of stormwater runoff and the bench planting will increase the pollutant removal. The primary problem indicators are pollutants, including nitrogen, phosphorus and total suspended solids.

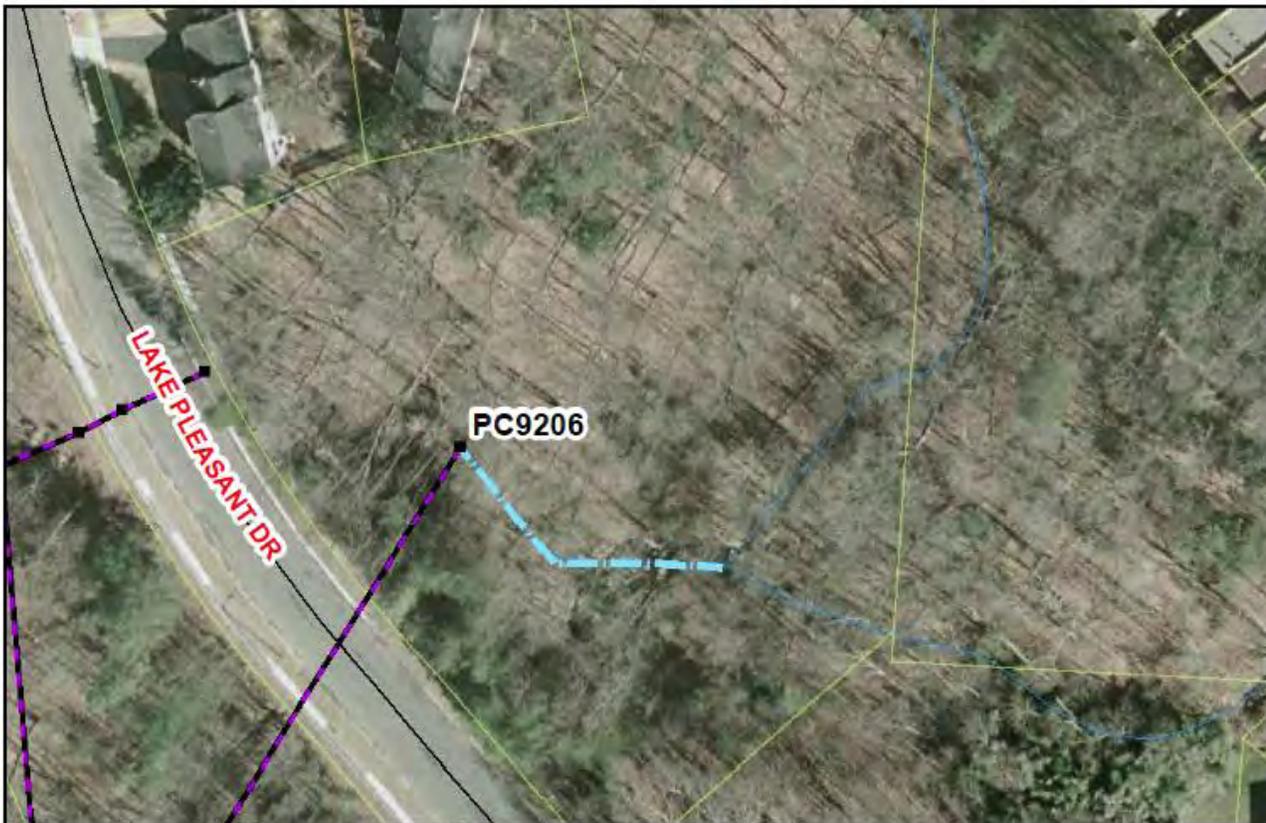
**Description:** The project proposes restoring the stream just northeast of Lake Pleasant drive. The current stream has bank and bed erosion and poor channel morphology. The stream stabilization will reduce sediment loads to the stream while maintaining capacity and controlling unwanted meander. This stream segment is steep and receives runoff from townhomes and a roadway outfall. Erosion will be stabilized through the use of bank shaping, toe of slope protection, erosion control fabric, and rapid vegetation establishment.

- Stream Restoration
- Storm Network
- Property Line
- Streams

**Project Benefits:** This stream restoration will reduce erosion and instream sediment. This will result in a deeper dry weather channel and better functioning stream shape. Below are the stream's estimated instream sediment pollutant amounts that will be eliminated after the stream restoration.
