The Pohick Creek Watershed Management Plan was a large effort and was made possible because of help and input from many people. We would like to thank those individuals and organizations for their time and effort.

Pohick Creek watershed is divided into 10 smaller watershed management areas (WMAs). A WMA is a small area, approximately 4 square miles, which drains to a specific stream or tributary. Each WMA is then divided into smaller subwatersheds, typically 100 to 300 acres. The purpose of these areas is to identify specific projects or opportunities to enhance the overall stream conditions, as well as to serve the basic units for watershed modeling and other

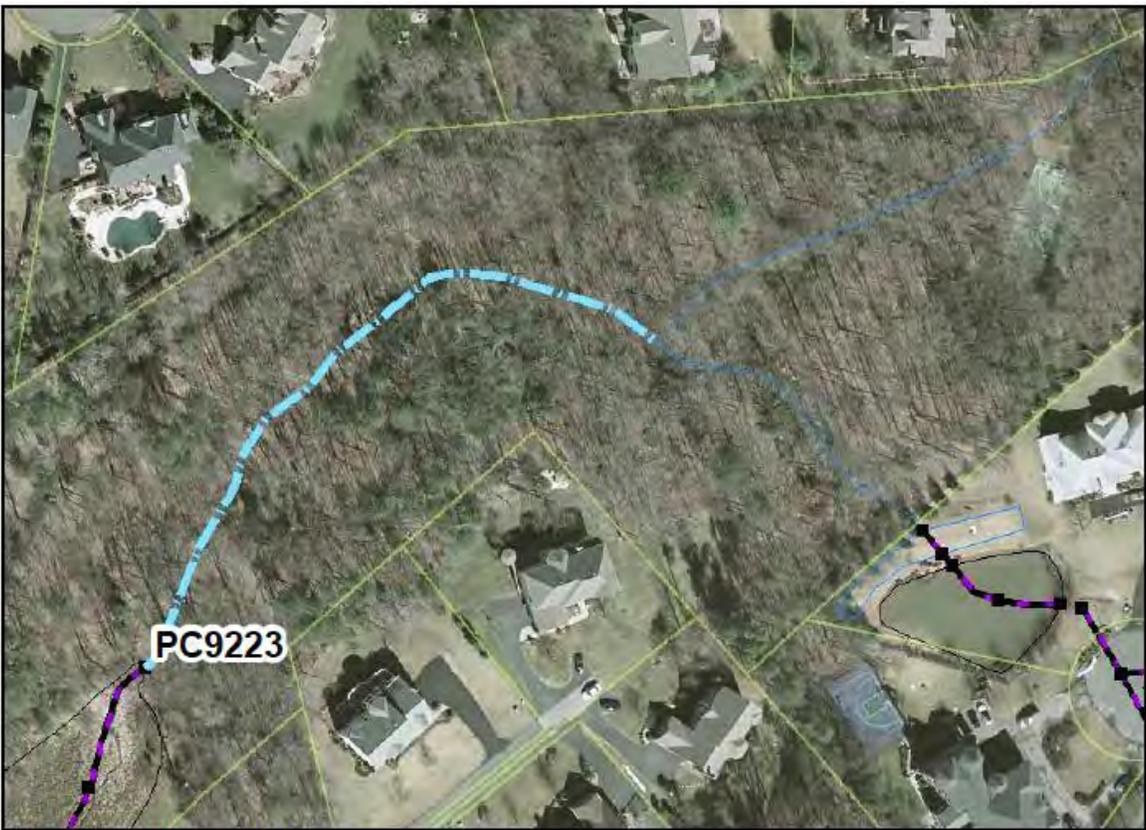
**Description:** The stream outfalls into a pond northeast of Lake Meadow Drive. The stream collects runoff by sheetflow from adjacent single family housing development. The primary indicator is poor channel morphology. The project proposes repairing bank and bed erosion, thereby restoring channel morphology. Erosion will be stabilized through the use of bank shaping, toe protection, erosion control fabrics, and rapid vegetation establishment.

**Project Benefits:** This stream stabilization will reduce sediment loads to the stream, maintaining capacity of the stream channel and controlling unwanted meander of the stream. Repairing the stream will help minimize erosion of the streambanks over time. Below are the stream’s estimated instream sediment pollutant amounts that will be eliminated after the stream restoration.

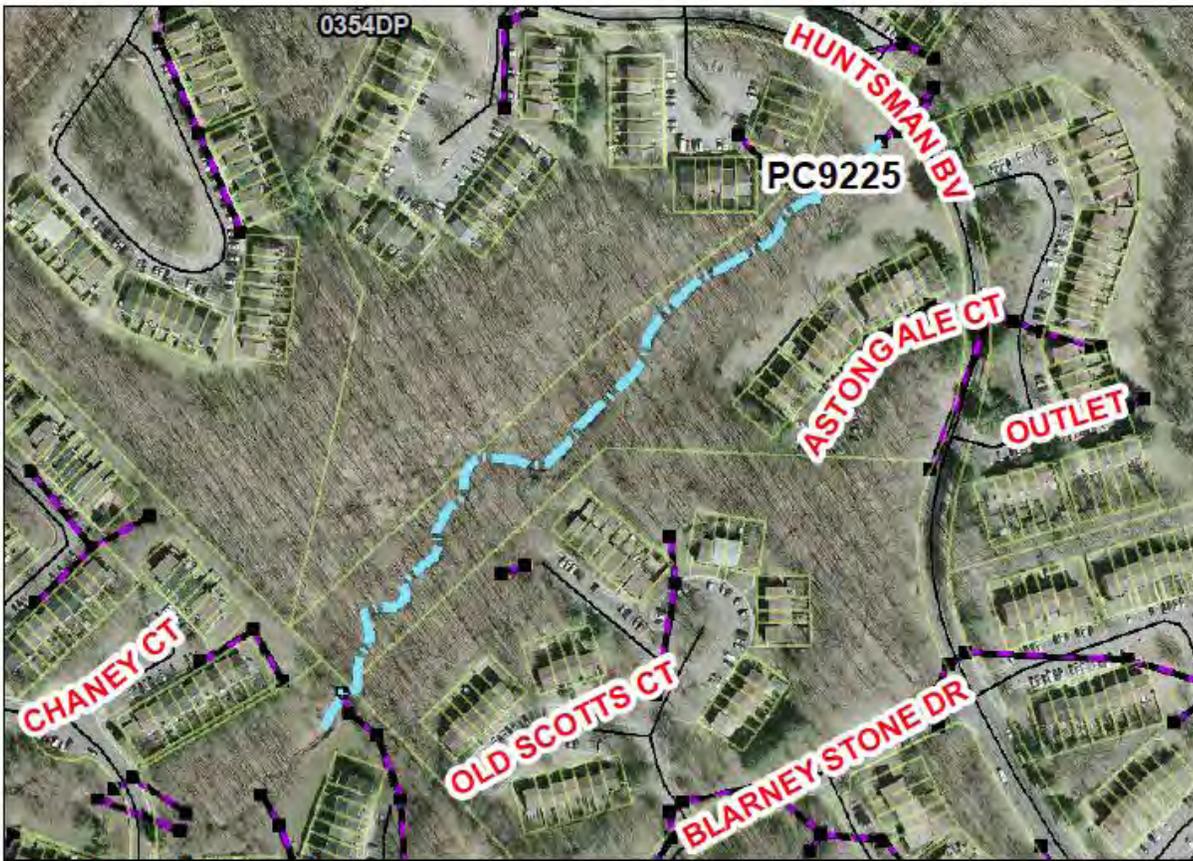
**Description:** Stream is located southwest of Huntsman Boulevard. Receives runoff from adjacent neighborhoods. This project proposes repairing bank and bed erosion to restore channel morphology. The primary indicator is poor channel morphology. Stream conveys runoff from dense residential development. Erosion will be stabilized through the use of bank shaping, toe protection, erosion control fabrics, and rapid vegetation establishment.

**Project Benefits:** Stream stabilization will reduce sediment loads while maintaining the capacity of the stream and controlling unwanted meander. Measures will be put in place to repair existing erosion and prevent future erosion over time. Below are the stream’s estimated instream sediment pollutant amounts that will be eliminated after the stream restoration.

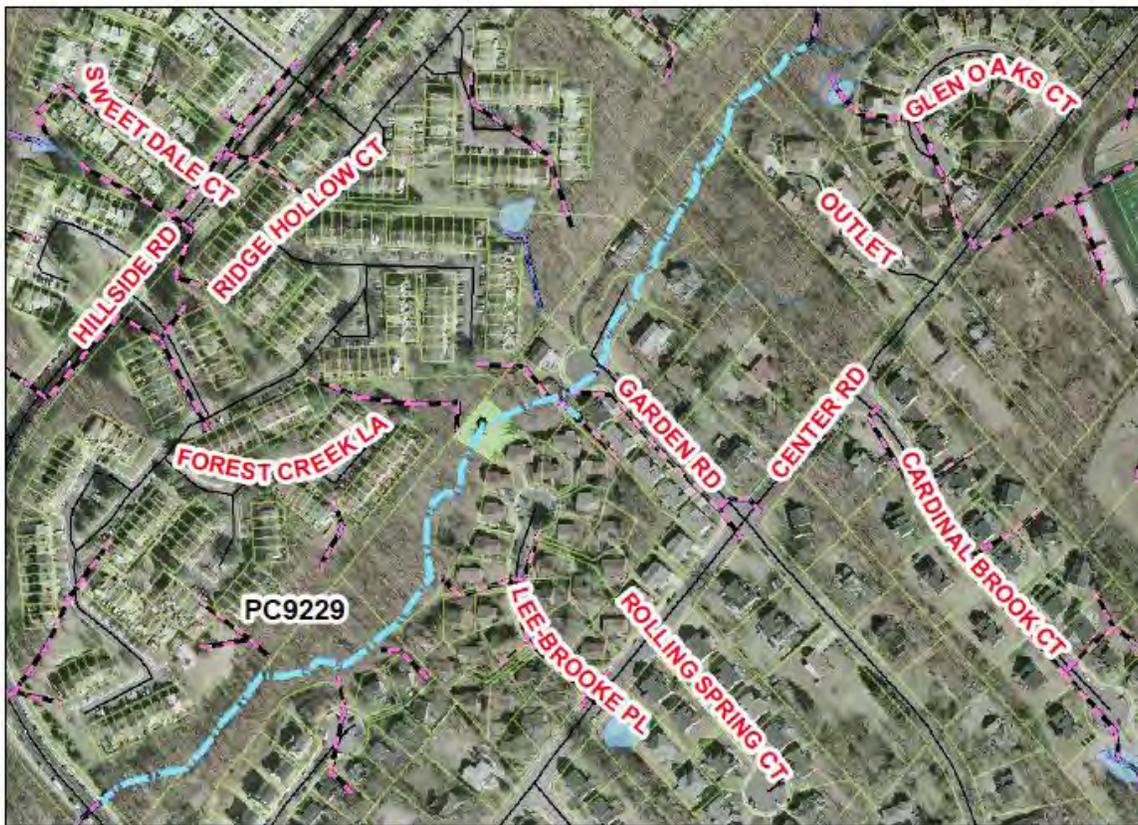
**Description:** This Suite of project proposes restoration projects along the stream northeast of Hillside Road. Subproject A will be along the main stream, subproject B is a riparian buffer restoration, and subproject C is a daylighting of a storm pipe that outfalls to this stream. The primary indicator is poor channel morphology. The Stream receives runoff from sheet flow and closed systems from adjacent residential neighborhoods. These projects will reduce sediment loads to the stream while maintaining capacity and controlling unwanted meander.

**Project Benefits:** Daylighting the storm pipe to the stream will increase infiltration and will decrease erosion near the outfall. The stream restoration will improve the other stormwater outfalls along the stream to help reduce the roadway fines from the untreated stormwater runoff. The buffer restoration will decrease the amount of pollutants following the stream. Below are the stream’s estimated instream sediment pollutant amounts that will be eliminated after the stream restoration.

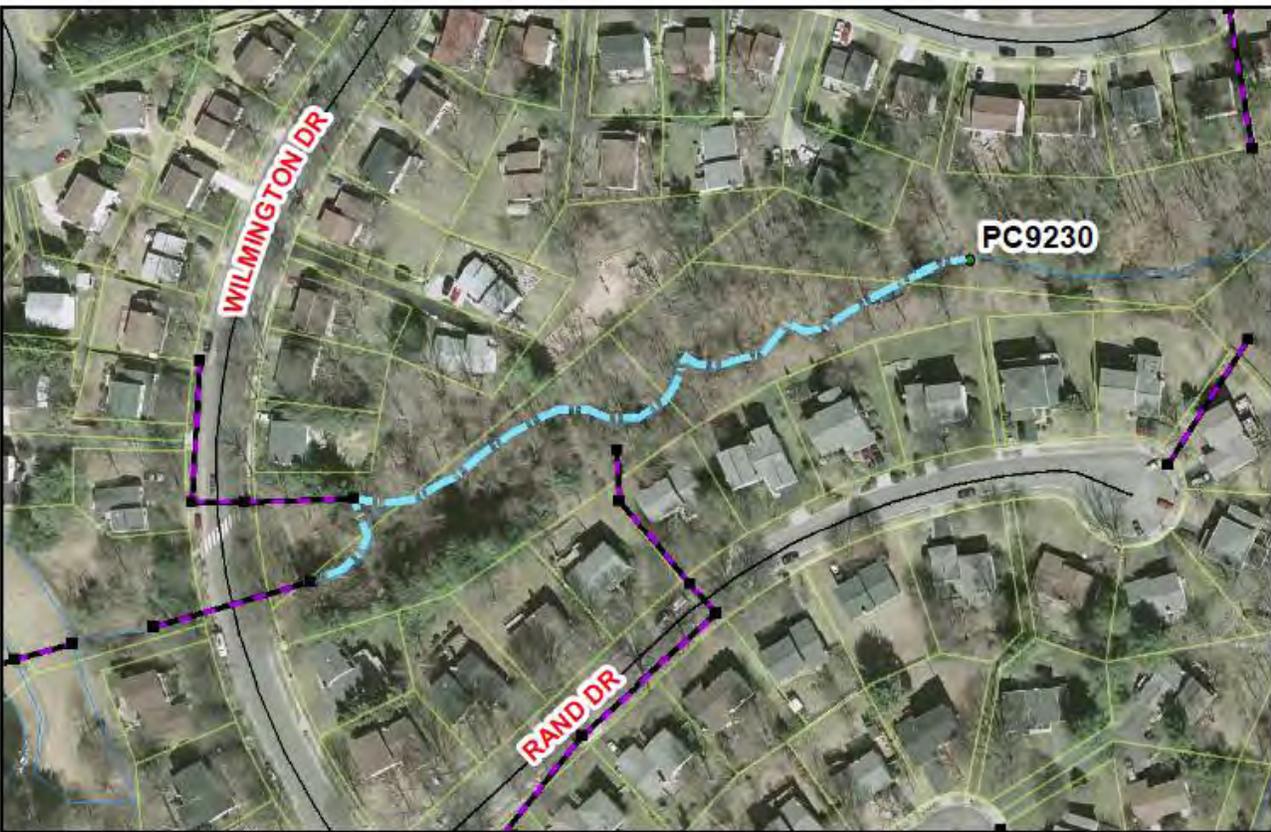
**Description:** The stream east of Wilmington Drive and north of Rand Drive has poor channel morphology. This project proposes repairing bank and bed erosion to restore channel morphology. Erosion will be stabilized through the use of bank shaping, toe of slope protection, erosion control fabric, and rapid vegetation establishment. The stream stabilization will reduce sediment loads while maintaining the capacity of the stream and controlling unwanted meander.

**Project Benefits:** Restoring this stream will reduce erosion and instream sediment. Below are the stream's estimated instream sediment pollutant amounts that will be eliminated after the stream restoration.

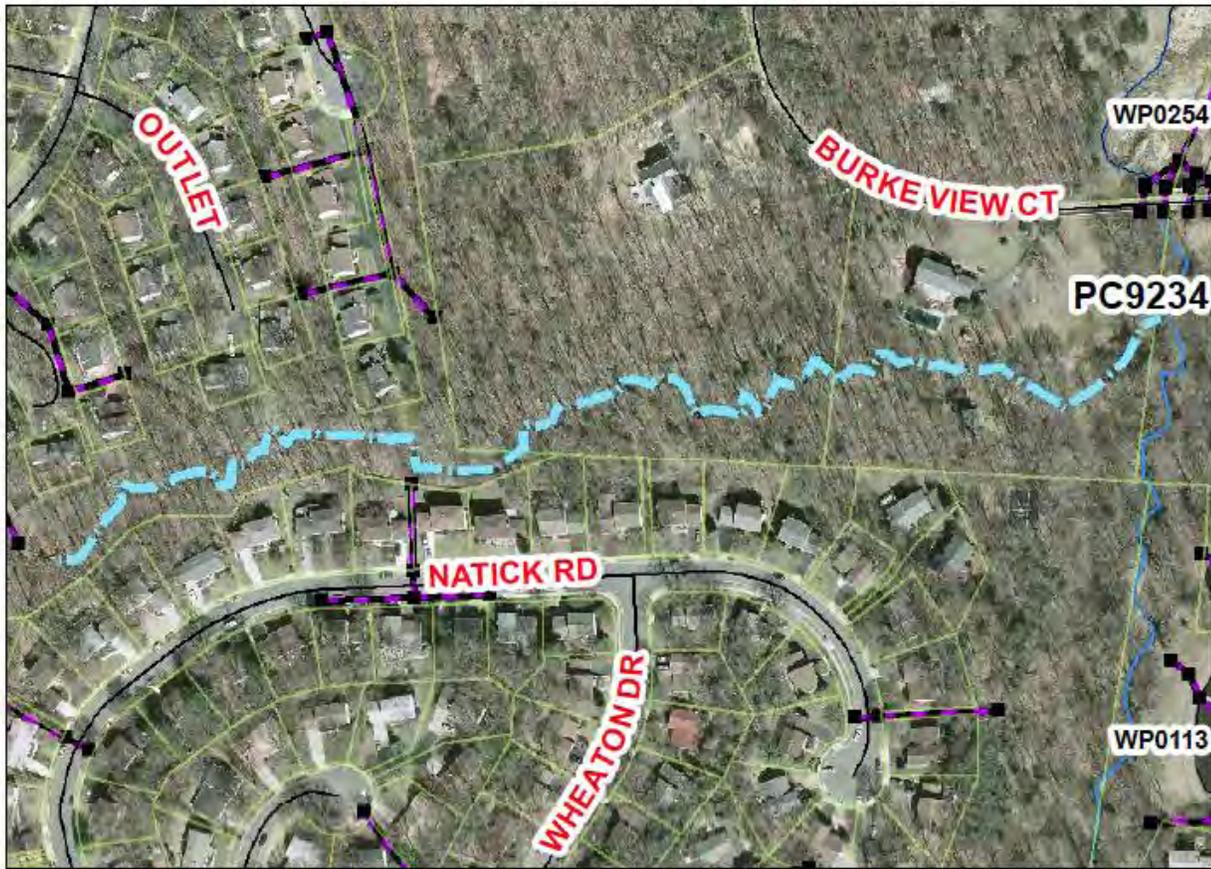
**Description:** This project proposes repairing bank and bed erosion, restoring channel morphology to a stream north of Natick Road. Stream receives runoff from a residential neighborhood by both direct runoff and from a closed system. Erosion will be stabilized through the use of bank shaping, toe protection, erosion control fabrics, and rapid vegetation establishment. The primary indicator is poor stream stabilization.

**Project Benefits:** This project will reduce sediment loads while maintaining the capacity of the stream and controlling unwanted meander. Repairing the stream erosion will also help minimize erosion of the streambanks over time. Below are the stream's estimated instream sediment pollutant amounts that will be eliminated after the stream restoration.

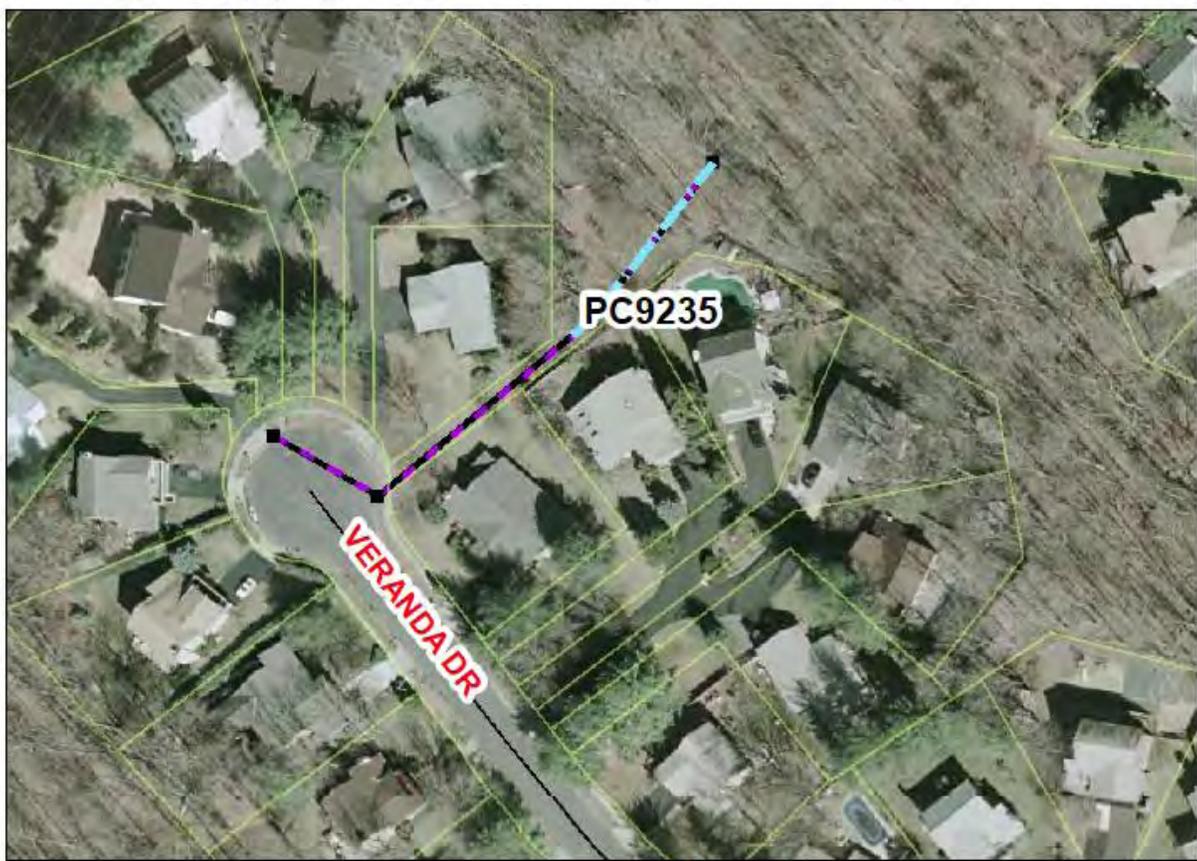
**Description:** Two inlets collect runoff from Veranda Drive and pipe it to an adjacent stream to the east. Due to poor channel morphology, this project has been proposed to daylight the pipe farther upstream by creating an open channel and using an energy dissipation device. This device consists of a series of step pools reinforced with either rocks or logs. The daylighting will help reduce the velocity of the water entering the stream.

**Project Benefits:** Daylighting this storm pipe will help poor downstream channel morphology by redirecting a closed system back to its natural state prior to entering the stream area, thereby reducing runoff rates and minimizing stream erosion. Below are the stream's estimated instream sediment pollutant amounts that will be eliminated after the stream restoration.

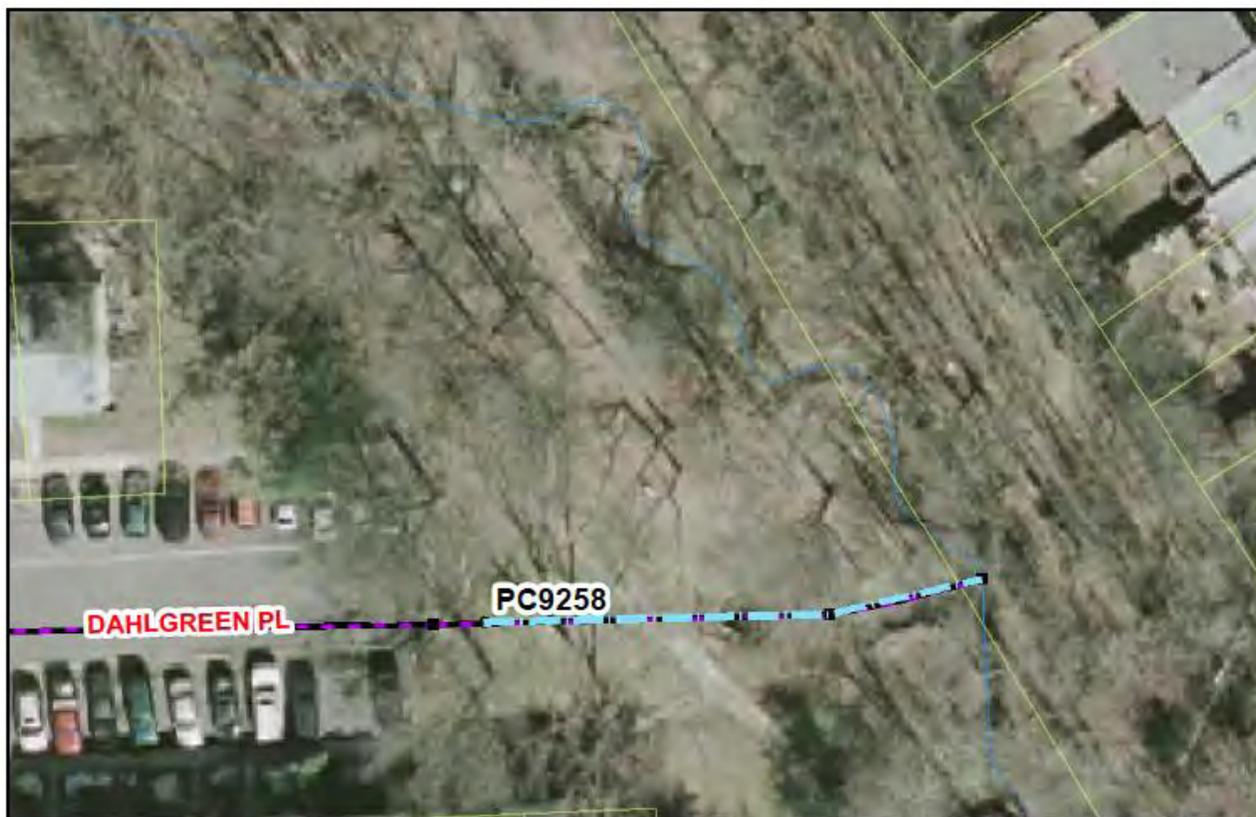
- Stream Restoration
- Storm Network
- Property Line
- Streams

**Description:** This project proposes daylighting a pipe from a residential neighborhood (Dahlgreen Place) farther upstream. The primary indicator is poor channel morphology. This project will return the water to its natural state. This will reduce the velocity at which stormwater enters the stream. Additionally, the daylighting will provide more opportunity for the stormwater to infiltrate. This will help reduce runoff rates and stream erosion.

**Project Benefits:** Restoring this stream will lessen the amount of erosion downstream and result in less instream sediment. Daylighting this pipe will allow the stormwater to return to a natural state earlier, which will allow the water to infiltrate better and will help reduce erosive velocities. Below are the stream's estimated instream sediment pollutant amounts that will be eliminated after the stream restoration.

**Project Design Considerations:** This project is located in Lake Braddock Community open space. Records show no easements. Stormwater runoff from these townhouses receives no treatment before being directly discharged to the stream. The existing outfall is reinforced with rip rap, but still shows signs of scour from erosive velocities. Daylighting the existing pipe farther upstream would increase the chance for the stormwater to infiltrate and for vegetation to absorb/ breakdown some of the pollutants. Depending on the slope of the pipe, stepping pools may be required. Other measures at this site could be the creation of storage below the outfall.

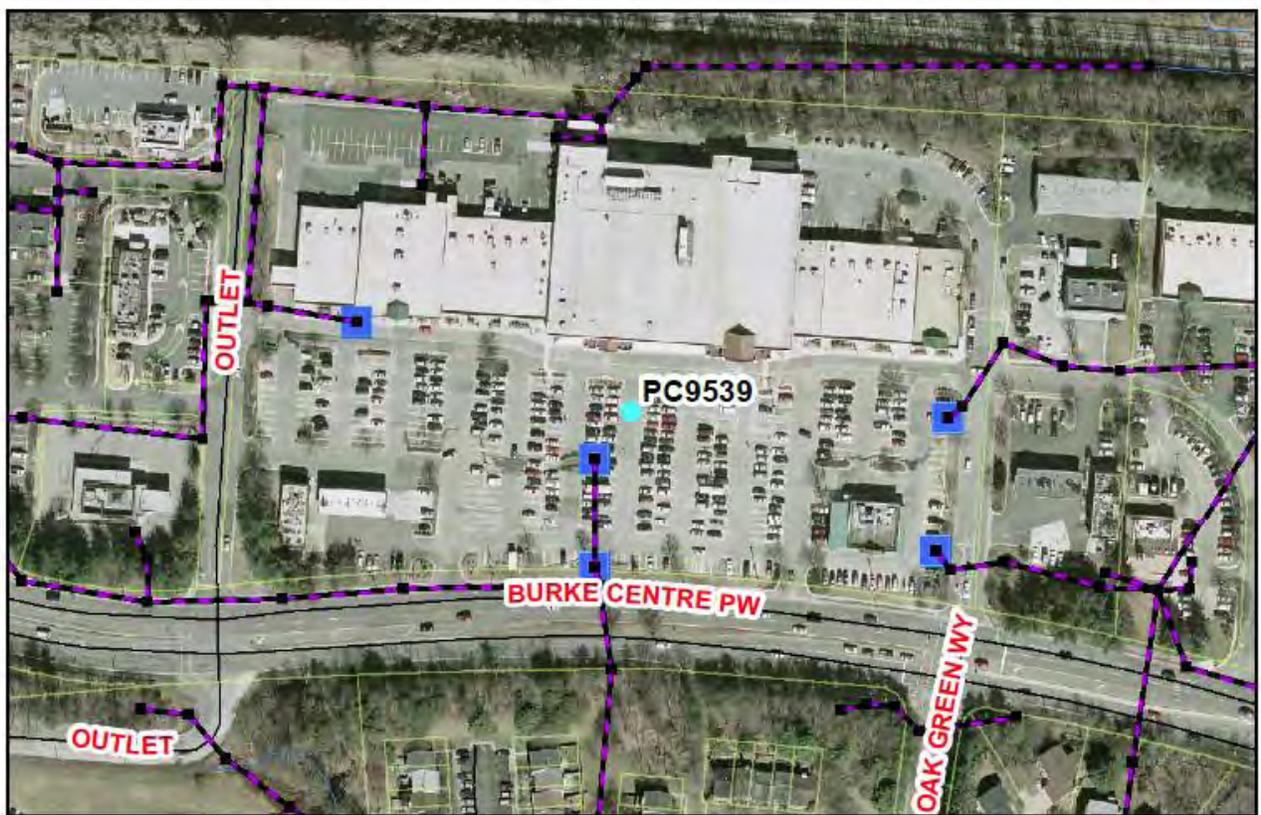
**Description:** This project is located at the shopping center near the intersection of Burke Centre Parkway and Oak Green Way. The storm system collects runoff from the shopping center and outfalls to stream along railroad tracks. A portion of the parking lot is conveyed in a closed system in the adjacent shopping center to the east and west and the remaining is conveyed by a closed system to a stream to the south. This project proposes incorporating BMP inlet inserts or manufactured BMP filtration systems to provide pollutant removal before outfalling into stream.

**Project Design Considerations:** The storm inlets appear to be catch basins in sag conditions. The four inlets chosen are at the farthest upstream ends of the storm system. The storm system needs to be examined to determine whether there is hydraulic head available to make cartridge filters work or if less effective basket filters will need to be used. The records show no existing storm easements. The installation and maintenance of these inserts will need to be coordinated with the shopping center. The inserts will receive runoff from a large amount of untreated impervious area, so maintenance will be more important than normal.

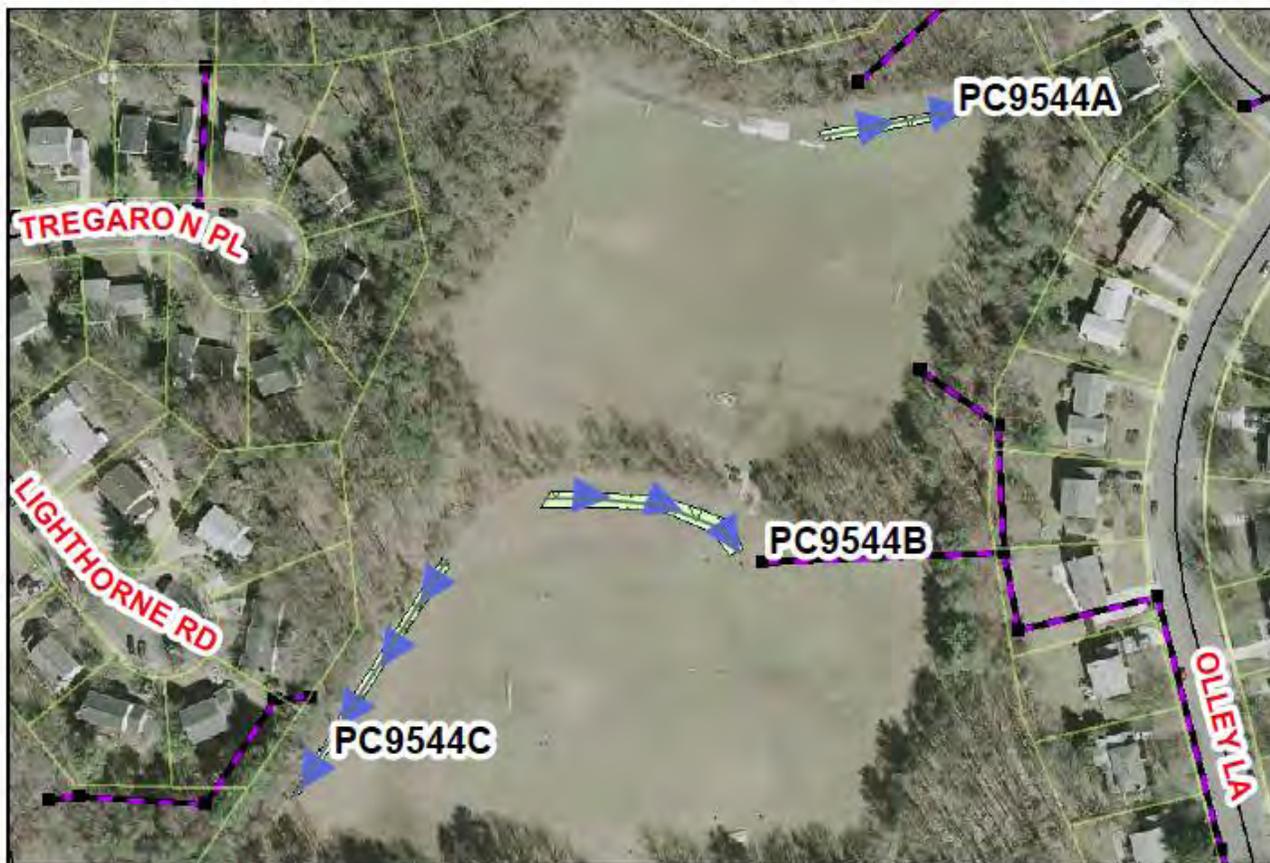
Bioswales

**Description:** This suite of projects proposes the installation of bioswales at Lake Braddock Park near the game fields. The bioswales would receive sheet flow from the fields and would increase infiltration and reduce pollutants, such as excessive fertilizer, grass clippings or animal waste. The primary indicators are pollutants, including nitrogen, phosphorus and total suspended solids.

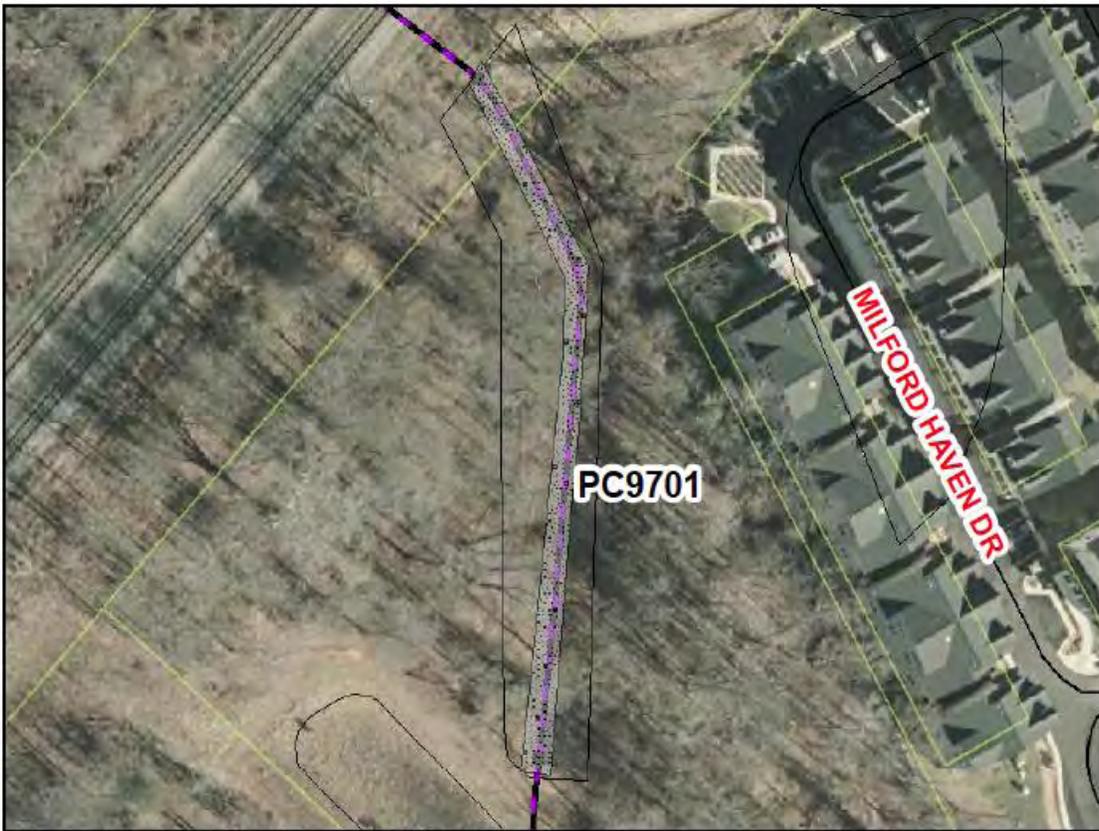
- Outfall Improvement
- Storm Network
- Property Line

**Description:** This project proposes improving the outfall west of Milford Haven Drive by replacing the existing concrete channel with a naturalized stream and an energy dissipation device. The concrete channel conveys runoff from pond 1158DP. This pond has a proposed stormwater pond retrofit project PC9105. The concrete channel discharges to a culvert under Henry G Shirley Memorial Highway. The surrounding area consists of mostly townhomes, open wooded area, highway and railroad tracks.

**Project Benefits:** The outfall reconstruction will reduce erosive velocities and sediment loads at the outfalls, protecting downstream channels. Improving the outfall will reduce instream sediment and its associated pollutants in the eroded stream on the downstream side of the highway (northwest of site). This outfall improvement will increase infiltration and reduce pollutant loads. Below are the estimated instream sediment pollutant amounts that will be eliminated after this project implementation.

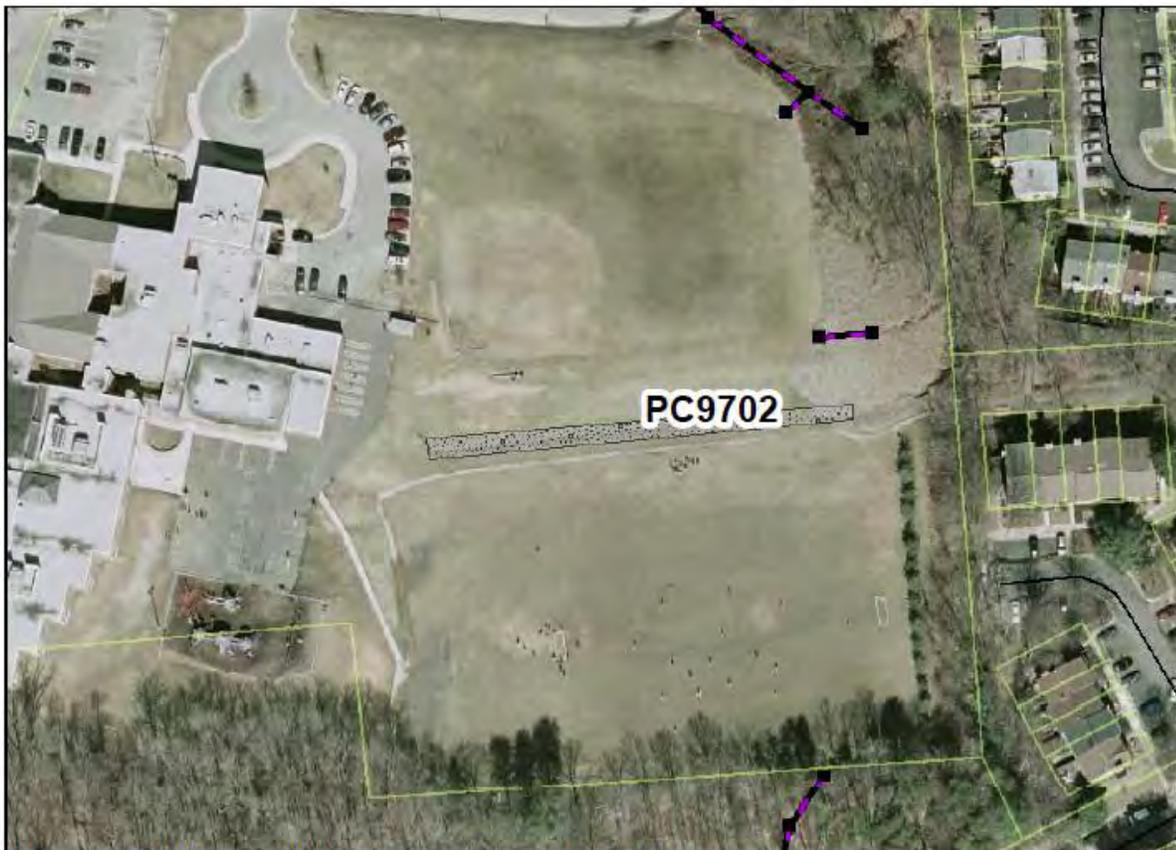
- Outfall Improvement
- Storm Network
- Property Line

**Description:** Swale reconstruction is proposed in the fields behind Fairview Elementary School. An existing grass swale discharges into the stream adjacent to the school. The swale is located between two playing fields. The project proposes adding energy dissipation devices to the swale, such as check dams and increased planting, to decrease velocities, increase infiltration, and improve stormwater quality.

**Project Benefits:** The proposed project will reduce erosive velocities in the swale. Decreasing velocities in the swale will promote infiltration and pollutant removal before discharge. This will also increase groundwater recharge and downstream channel protection. The swale is between fields at a school and excessive erosion could have negative impacts to the fields. Below are the estimated instream sediment pollutant amounts that will be eliminated after this project implementation.

**Project Design Considerations:** The drainage area of the swale is the adjacent fields. The Watershed Advisory Group (WAG) supports these low cost projects that will improve water quality and educate students. Swale needs to be retrofitted in such a way as to minimize potential impacts after construction. Due to its location, the outfall improvement will have a substantial amount of traffic. In order to insure the project will function properly, foot traffic should be directed to cross at stabilized check dams, and directed away from infiltration areas.

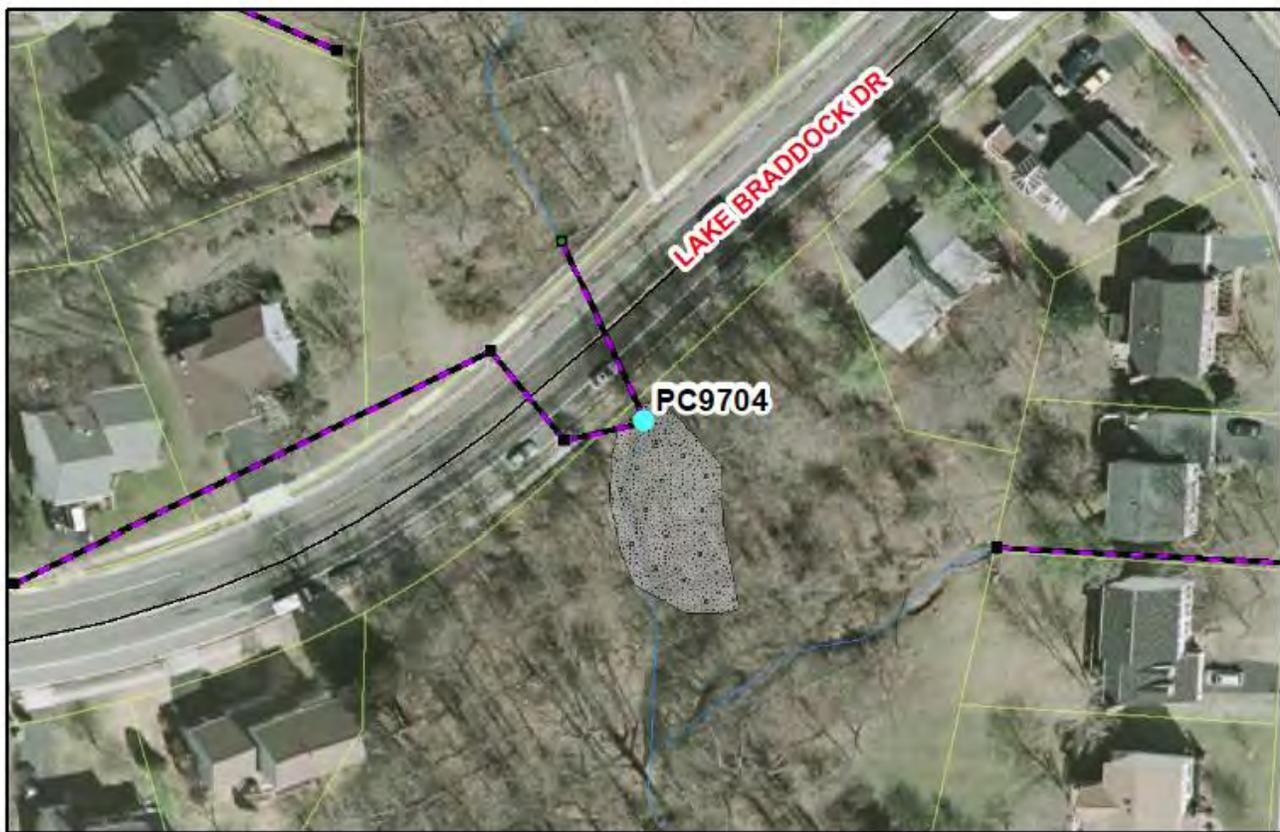
**Description:** This project proposes the construction of a new storage and treatment area below the outfall of a closed system from Lake Braddock Drive. The improvement will include an energy dissipation device and wetland plantings. The primary indicators include instream sediment. Outfall storage will reduce erosive velocities and sediment loads at the outfall and improve downstream habitats.
