POHICK CREEK DRAFT Watershed Workbook September 2008

Fairfax County
Watershed Planning & Assessment Branch
Stormwater Planning Division
Department of Public Works & Environmental Services

DRAFT Watershed Workbook –Pohick Creek Watershed

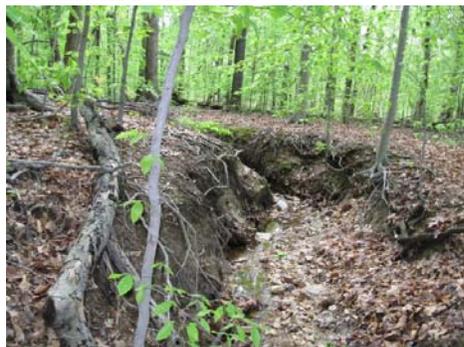
Figure 2: Pohick Creek Bank Erosion

In 2005, the County released the Stream Physical Assessment (SPA) report which documented the instream conditions of more than 800 stream miles. Both habitat assessment and some infrastructure assessment (if found instream) were captured. The infrastructure assessment was included to determine the impacts on streams from specific infrastructure and problem areas. For each watershed, a visual evaluation of infrastructure such as road culverts and stormwater outfalls was performed; any potential impacts to the stream were documented with an impact score. The impact scores ranged from zero to ten (10) or greater, with zero indicating no impact and ten indicating extreme conditions. An extreme condition would include such things as impervious encroachment near the stream severe erosional areas and large obstructions in the channel. See photo below for an example of stream bank erosion located along the South Run stream in Pohick Creek.

In Pohick Creek a total of 871 inventory points were visually assessed. The most significant problems were related to four head cuts, two exposed utility lines and one pipe, which were each given an impact score of 10, with the two highest impacts both being deficient buffers, each scoring a five. Table 4 below identifies the full scoring for the Pohick Creek watershed.

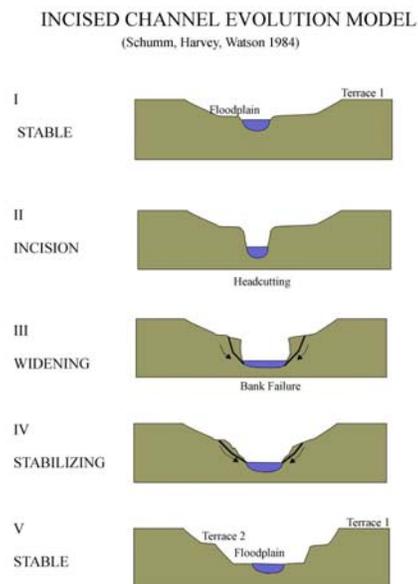
Over time, stream morphology naturally evolves and changes. These natural dynamics can be drastically affected by human land use changes. To identify and track these physical changes, the Channel Evolution Model (CEM) (Schumm et al. 1984), was developed in the early 1980s. Based on visual observations, the CEM classifies a stream evolution into five channel stages. Figure below provides a visual representation of the stream evolution. A Stage I stream/channel is characterized as the most stable system in the group with a well developed flow and strong vegetation coverage – this is a stream in which the watershed has never been disturbed from its naturally-formed character. As flow rates increase (from land use changes), down-cutting occurs in the channel bottom creating a Stage II channel – which is typified by a very narrow, deeply incised channel.

Heavy erosion begins to widen the channel bottom until stream bank failure occurs. This is a Stage III channel, which is the most unstable and typically generates the most issues. As stream bank erosion begins to decrease and the channel begins to re-stabilize according to the new flow regime, the channel is classified as a Stage IV. Finally at Stage V, the channel returns to a stable system with two floodplain terraces. Once a stream has reached this “dynamic equilibrium” it will remain in this stage until the watershed characteristics are once again changed (i.e.: increase in storm flows due to increased runoff from greater impervious area creation). This process can

take decades. If the land uses are continuously changing, then the stream never quite reaches equilibrium and will continue to respond to changes in the flow (runoff) regime.

Using the CEM, nearly 75% of Pohick Creek’s stream channels are classified as Stage III. Stage III is generally characterized as unstable, showing erosion signs of widening and deepening (in response to altered hydrologic characteristics of the watershed – usually a result of changing land uses). A small percentage of Pohick Creek’ stream channels are classified as Stage II, indicating incising head cuts (vertical erosion) that produces harmful amounts of instream sediments and could ultimately lead into Stage III. The remaining streams are classified Stage IV, which is much more stable and easily recognized by its two terraced stream banks. See Table 11 for CEM results.

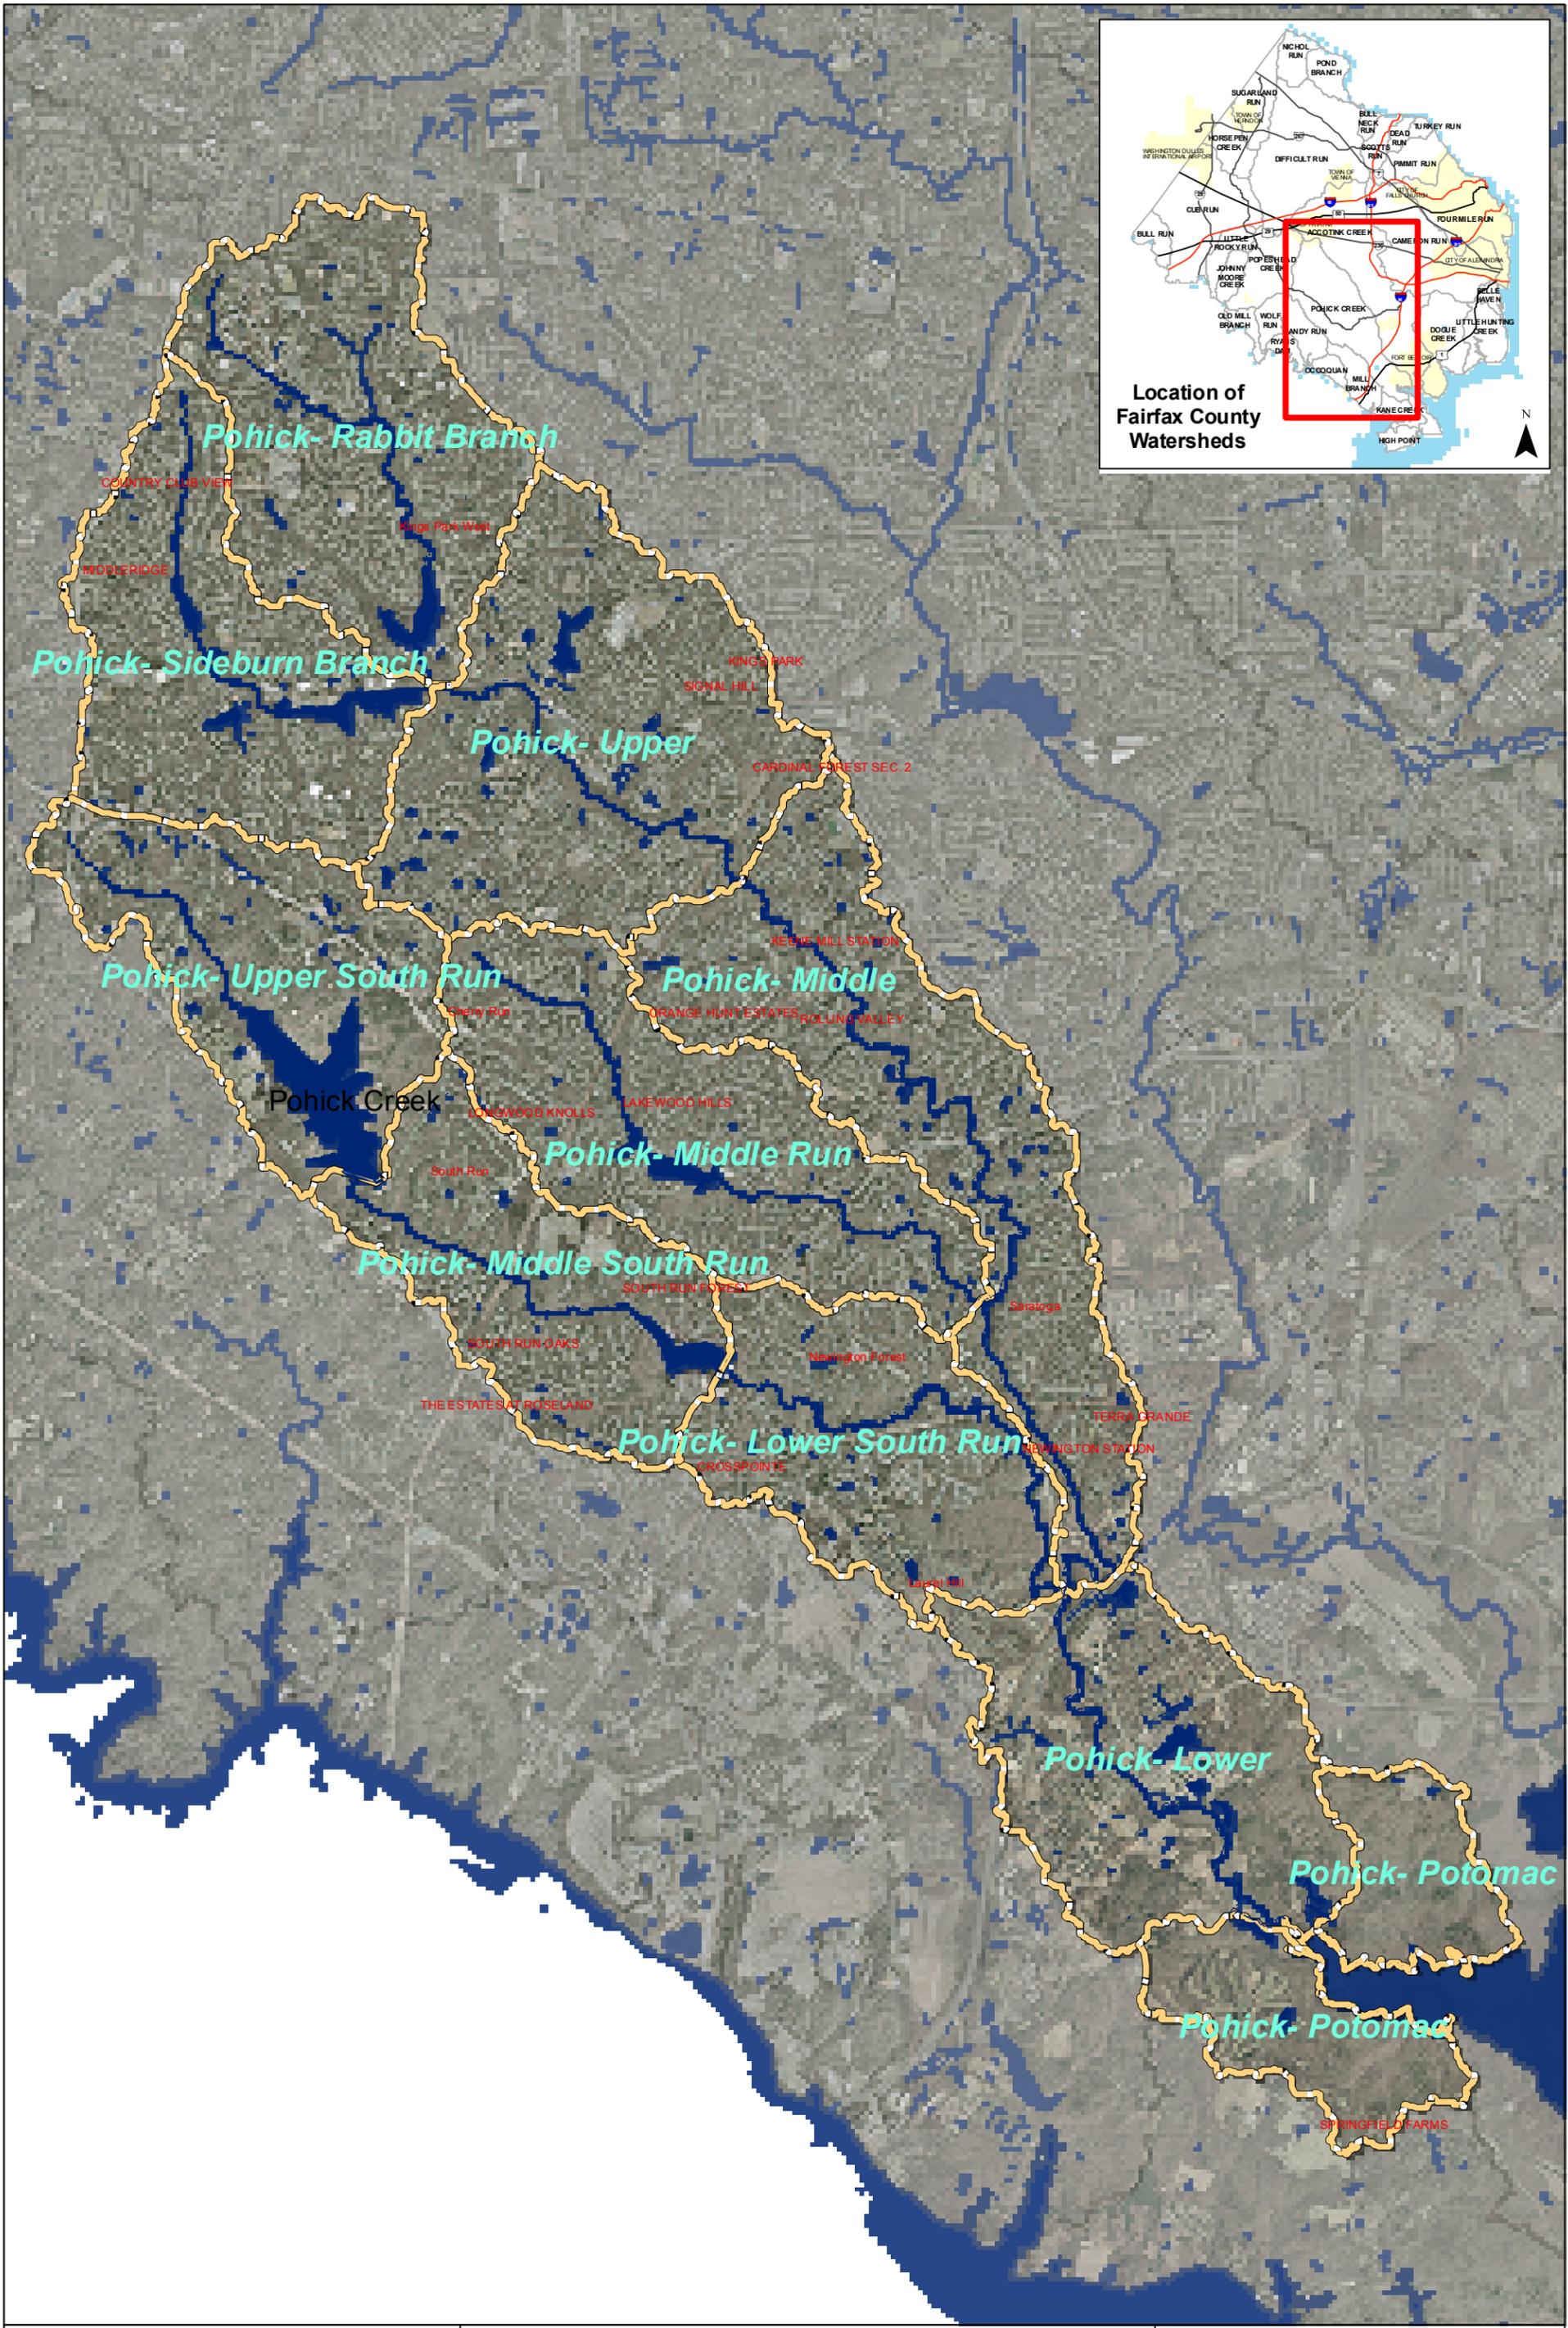
Map 1.2
Pohick Watershed

- WMA Boundary
- Water

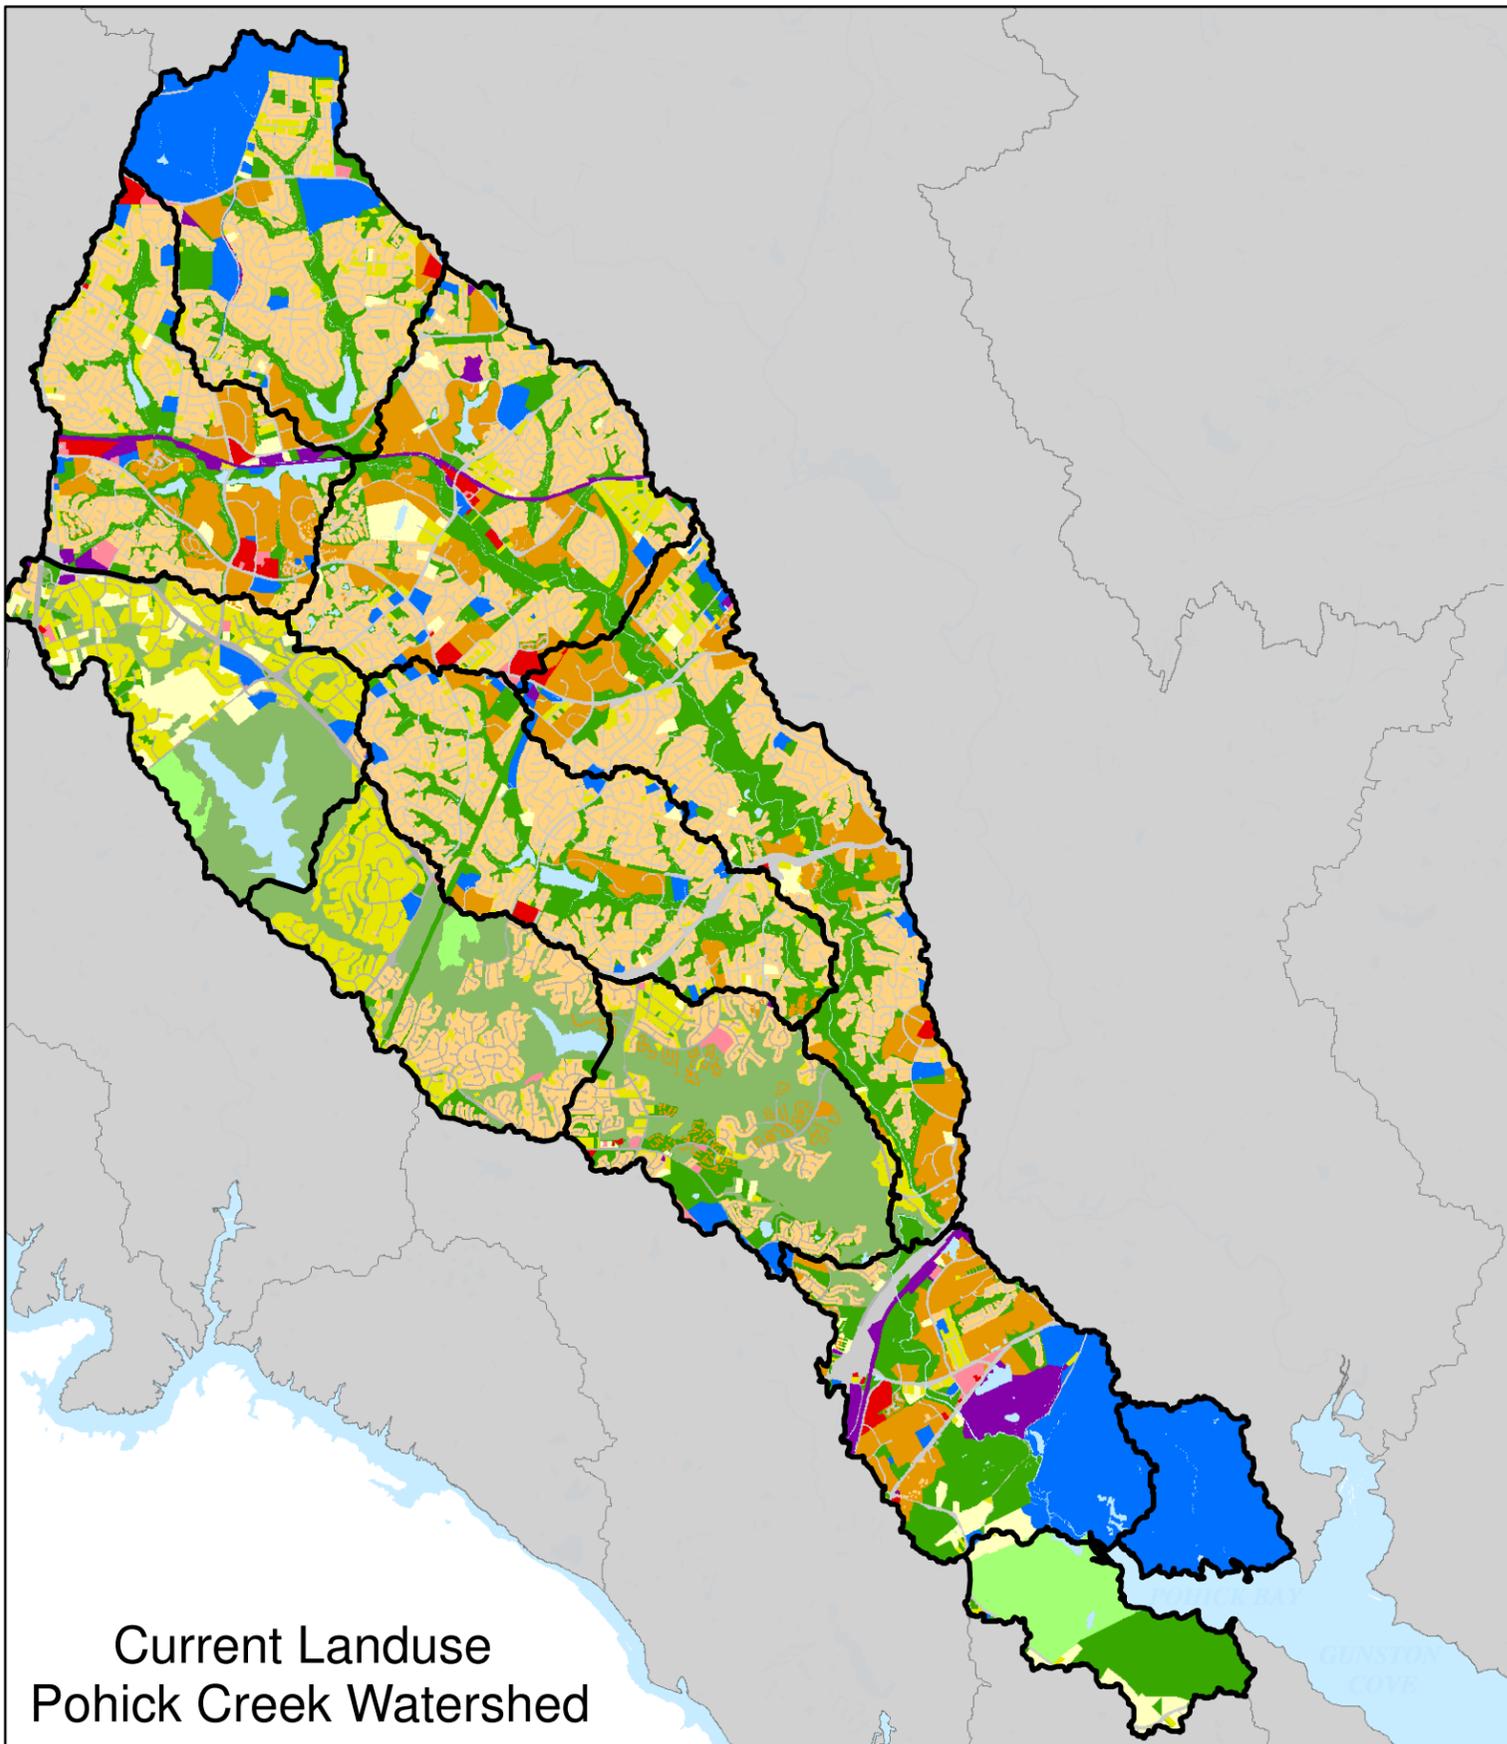
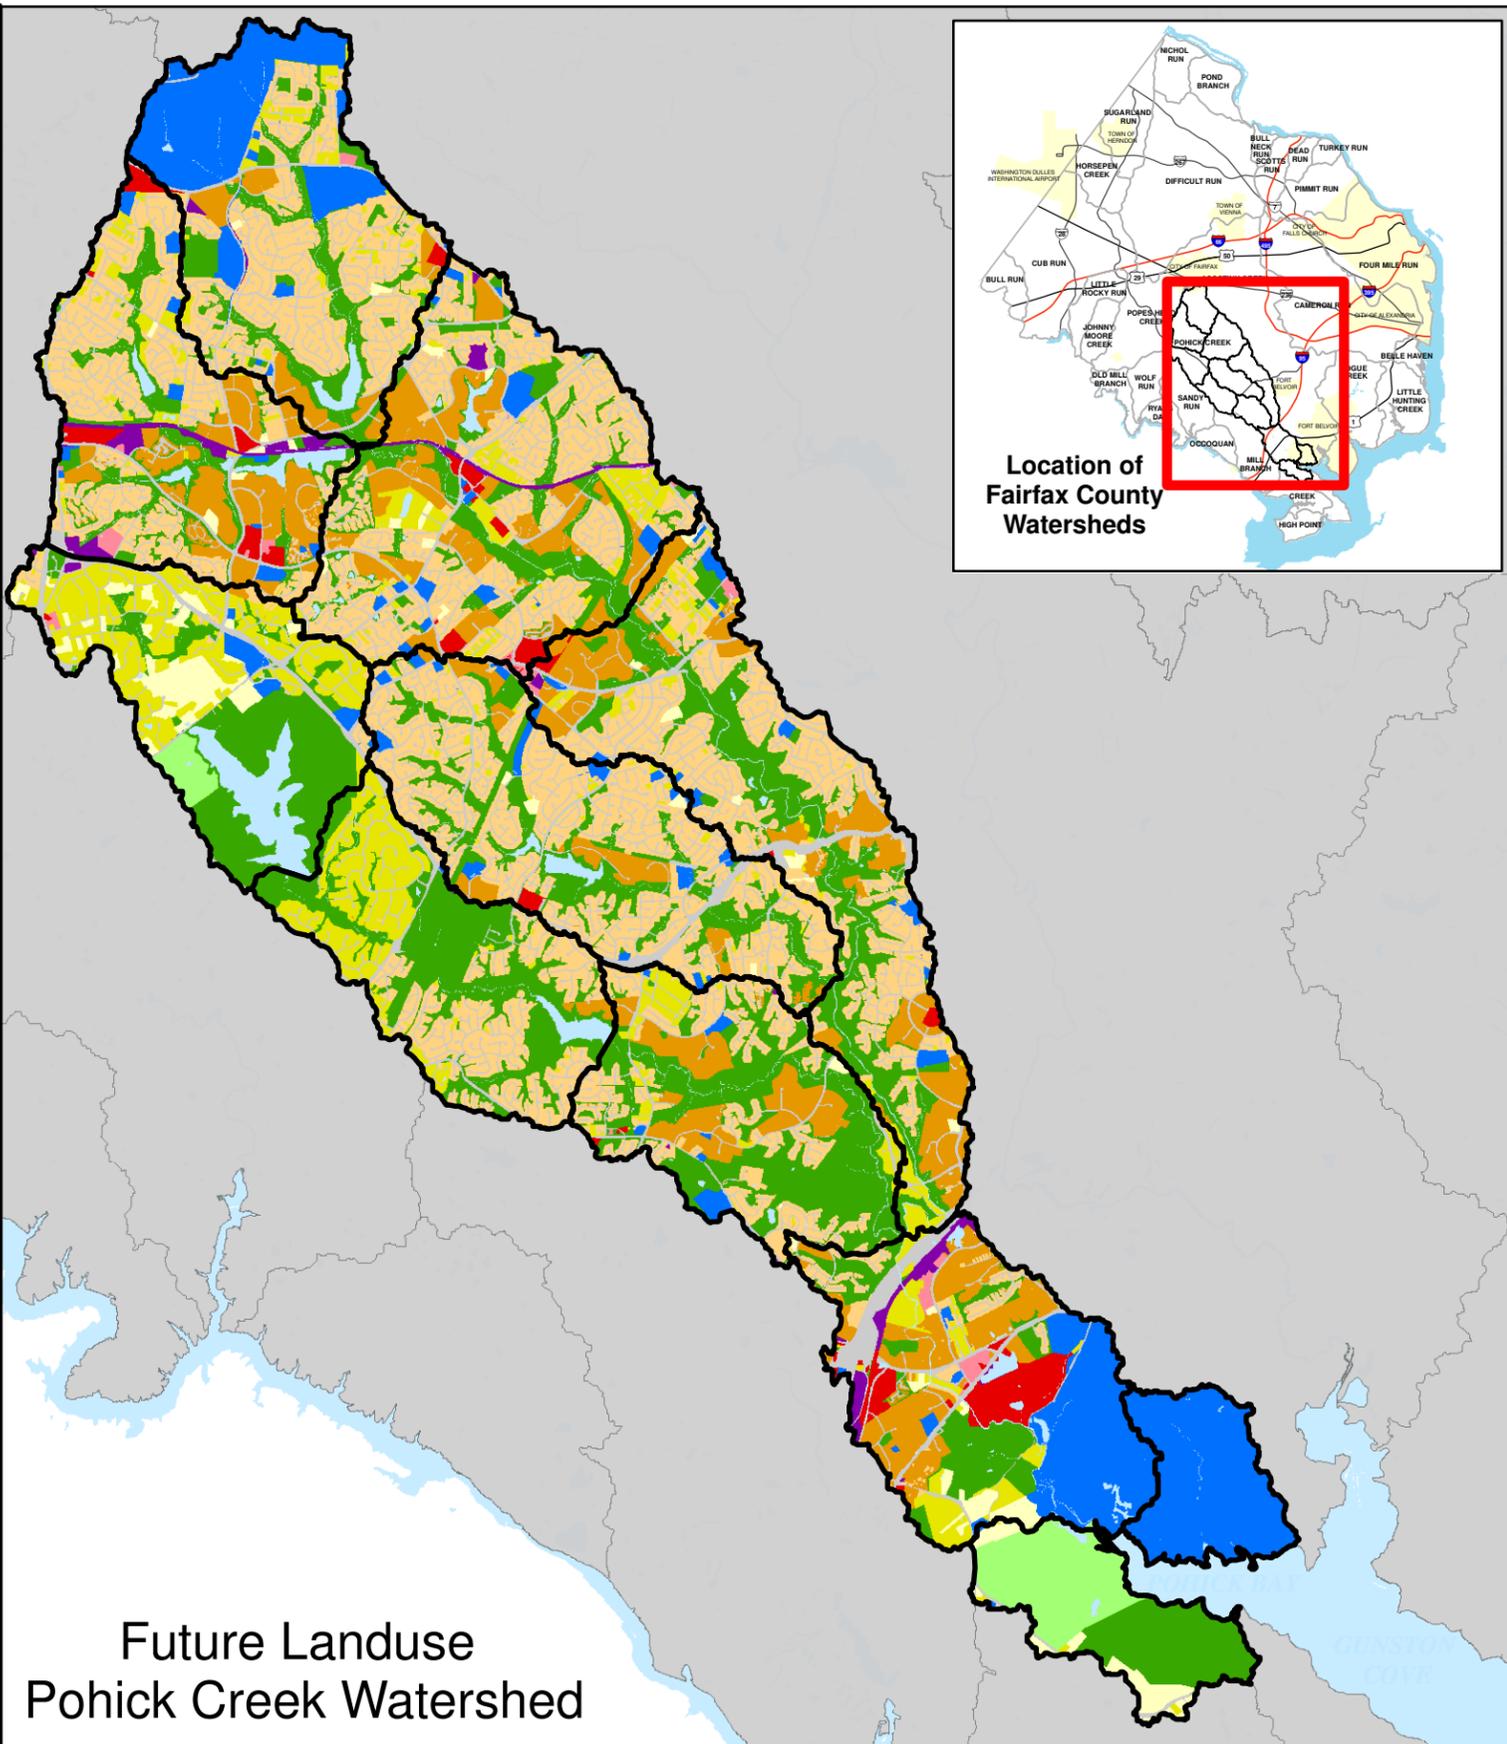
Map 1.3
Pohick Creek Watershed
Existing and Future Land Use

Current Landuse
Pohick Creek Watershed

Future Landuse
Pohick Creek Watershed

WMA Boundary	Estate Residential	Institutional
Open Space	Low Density Residential	Low Intensity Commercial
Forested	Medium Density Residential	High Intensity Commercial
Golf Course	High Density Residential	Industrial
	Transportation	Water

According to the Fairfax County Stream Protection Baseline Study (SPS), in 2001, more than half of Pohick Creek was forested, with nearly 30% of the watershed serving low-density residential uses; see Table 2 below for Pohick Creek land usage. Refer to **Map 1.3** for existing and future land use.

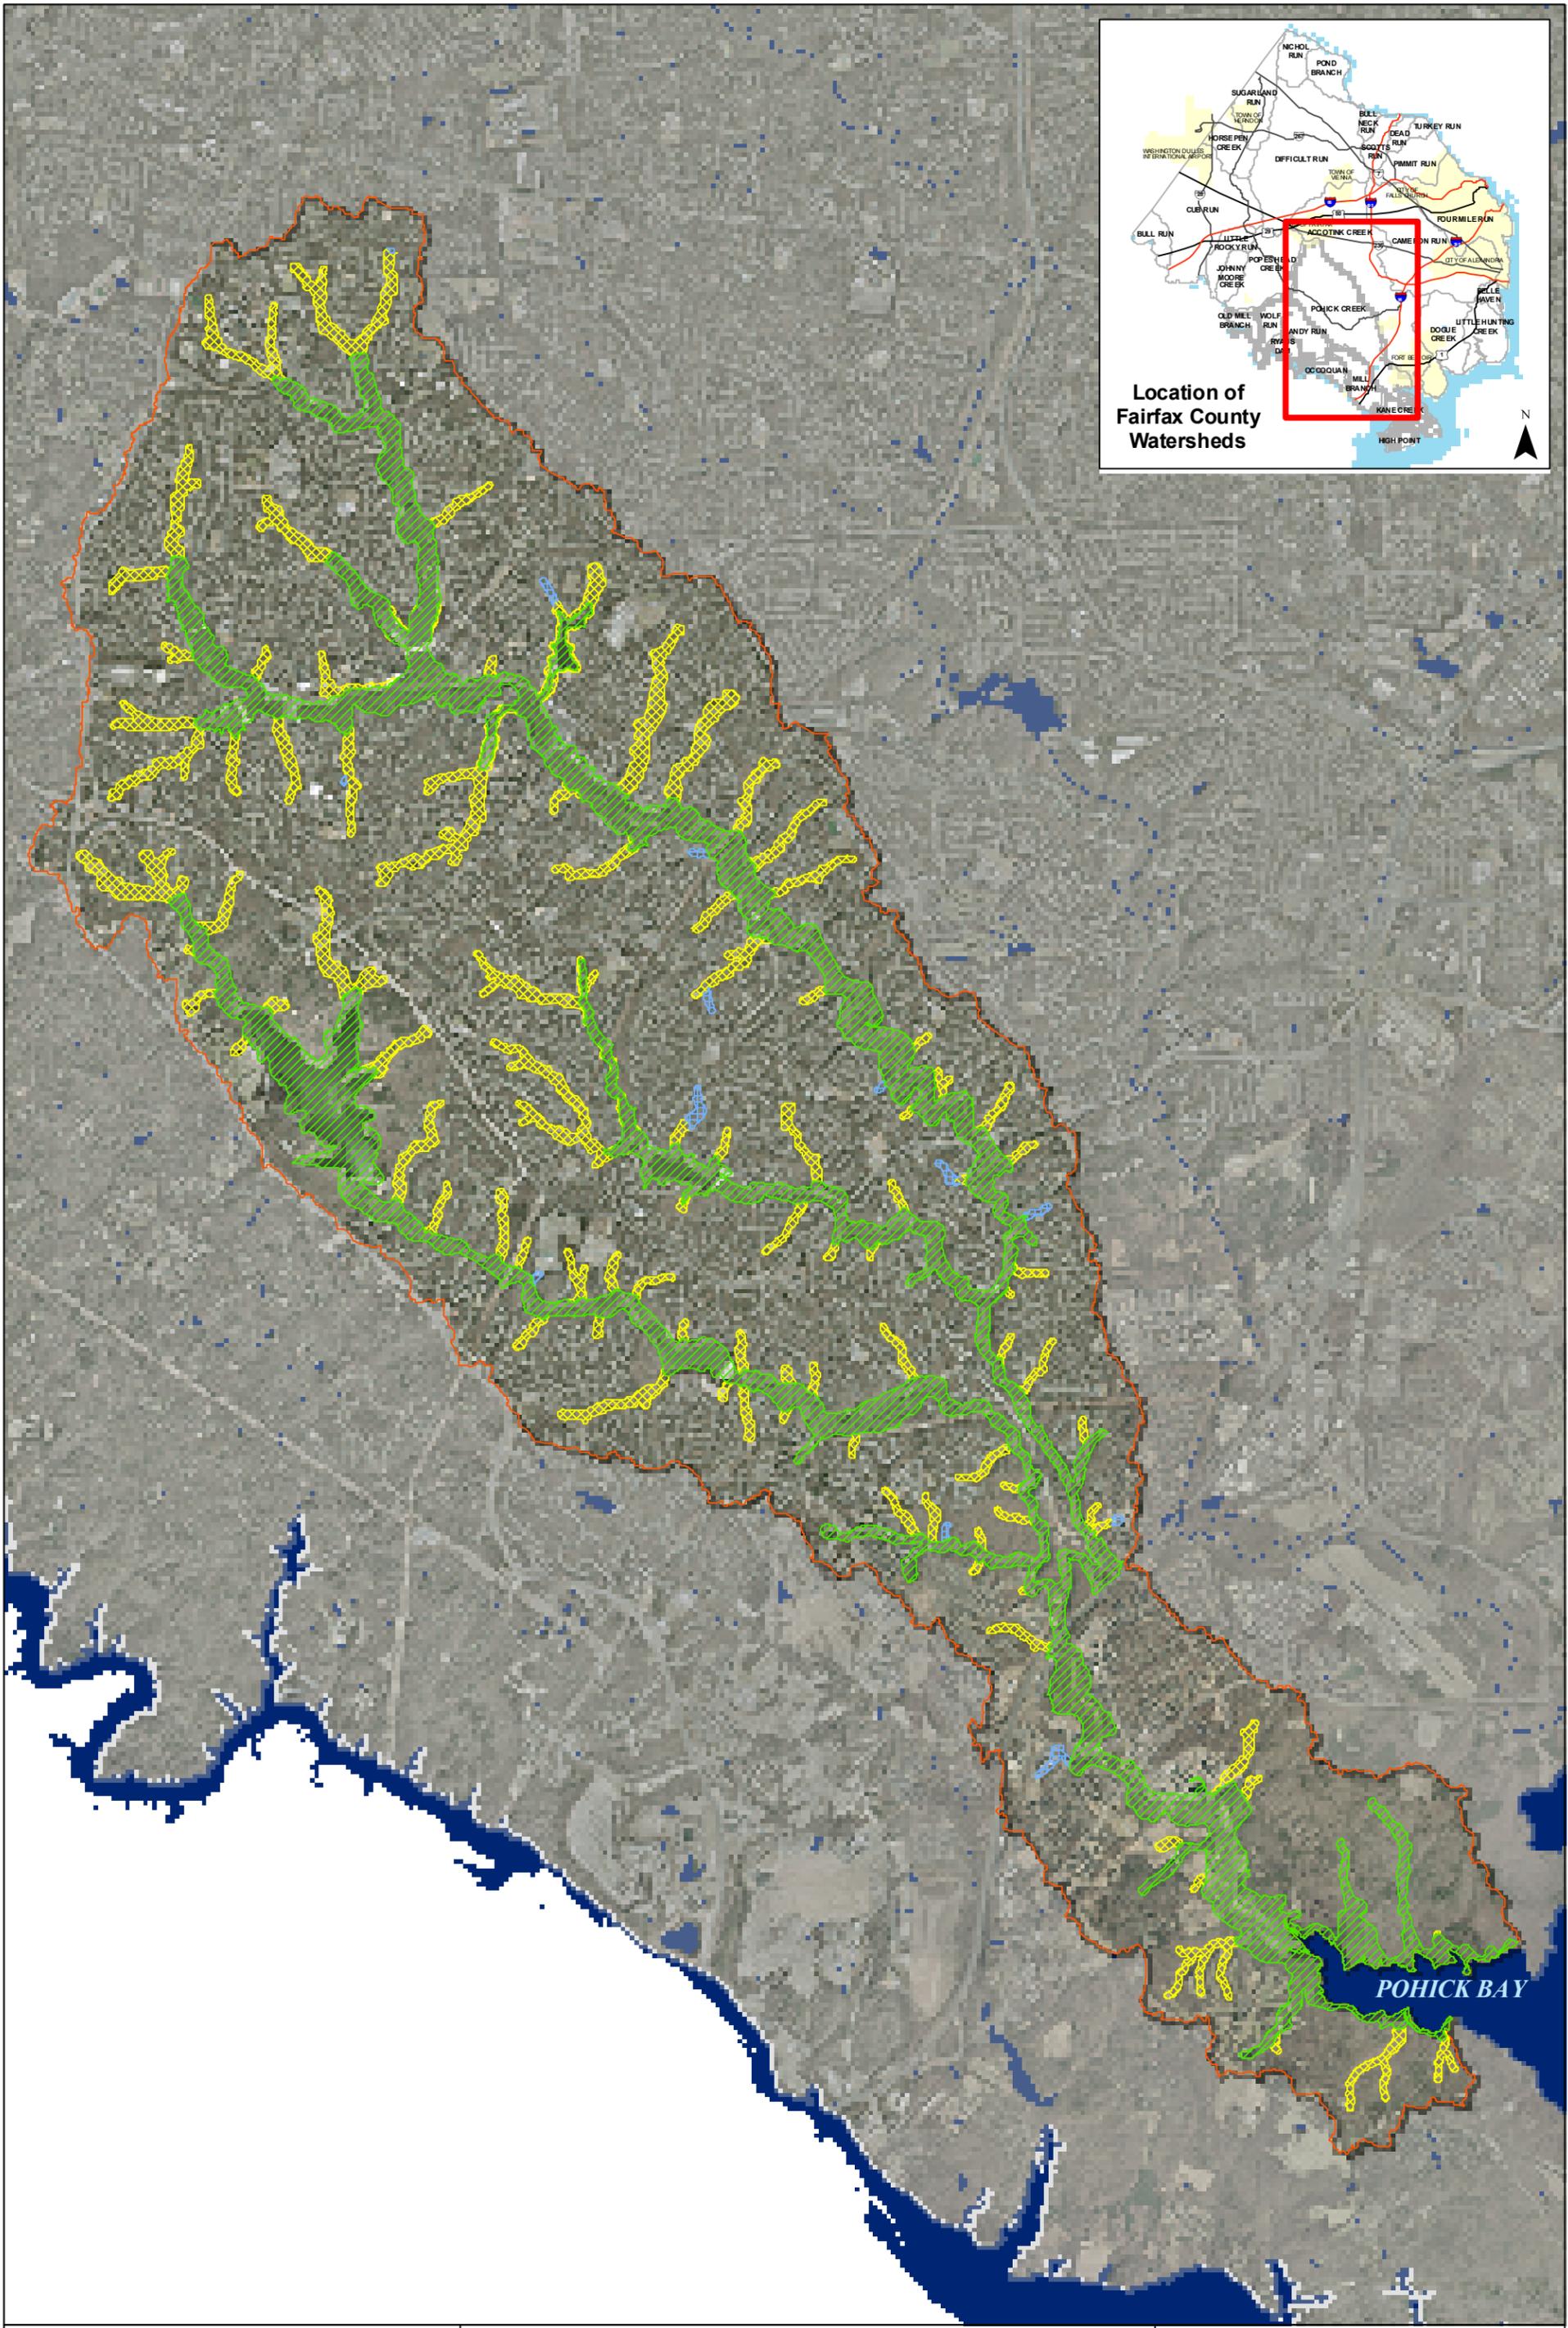
**Map 1.4
Pohick Watershed
Resource Protection Areas**

Resource Protection Areas

RPA 1993
-

RPA 2003
-

RPA 2005

As one of many measures used to protect stream water quality, the County adopted the Chesapeake Bay Preservation Ordinance, which imposes restrictions on development for any land that lies within a Resource Protection Area (RPA). Resource protection areas are buffers which protect sensitive areas adjacent to or near the shorelines of streams, rivers and other waterways from the excessive influx of pollutants. The sensitive areas include tidal and nontidal wetlands, tidal shorelines, floodplains and perennial streams (waters flowing year round). As **Map 1.4** indicates a majority, or more than 75% (134 of the 180 miles) of the streams within the Pohick Creek watershed lie within a RPA. (County GIS, 2008)

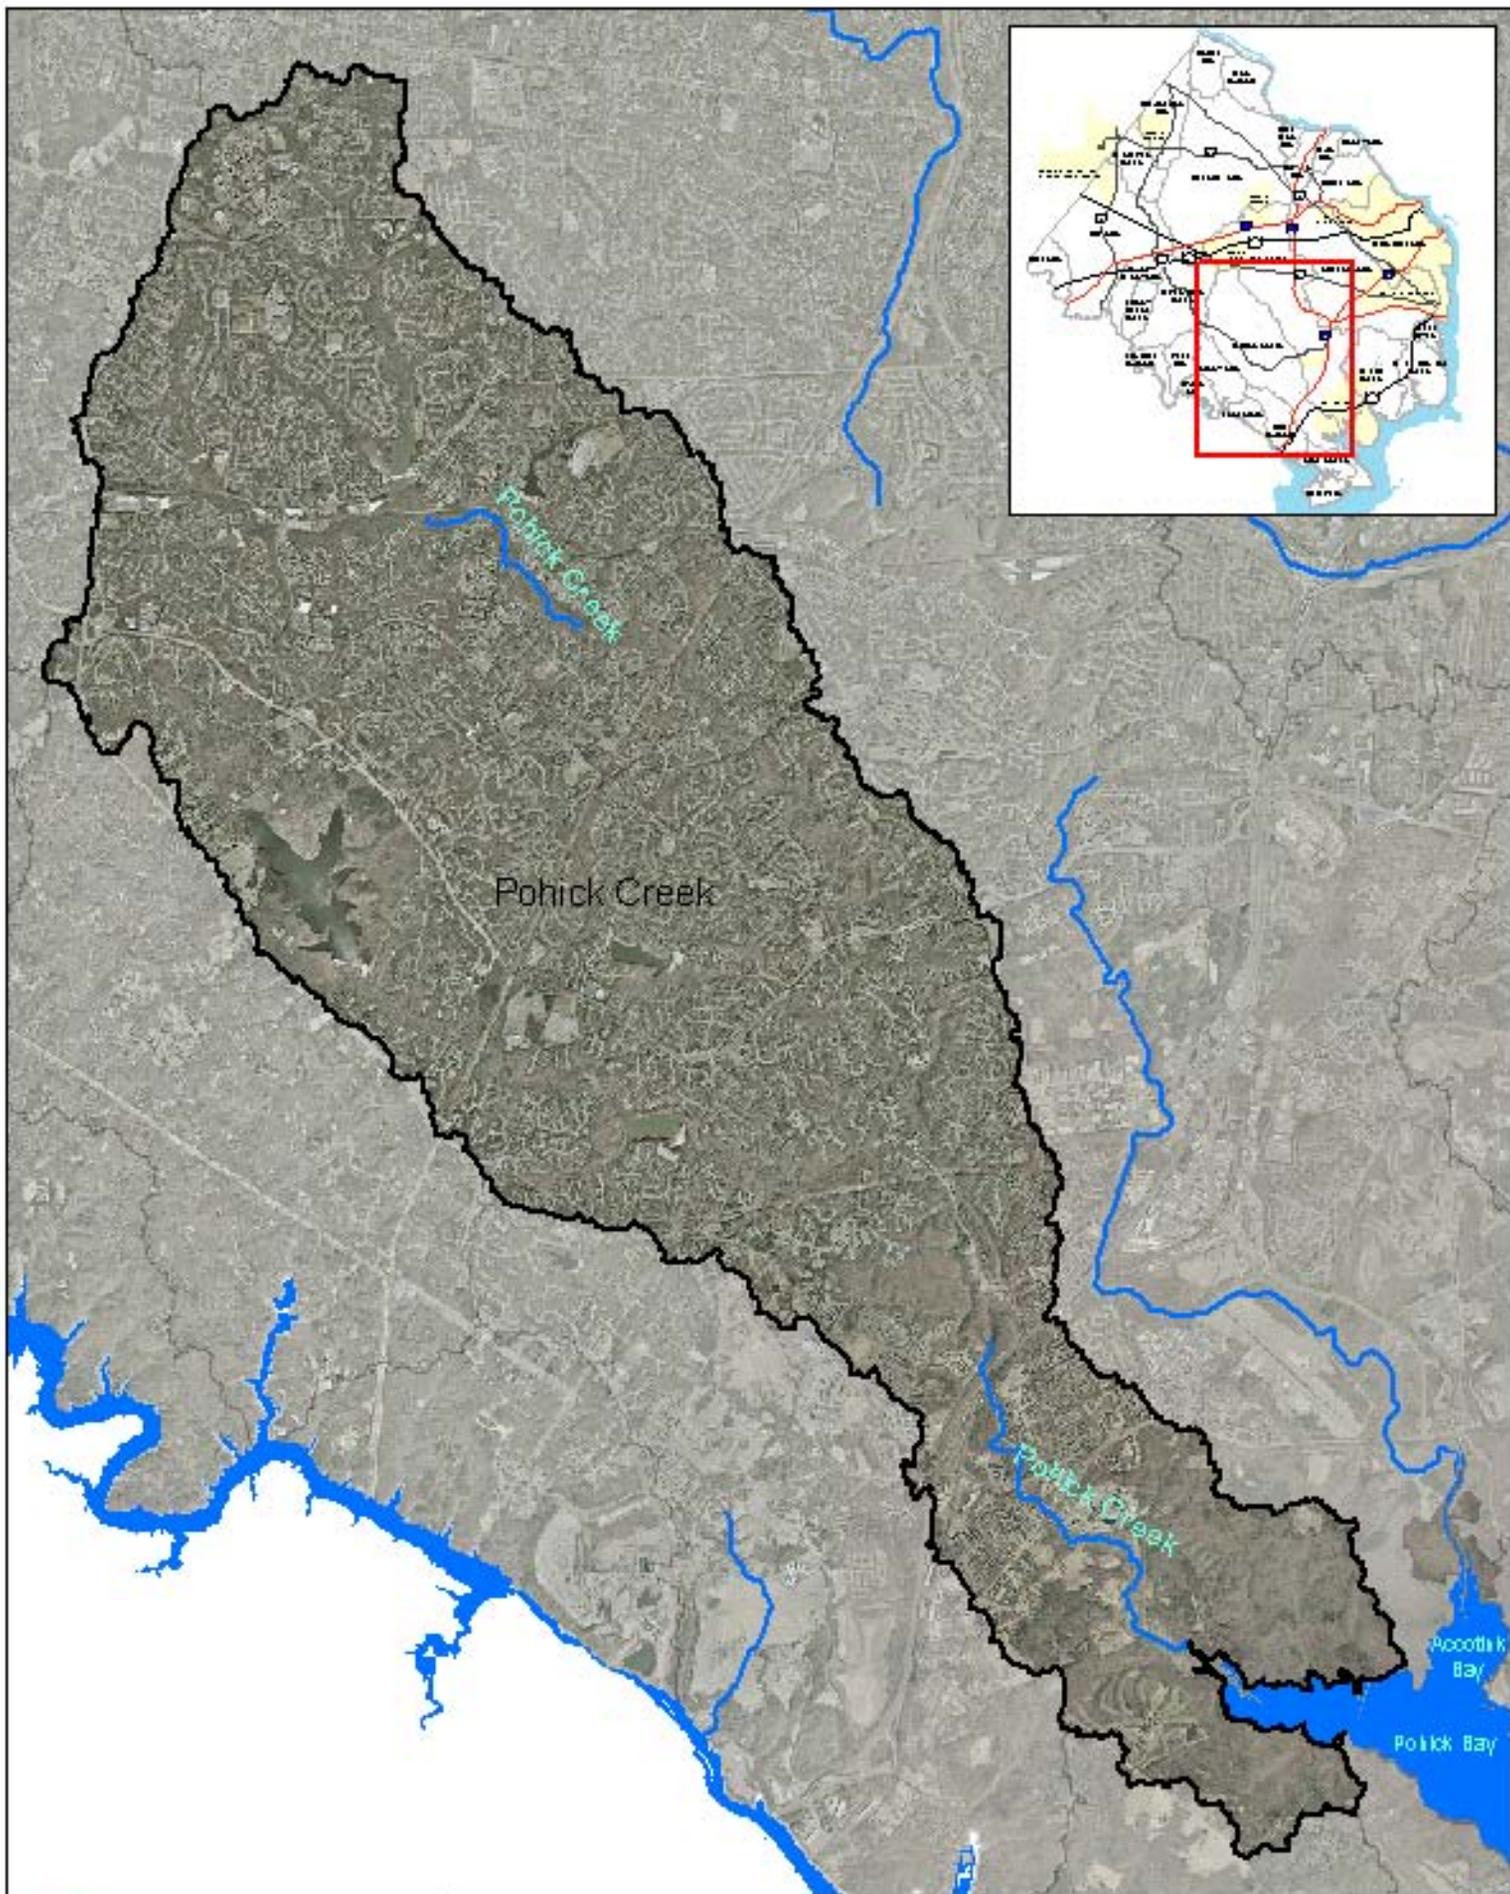
Map 1.5
Pohick Creek
Impaired Waters

Impaired Waters

To meet these standards, the county and the VDEQ regularly monitor water quality at various locations in the watershed. These sampling data reflect that Pohick Creek watershed has some of the best and worst water quality in the County; this is due in part to the multiple large impoundments located throughout the watershed. While many streams in the Pohick Creek watershed are considered “fair”, areas further downstream of the impoundments experience high levels of E coli. See **Map 1.5** and Table 8 below for complete impairments.
