Chapter 2: Watershed Management Area Characterization

DRAFT Watershed Workbook –**Pohick Creek Watershed**

Volume 2: Chapter 2

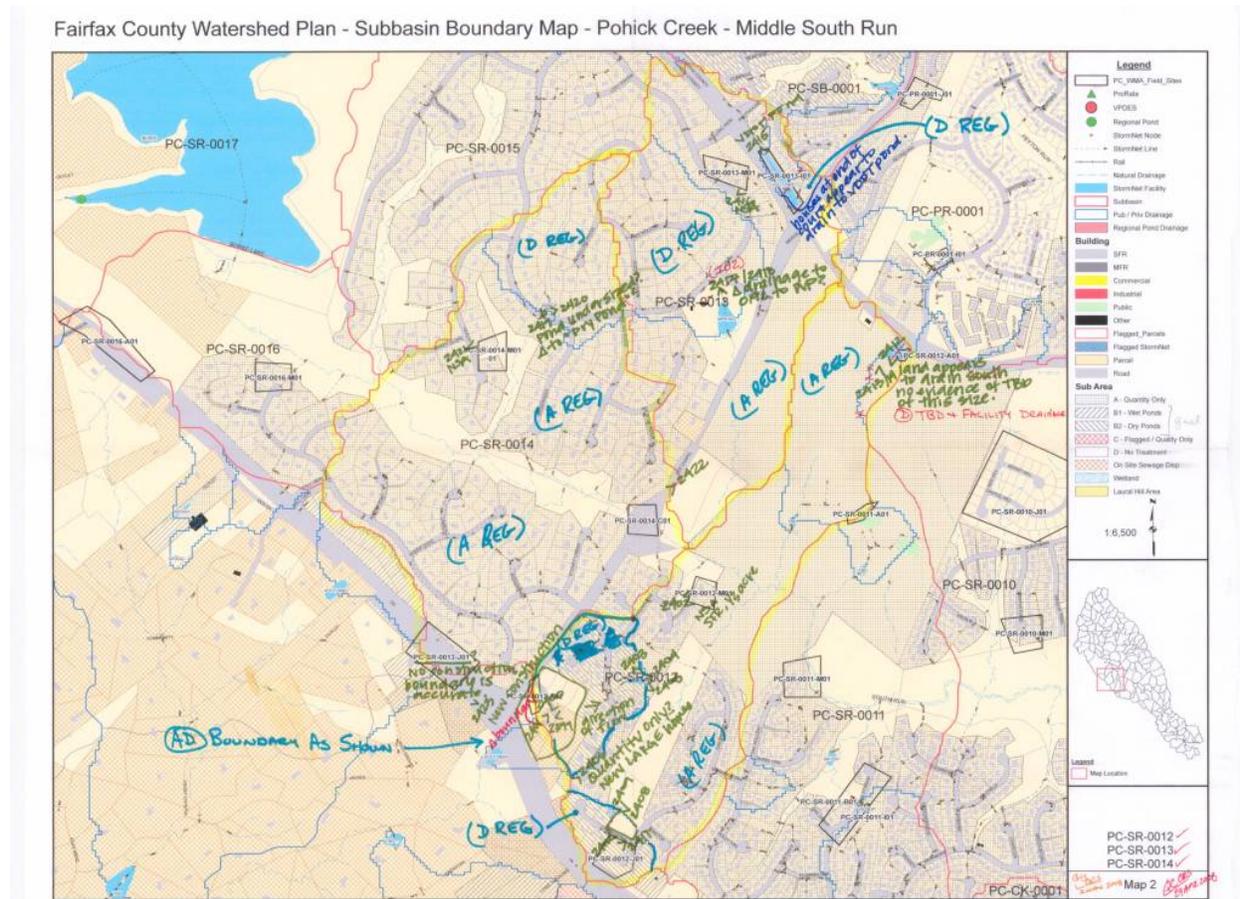
Field maps, photos and data forms were used to capture current watershed conditions. Below provides an example of one of the field maps used to identify unique issues within the WMA.

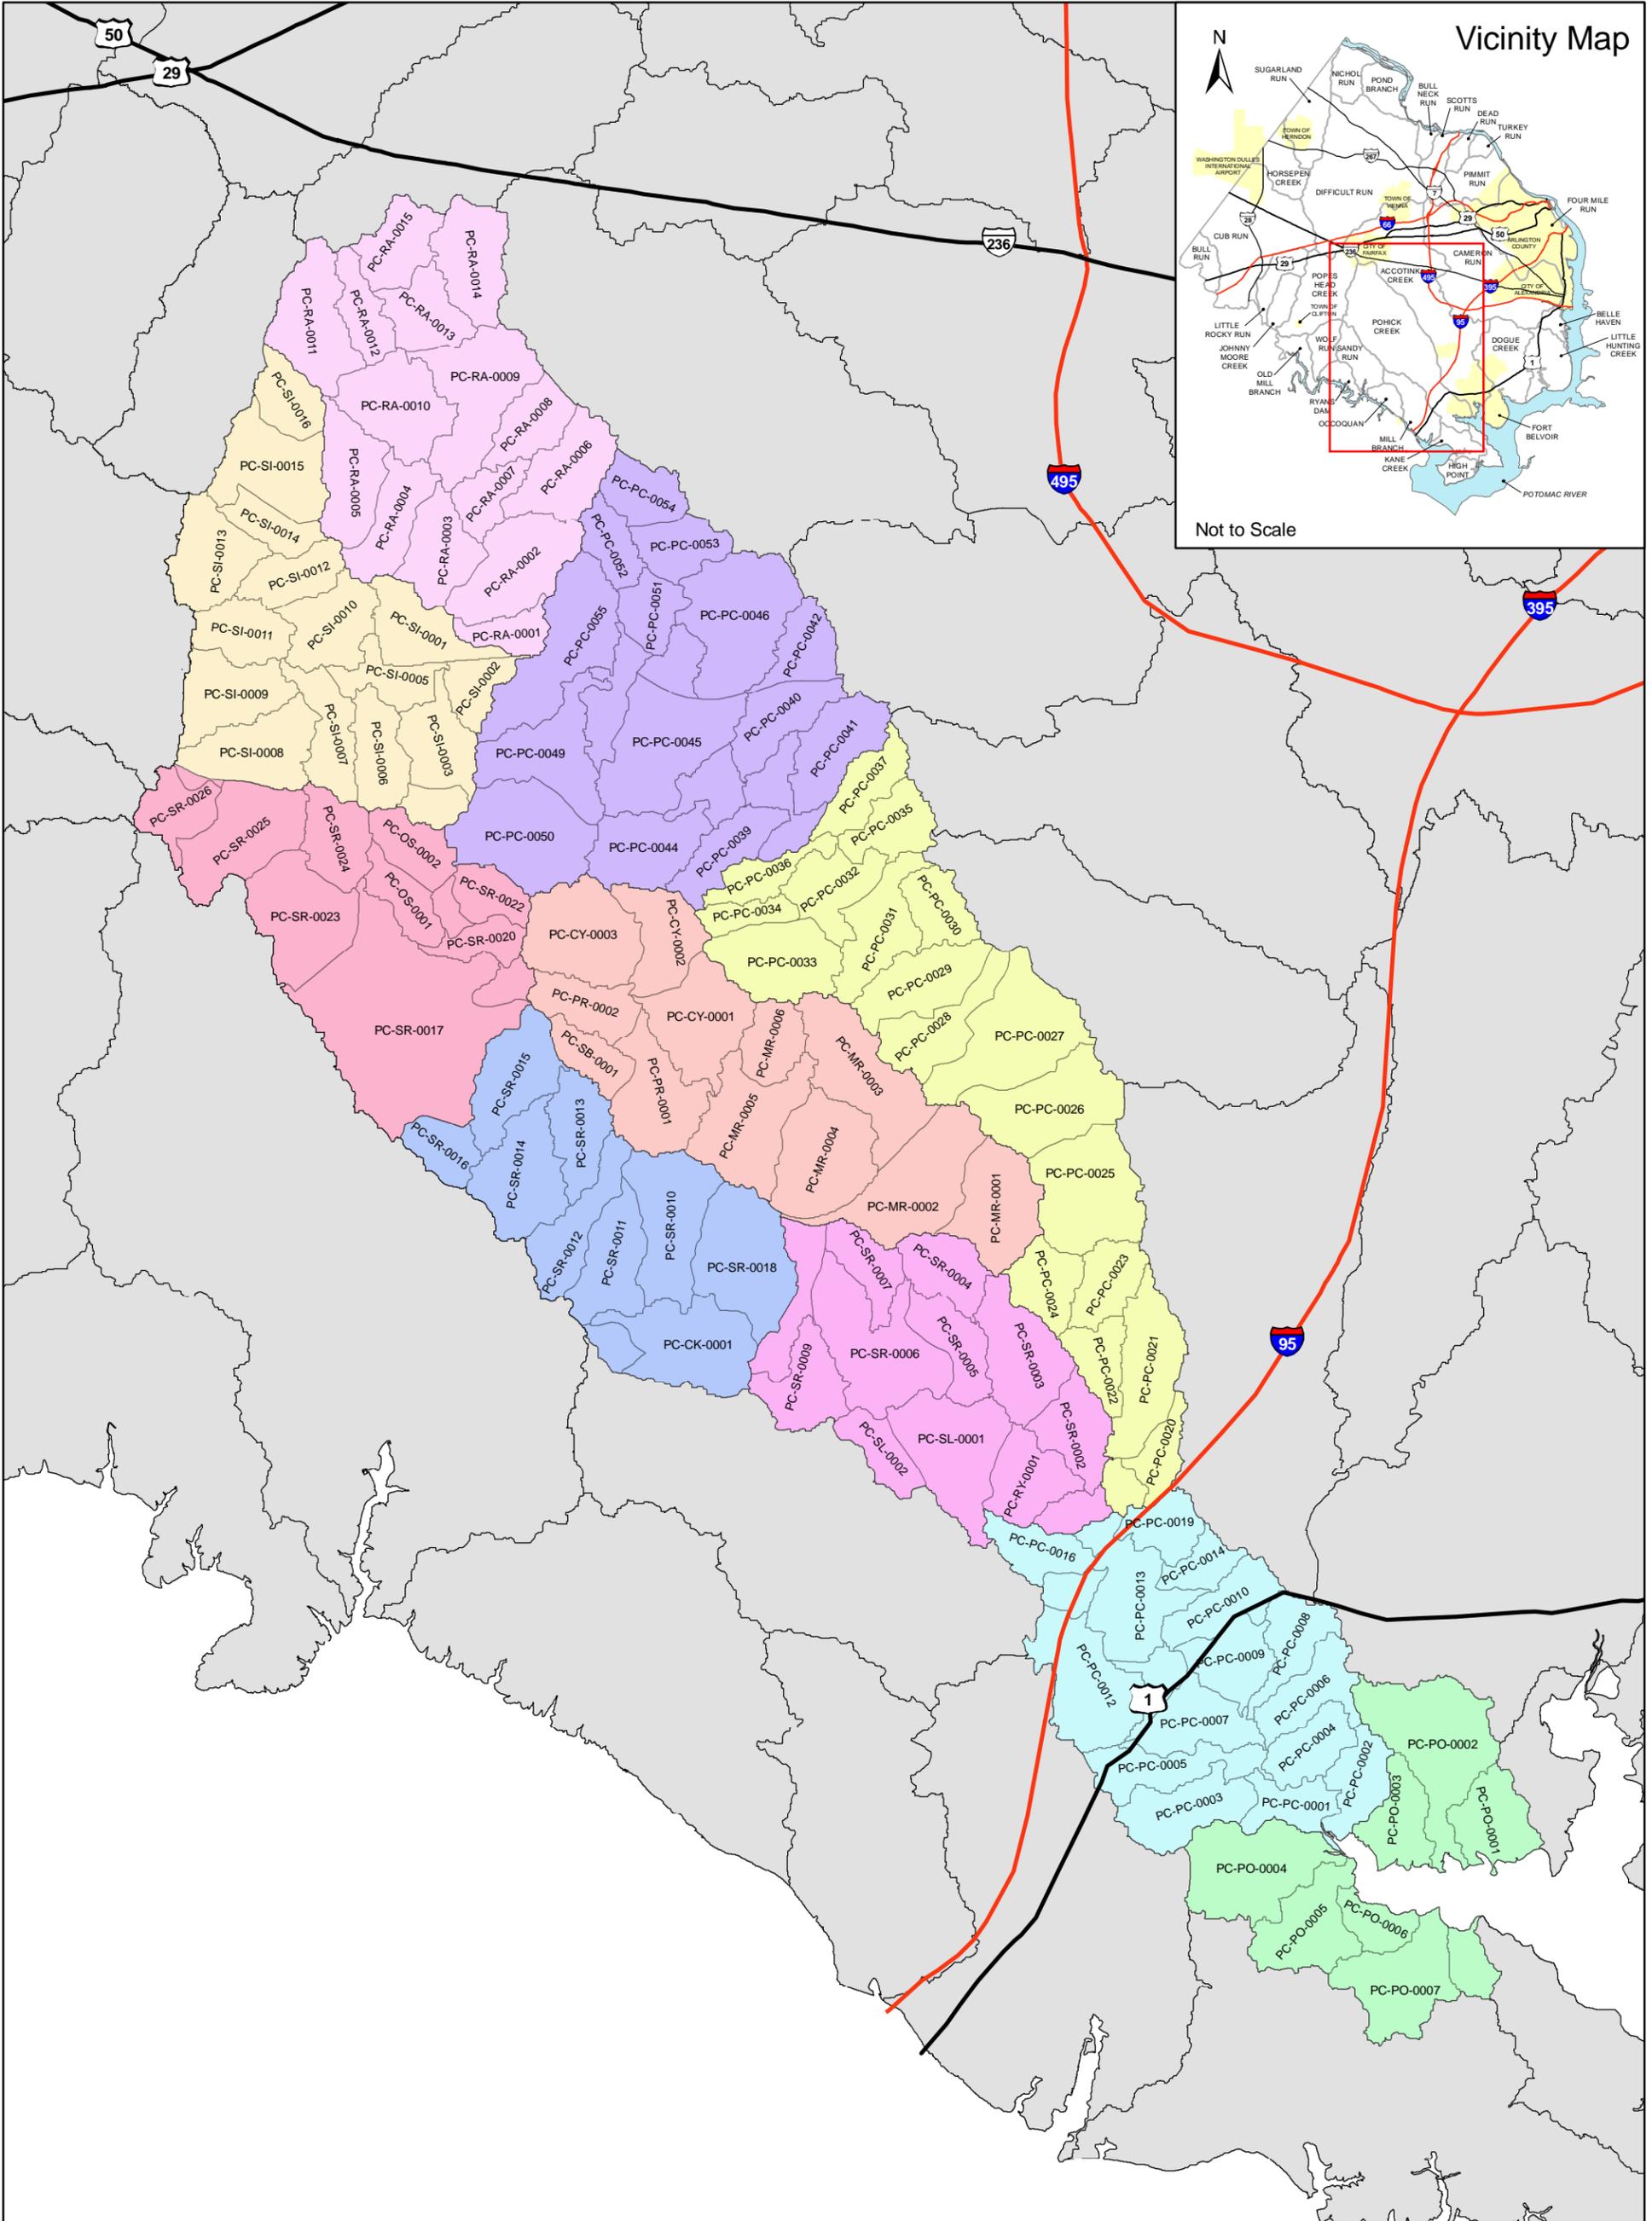
Map 2.1-2
Pohick Creek Subwatersheds

Consisting of more than 36 square miles, the Pohick Creek watershed is one of the larger watersheds in the County. Based on the terrain, the watershed is naturally divided into ten (10) smaller **watershed management areas** (WMAs). WMAs typically consist of a small area approximately 4 square miles which drains to a specific stream or tributary. Table 12 below identifies the 10 WMAs within Pohick Creek. Refer to **Map 2.1-1** for the locations of each WMA within Pohick Creek. For Fairfax County planning and management purposes, WMA are further subdivided into smaller **subwatersheds**, typically 100-300 acres. Refer to **Map 2.1-2** for the locations of each of the subwatersheds within Pohick Creek. These areas can be used to identify specific projects or opportunities to enhance the overall stream conditions, as well as serving as the basic units for watershed modeling and other evaluations.

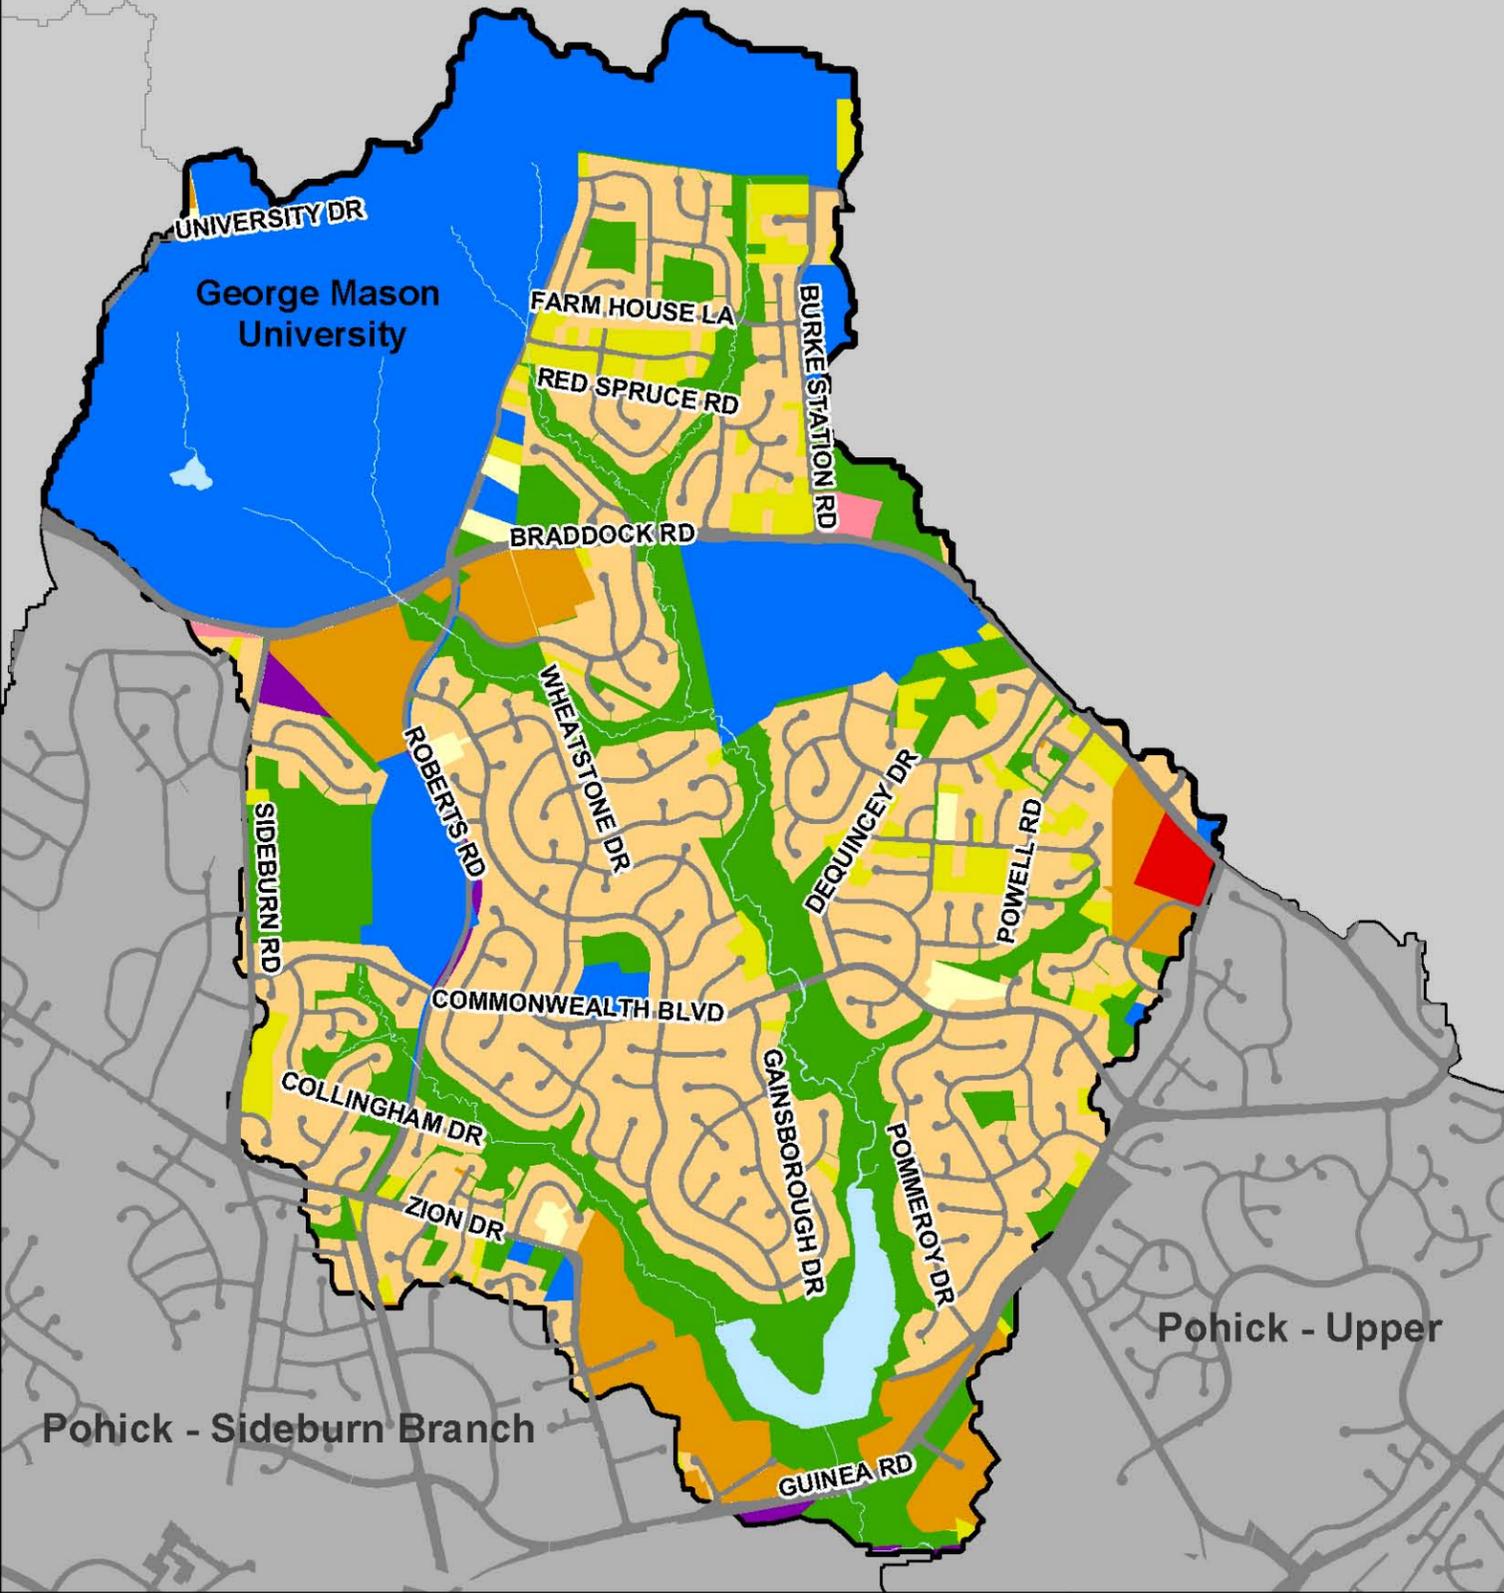
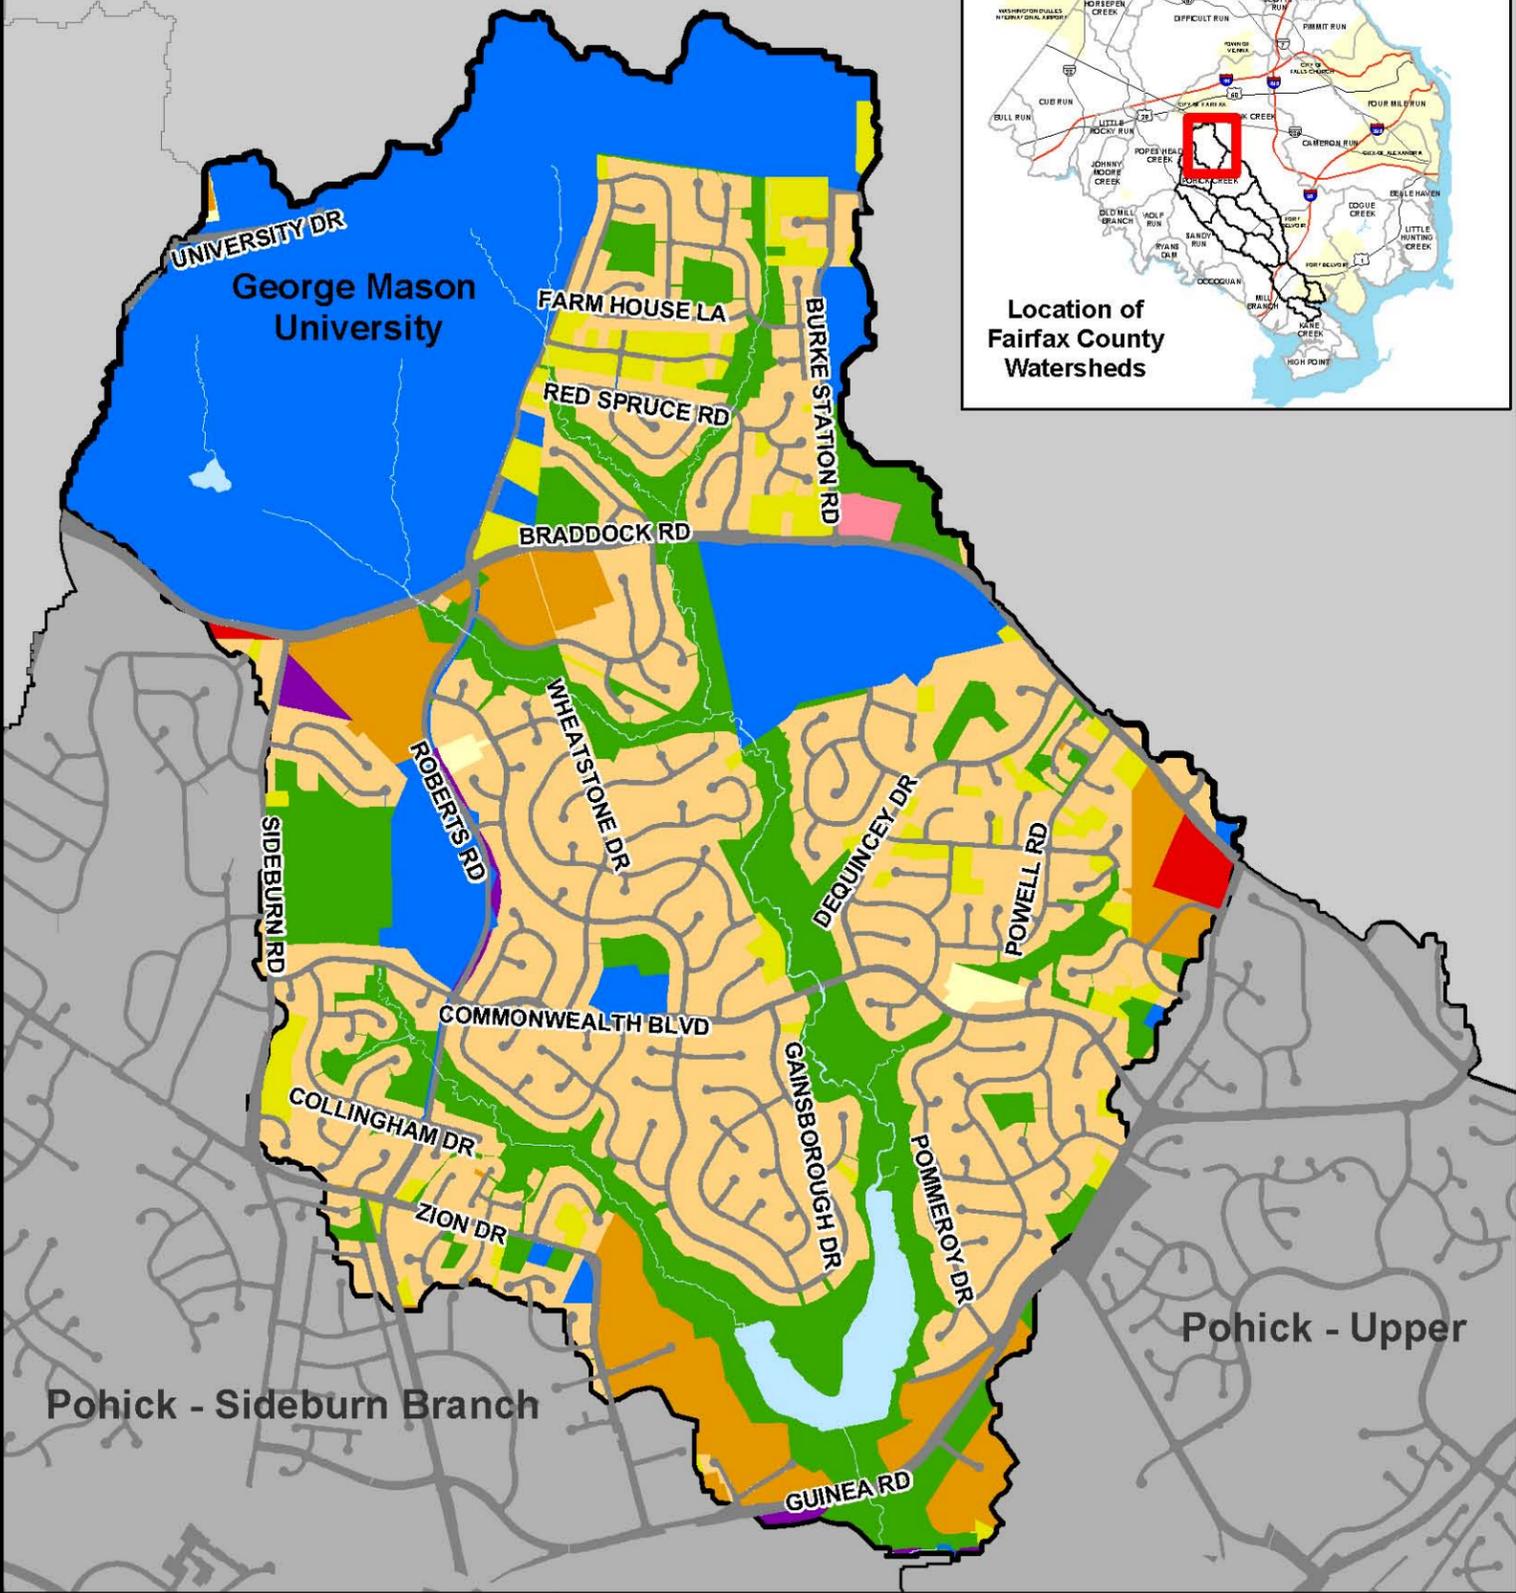
**Map 2.2.1-1
Pohick Creek- Rabbit Branch
Existing and Future Land Use**

Current Landuse Pohick - Rabbit Branch

Future Landuse Pohick - Rabbit Branch

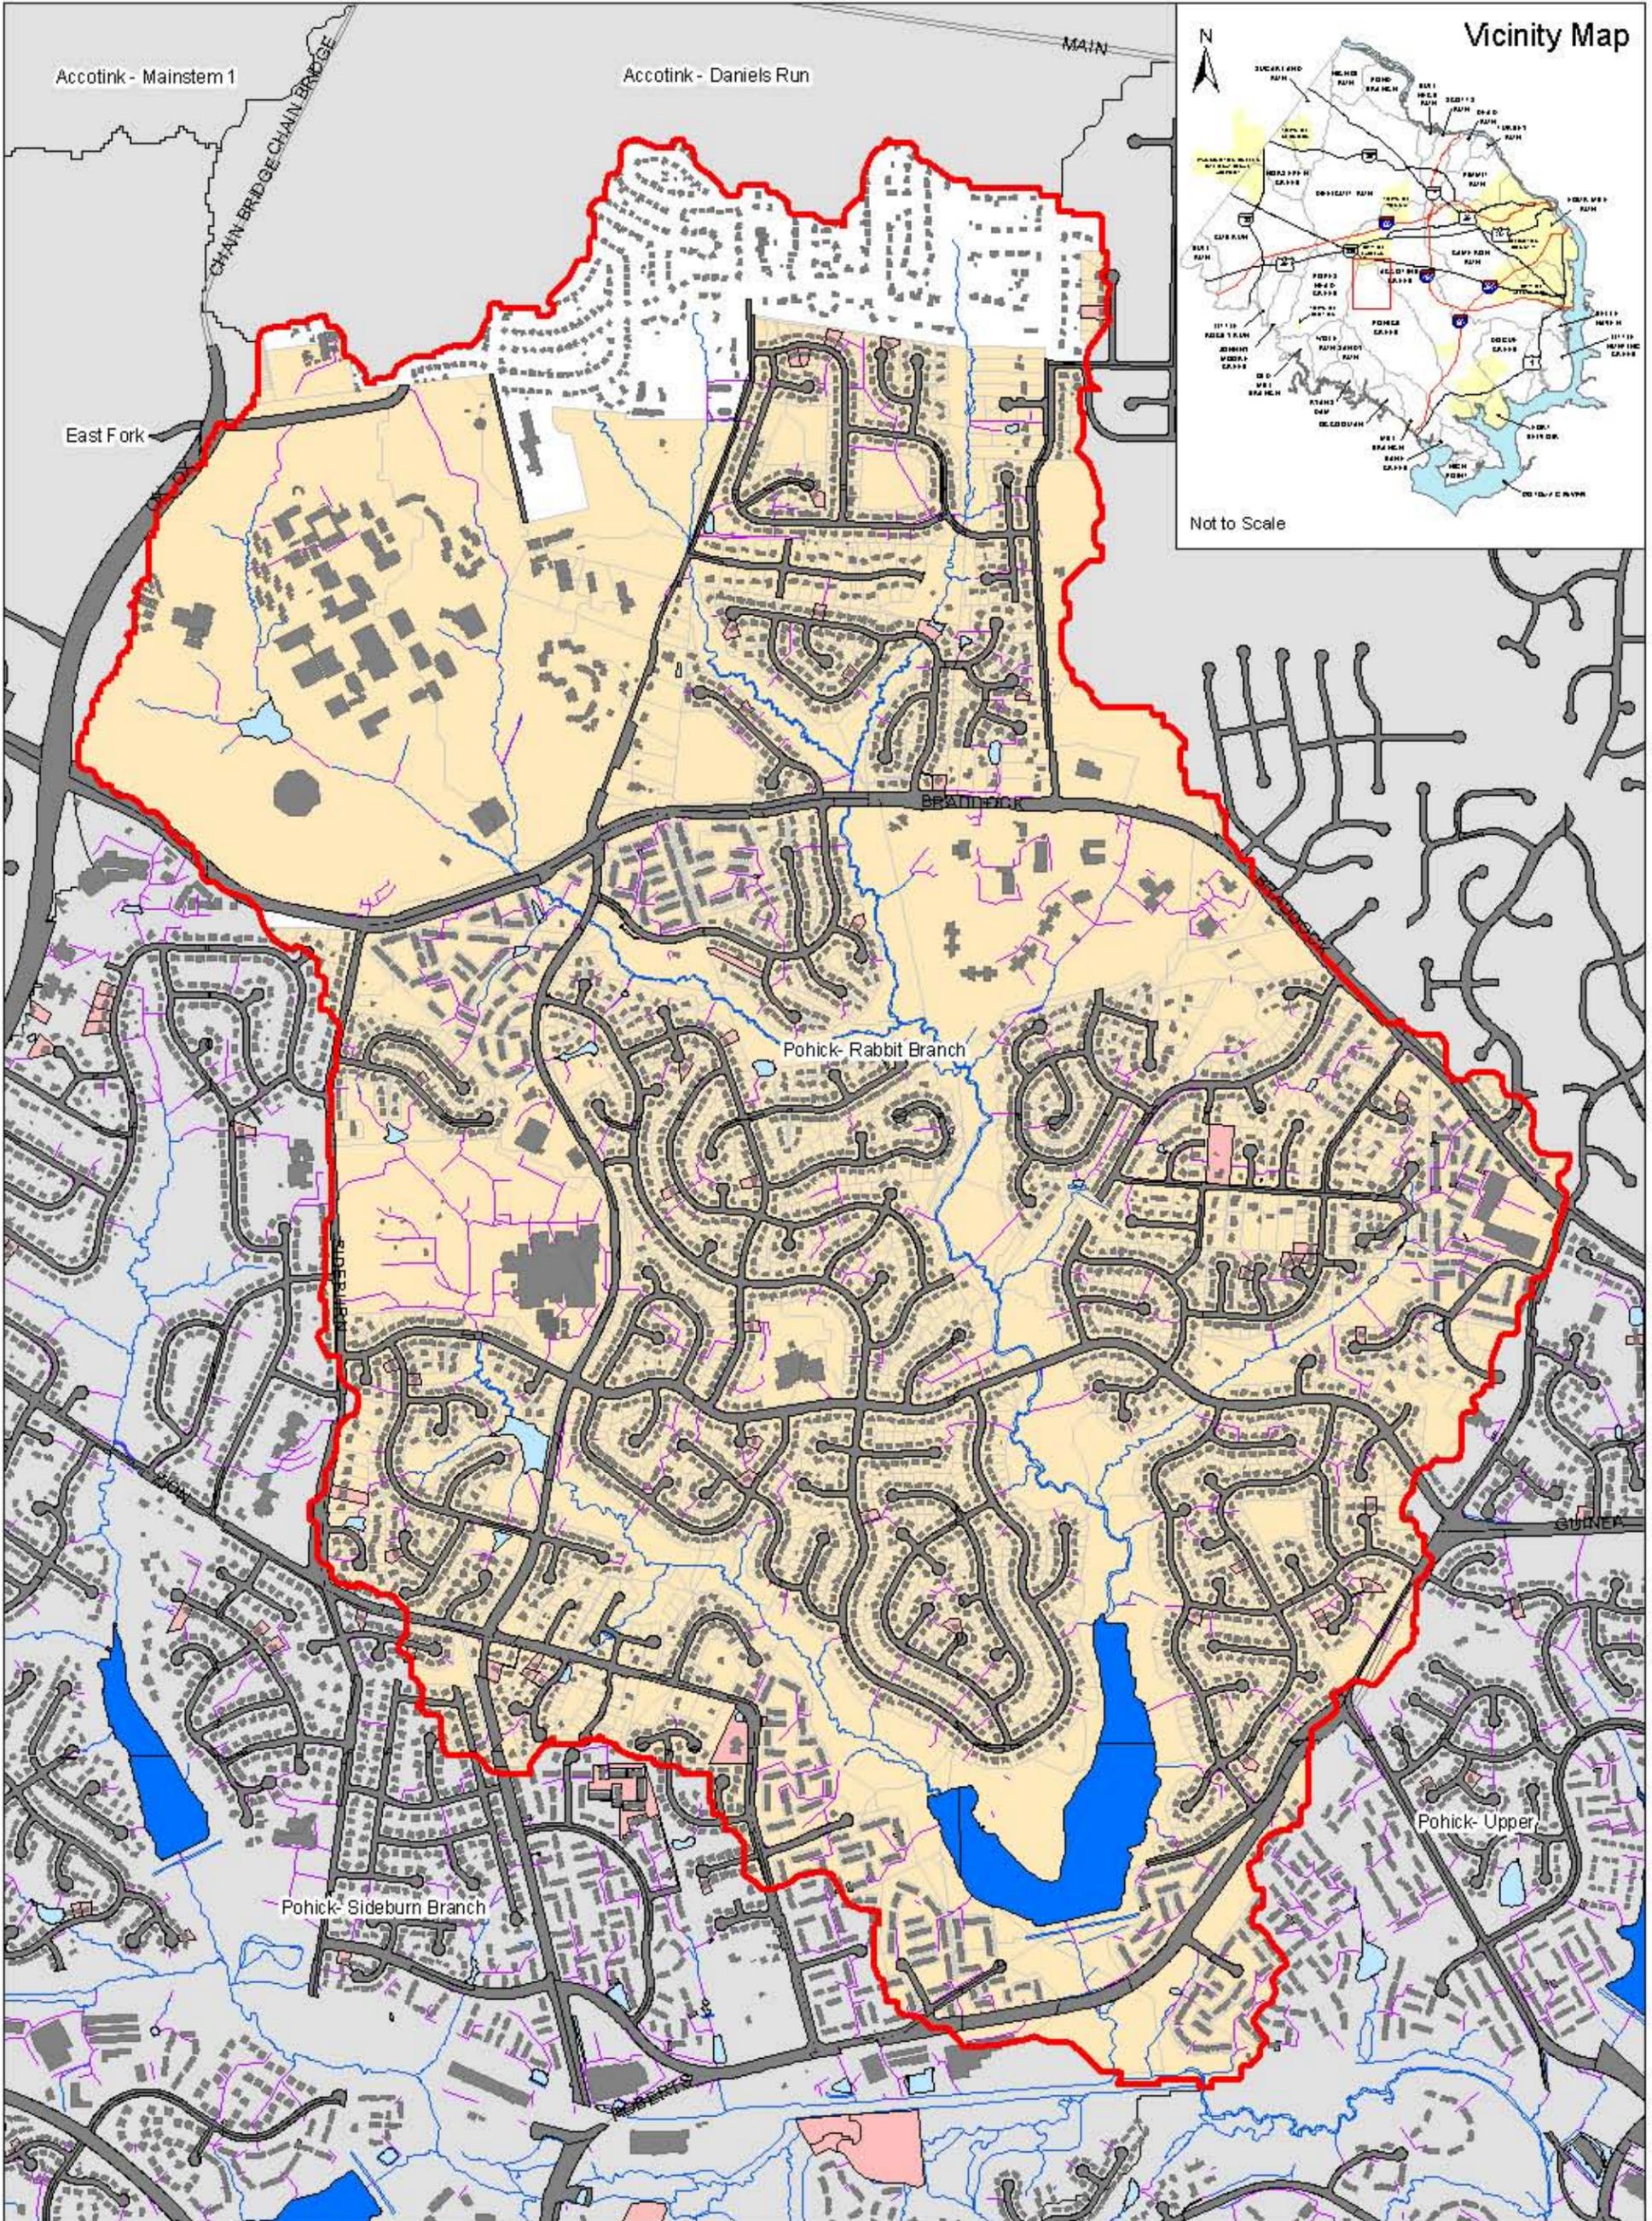
Map 2.2.1-2
 Pohick Creek
 Rabbit Branch
 Stormwater Infrastructure

Map 2.2.1-2 demonstrates the observed stormwater infrastructure conditions in the Rabbit Branch WMA. Stormwater infrastructure consists primarily of curb and gutter stormwater collection leading to a piped network of storm drains discharging to either dry detention basins or directly into Rabbit Branch and its associated stream valleys and tributaries on the way downstream to Lake Royal. The Rabbit Branch WMA contains approximately 25 dry detention facilities designed to manage stormwater quantity. In addition, the WMA contains two underground chambers, which store stormwater runoff in underground vaults and release the water at a slower pace (much like the peak flow attenuation employed in dry detention basins)

and one infiltration trench, which is a stormwater quality component designed to allow for the infiltration of stormwater into the ground rather than having the stormwater runoff directed to a control structure for treatment.

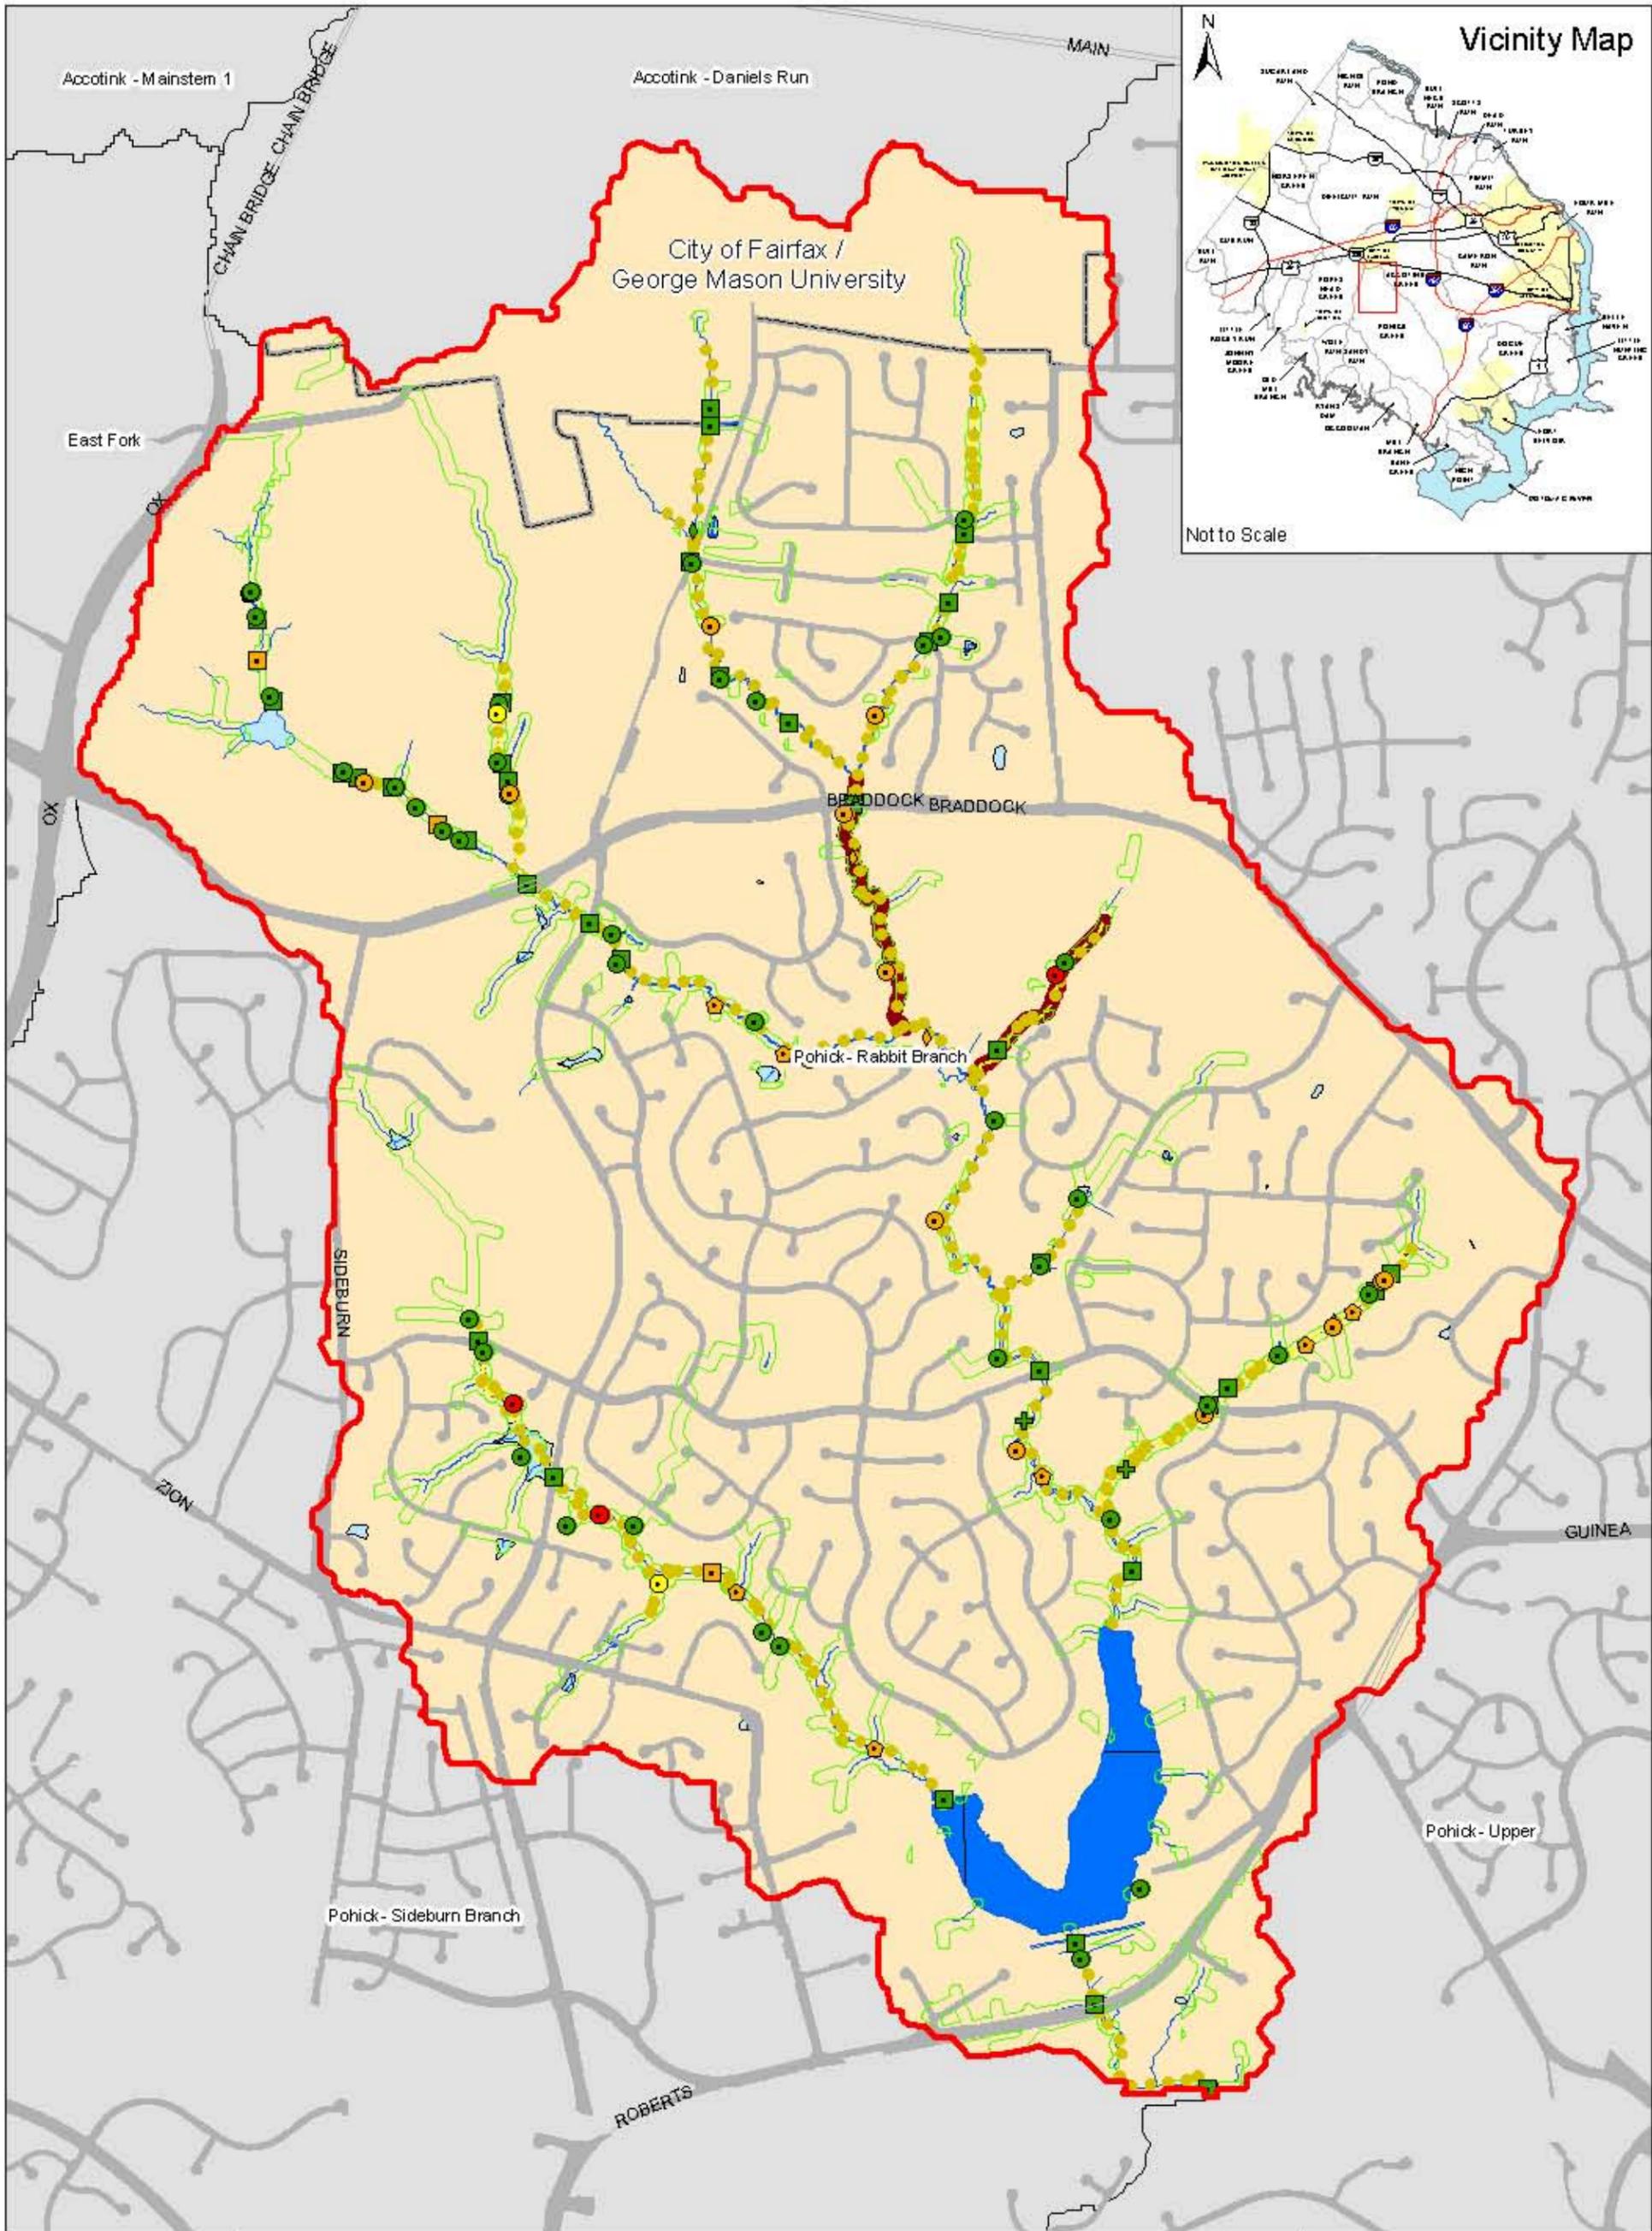
Map 2.2.1-3

The Stream Conditions **Map 2.2.1-3** denotes the generally observed stream conditions as documented in the 2005 SPA and through additional, windshield level field reconnaissance performed for this study. The Stream Conditions Map demonstrates the general conditions of the main stem streams and tributaries in the WMA along with a series of features that typically impact stream condition, including stream channel erosion, channel widening, stream buffer condition, discharge pipe and ditch impacts, and utility and road crossing impacts.

In the Rabbit Branch WMA, the most prevalent stream condition features noted include disturbed stream buffers and stream channel erosion and/or widening. In addition, pipe discharge and ditch discharge into the WMA's streams have a demonstrated impact as well, as these pipes and ditches discharge stormwater runoff directly into the streams in many instances, contributing to the observed widening and erosive conditions. Utility and crossing impacts in the Rabbit Branch WMA are generally minor. Instances of demonstrated stream head cutting, or an abrupt vertical drop in the bed of a stream channel that demonstrates active erosion (NC DWQ, 2005), were limited, with two instances recorded in the south western portion of the WMA at points where streams made significant turns.

Pohick Creek Rabbit Branch Stream Conditions
