Chapter 2: Watershed Management Area Characterization

DRAFT Watershed Workbook –**Pohick Creek Watershed**

Volume 2: Chapter 2

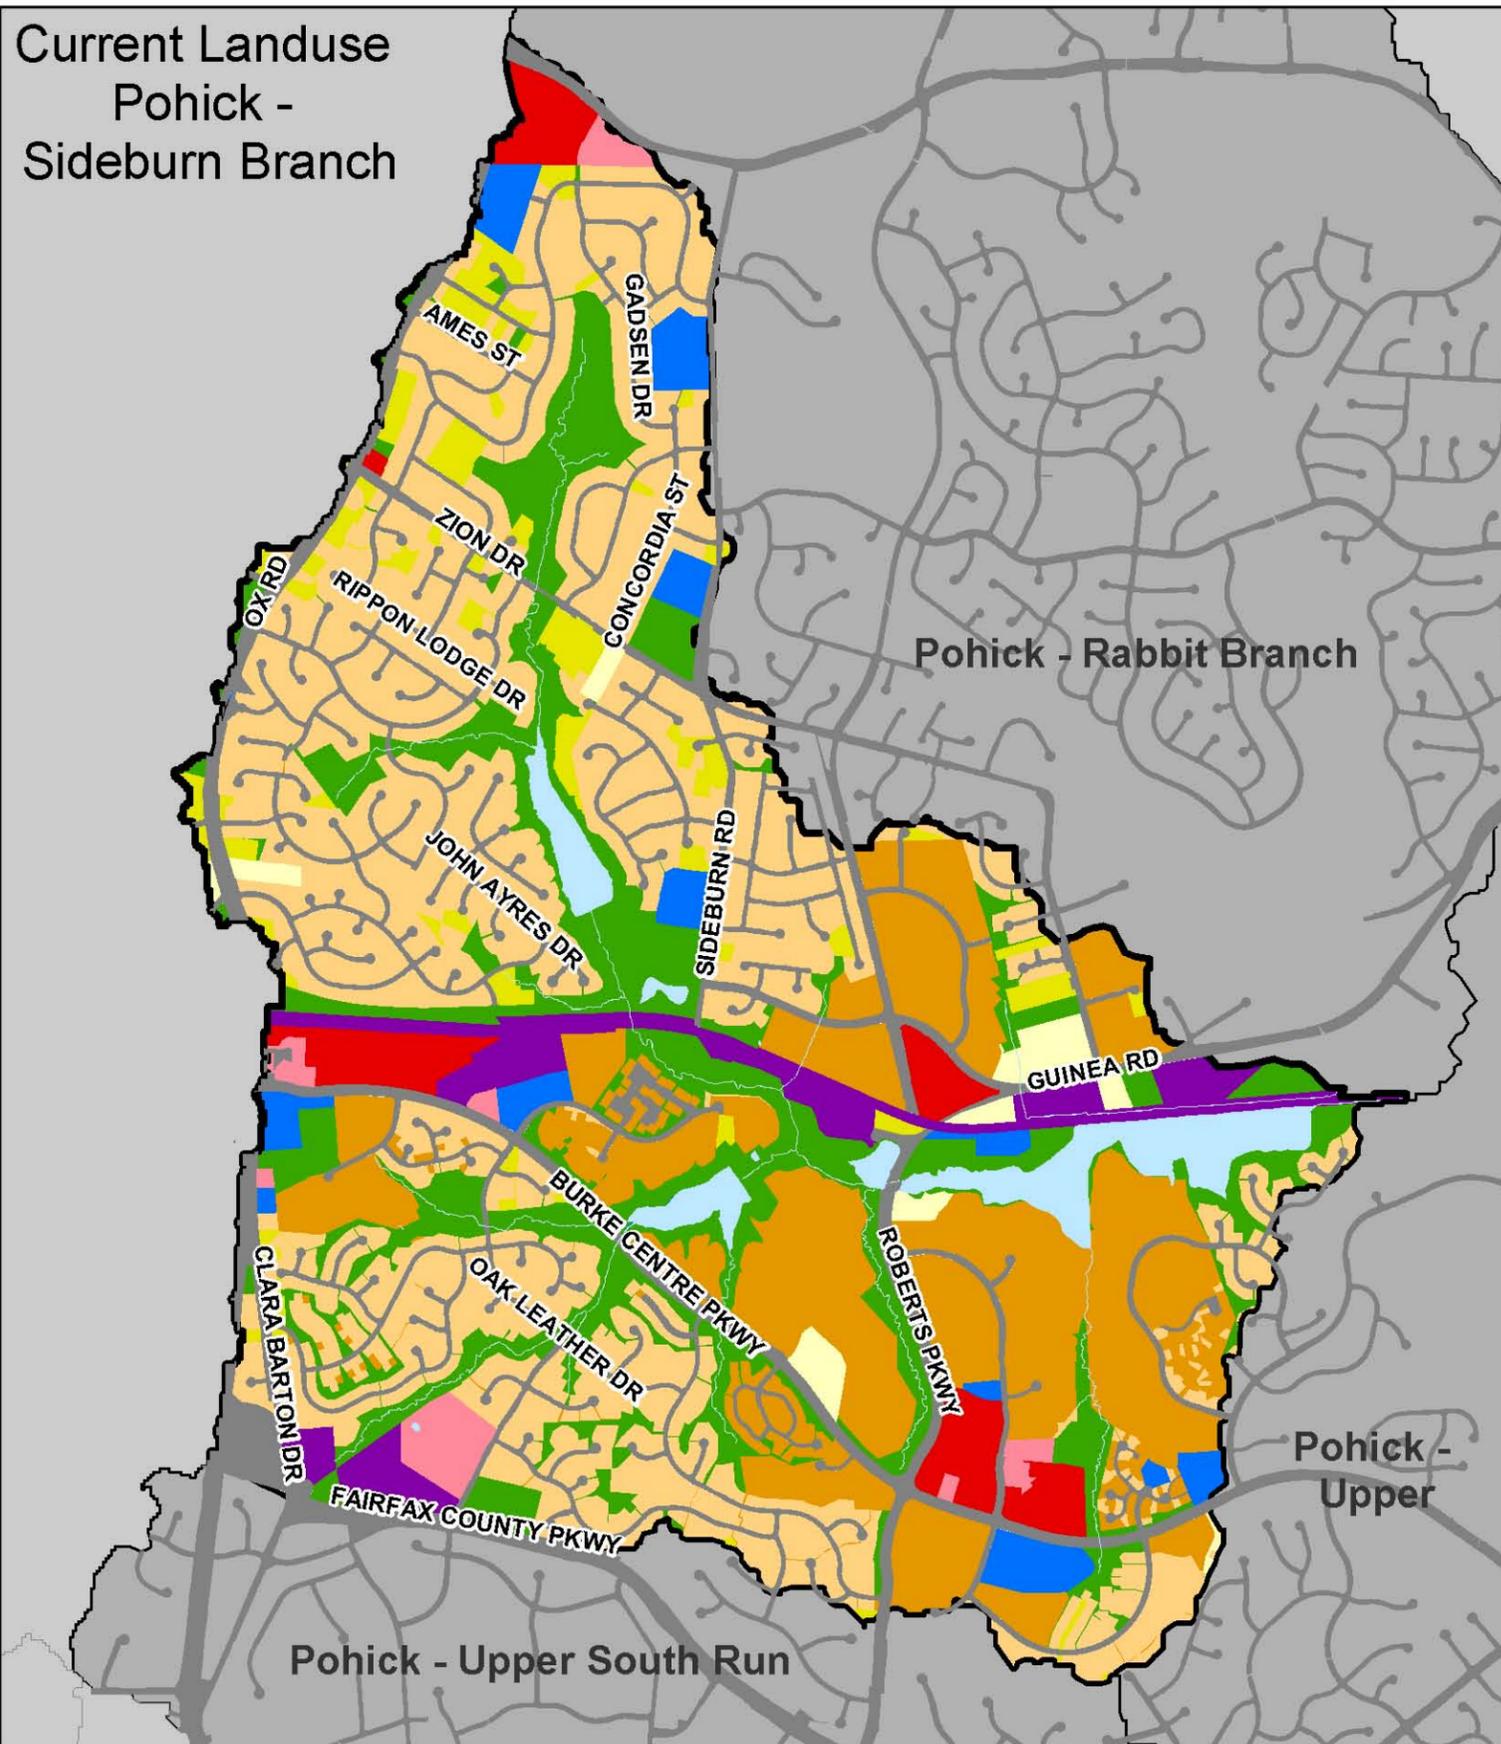
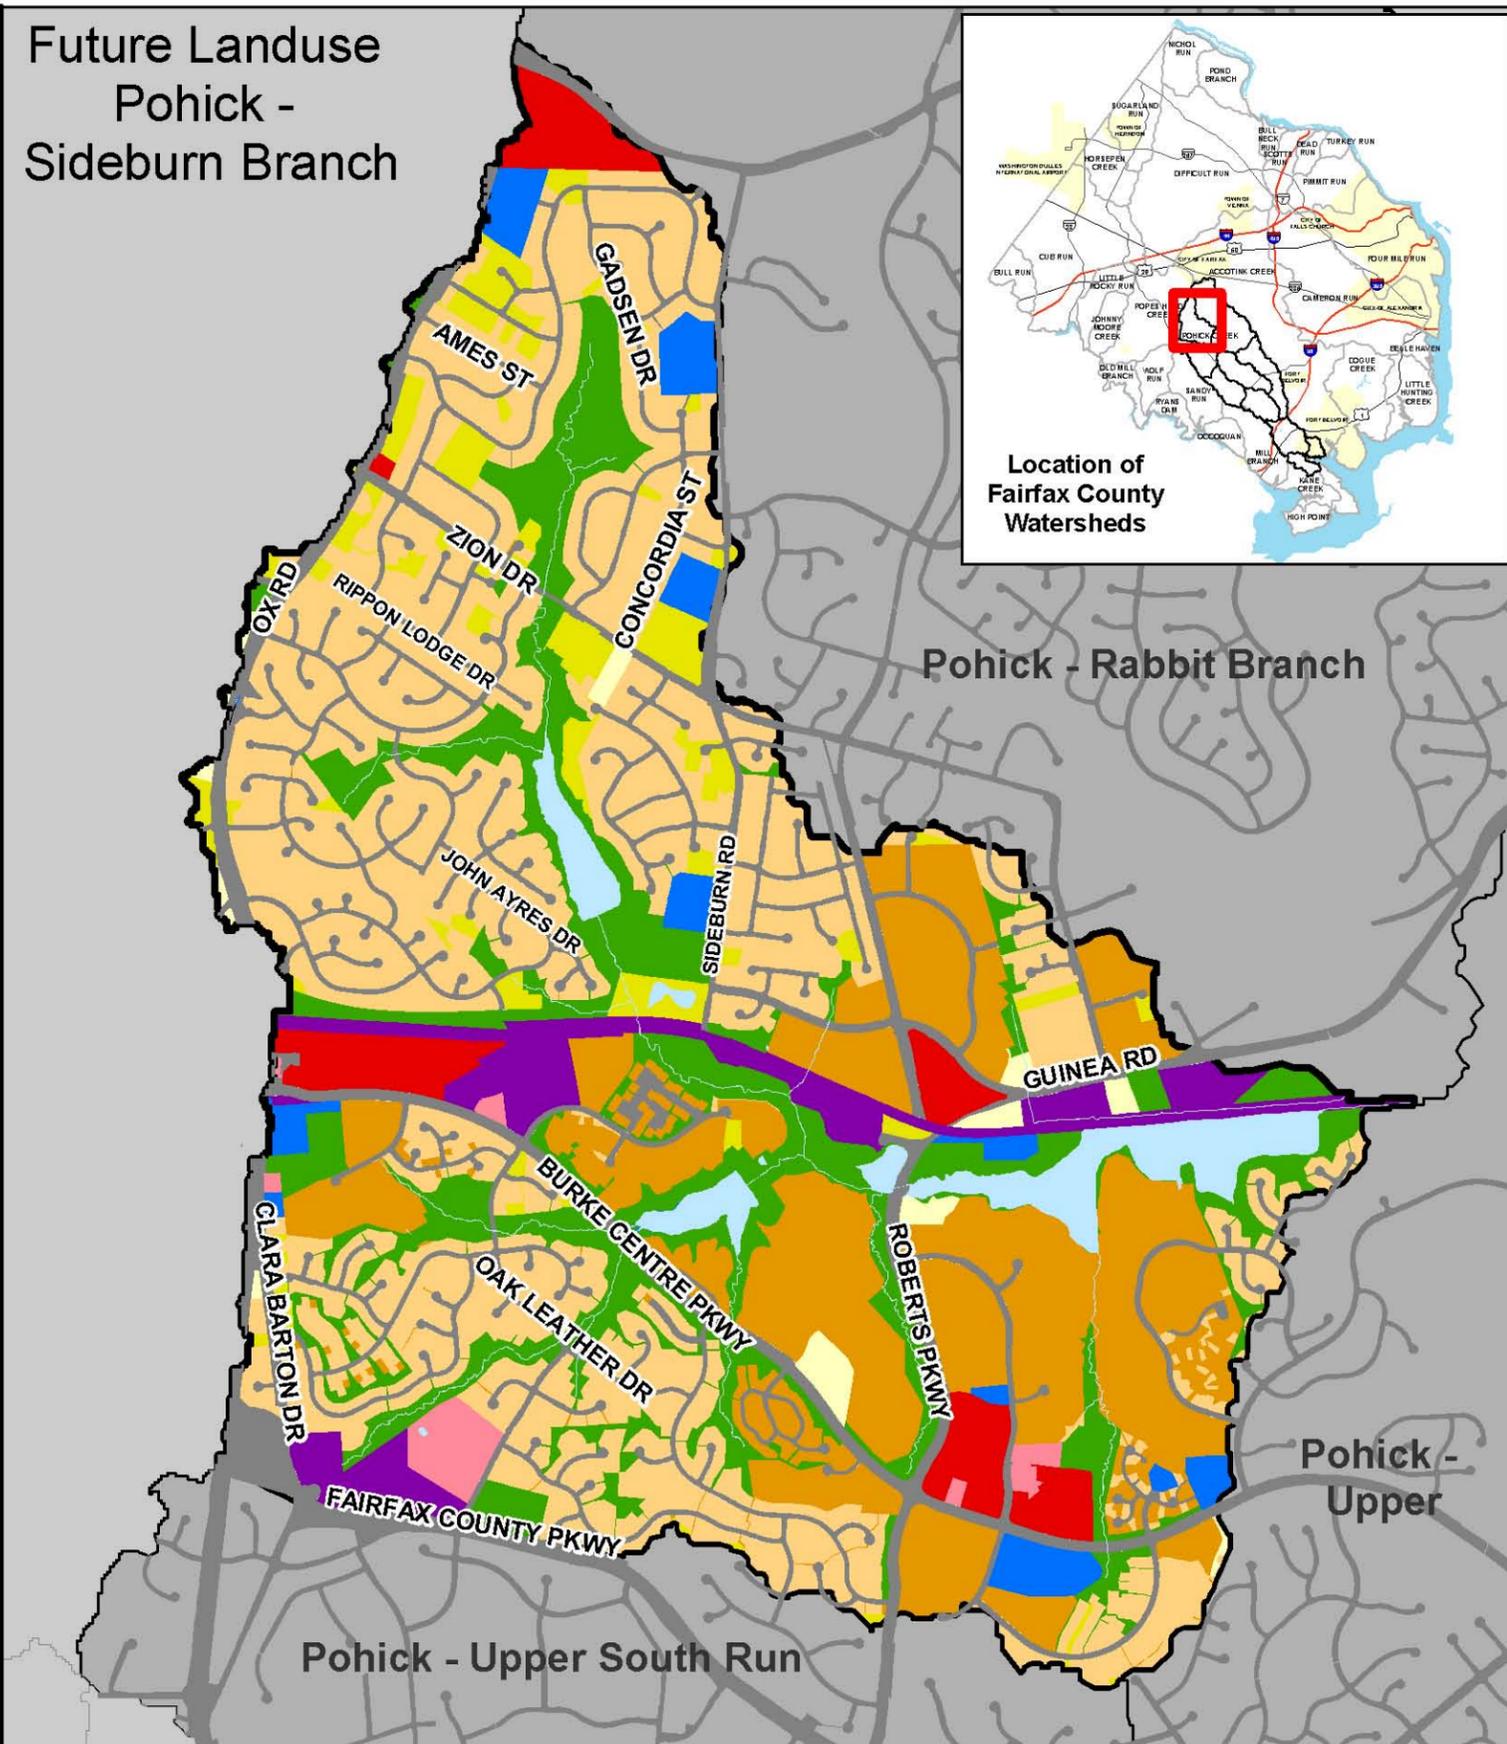
Map 2.2.2-1
Pohick Creek-Sideburn Branch
Existing and Future Land Use

Current Landuse
Pohick -
Sideburn Branch

Future Landuse
Pohick -
Sideburn Branch

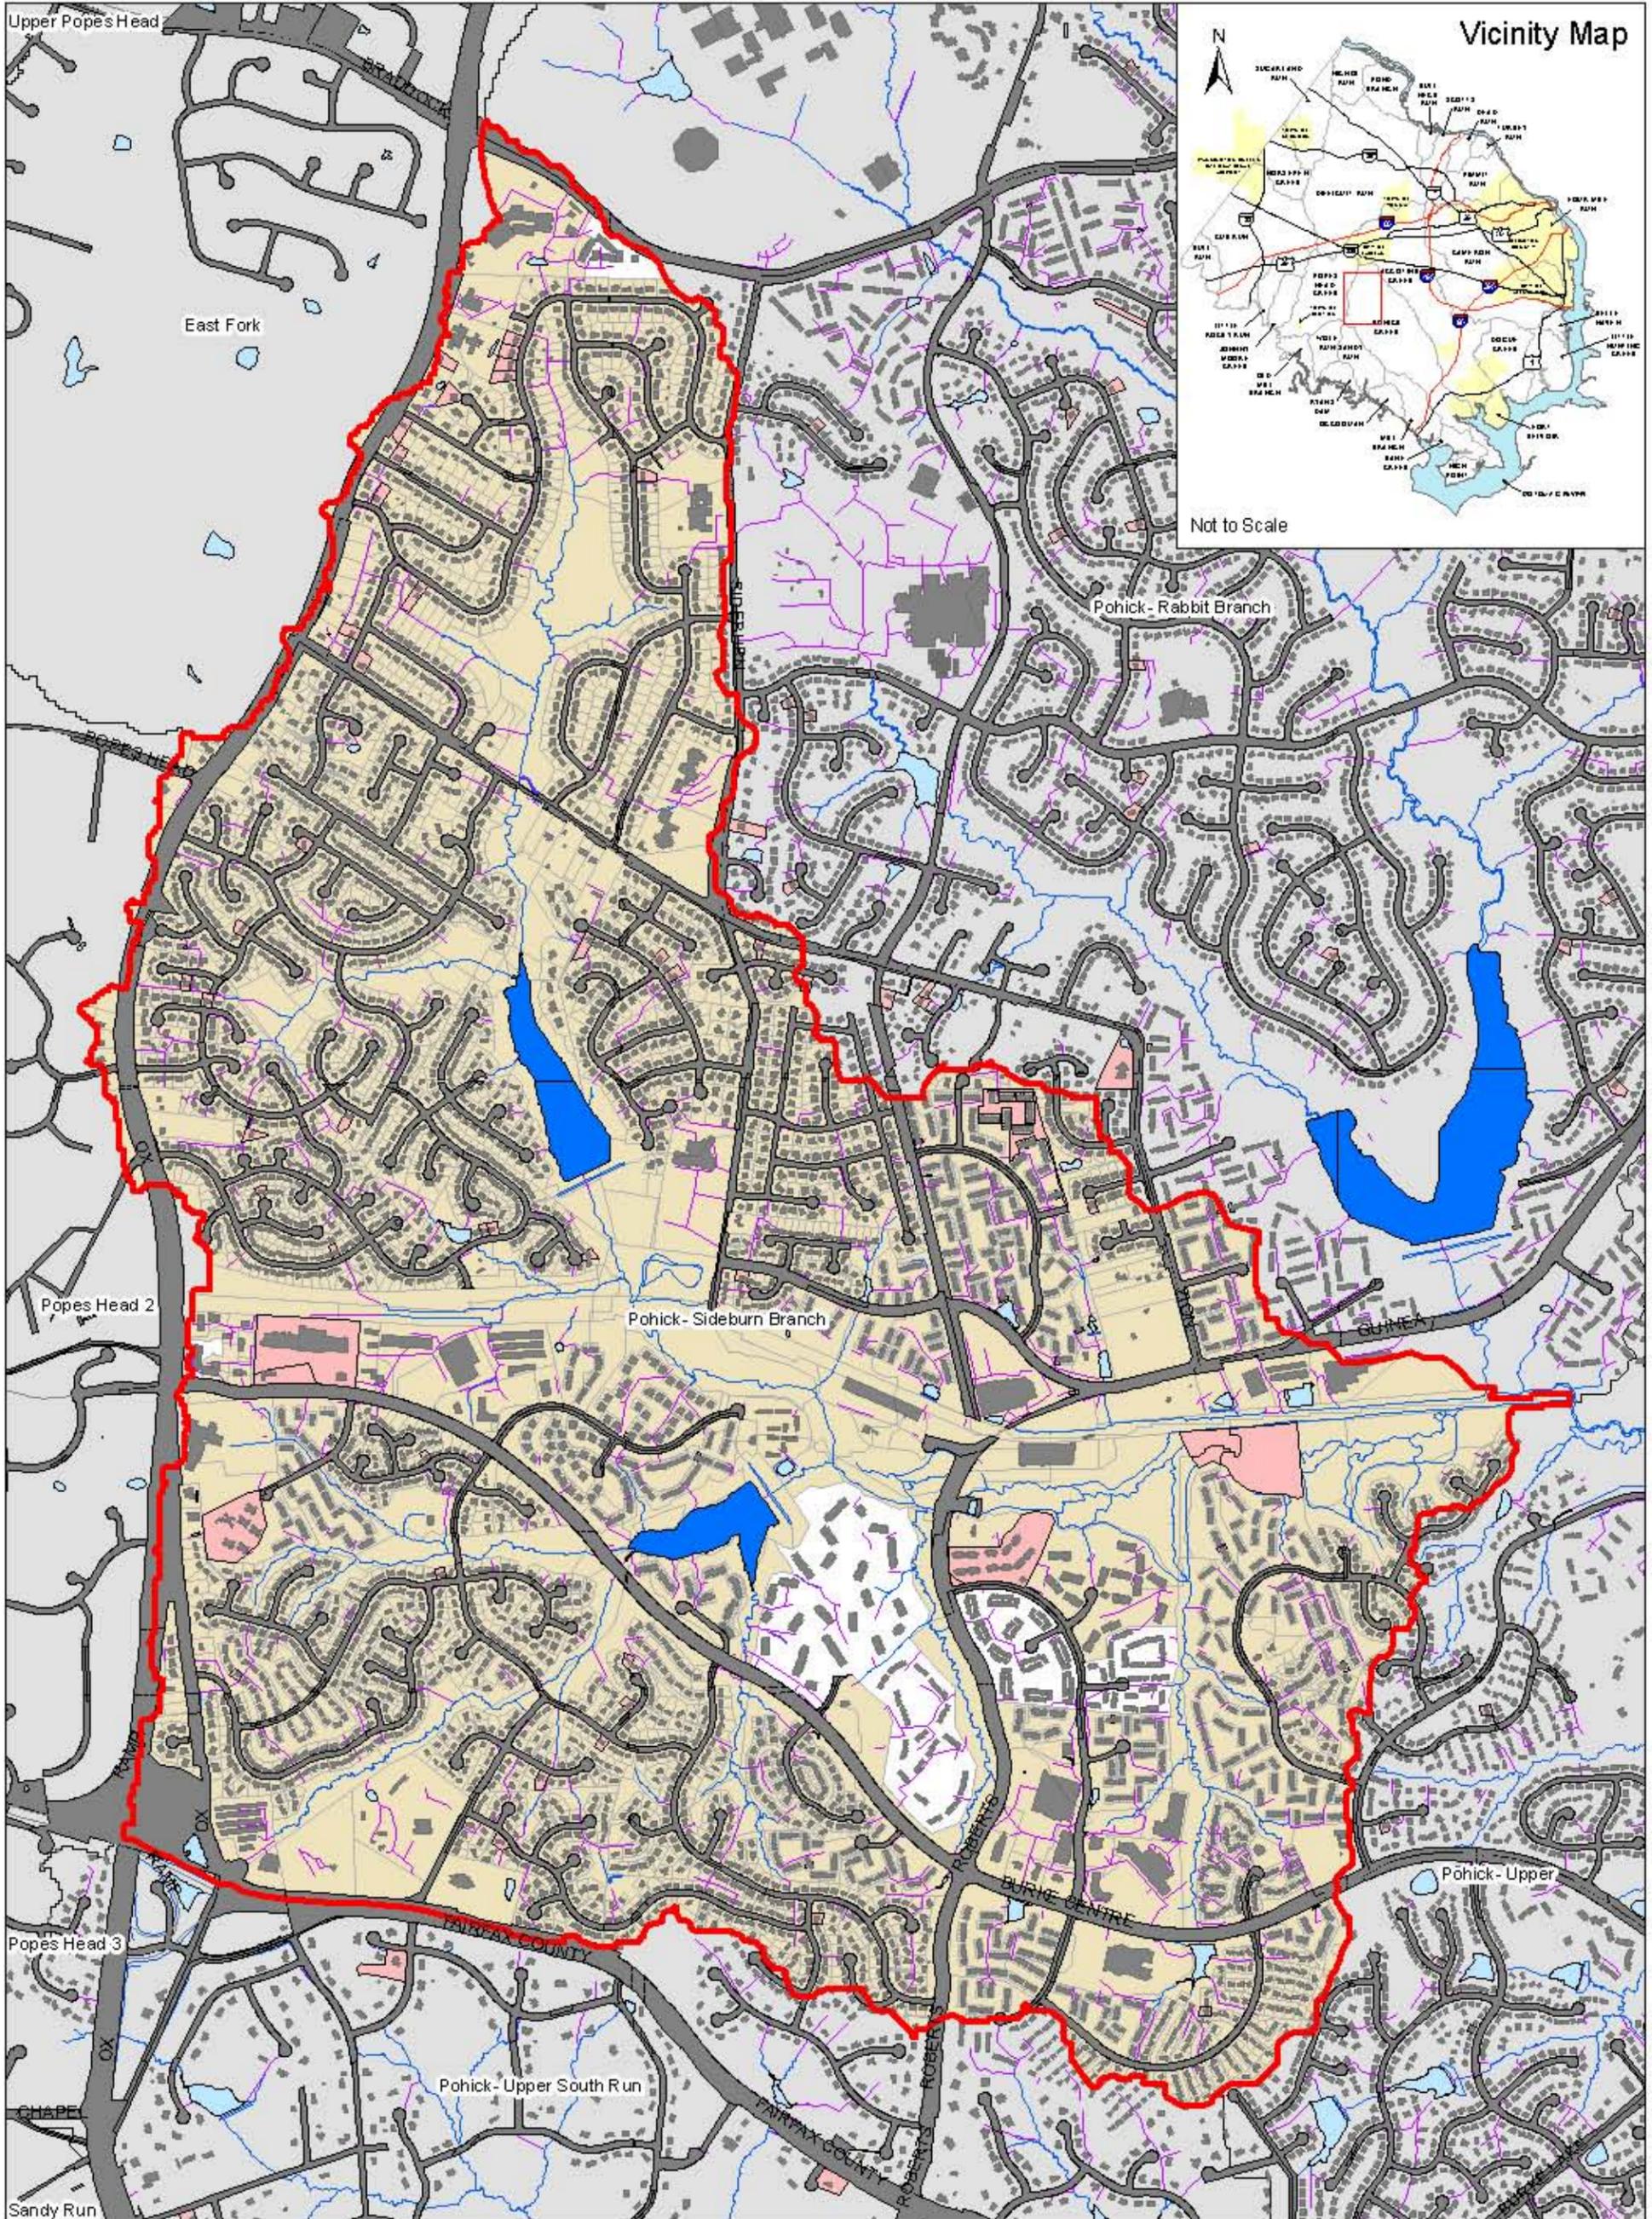
Map 2.2.2-2
 Pohick Creek
 Sideburn Branch
 Stormwater Infrastructure

Map 2.2.2-2 demonstrates the observed stormwater infrastructure conditions in the Sideburn Branch WMA. The upstream portions of the WMA contain stormwater infrastructure consisting primarily of curb and gutter stormwater collection leading to a piped network of storm drains discharging directly into the streams and tributaries leading to Woodglen Lake. Only five stormwater management facilities are evident upstream of Woodglen Lake, including three dry detention basins, one underground chamber, and one sand filter, which is a type of underground device that provides water quality treatment along with quantity control.

The observed stormwater infrastructure condition upstream of Lake Barton is similar to that of Woodglen Lake in that the upstream portions of the Lake Barton area contain stormwater infrastructure consisting primarily of curb and gutter stormwater collection leading to a piped network of storm drains discharging directly into the streams and tributaries leading the lake. Only two confirmed stormwater management facilities, both dry detention basins, exist in the upstream areas of Lake Barton.

Moving downstream to the east, the Sideburn Branch WMA contains approximately 15 dry detention facilities designed to manage stormwater quantity. In addition, the downstream portions of the WMA contain one infiltration trench, which is a stormwater quality component designed to allow for the infiltration of stormwater into the ground rather than having the stormwater runoff directed to a control structure for treatment; one rooftop detention device, which essentially stores rainwater on the roof of a structure and allows for a slower release; and one sand filter.

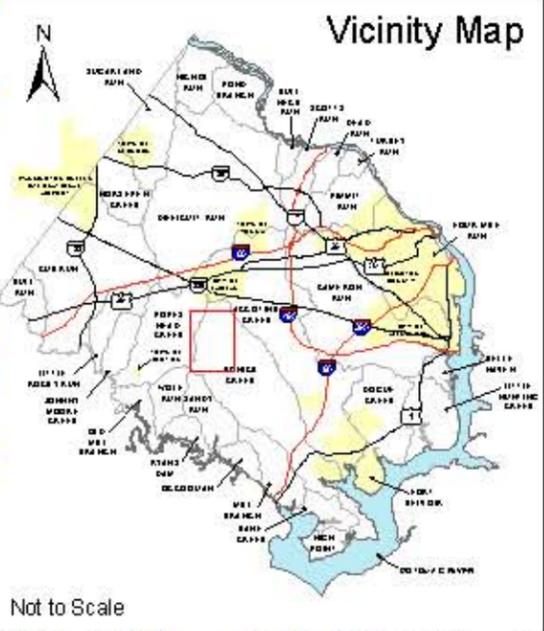
Legend

Storm Drainage	Roads	Drainage Complaints	WMA - Other
Rivers and Streams	Subbasins	Lake	Pohick - Sideburn Branch
Buildings	Storm Drainage Facilities

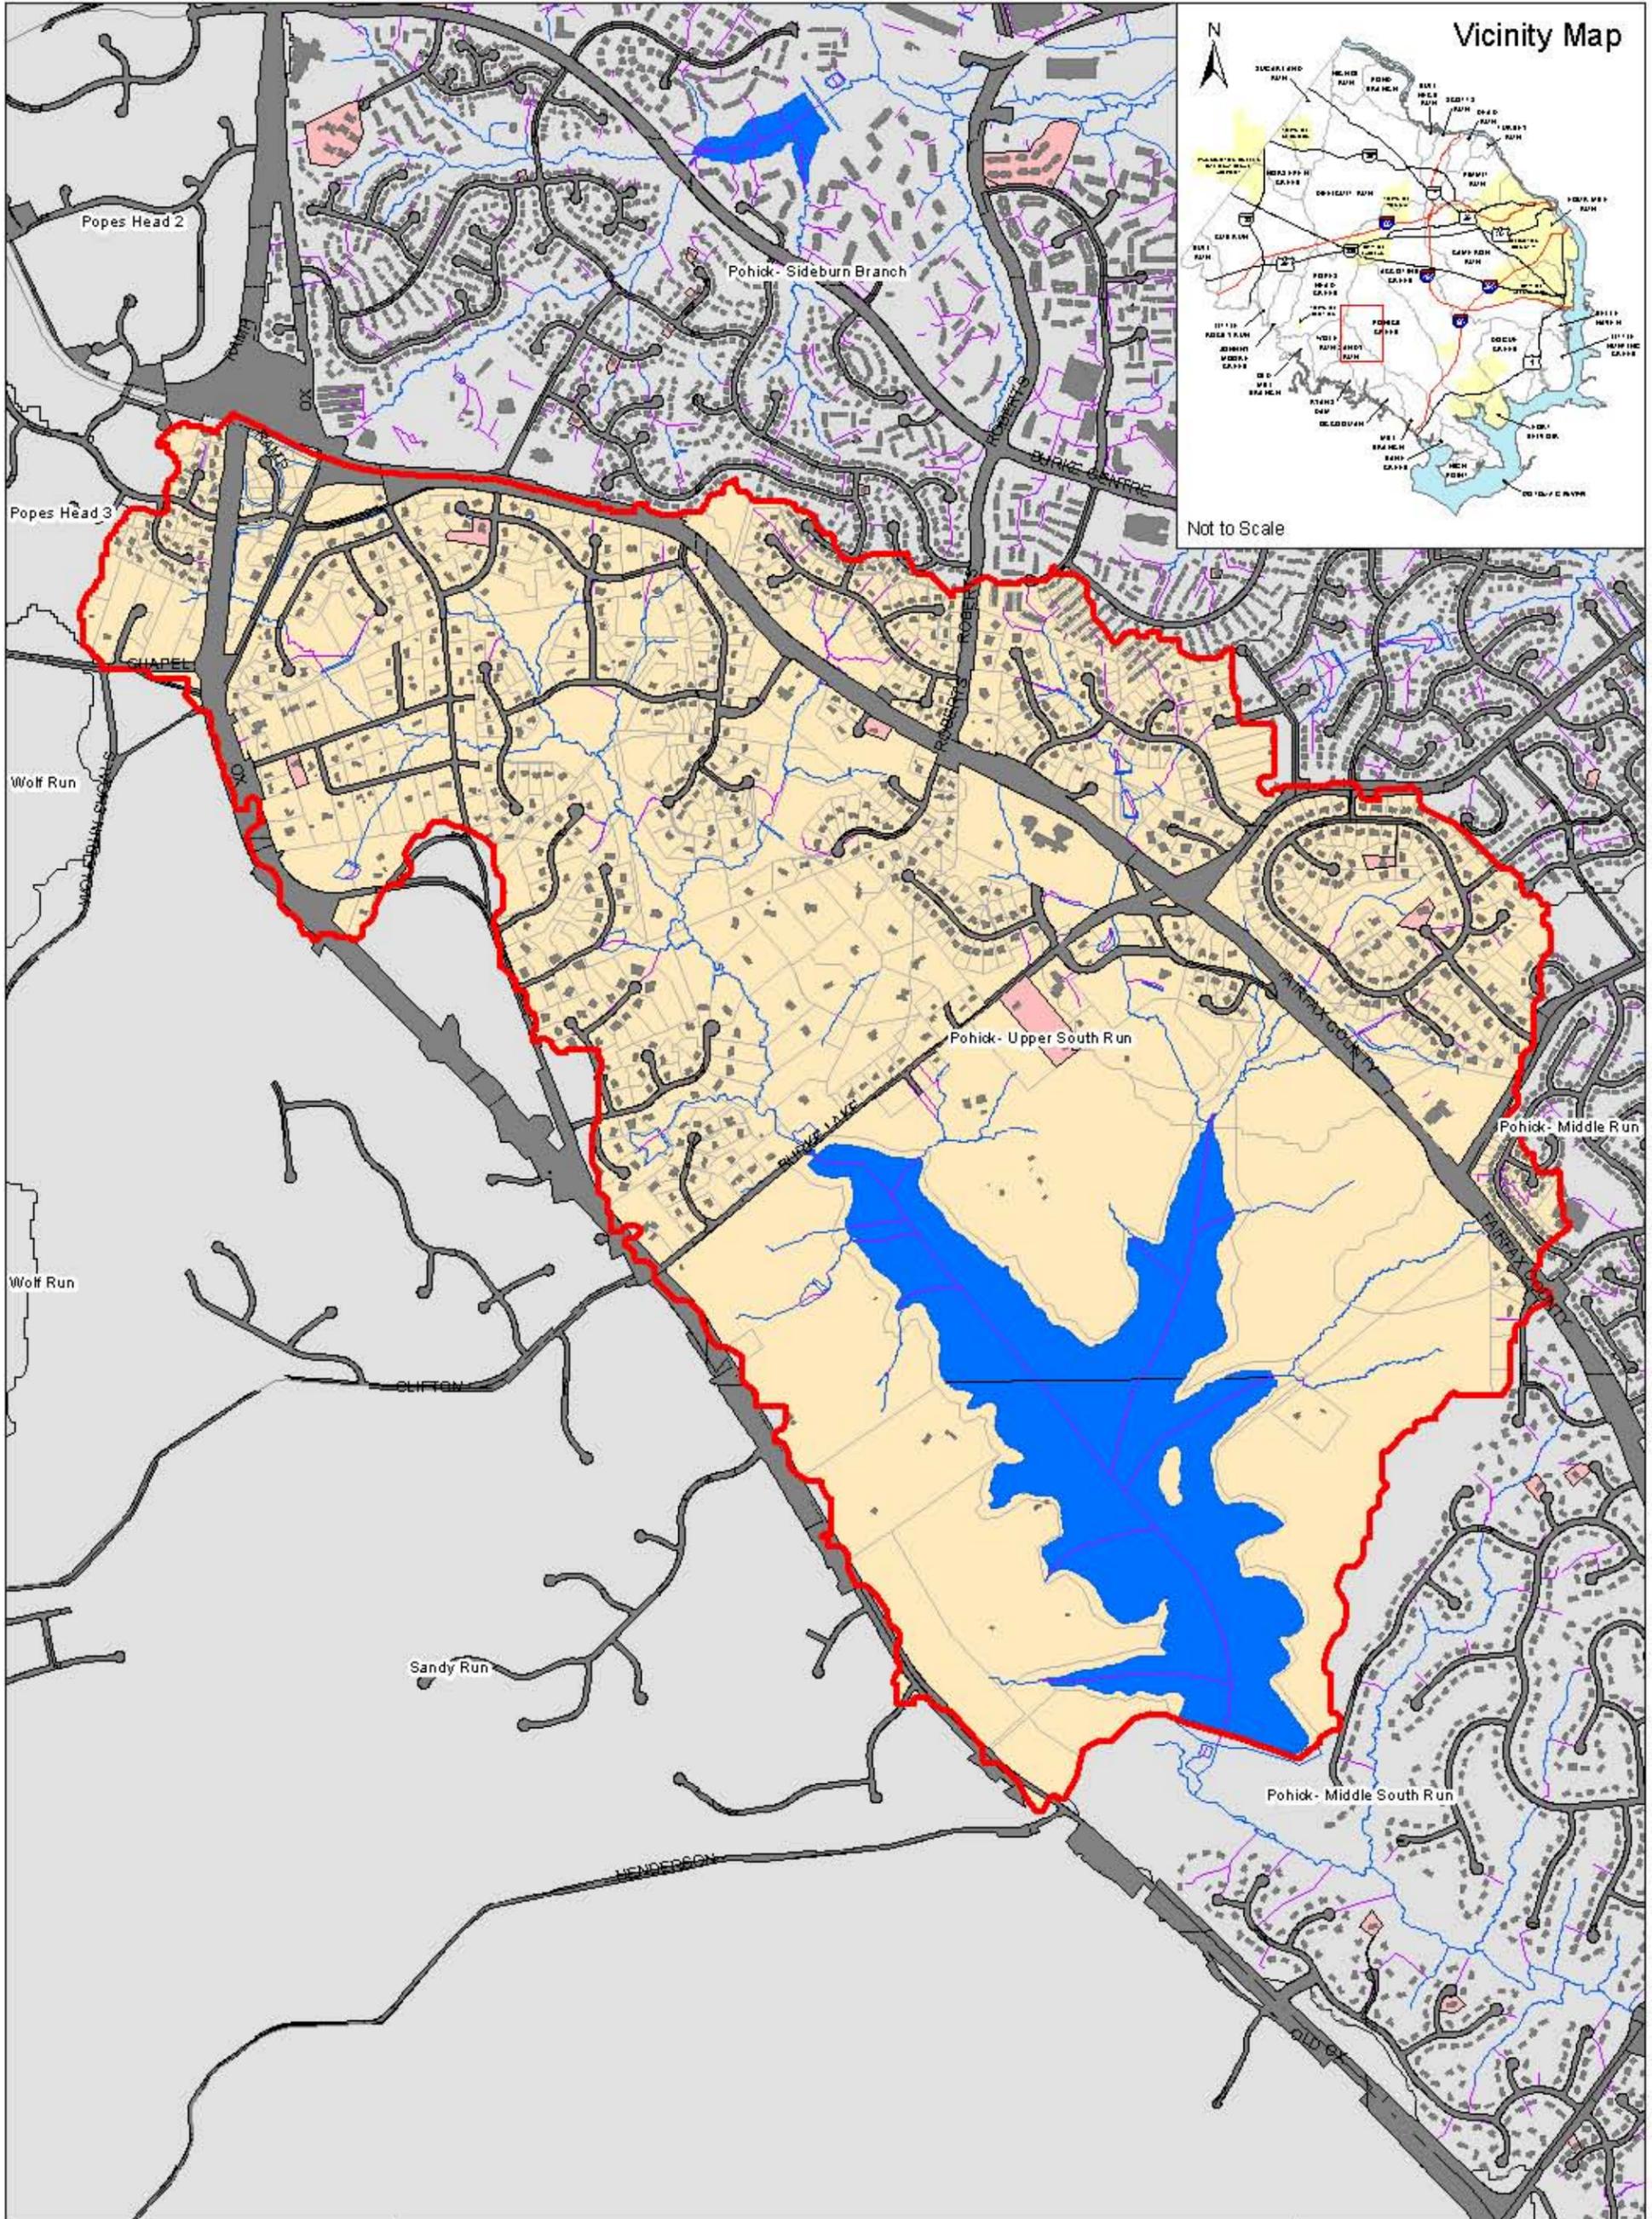
Map 2.2.3-2
Pohick Creek
Upper South Run
Stormwater Infrastructure

Map 2.2.3-2 demonstrates the observed stormwater infrastructure conditions in the Upper South Run WMA. Stormwater infrastructure consists primarily of open channel and overland stormwater collection leading to a limited upstream pipe network of storm drains discharging to either dry detention basins or directly into Upper South Run and its associated stream valleys and tributaries on the way downstream to Burke Lake. Many of the tributaries leading to Burke Lake directly are unimproved. The Upper South Run WMA contains approximately 11 dry detention facilities designed to manage stormwater quantity. In addition, the WMA contains two wet retention basins, which often serve to treat both water quantity and quality, and two infiltration trenches, which is a stormwater quality component designed to allow for the infiltration of stormwater into the ground rather than having the stormwater runoff directed to a control structure for treatment. Roughly half of the stormwater management facilities observed in the Upper South Run WMA are located north of the Fairfax County Parkway in the more densely developed areas of the WMA

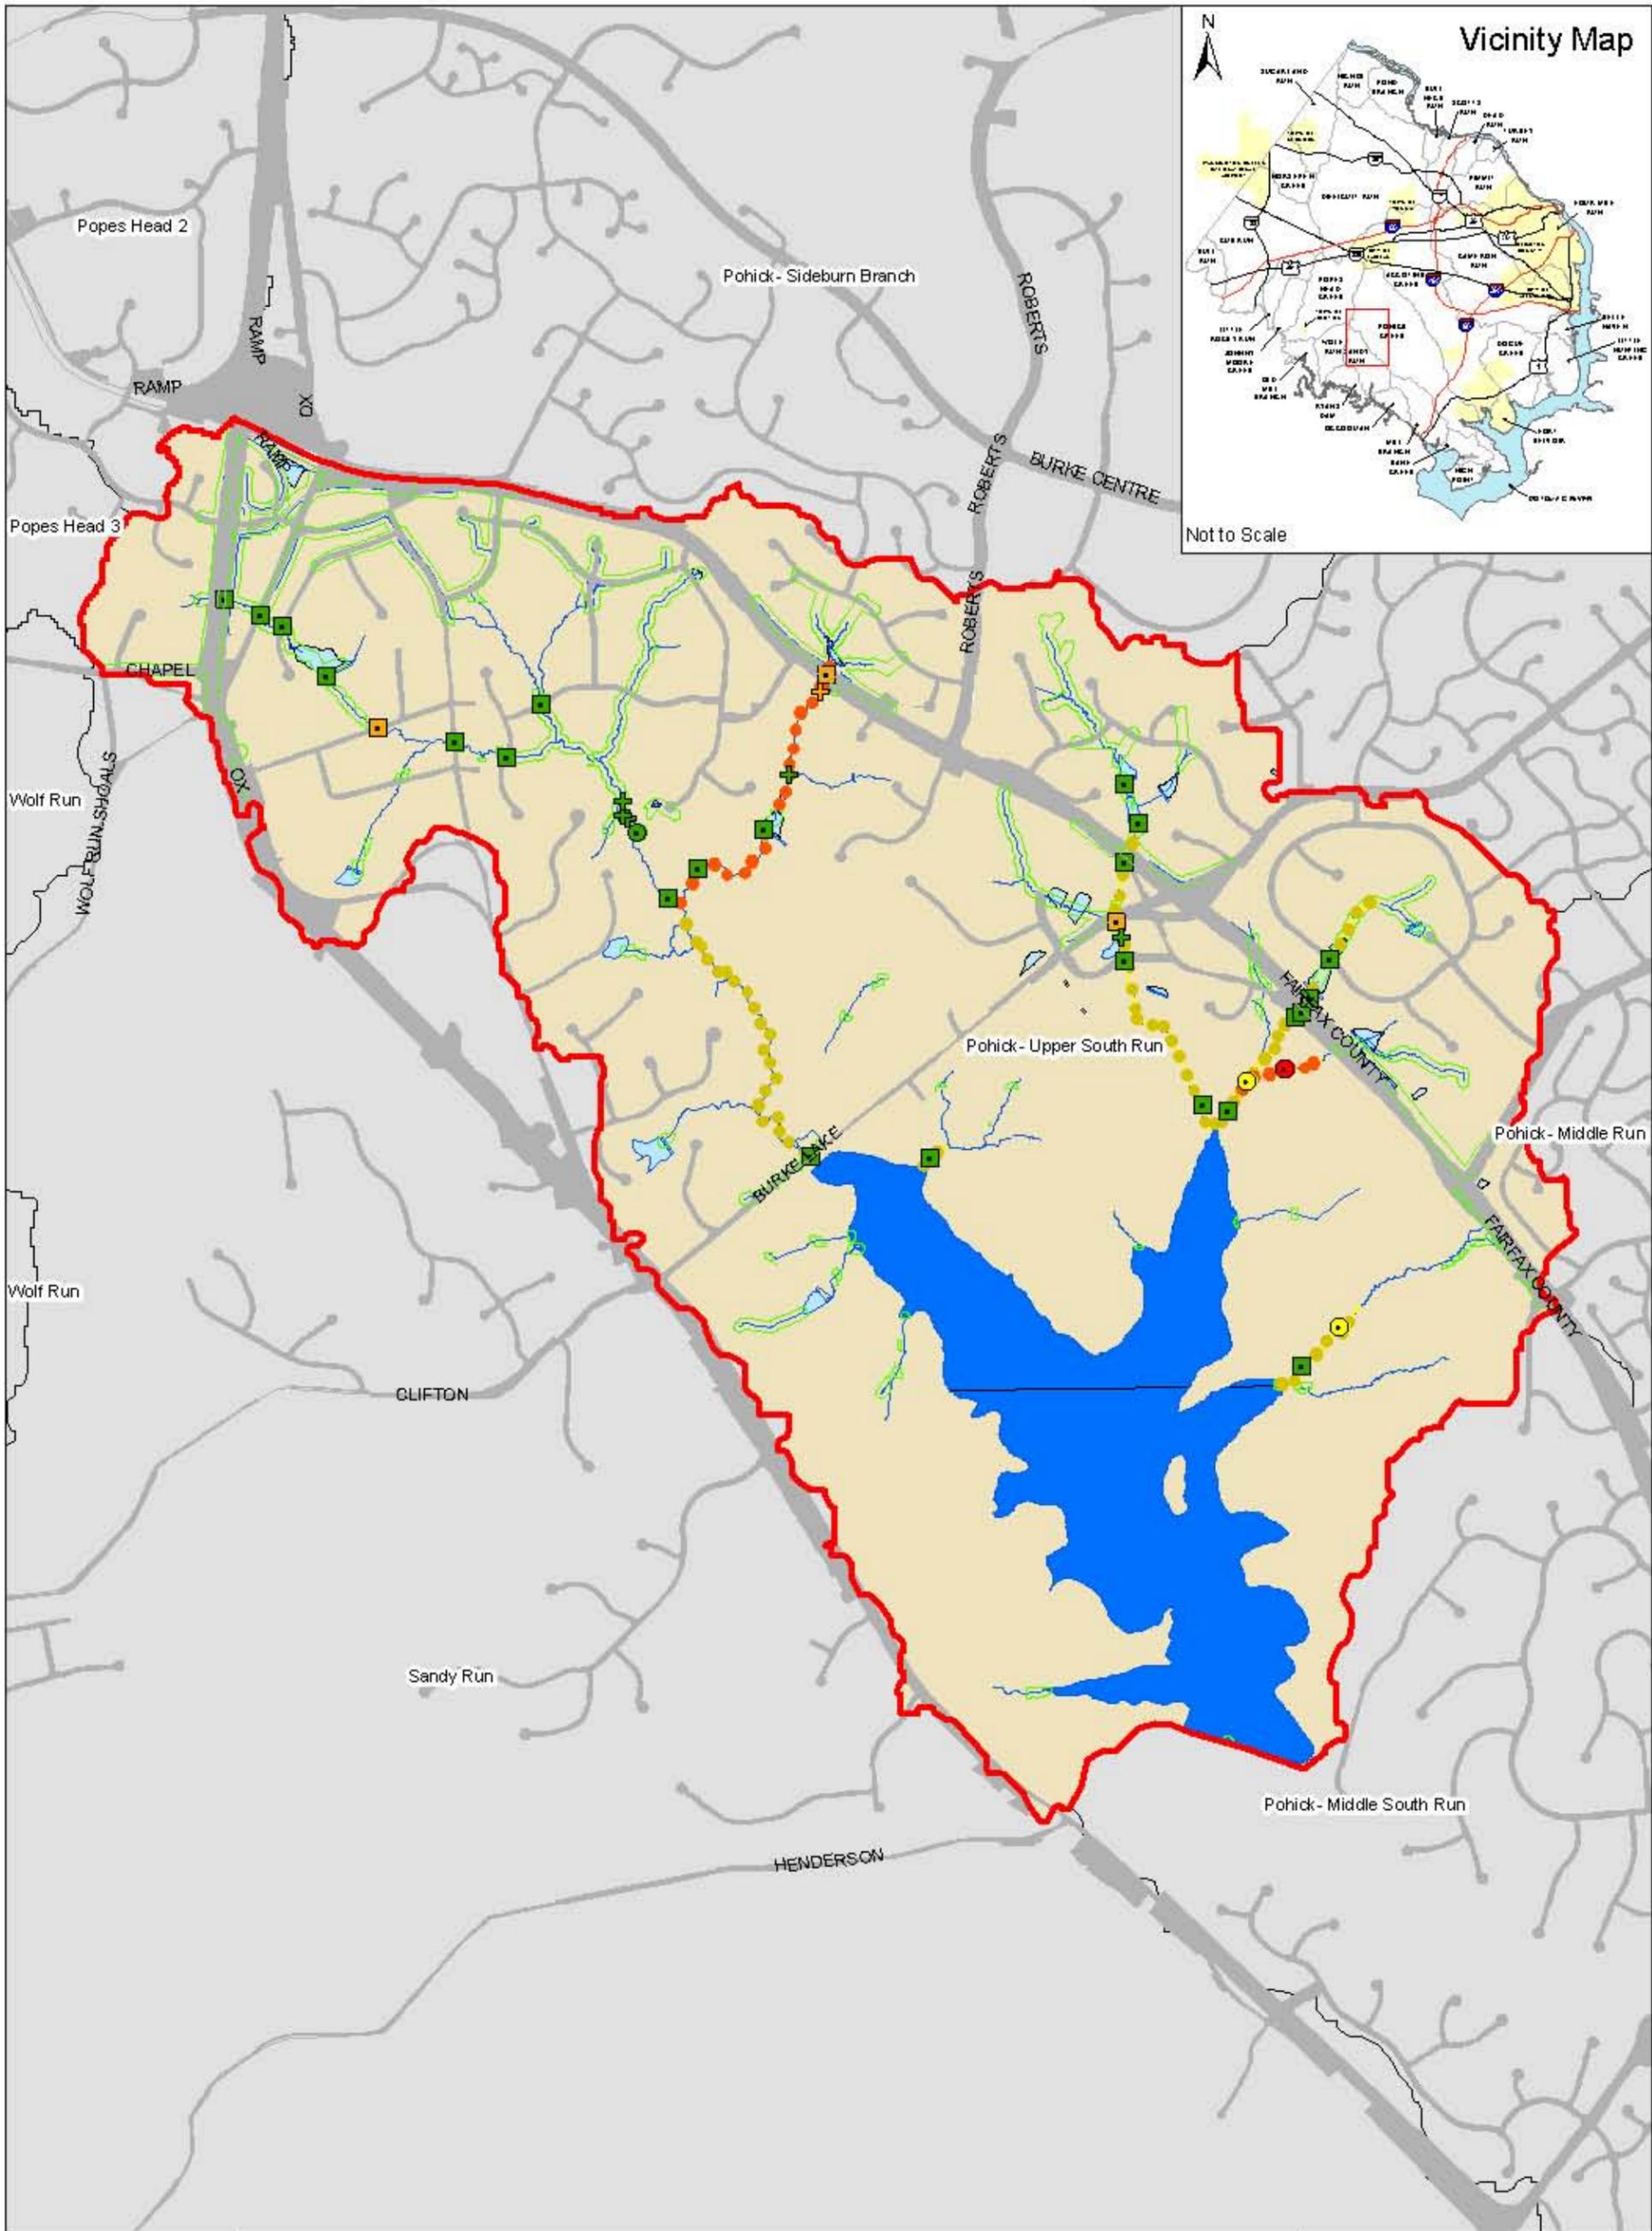
Map 2.2.3-3
Pohick Creek
Upper South Run
Stream Conditions

The Stream Conditions **Map 2.2.3-3** denotes the generally observed stream conditions as documented in the 2005 SPA and through additional, windshield level field reconnaissance performed for this study. The Stream Conditions Map demonstrates the general conditions of the main stem streams and tributaries in the WMA along with a series of features that typically impact stream condition, including stream channel erosion, channel widening, stream buffer condition, discharge pipe and ditch impacts, and utility and road crossing impacts.

In the Upper South Run WMA, the most prevalent stream condition features noted include disturbed stream buffers upstream of Burke Lake, and stream channel incision and widening in the streams and tributaries closer to Burke Lake. As this WMA contains less curb, gutter, and pipe stormwater infrastructure than others in the Pohick Creek watershed, pipe discharge and ditch discharge into the WMA's streams does not show the impact in this WMA that it does in others in the watershed. However, the Upper South Run WMA does display several significant crossing impacts, particularly the road crossings for the Fairfax County Parkway north of Roberts Road and south of the Burke Lake Road intersection. Additional crossing impacts are seen on Burke Lake Road itself just south of the intersection with the Fairfax County Parkway. Instances of demonstrated stream head cutting, or an abrupt vertical drop in the bed of a stream channel that demonstrates active erosion (NC DWQ, 2005), were limited to two tributaries entering Burke Lake, recorded in the south eastern portion of the WMA.
