2.2.4 Middle South Run

Field Reconnaissance

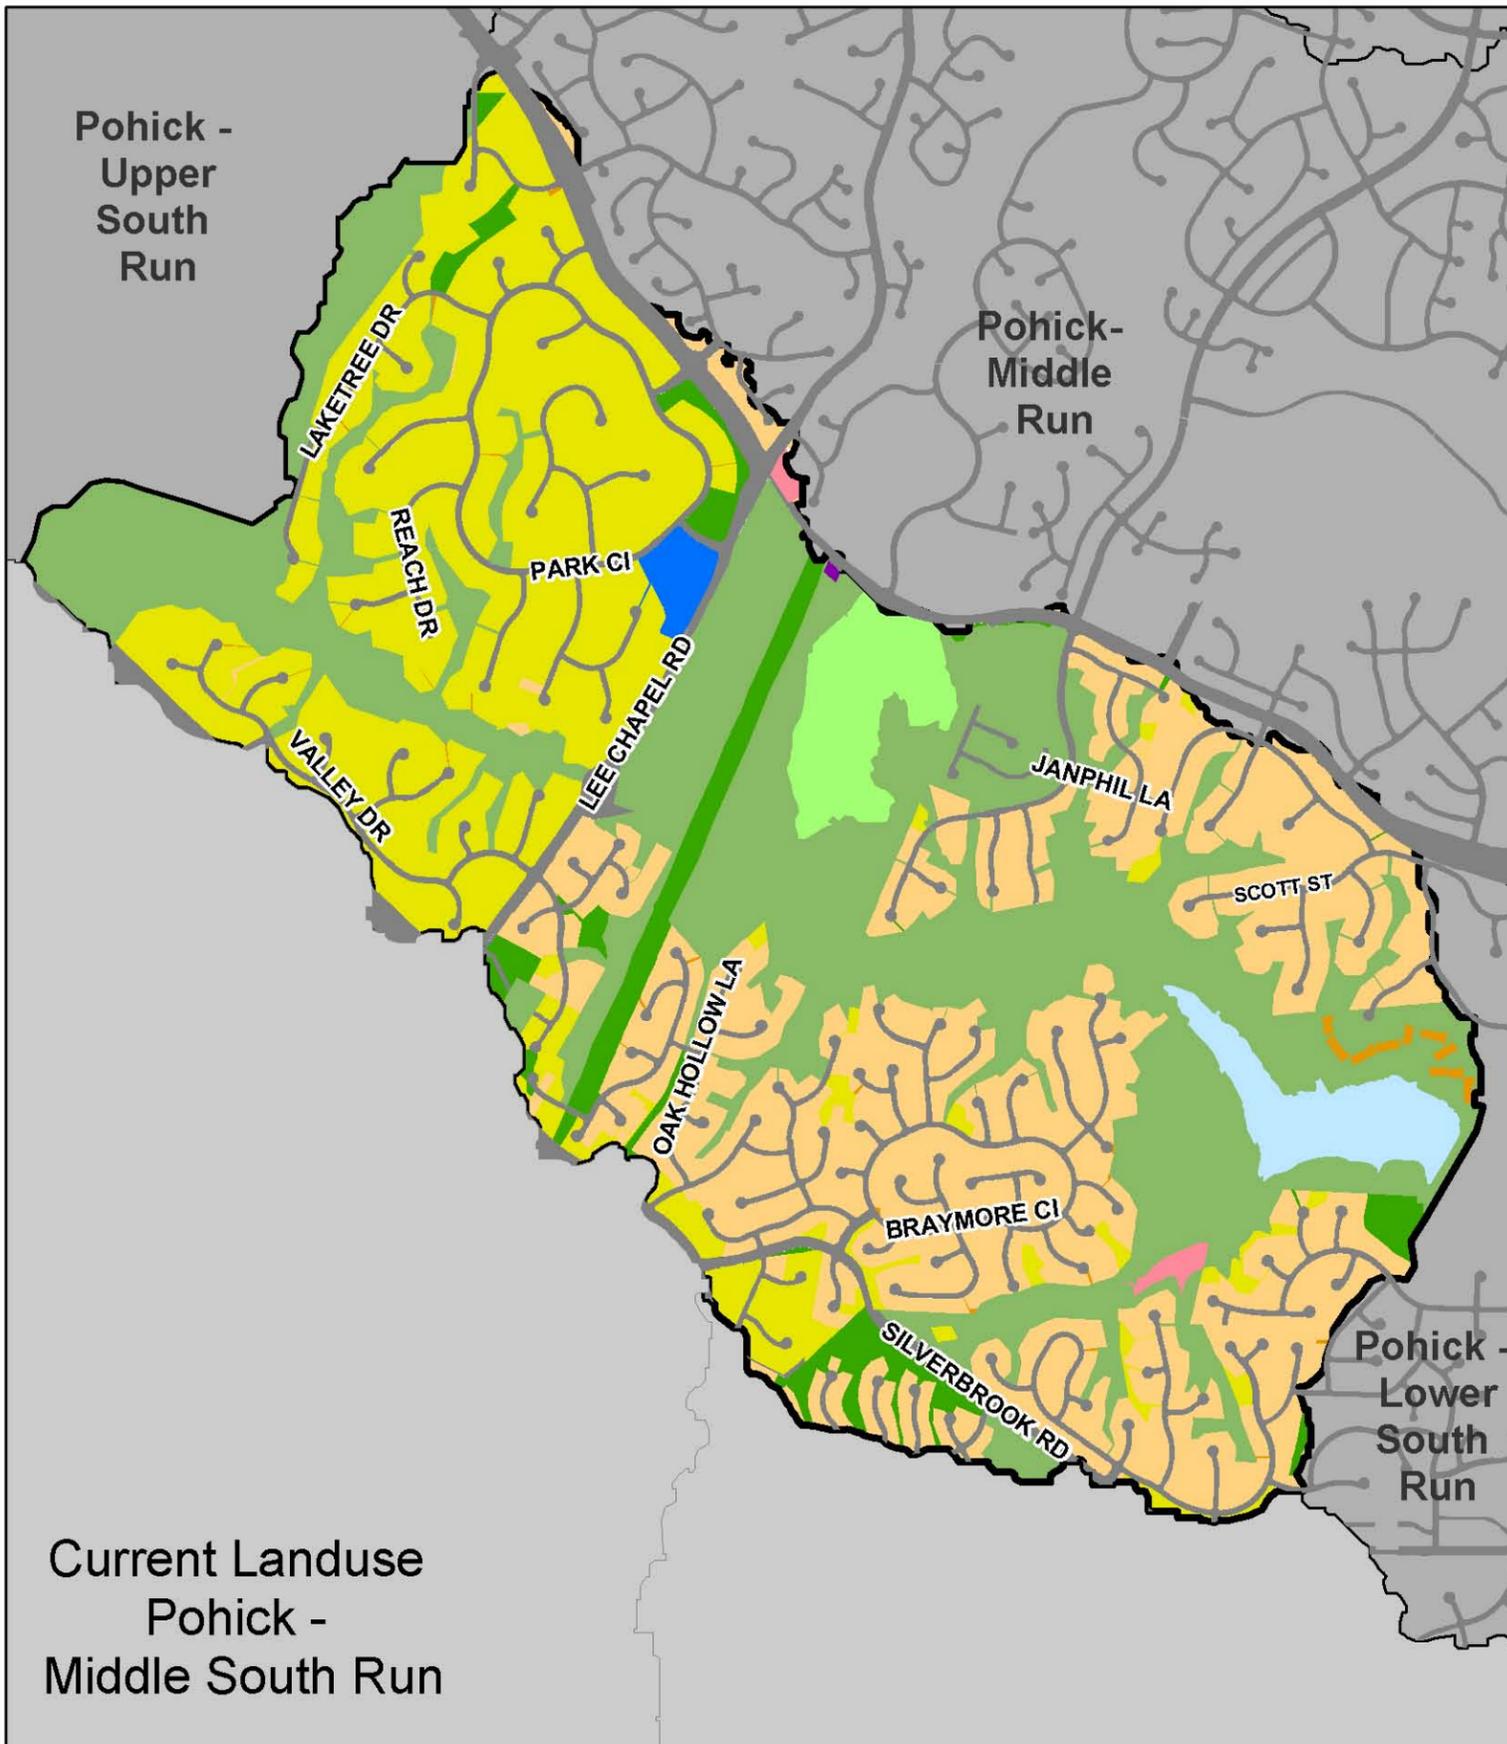
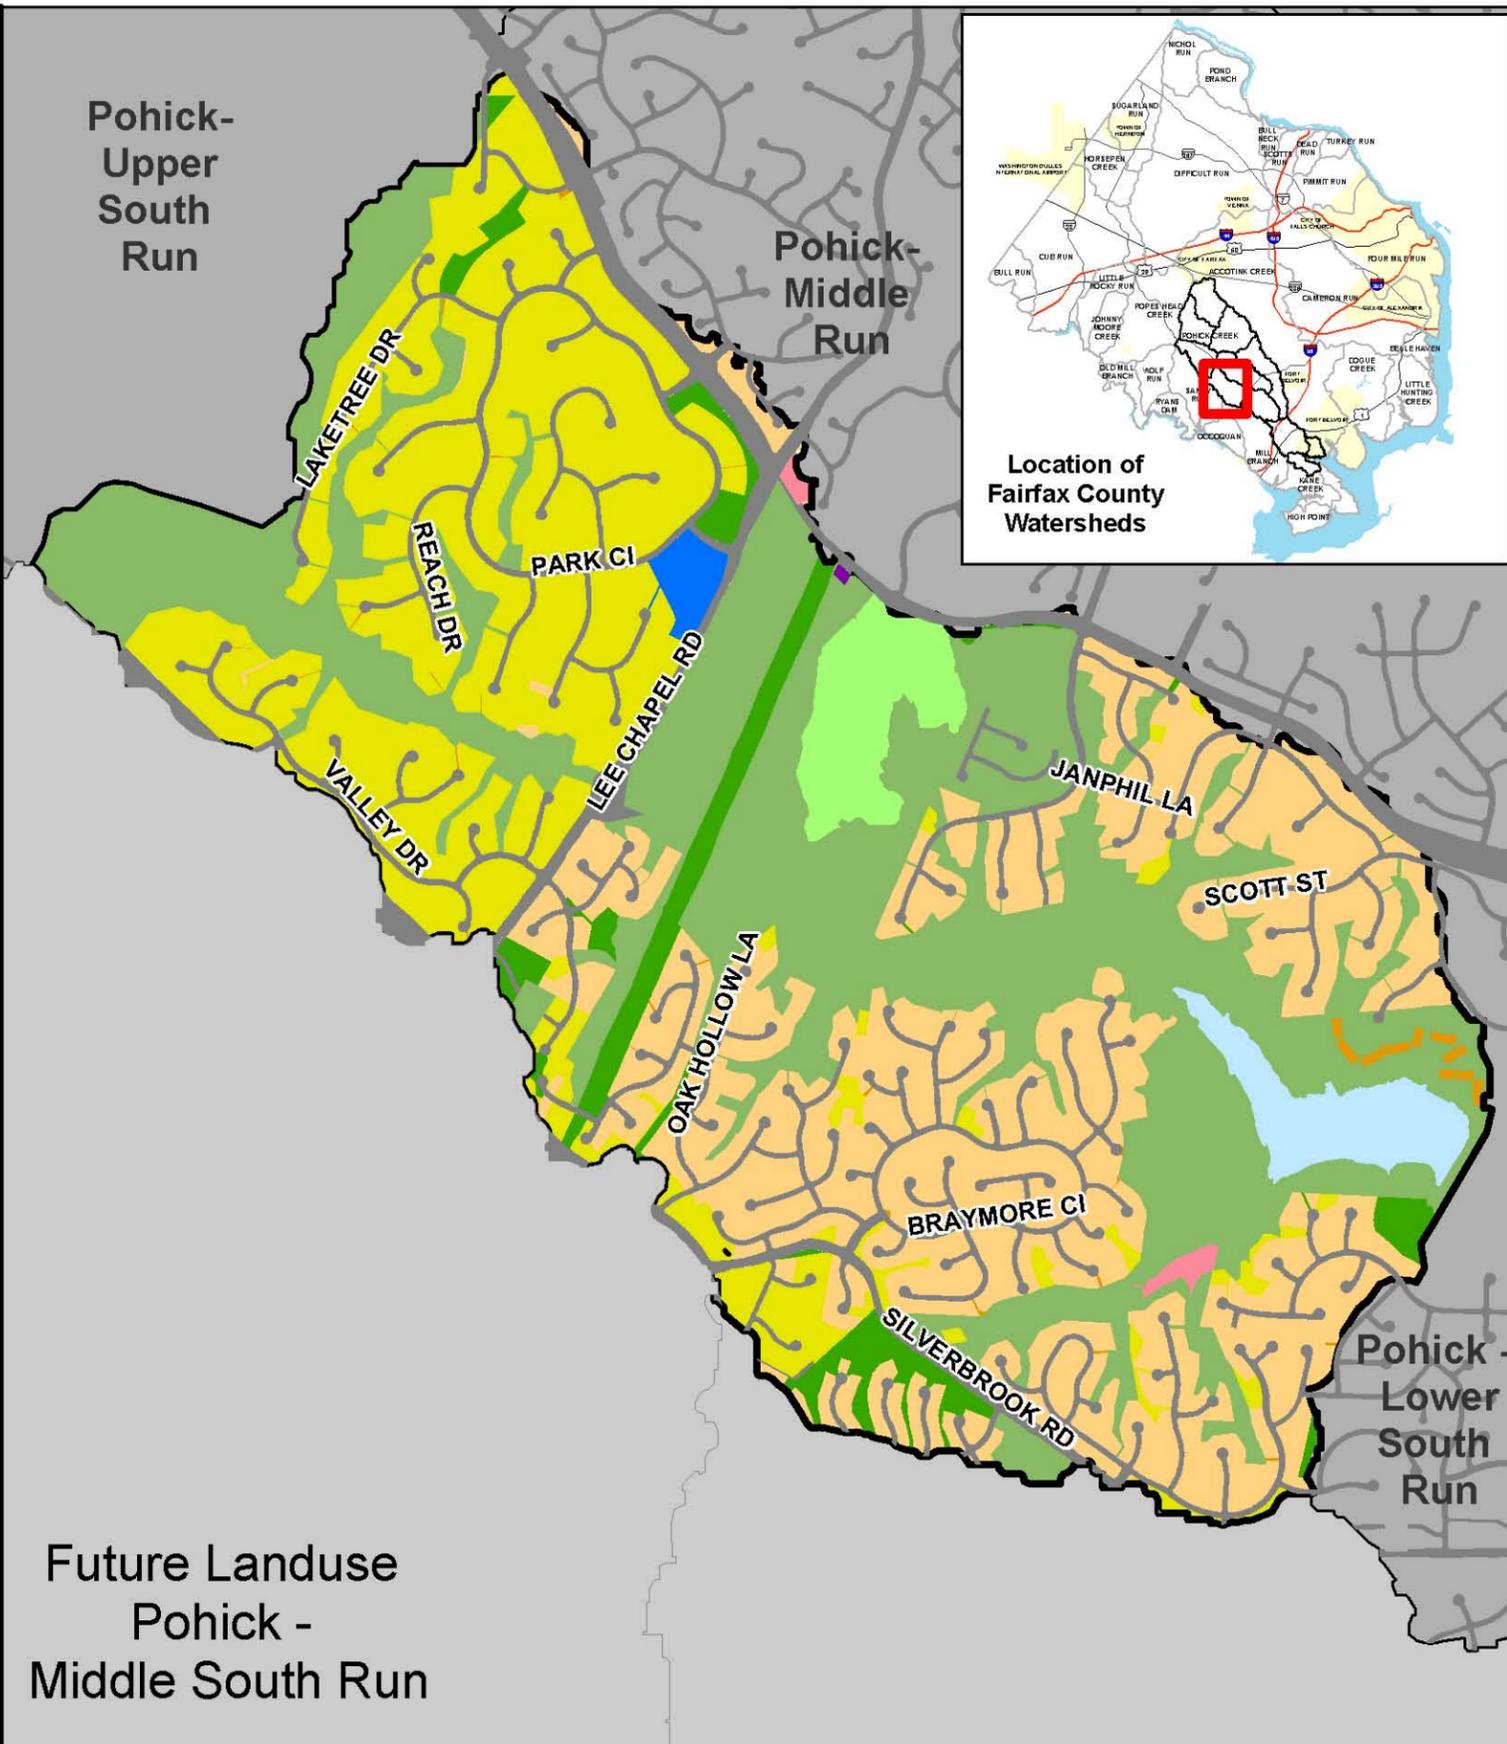
Map 2.2.4-1
Pohick Creek- Middle South Run
Existing and Future Land Use

The Middle South Run WMA is comprised primarily of single family detached residential properties, with the majority of the observed single family detached dwellings were constructed on estimated ¼ to ½ acre lots, including several large subdivisions such as Barrington, Timber Ridge, the Woods at South Run, and South Run Oaks. The residential development in this WMA is largely characterized by street patterns terminating in cul-de-sacs (i.e. not as many through streets). The age of development in this WMA ranges from an estimated 20 to 25 years old (1980's) up to new construction (2005 or newer) with little evidence of infill development. Land cover consists primarily of impervious surface associated with residential development (i.e. rooftops, streets and driveways, sidewalks, etc.) and associated landscaping, including managed turf. Curb and gutter on streets was observed in several subdivisions, primarily those with smaller lot sizes.

Current Landuse
Pohick -
Middle South Run

Future Landuse
Pohick -
Middle South Run

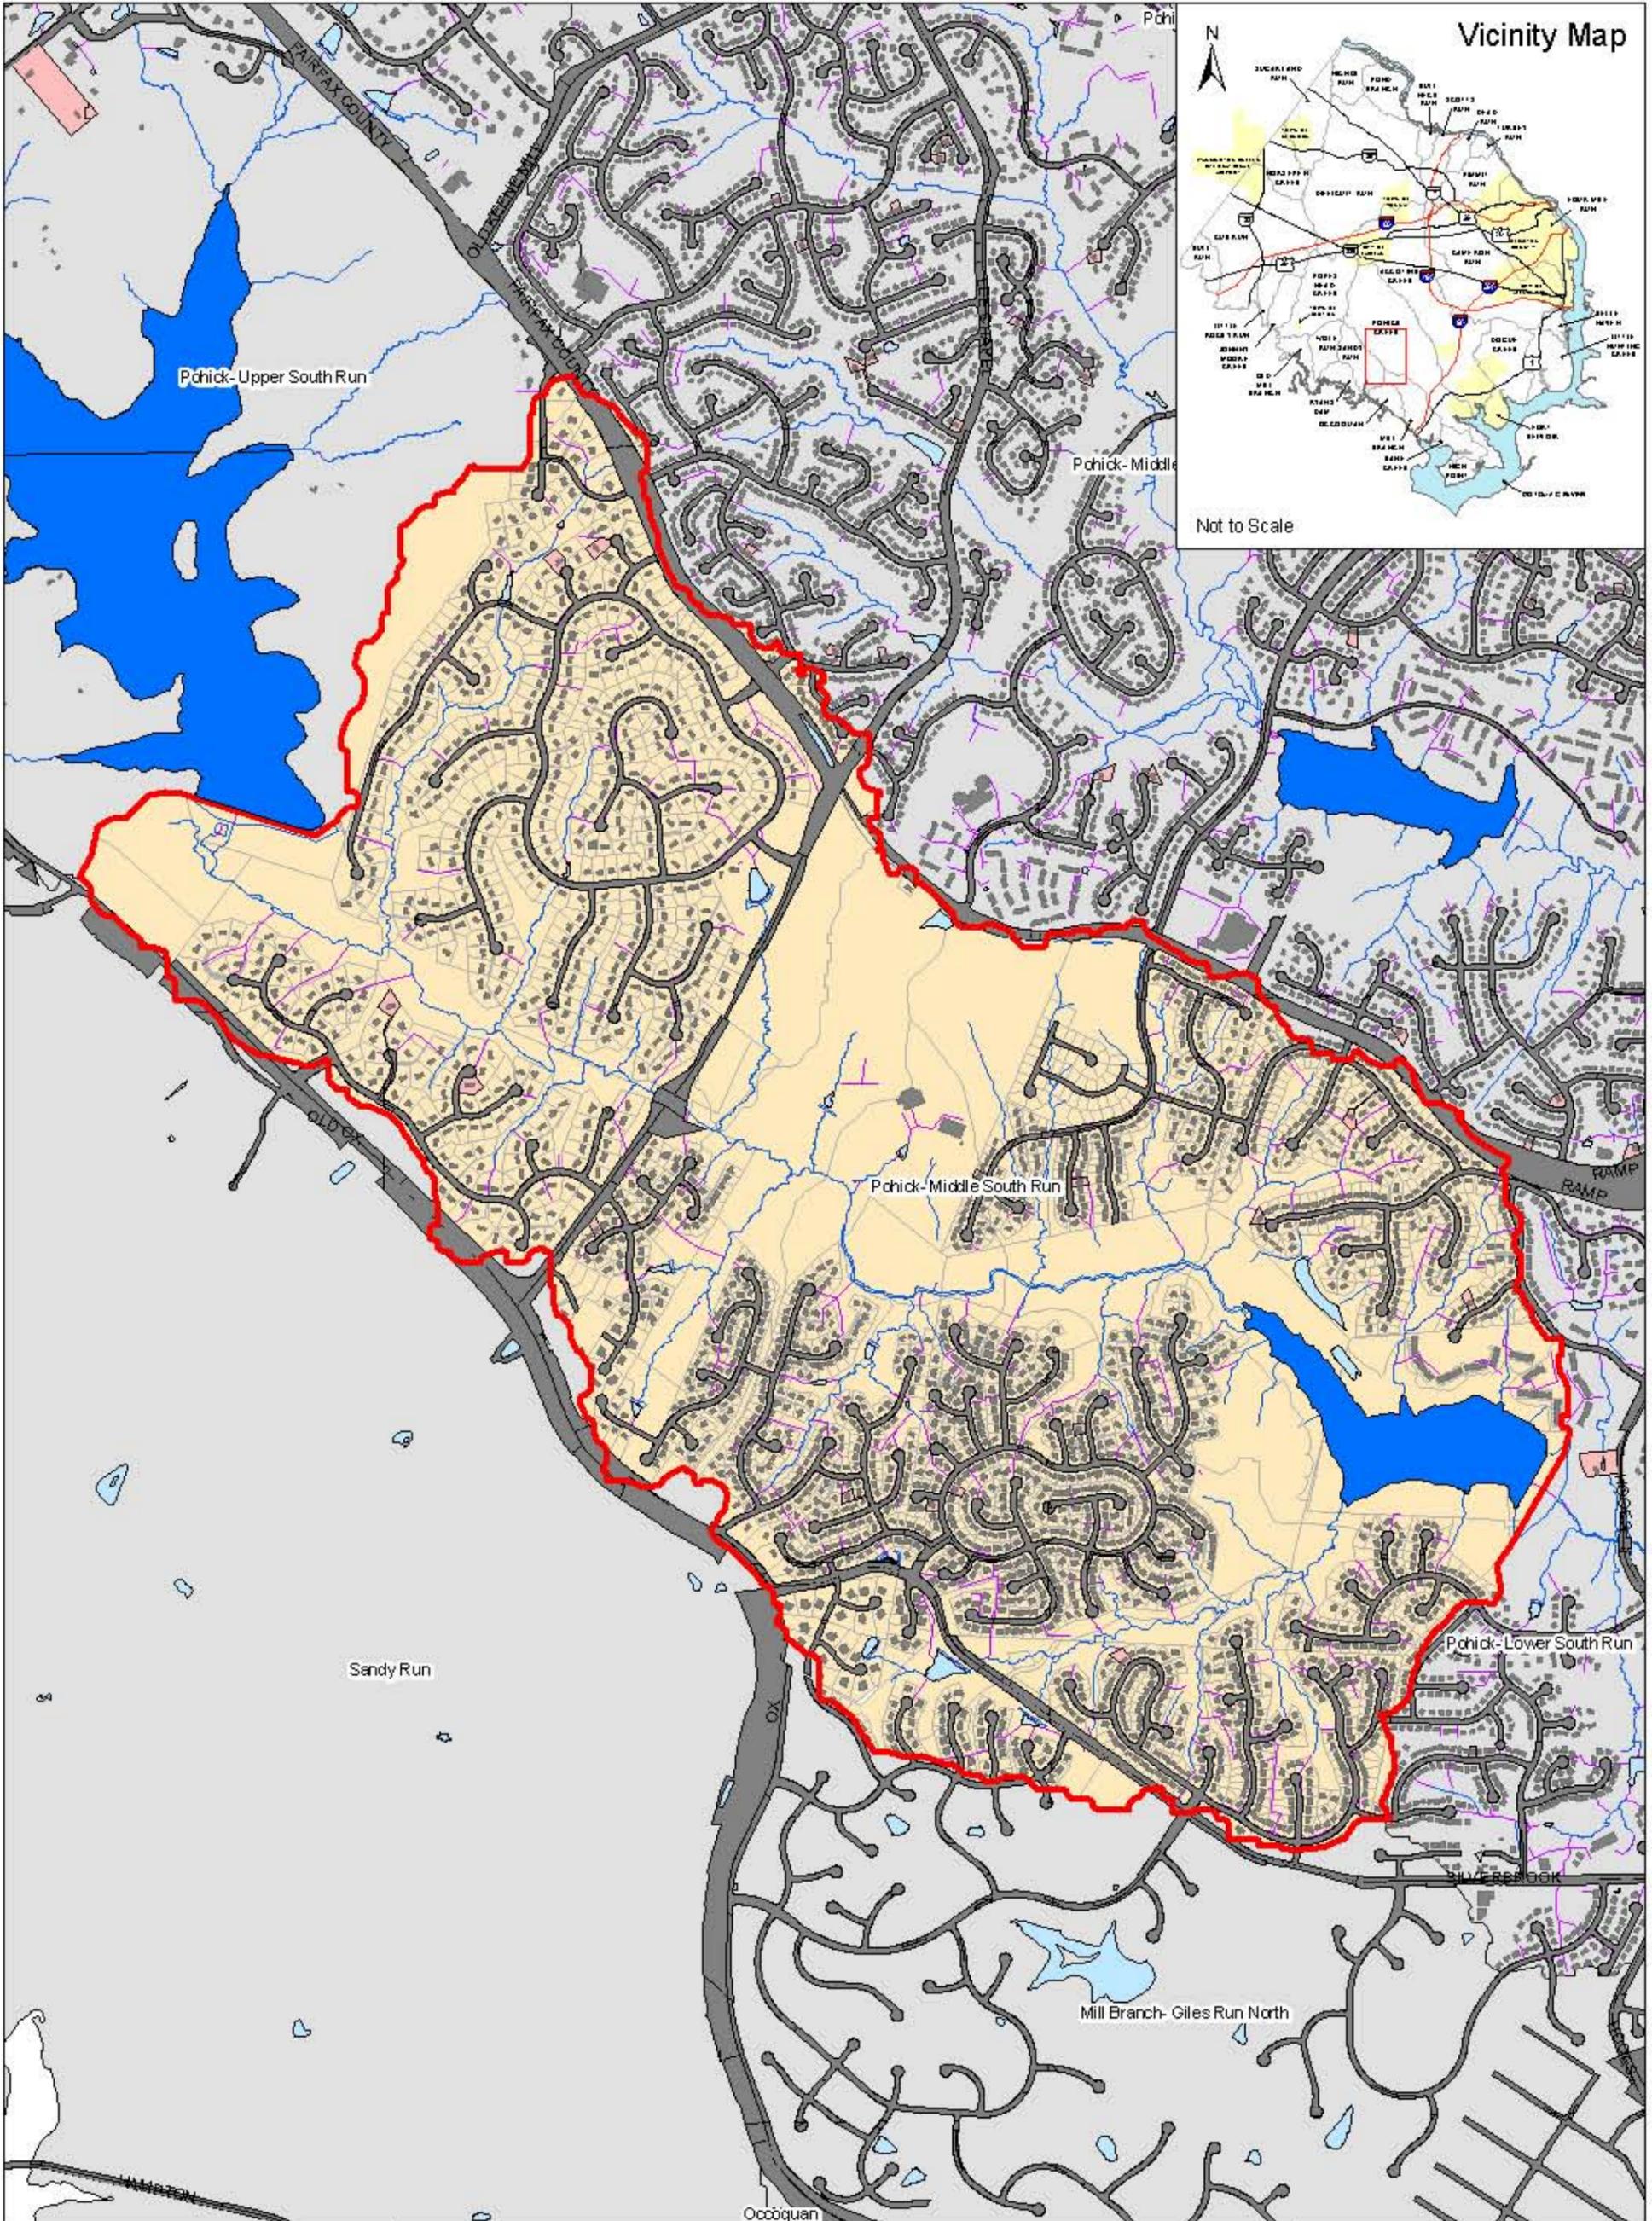
Map 2.2.4-2 depicts the observed stormwater infrastructure conditions in the Middle South Run WMA. The upstream portions of the WMA, west of Lee Chapel Road, contain a combination of curb and gutter stormwater collection and overland stormwater collection leading to a piped network of storm drains discharging directly into Middle South Run and its tributaries and directly to Lake Mercer. 11 stormwater management facilities are evident upstream of Lake Mercer, including 10 dry detention basins and one wet retention basin. Moving downstream to the east, the newer development in the Middle South Run WMA contains the majority of the stormwater management structures and facilities noted above, including more prevalent use of curb and gutter stormwater collection. Development east of Lee Chapel Road also tends to be more dense, with the majority of the single family residential development clustered onto smaller lots (1/4 acre and below).

Pohick Creek
Middle South Run
Stormwater Infrastructure

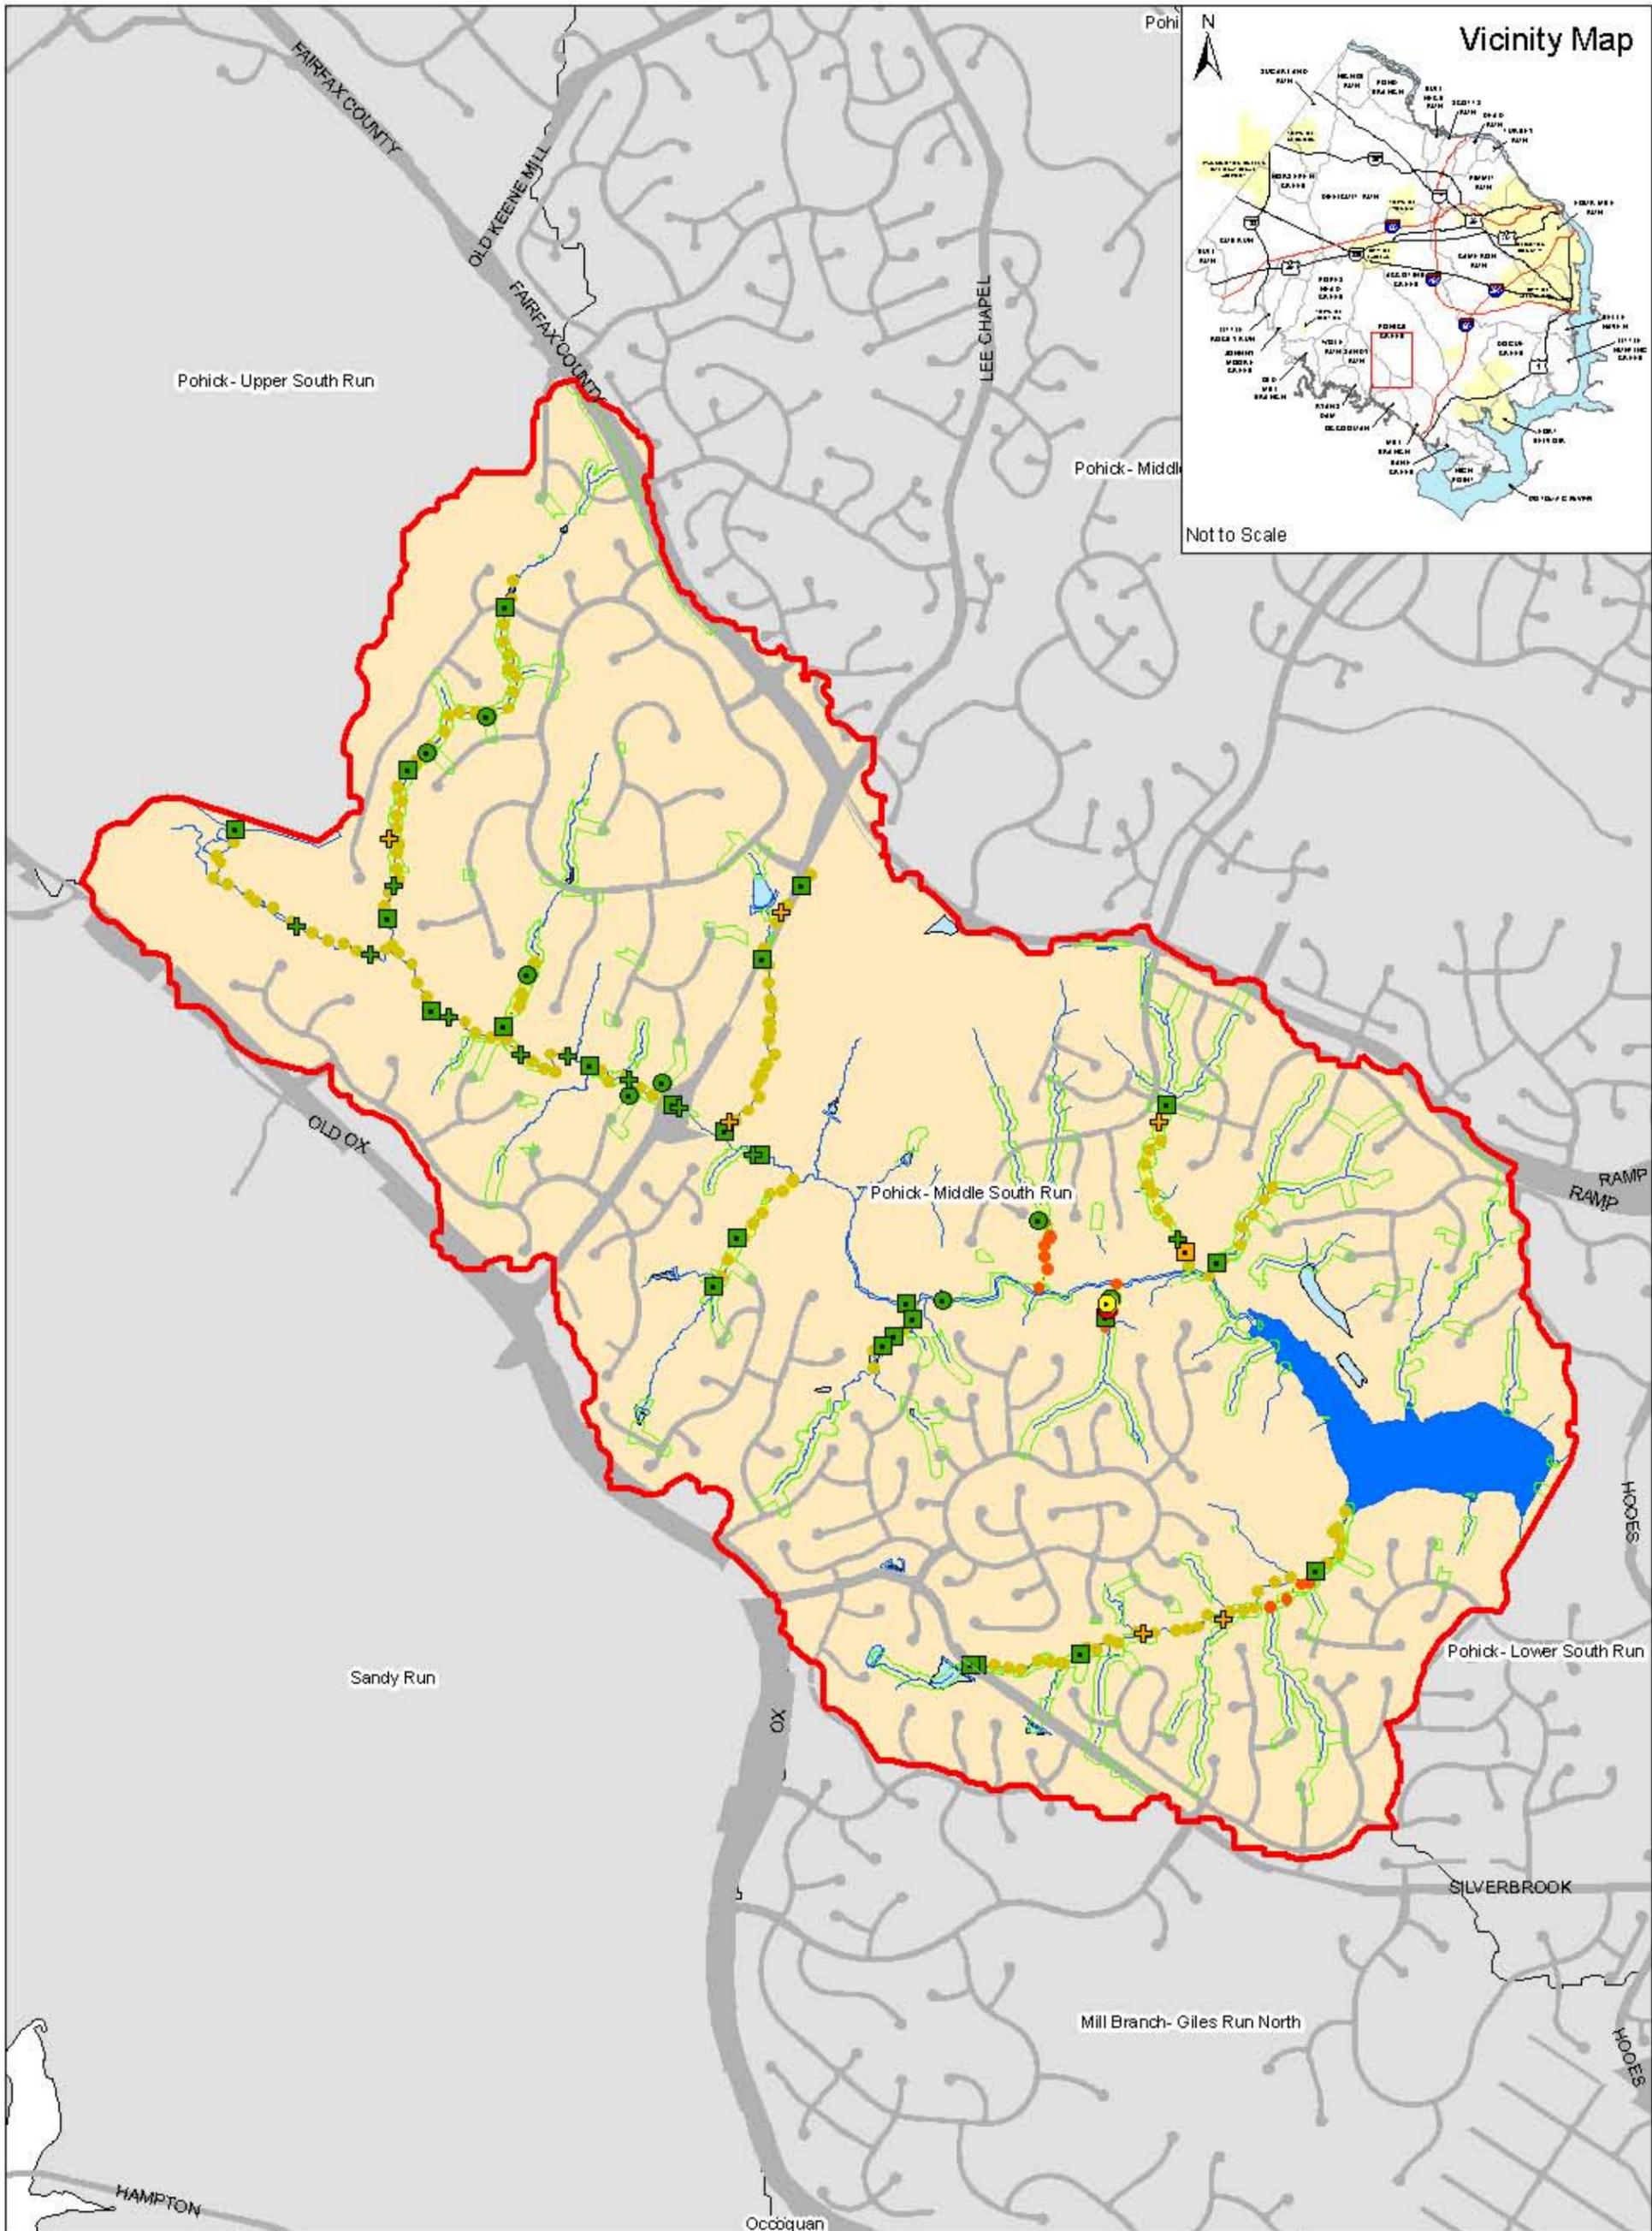
Map 2.2.4-3

The Stream Conditions **Map 2.2.4-3** denotes the generally observed stream conditions as documented in the 2005 SPA and through additional, windshield level field reconnaissance performed for this study. The Stream Conditions Map demonstrates the general conditions of the main stem streams and tributaries in the WMA along with a series of features that typically impact stream condition, including stream channel erosion, channel widening, stream buffer condition, discharge pipe and ditch impacts, and utility and road crossing impacts.

In the Middle South Run WMA, the most prevalent stream condition features noted include disturbed stream buffers and stream channel erosion and/or widening. Upstream of Lake Mercer, significant channel widening has been documented, along with some limited capture of channel incision and scour. In addition, pipe discharge and ditch discharge into the WMA's streams, numerous in the WMA, have an impact on the streams and tributaries as well, as pipes and ditches discharge stormwater runoff directly into the streams in many instances, contributing to the observed widening and erosive conditions. Several significant obstructions were documented in the WMA, and road crossing impacts in the WMA, while generally minor, were also documented at Lee Chapel Road as well as the interior of several of the WMA's subdivisions. Instances of demonstrated stream head cutting, or an abrupt vertical drop in the bed of a stream channel that demonstrates active erosion (NC DWQ, 2005), were limited, with one series of recorded examples on a minor tributary to Middle South Run in the center of the WMA.

Pohick Creek Middle South Run Stream Conditions

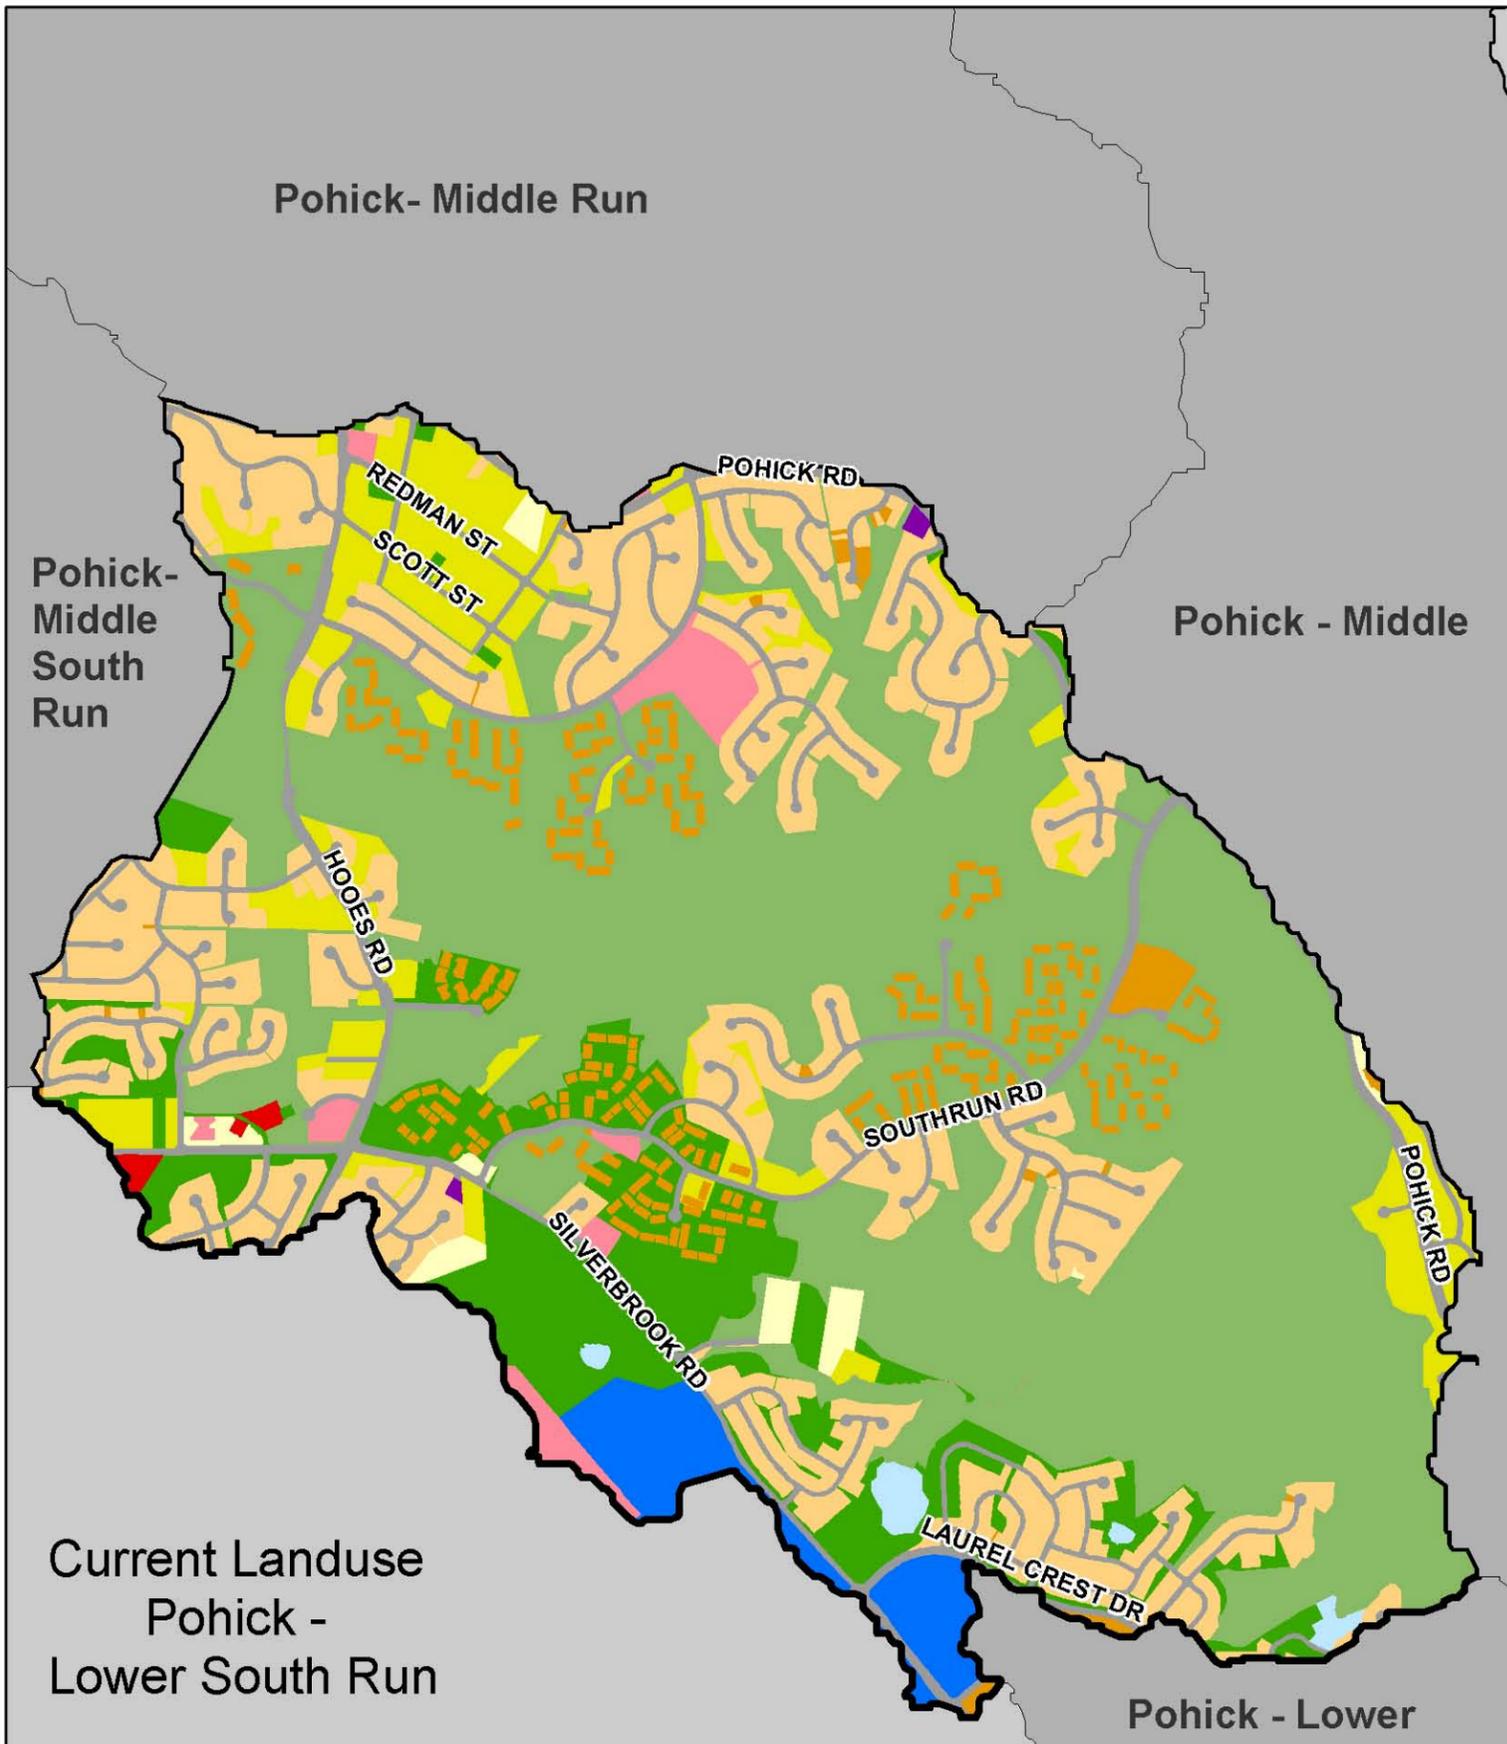
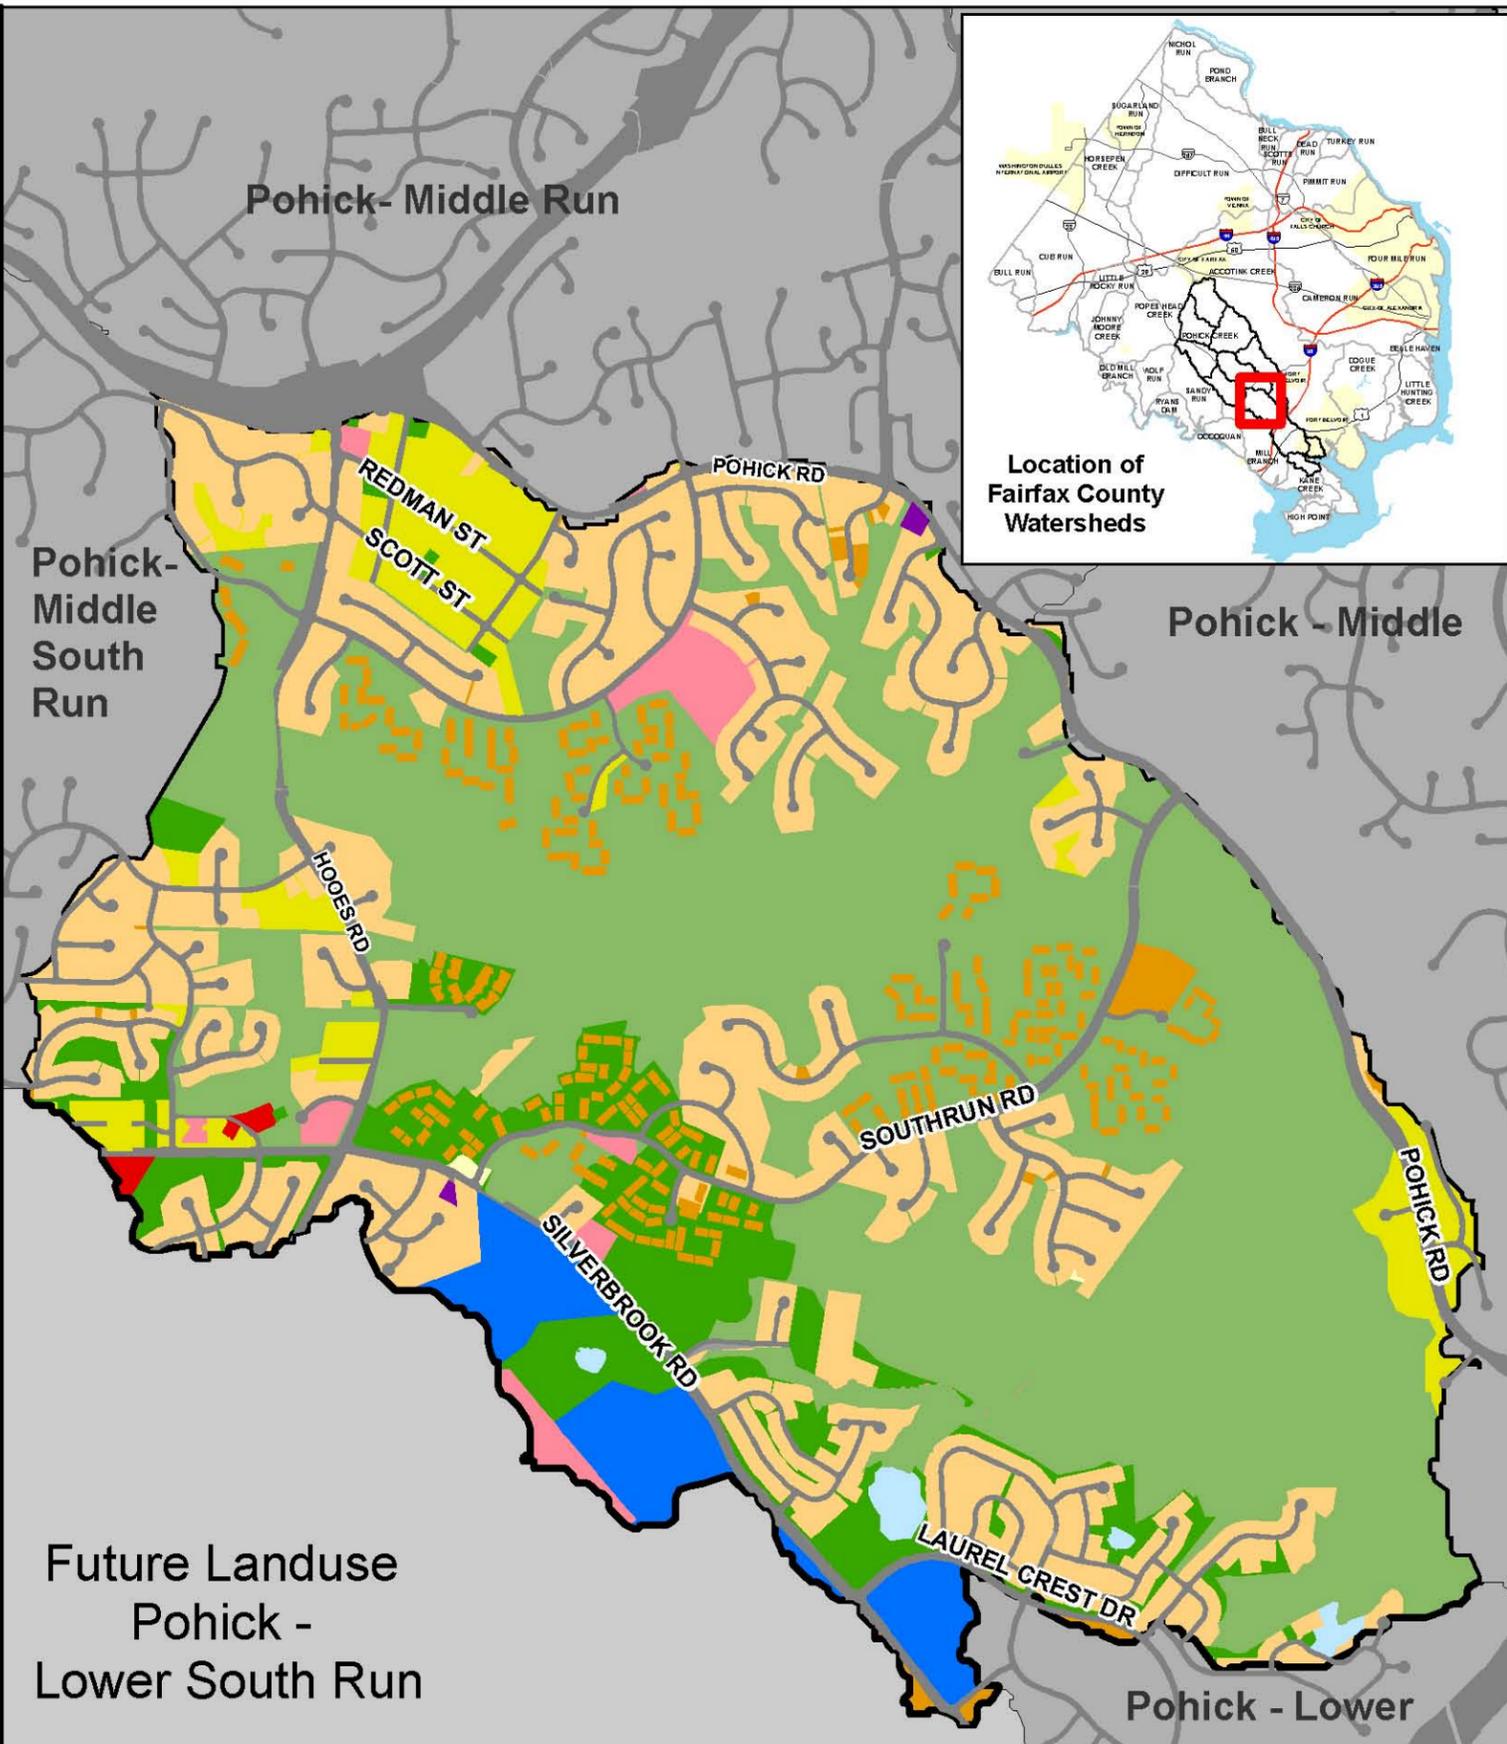
Map 2.2.5-1
Pohick Creek- Lower South Run
Existing and Future Land Use

The majority of the observed single family detached dwellings were constructed on estimated ¼ to ½ acre lots. The age of development in this WMA ranges from an estimated 35 to 30 years old (1970's) up to approximately 20 years old (1980's) with appreciable evidence of recent infill development in several areas. In addition, much of the southern portion of this WMA has been redeveloped as part of the Laurel Hill redevelopment project, including significant construction of residential structures and associated commercial and institutional development. In addition to the single family development, the Lower South Run WMA also contains a significant amount of single family attached (i.e. townhouses) development, especially along South Run Road, which bisects this WMA. These developments are characterized by their density, as well as street construction patterns that feature cul-de-sacs and dead end drives (i.e. limited through street access).
