2.2.4 Middle South Run

Field Reconnaissance

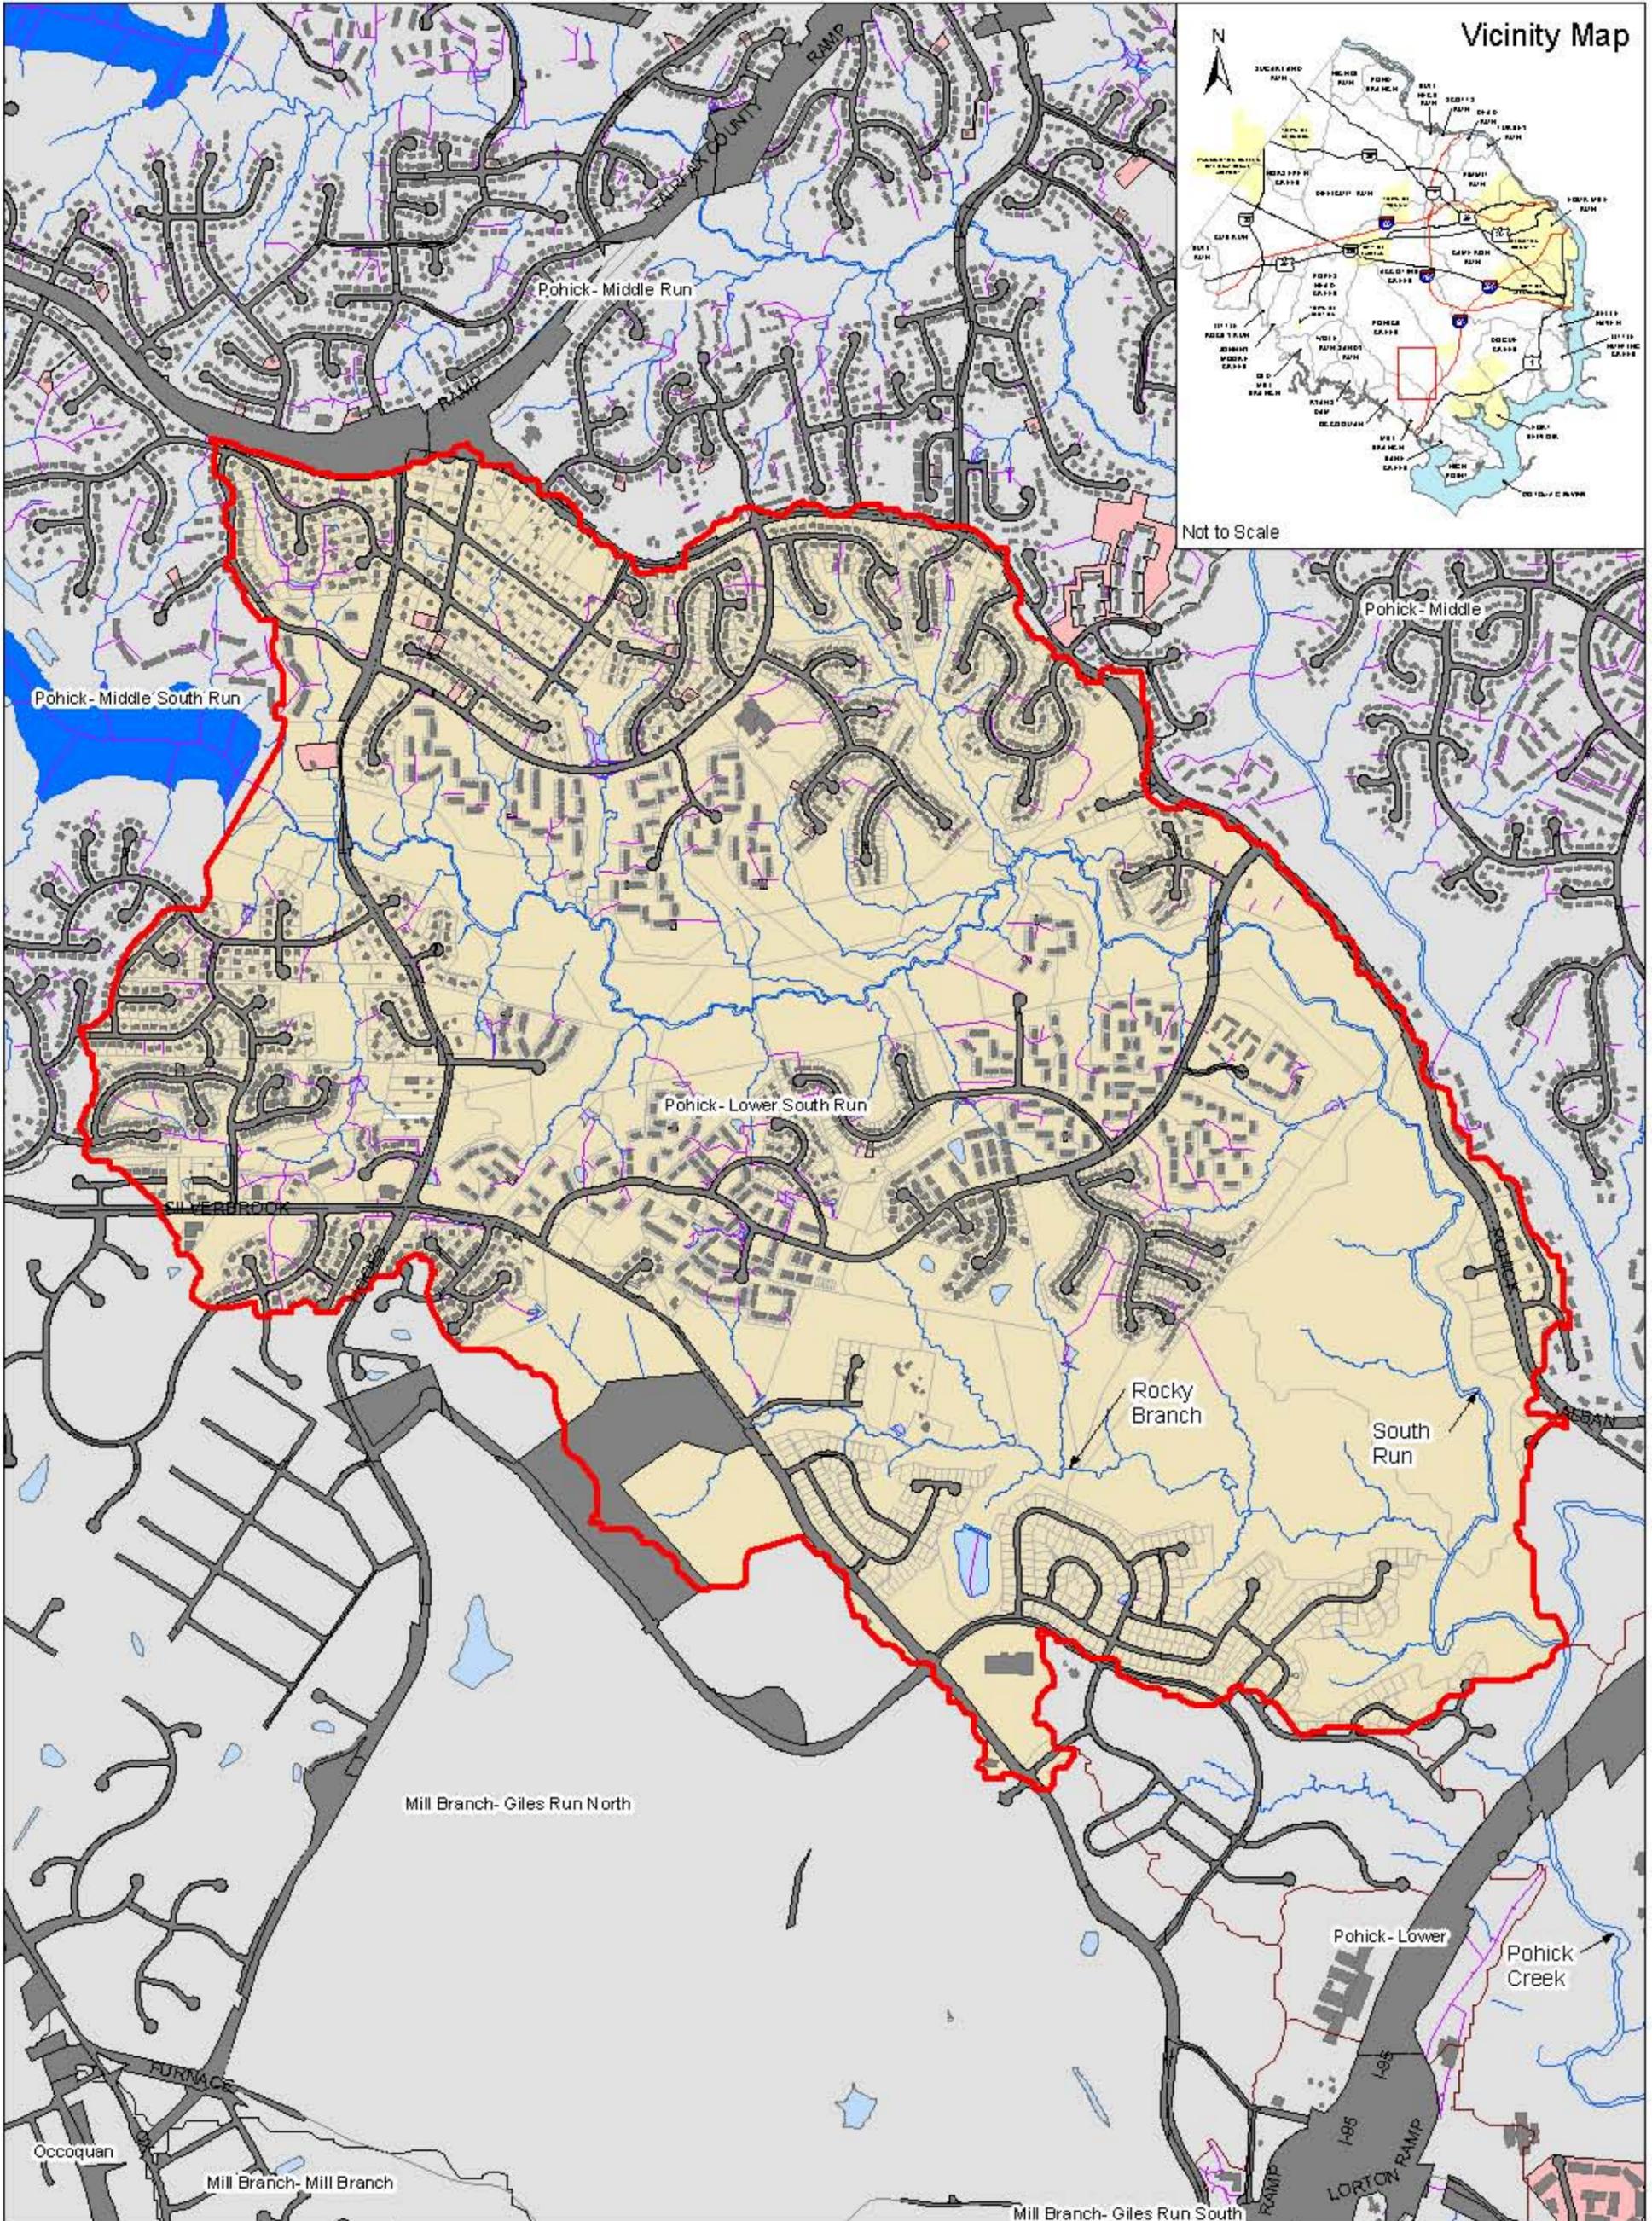
Map 2.2.5-2 demonstrates the observed stormwater infrastructure conditions in the Lower South Run WMA. Stormwater infrastructure consists primarily of curb and gutter stormwater collection leading to a piped network of storm drains discharging to either dry detention basins or directly into Lower South Run and its associated stream valleys and tributaries. The Lower South Run WMA contains approximately 26 dry detention facilities designed to manage stormwater quantity. In addition, the WMA contains one underground chamber. It should be

noted that as part of the Laurel Hill redevelopment project, a number of additional stormwater management facilities appear planned for construction. Given the current Fairfax County requirements for stormwater management, these facilities are likely to be designed to manage both the volume (quantity) of stormwater runoff as well as the quality of that runoff.

Pohick Creek
Lower South Run
Stormwater Infrastructure

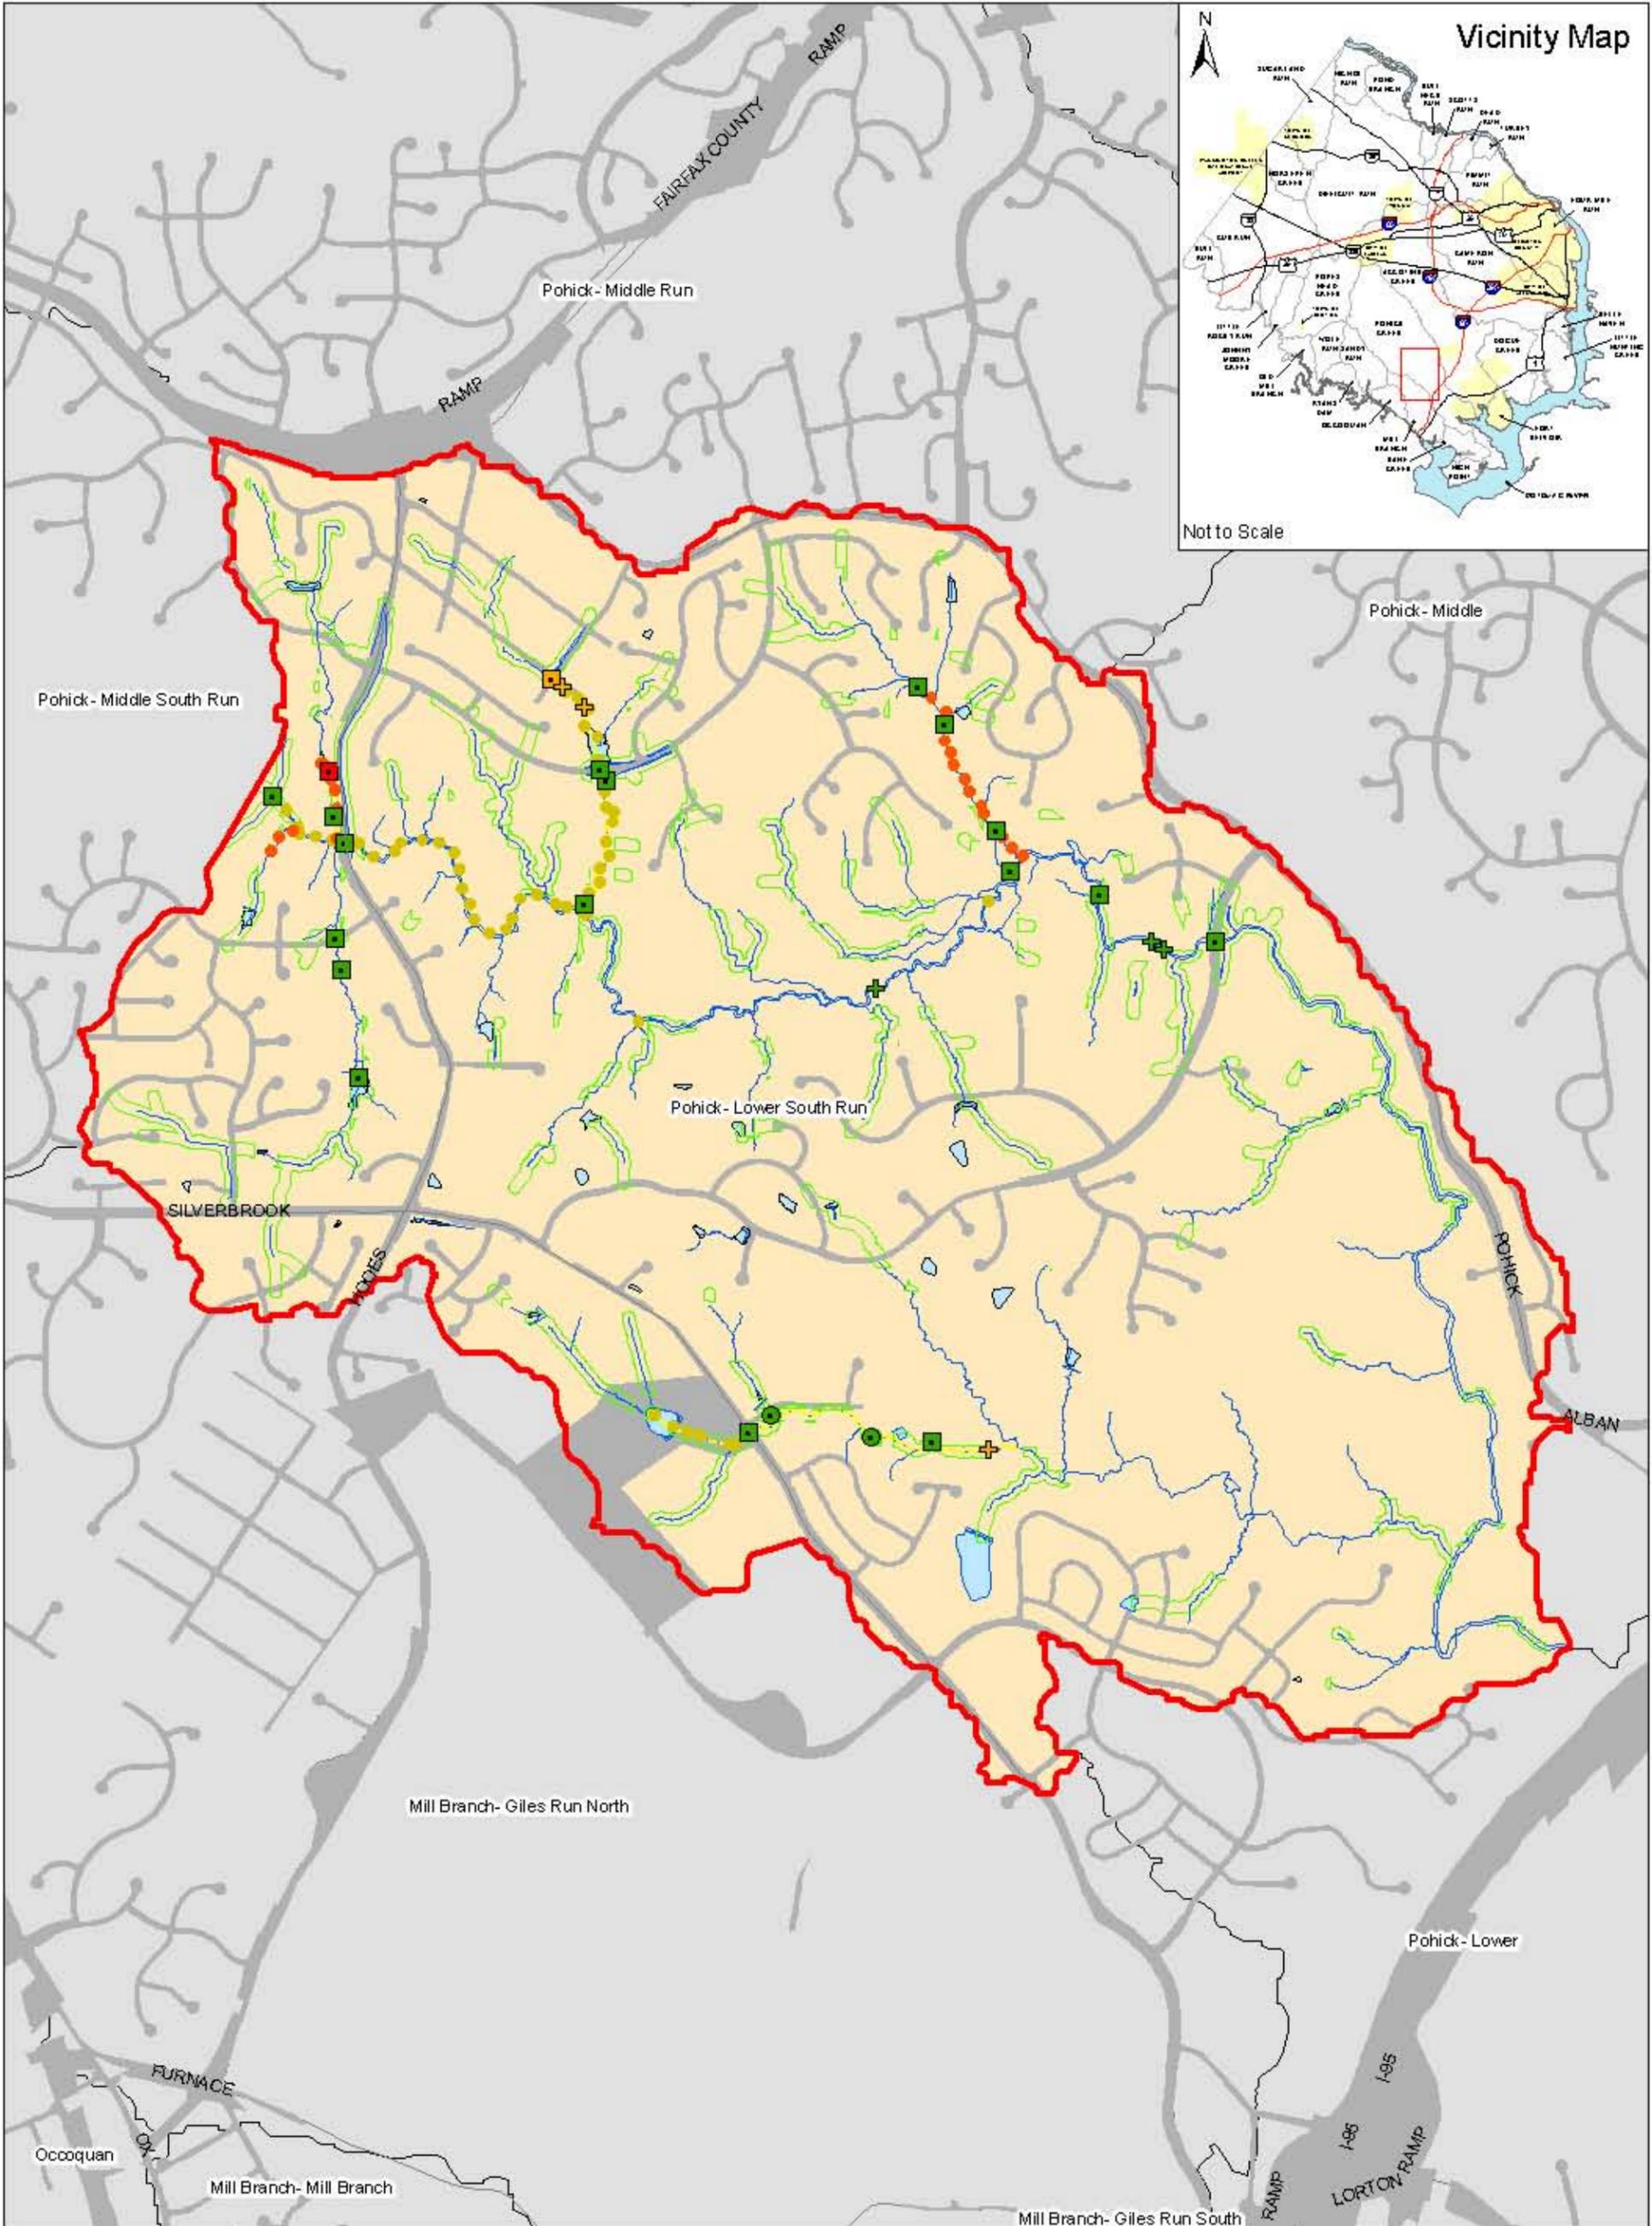
Map 2.2.5-3
Pohick Creek
Lower South Run
Stream Conditions

The Stream Conditions **Map 2.2.5-3** denotes the generally observed stream conditions as documented in the 2005 SPA and through additional, windshield level field reconnaissance performed for this study. The Stream Conditions Map demonstrates the general conditions of the main stem streams and tributaries in the WMA along with a series of features that typically impact stream condition, including stream channel erosion, channel widening, stream buffer condition, discharge pipe and ditch impacts, and utility and road crossing impacts.

In the Lower South Run WMA, the most prevalent stream condition features noted include disturbed stream buffers and stream channel erosion and/or widening. It should be noted, however, that with the Lower South Run WMA's wider stream valleys, the main stem of South Run and some of its tributaries have avoided the extremem widening and erosion/incision conditions plaguing other portions of the watershed. Channel wideing and incision conditions are noted in the head waters of the South Run main stem and Rocky Branch, a tributary, but the downstream main stem of South Run appears more stable. Pipe discharge into the WMA's streams have a demonstrated impact as well, as these pipes discharge stormwater runoff directly into the streams in many instances, contributing to the upstream widening and erosive conditions. Road crossing impacts in the Lower South Run WMA are generally minor, with the exception of a severe instance on Hooes Road to the west. Finally, a handful of obstructions are noted as moderate to severe, including areas to the north of Newington Forest Avenue and the area to the south in the Rocky Branch tributary.

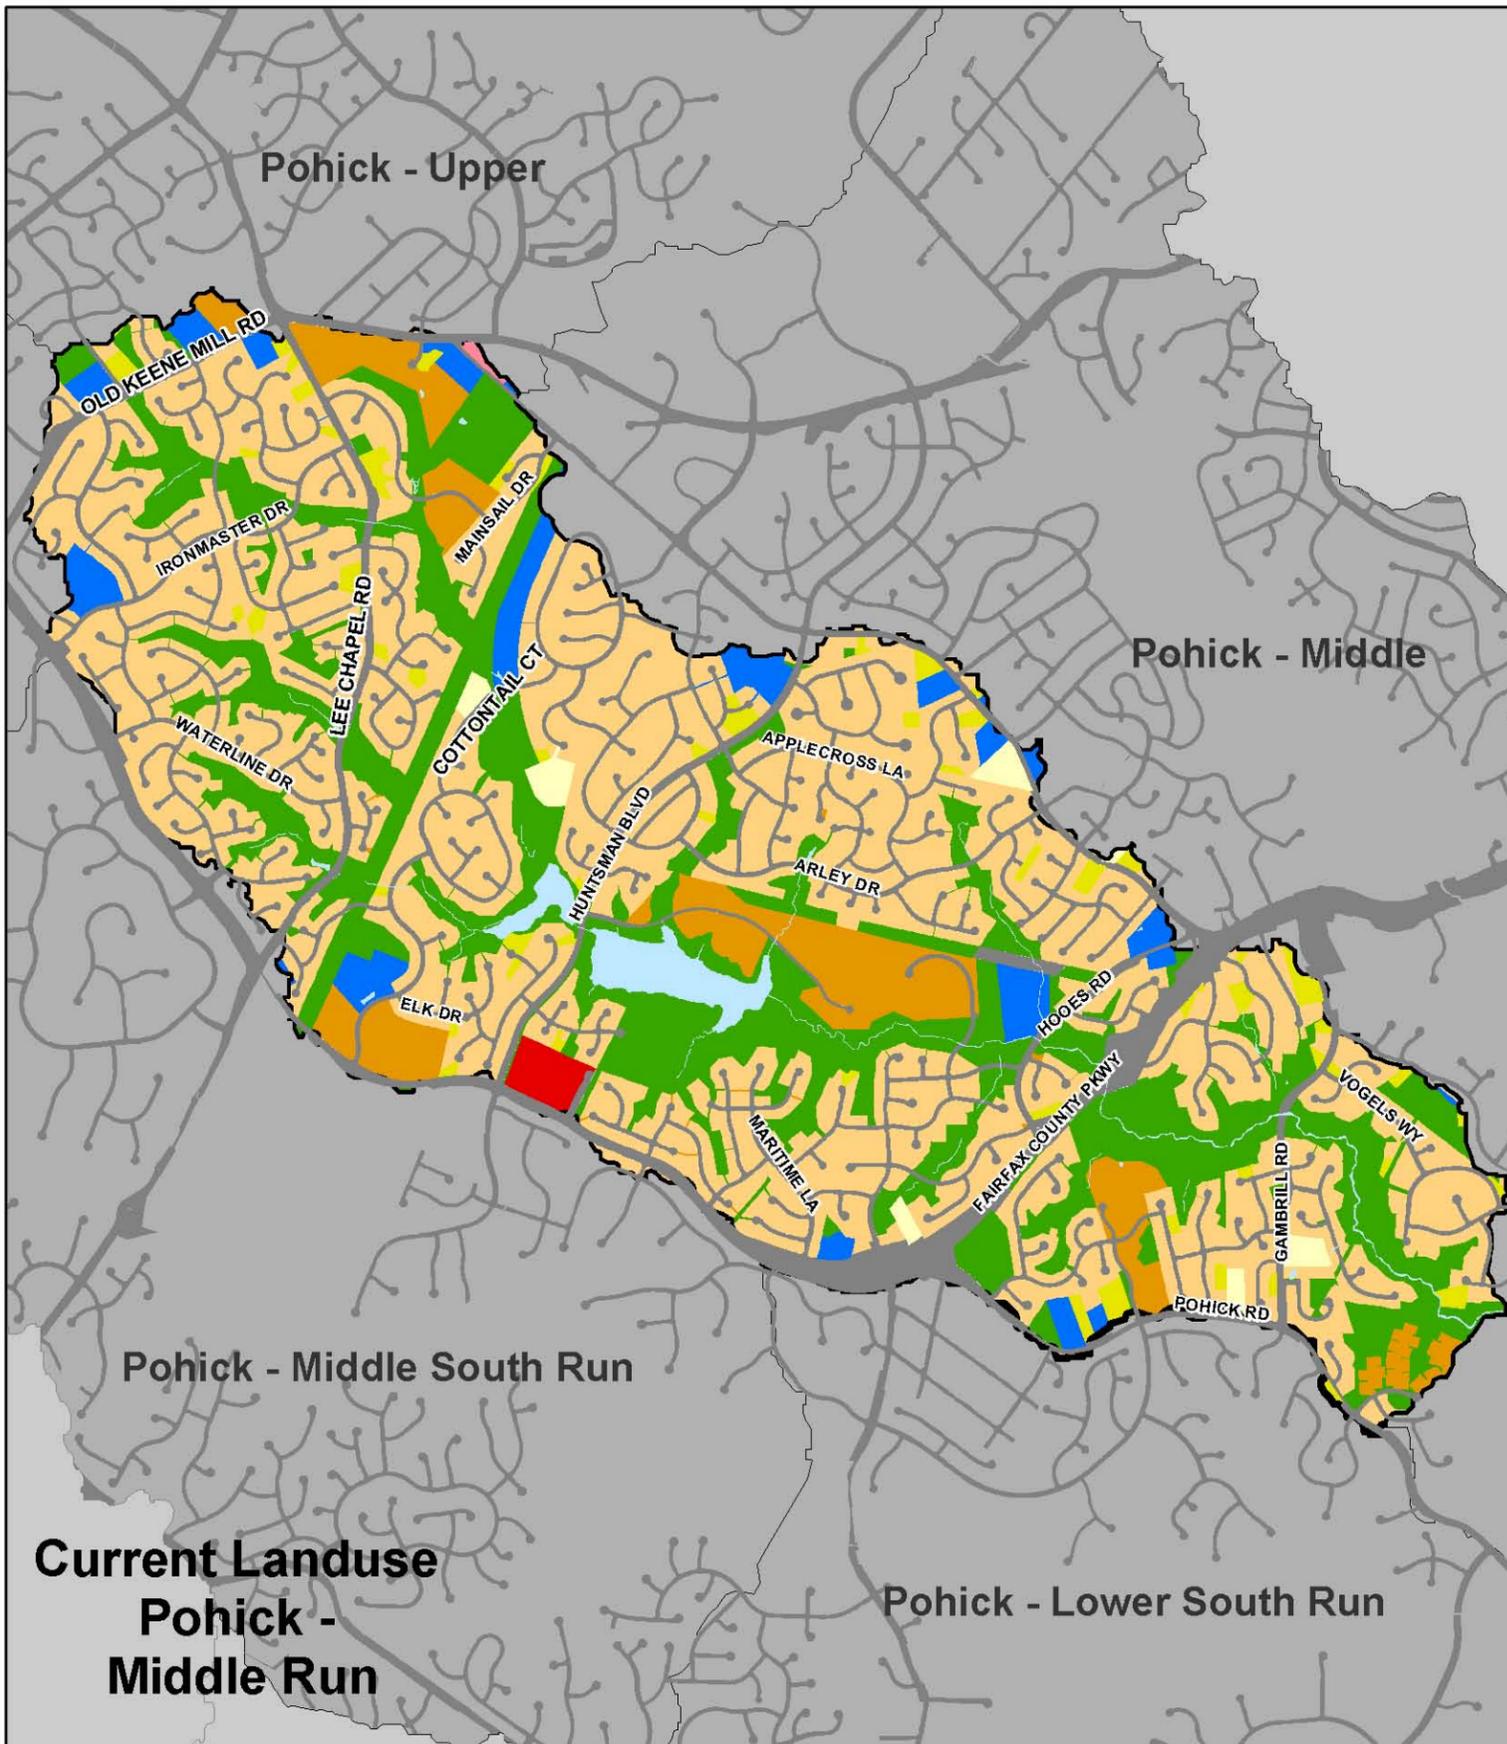
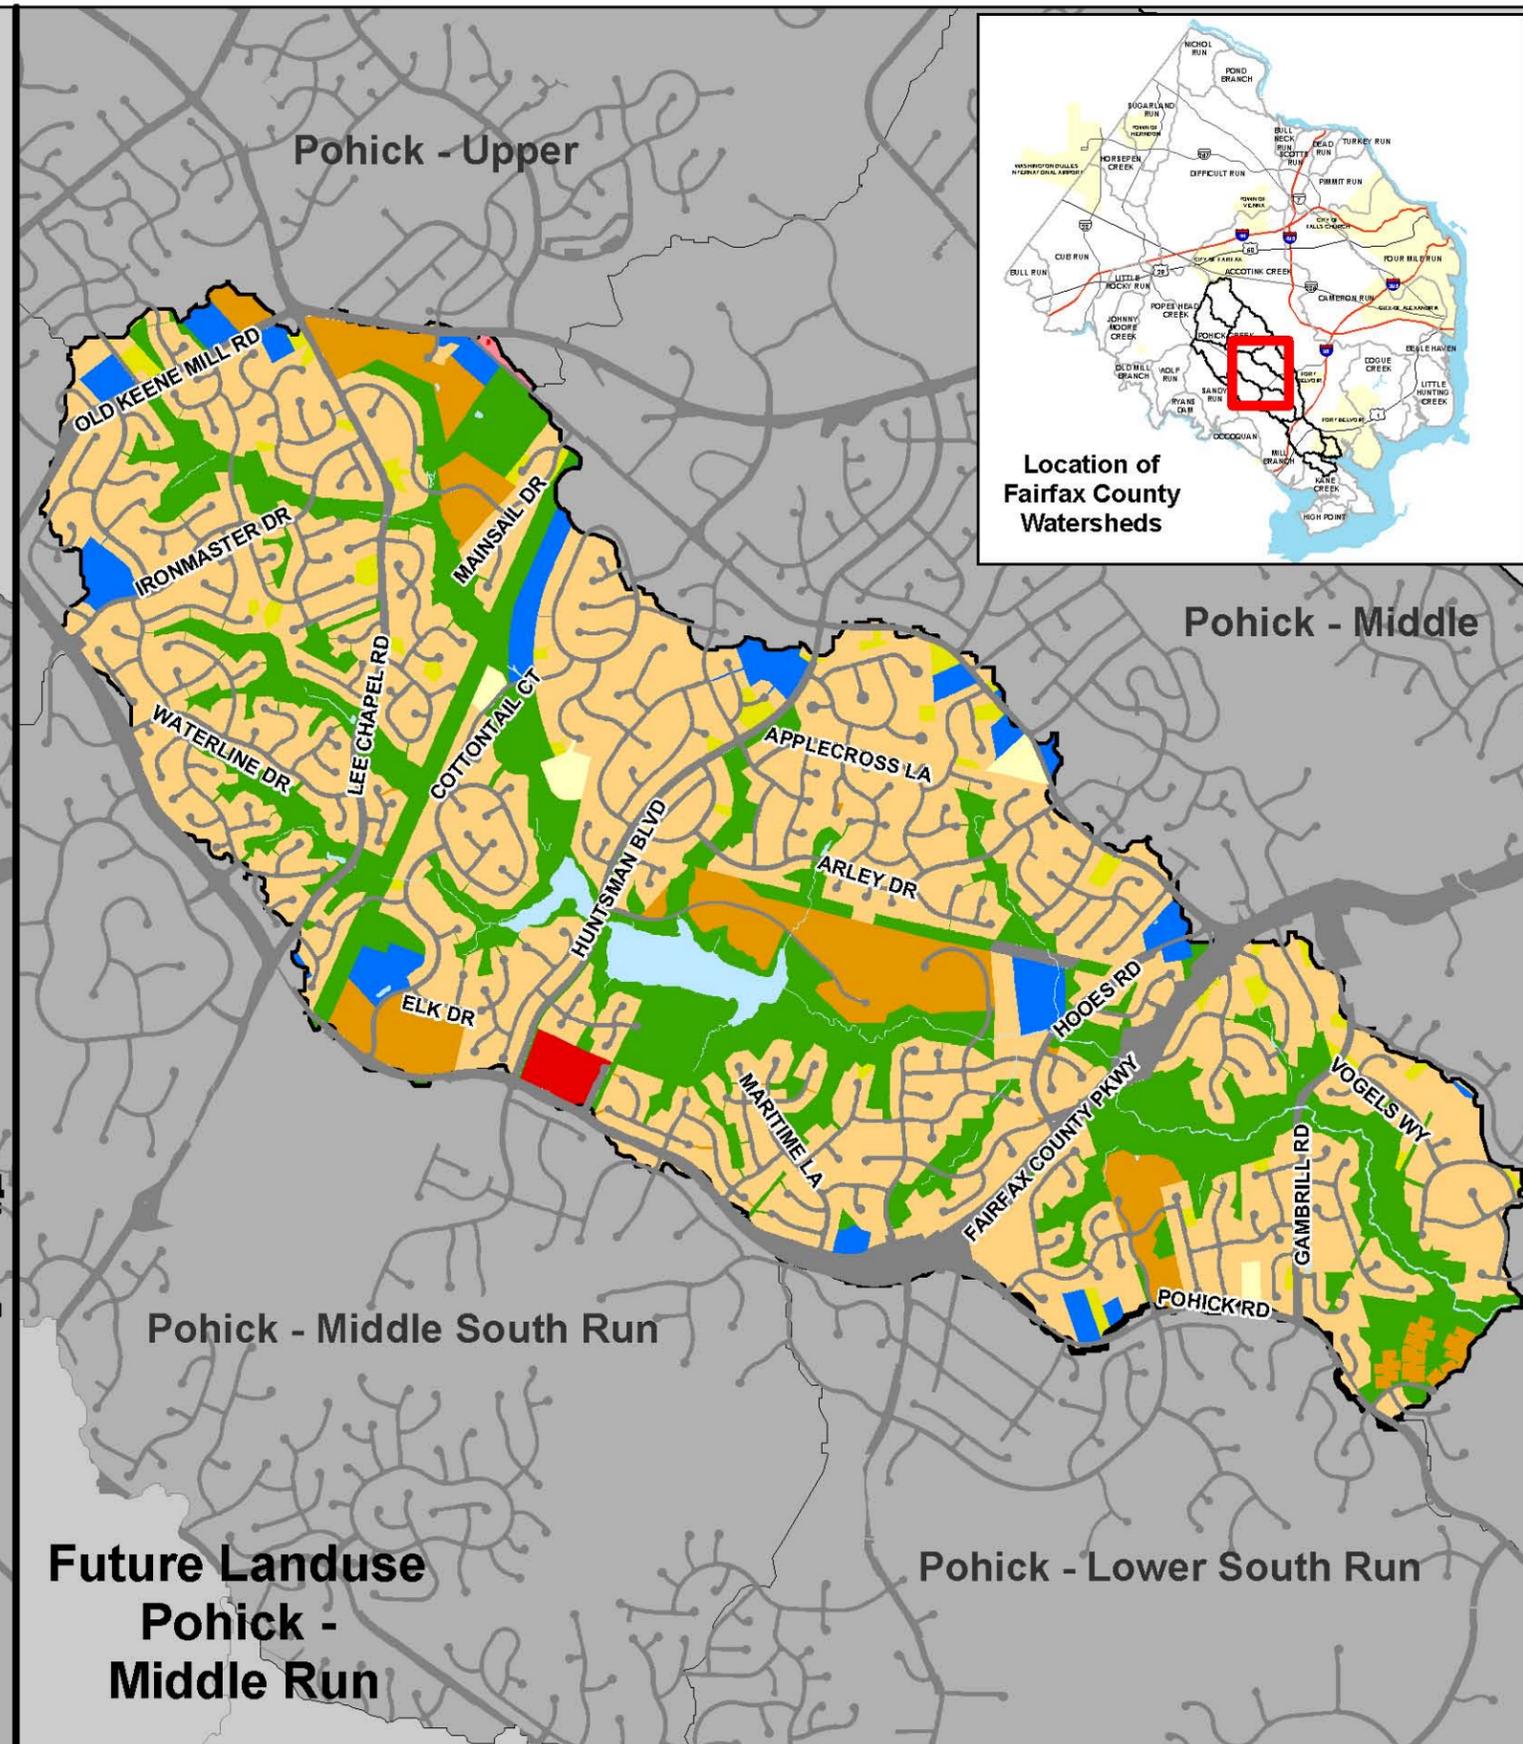
**Map 2.2.6-1
Pohick Creek- Middle Run
Existing and Future Land Use**

The majority of the observed multi-family dwellings were constructed on estimated ¼ or smaller lots, featuring dead end alleys and cul-de-sac street alignments, while the single family detached properties were constructed on estimated ¼ acre lots with similar street alignments. The age of development in this WMA ranges from an estimated 25 to 20 years old (1980's) up to approximately 15 to 10 years old (1990's) with little evidence of recent infill development. Land cover consists primarily of impervious surface associated with residential development (i.e. rooftops, streets and driveways, sidewalks, etc.), including more compact development associated with multi-family housing units, and associated landscaping, including managed turf. Curb and gutter on streets was observed as almost universally present in the Middle Run WMA.

**Current Landuse
Pohick -
Middle Run**

**Future Landuse
Pohick -
Middle Run**

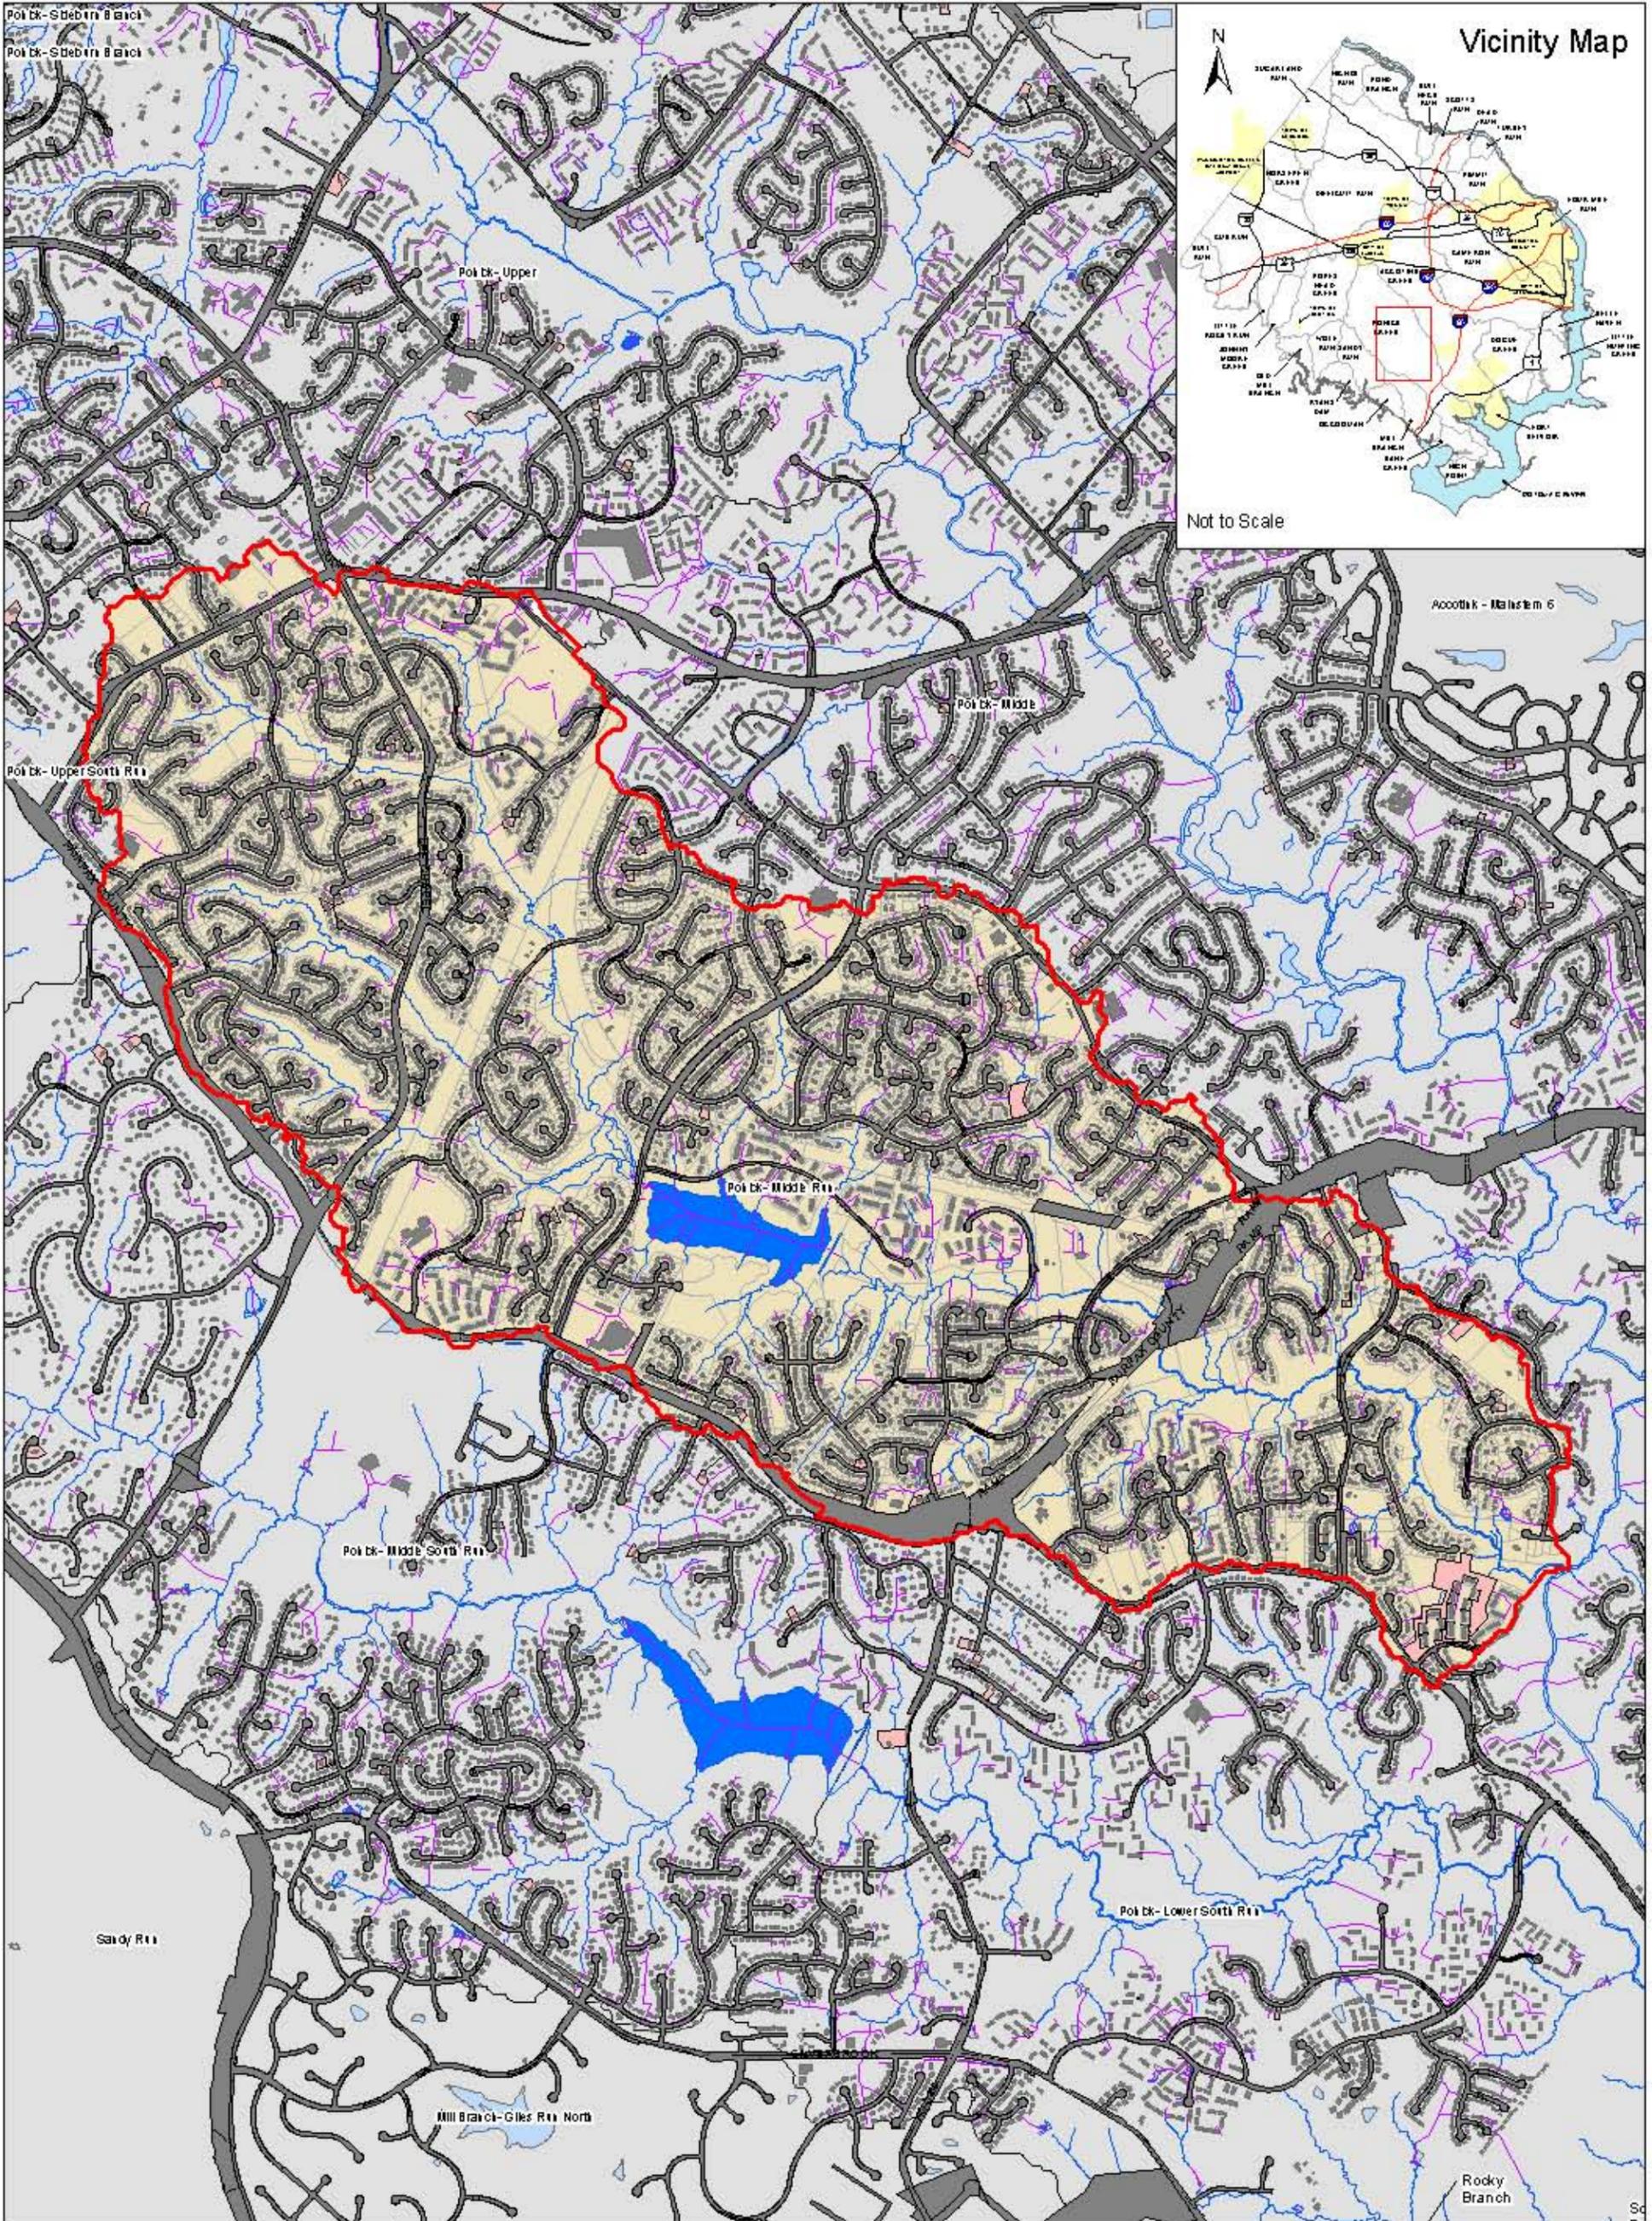
Map 2.2.6-2 demonstrates the observed stormwater infrastructure conditions in the Middle Run WMA. Stormwater infrastructure consists primarily of curb and gutter stormwater collection leading to a piped network of storm drains discharging to either dry detention basins or directly into Middle Run and its associated stream valleys and tributaries. The Middle Run WMA contains approximately 37 dry detention facilities designed to manage stormwater quantity. In addition, the WMA contains two underground chambers and one infiltration trench for water quality management.

Pohick Creek
Middle Run
Stormwater Infrastructure

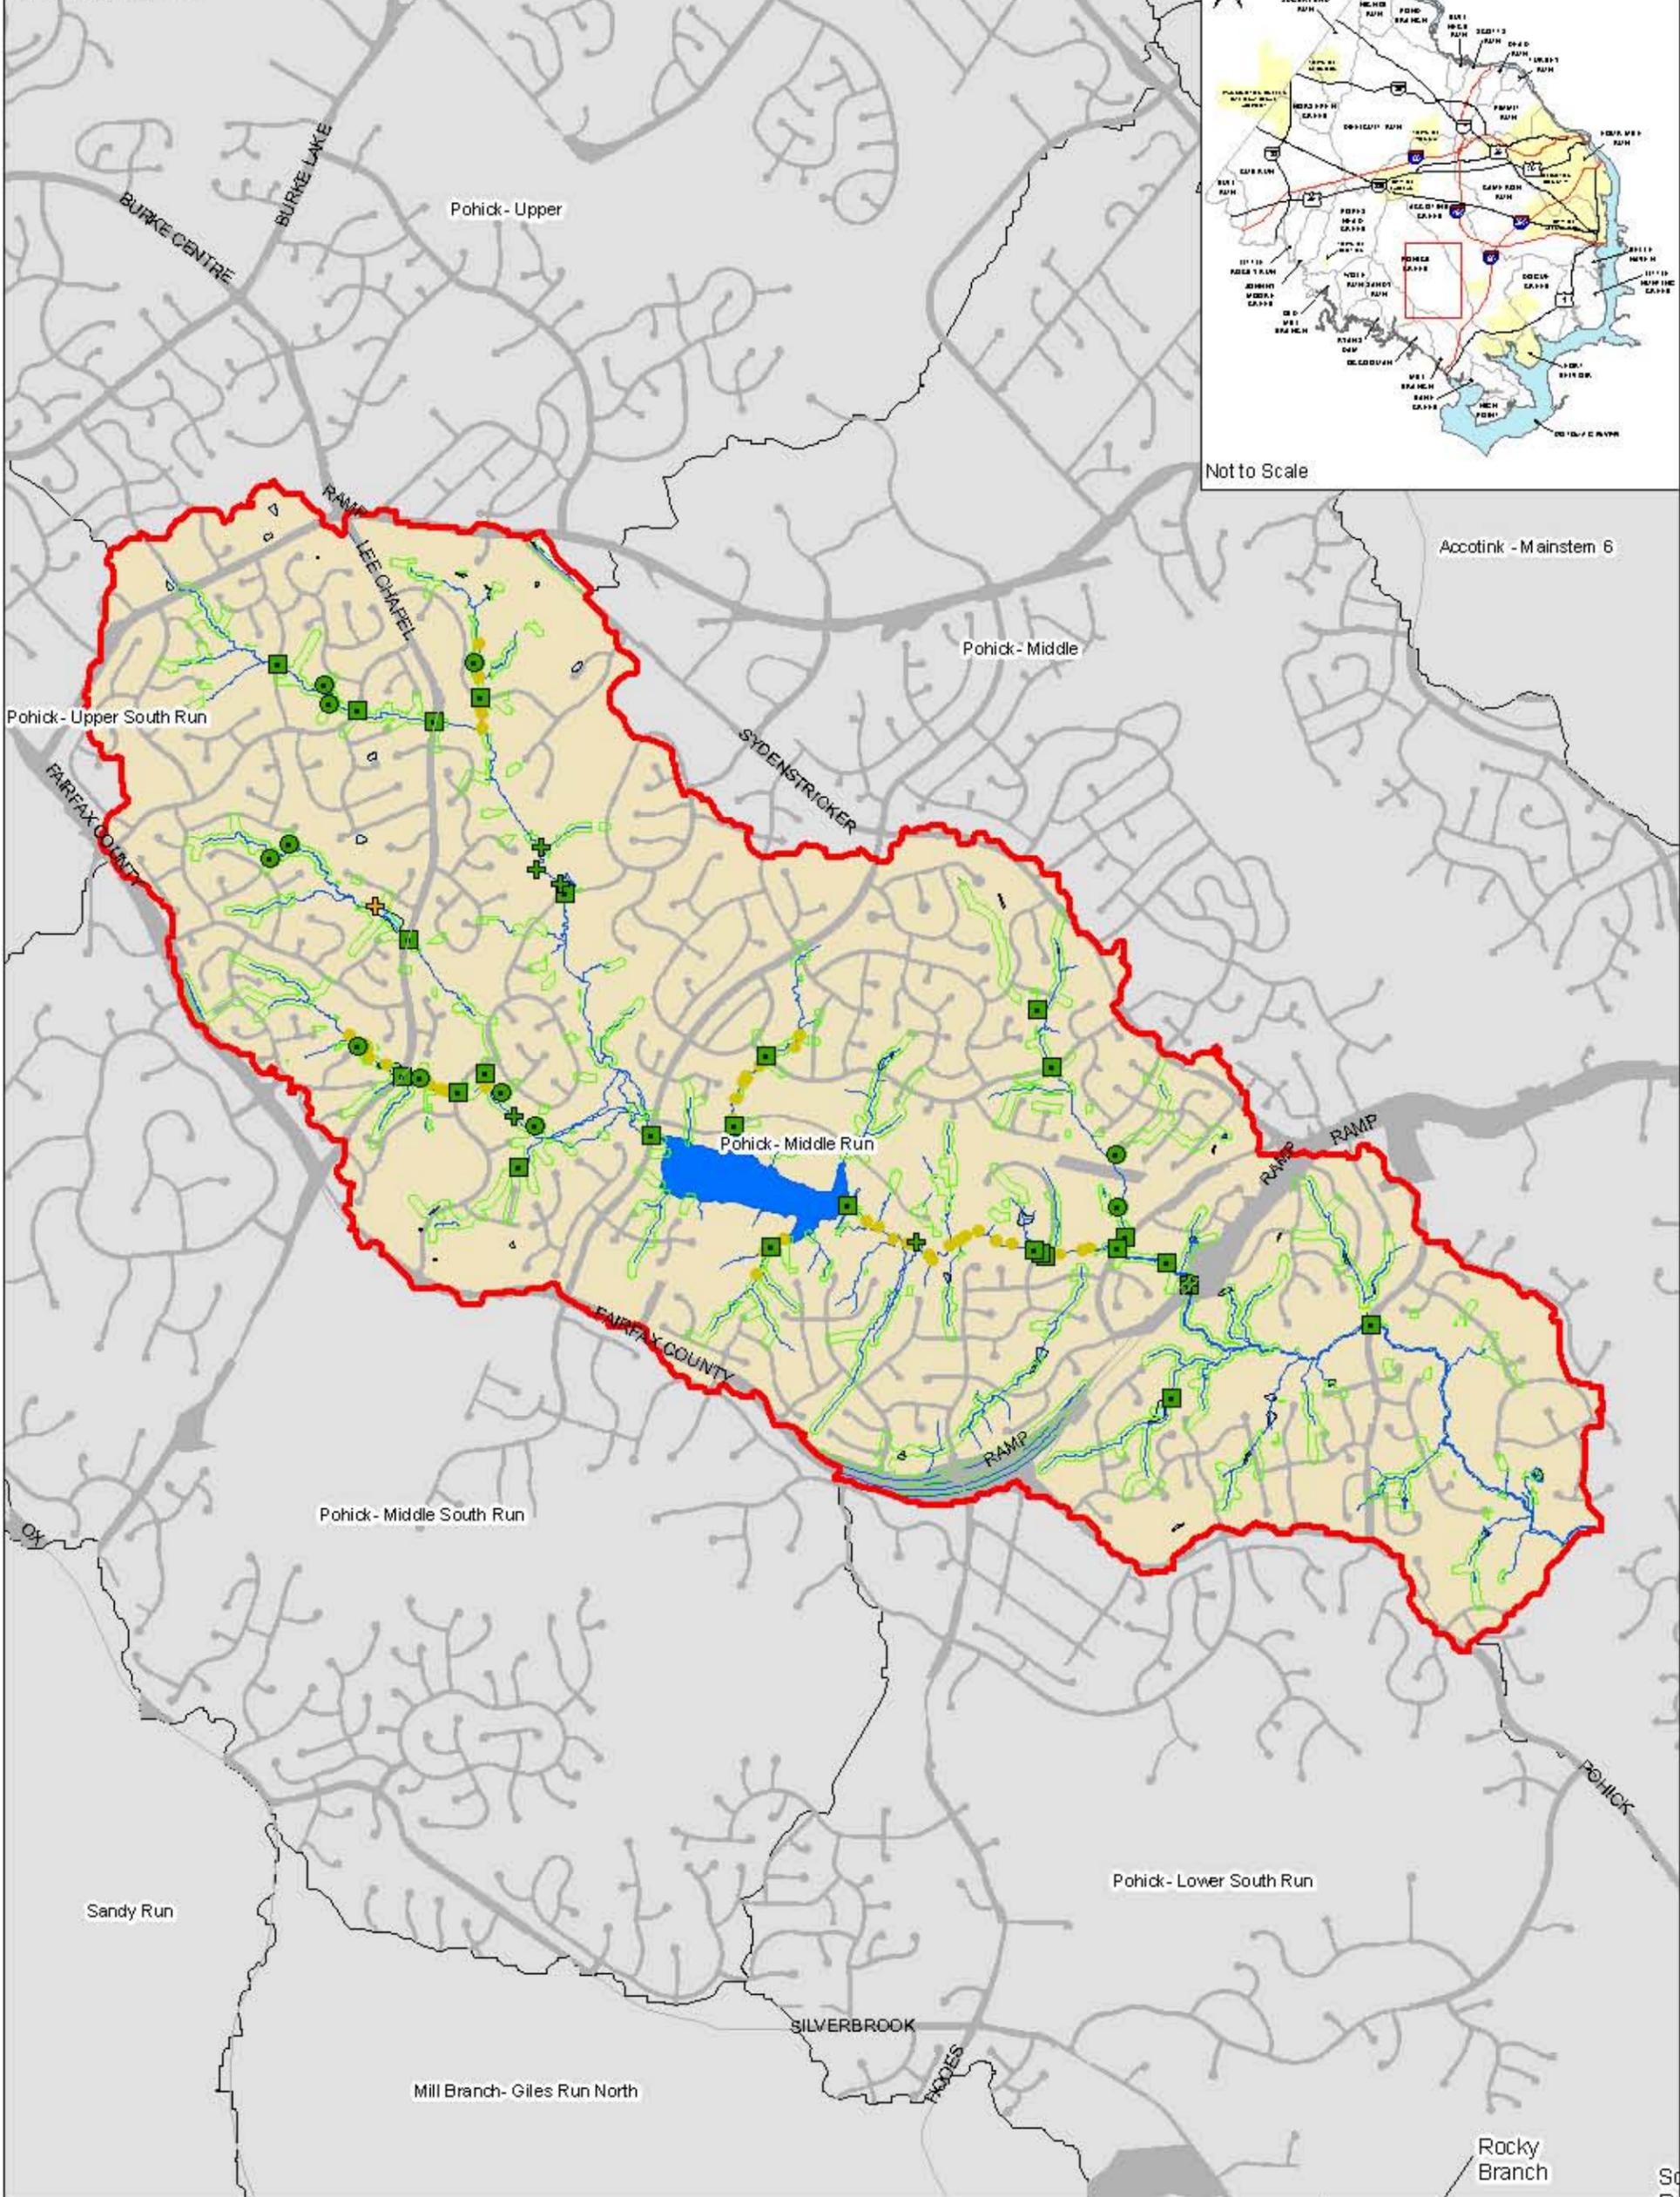
Map 2.2.6-3

The Stream Conditions **Map 2.2.6-3** denotes the generally observed stream conditions as documented in the 2005 SPA and through additional, windshield level field reconnaissance performed for this study. The Stream Conditions Map demonstrates the general conditions of the main stem streams and tributaries in the WMA along with a series of features that typically impact stream condition, including stream channel erosion, channel widening, stream buffer condition, discharge pipe and ditch impacts, and utility and road crossing impacts.

In the Middle Run WMA, the most prevalent stream condition features noted include disturbed stream buffers and stream channel widening. In addition, pipe discharge into the WMA's streams have a demonstrated impact as well, as these pipes discharge stormwater runoff directly into the streams in many instances, contributing to the observed widening conditions. Utility, road crossing, and obstructions noted in the Middle Run WMA generally had only a minor impact. No demonstrated stream head cutting, or an abrupt vertical drop in the bed of a stream channel that demonstrates active erosion (NC DWQ, 2005), were observed in this WMA

Pohick Creek Middle Run Stream Conditions
