2.2.4 Middle South Run

Field Reconnaissance

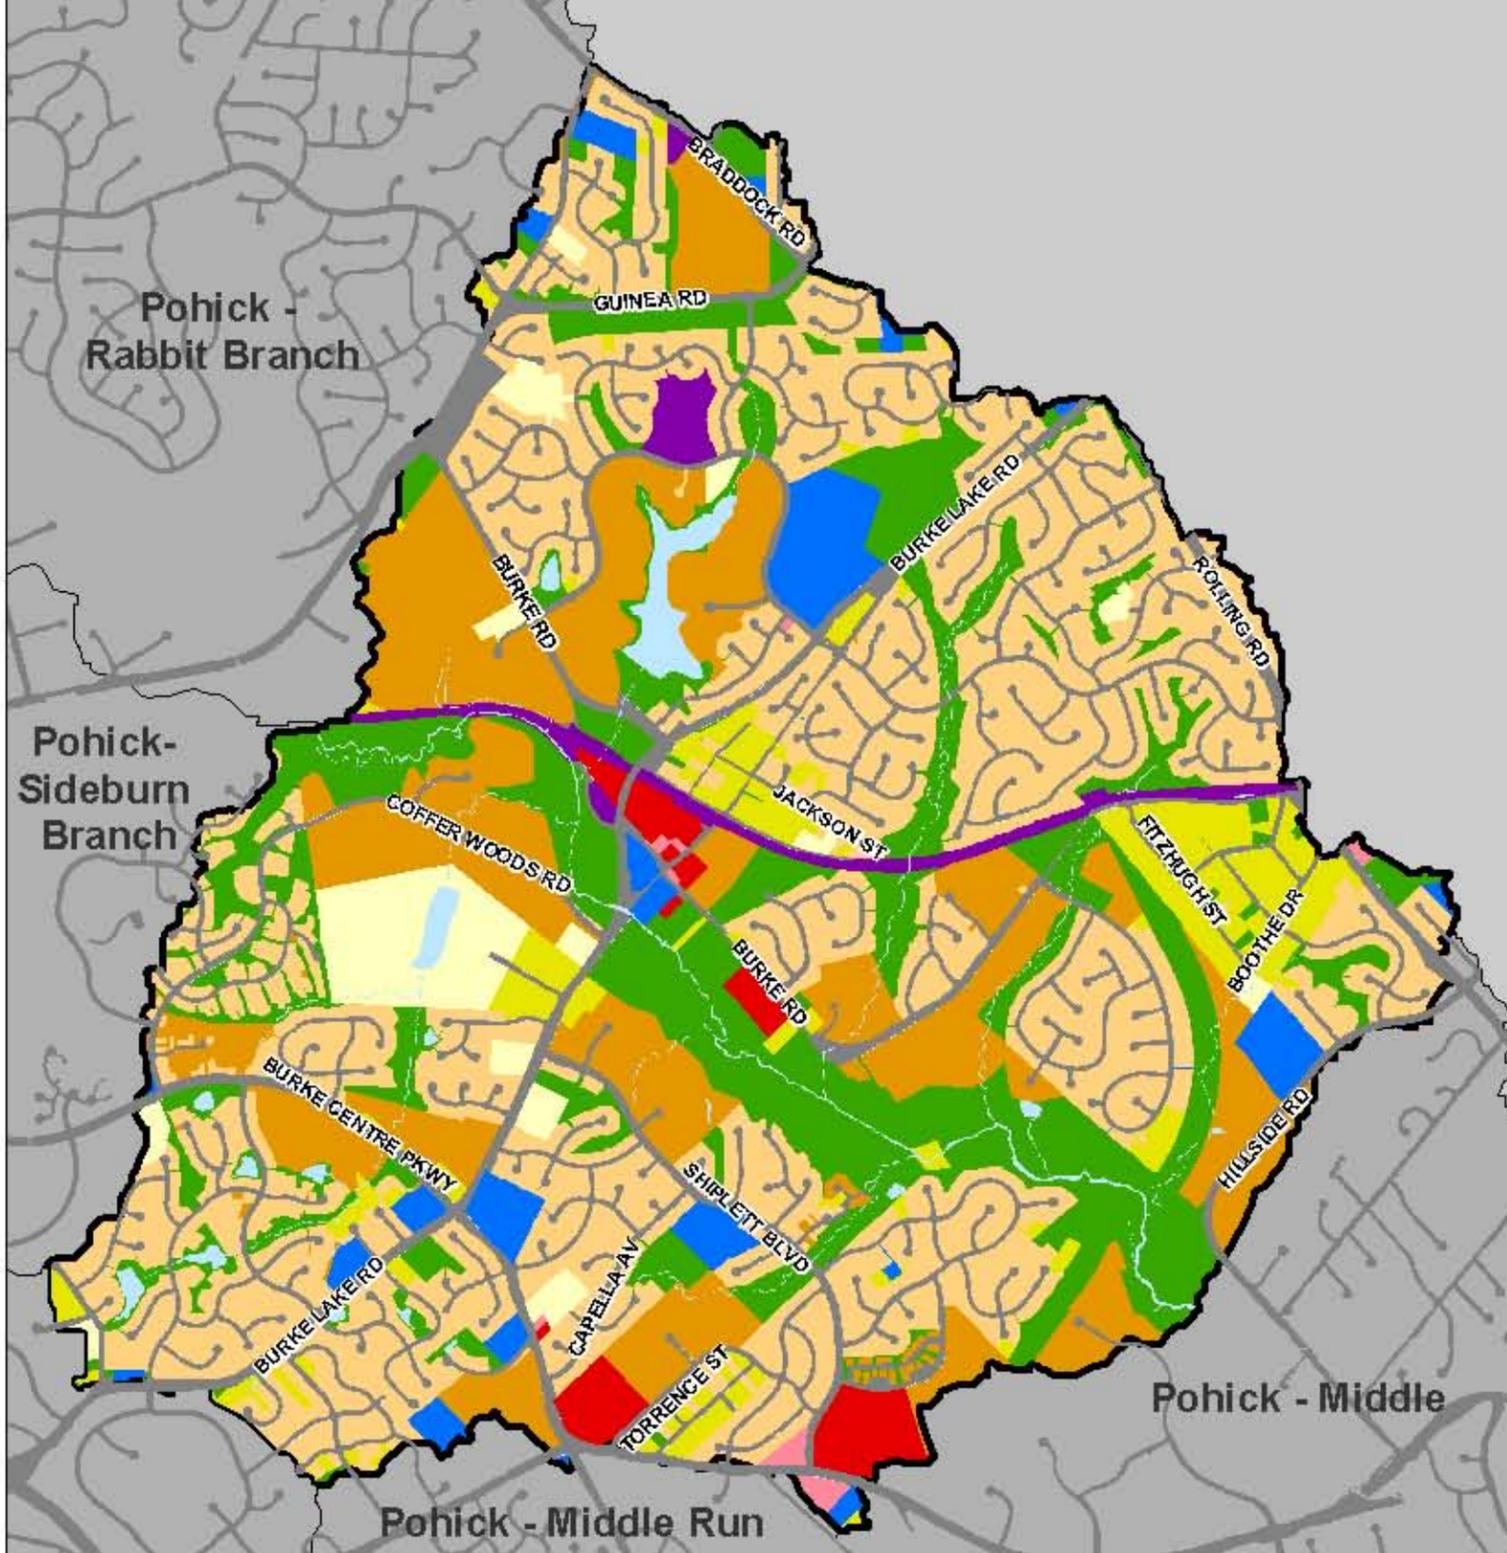
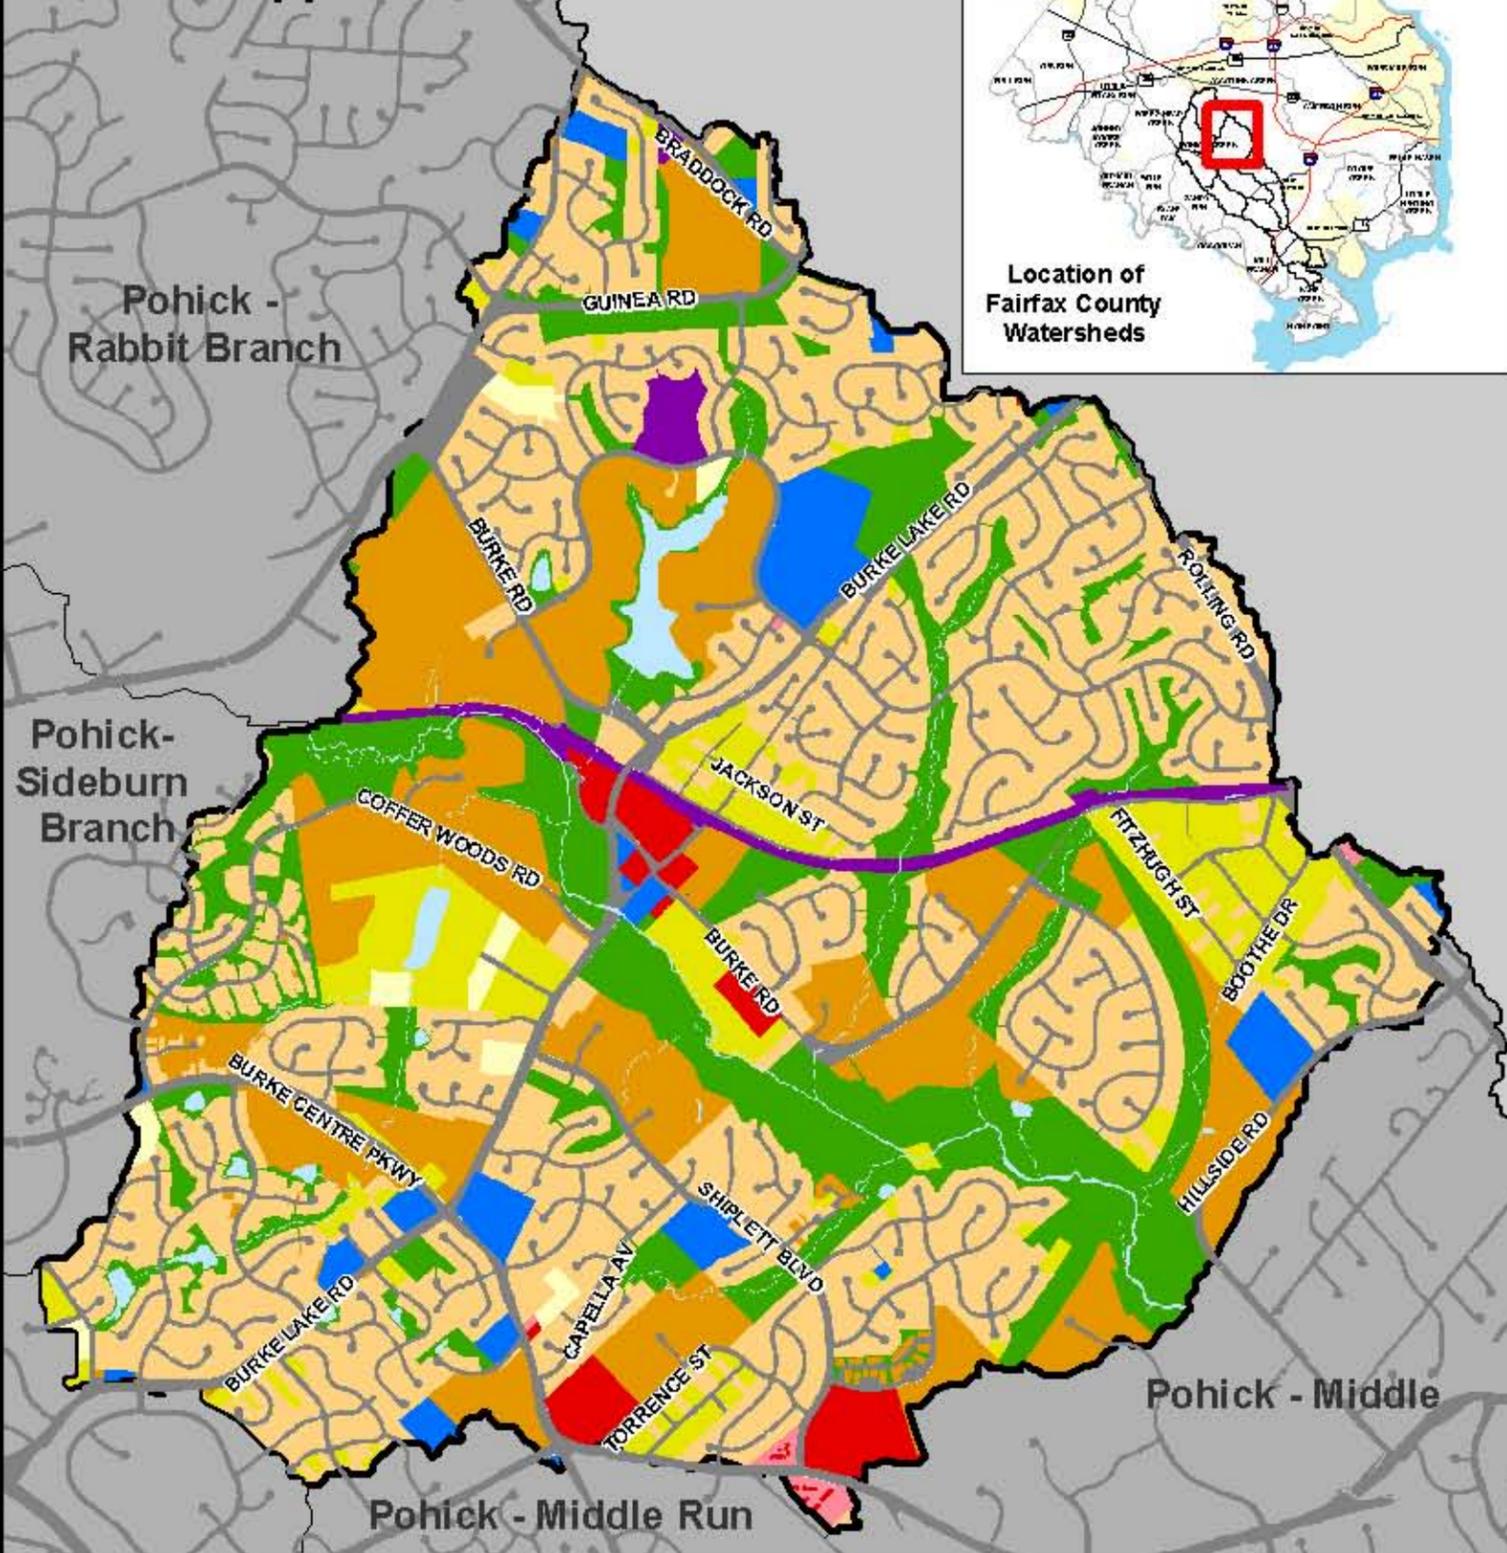
**Map 2.2.7-1
Pohick Creek- Upper
Existing and Future Land Use**

The majority of the observed single family detached dwellings were constructed on lots estimated at ¼ acre or less with single family attached structures and multi-family developments more densely developed (well under ¼ acre per unit). As is the case in the majority of the Pohick Creek watershed, these developments are characterized by street patterns ending in cul-de-sacs with few through streets in the WMA. The age of development in this WMA ranges from an estimated 35 to 30 years old (1970's) up to approximately 5 to 10 years old (2000's) with some evidence of recent infill development in places. Land cover consists primarily of impervious surface associated with residential development (i.e. rooftops, streets and driveways, sidewalks, etc.) and associated landscaping, including managed turf. Curb and gutter are present almost universally in the Upper WMA.

Current Landuse Pohick - Upper

Future Landuse Pohick - Upper

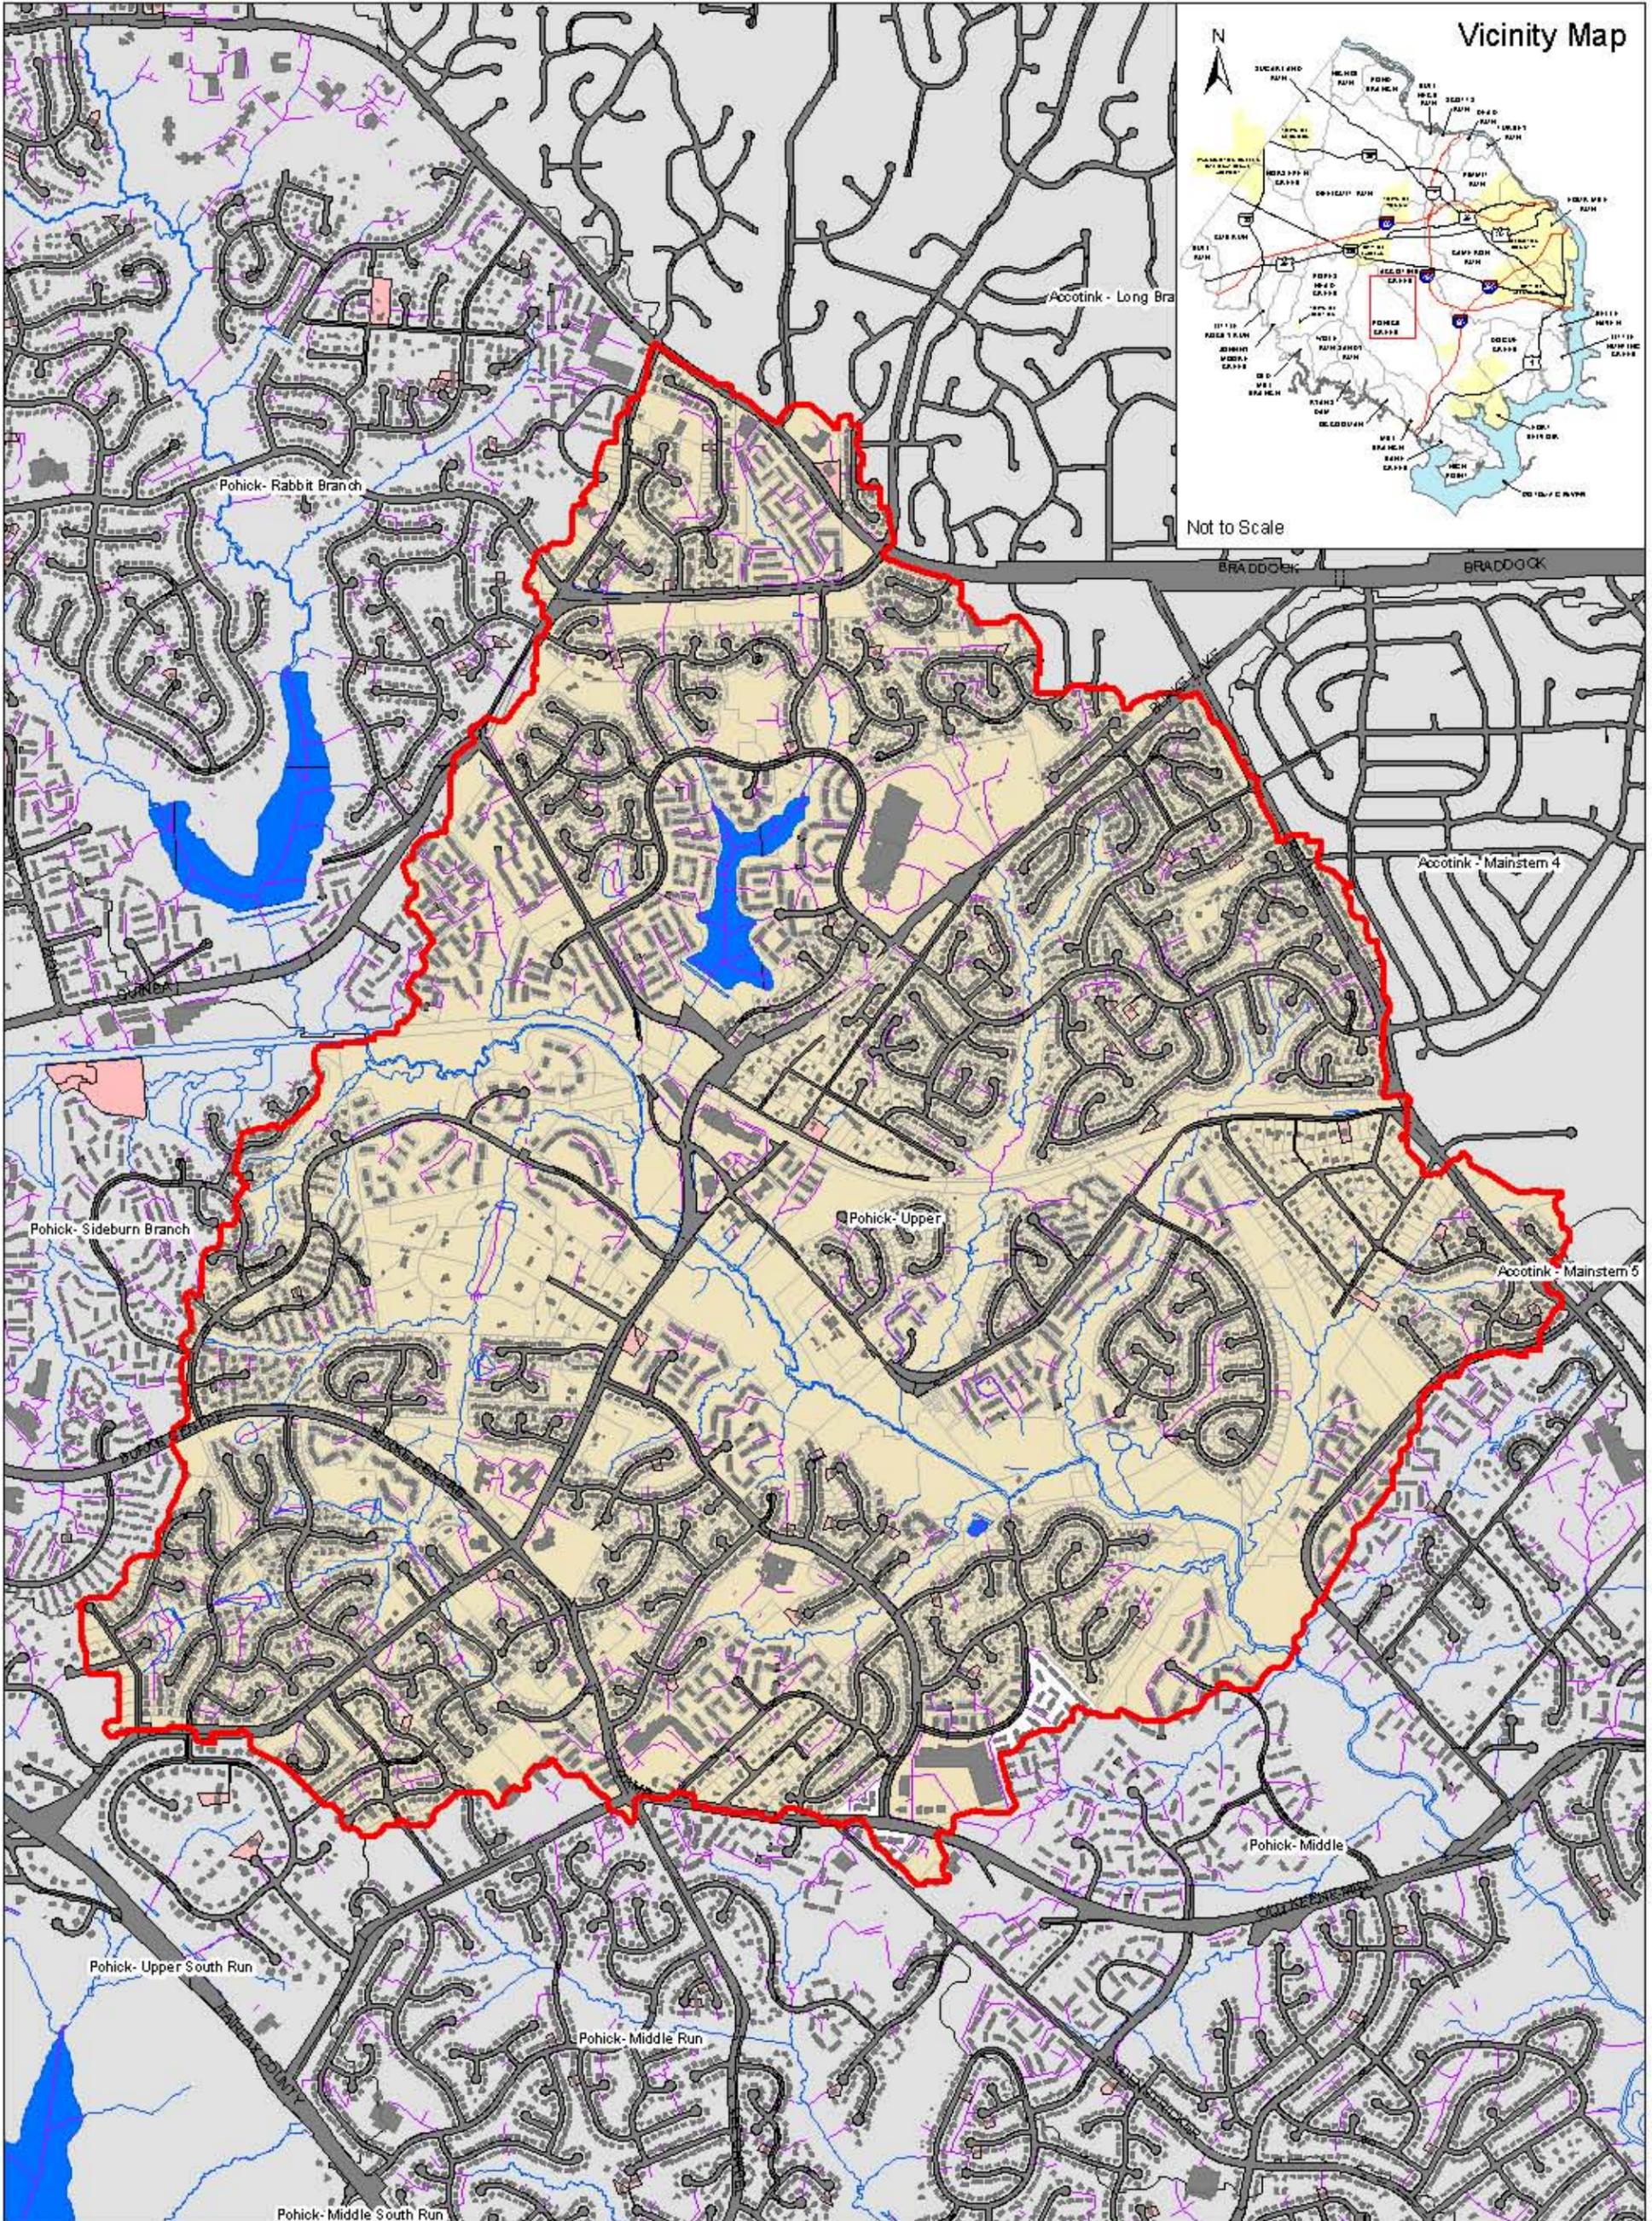
Map 2.2.7-2
 Pohick Creek
 Pohick Creek Upper
 Stormwater Infrastructure

Map 2.2.7-2 demonstrates the observed stormwater infrastructure conditions in the Upper WMA. Stormwater infrastructure consists primarily of curb and gutter stormwater collection leading to a piped network of storm drains discharging to either dry detention basins or directly into the upper reaches of Pohick Creek and its associated stream valleys and tributaries. Some of the stormwater conveyance system in the Upper WMA consists of ditches as well. The Upper WMA contains a wide variety of stormwater management facilities and structures, including approximately 27 dry detention facilities designed to manage stormwater quantity. In addition, the WMA contains six underground chambers; four infiltration trench for water quality management; five rooftop detention facilities; seven wet retention basins; and one parking lot detention facility, which are typically designed to manage stormwater quantity only.

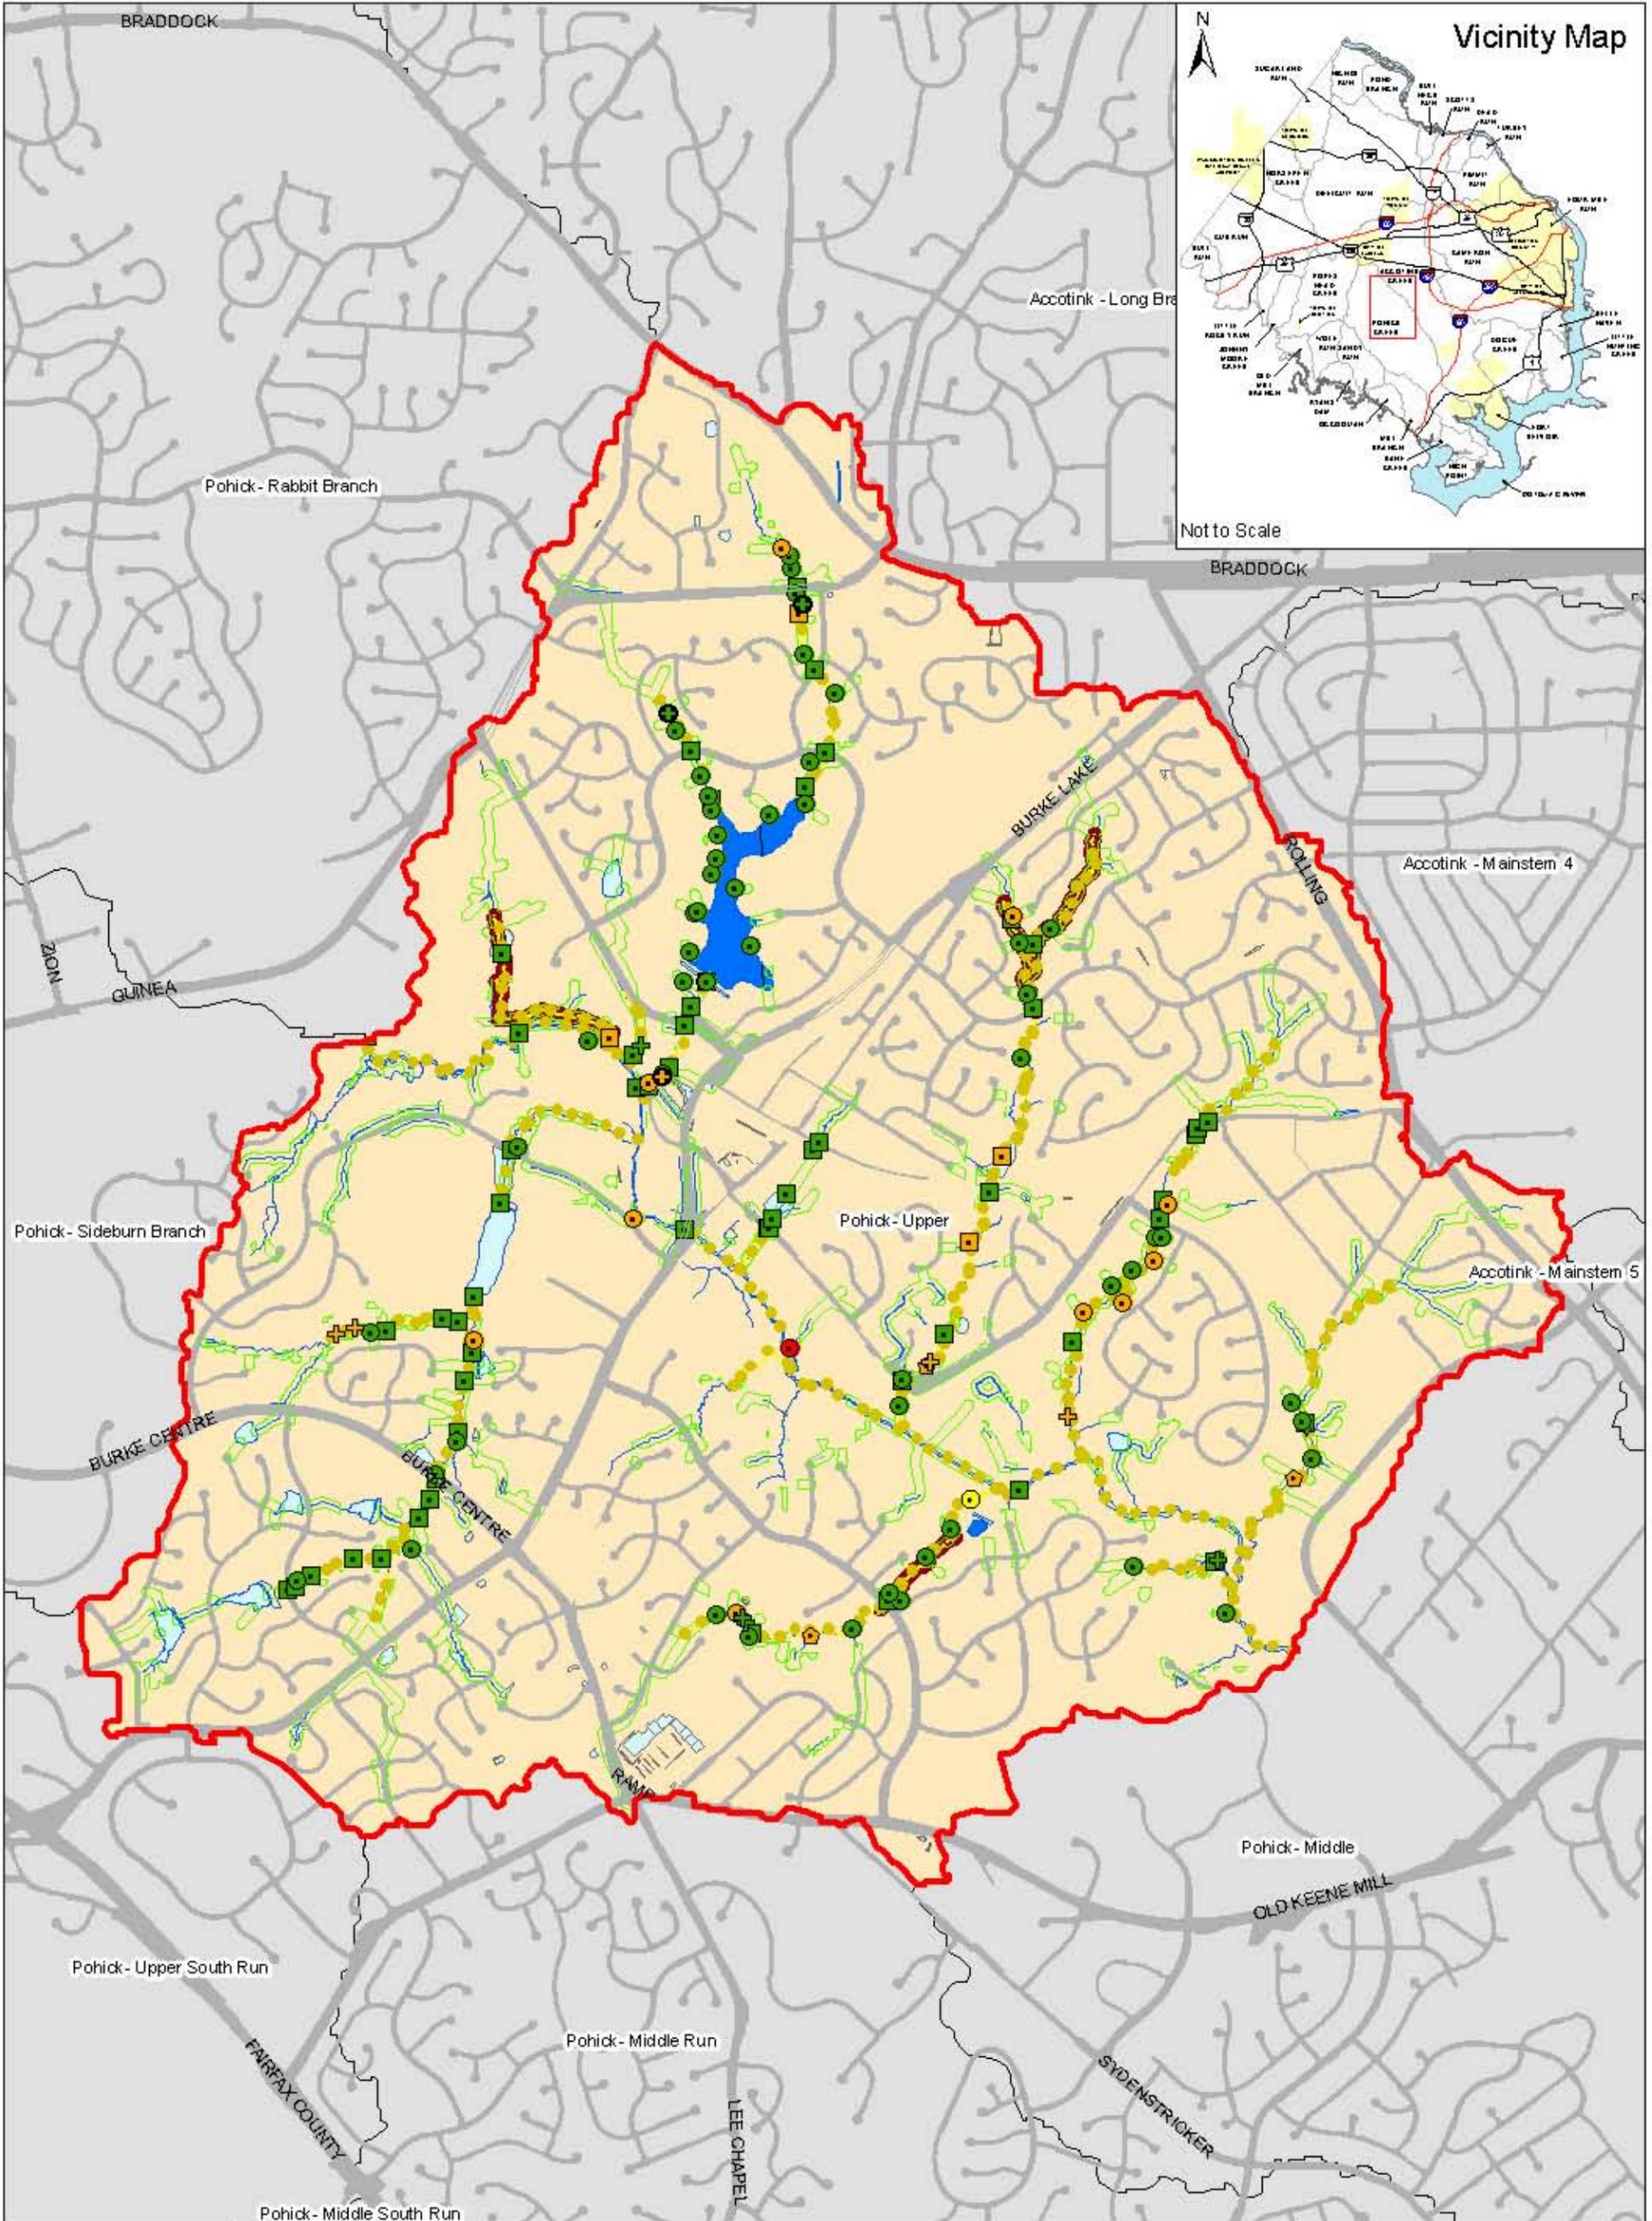
Map 2.2.7-3
 Pohick Creek
 Pohick Creek Upper
 Stream Conditions

The Stream Conditions **Map 2.2.7-3** denotes the generally observed stream conditions as documented in the 2005 SPA and through additional, windshield level field reconnaissance performed for this study. The Stream Conditions Map demonstrates the general conditions of the main stem streams and tributaries in the WMA along with a series of features that typically impact stream condition, including stream channel erosion, channel widening, stream buffer condition, discharge pipe and ditch impacts, and utility and road crossing impacts.

In the Upper WMA, the most prevalent stream condition features noted include disturbed stream buffers and stream channel widening and erosion/incision. In addition, pipe and ditch discharge into the WMA's streams have a demonstrated impact as well, including some severe impacts on the main stem of Pohick Creek, as these pipes and ditches discharge stormwater runoff directly into the streams in many instances, contributing to the observed widening and erosion conditions. Upstream of Lake Braddock, several road crossing impacts are noted, with some severe. Road crossings and obstructions noted in the remainder of the Upper WMA generally had only a minor impact, with some notable exceptions upstream of a wet retention basin north of Burke Centre Drive. Isolated stream head cutting, or an abrupt vertical drop in the bed of a stream channel that demonstrates active erosion (NC DWQ, 2005), was observed at the confluence of a tributary to Pohick Creek and Pohick Creek itself downstream of Burke Lake Road.
