2.2.8 Pohick Creek -Middle

DRAFT Watershed Workbook –**Pohick Creek Watershed**

Volume 2: Chapter 2

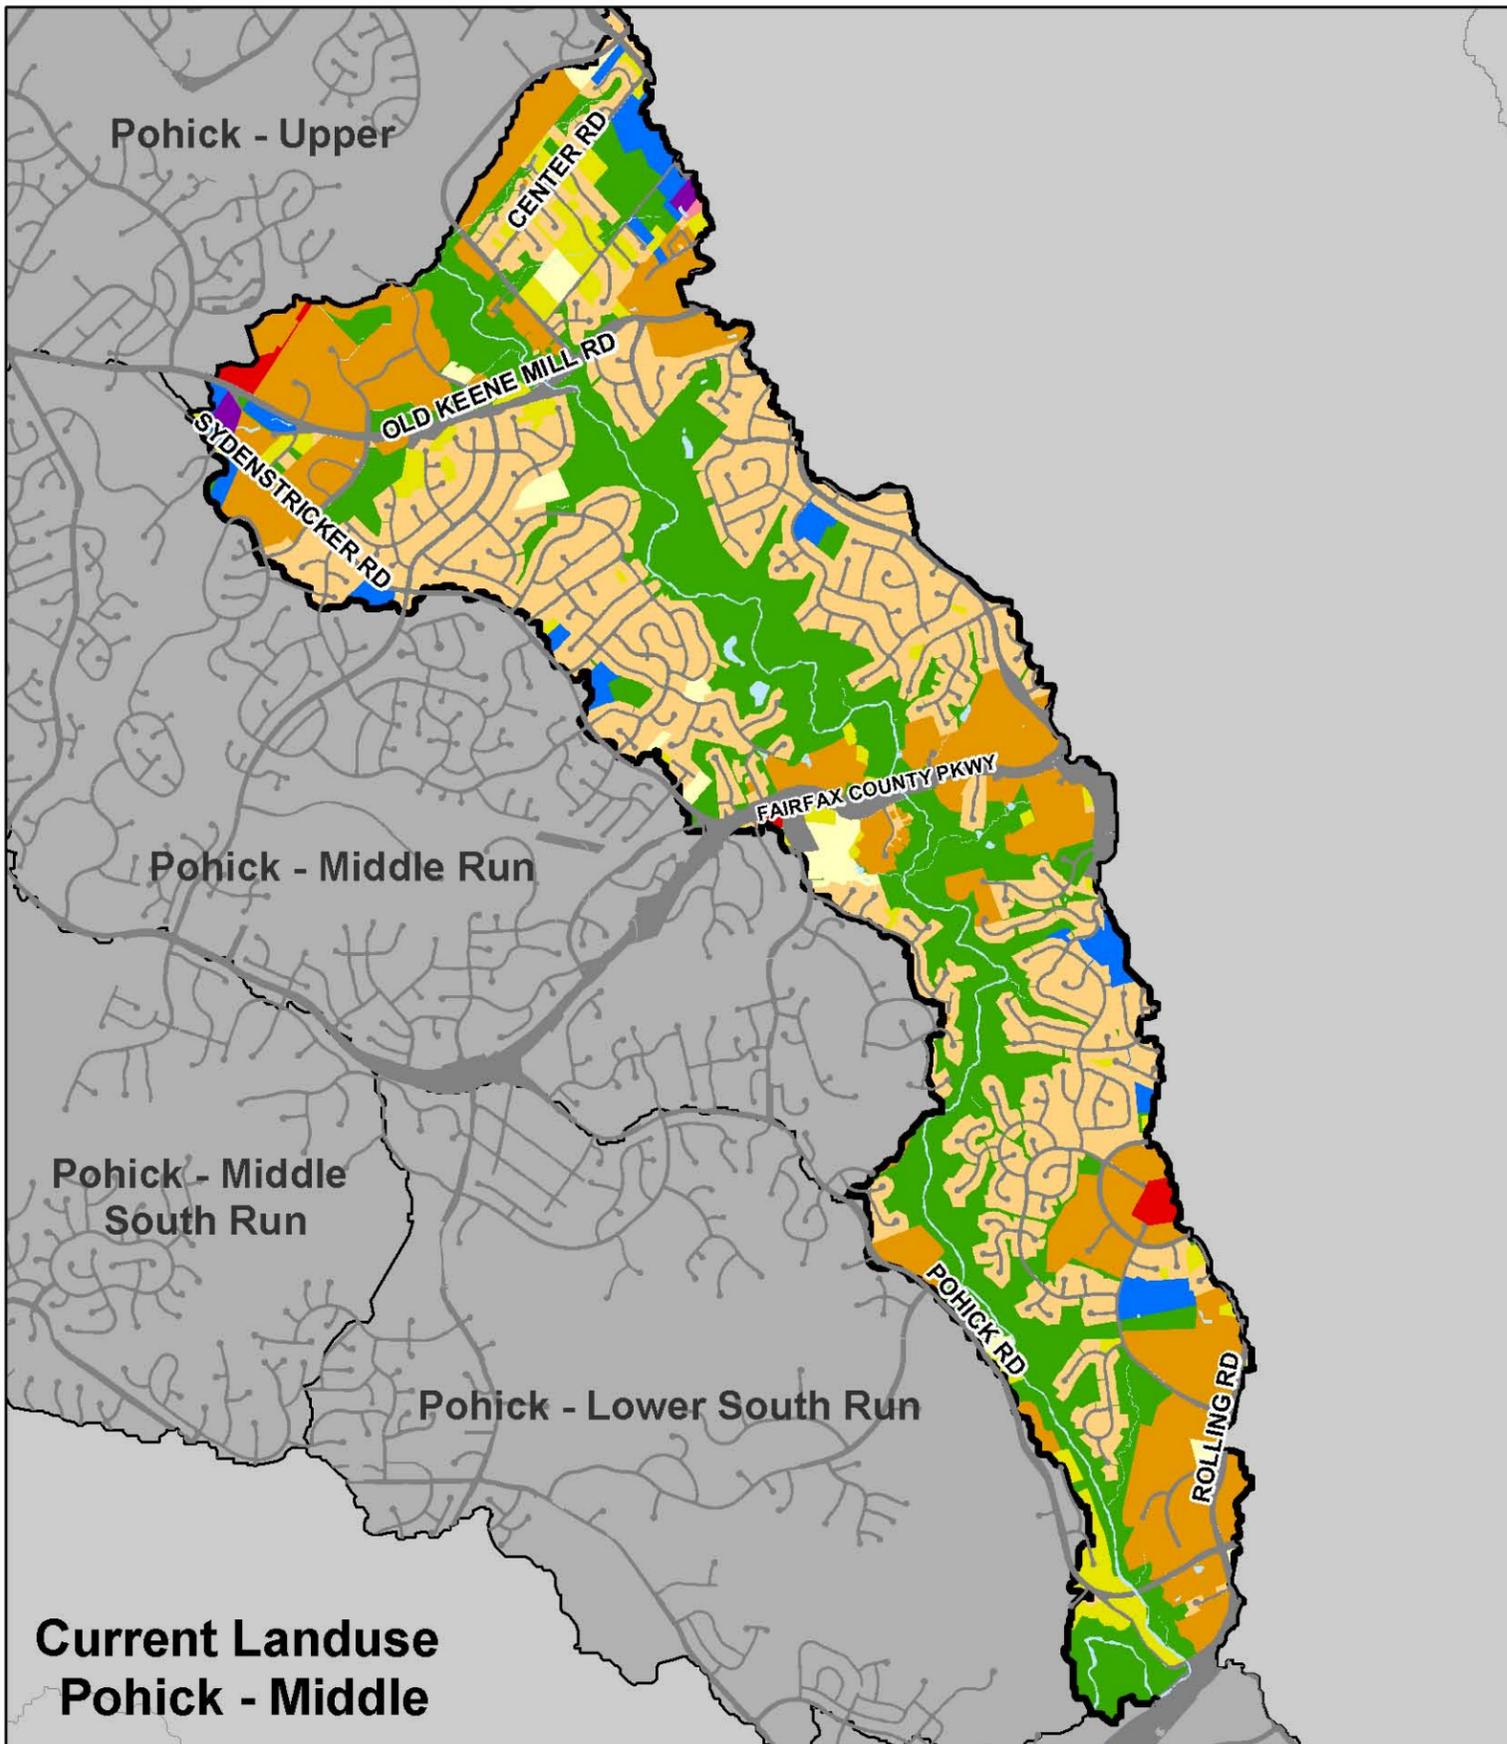
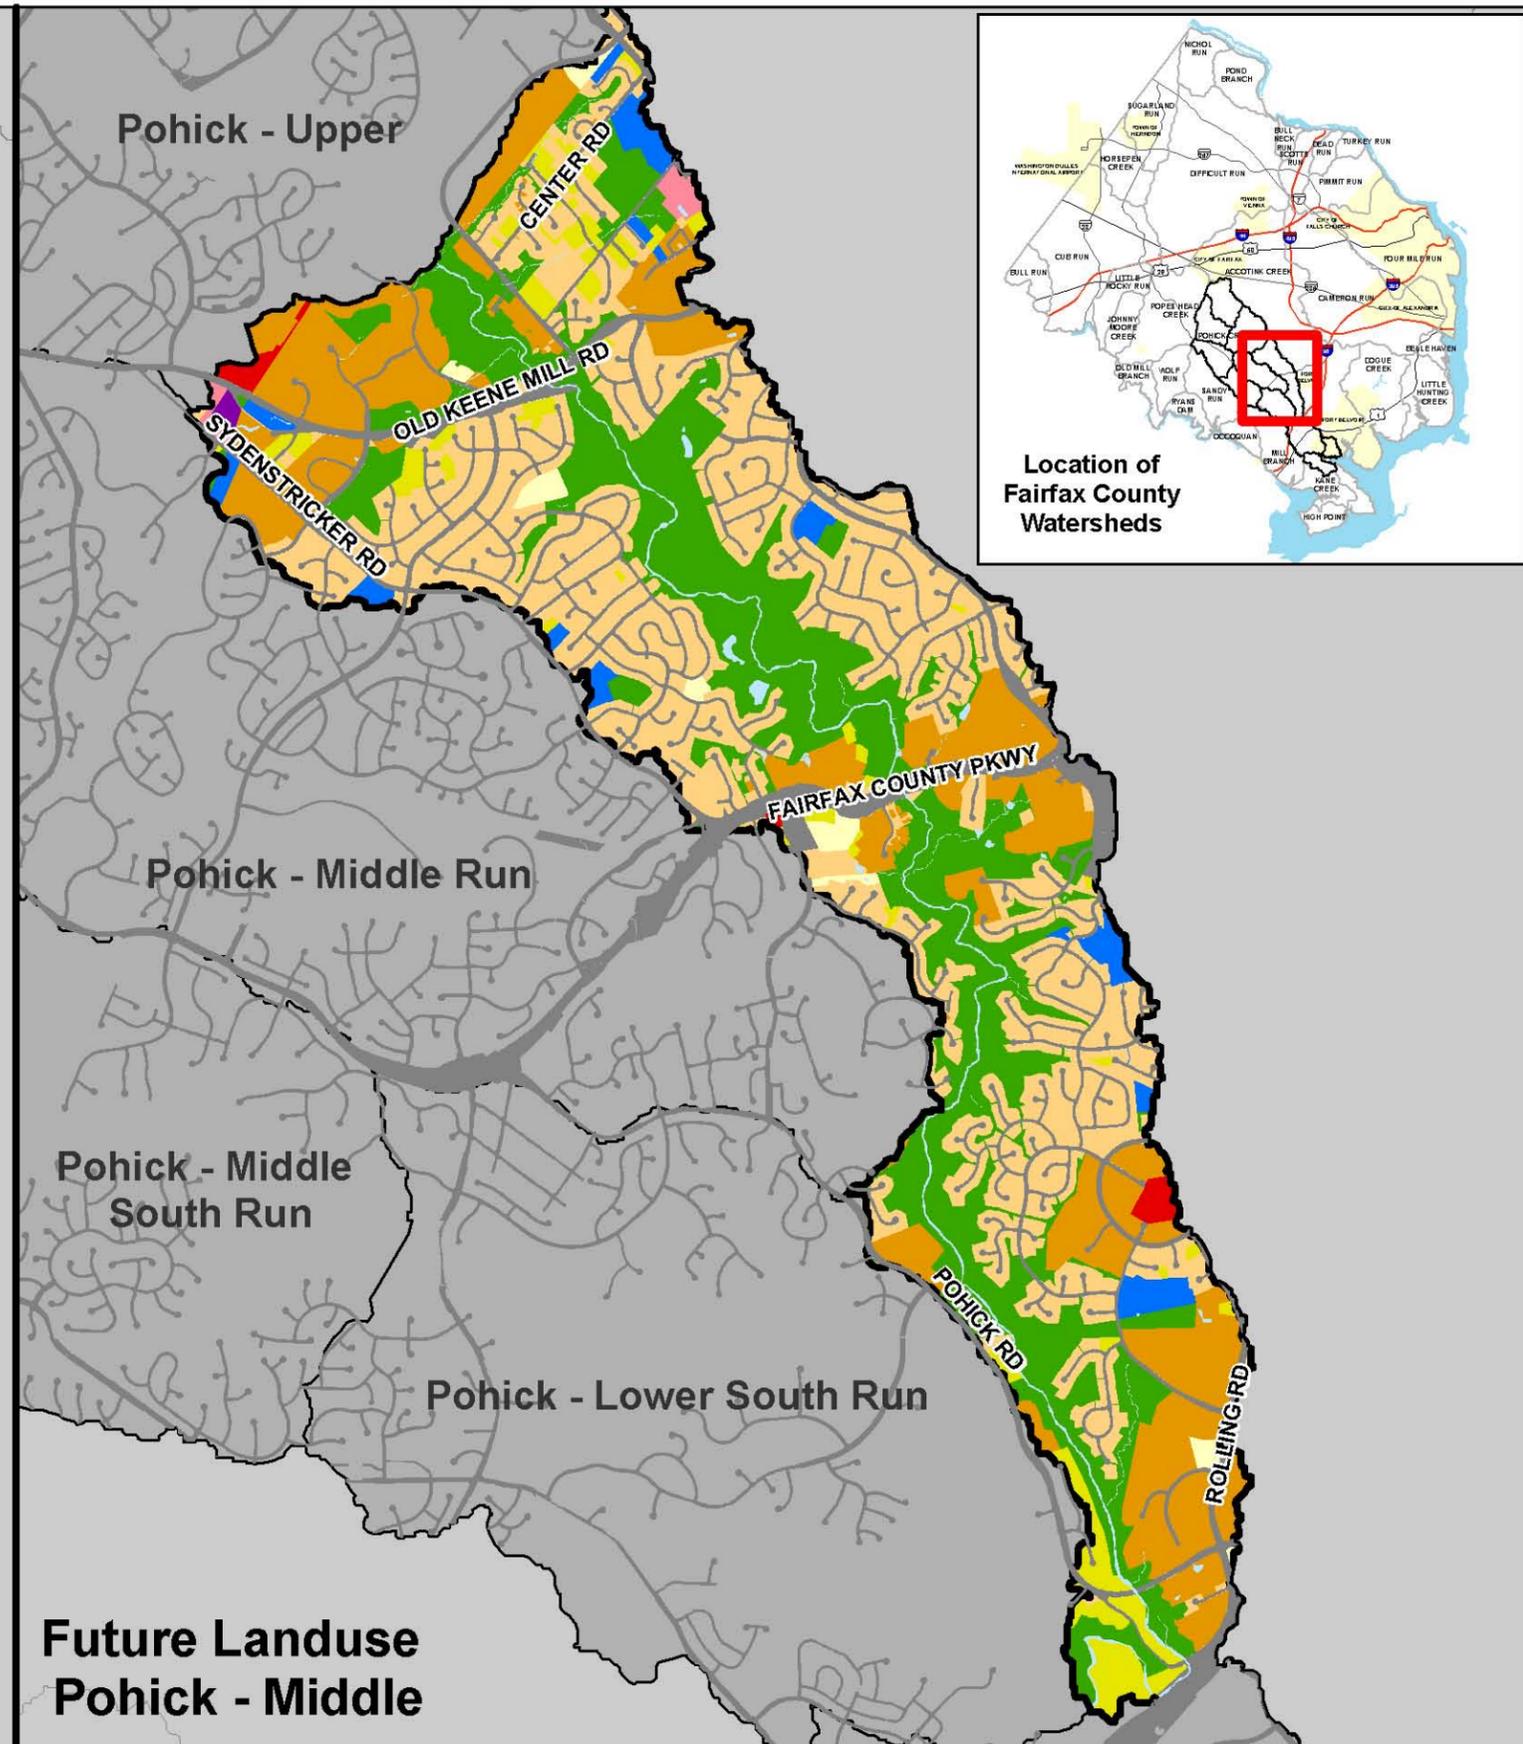
**Map 2.2.8-1
Pohick Creek- Middle
Existing and Future Land Use**

**Current Landuse
Pohick - Middle**

**Future Landuse
Pohick - Middle**

Utilizing the Technical Memorandum 3 guidance document, Table 21 below identifies the current and future impervious surface areas based on the existing and future land use conditions for Middle as well as the associated treatment types. See **Map 2.2.8-1** for existing and future land use. As expected Middle WMA is fully developed and contains a high percentage of impervious areas. In addition, much of stormwater management treatment consists of none, this is partly due to Pohick Creek stream flowing through the entire WMA. Small portions of the WMA has stormwater quantity and quality controls in place.

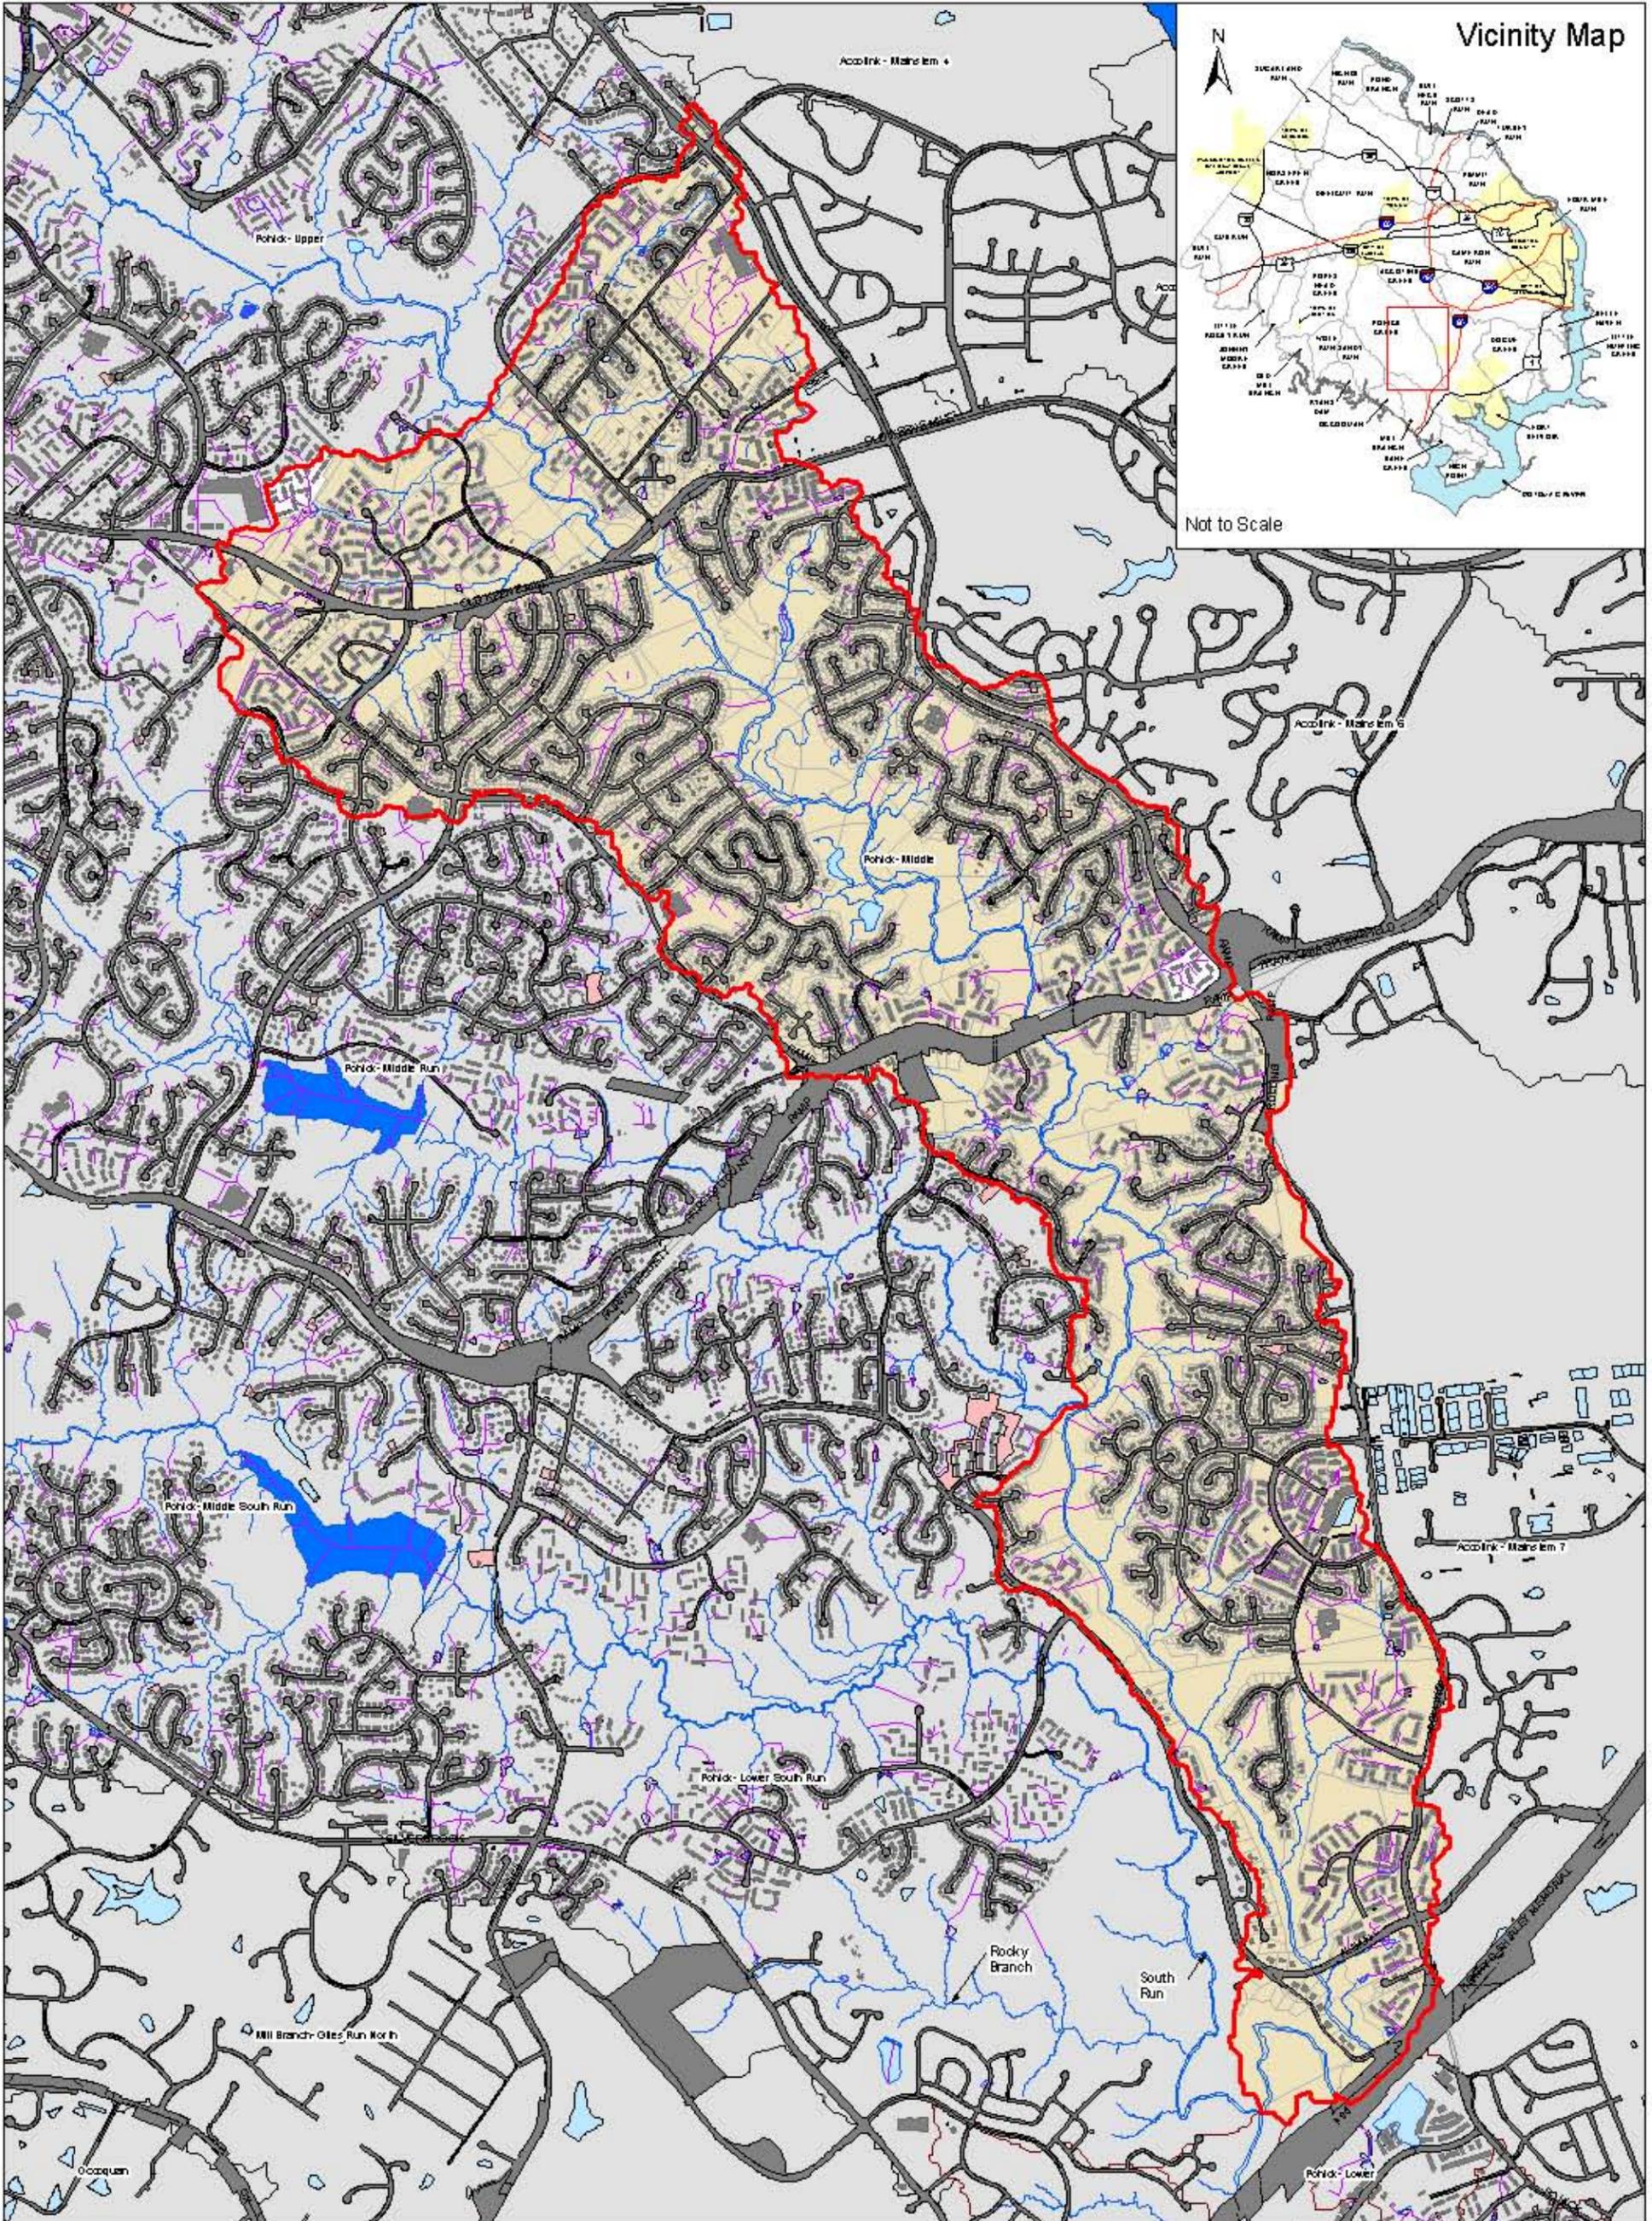
Pohick Creek
Pohick Creek Middle
Stormwater Infrastructure

Map 2.2.8-2 demonstrates the observed stormwater infrastructure conditions in the Middle WMA. Stormwater infrastructure consists primarily of curb and gutter stormwater collection leading to a piped network of storm drains discharging to either dry detention basins or directly into the middle reaches of Pohick Creek and its associated stream valleys and tributaries. Some of the stormwater conveyance system in the Middle WMA consists of ditches as well. The Middle WMA contains a wide variety of stormwater management facilities and structures, including approximately 34 dry detention facilities designed to manage stormwater quantity. In addition, the WMA contains three underground chambers; eight infiltration trench for water quality management; two wet retention basins; and one constructed stormwater wetland, which are typically designed to manage stormwater quantity and quality.

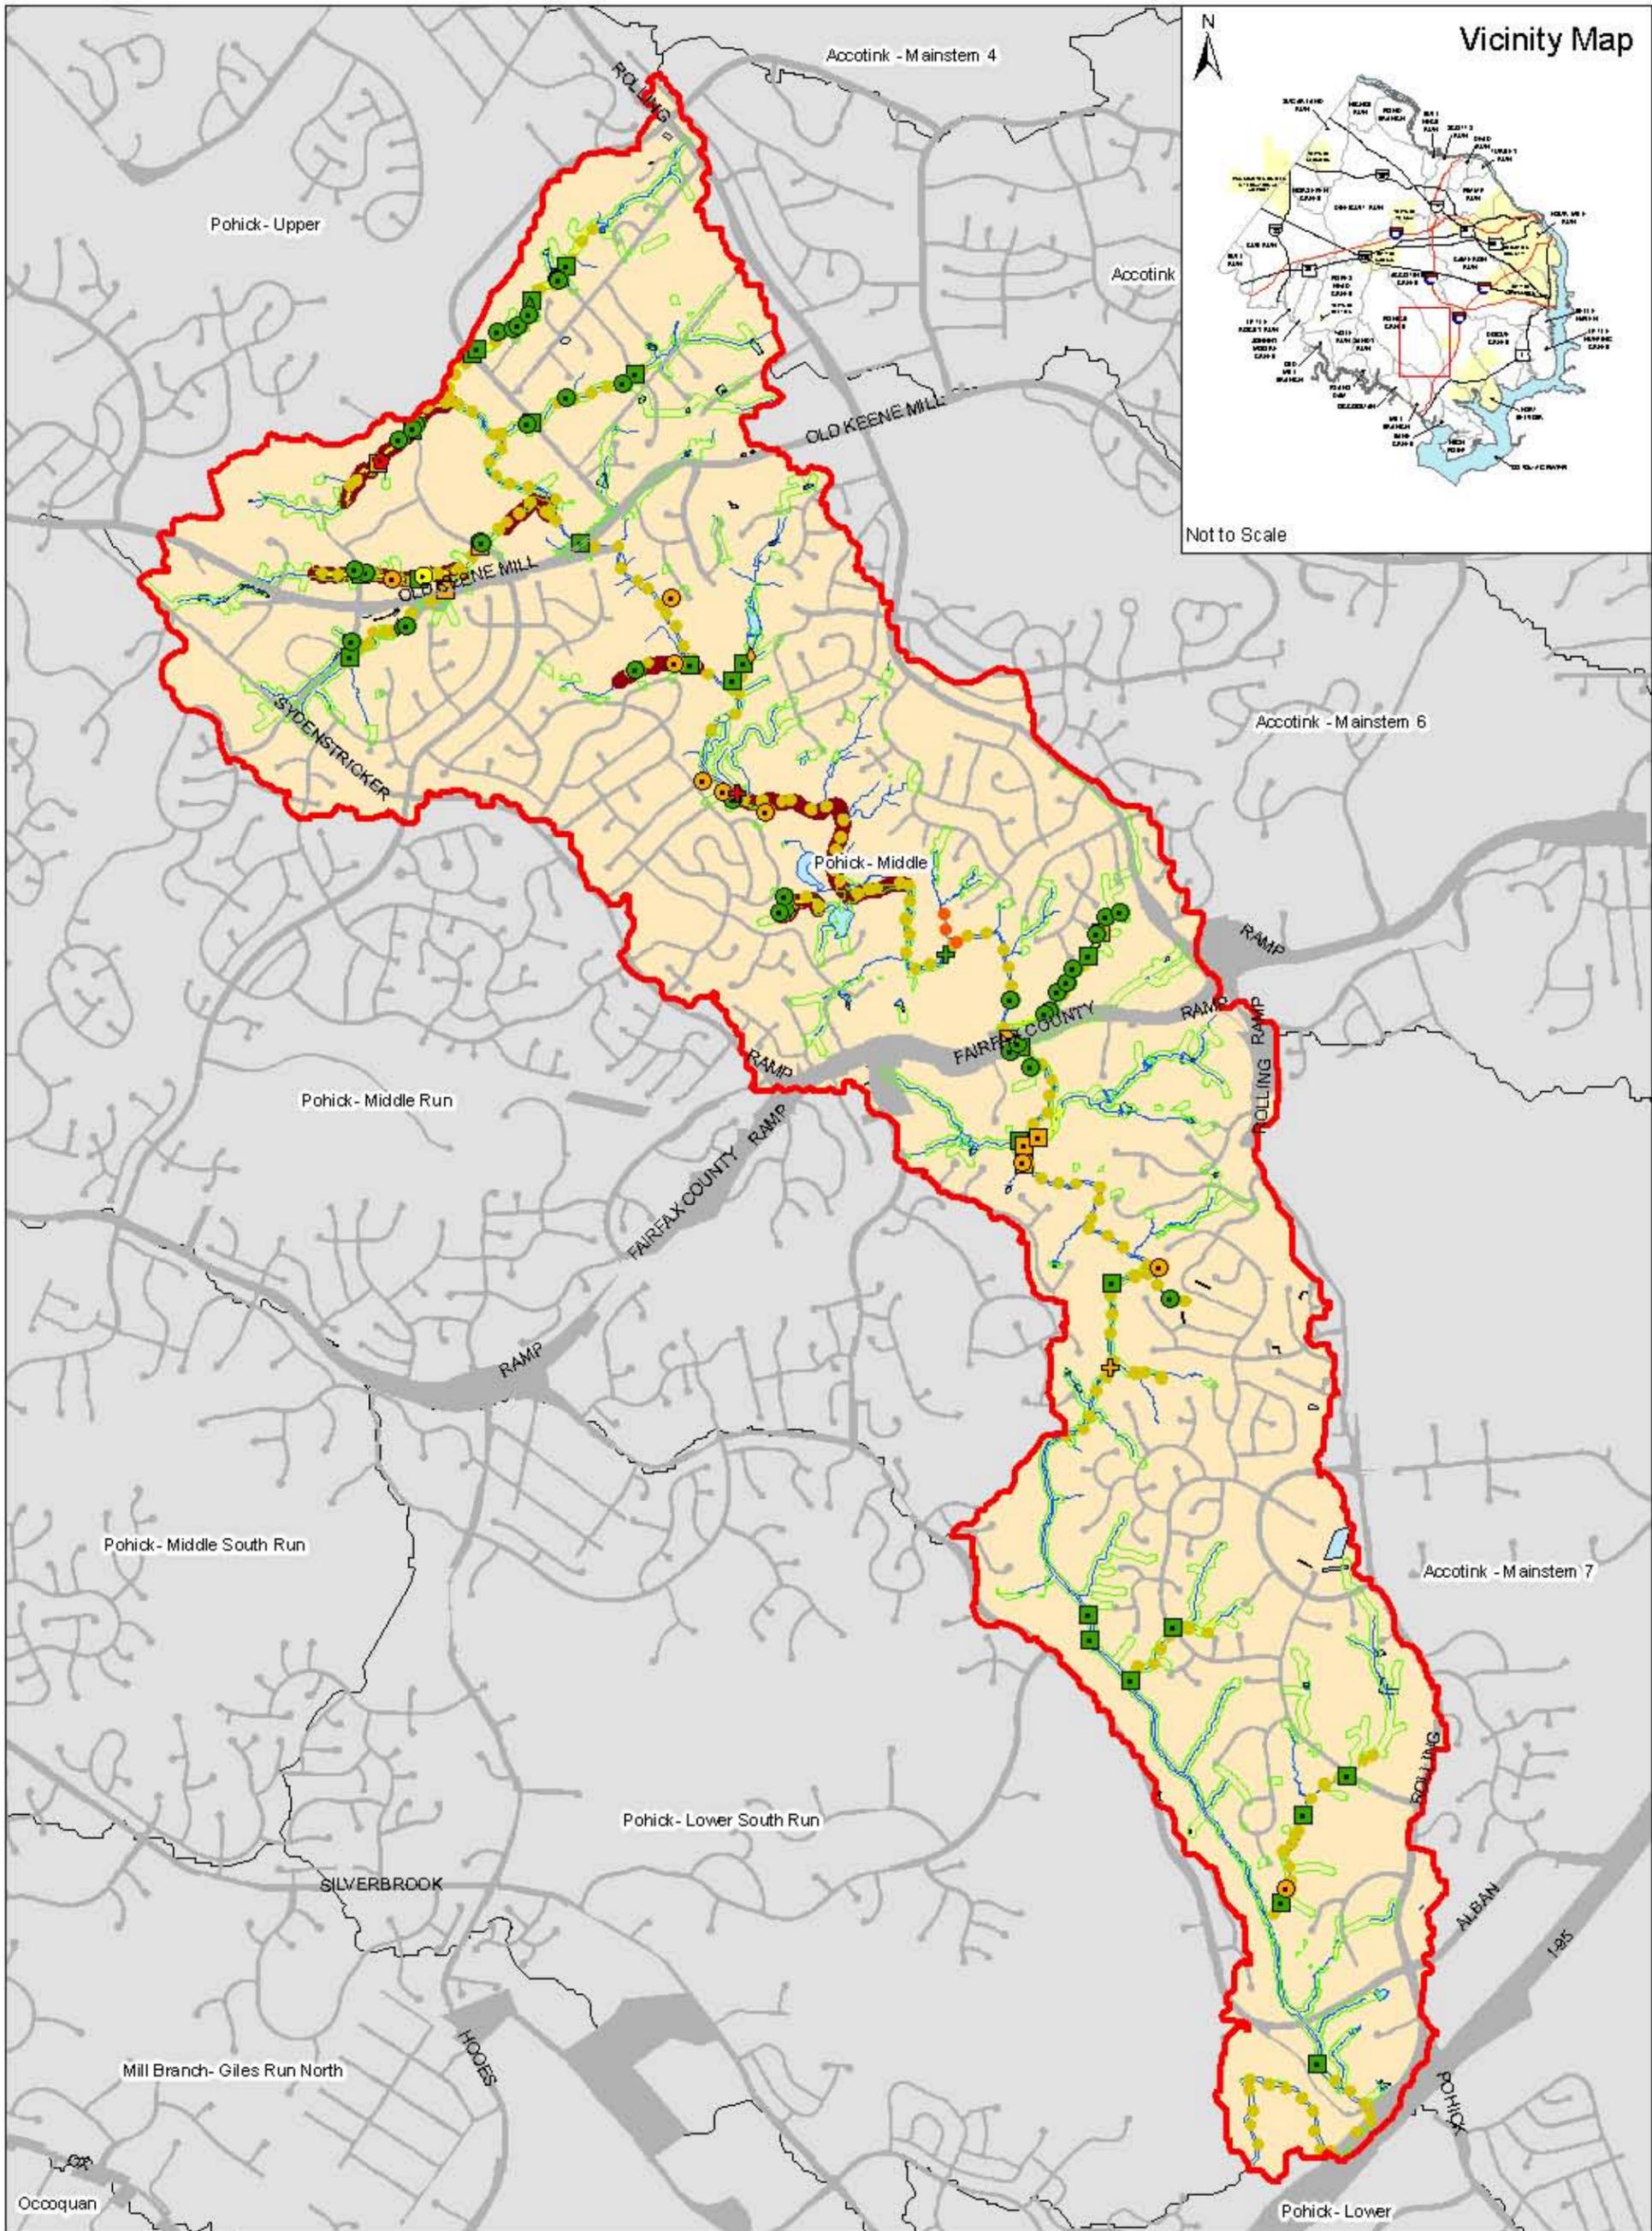
Map 2.2.8-3

Pohick Creek
Pohick Creek Middle
Stream Conditions

The Stream Conditions **Map 2.2.8-3** denotes the generally observed stream conditions as documented in the 2005 SPA and through additional, windshield level field reconnaissance performed for this study. The Stream Conditions Map demonstrates the general conditions of the main stem streams and tributaries in the WMA along with a series of features that typically impact stream condition, including stream channel erosion, channel widening, stream buffer condition, discharge pipe and ditch impacts, and utility and road crossing impacts.

In the Middle WMA, the most prevalent stream condition features noted include disturbed stream buffers and stream channel widening and erosion/incision. In addition, pipe and ditch discharge into the WMA's streams have a significant impact on this WMA as well, including some severe impacts on the WMA headwaters and the main stem of Pohick Creek, as these pipes and ditches discharge stormwater runoff directly into the streams in many instances, contributing to the observed widening and erosion conditions. The more severe pipe, ditch, obstruction, and crossing impacts appear upstream of the Fairfax County Parkway. Road crossings, utilities lines, and pipe impacts noted in the remainder of the Middle WMA generally had only a minor impact, with some notable exceptions downstream of the Fairfax County Parkway. Isolated stream head cutting, or an abrupt vertical drop in the bed of a stream channel that demonstrates active erosion (NC DWQ, 2005), was observed in the headwaters of the Middle WMA near Old Keene Mill Road.

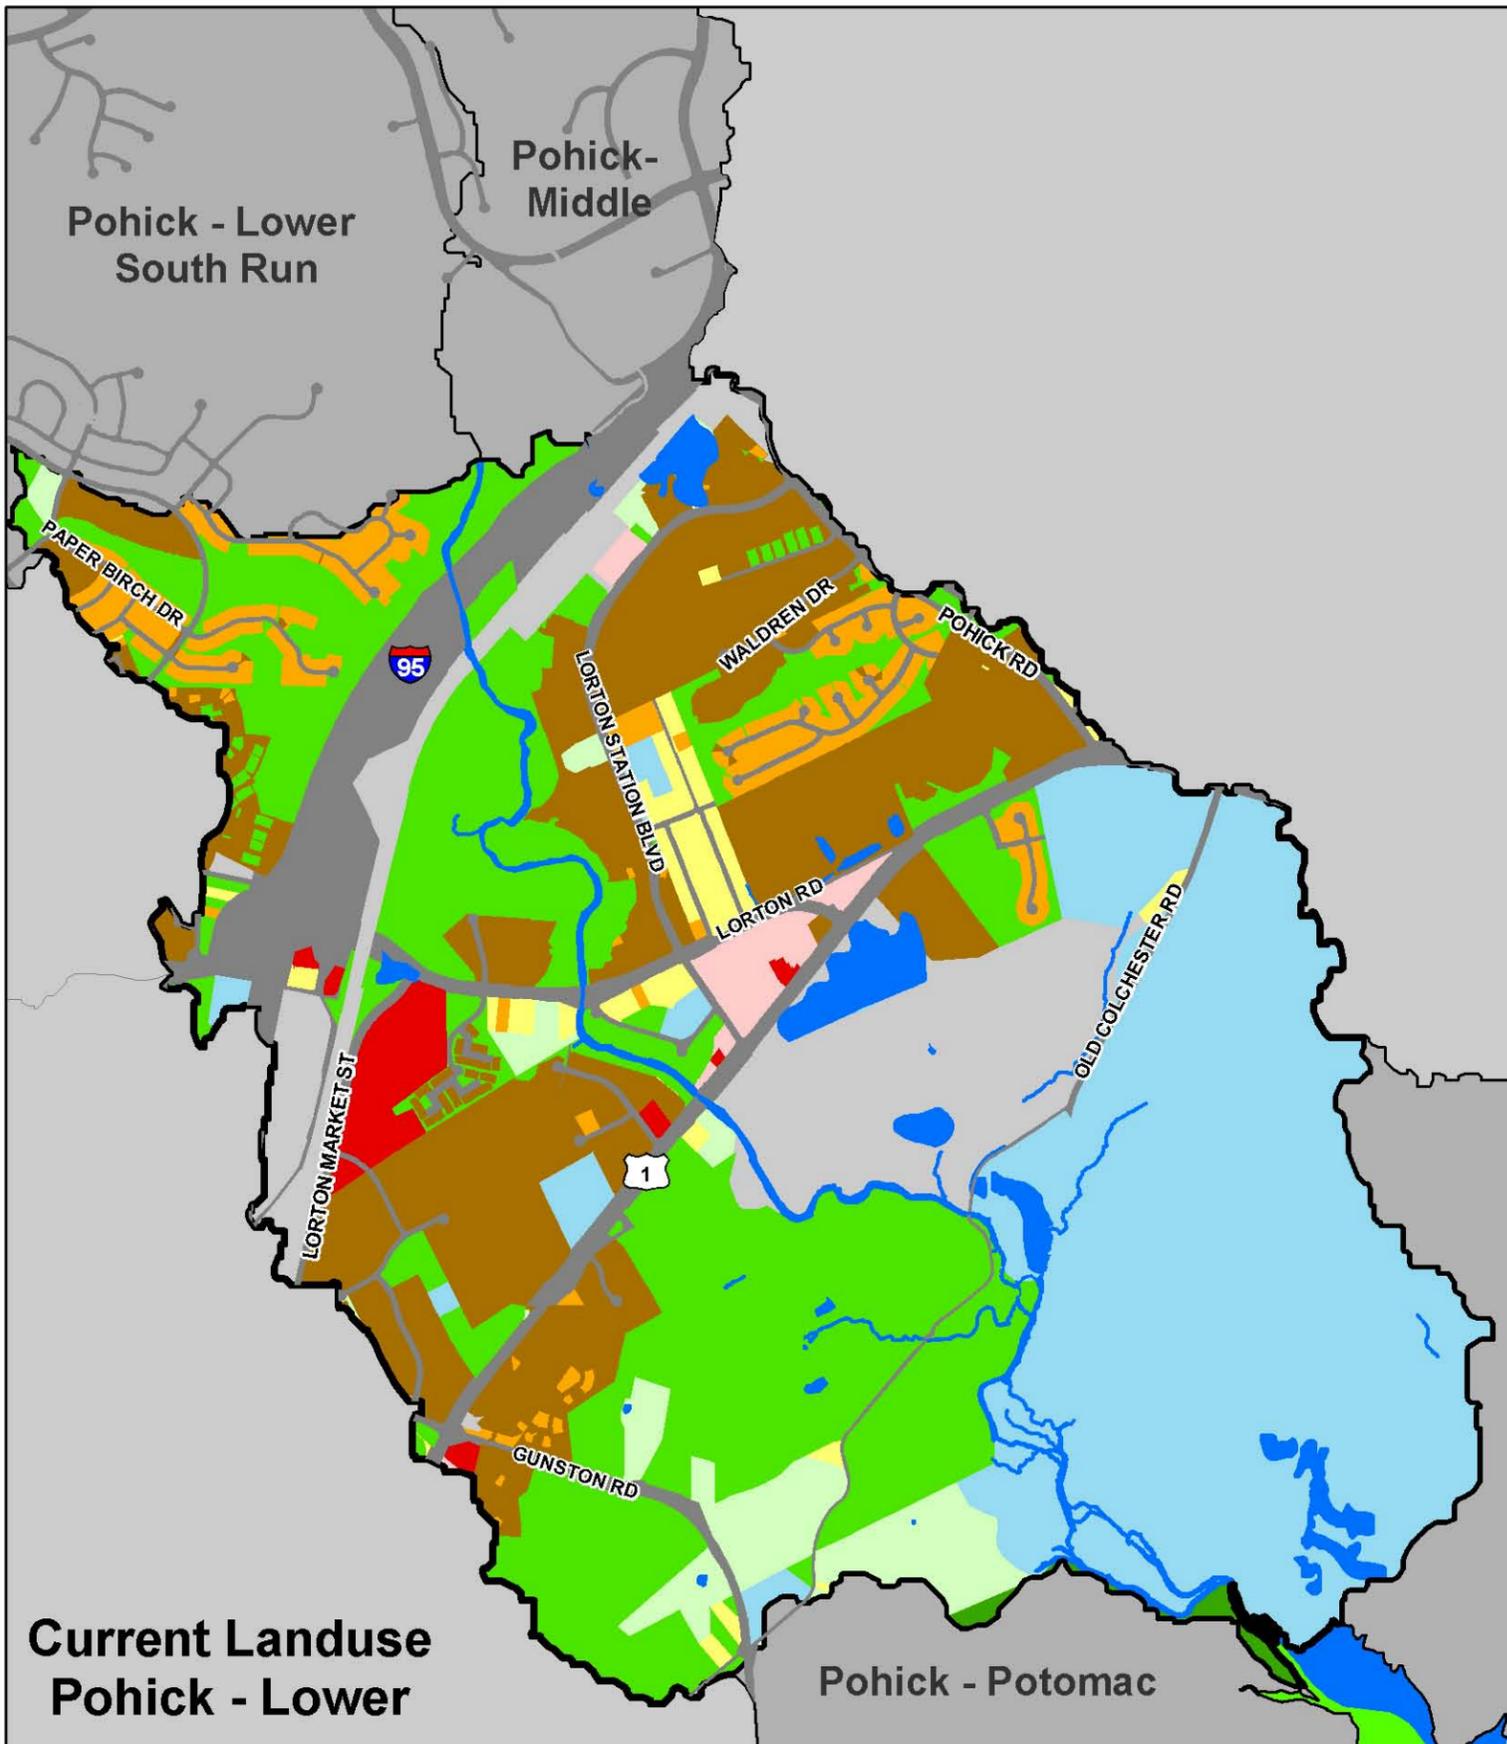
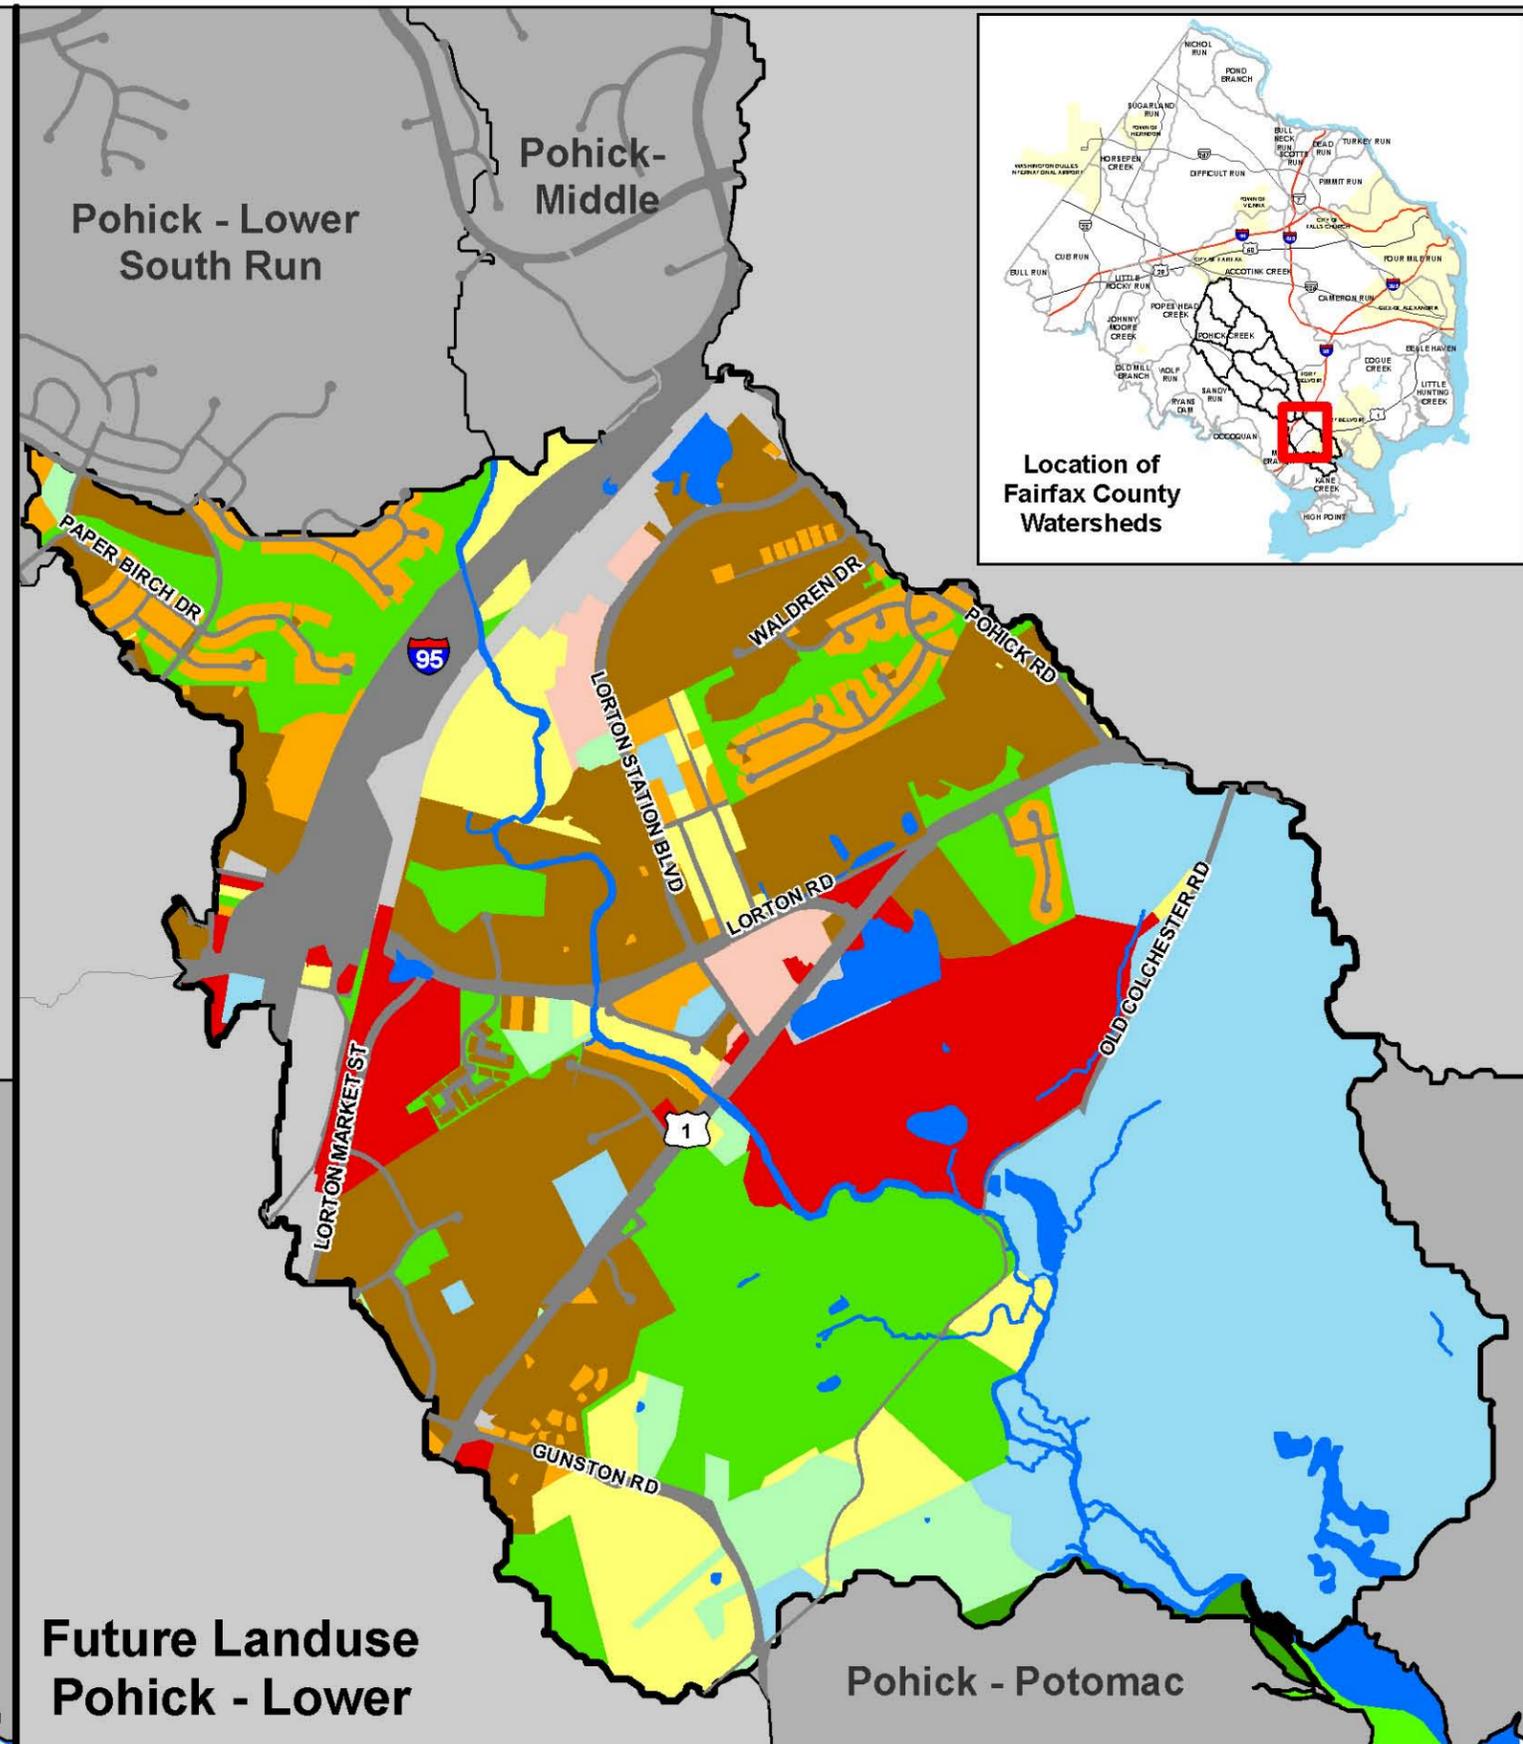
**Map 2.2.9-1
Pohick Creek- Lower
Existing and Future Land Use**

**Current Landuse
Pohick - Lower**

**Future Landuse
Pohick - Lower**

Utilizing the Technical Memorandum 3 guidance document, Table 22 below identifies the current and future impervious surface areas based on the existing and future land use conditions for Lower as well as the associated treatment types. See **Map 2.2.9-1** for existing and future land use. While Lower WMA is bisected by Route 1, which is heavily commercial/industrial, there are portions of Lower which contain the Accotink Bay Wildlife Refuge and Pohick Bay Regional Park. These areas experience relatively low impervious areas.

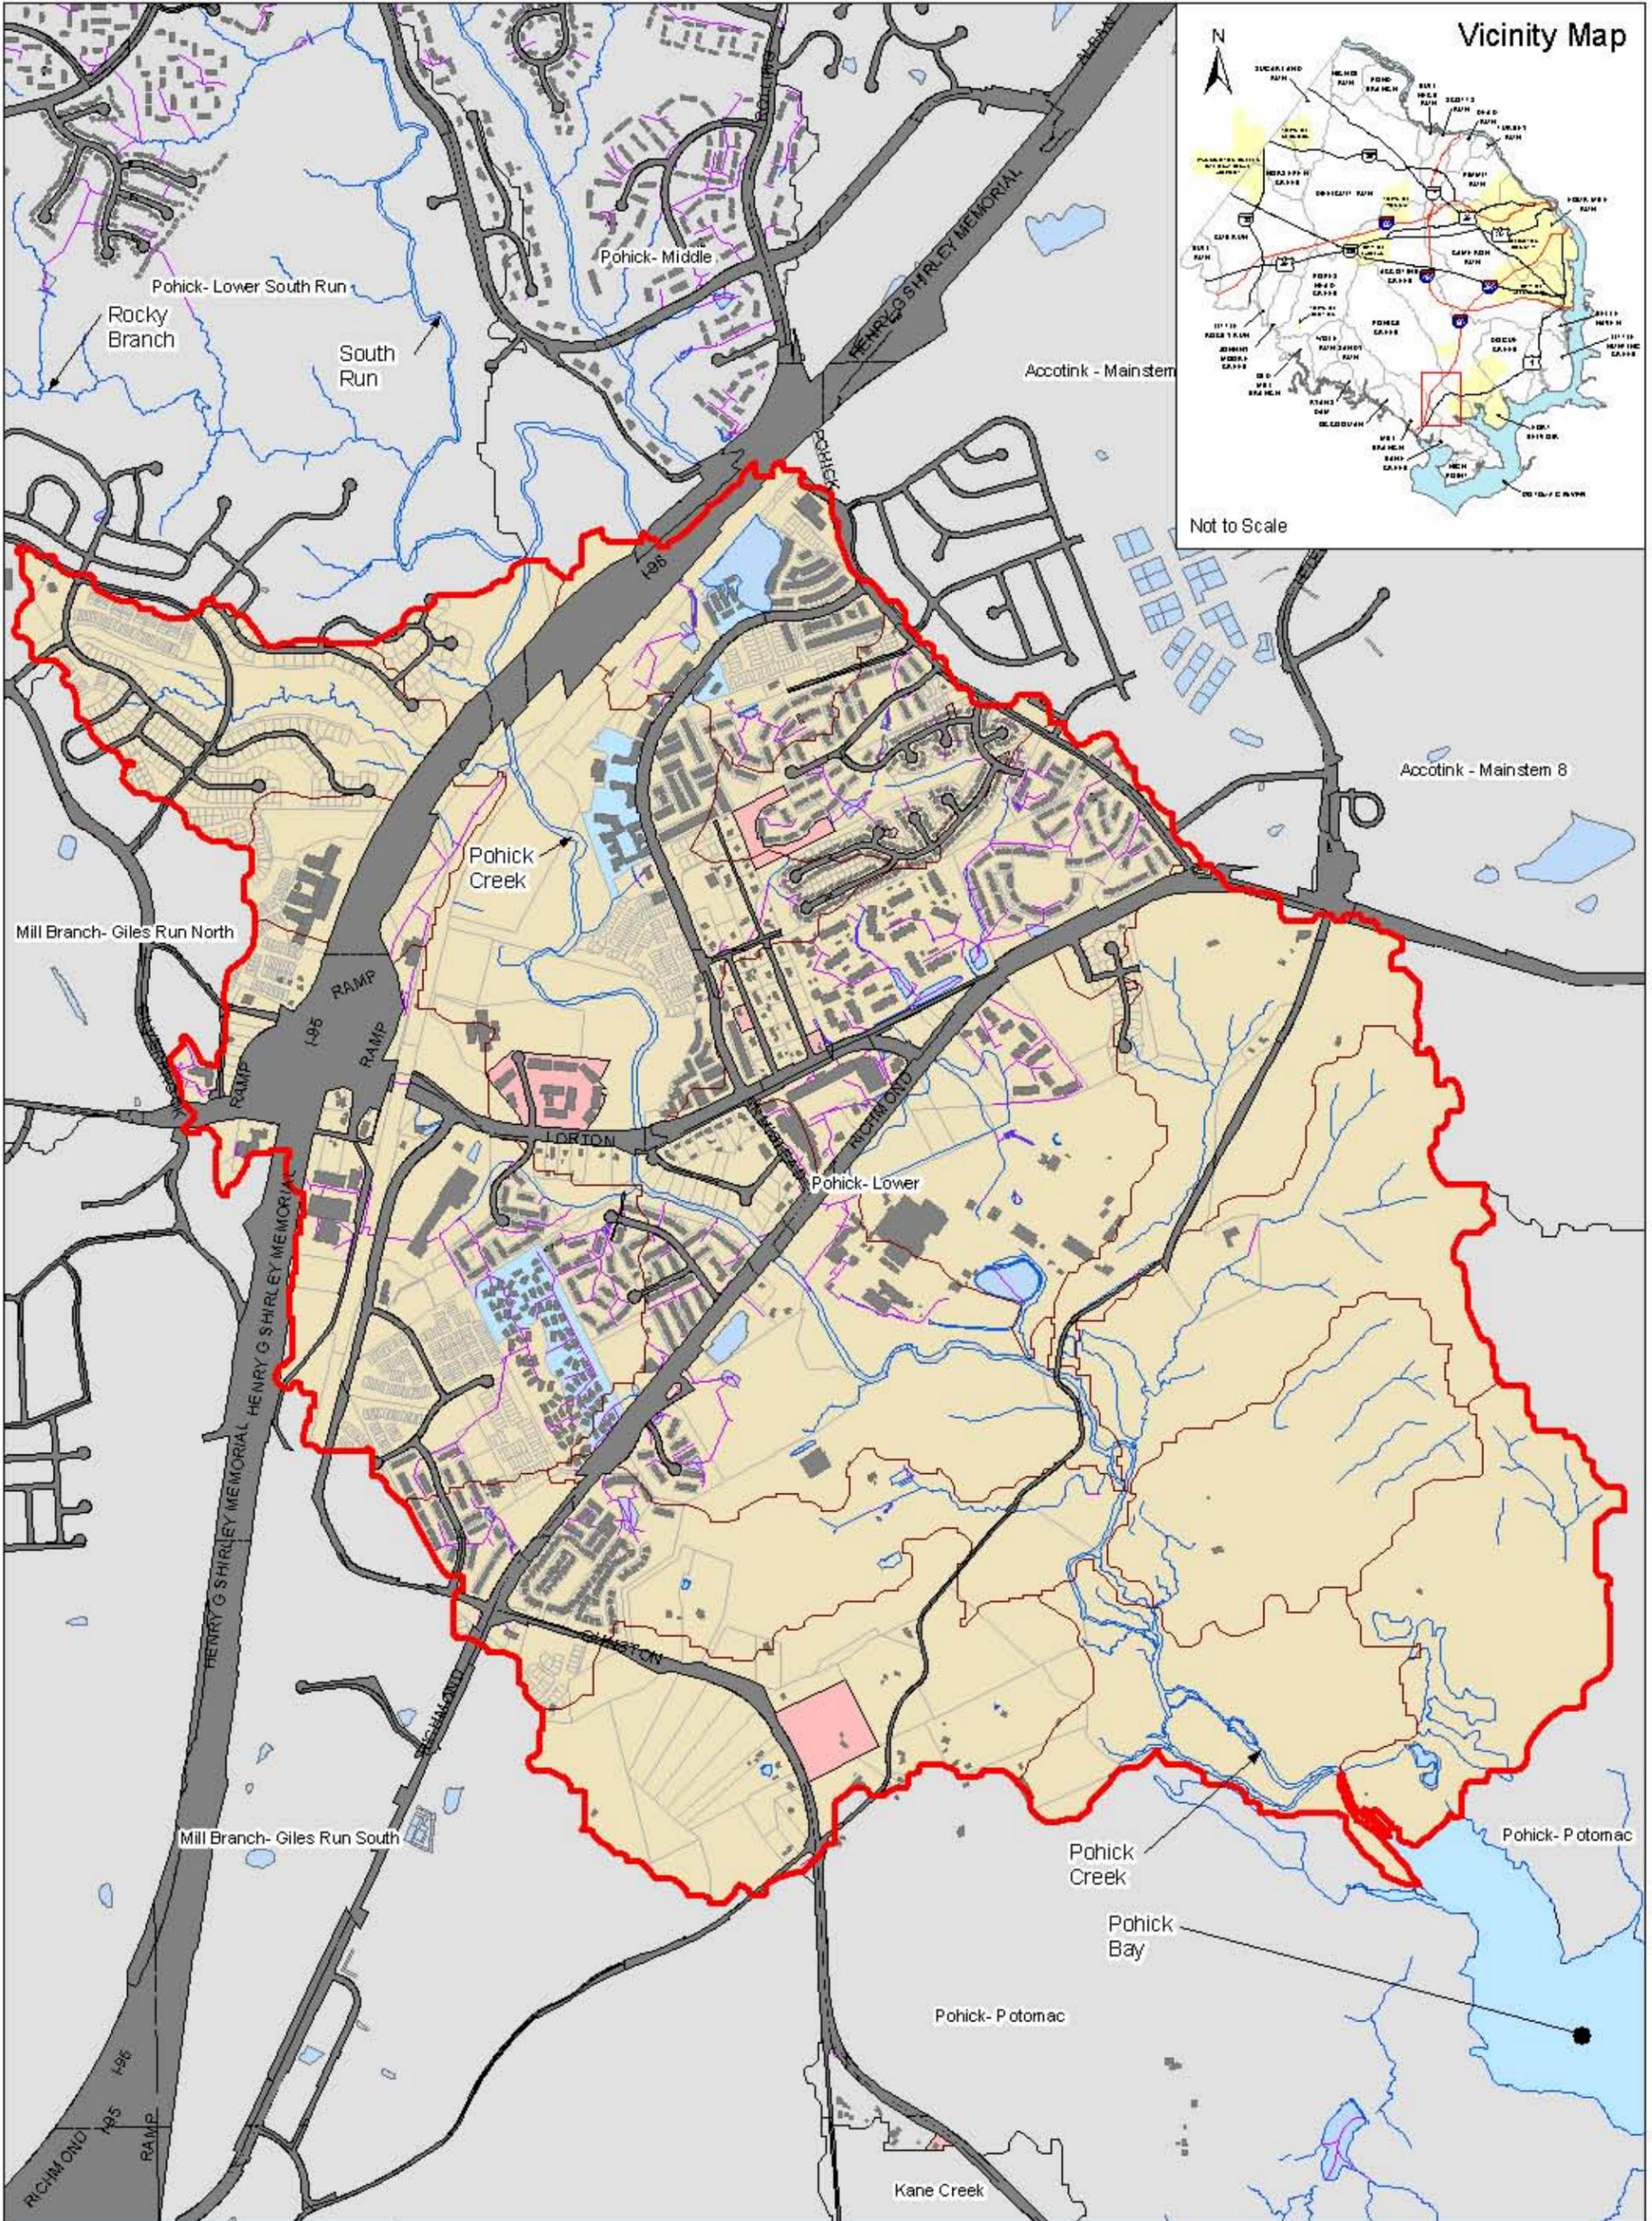
Pohick Creek
Pohick Creek Lower
Stormwater Infrastructure

Map 2.2.9-2 demonstrates the observed stormwater infrastructure conditions in the Lower WMA. Stormwater infrastructure in the developed portion of the WMA consists primarily of curb and gutter stormwater collection leading to a piped network of storm drains discharging primarily to dry detention basins that manage the quantity of runoff before discharging into Pohick Creek and/or its associated stream valleys and tributaries. Some of the stormwater conveyance system in the Lower WMA consists of ditches as well. The Lower WMA contains

approximately 17 dry detention facilities designed to manage stormwater quantity. In addition, the WMA contains one underground chamber. Of note, as development and redevelopment in and around the Lorton area continues, the reader can anticipate the implementation of additional stormwater management controls for both quantity and quality in accordance with current Fairfax County development standards
