2.2.8 Pohick Creek -Middle

DRAFT Watershed Workbook –**Pohick Creek Watershed**

Volume 2: Chapter 2

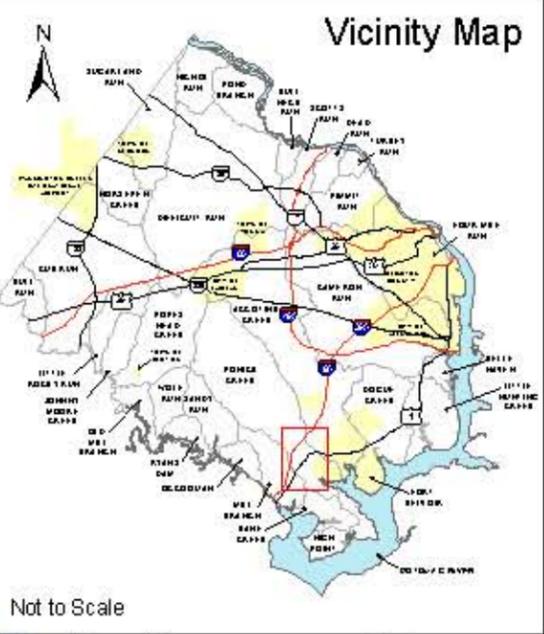
Map 2.2.9-2

Legend			
Storm Drainage	Roads	Drainage Complaints	WMA - Other
Rivers and Streams	Subbasins	Lake	Pohick - Lower
Buildings	Storm Drainage Facilities

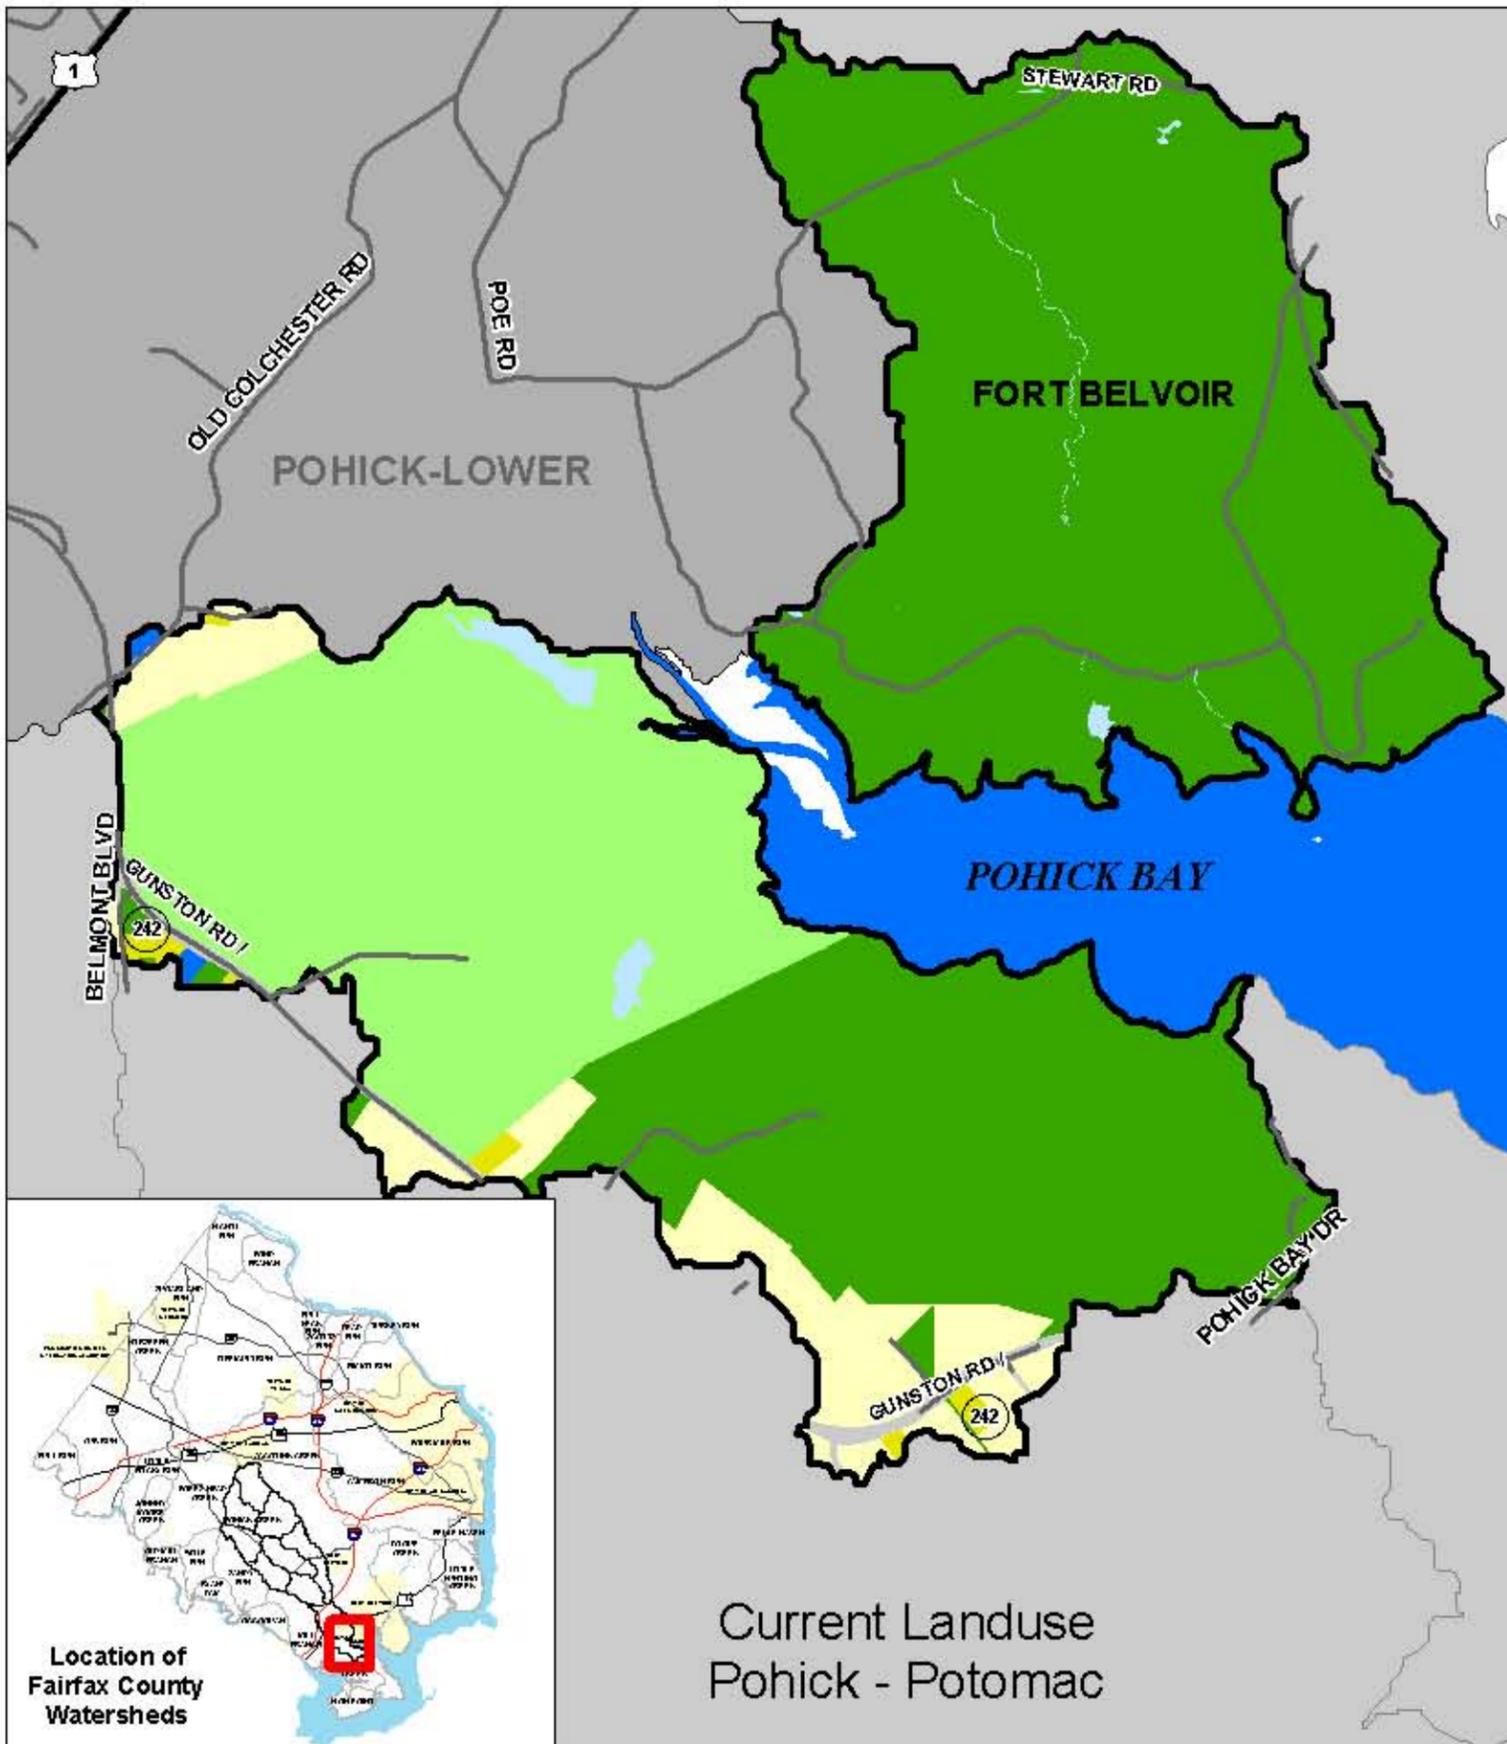
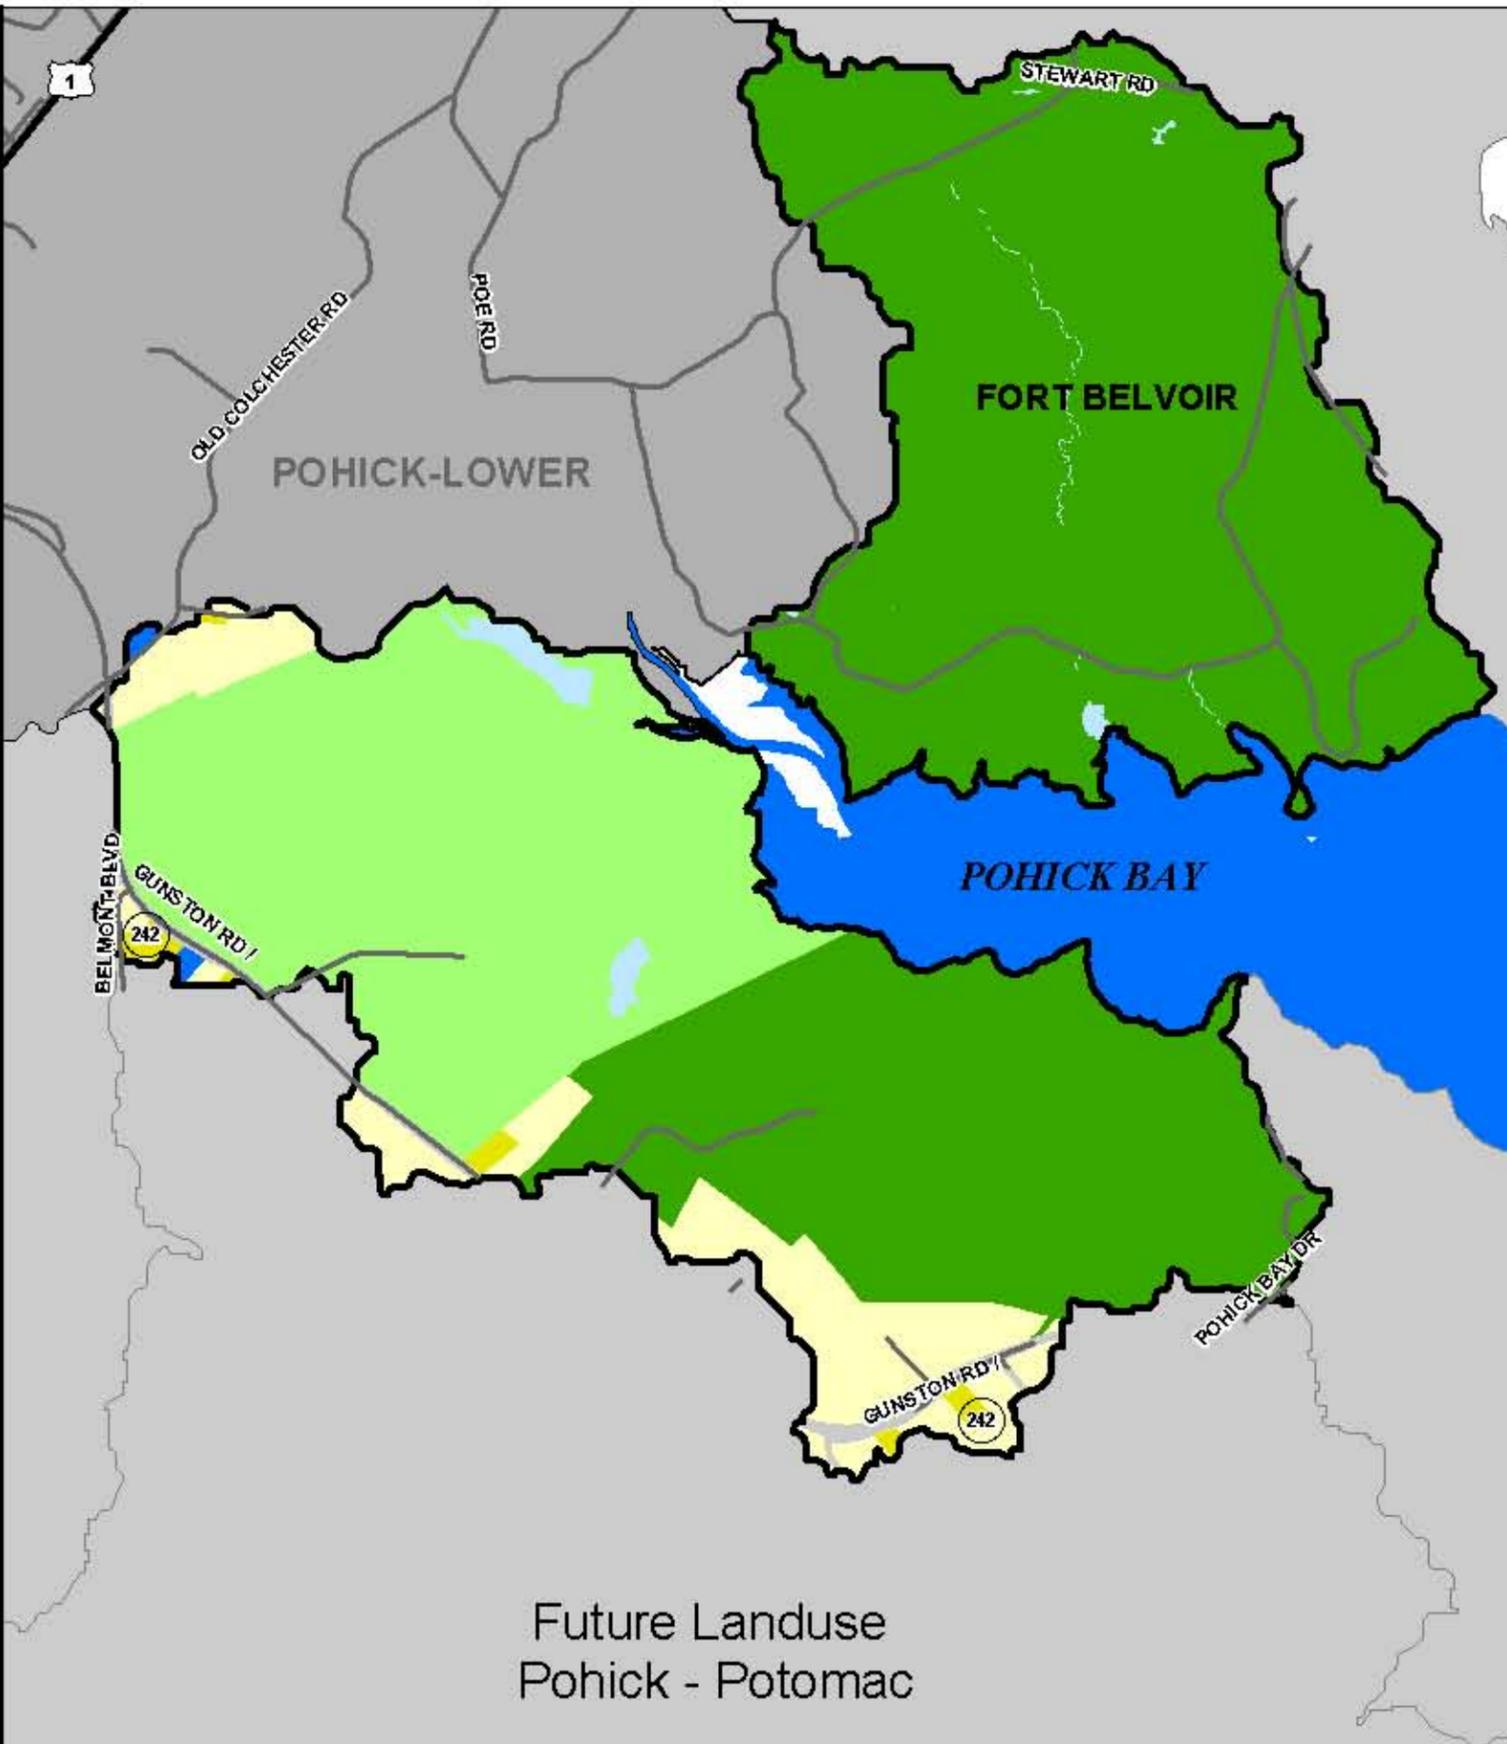
Map 2.2.10-1
Pohick Creek-Potomac
Existing and Future Land Use

Current Landuse
Pohick - Potomac

Future Landuse
Pohick - Potomac

for Potomac as well as the associated treatment types. See **Map 2.2.10-1** for existing and future land use. As expected Potomac WMA has almost no development and is comprised primarily of Fort Belvoir and Pohick Regional Park and therefore experiences one of the lowest impervious conditions in the County. Since the majority of the area is undeveloped, stormwater management treatment is minimal.

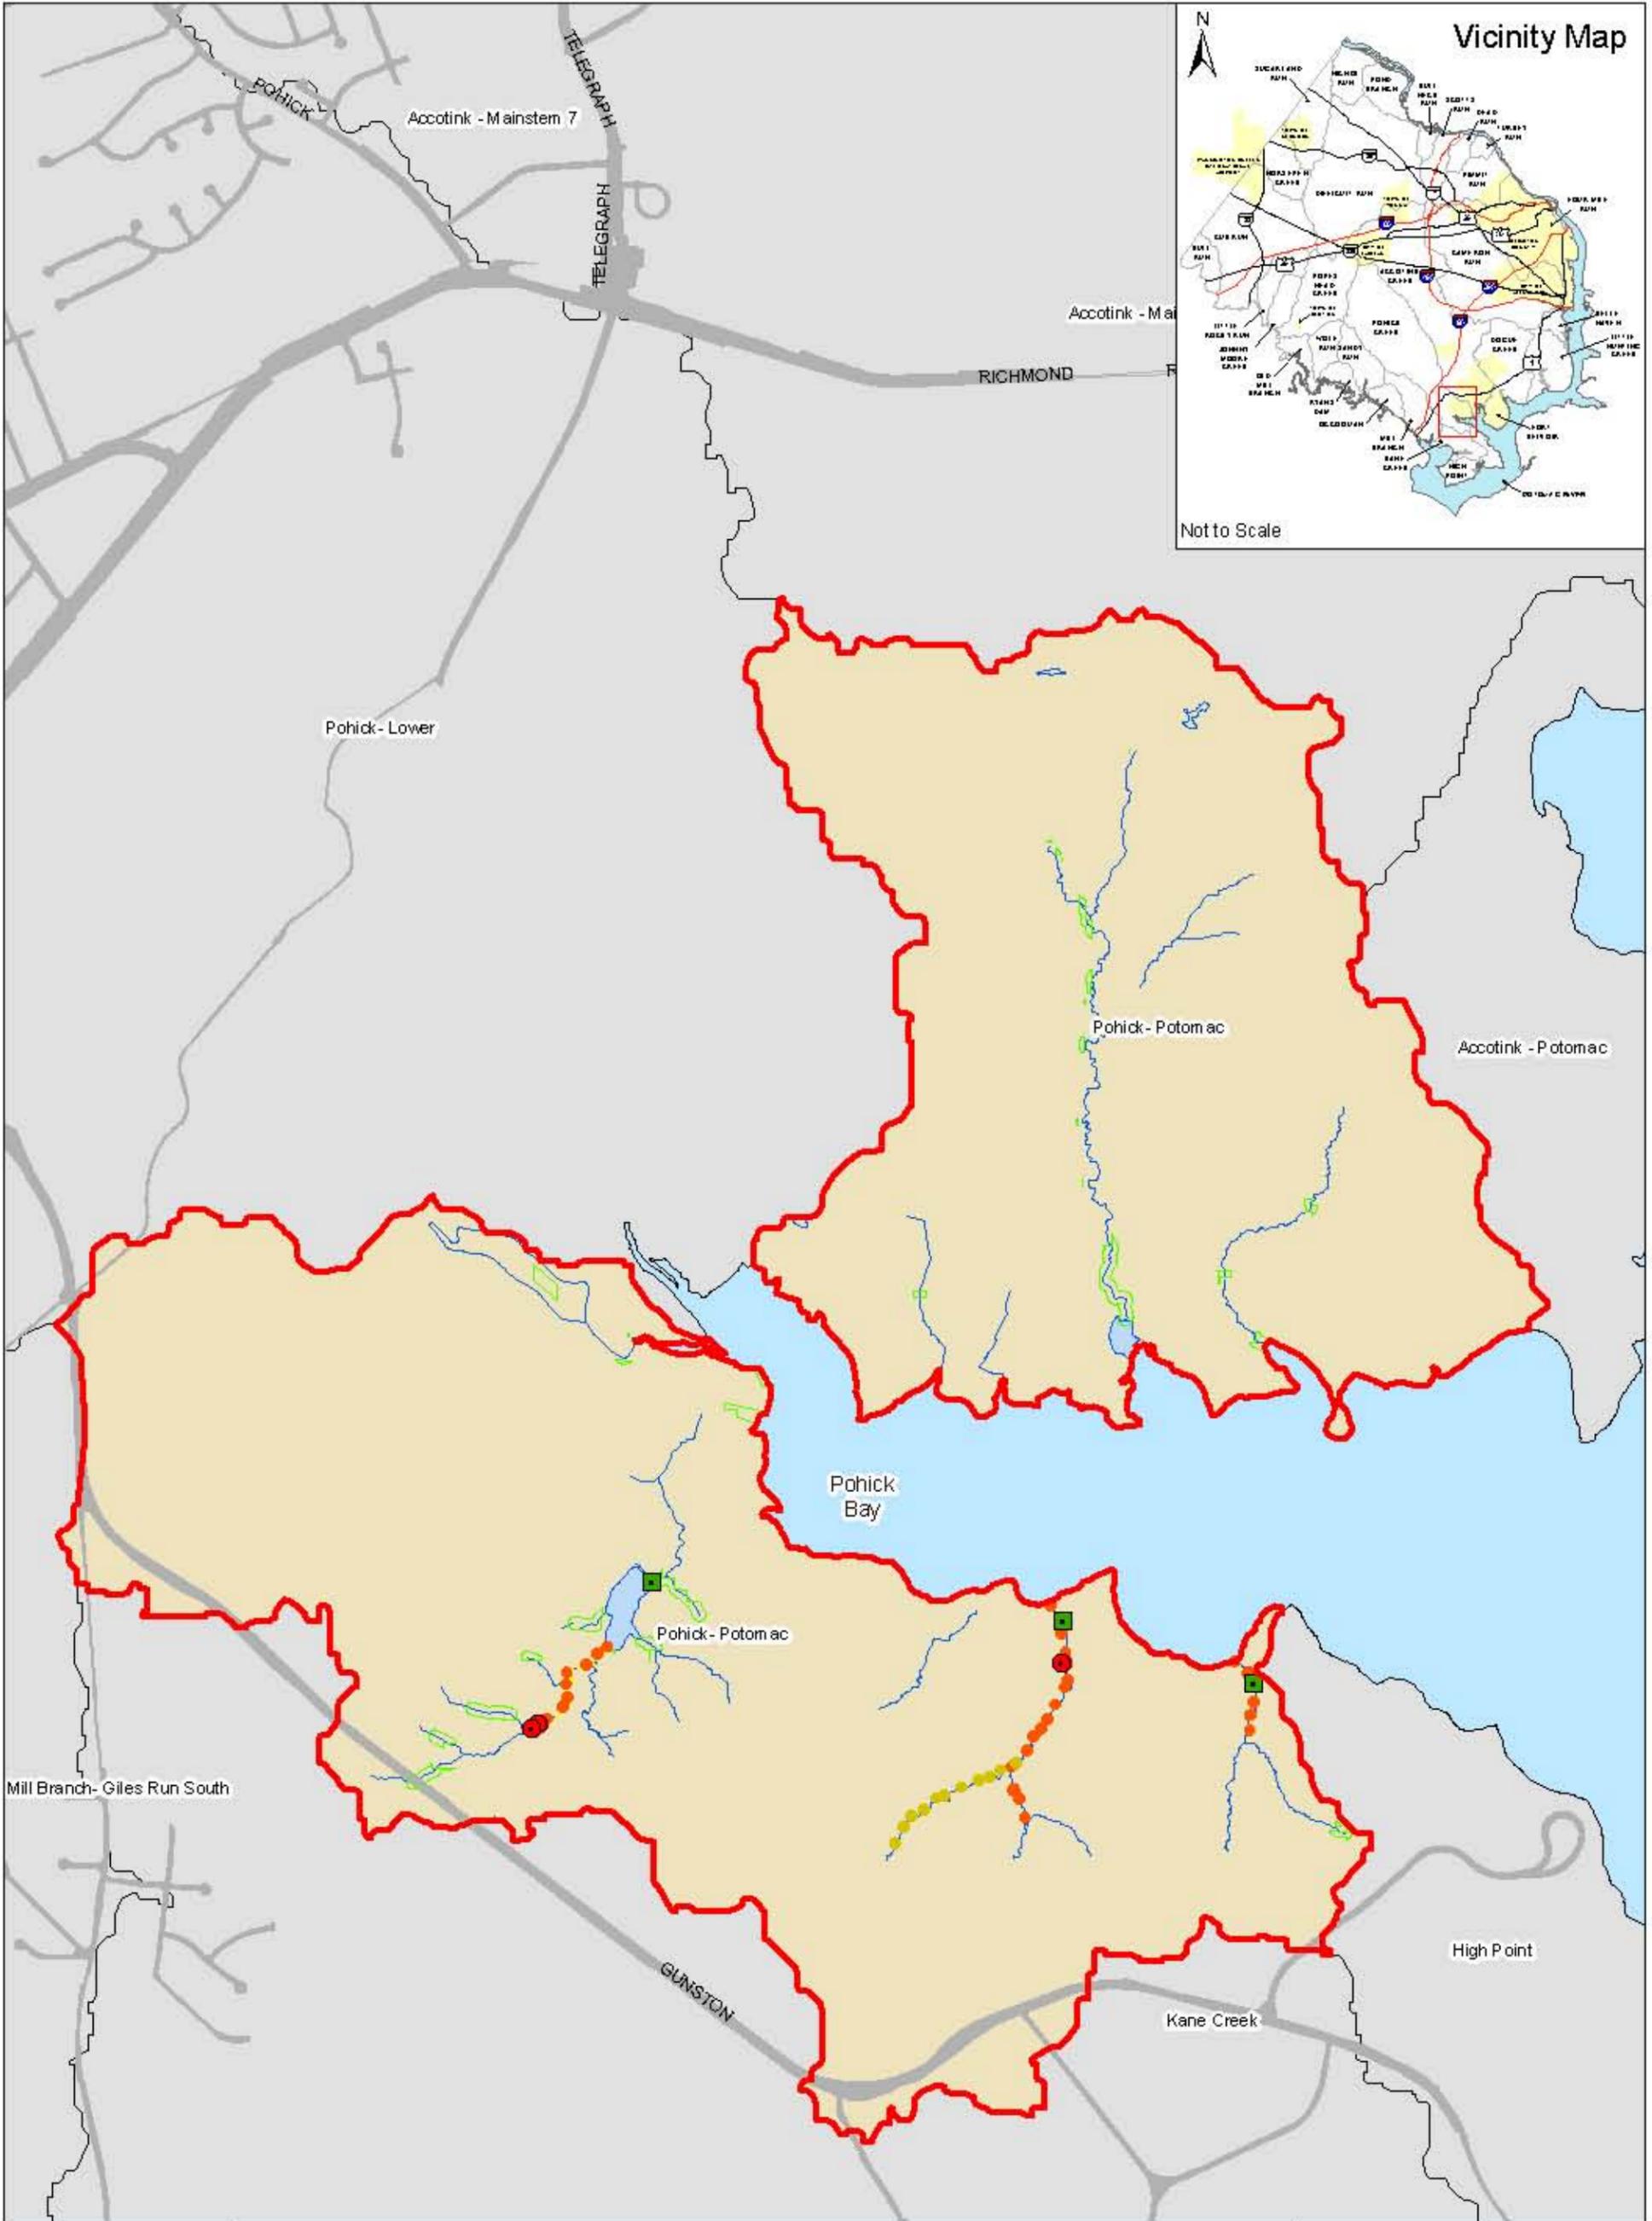
Map 2.2.10-3

Pohick Creek Potomac Stream Conditions

The Stream Conditions **Map 2.2.10-3** denotes the generally observed stream conditions as documented in the 2005 SPA and through additional, windshield level field reconnaissance performed for this study. The Stream Conditions Map demonstrates the general conditions of the main stem streams and tributaries in the WMA along with a series of features that typically impact stream condition, including stream channel erosion, channel widening, stream buffer condition, discharge pipe and ditch impacts, and utility and road crossing impacts.

In the Potomac WMA, the most prevalent stream condition features noted were stream channel widening and incision. Given the lack of development in this WMA, these conditions may be attributable to the fairly steep drop in elevation seen between points in Pohick Bay Regional Park

and Pohick Bay itself. The elevation drop and soil conditions may give rise to excessive channel incision and head cutting, which was also documented on two small tributaries in the park draining to Pohick Bay. No pipe infrastructure was documented in this WMA and no crossing or utility impacts were noted in this WMA.
