# POHICK CREEK DRAFT Watershed Workbook September 2008

Fairfax County  
Watershed Planning & Assessment Branch  
Stormwater Planning Division  
Department of Public Works & Environmental Services

DRAFT Watershed Workbook –**Pohick Creek Watershed**

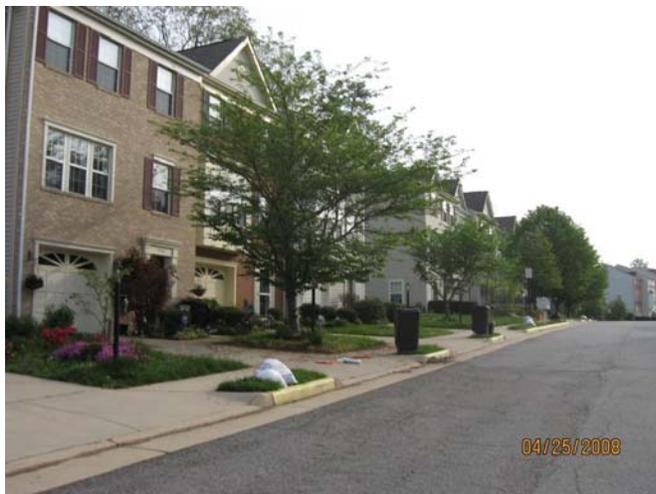
**Figure 1: Pohick Creek Impervious Areas**

Impervious areas can be described as hard surfaces that stormwater (rain water) can not penetrate and consequently runs off into a collection system. Increased impervious surfaces can result in channel erosion and downstream degradation caused by the increased volume and velocity of new stormwater runoff reaching receiving waters. It has been shown that levels of 10-20% impervious surface significantly reduce stream health (Annual Report, 2005). Over the decades, Pohick Creek has experience population growth and consequently an increase in impervious surface due to new development and supporting infrastructure development.

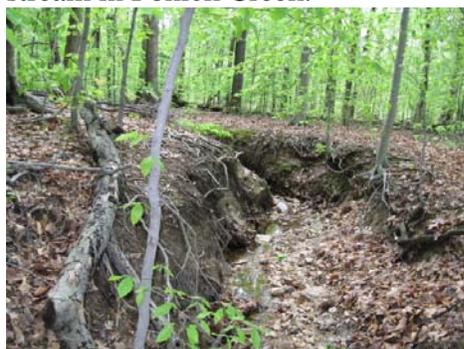
**Figure 2: Pohick Creek Bank Erosion**

In 2005, the County released the Stream Physical Assessment (SPA) report which documented the instream conditions of more than 800 stream miles. Both habitat assessment and some infrastructure assessment (if found instream) were captured. The infrastructure assessment was included to determine the impacts on streams from specific infrastructure and problem areas. For each watershed, a visual evaluation of infrastructure such as road culverts and stormwater outfalls was performed; any potential impacts to the stream were documented with an impact score. The impact scores ranged from zero to ten (10) or greater, with zero indicating no impact and ten indicating extreme conditions. An extreme condition would include such things as impervious encroachment near the stream severe erosional areas and large obstructions in the channel. See photo below for an example of stream bank erosion located along the South Run stream in Pohick Creek.

In Pohick Creek a total of 871 inventory points were visually assessed. The most significant problems were related to four head cuts, two exposed utility lines and one pipe, which were each given an impact score of 10, with the two highest impacts both being deficient buffers, each scoring a five. Table 4 below identifies the full scoring for the Pohick Creek watershed.

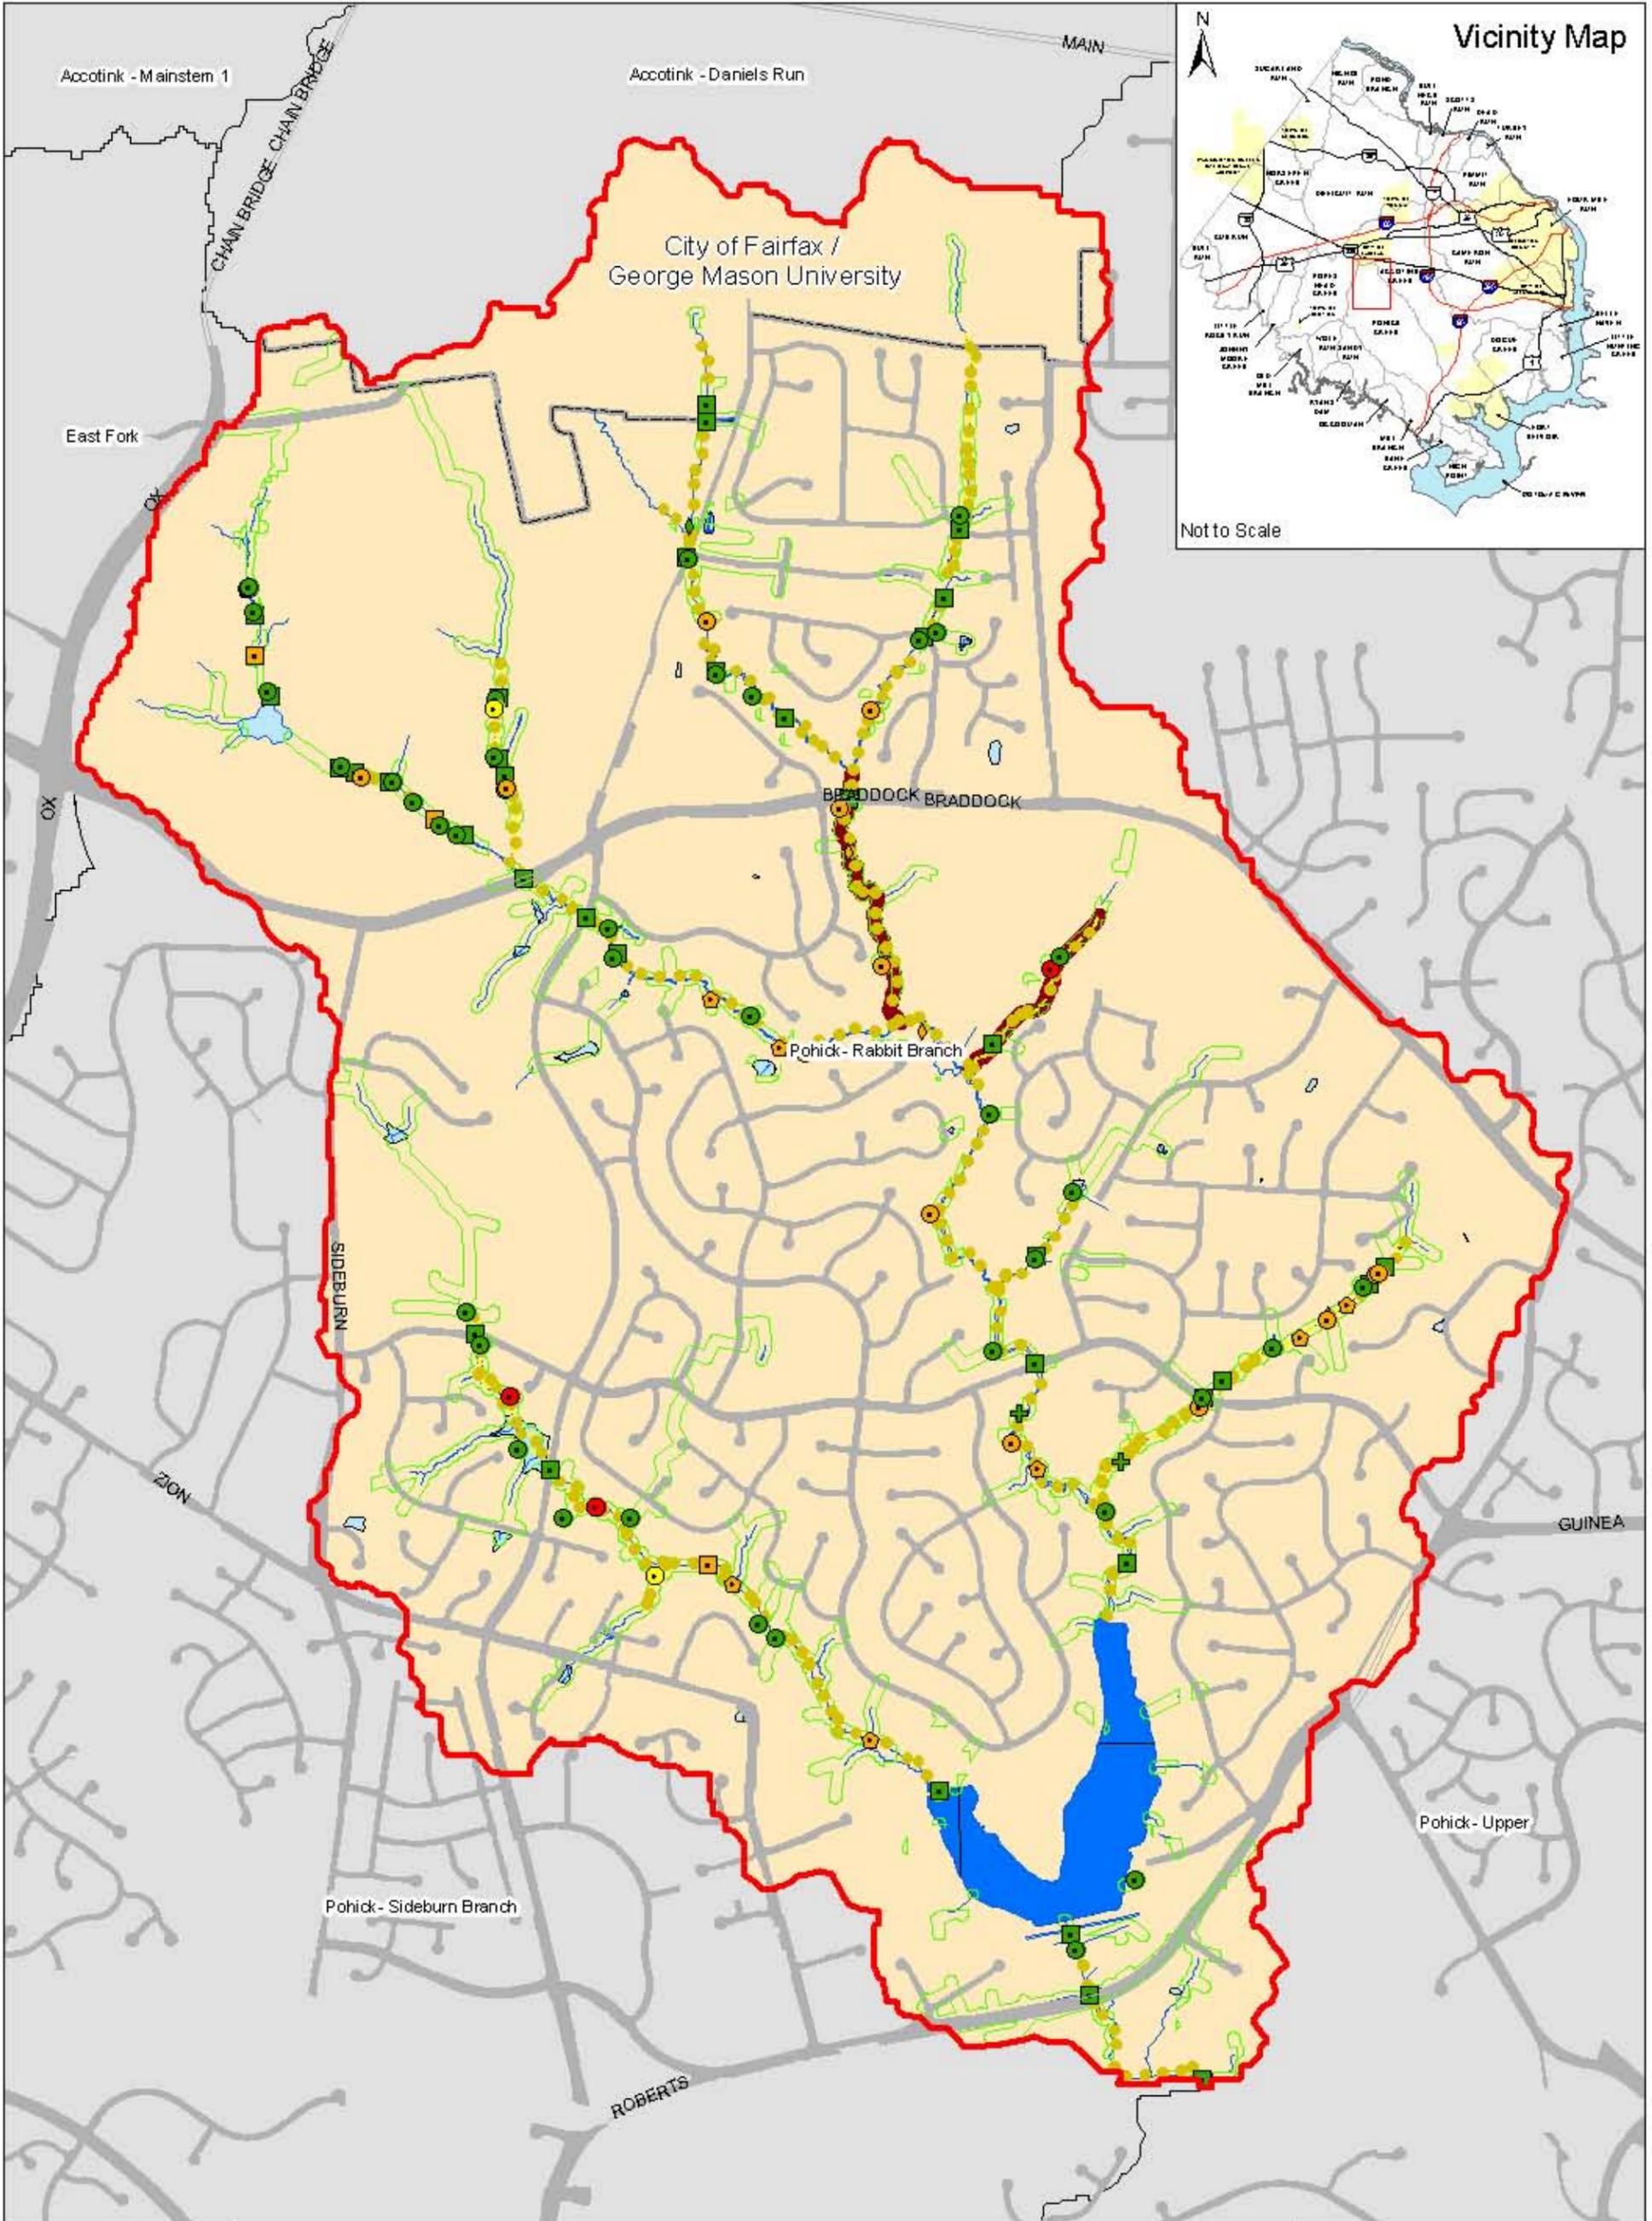
Map 2.2.1-3

Legend						
Poor/Very Poor Habitat	CEM - Type 2: Incision	Disturbed Buffer	Lake	Other WMA Boundaries	Pohick - Rabbit Branch	
Streams and Rivers	CEM - Type 3: Widening	Roads	Storm Drainage Facilities			
Erosion/Bank Instability						
<b>Obstruction Impact</b>	<b>Dump Site Impact</b>	<b>Head Cut Height</b>	<b>Pipe Impact</b>	<b>Ditch Impact</b>	<b>Utility Impact</b>	<b>Crossing Impact</b>
Minor to Moderate	Minor to Moderate	0.5' - 1'	Minor to Moderate	Minor to Moderate	Minor to Moderate	Minor to Moderate
Moderate to Severe	Moderate to Severe	1' - 2'	Moderate to Severe	Moderate to Severe	Moderate to Severe	Moderate to Severe
Severe to Extreme	Severe to Extreme	>2'	Severe to Extreme	Severe to Extreme	Severe to Extreme	Severe to Extreme

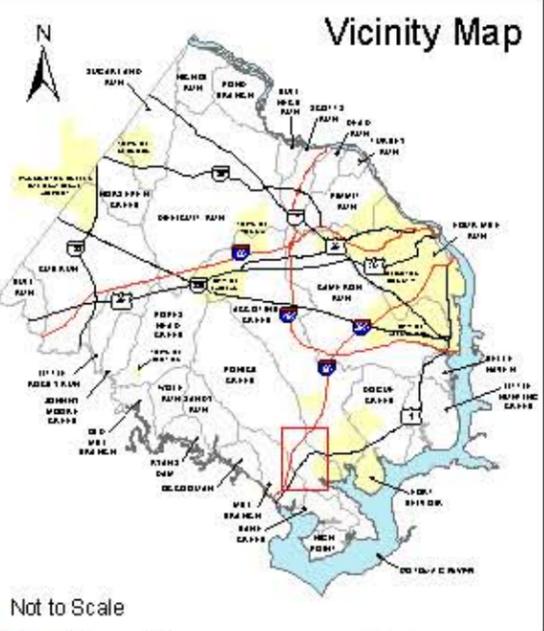
Map 2.2.9-2  
 Pohick Creek  
 Pohick Creek Lower  
 Stormwater Infrastructure

Legend			
	Storm Drainage		Roads
	Rivers and Streams		Subbasins
	Drainage Complaints		Lake
	Buildings		Storm Drainage Facilities
	WMA - Other		Pohick - Lower

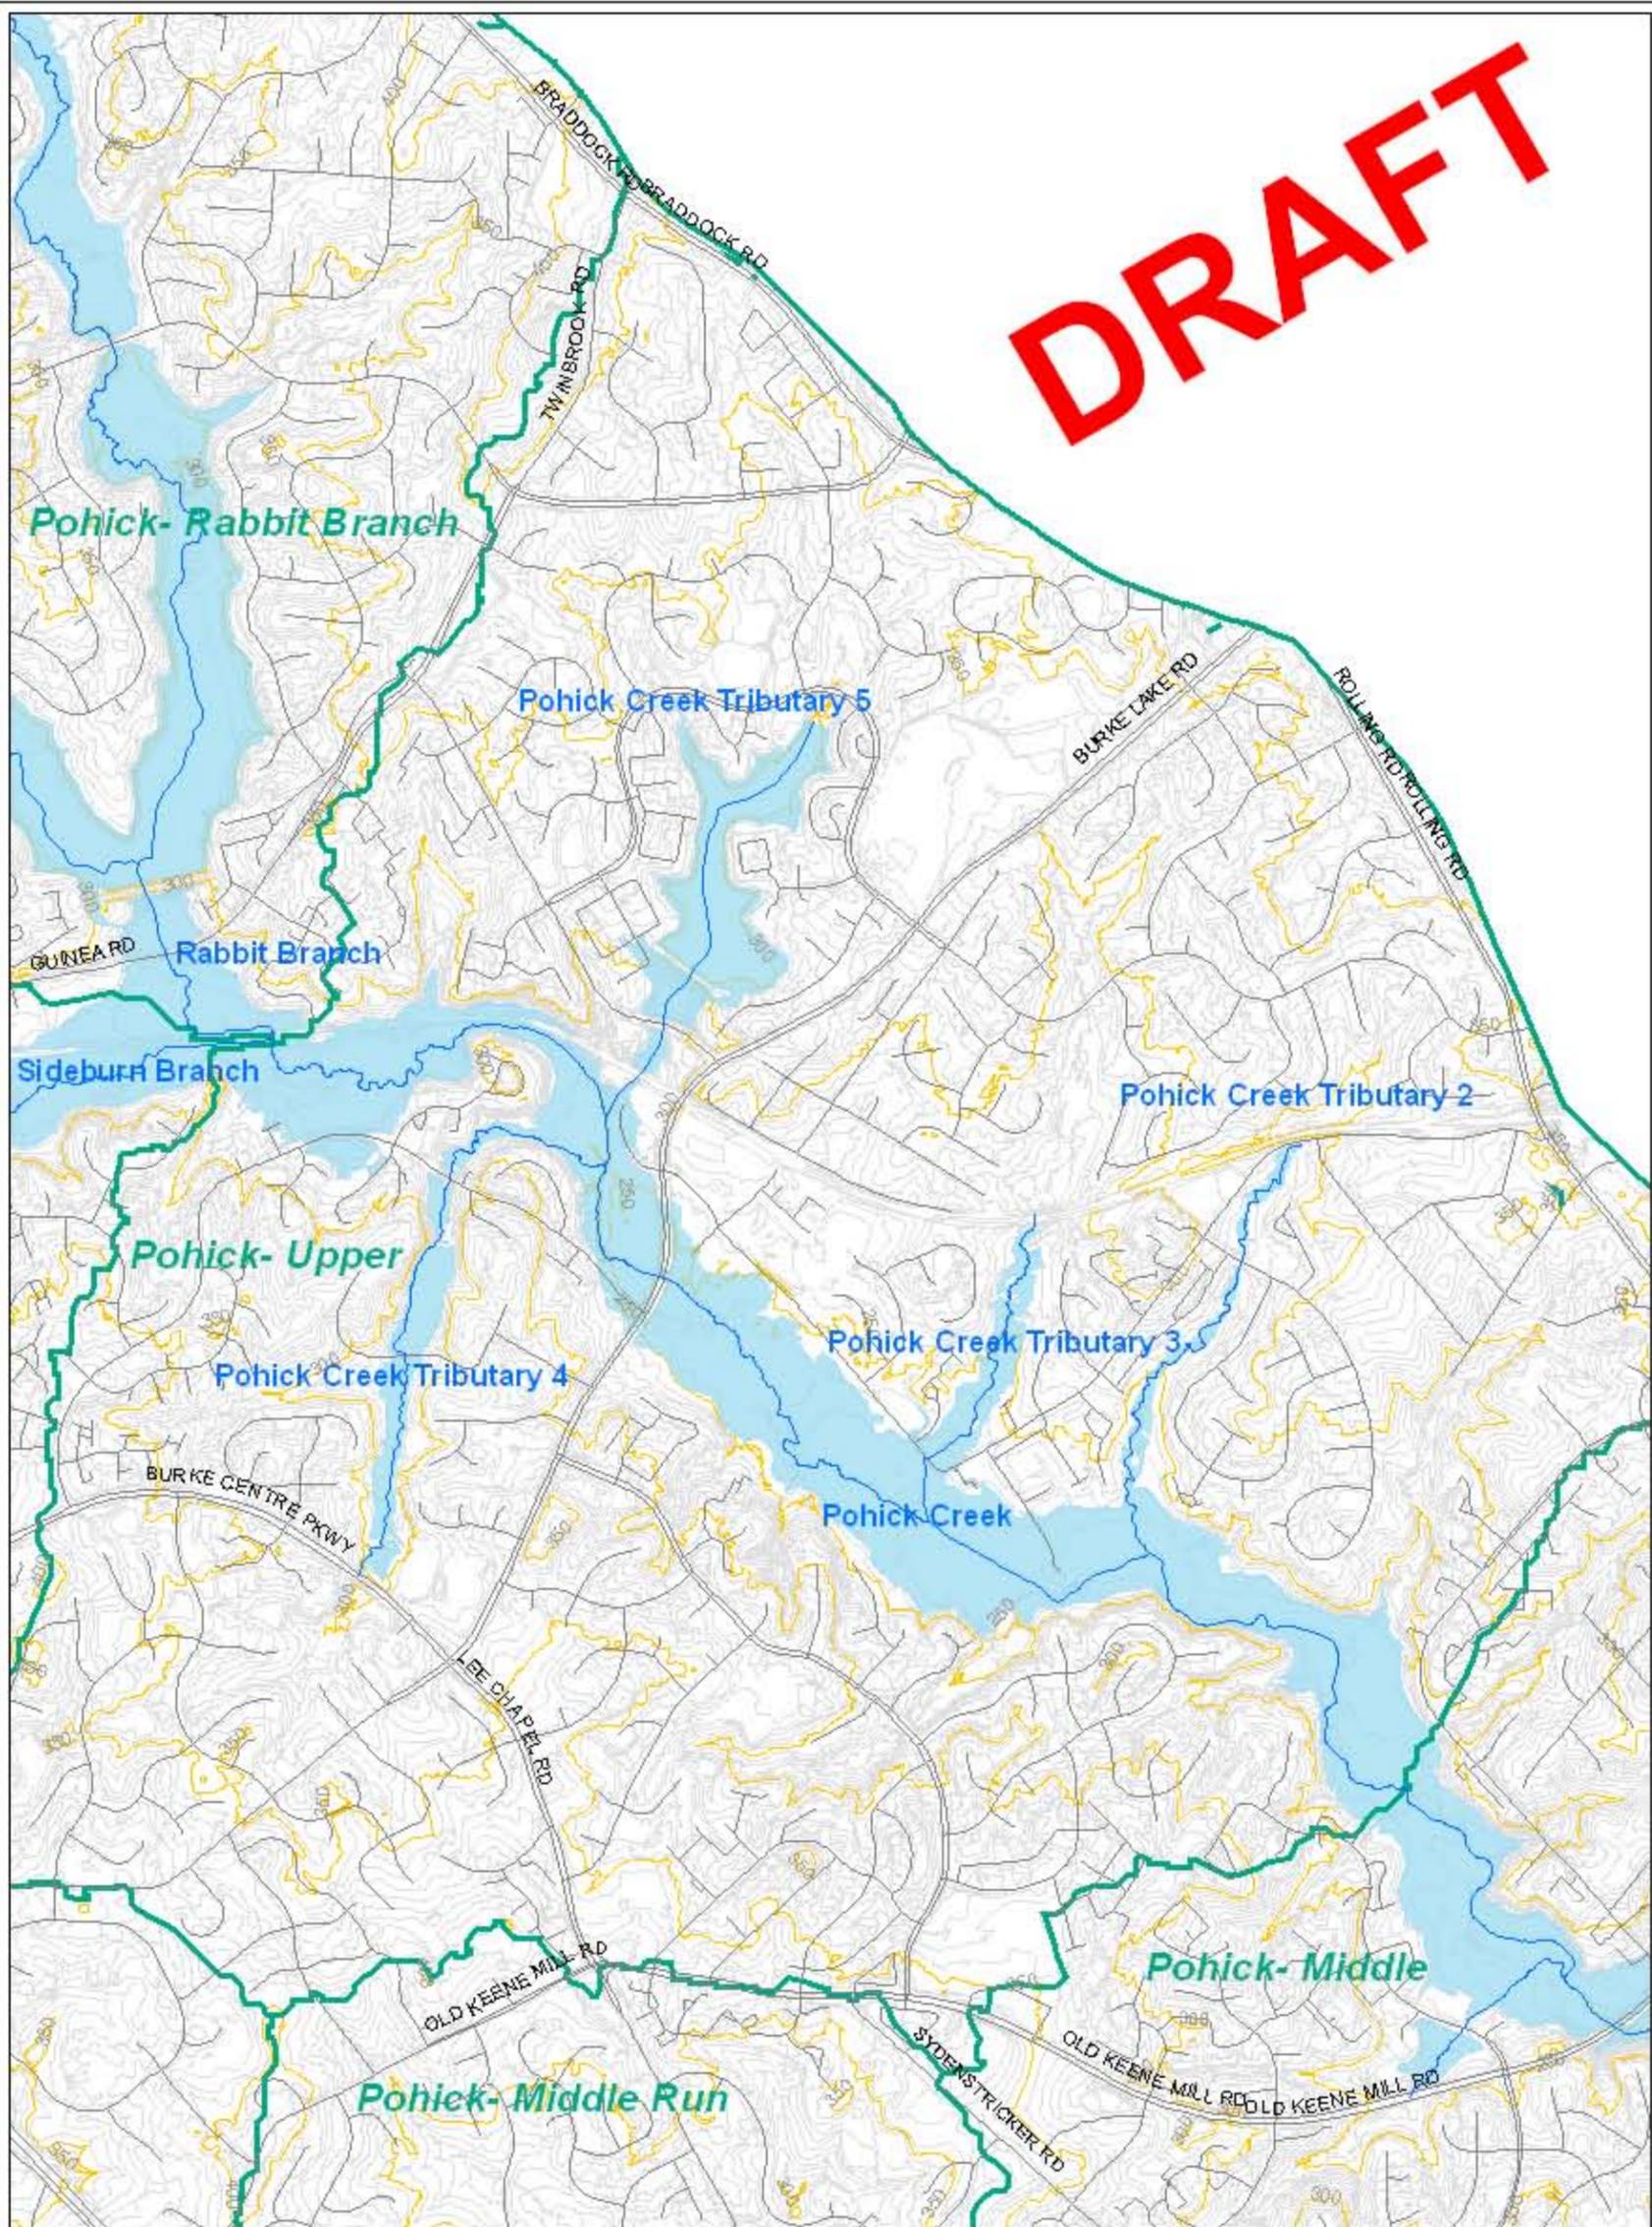
**Map 2.3.2-2 Pohick Creek Watershed  
Pohick - Upper WMA  
100 Year Floodplains**

- Legend**
- Streams
  - Streets
  - WMA
  - 100 Year Floodplain
  - Contours
  - 10-ft interval
  - 50-ft interval
