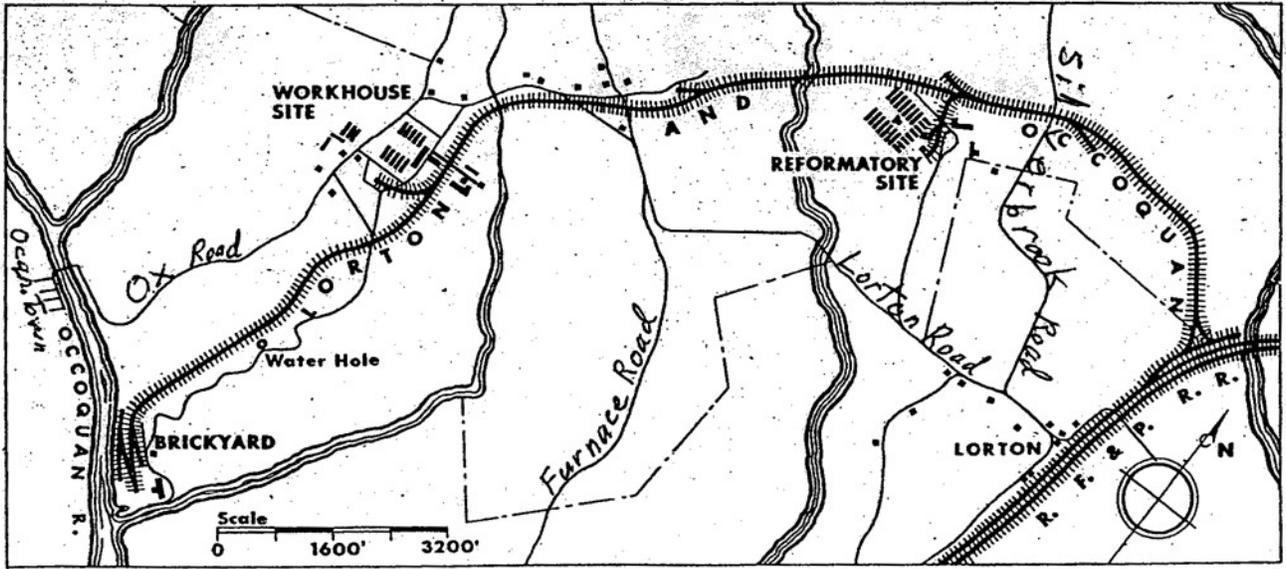
Map Showing the Lorton and Occoquan RR.
(Circa 1928-30)

Figure 1: Ca. 1928-30 the Prison constructed a short line, The Lorton and Occoquan Railroad, between a station at Lorton on the Richmond, Fredericksburg & Potomac Railroad and the brickyard along the Occoquan River (shown here). The line ran through both the Reformatory and Workhouse complexes.

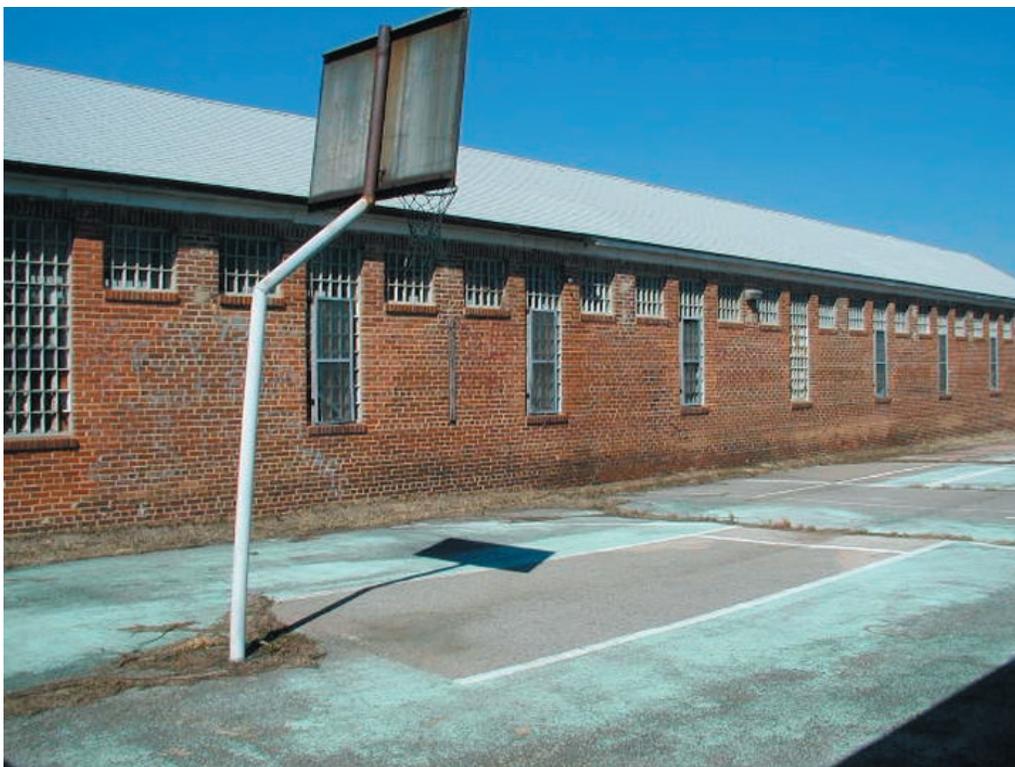
Photo 3: Building R-8 (Dormitory 12), east wall. This building forms a part of the Reformatory Quadrangle. The foreground is an exercise yard (S-2).

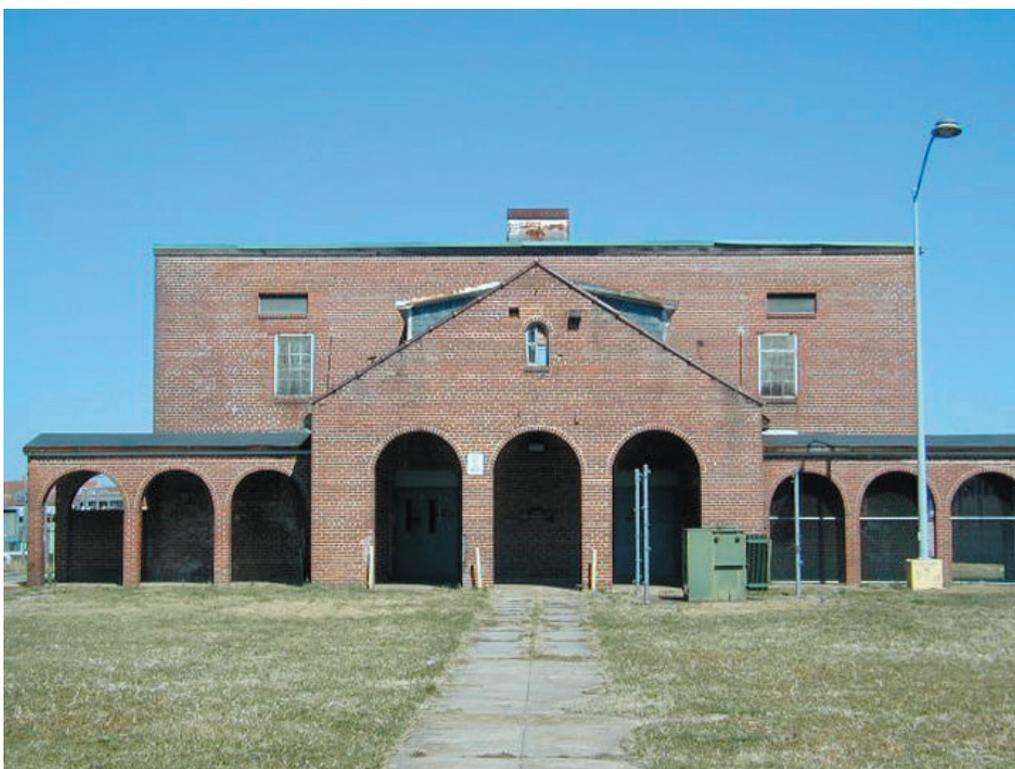
Photo 4: Building R-2 (Gymnasium) from the quad. This building was originally built as a school and hospital facility. It edges the Reformatory Quadrangle.

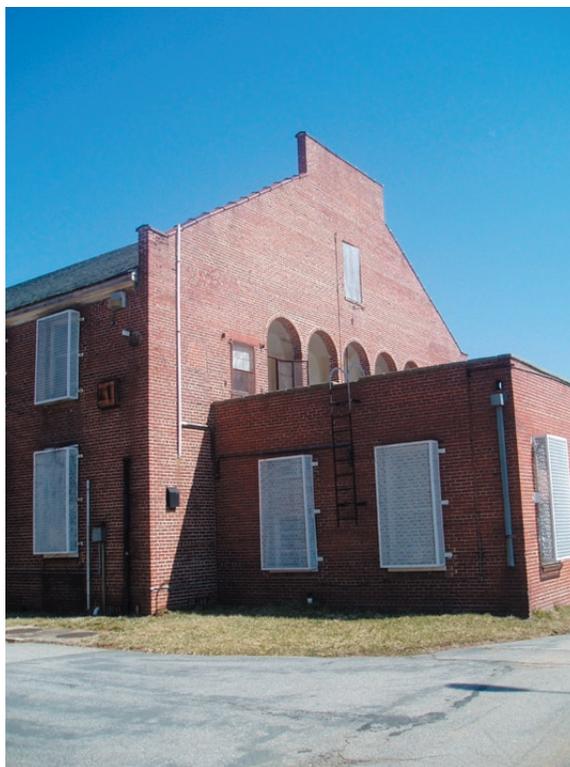
Photo 5: Building R-3 (the Dental Facility/
Dorm 24), southwest corner. This building
was originally built as a combination auditor-
ium and hospital.

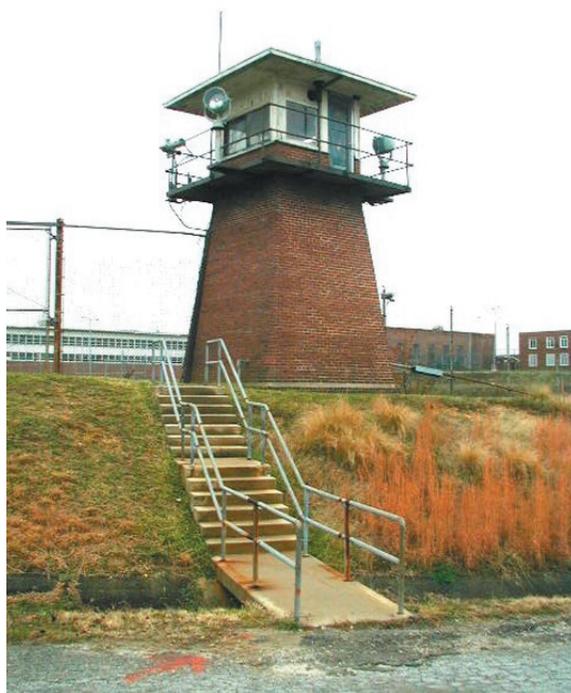
Photo 6: Building R-55 (Tower 2) was built
in 1940. It is located northwest of the Refor-
matory Quadrangle.

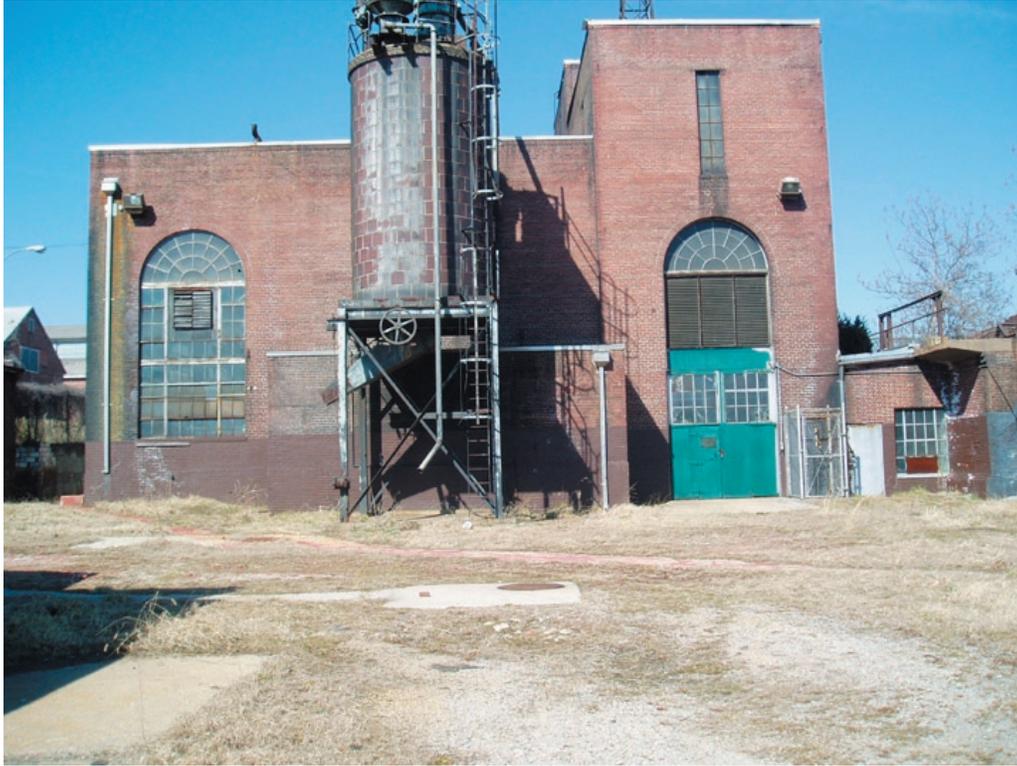
Photo 7: Building R-30 (Steam Heat Plant), south elevation. This structure was built in 1932.

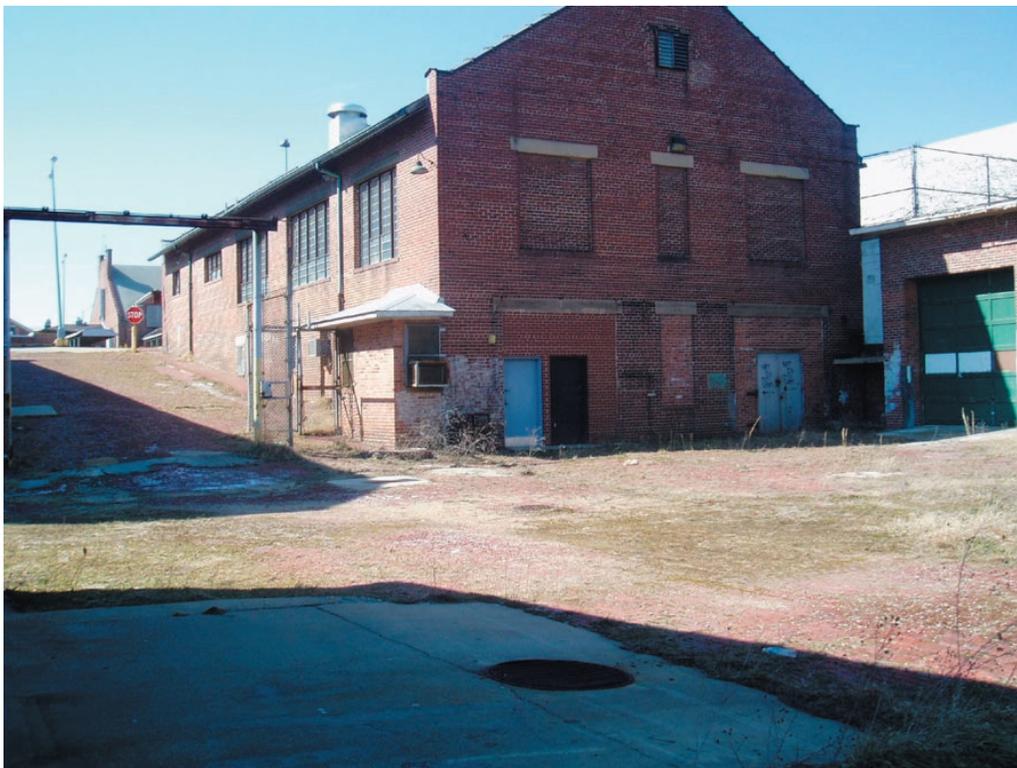
Photo 8: Building R-20 (Dorm 19-OFACM Shop), built in 1920-23, from the southeast. Note brick roads (RT-21) in the foreground and along the left side.

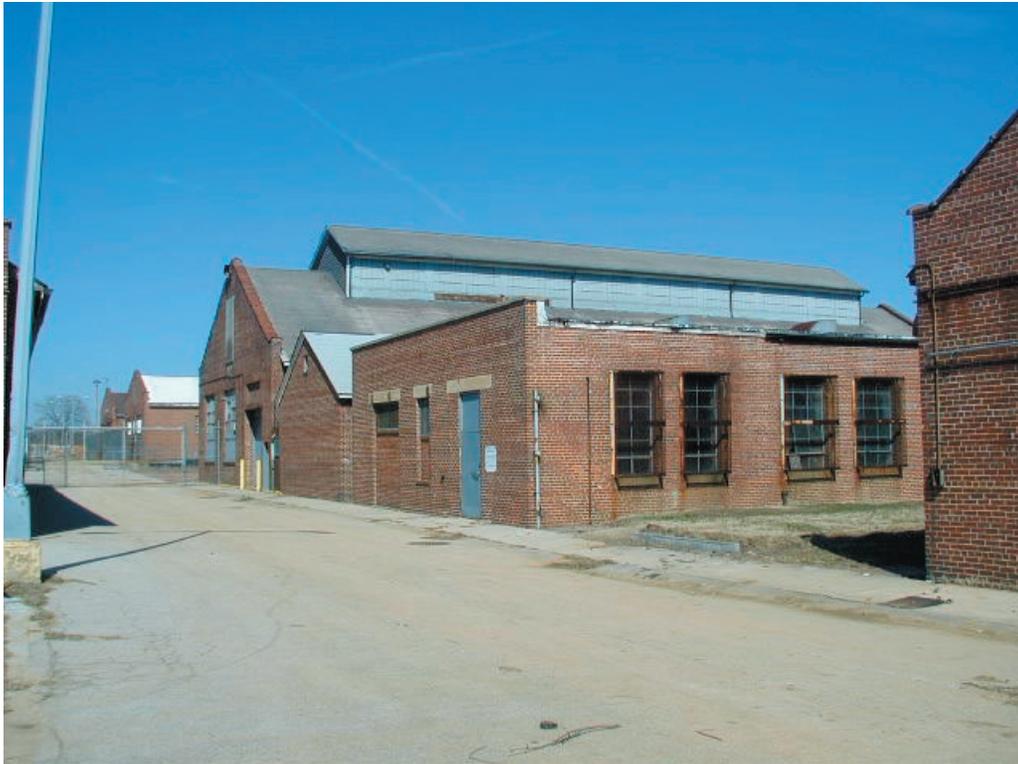
Photo 9: Buildings R-28 (Laundry) and R-23 (Laundry Annex), built ca. 1930, from the southwest.

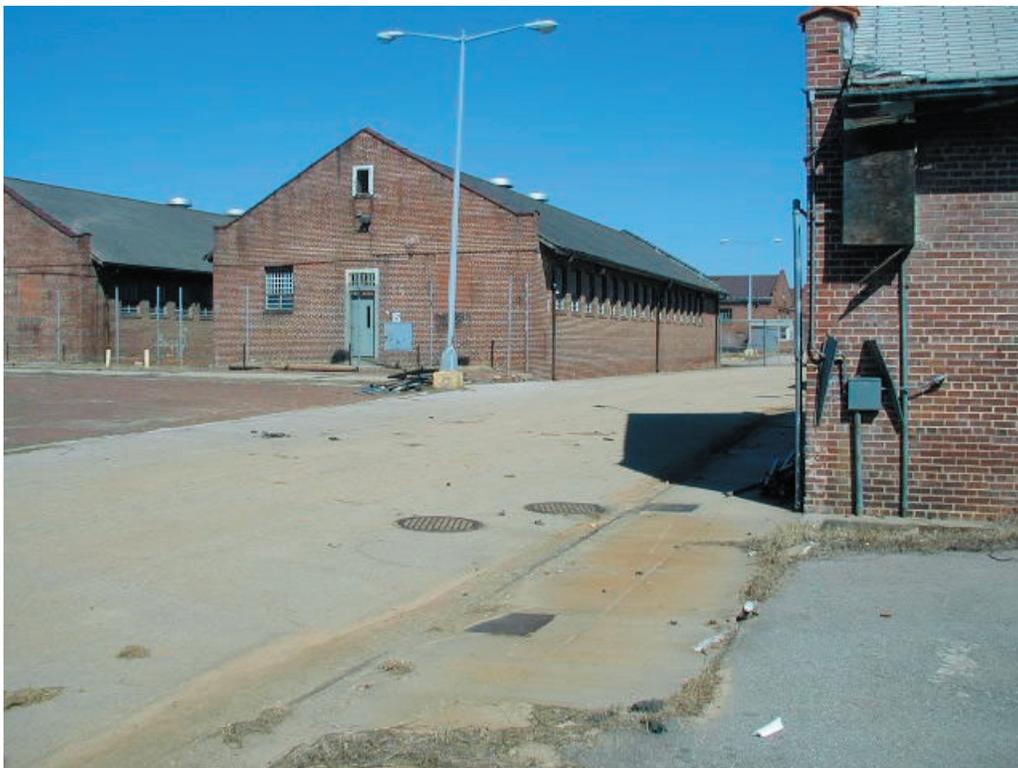
Photo 10: Building R-25 (Dorm 21) at center, built 1924-30, from the southeast.

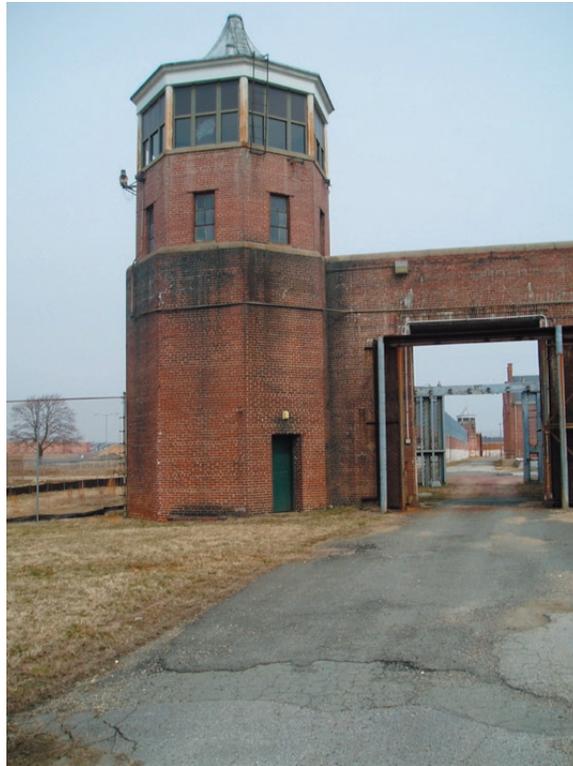
Photo 15: Building P-10 (Tower 7) and gate, south elevation. This tower was constructed in 1940.

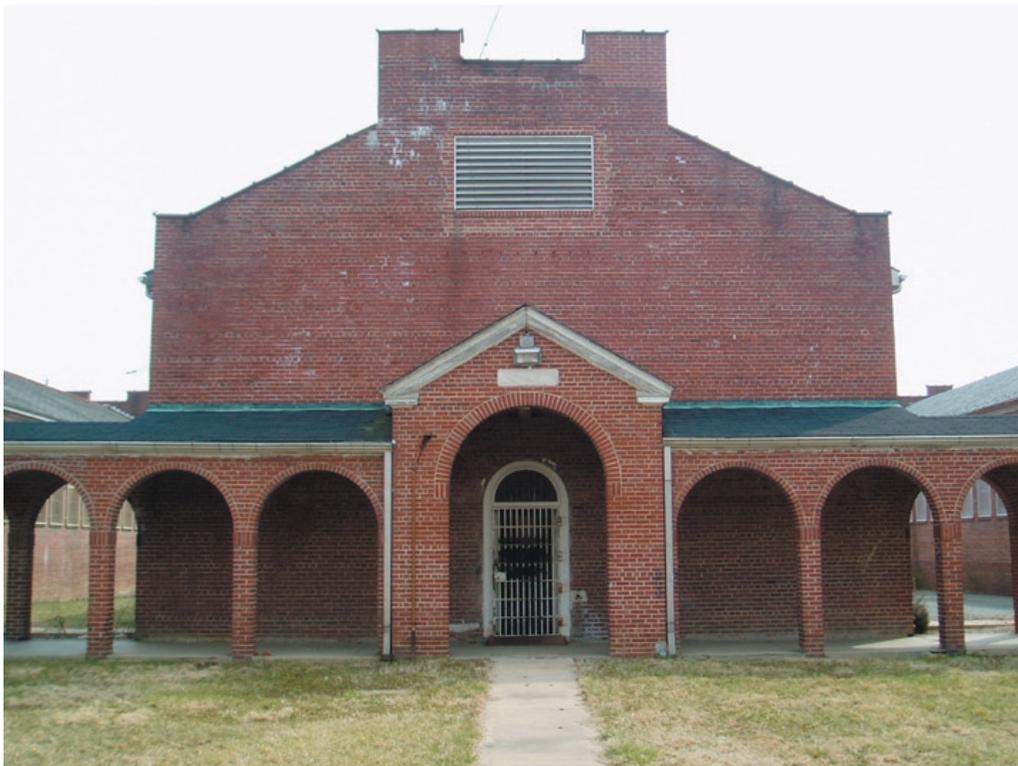
Photo 16: Building P-4 (Cellblock 4), west elevation. This building was constructed in 1935.

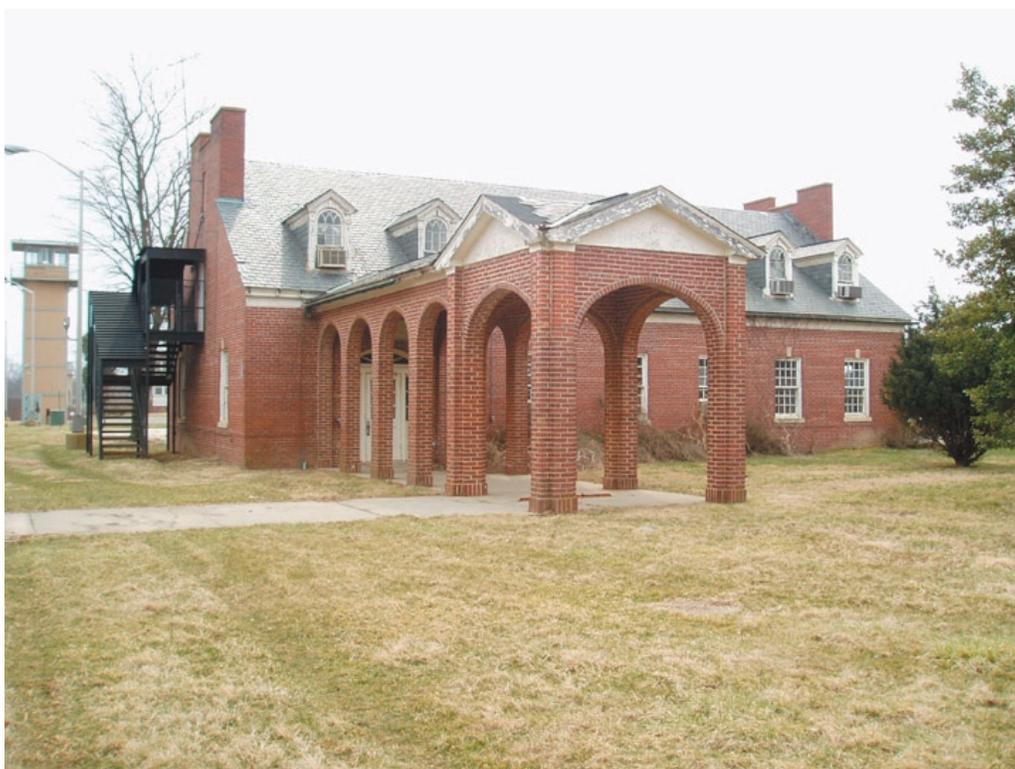
Photo 19: Building W-15 (Assistant Director's office), view of the northwest corner with its truncated arcade extension.

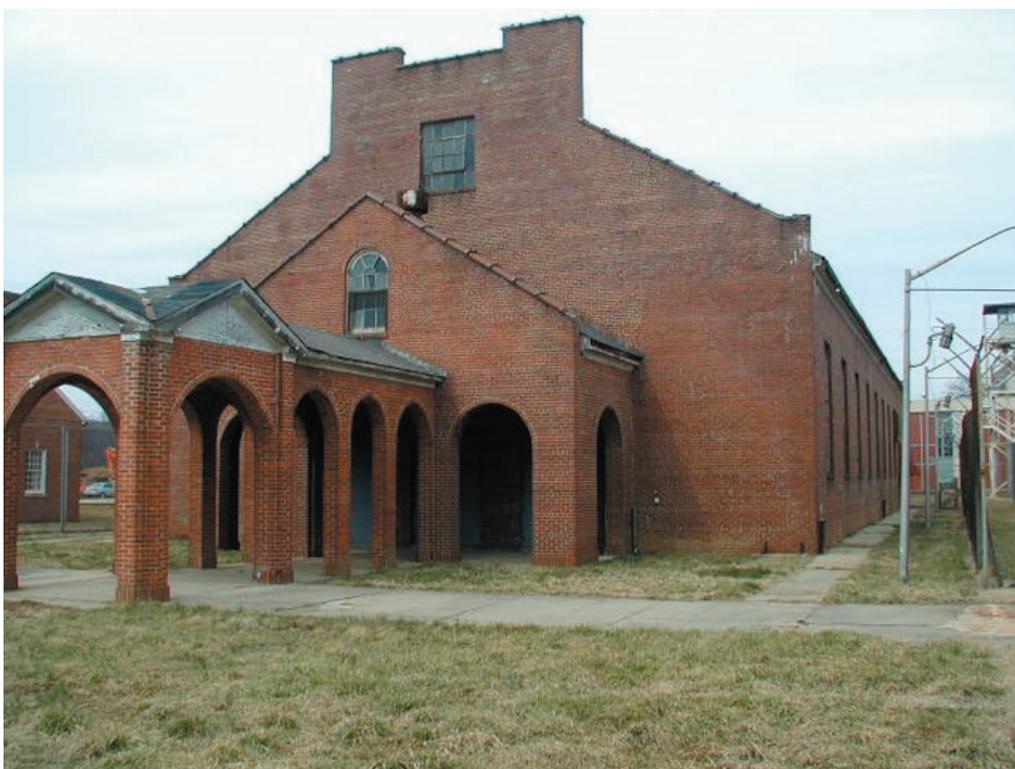
Photo 20: Building W-12 (Gymnasium), north gable elevation looking south-east. The building, constructed in 1930, has a slate roof, a projecting gabled entrance pavilion.

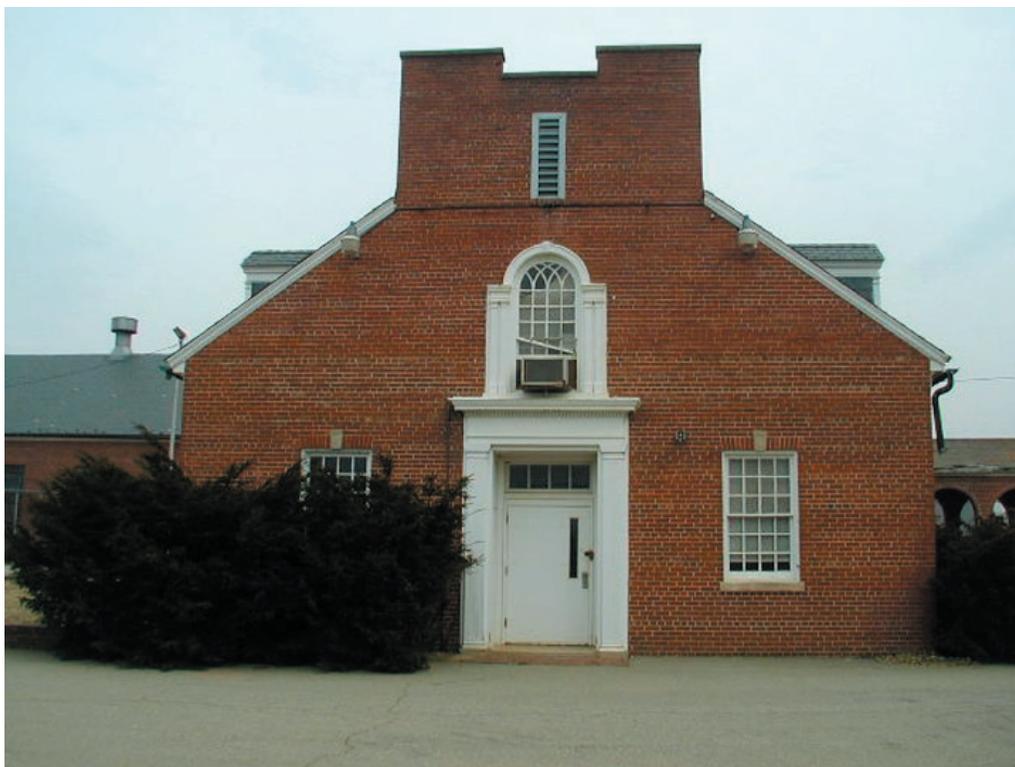
Photo 21: Building W-13 (Educational Services Building), east gable end. This Colonial Revival-style building was constructed in 1930.

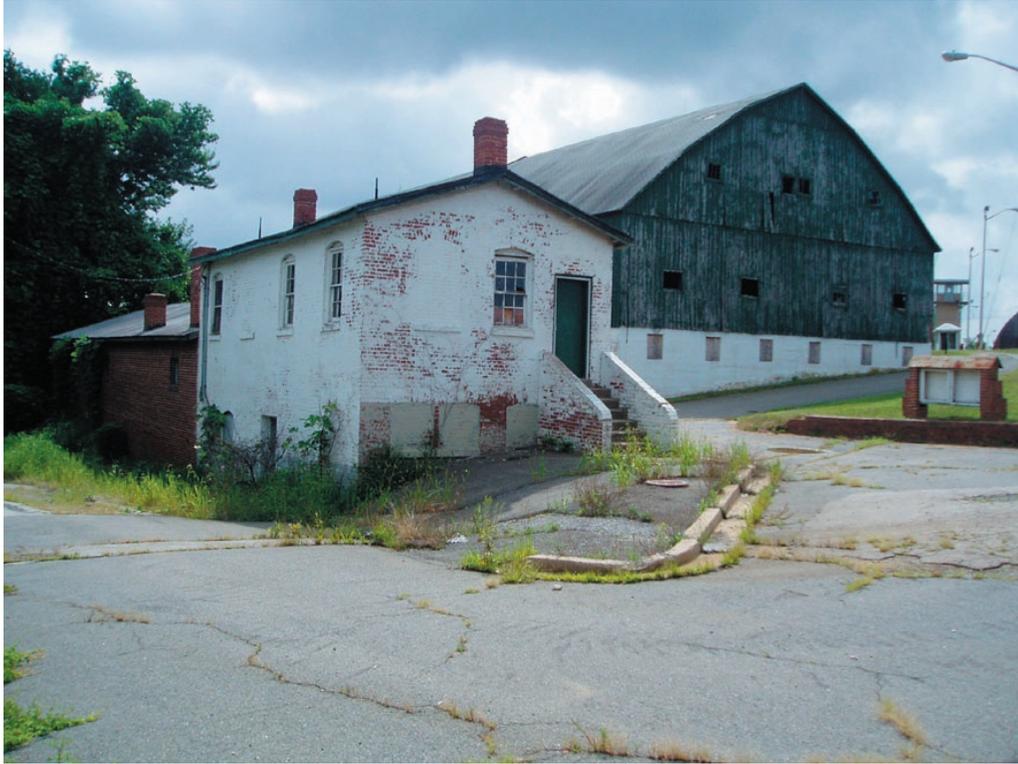
Photo 23: View from the northwest of W-23 (Farm equipment storage) and W-22 (Barn), built in 1925, at the Workhouse. WO-04 (Notice board) is visible at the right.

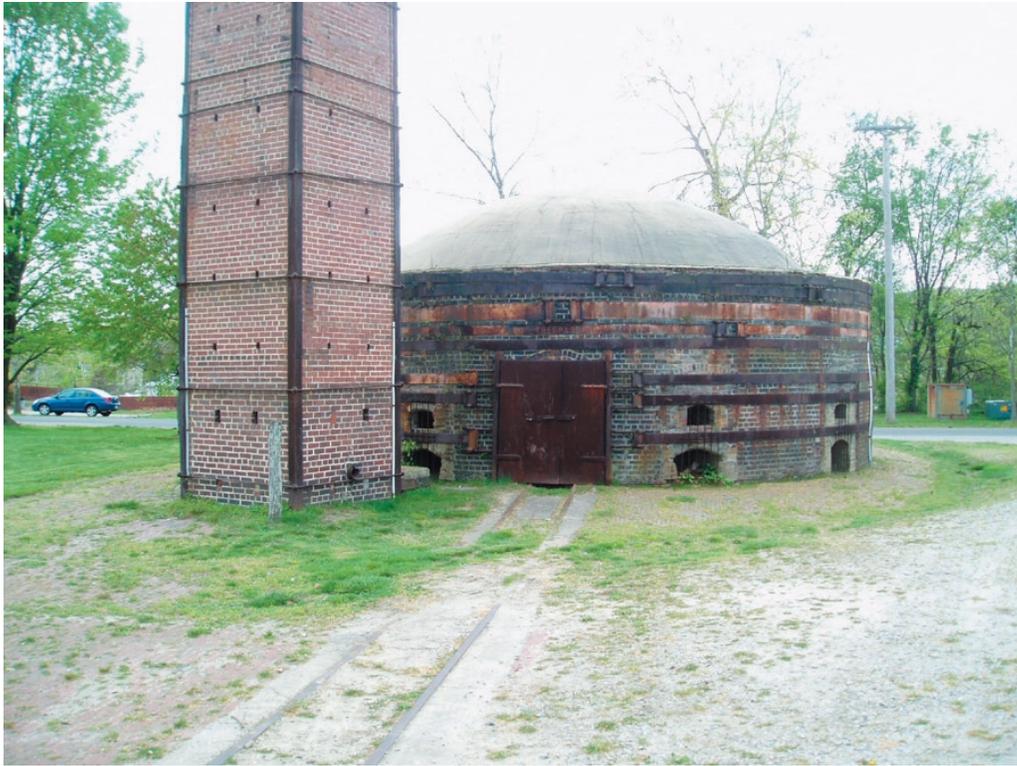
Photo 25: Structure LT-07, the beehive-style kiln was built circa 1915 as part of the prison brickyard complex.

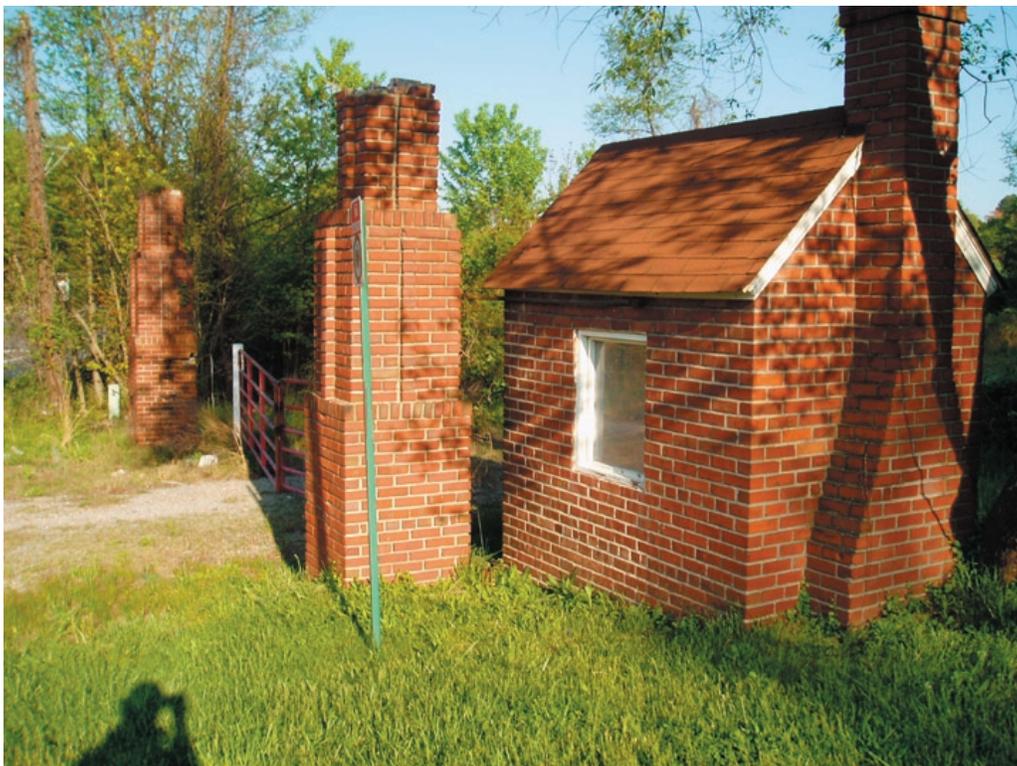
Photo 26: Old entry gate (RT-04), including gateposts and gatehouse, looking northwest.

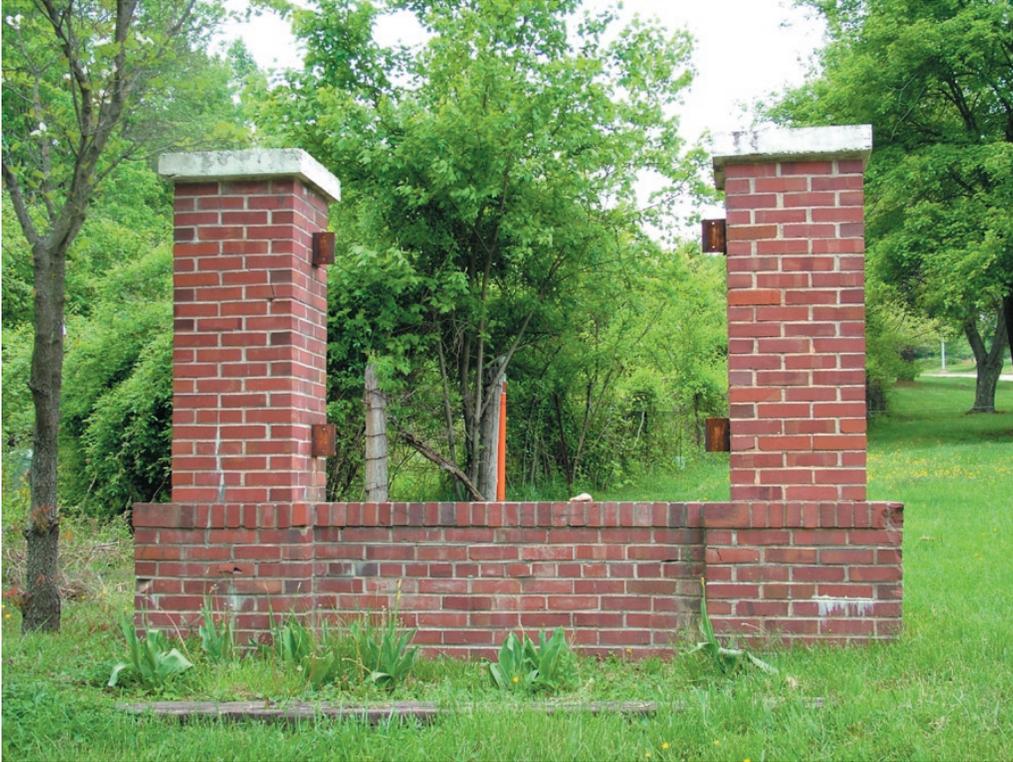
Photo 27: A brick sign support (RO-01) at the Reformatory's entrance drive.

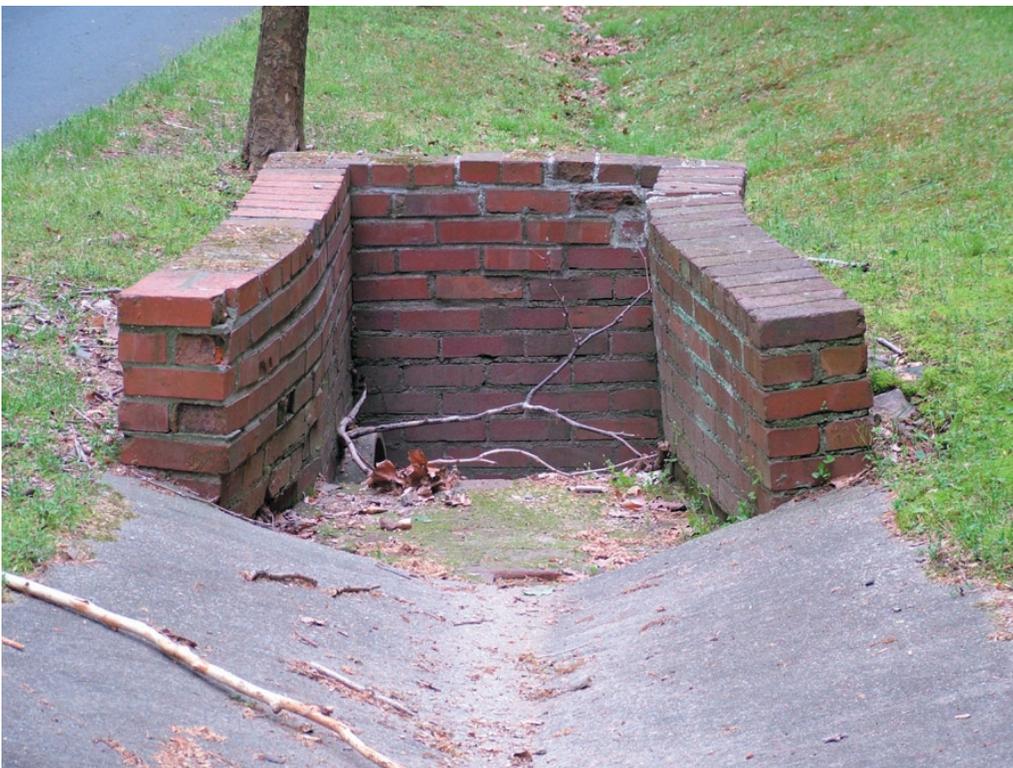
Photo 28: One of the collection of culverts with brick headwalls that exist throughout the district. This type of culvert (LO-02) is found along the rail trace to the brickyard.

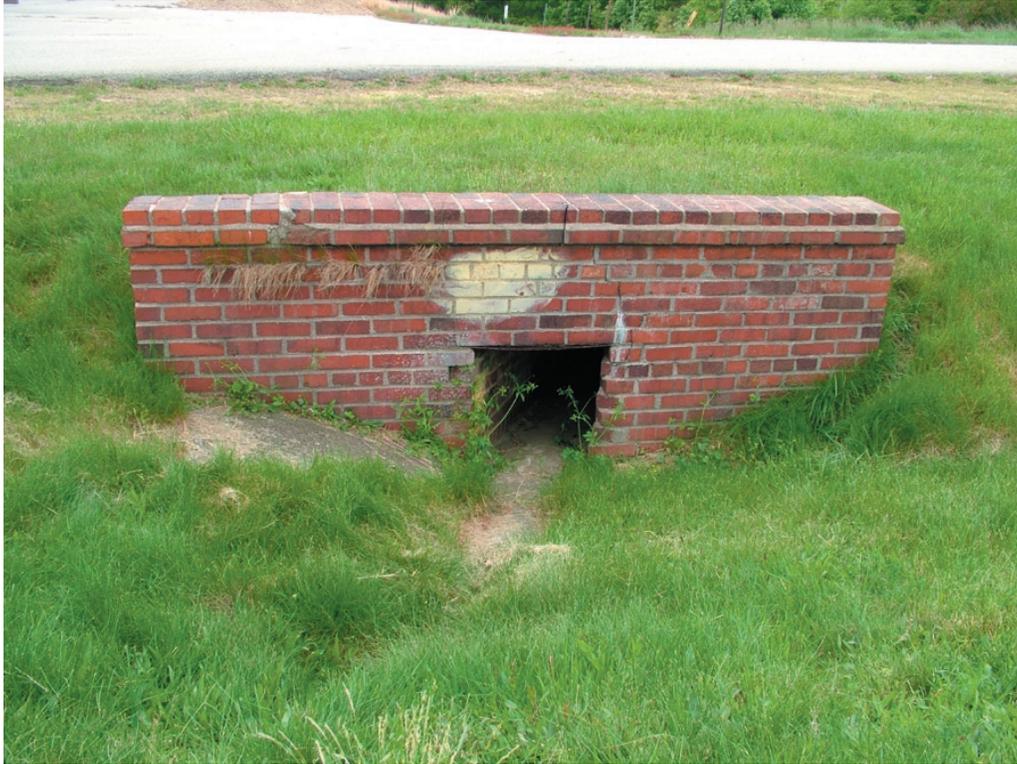
Photo 29: Another culvert brick headwall type (RO-04) at the Reformatory.

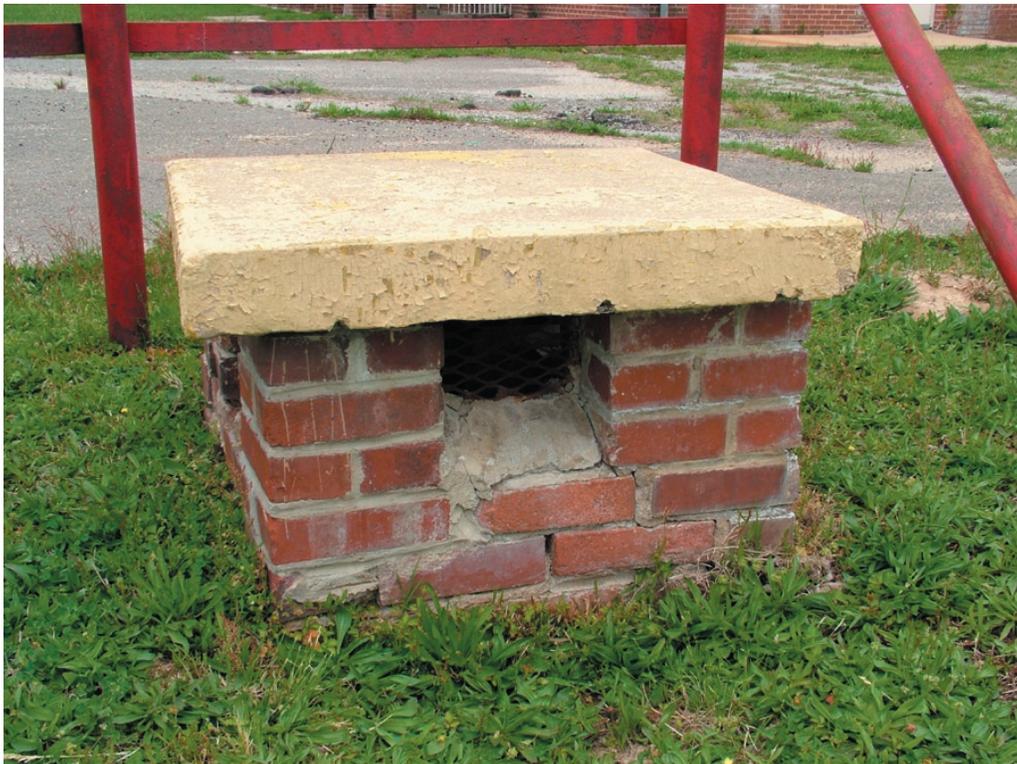
Photo 30: A brick and concrete ventilation shaft (PO-01) at the Penitentiary.

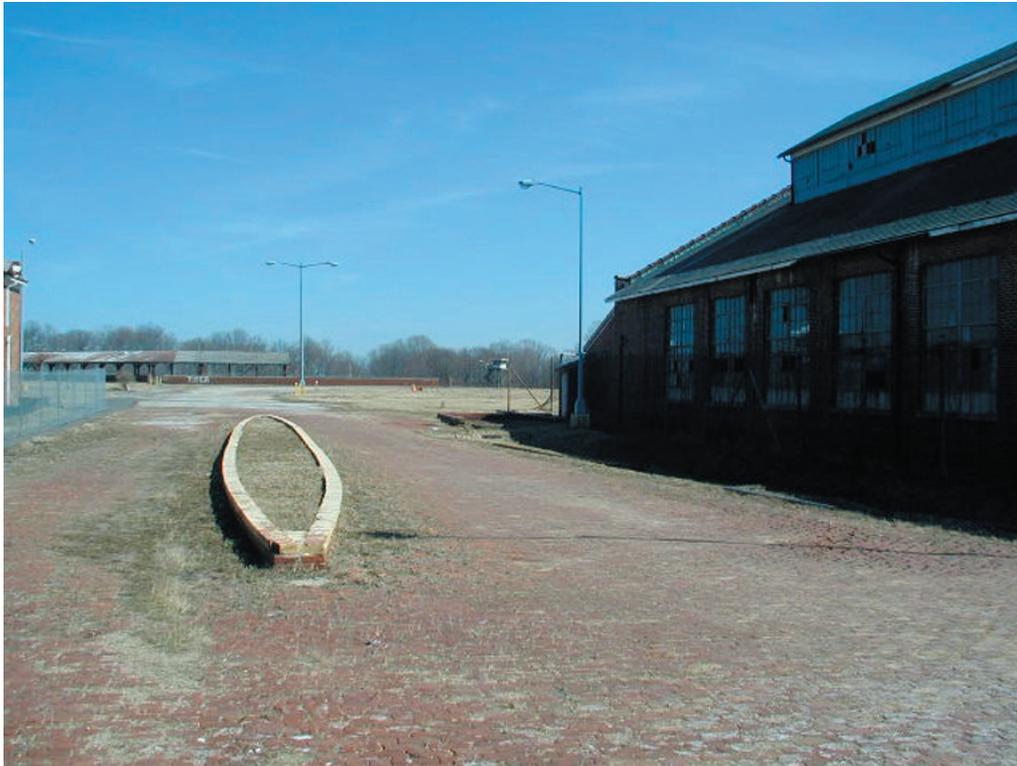
Photo 31: A lenticular-shaped brick-edged planter (RO-08) divides a brick paved road (RT-21) north of building R-28 (laundry).

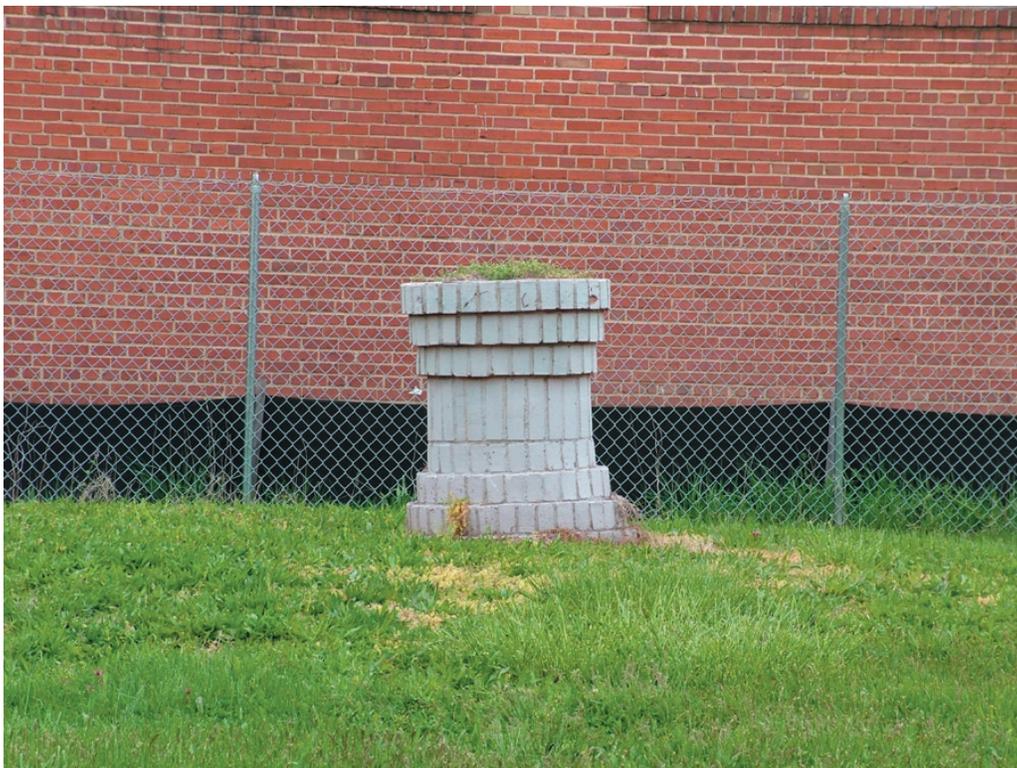
Photo 32: This brick planter (RO-09) is a feature of a remnant rose garden (S-03) at the Reformatory.

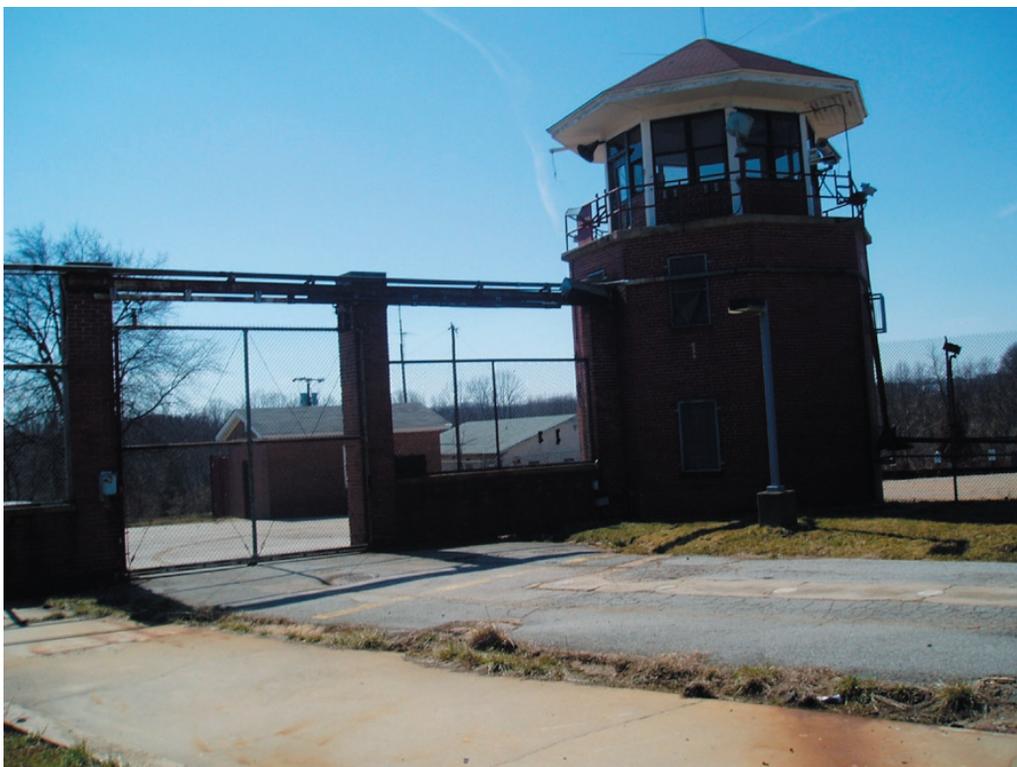
Photo 33: Reformatory Tower 1 (R-54) stands beside the southwestern gate into the complex, which is surrounded by a chain-link fence (RO-07).

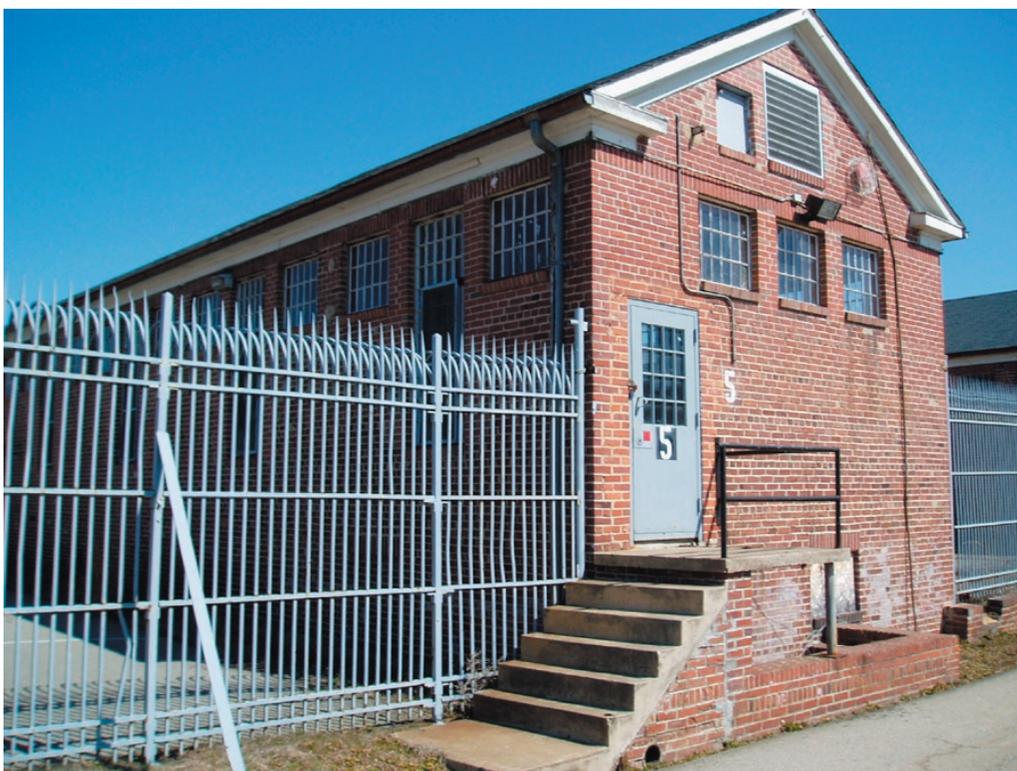
Photo 34: A painted wrought iron fence (RO-14) encloses the exercise yards between the Reformatory's south dormitories.

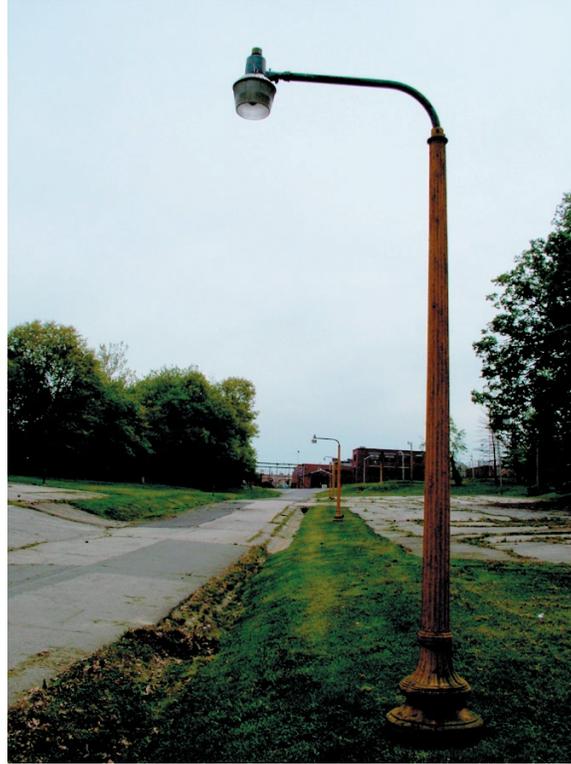
Photo 35: Historic lightposts (WO- 01) with more recent luminaires line the Workhouse Entrance Drive.
