Lake Accotink Park

Fairfax County, Virginia

Wood Turtle (*Glyptemys insculpta*) Survey and Habitat Evaluation

March 17, 2016

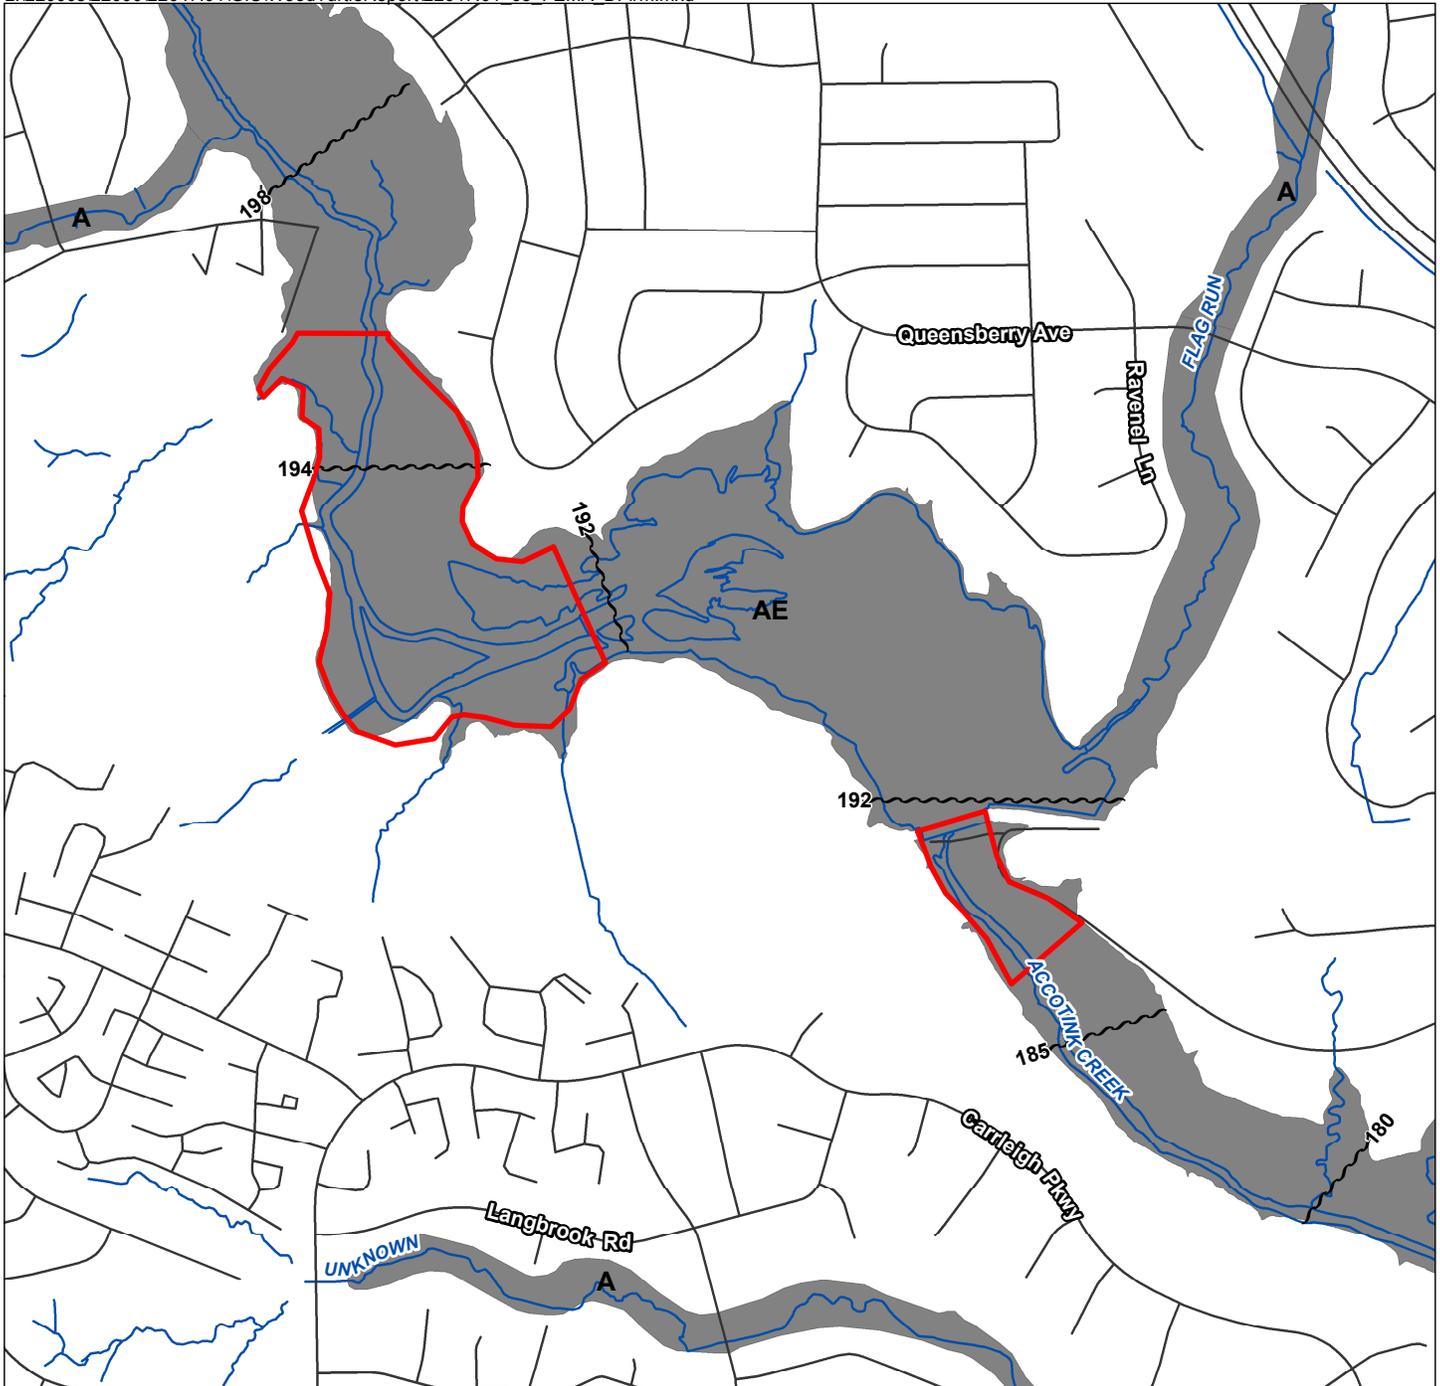
FEMA Digital Flood Insurance Rate Map
Panel 51059C0290E Effective 9/17/2010
Lake Accotink Park
Lake Sustainability Plan Ecological Survey
WSSI #22647.01
Original Scale: 1" = 1000'

- The Federal Emergency Management Agency (FEMA) Flood Insurance Rate Map Panel 51059C0290E, effective 9/17/2010 (Exhibit 3), which depicts the FEMA-mapped floodplain associated with Lake Accotink and Accotink Creek on the study areas.

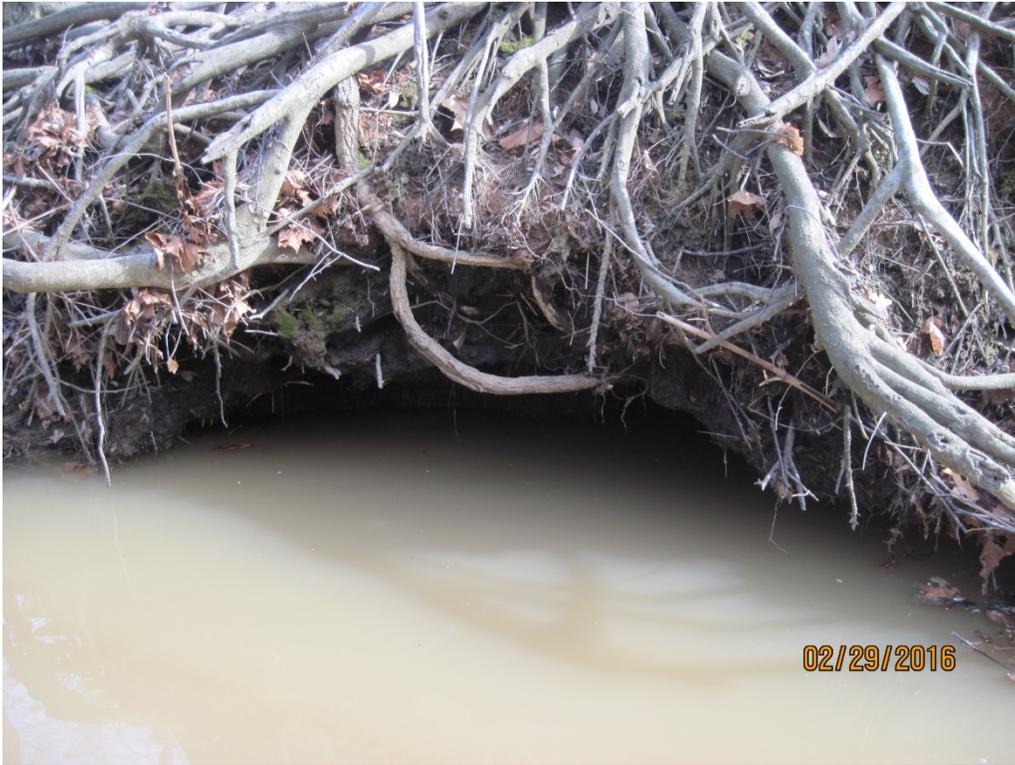
1. Looking northeast at the undercut bank of Accotink Creek, downstream of Lake Accotink. Suitable habitat for the wood turtle (*Glyptemys insculpta*) is not present in this portion of the study area due to the shallow nature of the stream and the high levels of turbidity.

The downstream portion of Accotink Creek has been heavily altered with the construction of an asphalt footpath (Photo #4) and the placement of riprap in the majority of the creek for stabilization purposes (Photos #2-3). One undercut bank was observed (Photo #1); however, the area was shallow (<2 feet) and very turbid with high siltation and thus was not considered optimal habitat for the wood turtle.

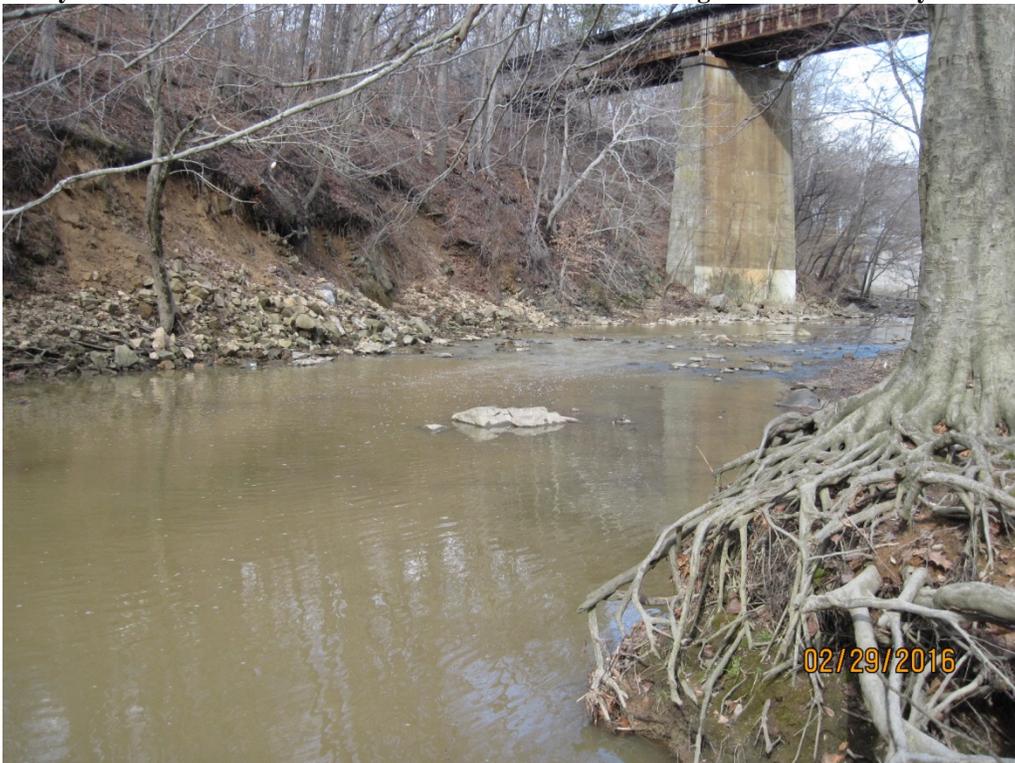
2. Looking northwest (upstream) at Accotink Creek, downstream of Lake Accotink. This area contains rip-rap and has shallow water with very turbid flow and does not provide suitable winter-phase habitat for the wood turtle.

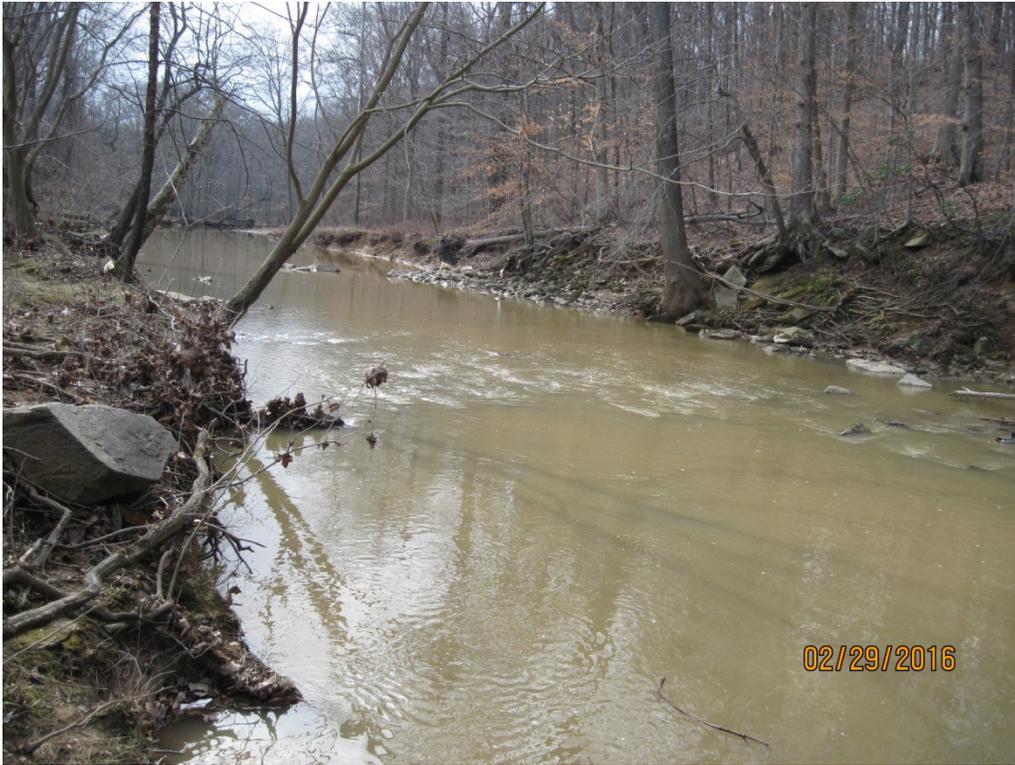
3. **Looking southeast (downstream) at Accotink Creek, downstream of Lake Accotink. This area contains rip-rap and has shallow water with very turbid flow and does not provide suitable winter-phase habitat for the wood turtle.**

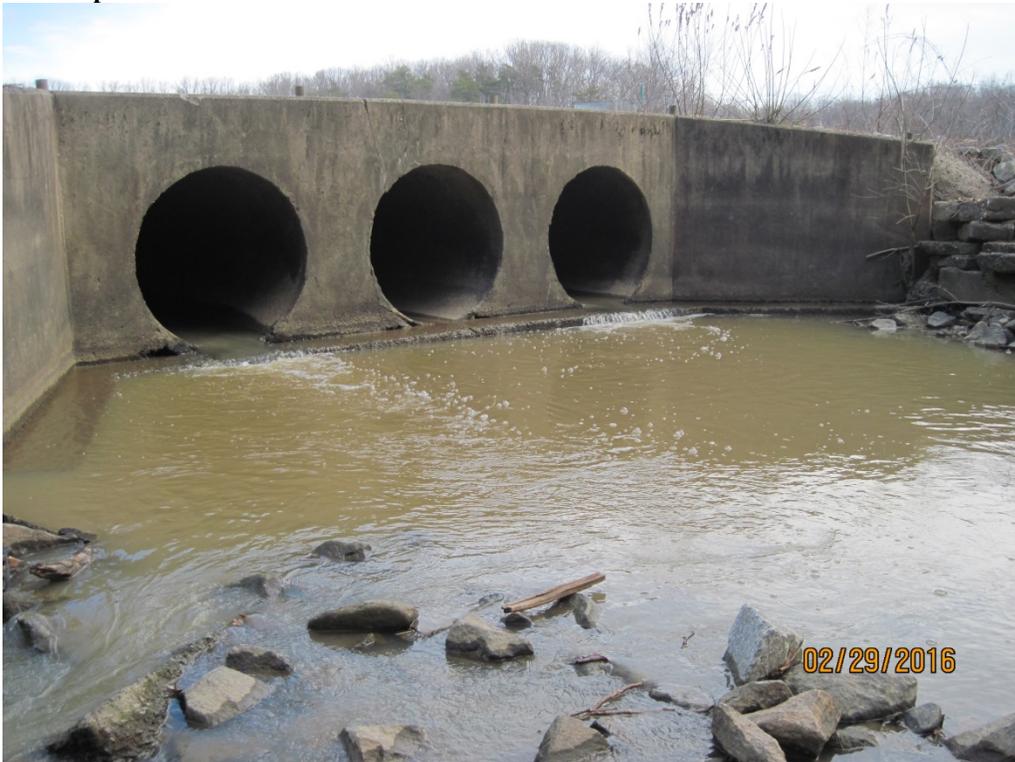
4. **Looking north-northeast at the triple culverts under the walking path downstream of Lake Accotink. This area contains rip-rap and has shallow water with very turbid flow and does not provide suitable winter-phase habitat for the wood turtle.**

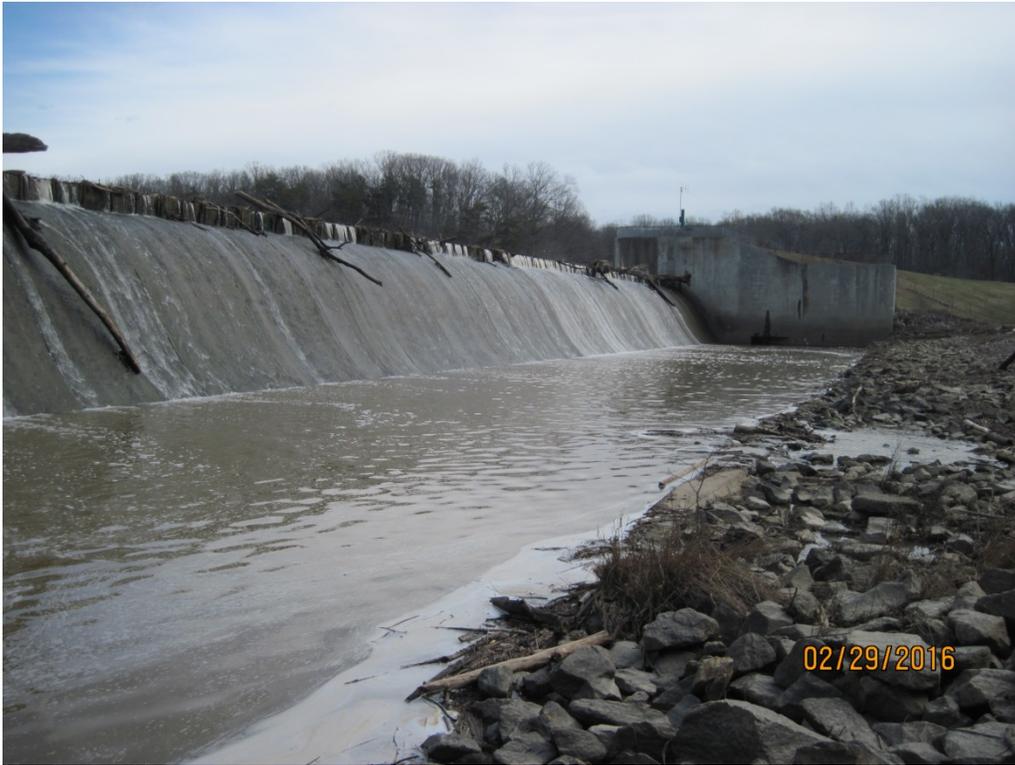
5. Looking northeast at the dam of Lake Accotink.

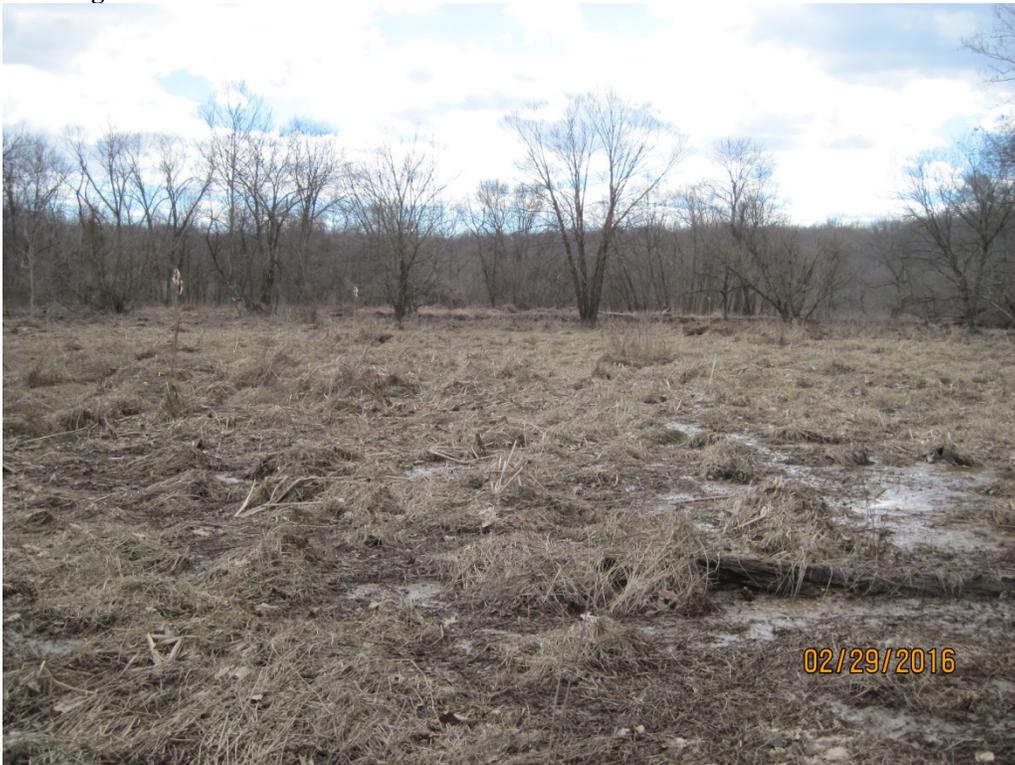
6. Looking southwest at the floodplain of Accotink Creek, upstream of Lake Accotink. This area provides suitable summer-phase habitat for the wood turtle.

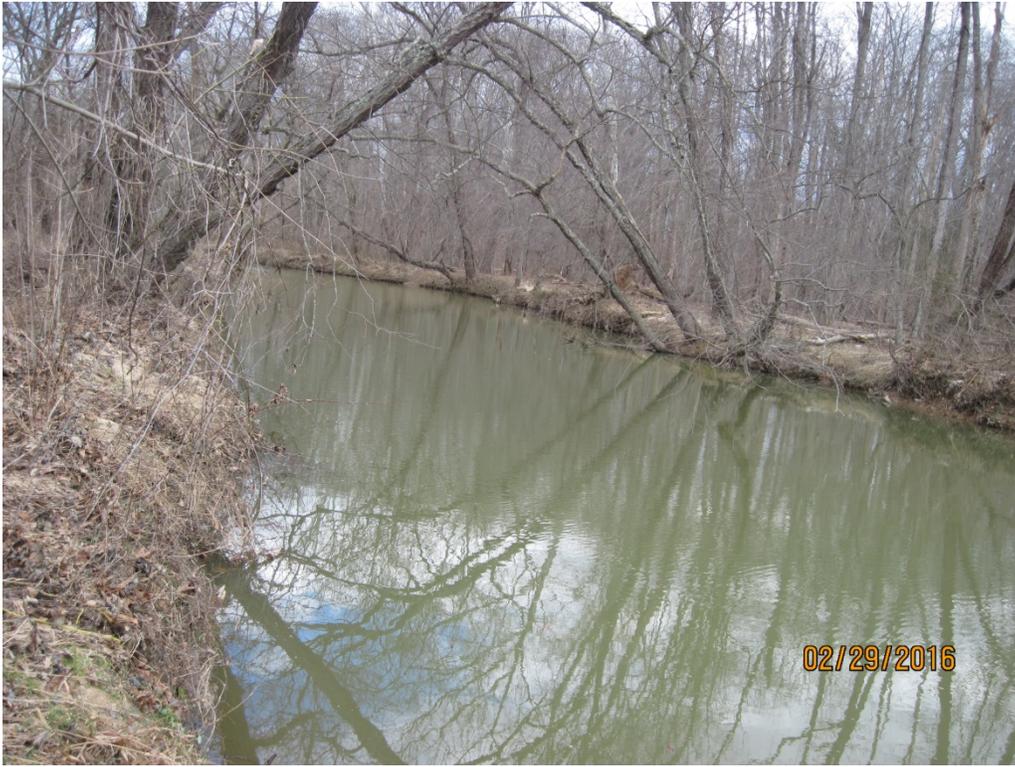
7. Looking northwest (upstream) at Accotink Creek, upstream of Lake Accotink. This area does not provide suitable winter-phase habitat for the wood turtle due to the lentic flow of the creek.

Based on our habitat evaluation, much of Accotink Creek, on and within 100 feet of the study areas, contained unsuitable winter-phase habitat for wood turtles (Attachment I). Optimal terrestrial wood turtle habitat was present in the upstream portion of Accotink Creek and includes an accessible mature forested floodplain, various wetland types (Photos #6) and a potential basking area (Photo #9). Although the portion of Accotink Creek above the lake is deep enough not to completely freeze during the winter, the water was slow moving (ie, low-oxygen) with high turbidity (Photos #7-10).

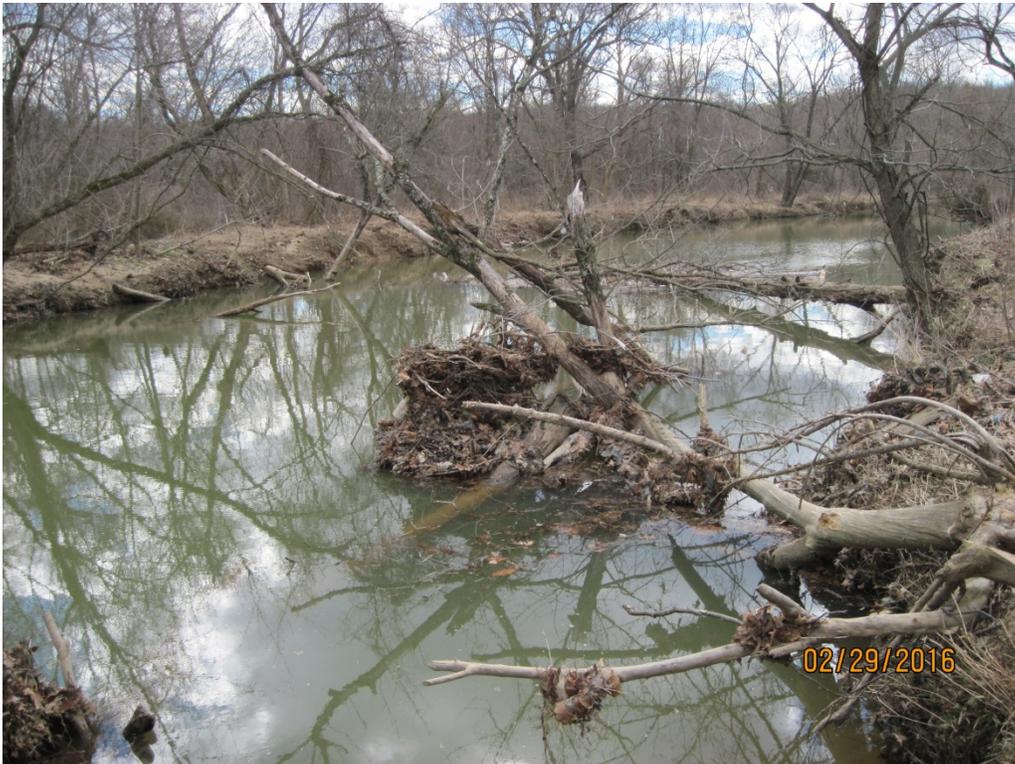
8. Looking southwest (downstream) at Accotink Creek, upstream of Lake Accotink. This area does not provide suitable winter-phase habitat for the wood turtle due to the lentic flow of the creek.

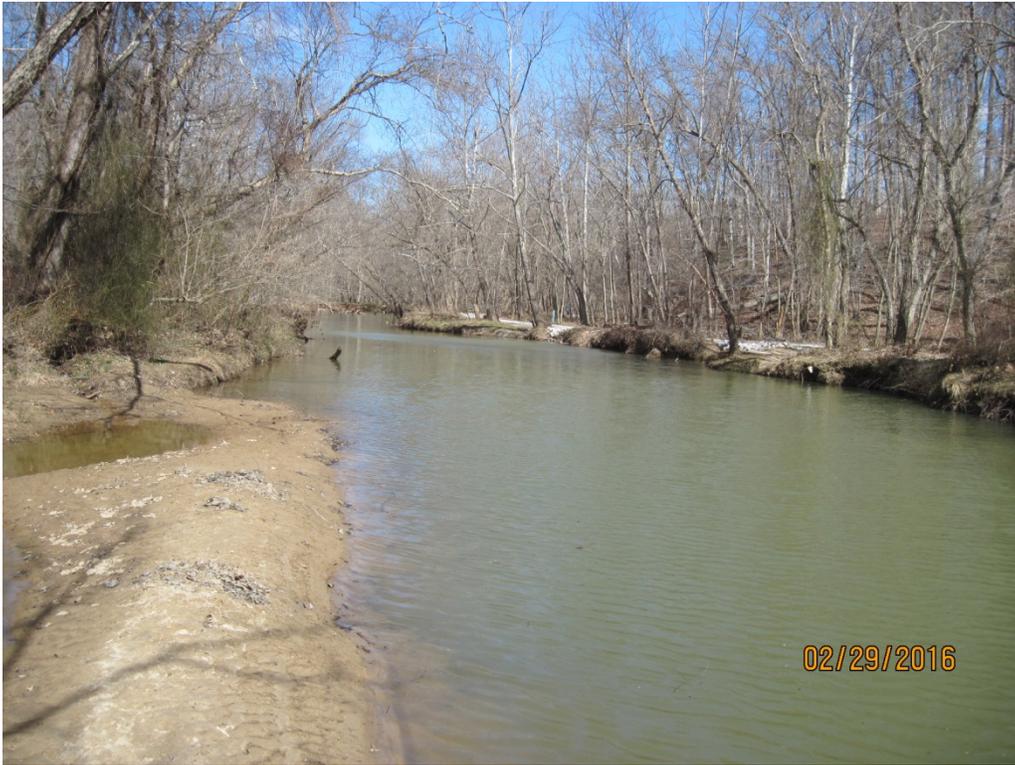
9. **Looking north (upstream) at Accotink Creek, upstream of Lake Accotink. This area does not provide suitable winter-phase habitat for the wood turtle due to the lentic flow of the creek. However, it may provide a potential basking area for wood turtles.**

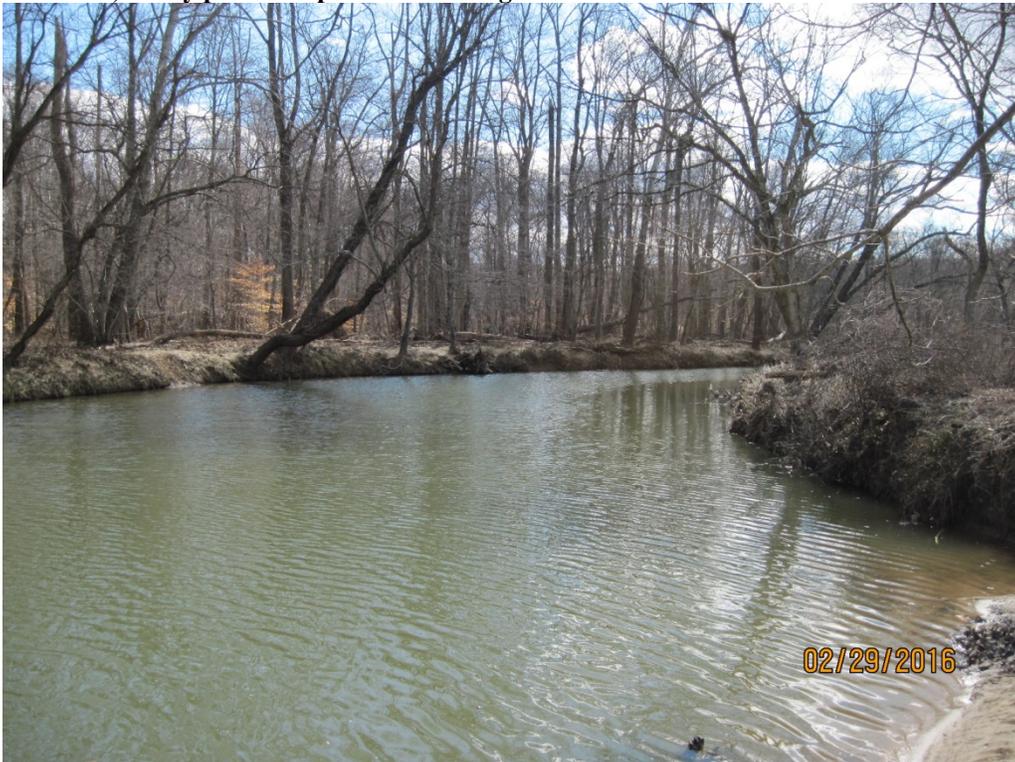
10. **Looking south (downstream) at Accotink Creek, upstream of Lake Accotink. This area does not provide suitable winter-phase habitat for the wood turtle due to the lentic flow of the creek.**
