Mt. Vernon RECenter

Building Condition Assessment Report Summary

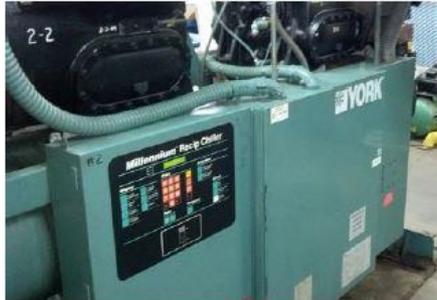
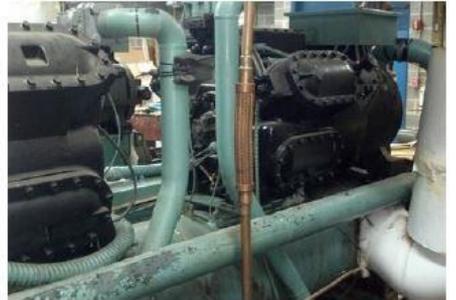
ASSESSMENT REPORT				
ITEM NO.	LOCATION	GRADE	PRIORITY	CATEGORY
M.28	Compressor Room	B	4	3
ASSESSMENT DESCRIPTION: Although they are nearing the end of their expected life cycle, the four York compressors and two chillers seem to be operating well to maintain the ice sheet to industry tolerances.				
RECOMMENDATION: Preparations should be made for replacement of this equipment in the next five years.

LIFE CYCLE STATUS	REPLACEMENT YEAR	REPLACEMENT COST		
15 yrs of 20	2020	\$ 529,000.00		
REFERENCE:

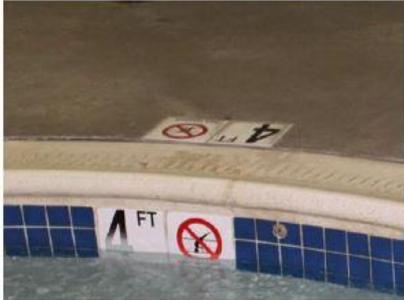
ASSESSMENT REPORT				
ITEM NO.	LOCATION	GRADE	PRIORITY	CATEGORY
A.21C	Spa Pool Finishes- Deck and Wall Depth Markers	A	5	1
ASSESSMENT DESCRIPTION: The spa includes two pair of deck and wall depth markers. The depth markers are slip-resistant tile and indicate 4FT water depth and include the international "no diving" symbol. Other than discoloration, the depth markers are in good condition.				
RECOMMENDATION: <ul style="list-style-type: none"> • Provide a deep cleaning • Anticipate replacement in 12 years

LIFE CYCLE STATUS	REPLACEMENT YEAR	REPLACEMENT COST		
13 yrs of 25	2027	\$ 13,740.10		
REFERENCE:
