**FAIRFAX COUNTY PARKWAY (ROUTE 7100) AND
FRANCONIA-SPRINGFIELD PARKWAY (ROUTE 7900) SAFETY
STUDY REPORT**

**TASK ORDER 96
VIRGINIA DEPARTMENT OF TRANSPORTATION
TRAFFIC ENGINEERING FOR NORTHERN OPERATION
REGION
LIMITED SERVICES CONTRACT – YEAR 3**

November 2010

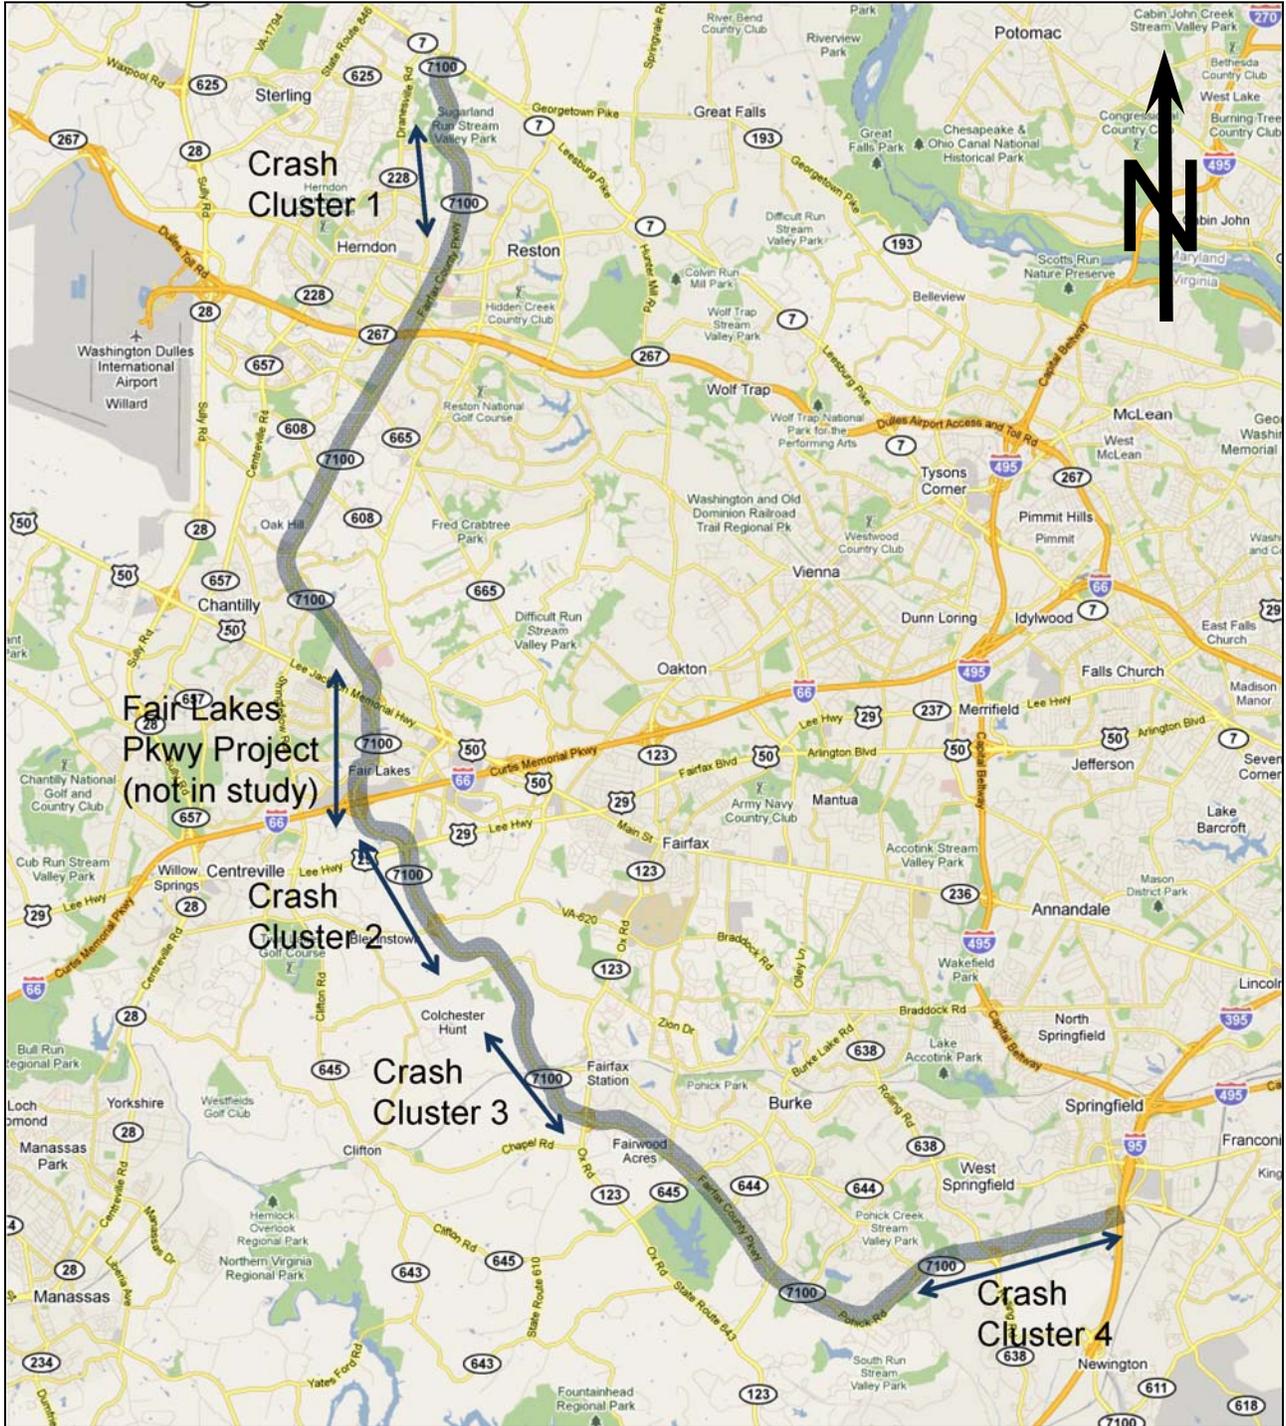
Figure 1: Project Study Area

The purpose of this project is to evaluate locations along the Fairfax County and Franconia-Springfield Parkways where motorists are crossing the medians and colliding and to provide recommendations for safety countermeasures to reduce these types of crashes. It should be noted that the placement of median barrier could potentially increase the number of property damage and minor injury accidents due to elimination of recovery area and deflecting vehicles back into travel lanes. The limits for the study are between Route 7 and I-95 but excluding the portion of the Fairfax County Parkway in the vicinity of the Fair Lakes Parkway/Fairfax County Parkway intersection since there are current VDOT roadway improvement plans for this area. See Figure 1 for a map of the project study area.

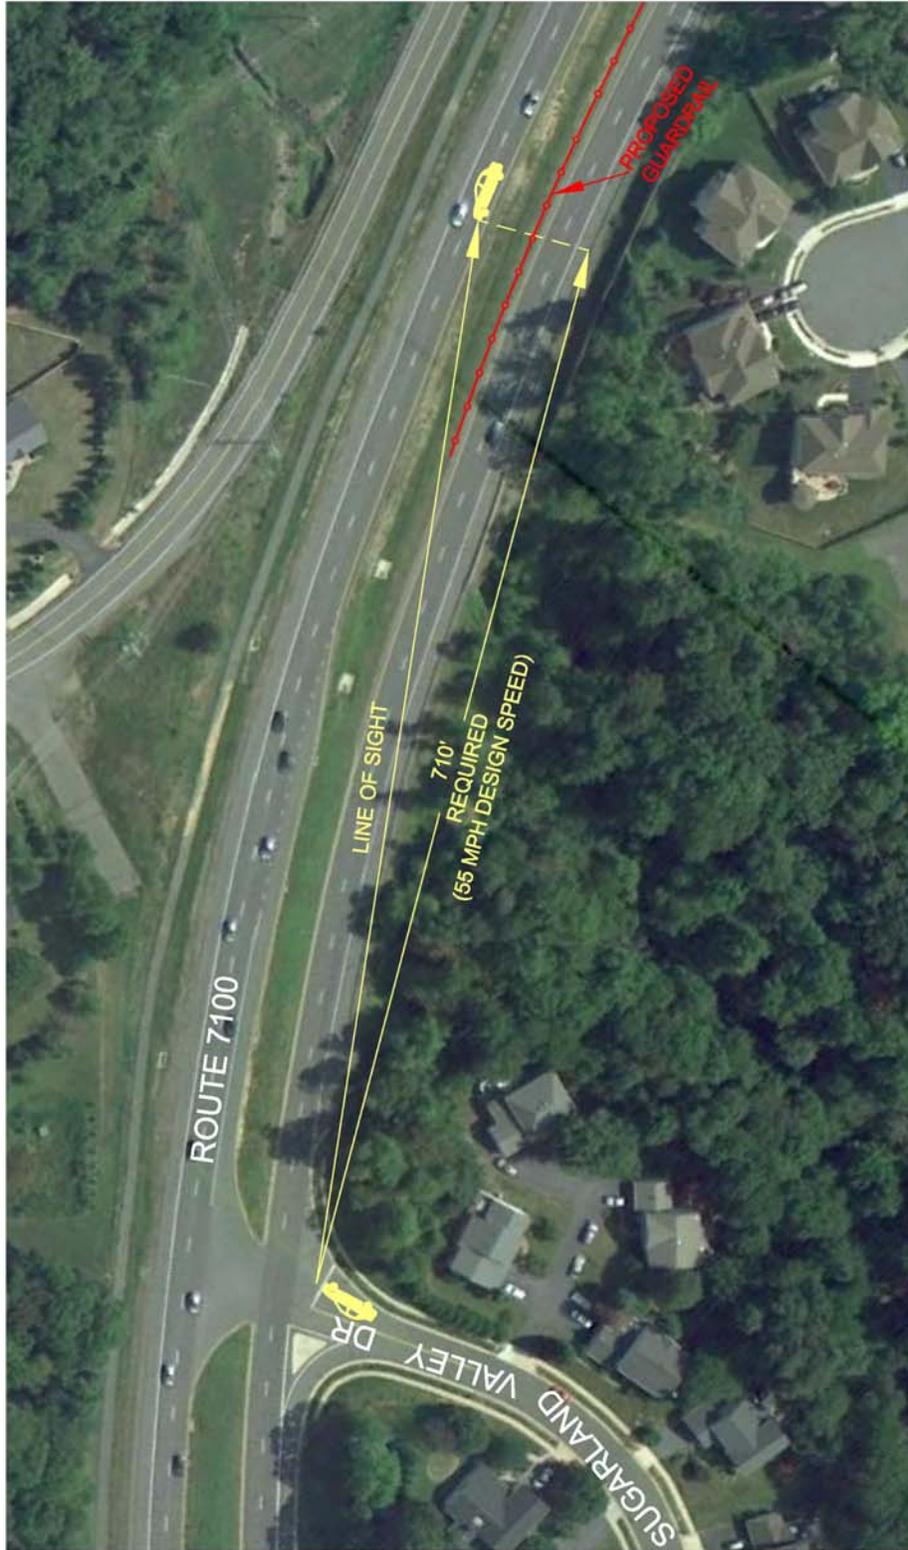
Figure 2: Median Barrier at Unsignalized Intersection

INTERSECTION SIGHT DISTANCE
SUGARLAND VALLEY DRIVE

SOURCE: AASHTO GREEN BOOK & VDOT ROAD DESIGN MANUAL (APPENDIX F)

- Design: The median barrier will have to be designed based on actual survey and the resulting intersection and stopping sight distances. Guardrail in the median only affects intersection sight distance at unsignalized intersections where there is a median break and the median is wide enough for guardrail. Right turns on red and left and right turns at a signalized intersection are not impacted by adding guardrail to the median. Median barrier was recommended as a part of this study in the vicinity of only one unsignalized intersection with a median break. The location of the guardrail in this case should be determined based on the intersection sight distance, see Figure 2. Guardrail in the median may reduce the horizontal stopping sight distance along curves based on some preliminary analysis using aerial photographs. The actual stopping sight distance will also depend on the vertical alignment in the locations where barrier is recommended. The designer will need to evaluate all the aspects that are involved with the installation of guardrail in the median including the AASHTO Roadside Design Guide. The horizontal stopping sight line is shown in Figures 3 and 4. Figure 3 is at a raised median that is approximately 18' wide on a curve. Figure 4 shows the horizontal stopping distance sight line for a graded median with a ditch. In some locations along the Parkway the sight line crosses the median and can be affected by the opposing traffic, as shown in Figure 3.

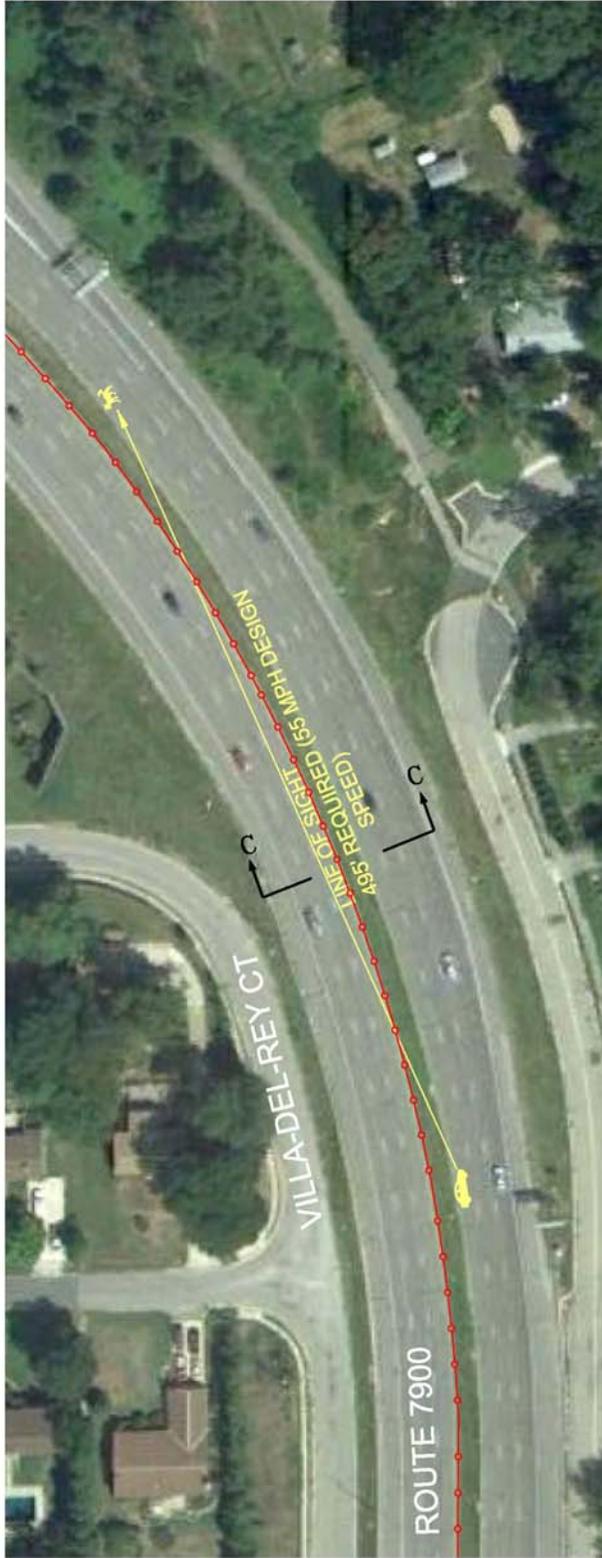
Figure 3: Median Barrier at 18' Wide Raised Median

STOPPING SIGHT DISTANCE

VILLA-DEL-REY CT

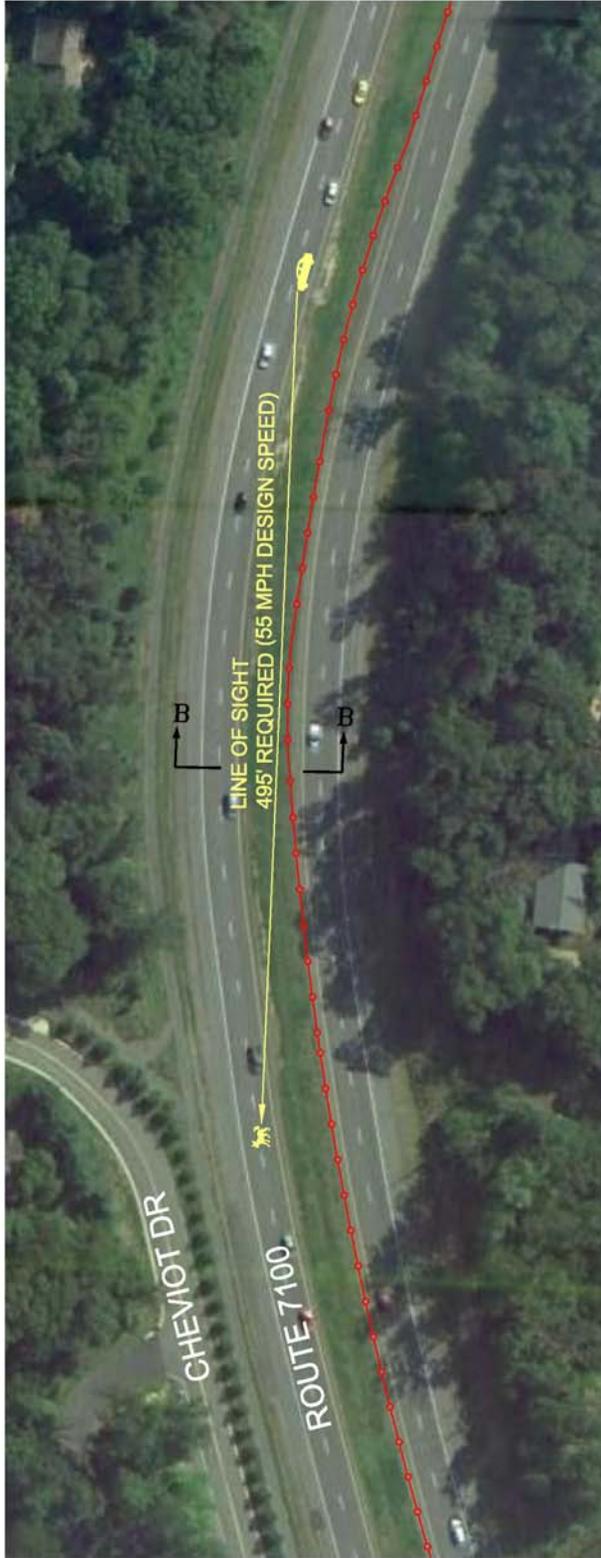
Figure 4: Median Barrier at Graded Median with Ditch

STOPPING SIGHT DISTANCE

CHEVIOT DR

GUARDRAIL PLACEMENT: SECTION B-B

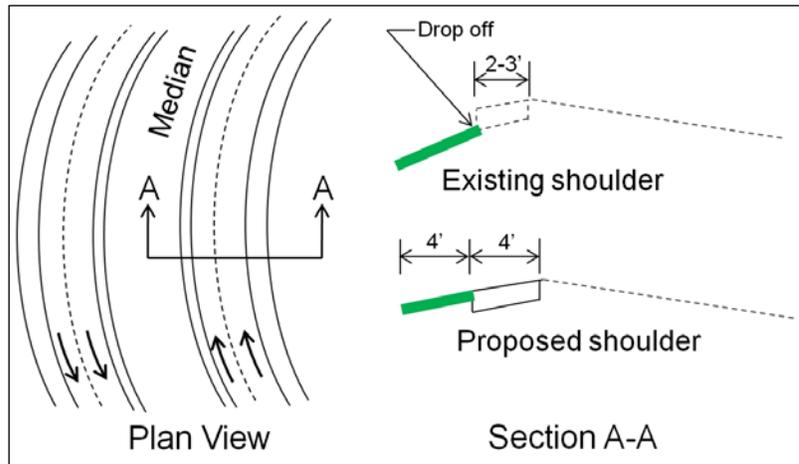
Provide Median Shoulder Improvements – Widen existing left side paved shoulders to 4 feet and provide an additional 4-foot graded shoulder in order to provide a recovery area, particularly on the insides of curves.

- Advantages: Decreases accidental run off the road crashes and crashes due to pavement drop off, increases width of stabilized recovery area, also provides a wider area for disabled vehicles to pull off out of the travel lanes
- Disadvantages: Does not prevent vehicles from crossing median
- Impacts: Regrading of median ditch
- Application: Install to left shoulders of the roadbed located on the inside of curves where the radius is less than 1190 feet or where loss of control is made more likely by the location of a sag within the curve also install within accident clusters where pavement drop off was involved in the cause of the accident

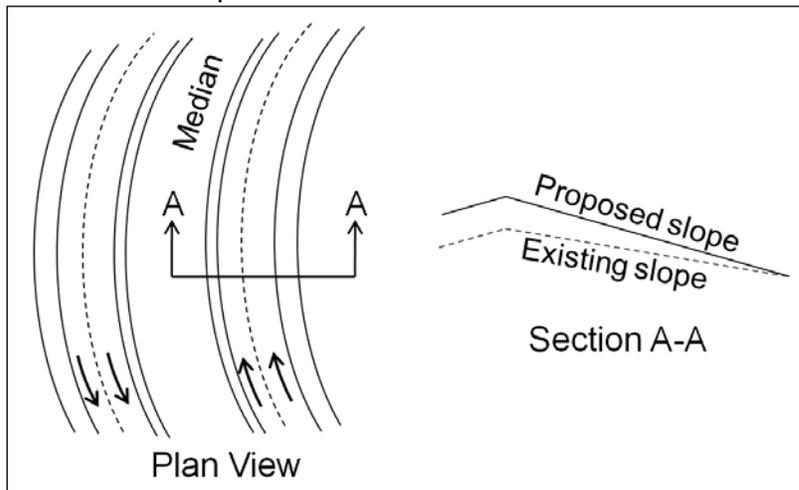
Superelevation Modification – Increase the rate of superelevation to 6% or higher on the roadbed located on the insides of curves where the radius is less than 1190 feet or where a sharper curve is located at the end of a long tangent to support the higher speeds of the traveling vehicles in order to help counter the momentum that pushes vehicles towards the median.

- Advantages: Decreases accidental run off the road crashes by increasing the speed that the curve can be safely driven
- Disadvantages: Does not prevent vehicles from crossing median
- Impacts: Regrading of median ditch and may impact existing retaining walls
- Application: Install to roadbed located the inside of curves where the radius is less than 1190 feet or where loss of control is made more likely by the location of a sag within the curve

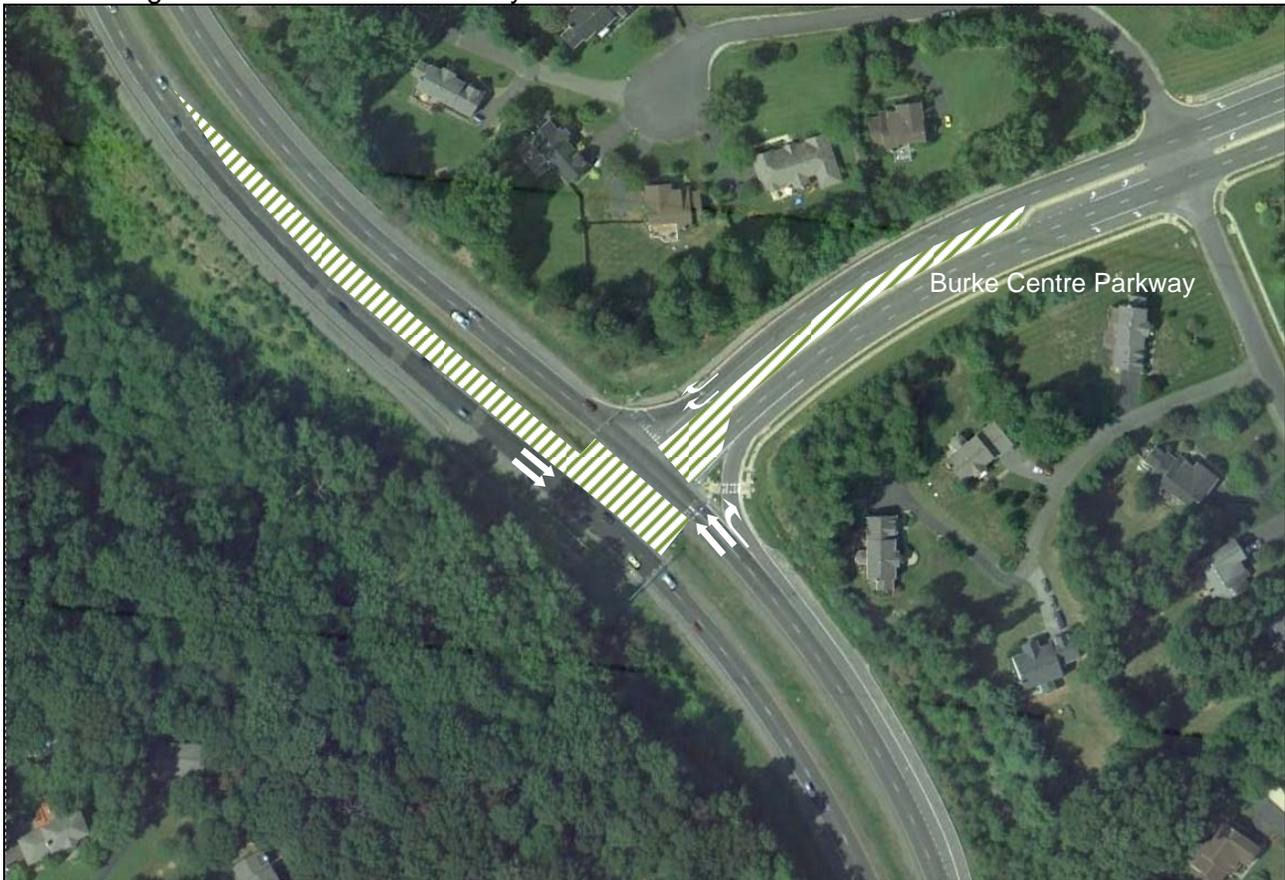
Intersection Modifications at Burke Centre Parkway

Intersection Modifications/Turn Restrictions – Modify intersection with full access to only allow right-in/right-out. This countermeasure was only found to be applicable at Burke Centre Parkway.

- Advantages: Decreases rear end crashes and crashes where vehicles avoiding an unexpected stopped vehicle swerve into the median
- Disadvantages: Reduced access for motorists and a corresponding increase in trip lengths. Increases traffic volumes on adjacent roads that act as alternates to the eliminated turning movements. Improvements may be required to adjacent roads to handle the increased traffic volumes.
- Impacts: Intersection modifications including median, islands, signals, signing, and pavement markings. A study will be required and public meetings will have to be held for changes to existing traffic pattern.
- Application: Construct where a high number of crashes are tied to congestion caused by an intersection and worsened by roadway geometrics that make it difficult to assess the congestion in time to react safely

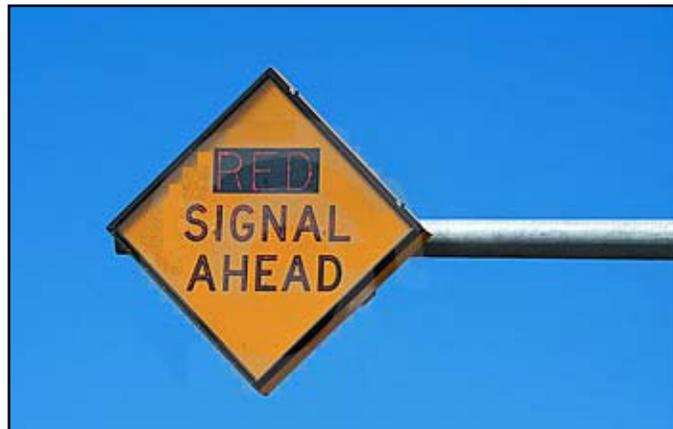
Red Signal Ahead Warning Sign – Provide a dynamic message sign to warn approaching drivers of a red signal condition at the next signal so that they slow down and look for stopped traffic.

Although this sign could be mounted on a mast arm above the roadway, it would be more cost effective to install ground mounted signs on both sides of the roadway and this is what the planning level cost for this countermeasure is based upon.

- Advantages: Provides active notification to oncoming traffic where sight distance is limited and where traffic queues are significant at the upcoming signalized intersection
- Disadvantages: higher cost than normal signal warning signs
- Impacts: Requires power and connection to signal system, post is a roadside object that must be protected or located outside the clear zone
- Application: Install where accidents occur due to queuing of vehicles in combination with limited sight distance.

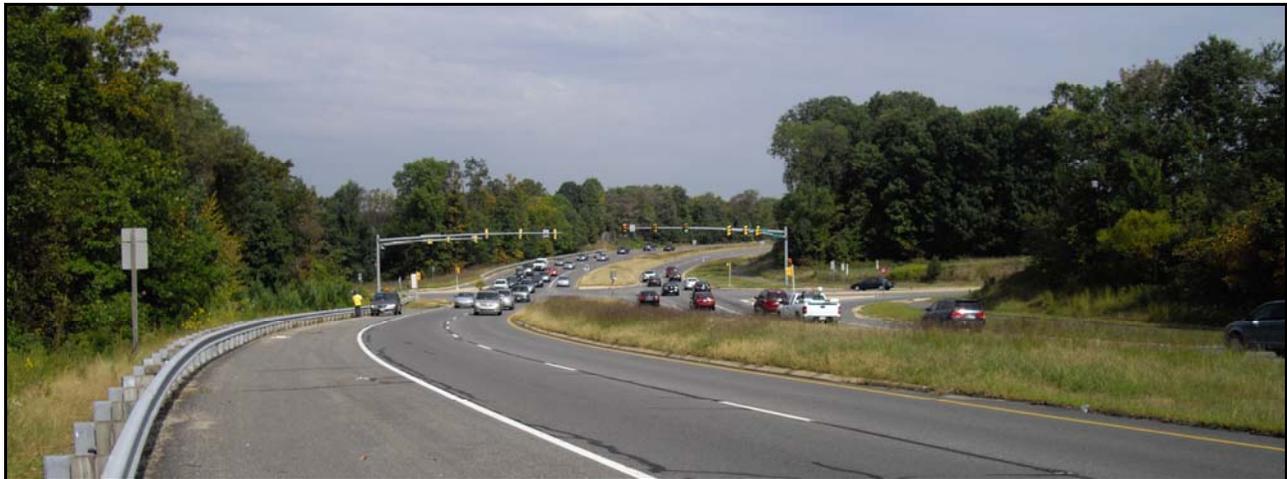
An assessment of the median crashes in this cluster did not indicate that the crashes would likely have been averted through the use of preventative measures. Median barrier is recommended in order to keep vehicles from crossing the median. The limits and quantities of recommended countermeasures are shown below:

Looking northbound towards the Wiehle Avenue intersection

Total costs to implement Cluster 1 Recommendations:

Long Term Countermeasures – \$554,000

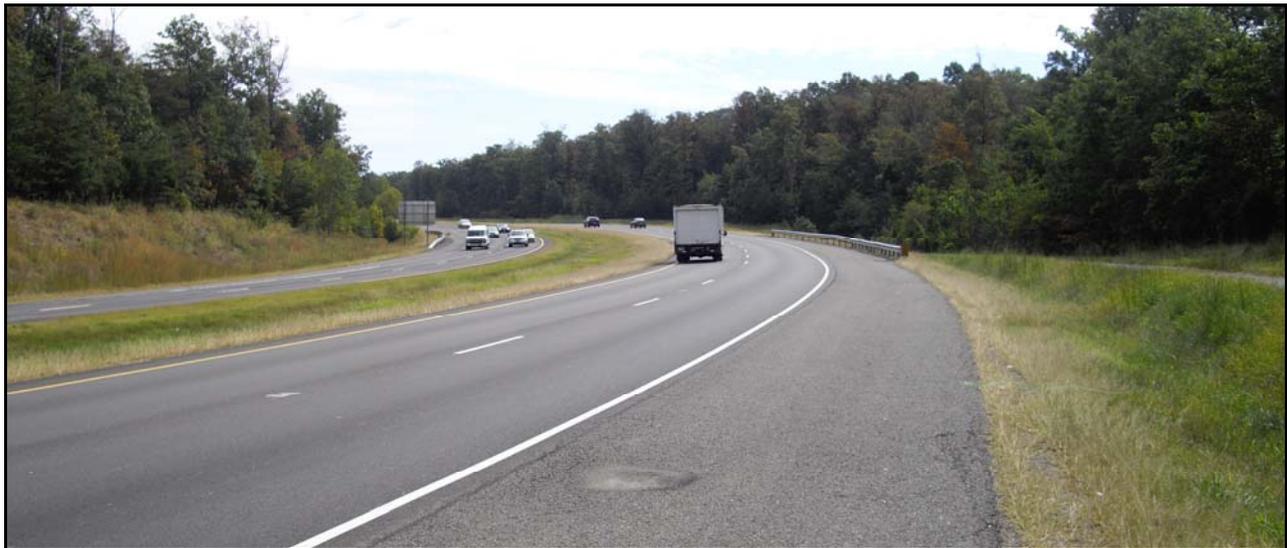
An assessment of the median crashes in this cluster indicated that the crashes might have been averted through the use of preventative measures to help drivers to maintain proper control. Rumble strips on the left and right shoulder edges for both northbound and southbound in conjunction with enhanced pavement markings consisting of a 6" yellow left edgeline and pavement markers on the left edgelines and between the two travel lanes are recommended for the limits of the cluster. A signal warning sign is recommended in advance of the Popes Head Road intersection due to the limited sight distance for southbound vehicles due to a vertical curve that blocks the view of queued of vehicles when the signal is red. Shoulder improvements are recommended for the northbound inside shoulder at the curve south of Braddock Road to provide a recovery area where the shoulder may have deteriorated. The limits and quantities of recommended countermeasures are shown below:

Looking southbound from south of Braddock Road interchange

Counter-Measure	Location (From)	Location (To)	Length (ft)	Cost
Rumble Strips	0.68 Mi North of Rte 29	0.19 Mi North of Popes Head Rd	15,500	\$372,000
Median Shoulder Improvements	0.28 Mi South of Braddock Rd	0.55 Mi North of Popes Head Rd	1,800	\$59,000
Red Signal Ahead Sign	0.44 mi South of Braddock Rd	N/A	N/A	\$27,000

Total costs to implement Cluster 2 Recommendations:
 Long Term Countermeasures – \$59,000
 Short Term Countermeasures – \$399,000

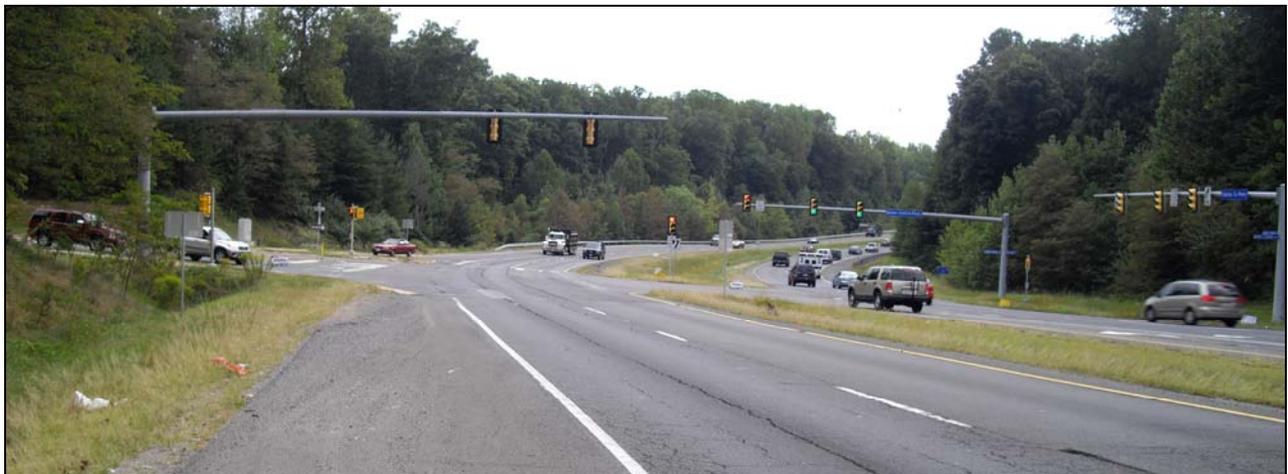
An assessment of the median crashes in this cluster indicated that four of the crashes (including a fatality) were located in the immediate vicinity of the Burke Centre Parkway intersection and two of the crashes were located on the inside of a substandard horizontal curve. Rumble strips on the left and right shoulder edges for both northbound and southbound in conjunction with enhanced pavement markings consisting of a 6" yellow left edgeline and pavement markers on the left edgelines and between the two travel lanes are recommended for the limits of the cluster. Signal warning signs are recommended at both approaches in advance of the Burke Centre Parkway intersection due to the limited sight distance due to vertical curves on both approaches that blocks the view of queued of vehicles when the signal is red. Superelevation modifications are recommended for the northbound lanes at the substandard horizontal curve located north of Ox Road to help vehicles maintain control (there is a downslope approaching this curve that exasperates the condition). The limits and quantities of recommended countermeasures are shown below:

Looking southbound towards the Burke Centre Parkway intersection

Total costs to implement Cluster 3 Recommendations:

Long Term Countermeasures – \$663,000

Short Term Countermeasures – \$280,000

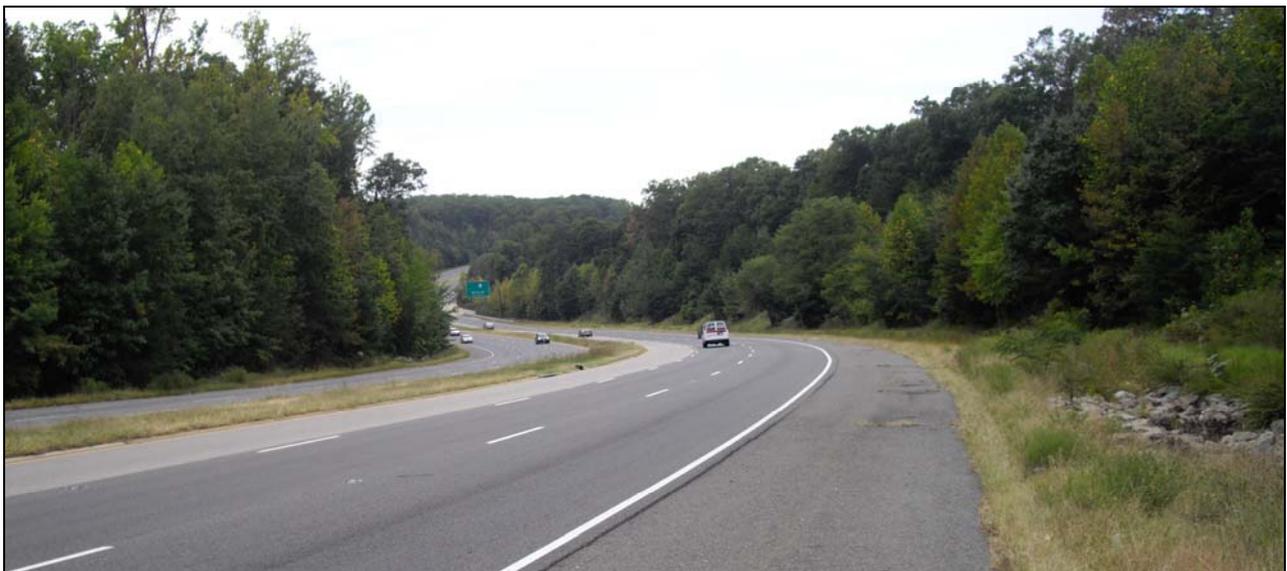
An assessment of the median crashes in this cluster indicated that two of the crashes occurred in the northern portion of this cluster due to driver inattention while 11 of the crashes (including two fatalities) were located in the southern portion of this cluster where the median width is 16 to 18 feet wide. Rumble strips on the left and right shoulder edges for both northbound and southbound in conjunction with enhanced pavement markings consisting of a 6" yellow left edgeline and pavement markers on the left edgelines and between the two travel lanes are recommended for the limits of the cluster. Superelevation modifications and median shoulder improvements are recommended for the southbound lanes for the curve located south of Gambriil Road to help vehicles maintain control. Median barrier is recommended in order to keep vehicles from crossing the median for the portion of this cluster with reduced median width. The limits and quantities of recommended countermeasures are shown below:

Looking northbound towards the Rolling Road interchange

Total costs to implement Cluster 4 Recommendations:

Long Term Countermeasures – \$1,345,000

Short Term Countermeasures – \$94,000

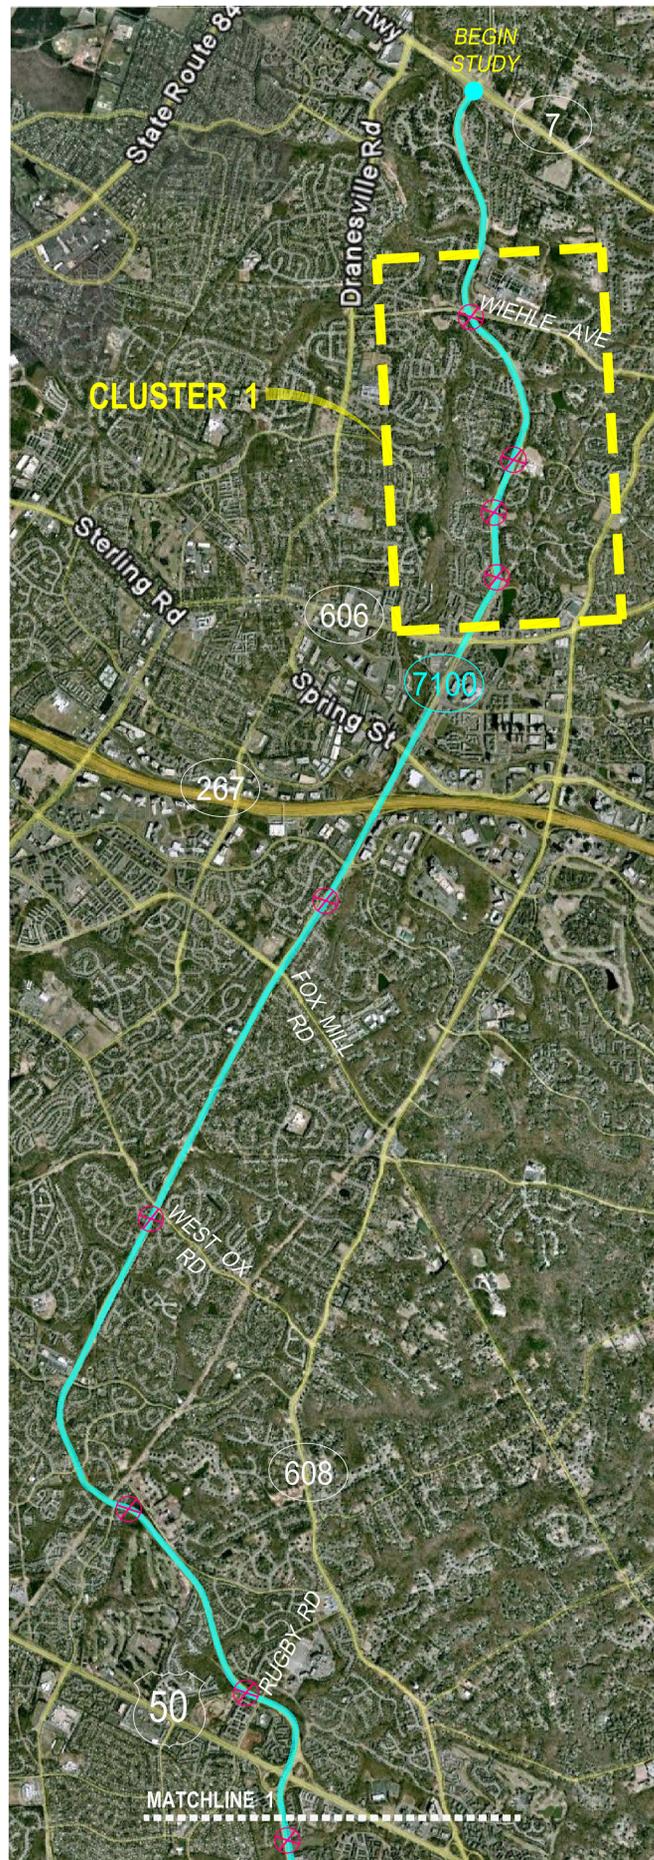
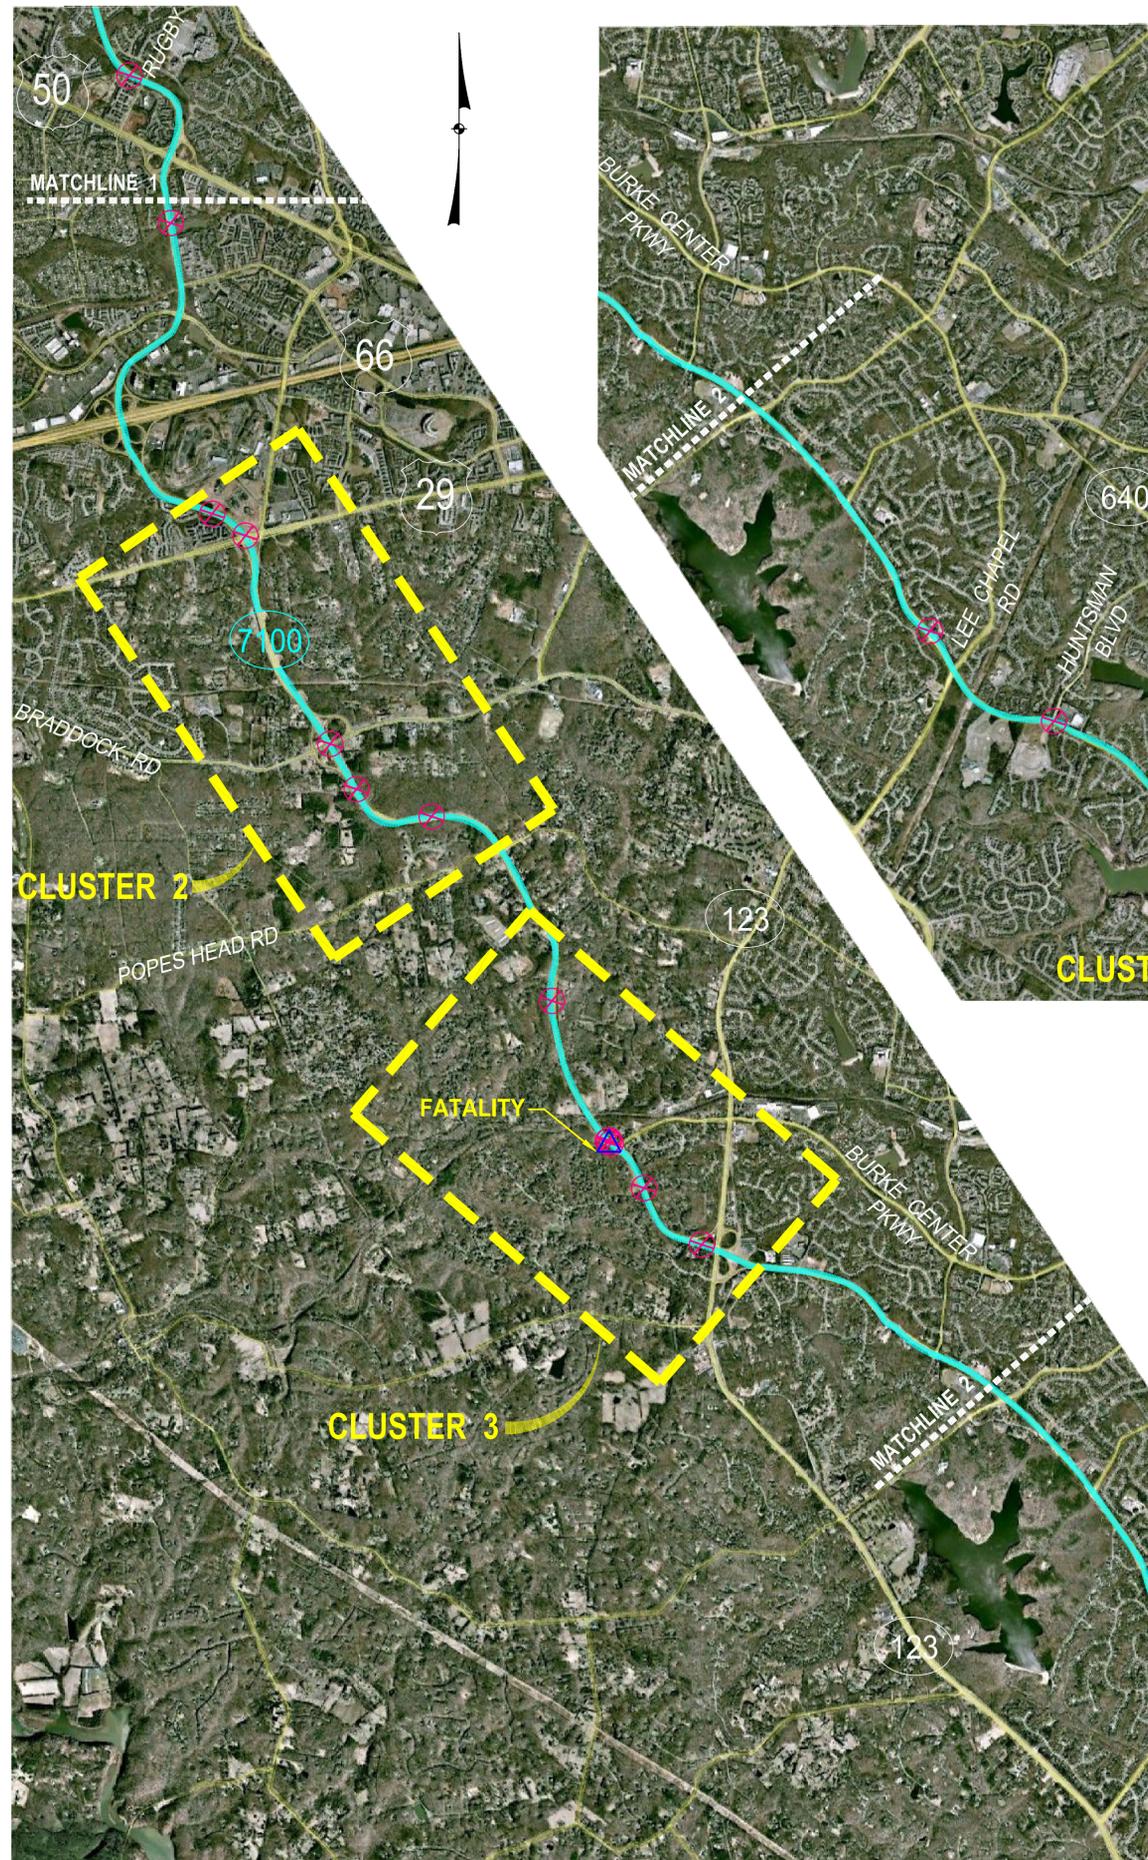
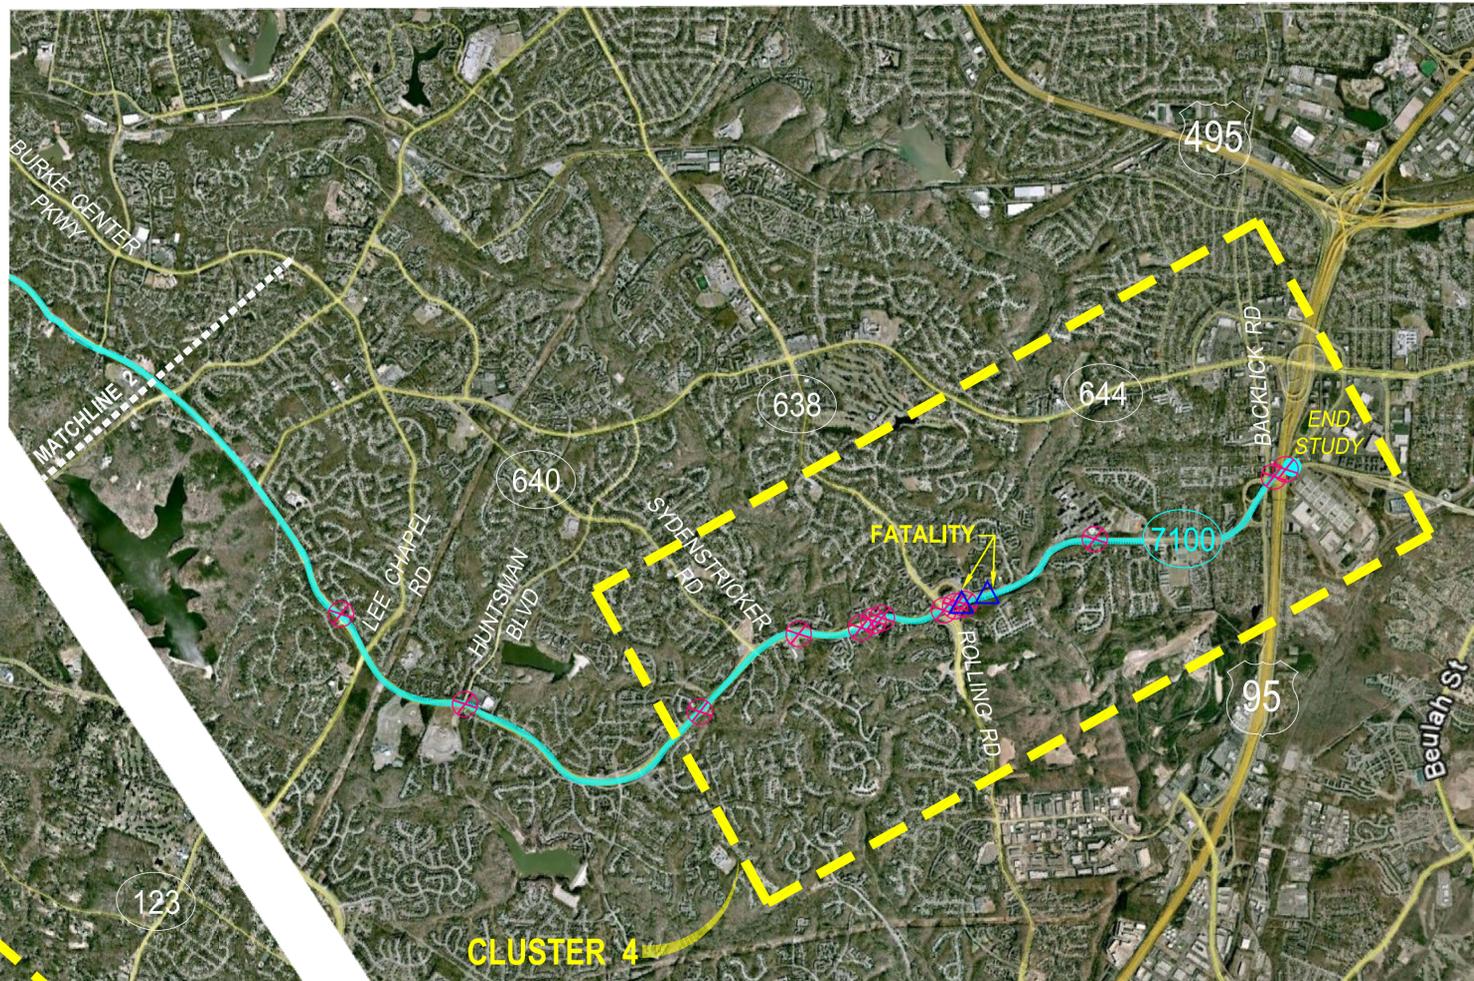
FAIRFAX COUNTY PARKWAY MEDIAN CRASH LOCATIONS

The Fairfax County Police provided crash data and police reports for all fatal or injury median crashes that occurred within the project limits for the years 2007 through 2009. These crashes total 3 fatal crashes and 33 injury crashes. The crashes were plotted on aerial imagery covering the project limits and the resulting display of median crash locations is provided in the Appendix.

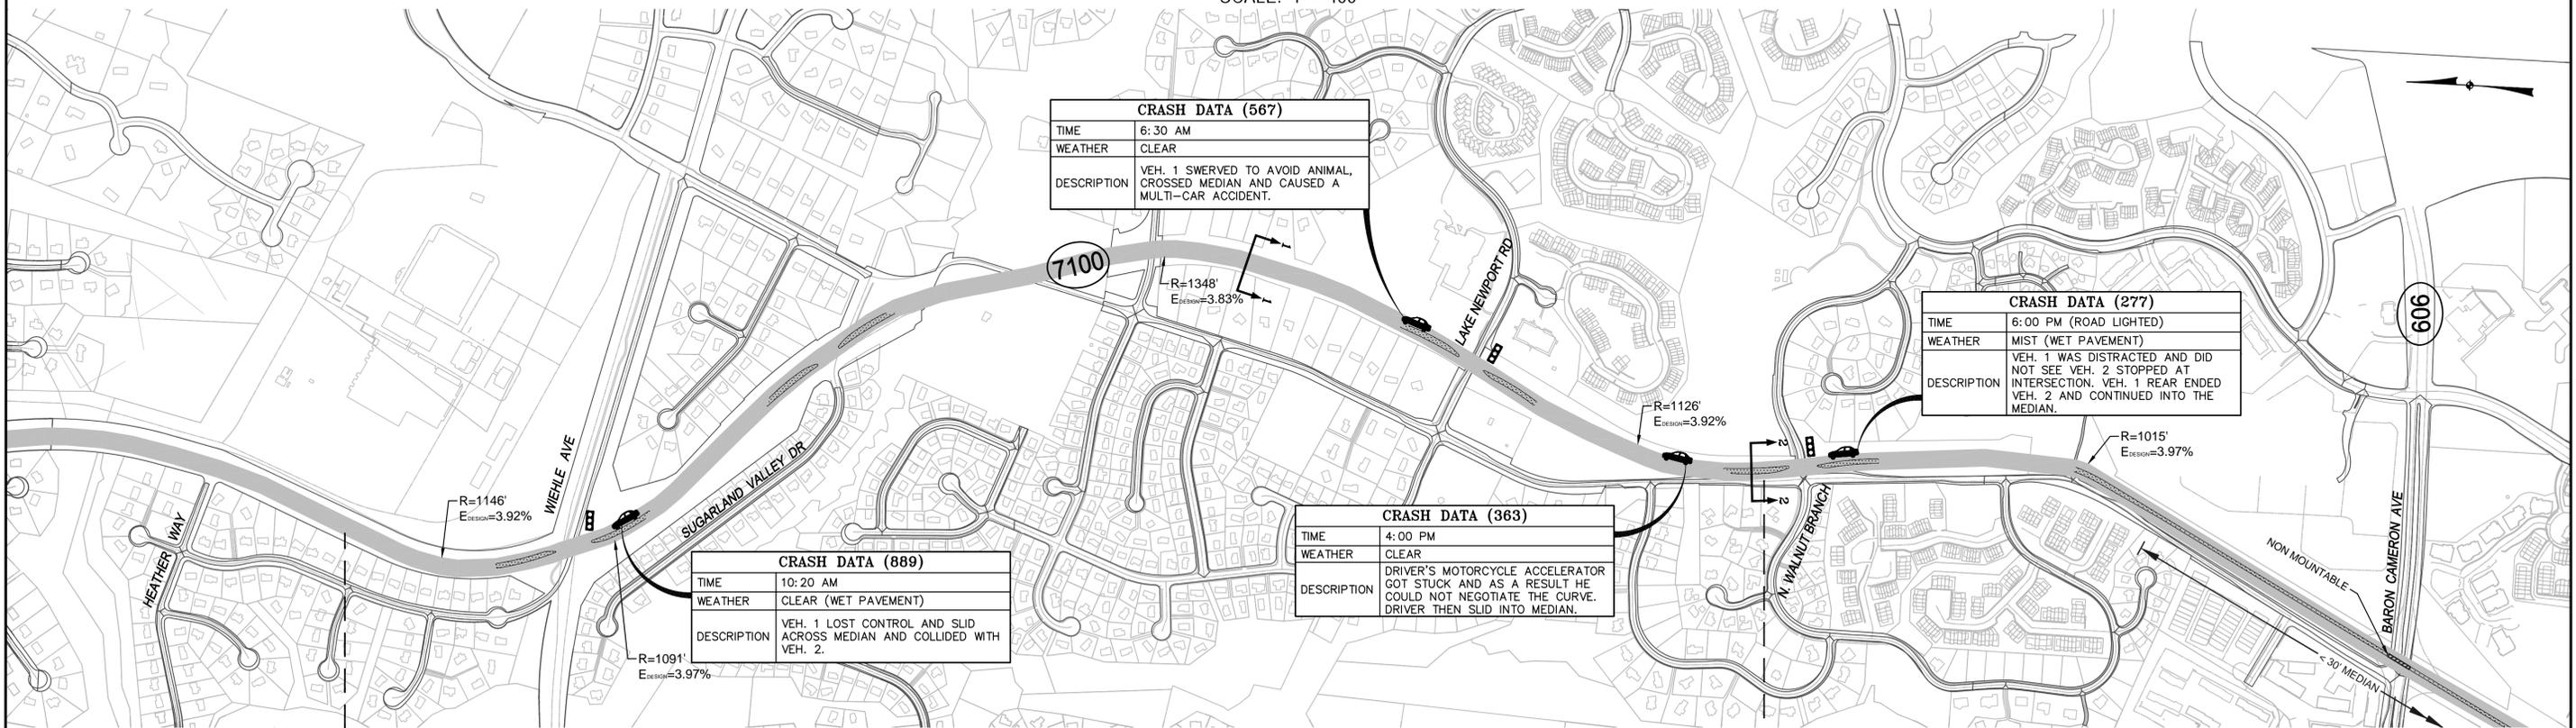
CLUSTER 1

CRASH DATA (567)	
TIME	6:30 AM
WEATHER	CLEAR
DESCRIPTION	VEH. 1 SWERVED TO AVOID ANIMAL, CROSSED MEDIAN AND CAUSED A MULTI-CAR ACCIDENT.

CRASH DATA (277)	
TIME	6:00 PM (ROAD LIGHTED)
WEATHER	MIST (WET PAVEMENT)
DESCRIPTION	VEH. 1 WAS DISTRACTED AND DID NOT SEE VEH. 2 STOPPED AT INTERSECTION. VEH. 1 REAR ENDED VEH. 2 AND CONTINUED INTO THE MEDIAN.

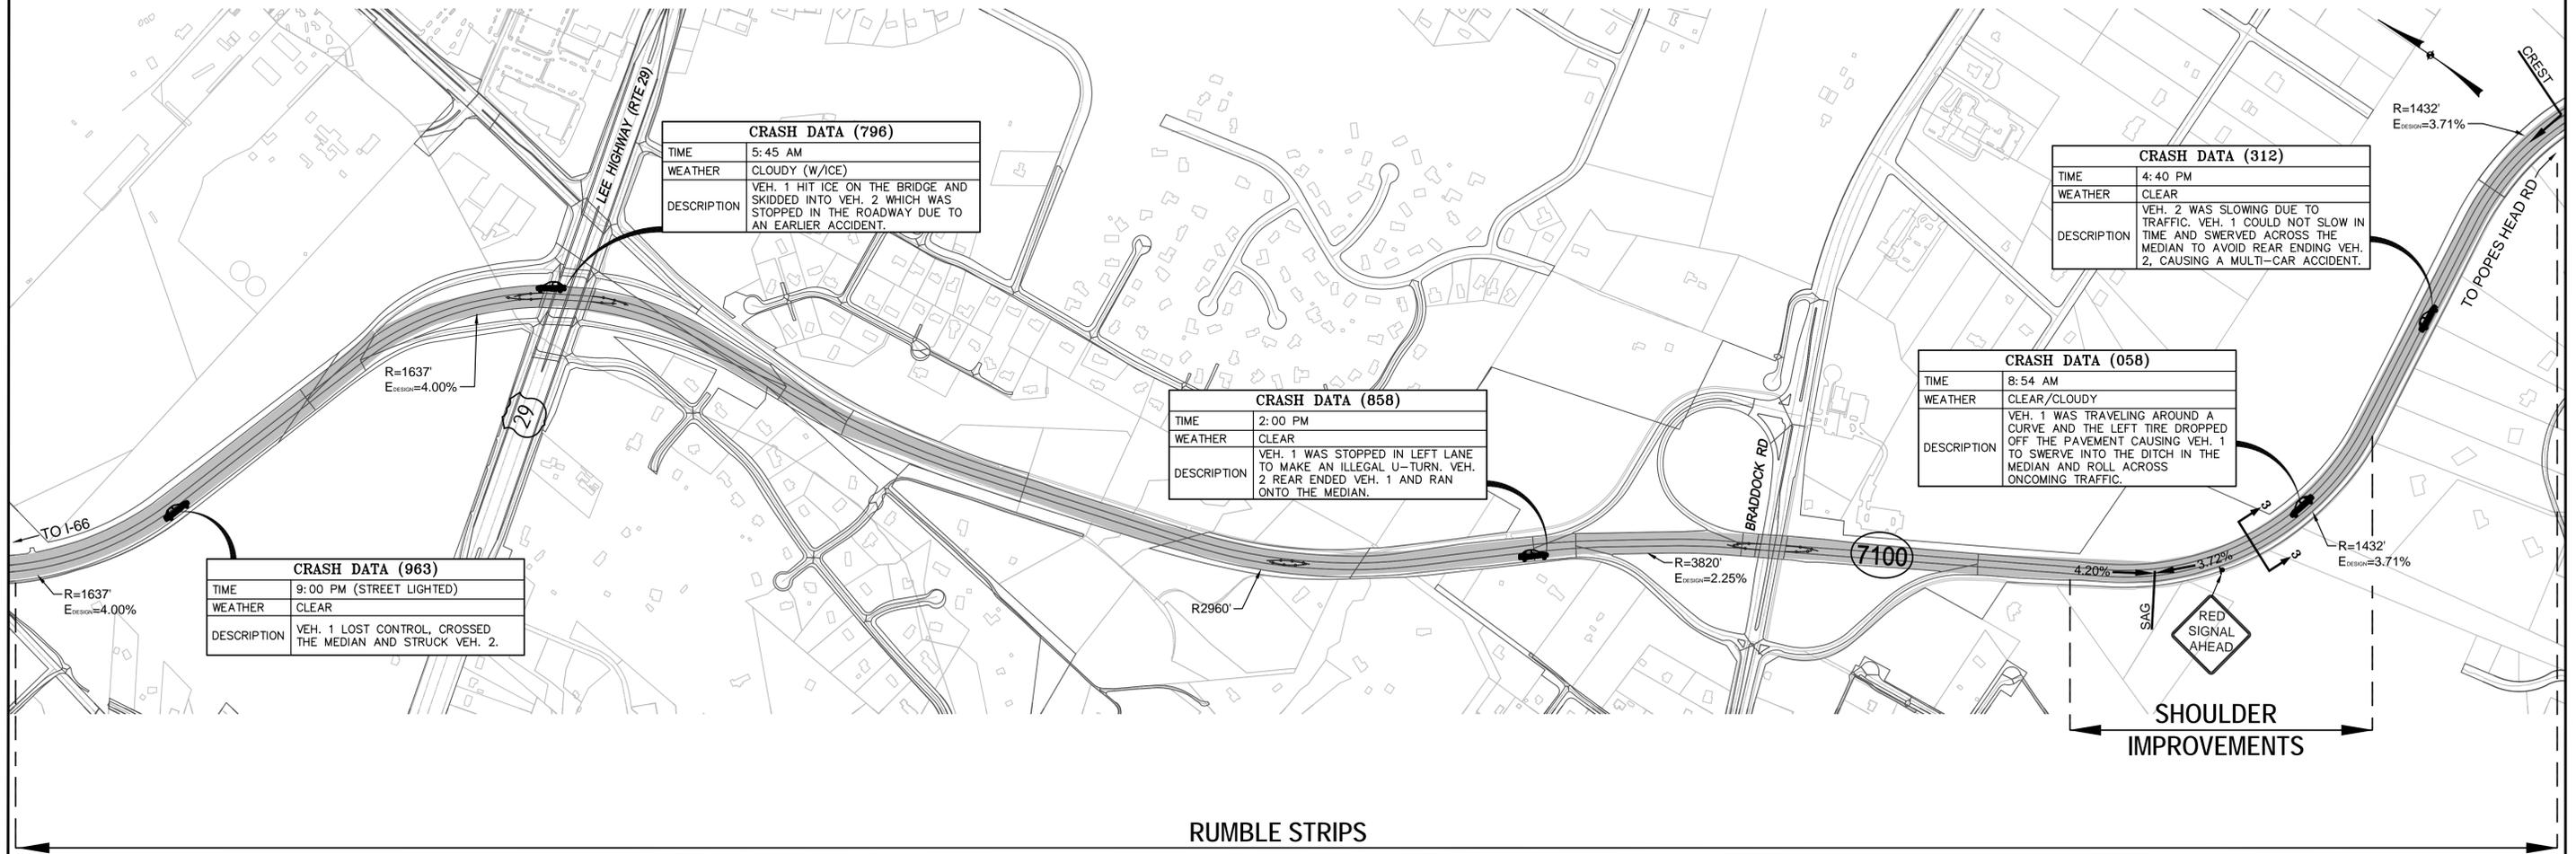
CLUSTER 2

CRASH DATA (796)	
TIME	5:45 AM
WEATHER	CLOUDY (W/ICE)
DESCRIPTION	VEH. 1 HIT ICE ON THE BRIDGE AND SKIDDED INTO VEH. 2 WHICH WAS STOPPED IN THE ROADWAY DUE TO AN EARLIER ACCIDENT.

CRASH DATA (312)	
TIME	4:40 PM
WEATHER	CLEAR
DESCRIPTION	VEH. 2 WAS SLOWING DUE TO TRAFFIC. VEH. 1 COULD NOT SLOW IN TIME AND SWERVED ACROSS THE MEDIAN TO AVOID REAR ENDING VEH. 2, CAUSING A MULTI-CAR ACCIDENT.
