Appendix A: Draft Watershed Workbook

LOWER OCCOQUAN DRAFT Watershed Workbook January 2009

Fairfax County
Watershed Planning &
Assessment Branch
Stormwater Planning Division
Department of Public Works &
Environmental Services

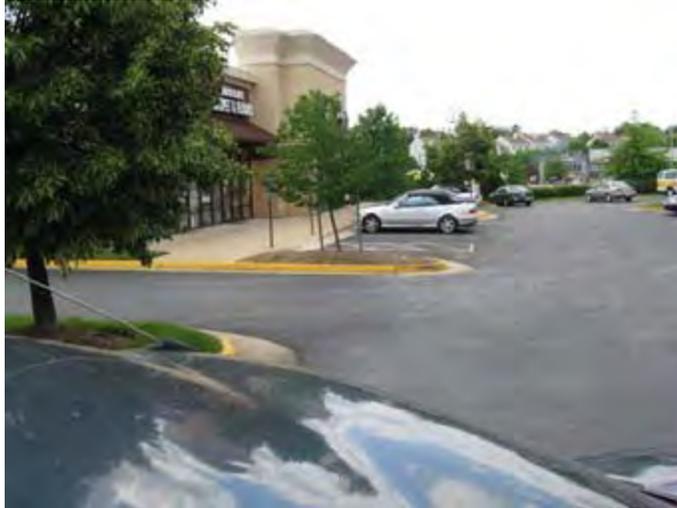
Figure 3: Typical Lower Occoquan Impervious Areas

Impervious areas can be described as hard surfaces that stormwater (rain water) can not penetrate and consequently runs off into a collection system. Increased impervious surfaces can result in channel erosion and downstream degradation caused by the increased volume and velocity of new stormwater runoff reaching receiving waters. It has been shown that levels of 10-20% impervious surface significantly reduce stream health (Annual Report, 2005). Over the decades, Lower Occoquan has experienced minimal population growth and consequently an increase in impervious surface due to new development and supporting infrastructure development.

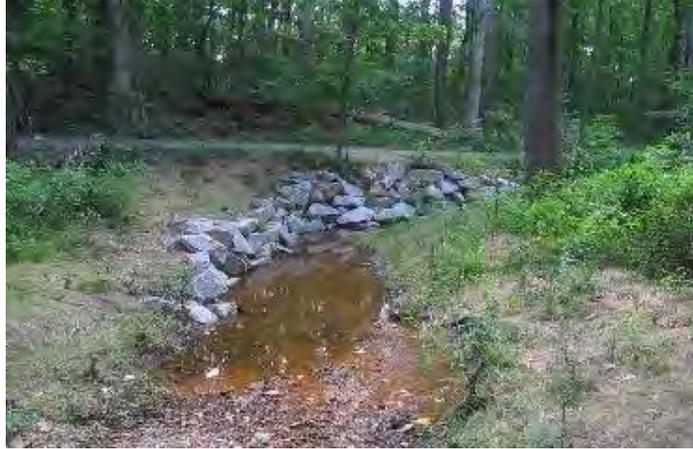
Figure 4: Typical riprap bank protection (VA DEQ)

Based on information gathered in the 1978 study, the following year, the County published a proposed drainage plan for the Occoquan watersheds. The document recommended 20 drainage improvement projects for five of the eight watersheds. Fifteen of the twenty projects were identified as “raise road and replace culvert” while the remaining 5 projects focused on installing riprap bank protection (Parsons, 1979). Photo source: VDEQ *Unified Stream Methodology Photos*.

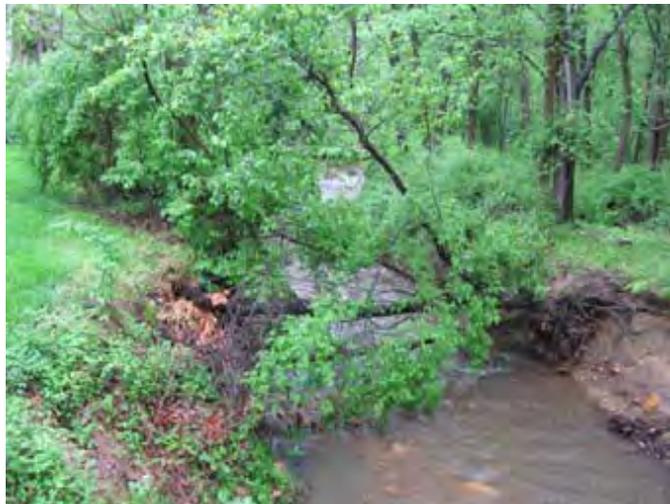
Figure 5: Lower Occoquan Bank Erosion

The majority Lower Occoquan streams are natural open channel flow, and the stormwater runoff is routed to the streams with minimal controls. While overall the majority of the streams in Lower Occoquan experience minimal impacts, some streams are experiencing erosion due to development and increased runoff. Below is an example of stream bank erosion in Lower Occoquan.

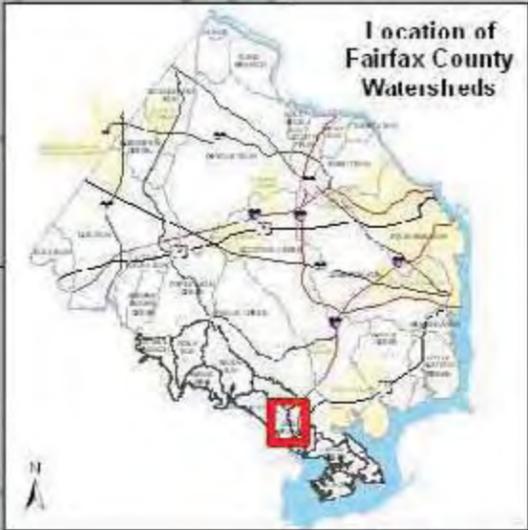
Map 2.2.2-3
Lower Occoquan
Mill Branch - Giles Run South
Stream Conditions

Poor/Very Poor Habitat	CEM - Type 2: Inclusion	Disturbed Buffer	Lake	Other WMA Boundaries
Streams and Rivers	CEM - Type 3: Widening	Road	Storm Drainage Facility	Mill Branch - Giles Run South
Erosion/Bank Instability	Park Boundary

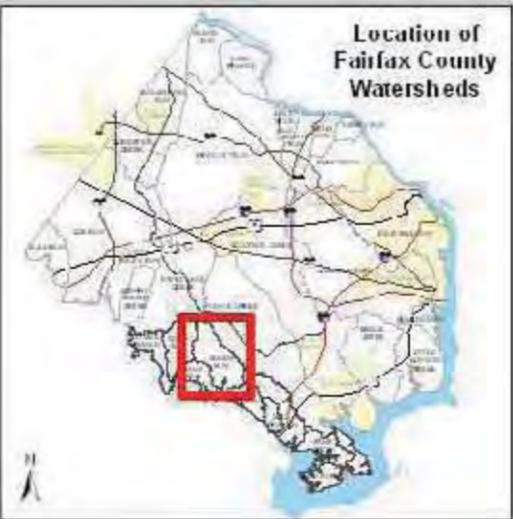
Map 2.2.3-3
 Lower Occoquan
 Mill Branch
 Stream Conditions

Legend							
— Poor/Very Poor Habitat	● CEM - Type 2: Incision	▭ Disturbed Buffer	■ Lake	▭ Other WMA Boundaries			
— Streams and Rivers	● CEM - Type 3: Widening	▭ Road	▭ Storm Drainage Facility	▭ Mill Branch- Mill Branch			
— Erosion/Bank Instability	▭ Park Boundary						
Obstruction Impact	Dump Site Impact	Head Cut Height	Pipe Impact	Ditch Impact	Utility Impact	Crossing Impact	
✚ Minor to Moderate	⊕ Minor to Moderate	● 0.5 - 1'	● Minor to Moderate	● Minor to Moderate	● Minor to Moderate	● Minor to Moderate	
✚ Moderate to Severe	⊕ Moderate to Severe	● 1 - 2'	● Moderate to Severe	● Moderate to Severe	● Moderate to Severe	● Moderate to Severe	
✚ Severe to Extreme	⊕ Severe to Extreme	● > 2'	● Severe to Extreme	● Severe to Extreme	● Severe to Extreme	● Severe to Extreme

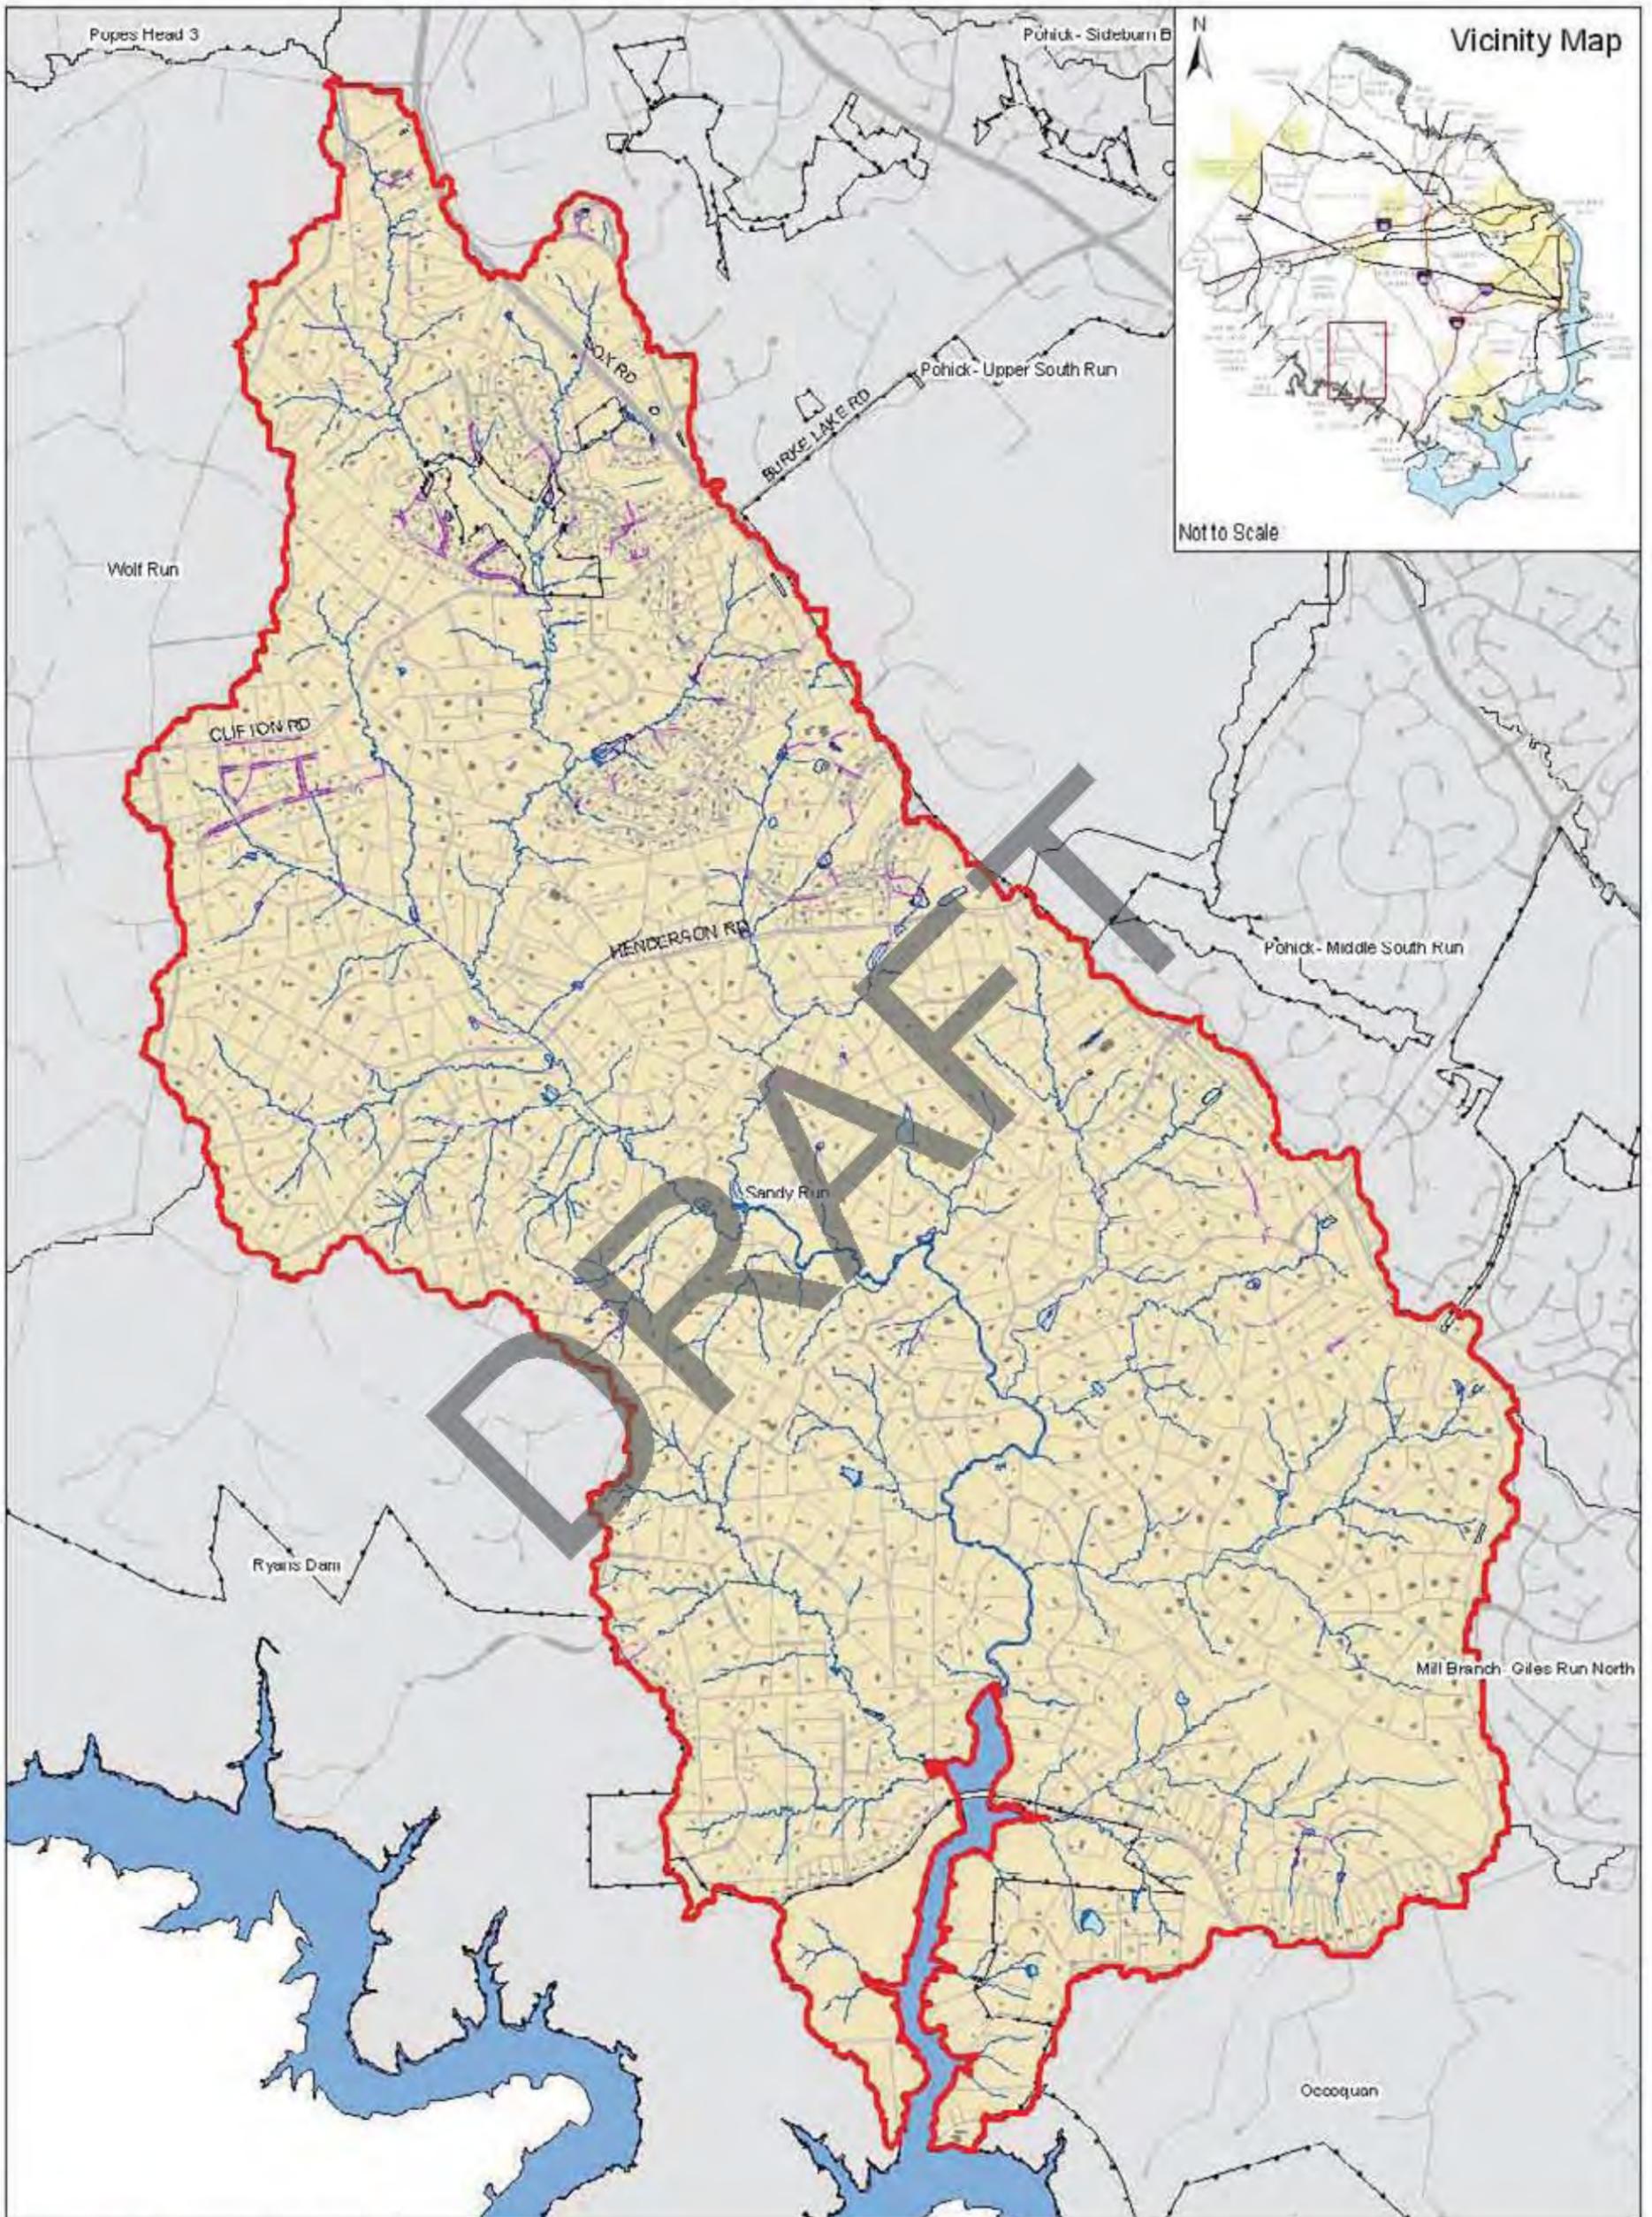
**Map 2.2.4-1
Sandy Run
Existing and Future Land Use**

WMA Boundary	Estate Residential	Institutional
Agricultural	Low Density Residential	Low Intensity Commercial
Open Space	Medium Density Residential	High Intensity Commercial
Forested	High Density Residential	Industrial
Golf Course	Transportation	Water

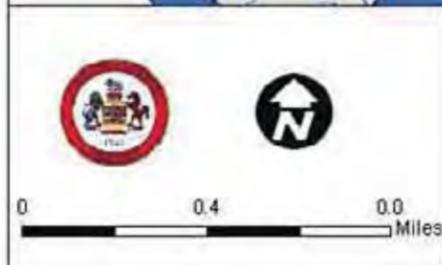
Map 2.2.6-2
 Lower Occoquan
 Wolf Run
 Stormwater Infrastructure

Legend		
Storm Drainage	Road	Storm Drainage Facility
Rivers and Streams	Building	Park Boundary
Drainage Complaint	Other WMA Boundaries	Wolf Run
Lake

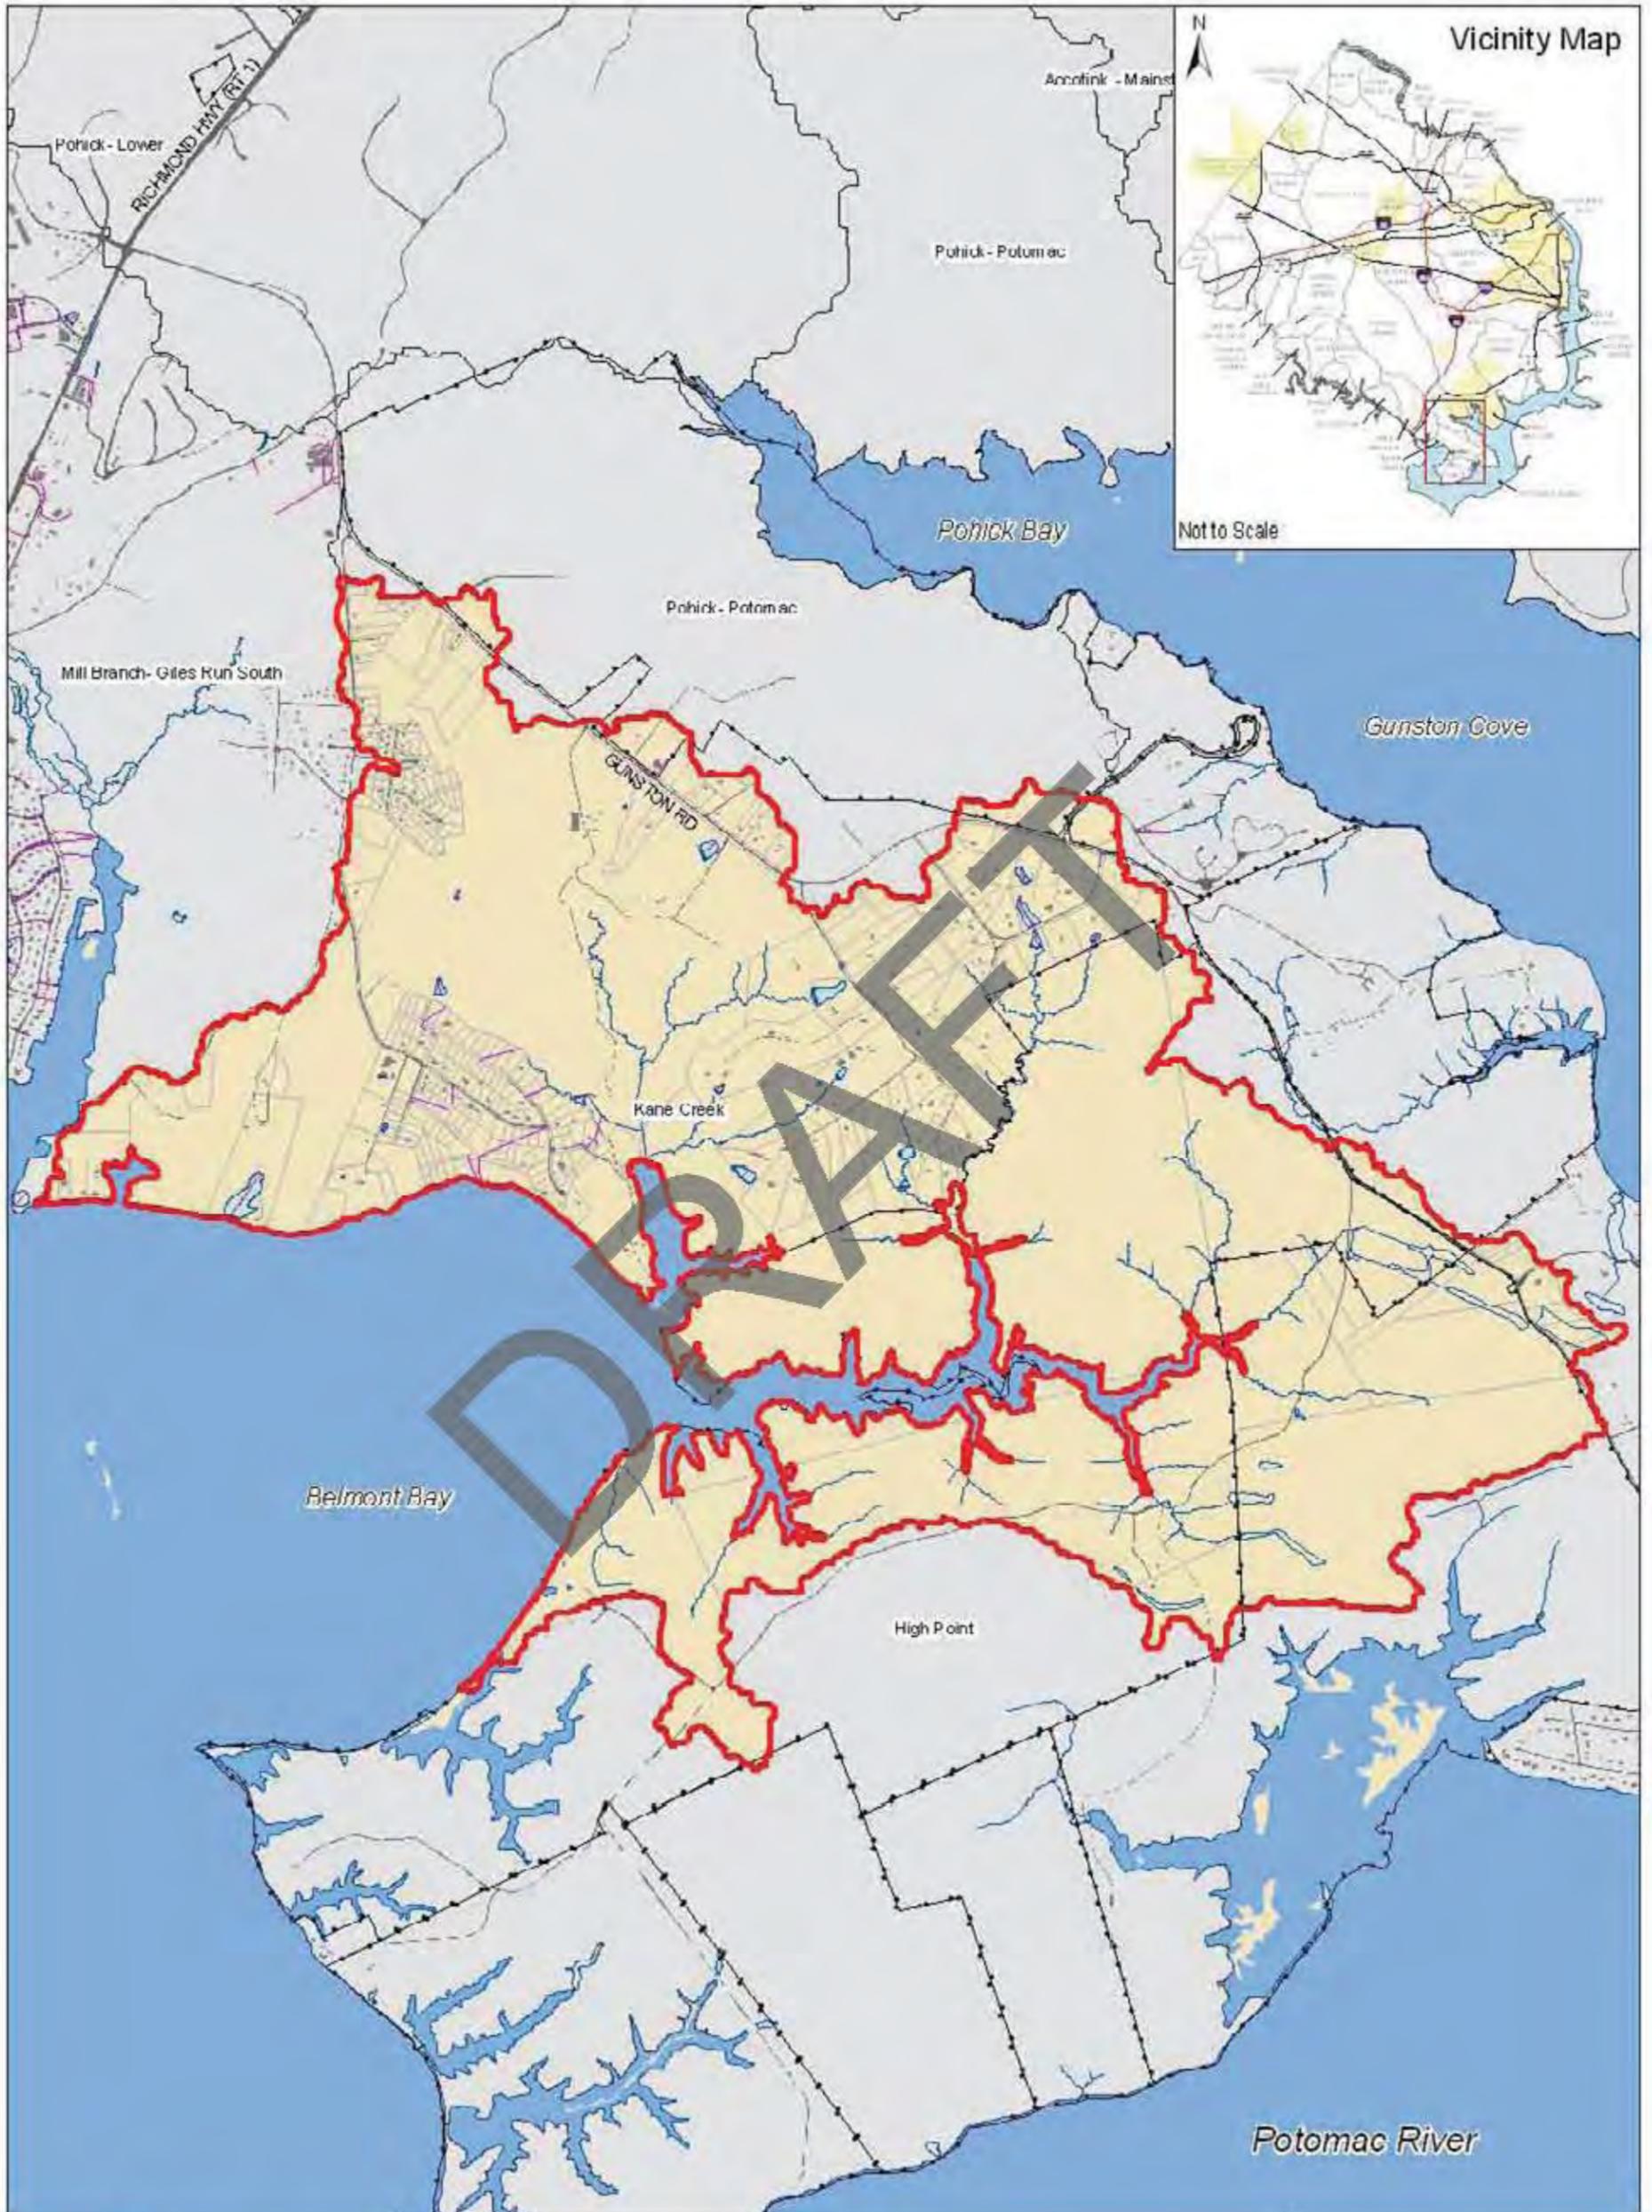
Map 2.2.7-1
Kane Creek
Current and Future Land Use

WMA Boundary	Estate Residential	Institutional
Agricultural	Low Density Residential	Low Intensity Commercial
Open Space	Medium Density Residential	High Intensity Commercial
Forested	High Density Residential	Industrial
Golf Course	Transportation	Water

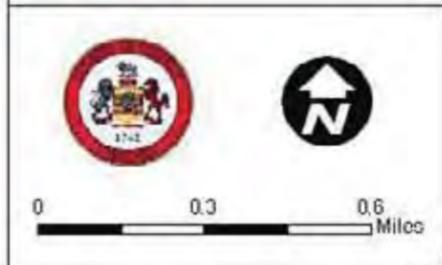
Map 2.2.8-2
 Lower Occoquan
 Old Mill Branch
 Stormwater Infrastructure

Legend		
Storm Drainage	Road	Lake
Rivers and Streams	Park Boundary	Storm Drainage Facility
Building	Other WMA Boundaries	Old Mill Branch
Drainage Complaint

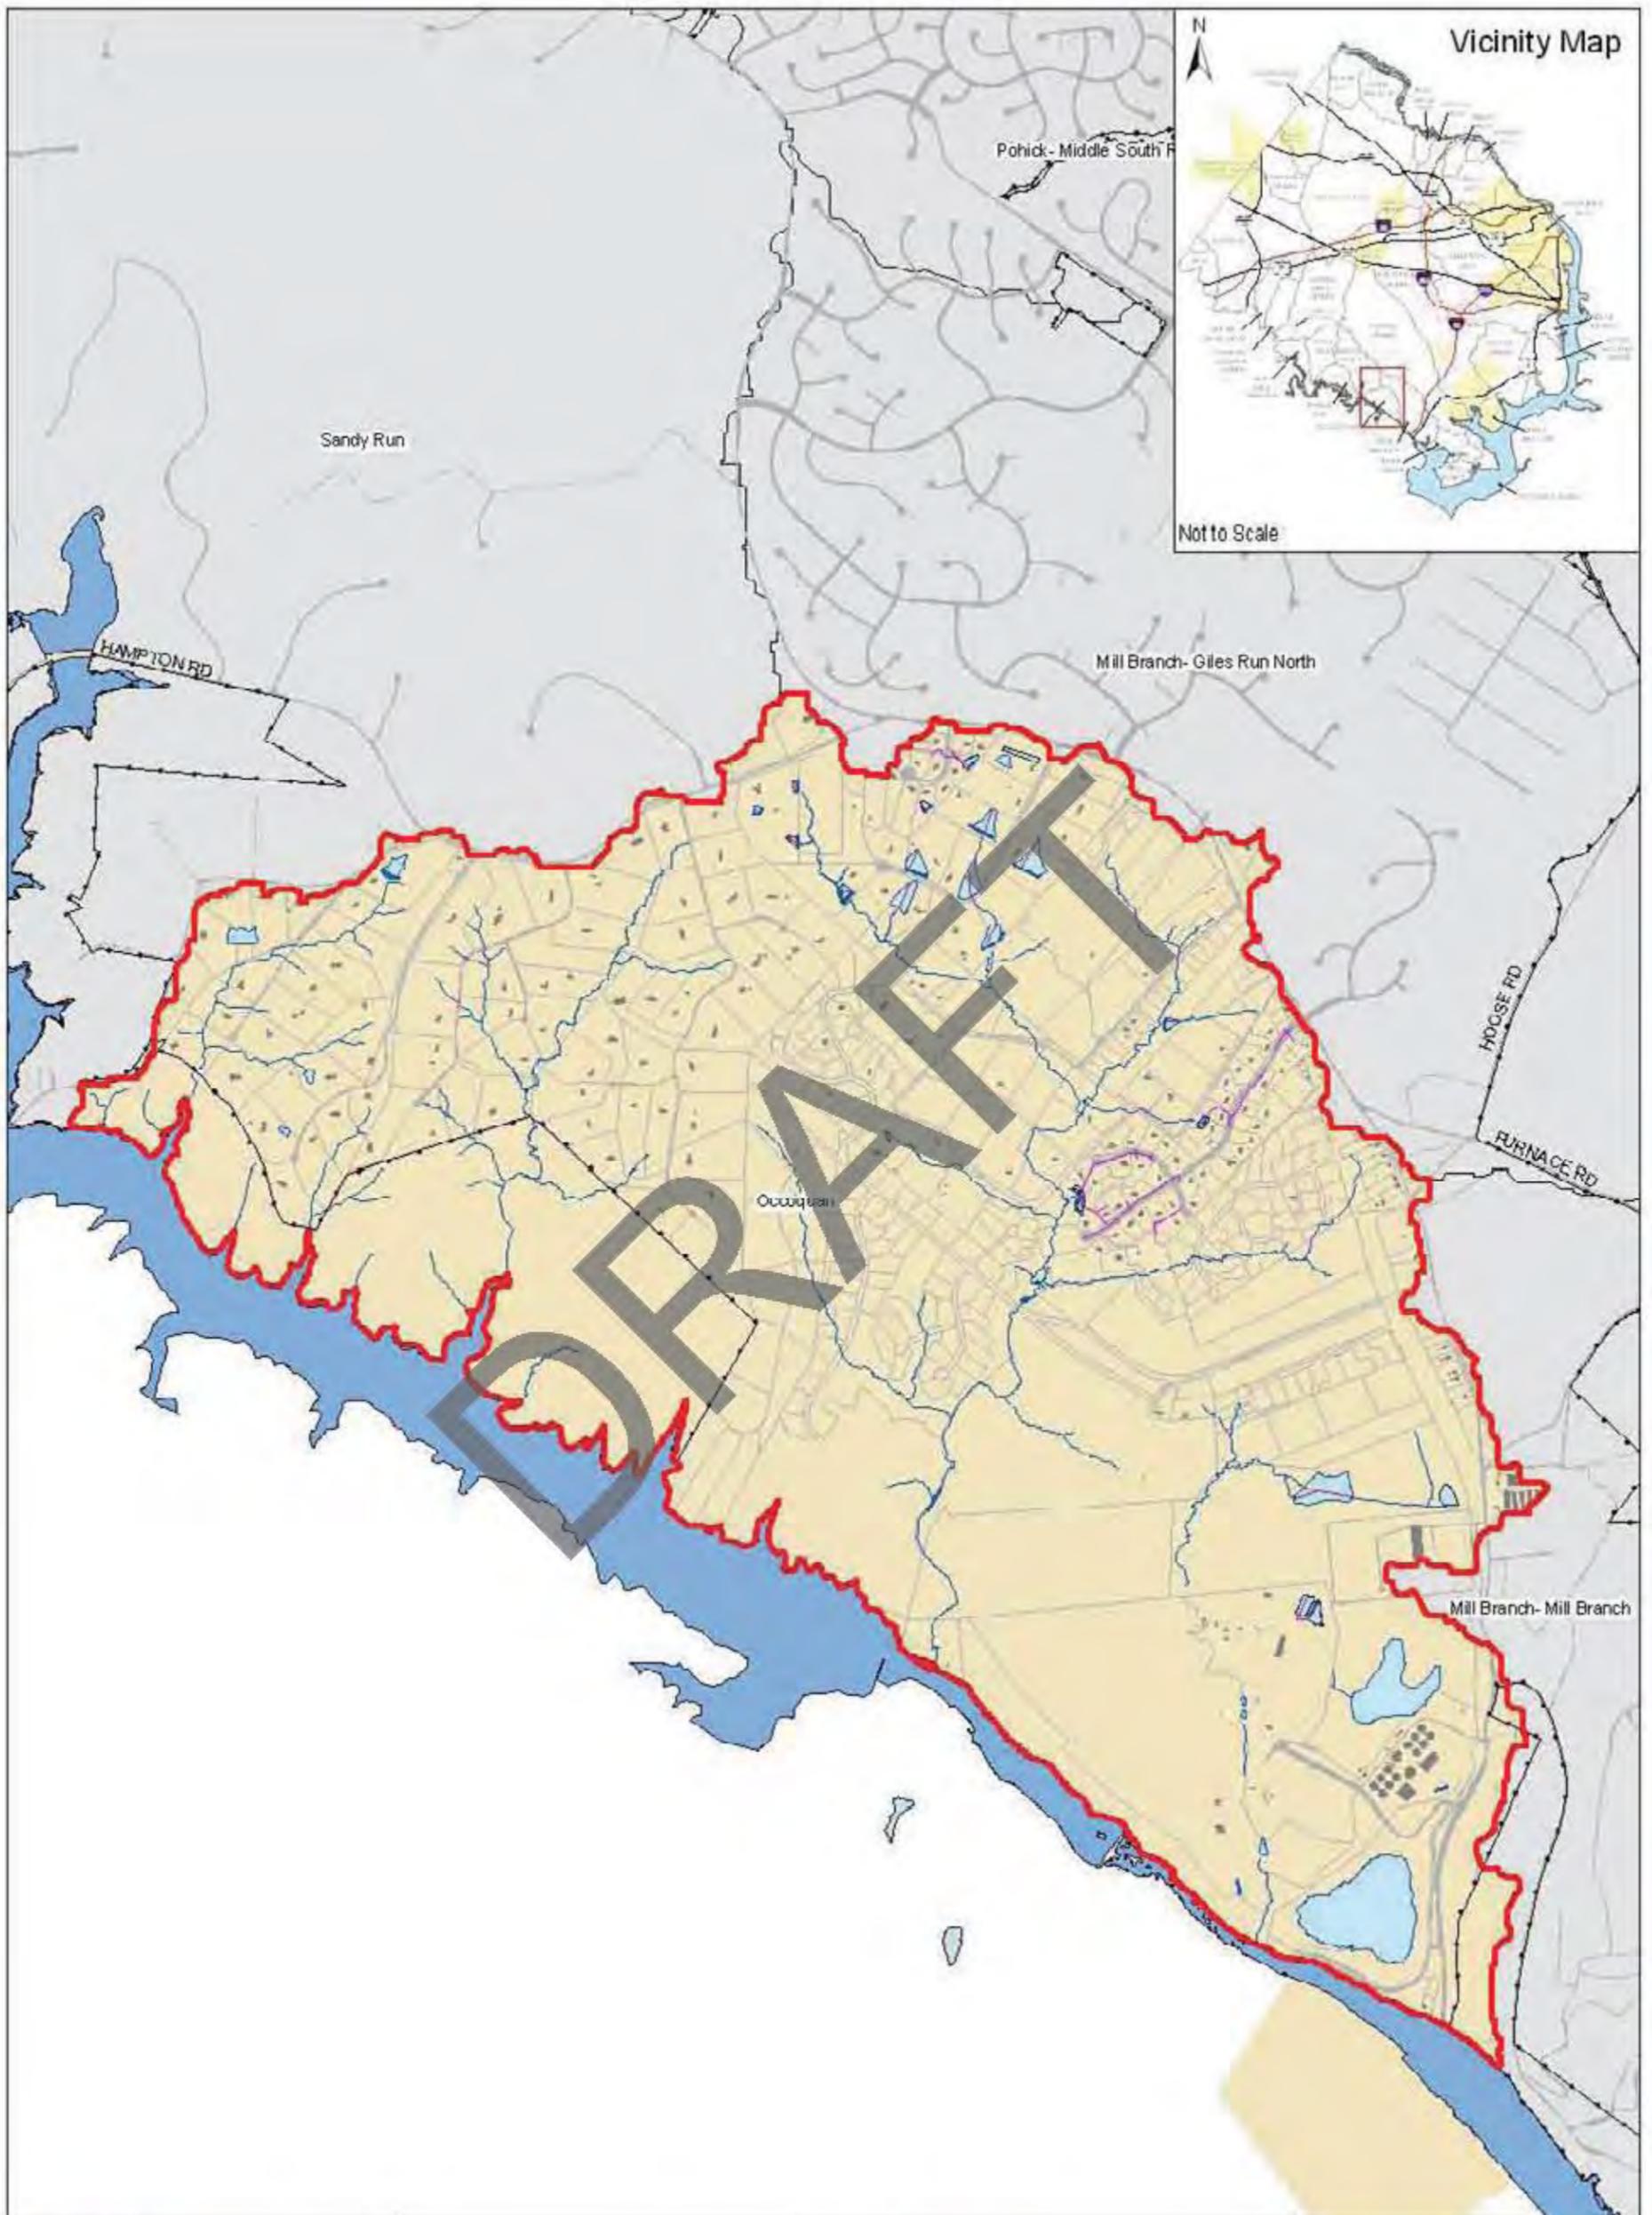
Map 2.2.10-1
Occoquan
Existing and Future Land Use

WMA Boundary	Estate Residential	Institutional
Agricultural	Low Density Residential	Low Intensity Commercial
Open Space	Medium Density Residential	High Intensity Commercial
Forested	High Density Residential	Industrial
Golf Course	Transportation	Water

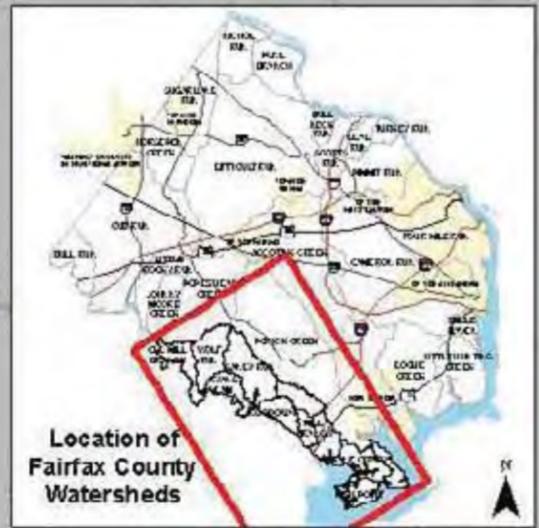
Map 2.3.1-4
Existing Total
Suspended Solids Load
(lb/ac/yr)
Lower Occoquan Watershed

■ 0.028841 - 0.079265	■ 0.116926 - 0.175286
■ 0.079266 - 0.116925	■ 0.175287 - 0.414617
