NATURAL RESOURCES REPORT

North Hill

Fairfax County, Virginia

March 7, 2008

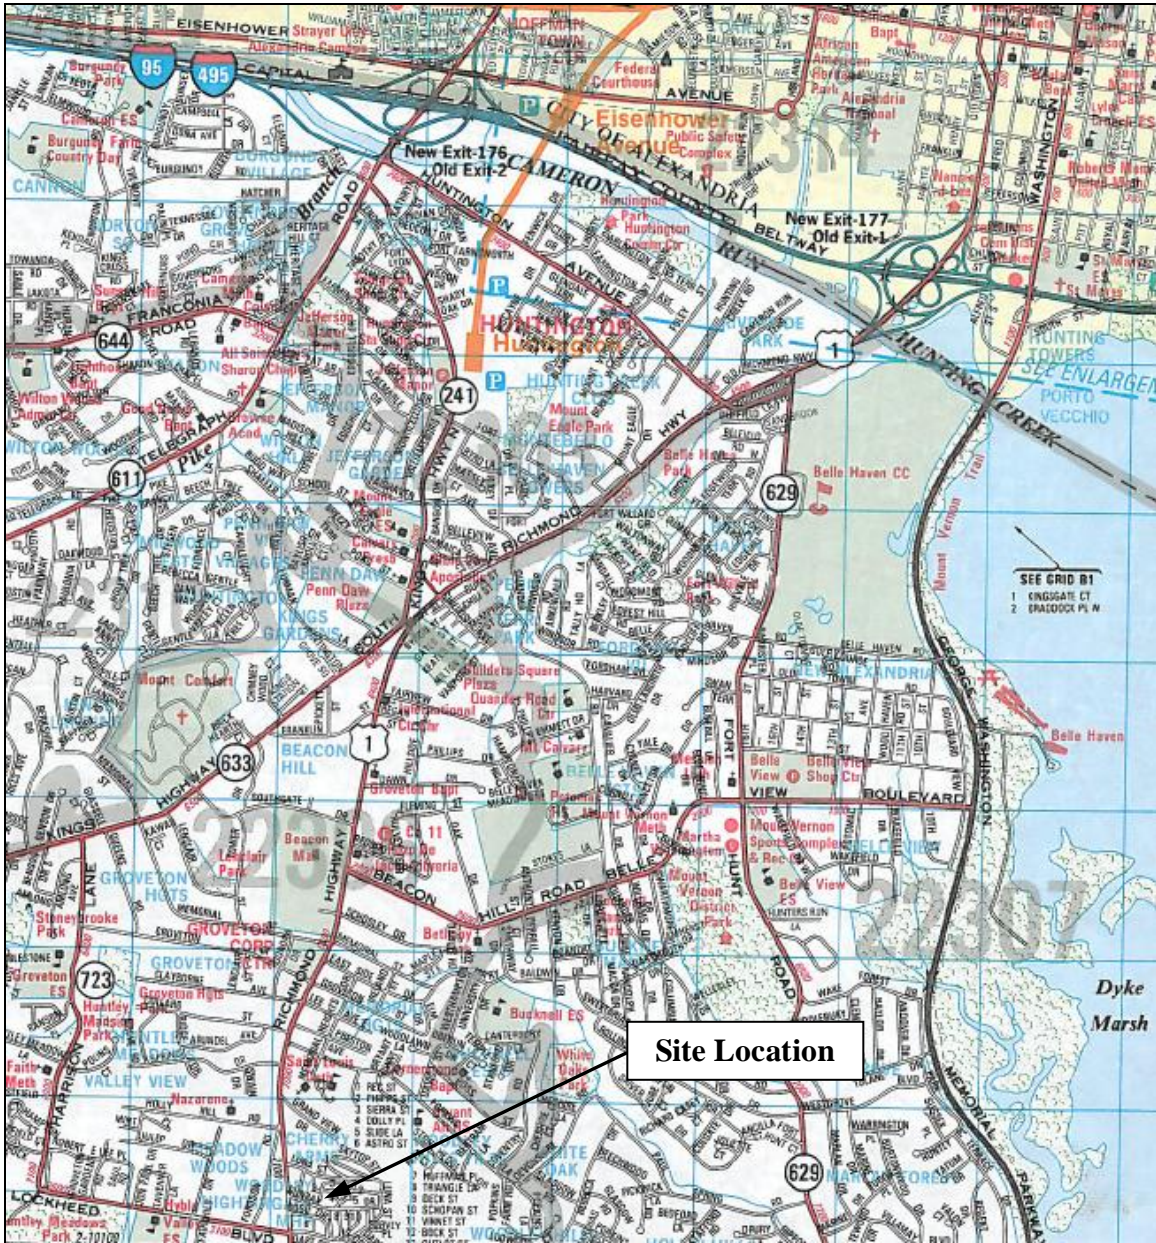
Figure 1. Vicinity Map

The approximately 33-acre North Hill site is located on Richmond Highway (US Route 1) in Fairfax County, Virginia (Figure 1). The site is bounded by Dart Drive and Woodley Estates Mobile Home Park to the south, residential development to the east, residential development and an outdoor track to the north, and Richmond Highway to the west. The North Hill site is located at latitude 38°45.71'N and longitude 77°05.00'W. Huntly Meadows Park is located approximately ½-mile southwest of the site. The Potomac River is located approximately 1 ½-miles east of the site. The North Hill site is located within the Middle Potomac-Anacostia-Occoquan Watershed, HUC # 02070010 (EPA, 2007).

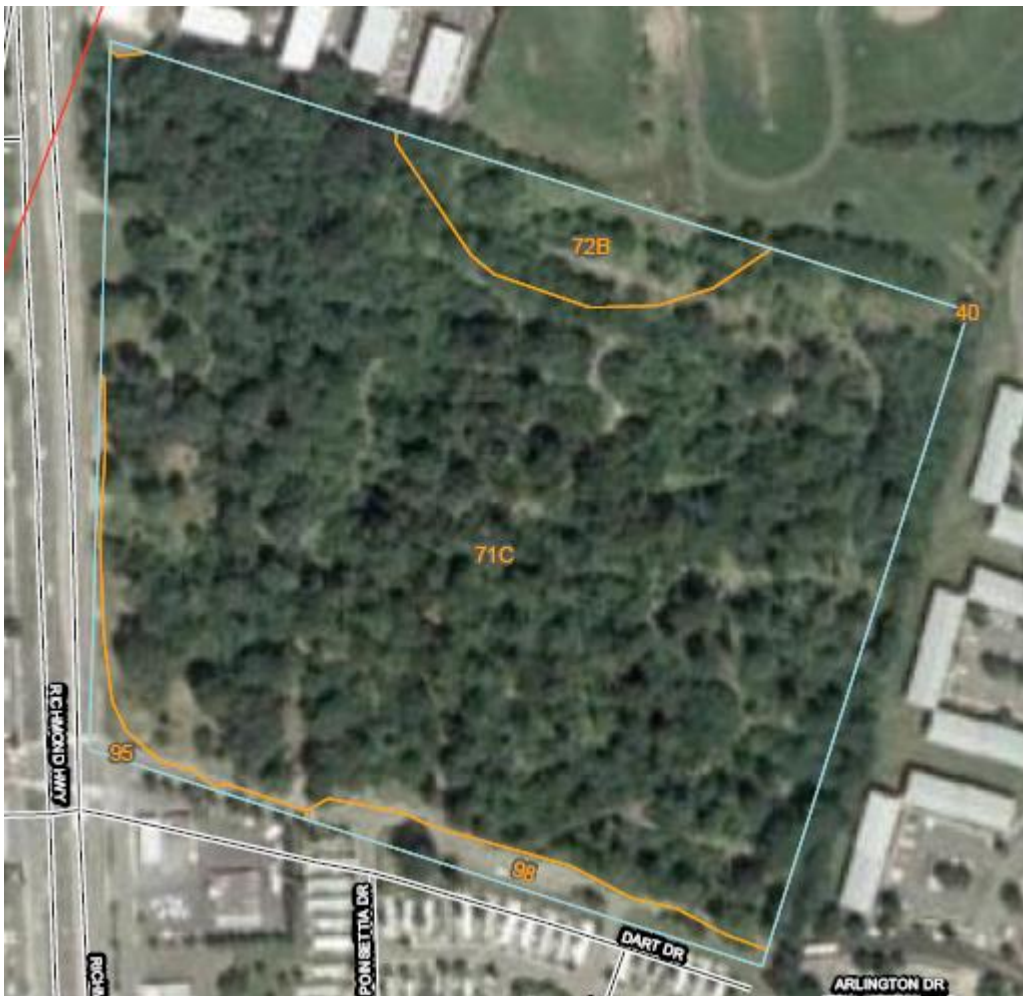
Figure 3. Soil Map

As of 2008, new soil data for the North Hill site is available from the USDA Web Soil Survey. Figure 3 shows the soil map unit types on the North Hill site. The majority, approximately 90 percent, of the North Hill site consists of Kingstowne-Sassafras-Marumsc complex (Map Unit Symbol 71C) soil. Map Unit 71C is well drained to moderately well drained soil with 7 to 15 percent slopes. Lesser amounts of Kingstowne-Sassafras-Neabsco complex (72B), Urban land (95), Urban land-Grist Mill (98), and Grist Mill sandy loam (40) soils exist on the site. All of the soils located on the North Hill site are identified as not hydric, except for the Urban land types, which are listed as unknown hydric.

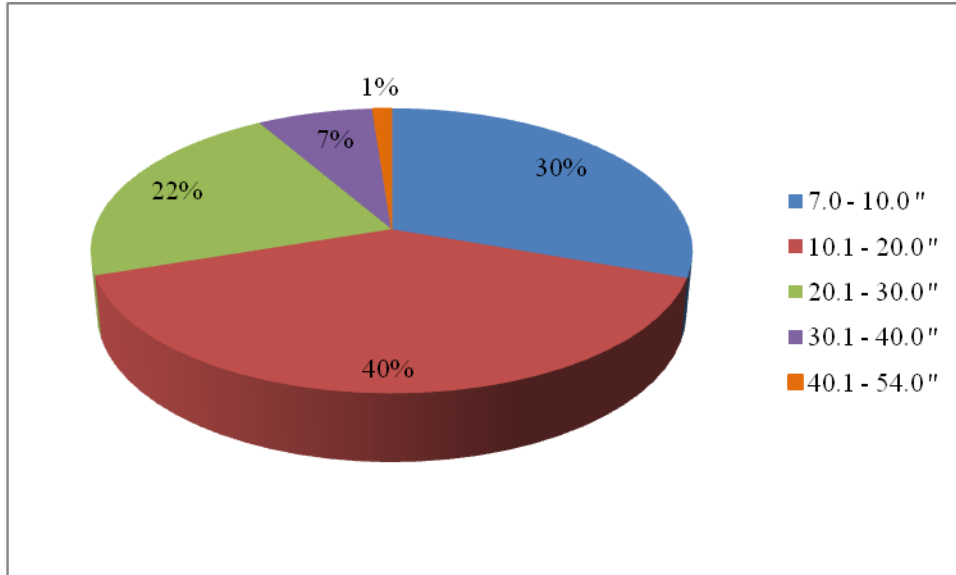
Figure 5. Percentage of Trees Greater than 7 " dbh (Per dbh Range)

Within the North Hill site, there are 1,427 trees that are greater than 7.0 inches in dbh. Two additional trees, an eastern red cedar and flowering dogwood, each having a dbh of 6, were surveyed (but not included in the 1,427 total) due to their good condition. The most common trees surveyed, along with their respective quantities, included: American elm (41), black cherry (103), black locust (397), box elder (110), red maple (119), sweet gum (180), tree-of-heaven (50), white oak (92), and willow oak (67). There are 434 trees with a dbh between 7.0 and 10.0 inches; 563 trees with a dbh between 10.1 and 20.0 inches; 310 trees with a dbh between 20.1 and 30.0 inches; 103 trees with a dbh between 30.1 and 40.0 inches; and 17 trees with a dbh between 40.1 and 54.0 inches. As illustrated in Figure 5, the majority of the trees (40 percent) are within the dbh range from 10.1 – 20.0 inches. The largest tree was a willow oak (Tree #726), having a dbh of 54 inches. Although not at dbh level, this willow oak has three main stems, which probably does not make it the best “excellent” tree on-site (Photograph 14, Appendix E). The largest single trunk tree in excellent condition is also willow oak (Tree #913), having a dbh of 47.5 inches. The next largest excellent tree with a single trunk is a white oak (Tree #343), having a dbh of 44 inches.

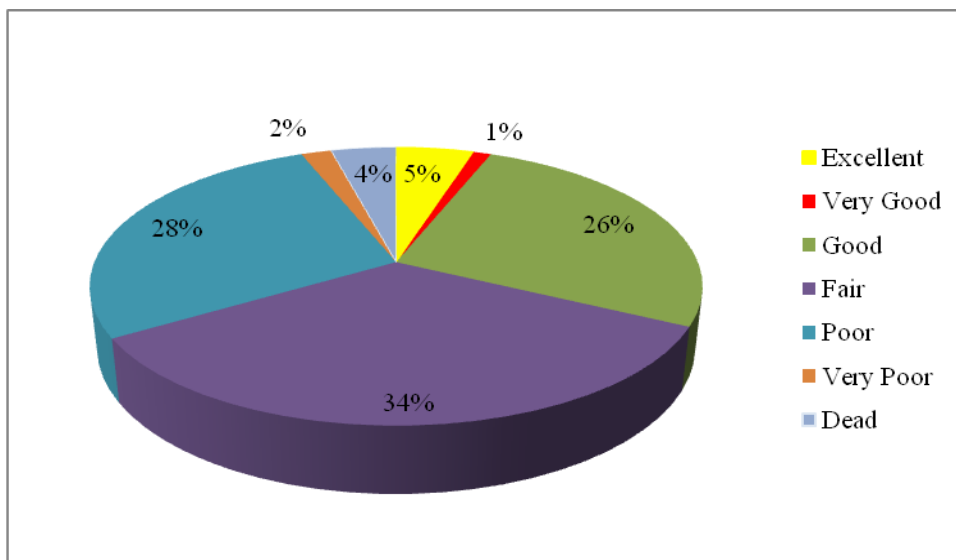
Figure 6. Percentage of Surveyed Trees by Condition

The majority of the trees on the North Hill site are in poor, fair, and good condition, which in total makes up 88 percent of the trees. Of the total number of surveyed trees, there are 69 trees in excellent condition, 16 trees in very good condition, 376 trees in good condition, 486 trees in fair condition, 395 trees in poor condition, 27 trees in very poor condition, and 58 trees are dead. The majority of those trees in excellent condition include white oak, willow oak, and American beech. Figure 6 illustrates the condition of the trees on the North Hill site.

As shown in the Tree Inventory Results (Appendix C), tree condition and recommendations on tree removal have been provided. At a minimum, it is recommended that all trees in excellent and very good condition be preserved, especially those that are greater than 20 inches in dbh. It is recommended that invasive trees, such as the tree-of-heaven, Bradford pear, and princess tree be removed on the North Hill site, where feasible. In some instances, hollow trees appear to be utilized by wildlife and are providing habitat. Therefore, some small dead or dying trees were not recommended for removal. Conversely, it is recommended that large unhealthy trees that are dying and/or dead be removed as a public safety precaution.

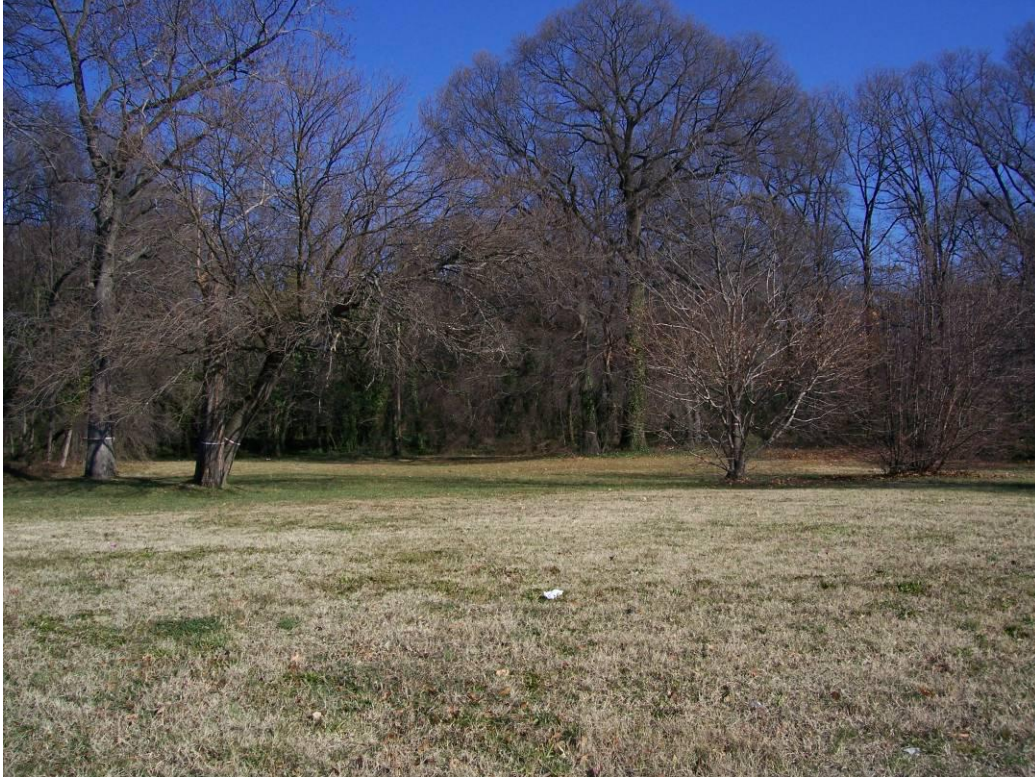
Photograph 1. Grassed area with scattered trees located in the southwestern region of the North Hill site. Photograph direction: Northeast

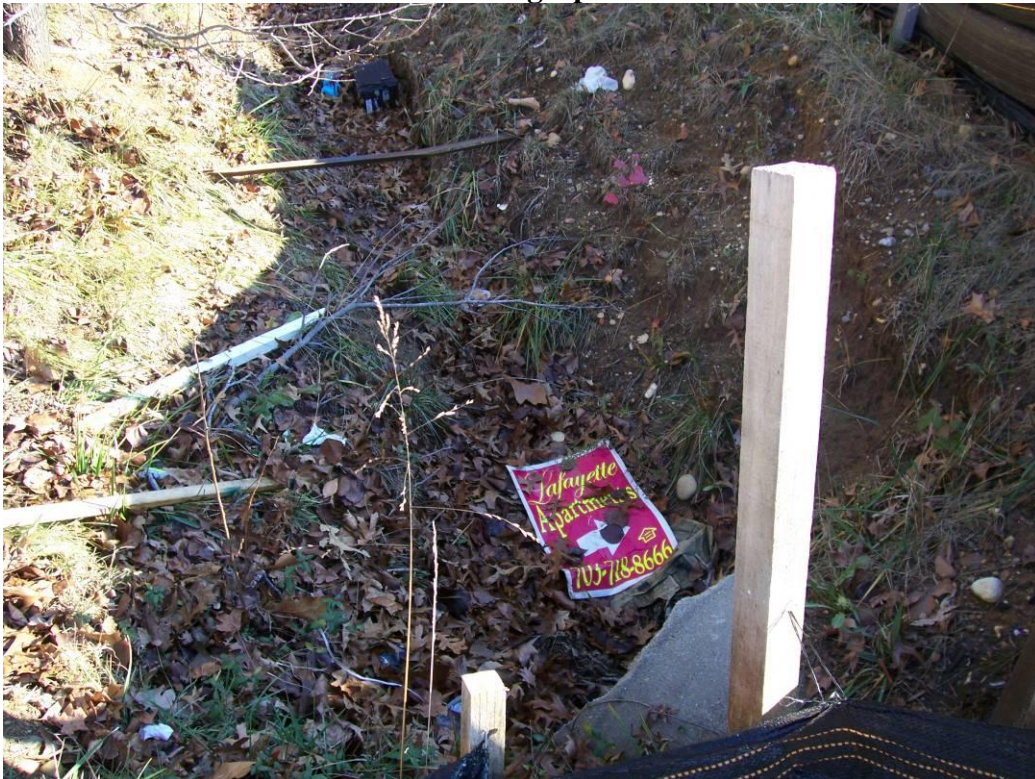
Photograph 2. View of a culvert with silt fencing directly adjacent to Route 1. Photograph Direction: East

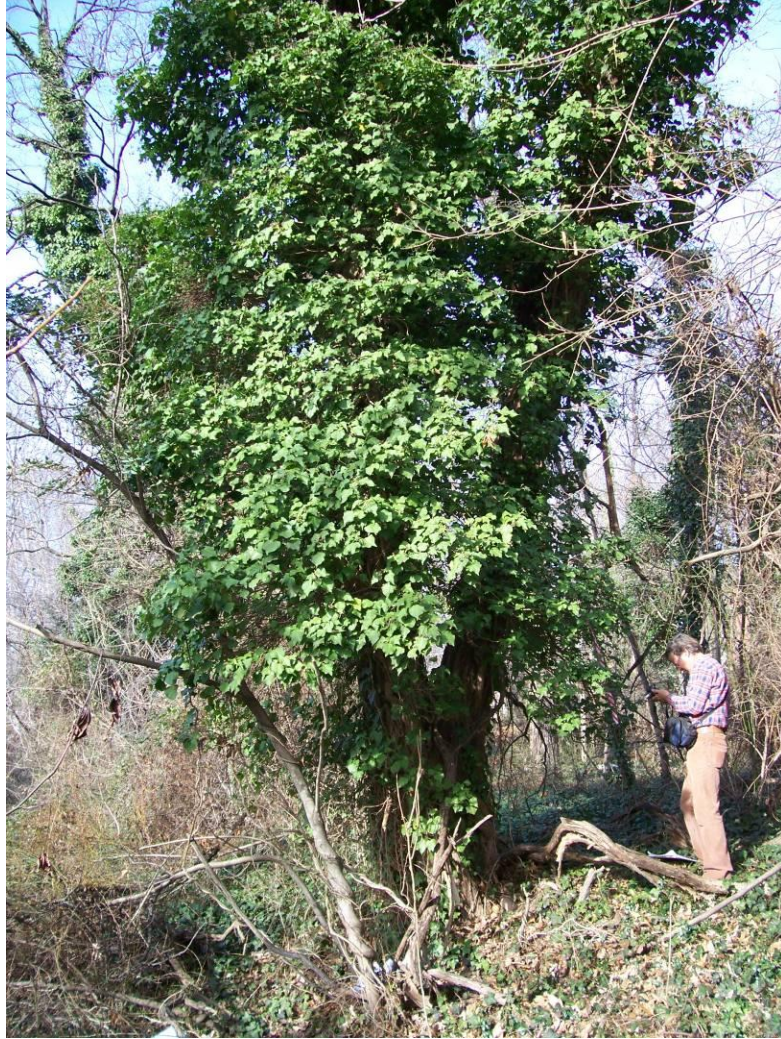
Photograph 3. View of tree number 204. Photograph Direction: North

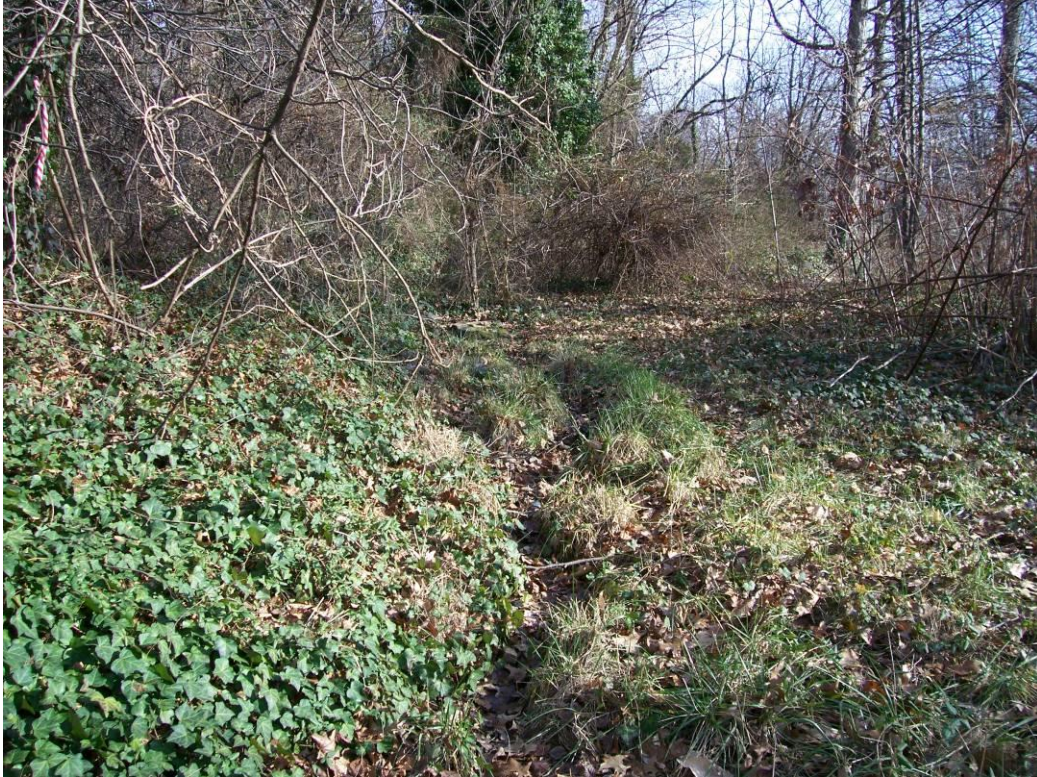
**Photograph 4. Drainage pattern created from a culvert, located near Route 1.
Photograph Direction: East**

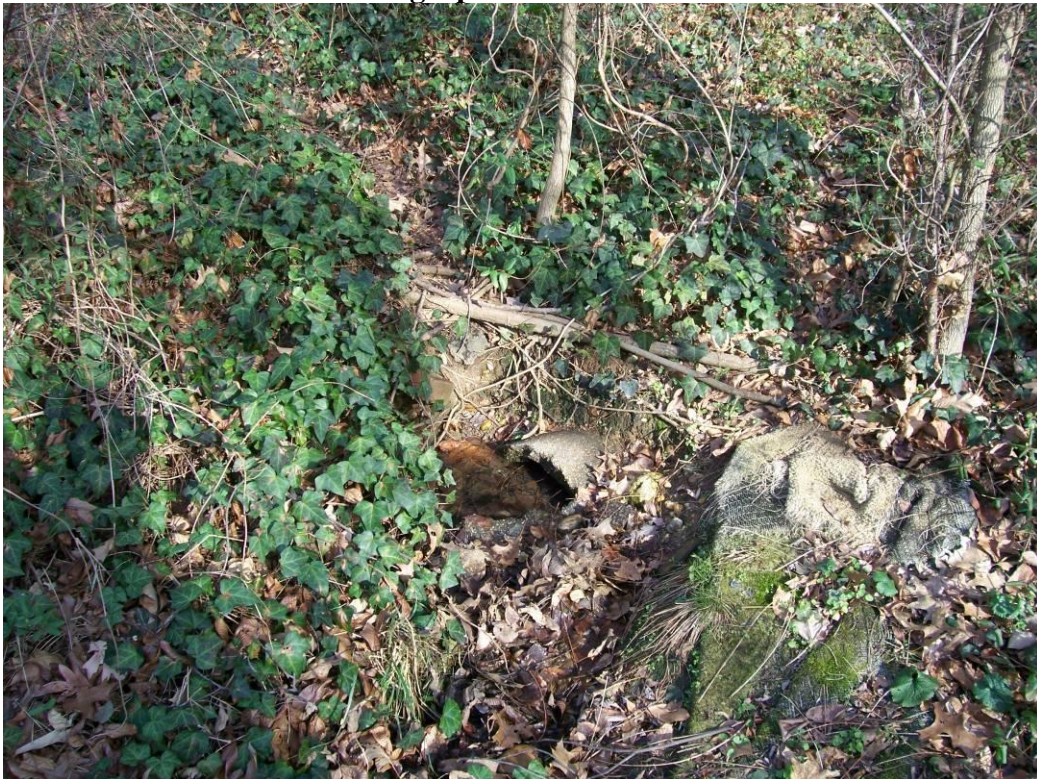
Photograph 5. Underground concrete culvert which empties into the drainage pattern, as shown in Photograph 4. Photograph Direction: Northeast

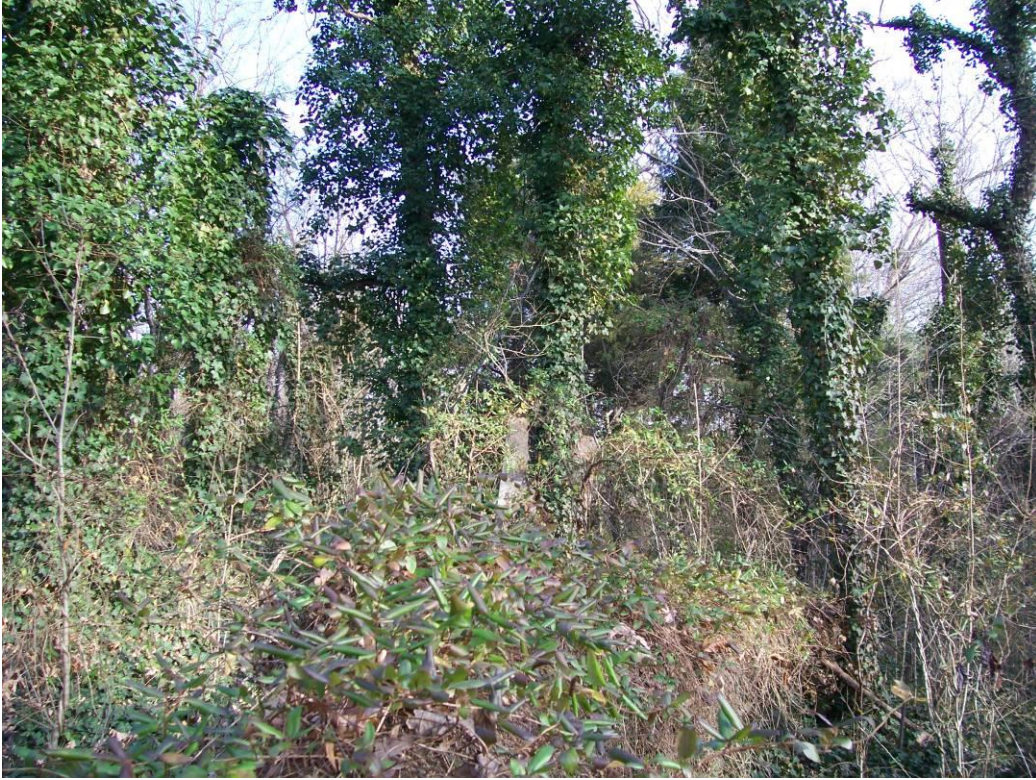
**Photograph 6. Typical view of vine-covered trees on site. Photograph Direction:
East**

where feasible. Many smaller trees that are in good condition and/or are providing food for resident wildlife are also recommended for preservation. For those trees that are to be preserved, it is recommended that the English ivy, poison ivy, utility wires, and/or other foreign objects (if present) be removed from the trees.

Larger vines such as English ivy and poison ivy may be removed by cutting the vine and applying the glyphosate solution to the bottom, rooted portion. To the extent possible, the upper portion of the vine may be pulled off the tree. Manually removing vines in this manner will not be possible in all cases. In such cases, there will be trees with dead vines clinging to them for some time after the removal process. For extensive patches of ivy on ground areas, spraying a foliar herbicide (under controlled conditions in accordance with herbicide application guidelines) may be more effective. For the English ivy, it will be necessary to mix a surfactant/detergent into the glyphosate solution since this plant has a very waxy leaf surface that must be penetrated in order for the herbicide to be effective (NPS, 2008).

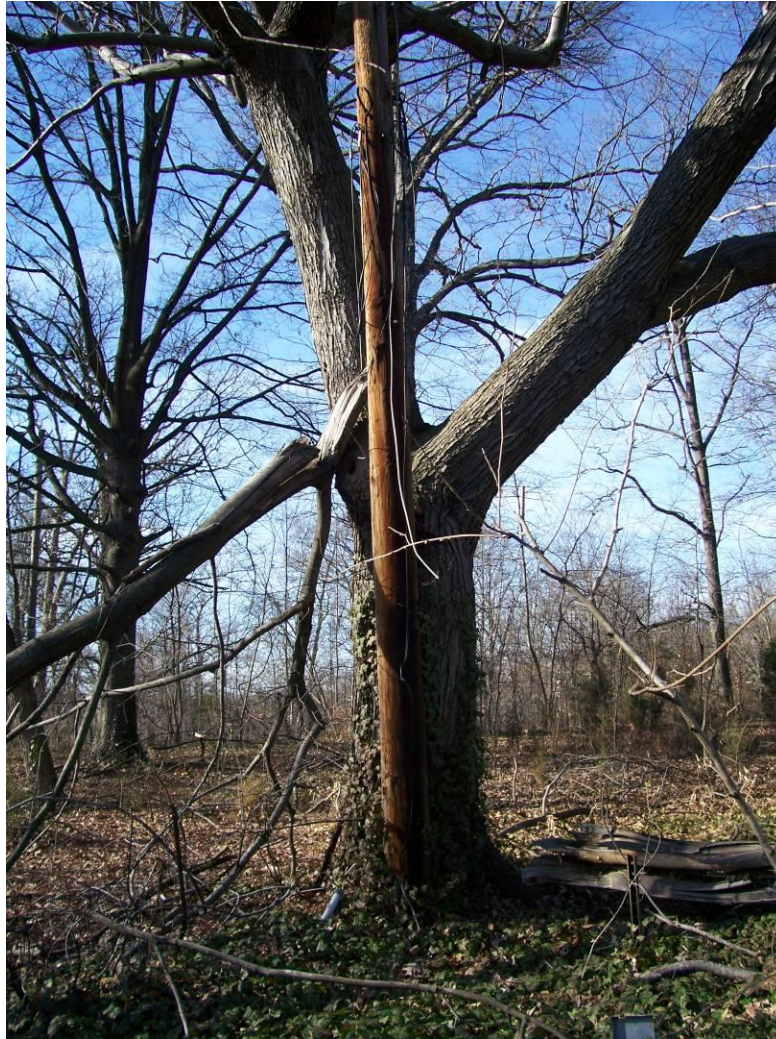
**Photograph 7. View of tree number 339 with broken limbs and adjacent utility pole.
Photograph Direction: West**

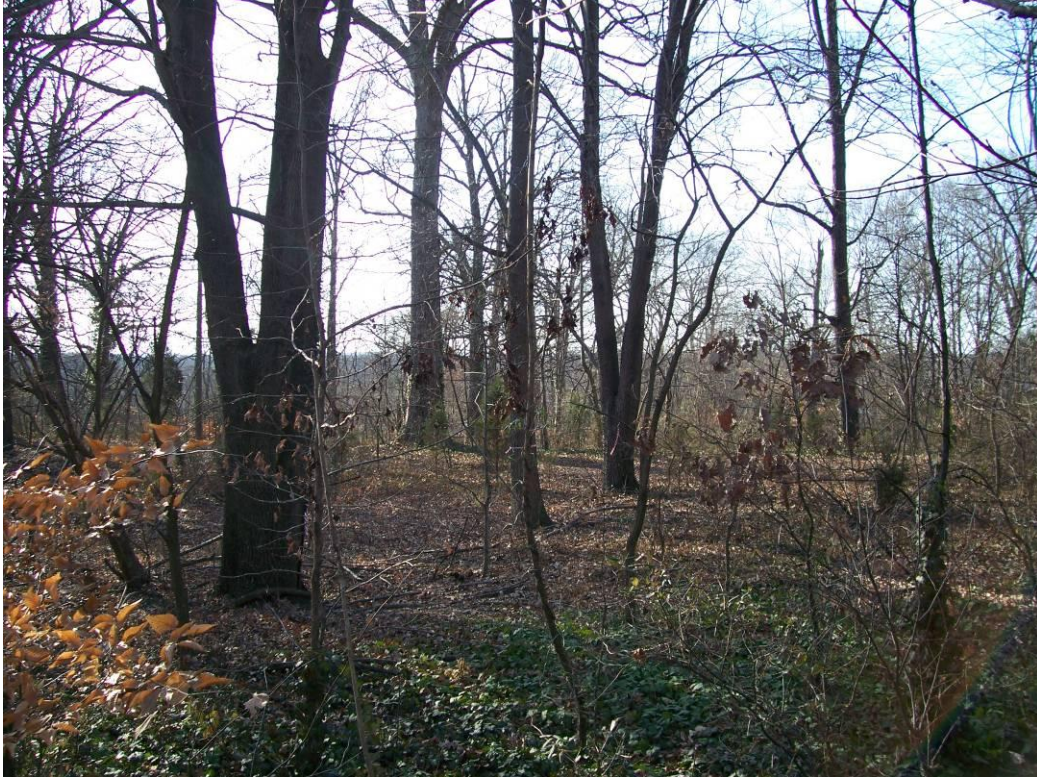
Photograph 8. View from upslope looking towards Route 1. Photograph Direction: Southwest

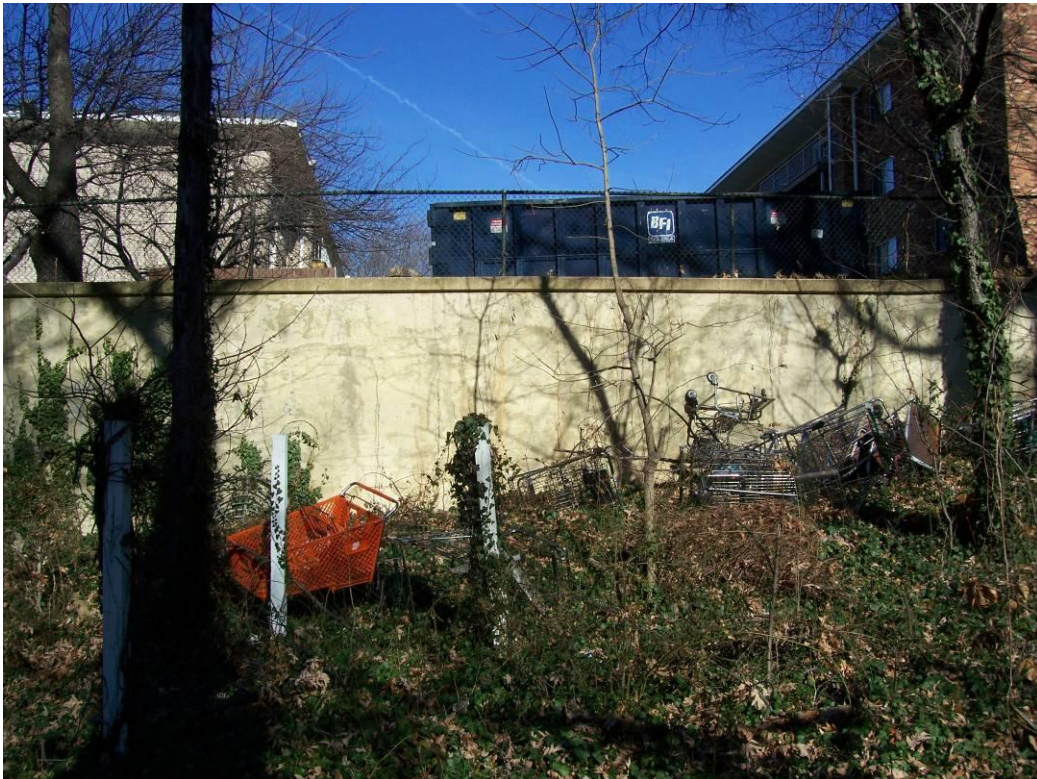
The North Hill site is relatively typical for a disturbed site surrounded by development and located in an urban setting. The site contains pockets of trash and debris (Photographs 9 and 10, Appendix E). Invasive species are present, and quite often excessive, throughout the site (Photograph 6). The site contains old paved roadways, remains of concrete trailer pads/bases, a concrete drainage structure, and utility poles (Photographs 7, 11, and 13). In addition, there are numerous locations with evidence of human habitants (i.e. shelters, sleeping bags, tarps).

Photograph 9. Shopping carts and debris located along the northern site boundary. Photograph Direction: North

Care should be exercised during any removal of debris, concrete, and asphalt. Some areas of asphalt could remain and serve as trails. Where this is not desirable, the removal process should be conducted in a manner consistent with minimizing damage to the adjacent vegetation, particularly large, healthy trees. Minimizing damage to vegetation includes not digging any deeper than necessary to remove the foreign materials, limiting the intrusion of equipment into healthy vegetated areas, and replanting disturbed areas with native vegetation as quickly as possible. All personnel involved in the removal of debris should be thoroughly briefed on the goals of the project and the need to minimize impacts on desirable vegetation. The staging of any debris removal activities is an important consideration. Larger equipment should be limited to specific areas, such as the existing paved areas along the north edge of Dart Drive. In addition, the debris located in the northern region of the site could be removed first, utilizing the existing paved areas for transport to the loading area for the larger equipment. This type of staging eliminates the need to cut any new access roads or to bring larger equipment any further into the site than absolutely necessary.

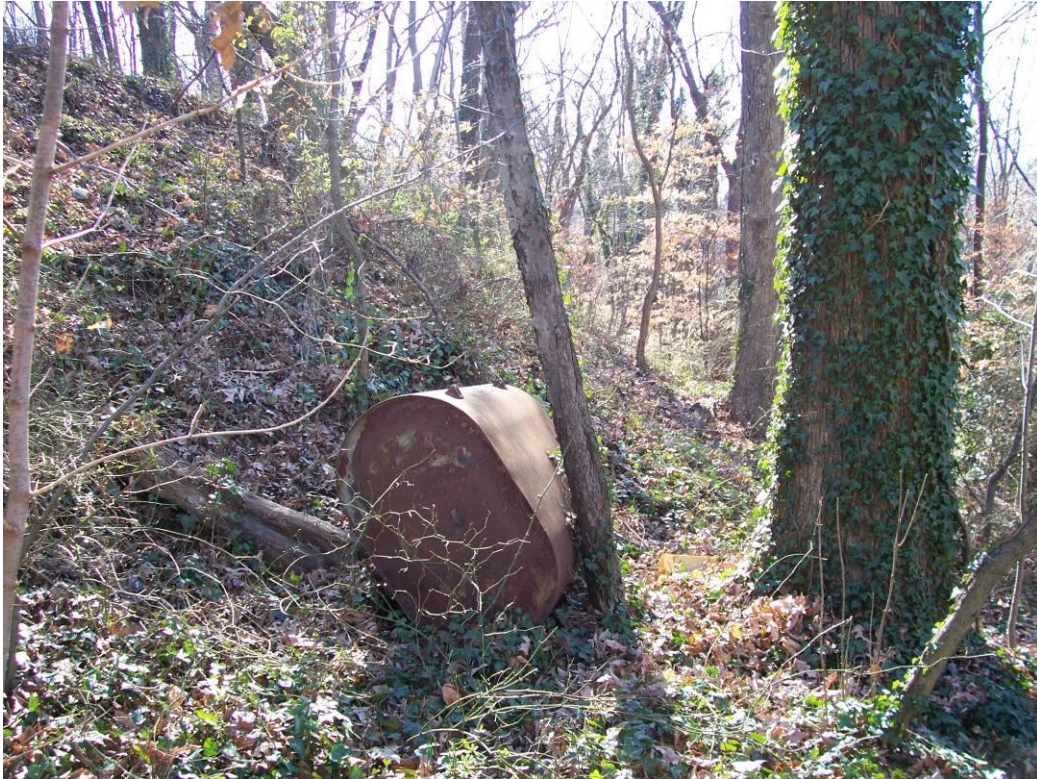
Photograph 10. Oil tank located on-site. Photograph Direction: South

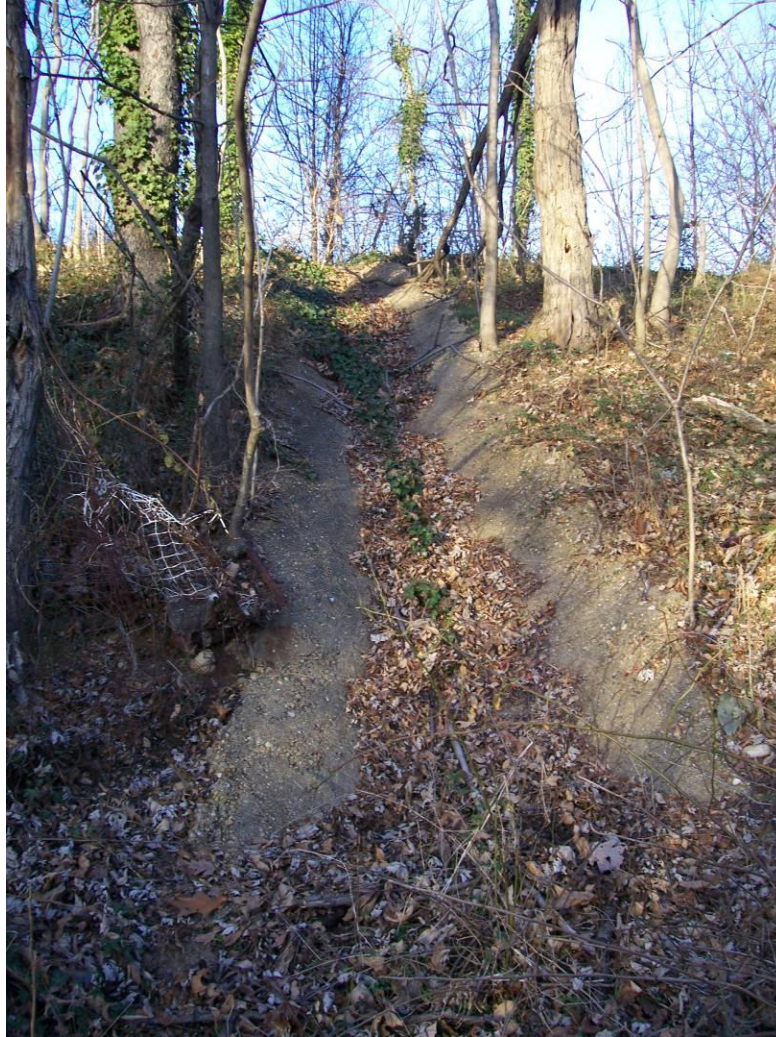
**Photograph 11. View of a concrete drainage, which leads into a ground grate.
Photograph Direction: Northeast**

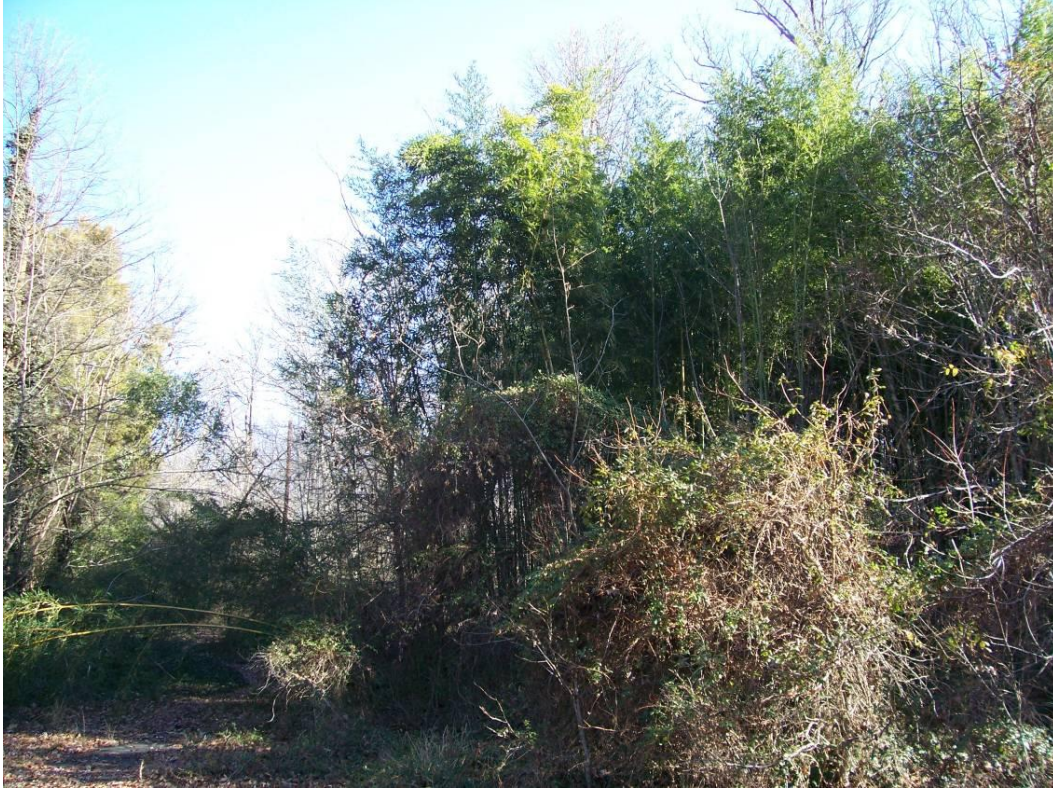
In addition, several stands of bamboo (*Phyllostachys sp*), which is likely golden bamboo (*Phyllostachys aurea*), exist on the site (Photograph 12, Appendix E). These bamboo stands are approximately 100 to 200 square feet in size. The thick bamboo stands may provide habitat cover for deer, which were observed near one stand.

Photograph 12. View of one of the on-site bamboo stands adjacent to an old paved roadway. Photograph Direction: North

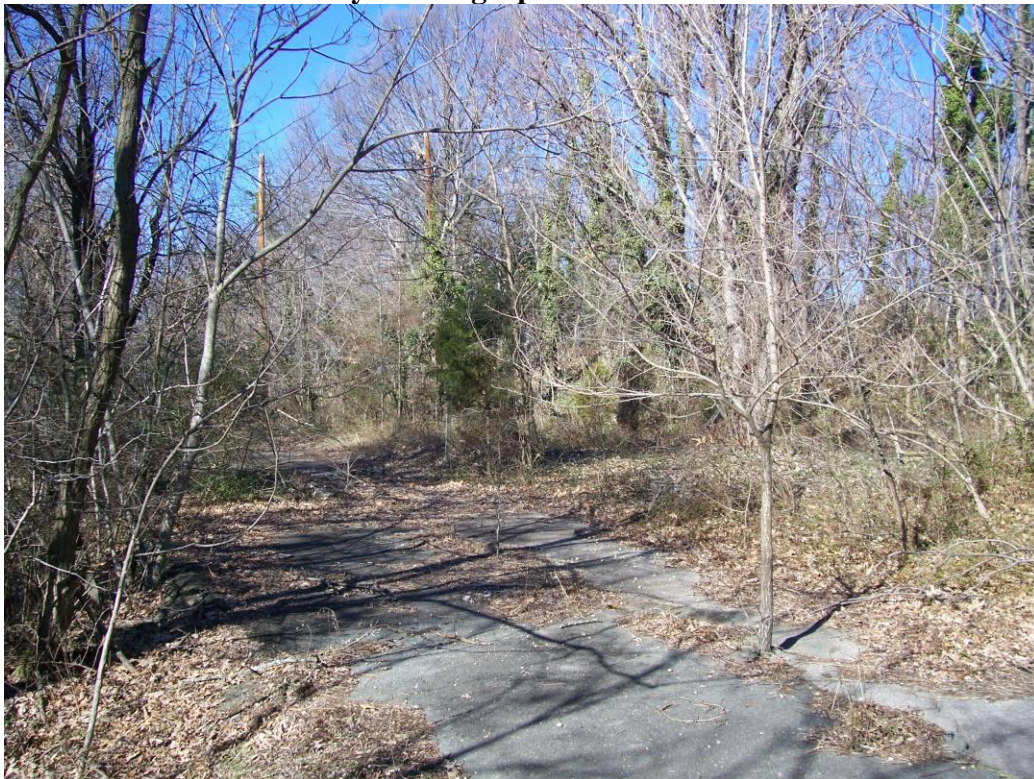
Photograph 13. View of the central region of the site. Photograph Direction: Northwest

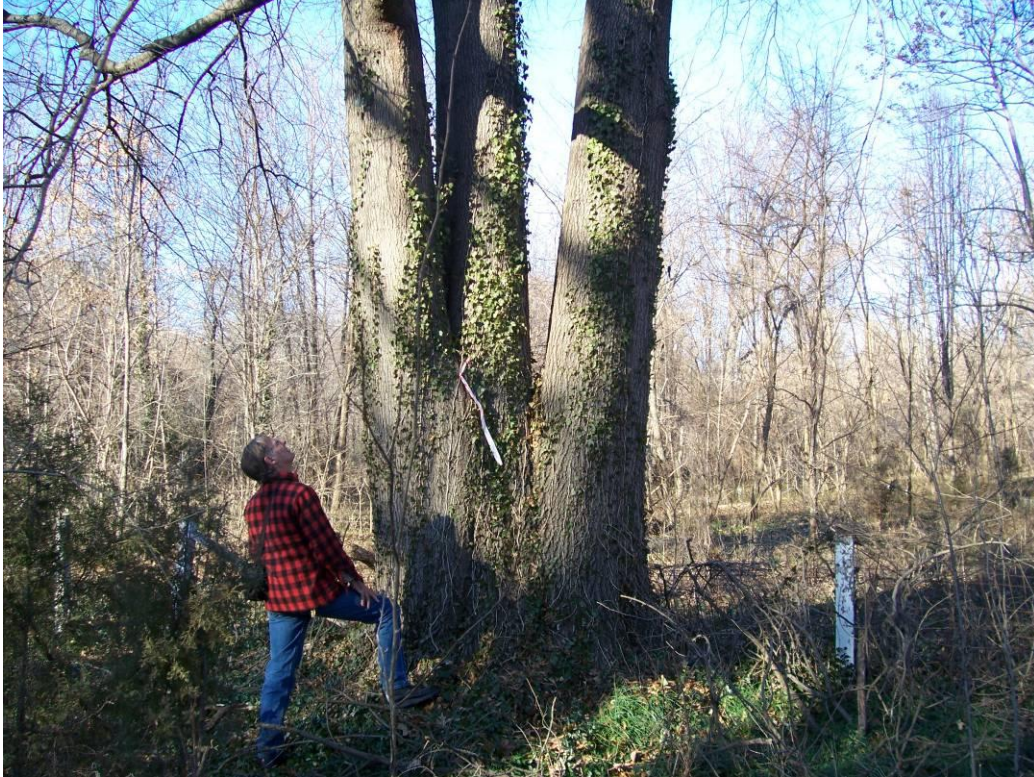
Photograph 14. View of the largest tree on site, willow oak (number 726) having a dbh of 54. Photograph Direction: North

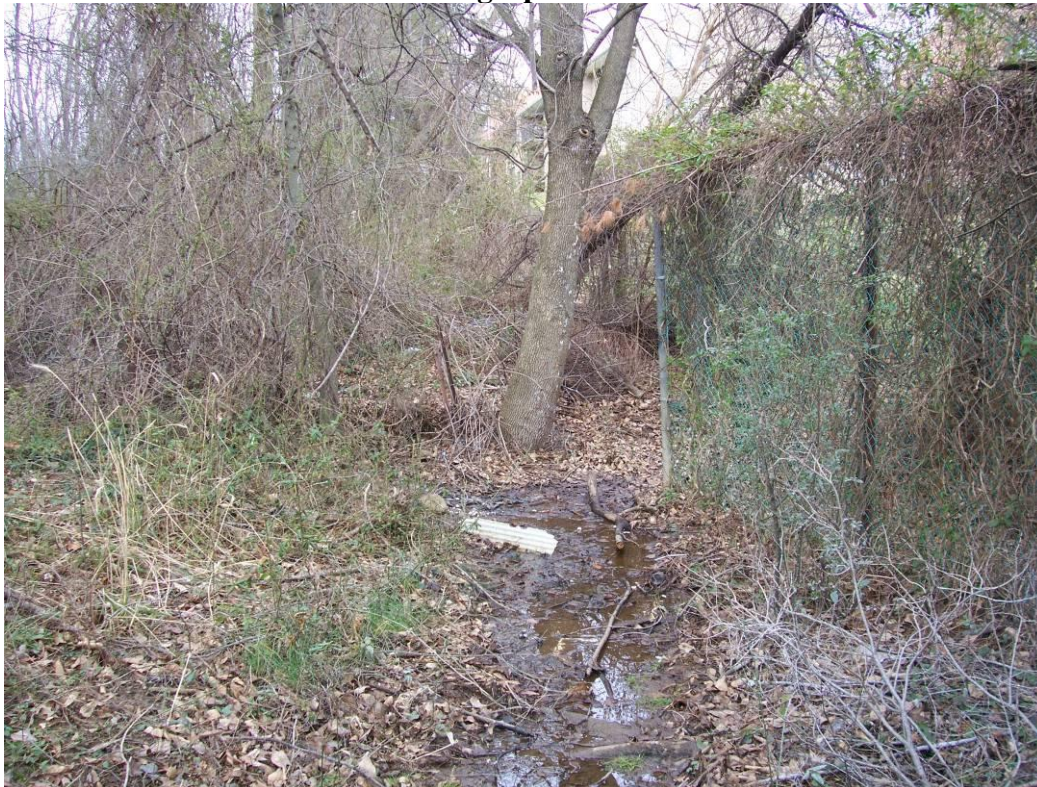
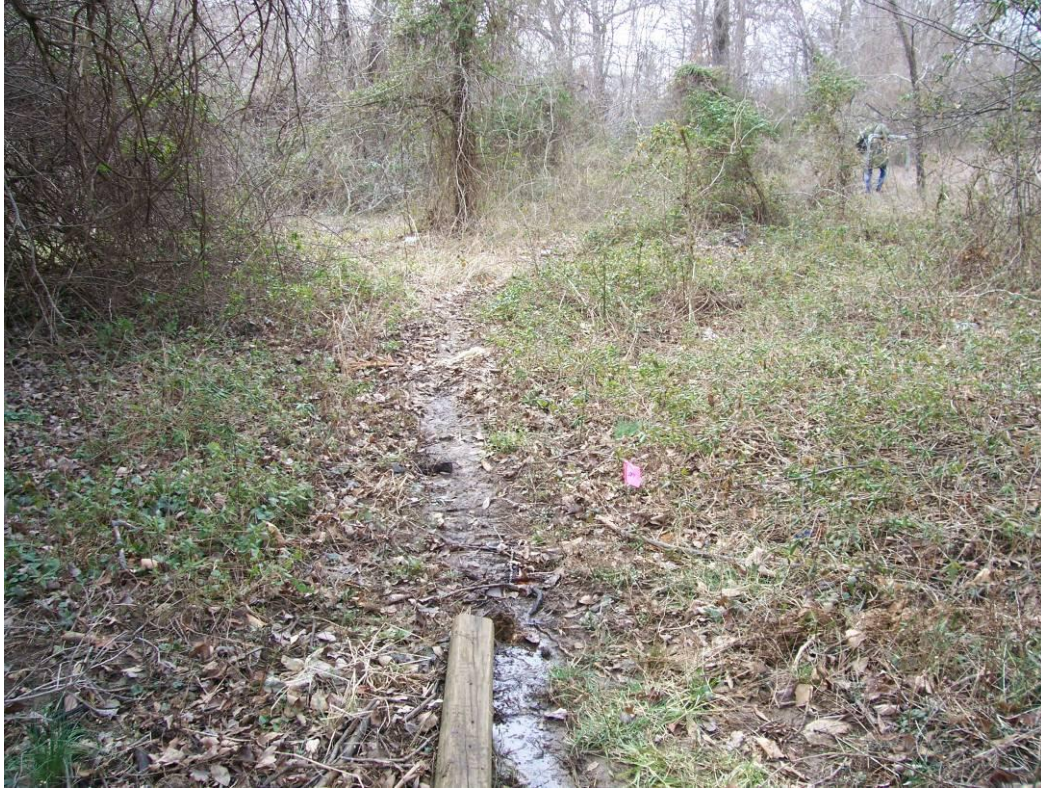
The soil at all four data points did not exhibit gleyed or low chroma colors. The soil consisted of primarily clay. The soil at Data Point (DP)-1 was 10 YR 4/3 in the upper 0-4 inches of soil (A horizon) and 10 YR 5/6 from 4-18 inches of soil (B horizon). The area near where DP-1 is located is shown in Photographs 15 and 16 in Appendix E. The soil at DP-2 was 10 YR 3/4 in the upper 0-4 inches of soil (A horizon) and 10 YR 5/4 from 4-18 inches of soil (B horizon). Underlain fill material and concrete appeared to exist at DP-2 and in the vicinity. The area near where DP-2 is located is shown in Photographs 17 and 18 in Appendix E. The soil at DP-3 was 10 YR 5/4 in the upper 0-6 inches of soil (A horizon) and 10 YR 7/4 from 6-18 inches of soil (B horizon). The soil at DP-4 was 10 YR 6/4 from 0-18 inches. The area near where DP-4 is located is shown in Photograph 20 in Appendix E.

Photograph 15. View of an on-site drainage swale near the eastern property boundary at DP-1. Photograph Direction: Northeast

Photograph 16. Down-gradient view of the on-site drainage swale near the eastern property boundary at DP-1. Photograph Direction: Southwest

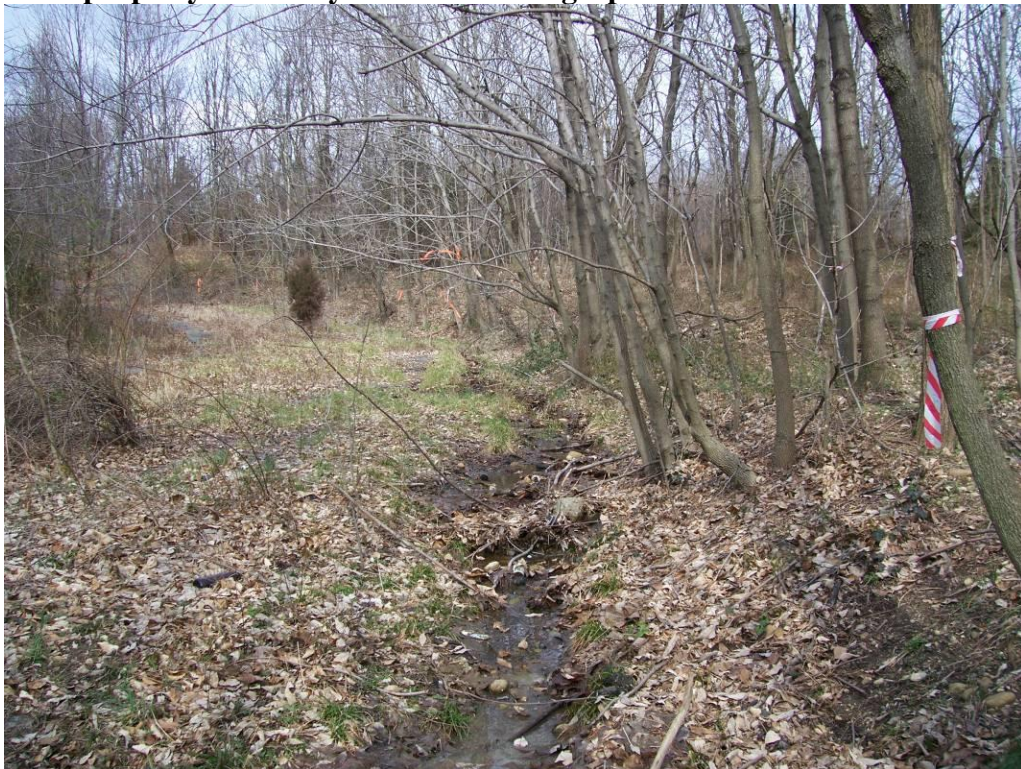
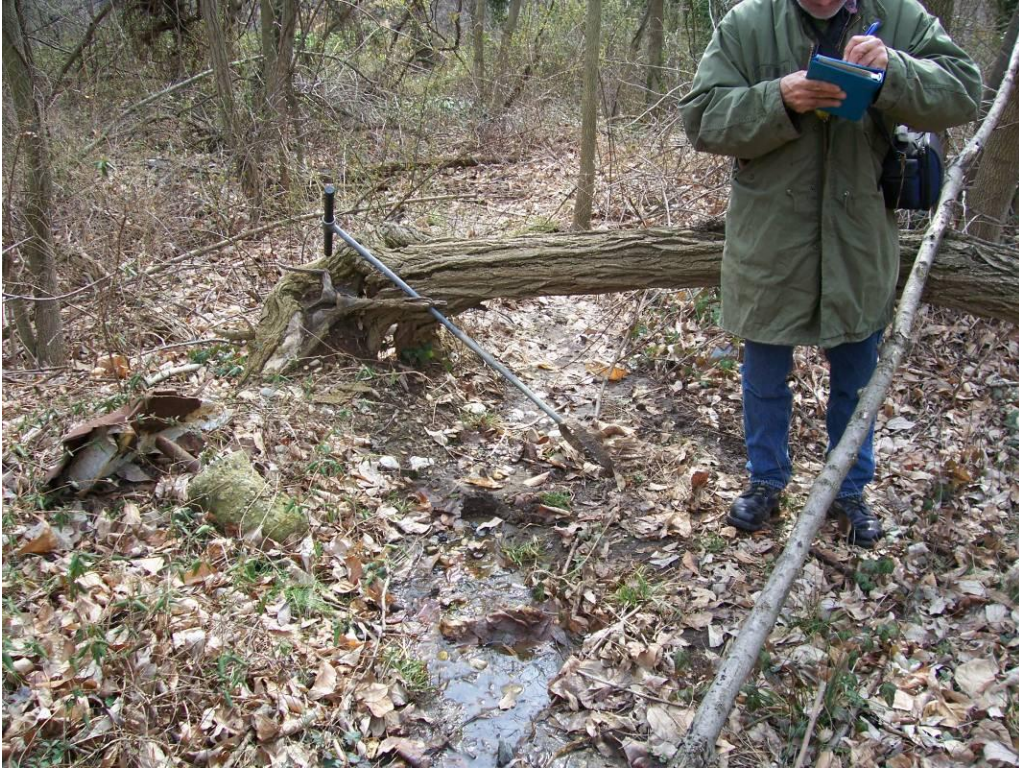
Photograph 17. View of on-site drainage swale at DP-2. Photograph Direction: North

Photograph 18. View of on-site drainage swale at DP-2. Photograph Direction: South

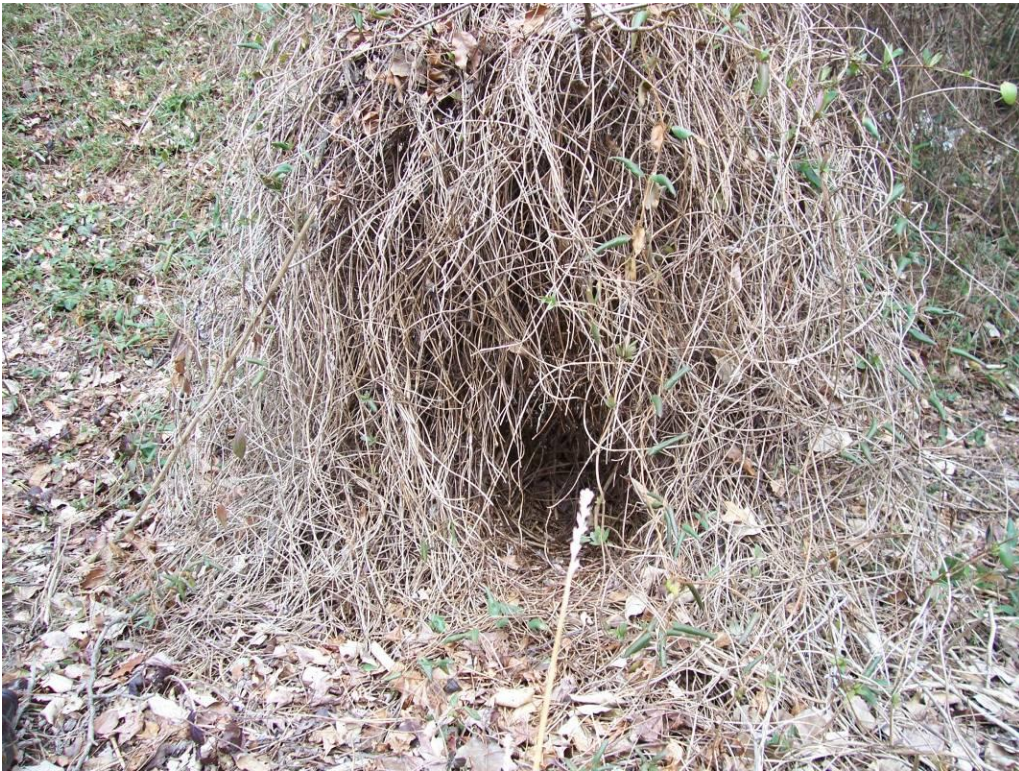
Photograph 19. Den created by possibly a red fox or domestic cat, located near the northeast property boundary. Photograph Direction: North

White-tailed deer (*Odocoileus virginianus*) are utilizing the site, as inferred from rub marks found on numerous trees around the site, observed deer tracks, and direct observation of four to six deer on-site. Evidence of raccoon (*Procyon lotor*) and eastern cottontail rabbit (*Sylvilagus floridanus*) was also observed. Several groundhog (*Marmota monax*) dens were also observed on-site. Numerous domestic cats were observed on the site. Although no species were observed, suitable habitat exists for the southern flying squirrel (*Glaucomys volans*). Southern flying squirrels are nocturnal and sleep during the day within cavities of dead or dying trees. Northern gray squirrels (*Sciurus carolinensis pennsylvanicus*) are abundant within the site. One red fox (*Vulpes vulpes*) was observed on the site. A smooth green snake (*Opheodrys vernalis*) was observed in the northeast area of the site. A possible fox den, which could have also been created by a domestic cat, was observed on the site as shown in Photograph 19 in Appendix E.
