NATURAL RESOURCES REPORT

North Hill

Fairfax County, Virginia

March 7, 2008

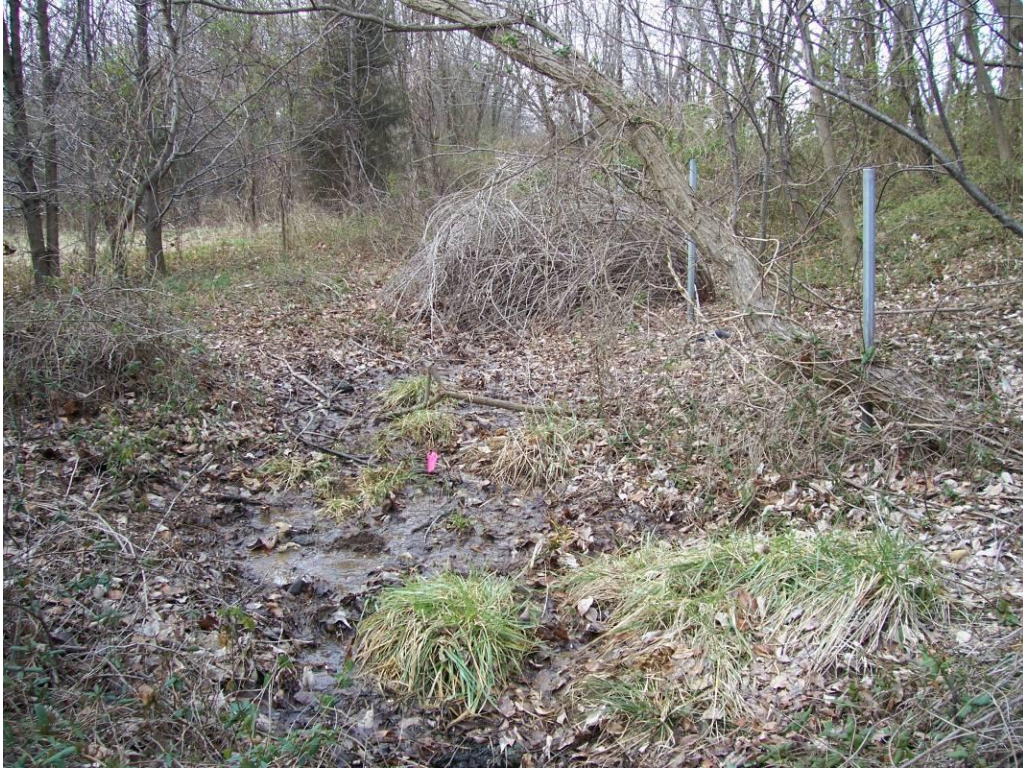
The soil at all four data points did not exhibit gleyed or low chroma colors. The soil consisted of primarily clay. The soil at Data Point (DP)-1 was 10 YR 4/3 in the upper 0-4 inches of soil (A horizon) and 10 YR 5/6 from 4-18 inches of soil (B horizon). The area near where DP-1 is located is shown in Photographs 15 and 16 in Appendix E. The soil at DP-2 was 10 YR 3/4 in the upper 0-4 inches of soil (A horizon) and 10 YR 5/4 from 4-18 inches of soil (B horizon). Underlain fill material and concrete appeared to exist at DP-2 and in the vicinity. The area near where DP-2 is located is shown in Photographs 17 and 18 in Appendix E. The soil at DP-3 was 10 YR 5/4 in the upper 0-6 inches of soil (A horizon) and 10 YR 7/4 from 6-18 inches of soil (B horizon). The soil at DP-4 was 10 YR 6/4 from 0-18 inches. The area near where DP-4 is located is shown in Photograph 20 in Appendix E.

Photograph 20. Surface hydrology located near the northeast property boundary at DP-4. Photograph Direction: West
