PHYSICIAN'S RESIDENCE

HISTORIC STRUCTURE REPORT

DEVELOPMENTAL HISTORY II.

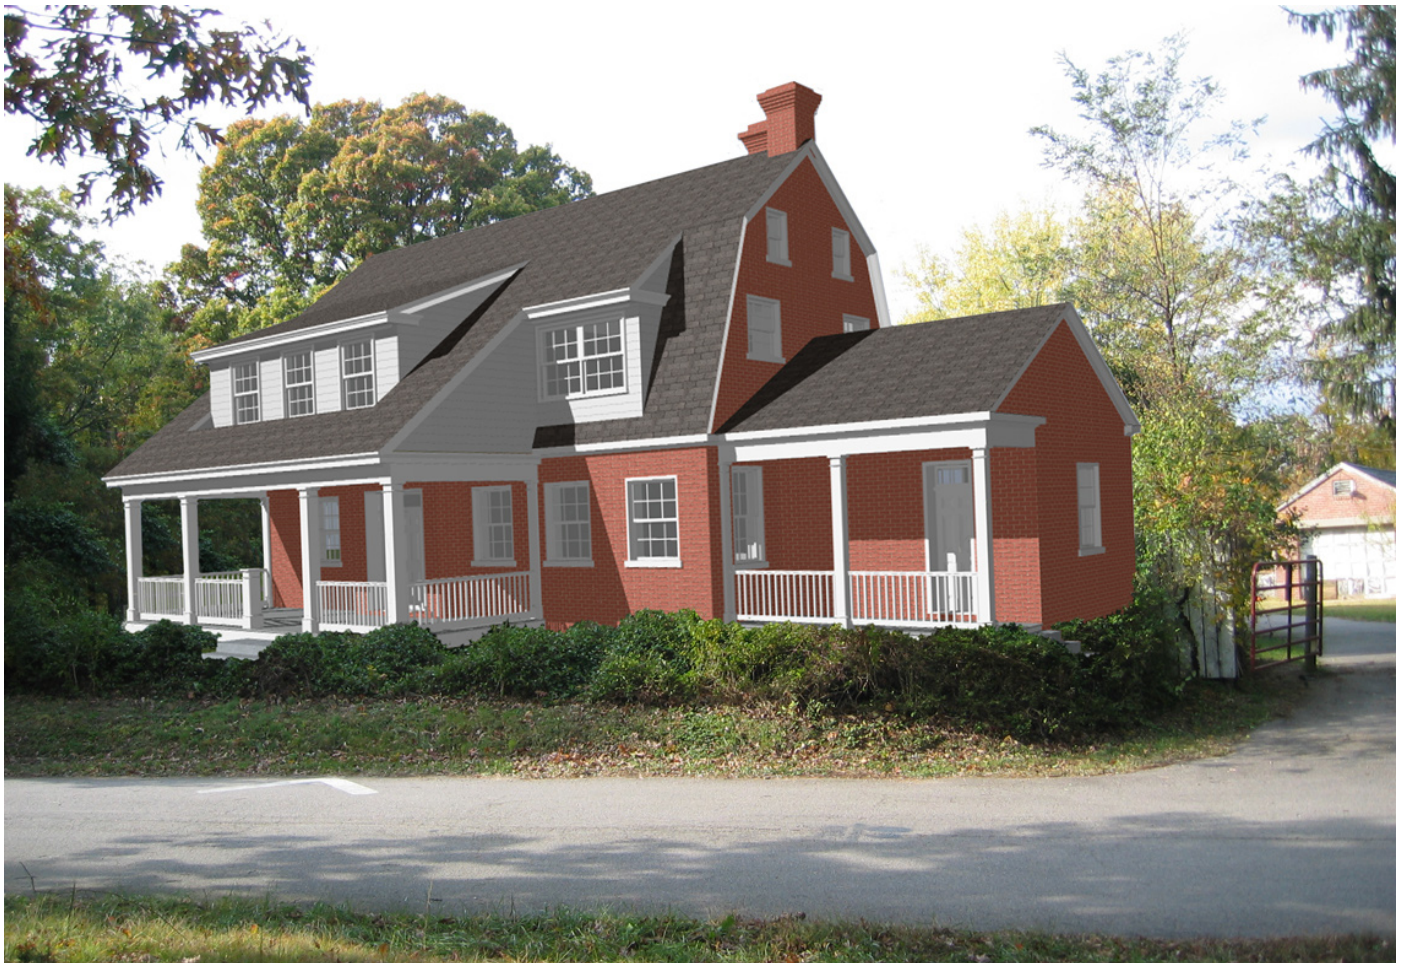
Figure 2.3 This photo-simulation shows the original appearance of the Physician's Residence, before the current stucco coating was added and the front porch screened.

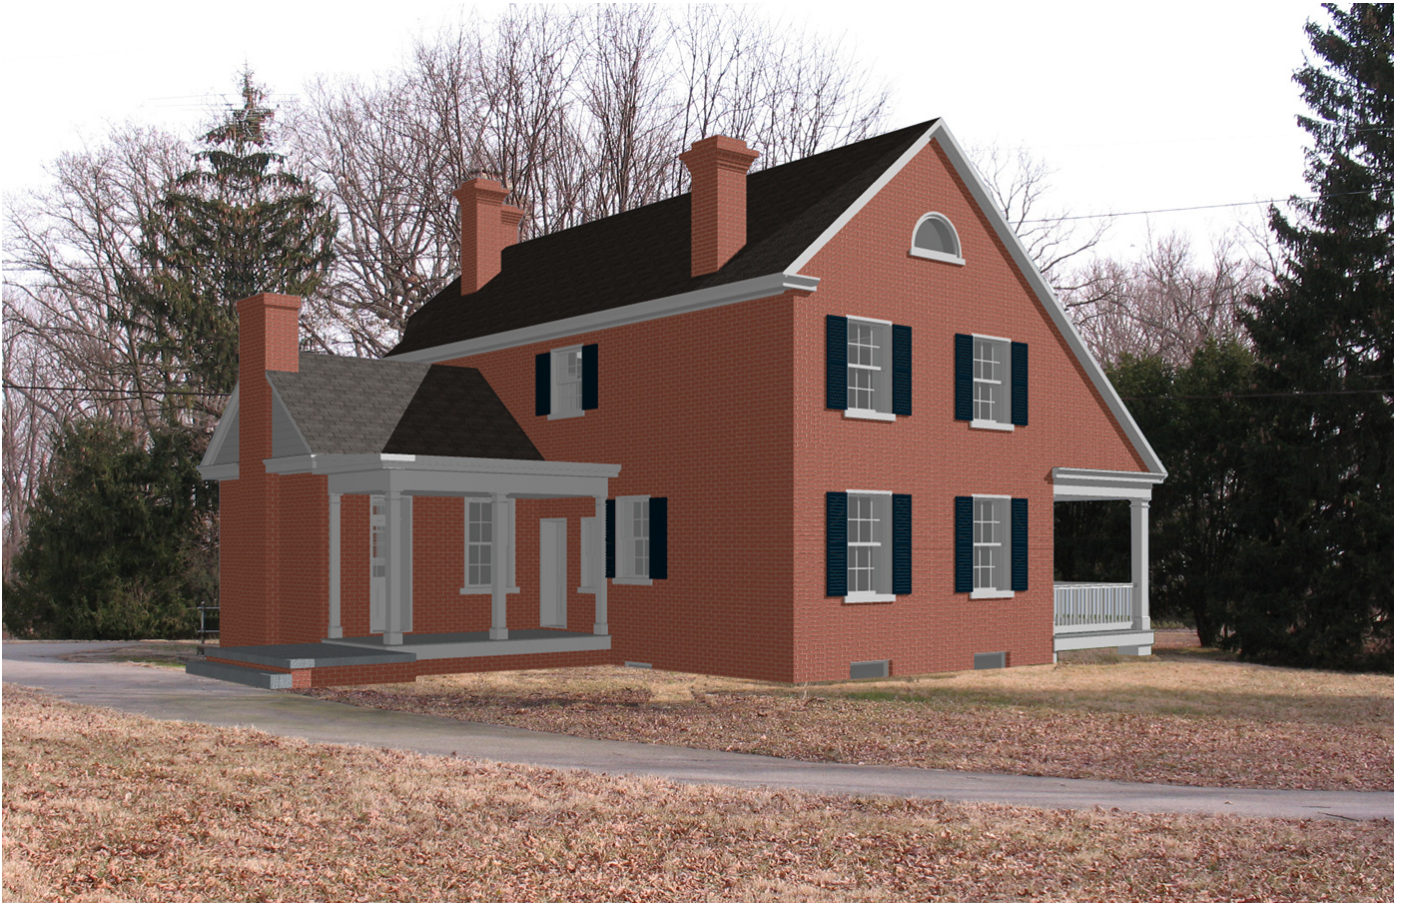
Figure 2.4 This photo-simulation of the rear of the Physician's Residence represents the appearance of the brick house with shutters, which were likely removed when the stucco was added. Also note that there was likely some type of a gable roof over the kitchen, approximating this wing's appearance before the sunroom was added.

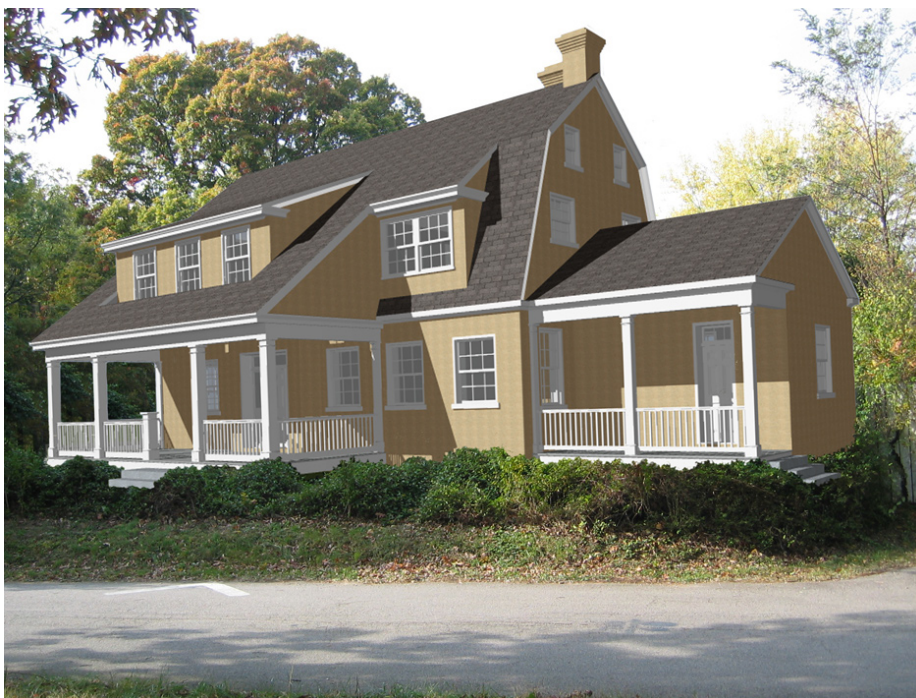
Figure 2.5 This photo-simulation shows the appearance of the south elevation after the stucco had been applied to the exterior and before the office door was replaced and the front porch screened.

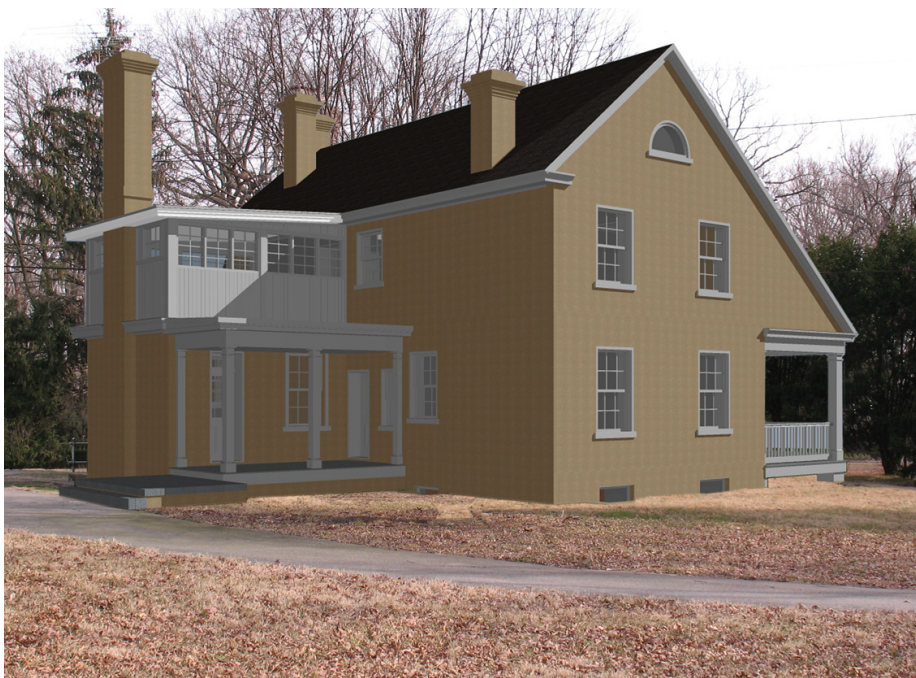
Figure 2.6 In this photo-simulation of the rear of the house, the shutters have been removed and the sunroom added over the kitchen.

The other significant modification is the frame sunroom addition. Unfortunately, it is structurally unsound and will require rebuilding or removal. As it was not a part of the original structure, and the date of the addition has not been ascertained, options will be given for adaptive use of the house both with and without this addition.
