Lorton Visioning Plan Amendment Study

Update: Pohick Creek Visioning (Environment, Trails & Recreation)

June 21, 2021

Lorton Visioning – Lorton Seepage Bog Stormwater Environmental Comments

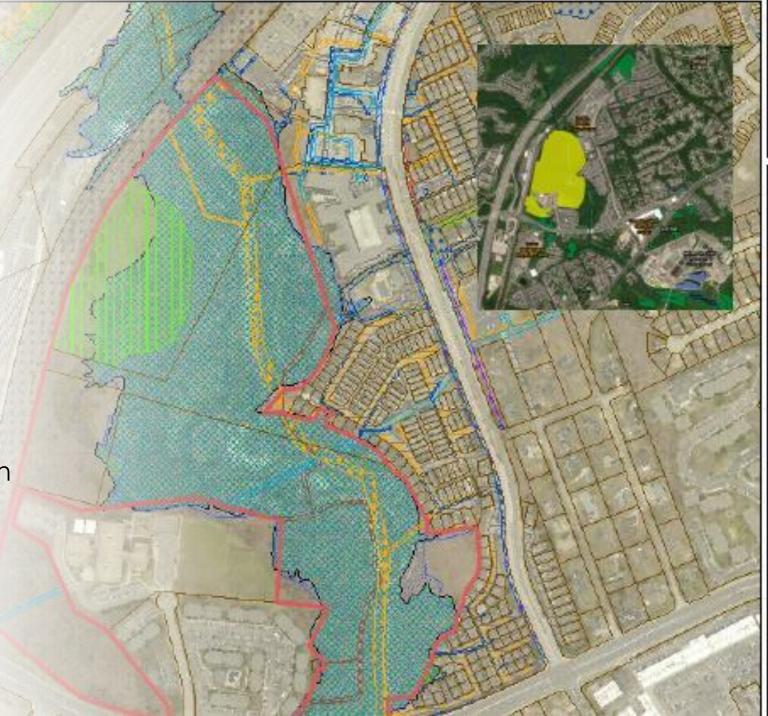
Globally Rare Natural Area

Existing Conditions

- Globally rare wetland communities
- Extremely rare forested wetland community

Preservation Goals and Strategies

- Conservation easements (see green hatching)
- The County's Stream Protection Strategy (SPS) Report recommends maintaining this section of Pohick Creek to prevent further degradation.

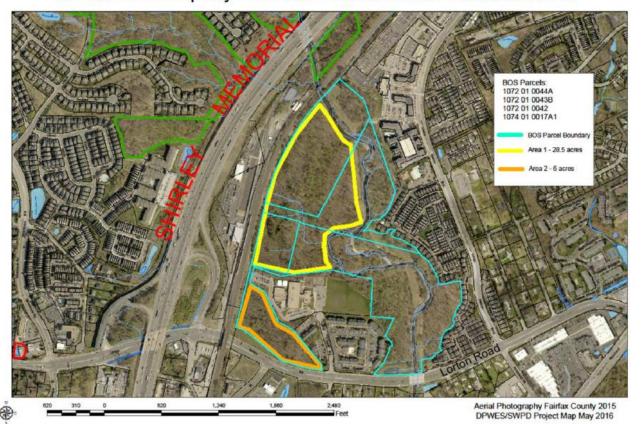
Lorton BOS Property Potential Conservation Easement Areas

Stormwater Conservation Easements

These conservation easements were established to offset water quality requirements from two Fairfax County capital projects: the Huntington Levee and a fire station project.

The conservation easements help preserve and protect the Pohick Seeps wetlands.

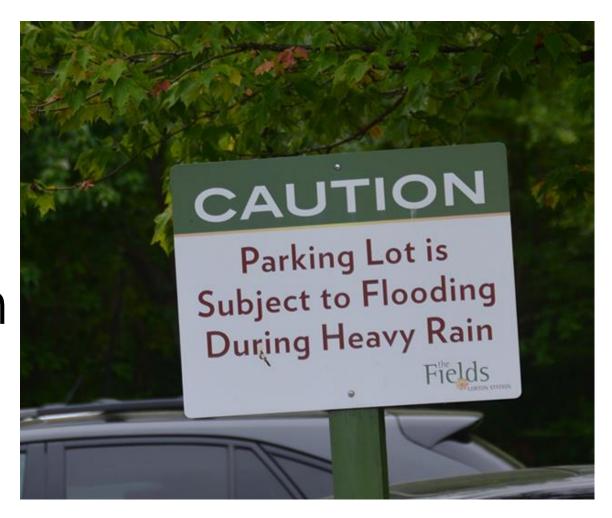
Parking Lot Flooding

Drainage issues at the Fields at Lorton Station are not caused by stormwater runoff from the Amtrak station.

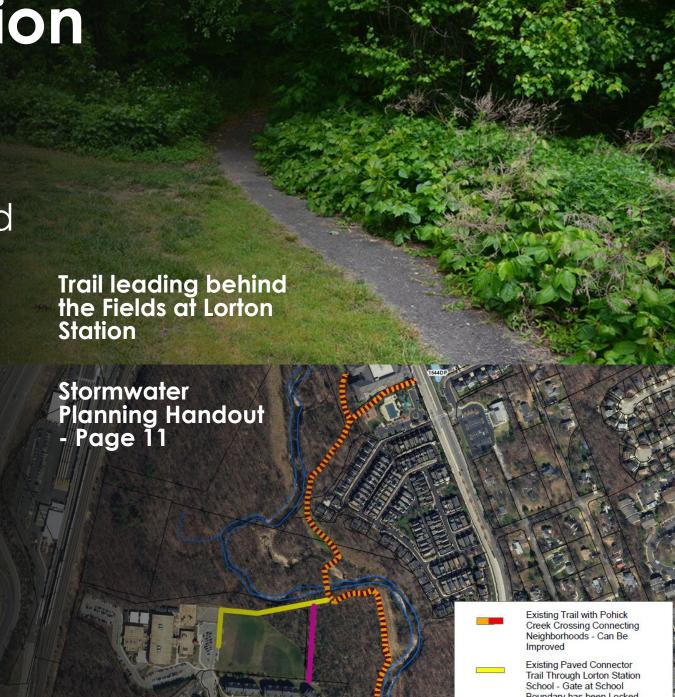
Trails and Recreation

Porous asphalt / concrete and similar permeable pavement solutions are not practical solutions in the floodplain.

The existing Trail with creek crossing connecting neighborhoods can be improved (to some extent).

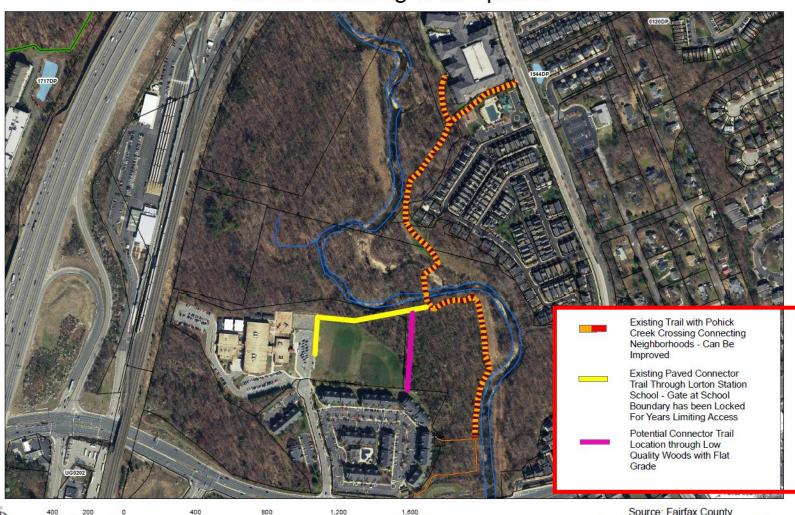
Lorton Visioning Trail Options

What can be done?

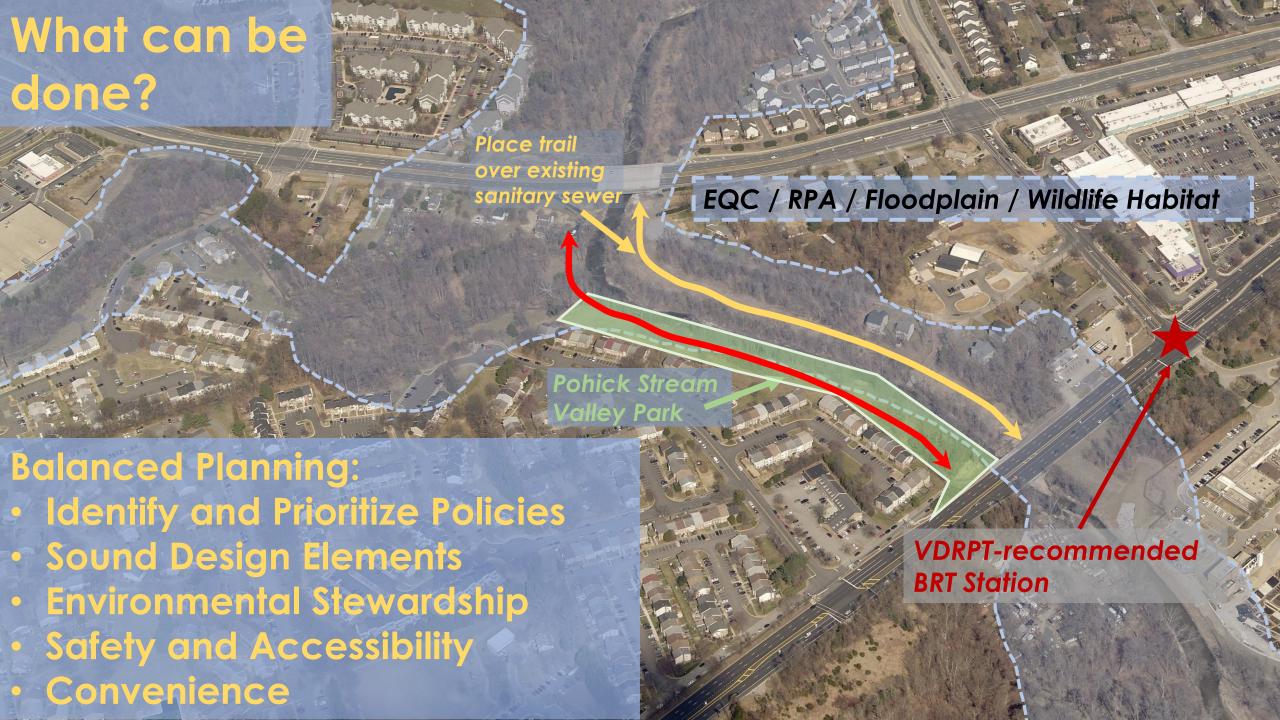
Source: Fairfax County
DPWES/SWPD Project Map June 2021

Solutions recommended by DPWES
