LAUREL HILL HOUSE

Historic Structure Report and Treatment Options

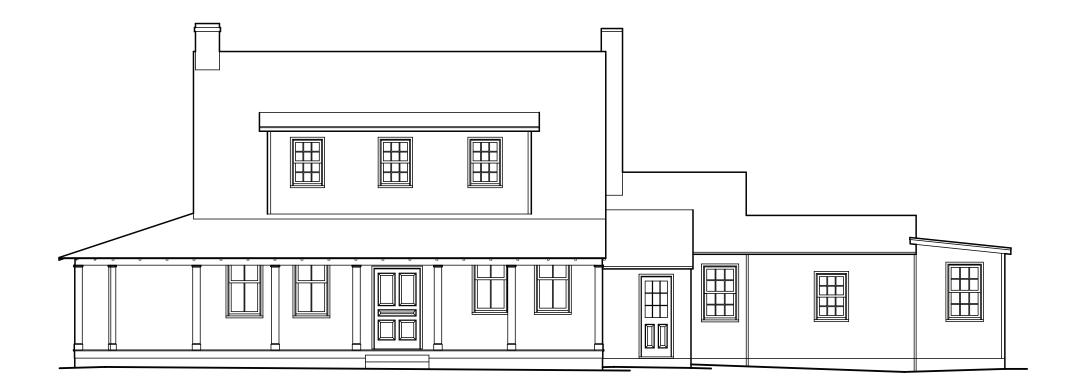
Option 2: Rehabilitation of house in its current configuration.

NOTE: STABILIZE FOUNDATION AND MAKE IMPROVEMENTS AS NEEDED FOR SAFETY AND SECURITY. ADD INTERPRETIVE SIGNAGE WITH HISTORICAL INFORMATION ABOUT THE BUILDING.
