BLAKE LANE PEDESTRIAN ROAD SAFETY AUDIT

Community Meeting

May 30, 2023

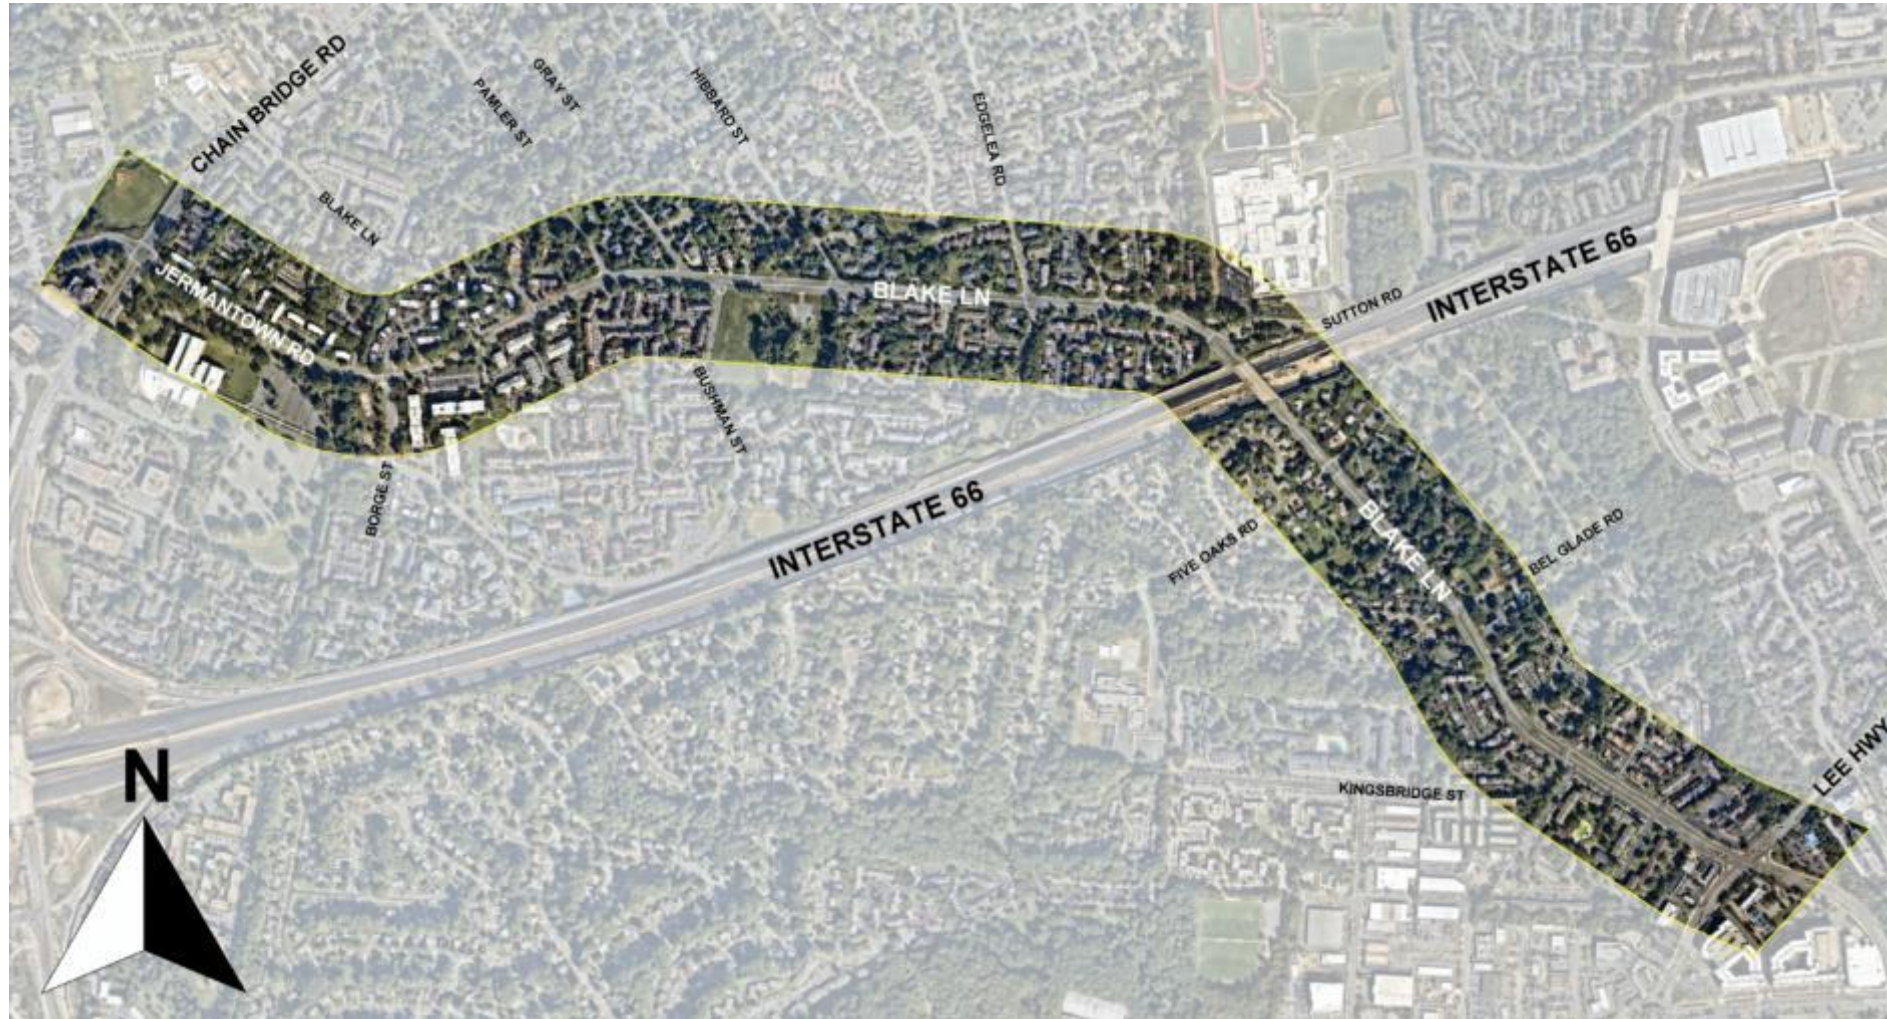
Road Safety Audit (RSA) Study Area

- 2.1 miles of Blake Lane/ Jermantown Road
- Pedestrian-focused RSA held April 26 from 7:00 am to 11:30 am
- Additional observations conducted by focus team in afternoon and evening hours

Blake Lane RSA study corridor from Chain Bridge Road to Lee Highway

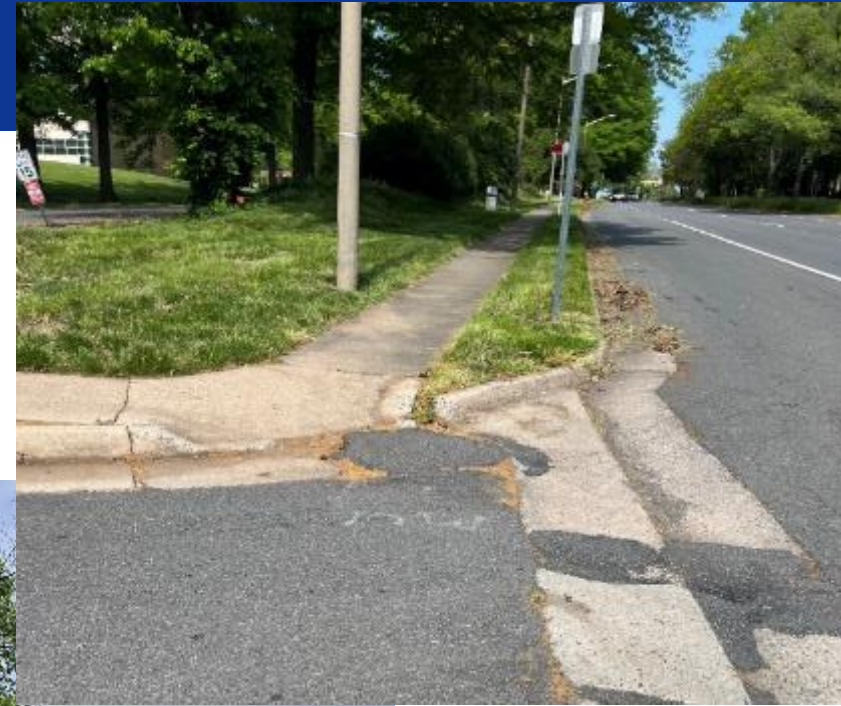
Existing curb ramp along Jermantown Road at driveway of AT&T facility

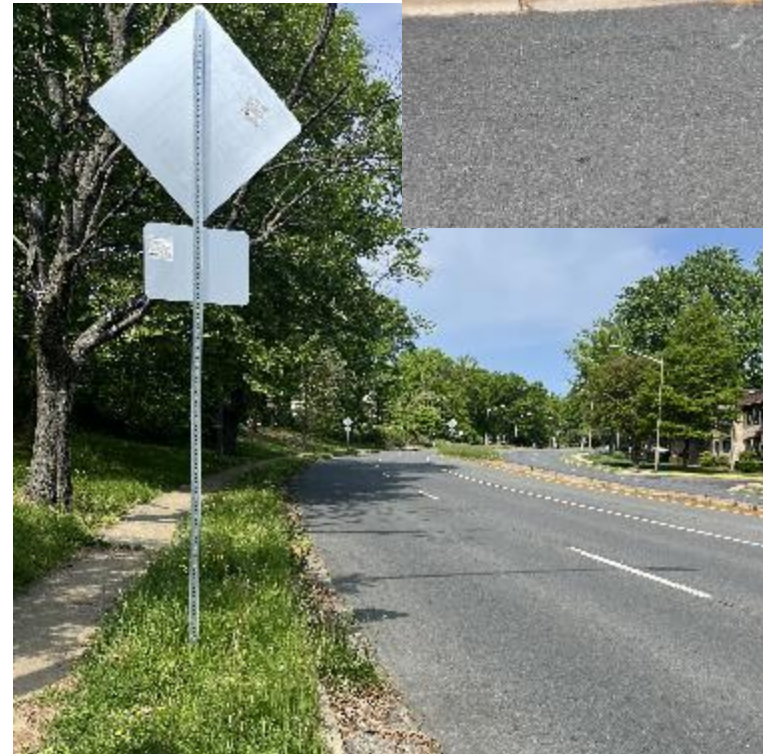
Vegetation infringing on sidewalk, creating narrow width

- Talk to your student drivers
- Trim vegetation infringing on sidewalks and in right-of-way
- Yield to pedestrians and bicyclists

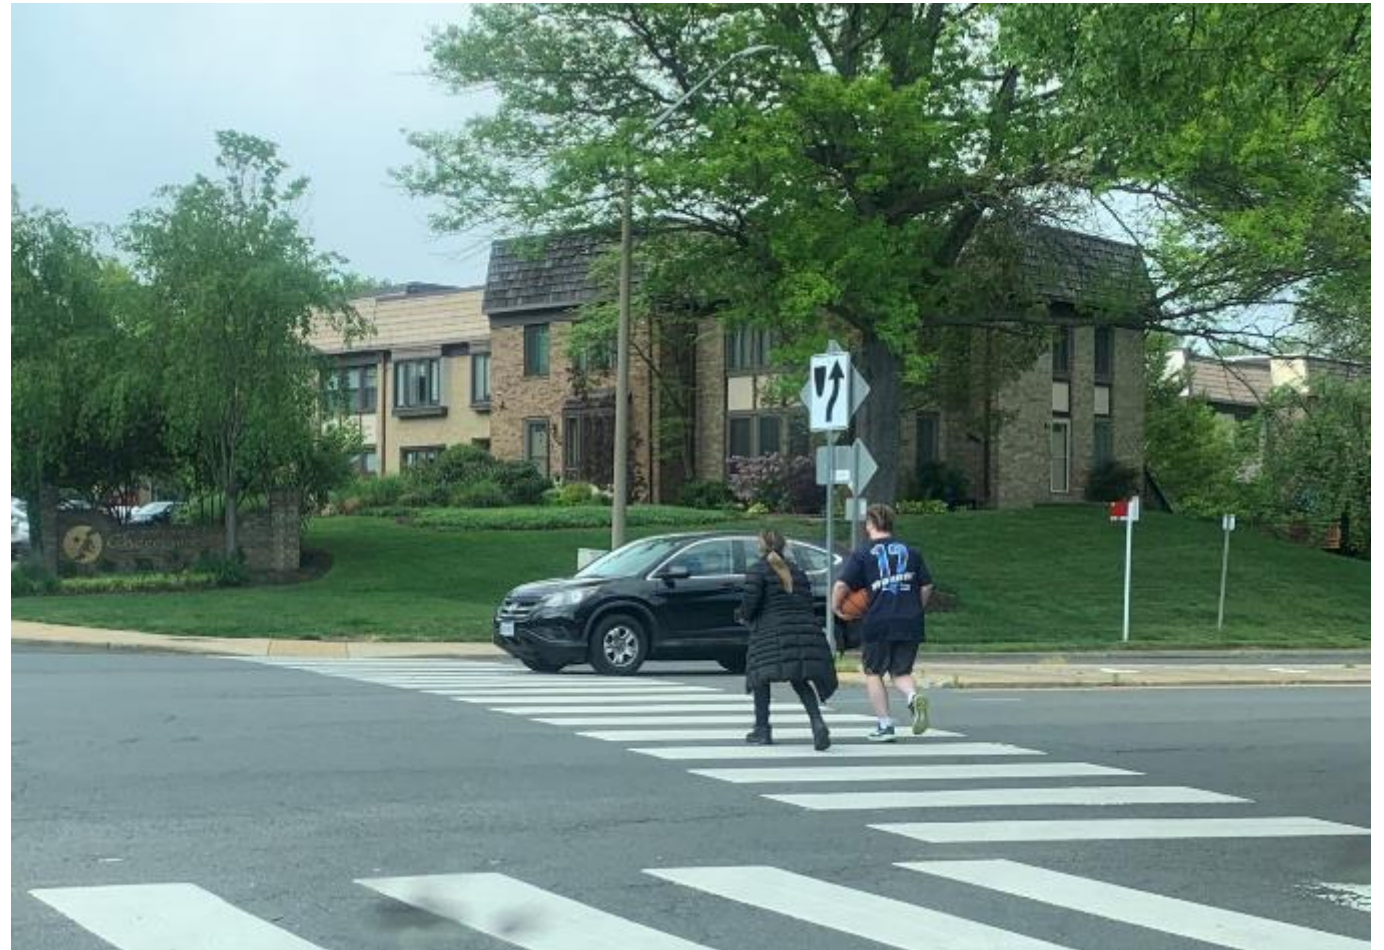
- Multiple threat for uncontrolled pedestrian and bicyclist crossing locations
- Wide pedestrian crossings across and along Blake Lane
- Misalignment of some transit stops to marked pedestrian crosswalks

Pedestrians crossing Blake Lane at Borge Street

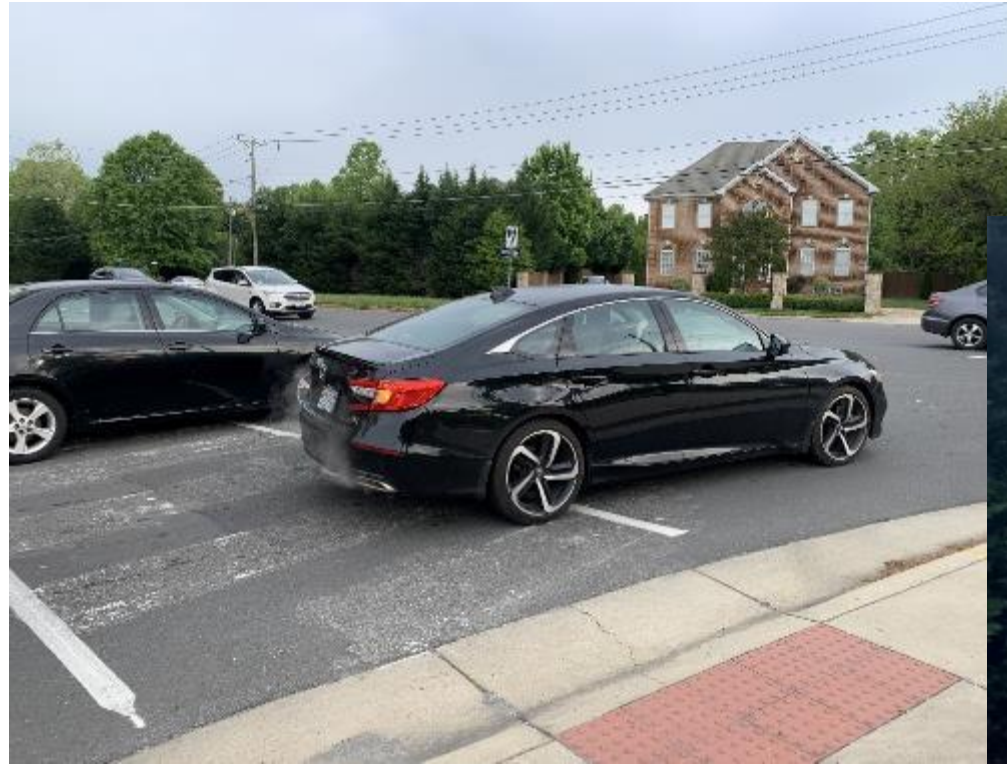
- Limited sight distance of approaching vehicles and non-motorized modes at several intersections and driveways
- Vehicles frequently pulling up into crosswalk

Drivers pulling into the crosswalk to turn left and right from Bushman Drive onto Blake Lane

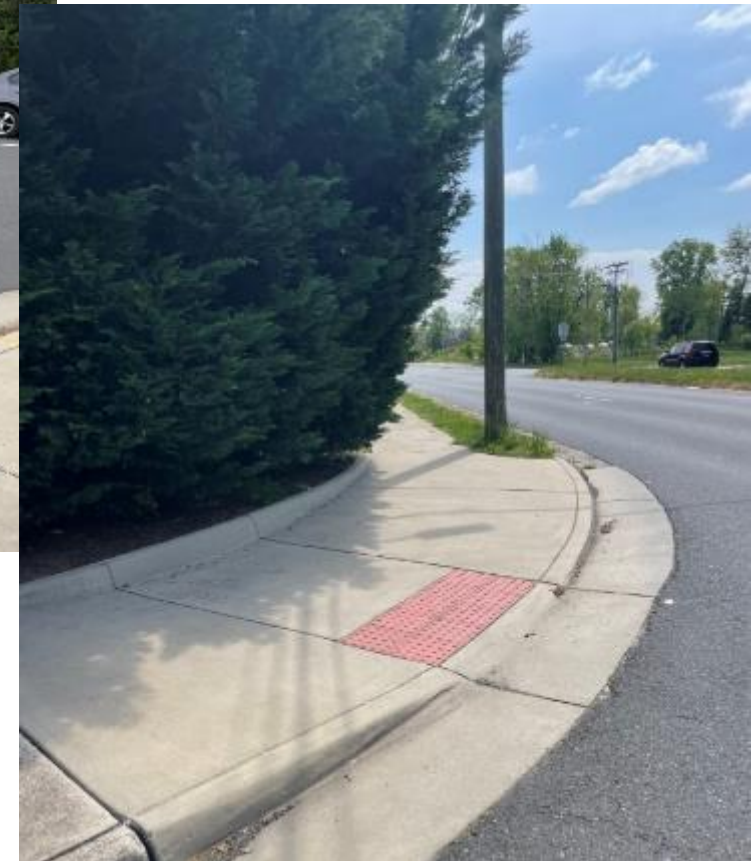
Vegetation blocking visibility for drivers looking eastbound on Blake Lane at Gray Street

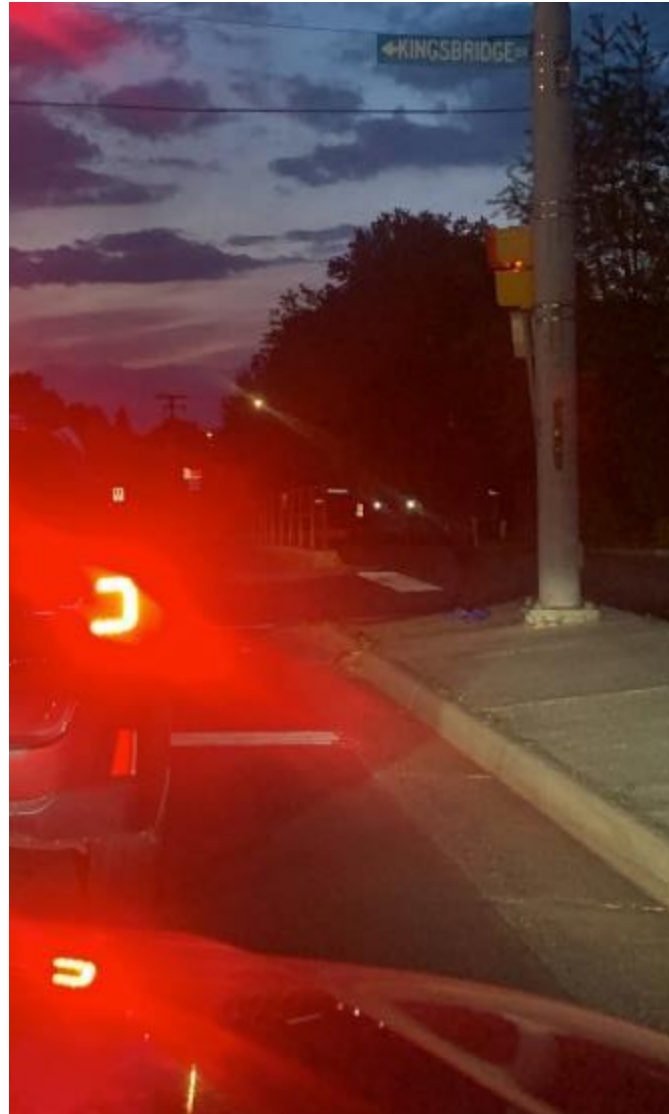
- Difficult to see pedestrians in dark conditions

Pedestrian on east curb waiting to cross Blake Lane at Kingsbridge Drive

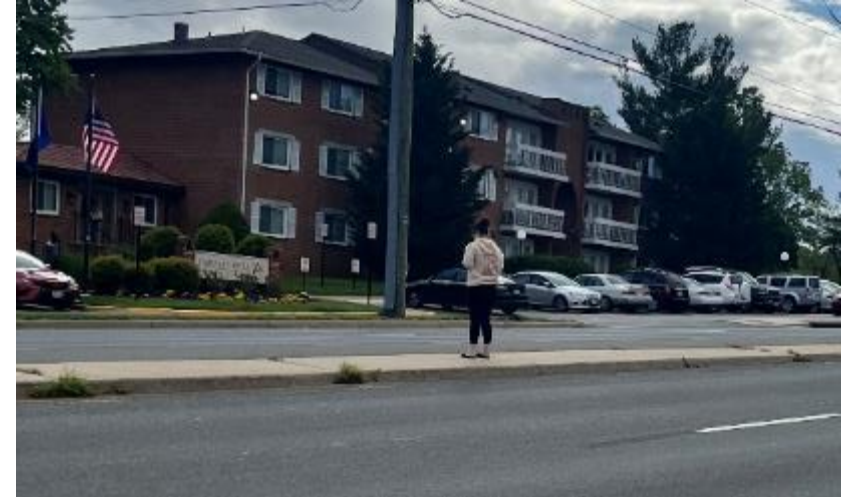
- Sidewalk along frontage road is narrow and close to traffic
- Observed pedestrians crossing Blake Lane using the narrow median as a refuge

Pedestrian crossing Blake Lane near Mission Square Drive

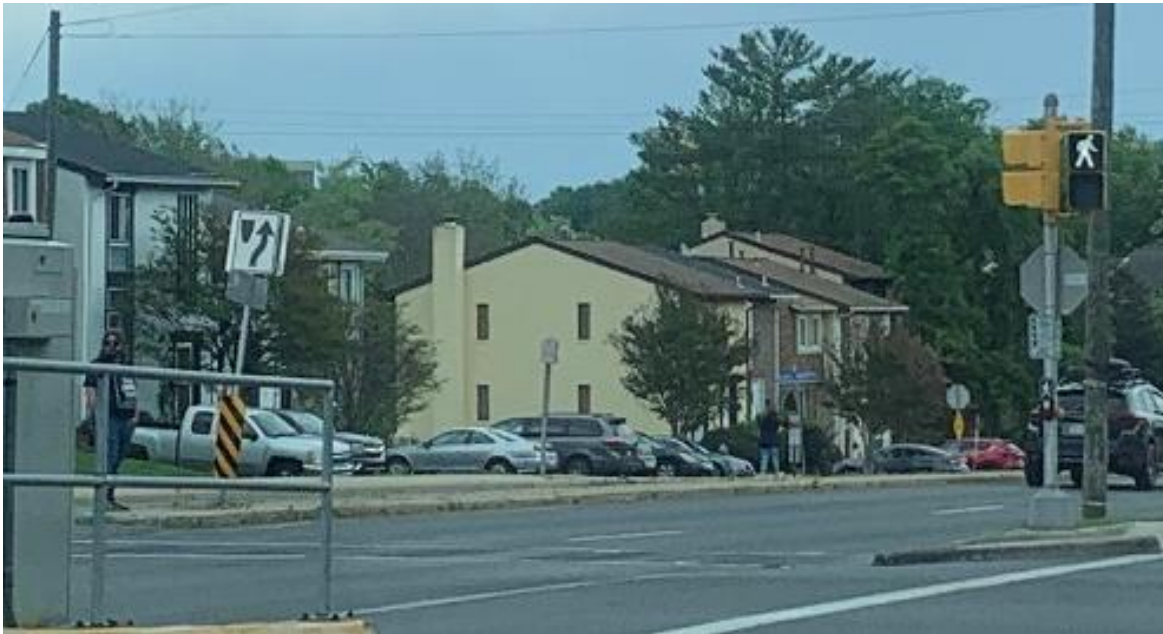
Pedestrian waiting in median for walk signal across Blake Lane at Kingsbridge Drive

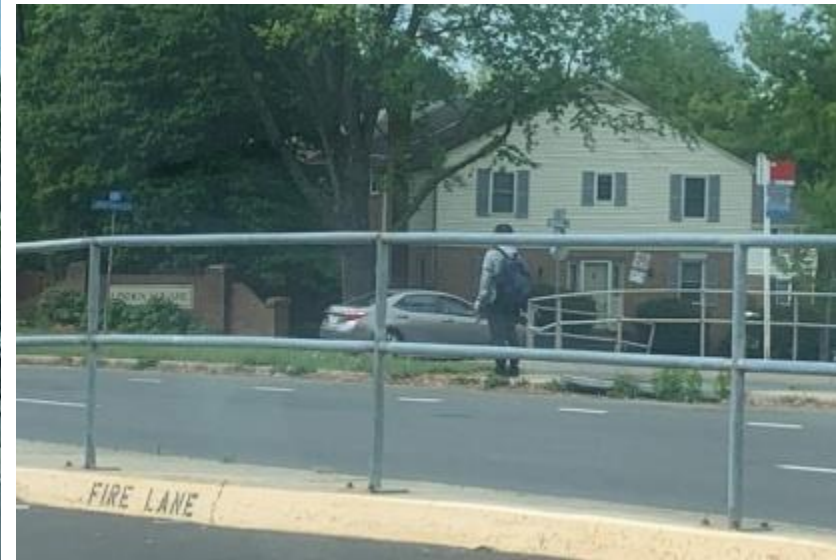
Pedestrian crossing Blake Lane south of Lindenbrook Street

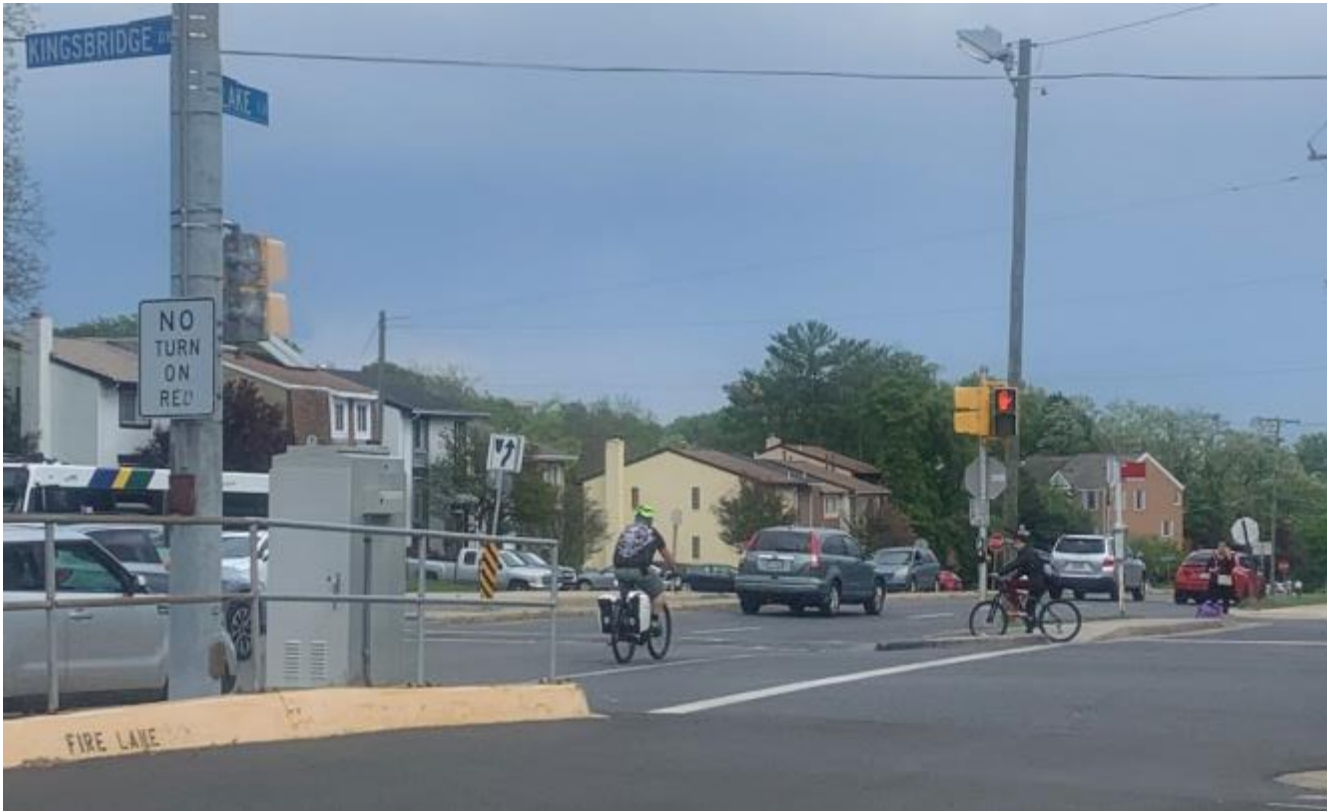
- Signal equipment is within pedestrian path on the sidewalk
- Signal visibility is reduced during certain times of day due to sun glare

Multimodal activity at the intersection of Blake Lane and Kingsbridge Drive

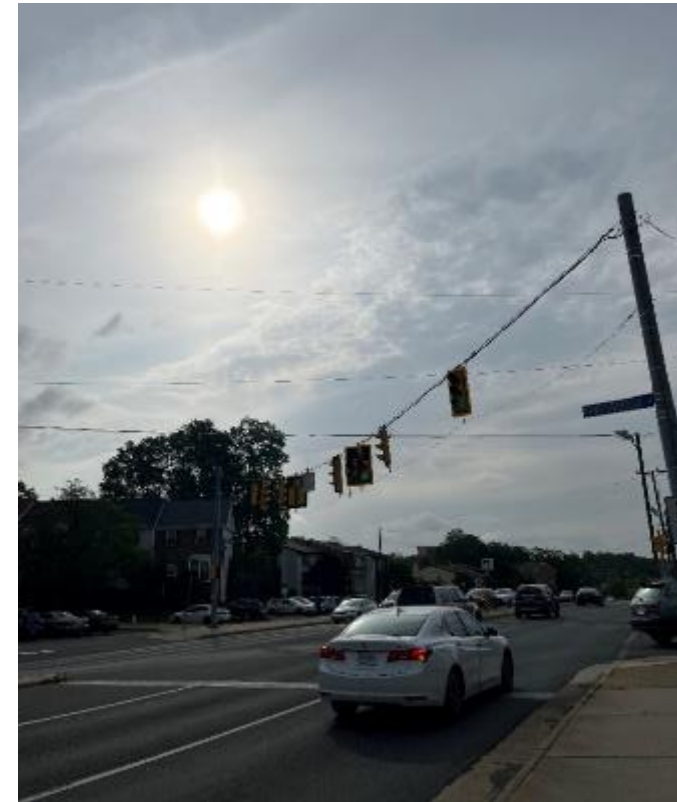
Sun position above the southeastbound Blake Lane signal at Kingsbridge Drive

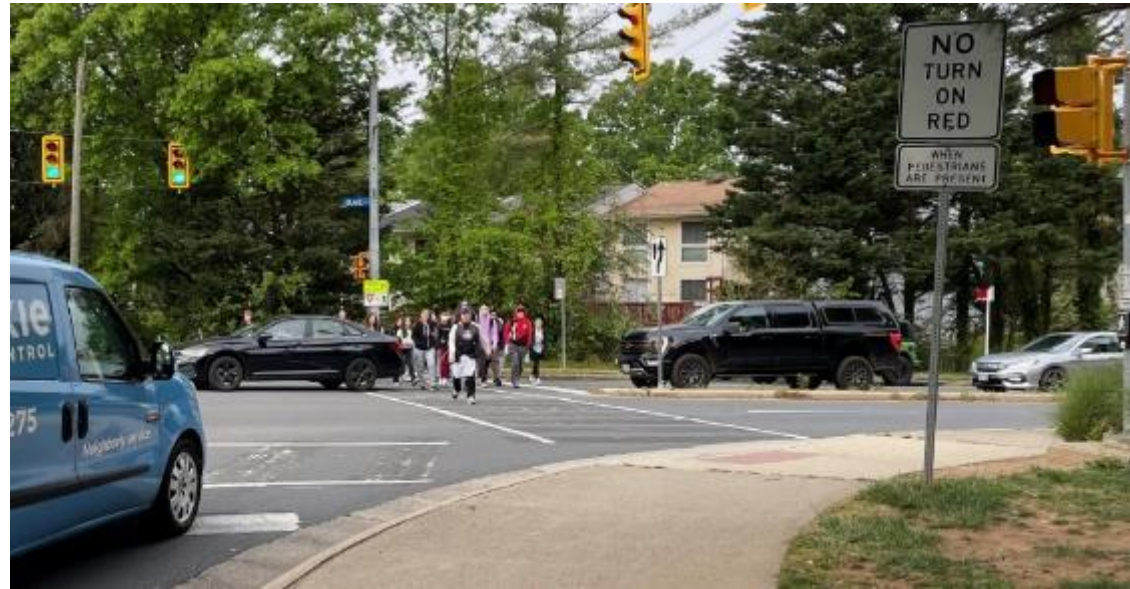
- Limited sight distance due to foliage and horizontal curve for southbound vehicles on Blake Lane
- Large number of pedestrians crossing Blake Lane conflicting with right turns from Sutton Road
- Major queuing due to Oakton High School drop-offs

Students crossing Blake Lane at Sutton Road

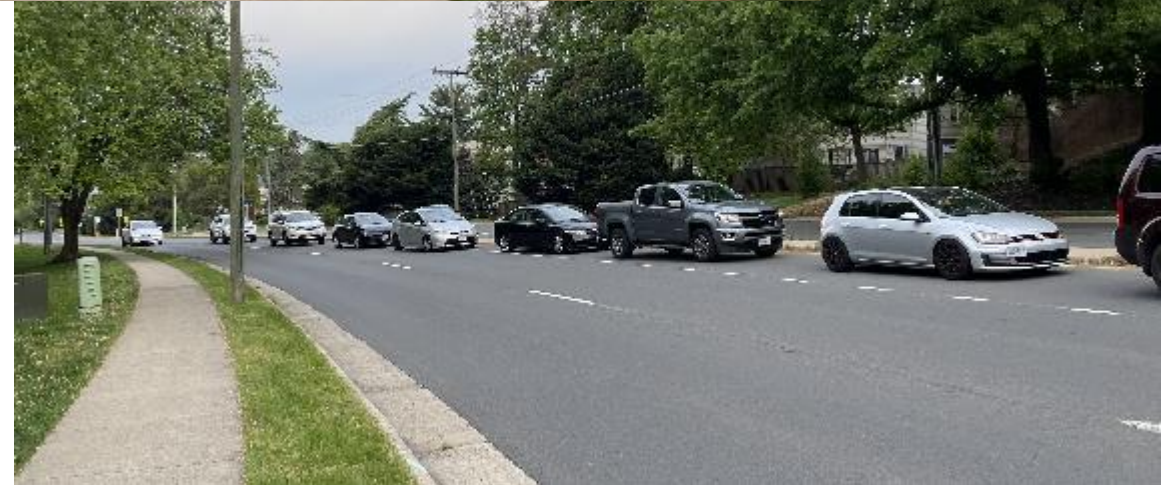
Queues generated by vehicles turning left into Oakton High School during morning arrival

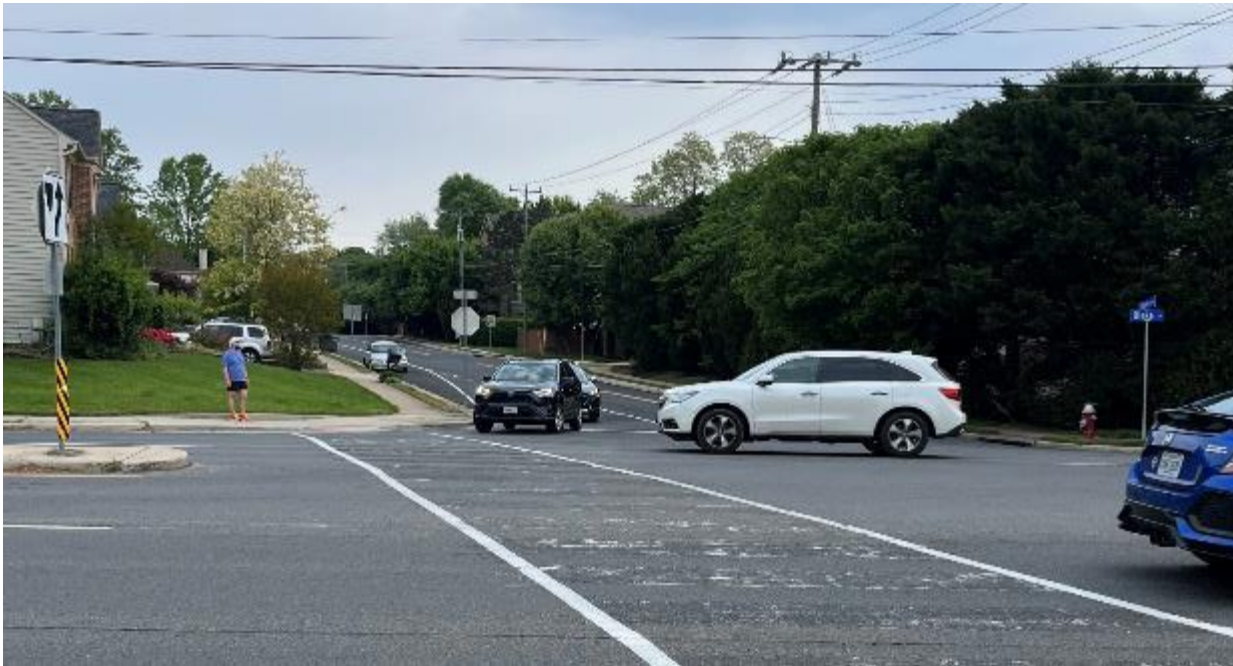
- Vehicles approaching from side streets have limited sight distance due to foliage and existing geometry
- Challenges with pedestrians crossing

Vehicle turning right from Edgelea Road onto Blake Lane looks for a gap in westbound traffic as a pedestrian waits to cross

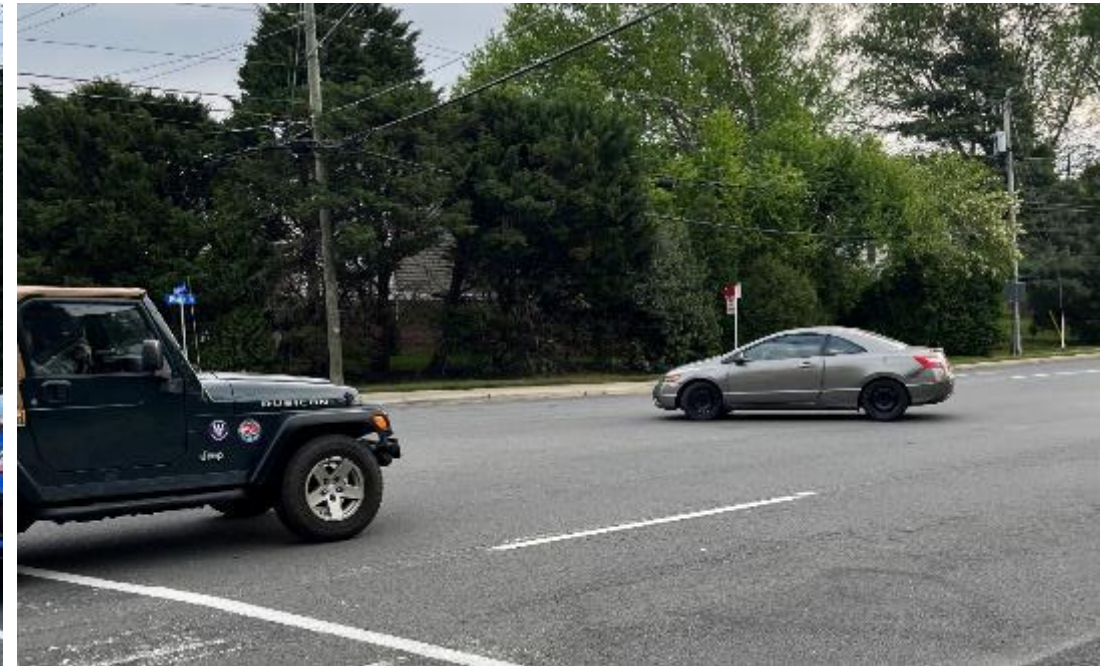
Vehicle turning left from Platten Drive onto westbound Blake Lane conflicts with vehicle turning left from Blake Lane onto Edgelea Road

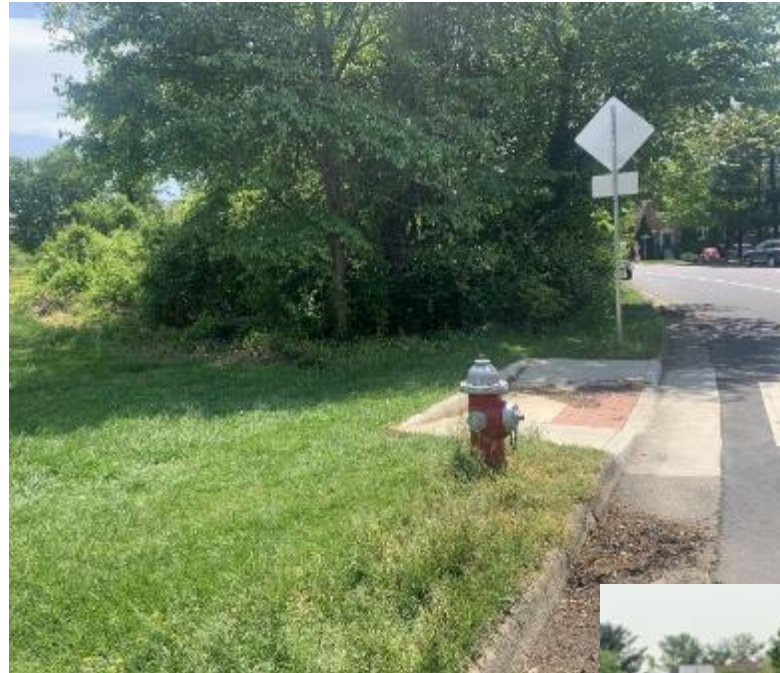
- Sidewalk present only on one side - pedestrians walking in the bike lane
- Vehicles used bike lane space during morning peak hour as right turn lane

Curb ramp to transit stop on Bushman Drive without connecting facilities

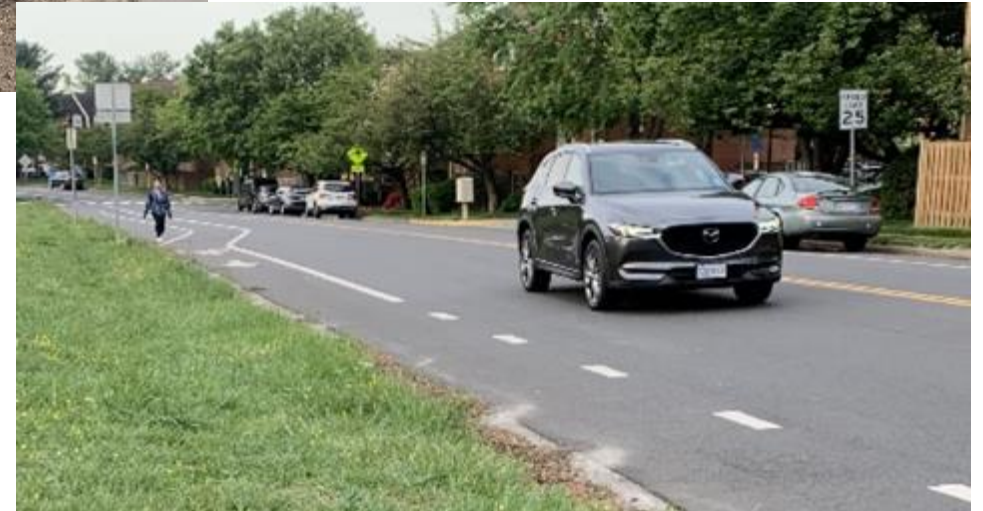
Student walking in bike lane on Bushman Drive

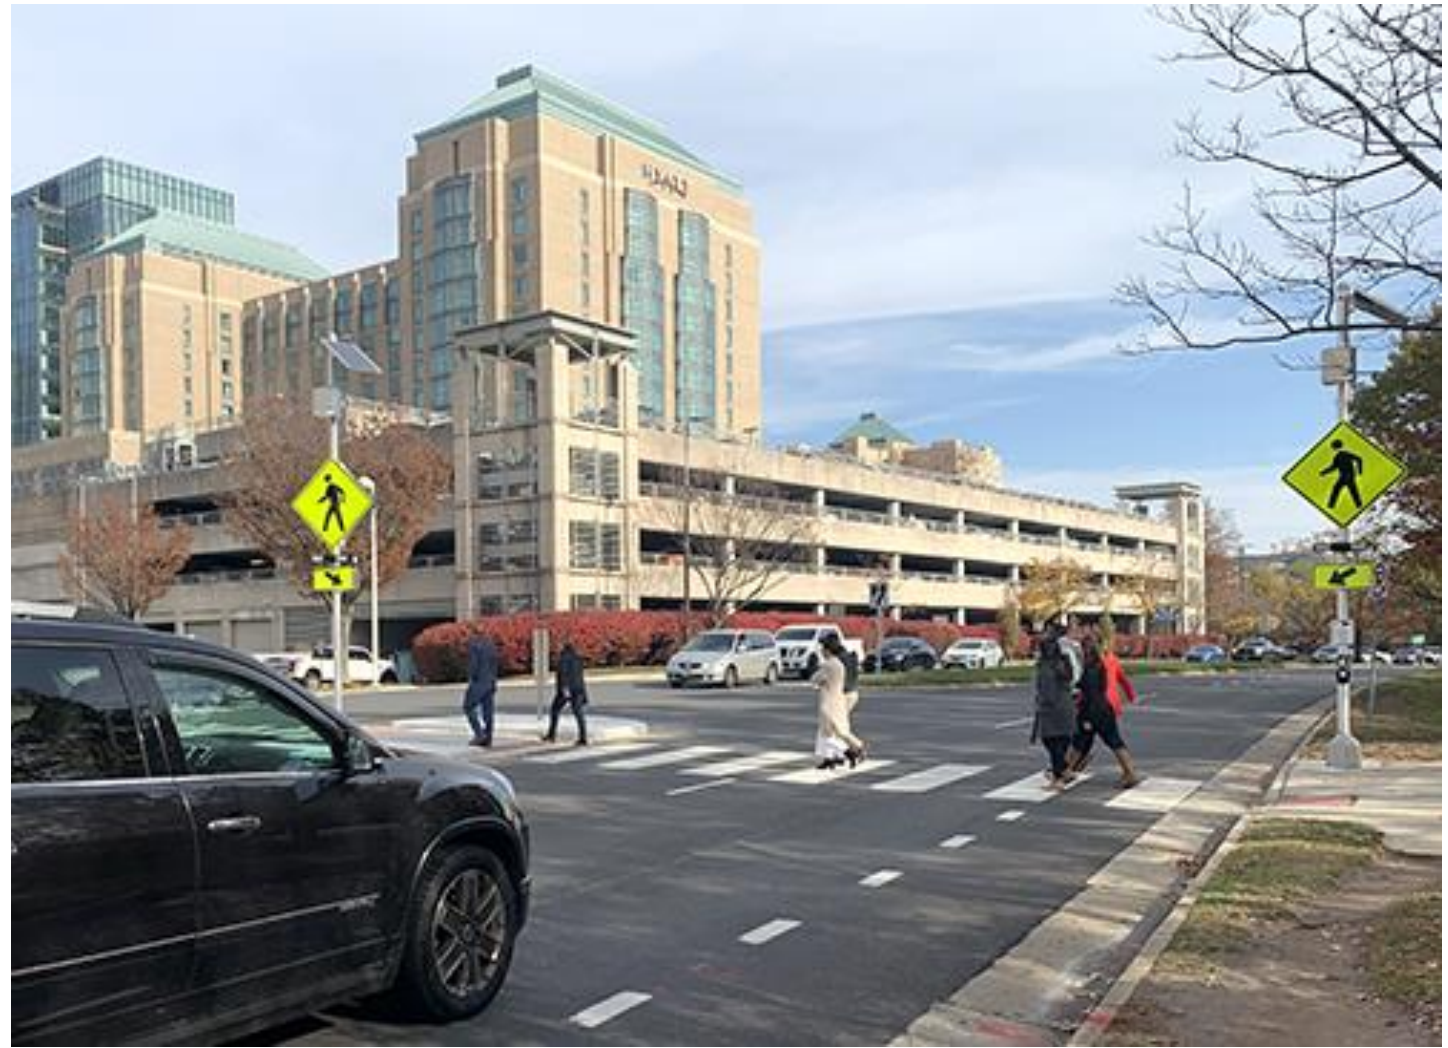
RRFB at Bluemont Way and Discovery Street in Reston, Virginia

- Rectangular Rapid Flashing Beacons (RRFBs) on Blake Lane at the Bushman Drive and Bel Glade Street (FCDOT)
- Sutton Road Intersection Enhancements

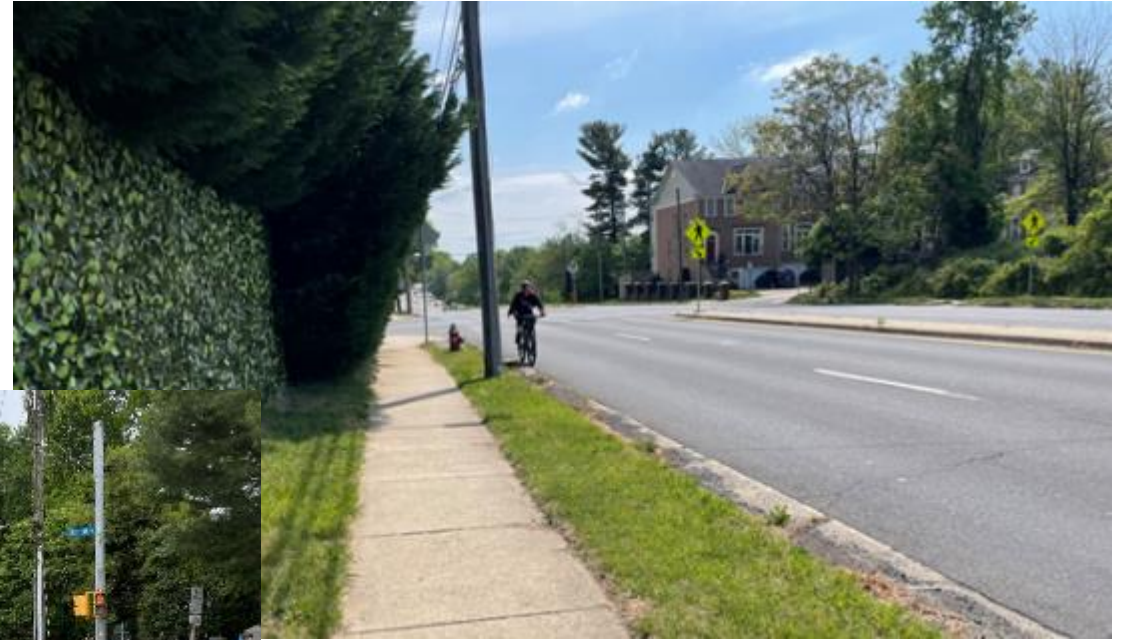
Bicyclist riding on Blake Lane - potentially due to vegetation blocking sidewalk

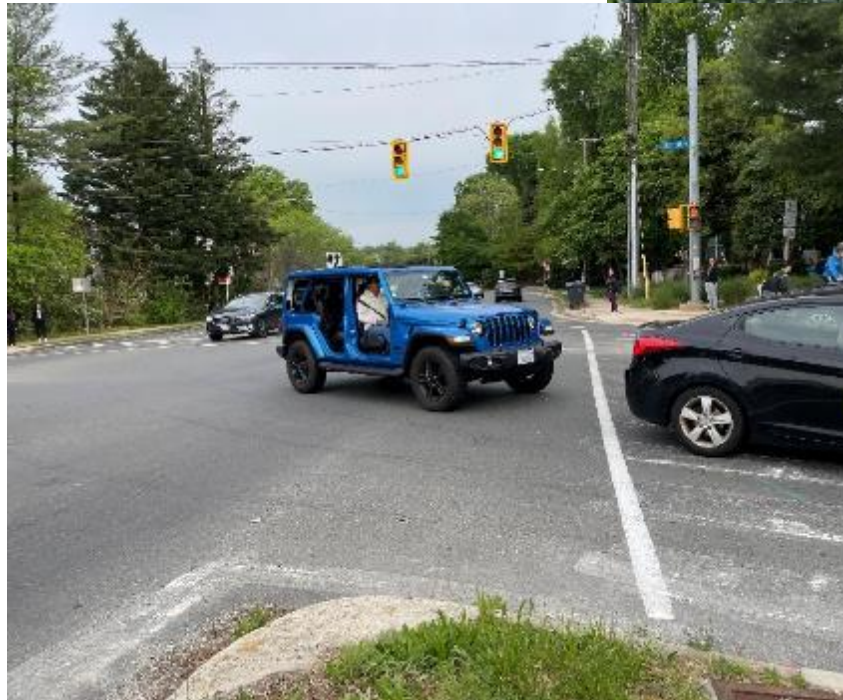
Driver (potentially a student) turning left onto Sutton Road during morning school arrival
