Fairfax County, Virginia 2022 Municipal Separate Storm Sewer System (MS4) Program Plan and Annual Report

September 30, 2022

Reporting Period: July 1, 2021 through June 30, 2022

Permit No: VA0088587 Effective Date: April 1, 2015 Expiration Date: March 31, 2020 (Administratively Continued)

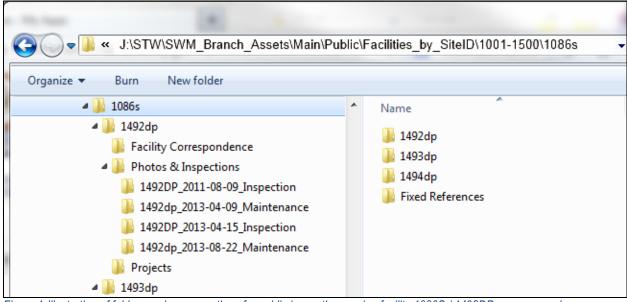
Figure 1-Illustration of folder naming conventions for public inspections, using facility 1086S / 1492DP as an example.

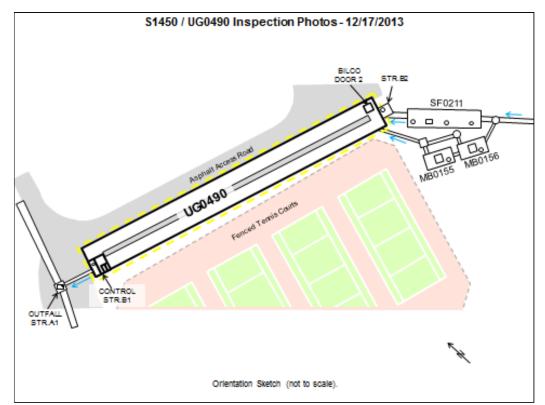
Figure 0-Orientation sketch example generated with the PowerPoint sketch tools.

As provided above, the first page of the PowerPoint template is reserved for the facility sketch. The sketch must be easily-read, with enough surrounding details (e.g., buildings, roads, parking lots) to orient the reader. All facility components referred to in the later photo captions must be so labeled on the sketch. The facility itself must also be clearly outlined and labeled. The sketch format is flexible; popular options range from using the sketch tools within PowerPoint to using GIS points and labels with aerial Pictometry imagery as the background. For some small facilities you may even use one of the inspection overall photos, if it shows the whole facility and the facility components are easily visible.

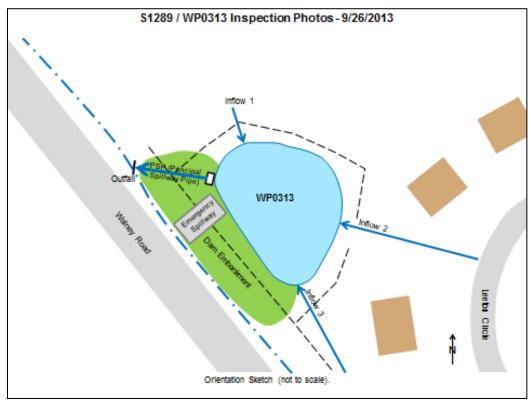
Figure 3-Orientation sketch example generated with the PowerPoint sketch tools.

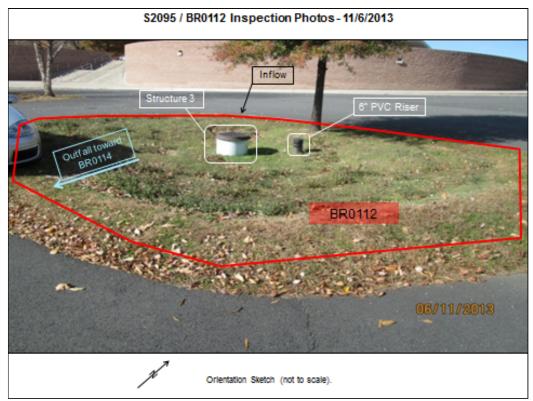
Figure 4-Orientation sketch example using an overall photo of the facility.

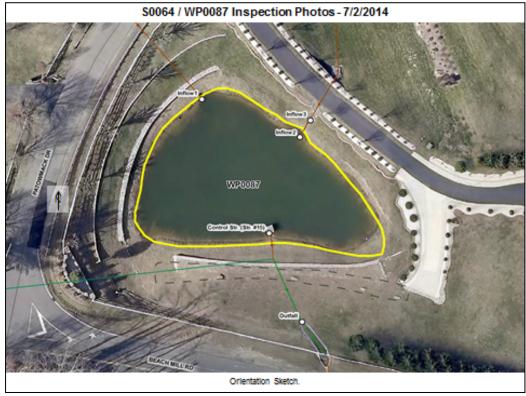
Figure 1-Orientation sketch example generated from GIS.

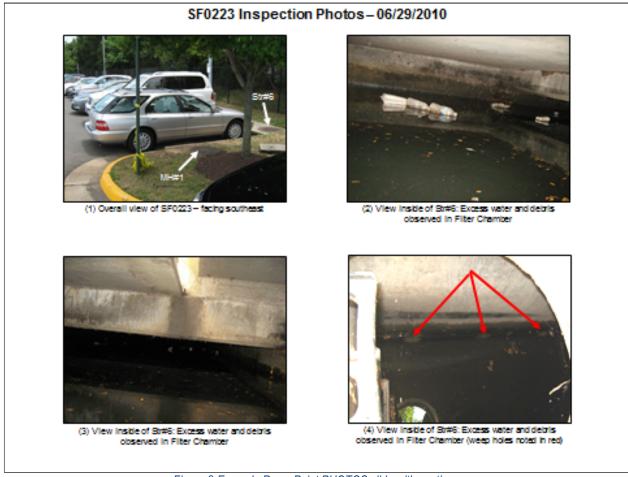
Here is an example layout showing the standard template of four photos with captions, slide header, and optional highlighting and labeling added.

Figure 2-Example PowerPoint PHOTOS slide with captions.

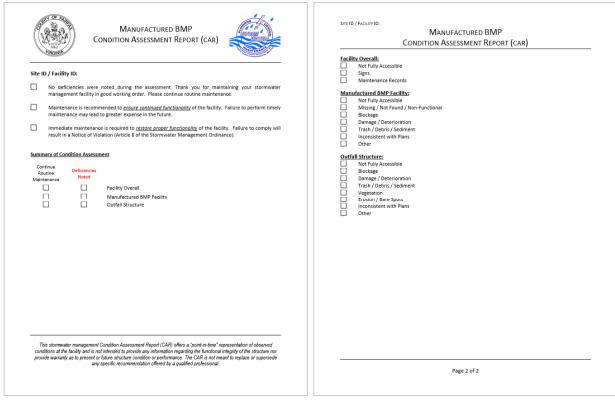
Figure 3-Example Condition Assessment Report.

All maintenance items noted on the inspection form should be either included in the CAR or noted as "minor" problems in the photo captions. For example, if some sediment was noted but it was not judged by the inspectors to require cleaning, they may choose to include it in the photo caption: "Minor sediment build-up was noted on some portions of the pond floor."

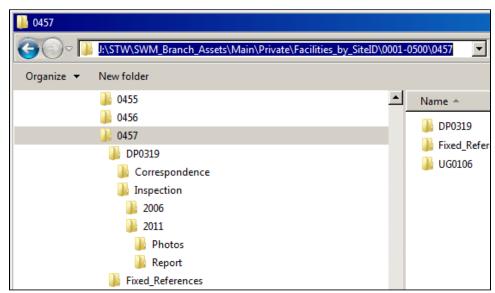
Figure 5-Where to save the inspection files, for example for the 2011 inspection of S0457 / DP0319.

At the time of package submittal, the electronic inspection files for the privately maintained facilities must be filed by site ID and facility ID, in the facility's Inspection folder, by inspection year. For each inspection year, a "Photos" and "Report" folder should be created. The "Photos" folder will store all the photos (JPG files) and the photo log while the "Report" folder will house all other documents and files related to that year's inspection, including the owner's response (MAR) to it. Figure 5 and Table 6 below provide more information on electronic file organization and naming.

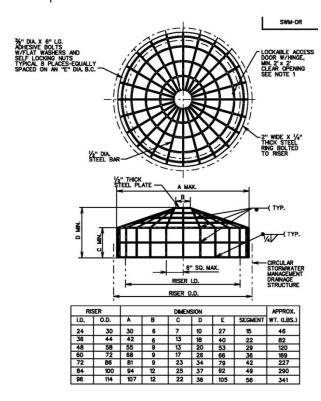
Example: A standard 4' circular riser structure is missing its top trash rack. Based upon the design, an anti-vortex device is required. The plan lacks specific design details and only calls out for a "standard trash rack". Since the plans do not specify the trash rack design and there is no trash rack installed in the field to measure, assumptions will be made based upon the VDOT Road & Bridge Standards. The following detail and table is taken from Section 114.07 of the VDOT Road & Bridge Standards:

then may be converted to a total weight to determine the cost on a per pound basis. In the event that the riser structure is also missing the trash rack, the anti-vortex device must be included in addition to the cost of the trash rack. The assumptions made under Subsection 3.6 do not include an anti-vortex device.

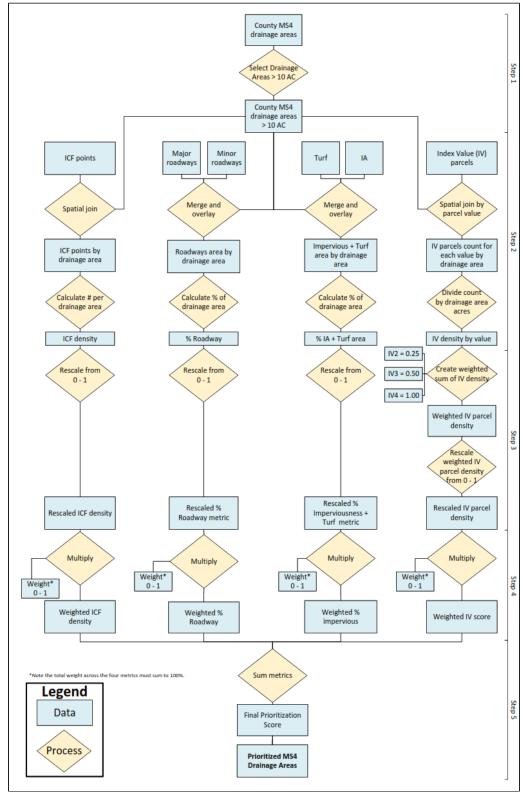
APPENDIX C: Graphical representation of site selection process

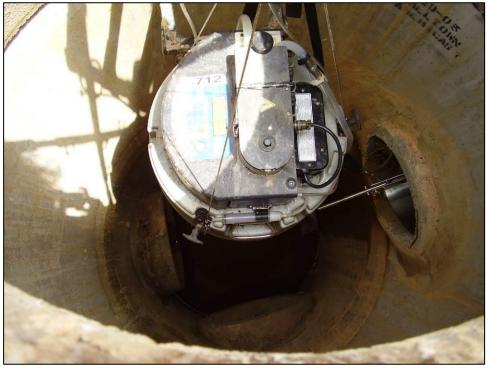
Automated sampler placed in manhole using hanger and spring ring

Should site conditions require, an ISCO Model 6712C compact portable sampler may be used. This sampler is of a size and configuration that will allow it to be inserted and retrieved from a manhole and suspended using a pro-hanger and appropriate harness (for manholes 18 to 24 inches in diameter). Alternatively, the samplers may be secured using rebar loops inserted into the ground and combination bicycle locks to discourage theft.

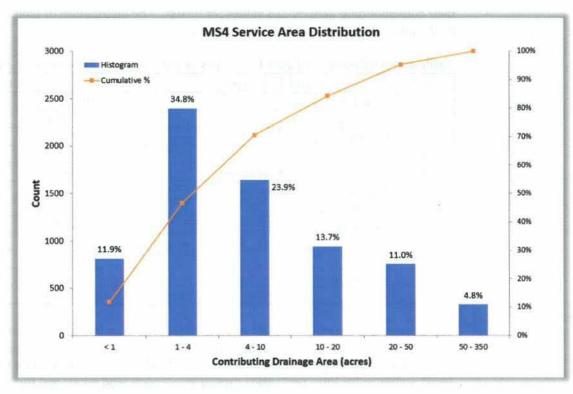
Figure 1. MS4 Service Area Size Distribution

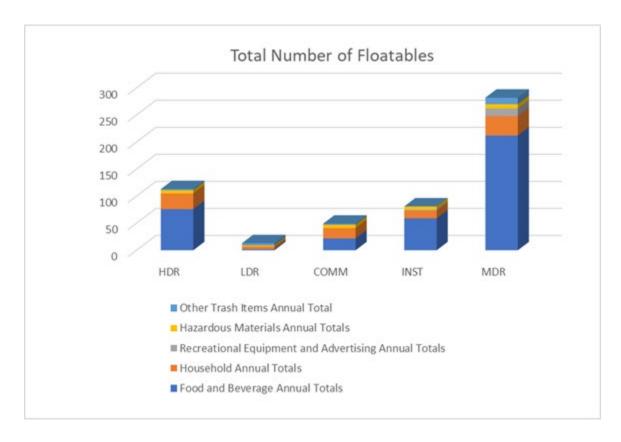
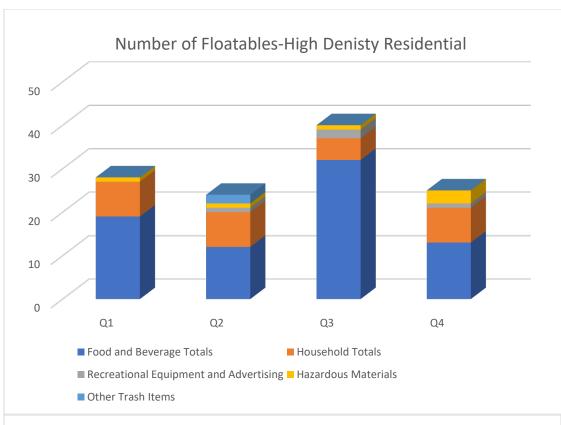
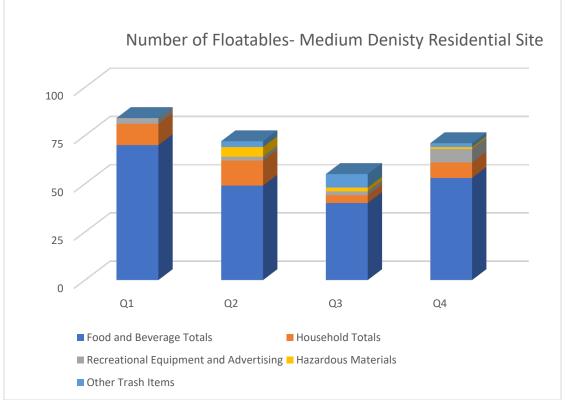
Floatables are consistently found in the highest numbers at the medium density residential site, and in the lowest numbers at the low-density residential site. Food and beverage containers, such as bottles, plastic bags, and wrappers are typically found in highest numbers across all of the sites. Staff have noted that improper disposal of floatables is occurring along the riparian area of some sites and some portion of the floatables does not originate from the MS4 outfall. This is most evident at the MDR and COMM sites.
