DEFICIENCY LETTER

**Re: Lorton CDD Landfill - 10001 Furnace Road, Lorton
Solid Waste Permit (SWP) 331**

Compliance Inspection Report

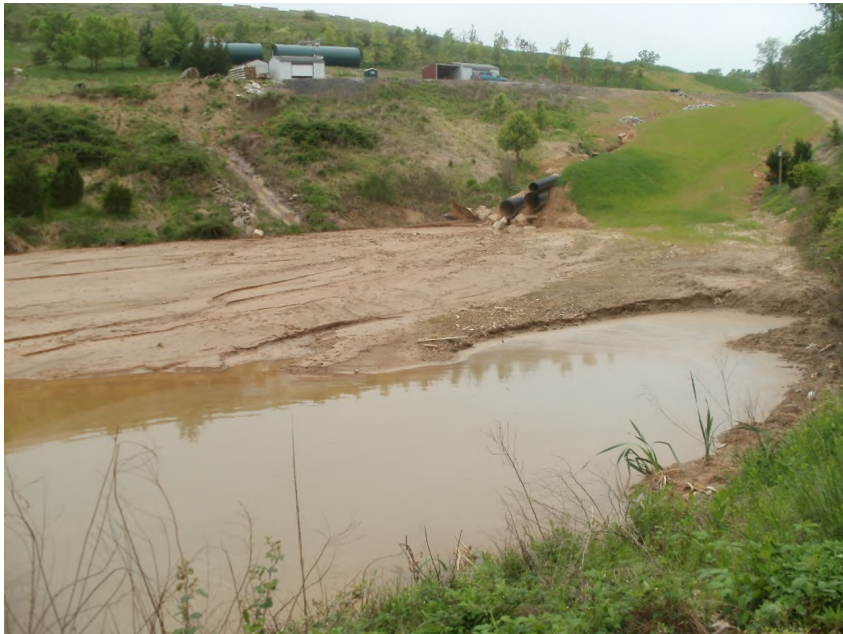
1. *Observations:* Sediment Basin 2 appeared to be full of sediment (Photo 1 and 2).

Reference	Comments
20-81-140.A.7	Stormwater control system maintenance - Sediment Basin 2 appeared to be full of sediment (Photo 1 and 2).

Photo Number: 1
Date: 5/1/2019
Comments: Sediment Basin 2 viewed towards the south.

This issue was discussed with facility representatives during the inspection. Please advise this office in writing within 20 calendar days of receipt of this letter if your facility has taken or intends to take corrective action to address these issues, or if there is other information that DEQ should consider. A schedule should be provided for any intended actions.

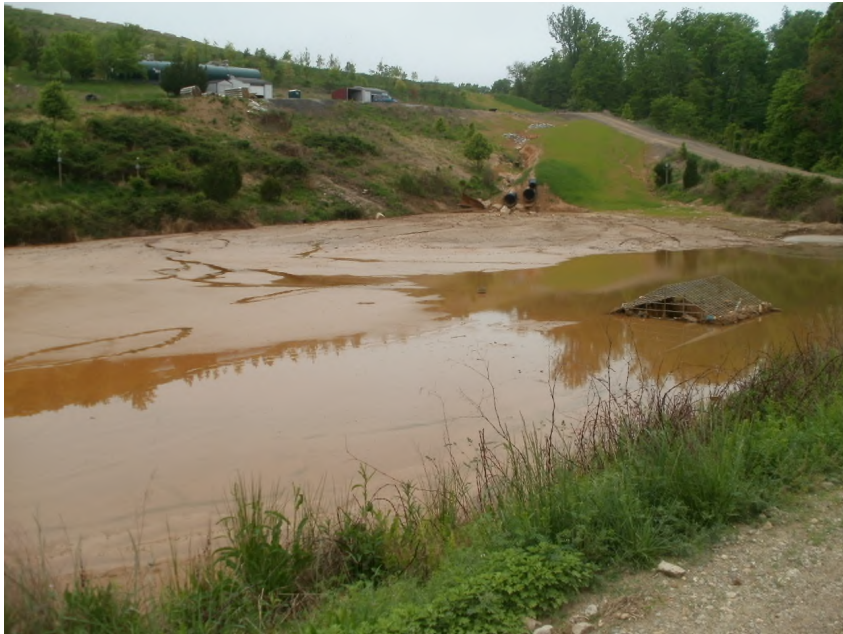
Photo Number: 2
Date: 5/1/2019
Comments: Sediment Basin 2 viewed towards the south.
